Performance Evaluation of the New Orleans and Southeast Louisiana Hurricane Protection System

Draft Final Report of the Interagency Performance Evaluation Task Force

Volume V – The Performance — Levees and Floodwalls

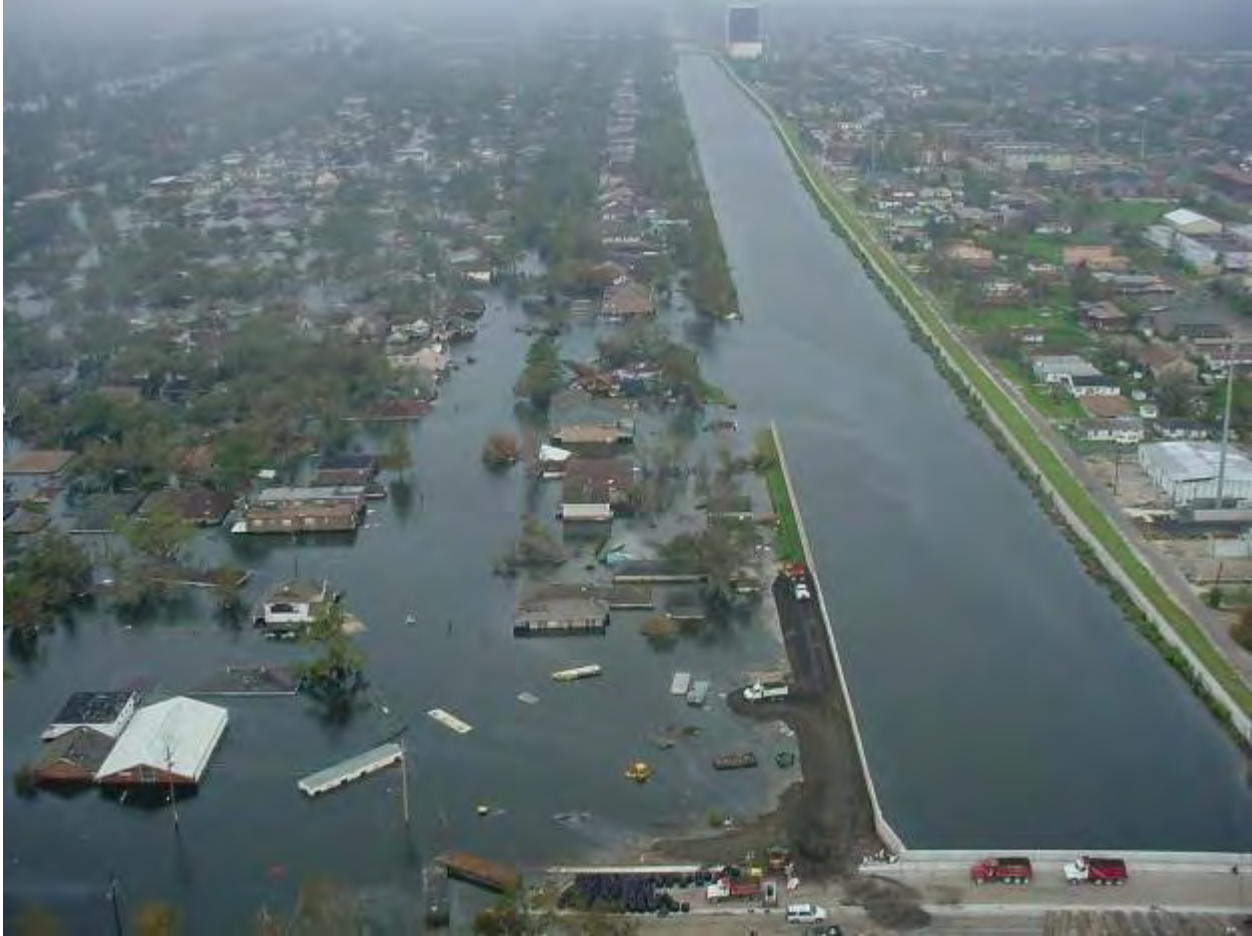
Observations made at the breach at the 17th Street Canal show that the most likely cause of breach is due to a soil foundation failure. Figure 3 shows an aerial photo showing an approximately 450-ft breach in the floodwall along the east side of the 17th Street Outfall Canal south of the old Hammond Road Bridge. Figure 4 shows that a section of levee has moved more than 40 feet inward to the land side. It appears that the remaining levee section making up the breach was washed away by the water flowing through the breach. The top of the I-wall section of the floodwall in the breach can be seen adjacent to the levee section that moved into the land side.

Figure 3. Aerial Photograph of the 17th Street Canal Breach Looking South From the Old Hammond Road Bridge

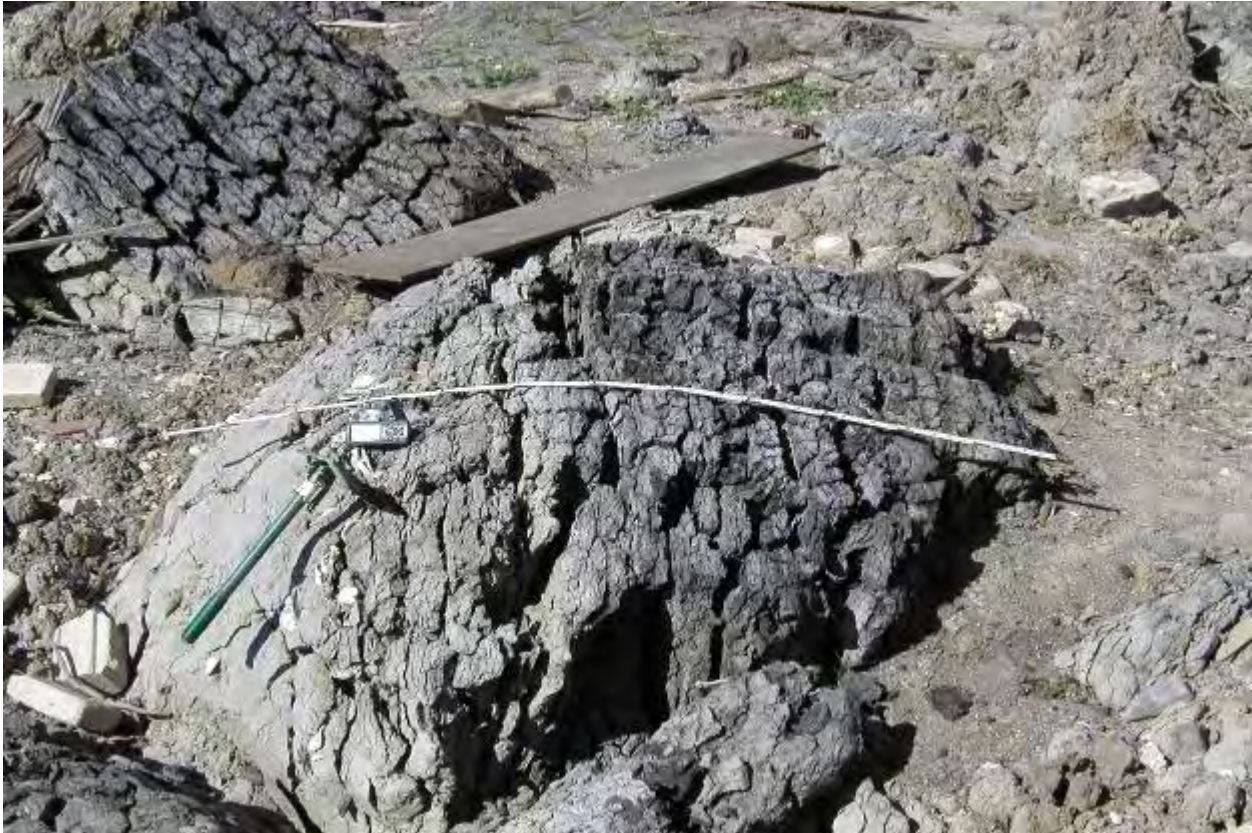
Figure 9. Clay Attached to Marsh Blocks at the 17th Street Canal Breach

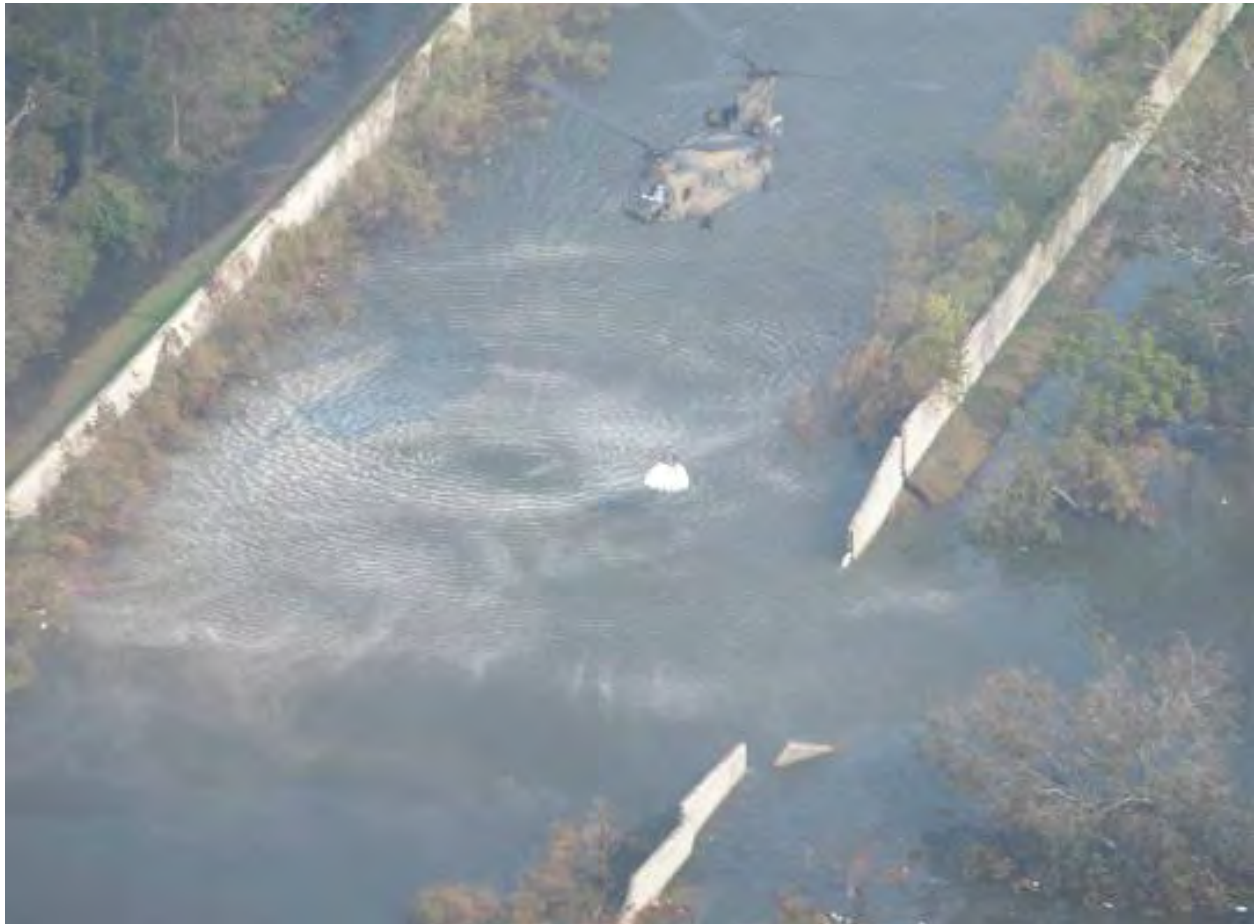
The south breach, shown in Figure 28, occurred about 6:00 AM to 7:00 AM on August 29th, when the water level in the canal was 7.1 ft to 8.2 ft NAVD88. The breach was narrower than the breach at the 17th Street and the London Avenue north breach. A deep scour hole formed due to the inrush of water, and a large amount of eroded sand was deposited in the neighborhood inland of the breach. It appears that the breach was quite narrow when it formed, and subsequently widened to about 60 ft as wall panels adjacent to the initial breach were undermined by scour, and tilted into the scour hole.

Figure 28. South Breach, London Avenue Canal

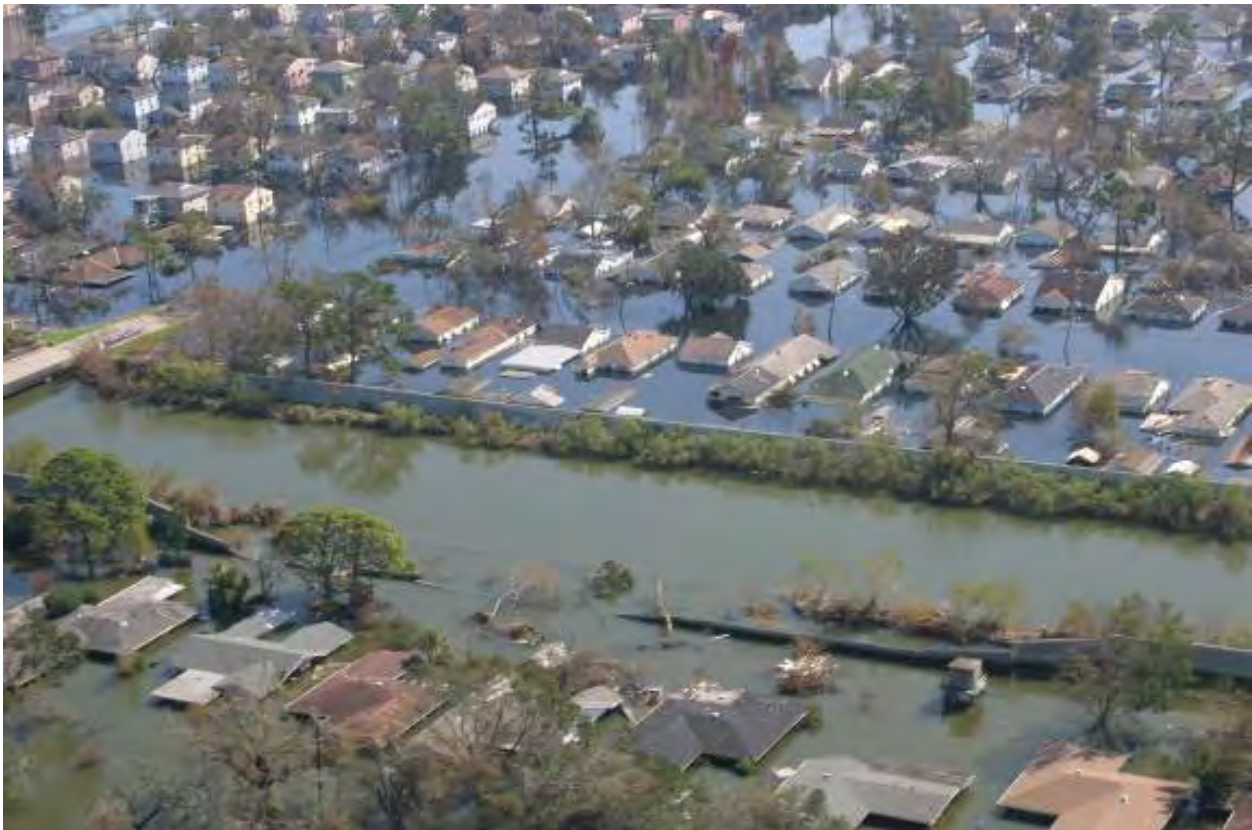
The north breach, shown in Figure 29, occurred about 7:00 AM to 8:00 AM on August 29th, about an hour after the south breach, when the canal water level was 8.2 ft to 9.5 ft NAVD88. The breach was about 410 ft wide, approximately the same width as the breach at 17th Street. As the breach occurred, the ground surface on the protected side of the levee heaved upward, taking with it the playhouse shown in Figure 30. The upward movement of the playhouse can be discerned by comparing the before and after photos in Figure 30. The I-wall opposite the north breach (on the east side of the canal) moved and tilted significantly, presumably at about the same time as the breach occurred on the west side, but the east I-wall did not breach; this tilted but intact I-wall is shown in Figure 31. A line of sinkholes was observed at the inland side of the distressed east I-wall, and a sand boil at the inboard embankment toe indicates that erosive seepage and piping had occurred beneath the levee.

Figure 29. North Breach, London Avenue Canal

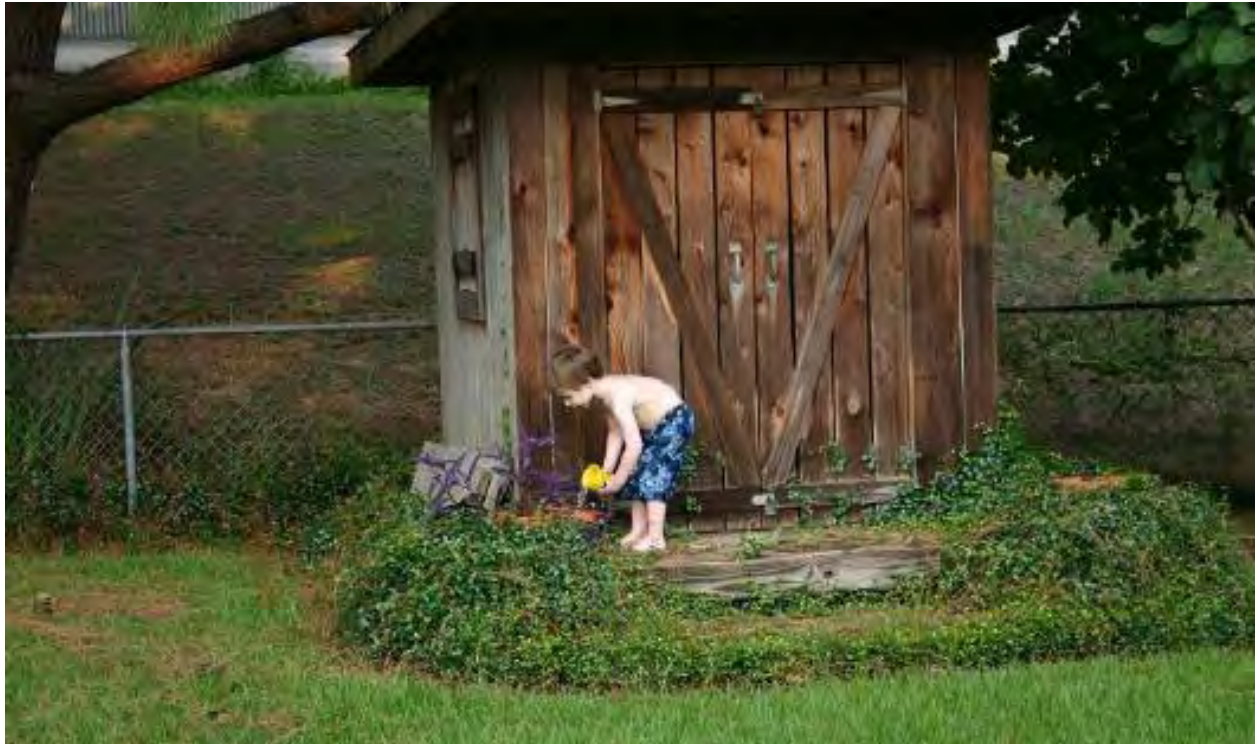
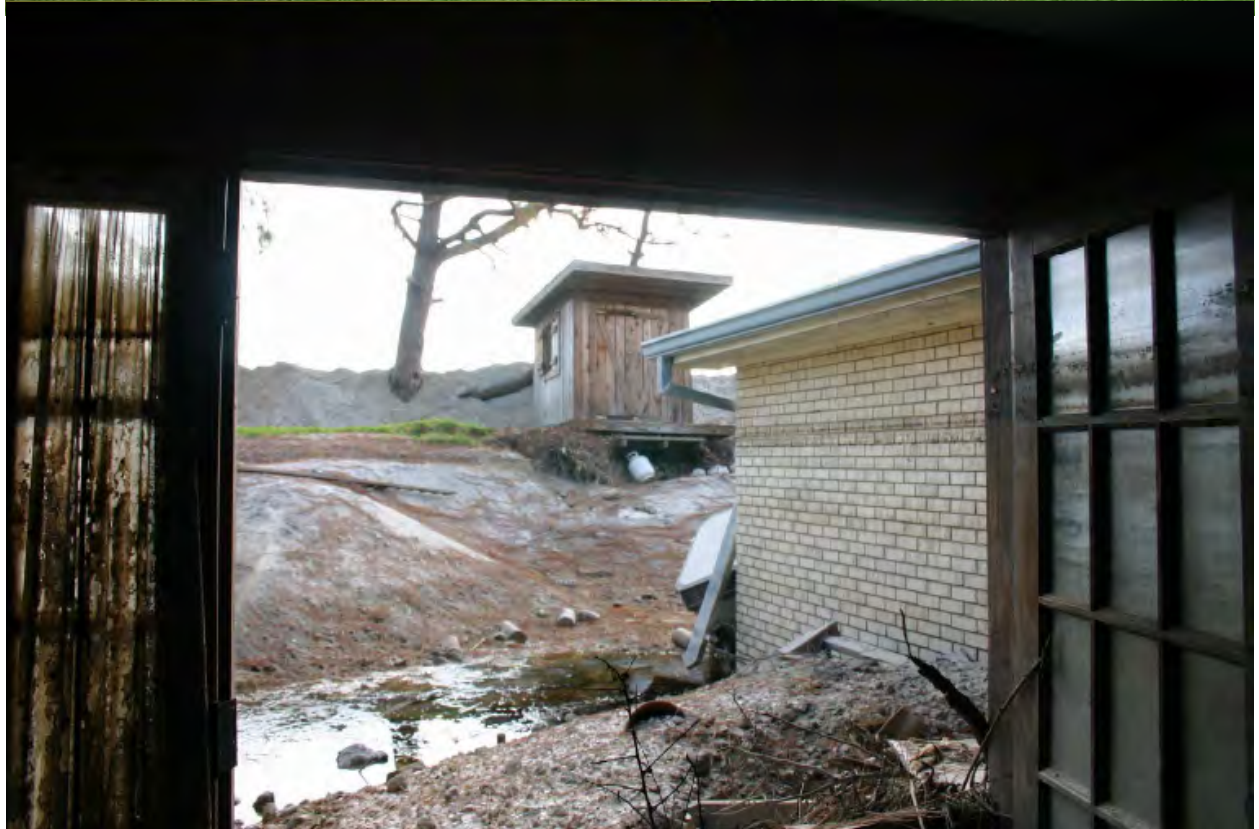
Figure 30. Playhouse at the London Avenue Canal North Breach Before the Failure (top photo) and After (bottom photo)

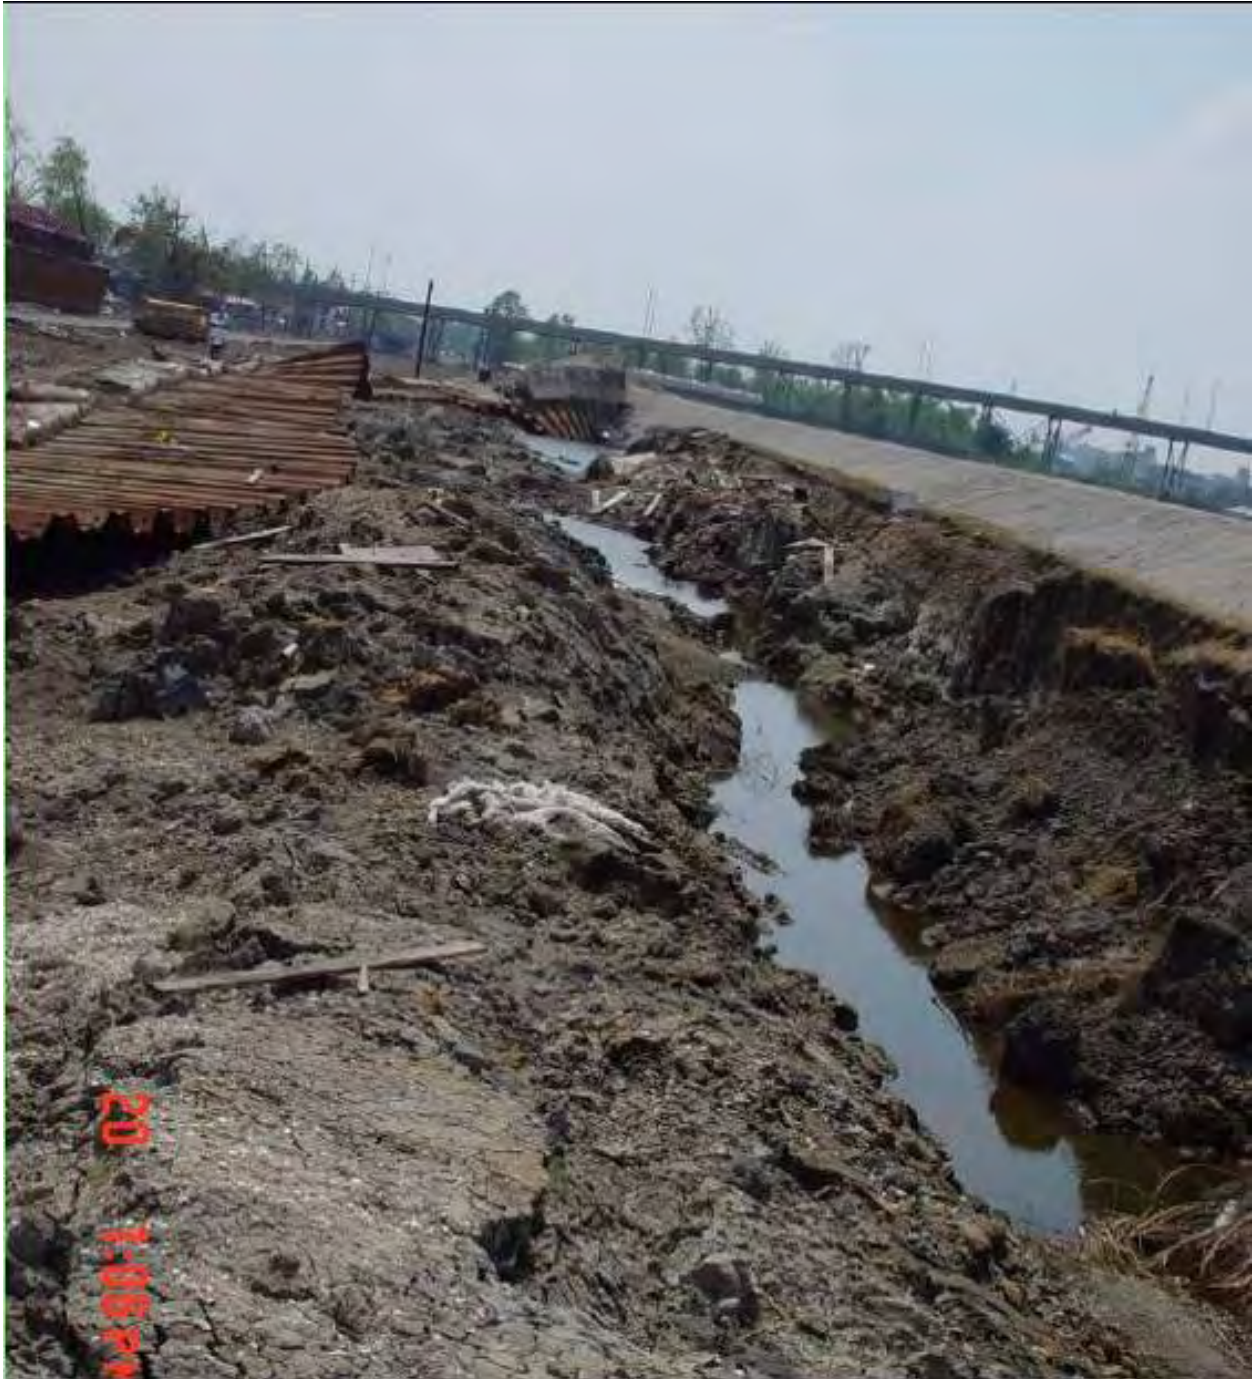
Figure 46. Scour and Erosion Leading to the Failure of the I-Wall on the IHNC Adjacent the South Breach (9th Ward)

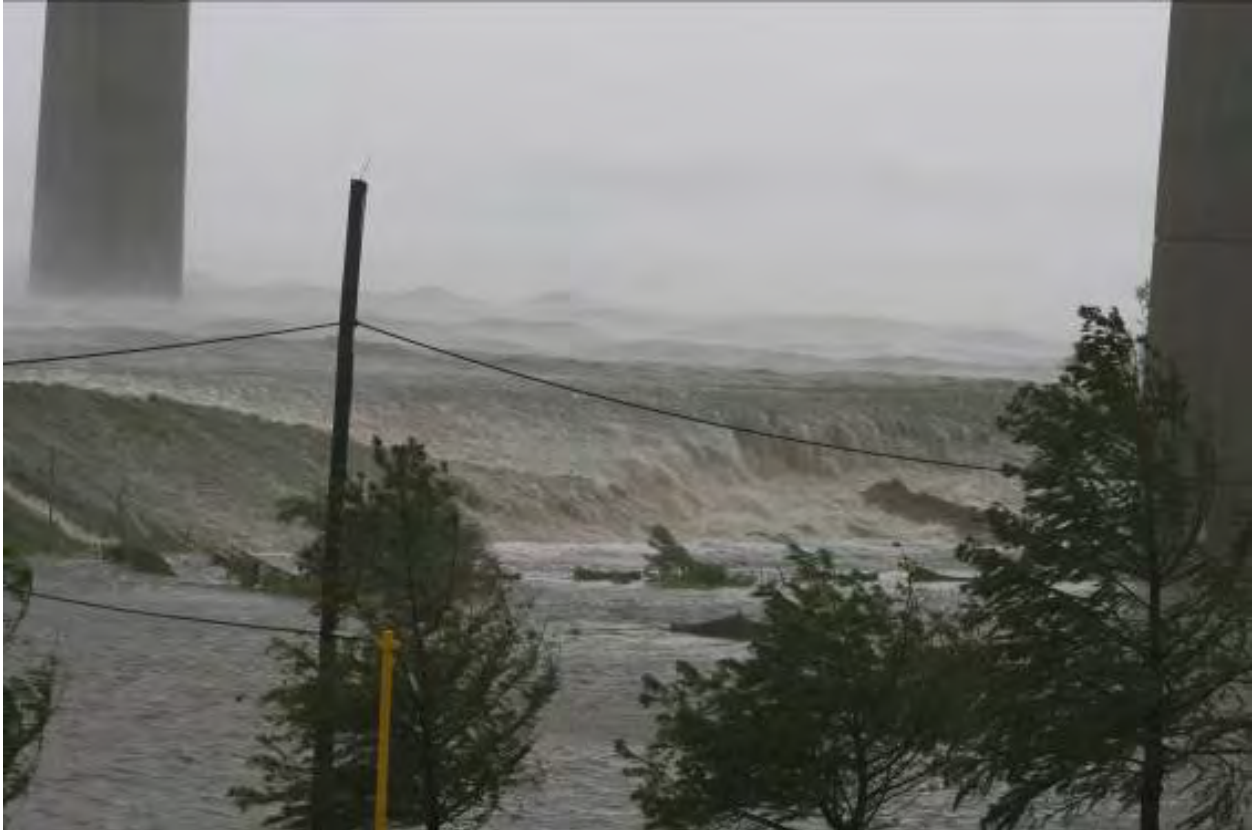
Figure 62. Overtopping of the Levee Under the Paris Road Bridge Adjacent to the Entergy Power Plant in the New Orleans East During Hurricane Katrina
