THE BATON ROUGE
AND
DENHAM SPRINGS-SCOTLANDVILLE
FAULTS

(Mapping and Damage Assessment)

Louisiana Geological Survey

June 1, 1981

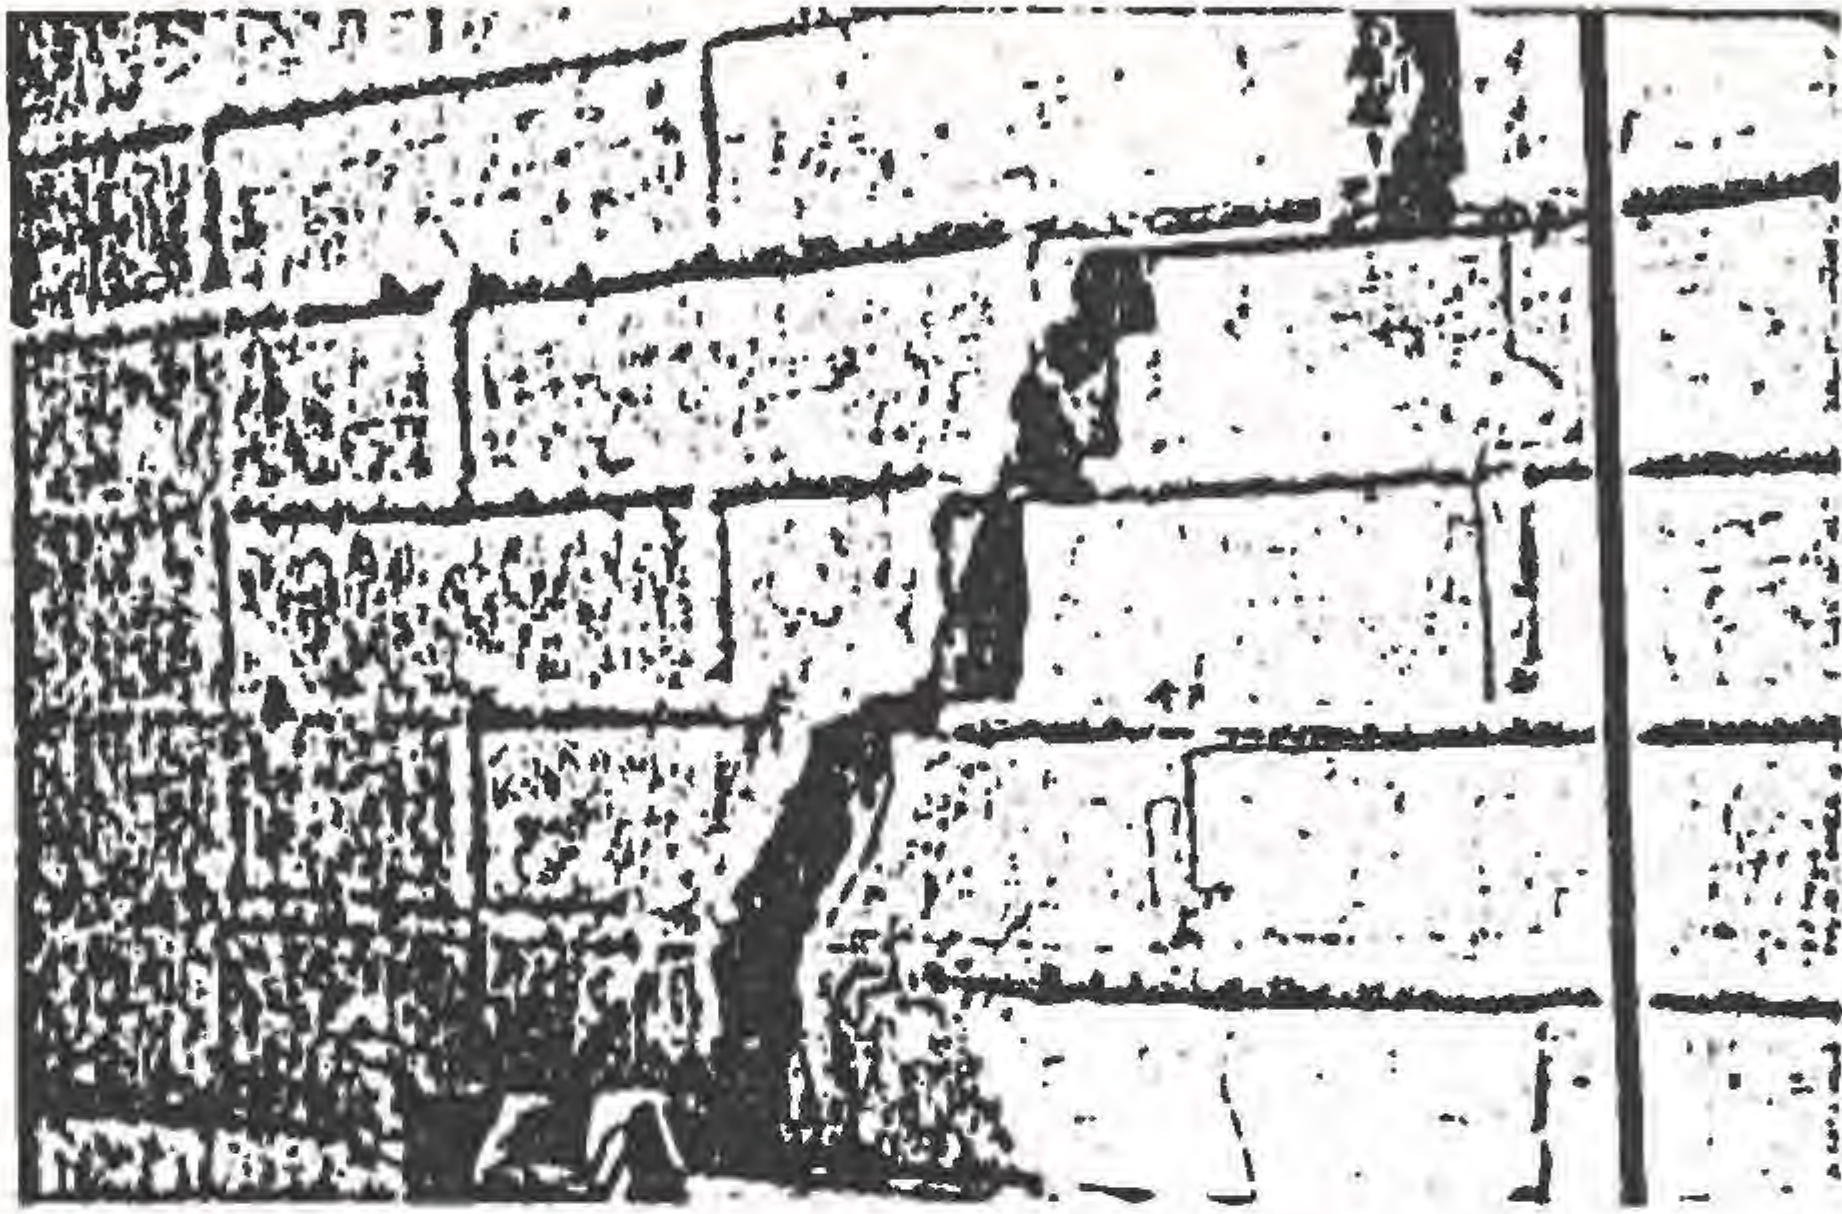
Figure 1

BLOCK SHEAR-2236 Cottonwood
This damage appears to be caused by tree growth.

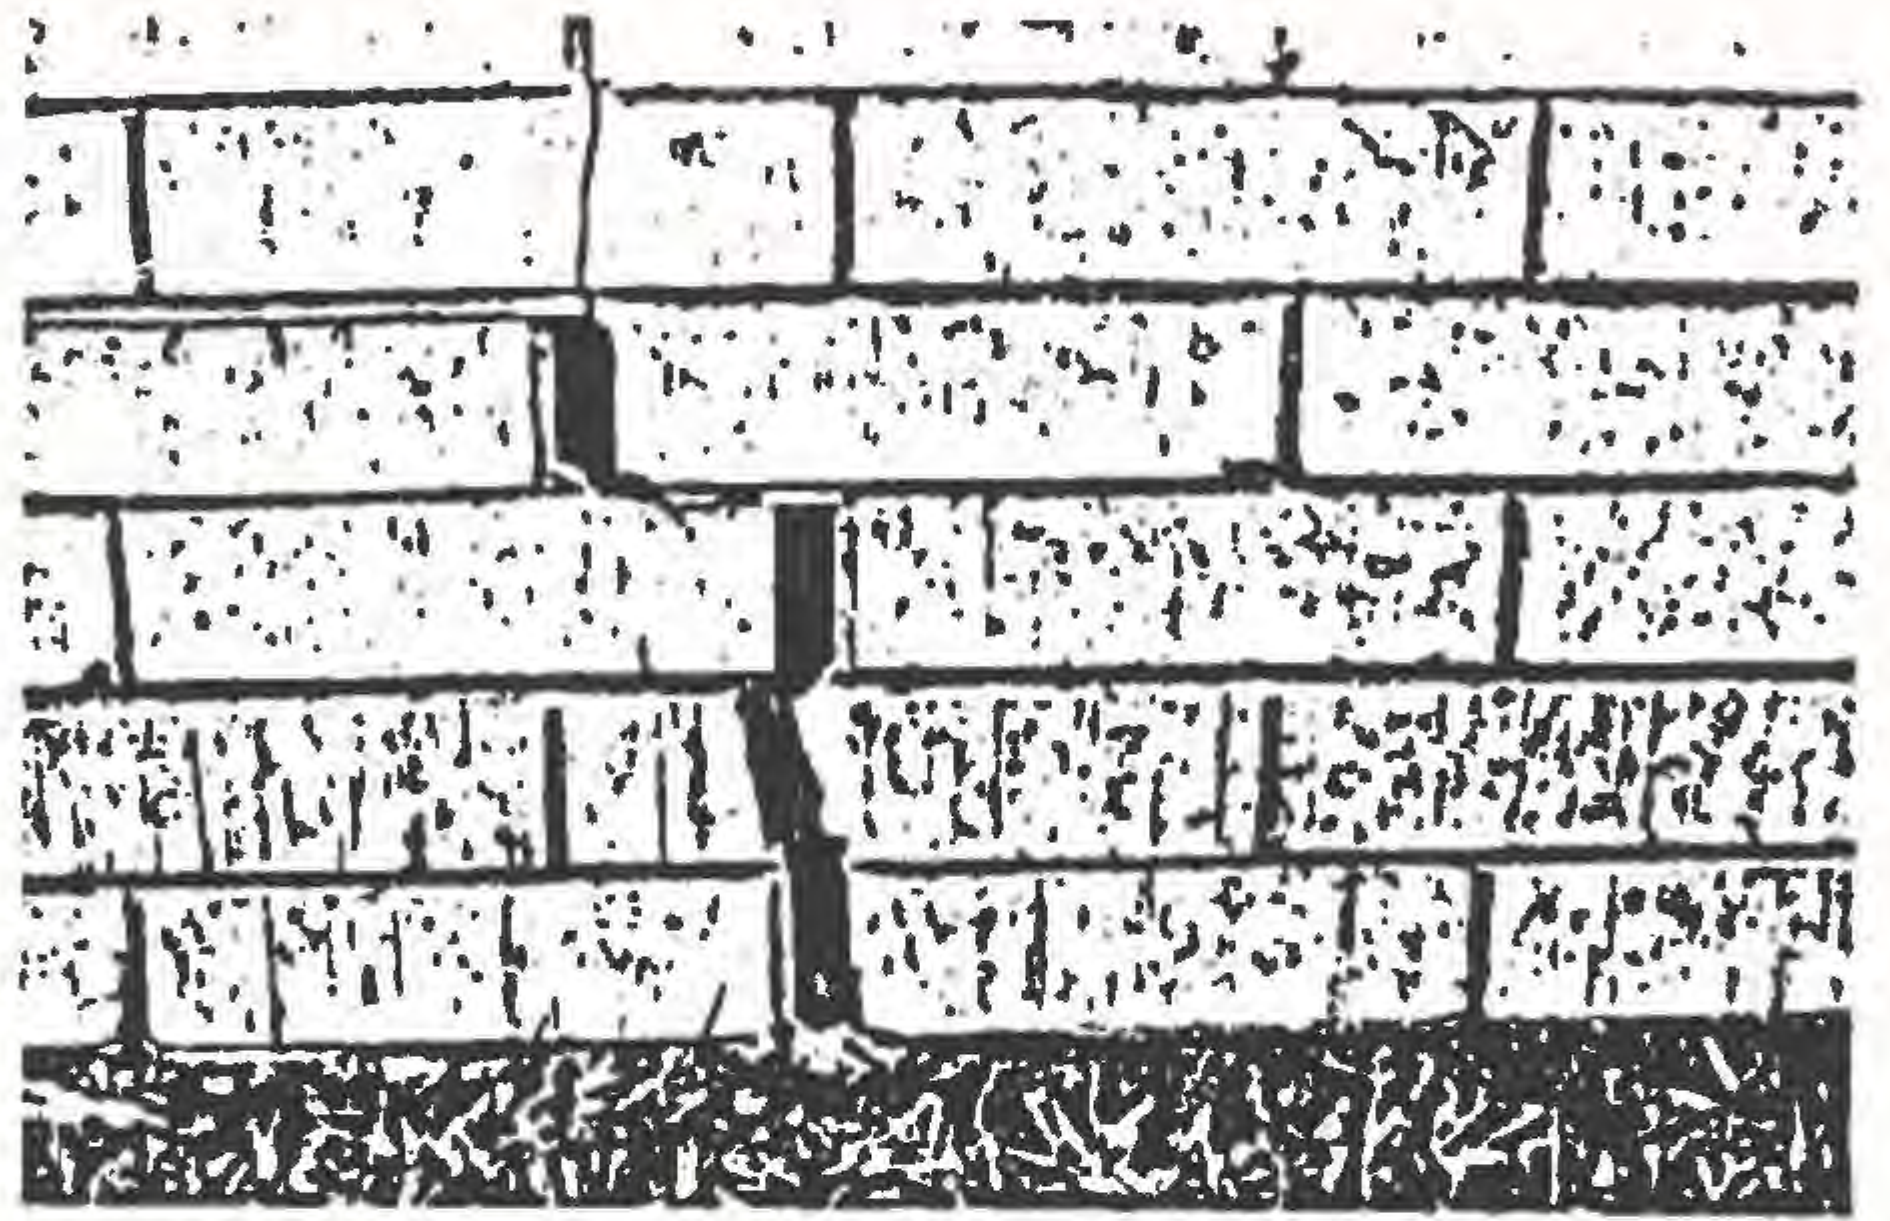
Figure 2

BLOCK SHEAR - 8727 Jefferson Hwy
(not fault associated)

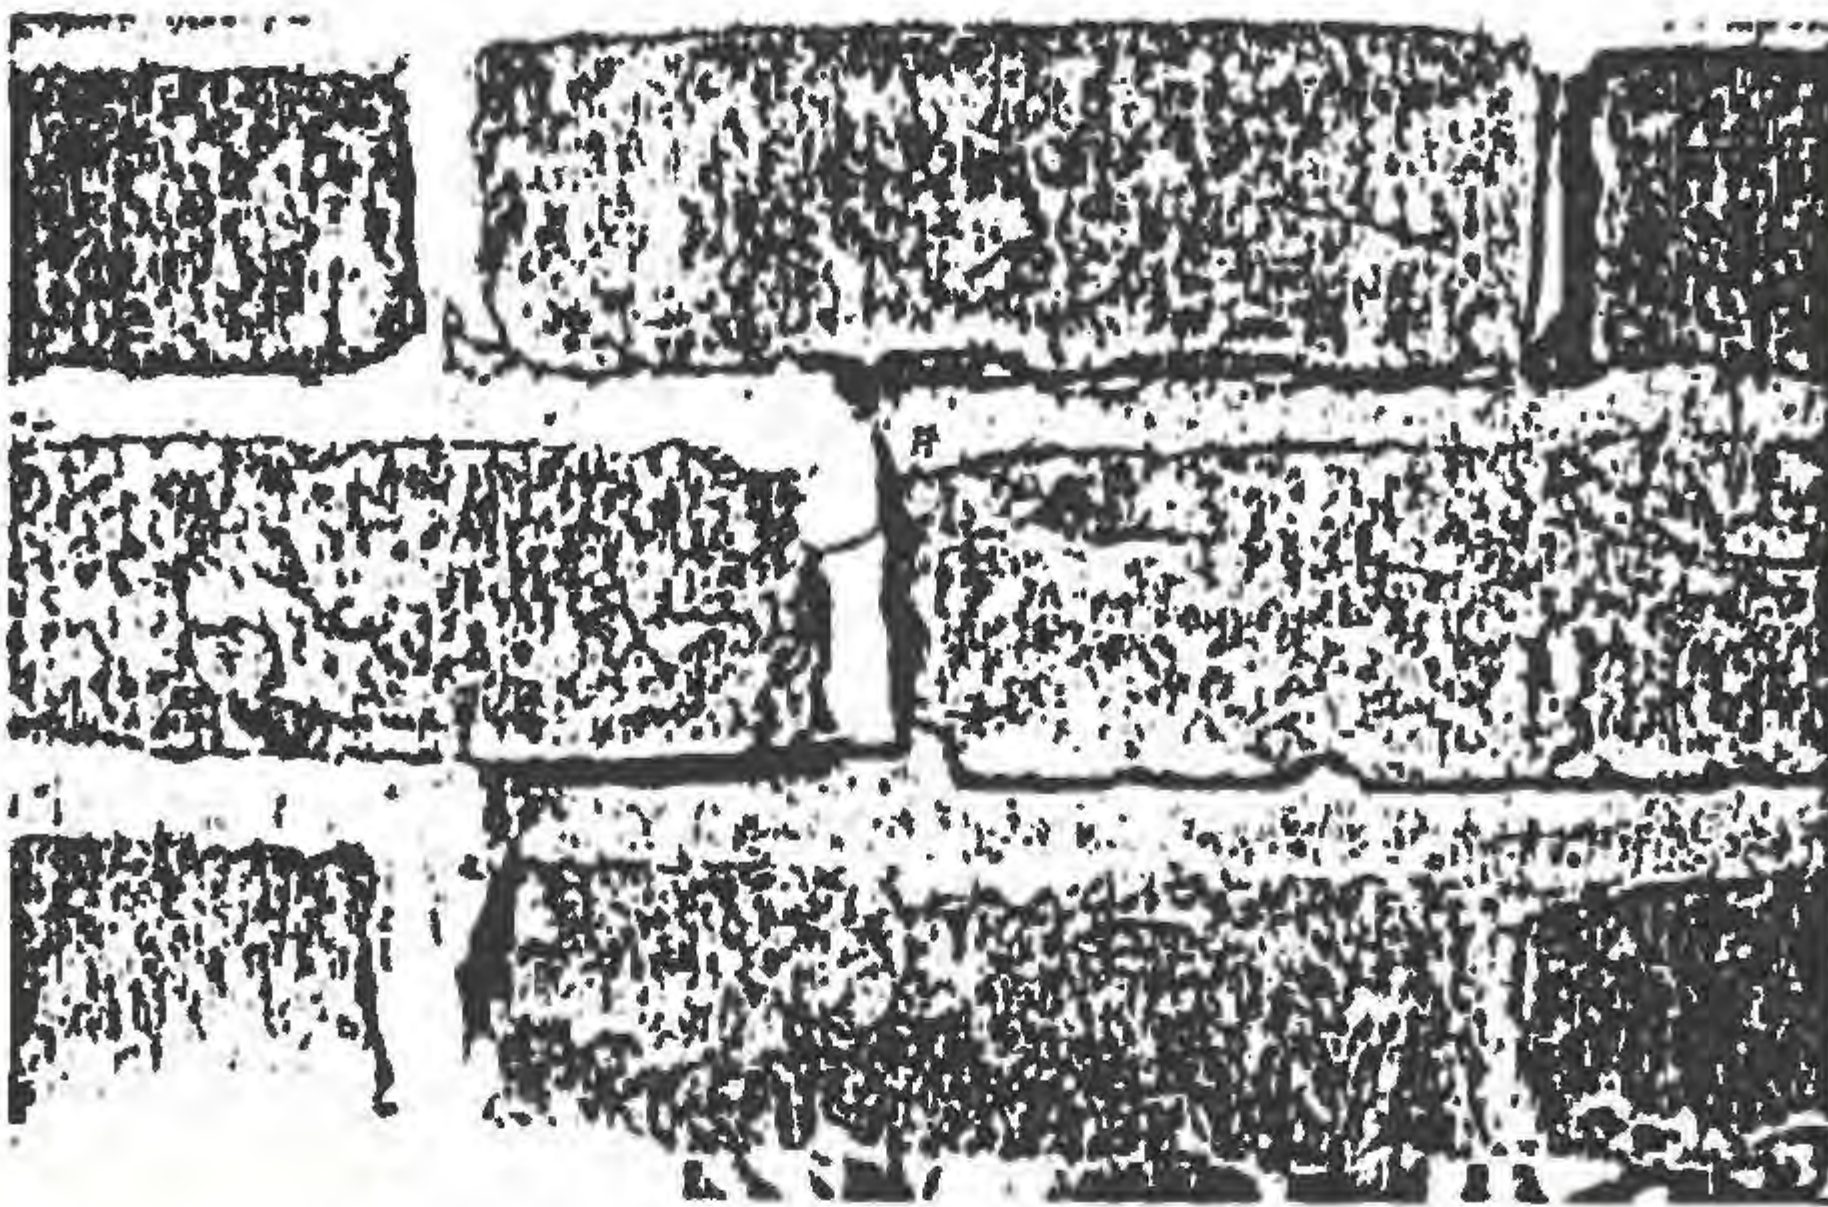
Figure 3

JOINING PLANE SEPARATION-2051
E. Ramsey (not fault associated)

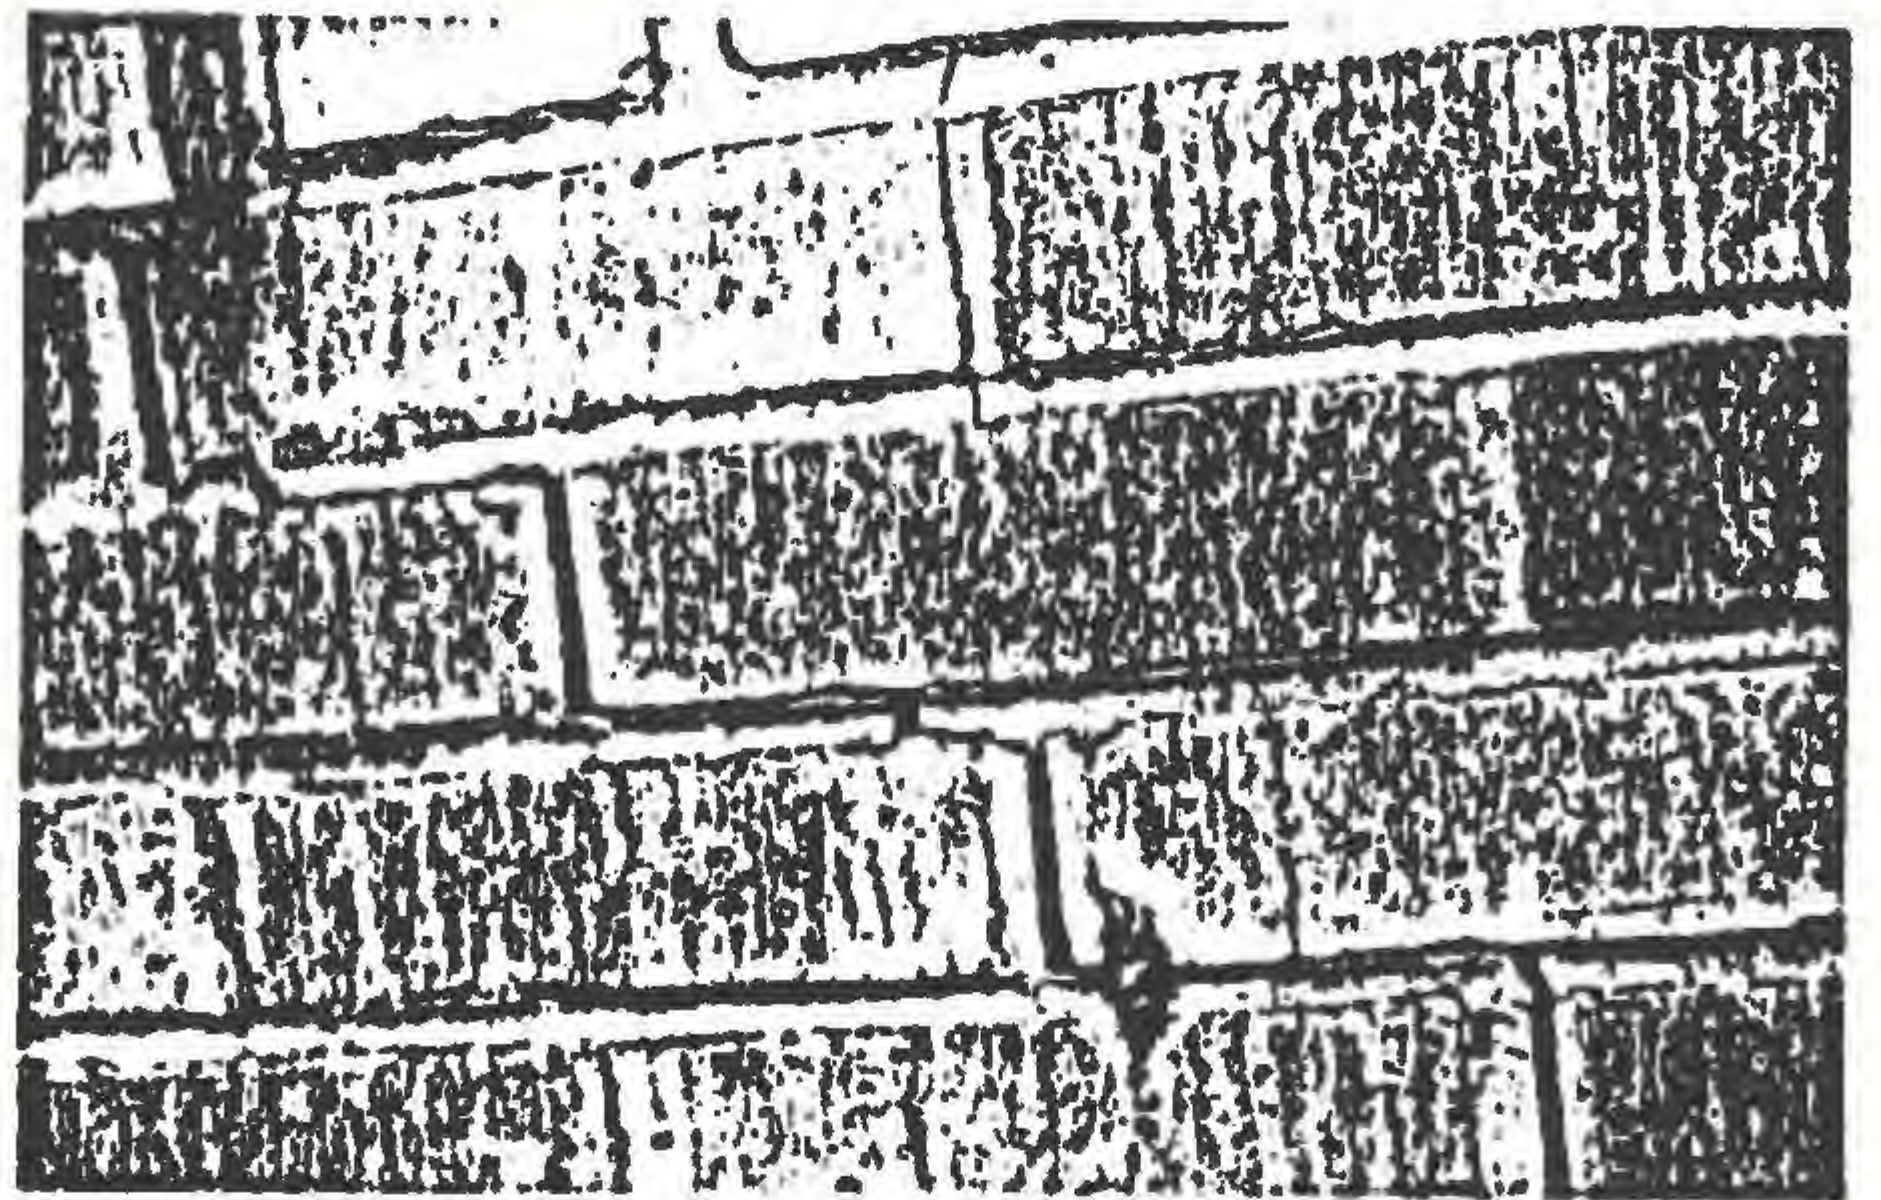
Figure 4

JOINING PLANE SEPARATION - 2460
Dogwood (Fault associated)

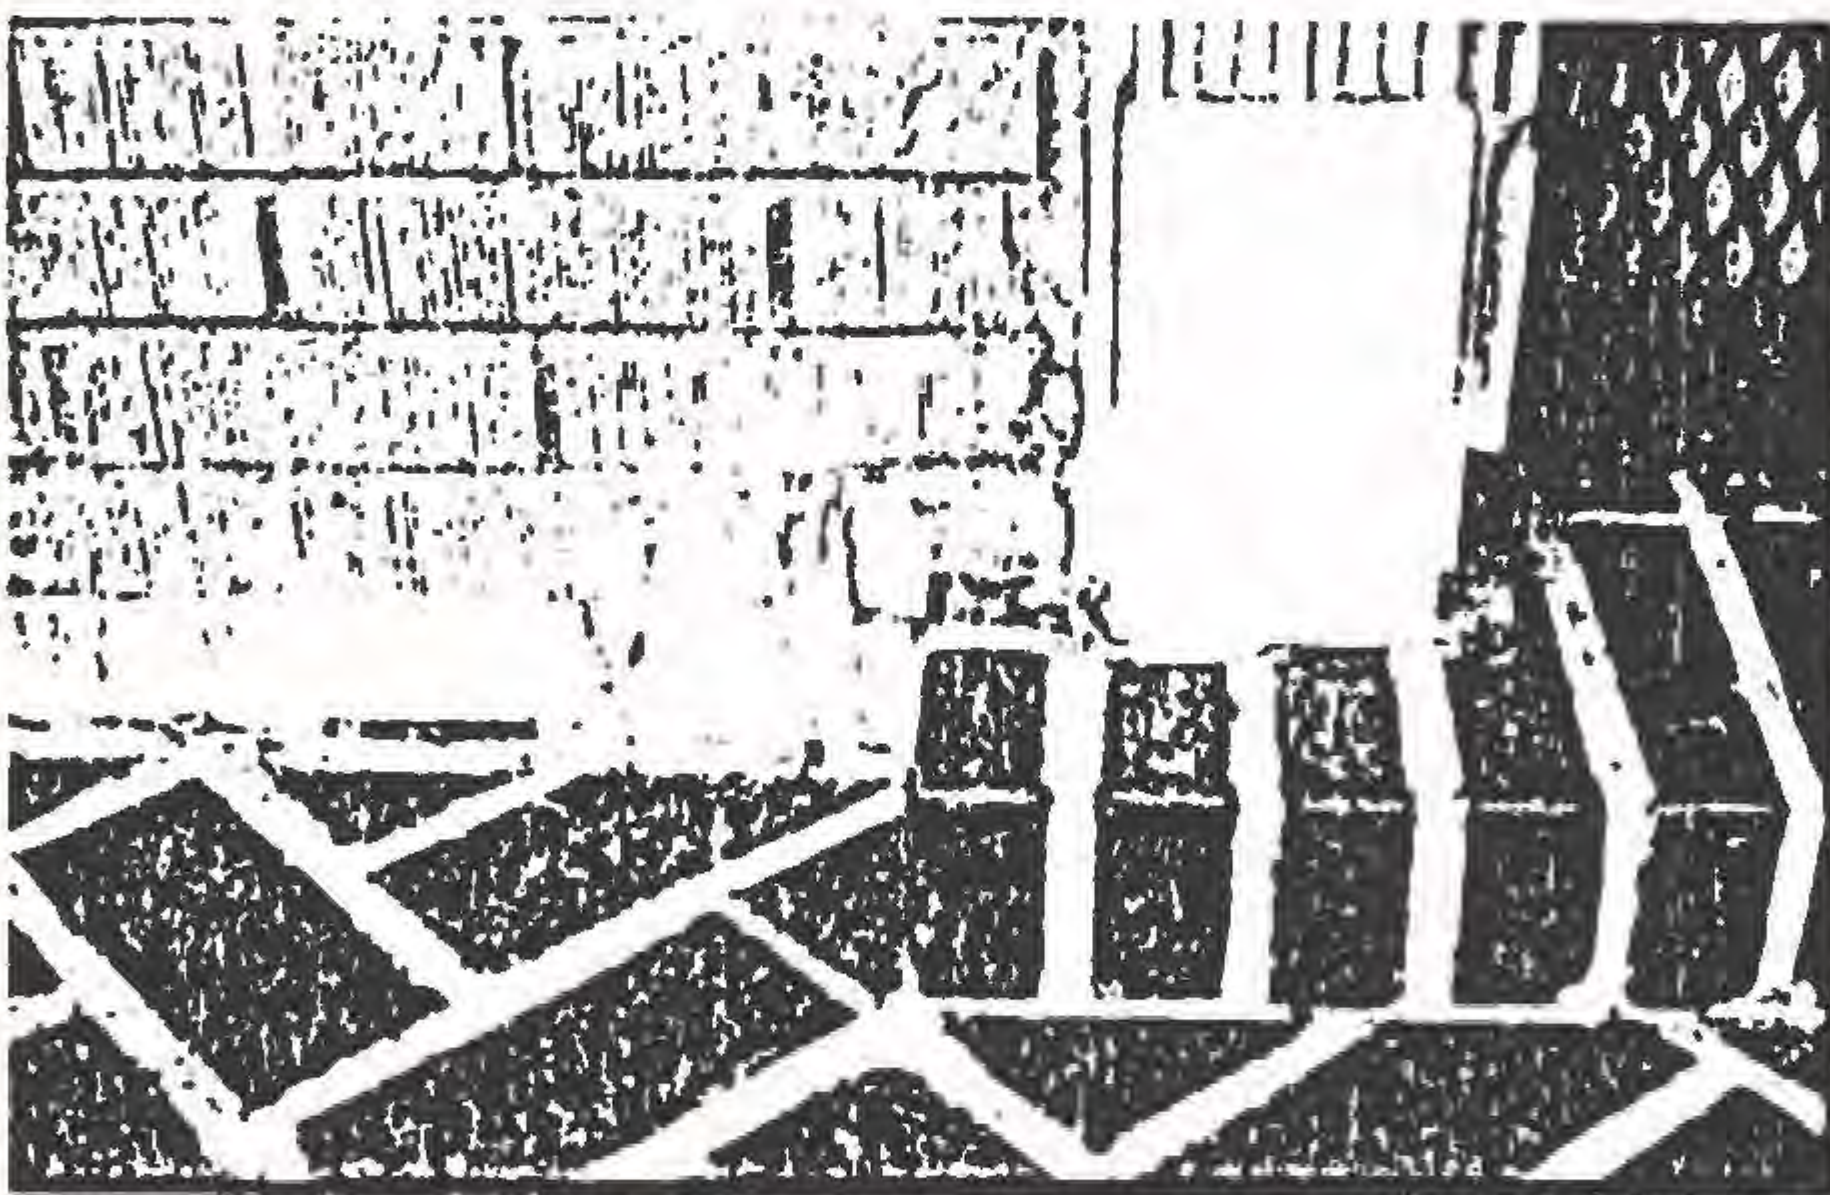
Figure 5

The second general form of damage was "appurtenant separation." This term is used to describe the damage which occurs when "Add-on" structures such as carports, added rooms, porches, steps, etc., break away from the main building. The causes for appurtenant separation are highly dependent on construction methods and techniques. Poorly designed and constructed attachments will show separation with a minimum application of stress forces. Figures 5 and 6 provide examples of appurtenant separation.

APPURTENANT SEPARATION - 2015
Lake hills (not fault associated)

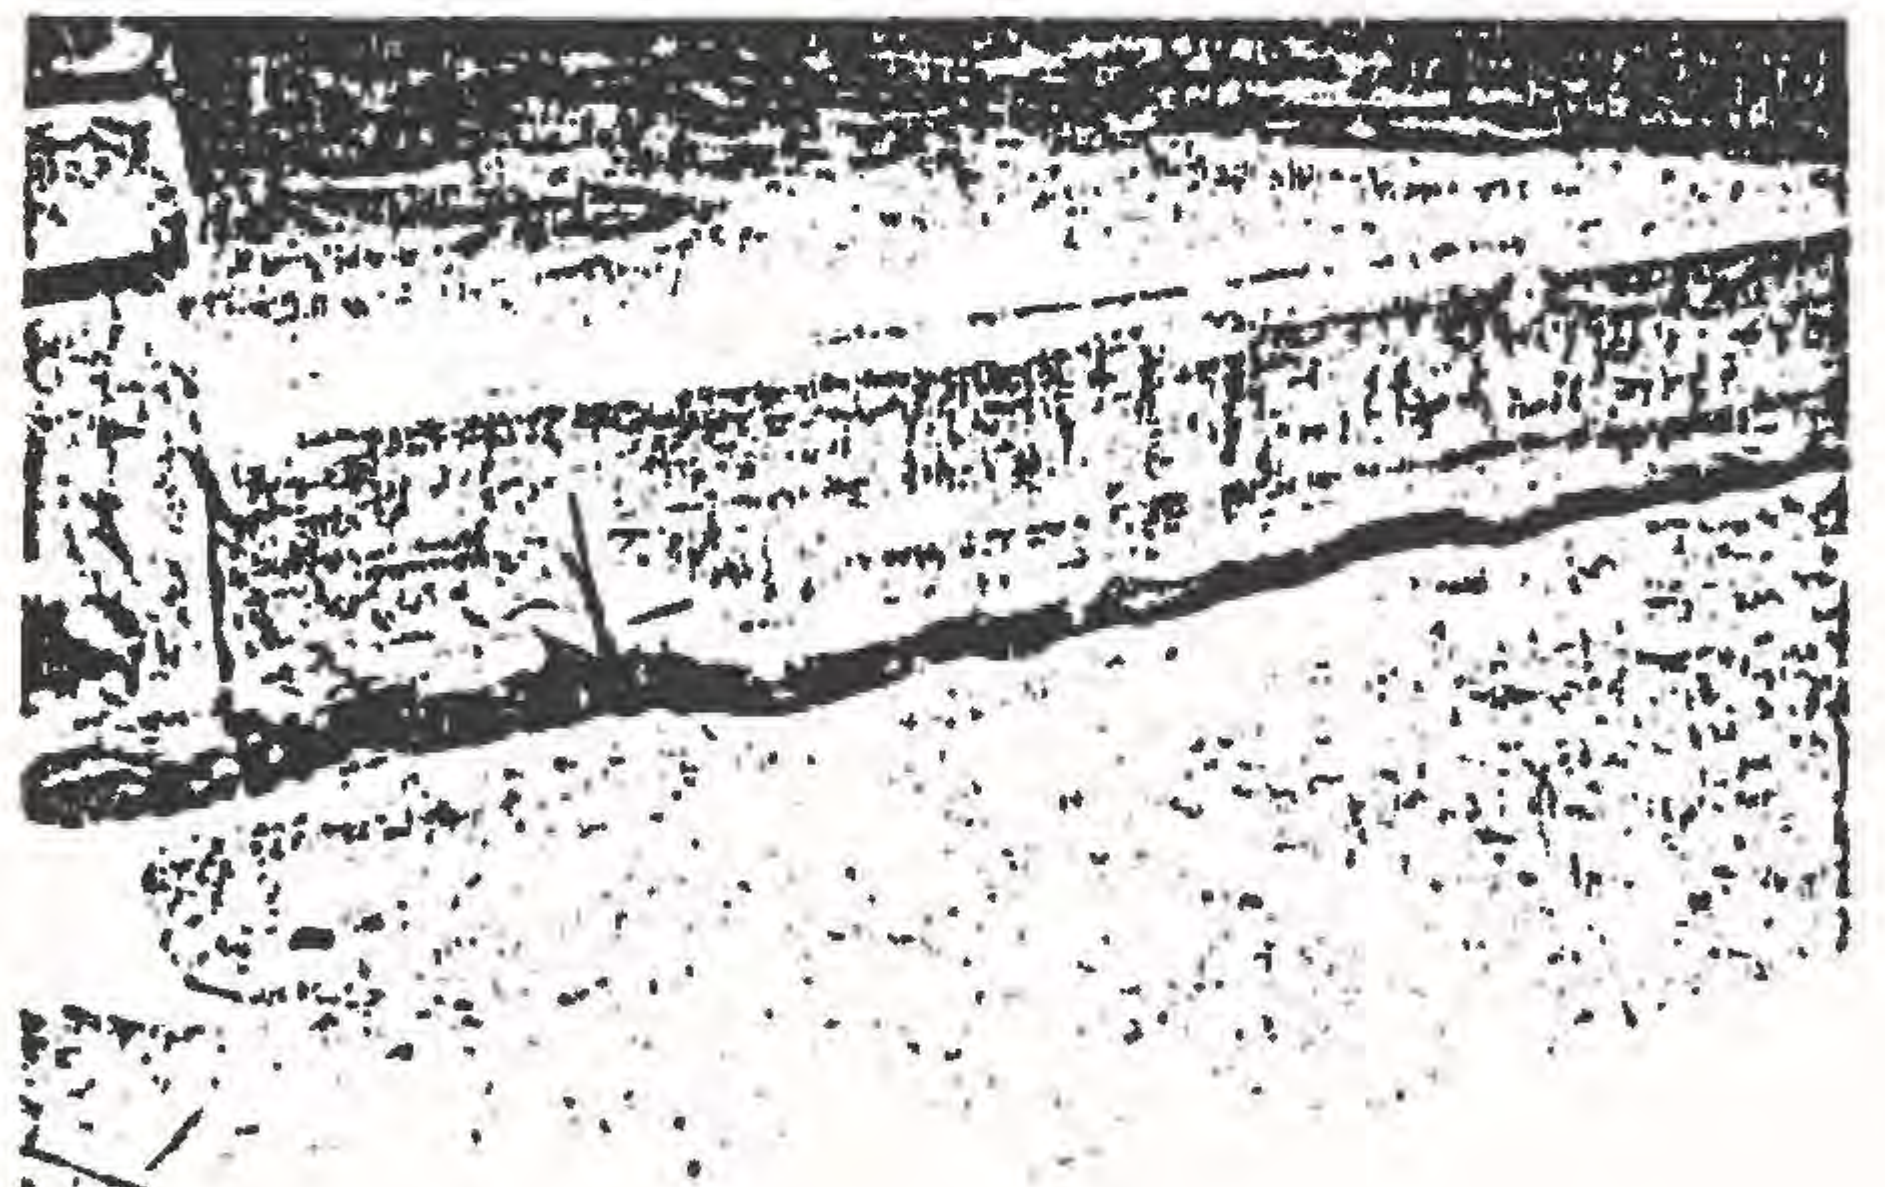
Figure 6

APPURTENANT SEPARATION - 3134
Fritchie (fault associated)

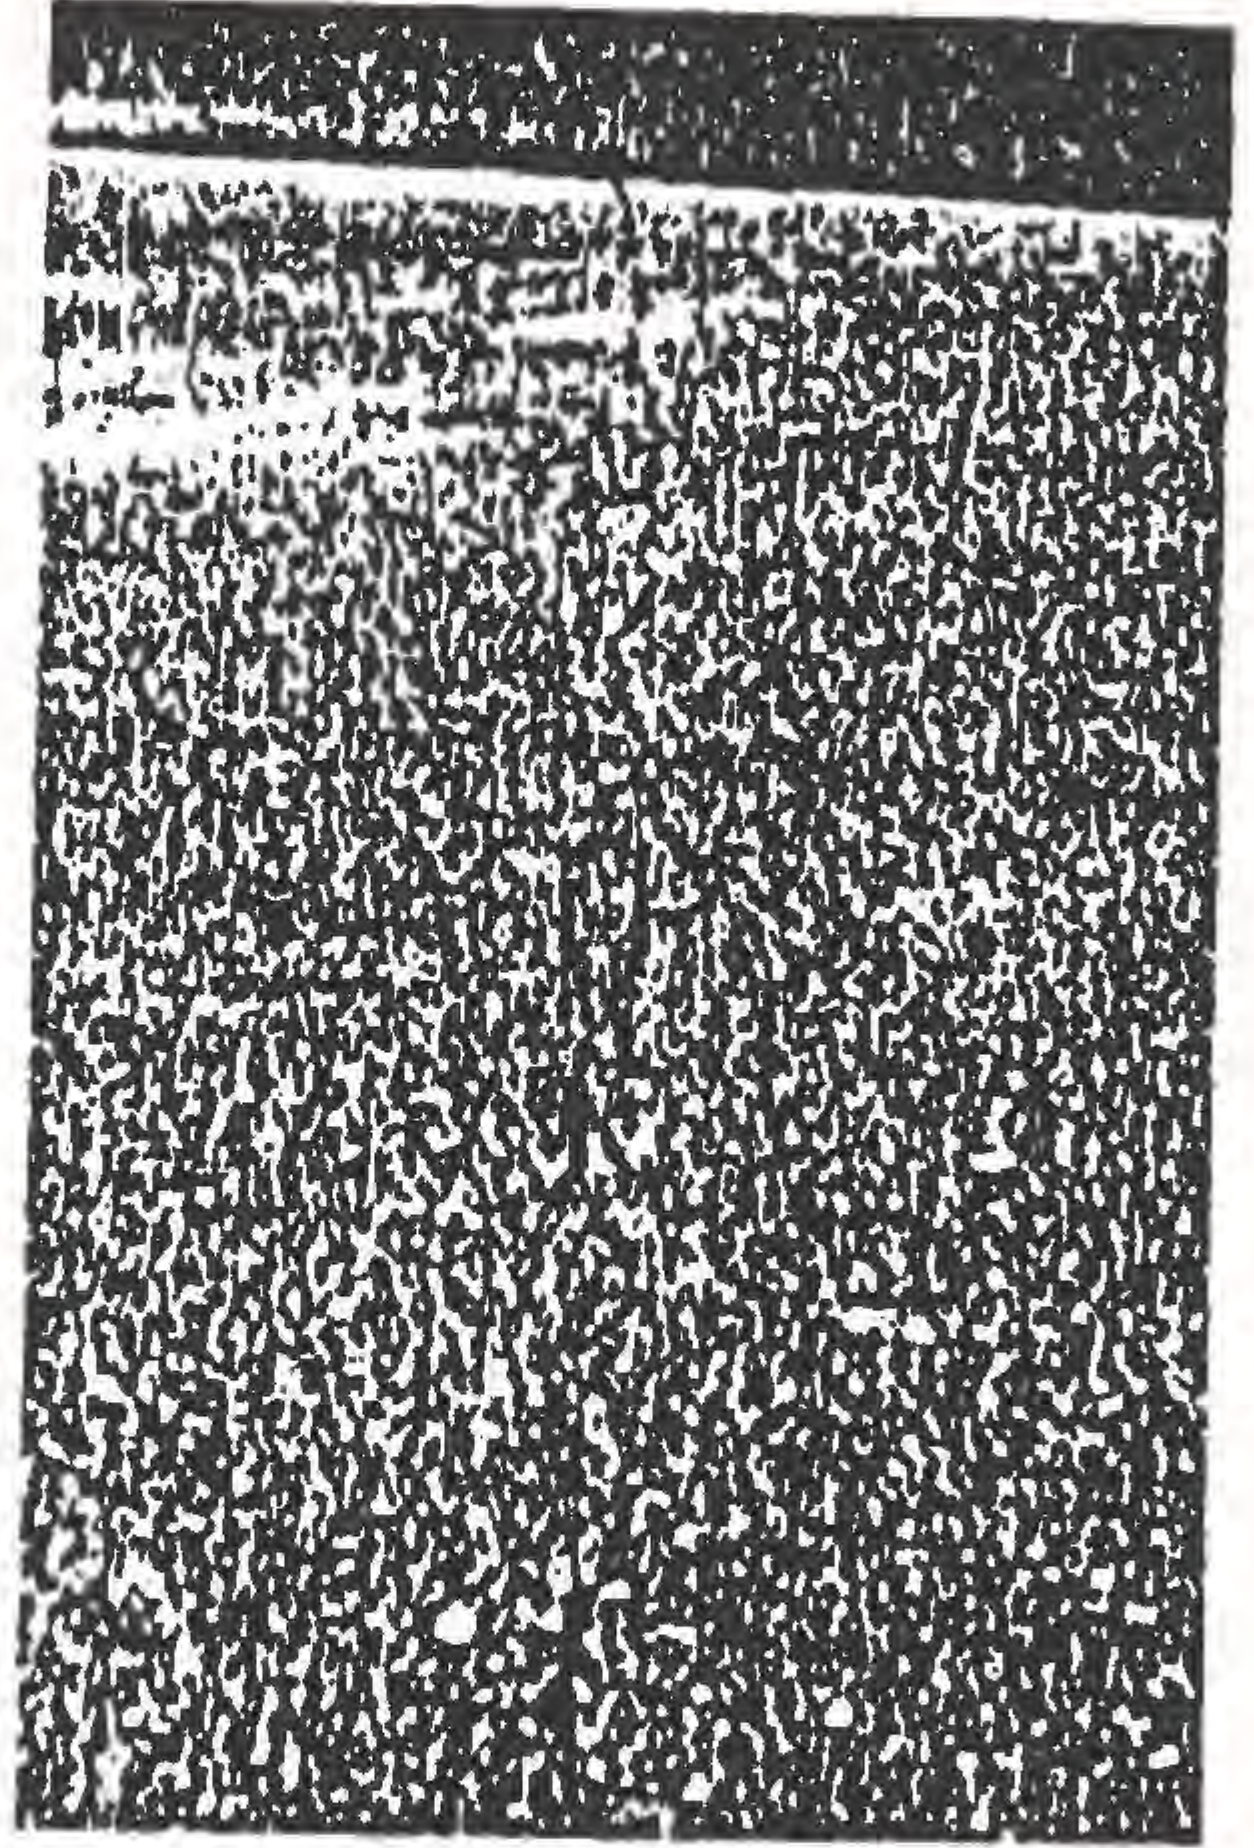
Figure 8

PAVEMENT CRACKS - Beachwood St.
(Fault associated)

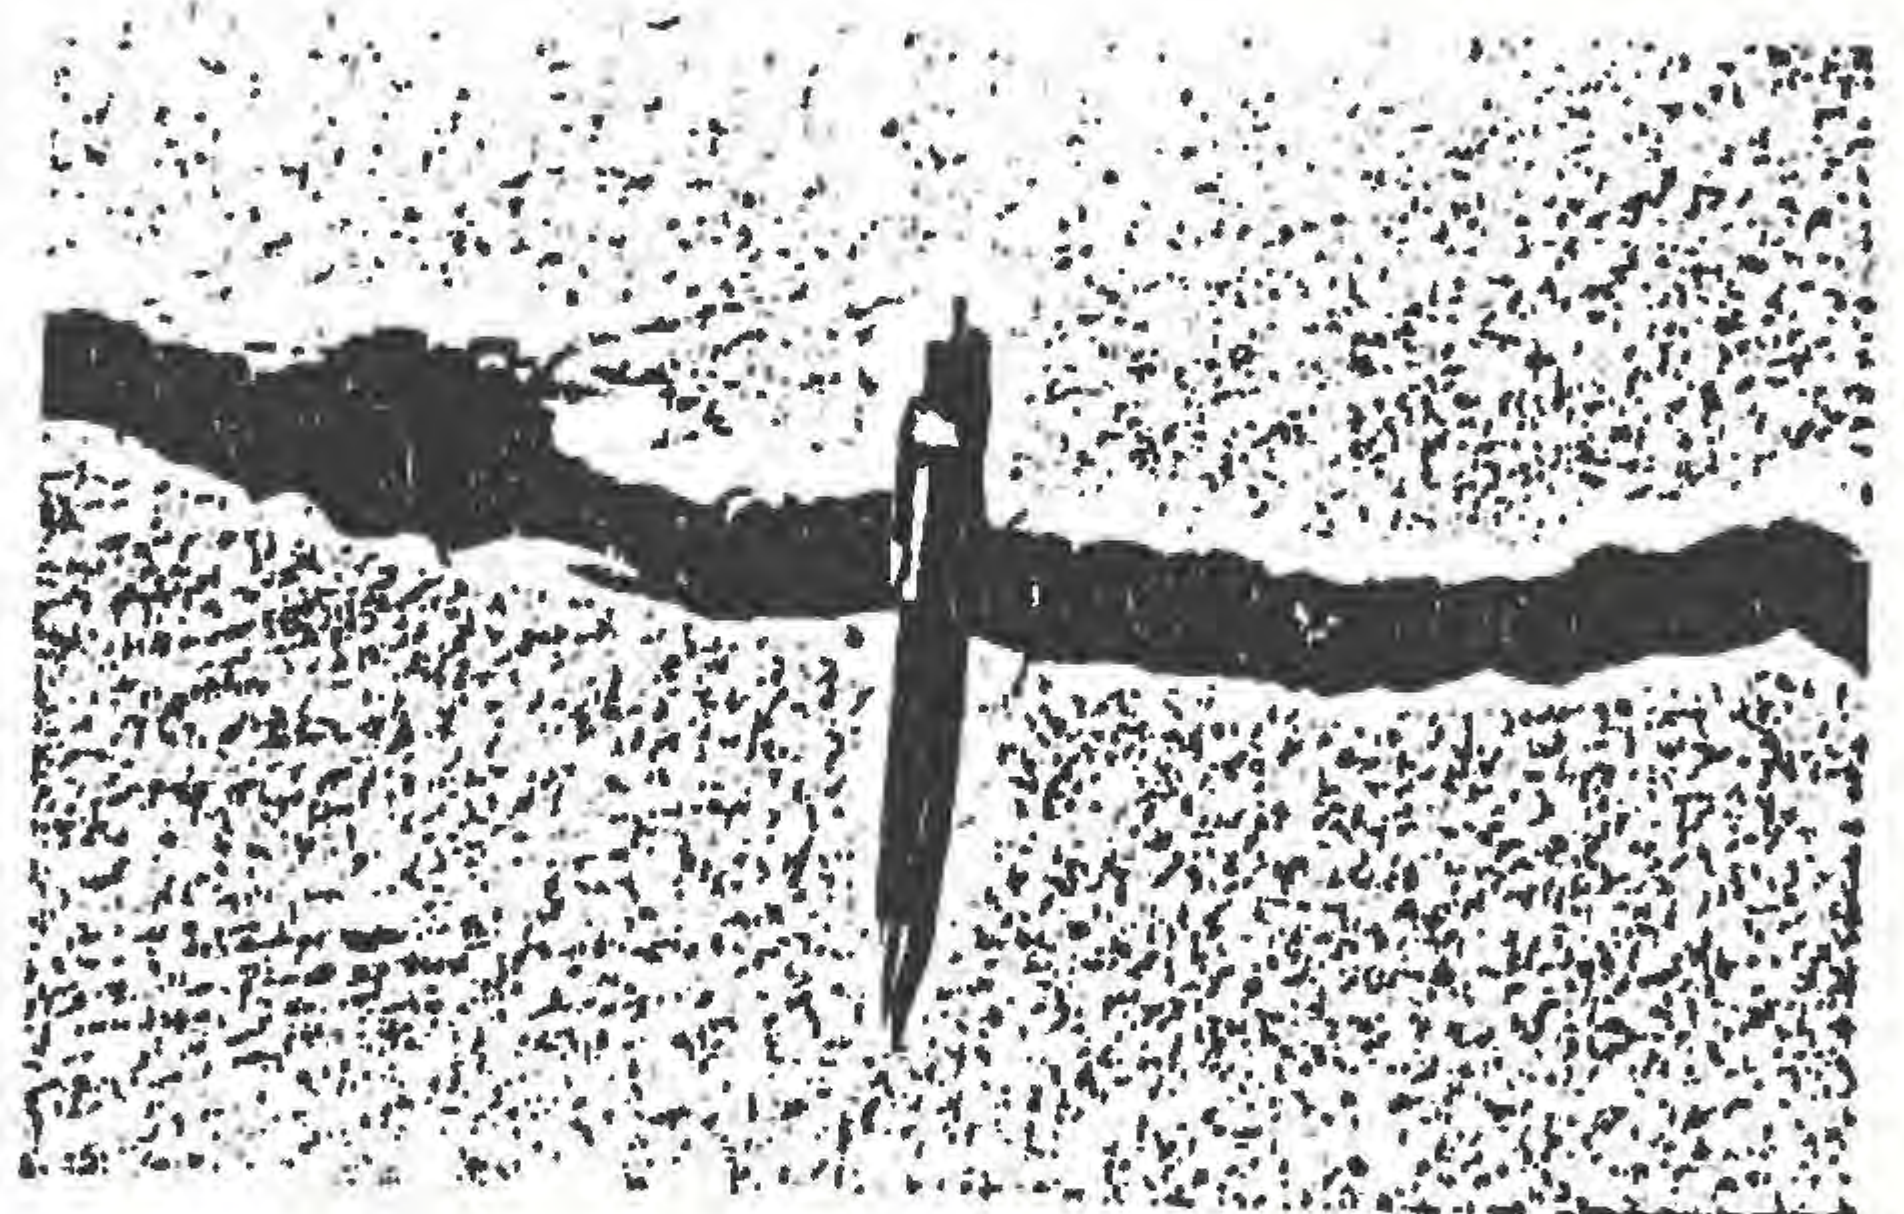
Figure 10

PAVEMENT CRACKS - 6187 Lacey -
Close up - (Fault associated)
