Geotechnical Reconnaissance of the Mississippi River Delta Flood-protection System After Hurricane Katrina

By Ronaldo Luna, David Summers, David Hoffman, J. David Rogers, Adam Sevi, and Emitt C. Witt

This article presents the post-Hurricane Katrina conditions of the flood-protection system of levees and floodwalls that failed in the environs of the Mississippi River Delta and New Orleans, La. Damage conditions and suggested mechanisms of failure are presented from the geotechnical point of view.

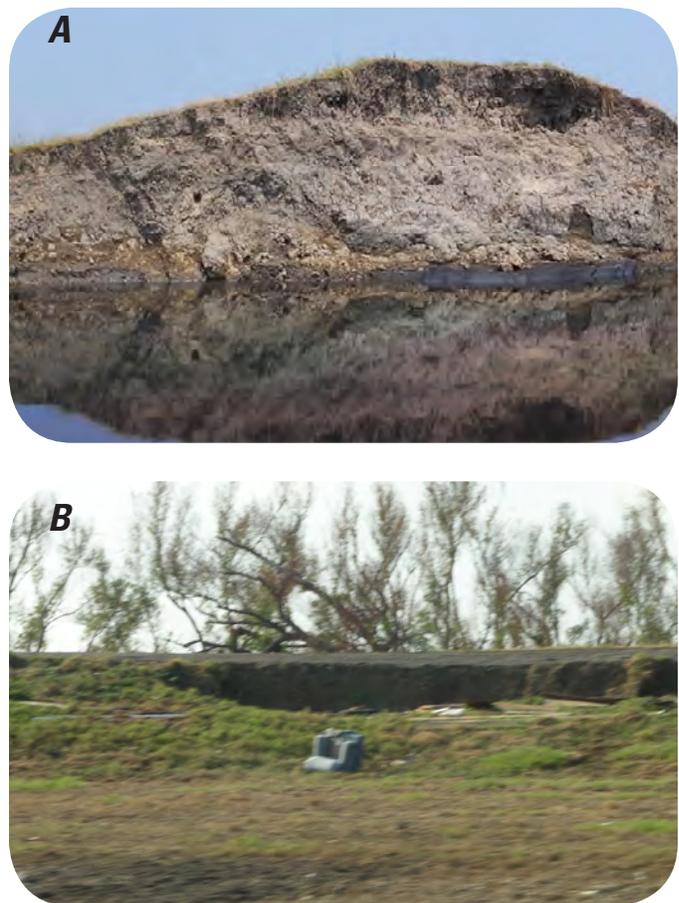
The flood-protection system for New Orleans and the towns that lie along the Mississippi River down through the delta comprises two separate types of flood-control barriers. The first of these is the earthen levee, and the second is the floodwall with a sheet-pile base. In some instances these two basic forms of flood protection are combined, such as a shorter floodwall over a smaller levee. Complete earthen levee failures were not observed in the New Orleans area, although a number of the earthen levees in locations along the delta of the Mississippi River in Plaquemines Parish exhibited severe damage. In some instances levees suffered complete failure (fig. 1A), and in other cases levee banks experienced severe erosion without complete failure (fig. 1B).

Figure 1. An example of a section of levee failure (A), and erosion of a levee during overtopping without failure (B).

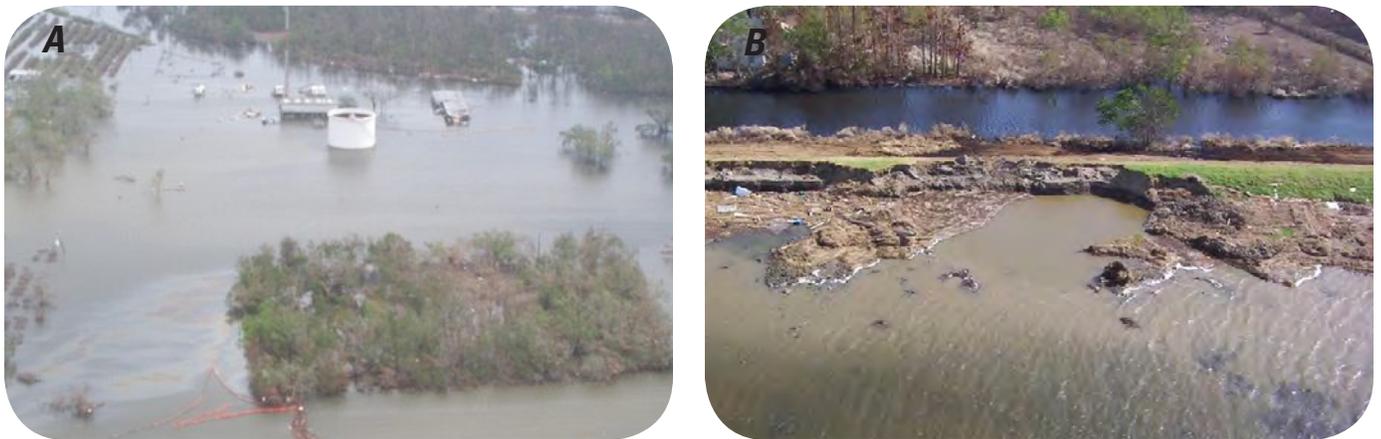
Examination of aerial photographs from files available at the Plaquemines Parish Web site (e.g., <http://photos.plaqueminesparish.com/displayimage.php?album=16&pos=6>) shows such failures very clearly. The breach at Nairn, La., however, was of a levee tied to a steel piling failure, and these types of flood-protection components were found much more commonly both in New Orleans and along the road on south LA-23 (fig. 2). Figure 2A is a view of the levee system that was breached, as seen in the bottom left of the photograph. Figure 2B is a partially failed levee with a reduced cross section.

Figure 2. Complete levee failure at Nairn, La. (A), and partial failure with severe loss of cross section (B) as a result of Hurricane Katrina in 2005. Photographs are from Plaquemines Parish government and used with permission.

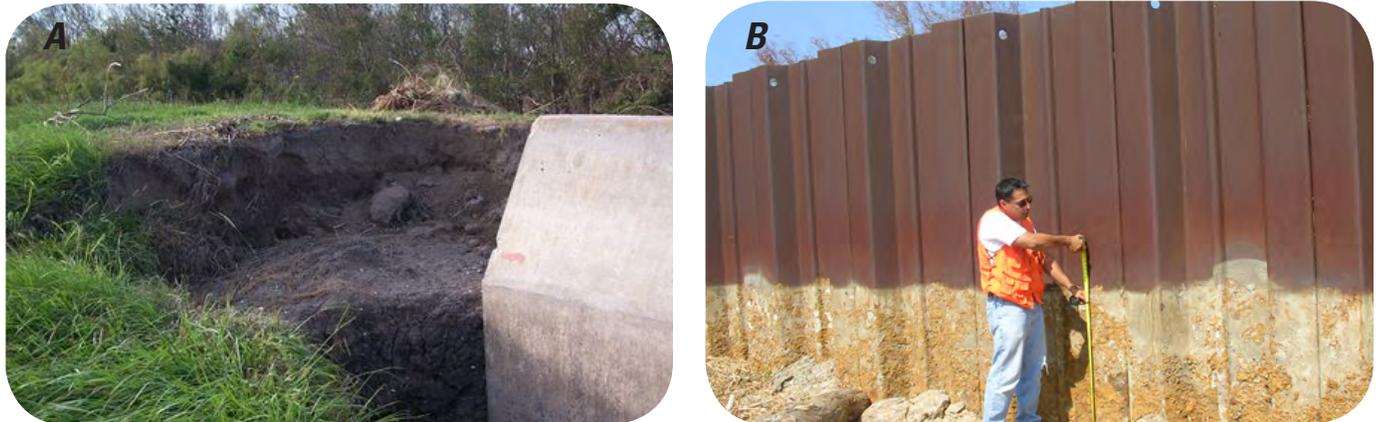
The most likely first step of the failure mechanism was water overtopping the wall, followed immediately by scouring of soil on the landward side adjacent to the wall. In many cases this was the only stage of damage that occurred, and the floodwall itself remained erect. Where the wall adjoined an earthen levee, however, there was additional scouring that could occur at the interface, as shown in figure 3.

Figure 3. Wall edge showing scour into the adjacent earth wall (A), and soil at protected side removed by overtopping (B).

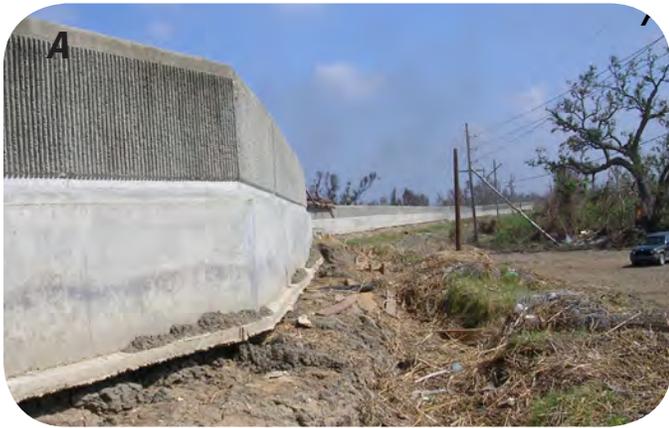
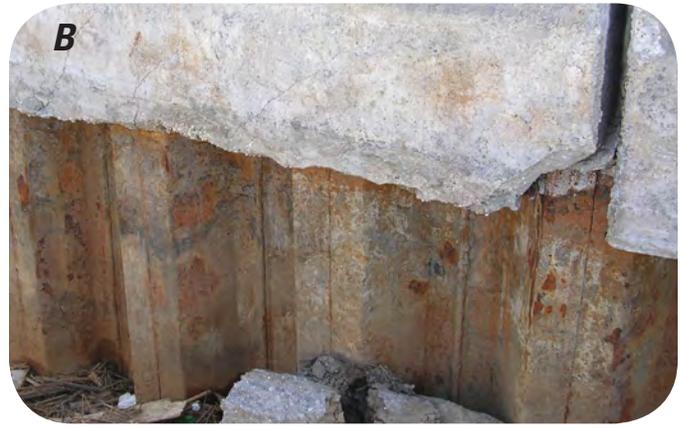
As the water continued to pour over the wall, it would remove the softened soil and consistently leave a trench on the landward side of the wall, often exposing the underlying piling. A similar event would occur if the piling were heightened with a concrete wall, with the scour opening a channel along the wall on the landward side. This often exposed the underlying piling as shown in figures 4A and 4B.

This linear scour trench resulted in a higher cantilever length with less foundation embedment, making the system weaker. When a metal sheet-pile wall without a concrete overwall and embedded in disturbed saturated soil was exposed, water pressure would push against the weakened soil until the piling was bent over in a landward (protected side) direction, as shown in figure 5. Similar failure mechanisms are evident at several points along LA-23 (figs. 6A and 6B).

Figure 4. Scour along wall along Louisiana Highway 23 (A), and exposed piling under concrete wall near Port Sulphur, La. (B), resulting from the effects of Hurricane Katrina in 2005.

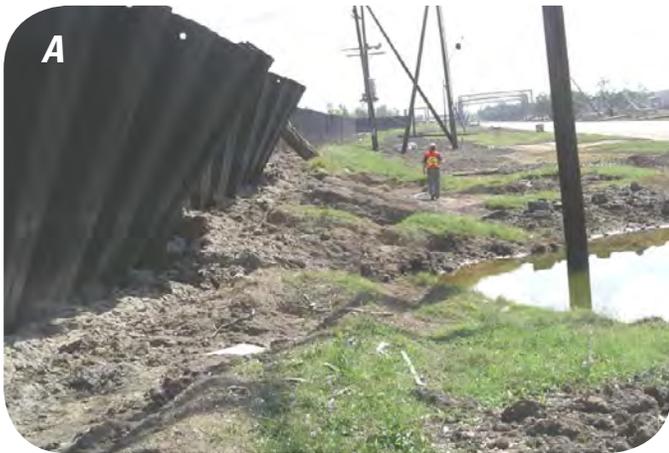
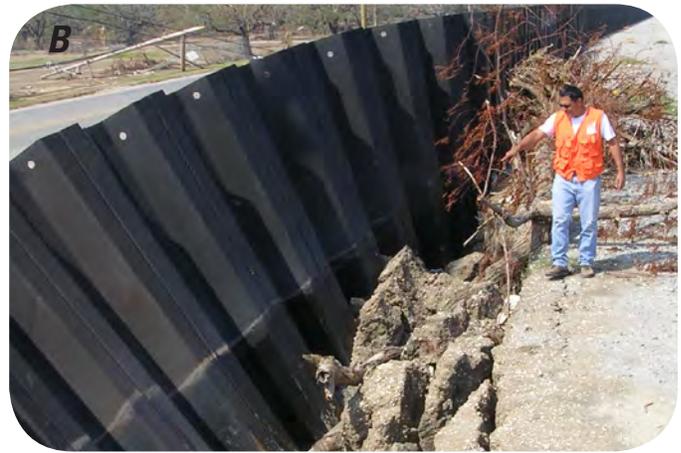
Figure 5. Piling that has rotated about the bottom, forming a lip that creates a stream of water over the wall. Landward side, showing scour of the soil around the pile (A), and large deformations shown from water side of piling (B).

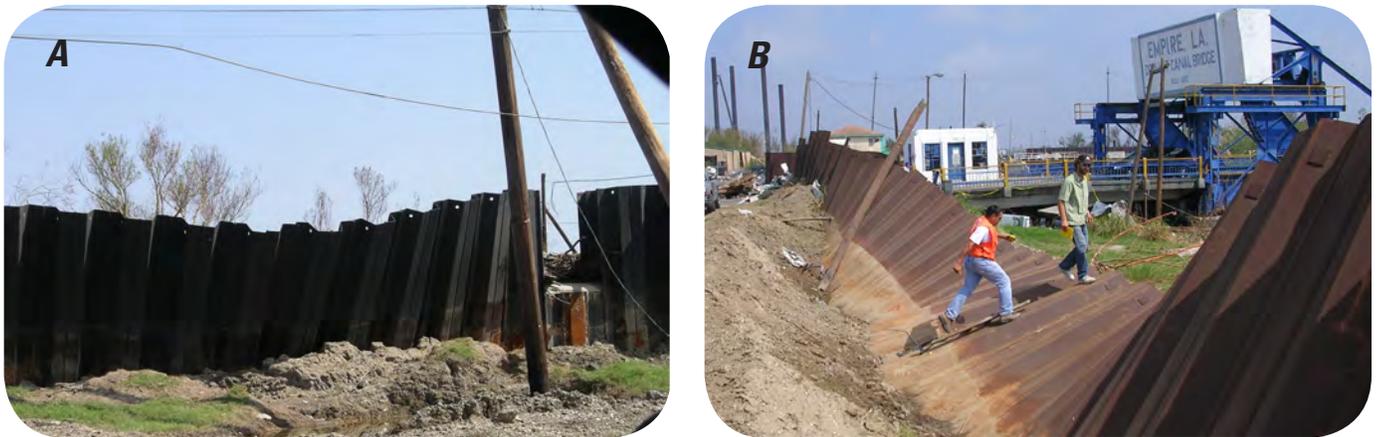
Figure 6. Rotational failure of the piling with possible toe movement (A), and total collapse of piling at Empire, La. (B), as a result of Hurricane Katrina in 2005.

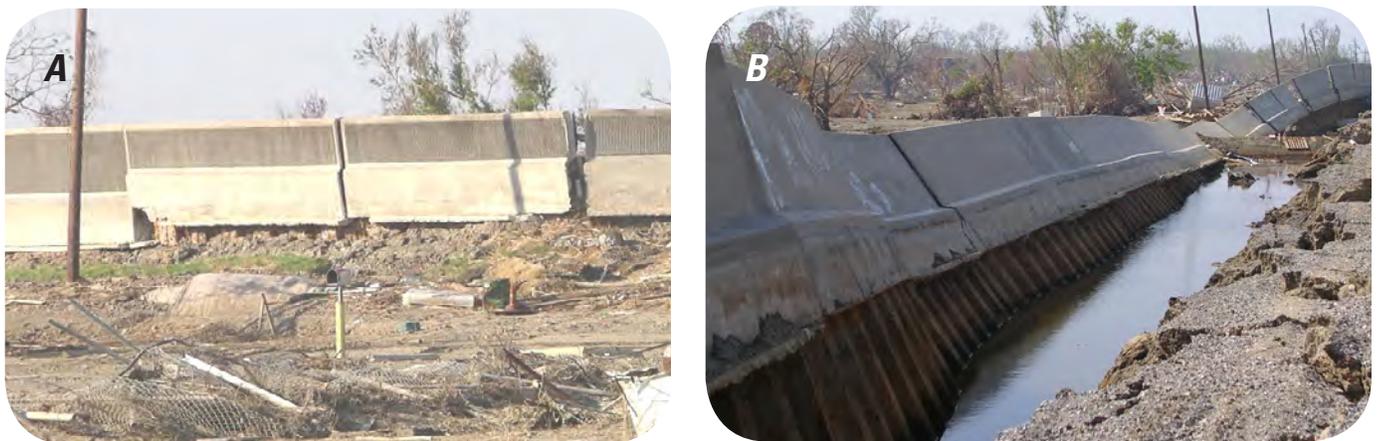
It is noteworthy that in most cases the piling wall remained connected even when significantly displaced, compromising its functionality. Being more brittle, however, a concrete overwall would separate at the joints, which in some instances led to a complete collapse, as shown in figure 7. With this background, it is interesting to examine some

Figure 7. Failure of a concrete overwall; note that the underlying piling keeps the wall segments in place. Landward (protected) side (A), and water side (B).

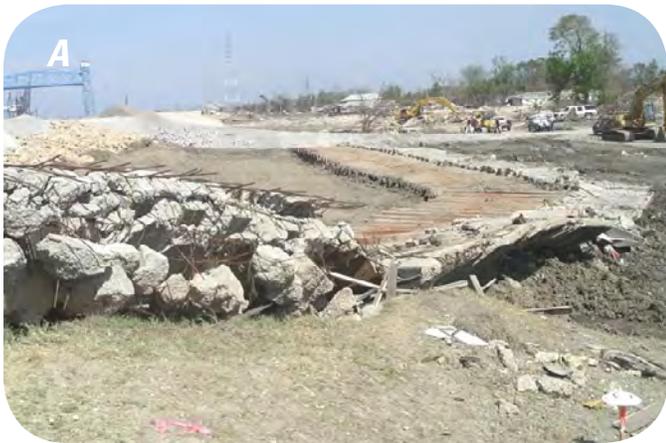
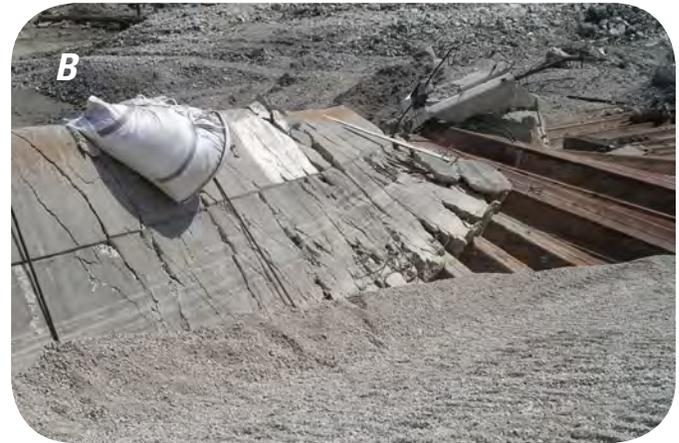
Two significant failures occurred along the eastern flood-protection system of the Industrial Canal in New Orleans. At the larger breach (~900 ft wide (274 m wide)) on the south side just north of Louisiana Highway 39 (Claiborne Avenue), the piling was carried an extended distance into the breach (more than 150 ft (46 m)). The flood-protection system consisted of a small (~5 ft high (1.5 m high)) earthen base levee with a partitioned structure called an I-wall on top. The term “I-wall” is used when the structural portion of the

wall above the ground is a single vertical panel (I-shaped as opposed to L-shaped) supported on steel sheet piling. More specifically at this location, the I-wall consisted of steel sheet piles embedded 15 ft (4.6 m) in the ground and a concrete panel which extends about 8.5 ft (2.6 m) above the ground. The concrete wall all along the segment was crushed, which is likely the result of a barge impact during the flood (figs. 8–10). The actual timeline and sequence of events or cause of the failure is not known. This barge was carried into the residential area from a significant distance, and the houses that lie behind the barge were protected from the flood waters and experienced less damage. It is clear that the levee failure was worsened by the impact of the barge, which likely caused a substantial portion of the wall to collapse and the piling wall (still largely intact) to be carried a significant distance into the breach.

Figure 8. The fractured concrete and continuous sheet piling pushed ~150 ft (46 m) away from levee alignment looking north at the Inner Harbor Navigational Canal (popularly known as the Industrial Canal) (A), and northern section still attached to remaining floodwall at the Industrial Canal (B), New Orleans, La., resulting from the effects of Hurricane Katrina.

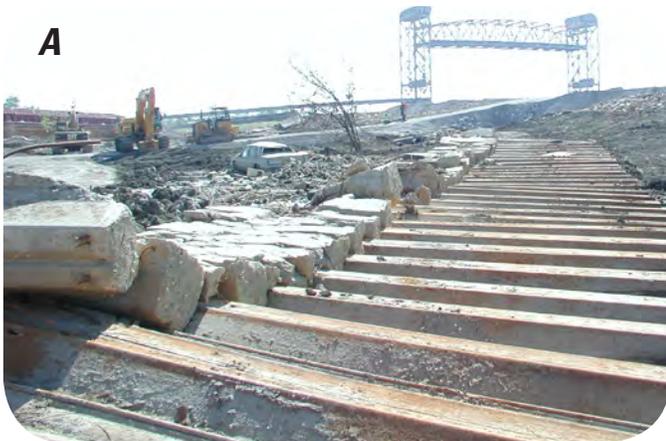
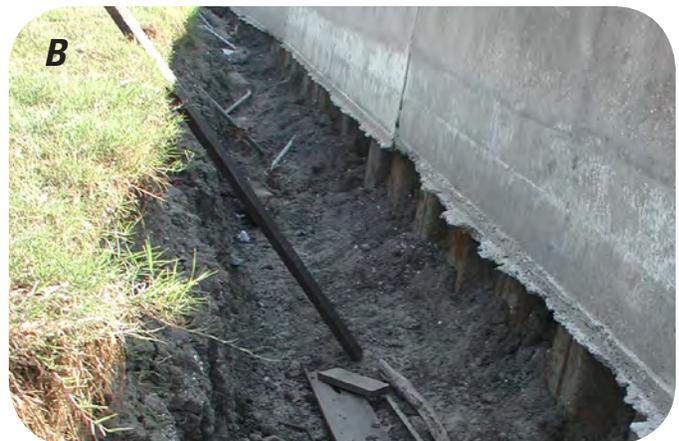
Figure 9. Details of Inner Harbor Navigational Canal (popularly known as the Industrial Canal) concrete wall fragmentation, looking south (A), and pronounced scour trench 5 ft (1.5 m) deep and 5 ft (1.5 m) wide (B), New Orleans, La., resulting from the effects of Hurricane Katrina in 2005.

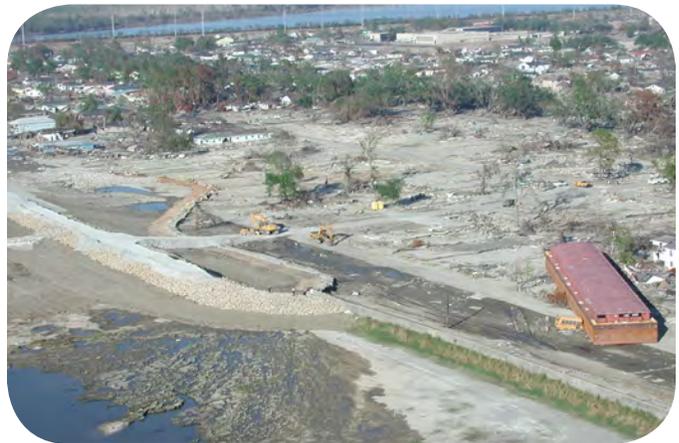
Figure 10. Panoramic view from the lift bridge seen in background in figure 9A. Note the barge on the right and the temporary levee repair by the U.S. Army Corps of Engineers.

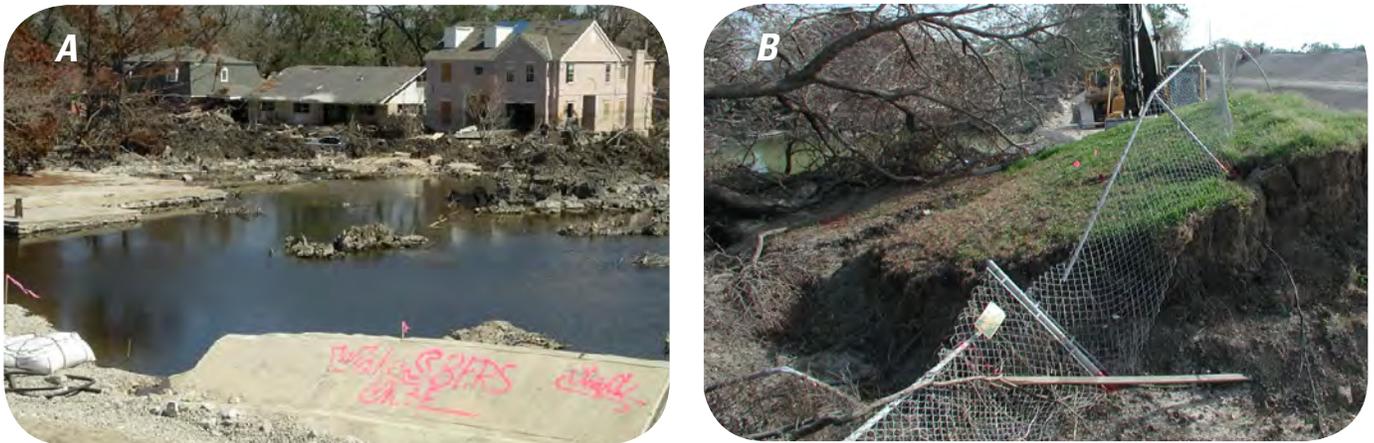
horizontally but experienced very little rotation, except at the very toe of the slide. The foundation soils consist of very soft, organic clay and peat and decomposing wood as can be seen in the dark soils shown in figure 11B. These extremely weak soil conditions are the most likely causes for the failure at this location, resulting in a major breach about 450 ft (137 m) wide, which caused flooding in the Lakeview residential area (fig. 12).

Figure 11. Failed concrete wall at the Metairie Outfall Canal (popularly known as the 17th Street Canal) breach (A), and horizontal translation of fence that used to be only 10 ft (3 m) from wall is now about 50 ft (15 m) away (B) resulting from the effects of Hurricane Katrina in 2005. Note the dark soft soil which formed a weak foundation for these structures.

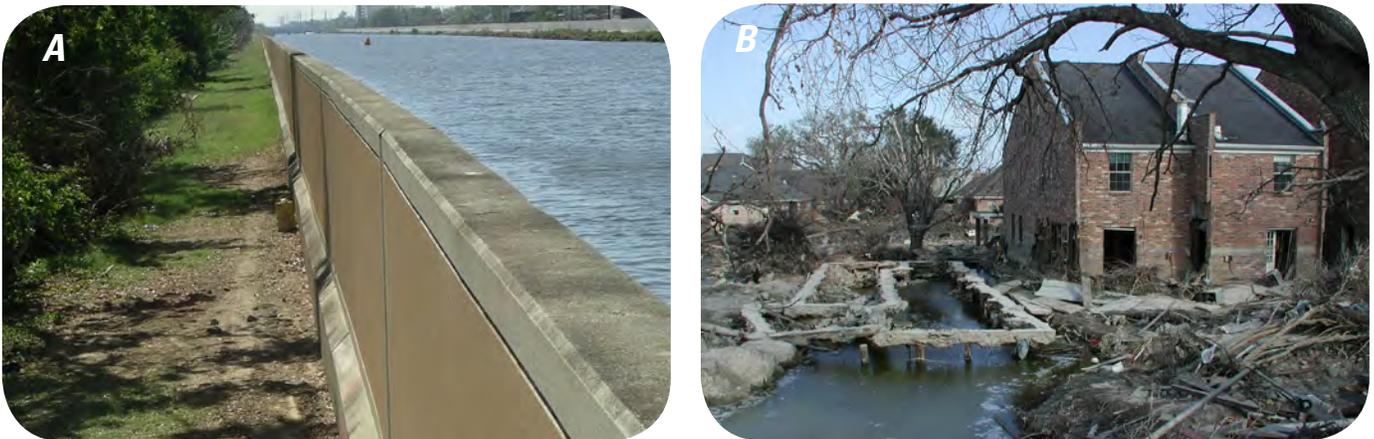
Figure 12. Area in the protected side of floodwall with no scour (A), and residential area with only foundations left in soils with high organics (B).
