Analysis of the Interstate 10 Twin Bridge's Collapse During Hurricane Katrina

By Genda Chen, Emitt C. Witt III, David Hoffman, Ronaldo Luna, and Adam Sevi

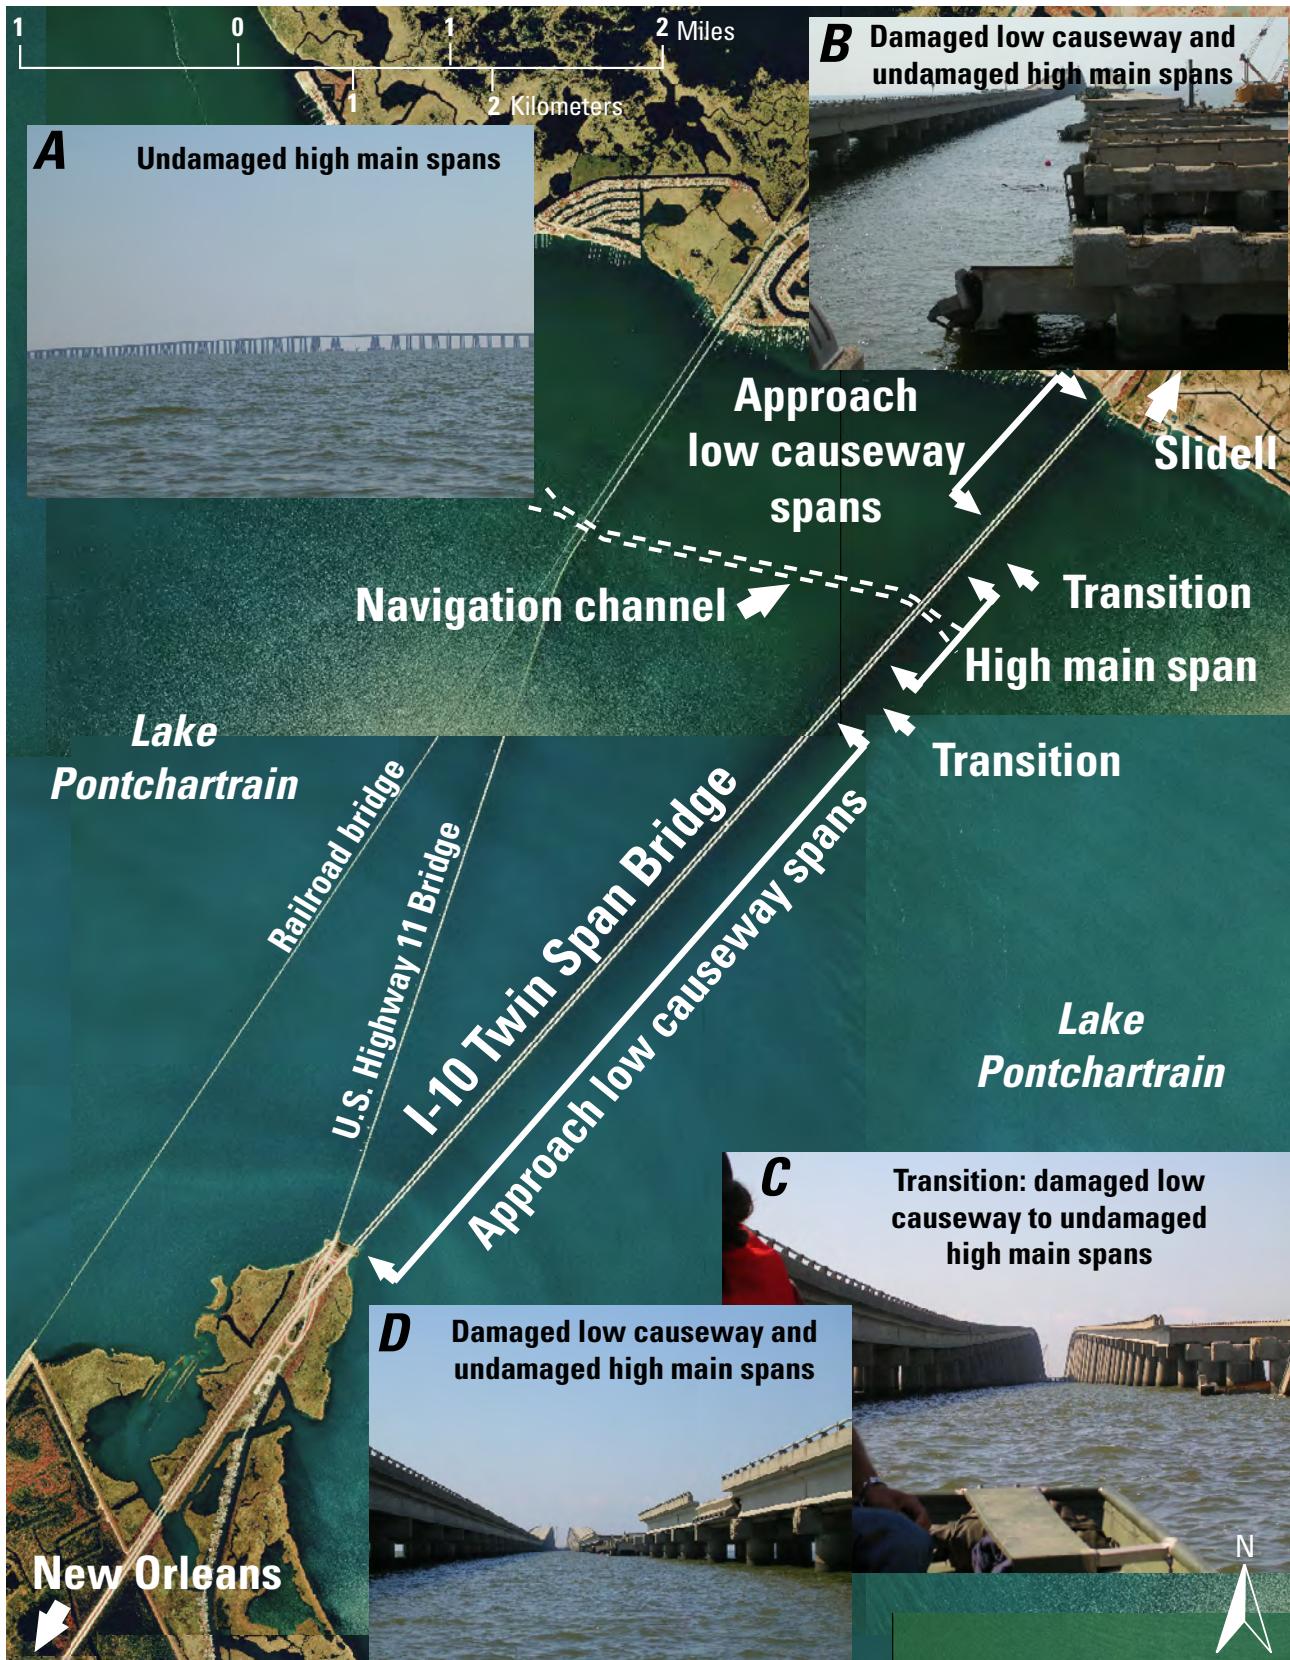
Figure 1. Damage of the Interstate 10 Twin Span Bridge between New Orleans and Slidell, La., distributed over the approaches' low causeways and the navigation channel.

The storm surge generated by Katrina severely damaged the I-10 bridge structures and rendered them impassable. Each approach causeway suffered significant damage or collapse (figs. 4 and 5), whereas the tall structure over the navigation channel shown in figure 3 withstood the storm. According to the bridge maintenance engineer for the Louisiana Department of Transportation and Development (Landers, 2005), 38 spans from the eastbound bridge and 20 spans from the westbound bridge were dislodged and fell either completely or partially into the water (fig. 5). One span from the westbound bridge collapsed into the water (fig. 6). Many spans from both bridges experienced excessive lateral displacement equal to one girder spacing and stopped at the exterior concrete pedestals shown in figure 4. Several spans were displaced into two girder spacings as shown in figure 7. In this case, the second girder passed over the exterior pedestals without experiencing significant damage.

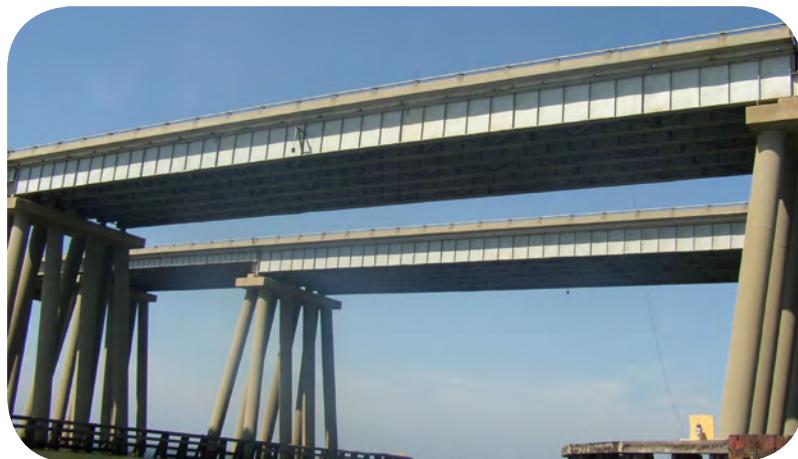
Figure 3. Elevated spans of the Interstate 10 Twin Span Bridge over the main navigation channel in Lake Pontchartrain, La. This tall structure is safe from the effect of storm surges.

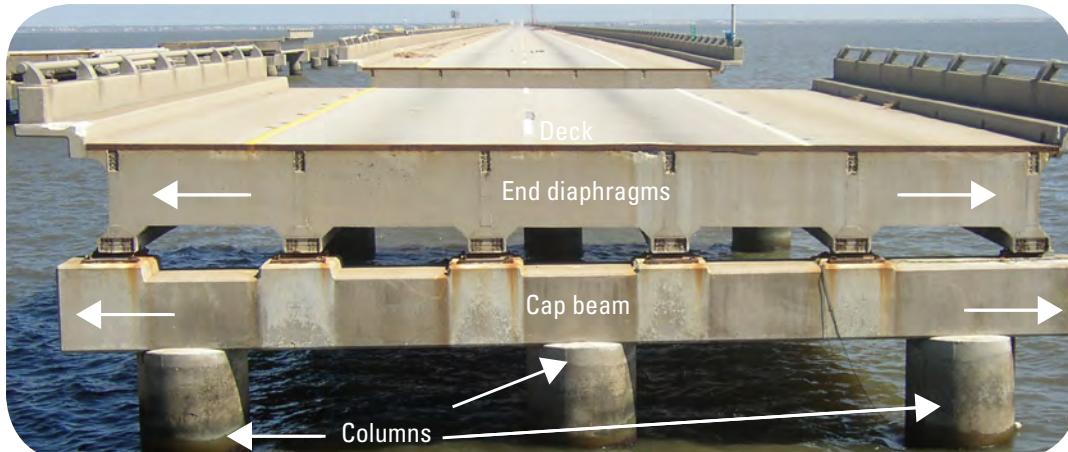
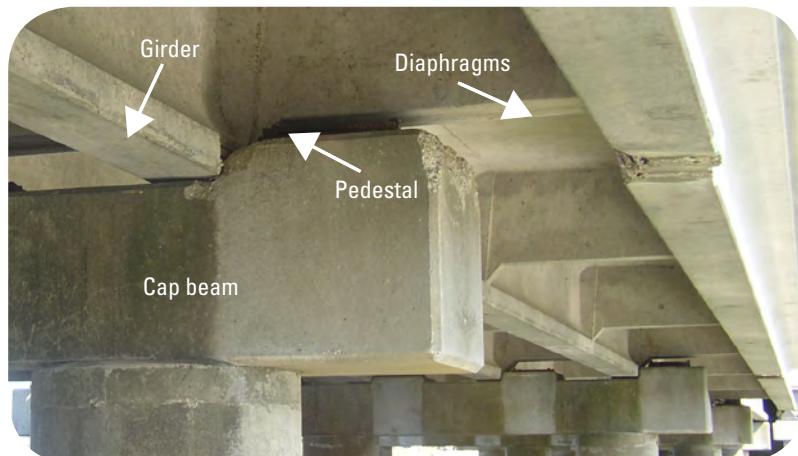
When the ratio of the volume of trapped air in a hollow box to the volume of a corresponding solid rectangular box reaches a value of 55 percent, the effective gravity load of the box becomes zero, and the concrete box will float on the surface of the water. For the I-10 twin bridges, the average ratio value of each bridge deck segment was estimated to be 70 percent. Thus, we conclude that deck flotation was in effect during Katrina. Under this condition, a small horizontal disturbance caused by drag force, wave action, or wind can relatively easily move the bridge deck laterally.

Therefore, the main reason for the collapse and excessive displacement of bridge spans was the apparent loss of effective gravity load which led to the bridge decks floating on the surface of water at the time of failure. After the air escaped and the space filled with water, the bridge decks landed again on the piers but at different transverse locations or dropped off their supports in the longitudinal (traffic) direction.

Figure 4. Cross section (top) of the Interstate 10 Twin Span Bridge's typical causeway approach span (deck, diaphragm, cap beam, and column) and profile with missing spans. The cross section (bottom) shows diaphragms and girders underneath the bridge decks, which create a concrete "box" facing downward.

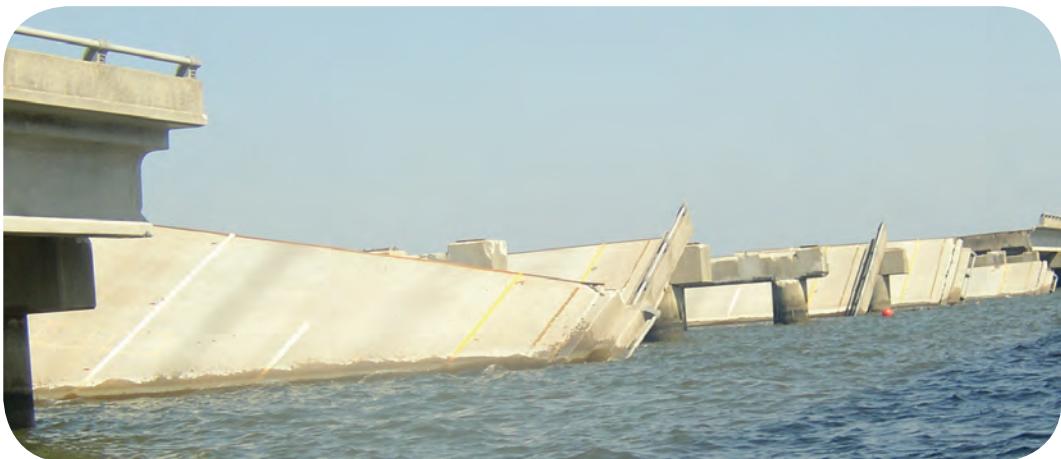
Figure 5. Interstate 10 Twin Span Bridge's causeway approach spans dropped off of bent cap beams. One end of each span is in the water.

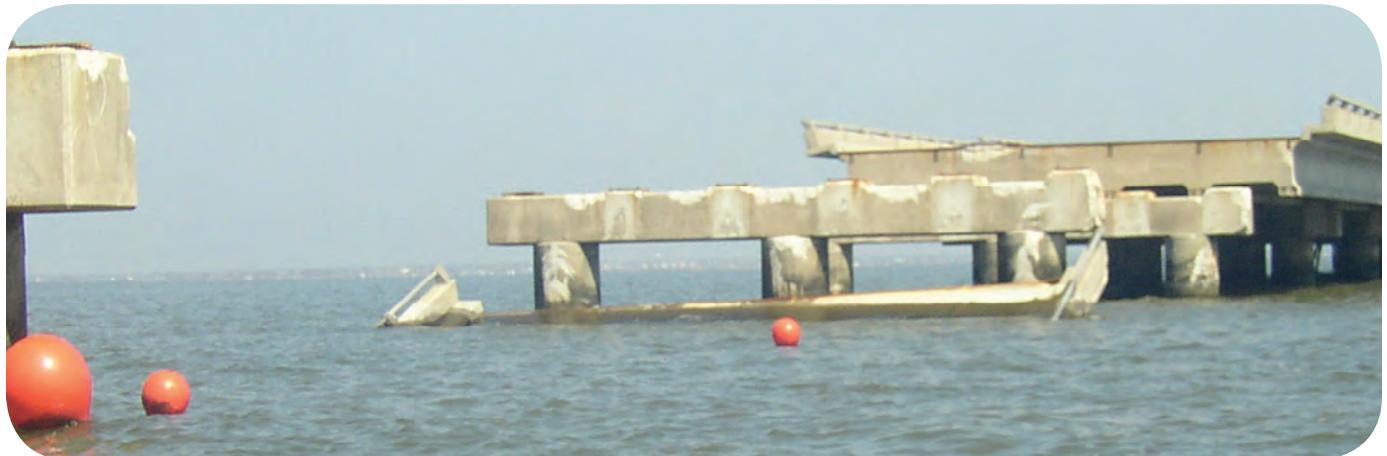
Figure 6. Westbound bridge of Interstate 10 Twin Span Bridge between New Orleans and Slidell, La., with collapsed and missing bent.

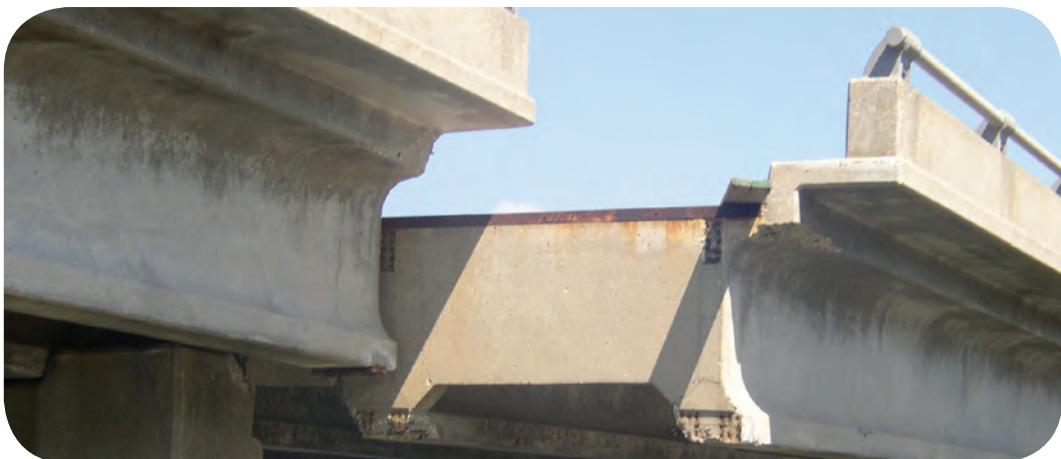
Figure 7. Westbound Interstate 10 Twin Span Bridge between New Orleans and Slidell, La., exhibiting excessive lateral displacement of approach's causeway deck. Decks stopped lateral displacement after a distance of one or two girder spacings.

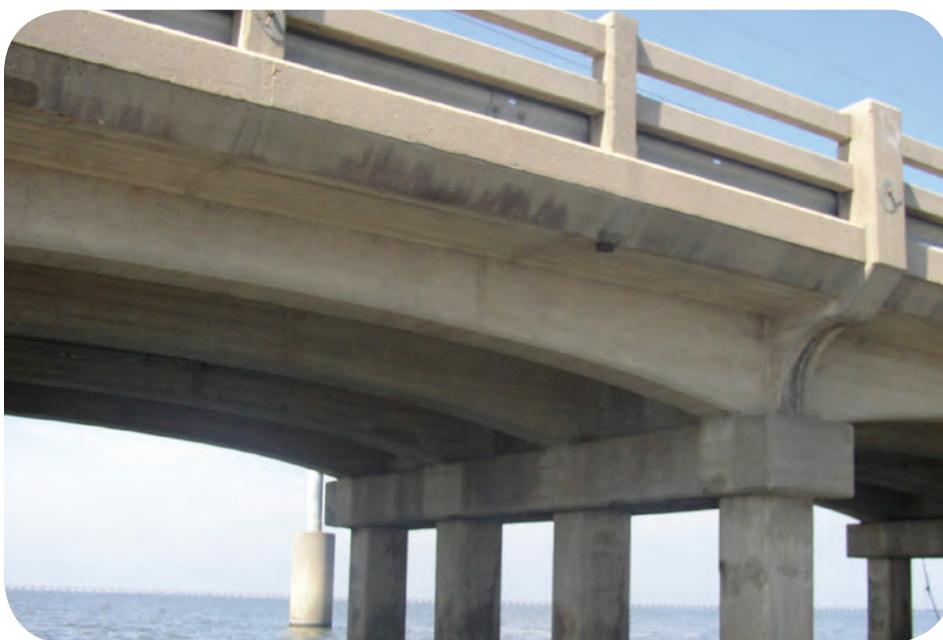
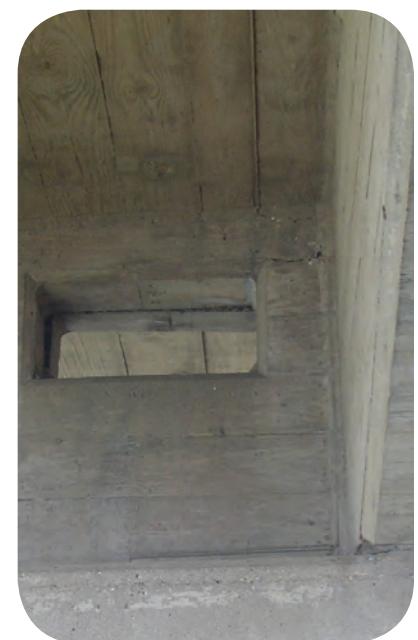
The “rectangular box” theory explained above is strongly supported by evidence collected from several bridge structures in the areas affected by Katrina. As shown in figures 2 and 8, west of and parallel to the I-10 twin bridges is a highway bridge carrying vehicular traffic on U.S. Highway 11 (US-11). This bridge was open to vehicles after only a short period of traffic interruption. As shown in figure 9, the US-11 bridge is a simply supported concrete girder structure similar to the I-10 bridges. The span lengths are shorter, however, and the depths of all of its girders are significantly shallower than those of the I-10 bridges. In addition, all girders are arch shaped, creating an even shallower section in the middle of every span. The deck sections also had holes in the lateral diaphragms that allowed air to escape the “box.” Therefore, the possibility of having significant air mass trapped beneath the decks of the US-11 bridge is much smaller in comparison with the I-10 bridges.

Figure 9. Superstructure of U.S. Highway 11 bridge adjacent to Interstate 10 Twin Span Bridge across Lake Pontchartrain between New Orleans and Slidell, La.; image on right shows important differences such as the use of shallow (height of cross section) arched girders and diaphragms with holes to prevent the trapping of air under the deck.

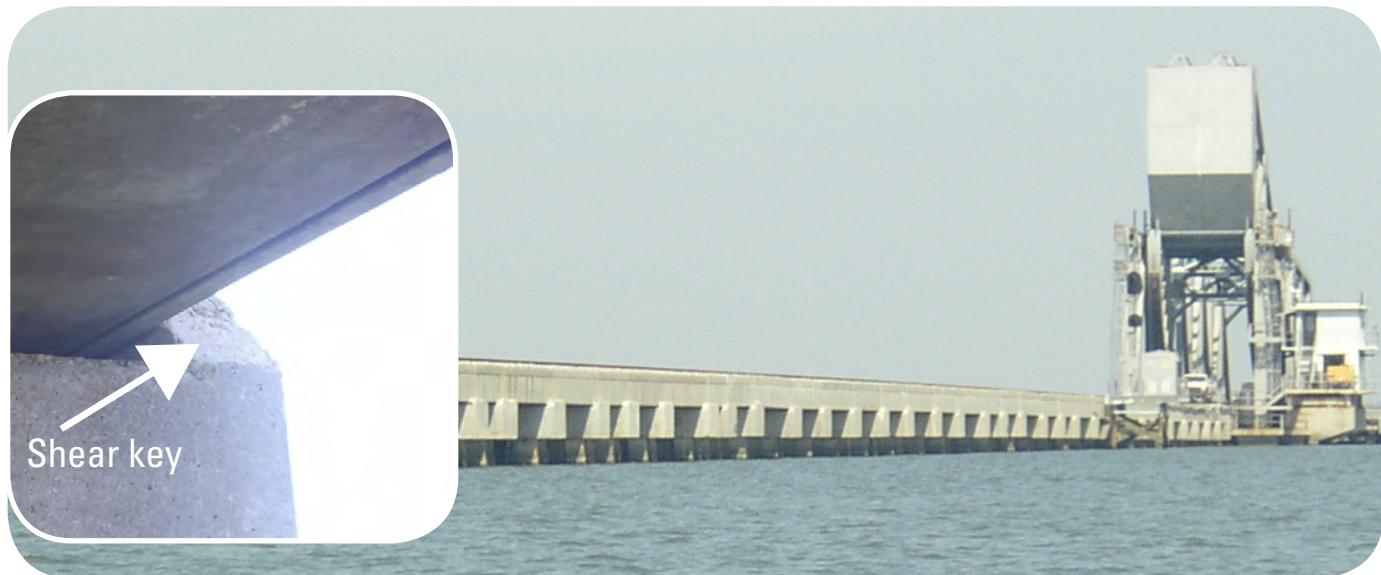
Still further west is a railway bridge (fig. 2) that did not suffer any structural damage except for a portion of track that washed away. The railroad bridge consists of solid slabs and supporting piers that are illustrated in figure 10. This design makes it difficult to trap air beneath the slabs to reduce their effective gravity loads; consequently, the bridge spans were unlikely to float during the hurricane. Even though a portion of railroad tracks were washed away, there was no evidence that bridge segments had dislocated. The shear keys at both ends of the cap beams may also have helped in this regard.

Figure 10. Overview and deck details of the railway bridge adjacent to Interstate 10 Twin Span Bridge between New Orleans and Slidell, La.; inset photo shows important differences such as the use of a solid deck (no hollow space underneath) and a shear key at ends of each cap beam (to prevent lateral movement).
