Appendix A: Terrestrial LIDAR Imagery of New Orleans Levees Affected by Hurricane Katrina

A.1 Introduction

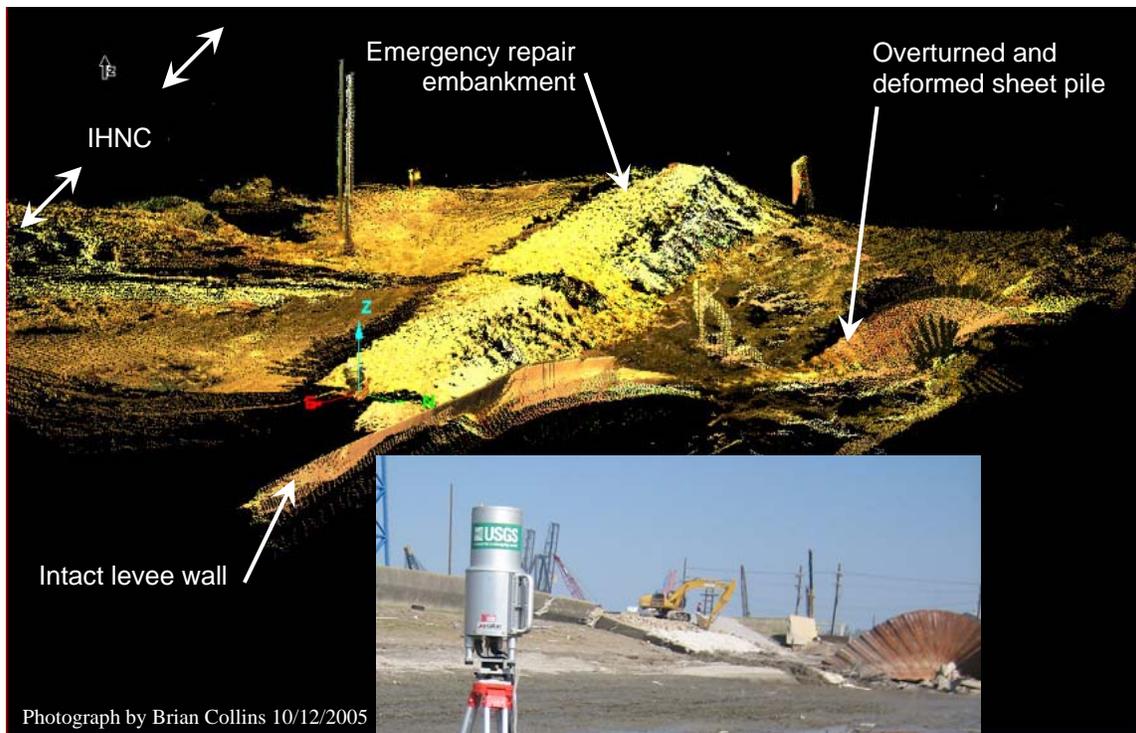
Figure A-4. For complete coverage of the IHNC-North levee breach the laser was moved around objects that cast shadows. The sheet pile foundation and levee were imaged from both sides to complete the 3-D model.

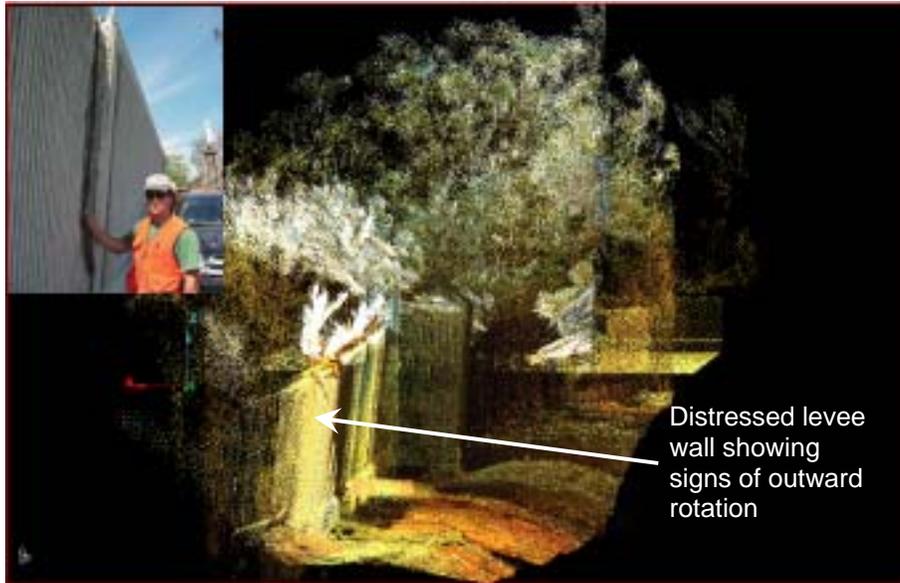
Laser mapping allows for highly accurate computation of rotation, length, area, and volume. Rotational displacement was common at areas of levee I-wall distress. For example, the east side of the London Avenue Canal immediately south of Robert E. Lee Boulevard suffered distress and lateral deformation associated with incipient failure of the levee. This movement is along a section of wall diagonally northeast of the west side breach across the canal. In Figure A-14, an oblique image of the distressed wall can be seen from the south. The wall, preserved in incipient failure, leans toward the levee maintenance road and landside portion of the levee. In the right-hand background, is the bridge abutment on Robert E. Lee Blvd for reference.

Figure A-14: Leaning I-wall of a distressed portion of the London Avenue Canal. The wall leans toward the levee maintenance road and landside portion of the levee. In the right-most background is the abutment of the bridge on Robert E. Lee Blvd. along with vegetation on the canal side of the levee.

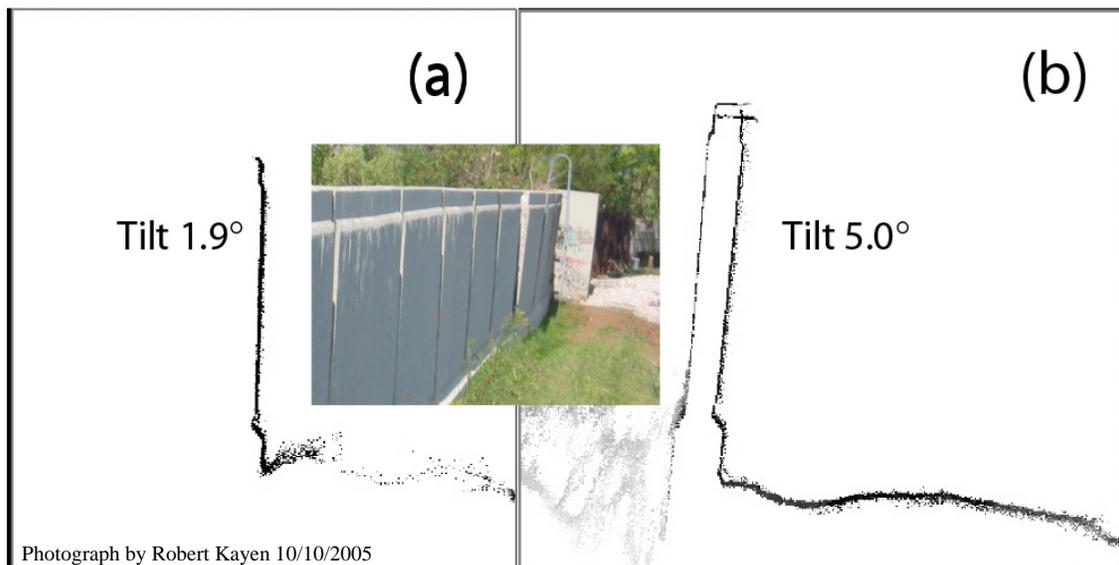
Considerable vegetation grows along the banks of the canal sides of the levees that are less maintained for growth than the landside neighborhood-side of the levee wall. Thin slices of the point-cloud data orthogonal to the alignment of the levee wall (Figure A-15) display highly accurate cross sections of the distressed I-wall at London Canal. Segment (a) is toward the south (left) of Figure A-14 and has a modest 1.9 degree rotational deformation. Near the

position of maximum distress, the I-wall has 5.0 degrees of rotational deformation toward the landside of the levee.

Figure A-15: Cross sections through two segments of distressed I-wall at London Avenue Canal. Segment (a) is toward the south (left) of Figure A-14 and has a modest 1.9 degree rotational deformation toward the landside of the levee. Near a position of maximum distress, the I-wall has 5.0 degrees of rotational deformation.

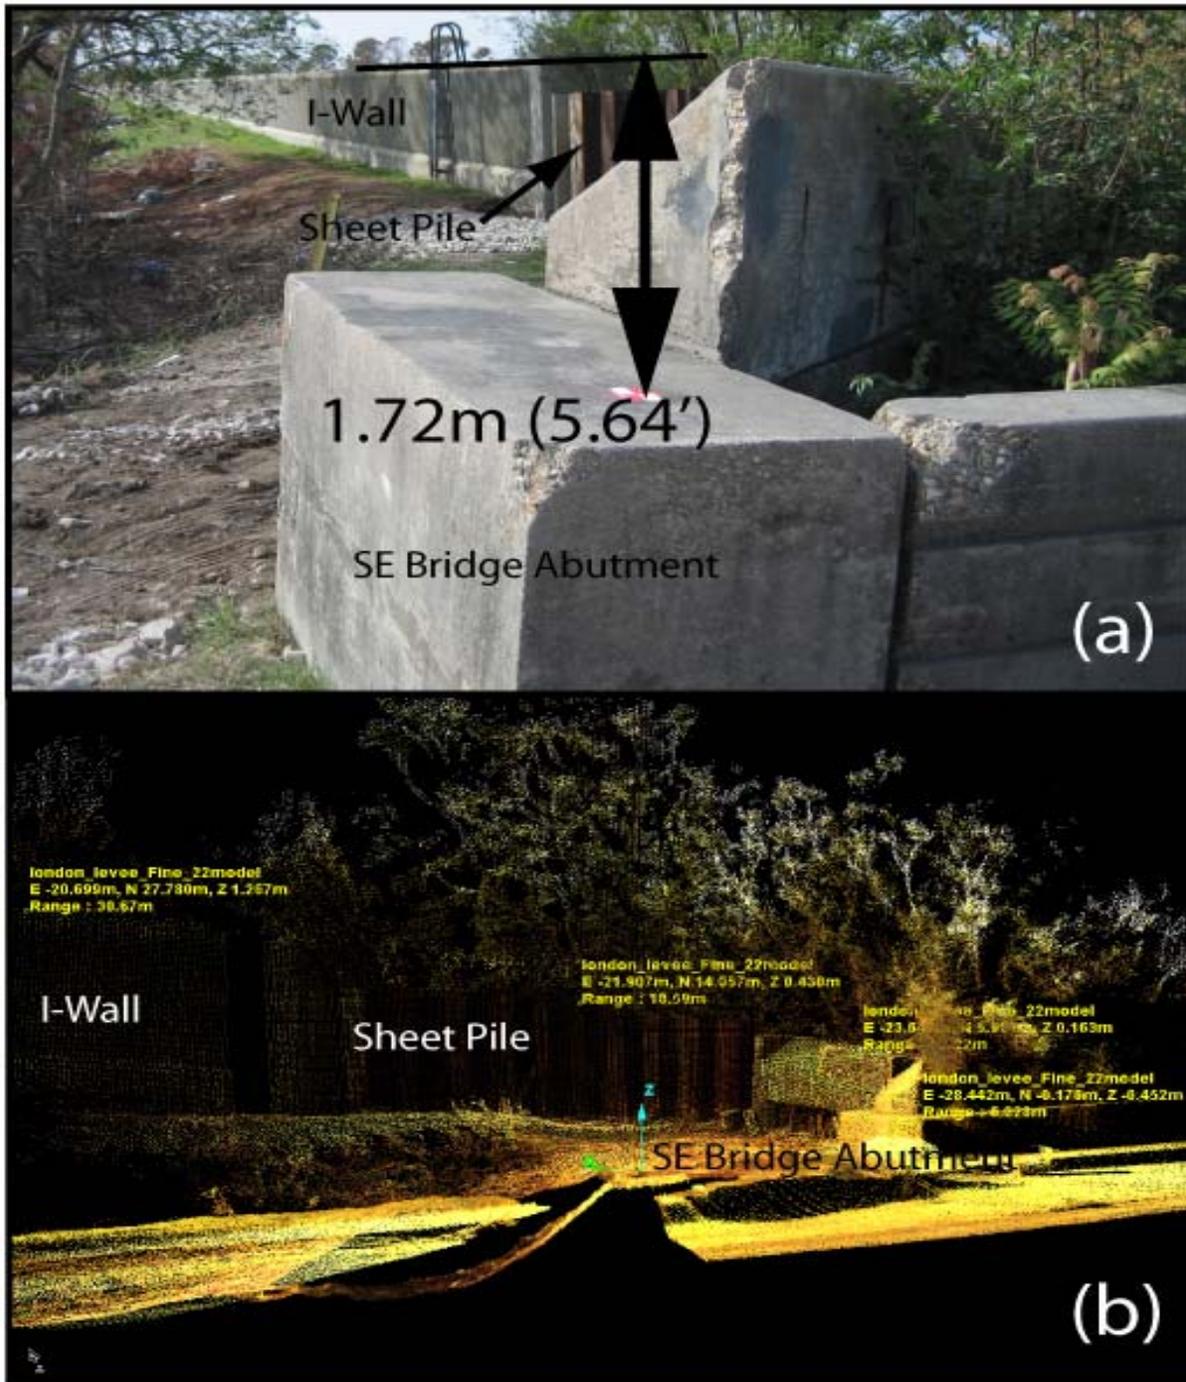
The London Canal levee failure (west side) and distressed wall (east side) are both immediately south of the bridge crossing at Robert E. Lee Boulevard. A significant gap in height between the lower un-walled bridge abutment and the I-wall prevents water from overtopping these I-walls. The height gap differs slightly between the walls located north and south of the bridge, due either to differing design heights or differential settlement following construction. At the distressed I-wall section on the southeast corner of the bridge, LIDAR surveys and visual inspection indicated the gap at this location was approximately 1.7 meters (5.6 feet). Therefore, water rising in the canal would overtop the bridge abutment and begin to flood the surrounding community when the water level was 1.7 meters (5.6 feet) below the top of the I-wall. Figure A-16 shows this considerable wall gap, as well as moderate scour at the southeast edge of the bridge abutment (Figure A-16a). On the northeast corner of the bridge abutment near the north levee wall, LIDAR surveys indicate the gap at this location to be approximately 1.51 meters (5.0 feet). Figure A-17 and A-18 show this gap, as well as a scour trench at the base of the northeast abutment (Figure A-18a).

Figure A-16: Photograph of the southeast abutment of the London Avenue Canal bridge at Robert E. Lee Blvd (a), and LIDAR scan of the same location (b). New soil and rock apparently fills scour and sink hole erosion beneath the abutment. The relative height gap between the bridge abutment and the flood wall is 1.72 meters (5.6 feet). Local coordinates are shown.

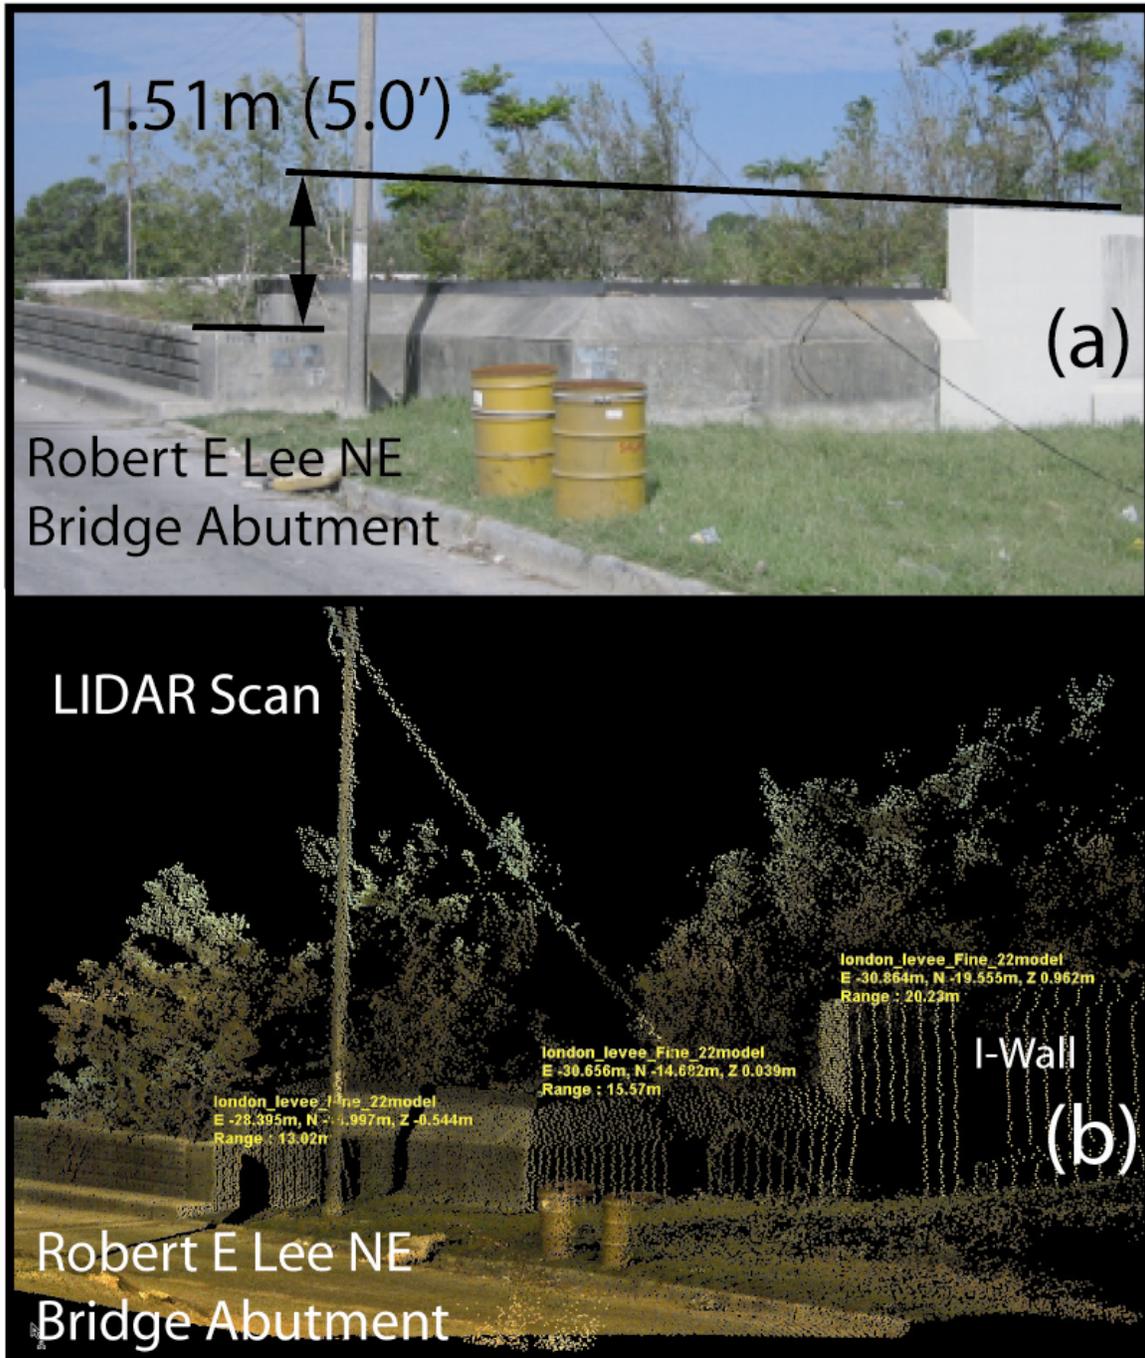
Figure A-17: The northeast abutment of the London Avenue Canal bridge on Robert E. Lee Blvd. in photograph taken from the lower portion of the bridge approach-fill embankment (a), and corresponding LIDAR scan (b). The wall gap here is 1.51 meters (5.0 feet). Local coordinates are shown.

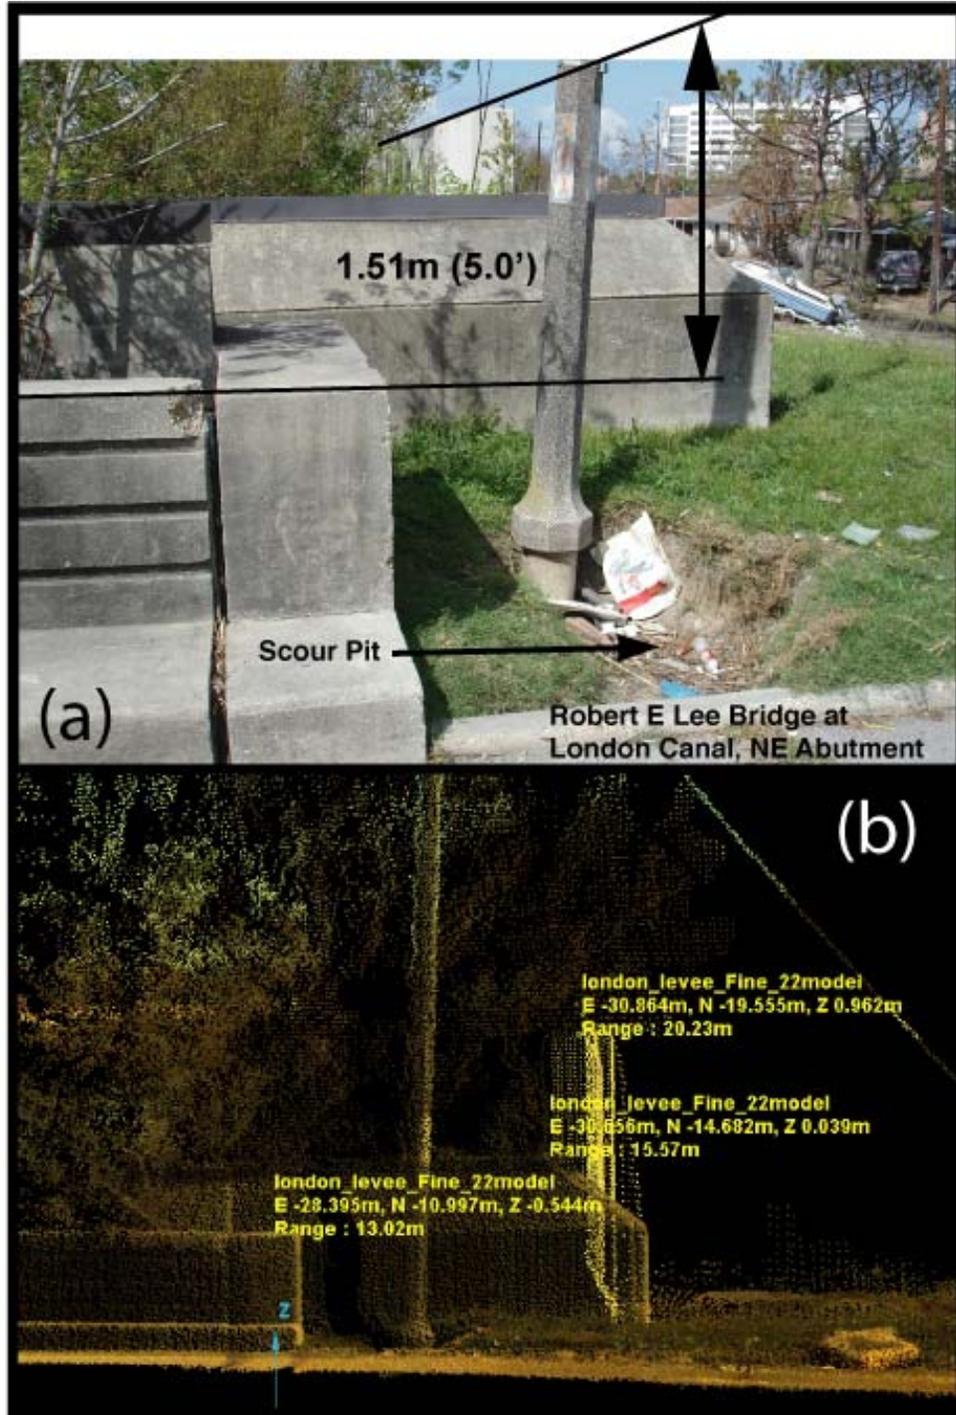
There was no evidence of overtopping of the levee walls or erosion scour anywhere along this section of the canal except at the gap at the bridge. The LIDAR and scour evidence therefore indicate that the floodwalls along the London Canal section, south of the Robert E. Lee Boulevard Bridge were not overtopped prior to failure of the levee wall.

Figure A-18 Photograph taken directly south and adjacent to the northeast abutment of the Robert E. Lee Bridge (a), and corresponding LIDAR scan of the same location (b). A scour trench is clearly visible beneath the abutment. The wall gap here is 1.51 meters (5.0 feet). Local coordinates are shown.

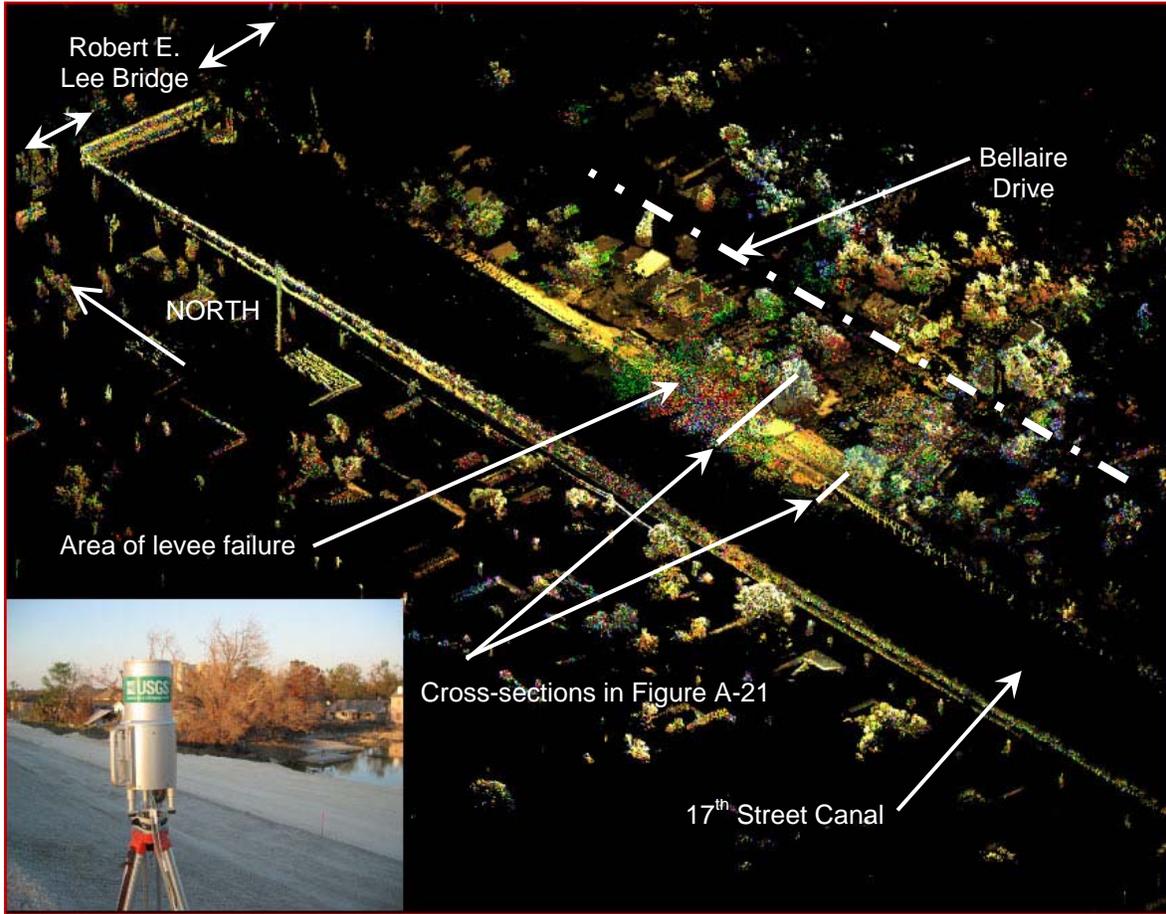
Measurement of displacement along the 17th Street Canal breach can be made by identifying the blocks of ground formerly within the intact levee that slid eastward toward the landside of the levee. Figure A-19 is an overview image of a portion of the 17th Street point cloud data set consisting of 11 individual scans. In this image, the bridge crossing over the canal at Robert E. Lee Blvd. (also called the Hammond Highway) is toward the upper left (north). A dense cluster of points is visible at the levee breach in the center of the image as are the houses in the affected area. Close in to the levee breach in Figure A-20, the remaining I-wall can be seen in alignment with the crest of the replacement structure. Here, a total breach repair width of 142 meters (466 ft) as measured between intact I-wall sections has been calculated directly from the LIDAR data set. A cross section taken through this area is shown in Figure A-21. A multi-section view is shown, consisting of a section of the intact southern I-wall overlain over the failed section of the levee. The geometry of the emergency repair embankment is clearly visible. The sections also show the magnitude of the displacement of several earth blocks that moved away from the levee break during failure. The LIDAR data shows that blocks translated approximately 14 meters (46 ft) as measured from the existing alignment of the cyclone fence line to its new position within the displaced blocks. From the perspective shown in Figure A-21, it can also be seen that the width of the 17th St. Canal has been reduced about 6 meters (20 ft) by the placement of the earthen embankment.

Figure A-19: Overview oblique image of the 17th Street Canal area in the vicinity of the breach. The Robert E. Lee Blvd. Bridge is to the north (upper left) and the breach area is to the upper right (east). Houses within the neighborhood breach area and the scour pond were imaged from the new levee and Bellaire Drive.

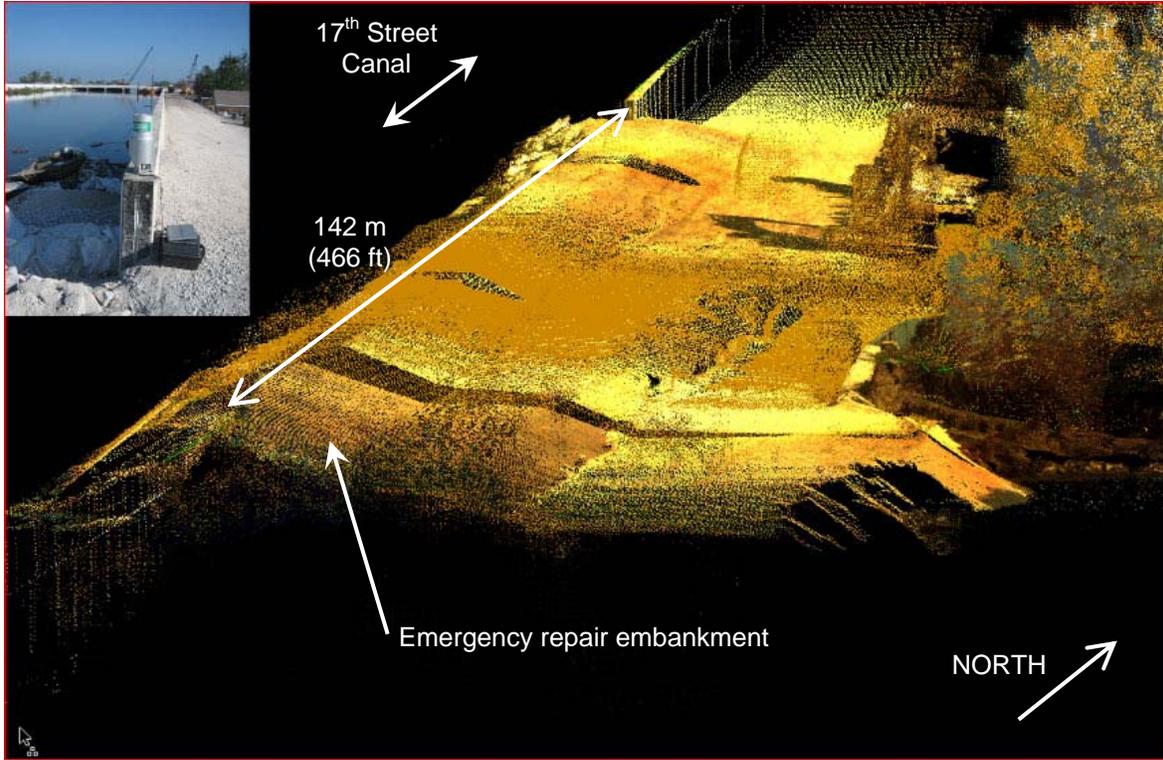
Figure A-20. An oblique close-in image of the as built replacement levee at the 17th Street Canal breach from the south. The remaining I-wall is visible on either side of the earthen embankment.

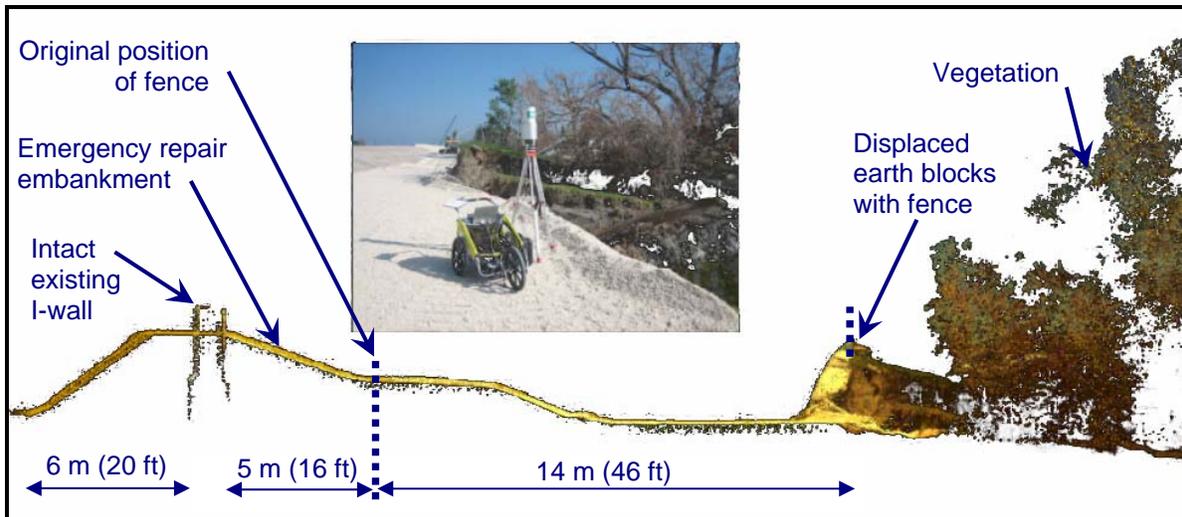
Figure A-21 Cross-section of the 17th Street Canal breach looking northward. Measurement of the lateral translation of the landside soil levee from its original position is approximately 14 meters (46 ft). The I-wall in this image is offset (out of the page) from the slide block.

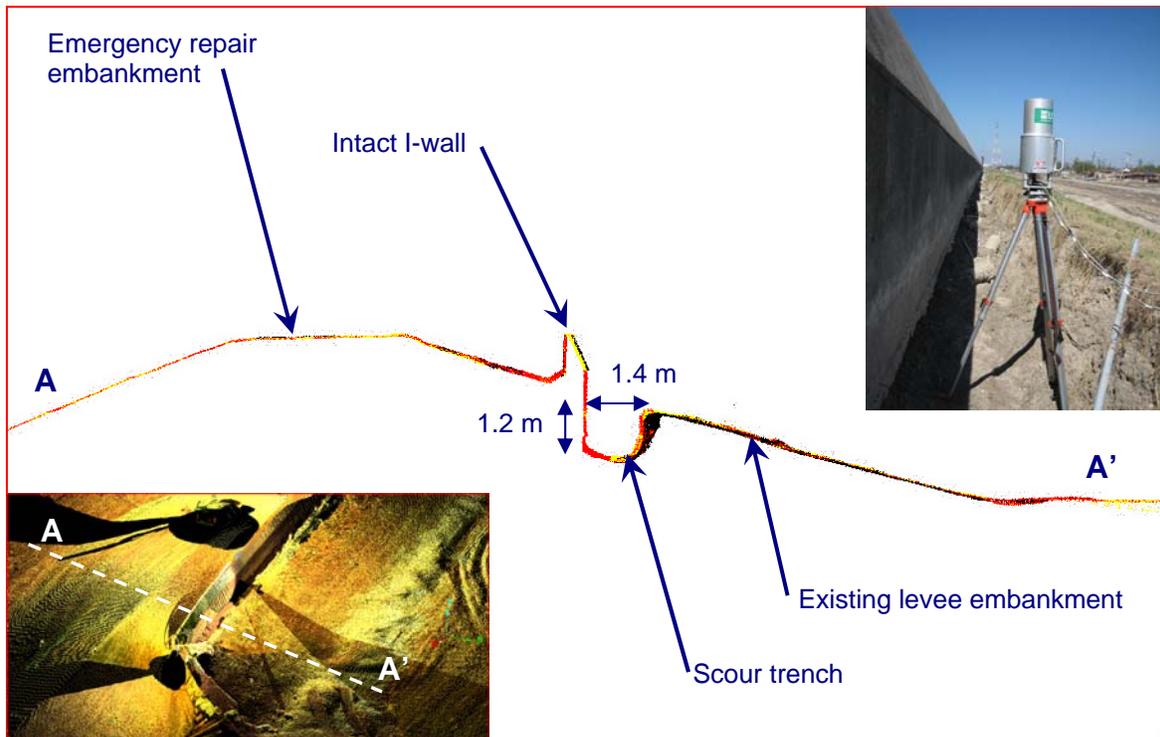
A final example of the use of the LIDAR data is shown in Figure A-22. Here, the dimensions of the scour trench in the vicinity of the east side IHNC – south breach are outlined. This view shows the depth of scour adjacent to the I-wall and into the embankment so that a direct comparison of the scour depth to sheet pile embedment can be made.

Figure A-22: Measurement of scour trench dimensions at the IHNC – South site.
