CHAPTER TEN: ENGINEERING OVERVIEW; EARTHEN LEVEES AND FLOODWALLS

10.1. Overview

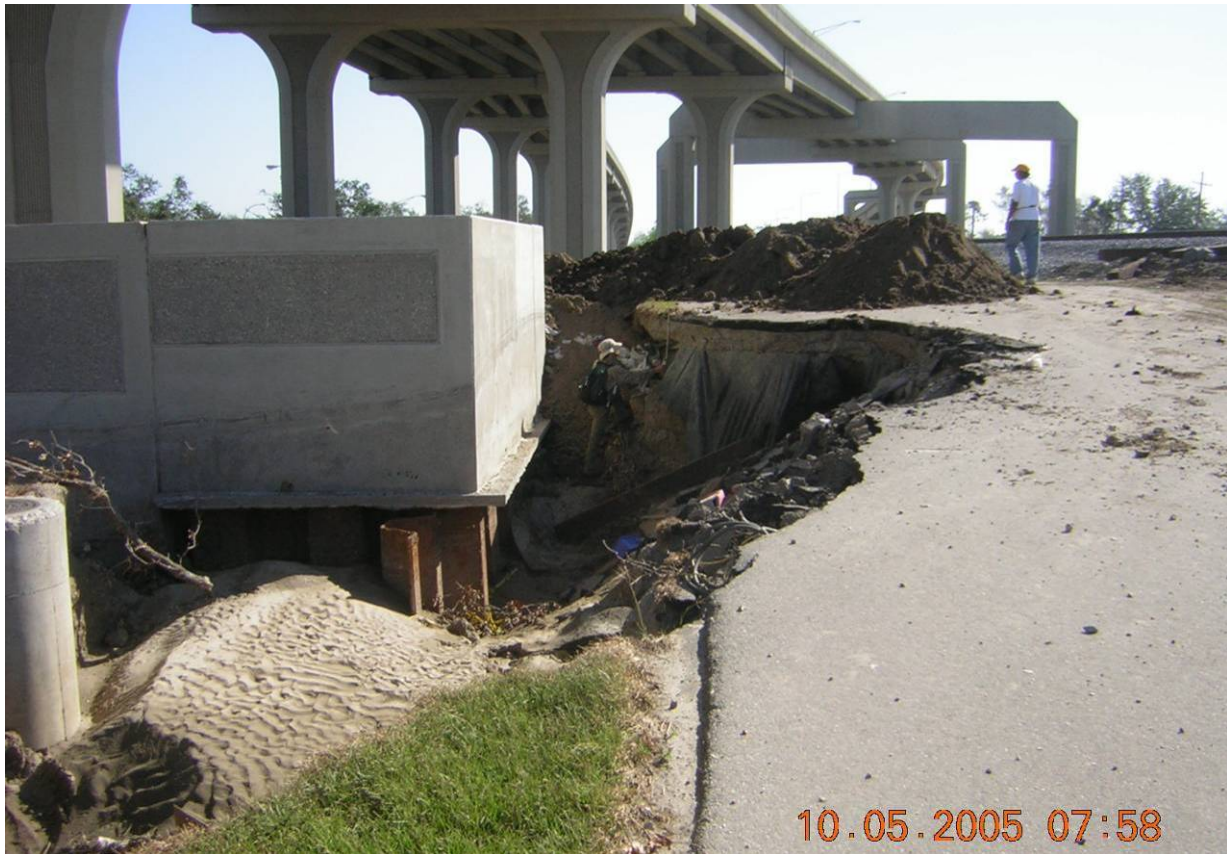
Figure 10.8: Lakefront levee near the Lakefront Airport at location 1 (as indicated on Figure 10.7) where overtopping occurred and significant scour around the floodwall was observed.

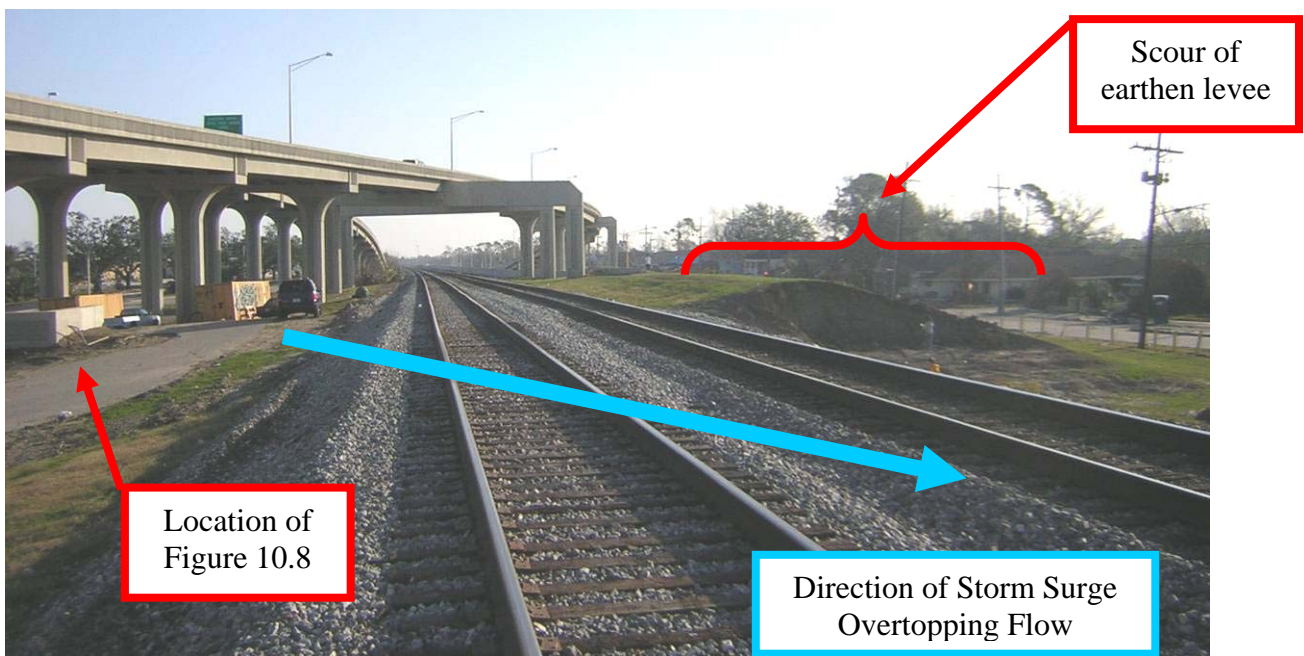
Figure 10.9: Significant erosion was observed on the levee behind the floodwall shown in Figure 10.8. The storm surge overtopped the floodwall and railroad ballast and failed the earthen levee.

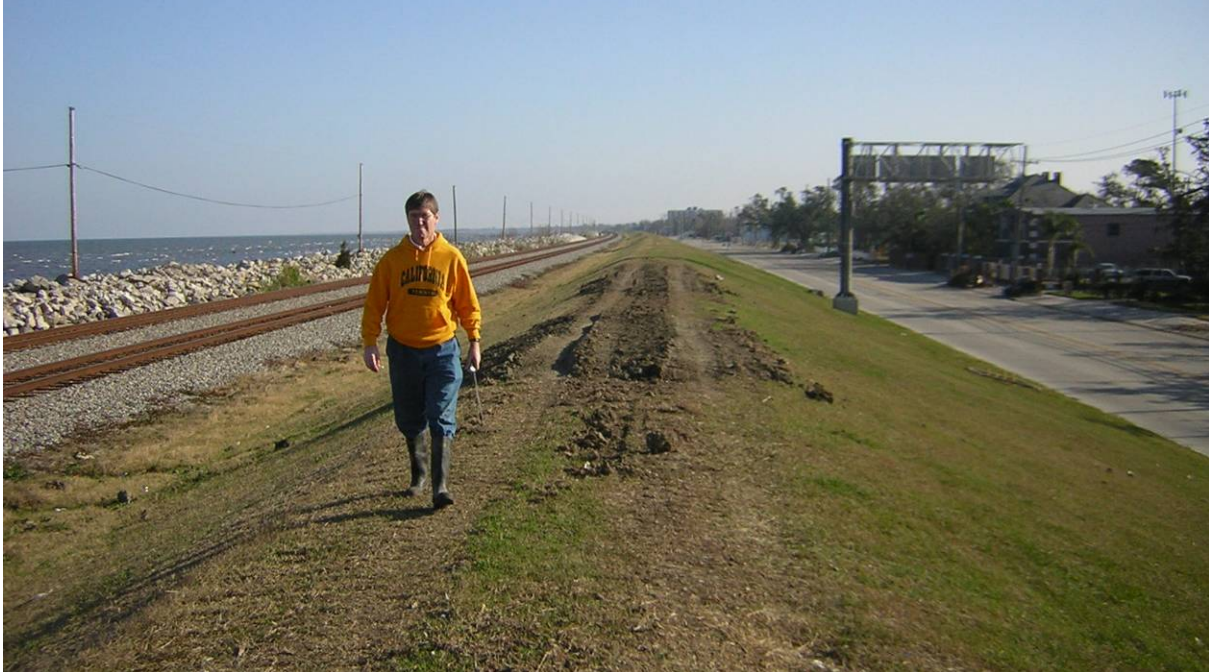
Figure 10.10: Lakefront levee at location 2 (as indicated on Figure 10.6) where minor overtopping occurred. These levees performed well and only minor, surficial damage was observed.

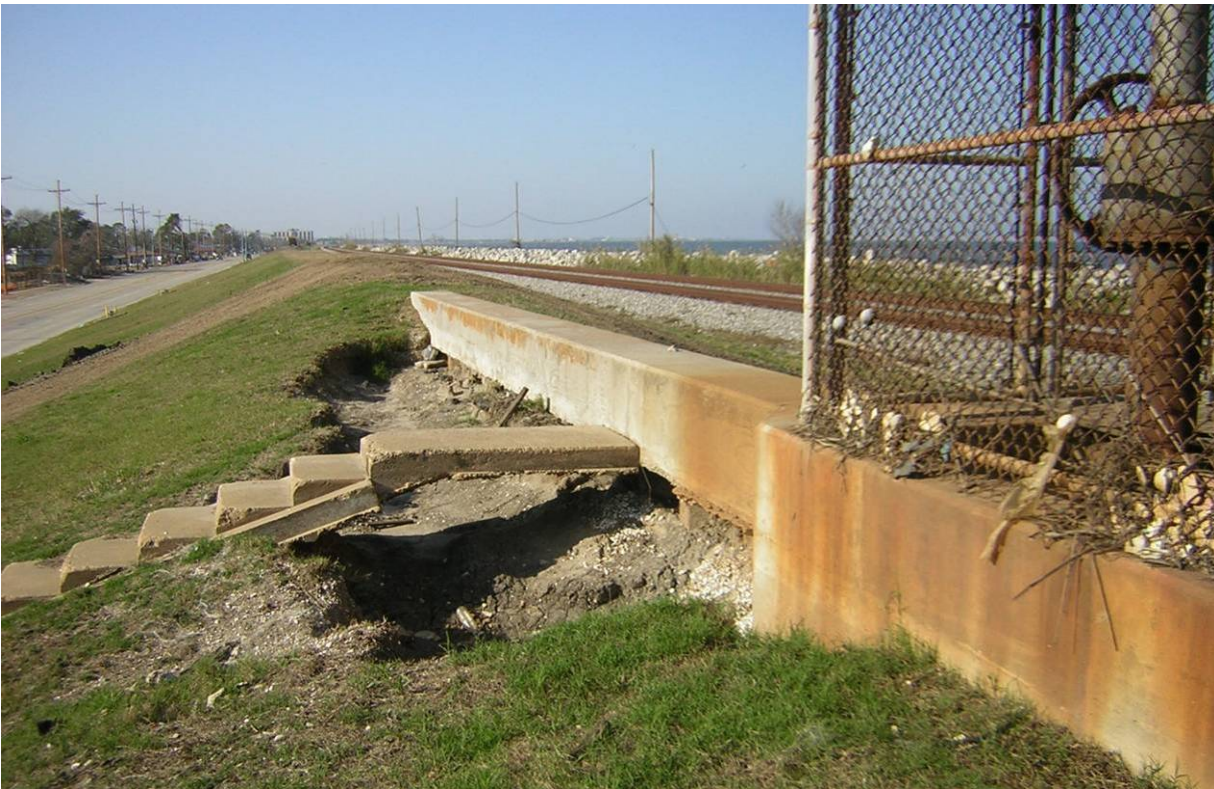
Figure 10.11: Observed scour at the Jahncke Pump Station outfall structure (location 2 as indicated on Figure 10.6). Scour was limited to areas of soil-structure interfaces, and no full breach occurred.

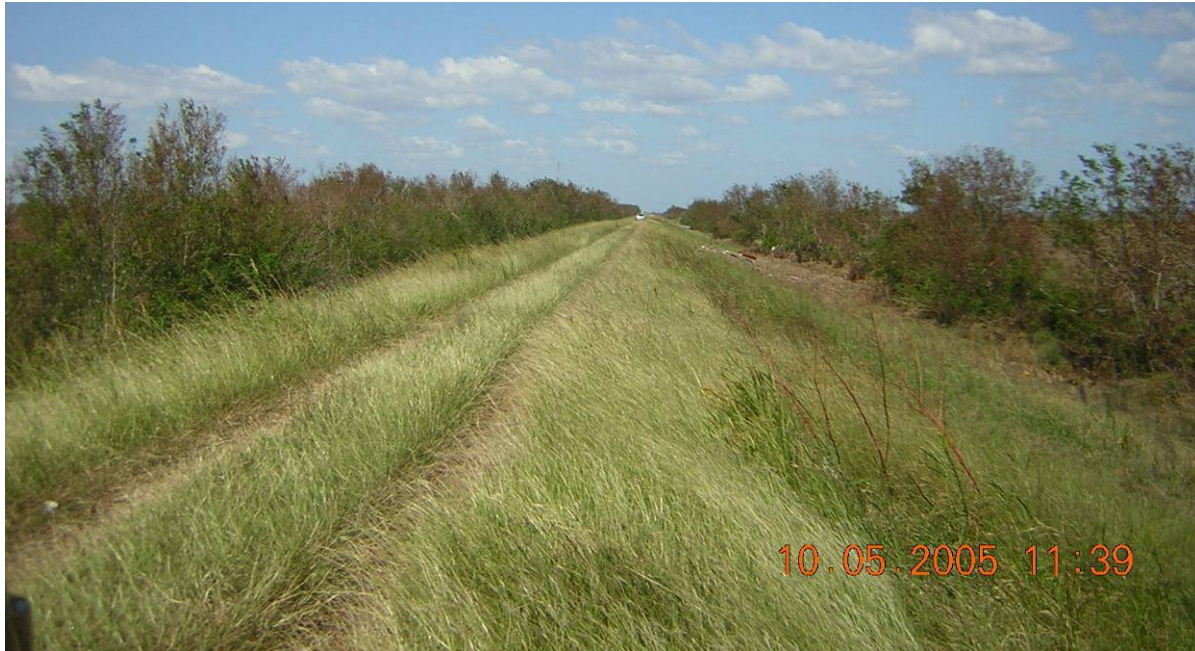
Figure 10.12: Condition of levees east of HWY 11 (location 3 on Figure 10.6) in October 2005. These levees performed exceptionally well and were not eroded during Hurricanes Katrina or Rita.

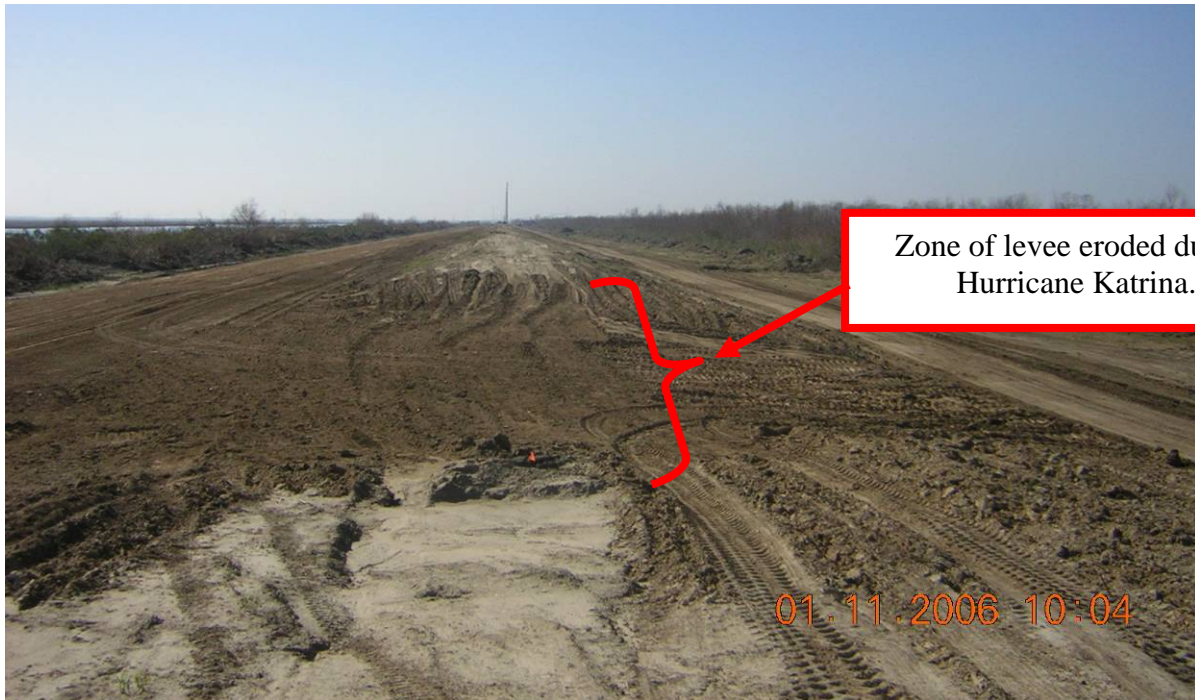
Figure 10.14: Zones of earthen levees at the southeast corner of the New Orleans East polder (location 4 on Figure 10.6) were washed out during Hurricane Katrina allowing water to rush in.

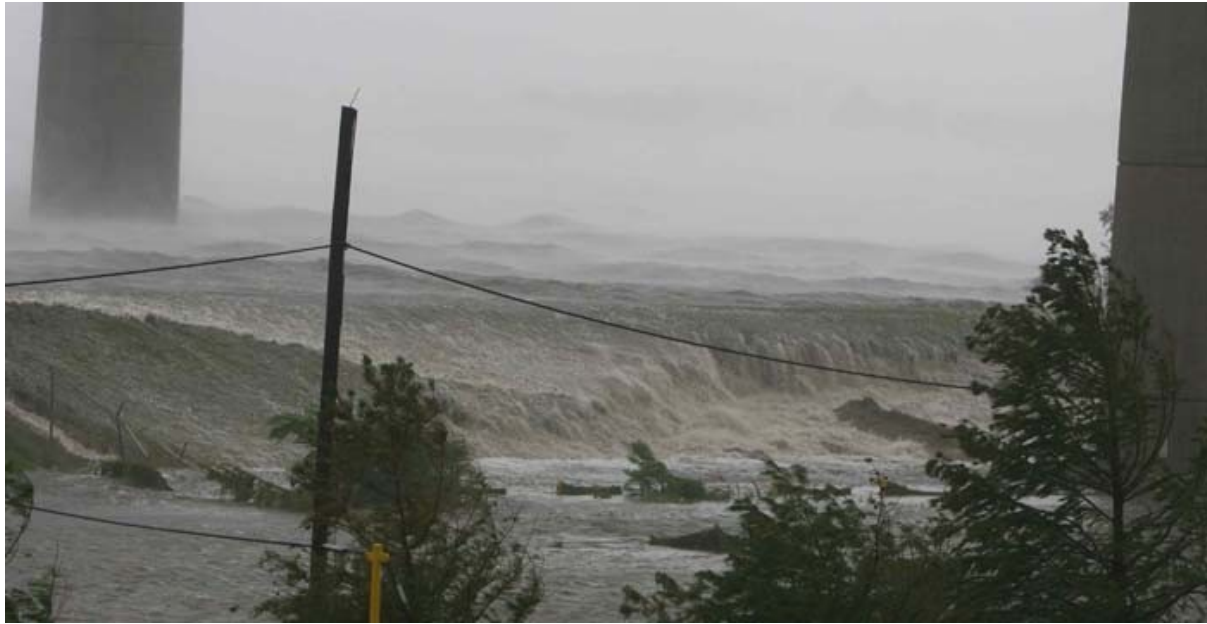
Figure 10.16: Photographs (location 5 on Figure 10.6) captured by a security camera at the Entergy Michoud Generating Plant beneath Route 47, on the IWW/MRGO show active overtopping during Hurricane Katrina.

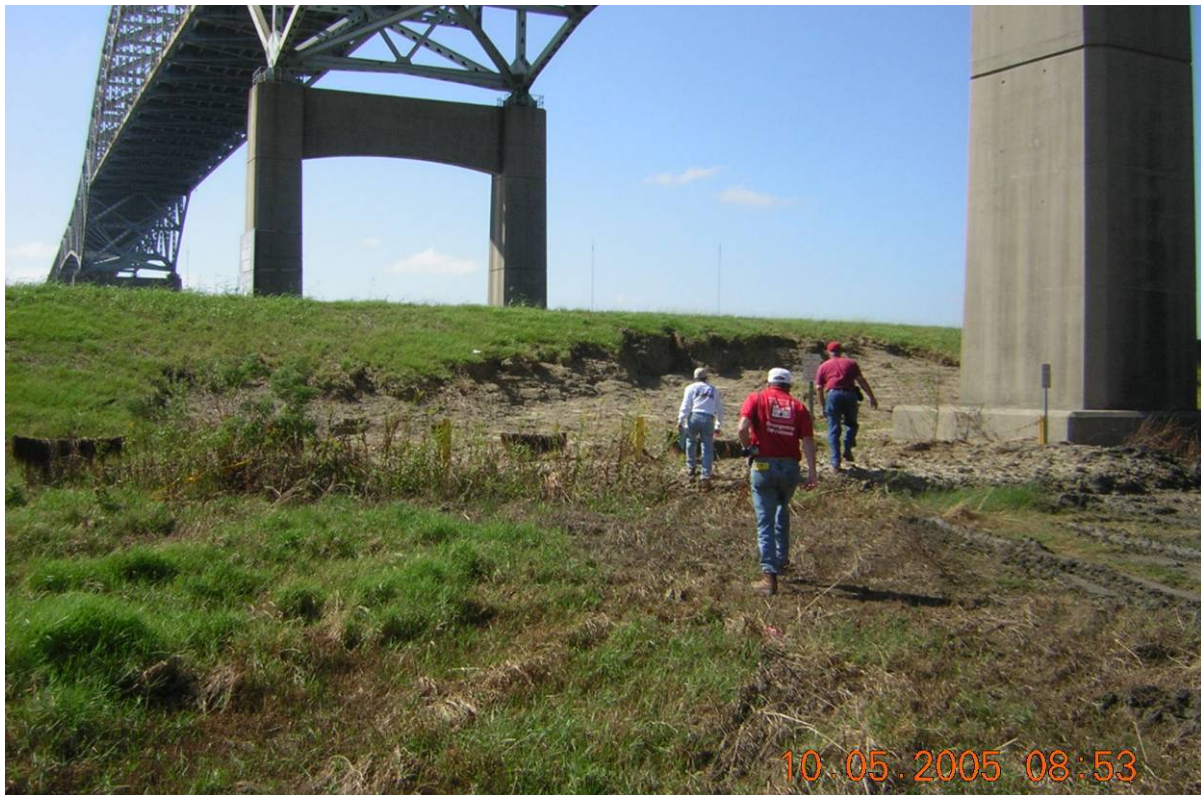
Figure 10.17: Post Hurricane Katrina view of the earthen levee shown in Figure 10.16. Only minor damage on the protected side was observed, with the majority of the damage a result of wave reflection from the bridge abutment at the right-hand side of the picture.

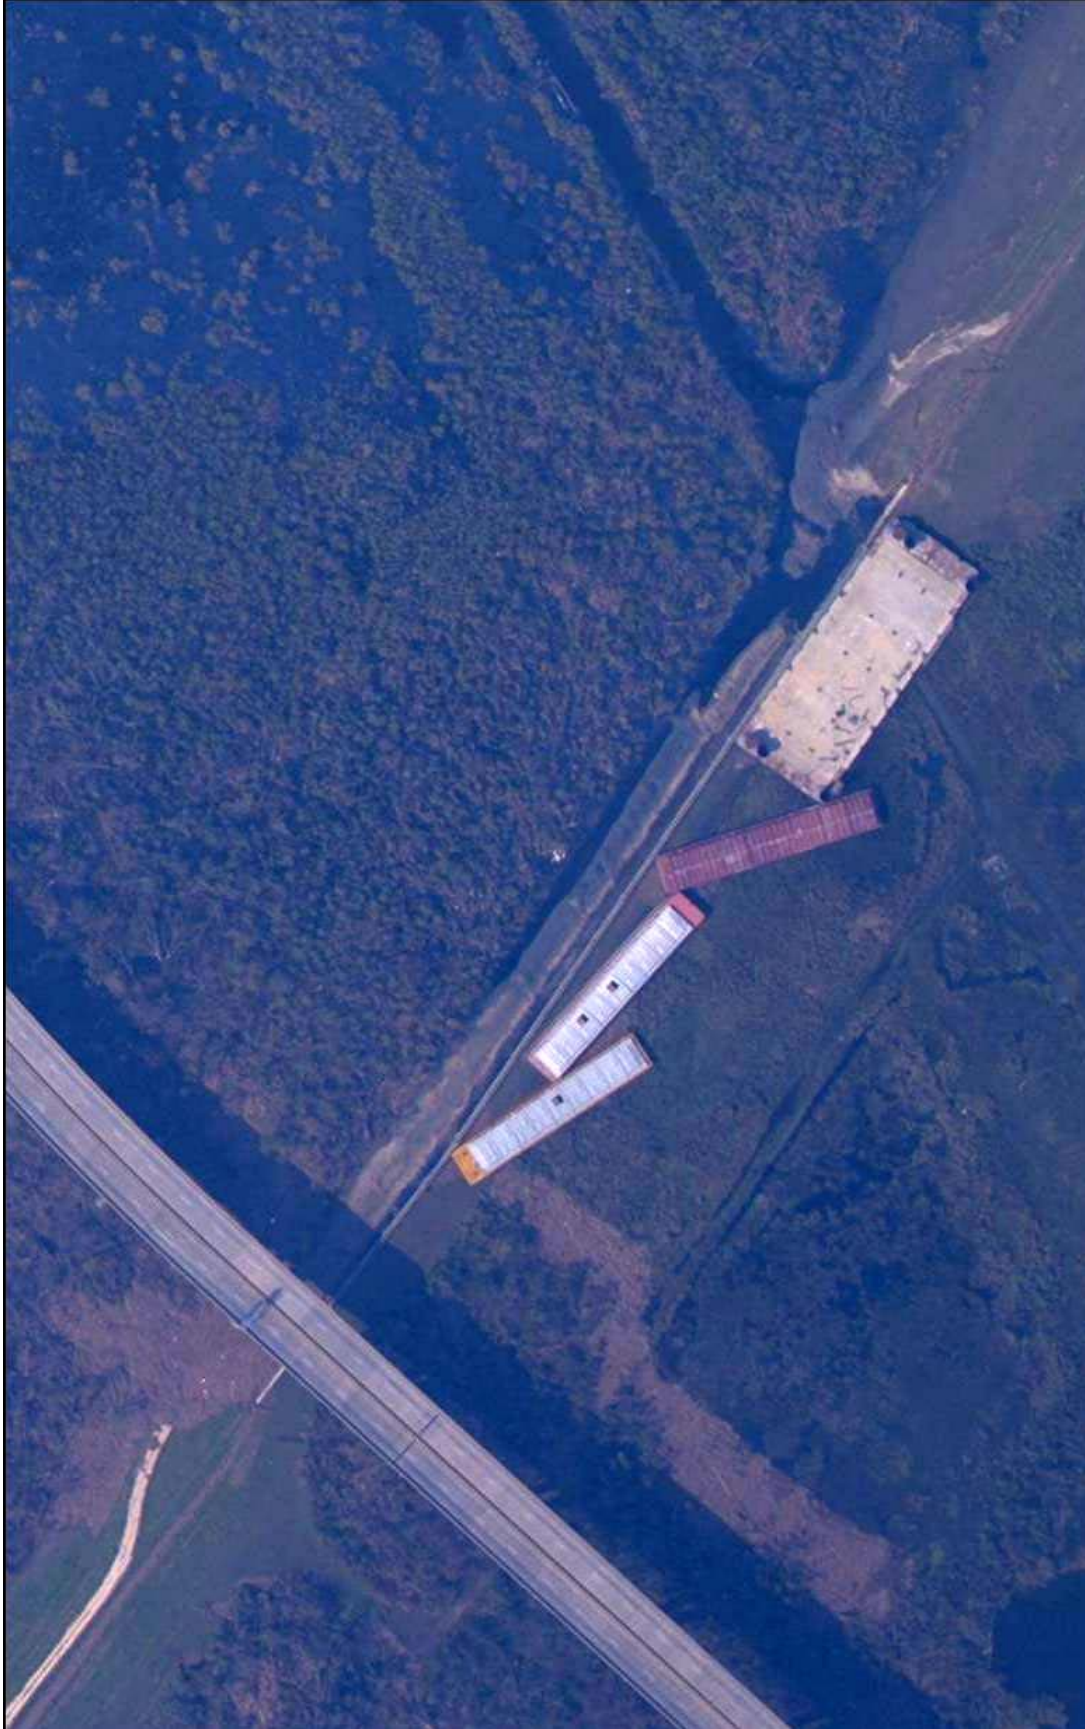
Figure 10.18: The presence of a concrete floodwall beneath the Hwy 47/Parish Road Bridge acted as a weir during the overtopping stages of the storm and “sucked” in nearby barges. Scour can be observed behind the concrete floodwall, but there is only minor scour damage visible at the earthen levee/concrete floodwall transition. Overall, this system performed well (also considering the impact associated with the barges).

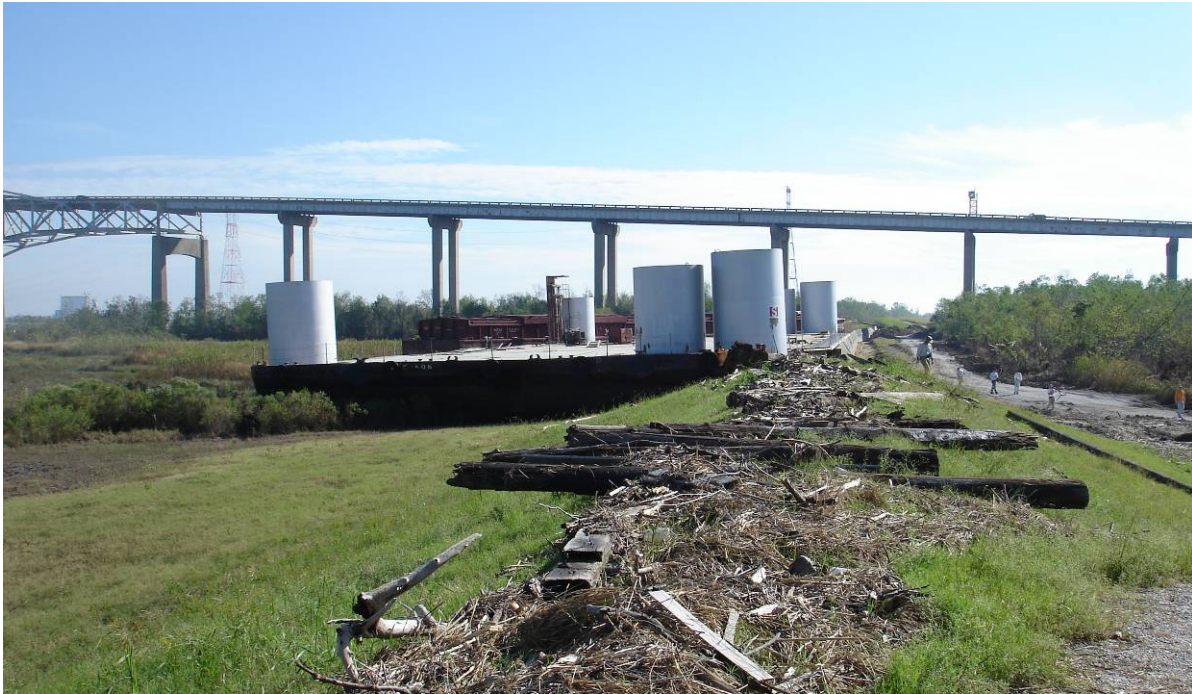
Figure 10.19: Woody debris and steel barges “washed up” on the southern ICWW/MRGO levee just west of Route 47 (location 6 on Figure 10.6). This is a side view from the aerial photograph presented in Figure 9.24.

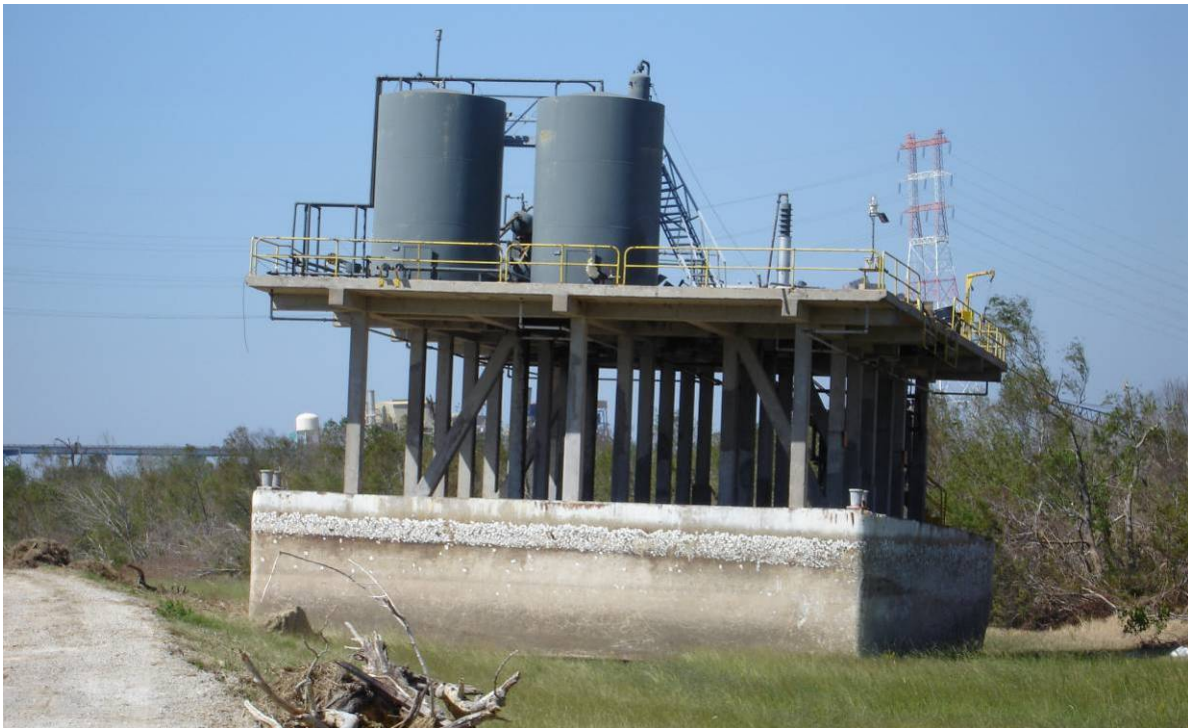
Figure 10.20: A gas processing barge “washed up” on the southern IWW/MRGO levee just east of Route 47 (location 6 on Figure 10.6). This levee was also overtopped and was not significantly damaged by the barge impact.

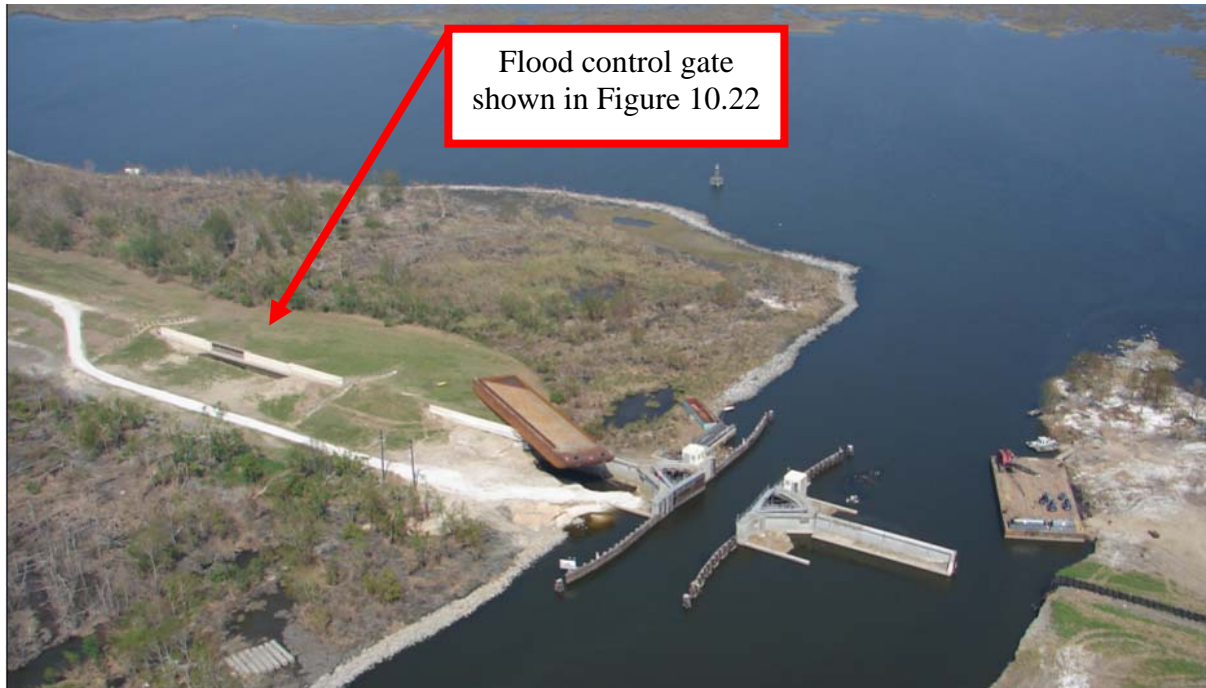
Figure 10.21: Aerial photograph of the Bayou Bienvenue Control Structure (location 7 on Figure 10.6). The northwestern half of the control structure levee system performed extremely well (withstanding significant impact loads from the steel barge), while the southeastern portion suffered severe erosion.

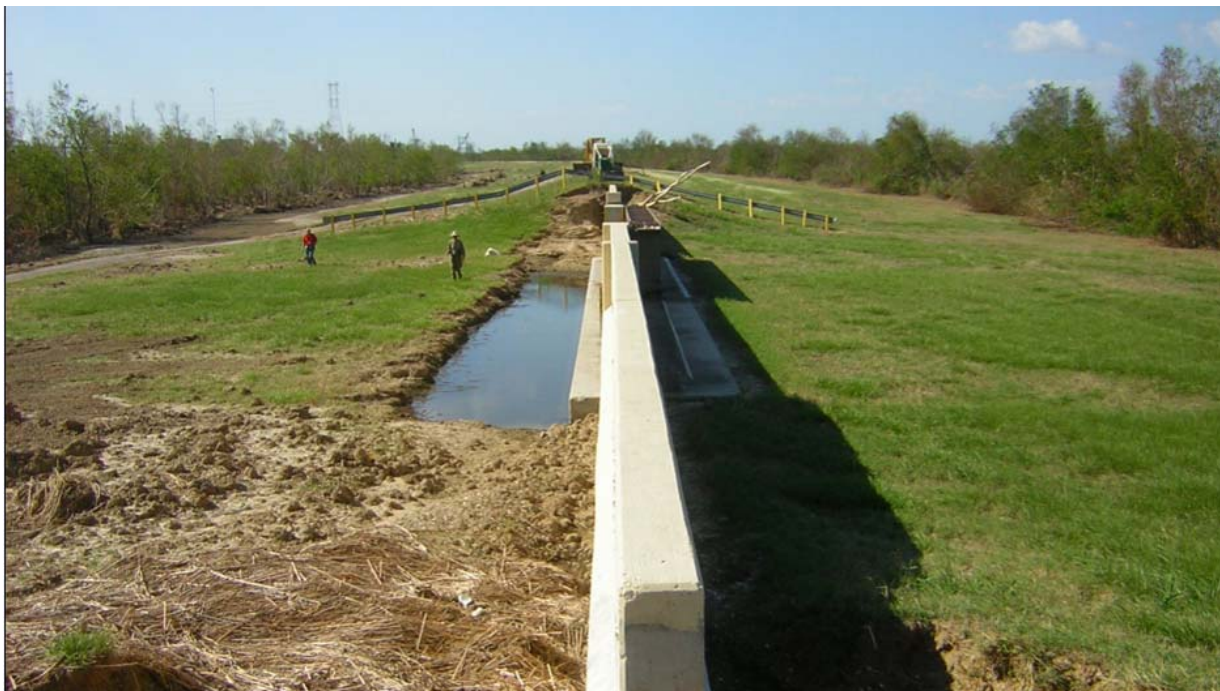
Figure 10.22: This flood control gate acted like a weir as water overtopped the structure during the storm surge. Significant scour and erosion was observed around the flood control gate structure.

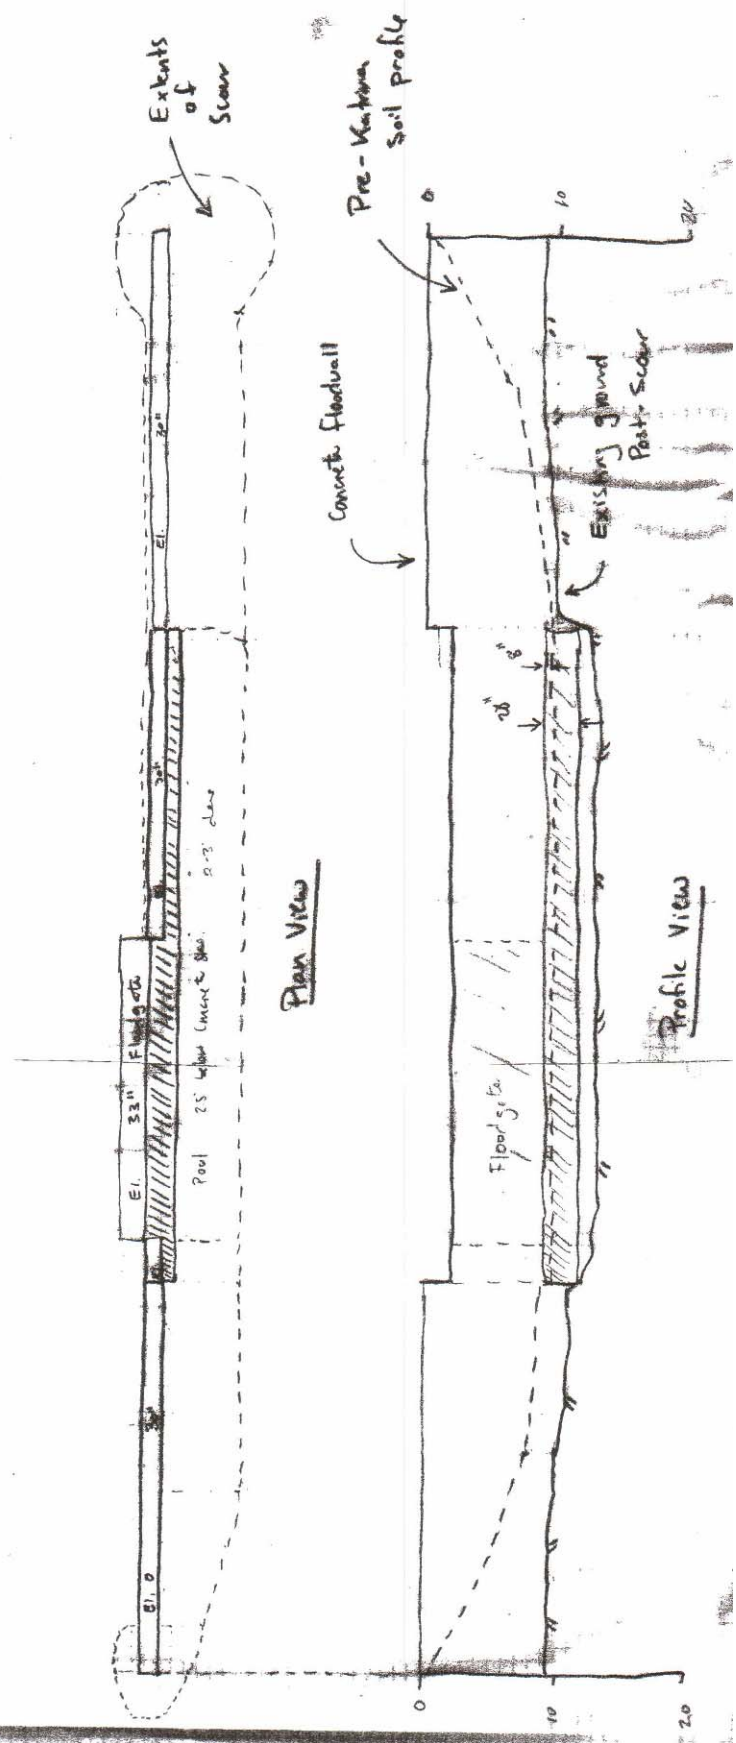
Figure 10.25: Scour pattern behind around the floodgate structure at the Bayou Bienvenue Control Structure shown in Figure 10.22.

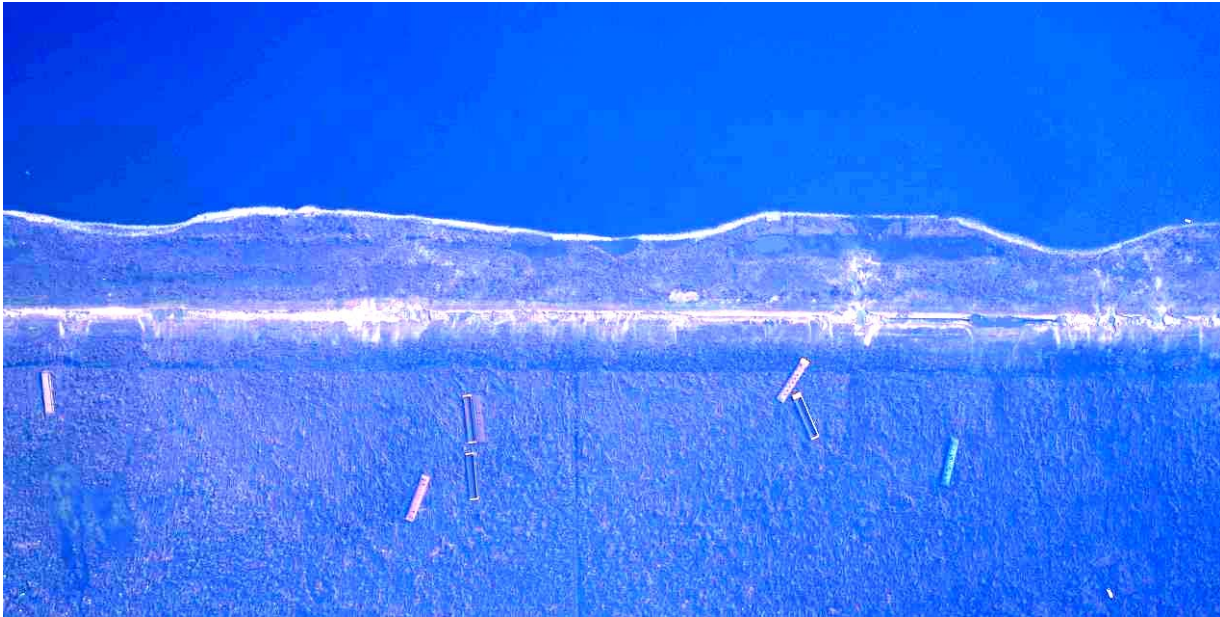
Figure 10.27: Aerial photograph taken by NOAA in early September 2005 along the MRGO showing severe erosion/breaches of the earthen levee and transport and deposition of large barges over the levee as a result of the storm surge (location 8 on Figure 10.6).

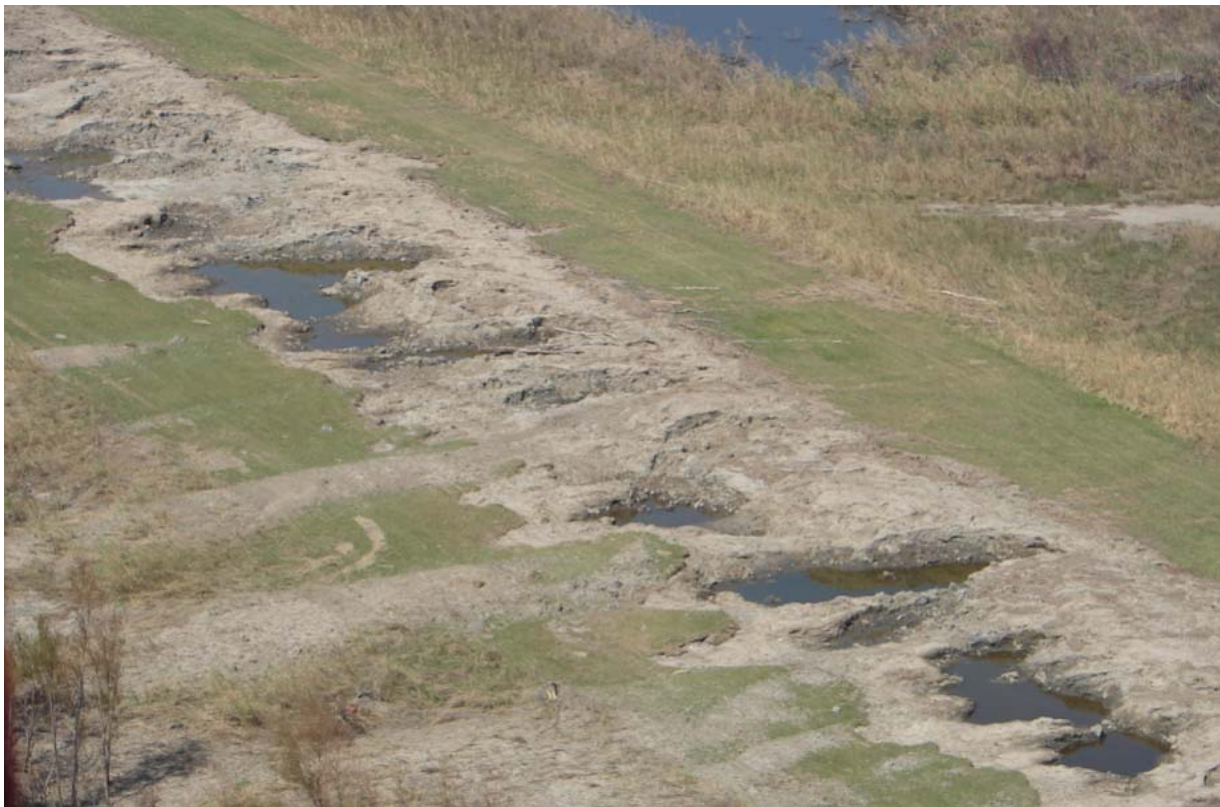
Figure 10.28: Close up aerial photograph of severely eroded MRGO levees at location 8 on Figure 10.6.

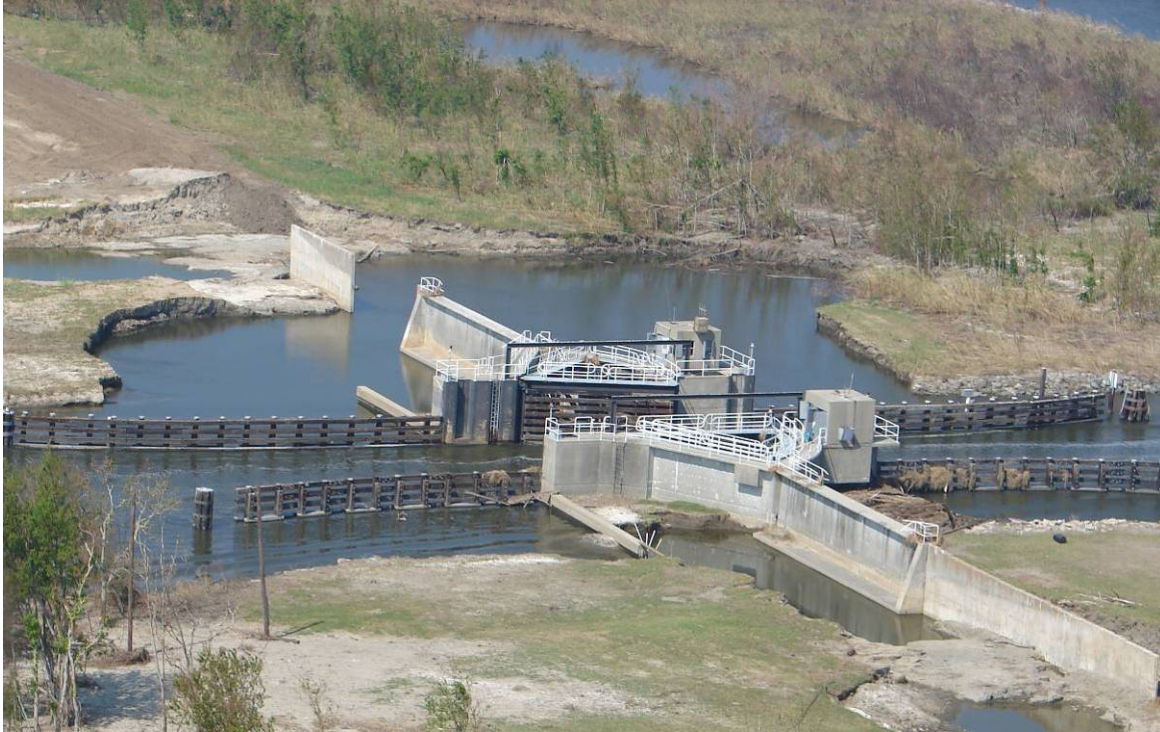
Figure 10.29: Control structure at Bayou Dupre (location 9 on Figure 10.6) suffered extensive scour and erosion during the storm surge and overtopping conditions associated with Hurricane Katrina.

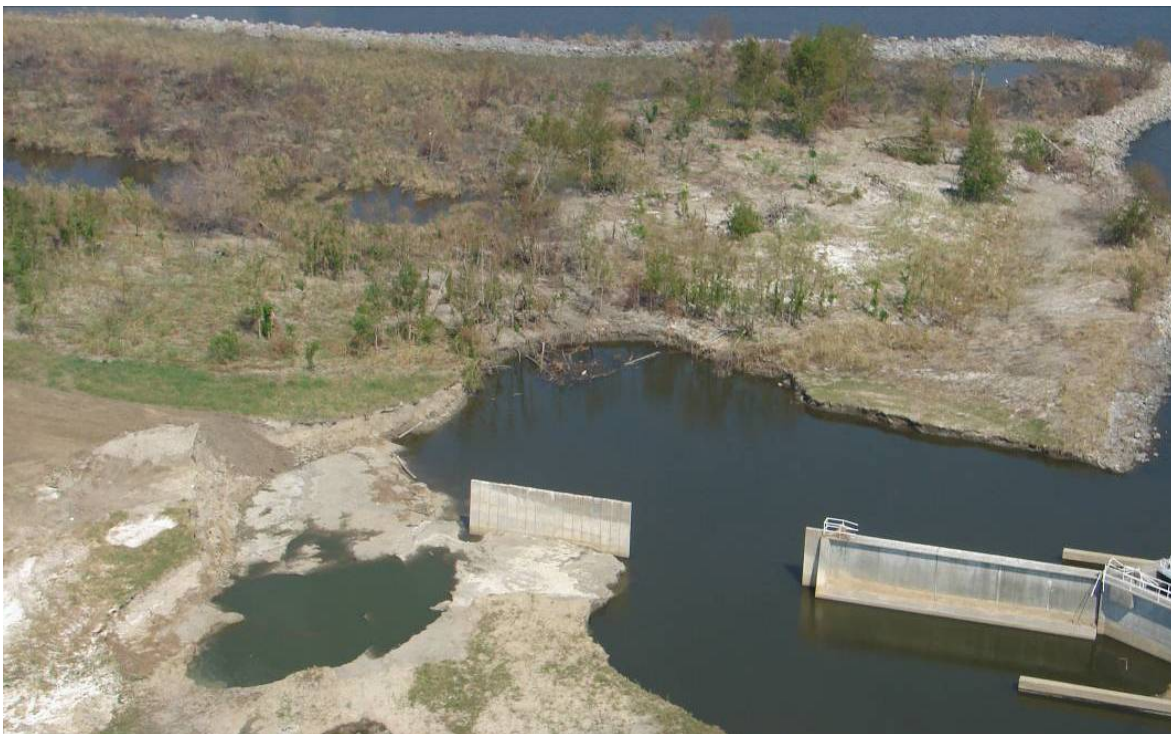
Figure 10.30: Another aerial photograph of the scour and erosion damage to the Bayou Dupre control structure.

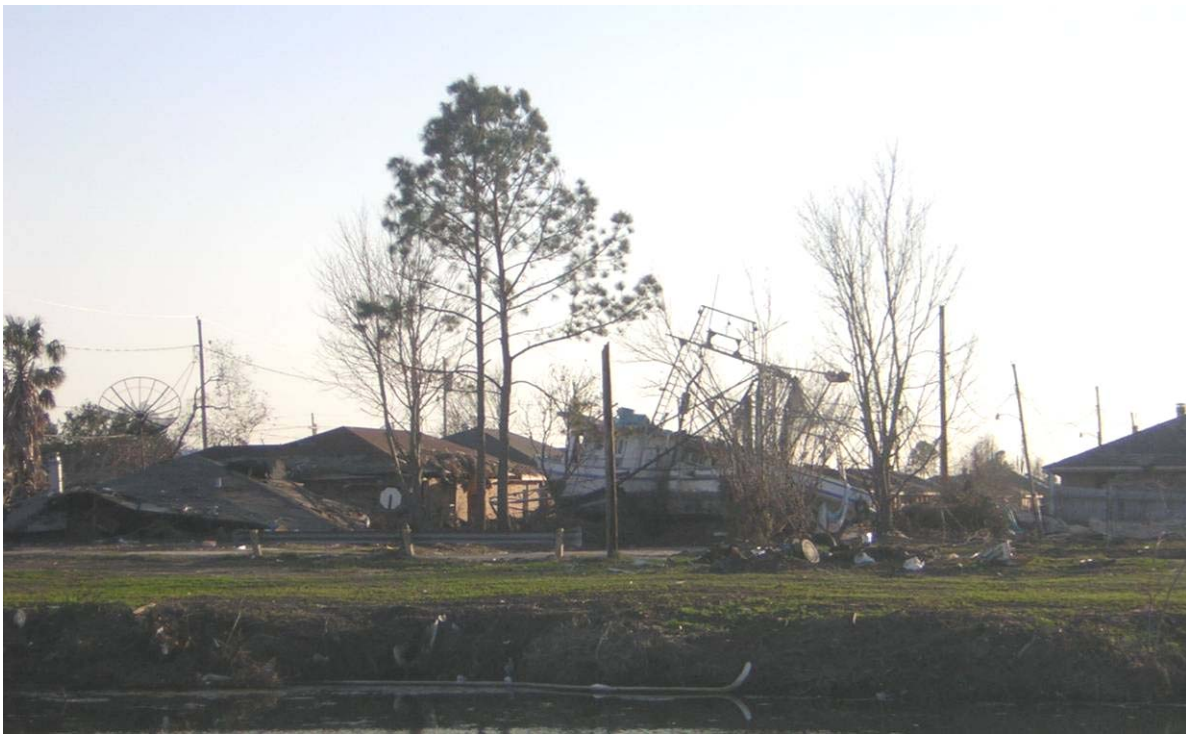
Figure 10.35: A fishing boat was washed over the levee shown in Figure 10.34 and landed in this Chalmette residential neighborhood within St. Bernard Parish.
