CHAPTER ELEVEN: SUMMARY OF ENGINEERING LESSONS

11.1 Introduction

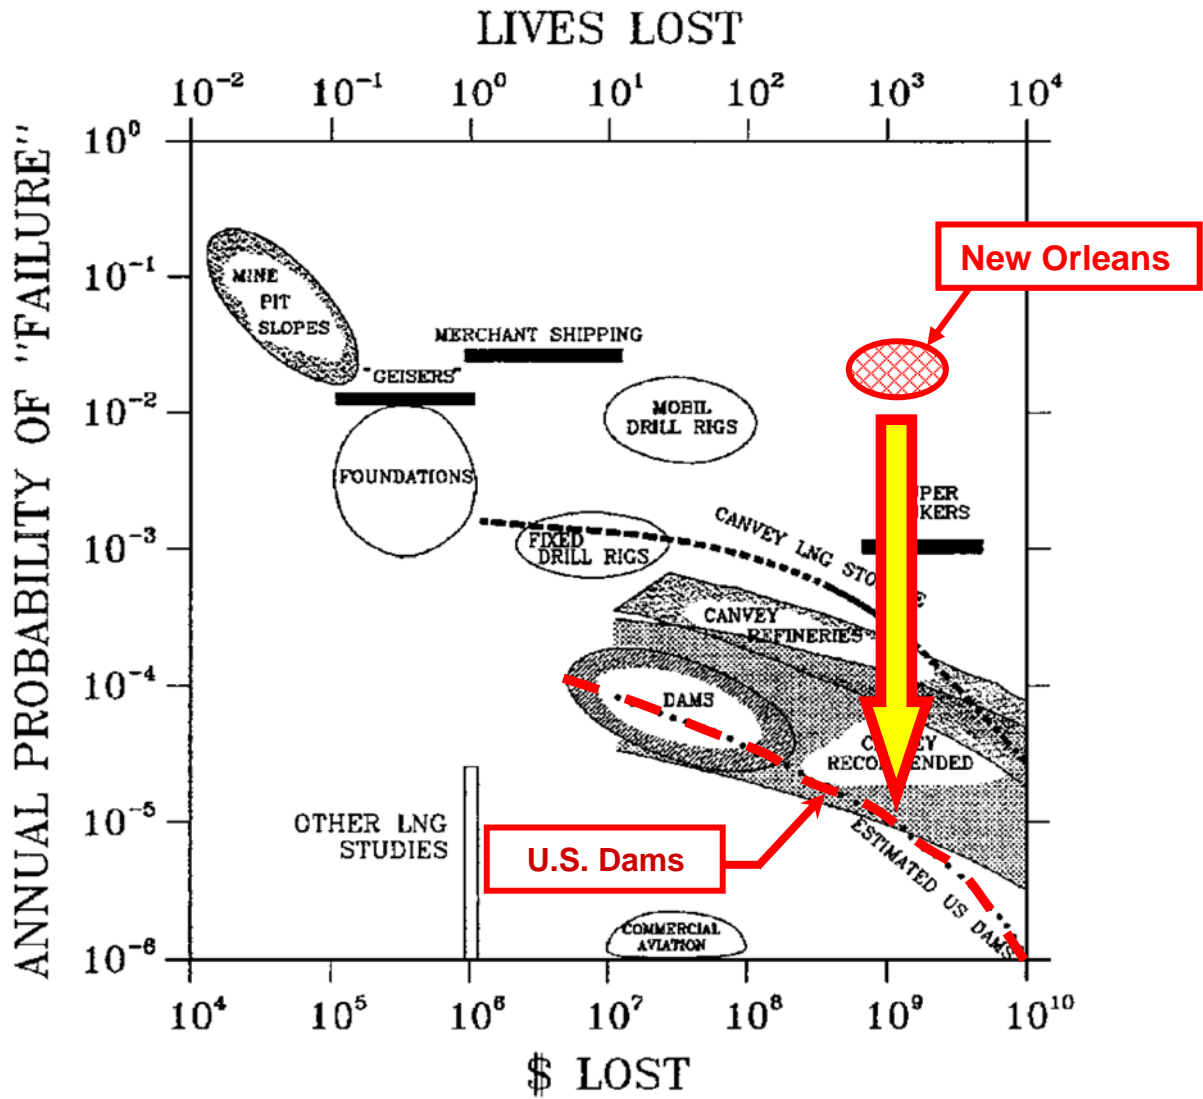
Figure 11.1 shows a “risk plot” with the vertical axis representing the annual likelihood of failure, and the horizontal axis representing the expected cost of such failure either in dollars (bottom axis) or in lives lost (top axis). This figure shows the ranges of risk, or reliability, representing common practice for a number of areas of human endeavor. Highlighted with a heavy red dashed line near the bottom is current U. S. practice in the field of dam engineering.

Also shown on this plot is our investigation’s view of the level of reliability associated with the New Orleans regional flood protection systems prior to hurricane Katrina. Our best estimate, based on information currently available, and given the targeted design levels and the flaws and vulnerabilities embedded in the system, is that the pre-Katrina system was likely to fail catastrophically approximately every 30 to 75 years. The cost of the failure (in hurricane Katrina) was on the order of \$100 to \$200 billion in losses, and approximately 1,500 lives were lost.

As indicated by the large arrow in Figure 11.1, the difference between the level of risk (or reliability) of the New Orleans regional flood protection systems and conventional U.S. dam practice is approximately three orders of magnitude; a factor of roughly 1,000 times safer and more reliable. Reliability is a function of two sub-elements: (1) the targeted level of

Figure 11.1: Risk plot showing the estimated pre-Katrina risk associated with the New Orleans regional flood protection system, and customary risk levels for current U.S. Practice with dams.

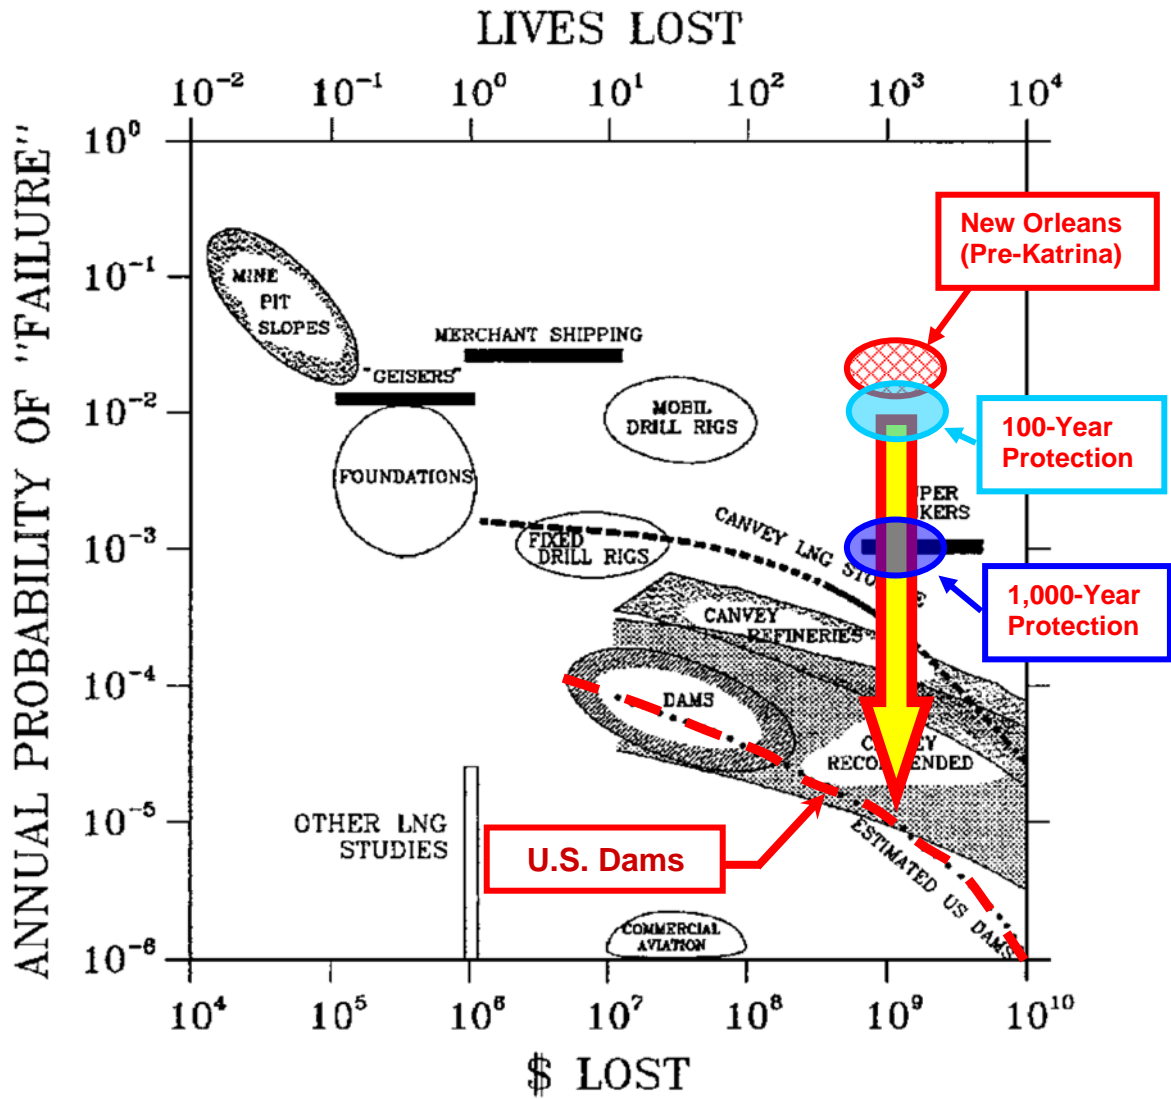
Figure 11.2: Risk plot showing the estimated pre-Katrina risk associated with the New Orleans regional flood protection system, and customary risk levels for current U.S. Practice with dams. Also shown are projected New Orleans risk levels for “successful” 100-year and 1,000-year storm and flood design.

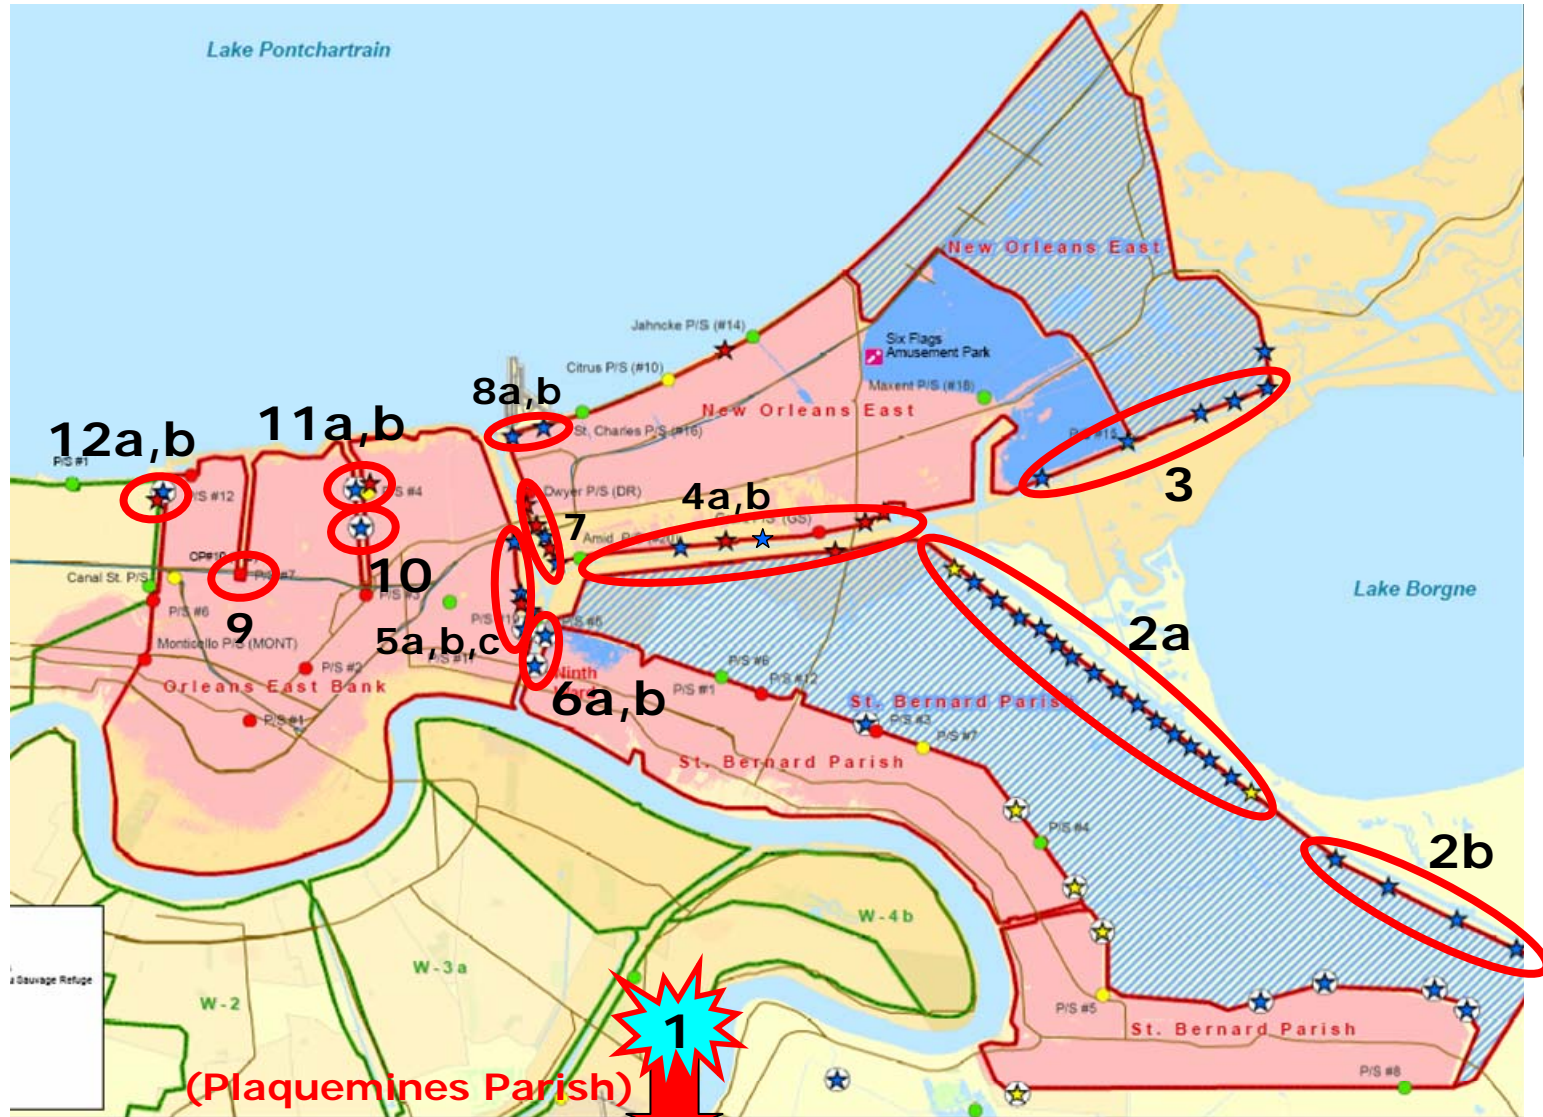
Figure 11.4 shows an overview of the New Orleans area, indicating the locations of the principal failures, breaches, and distressed sections of the New Orleans regional flood protection system studied in this investigation. Plaquemines parish (along the lower reach of the Mississippi River) is not included in this figure; instead it is indicated by the large arrow at the bottom. The individual features, and groups of features, in Figure 11.4 are numbered for purposes of discussion. Table 11.1 presents a summary of issues at each of these locations, using the same numbering scheme as Figure 11.4.

Two breaches occurred along the north bank of this channel, at Sites #4a and #4b in Figure 11.4 (and Table 11.1.) The first of these (Site #4b) was a breach at an inadequate “transition” between a long reach of full height earthen levee as it joined (abutted) a mid-rise earthen levee reach with a sheetpile-supported concrete floodwall at its crest. The transition between these two adjacent project sections was a simple sheetpile wall, of lesser height than either the earthen levee to the west, or the floodwall section to the east. As a result, overtopping was most severe over the top of the short sheetpile wall transition section, and this overtopping preferentially eroded a deeply scoured trench at the rear side of the sheetpile wall. This, in turn, reduced the lateral support at the back side of the sheetpile wall section, and the laterally unbraced sheetpile wall was then pushed sideways by the storm surge water pressures on its front (outboard) side, and it failed.

The second breach along this frontage (Site #4a) was a failure of a concrete floodwall. This floodwall was mainly a simple sheetpile-supported I-wall, but it had two short sections of T-wall with battered piles to provide increased rotational and lateral support. The T-wall sections performed well, but major lengths of the I-wall did not. The walls were overtopped, and the water cascaded over the walls and eroded trenches at the back sides of the walls. This, in turn, laterally unbraced the walls and some sections were laterally displaced while other sections rotated, some to a nearly fully horizontal position.

Two of the largest failures during hurricane Katrina were the pair of failures on the east bank of the IHNC, at the west end of the Lower Ninth Ward (Sites #6a and 6b.) These two major breaches were studied in detail, as presented in Chapter 6; Sections 6.3.1 and 6.3.2.

Figure 11.4: Summary of principal failures, breaches, and other locations of interest. (Blue stars mark breaches, red stars mark locations of distress.) [Base map provided by the USACE]
