CHAPTER TWO: OVERVIEW OF HURRICANE KATRINA AND ITS AFTERMATH

2.1 Hurricane Katrina

2.2 Overview of the New Orleans Flood Protection Systems

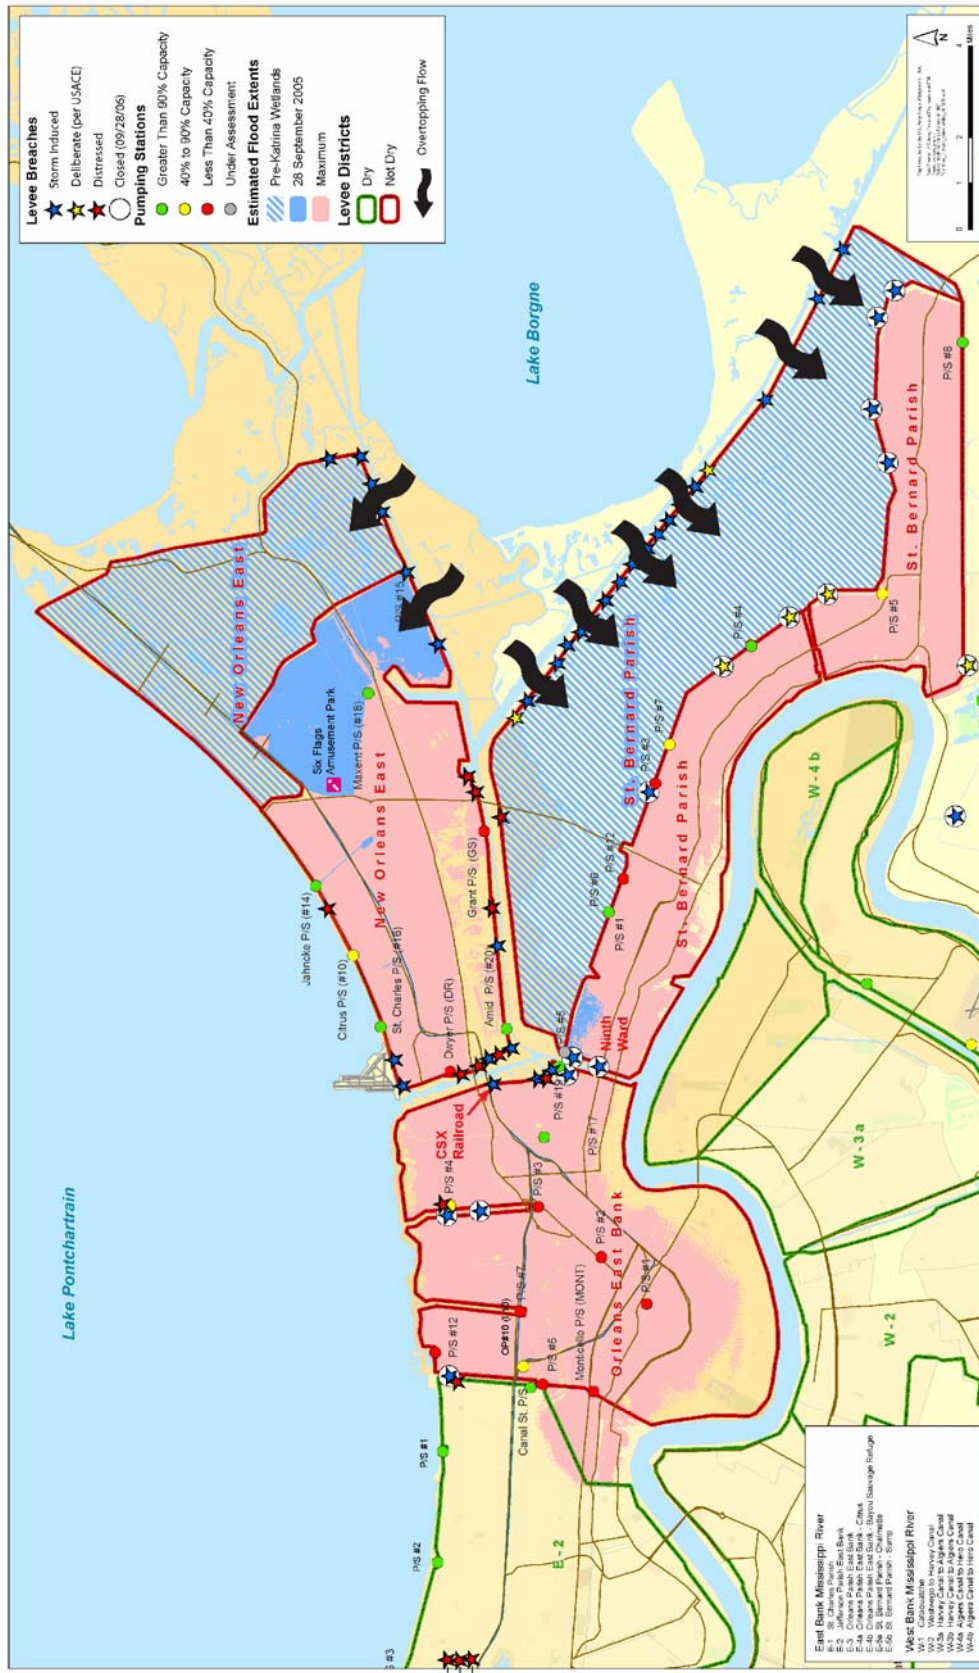
Based on analytical storm surge analyses and analytical “hindcasts” performed by various investigation teams, as well as eyewitness reports and timings of flooding and damages in St. Bernard Parish and the Ninth Ward, it is estimated that the storm surge passed over and through the MRGO levee frontage between approximately 6:00 to 7:00 a.m. The storm surge along the northeastern frontage of the St. Bernard Parish protected area peaked at approximately 7:30 to 8:00 a.m. (see Figure 2.9.) By the time the storm surge peaked along this important frontage, however, the unfinished “sand core” levees fronting Lake Borgne had been massively eroded and the brunt of the storm surge passed over and through the levees and raced across the undeveloped swamplands shown in Figure 2.11 towards the developed areas of St. Bernard Parish.

This is illustrated schematically in Figure 2.11. The levees along this frontage were so badly eroded, and so rapidly, that they did little to impede the passage of the storm surge which then crossed the roughly 7 to 10 miles of open swamp and reached the secondary levee that separates the northern (undeveloped) swampy section of this protected area from the populated southern section.

Figure 2.11: Storm surge overtopping the eastern flank of the regional flood protection system at the northeast edge of the St. Bernard Parish and Ninth Ward protected areas.

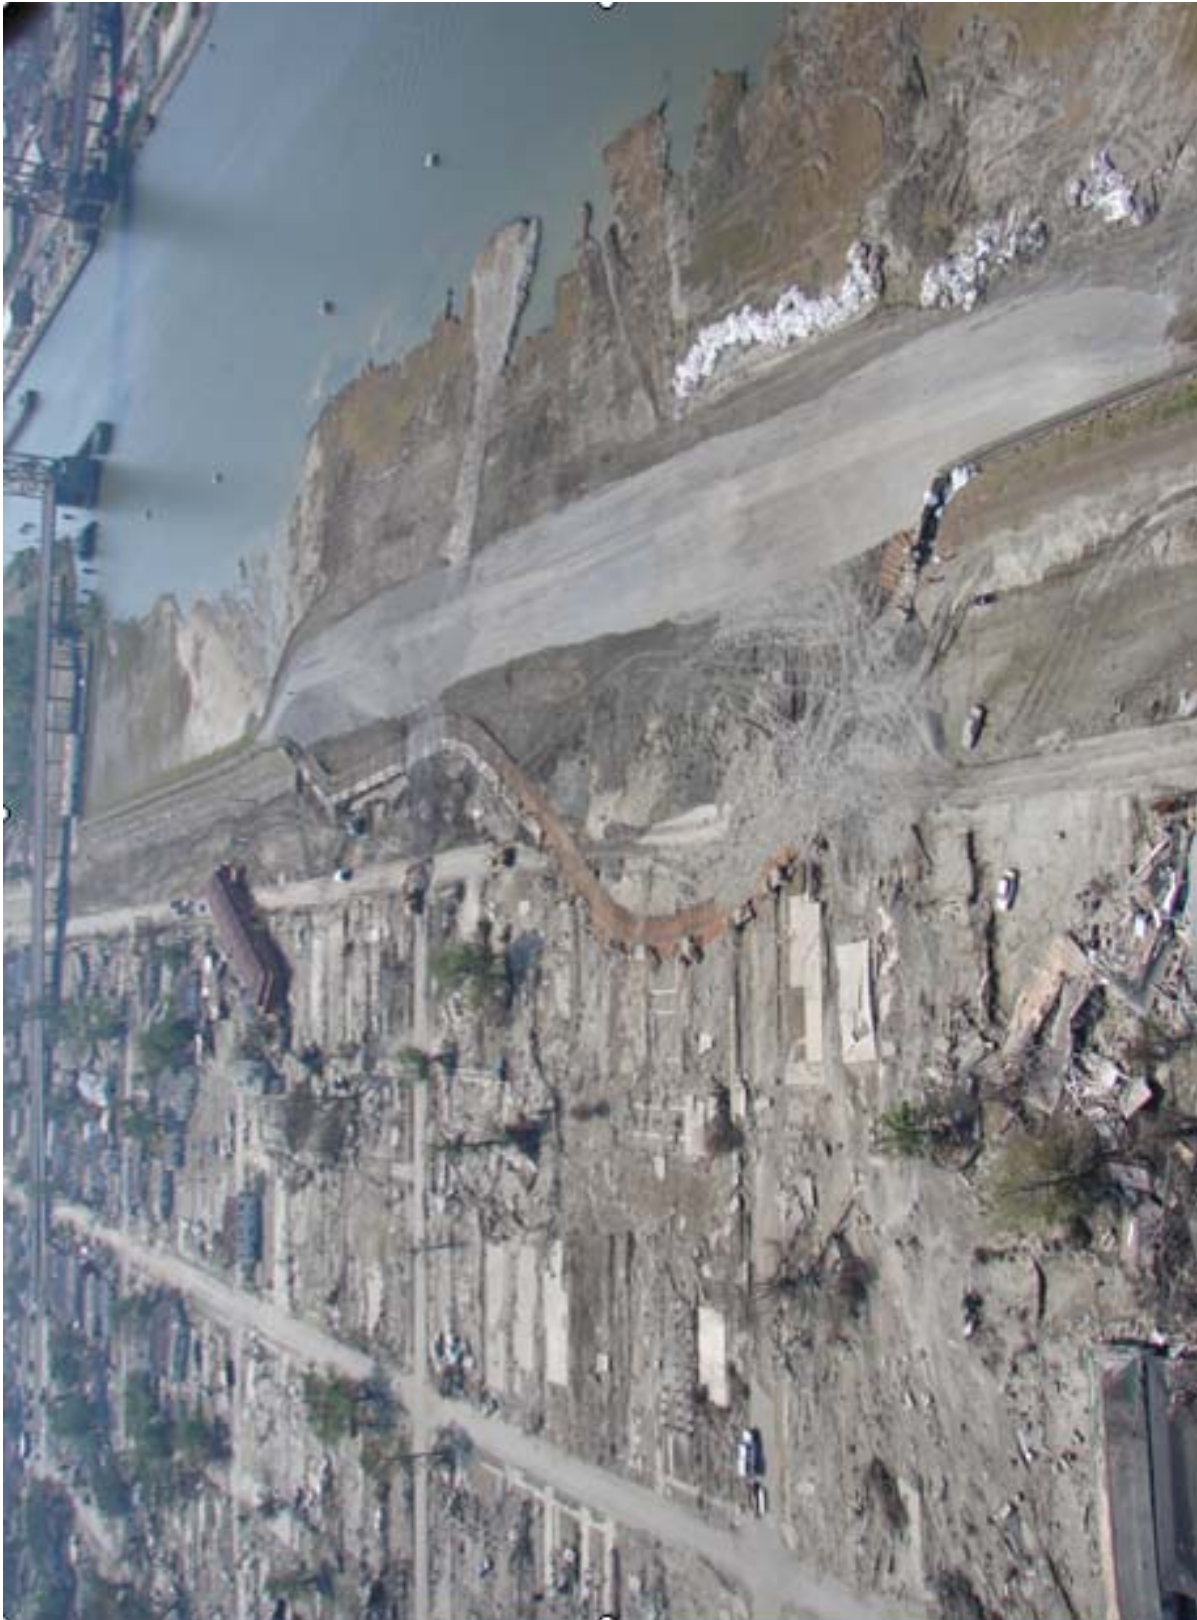
A pair of major breaches occurred at the west end of the Lower Ninth Ward as this overtopping occurred along the IHNC, and the larger of these two breaches is shown (roughly seven weeks later, after construction of an interim repair embankment just outside the breach) in Figure 2.13. A large barge passed in through this breach, and can be seen in the rear of the photo. It is worth noting the tremendous scour-induced damage to the homes immediately inboard of this massive breach; most of the homes in Figure 2.13 were washed off of their foundations and transported laterally (often in pieces) by the inrushing floodwaters. A more detailed examination of the two large breaches at the west end of the Ninth Ward is presented in Chapter 6; Sections 6.4 and 6.5. The large breaches at the west end of the Lower Ninth Ward appear to have occurred by approximately 7:45 a.m. (Louisiana State University Hurricane Center, 2006.)

Close to major breaches, the hydraulic forces of the inflowing floodwaters often had devastating effect on the communities. Figure 2.13 shows the devastation immediately inboard

from the large breach at the west end of the Ninth Ward site after the area had been unwatered. Note the numerous empty slabs where homes had been stripped away and scattered, mostly in pieces, across a large area.

Figure 2.13: Oblique view of the (south) levee break at the Inner Harbor Navigation Canal into the lower Ninth Ward.

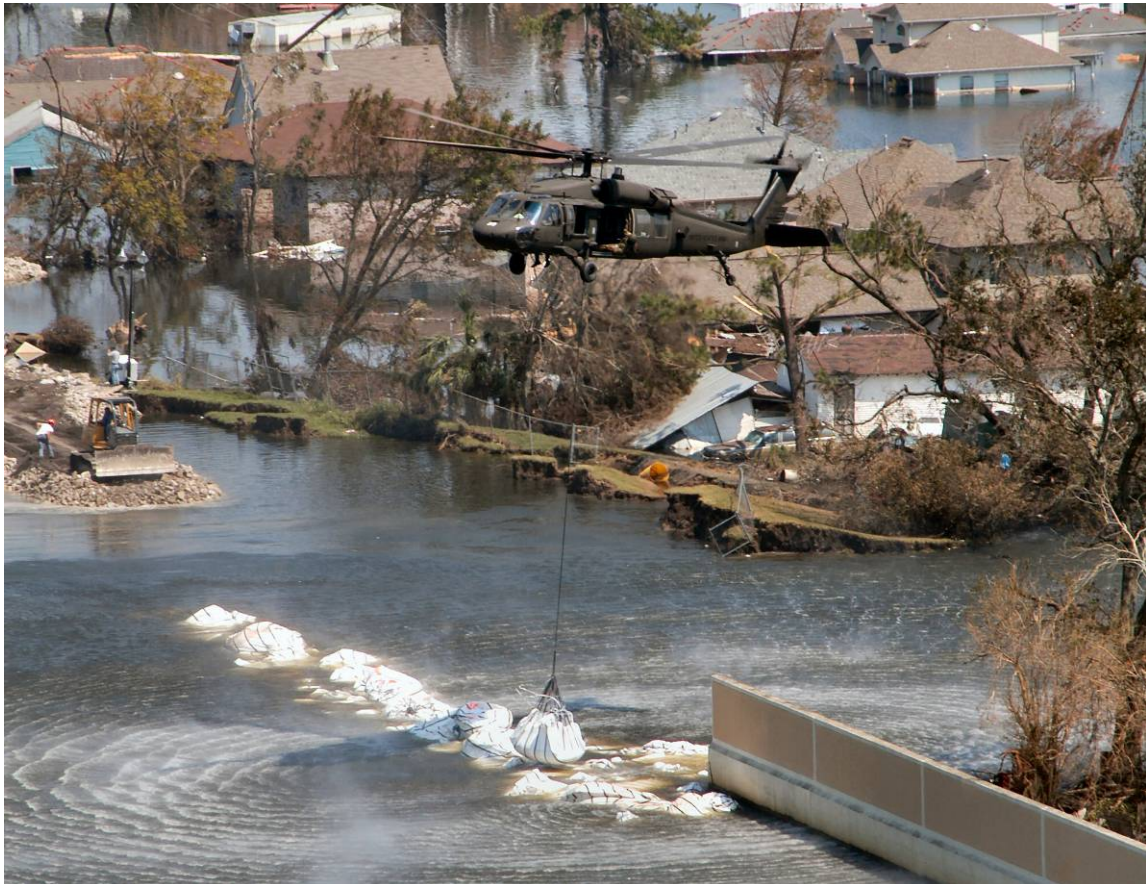
Figure 2.14: Initial closure of the large breach at the north end of the 17th Street Canal.

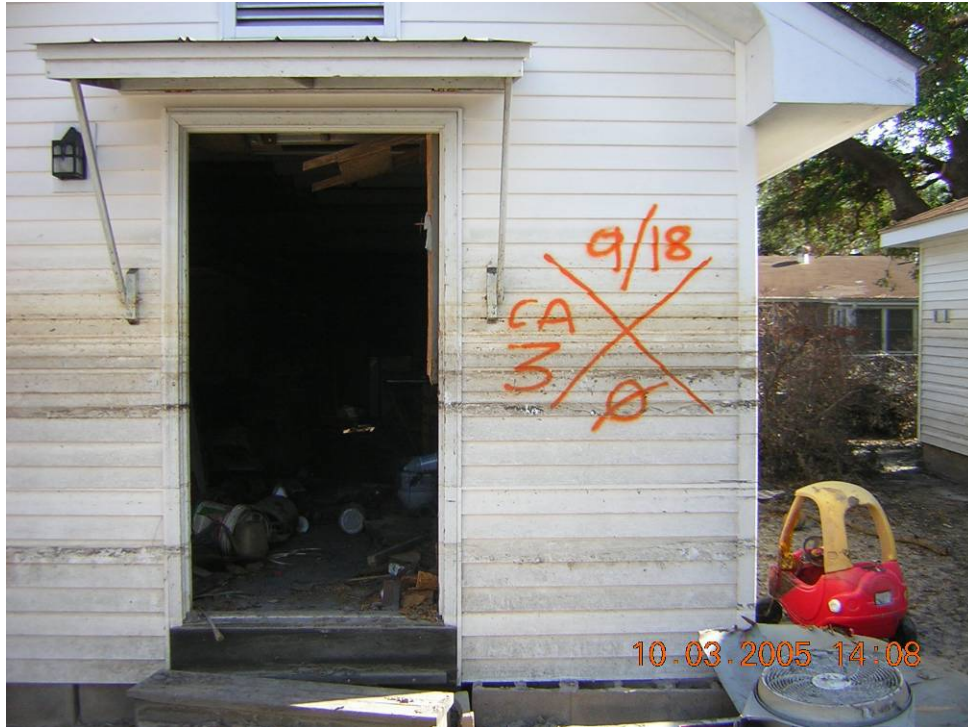
Neighborhoods that were inundated exhibit stark evidence of this catastrophic flooding. Water marks, resembling oversized bathtub rings, line the sides of buildings and cars in these stricken neighborhoods, as shown in Figure 2.18. Household and commercial chemicals and solvents, as well as gasoline, mixed with the salty floodwaters in many neighborhoods, and at the time of this investigation’s first field visits shortly after the event the paint on cars below the watermarks on adjacent buildings had been severely damaged, and bushes and shrubs were browned below the watermarks, but often starkly green above. Driving through neighborhoods that had been flooded, there was often the impression that one was viewing a television screen where the color of the picture was somehow distorted or altered below a horizontal line; the level at which the floodwaters had been ponded. The devastation in these neighborhoods, and its lateral extent across many miles of developed neighborhoods, was stunning even to the many experienced members of our forensic teams that had seen numerous devastating earthquakes, tidal waves, and other major disasters.

Figure 2.18: High water marks remain on structures after temporary levee repairs have been completed and flood waters have been pumped out.

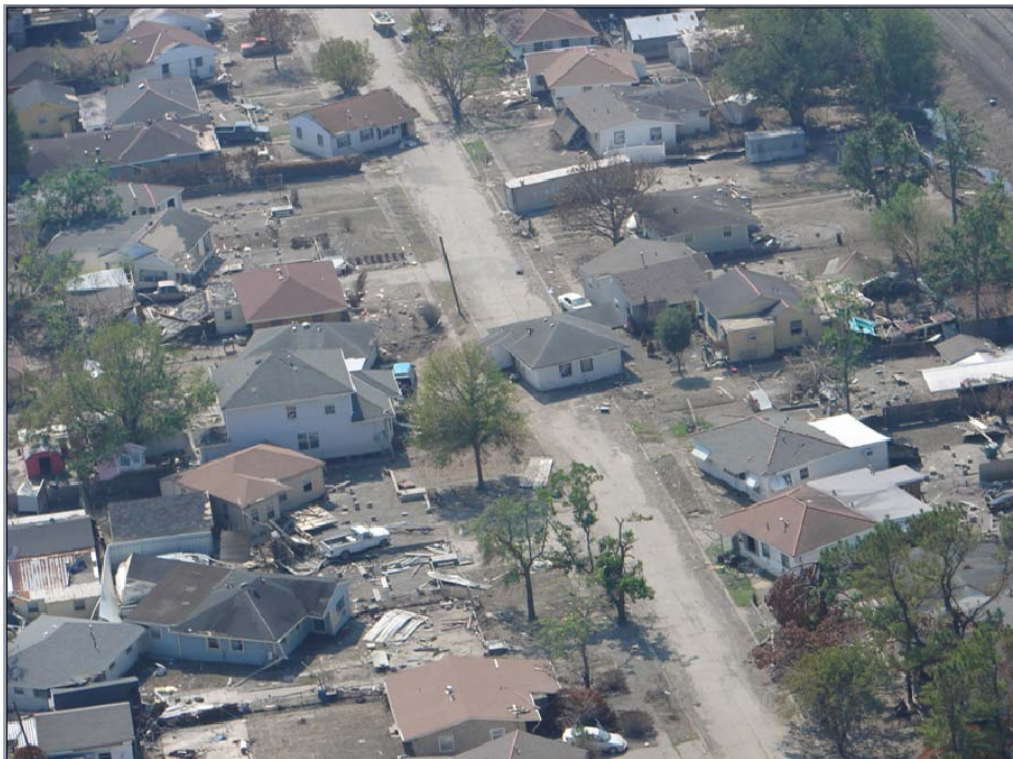
Figure 2.19 shows another aspect of the flooding. This photograph shows a region within St. Bernard Parish in which some of the homes were transported from their original locations by the floodwaters, and then deposited in new locations. Figure 2.20 shows a number of homes in the Plaquemines Parish polder that were carried across the narrow polder (from left to right in this photograph) as the west side (left side of photo) “hurricane levee” or back levee was breached, and were then deposited on the crest of the Mississippi River levee. The water side slope face of the Mississippi River levee is clearly shown in this photograph, as evinced by the concrete slope face protection on the outboard side of the riverfront levee in the right foreground of the figure.

Figure 2.19: Flooded neighborhood in St. Bernard Parish, showing homes floated off their foundations and transported by floodwaters.

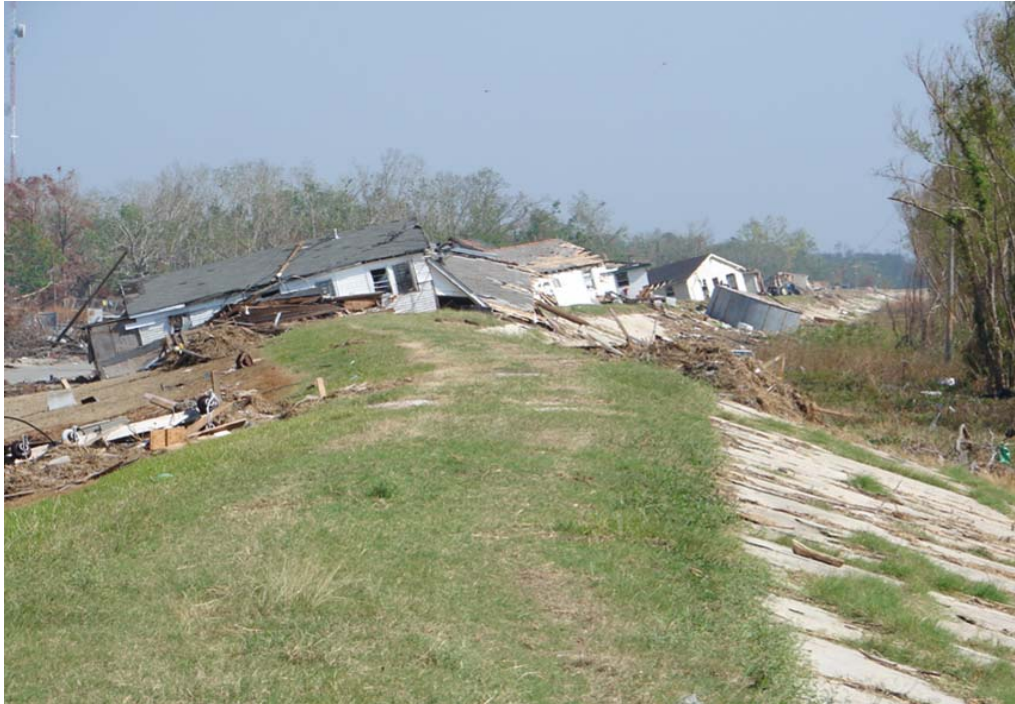
Figure 2.20: Homes in Plaquemines Parish carried from left to right in photo and strewn across the crown of the Mississippi Riverfront levee.

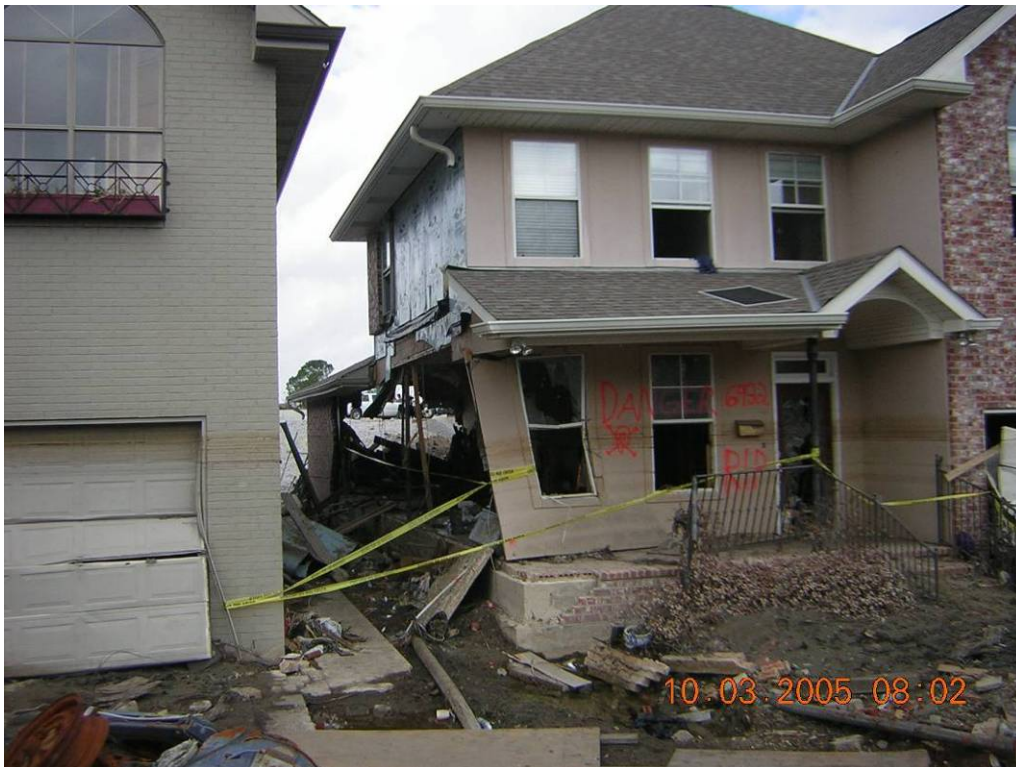
Figure 2.21: Damage to a residential neighborhood in the 17th Street Canal area due to flooding.

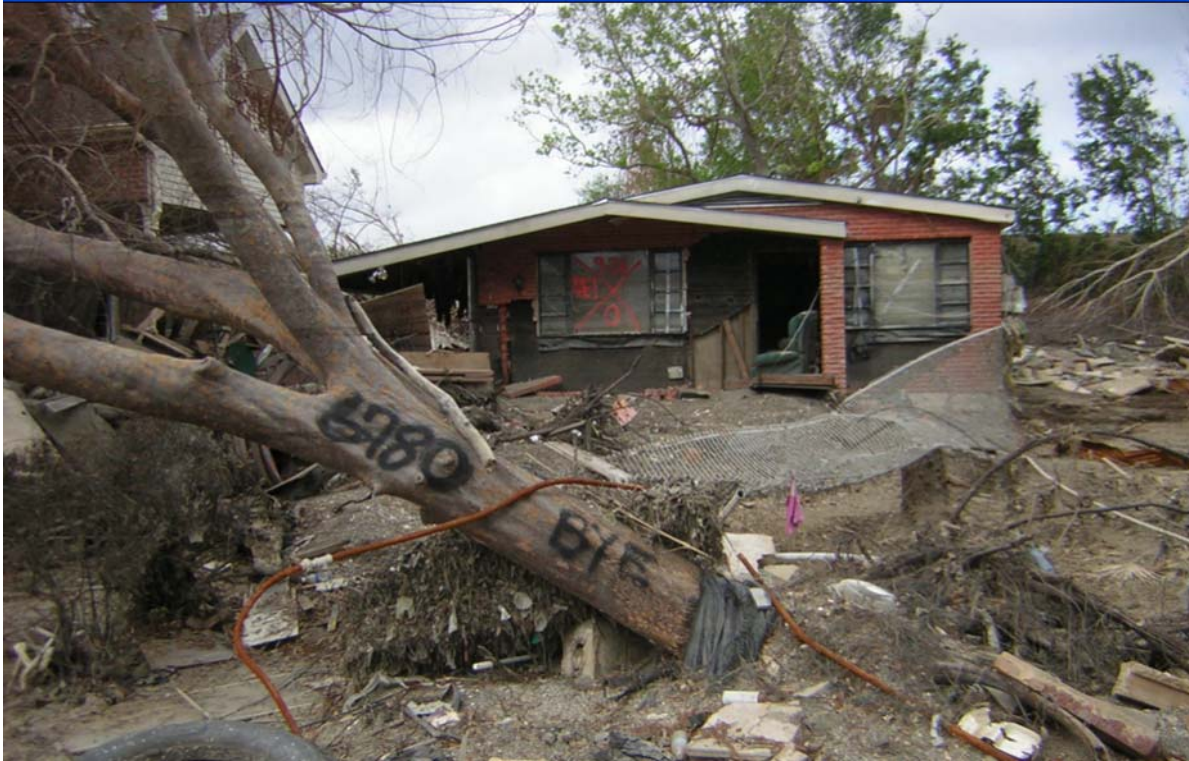
Figure 2.22: Search and rescue markings on a residence in the Canal District.

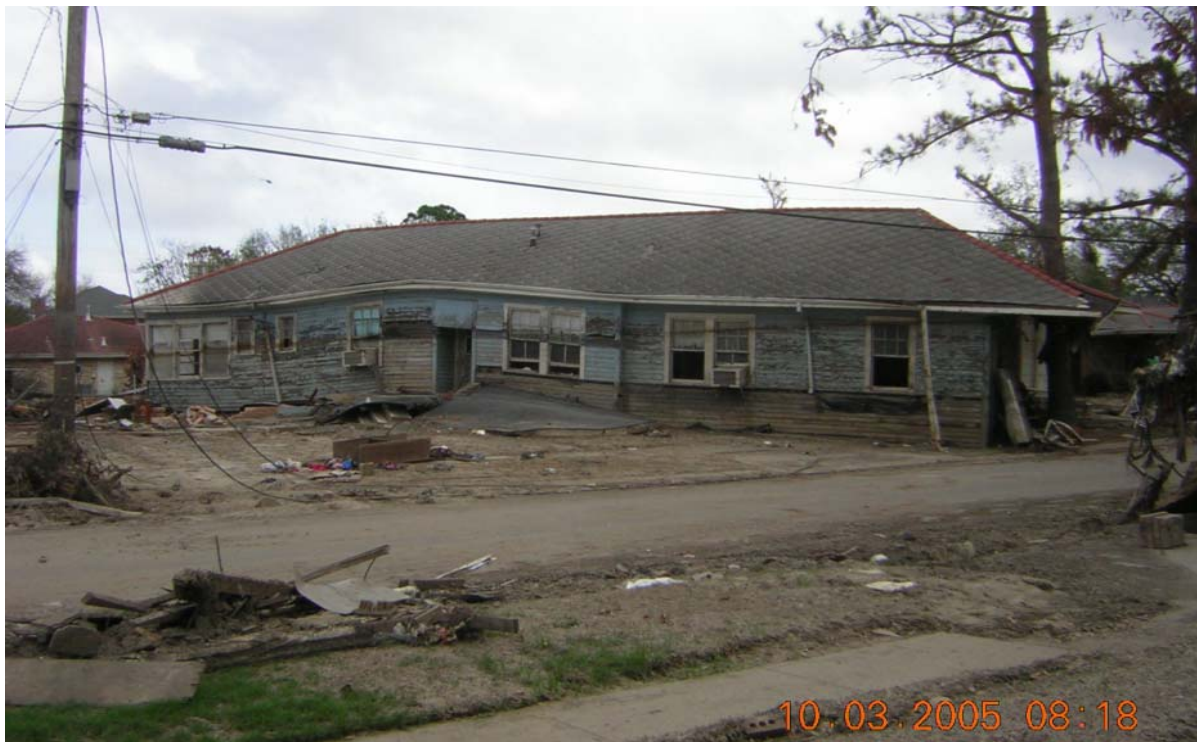
Figure 2.23: Another view of flooding damage in the Canal District.

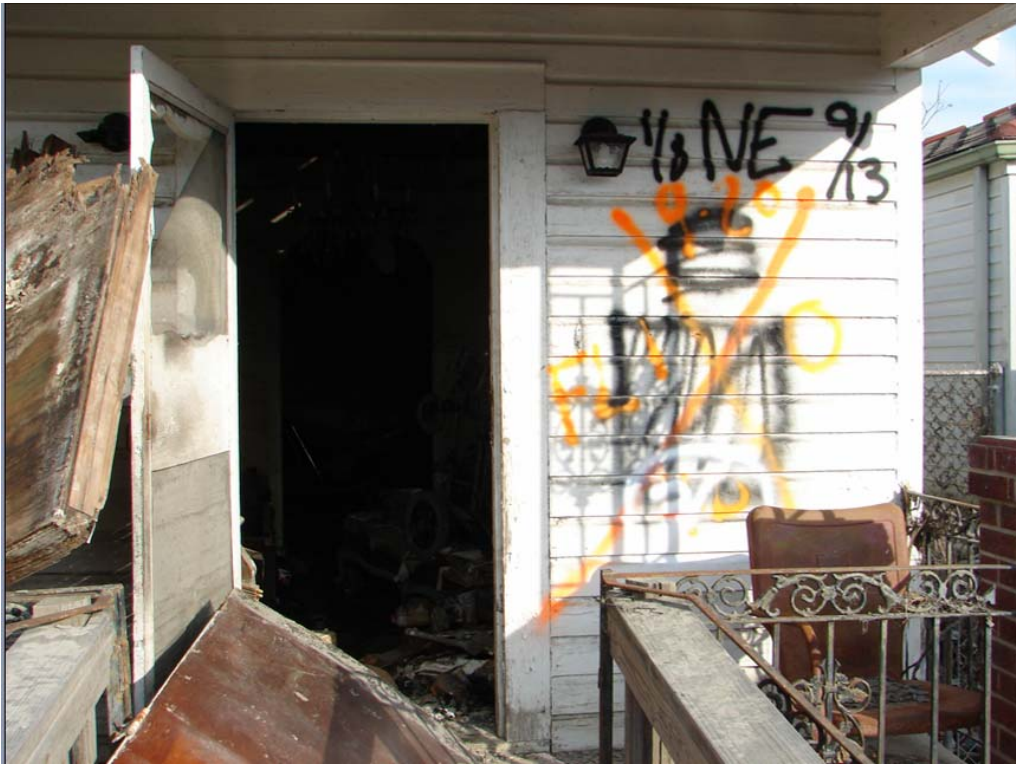
Figure 2.24: Search and rescue team markings on a building in the lower Ninth Ward where three inhabitants died.

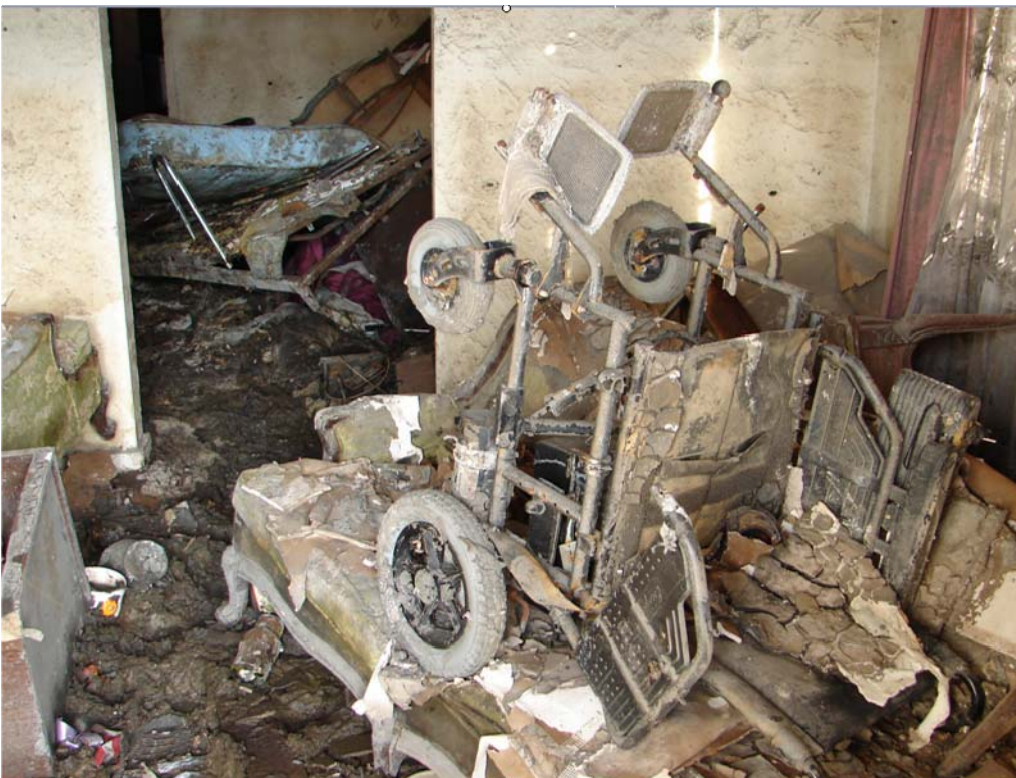
Figure 2.25: View inside structure shown previously in Figure 2.21.

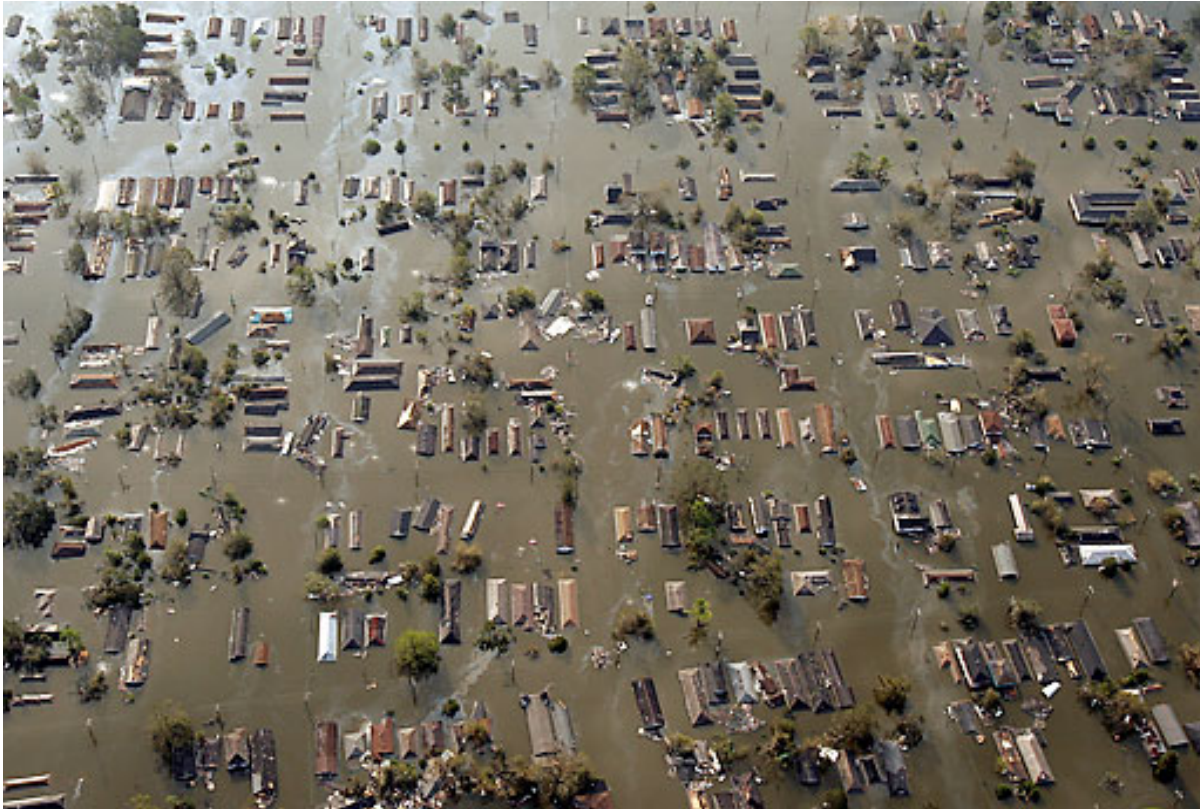
Figure 2.26: Neighborhood in New Orleans East fully flooded.

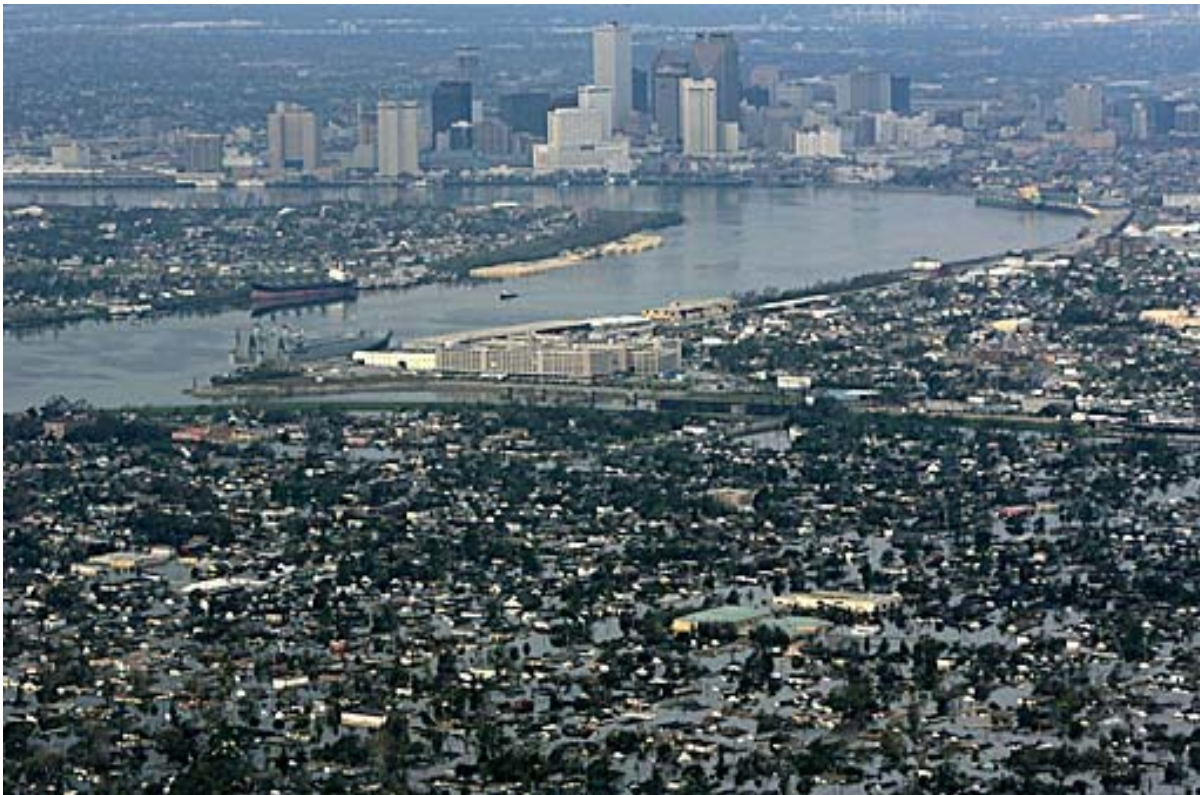
Figure 2.27: View of the City of New Orleans at the peak of the flooding.
