## CHAPTER SIX: THE ST. BERNARD AND LOWER NINTH WARD PROTECTED AREA

### 6.1 Introduction

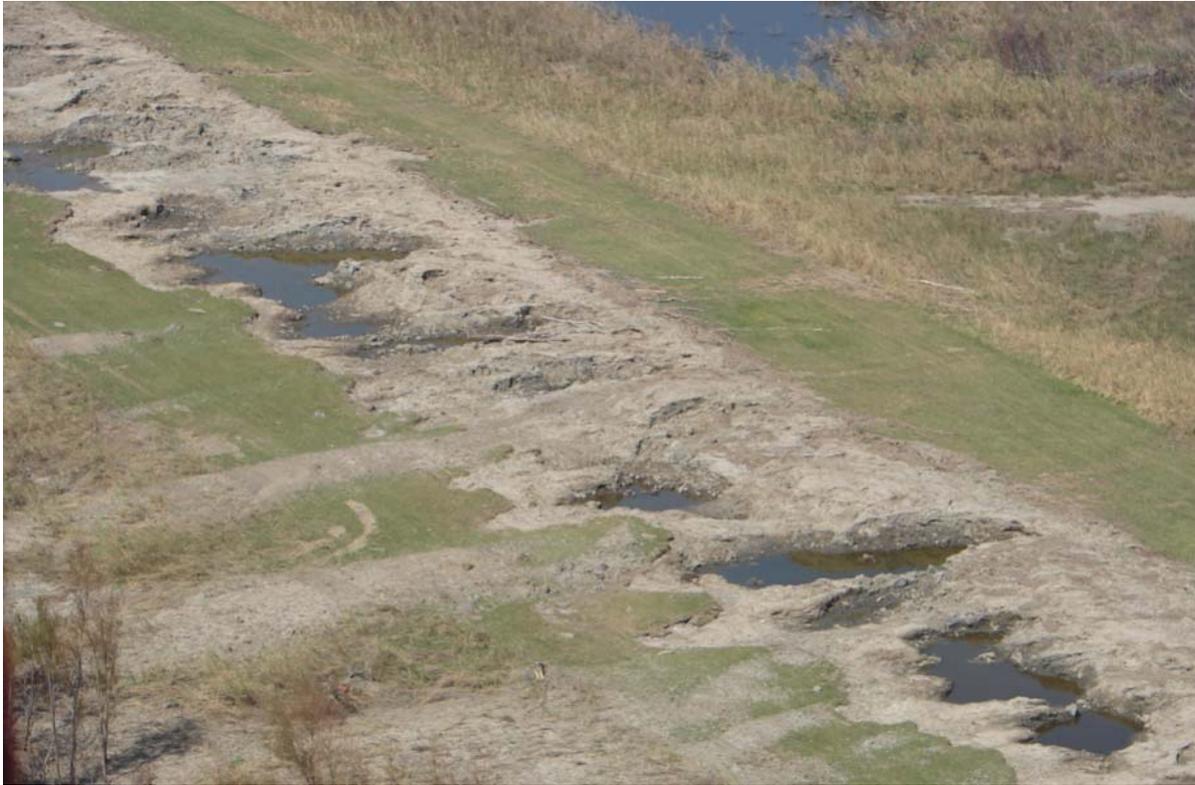
Figures 6.3 and 6.4 show two sections of the levees along this frontage after this event. These are aerial views taken from significant elevation, and they each show many hundreds of feet of levee section that have been catastrophically eroded. In Figure 6.3, the depression in the foundation soils induced by the settlement of the now-vanished levee, and the erosion produced by the turbulent flow across the original levee footprint, is the only sign of the former presence of a levee. In Figure 6.4, a sheetpile curtain had been driven along the centerline of the levee crest, to raise a section that had settled as an interim measure until the

Figure 6.3: Catastrophically eroded levee section along the northeast frontage of the St. Bernard Parish protected basis, fronting the MRGO channel.

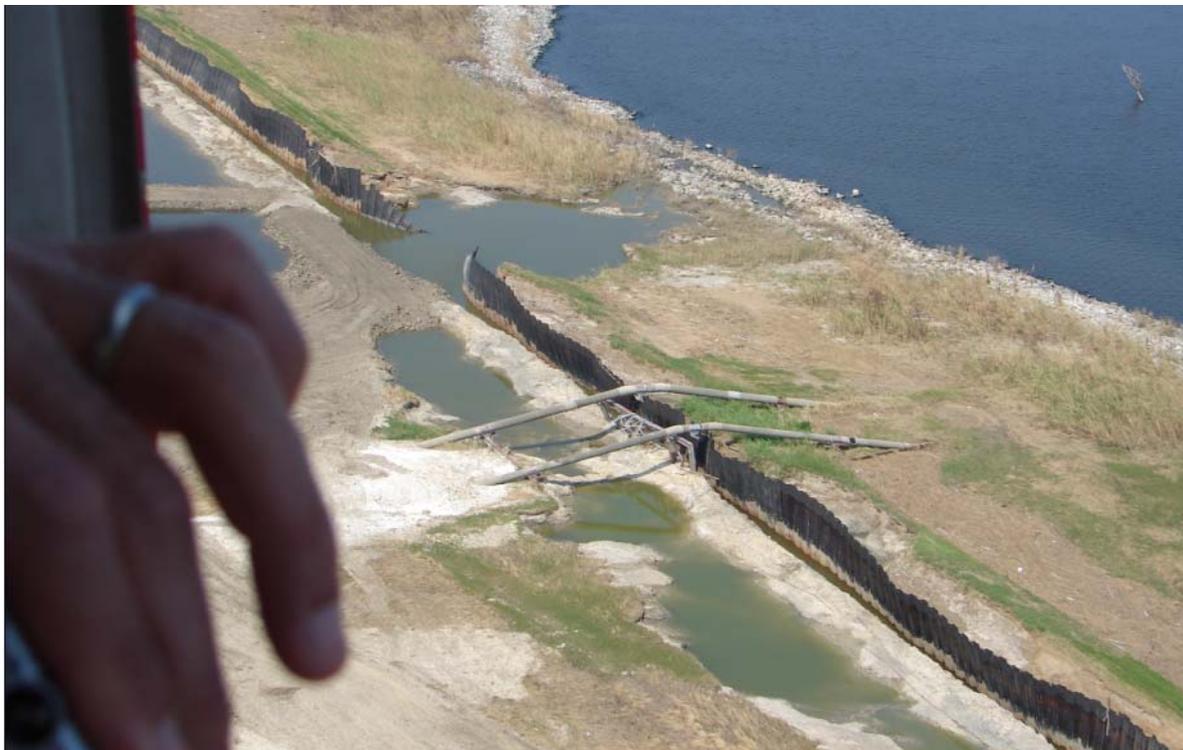
final stage of fill placement could re-raise this embankment section to the final design grade. The levee embankment has eroded completely from both sides of these sheetpiles, and the large diameter pipe in this figure was resting on the crest and slopes of the now vanished levee and so serves as a visual template to show the size and shape (the outline) of the levee section that is now gone.

Figure 6.4: Catastrophic erosion of levee embankment leaving central sheetpile curtain; also along the northeast frontage of the St. Bernard Parish protected basin fronting the MRGO channel.

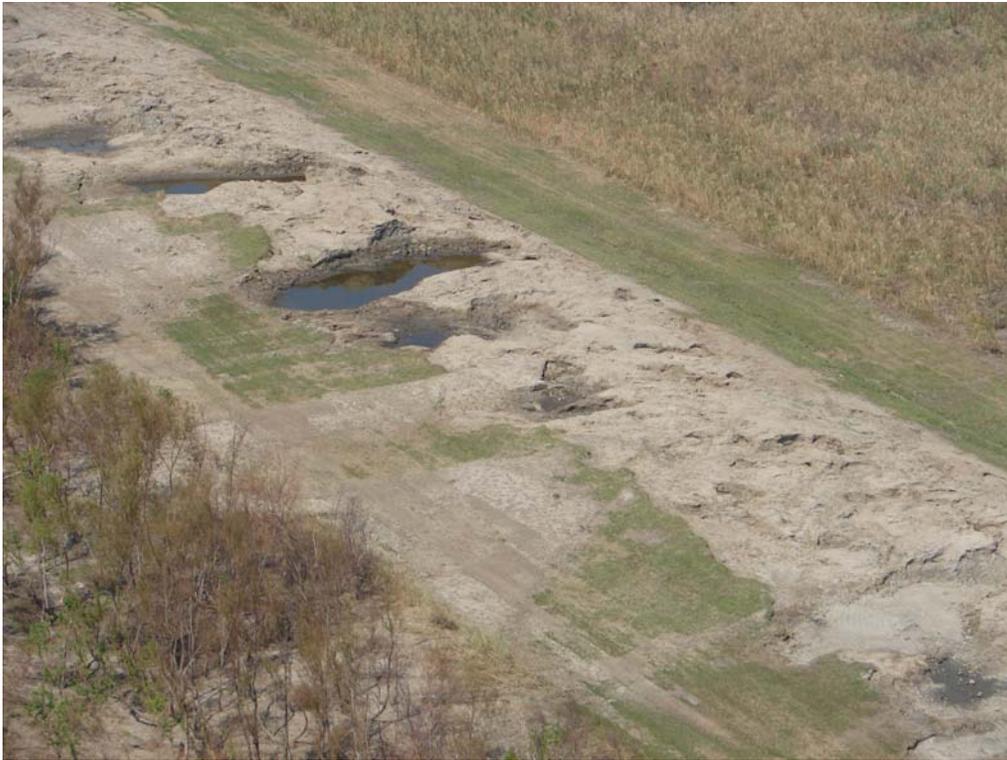
Figure 6.5: Extensive erosion of levees along the MRGO frontage at the northeast edge of the St. Bernard Parish protected area.

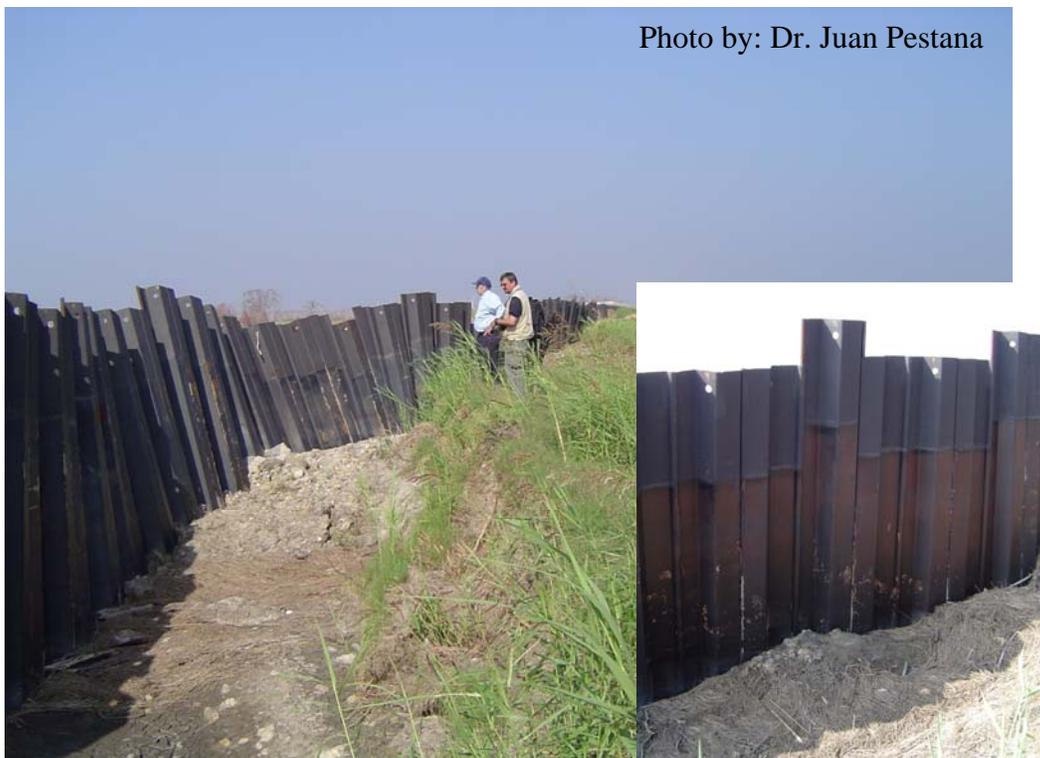
Figure 6.6 shows a ground level view of the sheetpiles from Figure 6.4. In this photo it can be clearly seen that the sheetpiles, which had originally been driven to constant grade, have settled differentially under the pounding of the storm surge and storm driven waves. This would suggest that the cyclic wave loading may have caused pore pressure increases in the fine, sandy foundation soils into which the sheetpiles were embedded, and that this (full or partial) liquefaction reduced the bearing strength and stiffness of these foundation soils and led to the observed differential sheetpile settlements as the sheetpiles were only lightly self-loaded with regard to vertical bearing and settlements.

Figure 6.6: View of sheetpiles left behind at catastrophically eroded section of the MRGO frontage levee.

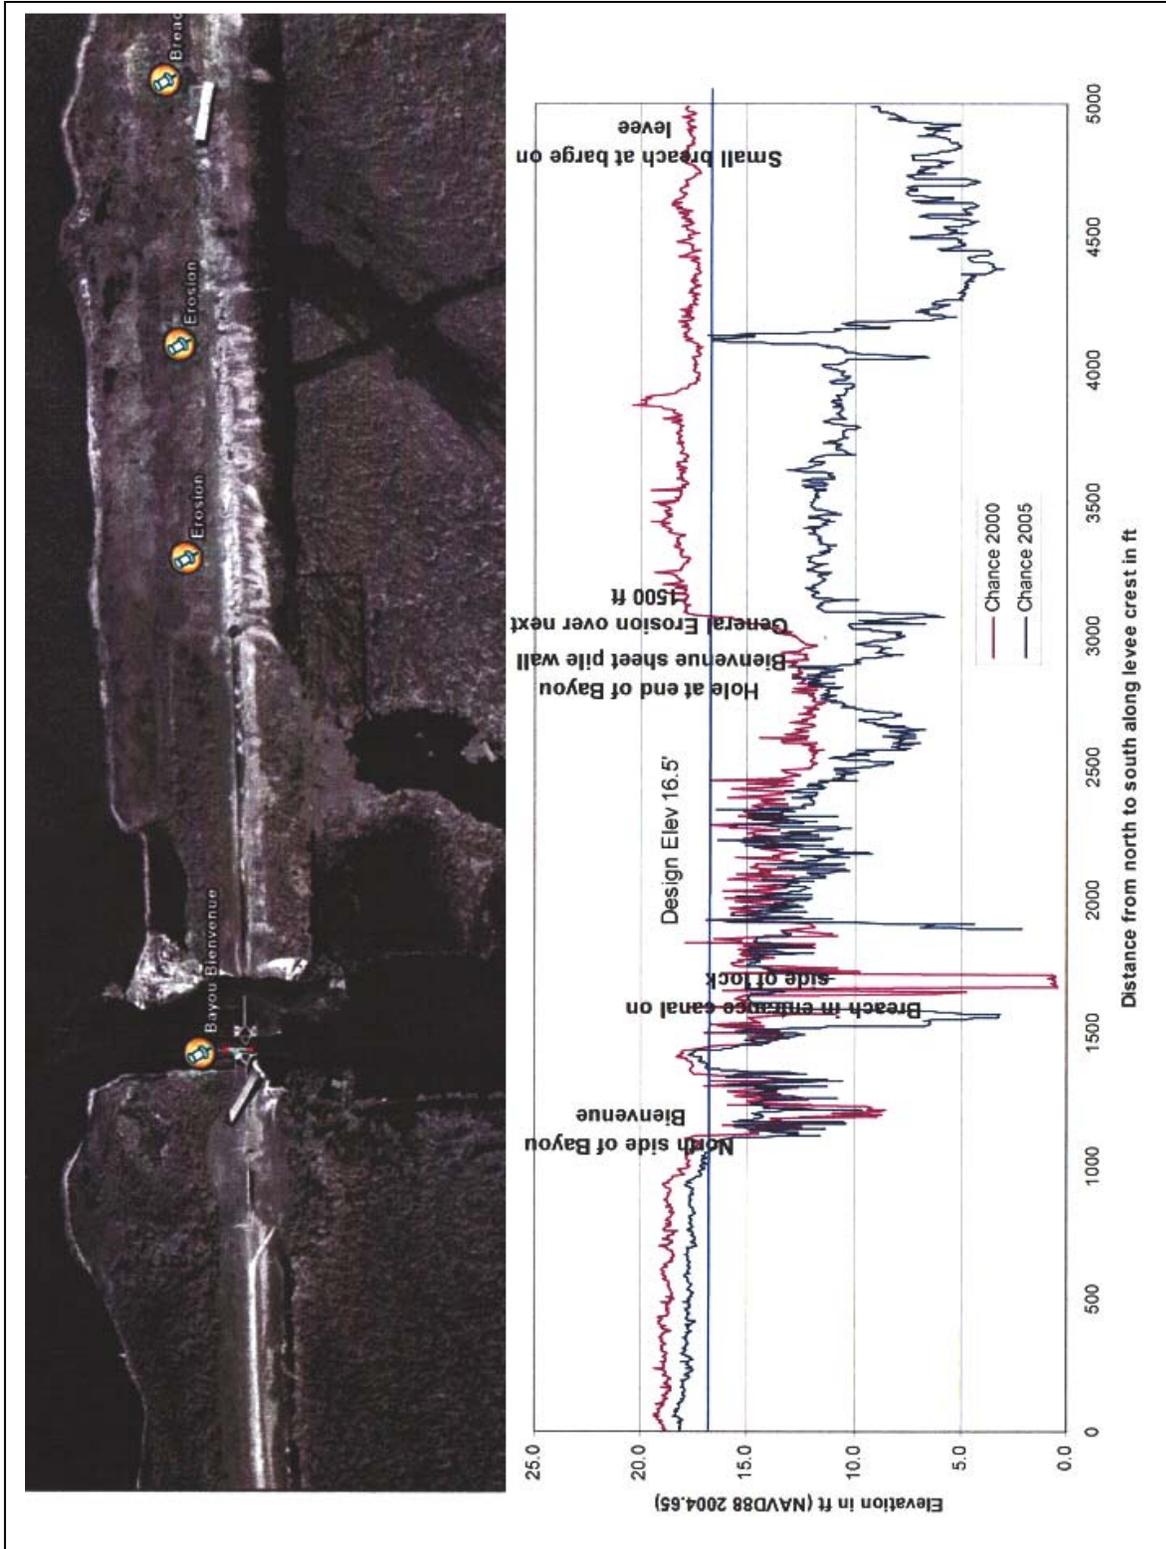
The crest heights of the levees along much of this MRGO frontage section were several feet below design grade at the time of Katrina's arrival. This levee frontage was being constructed in stages, to allow time for settlement of the evolving levees and for dissipation of pore pressures (which results in progressive strength and stiffness gain in both the levee fill and in the underlying foundation soils, so that the softer foundation soils can safely support the increasing levee section height and weight of the next stage.) The USACE had reportedly long requested appropriation of the funds necessary to place the final stage of fill and bring this critical 11-mile long section up to full design grade. That funding did not arrive in time.

Figure 6.7: LIDAR survey data showing crest elevations before and after hurricane Katrina along a section of the MRGO frontage levees at bayou Bienvenue, and corresponding post-event plan view aerial photo along the same section.

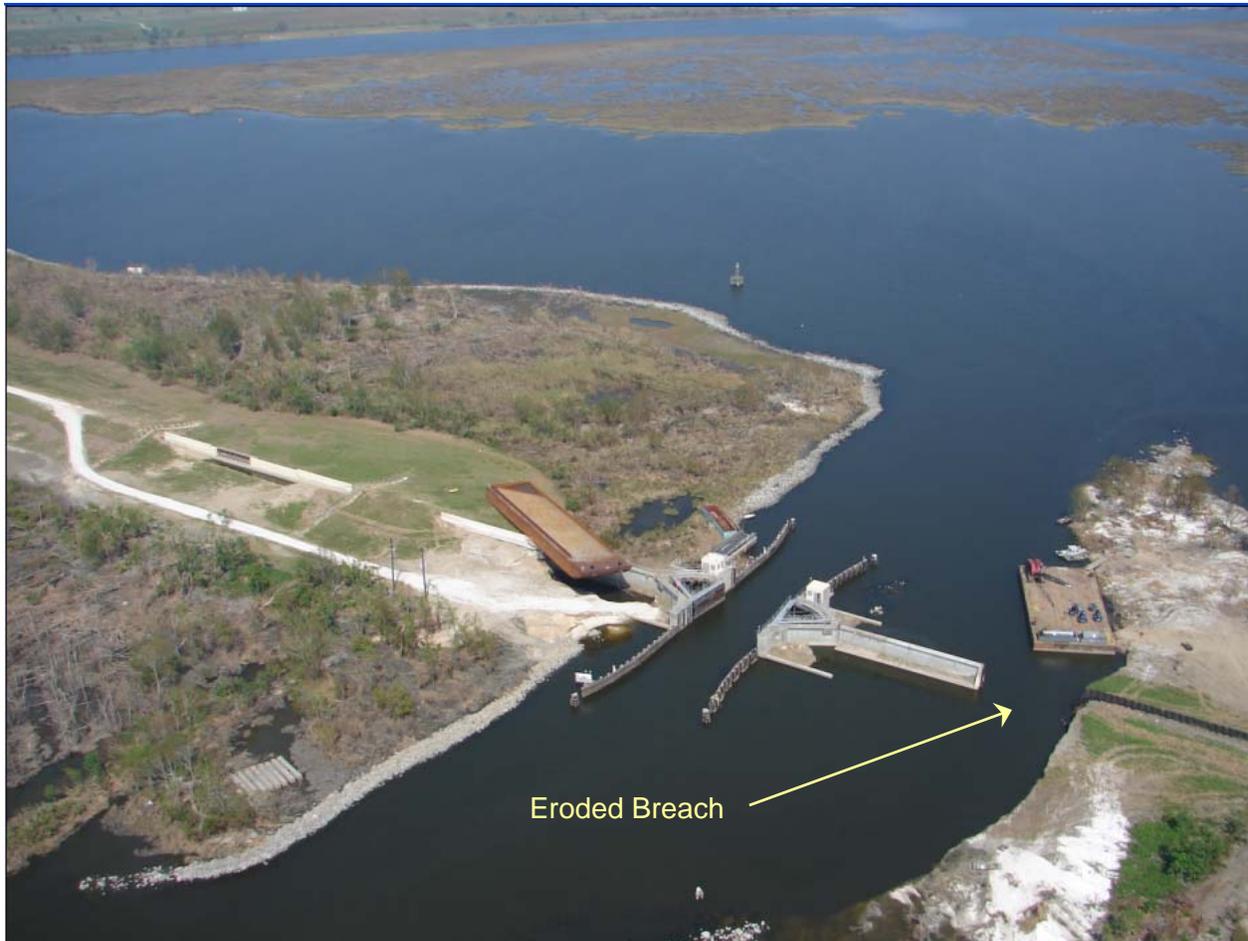
Figure 6.8: Large eroded breach at the contact between the south end of the massive concrete navigational lock structure at Bayou Bienvenue and the adjacent levee section.

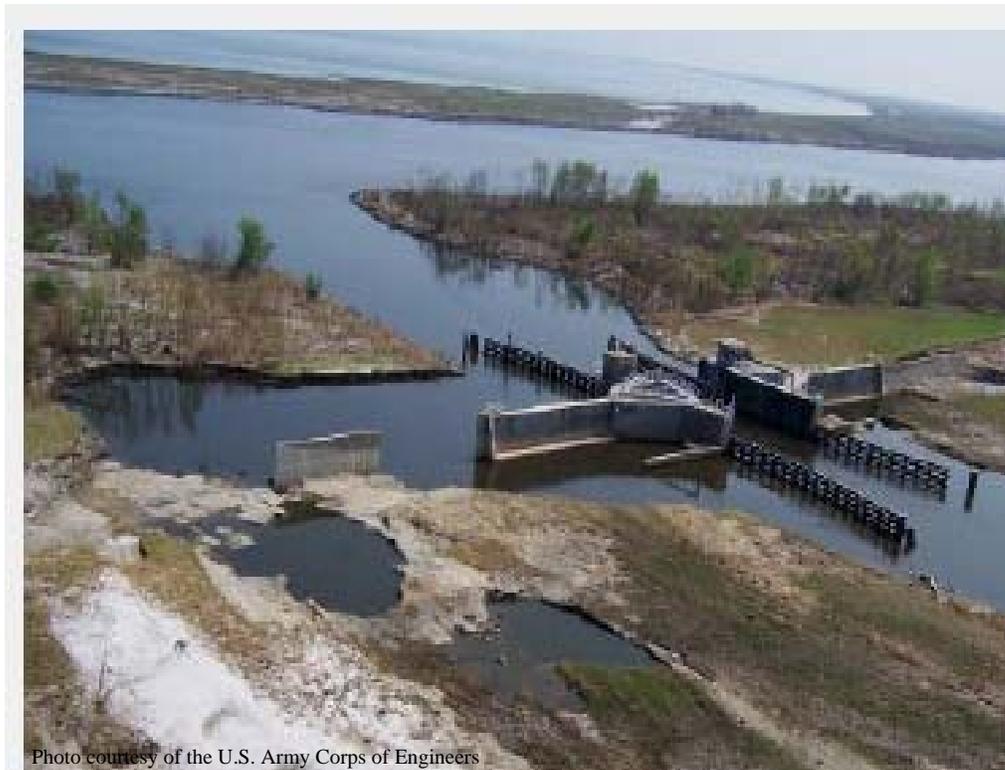
Figure 6.9(a): Aerial view of the large erosional breach at the contact between the north end of the concrete navigational lock structure and the adjoining levee embankment at Bayou Dupres.

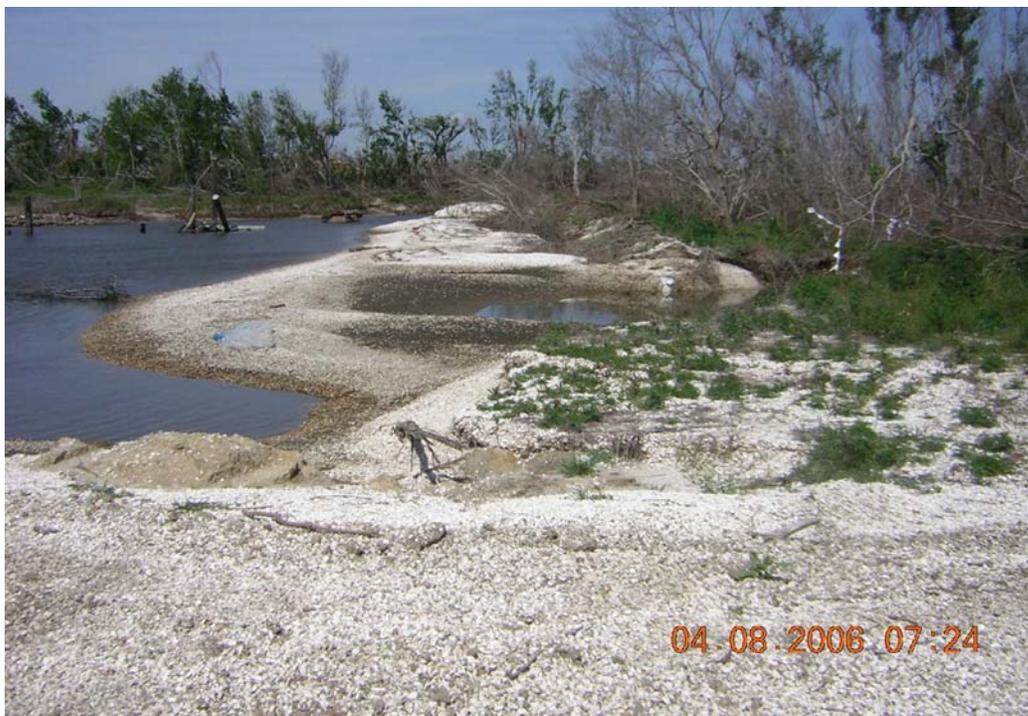
Figure 6.9(b): View looking to the inboard side from the breach shown in Figure 6.5 above; showing eroded shell sand detritus deposited from the breach.

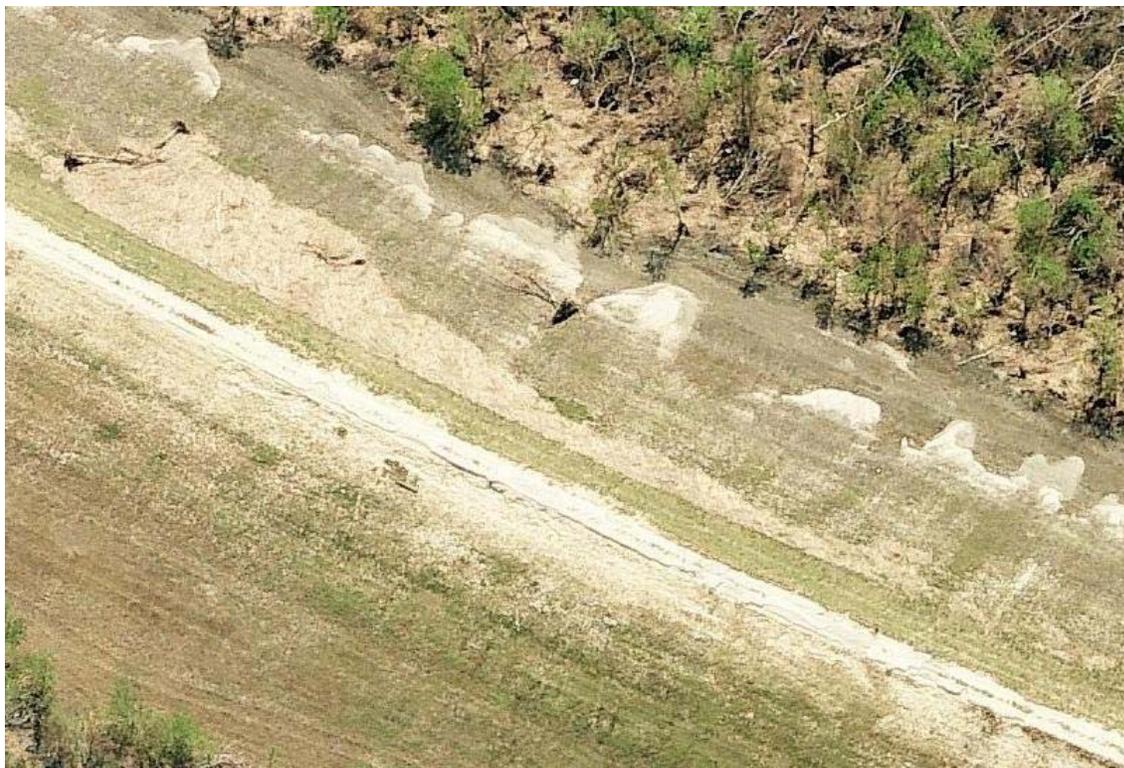
The highly erodeable (and pervious) sands and shell sands that comprised significant sections of the levees along this frontage were vulnerable to all three types of erosion, and would have been expected to have been damaged by waves and by through flow from the rising storm surge well before the storm surge actually overtopped some sections. Evidence of front face scalloping erosion, and “notching” at the crest and front crest lip of levees along this MRGO frontage section are presented in Figures 6.12 and 6.13.

Figure 6.12: Photo of outboard side wave-induced erosion on the MRGO levee frontage at the northeast edge of the St. Bernard/Ninth Ward protected area.

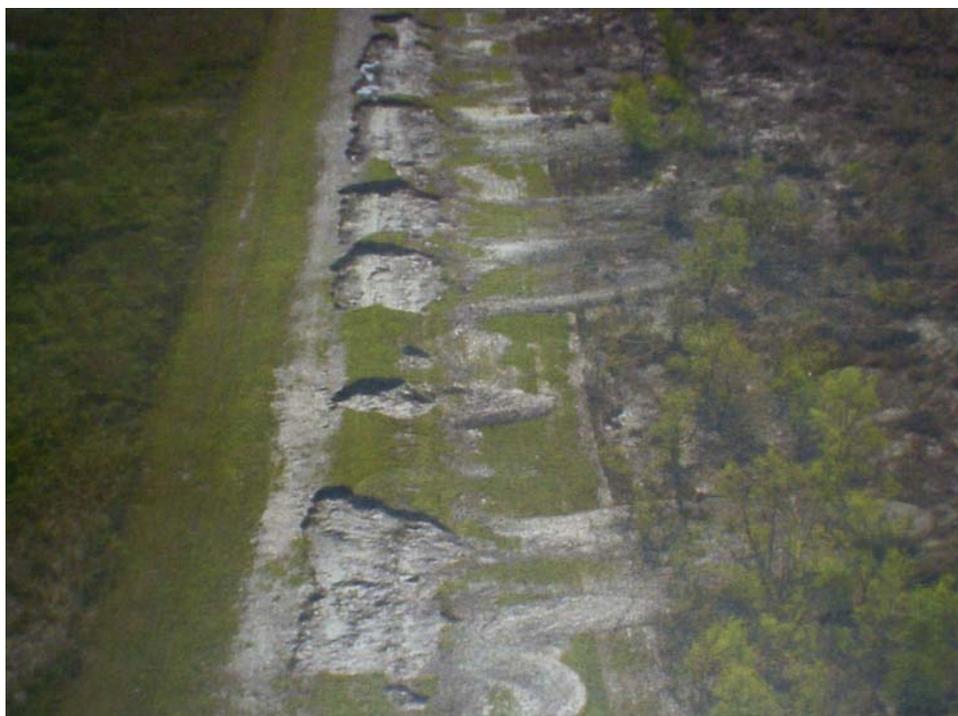
Figure 6.13: Photo of outboard side levee erosion and crest “notching”, as well as crenellation, due to storm wave erosion and overtopping along the MRGO frontage levees at the northeast edge of the St. Bernard/Ninth Ward protected area.

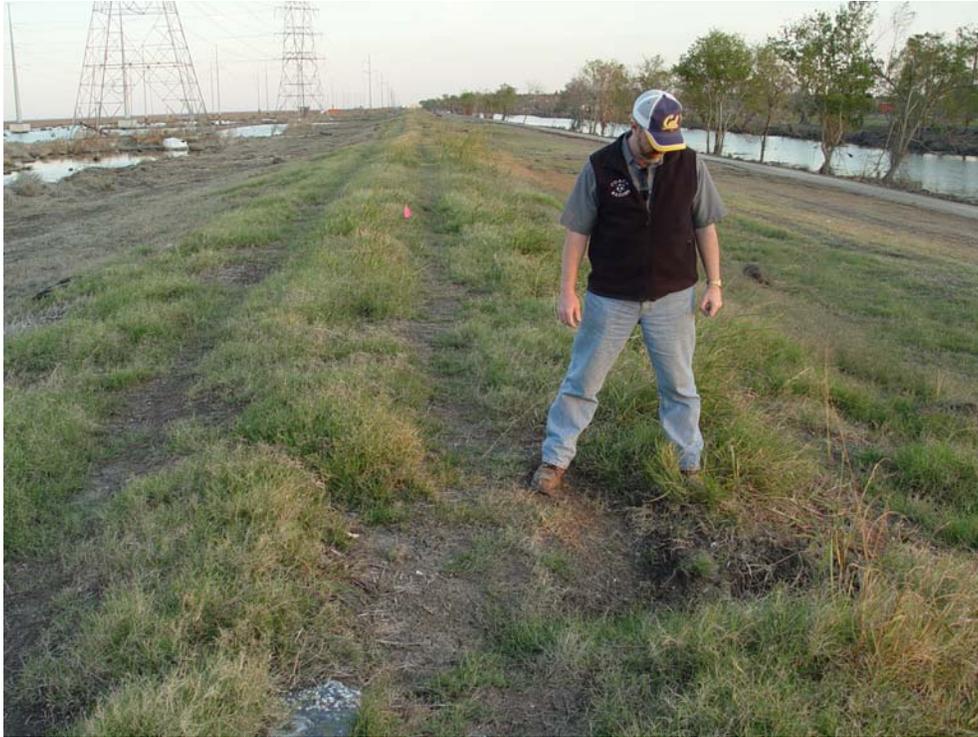
Interestingly, the smaller (secondary) Forty Arpent levee was severely overtopped along much of its length, but it suffered relatively little erosional damage as a result. This appears to be because it was constructed of significantly better materials than the outer (MRGO frontage) levees; the Forty Arpent levee appears to have been constructed primarily of clay, with good intrinsic resistance to erosion. Figure 6.14 shows a section of the Forty Arpent levee that was apparently significantly overtopped, but which suffered only slight “cosmetic” erosional damage as a result.

Figure 6.14: View of the secondary (Forty Arpent) levee across the middle of the St. Bernard protected basin.

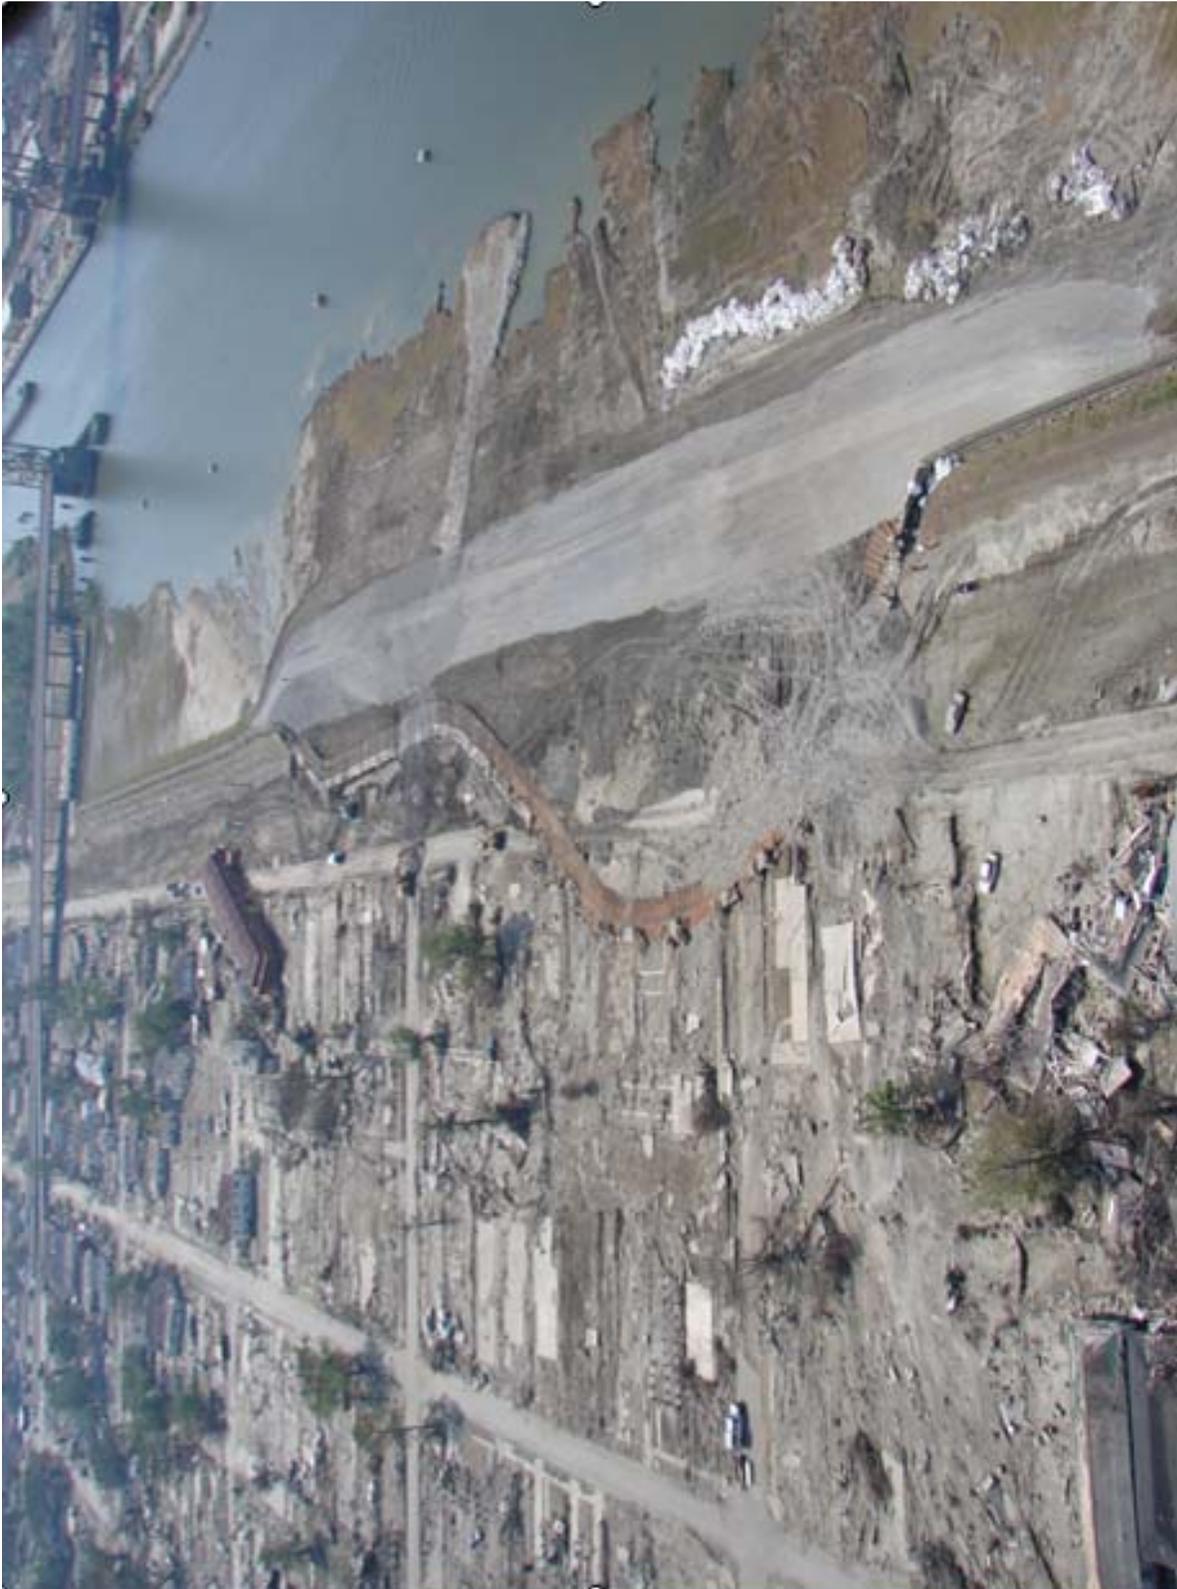
Figure 6.19 also shows the sheetpile curtain that had supported the floodwall at the crest of the earthen levee at this section. It is interesting to note that the sheetpiles (which were cold-rolled steel sections) remained interlocked throughout the cataclysmic failure and the ensuing hydrodynamic loading of the massive intruding floodwaters. The concrete floodwall is largely absent from the tops of these sheetpiles, as the sheetpiles have been stretched out (like an accordion), flattening their bent flanges in order to accommodate the extension imposed on them by the intruding flow.

Figure 6.19: Oblique view of the (south) levee break at the Inner Harbor Navigation Canal into the lower Ninth Ward.

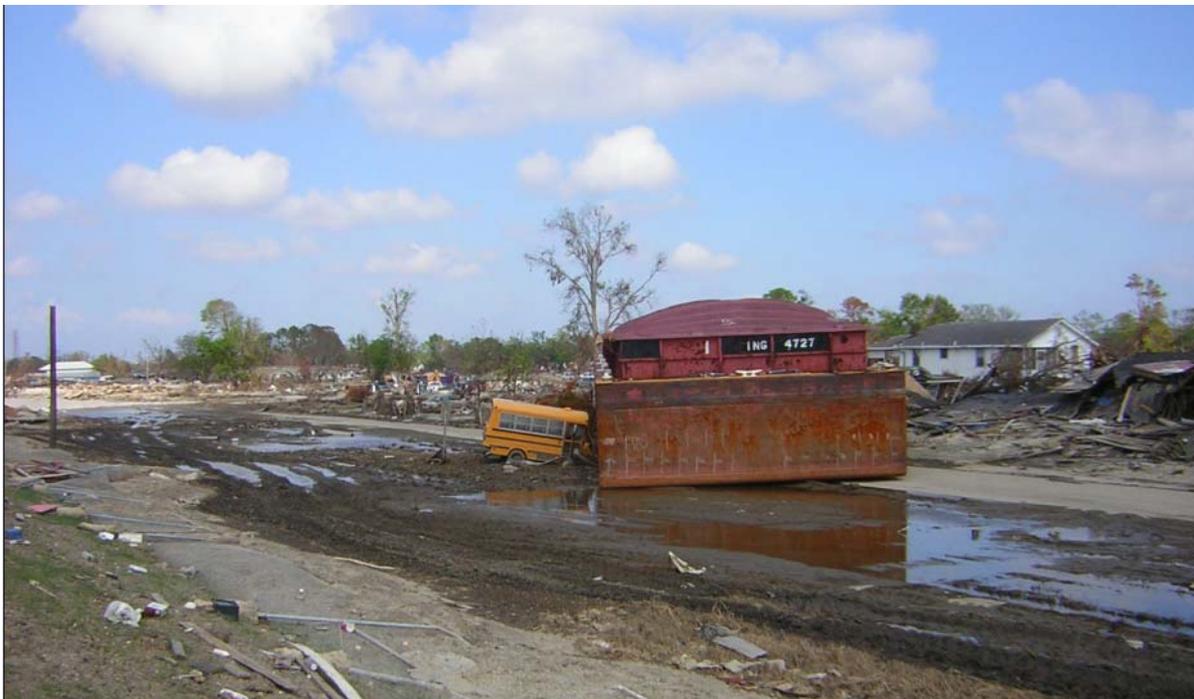
Figure 6.20 shows the large barge, in its final resting position (prior to being cut apart with torches to remove it) atop a small yellow bus. This was not the initial resting location of this barge immediately after hurricane Katrina, however. Initially, after Katrina, the barge had come to rest a bit farther to the east. It was then re-floated several weeks later when the temporary breach repair failed during the second hurricane surge produced by hurricane Rita on September 24, 2005 (see Chapter 11), and came to rest at its current position at that time. The small yellow school bus also arrived between hurricanes Katrina and Rita, having been appropriated and used for interim transport and then abandoned in its location as shown.

There is a single large dent low on the side of the barge just around the left side of the bow (not quite visible in Figure 6.20), and a pronounced scrape on the bottom of the barge at that same location. Most of the concrete floodwall was failed in extension and flexure, with its reinforcing steel (rebar) fairly extended. There was one single section of wall which clearly evinced a major impact, however, and that was at the extreme southern end of the breach. Figure 6.21 shows a close-up view of the floodwall at this location. The rebar is compressed and bent, and the concrete crushed at this location. It was the consensus view of our investigation team that the barge had scraped along the wall and then impacted the end of the wall at this location.

As this was the extreme southern end of the very long breach; this impact was not the cause of the breach and failure. Instead, the barge was apparently traveling southwards along the IHNC (driven by the prevailing storm winds at that time) and was drawn into the breach by the inflowing waters. The barge did not enter cleanly into the breach, but struck at the south end before passing in.

That does not mean that the barge might not have struck the floodwall twice (or more times) before finally impacting the southern end of the breach, but our investigation's view is that there are other modes of failure that would have been expected to fail this section without any need for help from the barge, so that the likelihood is that the barge slipped its moorings and was eventually drawn in through a breach that was already well developed.

**Figure 6.20:** Close-up view of the large barge that entered through the south breach at the east bank of the IHNC at the west end of the Lower Ninth Ward.

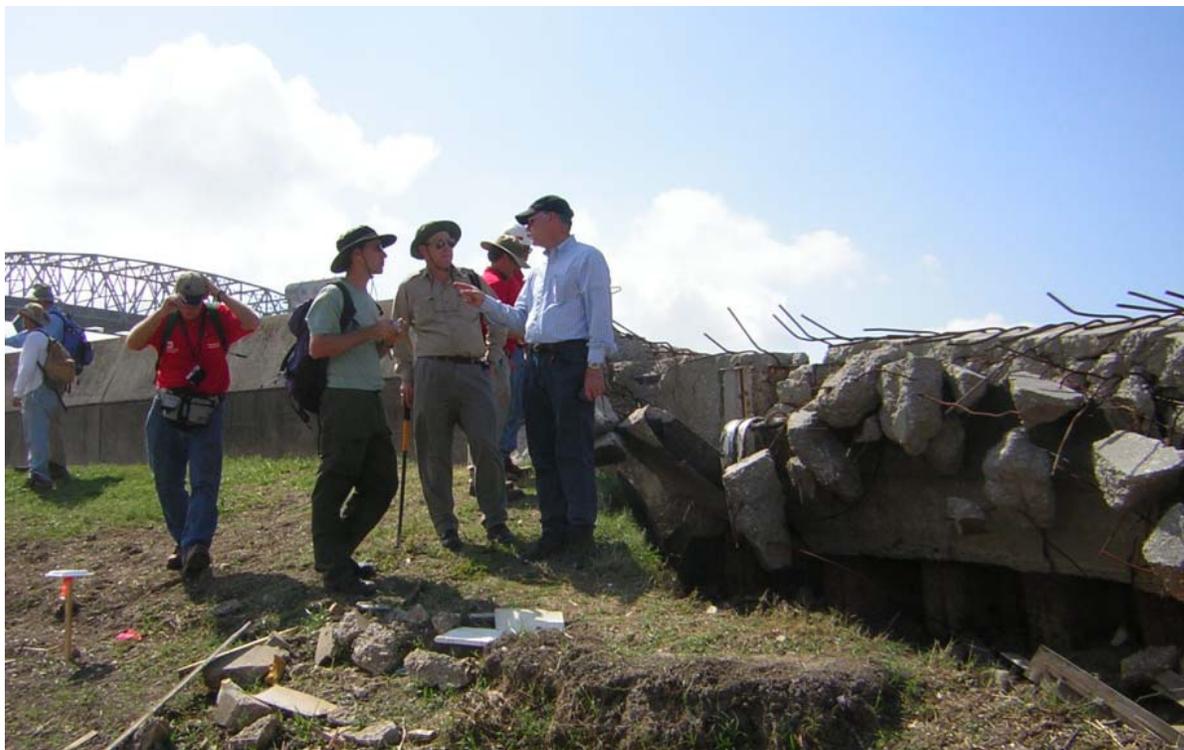
**Figure 6.21:** Close-up view of crushed (impacted) concrete floodwall at the south end of the south breach at the east bank of the IHNC at the west end of the Lower Ninth Ward.

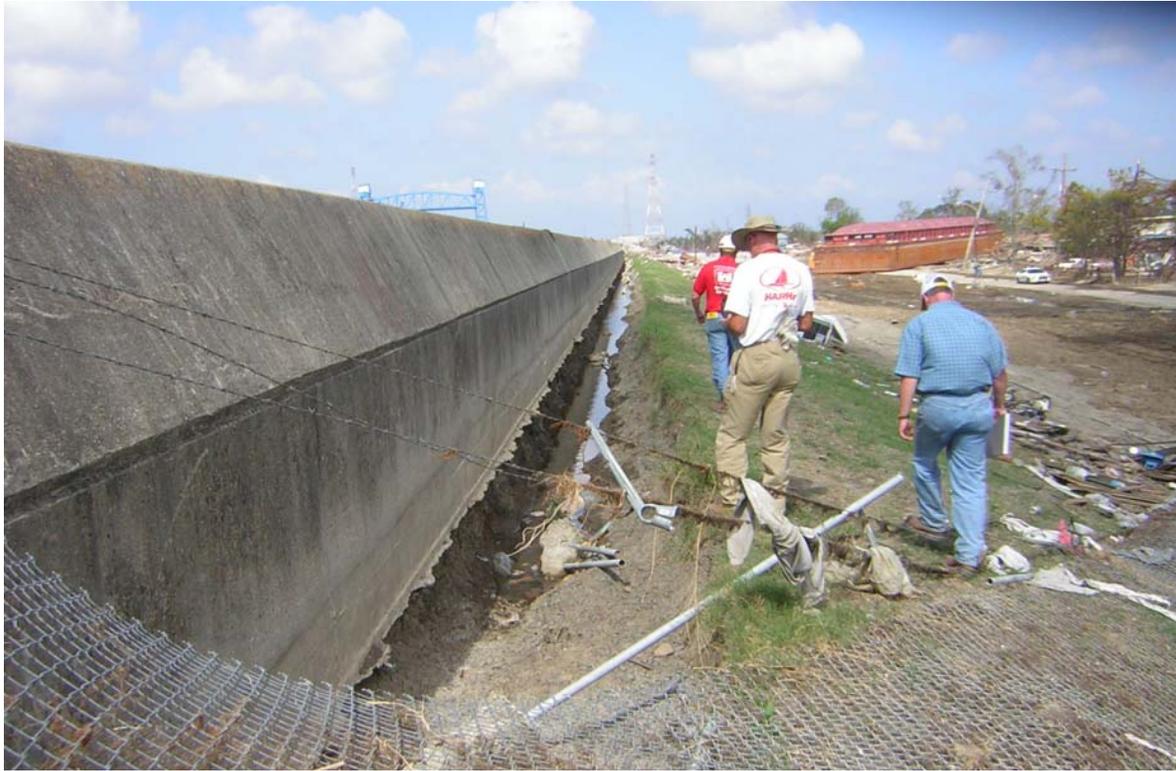
Figure 6.22 shows the trench that was eroded by water that passed over the top of the concrete floodwall at the south end of the large breach. (The barge can be seen at the right in this photo.) Overtopping and scour occurred at both ends of this breach feature, and the resulting scoured trenches reached depths of up to 5.5 feet in sections that did not subsequently fail. It is, of course, not possible to determine whether deeper scouring/trenching might have occurred at the actual breach inception location, as the embankment and foundation soils at the center of the breach were deeply scoured out by the massive flows in through the breach. One of the potential failure modes evaluated by our (ILIT) studies was the possibility that this scour had sufficiently laterally unbraced the concrete floodwall (and its supporting sheetpile curtain) that the lateral force of the elevated canal water was able to displace it laterals and foment a resulting breach.

**Figure 6.22:** Eroded trench at the rear (inboard) side of the floodwall at the south end of the south breach at the east bank of the IHNC at the west end of the Lower Ninth Ward.

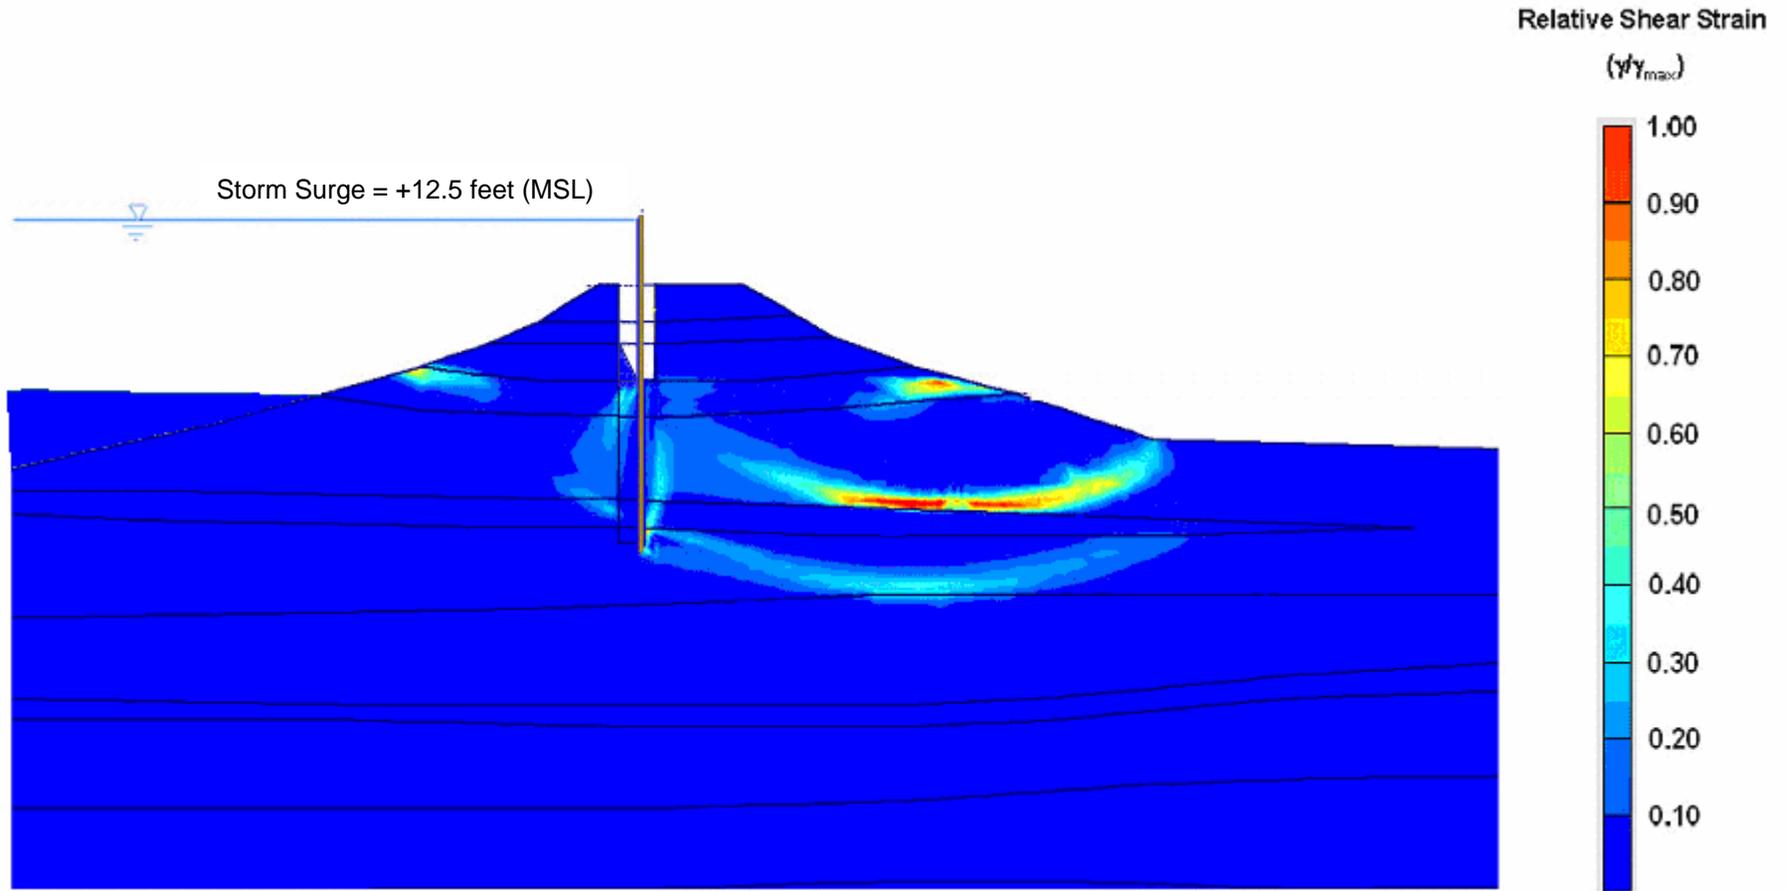
Figure 6.30 shows conditions calculated just as the canal water level reached the top of the concrete floodwall. Plotted in this figure (as color contours) are levels of relative shear strain (shear strain developed, divided by shear strain to failure) within the levee embankment and foundation soils. As shown clearly in this figure, two distinct failure mechanisms are beginning to develop. The lower one is a shear surface concentrated at the interface between the base of the upper gray clay (CH/CL) layer and the underlying layer of marsh deposits, and the upper failure surface attempting to develop is concentrated at the interface between the top of the upper marsh stratum and the lower levee embankment fill section. Both of these mechanisms represent the results of underseepage-induced increases in pore pressures being "trapped" at the bases of less pervious overlying strata. These pore pressure increases are decreasing the strength and stiffness of the soils at these two critical interfaces.

At the water stage shown in Figure 6.30, a gap has begun to form at the outboard side of the floodwall and its supporting sheetpile curtain. When effective tensile stress was calculated between the floodwall/sheetpile wall and the adjacent soils, the analysis was temporarily stopped, the tension was eliminated by changing the mesh details to insert a small gap (and to insert hydrostatic water pressures within the gap), and the analysis was resumed. This was done iteratively, as water levels continued to rise, so that the progressive development of a water-filled gap between the floodwall/sheetpile curtain and the outboard section of the levee embankment could be modeled. At this section, within reasonable parameter variations modeled, gap formation generally initiated at canal water levels on the order of Elev. +11.5 to +13 feet (MSL), and the gap then tended to progress fairly rapidly to the base of the sheetpiles (within the next 1 to 2 feet of water level rise in the canal).

**Figure 6.30:** Normalized shear strain contours (shear strain divided by strain to failure) for a storm surge at Elev. + 12.5 feet (MSL) at the Lower Ninth Ward, IHNC East Bank, South breach site; gapping at outboard toe of floodwall is developed fully through the embankment fill material.

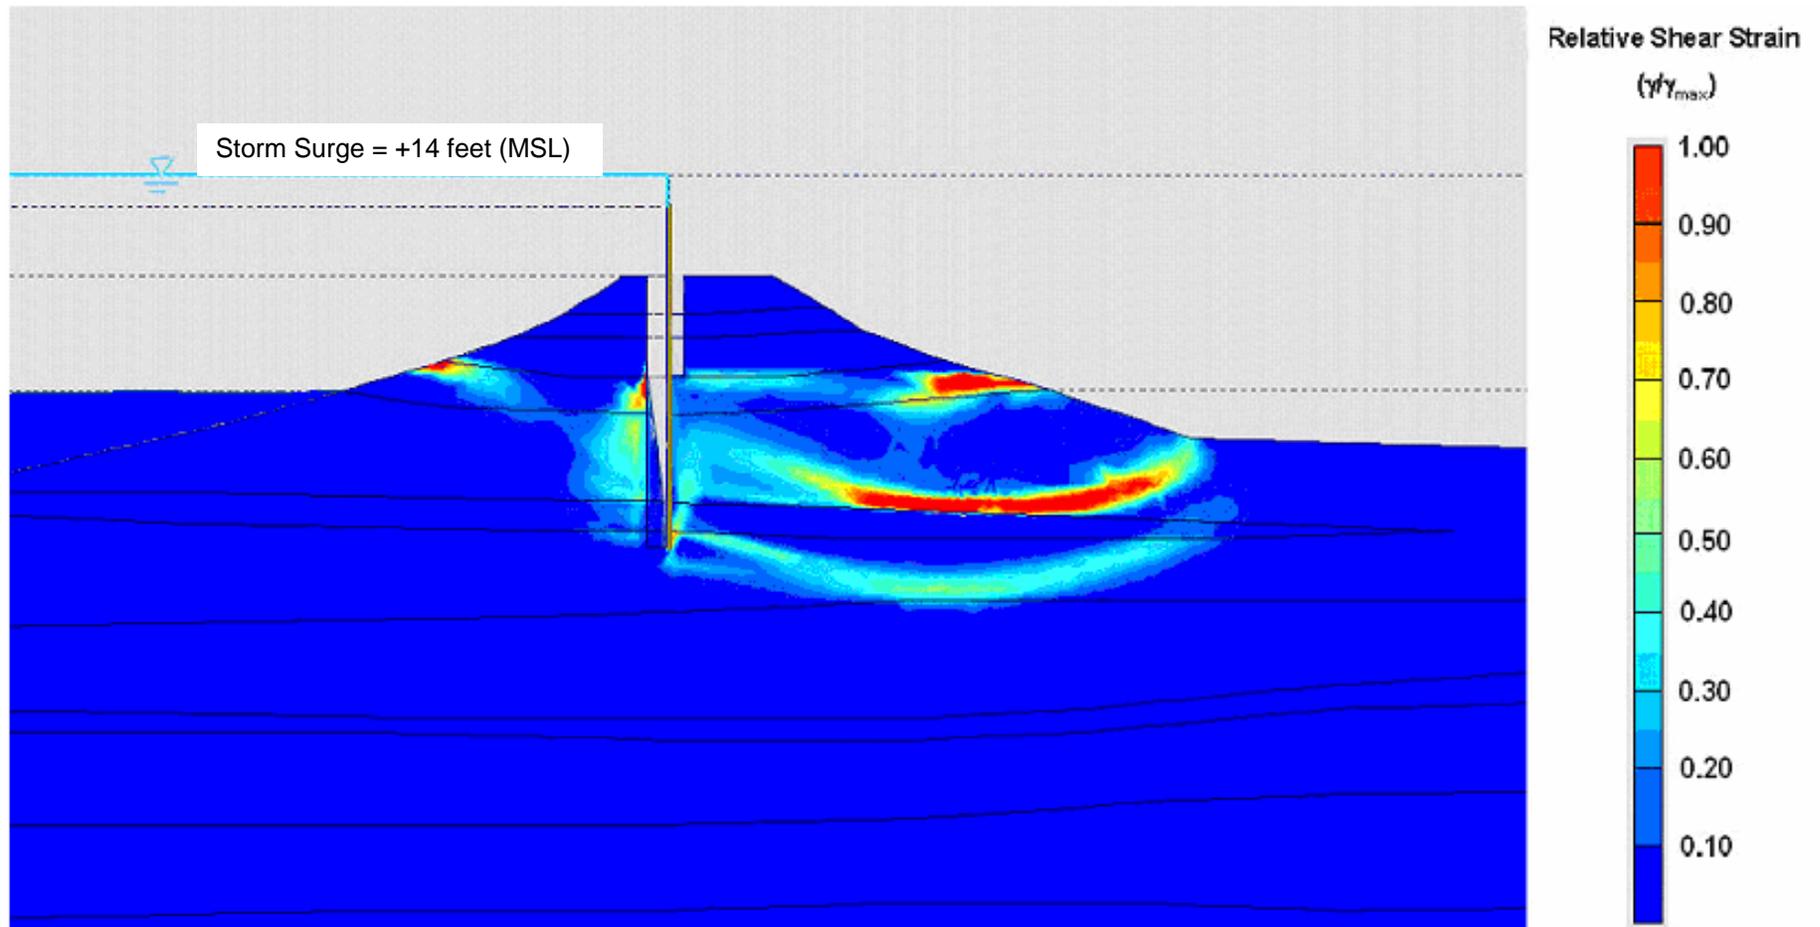
Figure 6.31 shows calculated conditions for a canal water level at Elev. +14 feet (MSL). At this stage, water is now overtopping the floodwall, the gap at the outboard side of the sheetpile wall is developed to full depth, and stability failure is occurring on the

uppermost of the two potential failure surfaces. This upper failure is serving to “protect” against further development of the lower failure surface (which can also be seen in this figure.) If the upper failure surface is strengthened a bit, to prevent the upper failure, then the lower failure becomes critical.

**Figure 6.31:** Normalized shear strain contours (shear strain divided by strain to failure) for a storm surge at Elev. + 14 feet (MSL) at the Lower Ninth Ward, IHNC East Bank, South breach site; gapping at outboard toe of floodwall is fully developed.

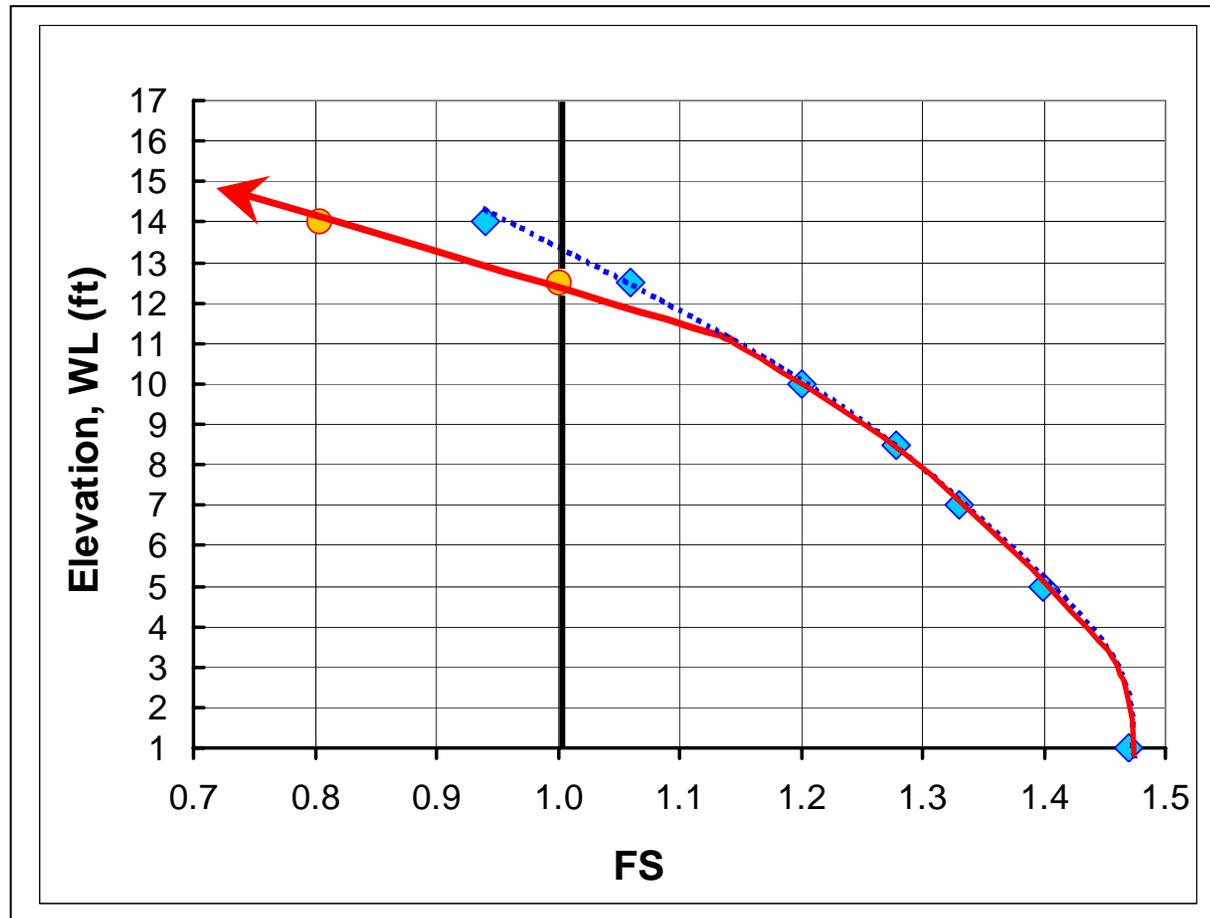
Figure 6.32 shows the postulated path to failure based on the finite element (PLAXIS) analyses performed. In this figure, the Factor of Safety at any given surge height was assessed by stopping the analysis at each stage of water level rise, and evaluating Factor of Safety by means of progressive  $c - \phi$  reduction. Two sets of conditions were analyzed; conditions in which a “gap” was allowed to form on the outboard side of the sheetpile/floodwall (and the gap was allowed to fill with water as it opened), and a second set of analyses without allowing the opening of this gap. The light blue diamonds in Figure 6.32 represent conditions without gapping, and the yellow circles represent conditions with progressive opening of a water-filled gap.

**Figure 6.32:** Calculated Factors of Safety for two modes based on PLAXIS analyses of the Lower Ninth Ward South breach site (east bank IHNC) for various canal water elevations; showing the best-estimated path to failure.
