## CHAPTER SIX: THE ST. BERNARD AND LOWER NINTH WARD PROTECTED AREA

### 6.1 Introduction

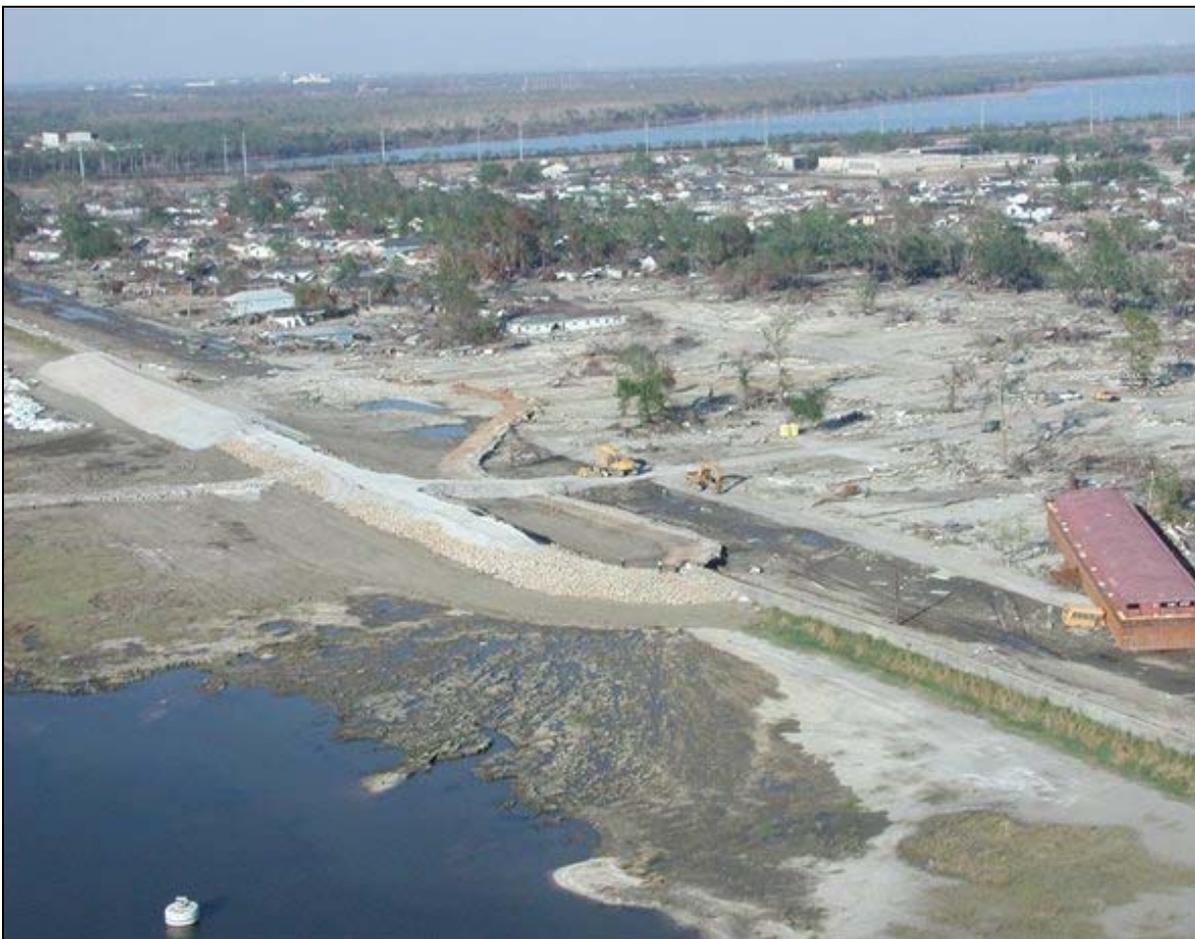
Figure 6.45: Aerial view of the south breach at the east bank of the IHNC (at the west end of the Ninth Ward), showing the crevasse splay generated by reverse drainage flow.
