CHAPTER SEVEN: THE NEW ORLEANS EAST PROTECTED AREA

7.1 Introduction

7.3 Performance of the New Orleans East Hurricane Protection System in Hurricane Katrina

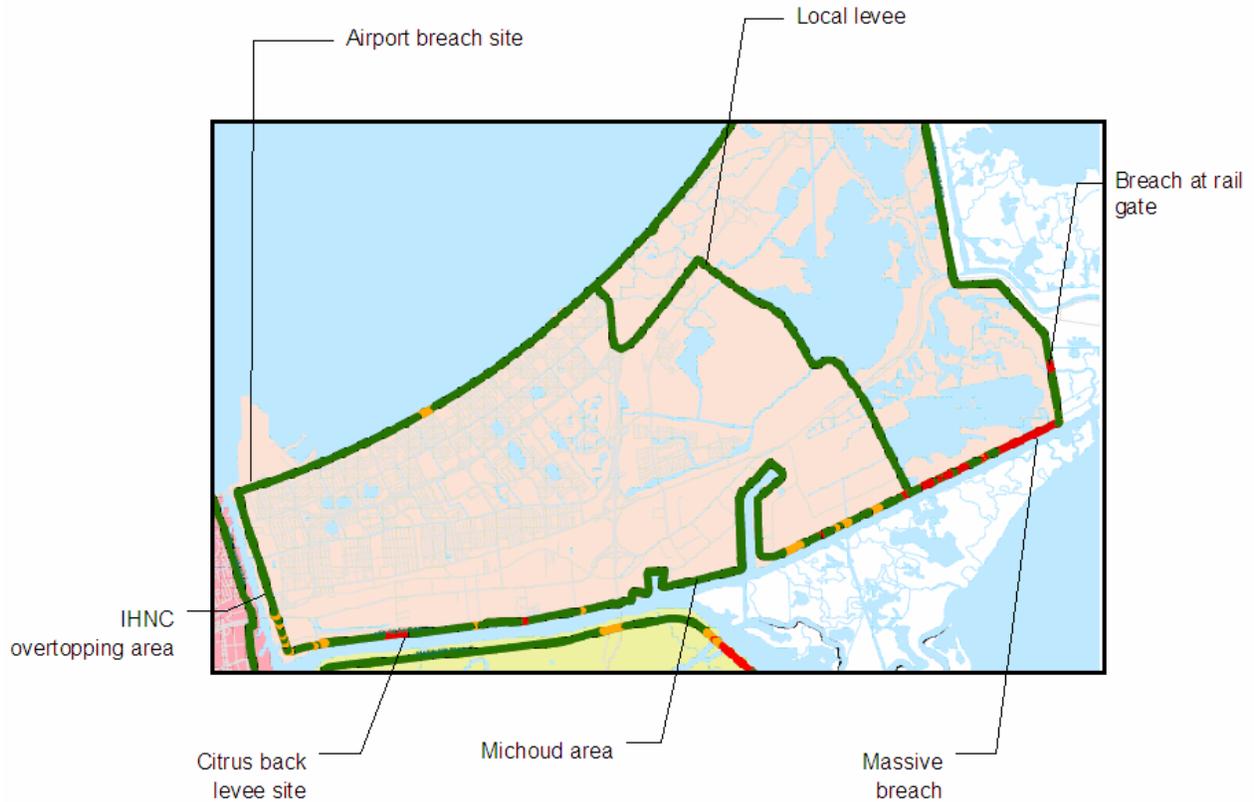
Figures 7.1 and 7.2 show the locations of damage to the levee system surrounding the New Orleans East (NOE) protected area. The most significant damage to the system occurred to East Back Levee that fronts the GIWW and Lake Borgne. Here the storm surge completely destroyed (and massively eroded) large expanses of earthen levee in the southeastern corner of the NOE protected area. Additional smaller, but nevertheless significant breaches also occurred along other portions of these NOE back levee reaches. As the storm surge next passed west two significant levee breaches occurred, both due to overtopping, along the north bank of the east-west trending channel of the GIWW/MRGO. Damage (mostly in the form of scour) also occurred along the IHNC East Levee and portions of the New Orleans Lakefront Levee located near the Lakefront Airport as the storm surge raised the water levels within the IHNC. Finally, the reverse (counterclockwise) swirl of the storm winds raised the levels along the south shore of Lake Pontchartrain. Portions of the levee system fronting Lake Pontchartrain, such as the New Orleans Lakefront, Citrus Lakefront, and New Orleans East Lakefront Levees, generally performed well in the hurricane, as did most of the New Orleans East Levee located to the east.

Figure 7.2: Damage locations in the NOE protected area (base map from USACE.) Color indicates severity of damage, with red being the worst. [IPET; March 10, 2006]

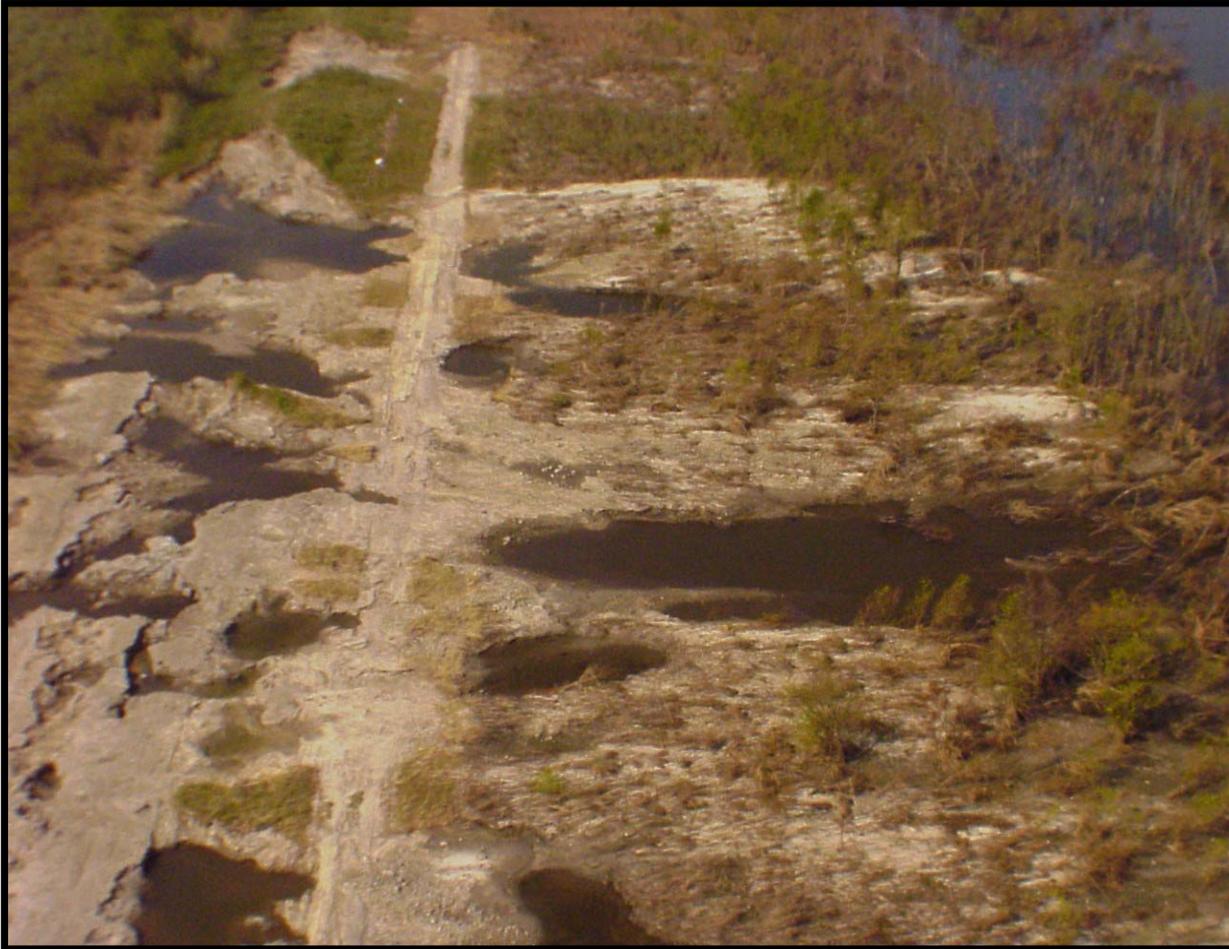
This damage to this segment of the levee system was similar to that which occurred along the Mississippi River Gulf Outlet (MRGO) levees in St. Bernard Parish: entire sections were completely eroded leaving virtually no trace of the original earthen levee (Figures 7.1 and 7.2). Figure 7.6 shows typical erosion along the eastern end of this levee frontage; the levee embankment is entirely removed by erosion along much of this reach.

Figure 7.6: Some of the most severe damage to the New Orleans regional levee system occurred along this section of the New Orleans East Back levee, which is situated in the southeast corner of the protected area, facing south toward Lake Borgne.

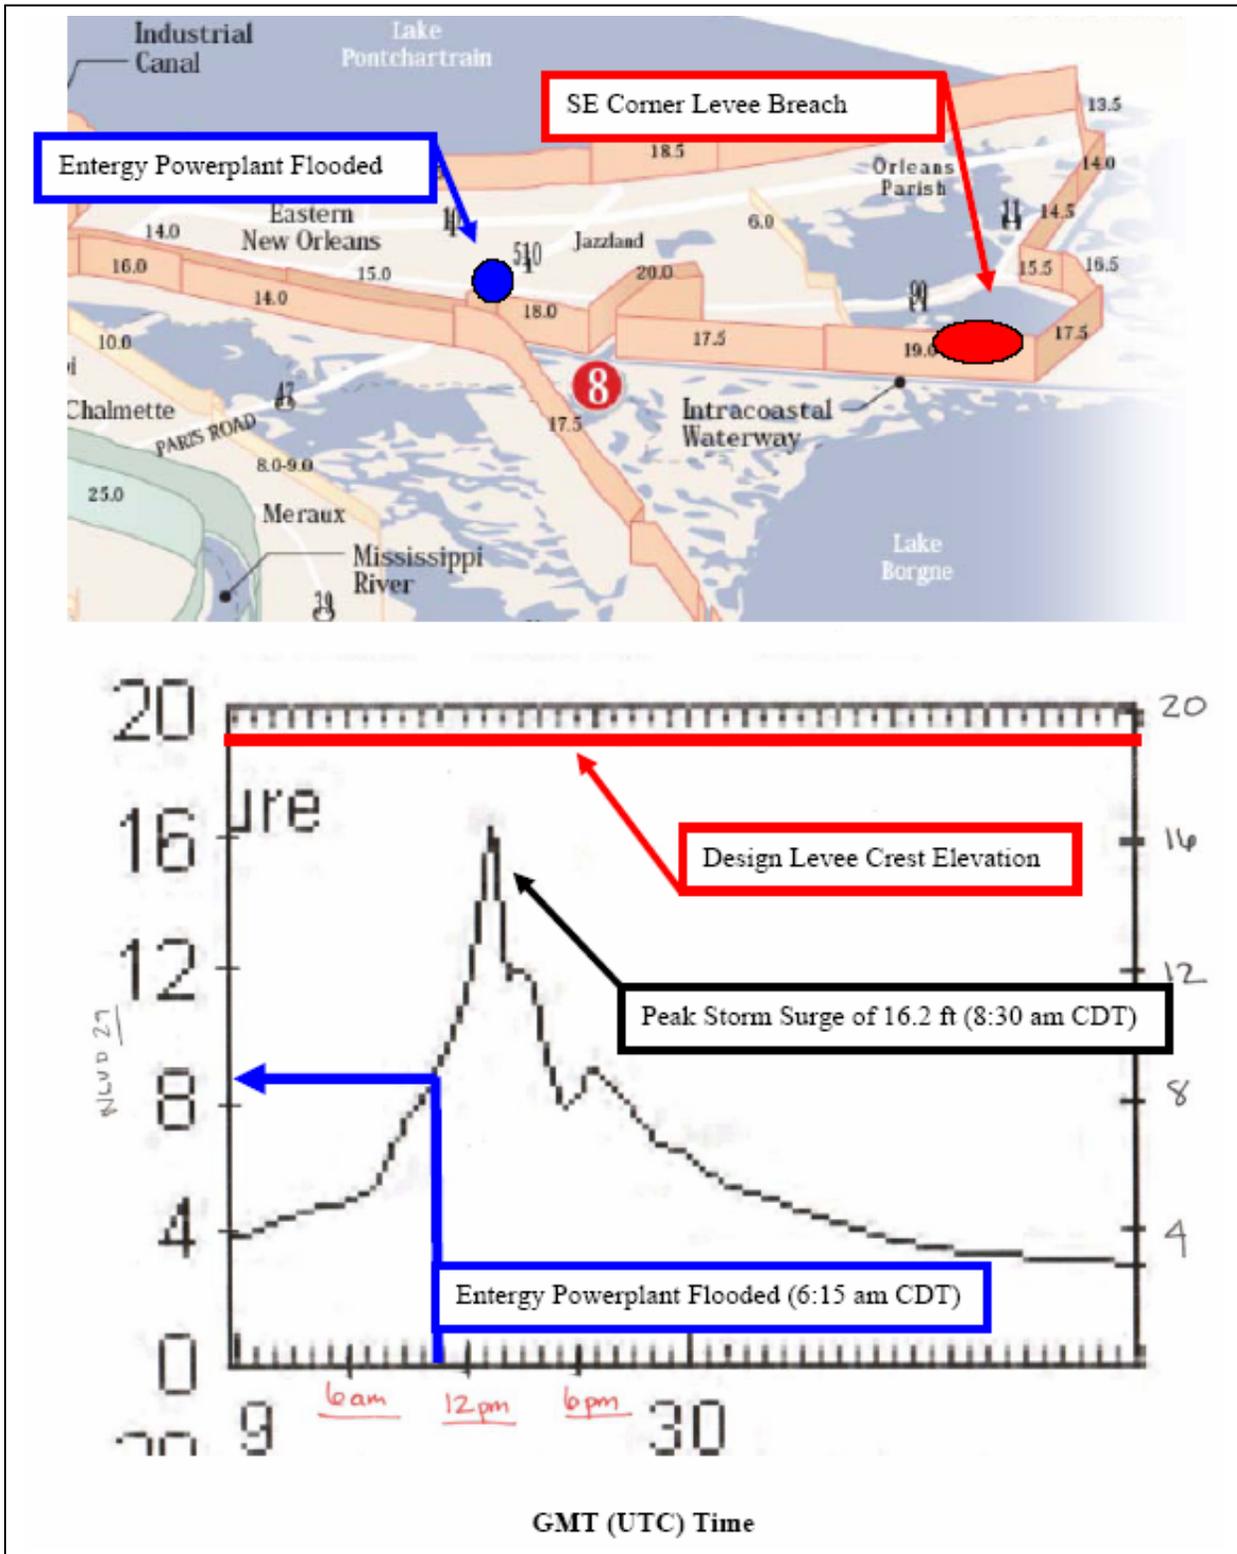
Figure 7.9 (top) shows the location of this power plant. There are only three possible breaches/sites that could have been the source of these well-timed floodwaters; (1) overtopping, and two breaches, along the Citris levees (along the GIWW/MRGO channel, to the west, (2) local overtopping adjacent to the power plant itself, and (3) the massive breaches at the southeast corner of NOE, along the NOE back levees fronting Lake Borgne. Given the crest heights, and water elevations vs. time, it can be established that the overtopping required for options (1) and (2) above did not begin until well after 7:00 a.m., so the only likely source of these floodwaters appears to be the massively eroded sections of the NOE back levee frontage.

Figure 7.9: Timing of observed flooding at Entergy Powerplant and storm surge at New Orleans East back levee breach (southeast corner fronting Lake Borgne.) [Times shown are UTC or Greenwich Mean Time. Elevations shown are in feet, NGVD29.]

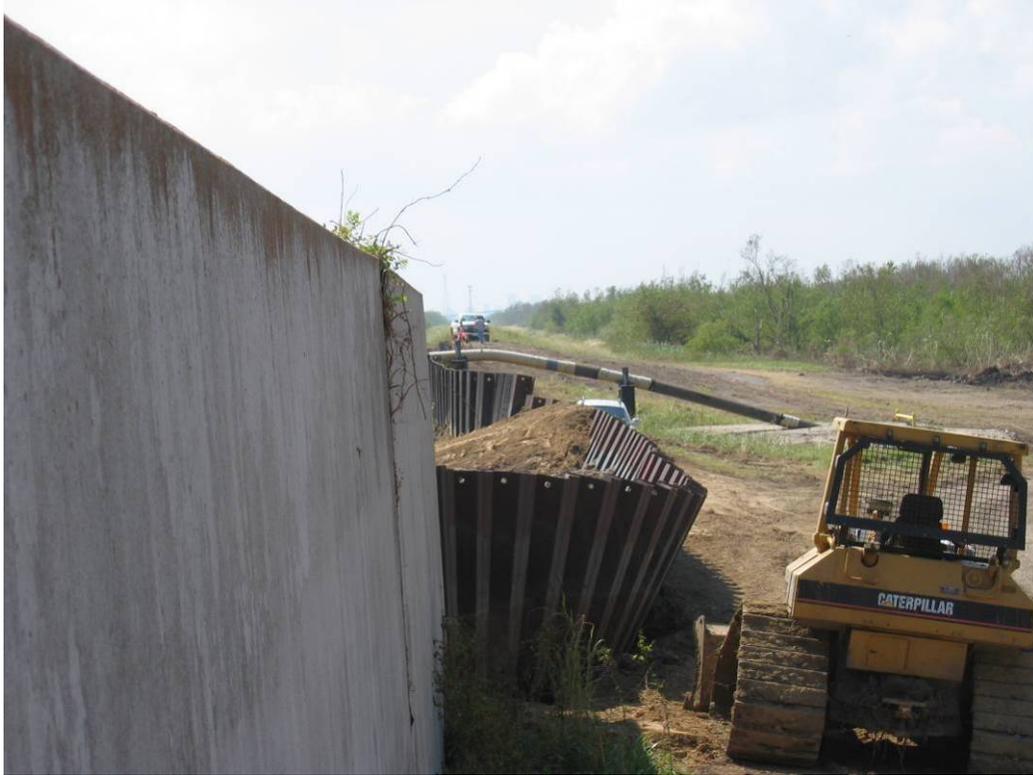
Damage to the NOE back levee reach also occurred further west, between the interior secondary levee and the Michoud Canal. A sheetpile levee “transition” section located near Pump Station 15 deflected and tilted inward (i.e., toward the protected side, see Figure 7.10), as the result of overtopping-induced erosion at the base of the backside of the sheetpile wall. Sheet piling was used at these locations to transition between concrete floodwall and full-height earthen levee sections. The tops of the damage sheet pile wall had pre-Katrina elevations that were less than the immediately adjacent concrete floodwall sections, and hence scour at this location was worsened by preferential overtopping during the peak of the storm surge. Further to the west near the Air Products Corporation site, a similar sheet pile transition section overturned and collapsed in response to scour and the associated loss of passive resistance on the protected side (Figures 7.12 and 7.13). Once again, the top of the damaged section was at a lower elevation than adjacent levee segments resulting in highly concentrated overflow (and resulting scour, that laterally unbraced the sheetpile wall) at this location. Note that there is little or no evidence of overtopping erosion adjacent to the failed sheetpile transition section. This is one of numerous cases wherein the adjacent long reaches

Figure 7.10: Deflected and tilted sheet pile sections near Pump Station 15.

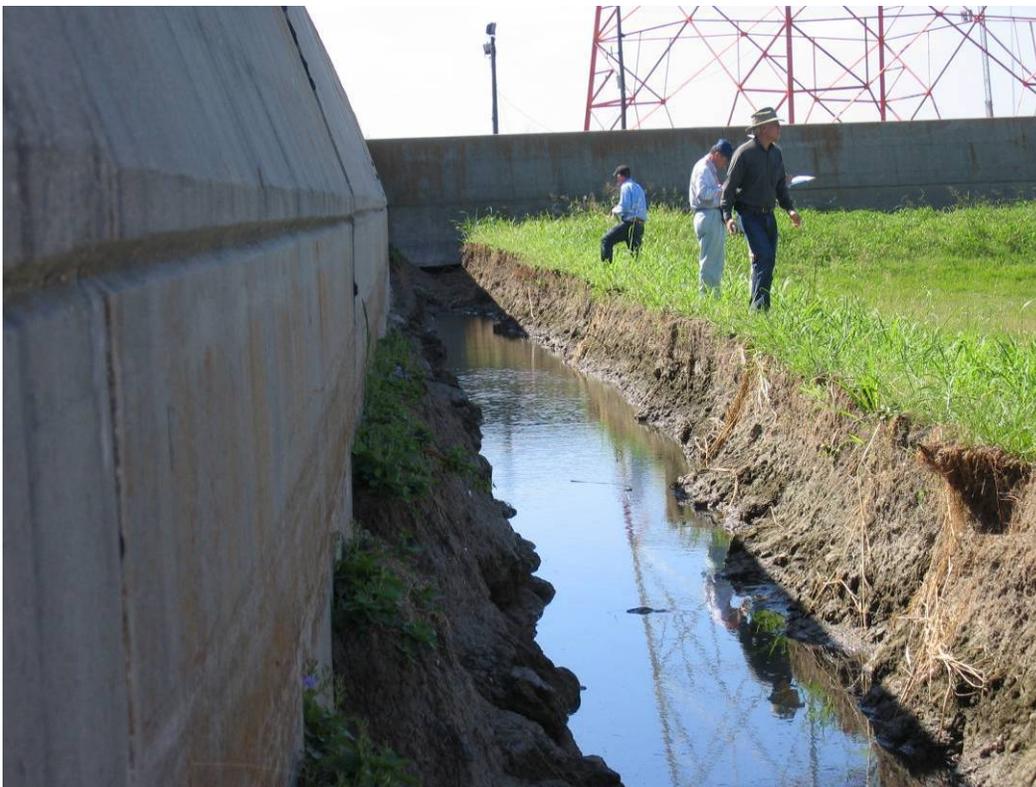
Figure 7.11: Scour at the base of floodwalls near the Michoud Canal.

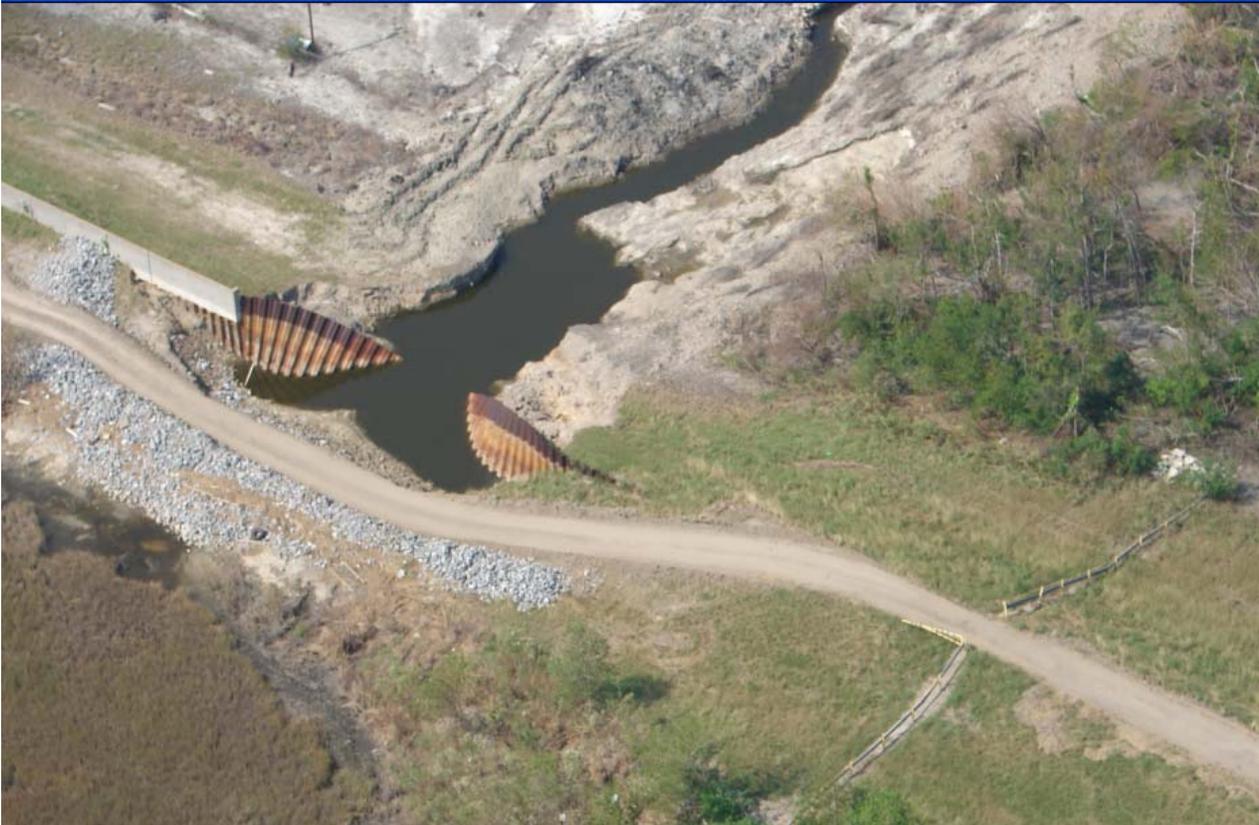
Figure 7.12: Failed sheetpile transition at the Air Products Corporation site; NOE back levee.

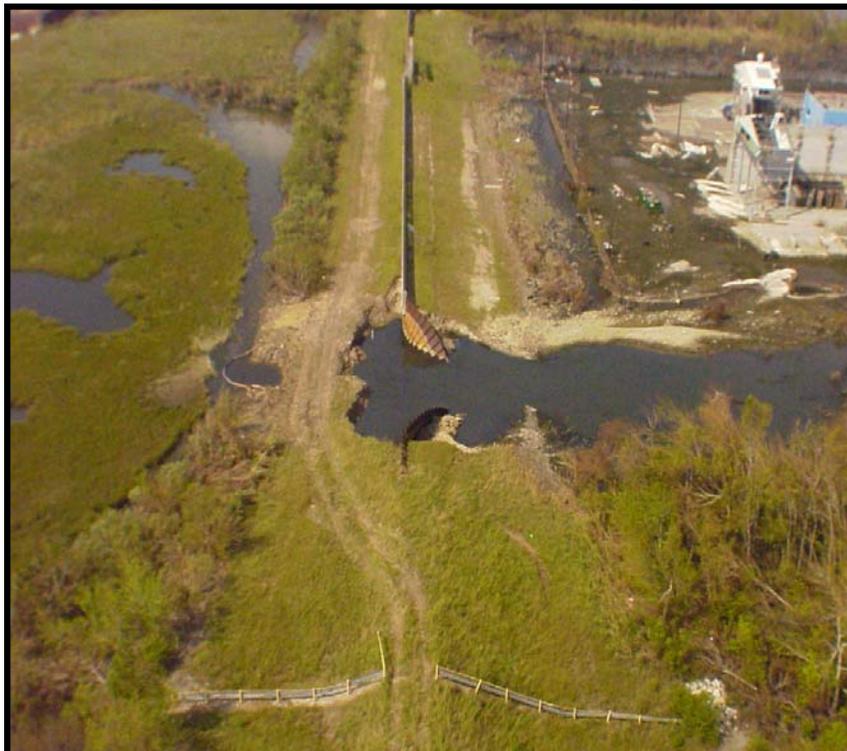
Figure 7.13: Second view of failed sheetpile transition.

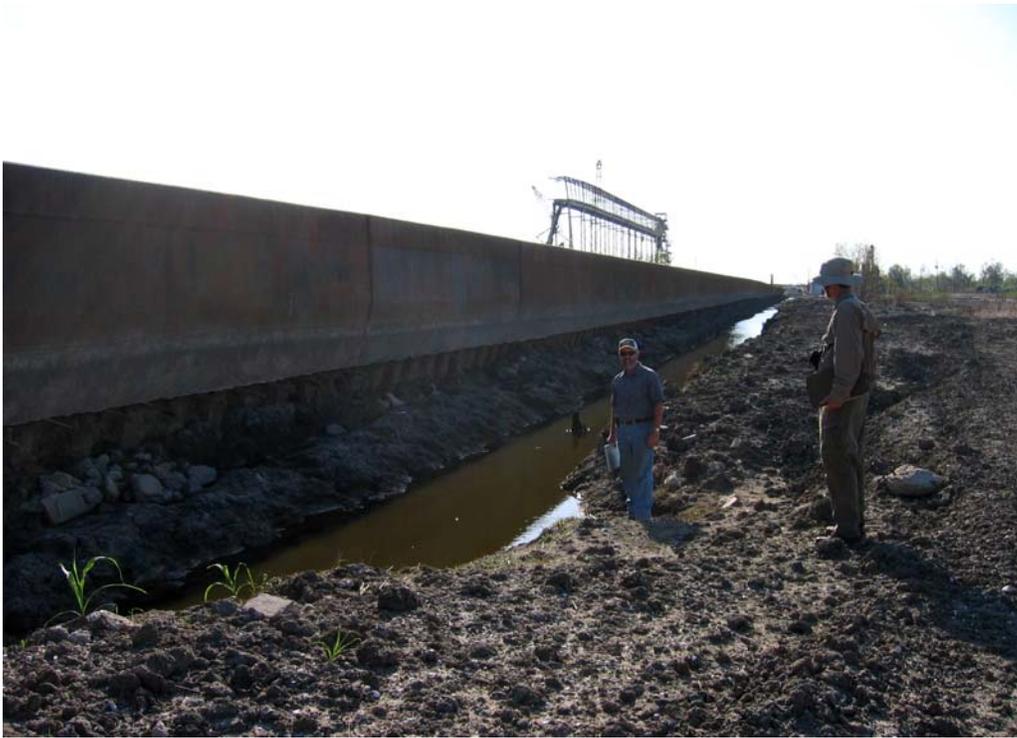
for the sheetpiles and the concrete floodwall they supported, and the lateral forces of the outboard side storm surge pushed the laterally unbraced floodwalls sideways. Figure 7.14 shows the eroded trench at the inboard side of a floodwall section that experienced only limited movement; note the heave of soils immediately at the toe of the sheetpiles/floodwall. Figure 7.15 shows a view of the outboard side of a floodwall section that was nearly completely overturned. In this figure, the “gap” between the sheetpiles and the non-displaced outboard side levee embankment toe can be clearly seen. As discussed in numerous other sections of this report, the formation of this water-filled gap served to increase the lateral forces acting against the outboard side of the sheetpile/floodwall.

Figure 7.14: Significant lateral deflection of the Citrus Back Levee floodwall, seen from the inboard (protected) side. Note the heave adjacent to the displaced sheetpiles and wall.

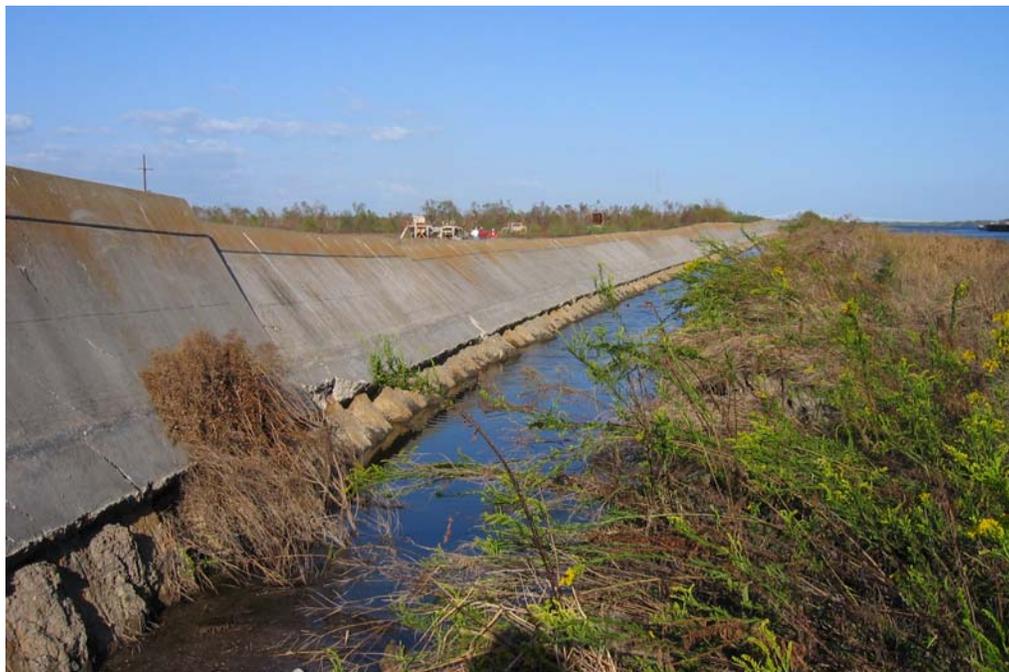
Figure 7.15: Deflection and tilting of another section of the Citrus Back Levee Floodwall, this time viewed from the outboard side. Note the gap between the outboard levee toe section and the sheetpile curtain.

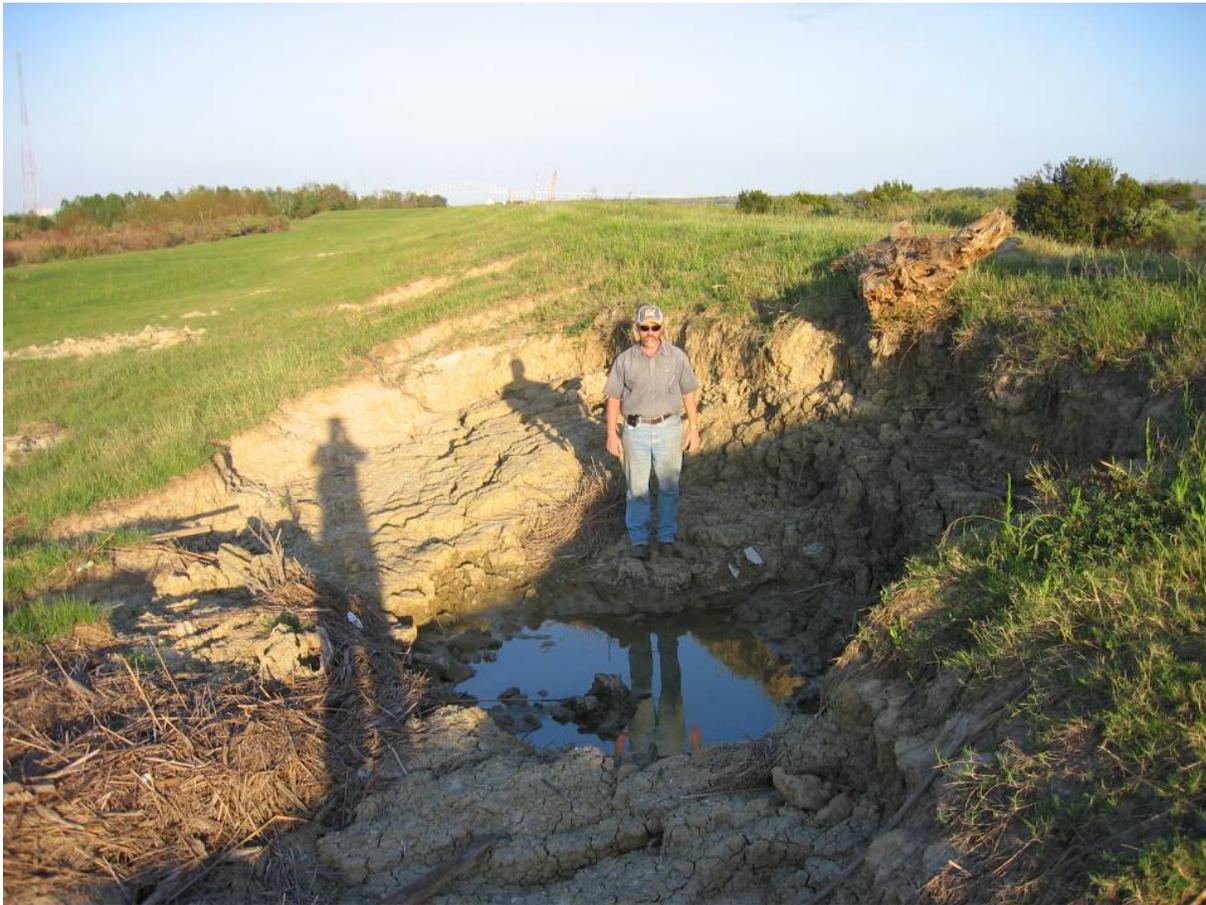
Figure 7.16: Scour varied greatly along the Citrus Back Levee. It was significant on the back (inboard side) slope of the levee at this location; nearly breaching the levee crest.

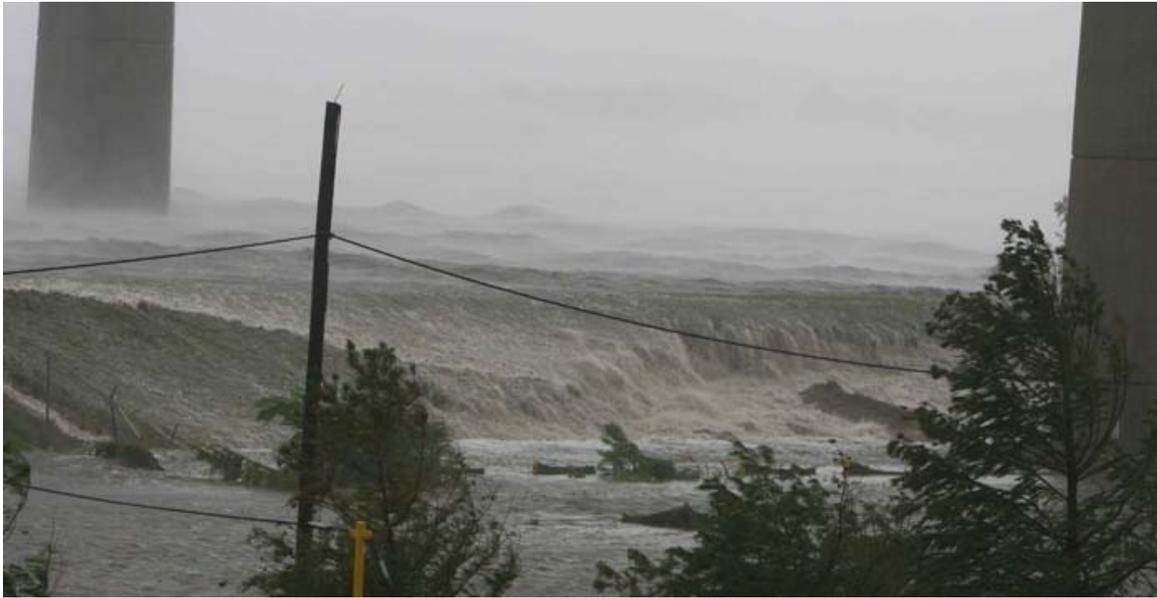
Figure 7.17 shows a still image from a security videotape showing significant overtopping of the earthen levee adjacent to the Entergy power plant, immediately east of the highway bridge to the St. Bernard parish. Figure 7.18 shows the same site after the hurricane had passed. The overtopping had produced moderate damage, but again no beaching of the levee crest and no failure at this location. Erosion-related performance was generally more favorable than these two examples along the earthen levees that comprised most of the Citrus levee frontage, and many sections showed no indication of overtopping erosion whatsoever.

Figure 7.17: Still image from security videotape taken at Entergy power plant showing overtopping adjacent to the I-510/Hwy 47 Bridge on the NOE Back Levee.

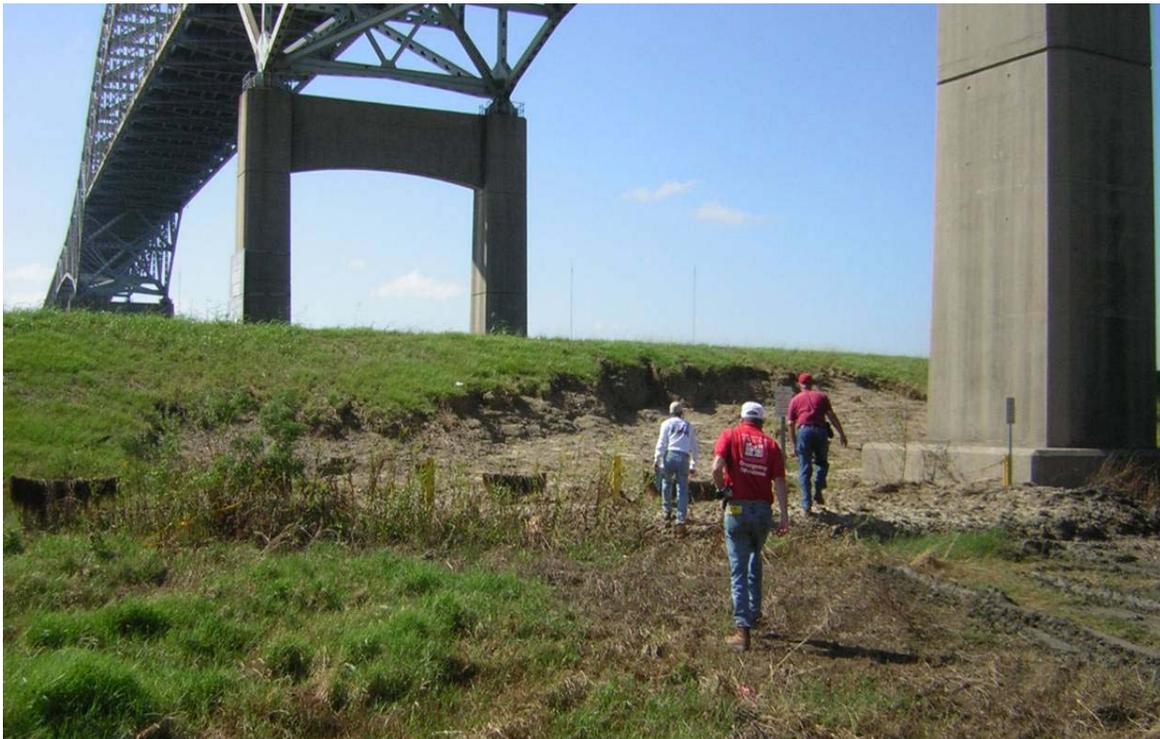
Figure 7.18: Post-Katrina photo of the same levee section shown above in Figure 7.17.

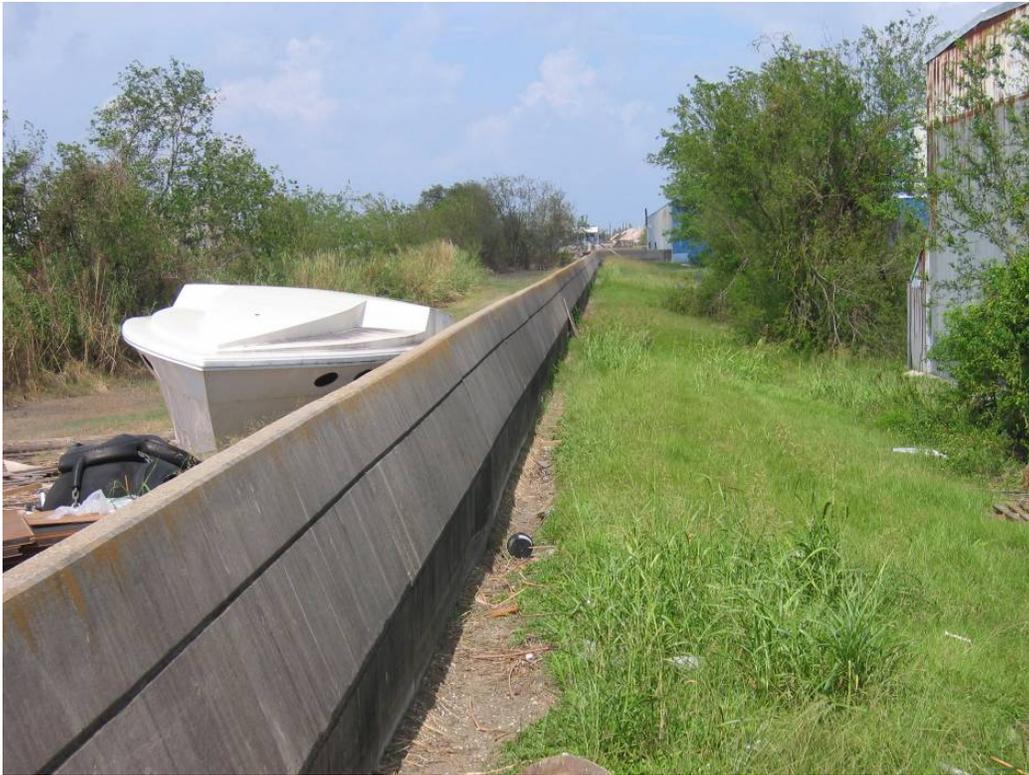
Figure 7.19 shows a typical example of overtopping-induced scour behind a concrete floodwall along this frontage. This was common along this frontage, but no full failures resulted. It is not possible to know with certainty to what extent this type of erosional damage was limited by the fact that waters were likely already accumulating at the inboard sides of these floodwalls due to overtopping and breaches at other locations.

Figure 7.19: Minor scour along the base of the IHNC floodwall. Note the boat pushed against the outboard (flood) side of the wall.

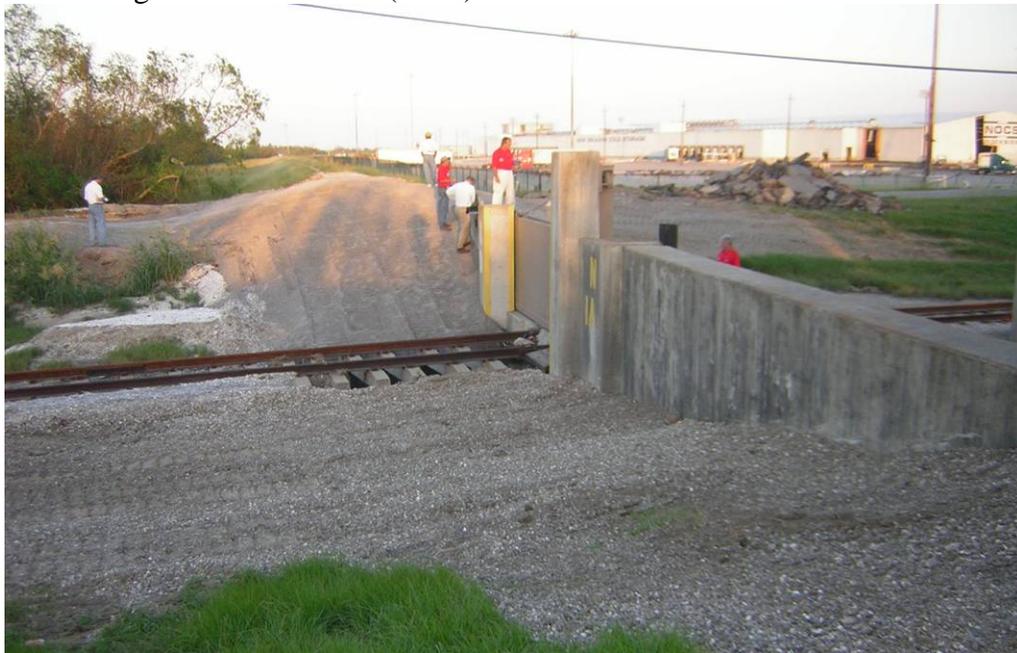
Figures 7.20 through 7.22 show several examples of the 8 locations along this frontage where erosion occurred, but did not develop fully to the point of “failure”, at transitions between adjoining flood system elements. Transitions between full height earthen levees and adjacent, composite levee/floodwall sections, and transitions between levees and concrete gate structures (with rolling steel floodgates), were routinely problematic in this regard, and it was common to find partially developed erosion problems at both ends of most gate structures along this frontage. Inadequate attention to transition details, especially to lateral embedment of transitions, and differences in top elevations of adjoining elements, were common. Also disconcerting were sites where the eroded materials appeared to be comprised, at least in part, of lightweight shell-sands; materials notorious for lack of erosion resistance that have no place in these levees protecting large populations.

Figure 7.20: One of numerous examples of partially exploited erosive vulnerability at a “transition” section along the IHNC levee frontage; in this case a transition from a gated concrete floodwall to a full height earthen levee section.

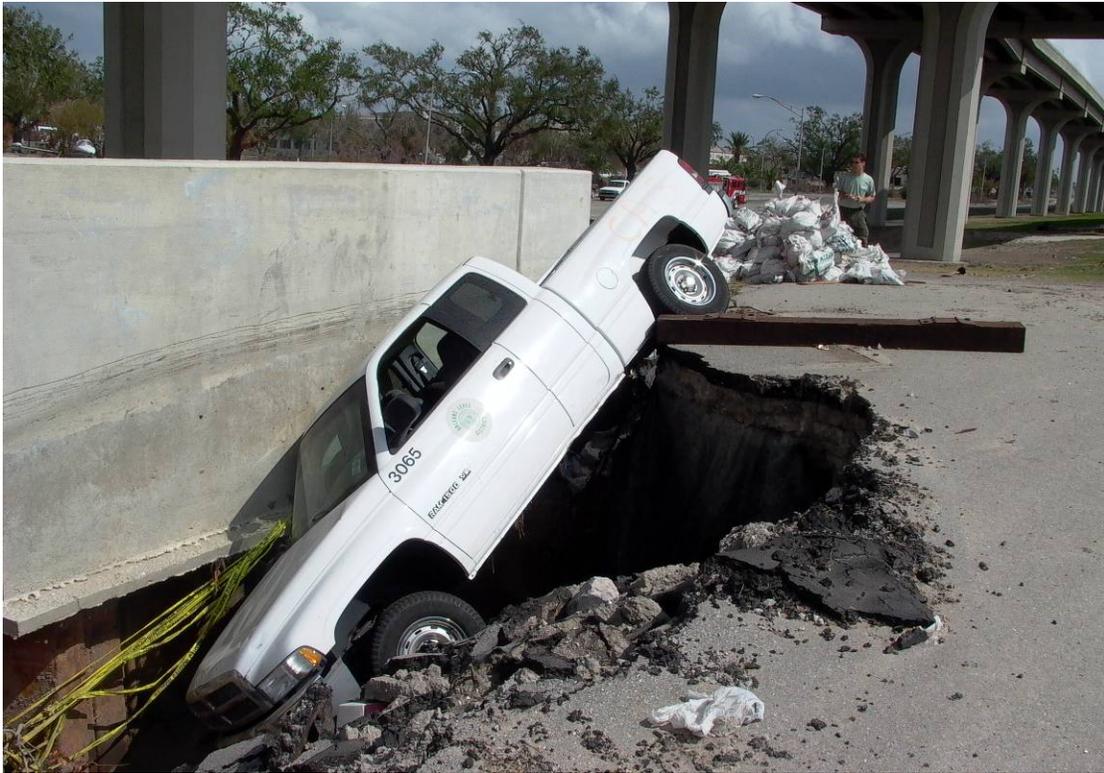
Figure 7.21: Another example of partially exploited erosive vulnerability at a “transition” section along the IHNC levee frontage; in this case a transition from a roadway floodgate to a full height earthen levee section.

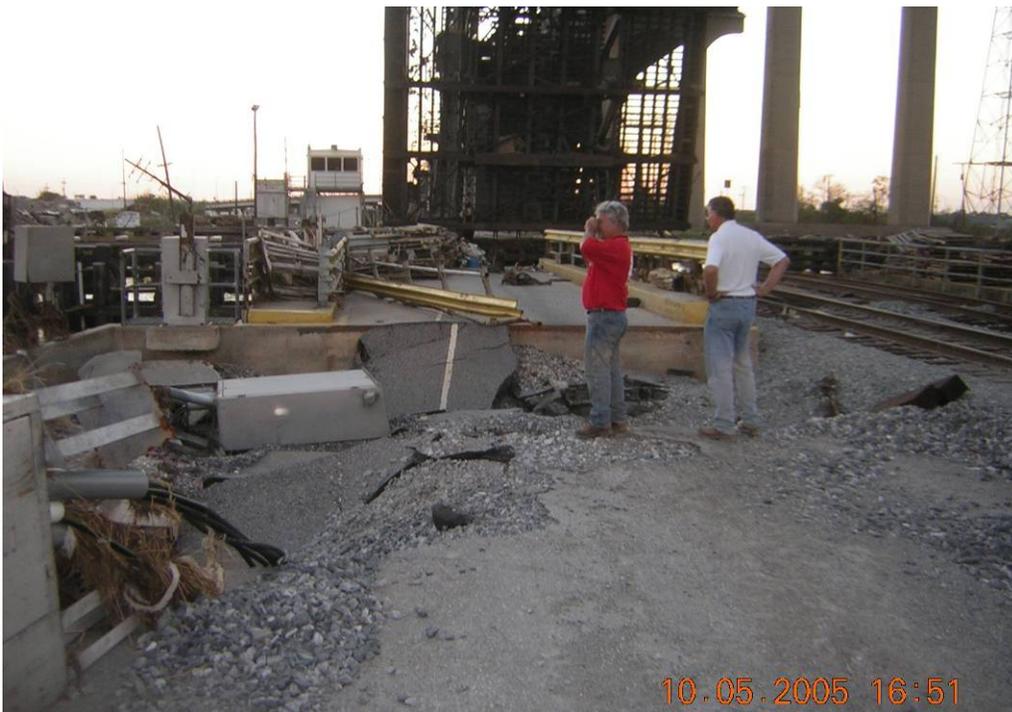
Figure 7.22: Erosion at the east bank IHNC CSX Rail Crossing.

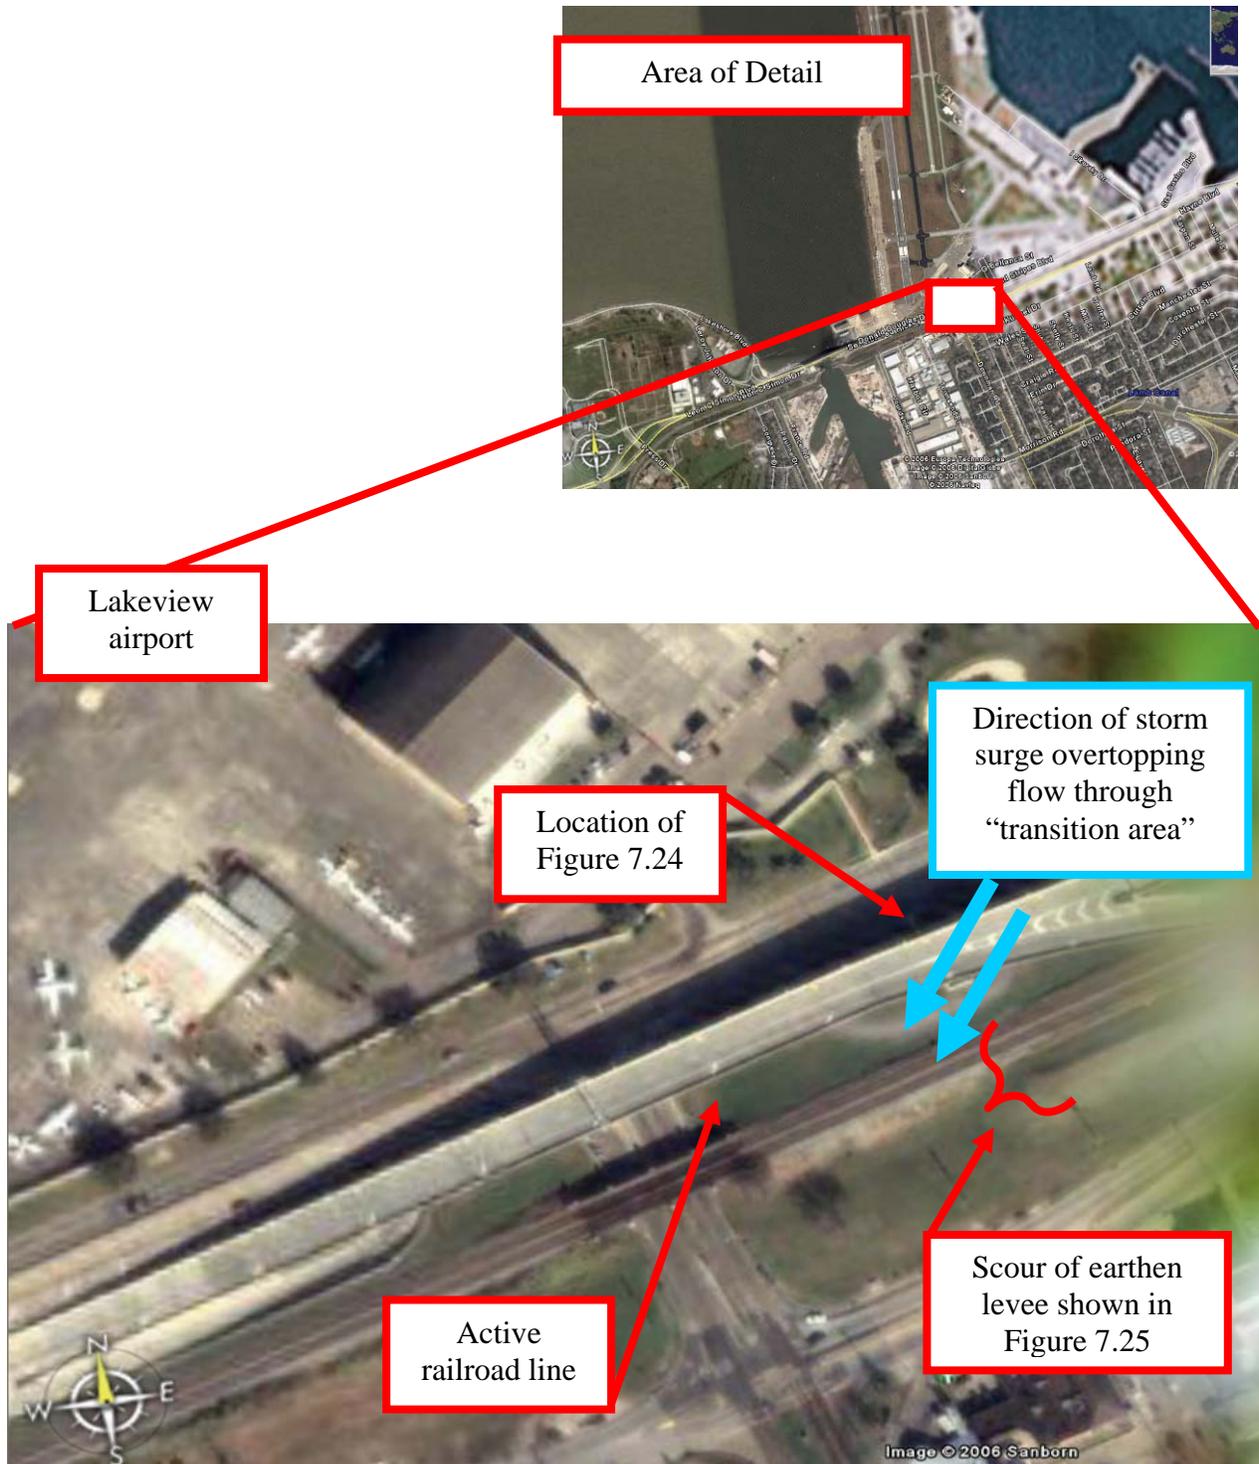
Figure 7.23 shows this location in plan view. Significant overtopping occurred along a nearly mile-long section of the Lakefront levee that had an unexpectedly low floodwall crest height, and this flow passed through the gravel ballast of the railroad embankment (a local low spot, as it was pervious) and eroded the adjacent earthen perimeter levee. This flow also eroded the transition between a concrete floodwall and the adjoining earthen levee section beneath the elevated highway, as shown in Figure 7.24.

Figure 7.23: Storm-surge induced overtopping traveled through the granular gravel ballast for the railroad line and eroded the railroad line embankment, which served as a transition levee between the concrete floodwall and the earthen levee shown in Figure 7.25. [Base image from Google Earth, 2006]

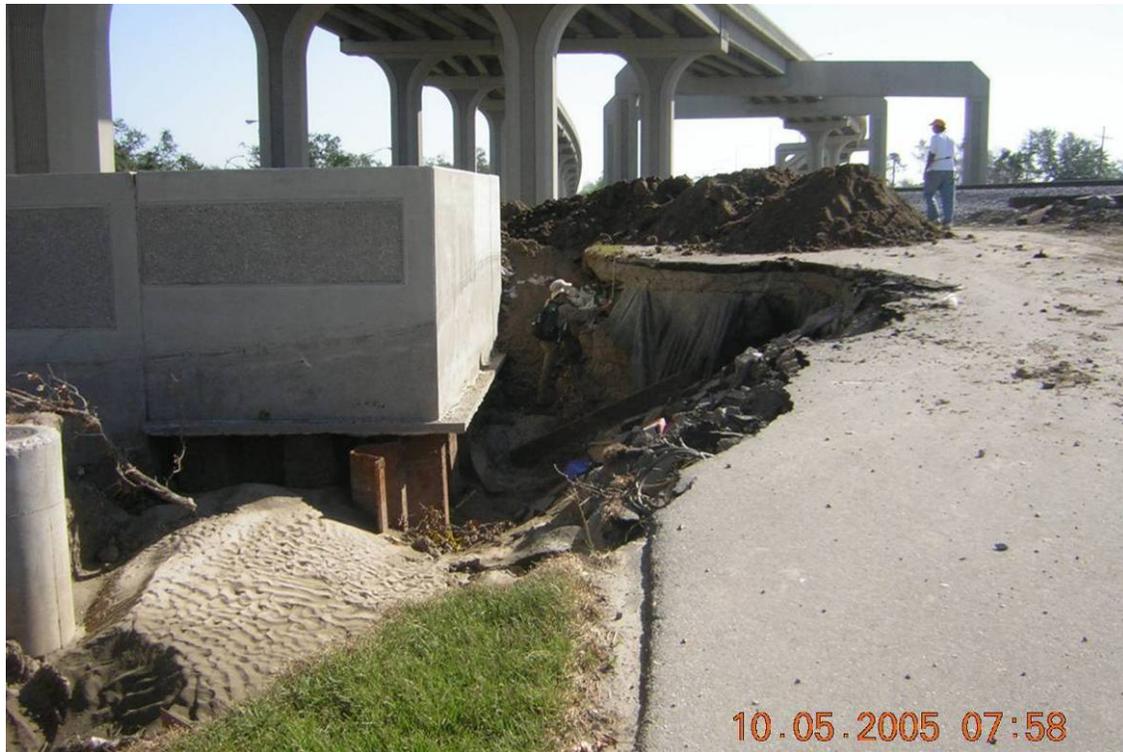
Figure 7.24: IHNC levee near the Lakefront Airport adjacent to the railroad section from Figure 7.23, showing erosional failure and scour at transition to concrete floodwall protecting highway support.

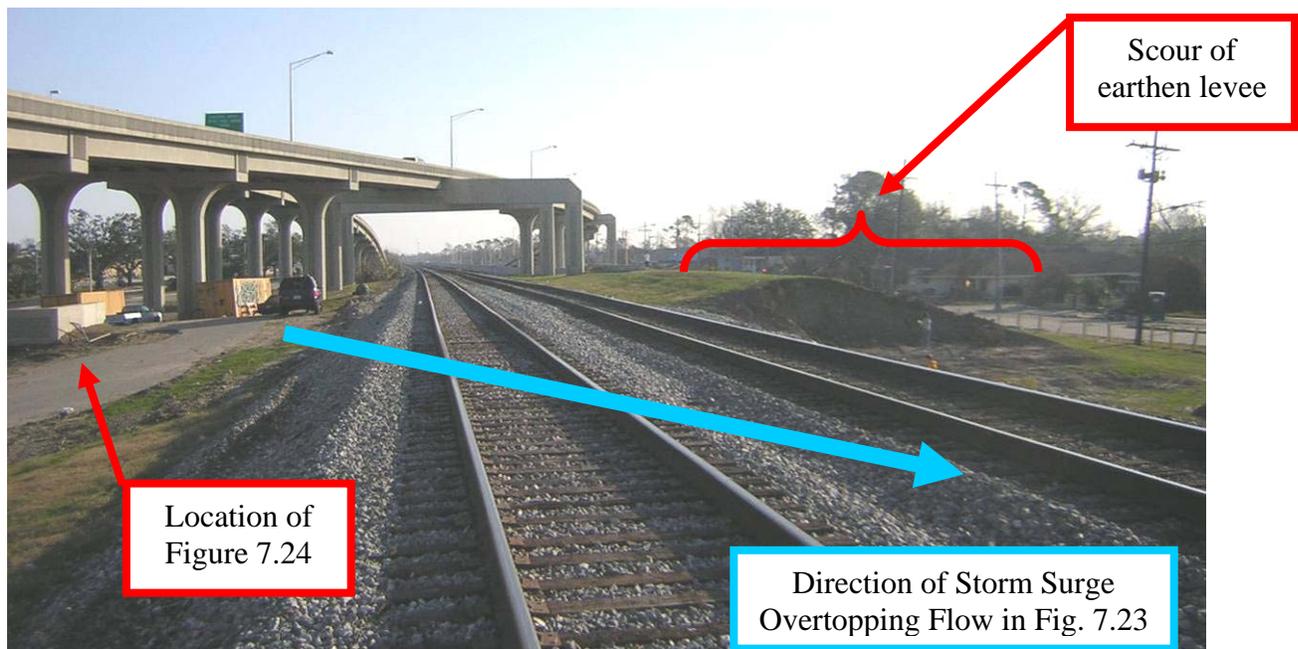
Figure 7.25: Significant erosion was observed on the levee adjacent to (and behind) the floodwall shown in Figure 7.24. The storm surge overtopped the floodwall and railroad ballast and failed the earthen levee behind the railroad.

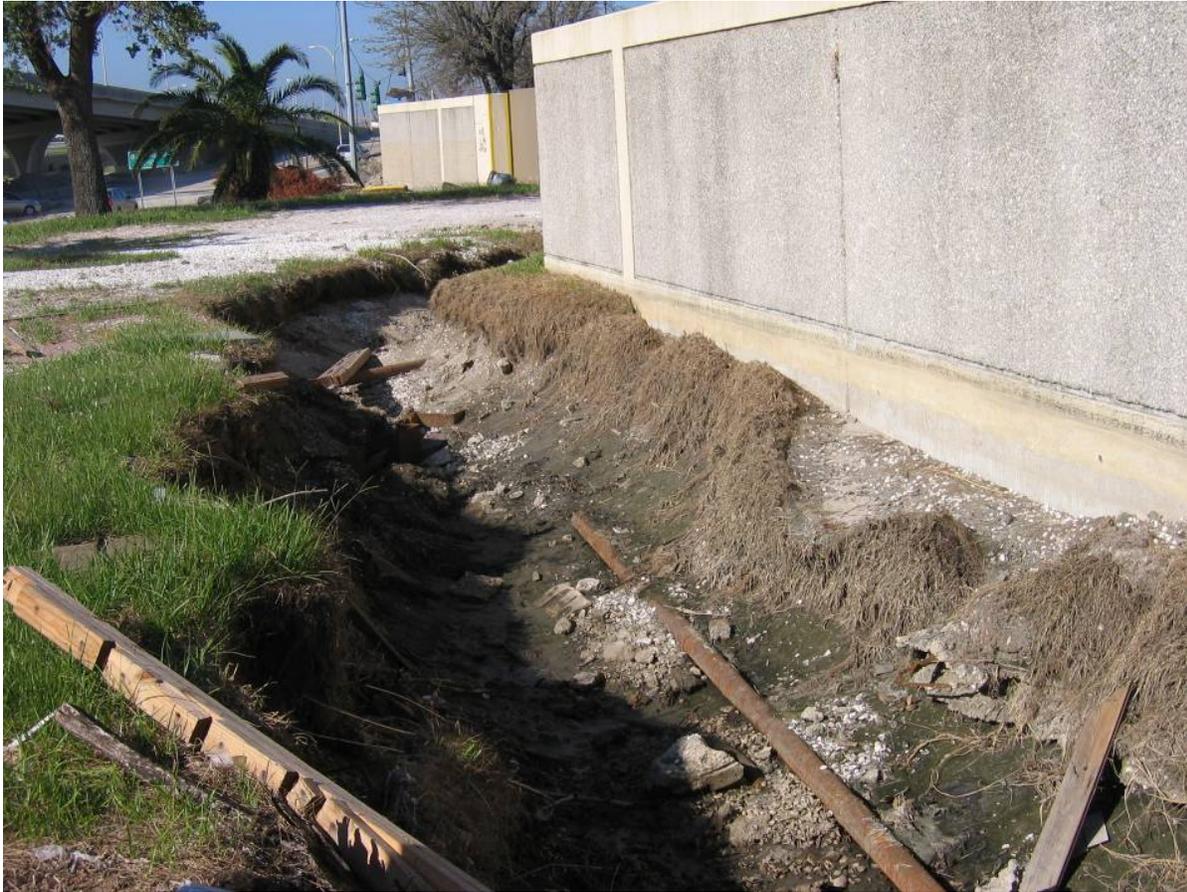
Figure 7.26: Scour near the base of a floodwall near the Lakefront Airport.

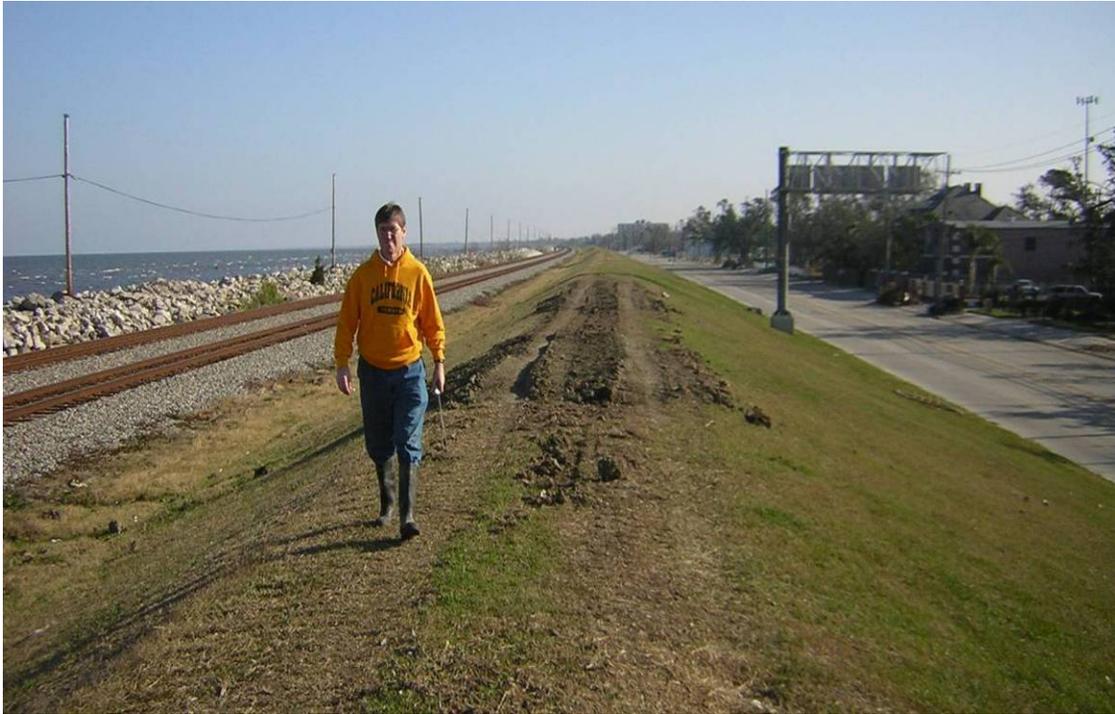
Figure 7.27: Lakefront levee near the Jahncke Pump Station outfall structure, where minor overtopping erosion occurred. These levees performed well and only minor, surficial damage was observed.
