CHAPTER SEVEN: THE NEW ORLEANS EAST PROTECTED AREA

7.1 Introduction

7.3 Performance of the New Orleans East Hurricane Protection System in Hurricane Katrina

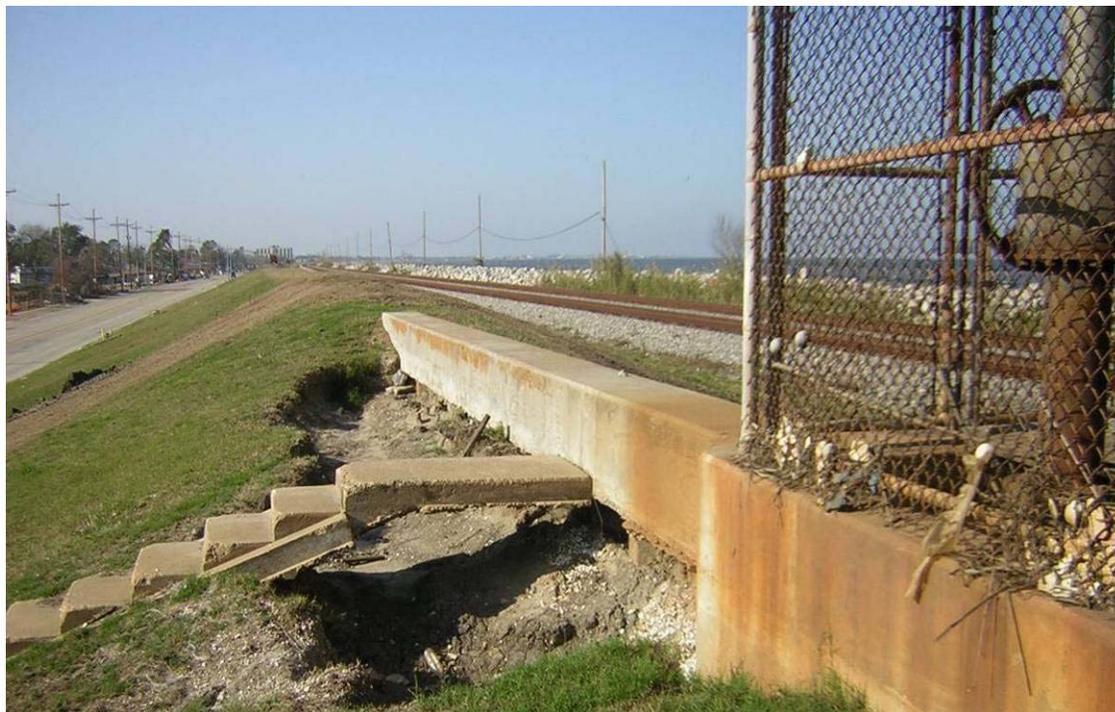
Figure 7.28: Observed scour at the Jahncke Pump Station outfall structure, Lakefront. Scour was limited to areas of soil-structure interfaces, and no full breach occurred.

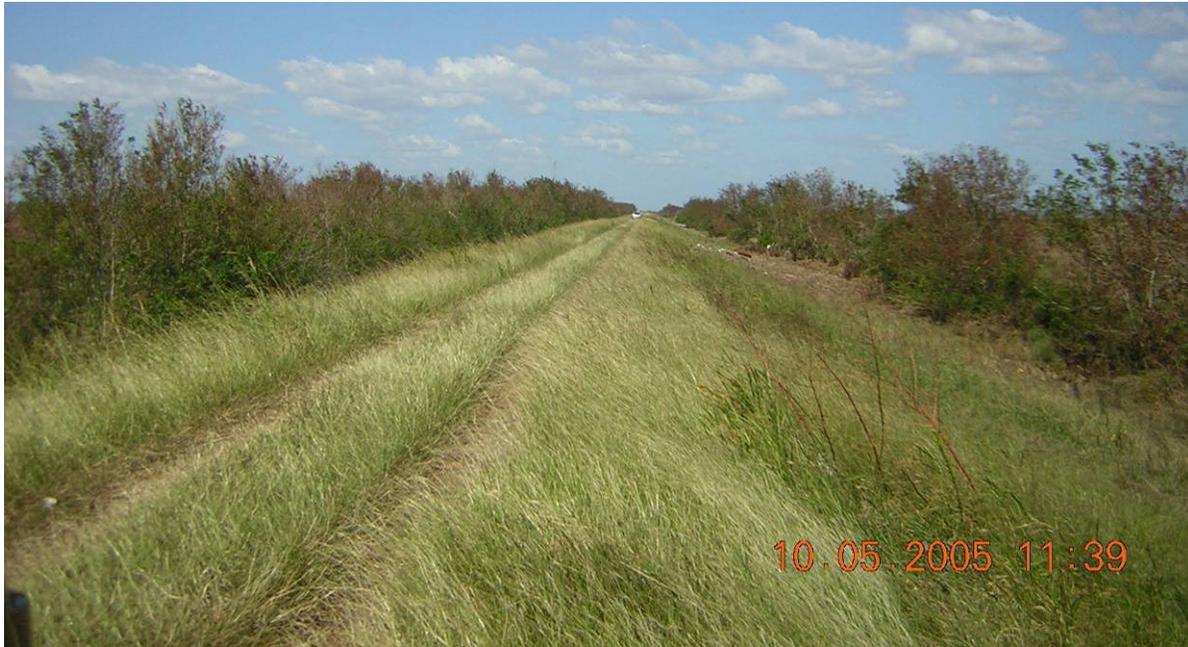
Similar performance was also noted along the eastern levee frontage, which is buffered from the nearby lake systems by a large stretch of wetlands to the east. Figure 7.29 shows a post-event view of a typical levee segment along this frontage. No damage at all was noted along most of this frontage, and only limited erosion at a few locations. This was despite evidence suggesting that overtopping had occurred along at least some portions of this frontage. This favorable performance was likely due to: (1) the use of compacted, clayey fill for the levee embankments (materials with a high resistance to erosion), and (2) the presence of significant widths of swamps and cypress and other vegetation on the outboard sides of the levee (which served to buffer the wave action.)

Figure 7.29: Condition of levees east of HWY 11 (location 3 on Figure 10.6) in October 2005. These levees performed exceptionally well and were not eroded during Hurricanes Katrina or Rita.
