CHAPTER EIGHT: THE ORLEANS EAST BANK (DOWNTOWN) AND CANAL DISTRICT PROTECTED AREA

8.1 Overview

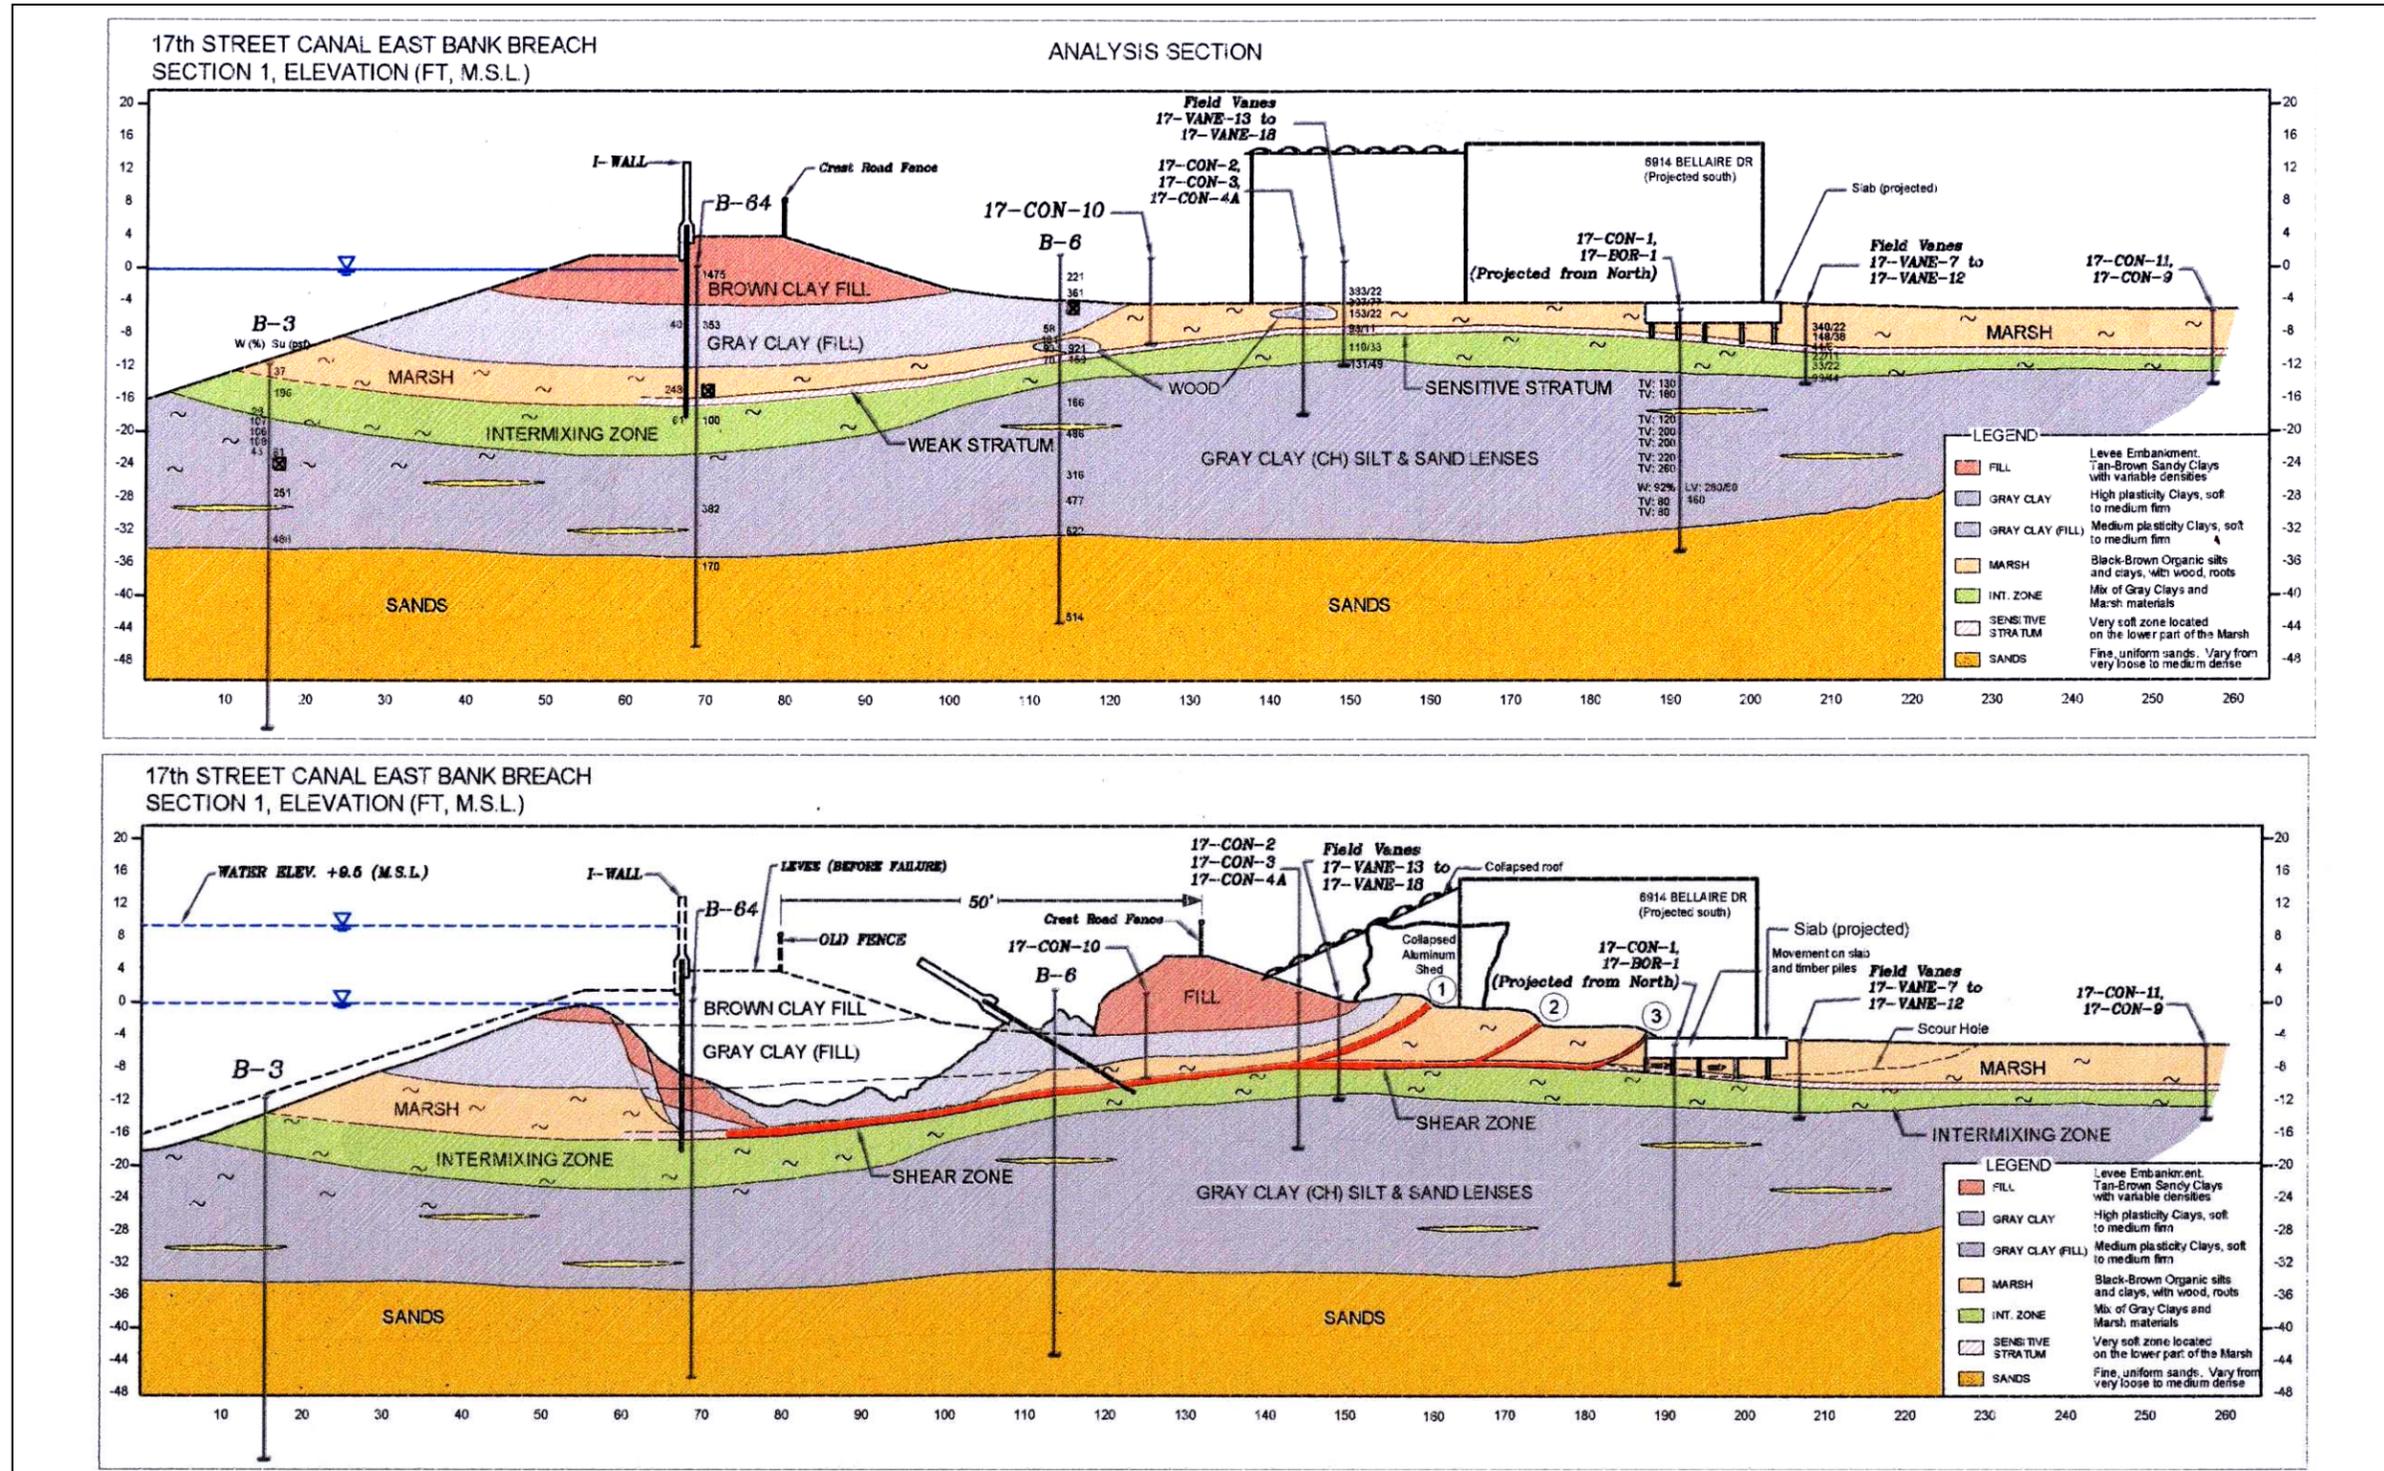
Figure 8.26: Cross-section through the 17th Street Canal breach showing conditions (a) before the hurricane, and (b) after the breach and failure.

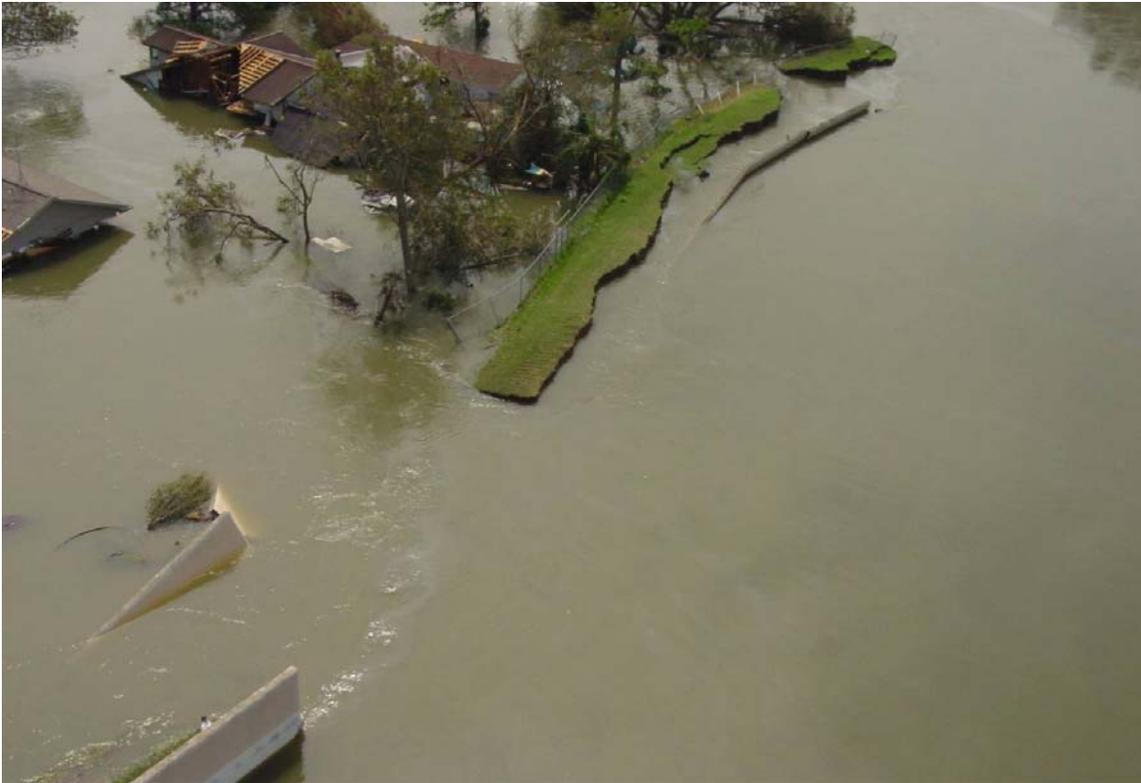
Figure 8.28: View of the 17th Street Canal breach site showing the tops of the I-wall sections that “pushed” (and followed) the displaced levee embankment section, and then toppled backwards towards the canal.

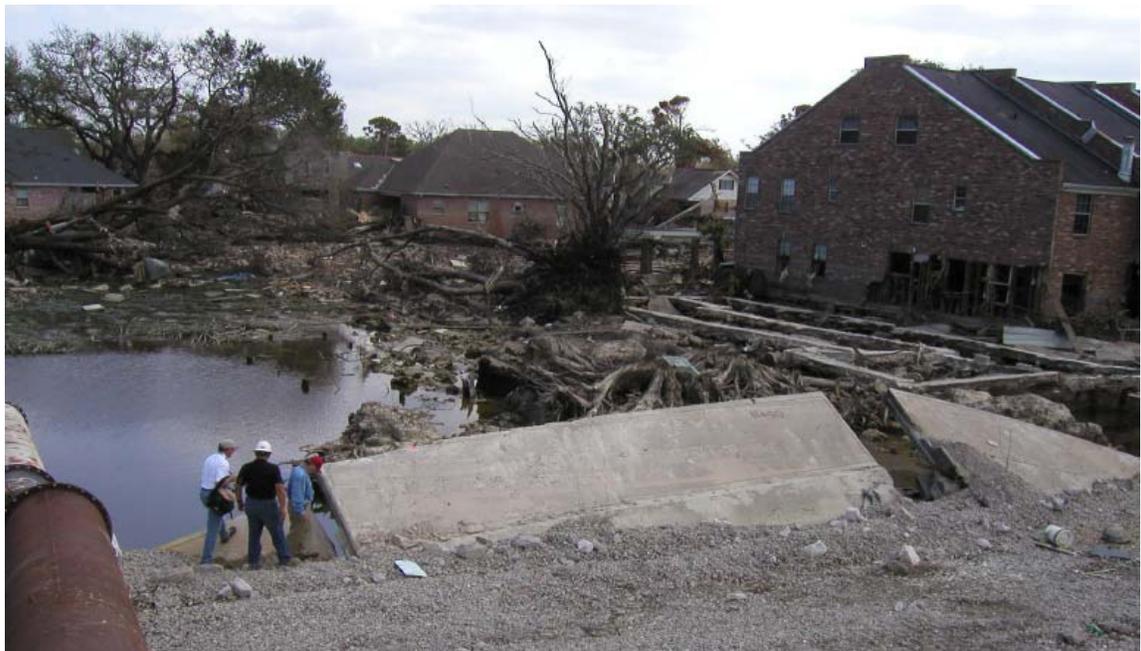
Figure 8.29: View of the 17th Street canal breach site showing the I-wall sections at the south end of the breach toppled forward (to the inboard side) by the inrushing floodwaters. Note the severe scour inboard of the failure at this location.

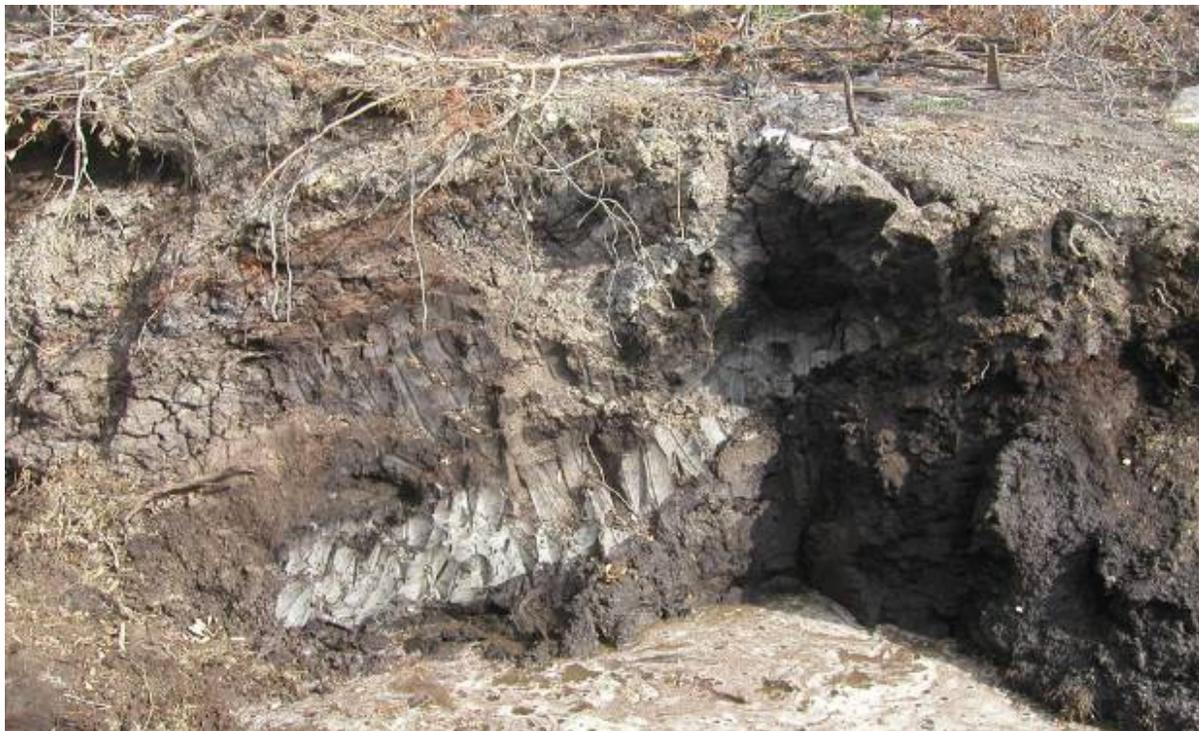
Figure 8.32: View of the exit of the upper failure surface (shear surface No.1 from Figure 8.27) at the inboard toe of the laterally translated embankment (toe scarp No. 1 in Figures 8.26 and 8.27).

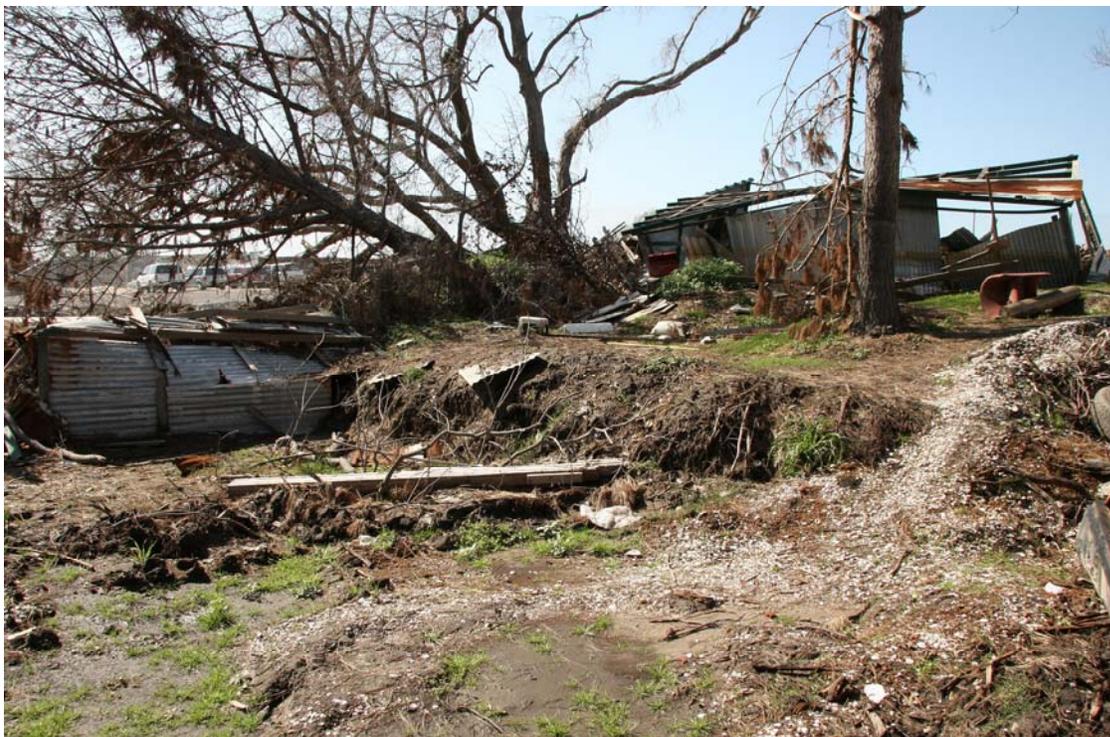
Figure 8.33: View of toe scarps No's. 2 and 3 at the inboard edge of the lateral translational failure at the 17th Street drainage canal.

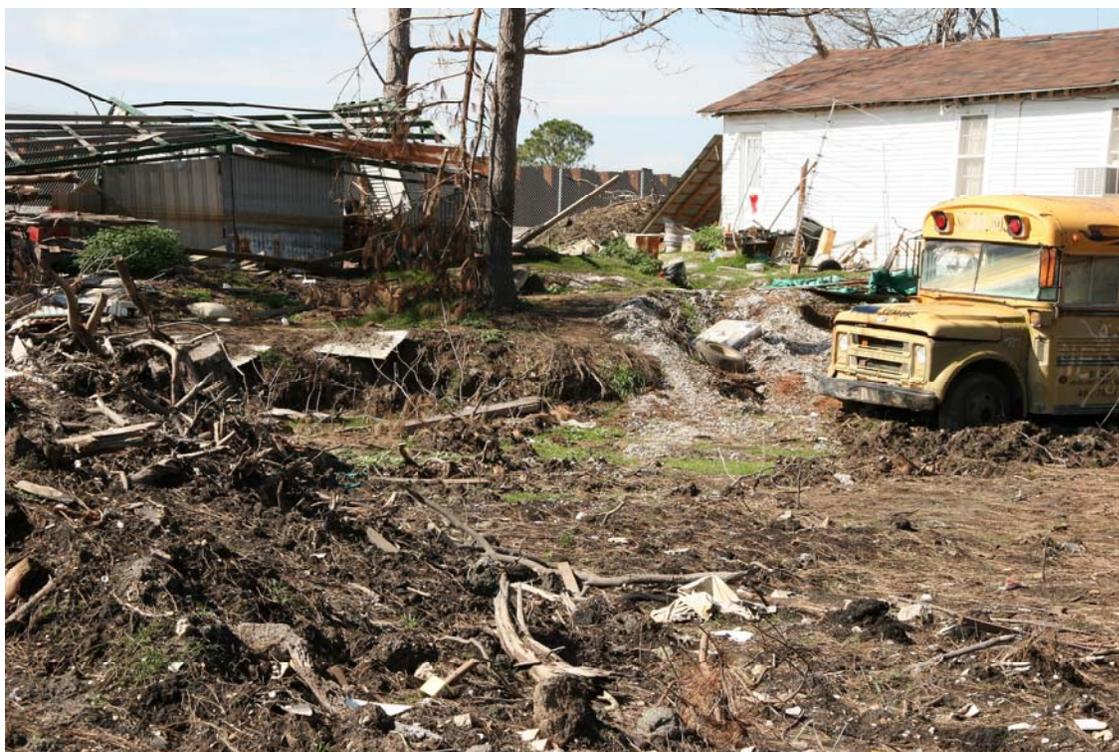
Figure 8.34: Additional view of toe scarps No's. 2 and 3 at the inboard edge of the lateral translational failure at the 17th Street drainage canal.

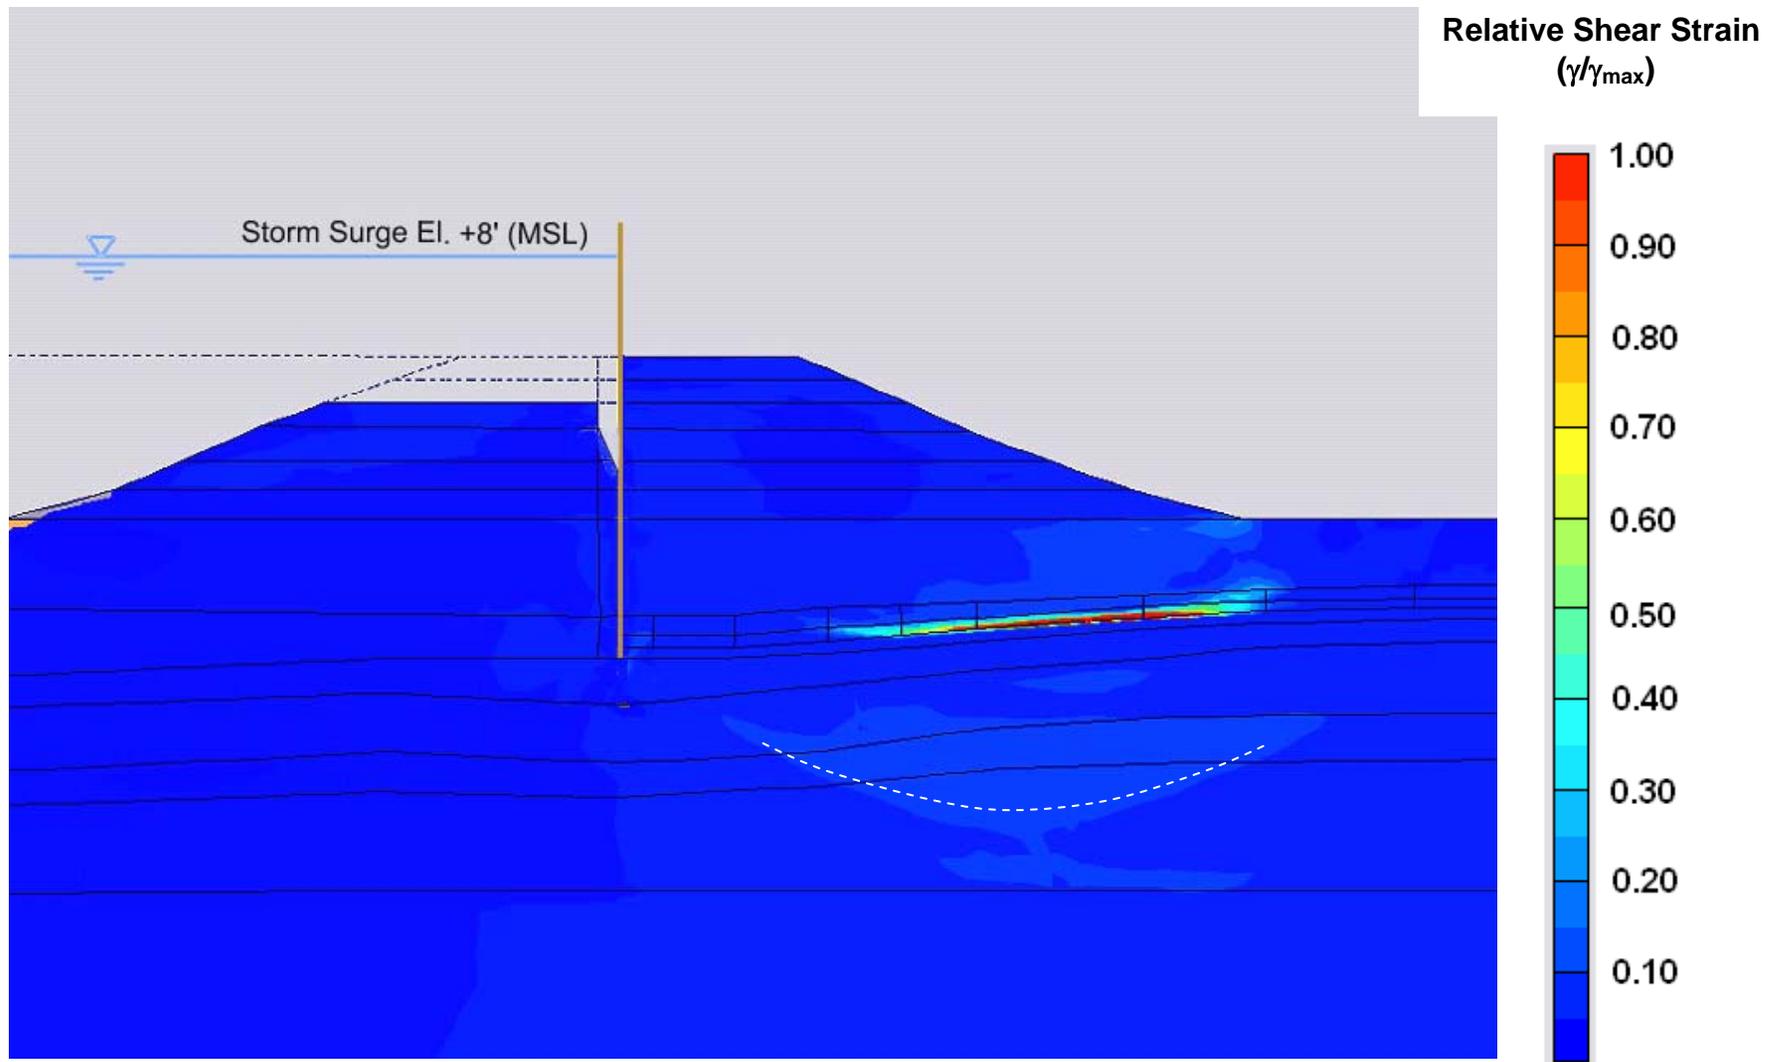
Figure 8.59: Normalized shear strain contours (shear strain divided by strain to failure) for a storm surge at Elev. + 8 feet (MSL) At the 17th Street Canal breach site; initiation of gapping at outboard toe of floodwall.

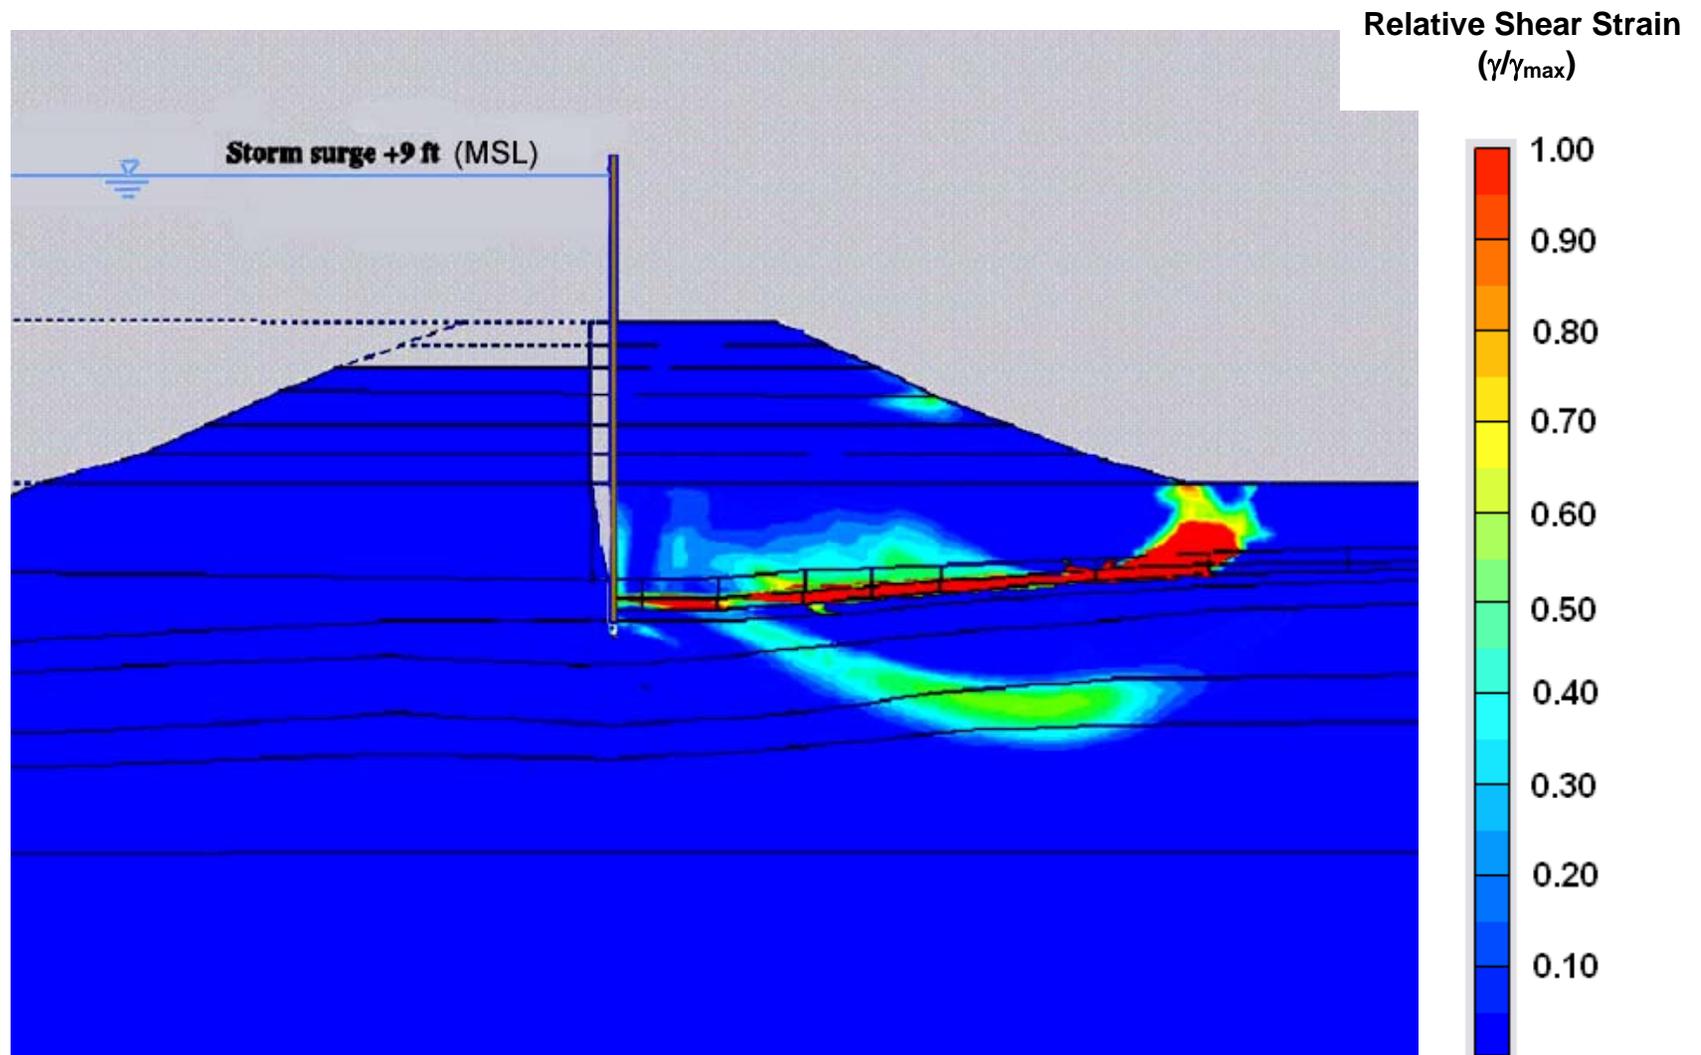
Figure 8.60: Normalized shear strain contours (shear strain divided by strain to failure) for a storm surge at Elev. + 8 feet (MSL) at the 17th Street Canal breach site; gapping at outboard toe of floodwall is now developed to full depth.

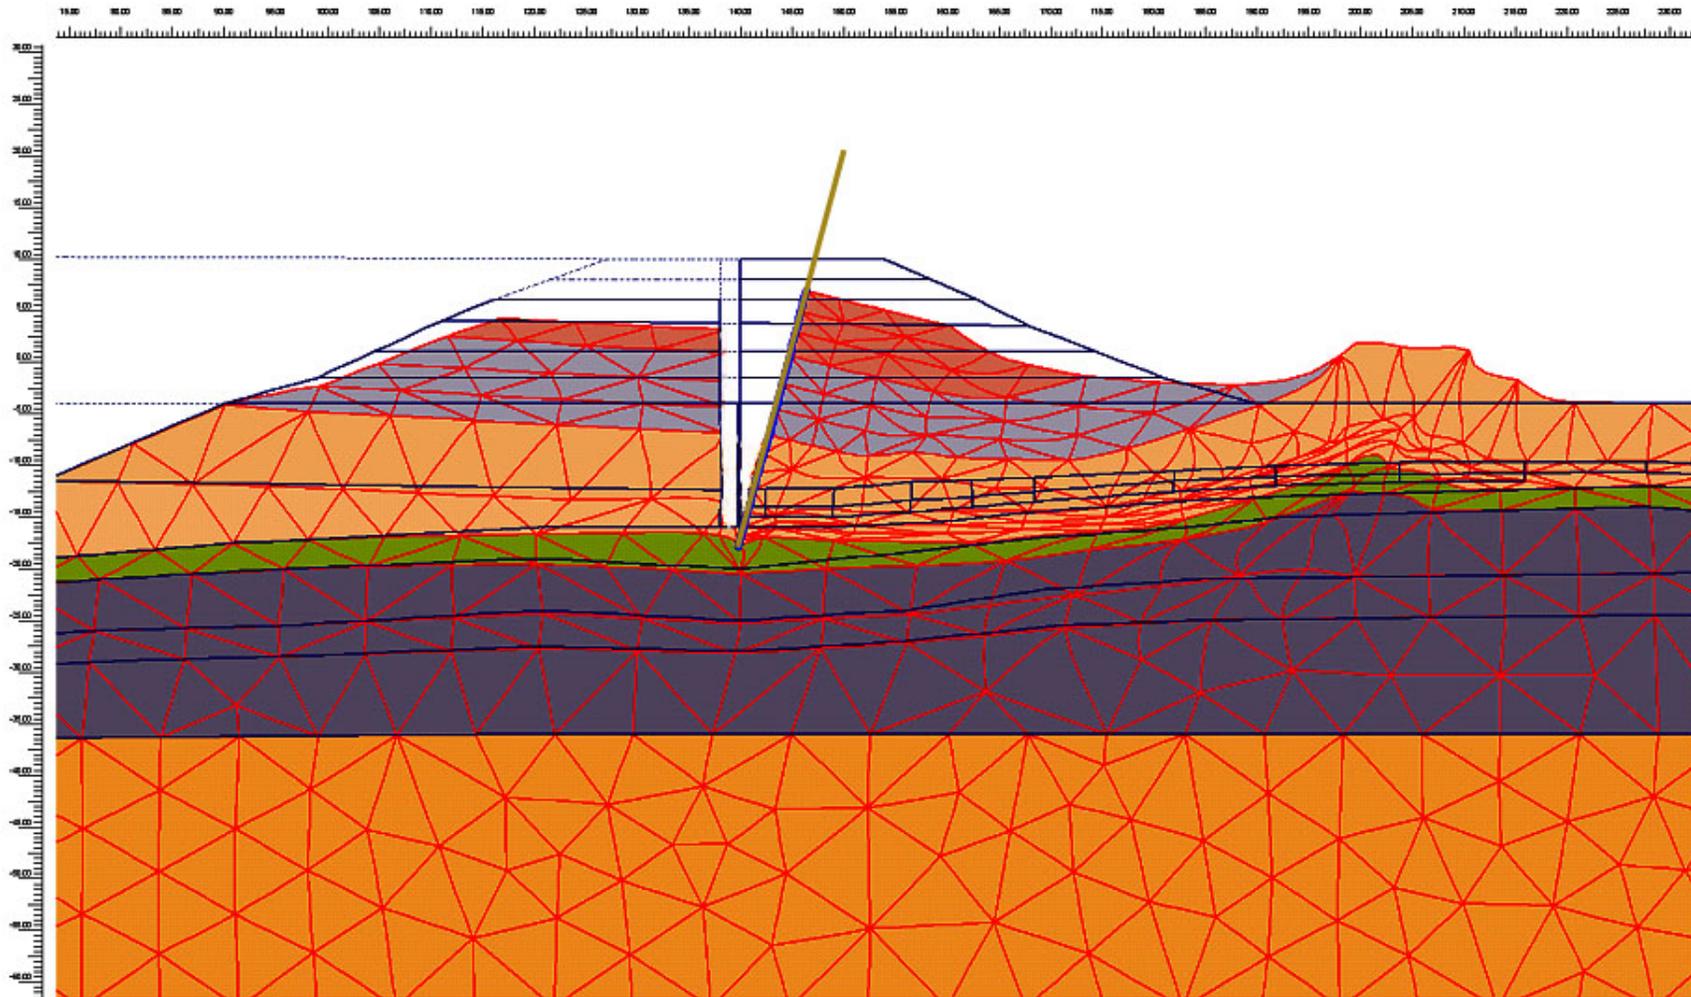
Figure 8.61: Displaced mesh for storm surge height at Elev. + 8.5 feet (MSL) at the 17th Street Canal breach site; displacements are increased by a factor of 3 in this figure.

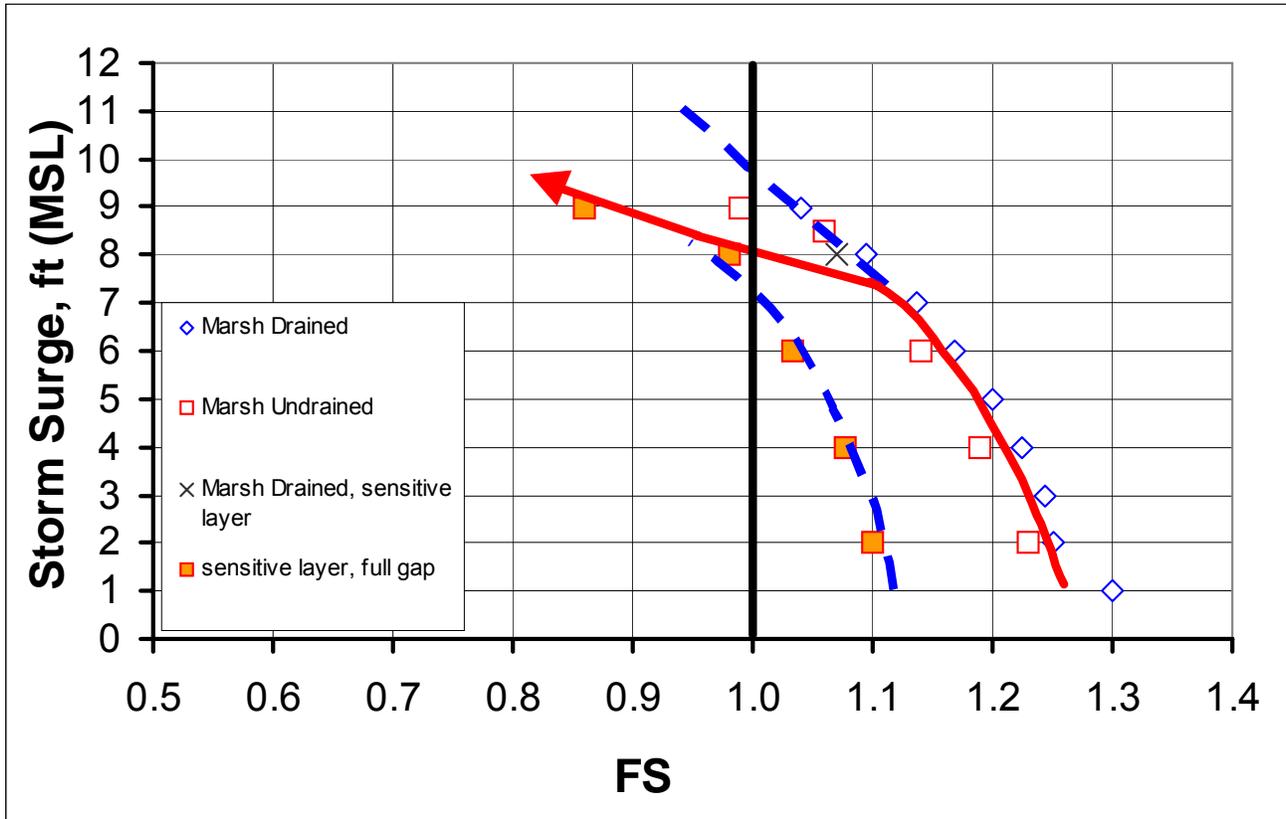
Figure 8.62: Calculated Factors of Safety for three modes based on PLAXIS analyses of the 17th Street Canal breach section for various canal water elevations; showing the best-estimated path to failure.

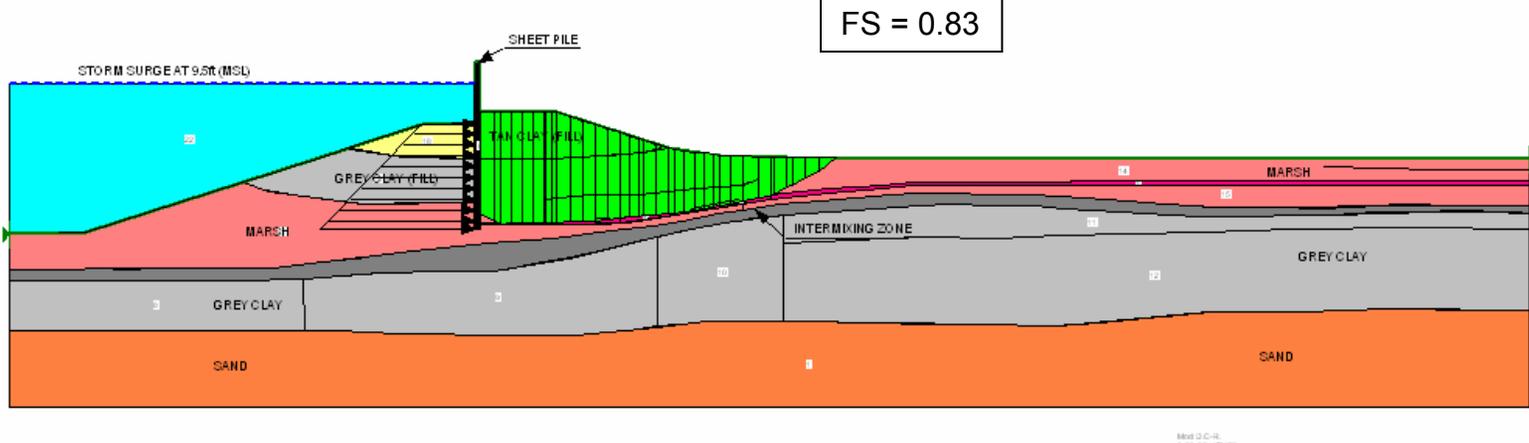
Figure 8.66: Stability analysis for actual observed failure mechanism at the 17th Street Canal breach section, with storm surge at Elev. + 9.5 feet (MSL) and with fully developed crack at the outboard side of the sheetpile/floodwall.

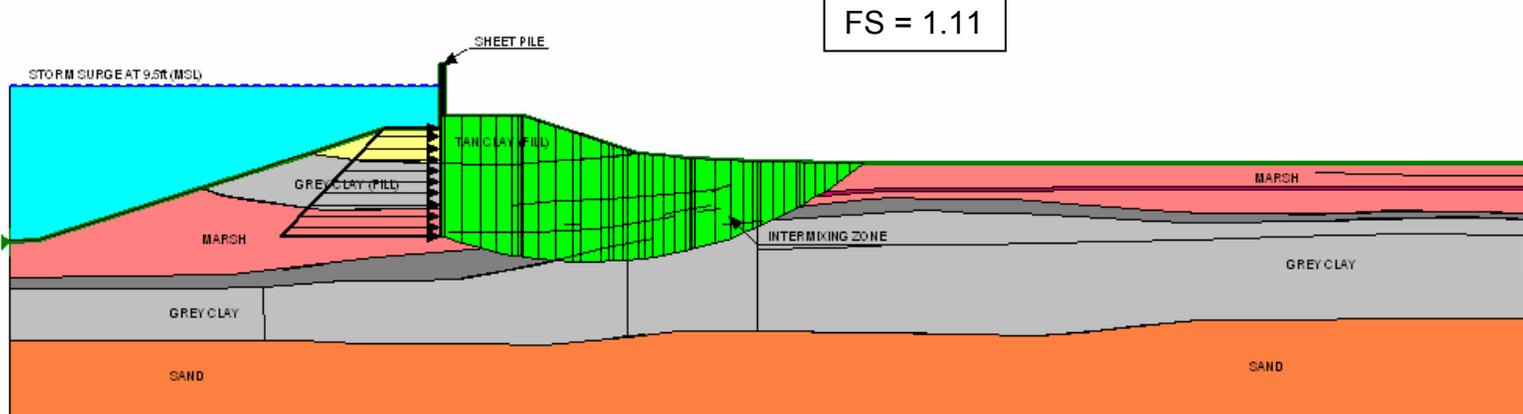
Figure 8.67: Stability analysis for shear failure through the deeper soft gray clays (CH) at the 17th Street Canal breach section, with storm surge at Elev. + 9.5 feet (MSL) and with fully developed crack at the outboard side of the sheetpile/floodwall.

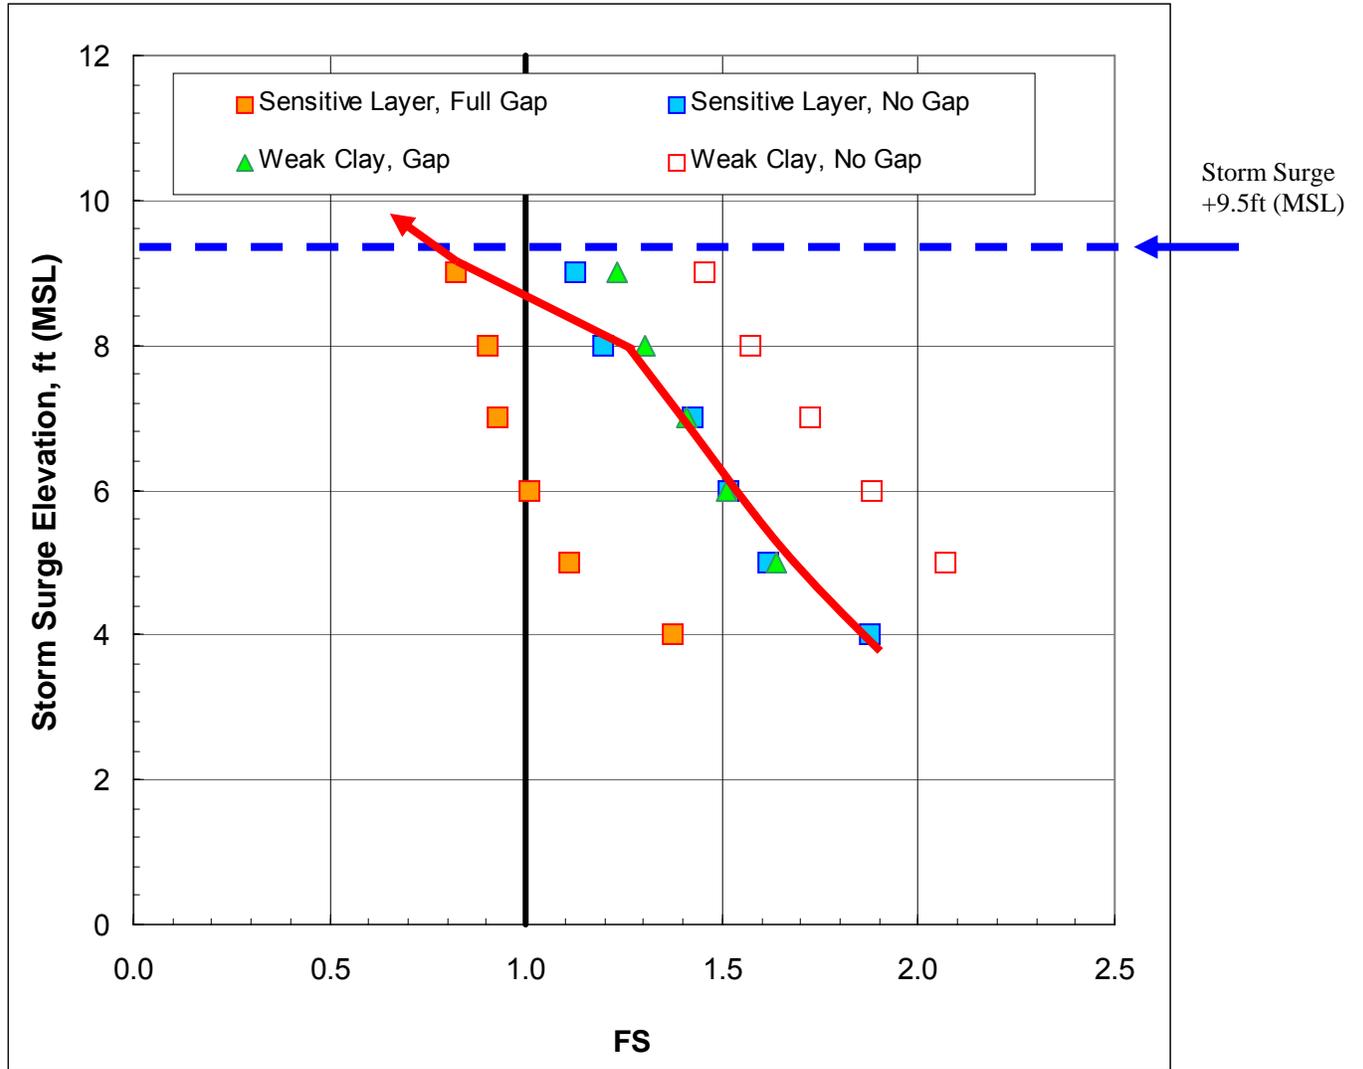
Figure 8.68: Factor of safety for four modes of failure at the 17th Street Canal breach site as a function of canal water elevation based on static Limit Equilibrium slope stability analyses: again showing the best-estimated path to failure.

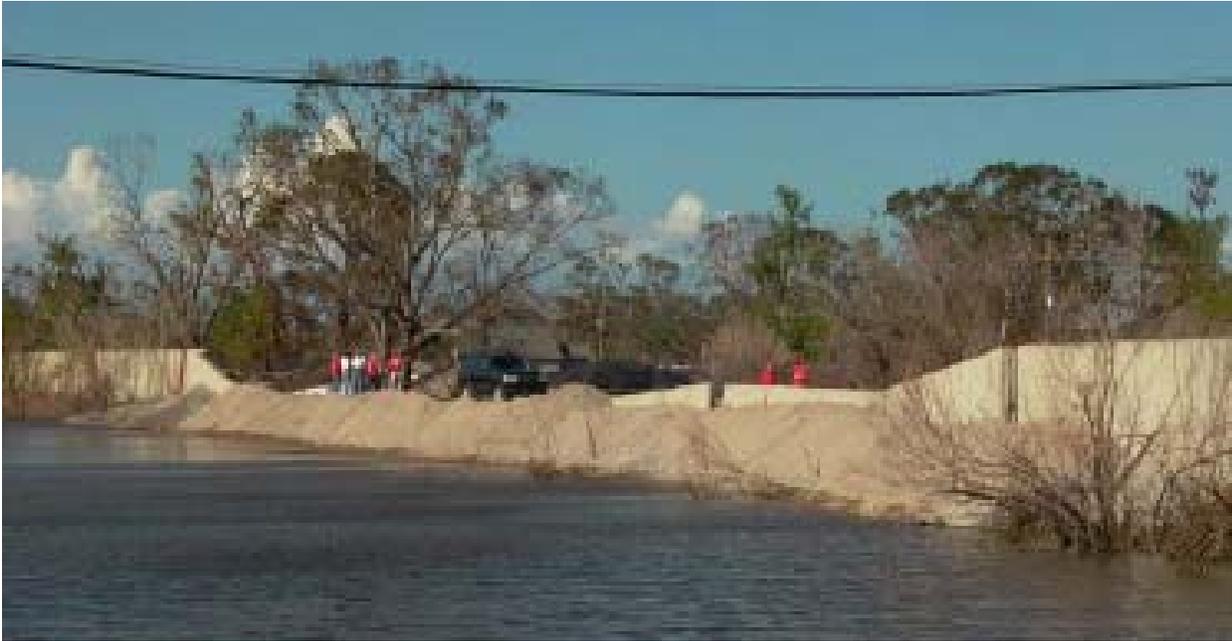
Figure 8.89: View of failure and breach on the east bank near the south end of the London Avenue Canal.

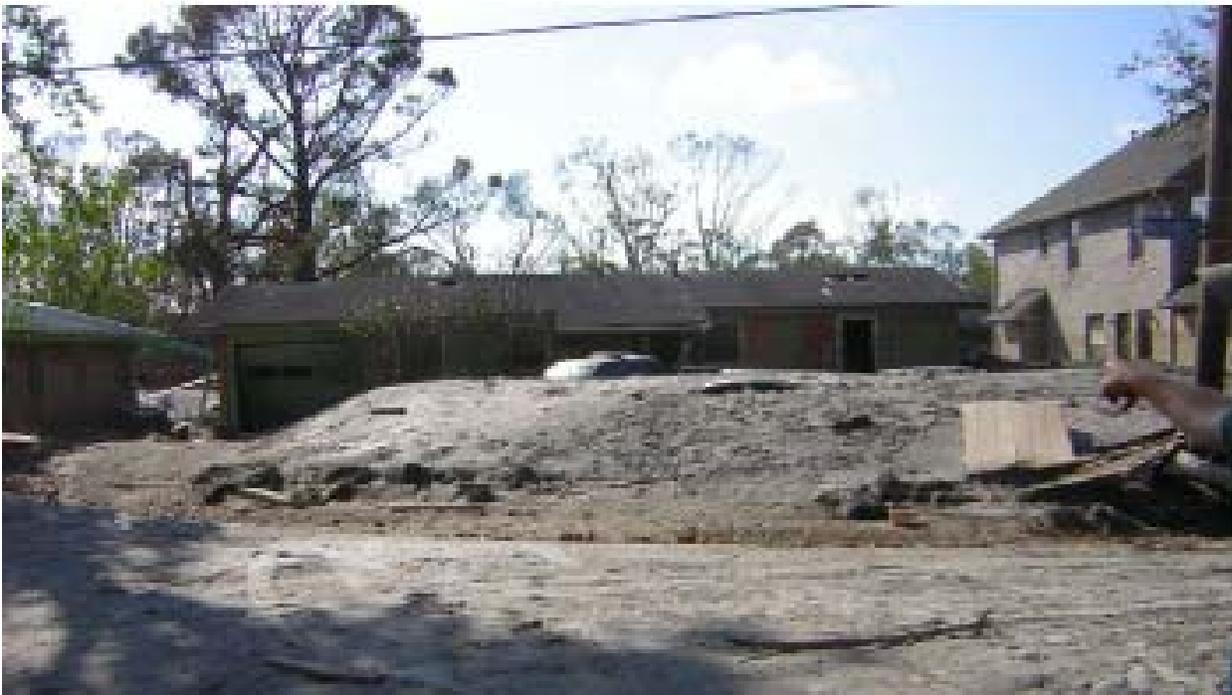
Figure 8.90: View of sands piled in neighborhood inboard of the south London Avenue Canal breach.

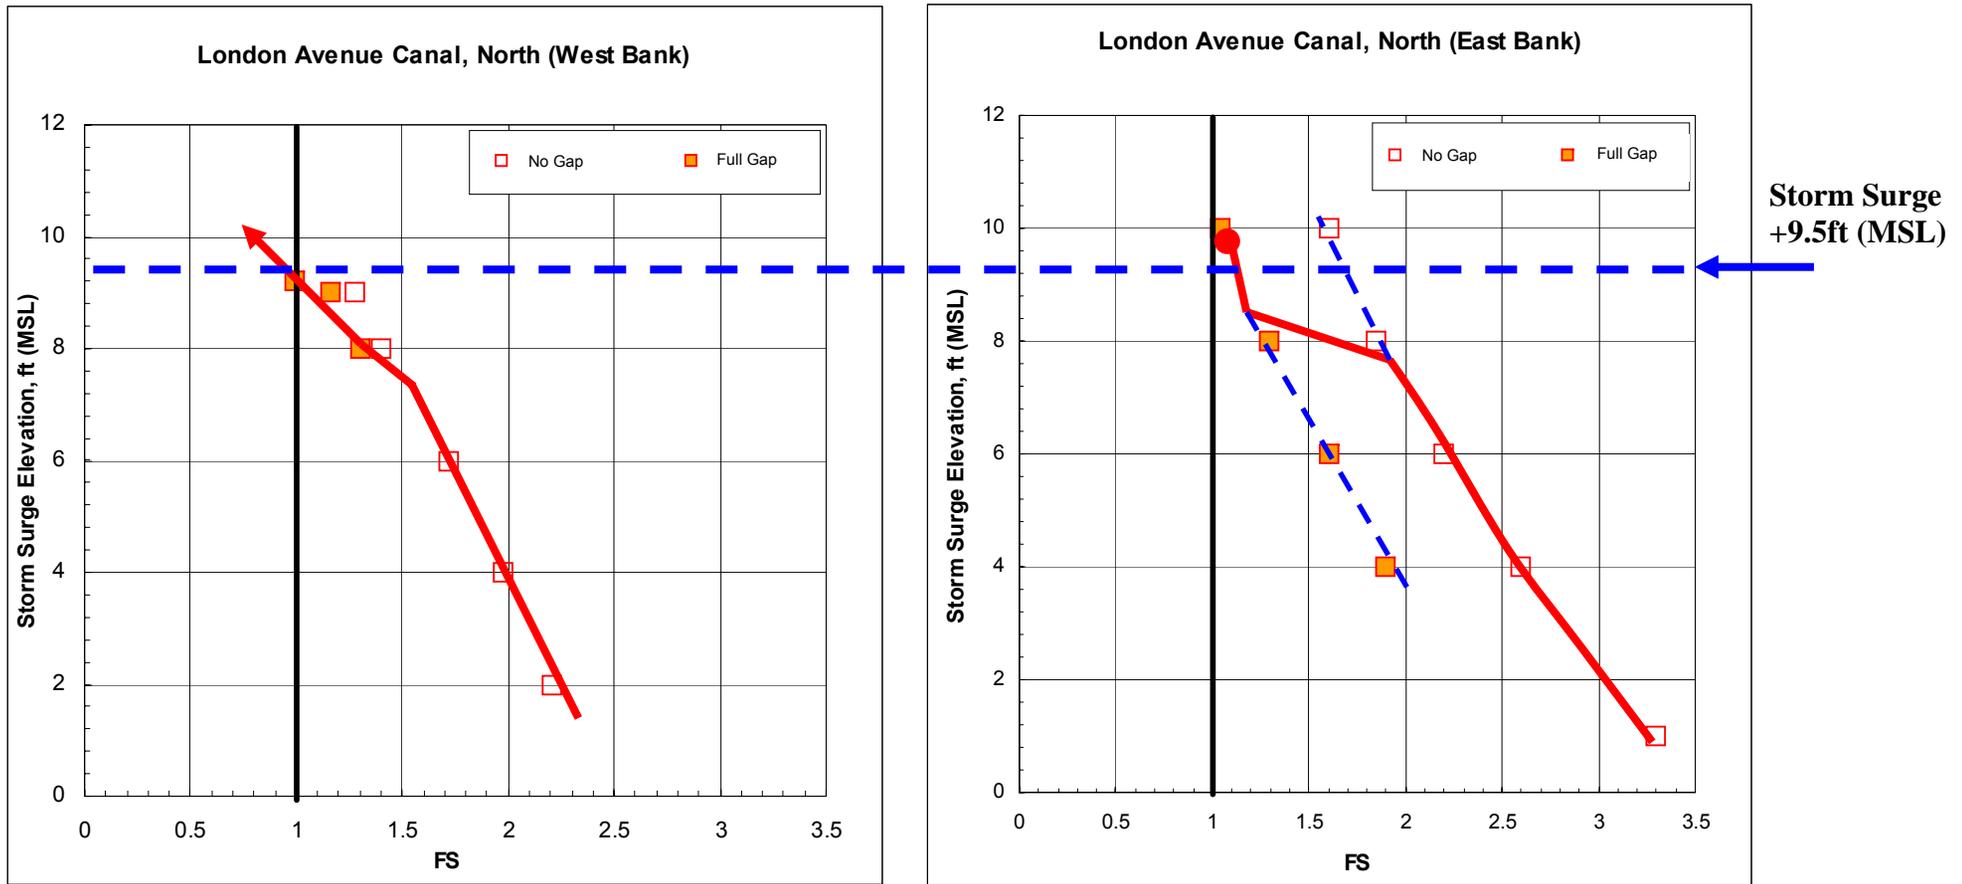
Figure 8.136: Calculated Factors of Safety for two modes based on PLAXIS analyses of the London Avenue Canal breach and distressed section for various canal water elevations; showing the best-estimated path to failure.

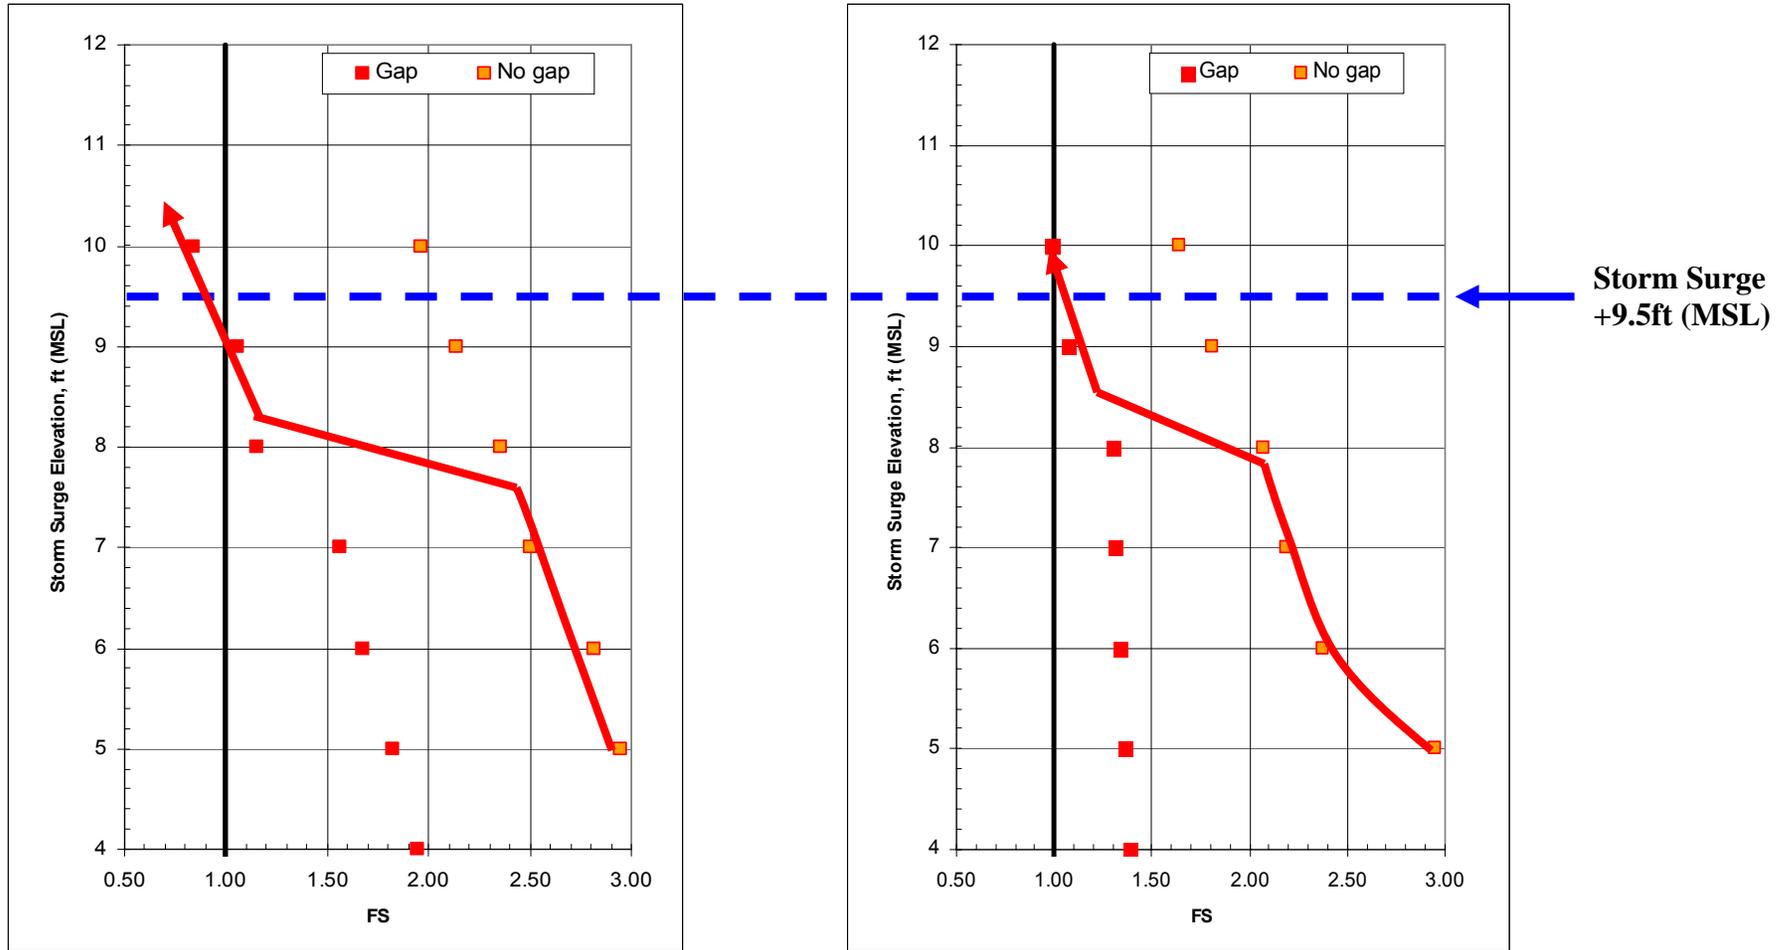
Figure 8.159: Calculated Factors of Safety for two modes based on Limit Equilibrium Analyses of the London Avenue Canal breach and distressed section for various canal water elevations; showing the best-estimated path to failure.
