# Investigation of the Performance of the New Orleans Flood Protection Systems in Hurricane Katrina on August 29, 2005

## Volume I: Main Text and Executive Summary

**Final Report**  
**July 31, 2006**

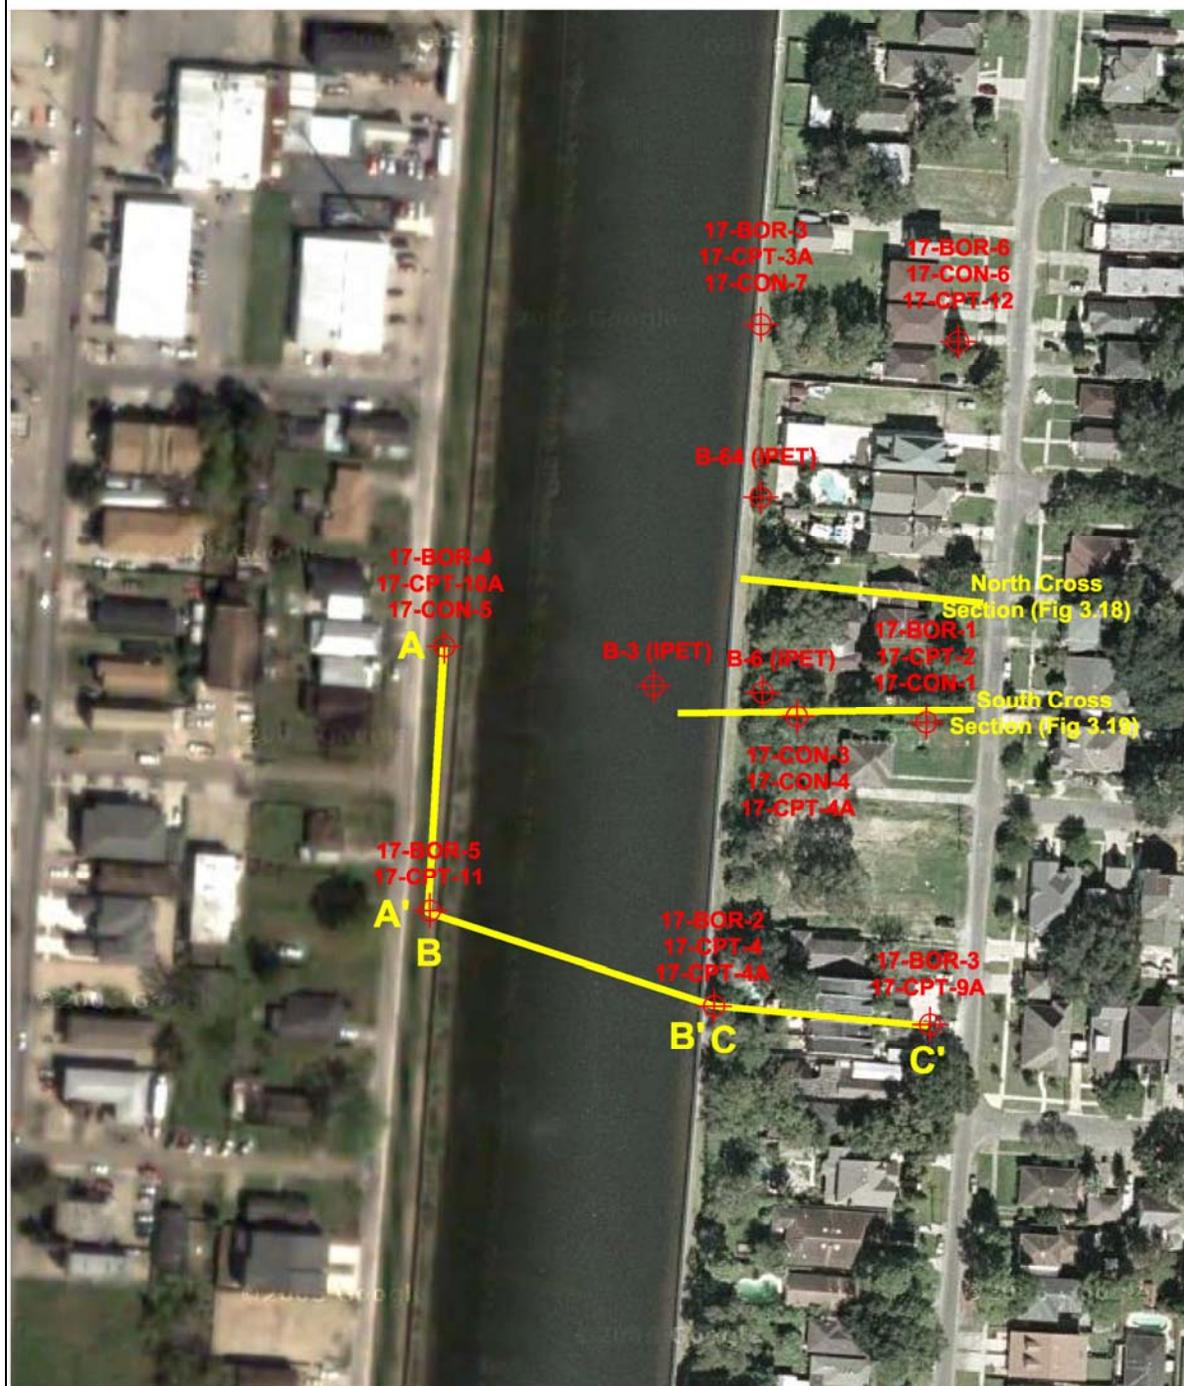
Figure 3.17: Aerial photo of the 17<sup>th</sup> Street Canal breach site before the failure of August 29, 2005. The yellow lines (at middle right) indicate the positions of the geologic sections presented in Figures 3.18 and 3.19, while cross sections A-C' are shown in Figure 3.21.

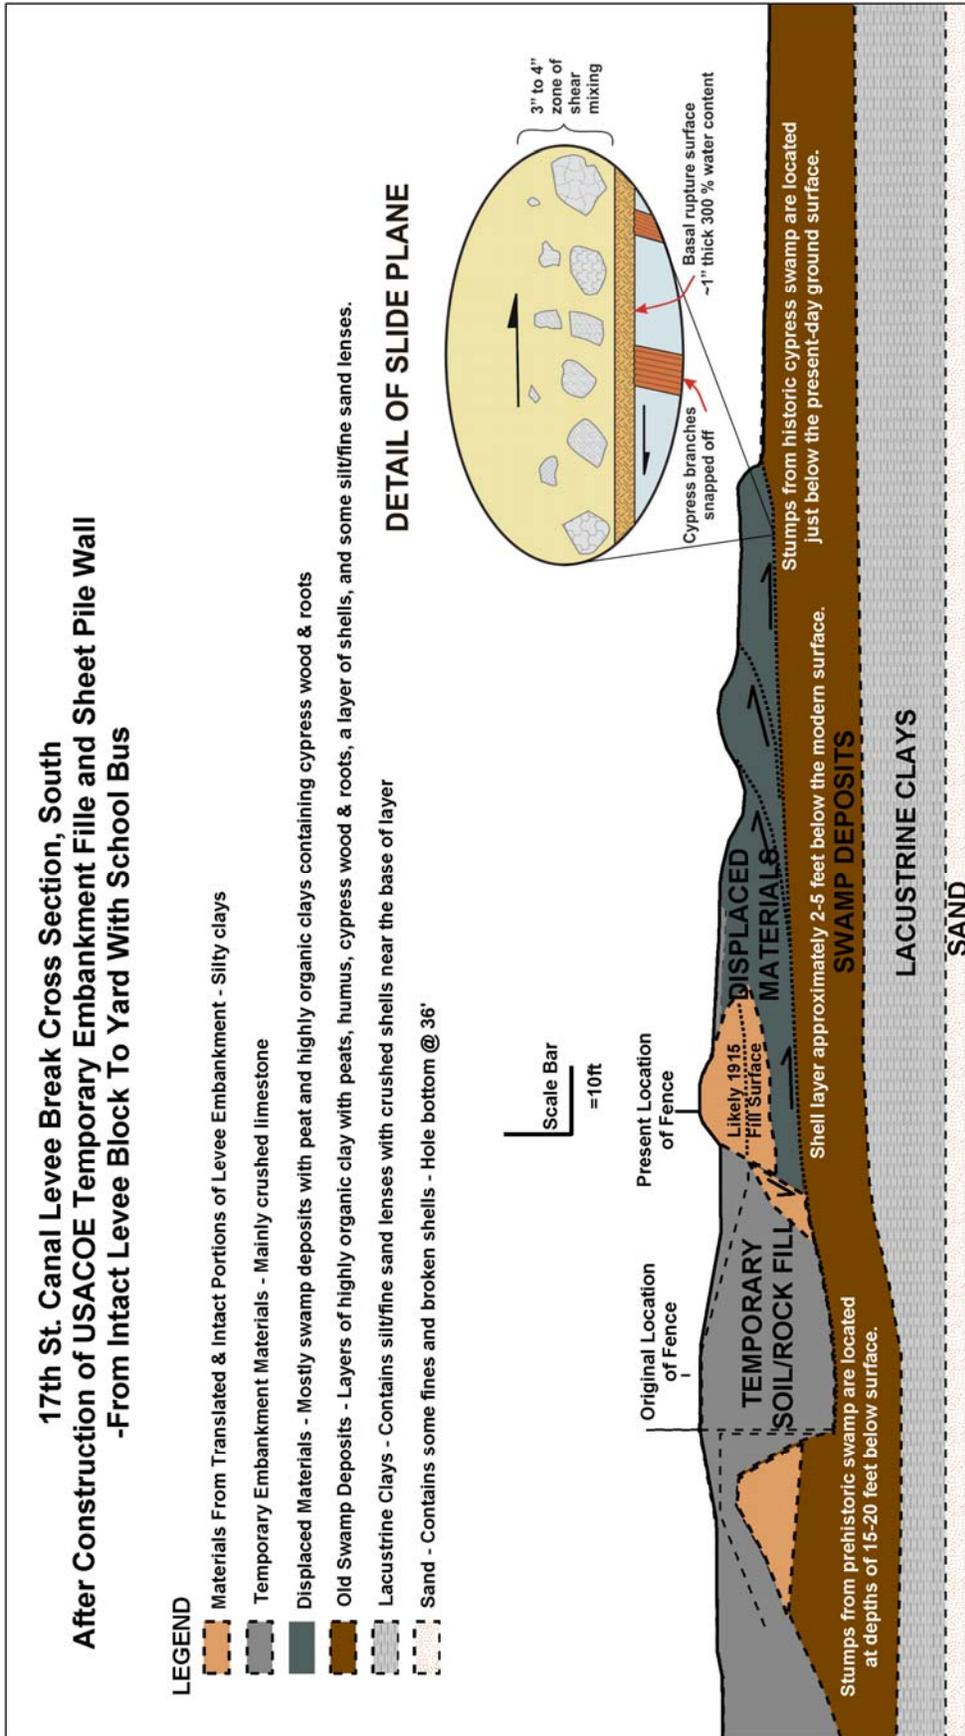
Figure 3.18: West-to-east geologic cross section through the 17<sup>th</sup> Street Canal failure approximately 60 feet north of the northern curb of Spencer Avenue, close to the yellow school bus. A detailed sketch of the basal rupture surface is sketched above right. The slip surface was about one inch thick with an extremely high moisture content (watery ooze). A zone of brecciation 3 to 4 inches thick was above this. Numerous pieces of cypress wood, up to 2 inches diameter, were sheared off along the basal rupture surface.

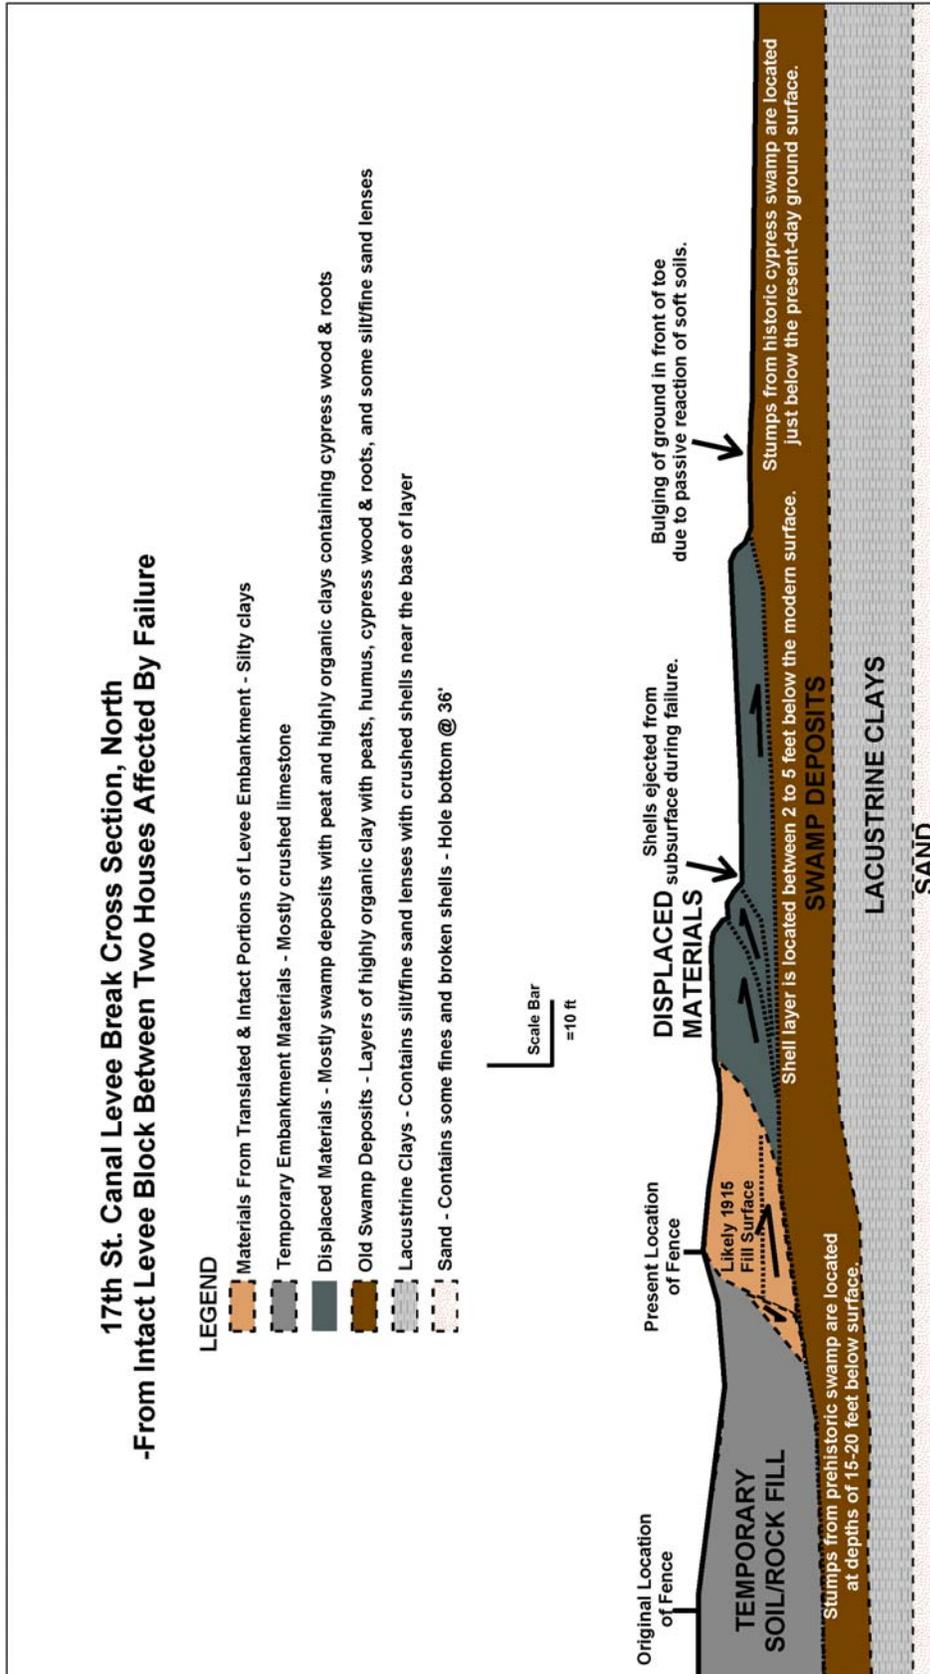
Figure 3.19: West-to-east geologic cross section through the 17<sup>th</sup> Street Canal failure approximately 140 feet north of the northern curb of Spencer Avenue, just north of the first surviving home next to the canal. Large quantities of bivalve shells were extruded by high water pressure along the regressing toe thrusts (shown in Figure 3.20). Note the slight back rotation of the distal thrust block.

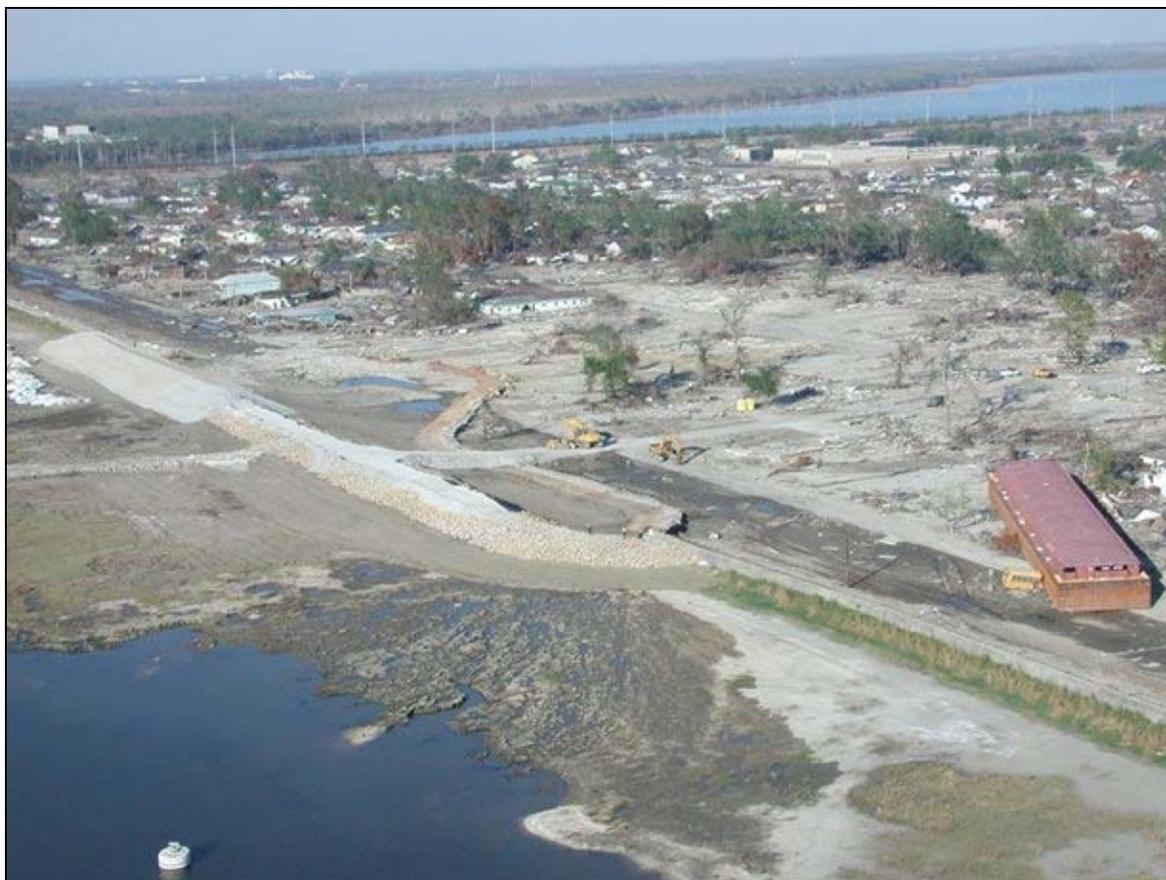
Figure 4.30: Seepage crevasse splay exposed on the water side of the east levee of the IHNC breach, likely from back-drainage of the flood-inundated area of the Lower Ninth Ward, after Hurricanes Katrina and Rita. This same section of the IHNC levee failed in 1965 during Hurricane Betsy. Seepage crevasse splays tend to occur where high permeability materials daylight, or come into proximity of the existing ground surface. They are easily recognized by anomalous seepage and the birdfoot pattern of the splays, which are often filled with soils displaced by seepage and hydraulic piping. (photo from U.S. Army Corps of Engineers).

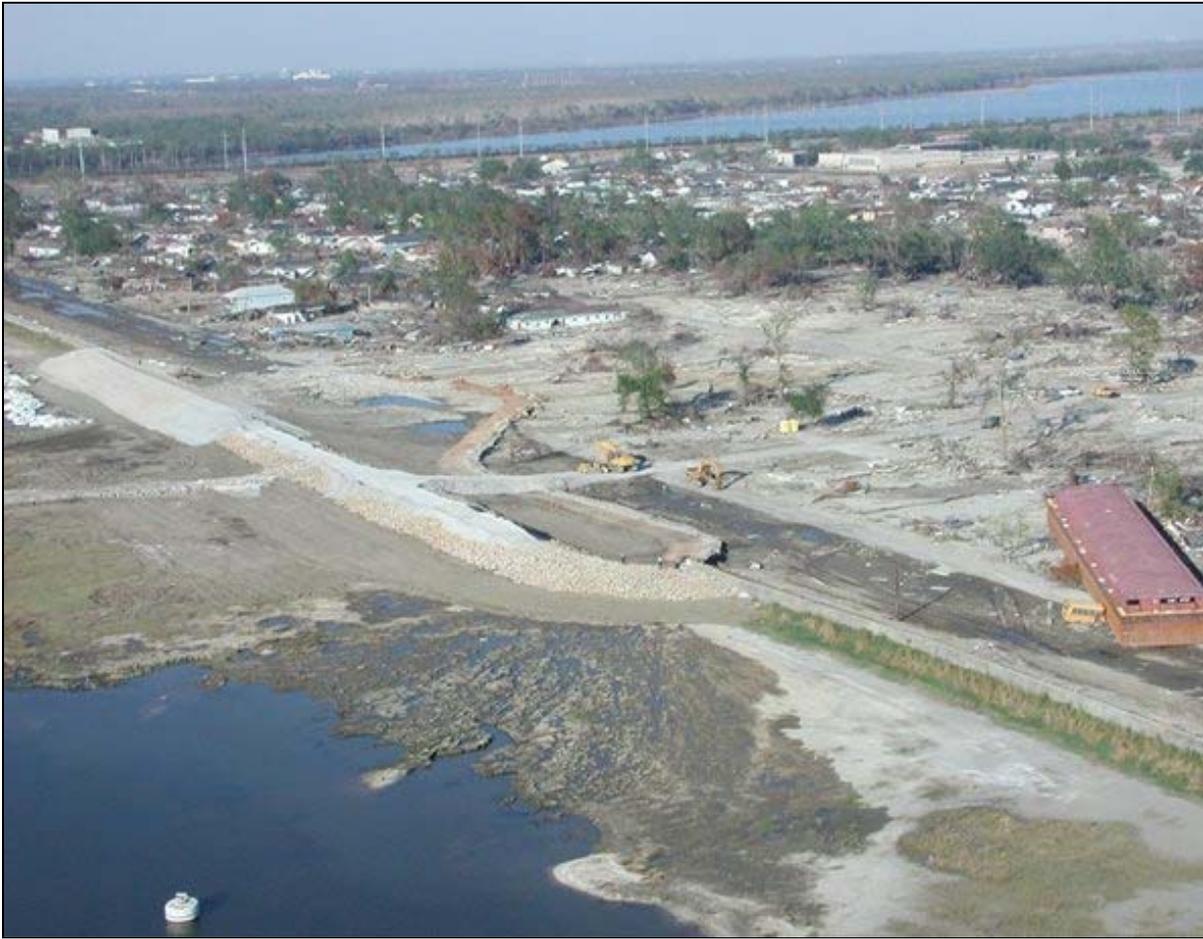
Figure 6.45: Aerial view of the south breach at the east bank of the IHNC (at the west end of the Ninth Ward), showing the crevasse splay generated by reverse drainage flow.

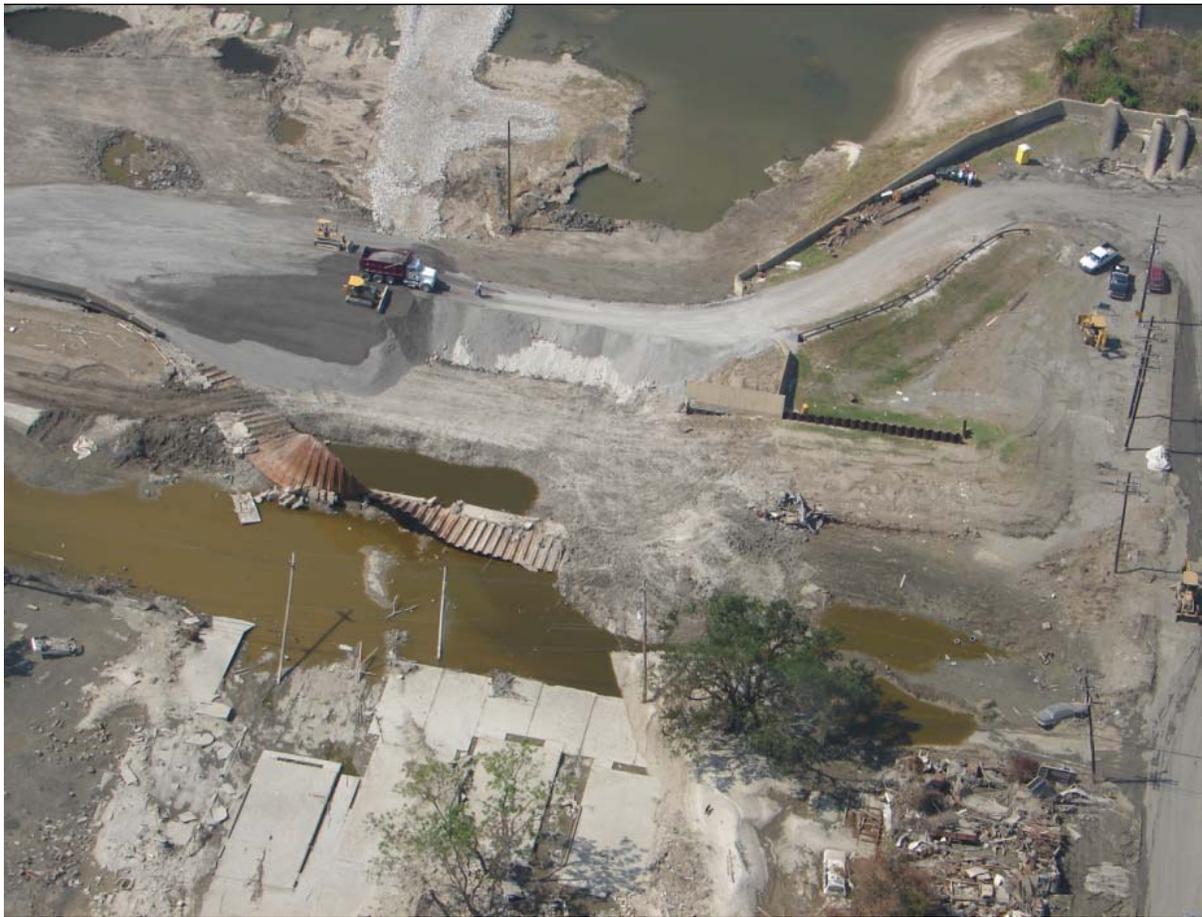
Figure 6.46: Aerial view of the partially repaired north breach on the east bank of the IHNC at the west end of the Lower Ninth Ward.

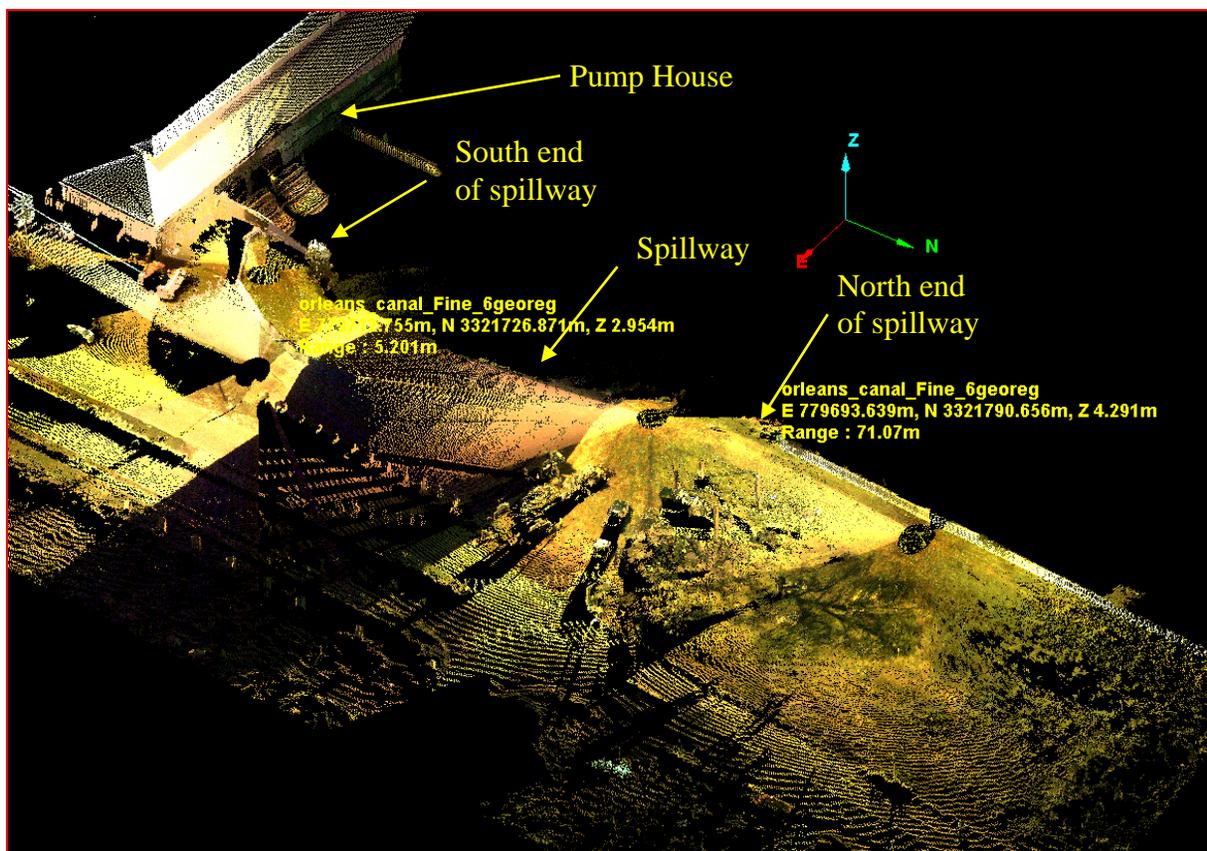
Figure 8.21: Oblique view of LIDAR survey of the southern end of the Orleans Canal, showing the “gap” on the east side where the levee and floodwall that should have sealed the end are omitted, and a “spillway” replaces them.

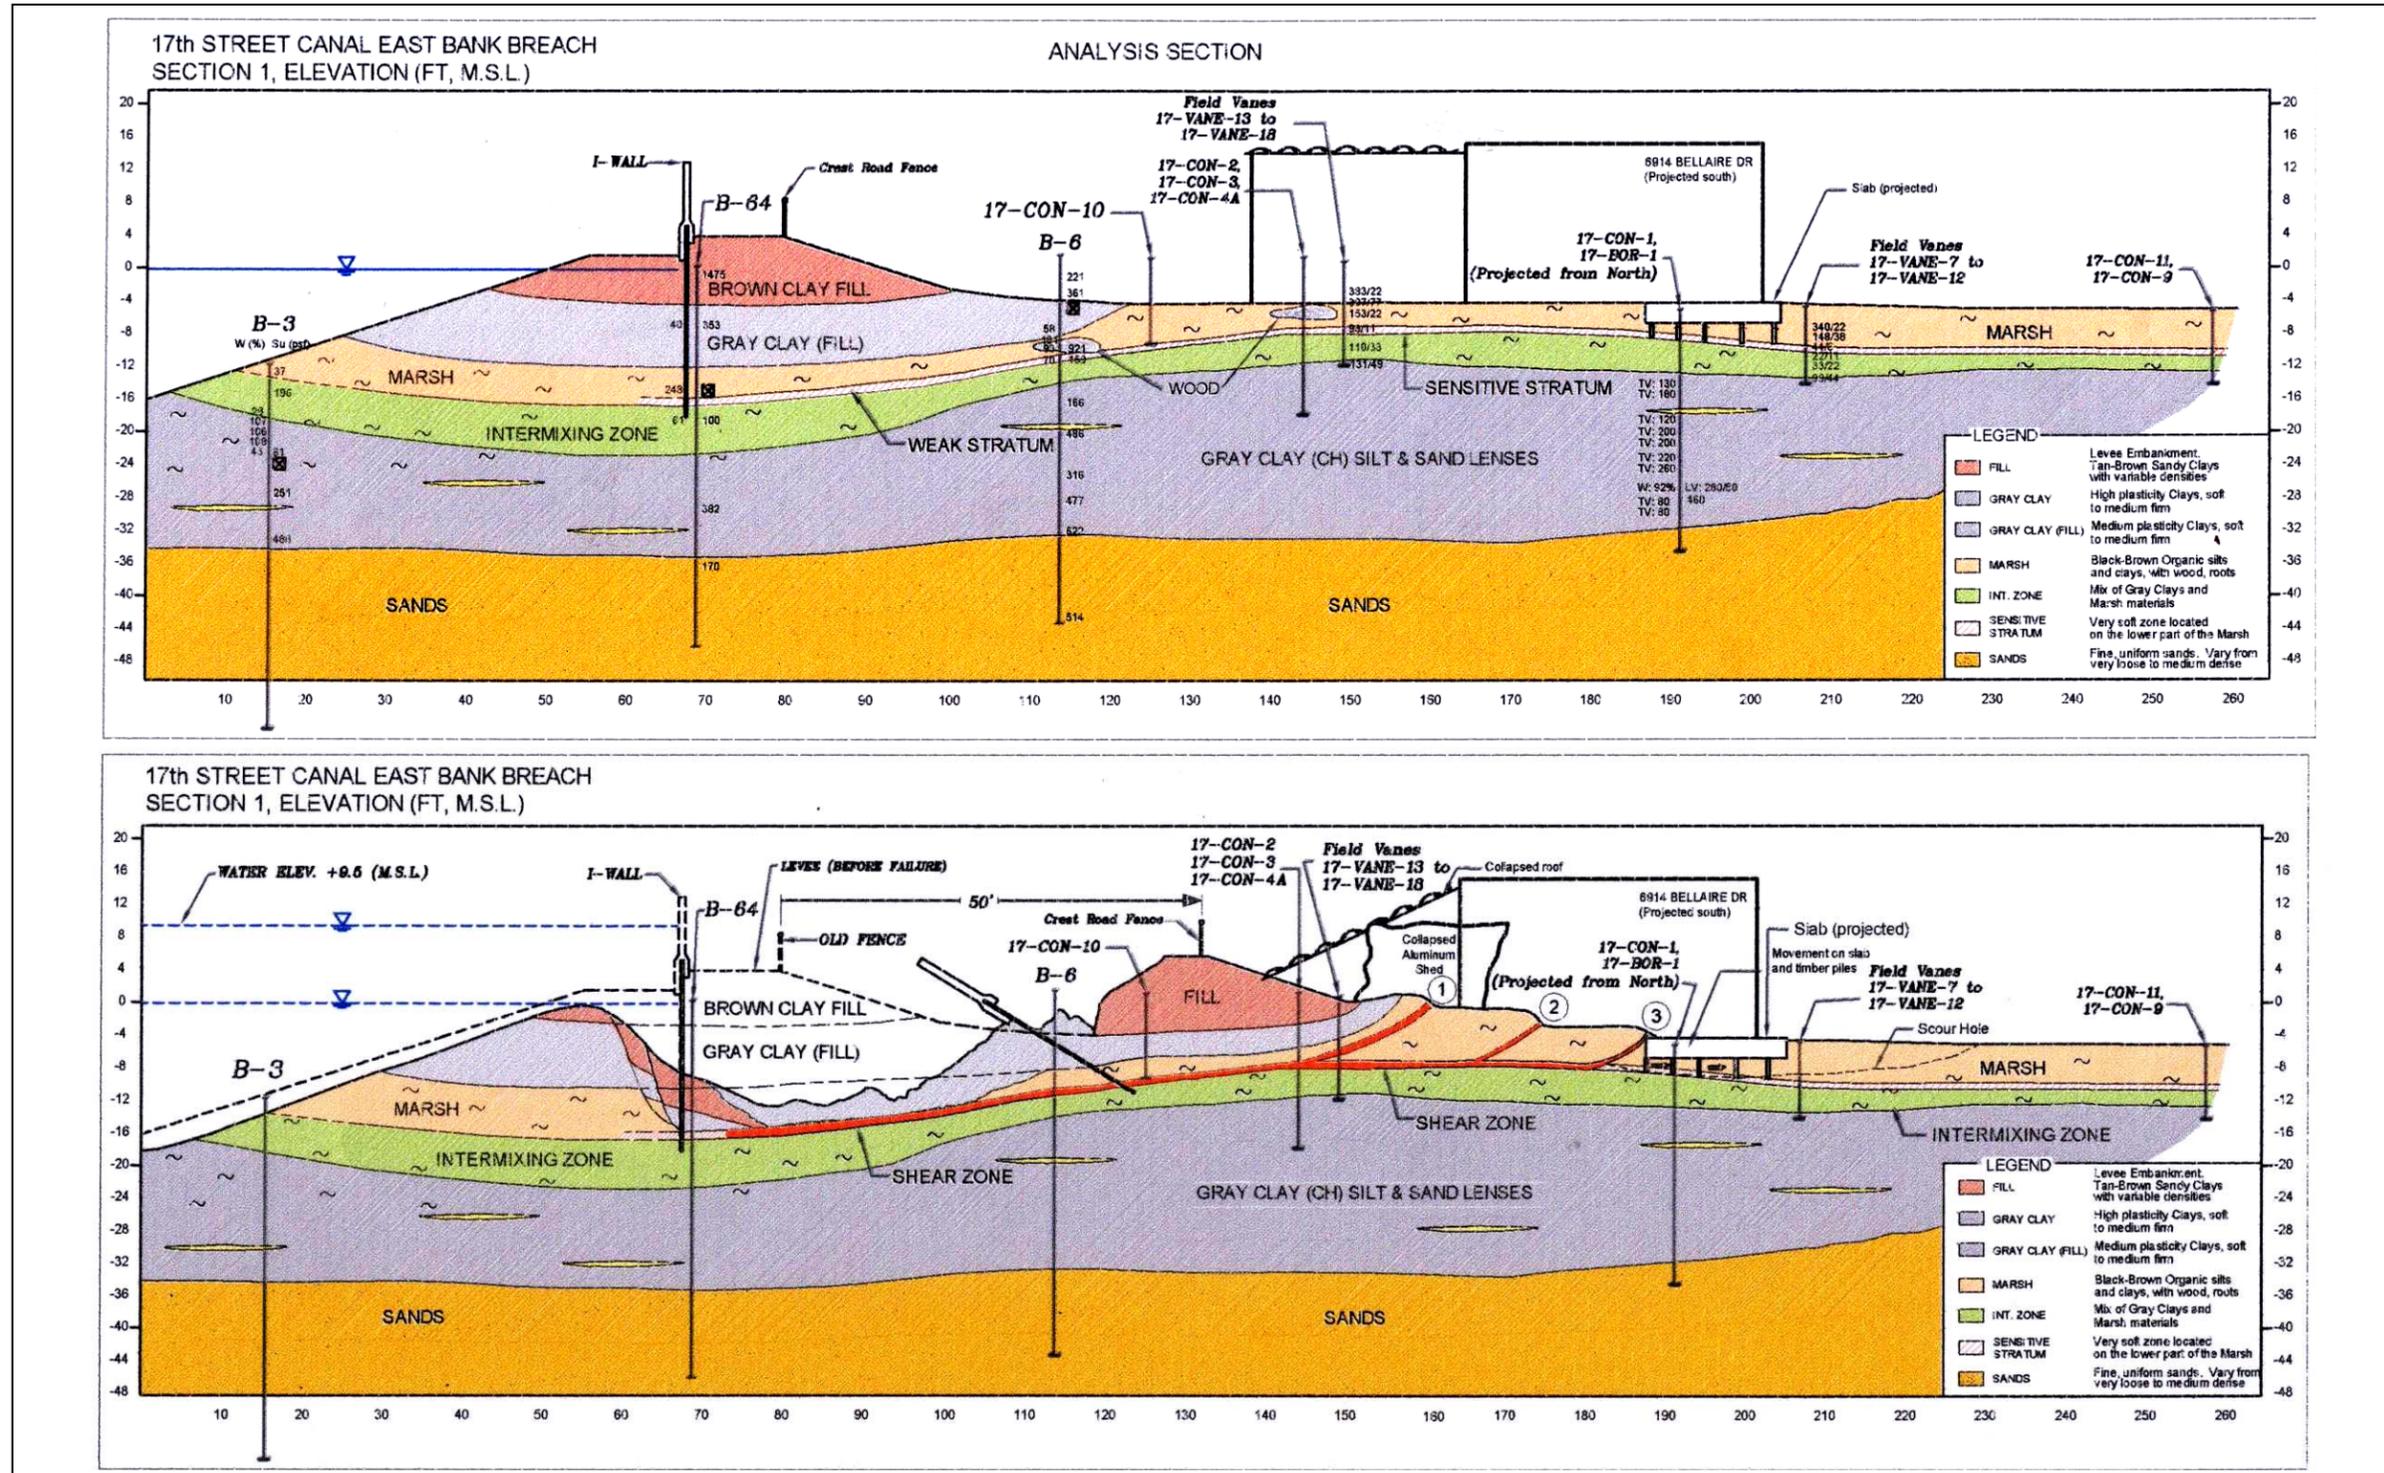
Figure 8.26: Cross-section through the 17<sup>th</sup> Street Canal breach showing conditions (a) before the hurricane, and (b) after the breach and failure.

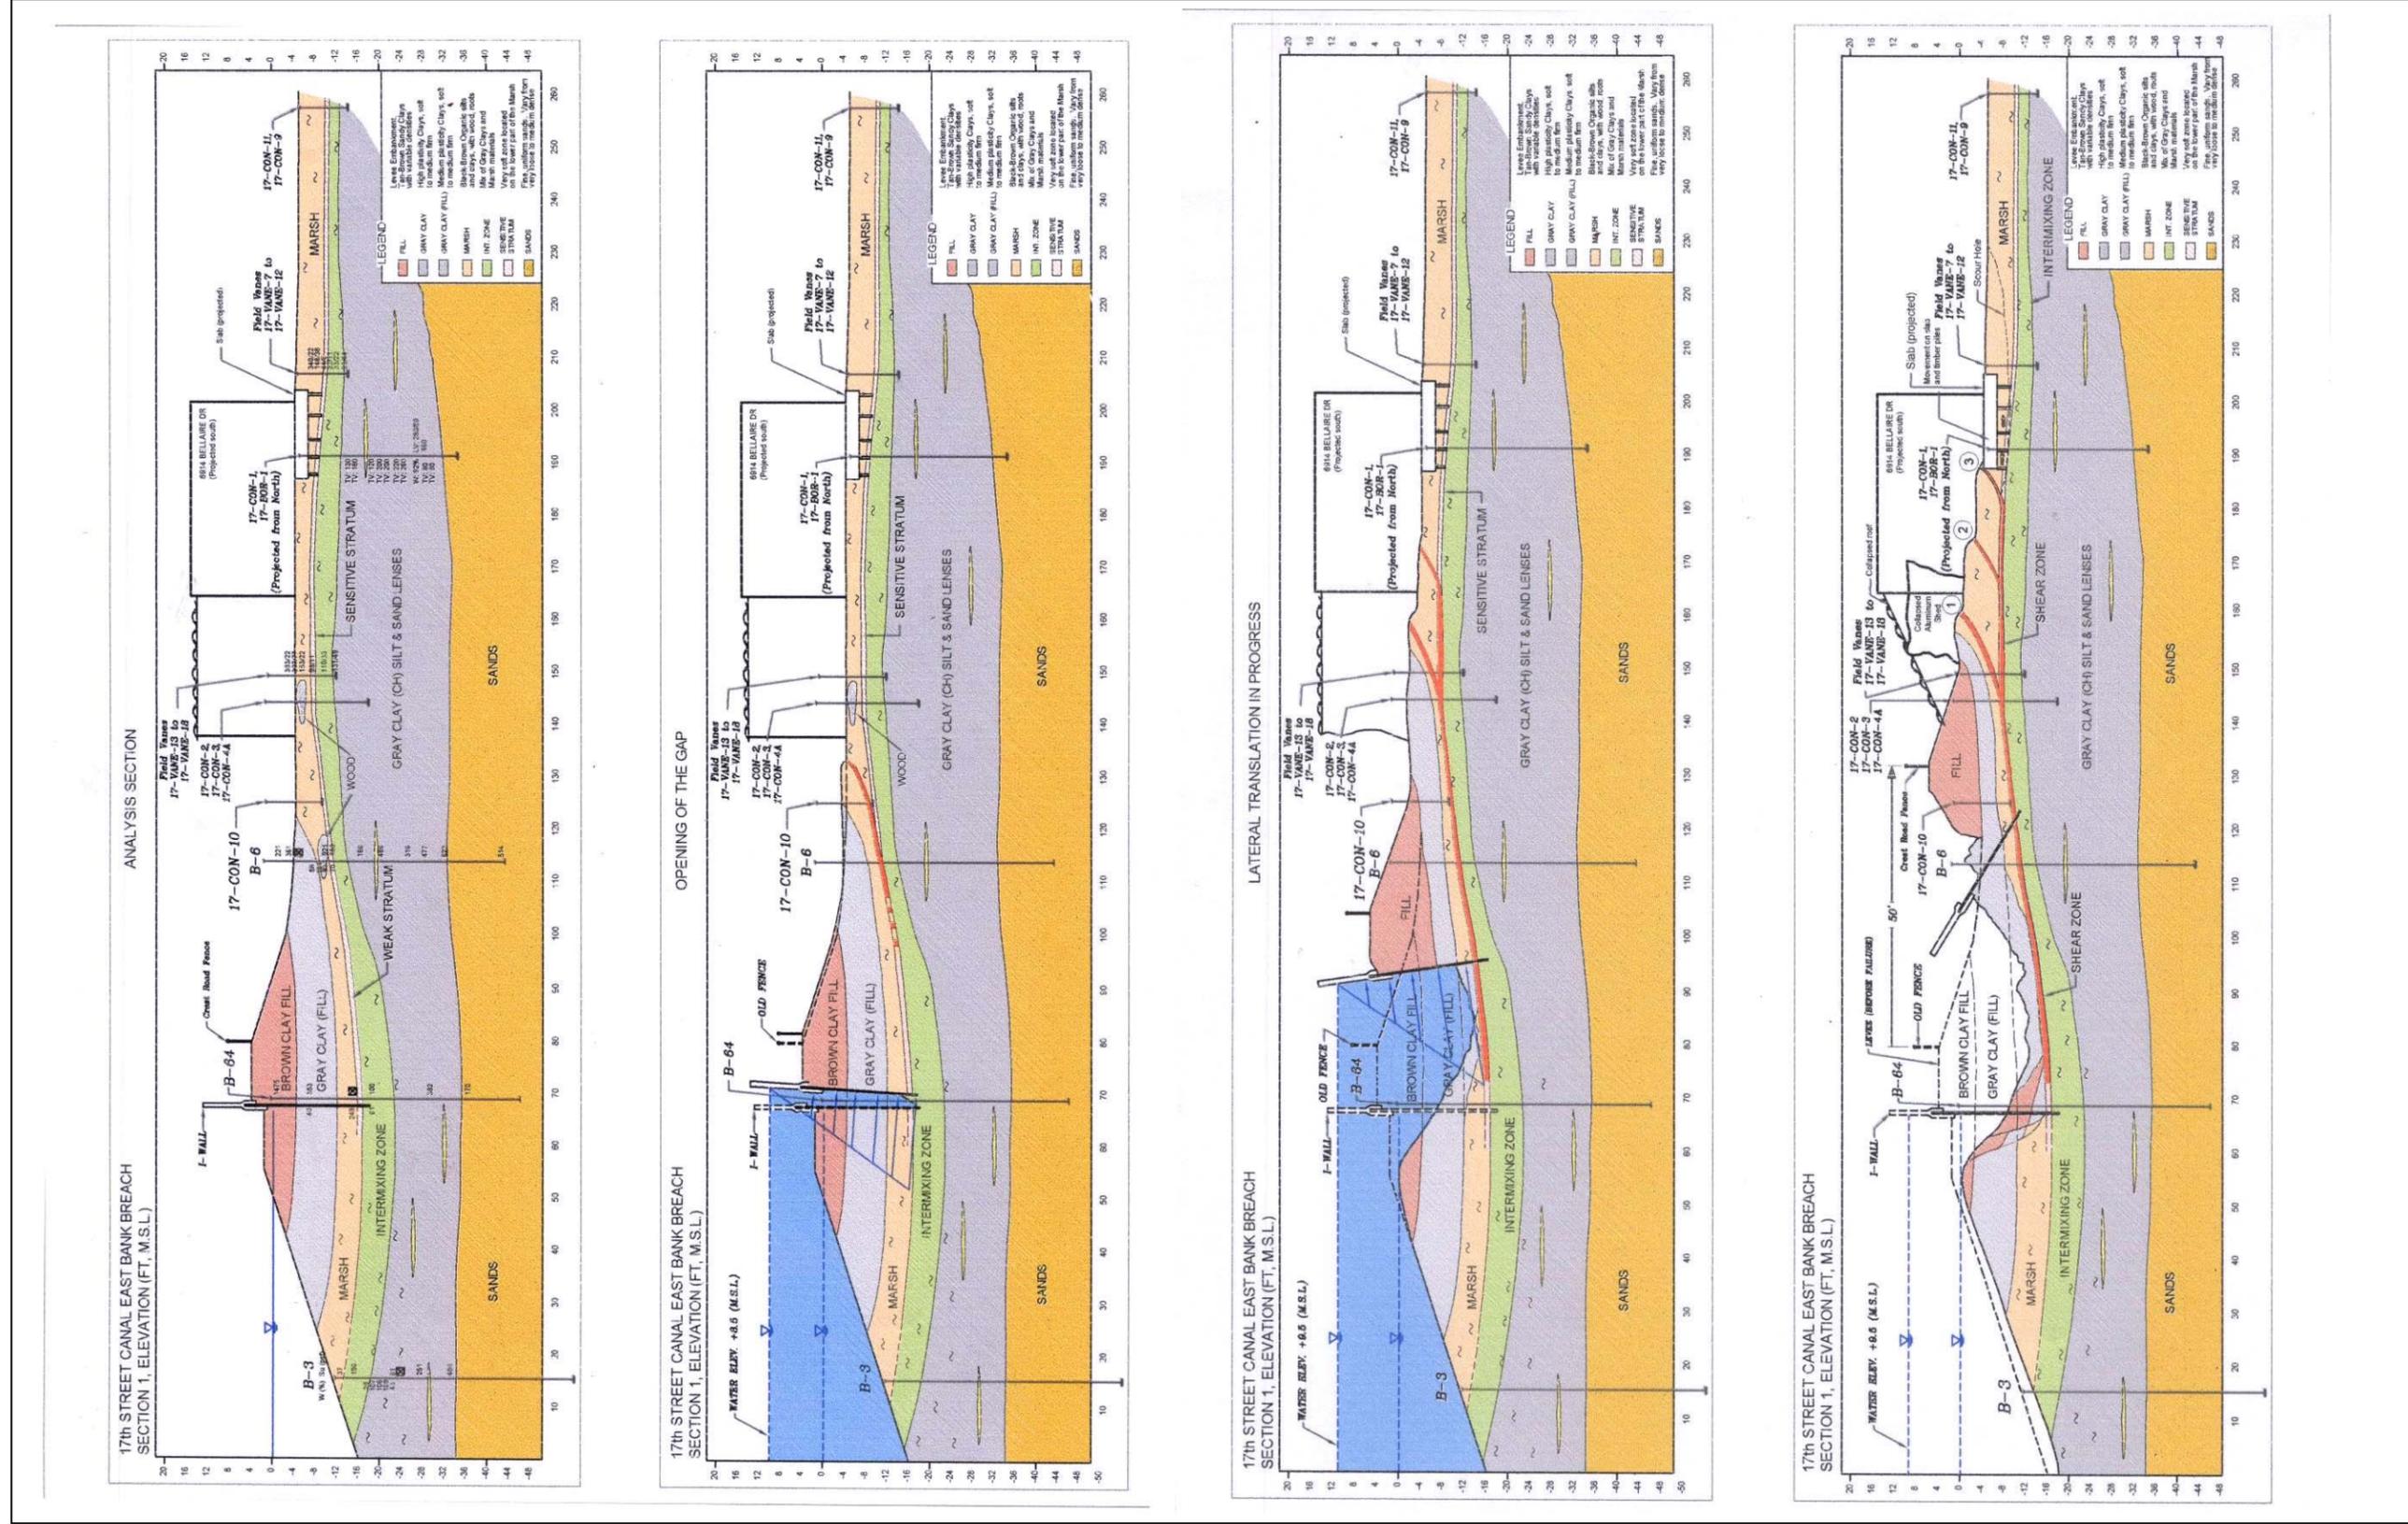
Figure 8.27: Cross-sections through the 17<sup>th</sup> Street Canal breach showing conditions as: (a) pre-storm surge, (b) a gap opens between the outboard side of the earthen embankment and the sheetpile curtain and the elevated water levels increase within this gap pushing the I-wall and the inboard side of the embankment laterally away from the canal, and (d) final configuration at the end of displacement after I-wall topples backwards towards the canal.

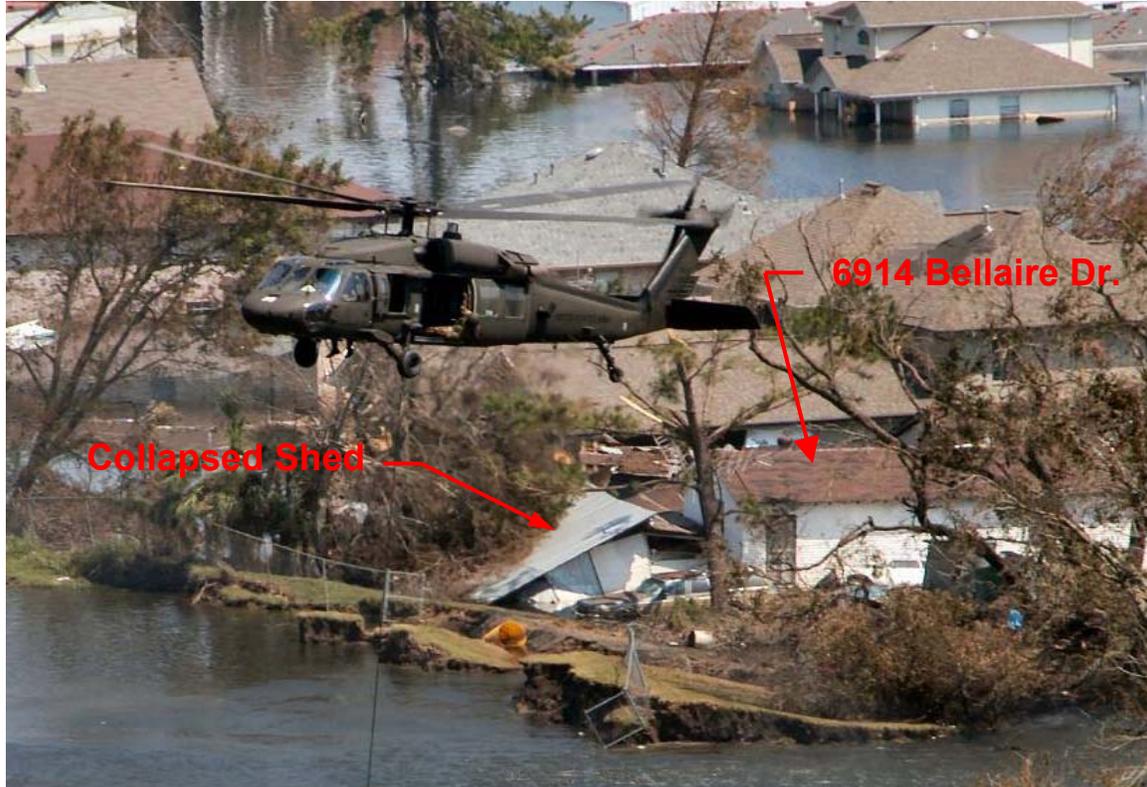
Figure 8.30: Side view of the collapsed shed pushed into the house at 6914 Bellaire Drive as illustrated in the cross-section of Figure 8.27.

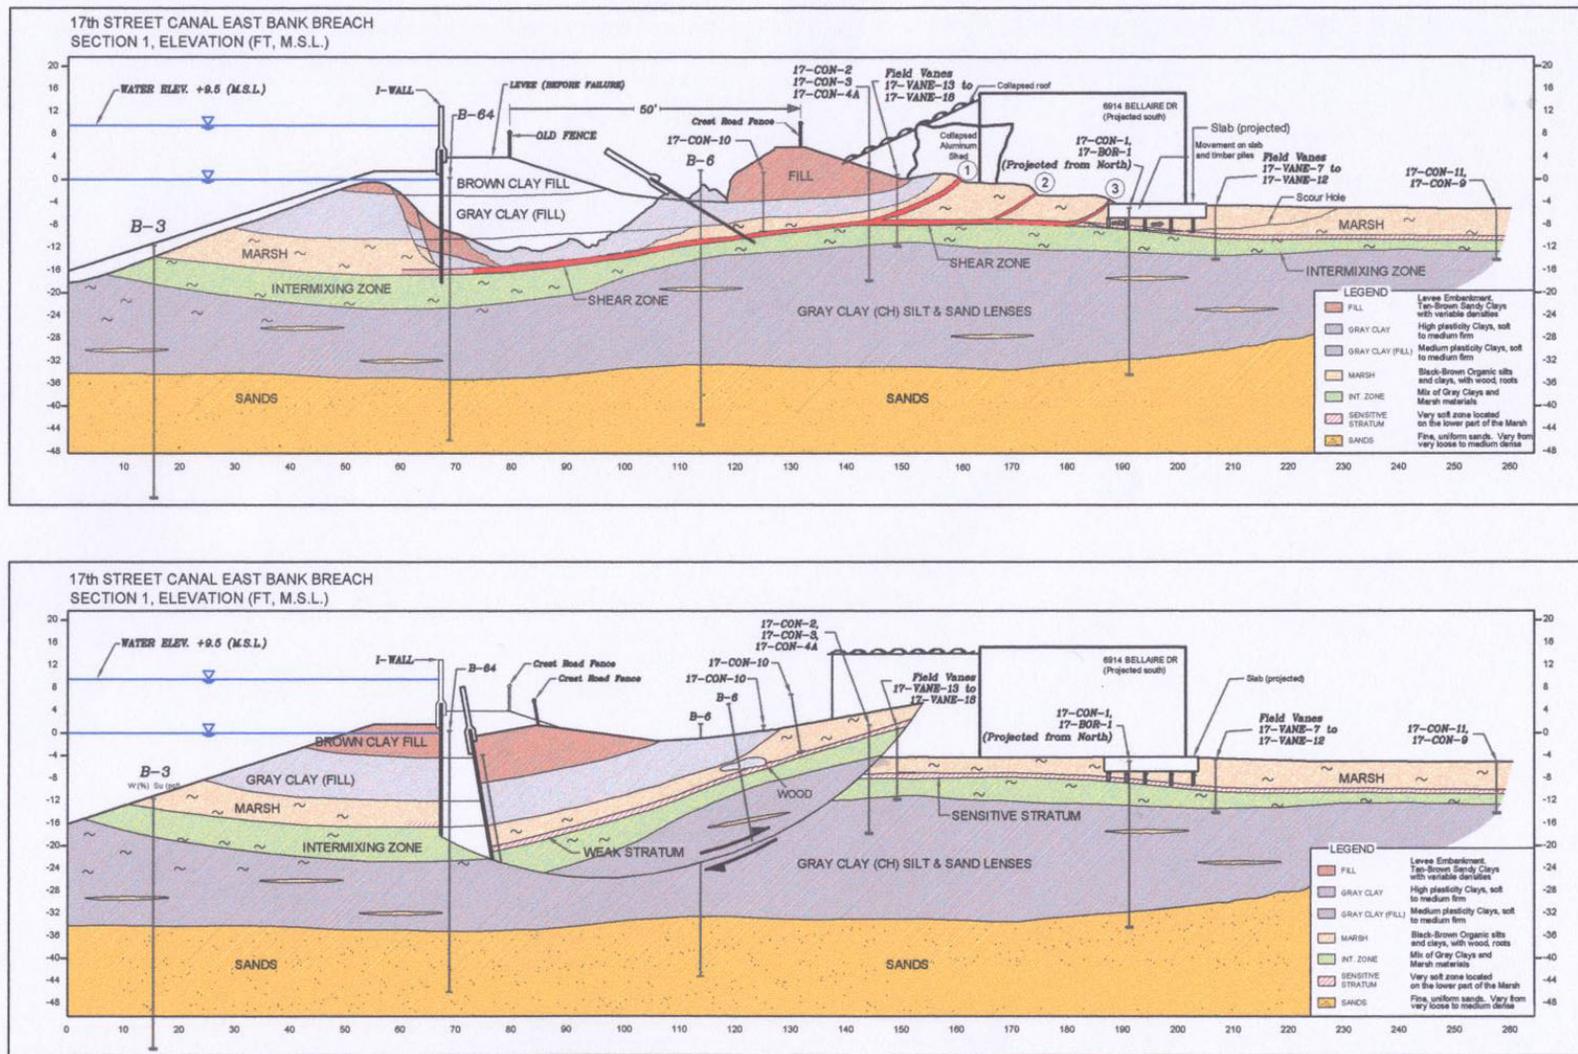
Figure 8.69: Comparison between deep rotational failure through the soft gray clay (CH) and translational failure along the sensitive clay layer within the marsh deposits as actually observed.

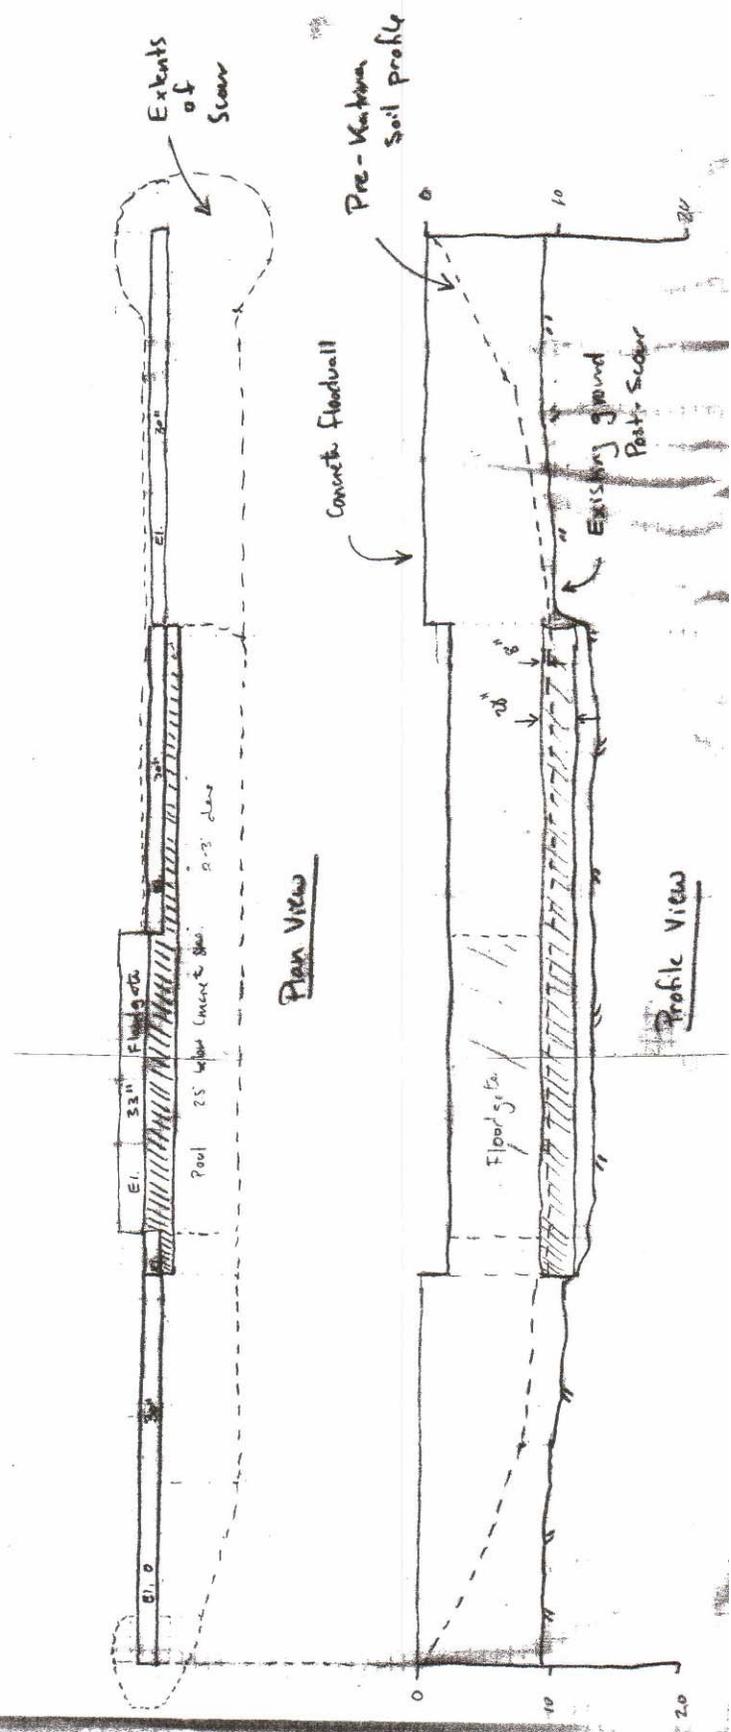
**Figure 10.25:** Scour pattern behind around the floodgate structure at the Bayou Bienvenue Control Structure shown in Figure 10.22.
