# Appendix 1

## Hydrograph and High Water Mark Analysis

### Introduction

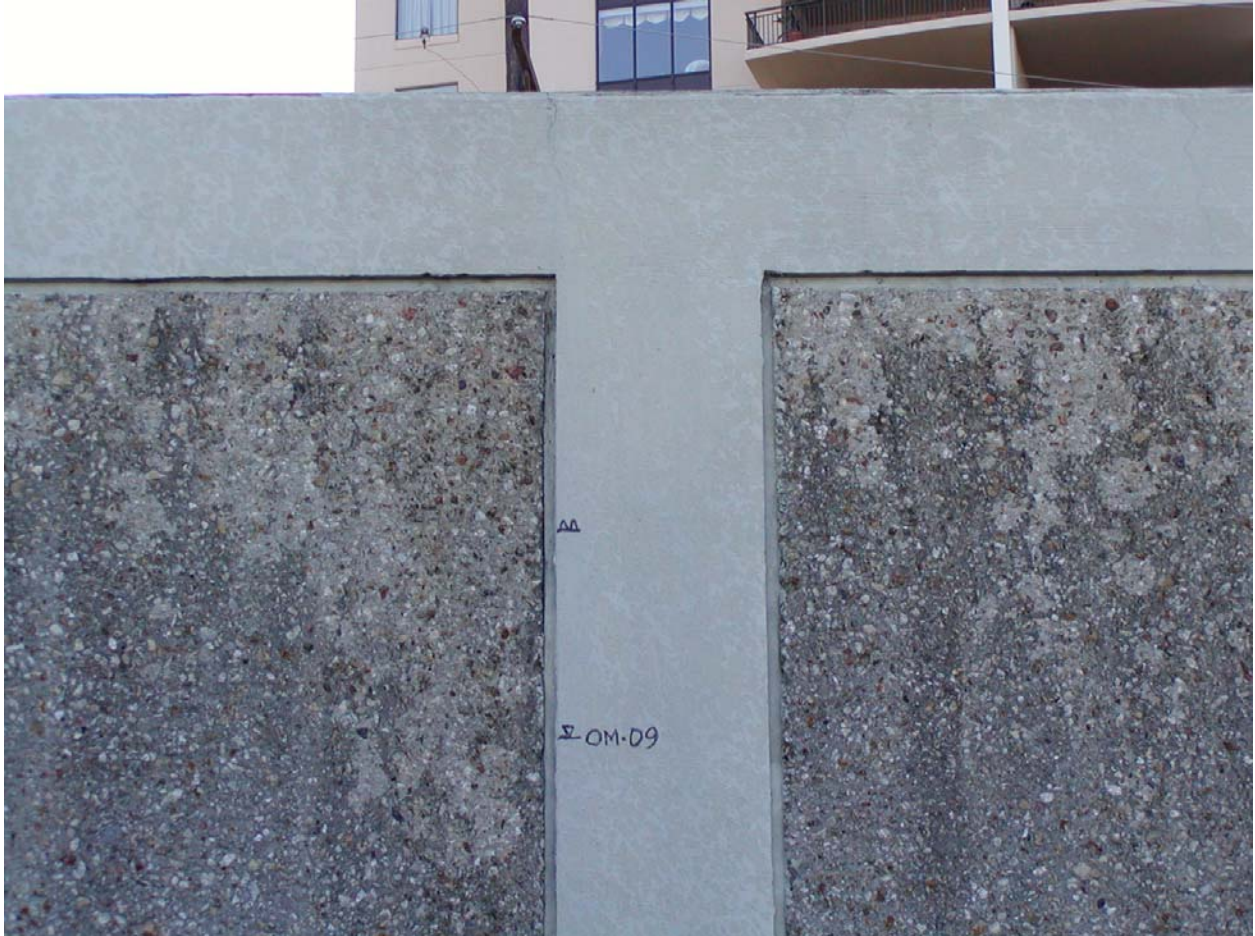
- h. Monday 8/29/05, 11:00, elevation 9.2 ft: The boat owner stated that he observed the water on the floodwall was falling at 1100 hrs. He pointed to a location on the floodwall that was 2'3" below the top of floodwall (floodwall at 12.5 ft NAVD88, 2004.65) that was the location of the peak of the 2 ft waves being caused by the West wind. A survey point was placed at 3'3" below the top of wall and asked if this level would represent an average water level. He agreed that it was. Survey point OM-09, Figure 1-30, was the average level. This point has a high degree of uncertainty.

Figure 1-30. Time 11:00 on 8/29/05, elevation 12.5 ft (top of floodwall), 10.2 ft (peak of 2 ft waves), 9.2 ft (average water level at OM-09)

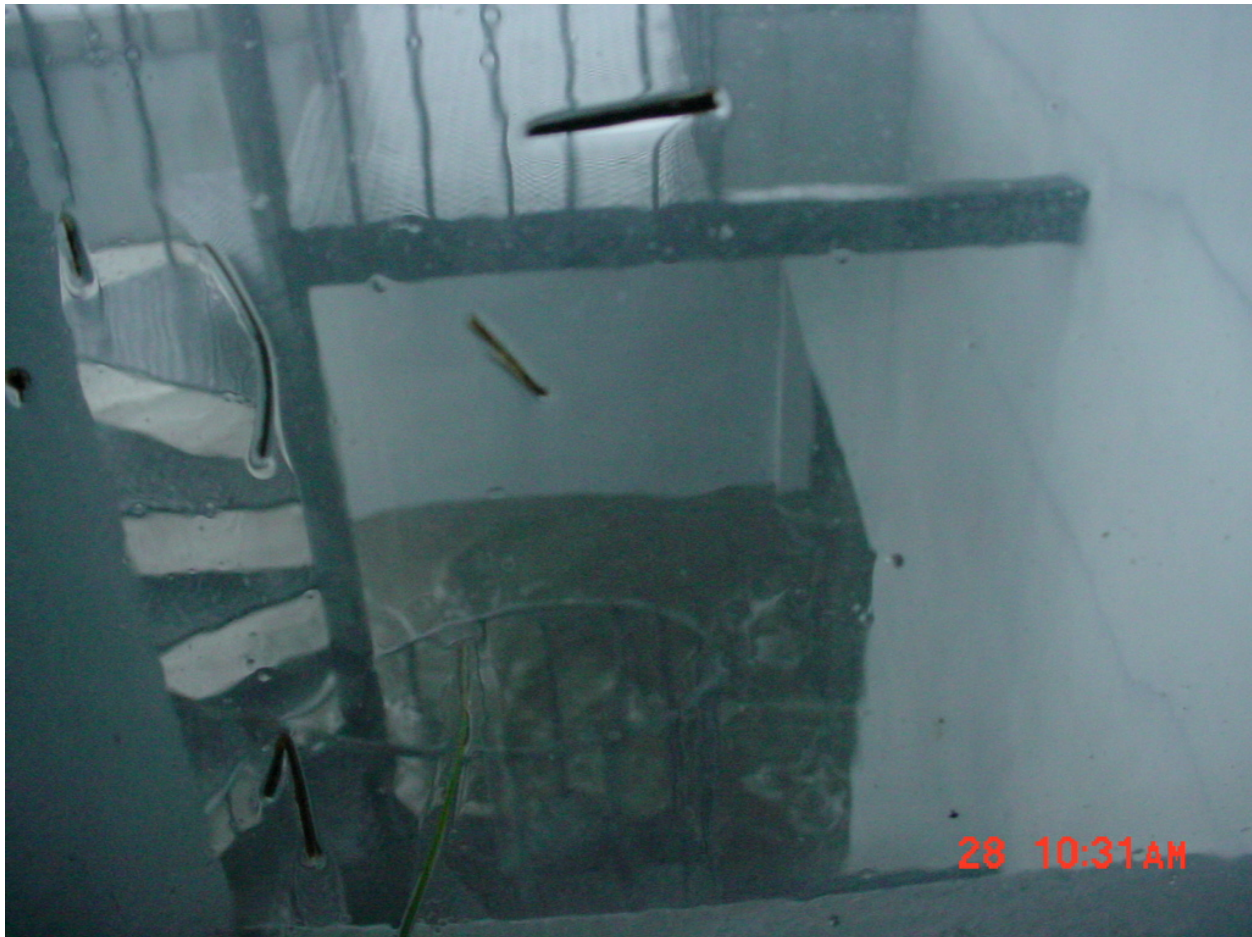
Figure 1-43. Time = 10:31 AM, APH-02. Wall north of west spiral staircase.

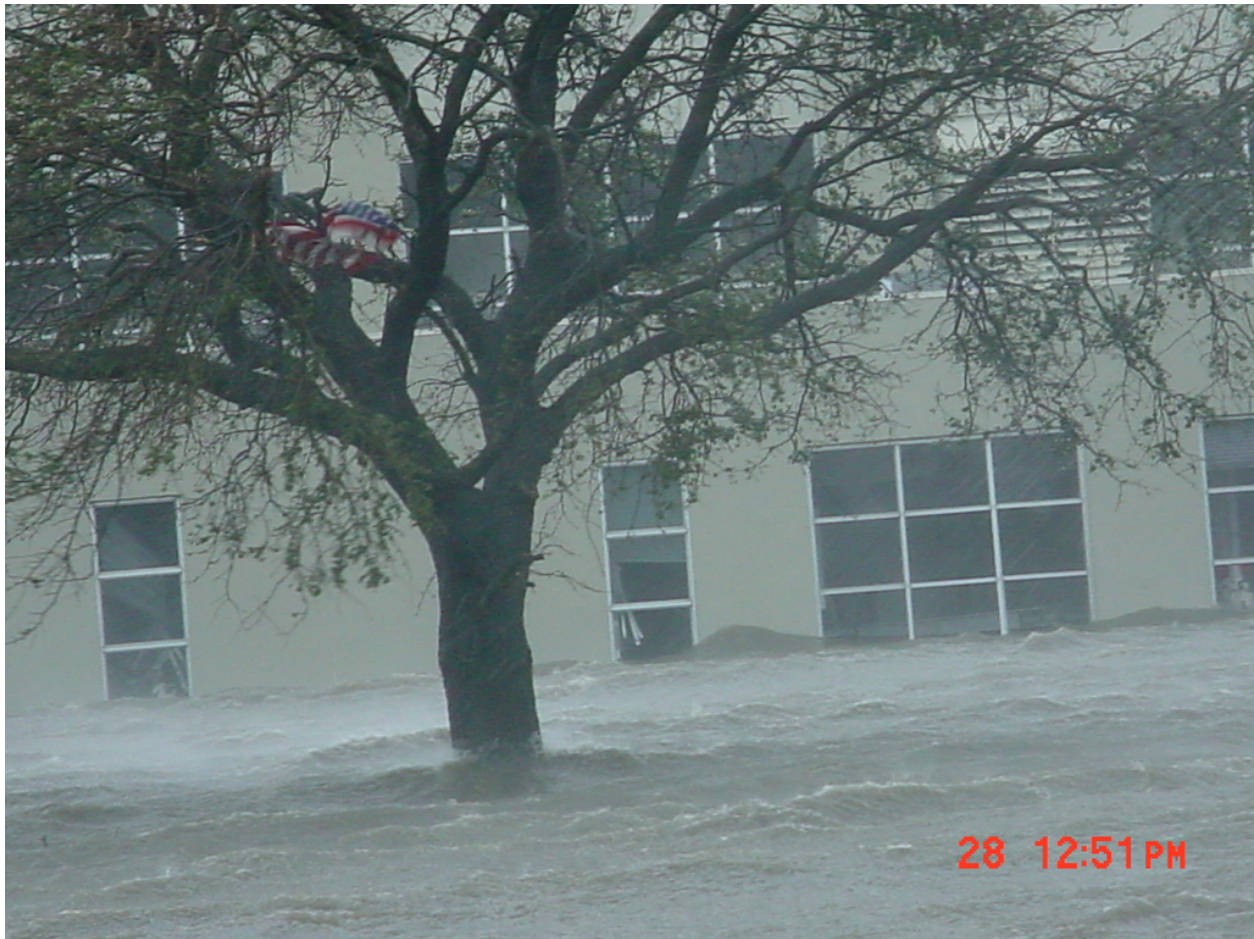
Figure 1-50. Time = 12:51 PM, APH-13. Windows on building east of terminal building.

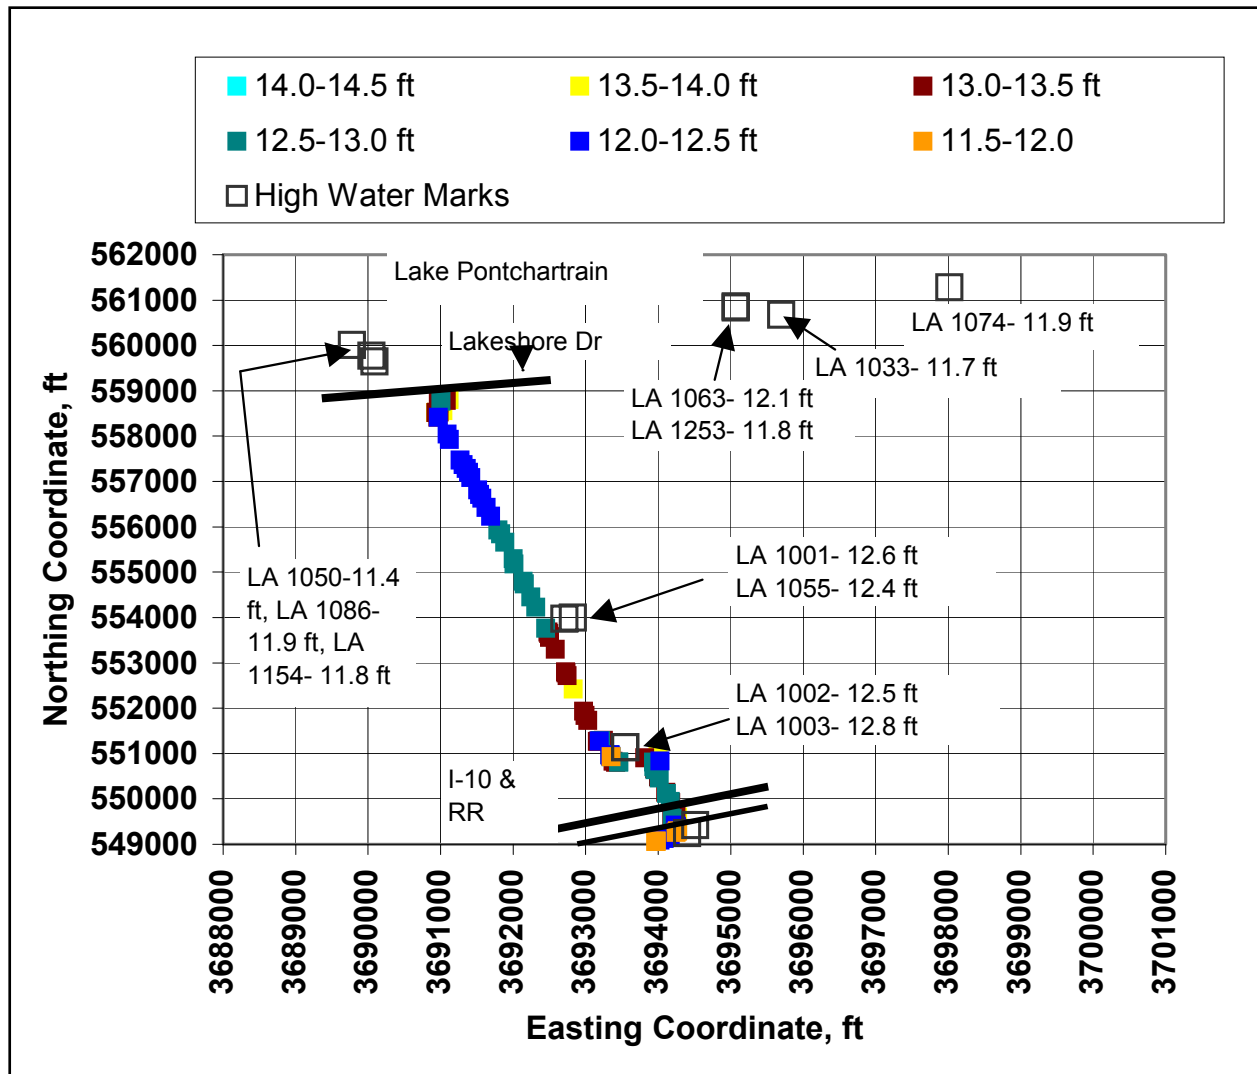
sandbagged prior to Katrina and failed sometime during Katrina. High water mark LA 1054 at 13.0 ft is close to this opening and may have been affected by the sandbag failure. The other marks in this area of 14.2-14.4 ft are believed to better represent water levels immediately south of the railroad bridge just south of the I-10 bridge. The railroad bridge was in the down position during Katrina. High water marks on the north and south sides of the railroad bridge show about a 1.5 ft drop in water level across the bridge. Evidence on the ground (Figure 1-68) showed vegetation laid down indicating high velocity through the I-10/railroad area of the IHNC.

Figure 1-65. Floodwall layout, wall elevations, and high water marks along the west side of IHNC, Lake Pontchartrain to I-10.

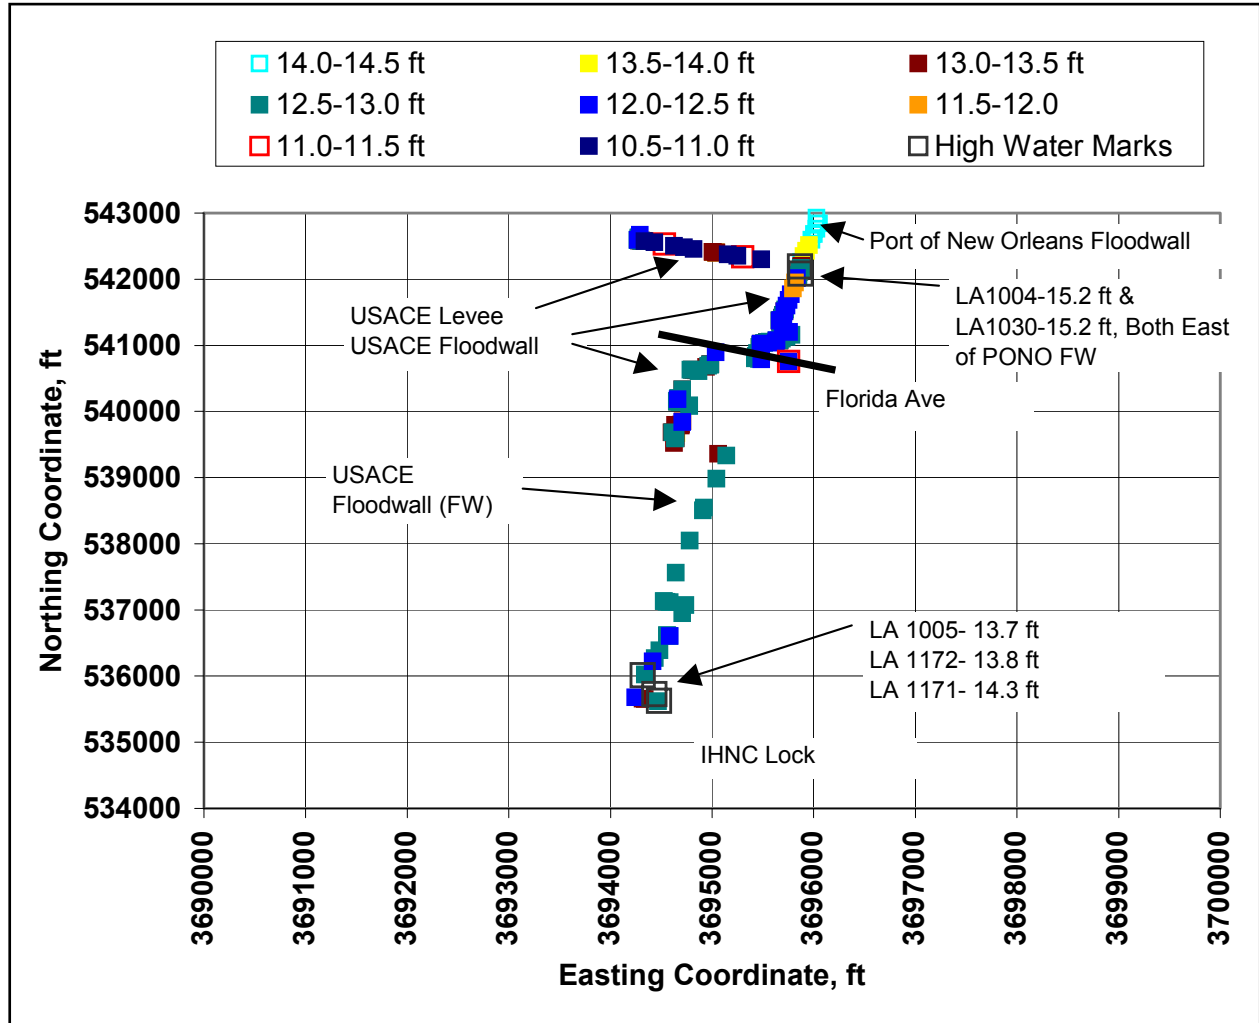
marks in this area. Both marks are based on debris in the rafters of a heavily damaged building that is close to the floodwall and levee breach on the west side of the IHNC. Both LA 1026 and LA 1027 were described as possibly low. Subsequent visits to this building by other IPET members has not resolved the peak water level in this building. The agreement of LA 1026 at elevation 14.3 ft with 4 other marks west of the PONO is the reason LA 1027 is not accepted.

Figure 1-67. Floodwall layout, wall elevations, and high water marks along the west side of IHNC, Florida Avenue railroad bridge to IHNC Lock.

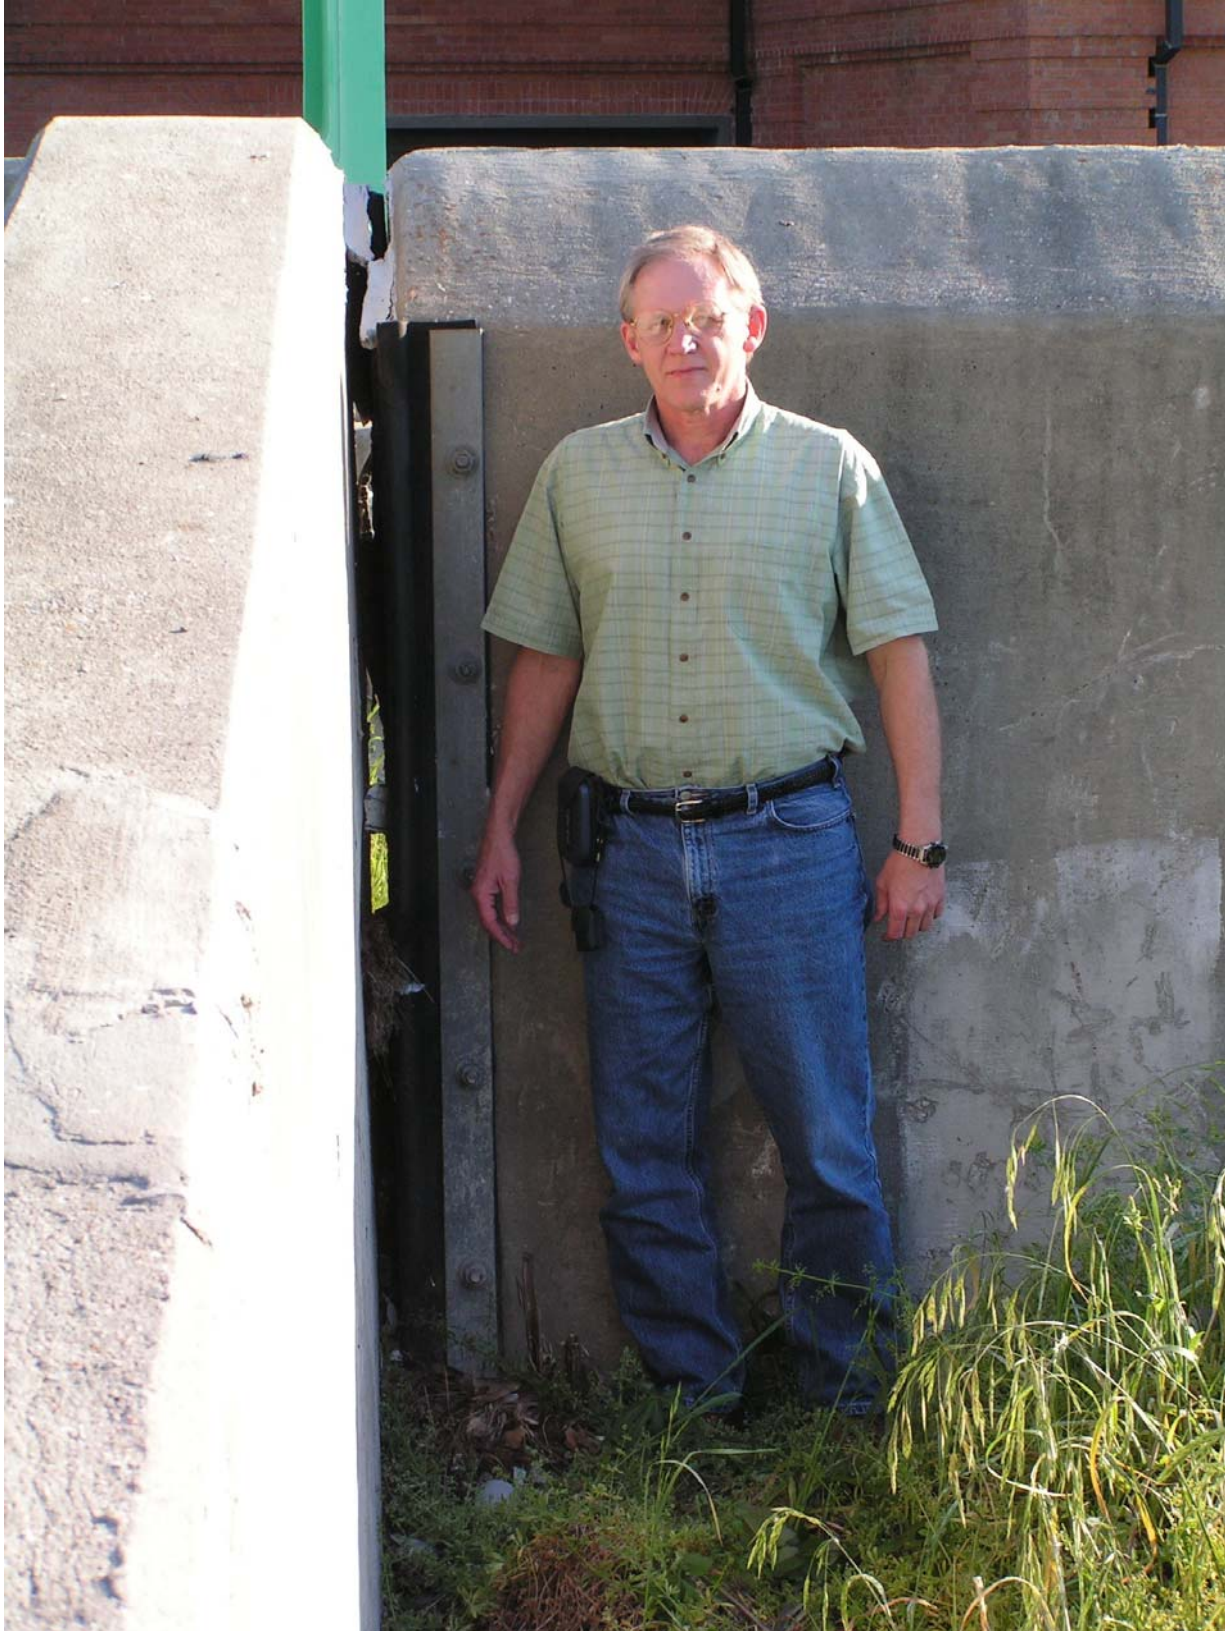
Figure 1-86. LA 1251 at crack in wall. Picture taken 4/06/06. Debris in crack was 2.2 ft below top of wall on 9/29/05.

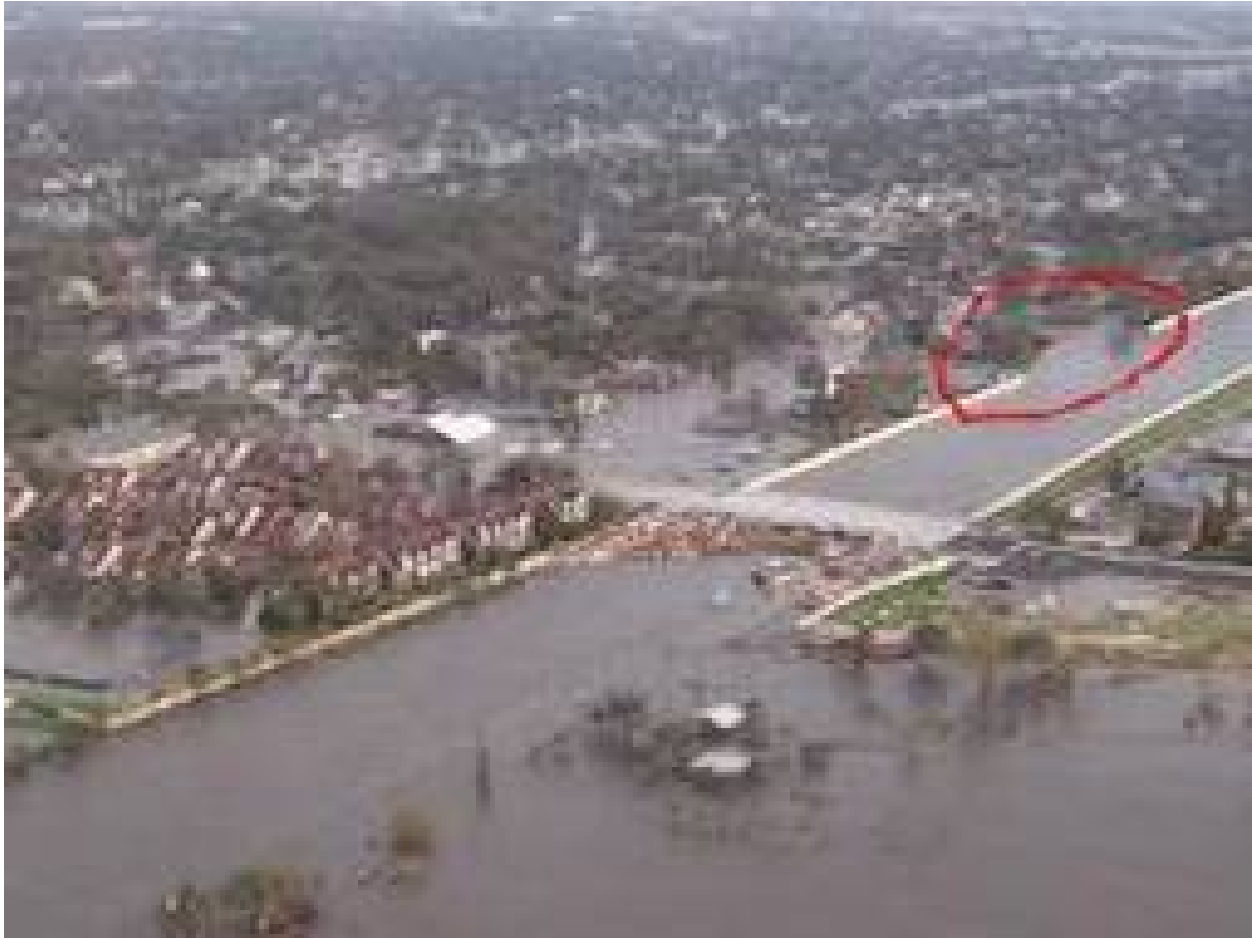
Figure 10-1. 17th Street Canal August 29, 2005. Looking south showing breach and debris impounded against Hammond Highway Bridge

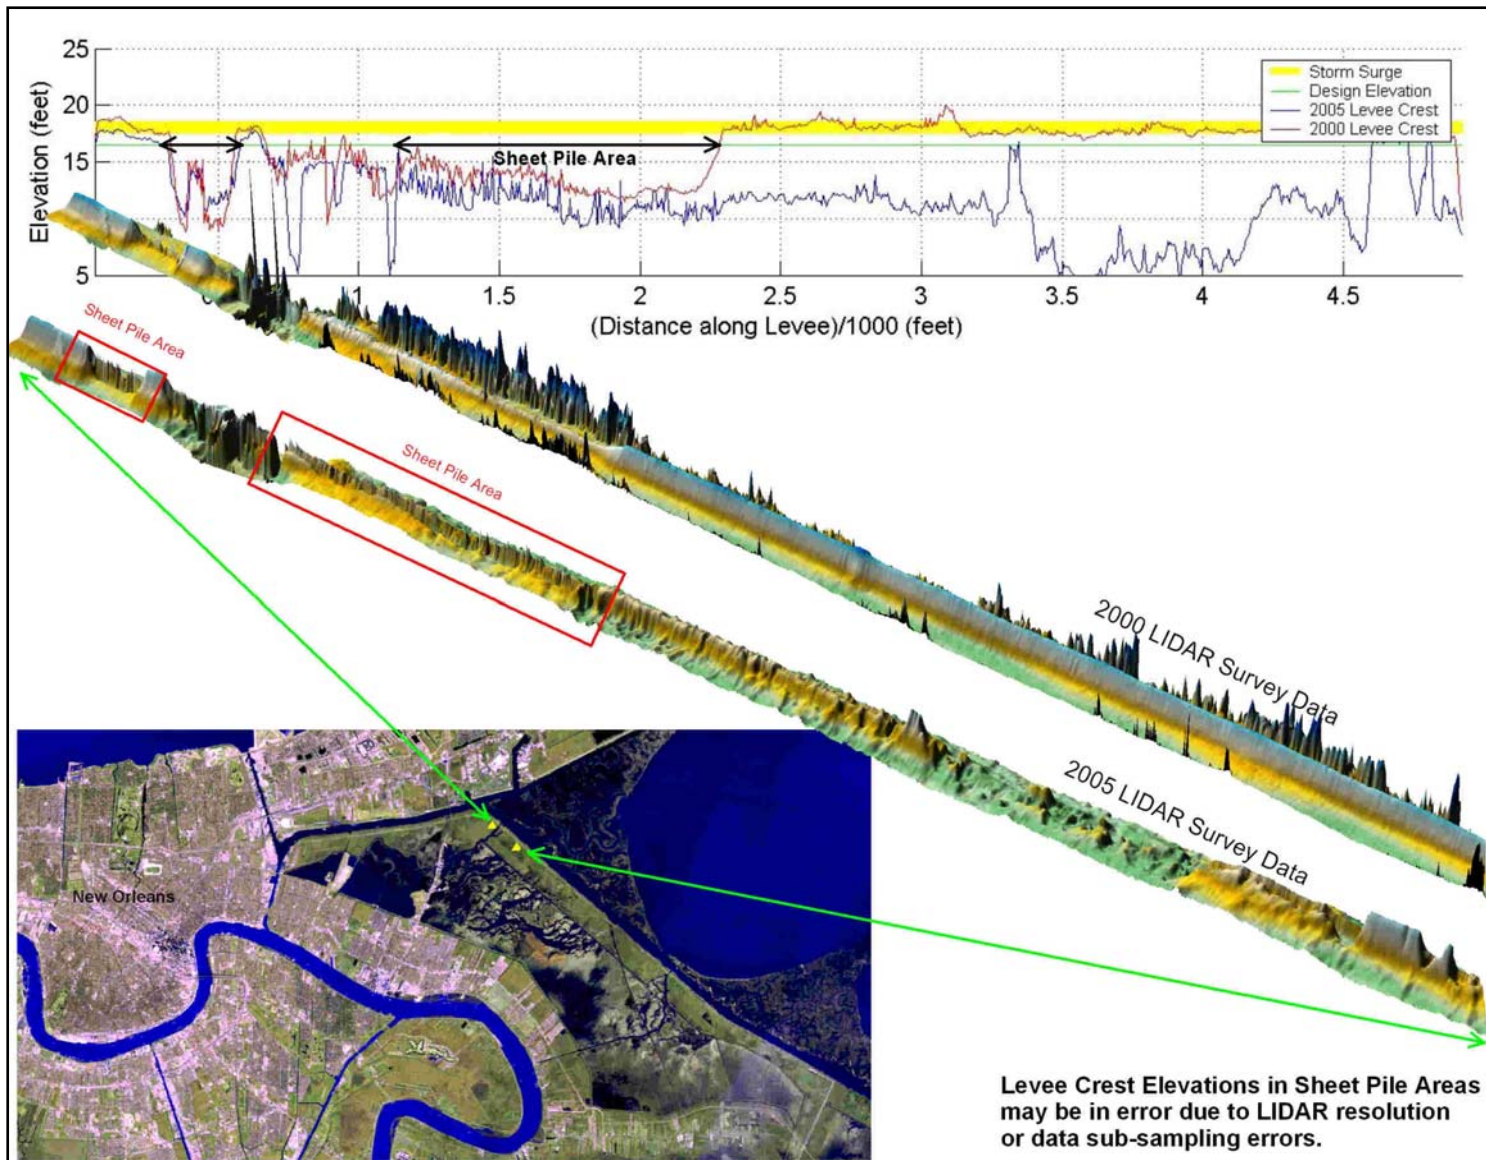
Figure 16-1. MRGO levee damage determined from LIDAR surveys; Station 0 to 4,500 ft

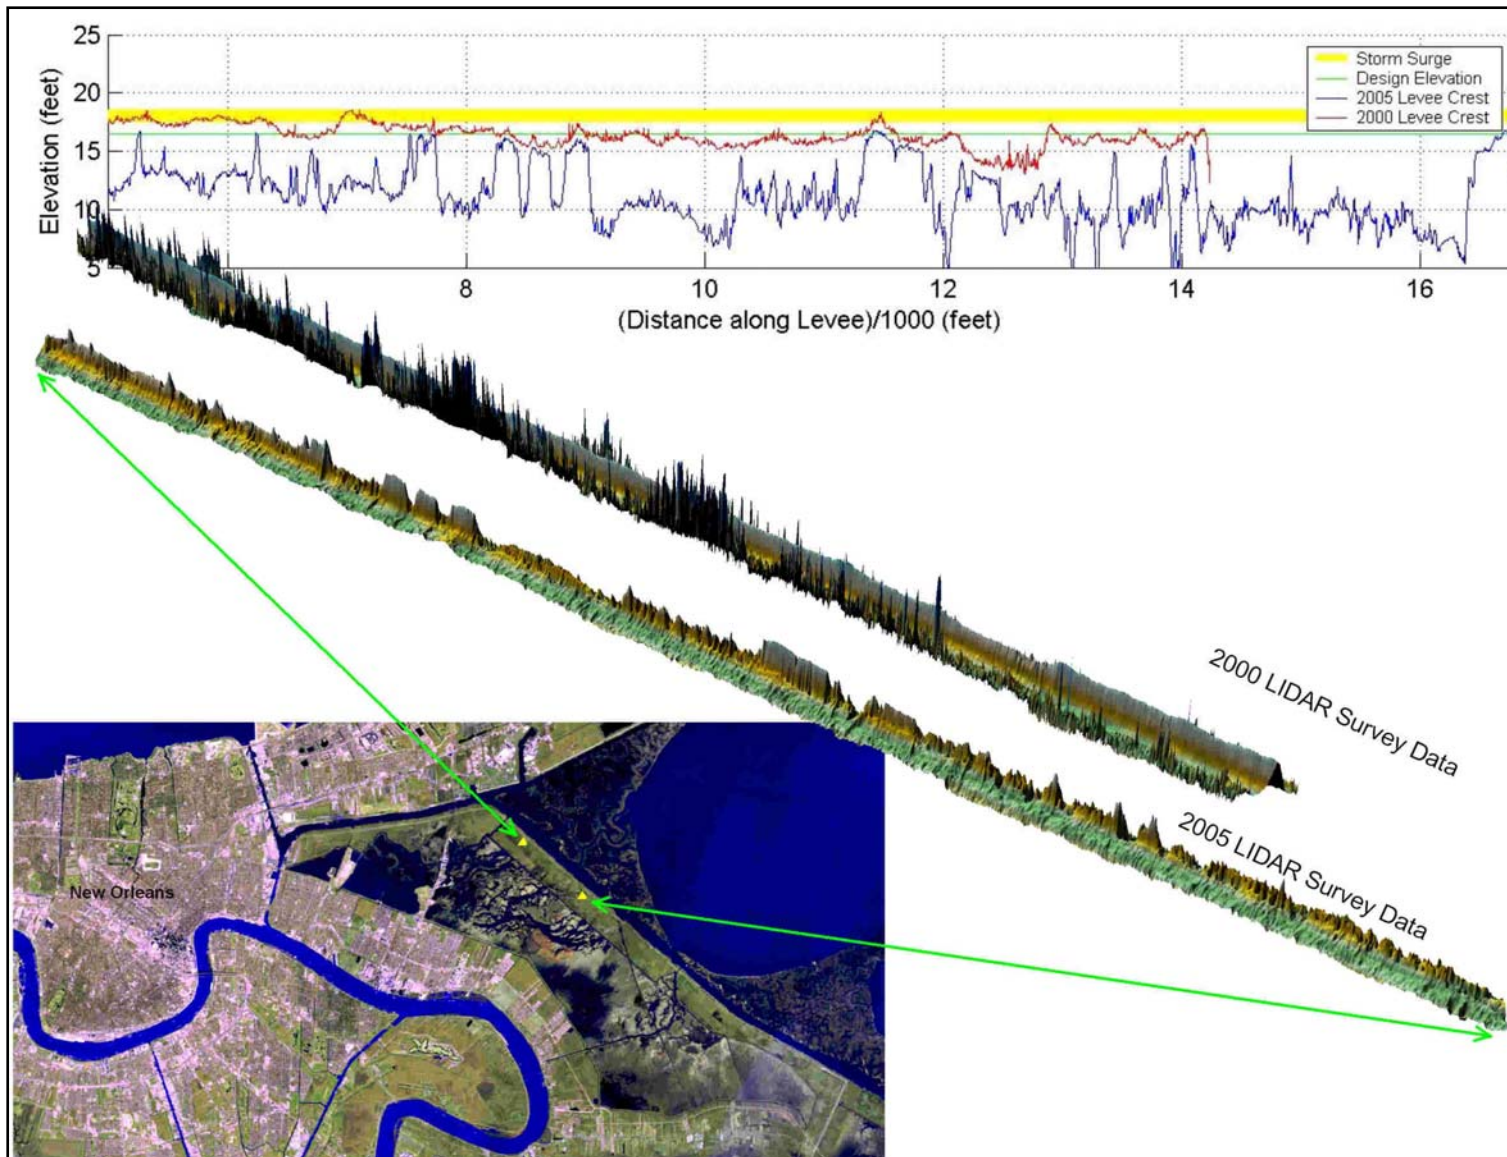
Figure 16-2. MRGO levee damage determined from LIDAR surveys; Station 6,000 to 16,000 ft

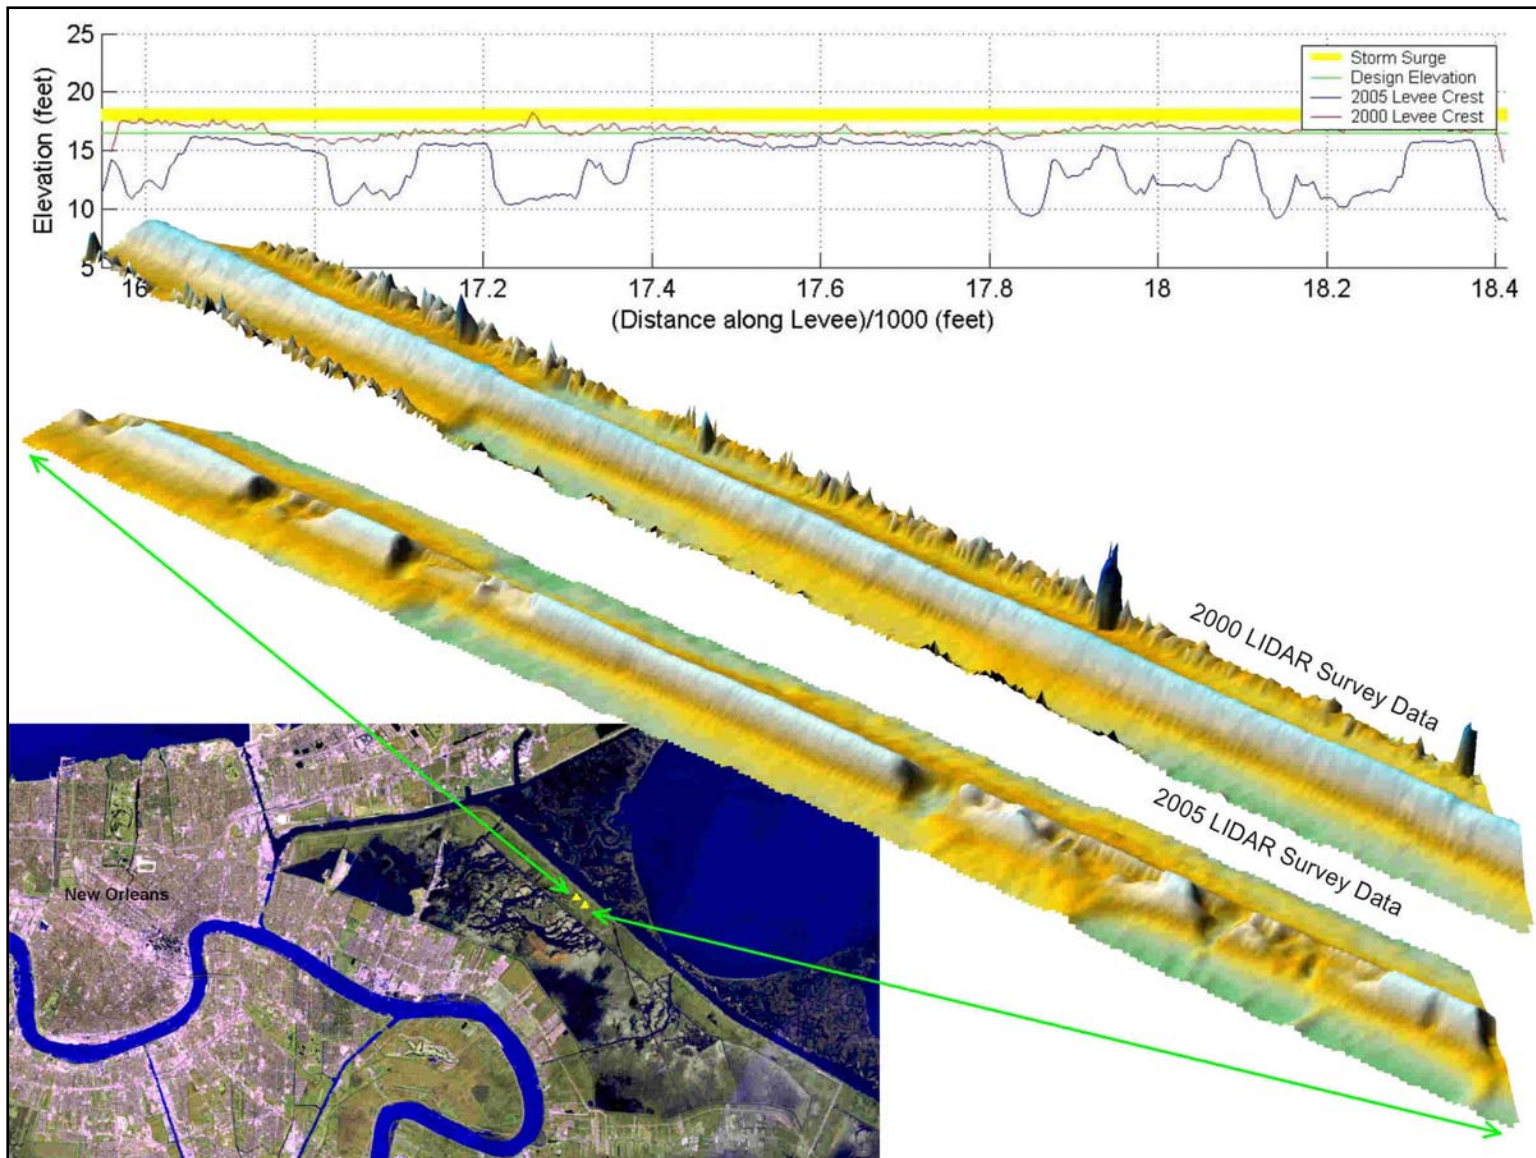
Figure 16-3. MRGO levee damage determined from LIDAR surveys; Station 16,800 to 18,400 ft

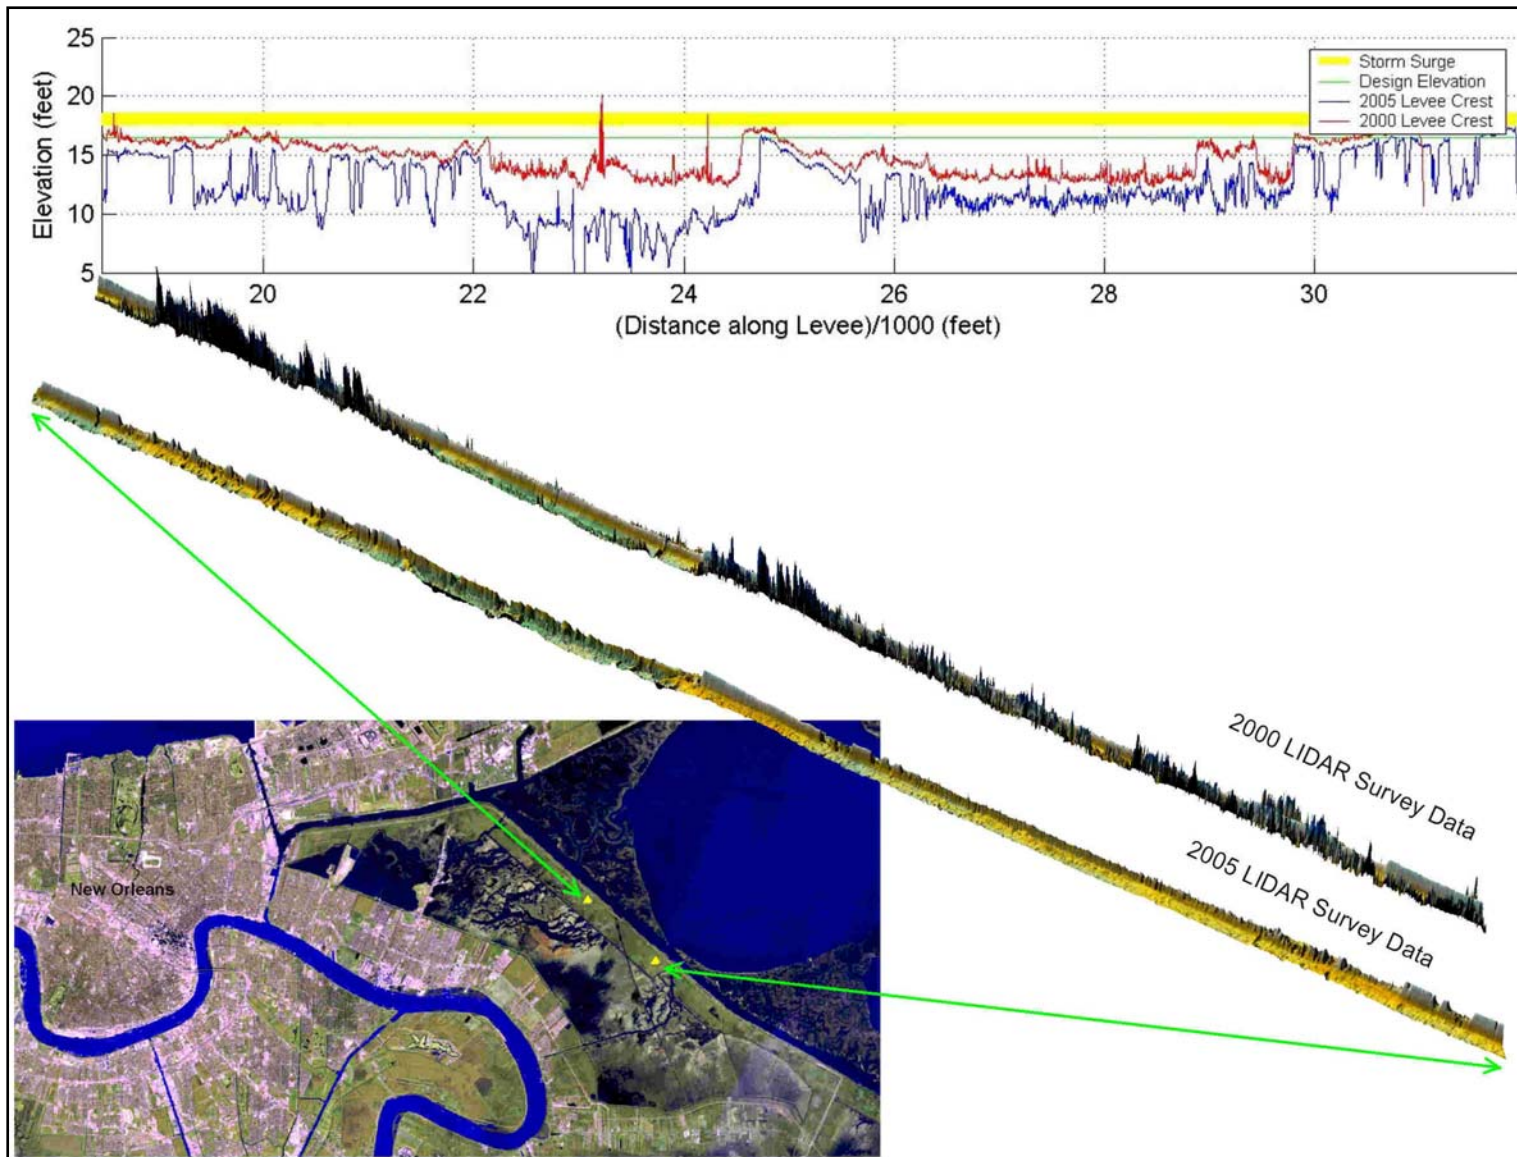
Figure 16-4. MRGO levee damage determined from LIDAR surveys; Station 20,000 to 30,000 ft

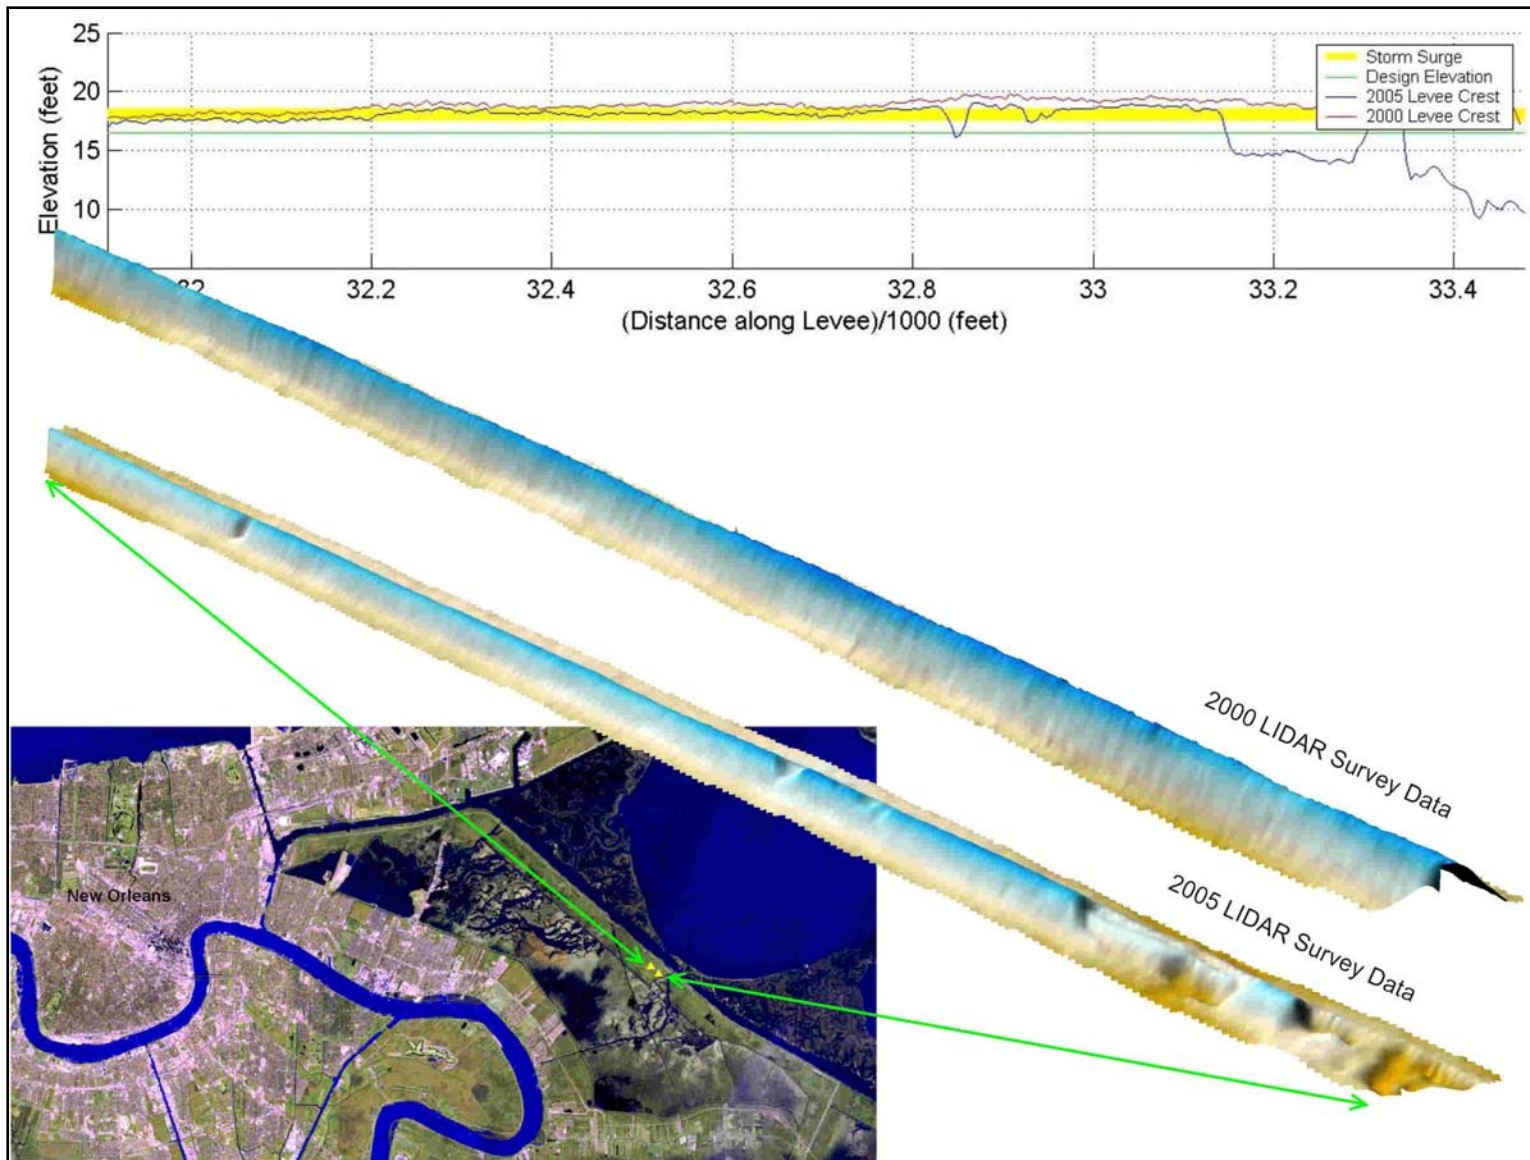
Figure 16-5. MRGO levee damage determined from LIDAR surveys; Station 32,000 to 33,400 ft

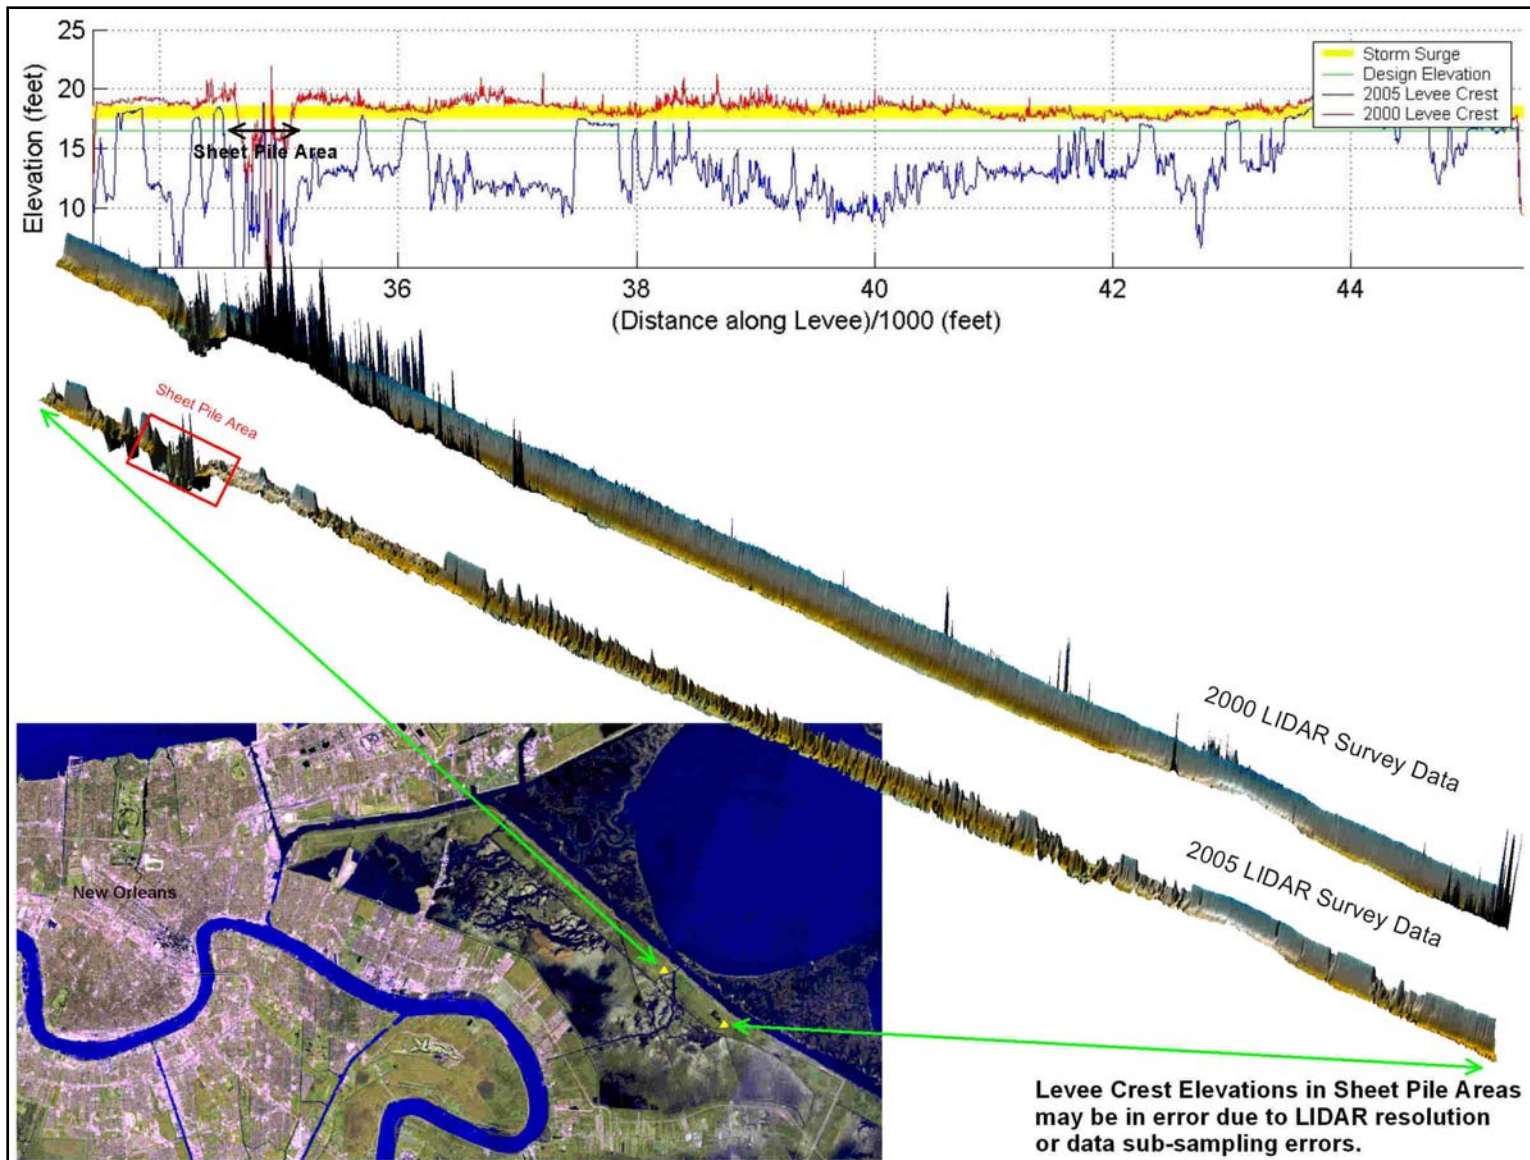
Figure 16-6. MRGO levee damage determined from LIDAR surveys; Station 34,000 to 44,000 ft

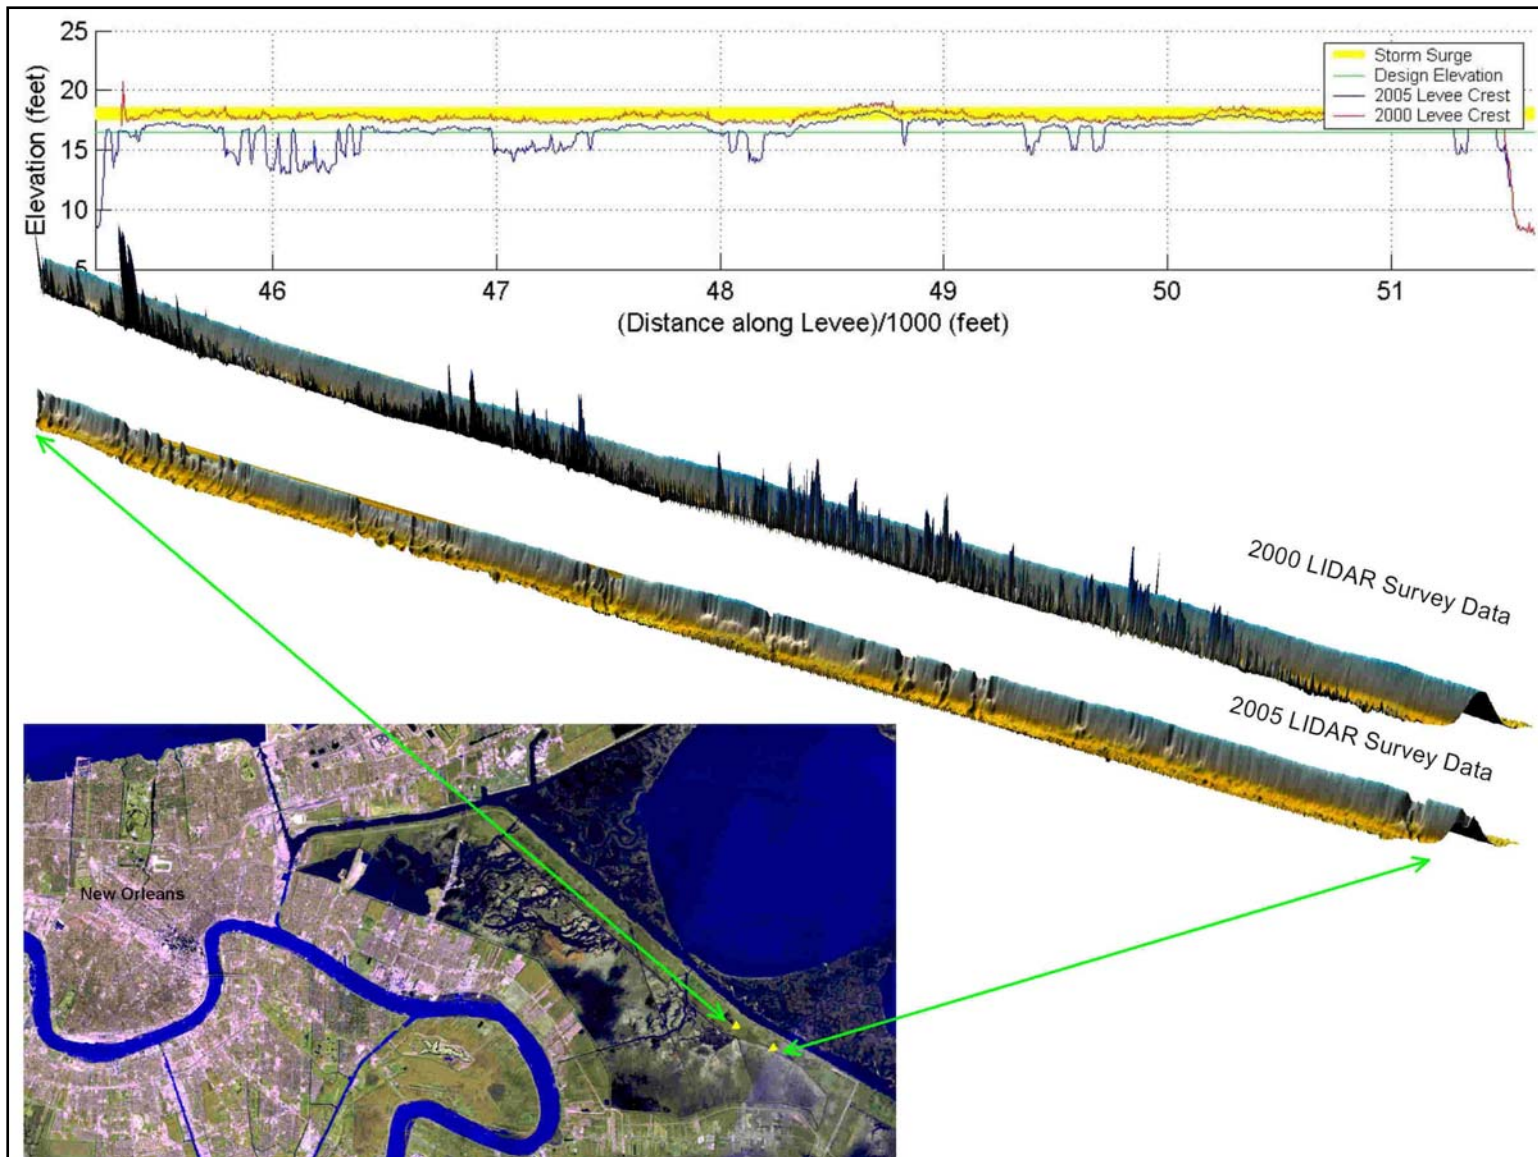
Figure 16-7. MRGO levee damage determined from LIDAR surveys; Station 46,000 to 51,000 ft
