# Appendix 1

## Hydrograph and High Water Mark Analysis

### Introduction

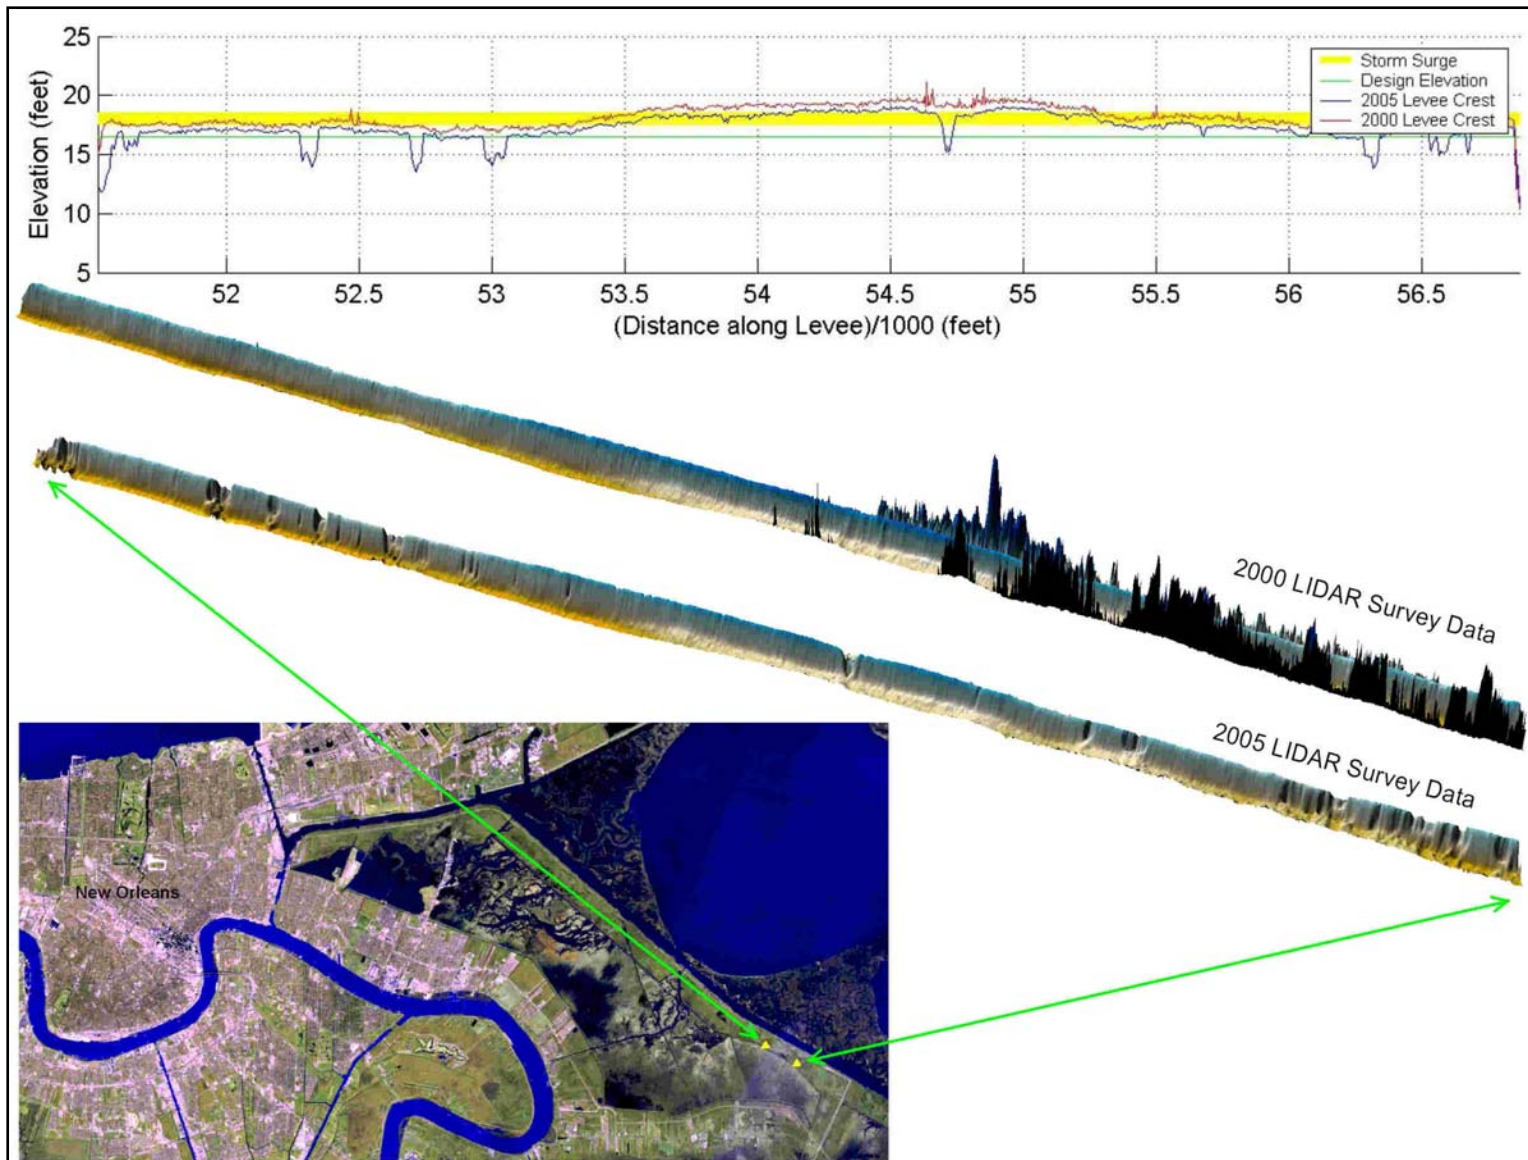
Figure 16-8. MRGO levee damage determined from LIDAR surveys; Station 52,000 to 56,500 ft

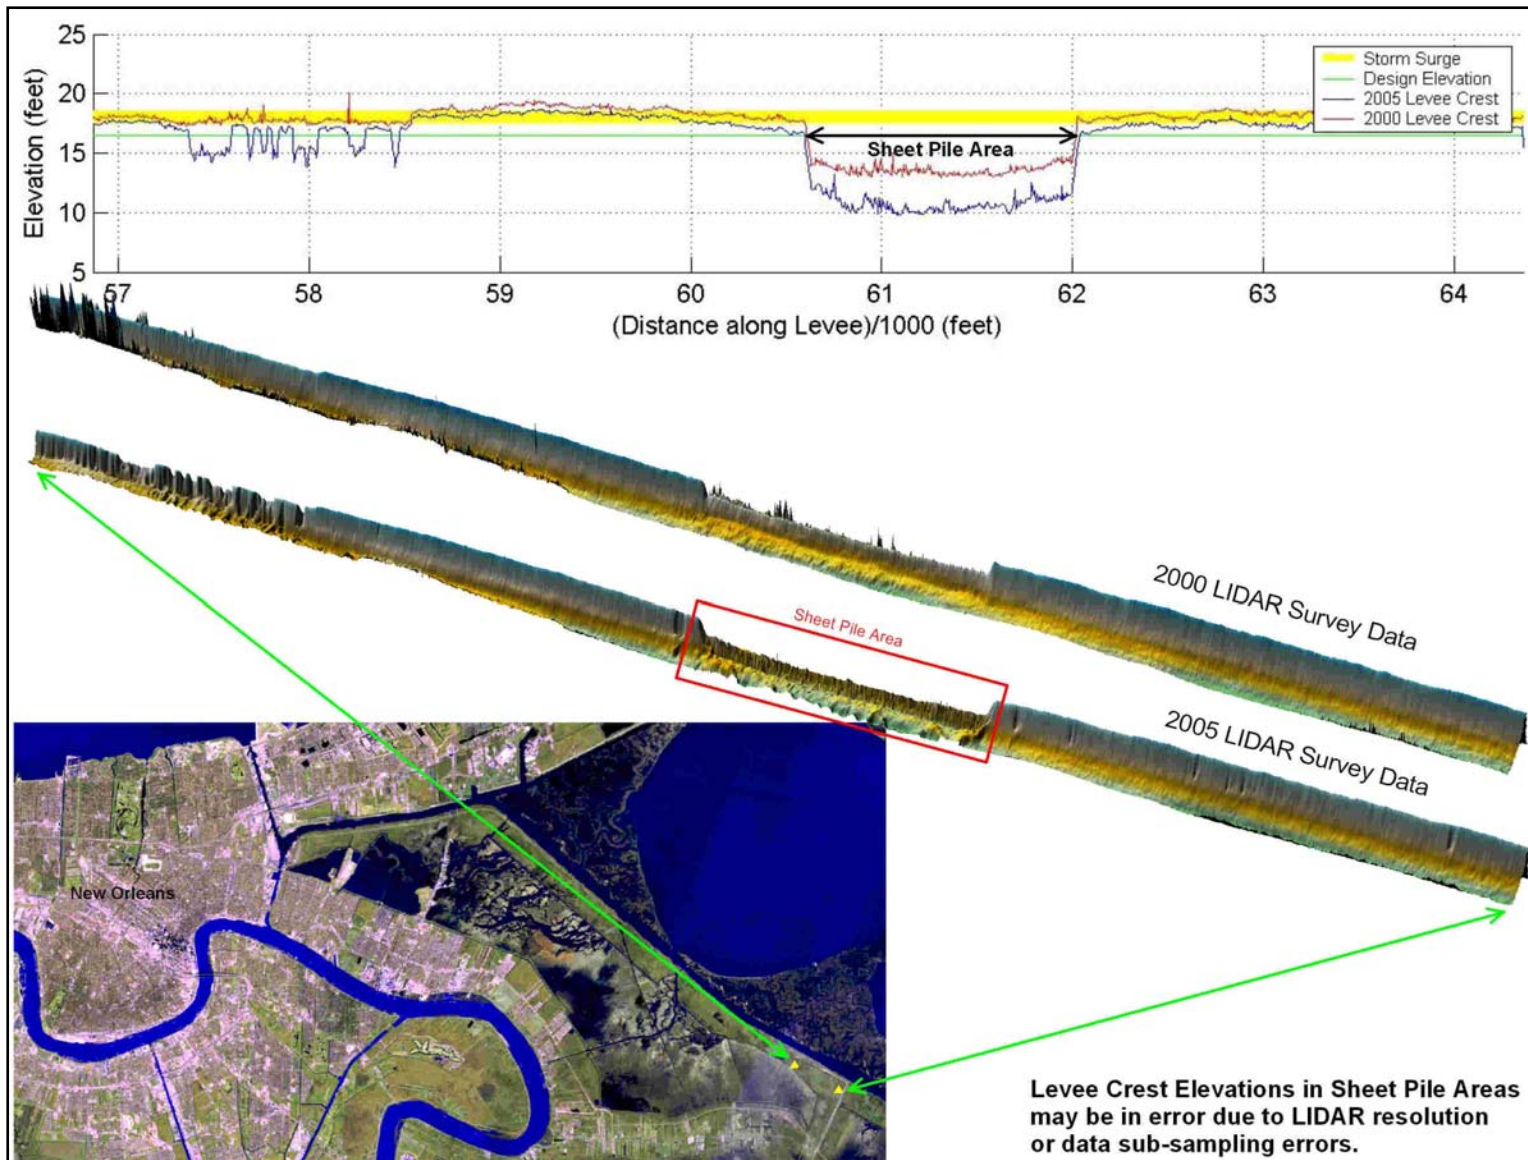
Figure 16-9. MRGO levee damage determined from LIDAR surveys; Station 57,000 to 64,000 ft
