Performance Evaluation of the New Orleans and Southeast Louisiana Hurricane Protection System

Final Report of the Interagency Performance Evaluation Task Force

Volume V – The Performance — Levees and Floodwalls

June 2007

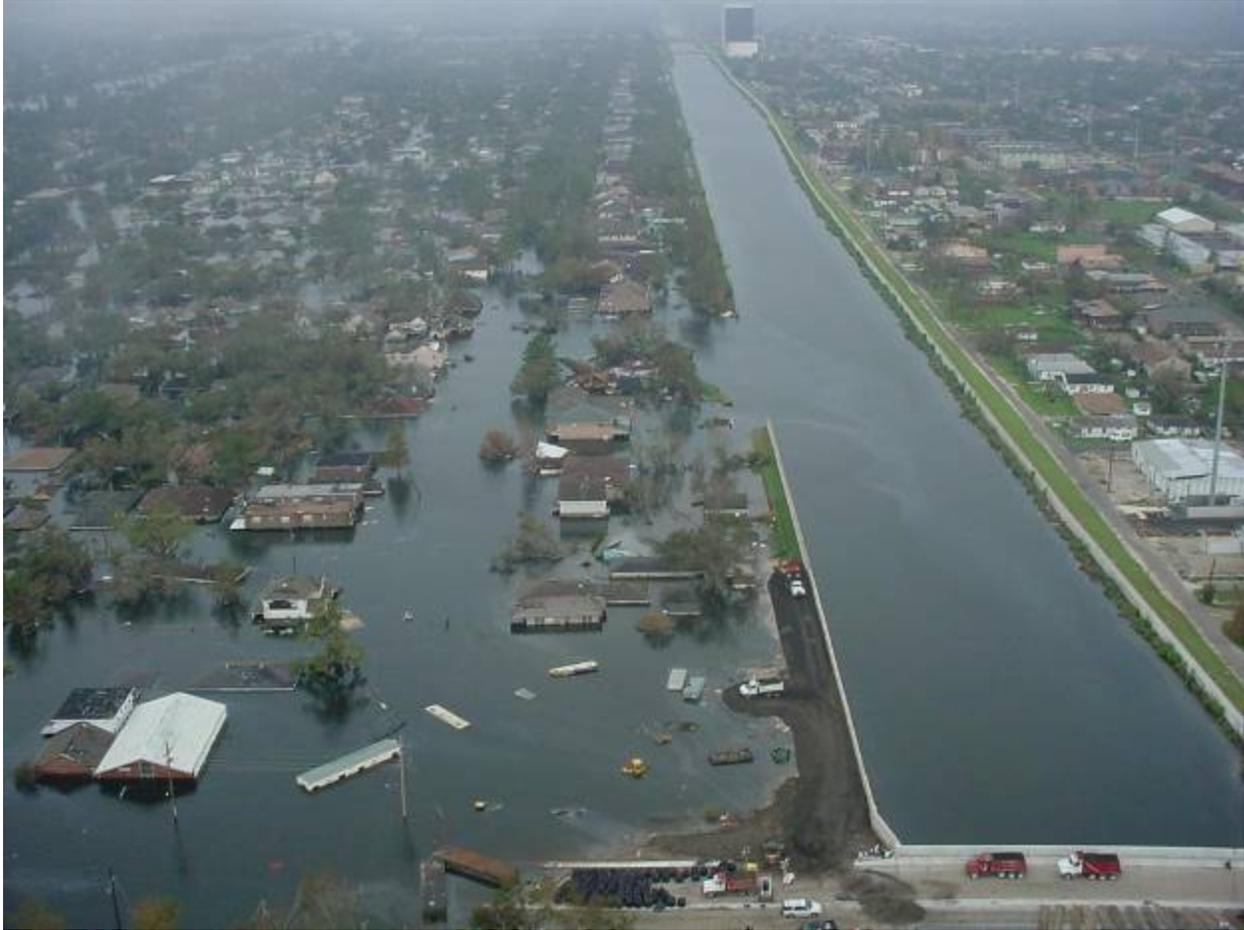
Observations made at the breach at the 17th Street Canal show that the most likely cause of breach is a soil foundation failure. Figure 9 shows an aerial photo of an approximately 450-ft breach in the floodwall along the east side of the 17th Street Outfall Canal south of the old Hammond Road Bridge. Figure 10 shows that a section of levee has moved more than 40 ft inward to the landside. It appears that the remaining levee section making up the breach was washed away by the water flowing through the breach. The top of the I-wall section of the floodwall in the breach can be seen adjacent to the levee section that moved into the landside.

Figure 9. Aerial photograph of the 17th Street Canal breach looking south from the Old Hammond Road Bridge.

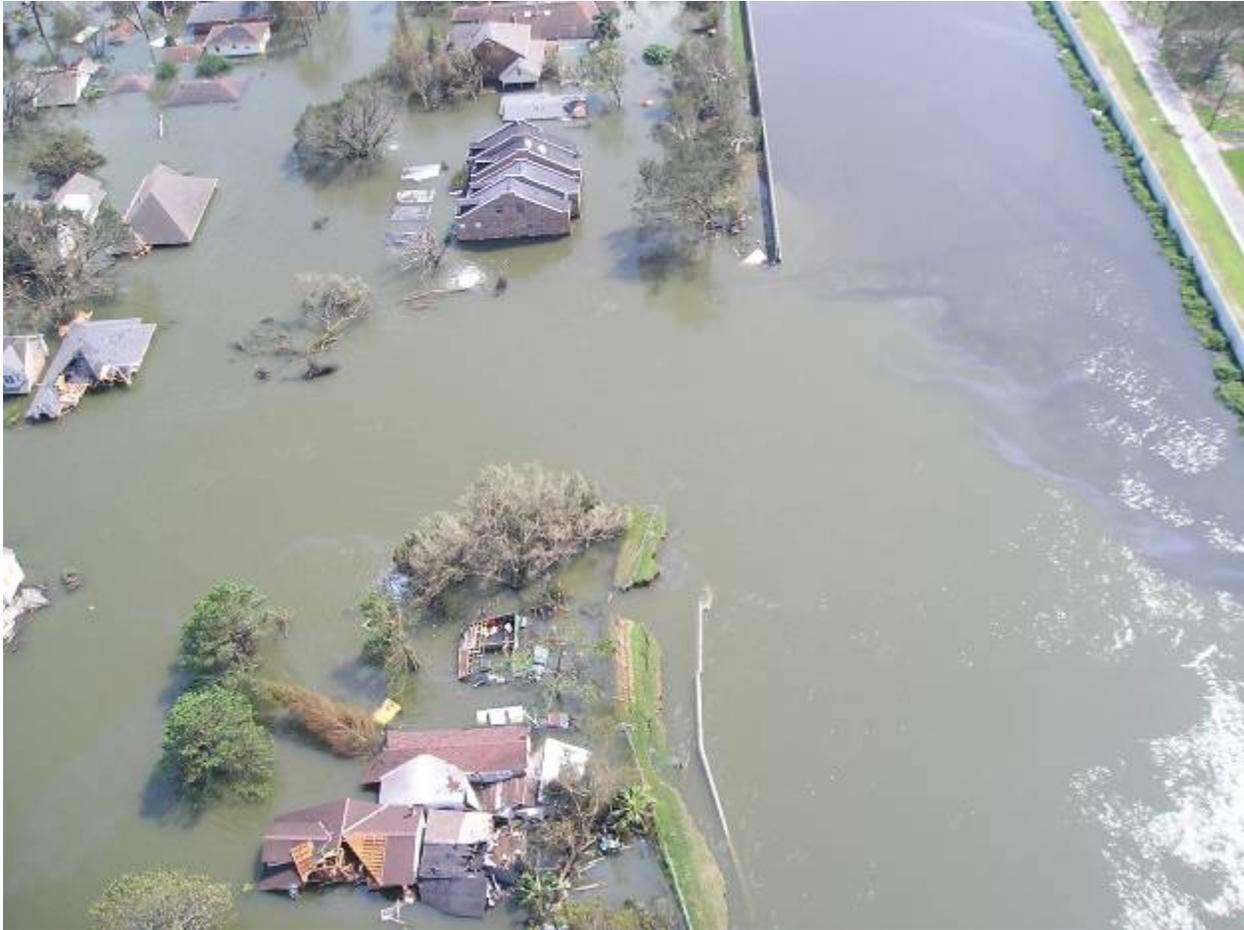
Figure 10. Aerial photograph of the 17th Street Canal breach showing I-wall and embankment translation.

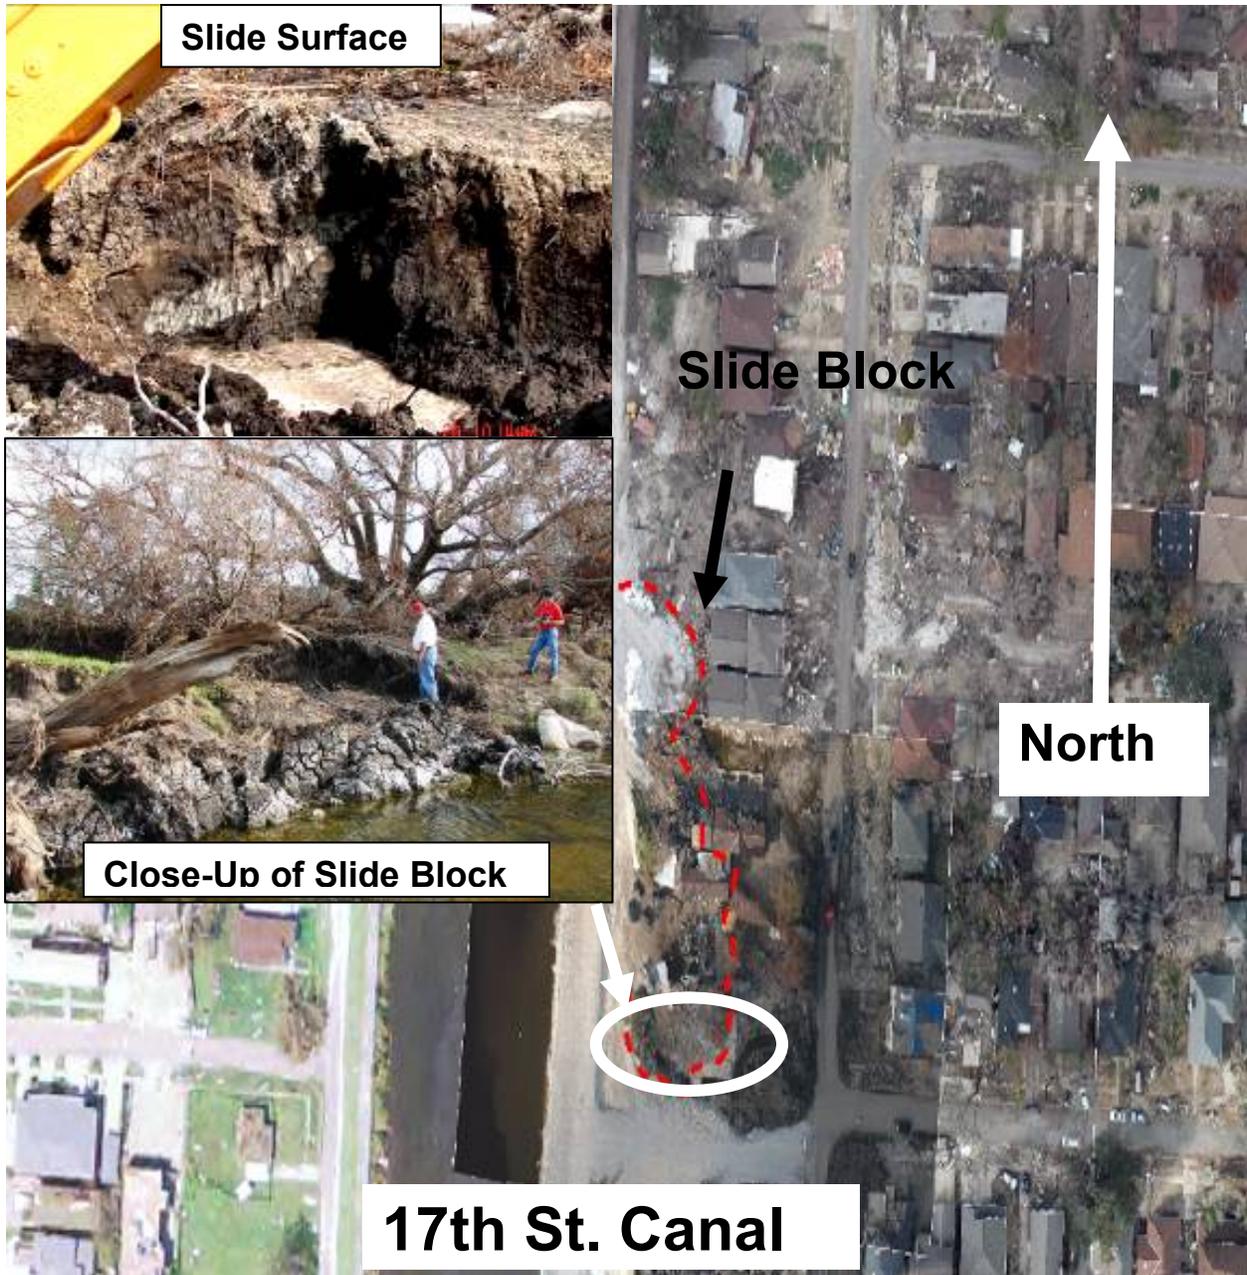
Figure 16. Photographs taken at the 17th Street Canal breach after the failure.

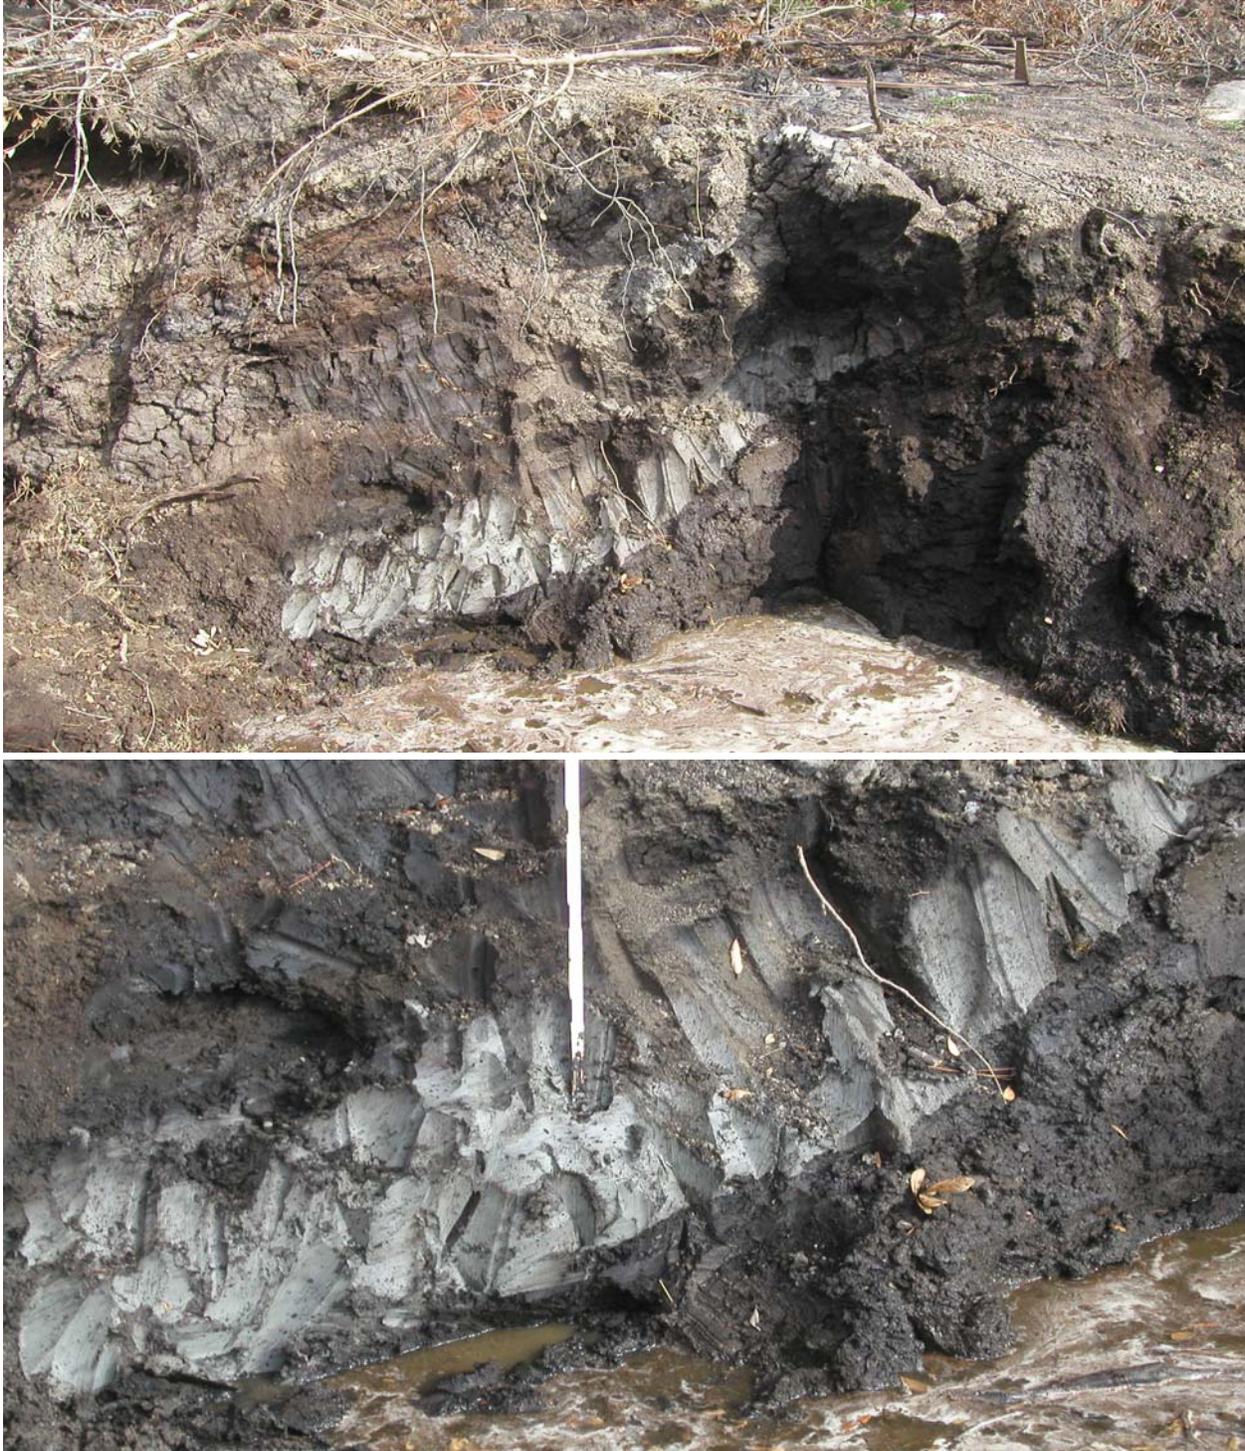
Figure 17. Exposed failure plane at the 17th Street Canal breach, showing clay that was initially below the marsh layer was displaced above some of the marsh material during the failure. The marsh material above and below the clay is the same layer, confirmed by age dating. The clay was moved into this position during the failure, as shown in Figure 18.

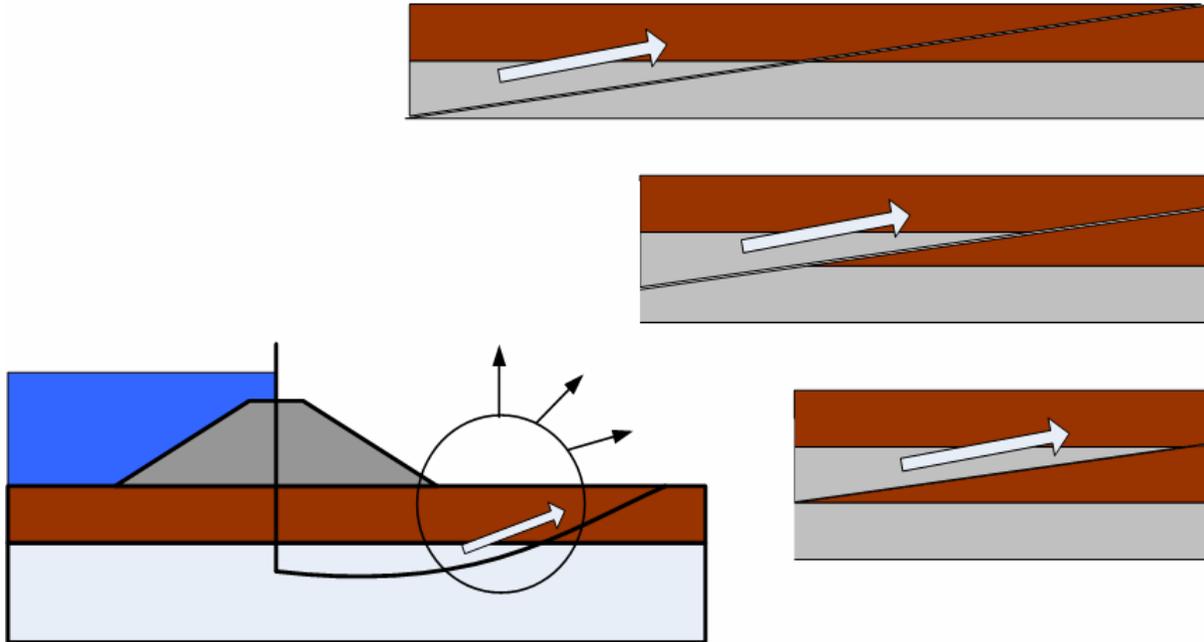
Figure 18. A portion of the clay layer, initially located beneath the marsh layer, was displaced upward and over a portion of the marsh layer as it was displaced laterally by the failure. A photograph of the displaced clay, with marsh material above it and below it, is shown in Figure 17.

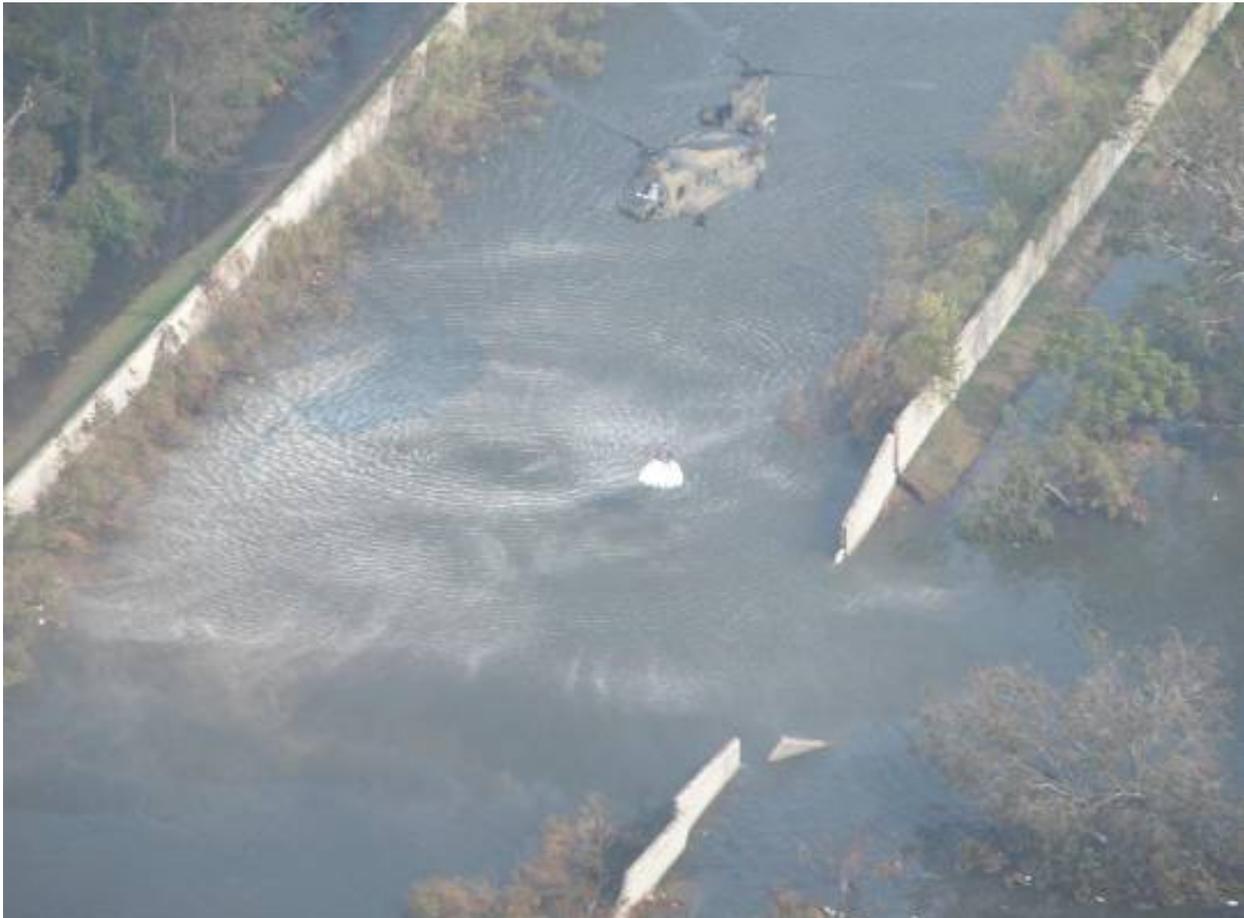
The south breach, shown in Figure 35, occurred about 7:00 a.m. to 8:00 a.m. on 29 August 2005, when the water level in the canal was 8.2 ft to 9.5 ft NAVD88. The breach was narrower than the breach at the 17th Street and the London Avenue north breach. A deep scour hole formed due to the inrush of water, and a large amount of eroded sand was deposited in the neighborhood inland of the breach. It appears that the breach was quite narrow when it formed, and subsequently widened to about 60 ft as wall panels adjacent to the initial breach were undermined by scour, and tilted into the scour hole.

Figure 35. South breach, London Avenue Canal.

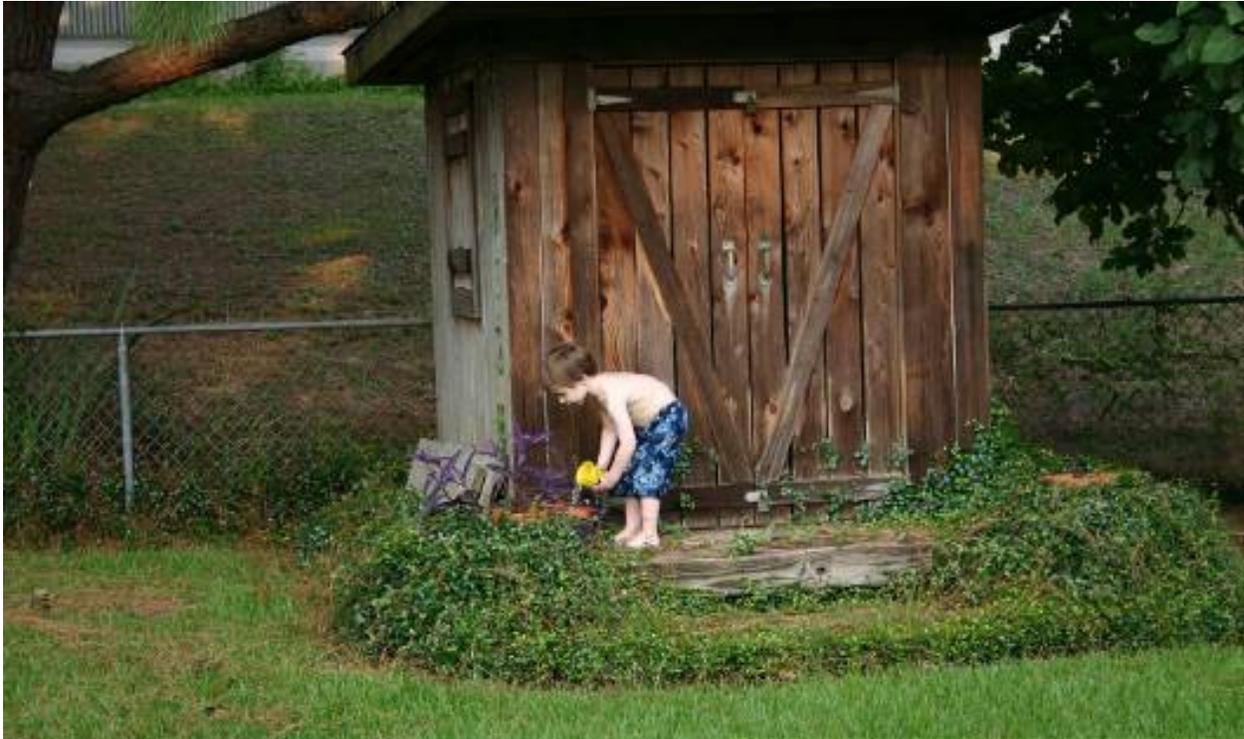
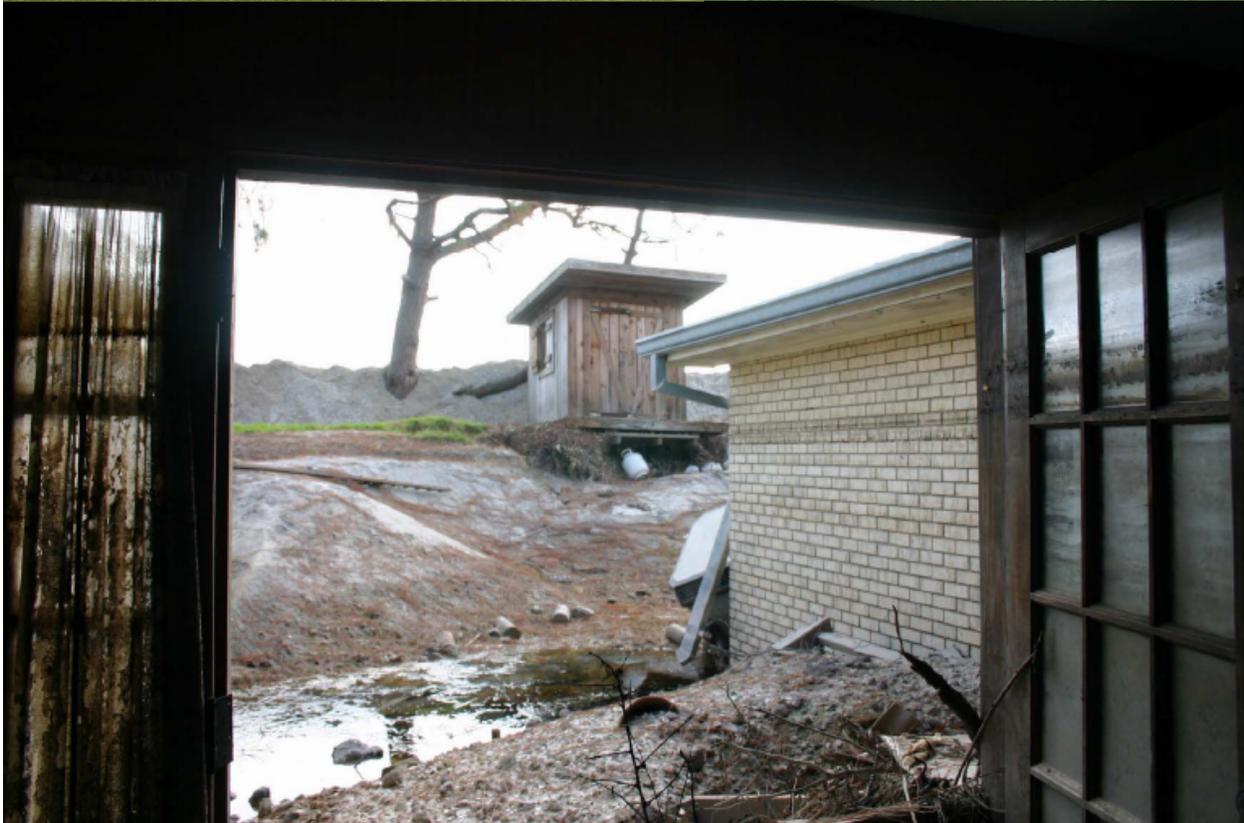
Figure 37. Playhouse at the London Avenue Canal north breach before the failure (top photo) and after (bottom photo).

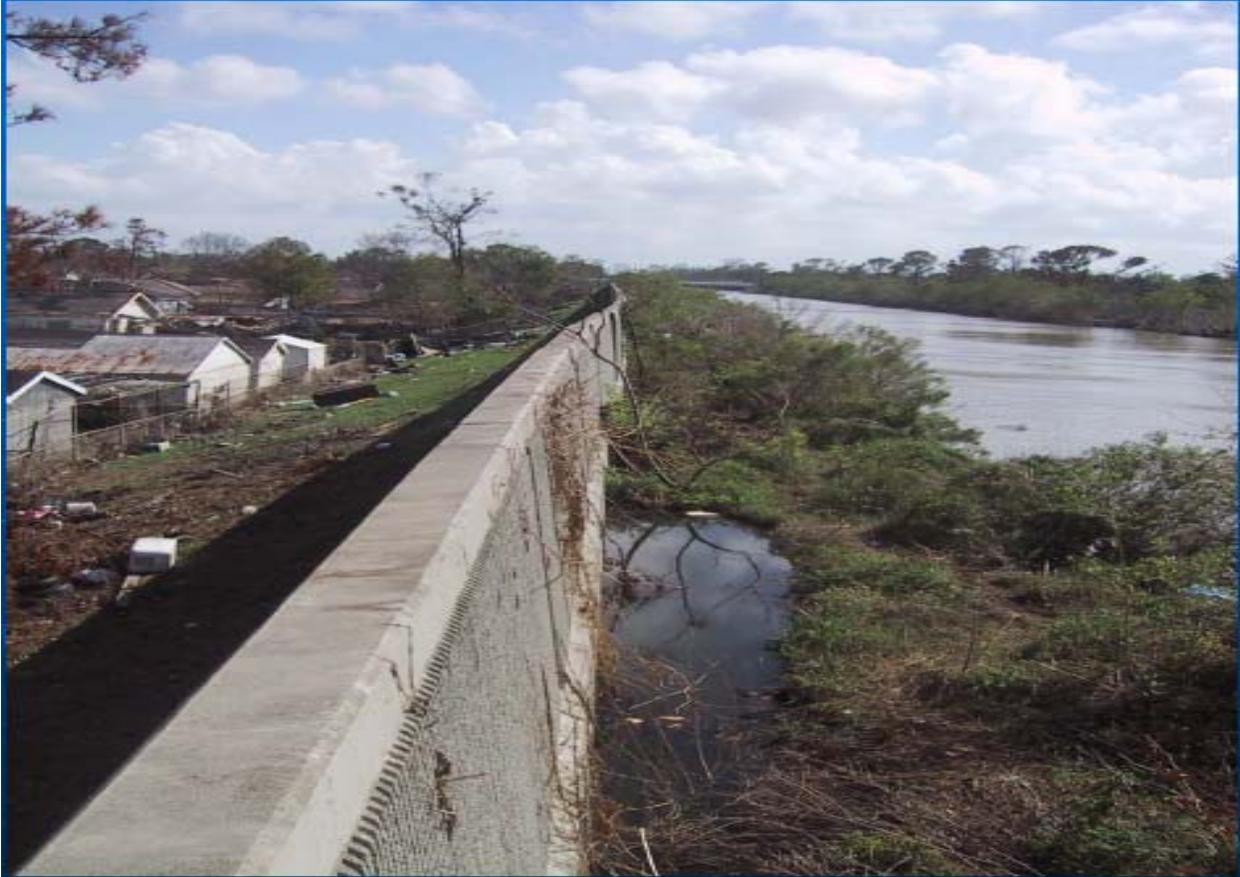
Figure 38. Tilted I-wall opposite the north breach on the London Avenue Canal.

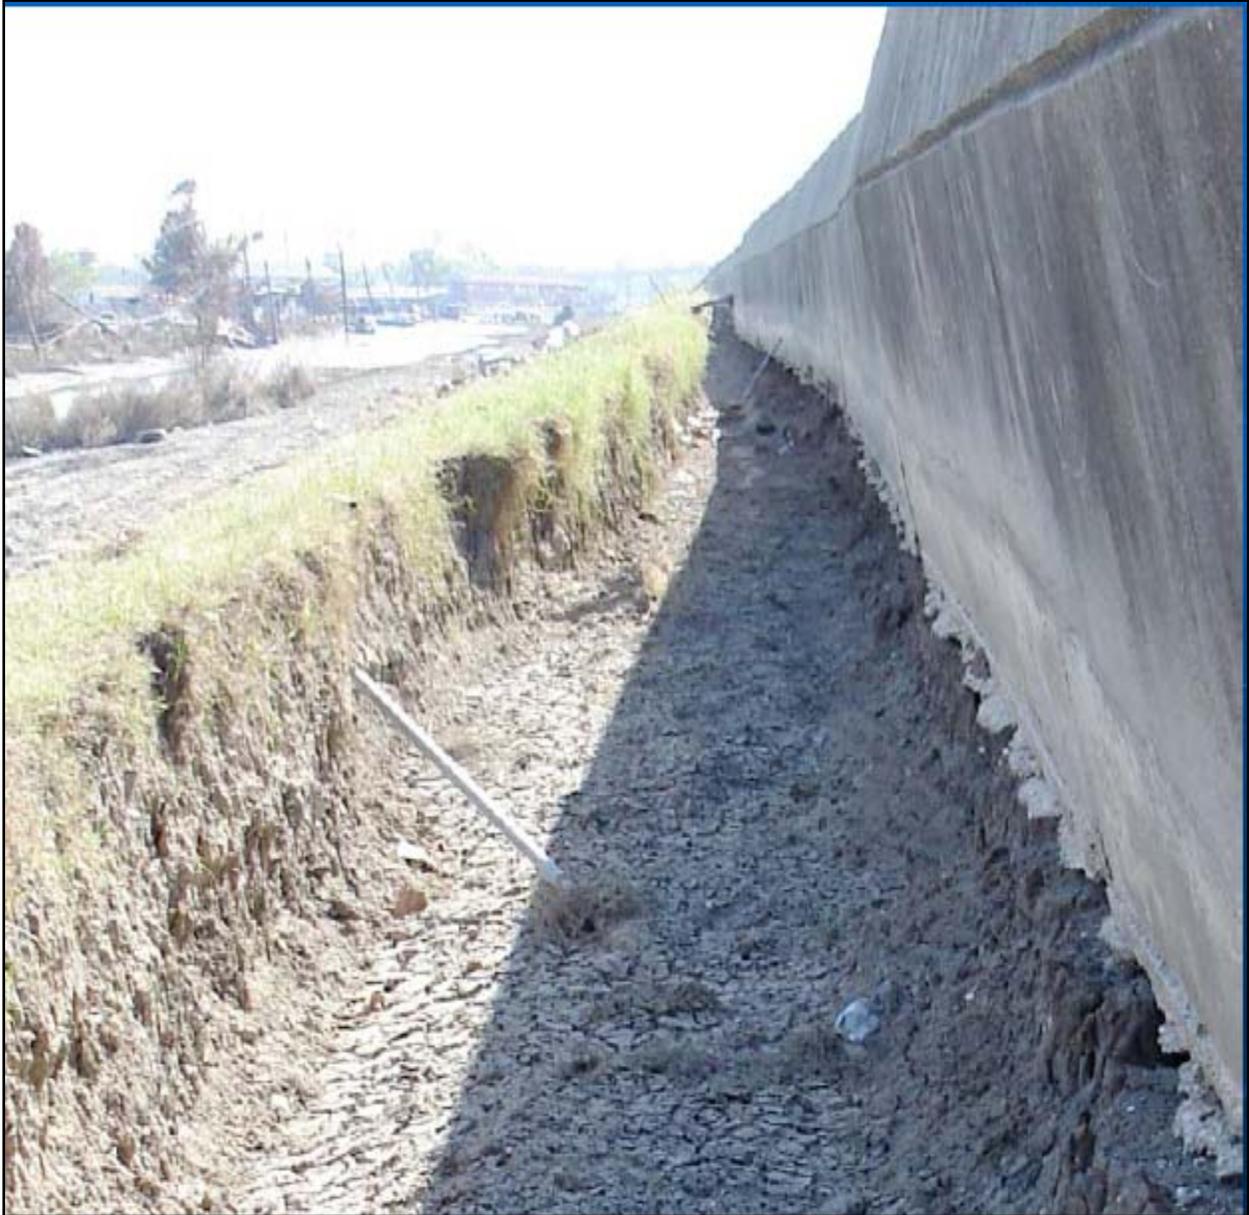
Figure 52. Scour and Erosion on the Protected Side of the IHNC adjacent to the 9th Ward in the vicinity of the south breach.

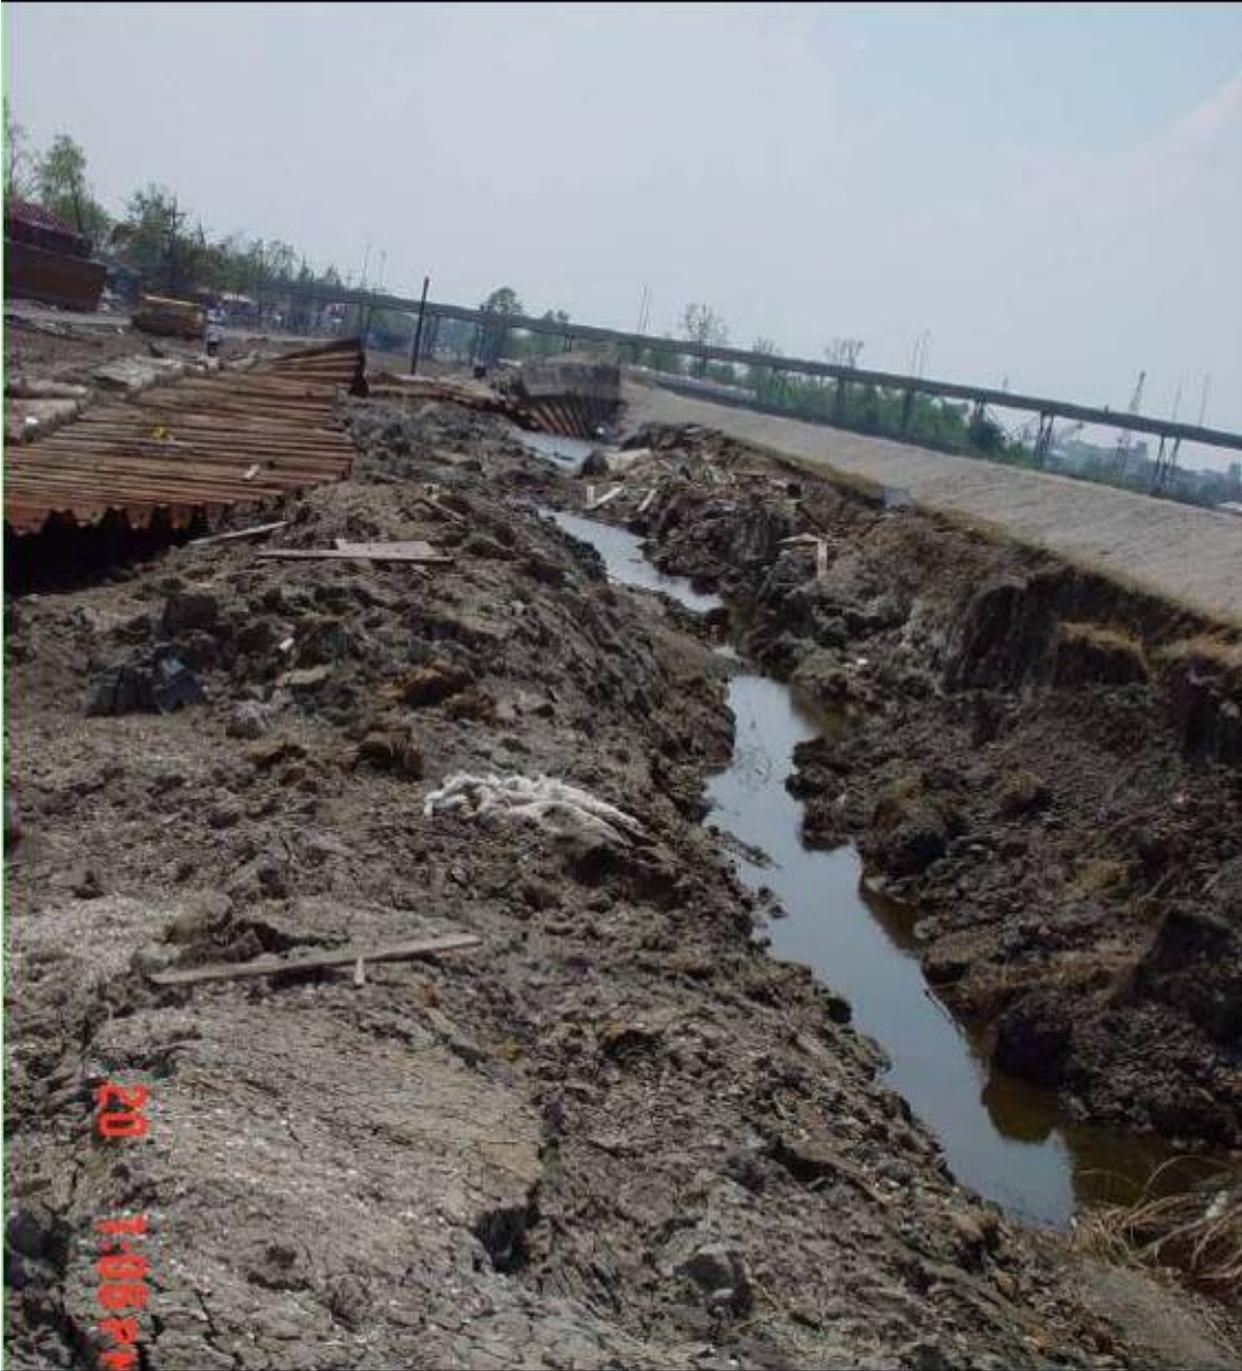
Figure 53. Scour and erosion leading to the failure of the I-wall on the IHNC adjacent the south breach (9th Ward).

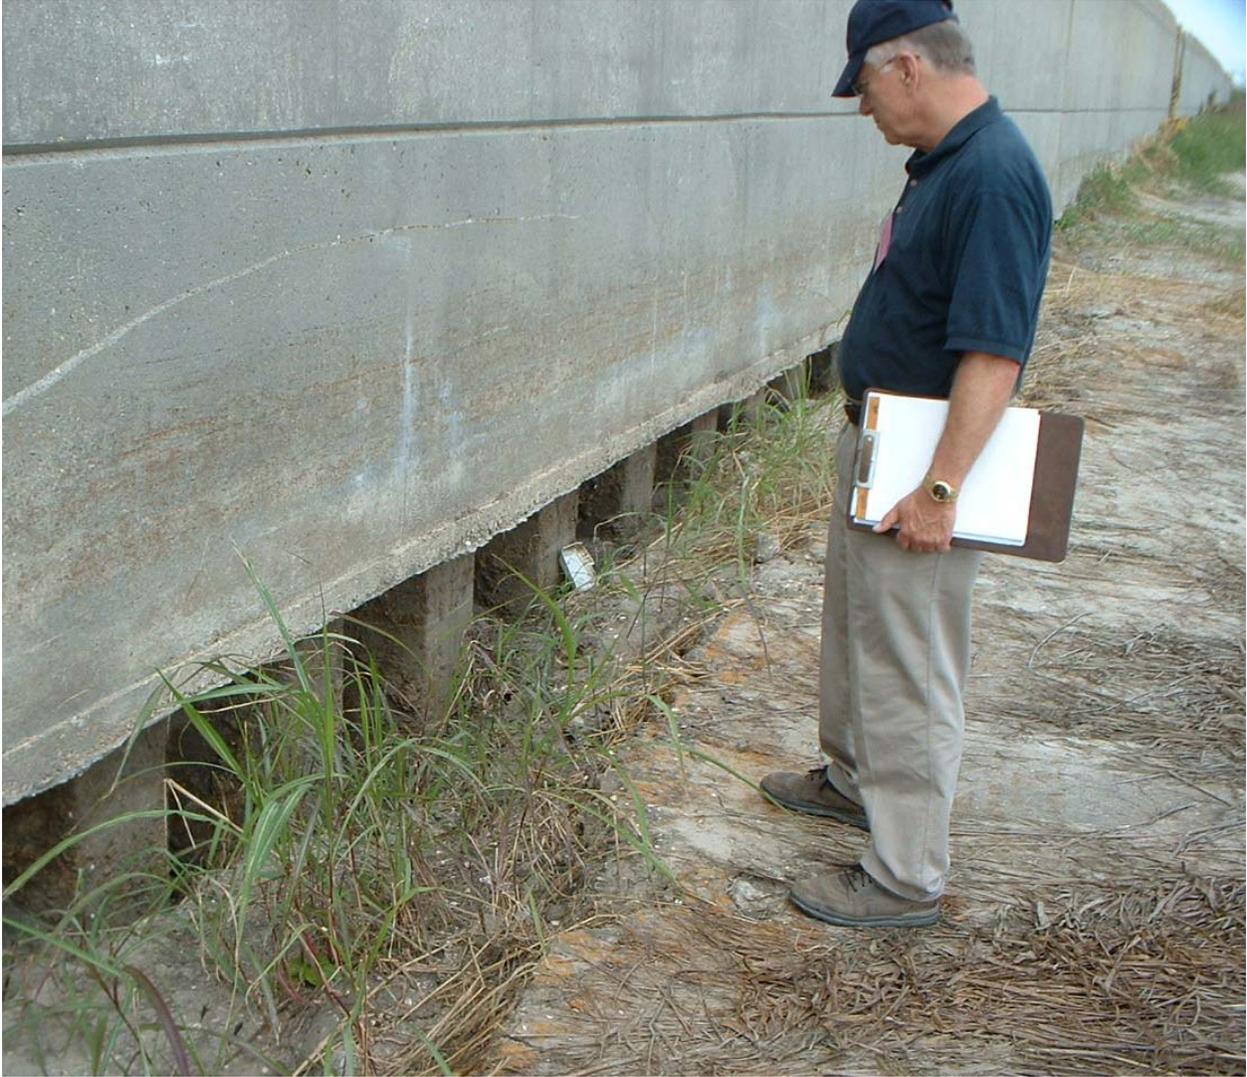
Figure 65a. Post-Katrina photographs of Michoud Canal I-wall at pump station.

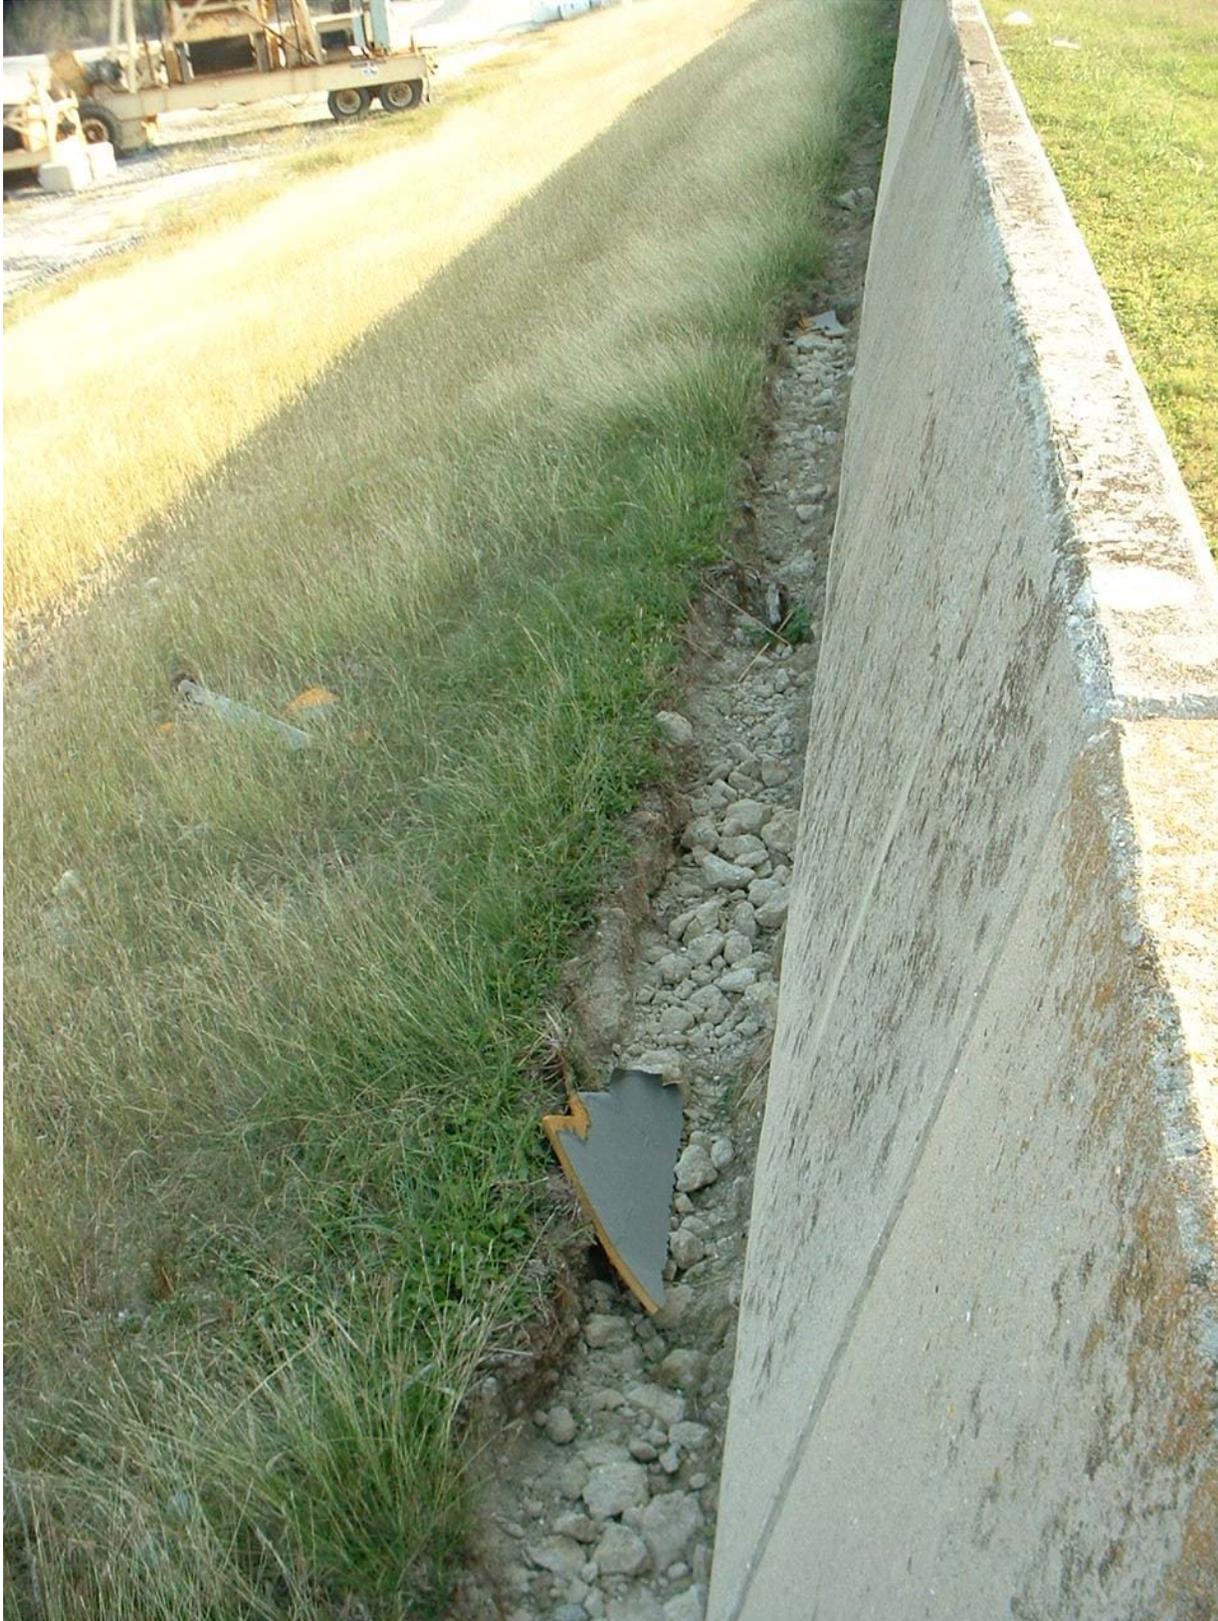
Figure 65b. Post-Katrina photographs of Michoud Canal I-wall showing erosion from overtopping waves.

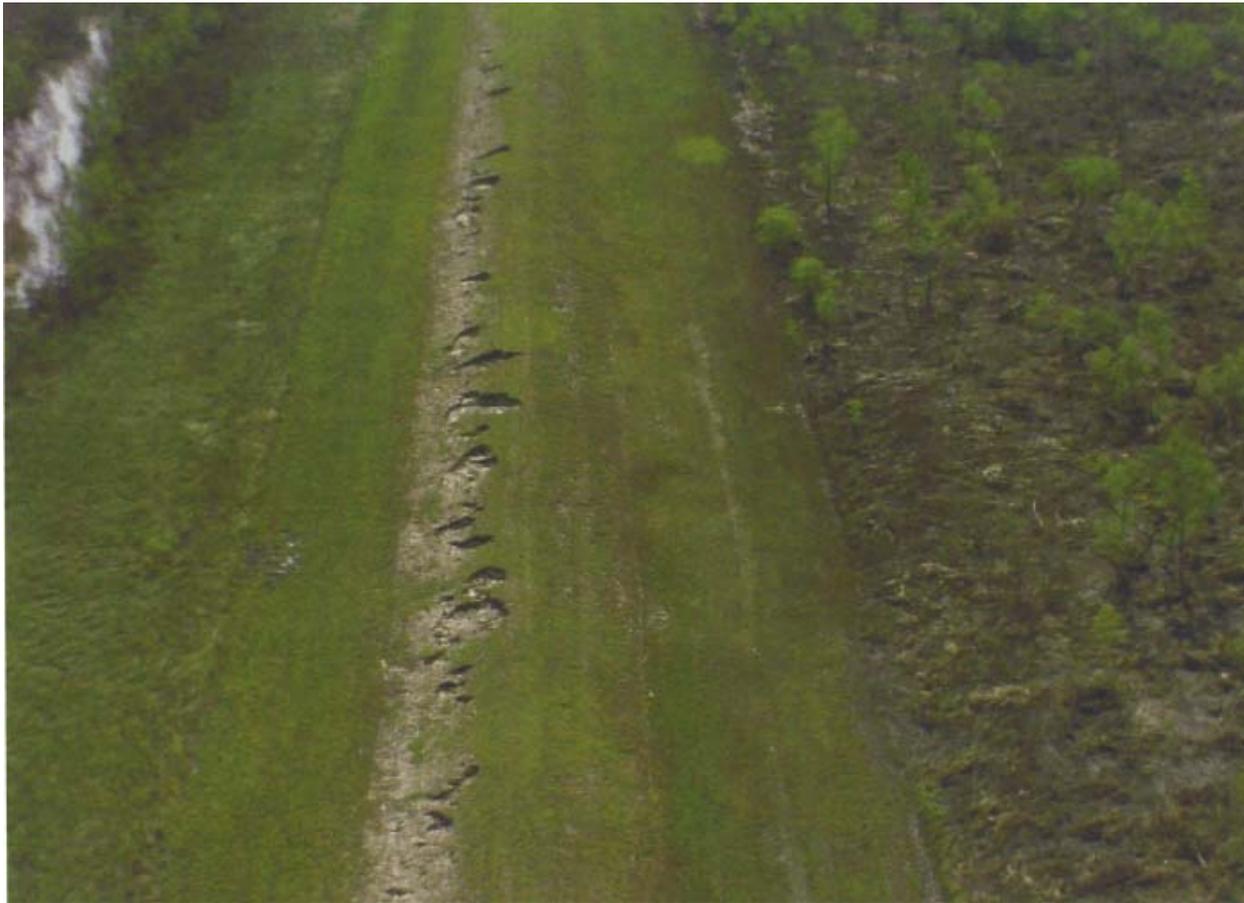
Figure 68. Front side levee erosion along the Mississippi River Gulf Outlet.

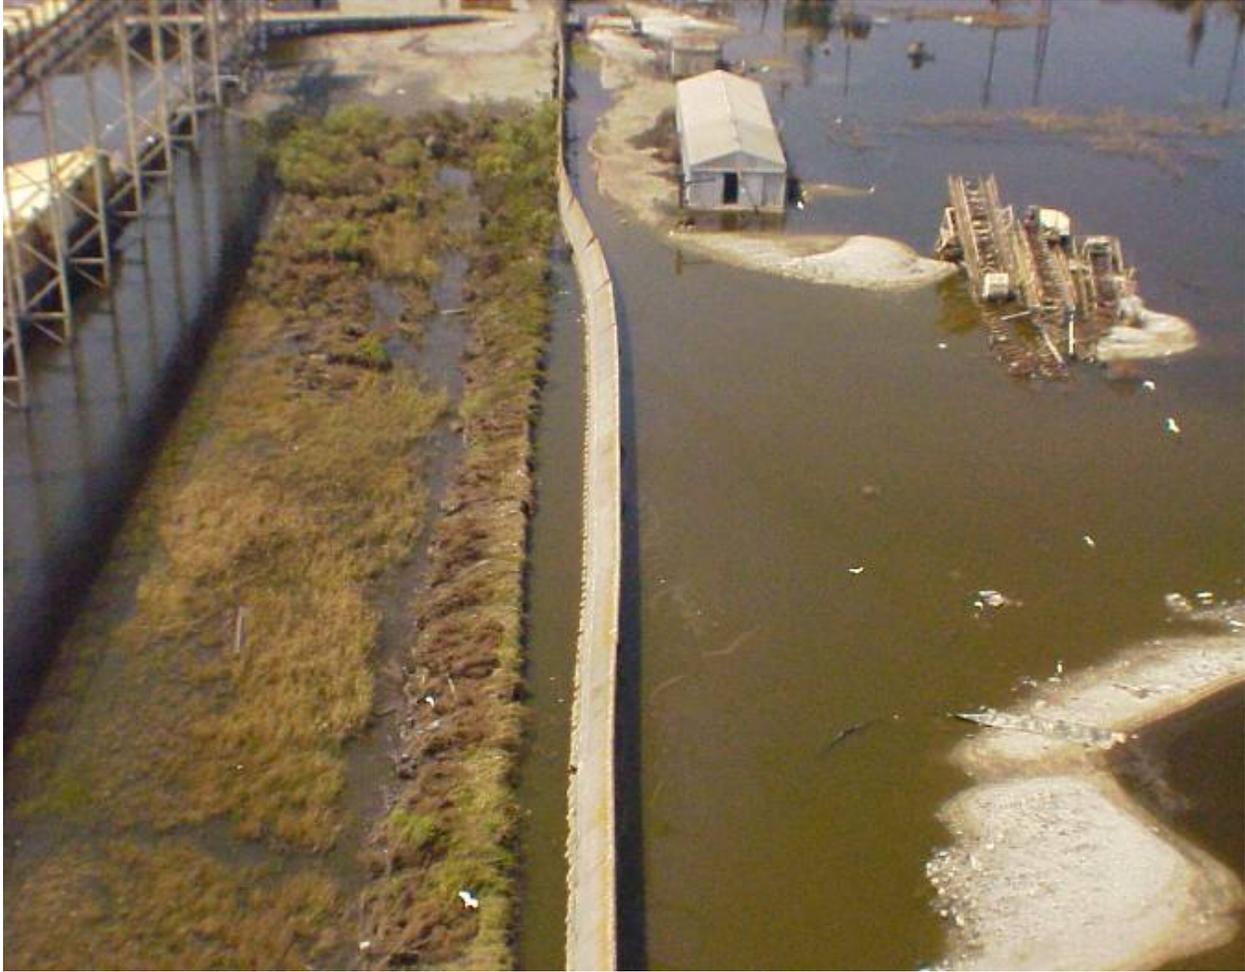
Figure 76. Aerial photo showing the deflection and tilting of the Citrus Back Levee I-wall.

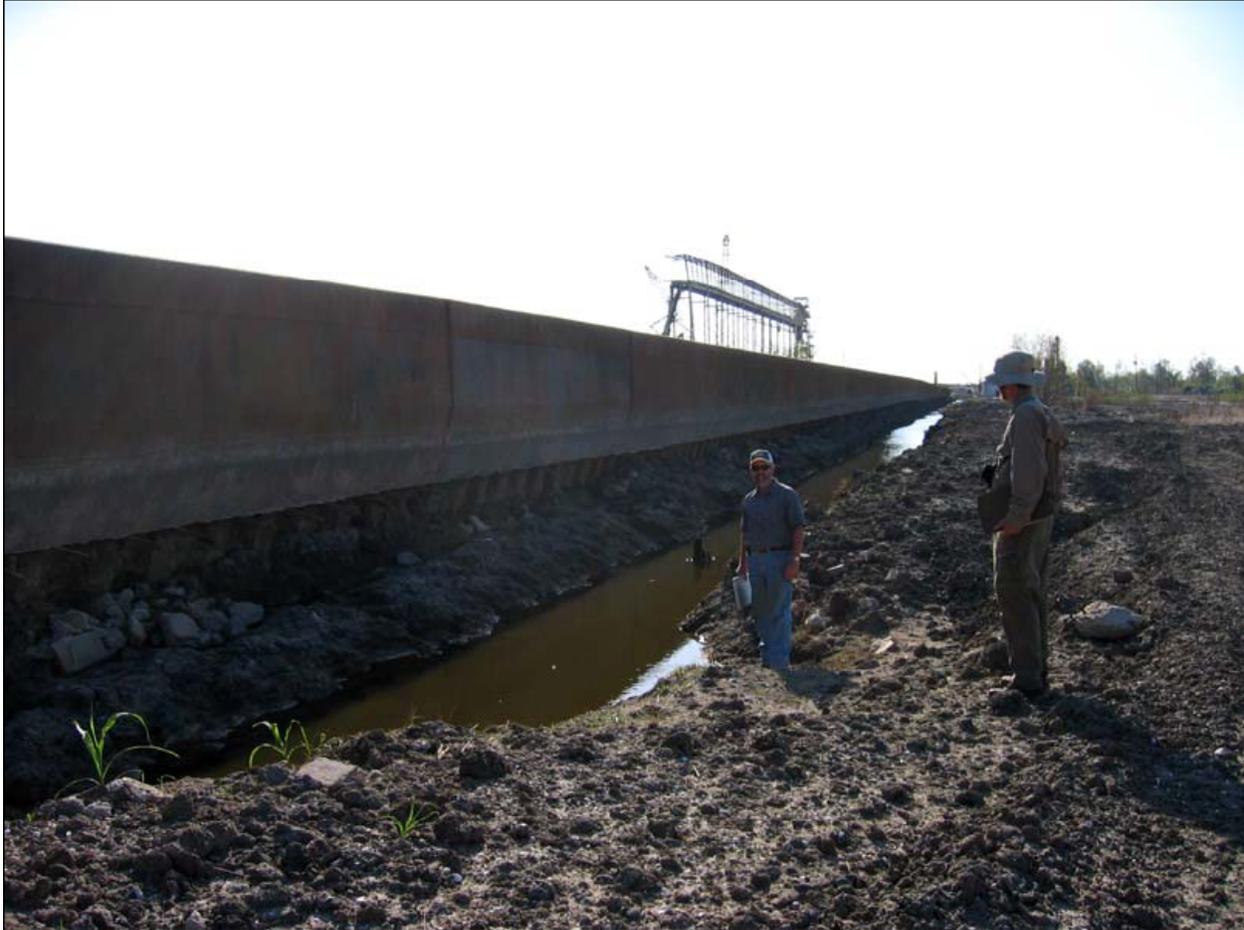
Figure 77. Scour trench on the protected side of the Citrus Back Levee I-wall. (Figure 7.14, NSF-Berkeley report (ILIT Final Report, 31 July 2006).)

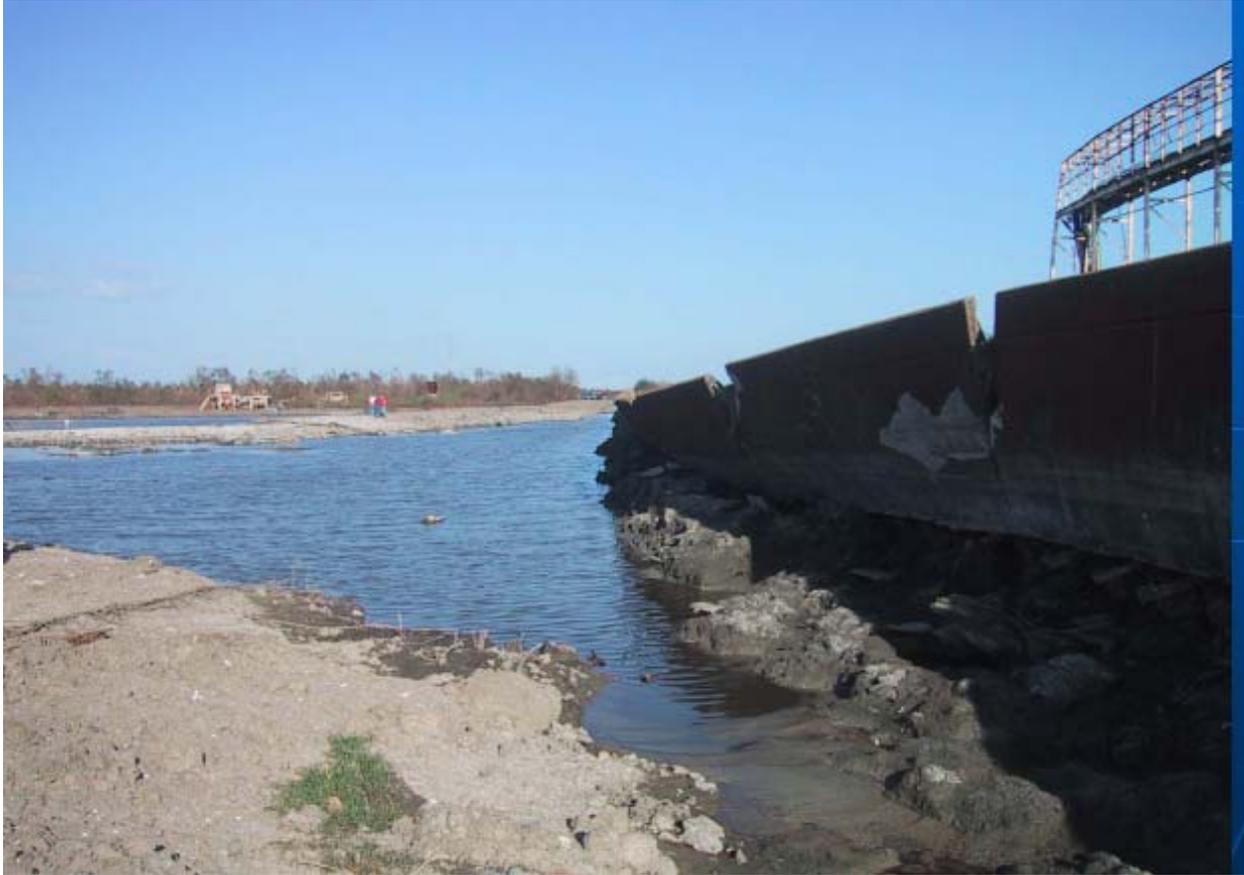
Figure 78. Another section of the Citrus Back Levee I-wall showing erosion of the levee, lateral deflection, and tilting from overtopping.
