Performance Evaluation of the New Orleans and Southeast Louisiana Hurricane Protection System

Final Report of the Interagency Performance Evaluation Task Force

Volume V – The Performance — Levees and Floodwalls

June 2007

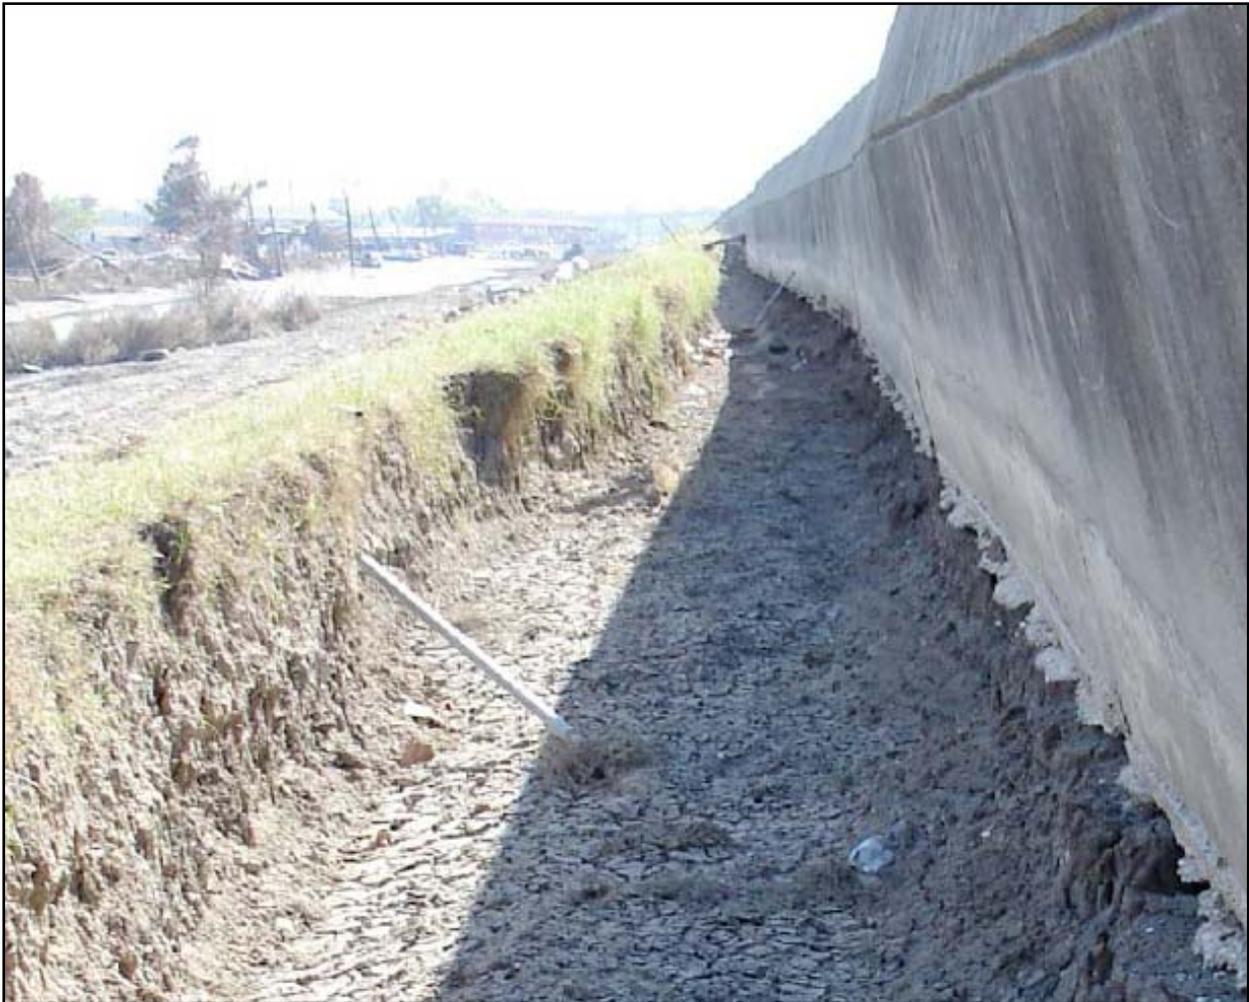
Figure 82. Stage A erosion along the eastern side of the IHNC adjacent to the Lower Ninth Ward.

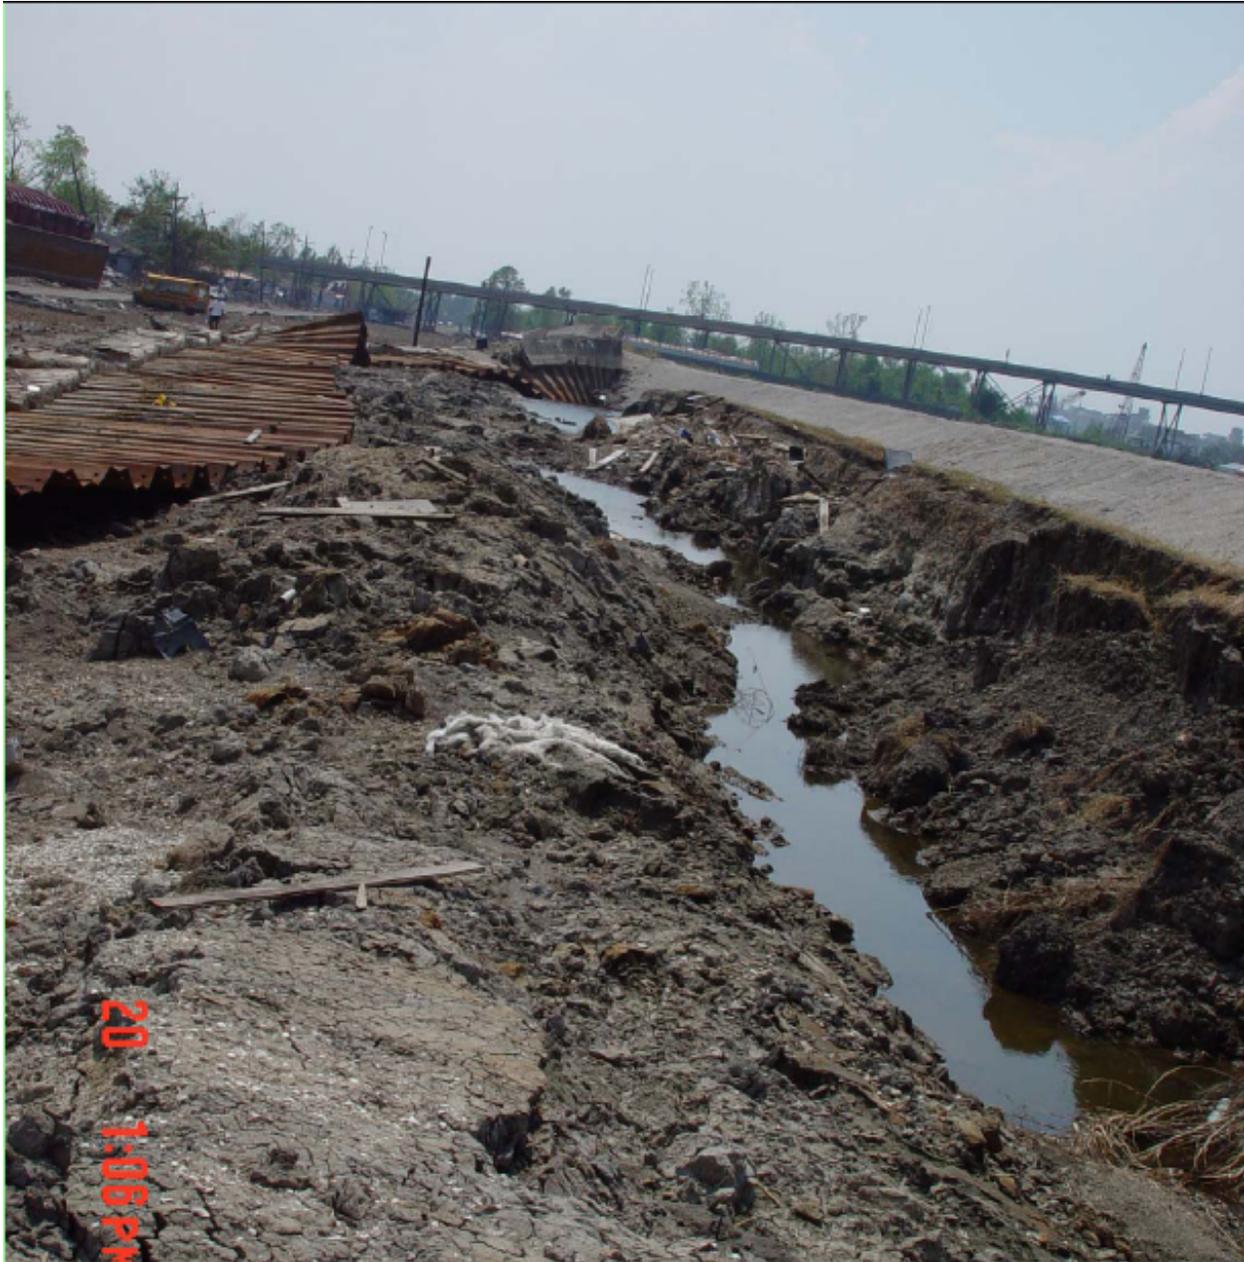
Figure 83. Stage D erosion along the eastern side of the IHNC adjacent to the Lower Ninth Ward.
