Appendix 1

Soil Data Report for 17th Street Canal

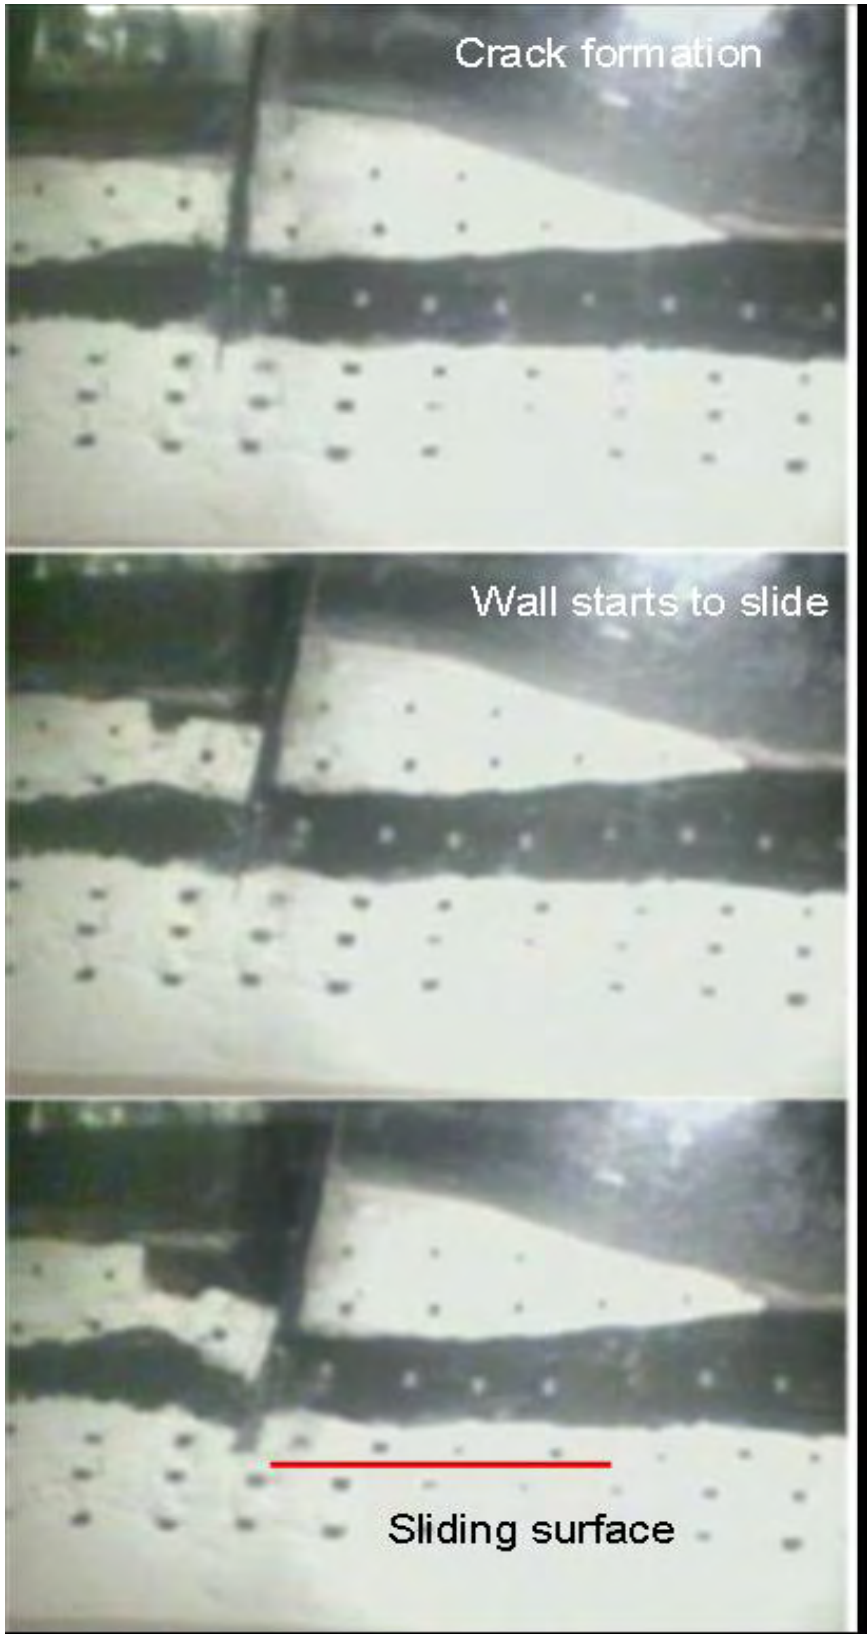
In one model of the 17th Street levee, the weight of the levee on the landward side was sufficient to provoke bearing failure in the clay foundation, Figure 5.33, with the formation of inclined slip planes, prior to the flood condition. This is a situation analogous in the field to raising the height of the levee too rapidly, without allowing time for the high excess pore pressures in the foundation to dissipate and the strength of the clay to develop. On the surface, the only evidence is increased settlement. At depth, however, local slip surfaces form in the soft clay and swampy marsh

Figure 5.32. Sliding surface forms at top of clay layer in 17th Street Model 1

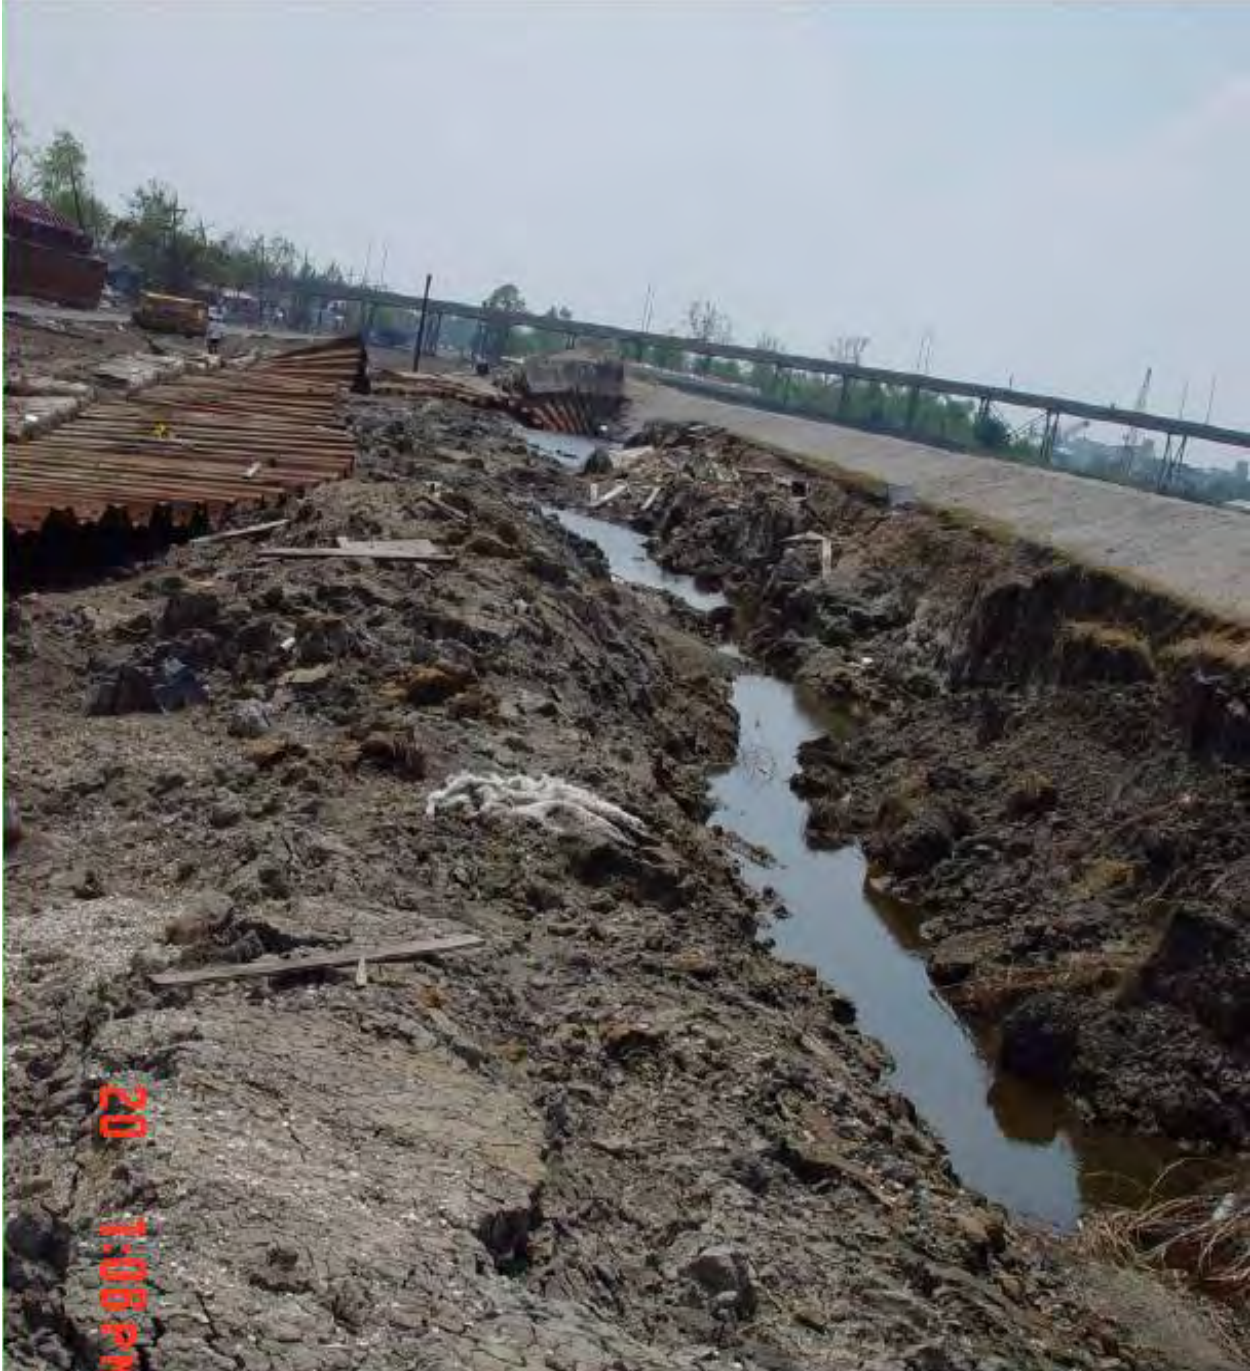
Figure 11-5. Scour and Erosion Leading to the Failure of the I-Wall on the IHNC Adjacent the South Breach (9th Ward)

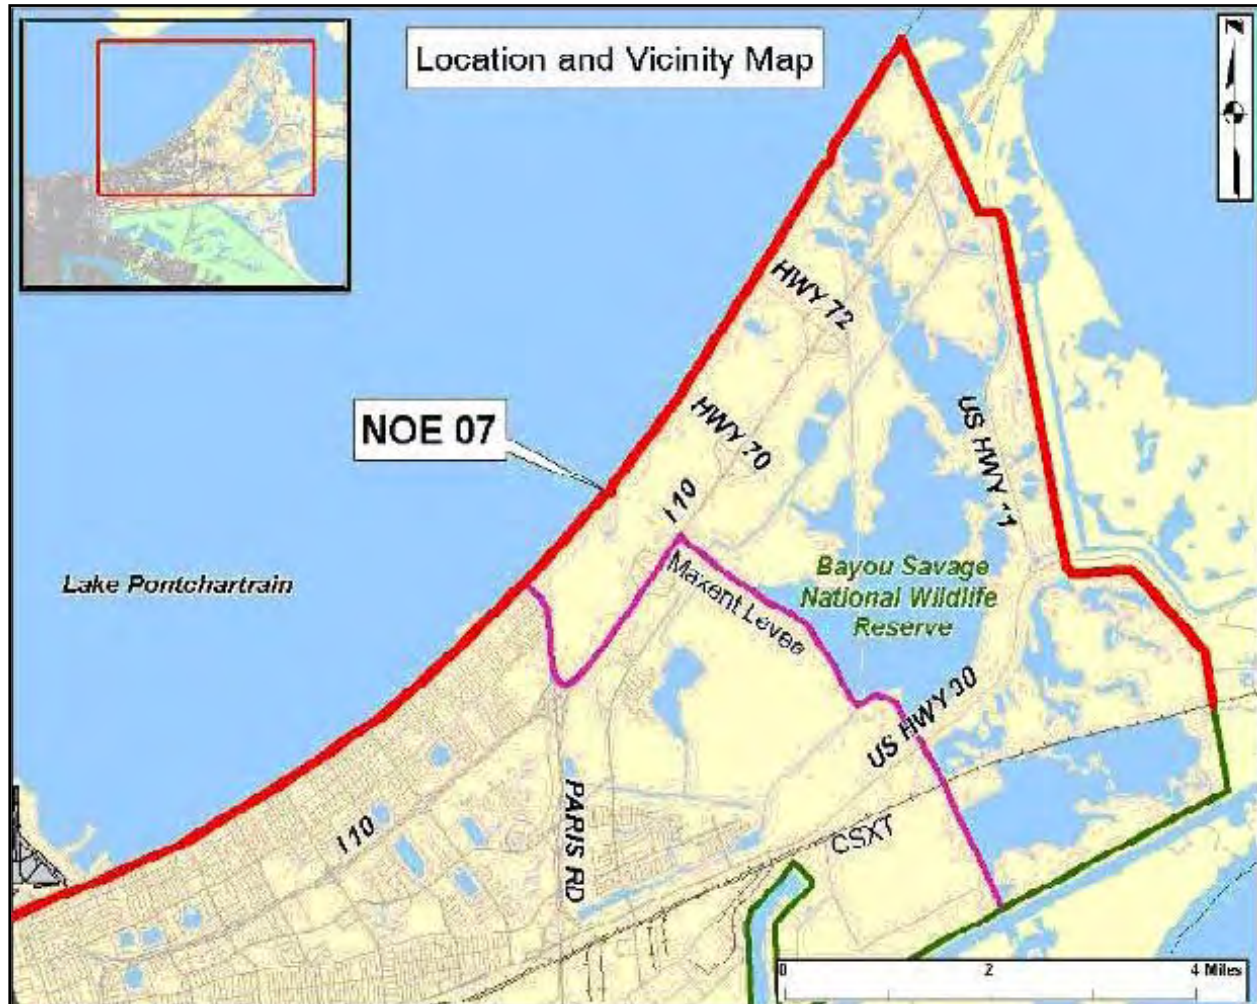
Figure 12-9. NOE7_A Project NOE10 Addresses Levee/Wall Repairs Near the Lakefront Airport, at Specific Locations. This project will provide scour aprons and concrete /pavement repair at less than 10 locations

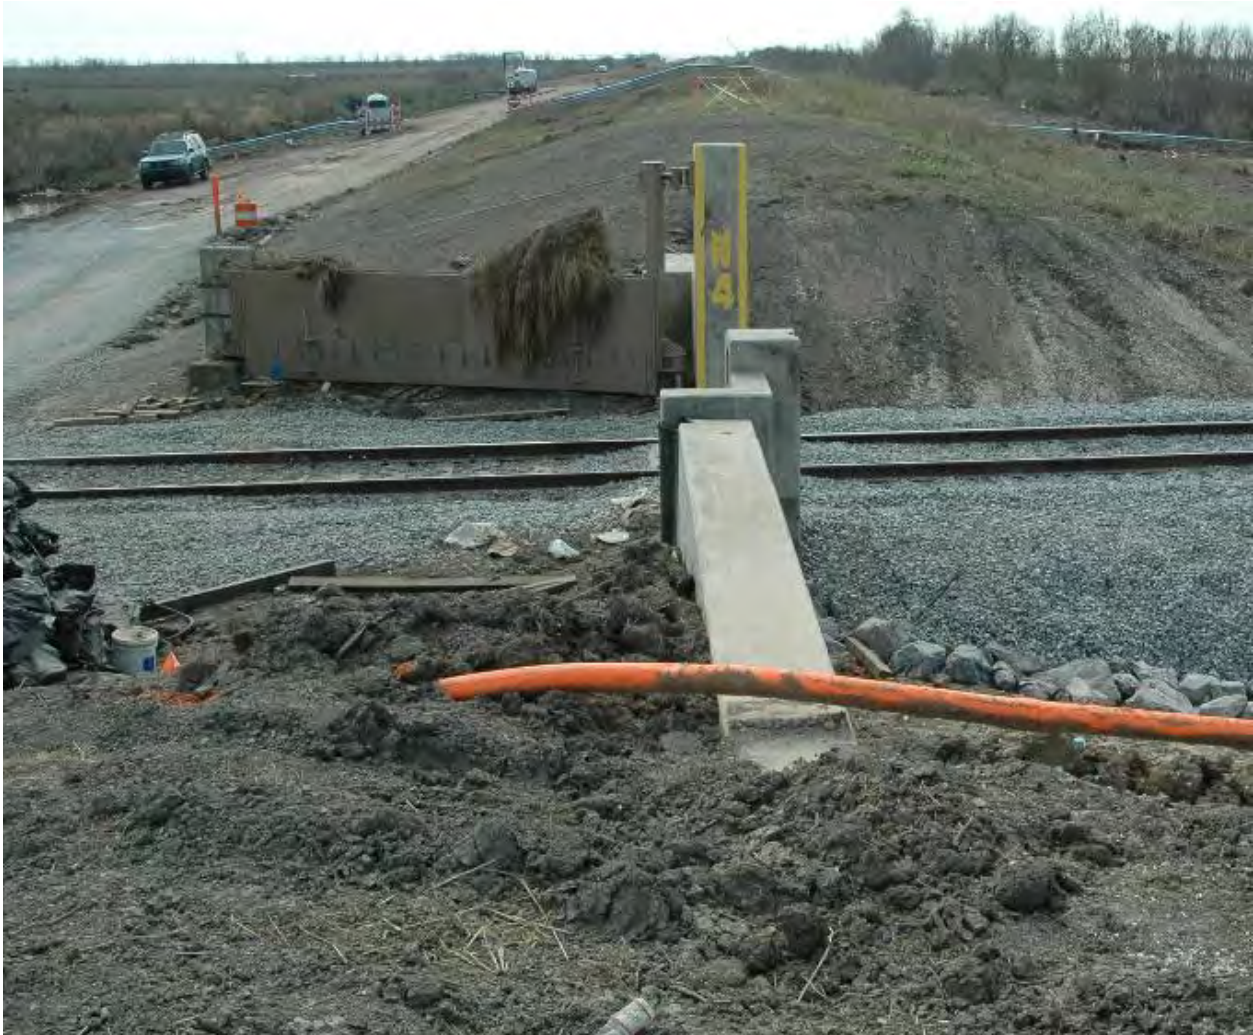
Figure 12-20. NOE5_C. Filled-In Scour Holes

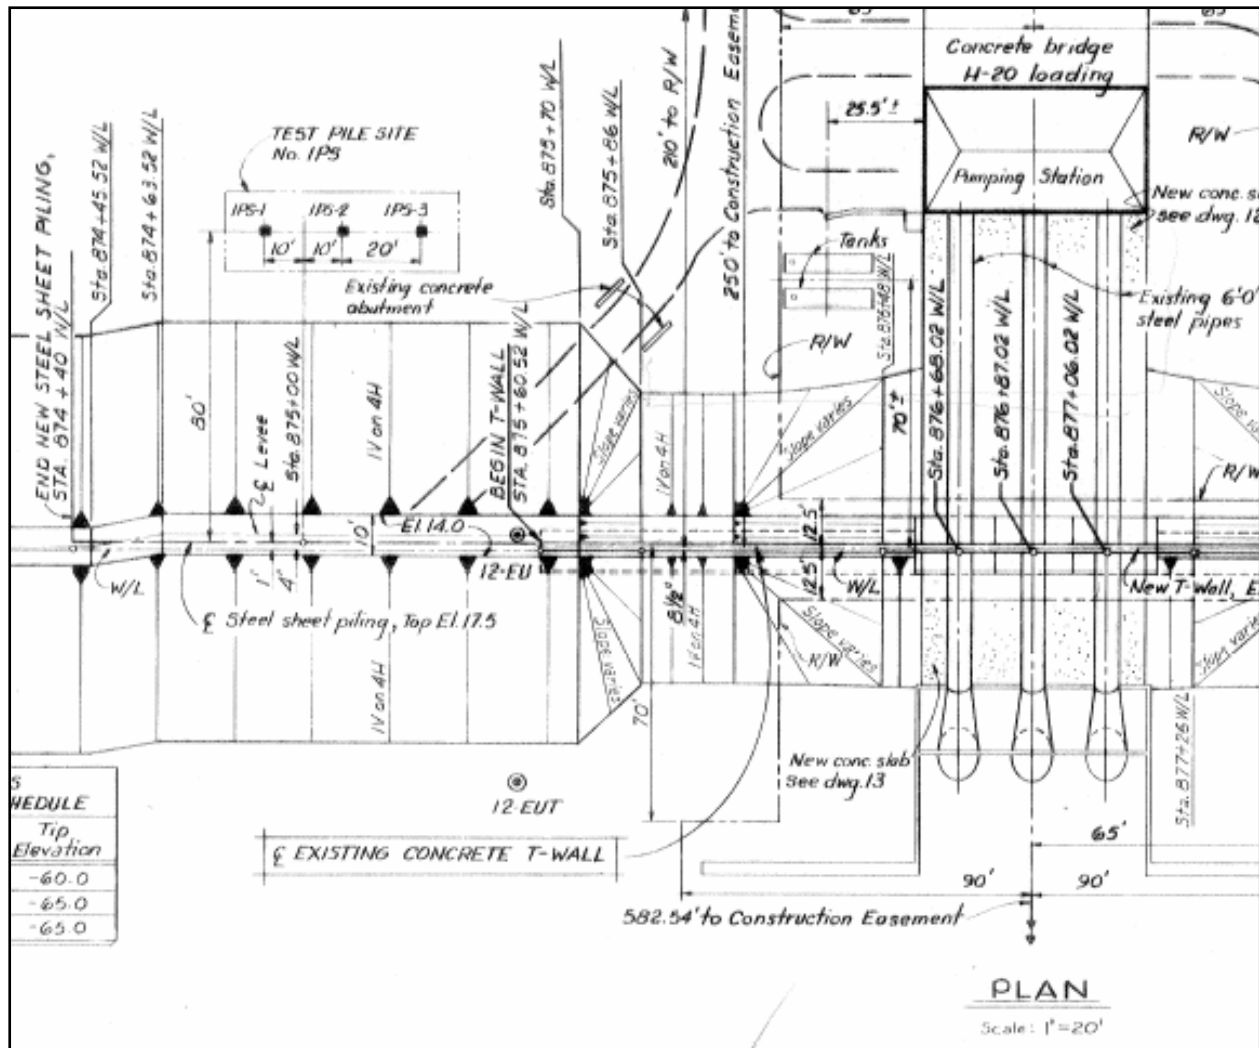
Figure 12-26. NOE2_F Failed Sheet Pile Section Between Sta 874+40 and T-Wall at Sta 875+60 (Plan view)

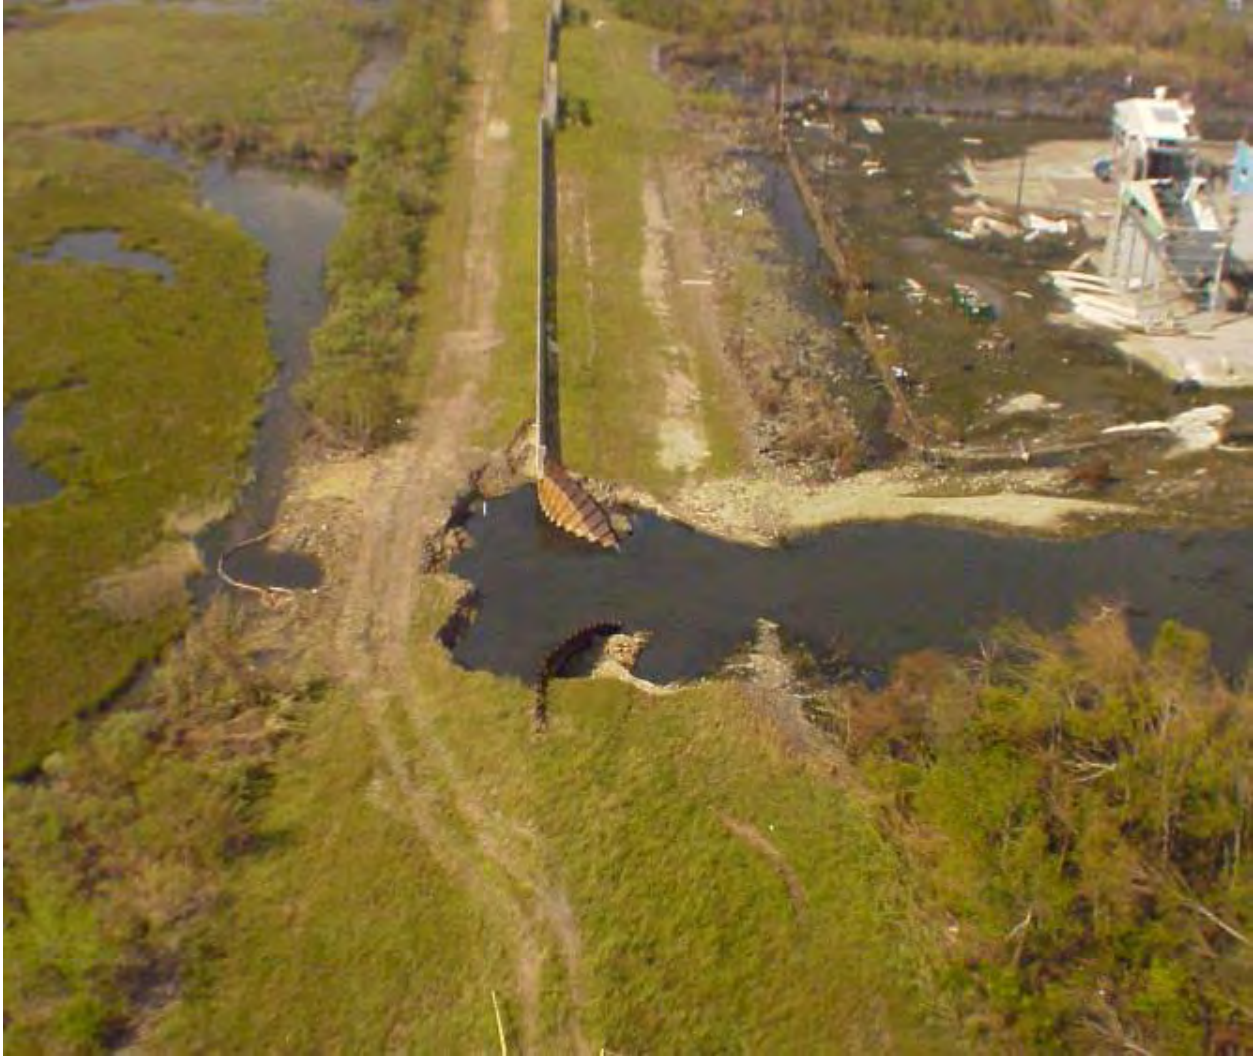
Figure 12-44. NOE3_D Sheetpile Wall Failure (near Sta 772+00 B/L New Orleans East Back Levee)
(Coordinates 30 deg 01 min 04.30 sec N, 89 deg 53 min 49.36 sec W)

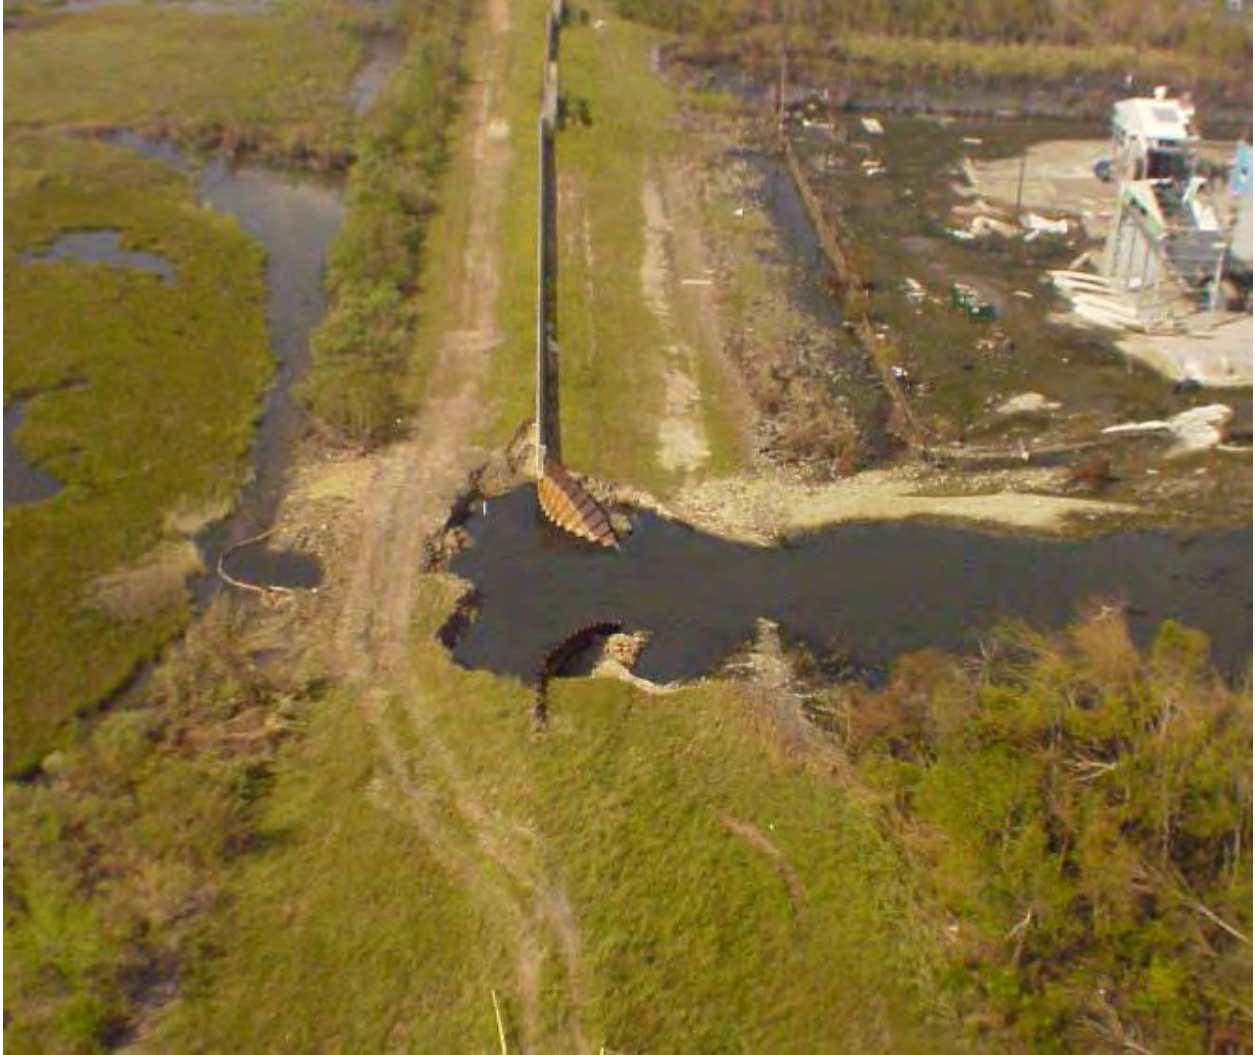
Figure 13-32. Air Products Sheetpile Breach

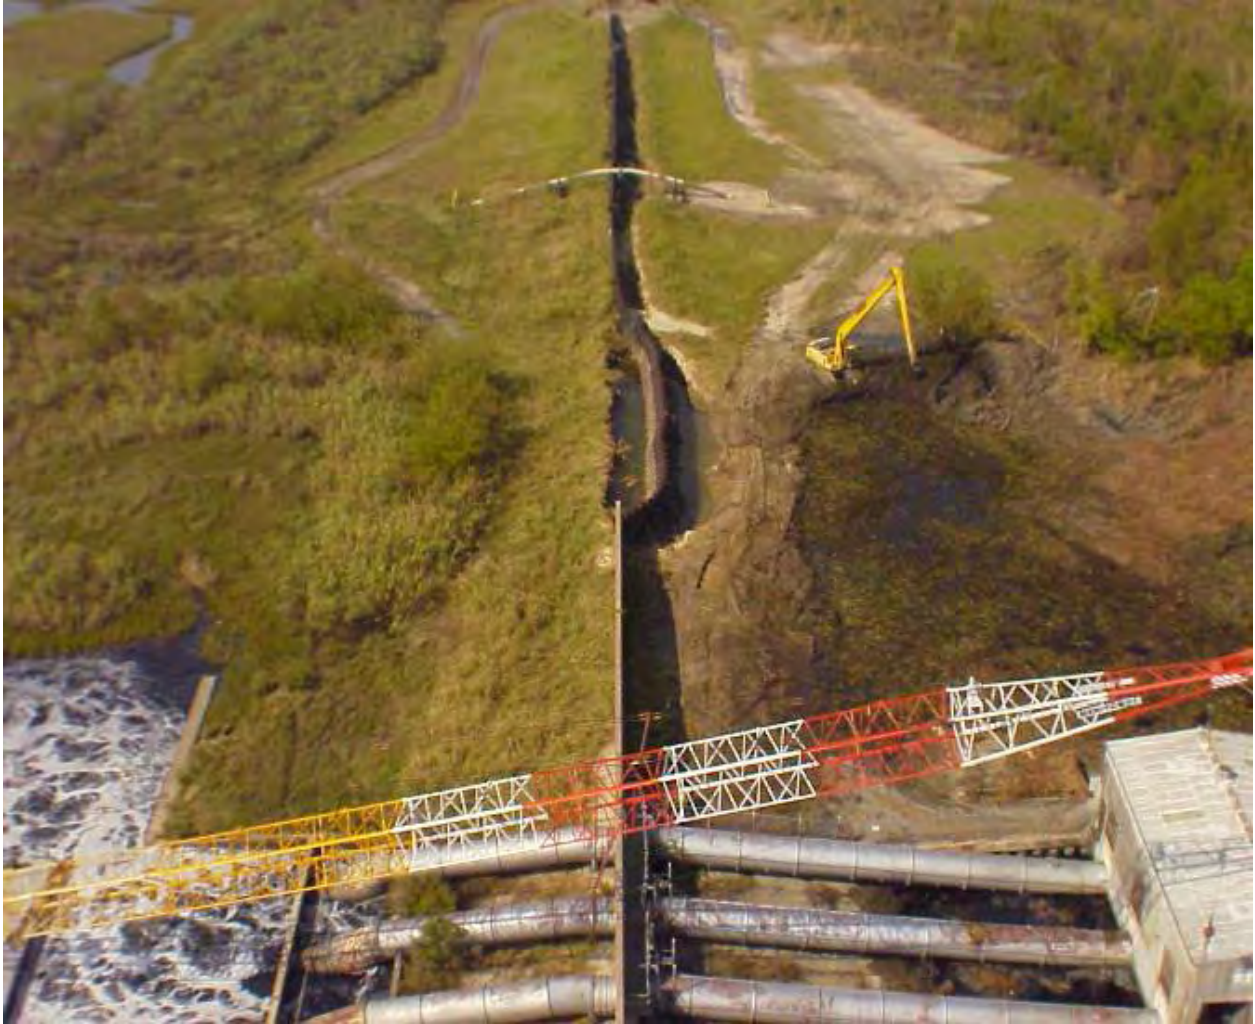
Figure 13-36. New Orleans East Basin, Pump Station 15 on the North Bank GIWW. Failed sheetpile between B/L Sta 874+40 and Sta 875+60 (N.O. East Back Levee). Pre-Katrina elevations ranged from 17.5 to 19.5 ft in this reach

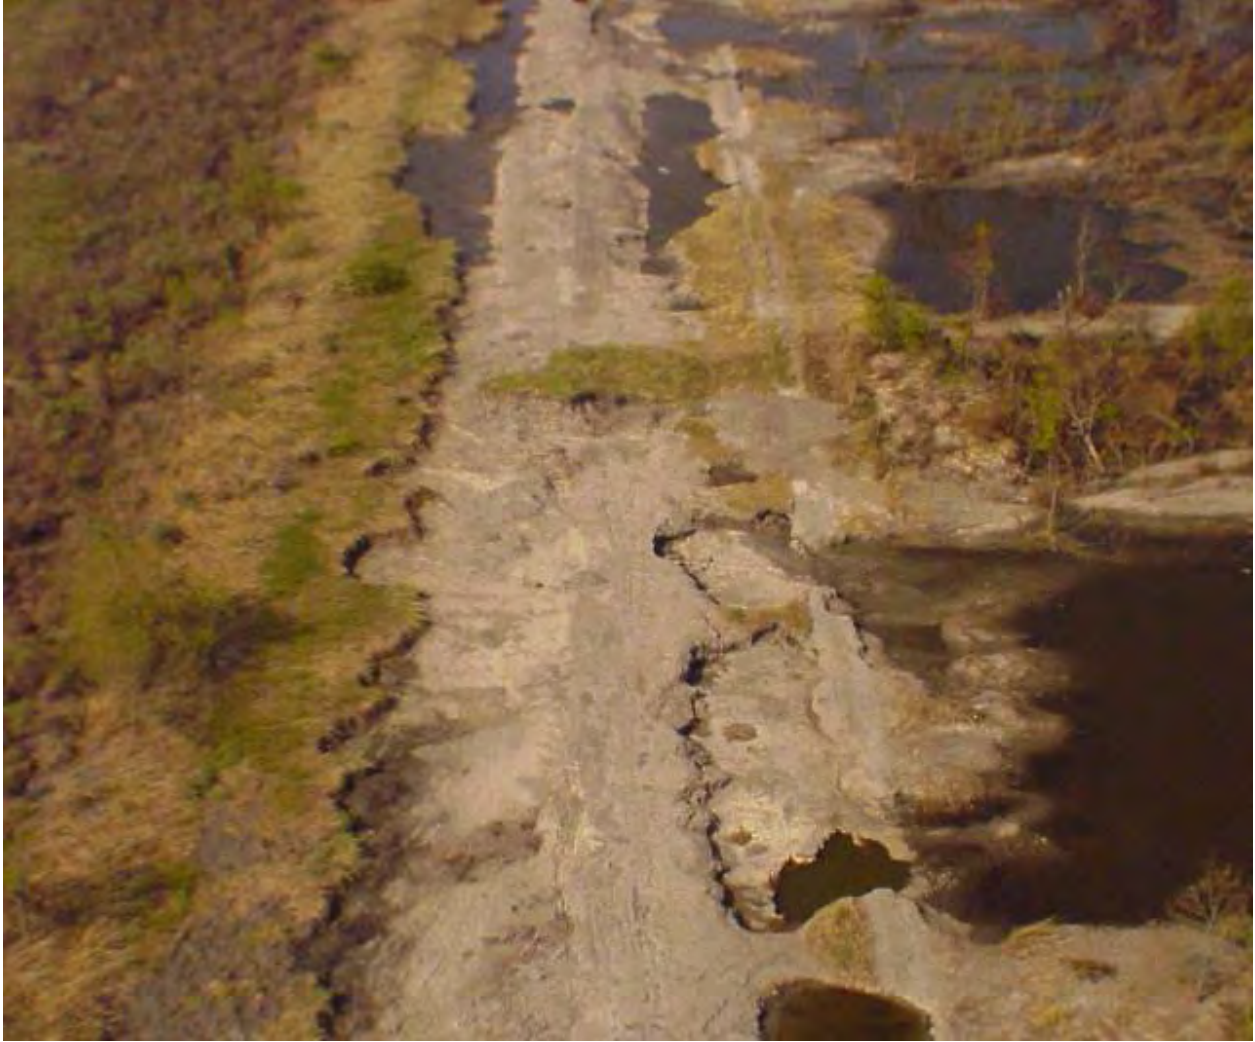
Figure 13-60. East of Pump Station 15 (N.O. East Back Levee), North Bank of GIWW. 12,750 feet of levee east of Pump Station #15 was completely degraded (Station 876+87 B/L to 1101+90 B/L). West of the pump station, 9,800 feet of levee was completely degraded (approx Sta 778+00 to 876+00). The levees in these reaches were constructed from GIWW hydraulic fill in stages over three years

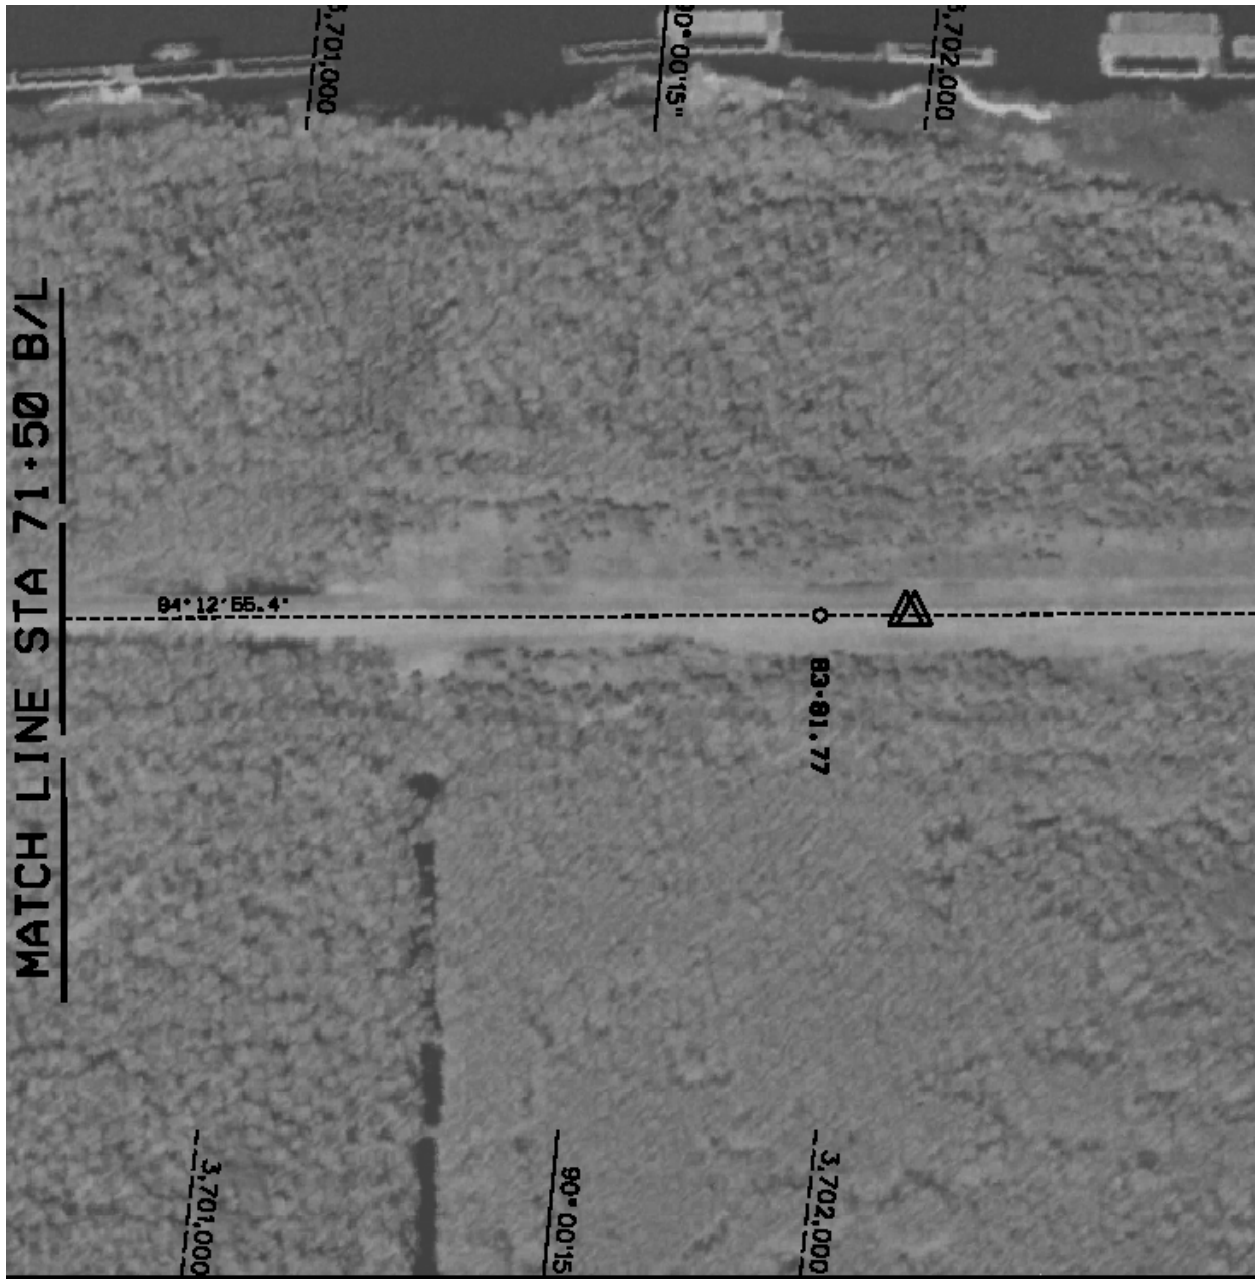
Figure 14-92. Major Scour Damage (Marked With Triangle) Identified East of B/L Sta 81+50 (From TFG Contract Solicitation W912PB-06-R-0022, Drawing 3 of 12)

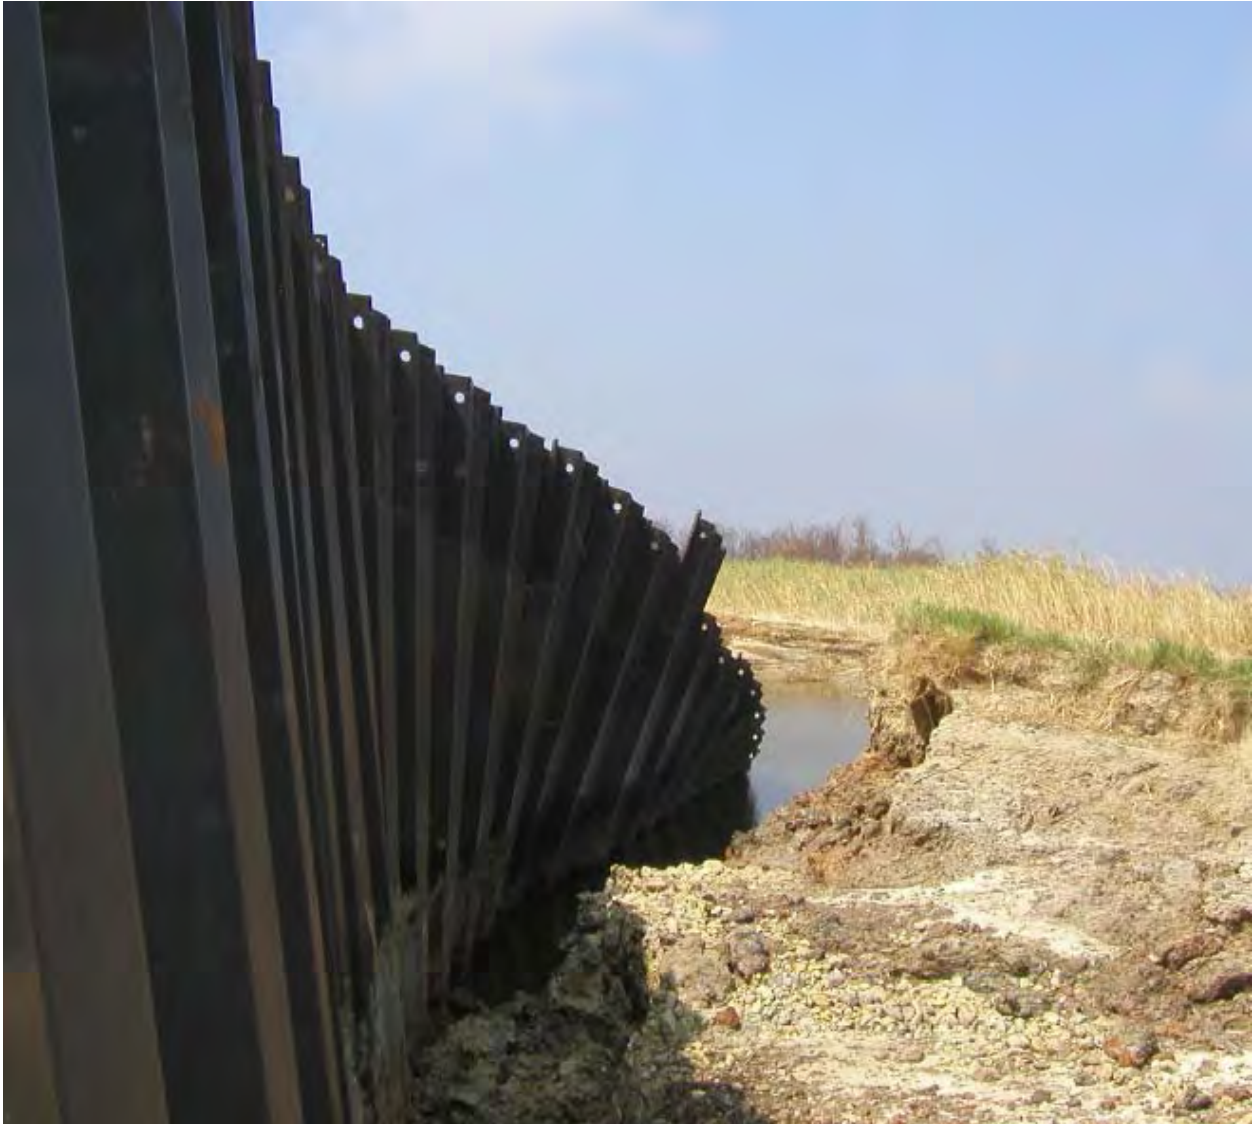
Figure 14-122. Closeup of Damaged Sheetpile and Scour. Note stratified layers in adjacent soil profile of existing hydraulic fill from the MRGO

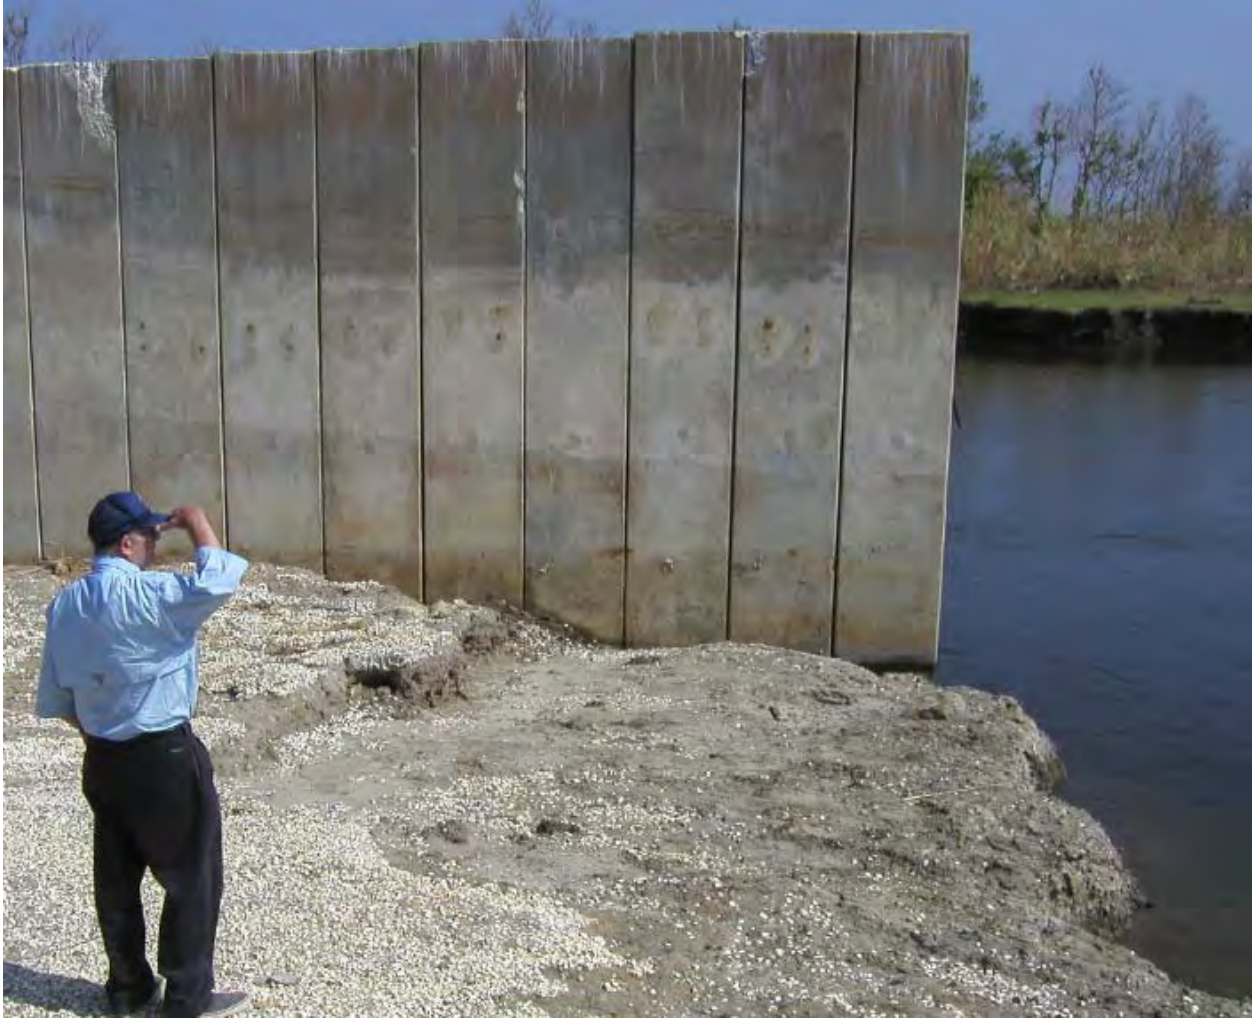
Figure 14-140. Missing Levee and Part of Wall on West Side of Control Structure
