Appendix 1

Hydrograph and High Water Mark Analysis

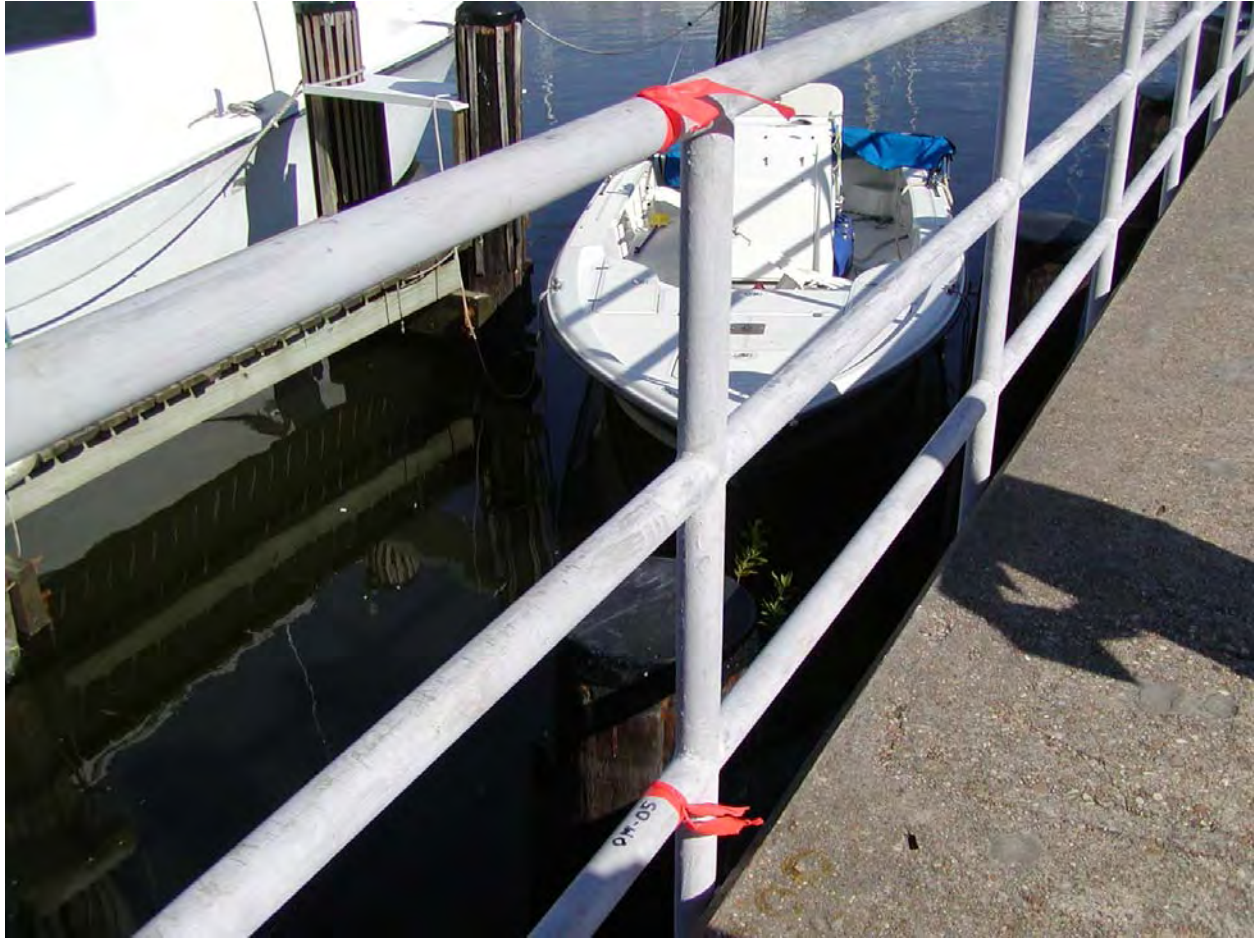
Figure 1-29. Time 6:15 on 8/29/05, elevation 7.0 ft (bottom rail) and 10.1 ft (top rail)

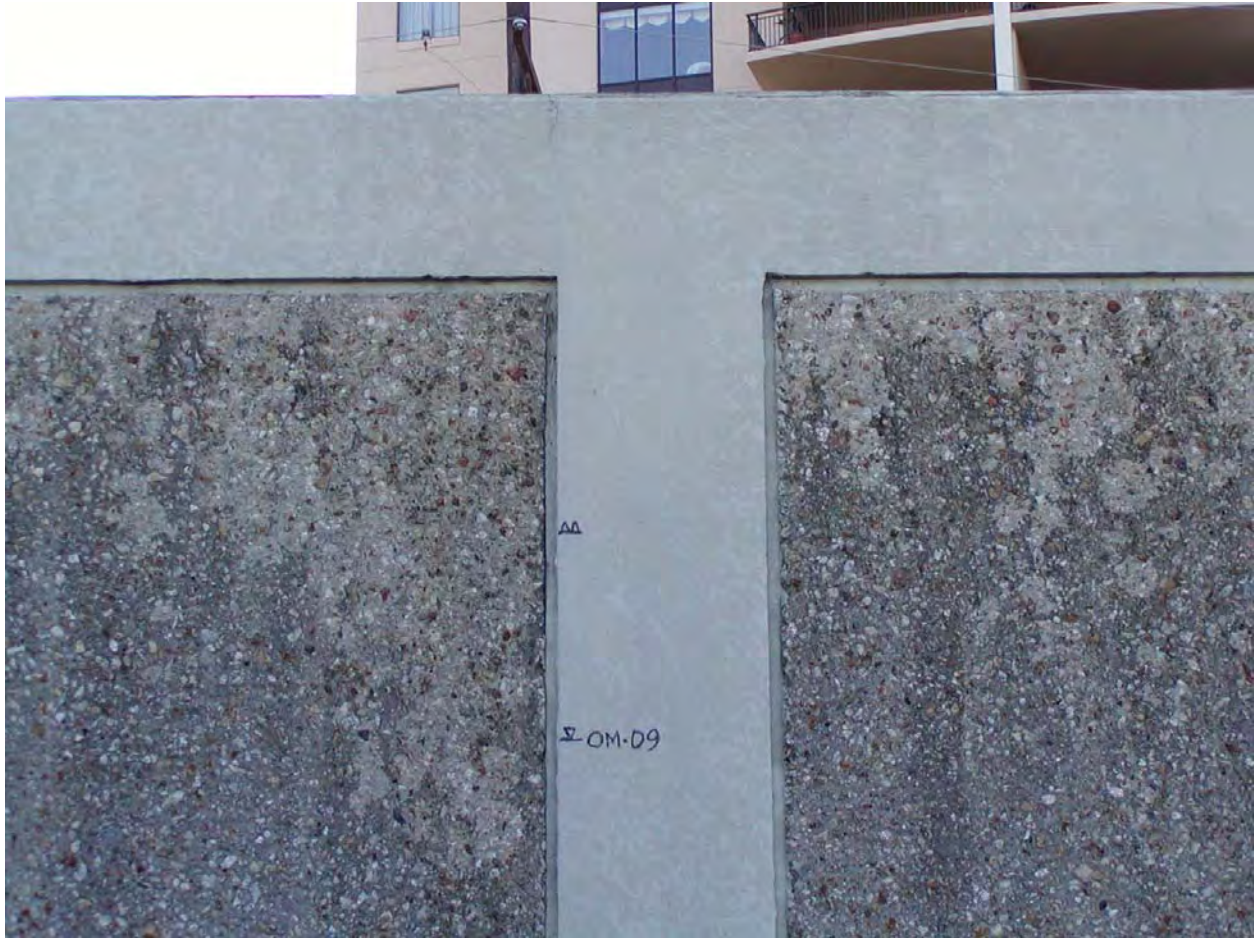
- h.* Monday 8/29/05, 11:00, elevation 9.2 ft: The boat owner stated that he observed the water on the floodwall was falling at 1100 hrs. He pointed to a location on the floodwall that was 2'3" below the top of floodwall (floodwall at 12.5 ft NAVD88, 2004.65) that was the location of the peak of the 2 ft waves being caused by the West wind. A survey point was placed at 3'3" below the top of wall and asked if this level would represent an average water level. He agreed that it was. Survey point OM-09, Figure 1-30, was the average level. This point has a high degree of uncertainty.

Figure 1-30. Time 11:00 on 8/29/05, elevation 12.5 ft (top of floodwall), 10.2 ft (peak of 2 ft waves), 9.2 ft (average water level at OM-09)

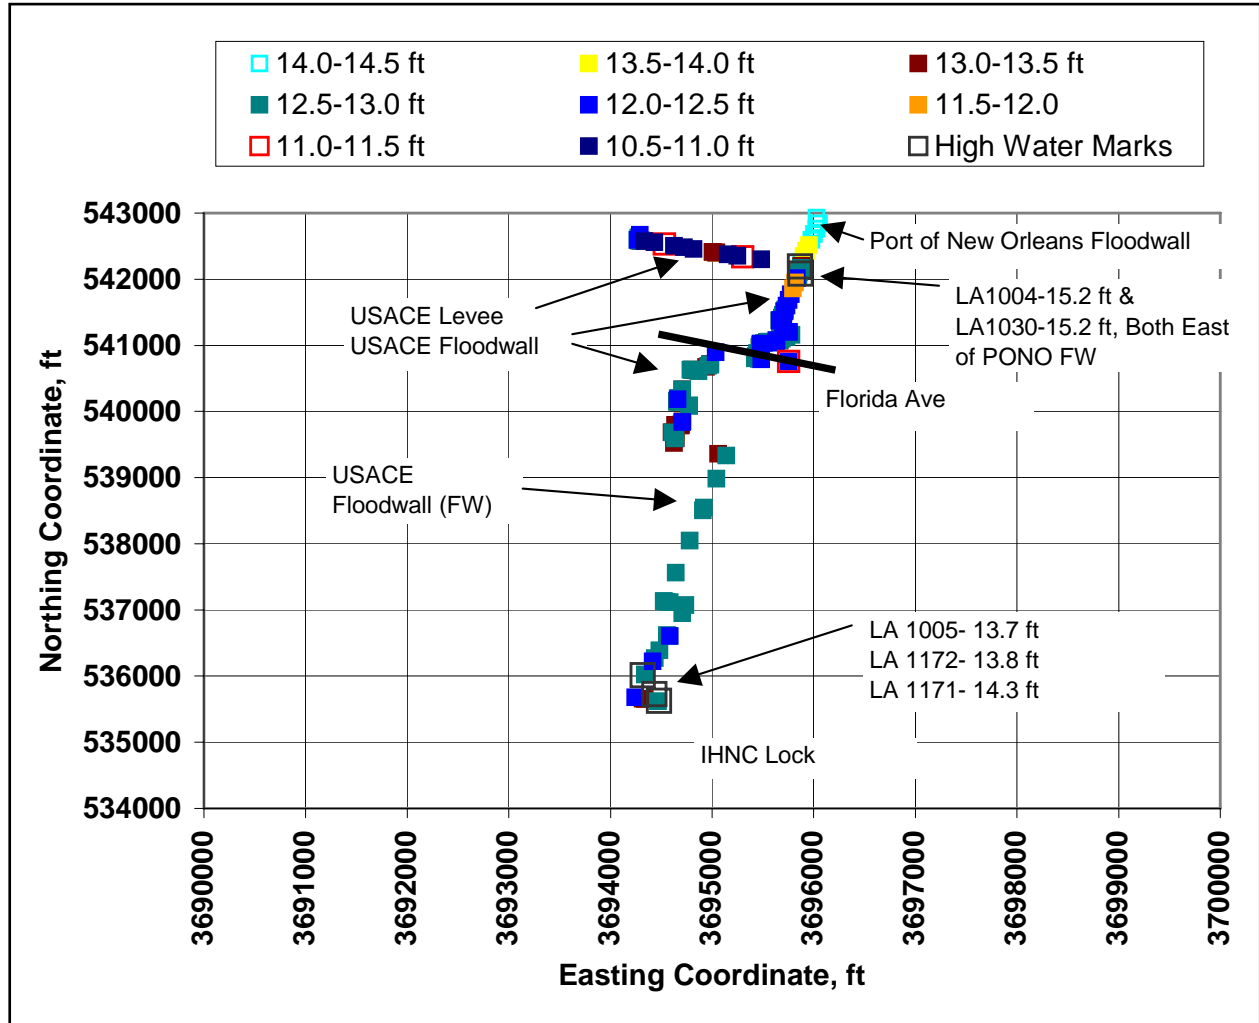
marks in this area. Both marks are based on debris in the rafters of a heavily damaged building that is close to the floodwall and levee breach on the west side of the IHNC. Both LA 1026 and LA 1027 were described as possibly low. Subsequent visits to this building by other IPET members has not resolved the peak water level in this building. The agreement of LA 1026 at elevation 14.3 ft with 4 other marks west of the PONO is the reason LA 1027 is not accepted.

Figure 1-67. Floodwall layout, wall elevations, and high water marks along the west side of IHNC, Florida Avenue railroad bridge to IHNC Lock.

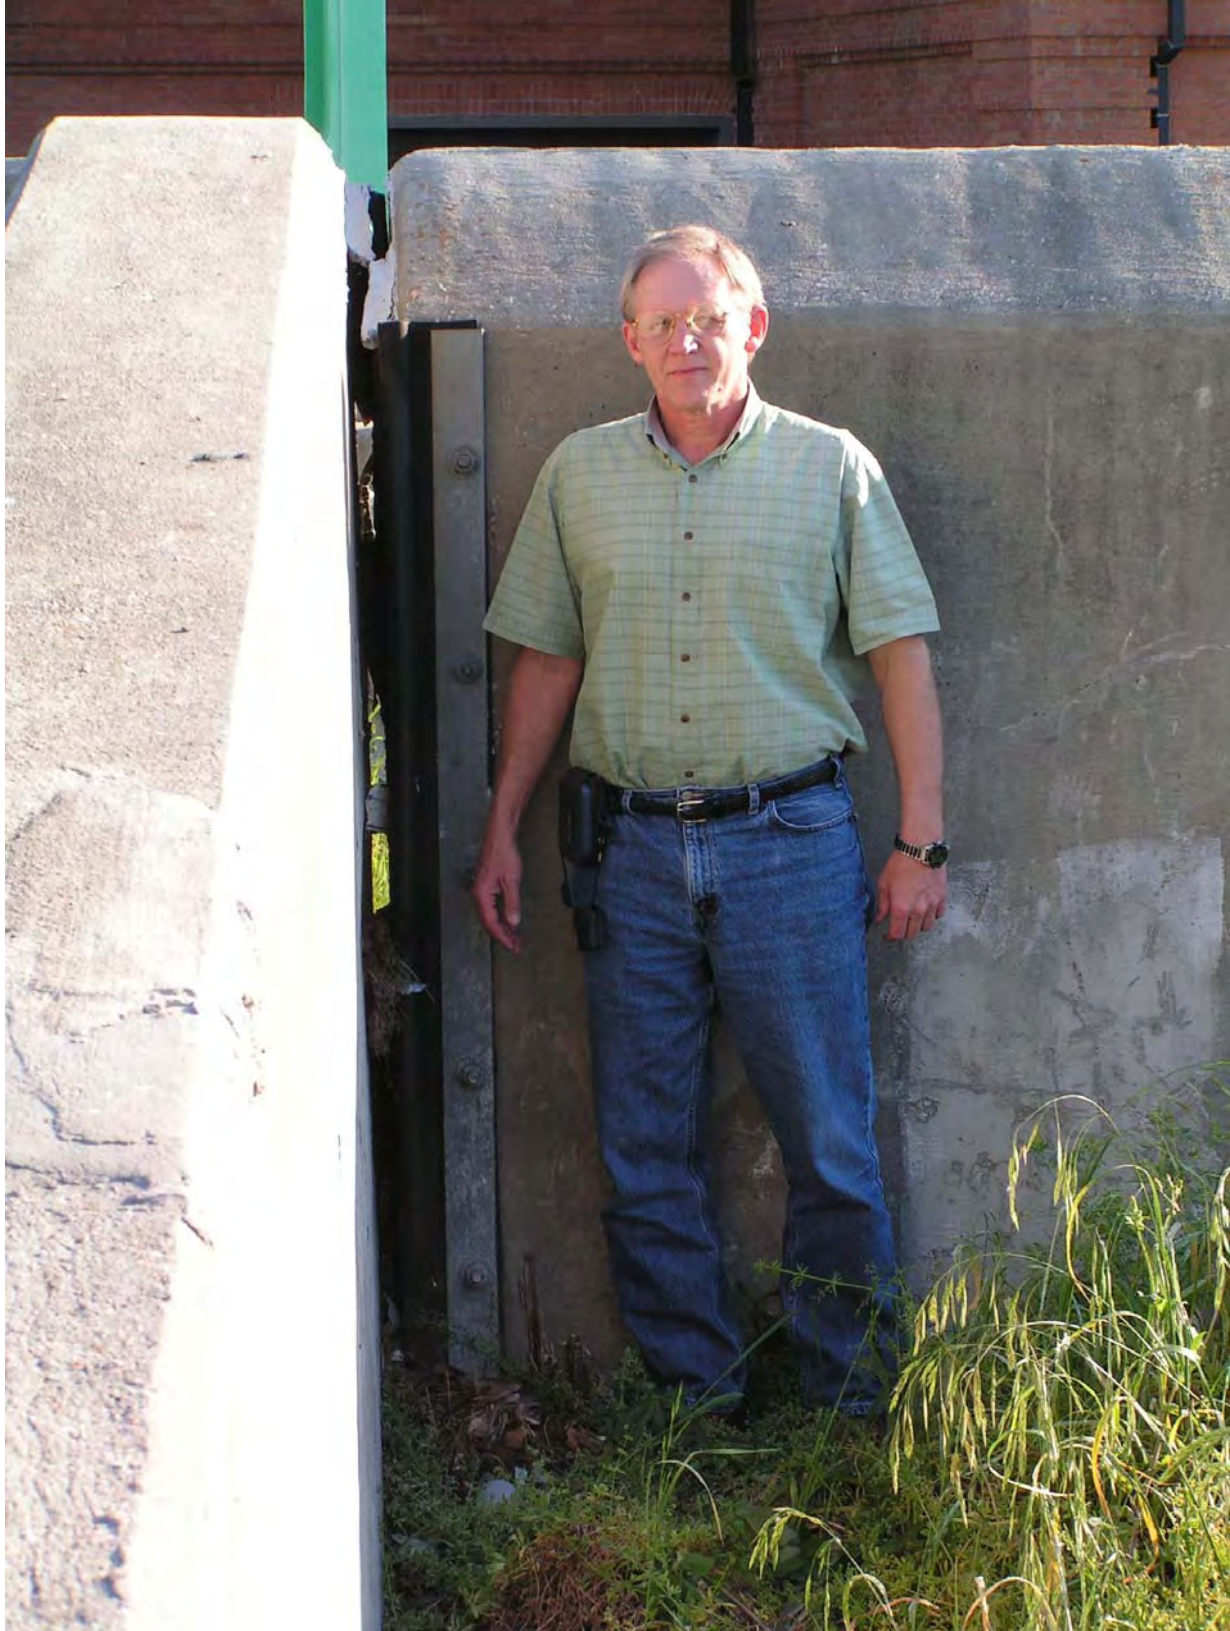
Figure 1-86. LA 1251 at crack in wall. Picture taken 4/06/06. Debris in crack was 2.2 ft below top of wall on 9/29/05.

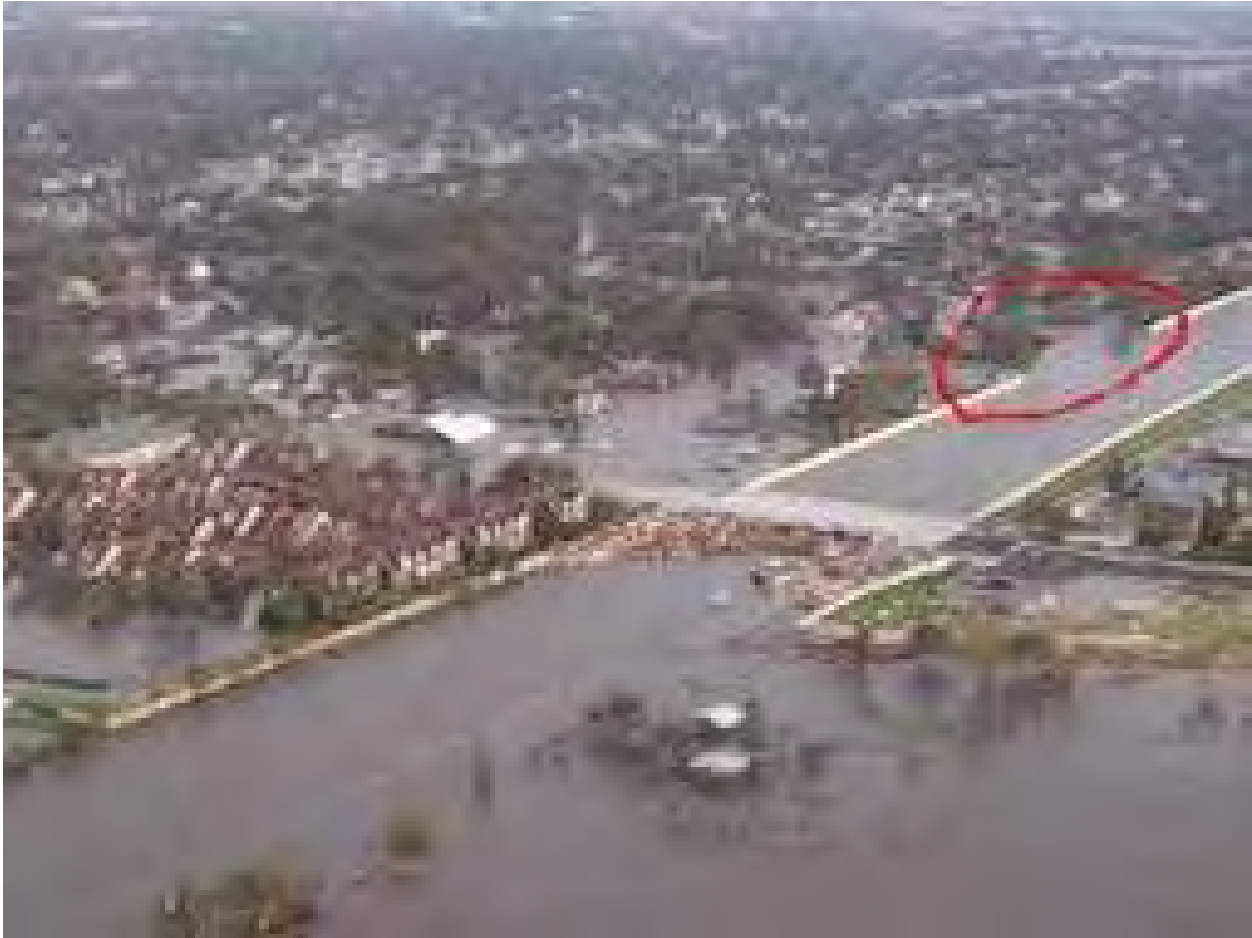
Figure 10-1. 17th Street Canal August 29, 2005. Looking south showing breach and debris impounded against Hammond Highway Bridge

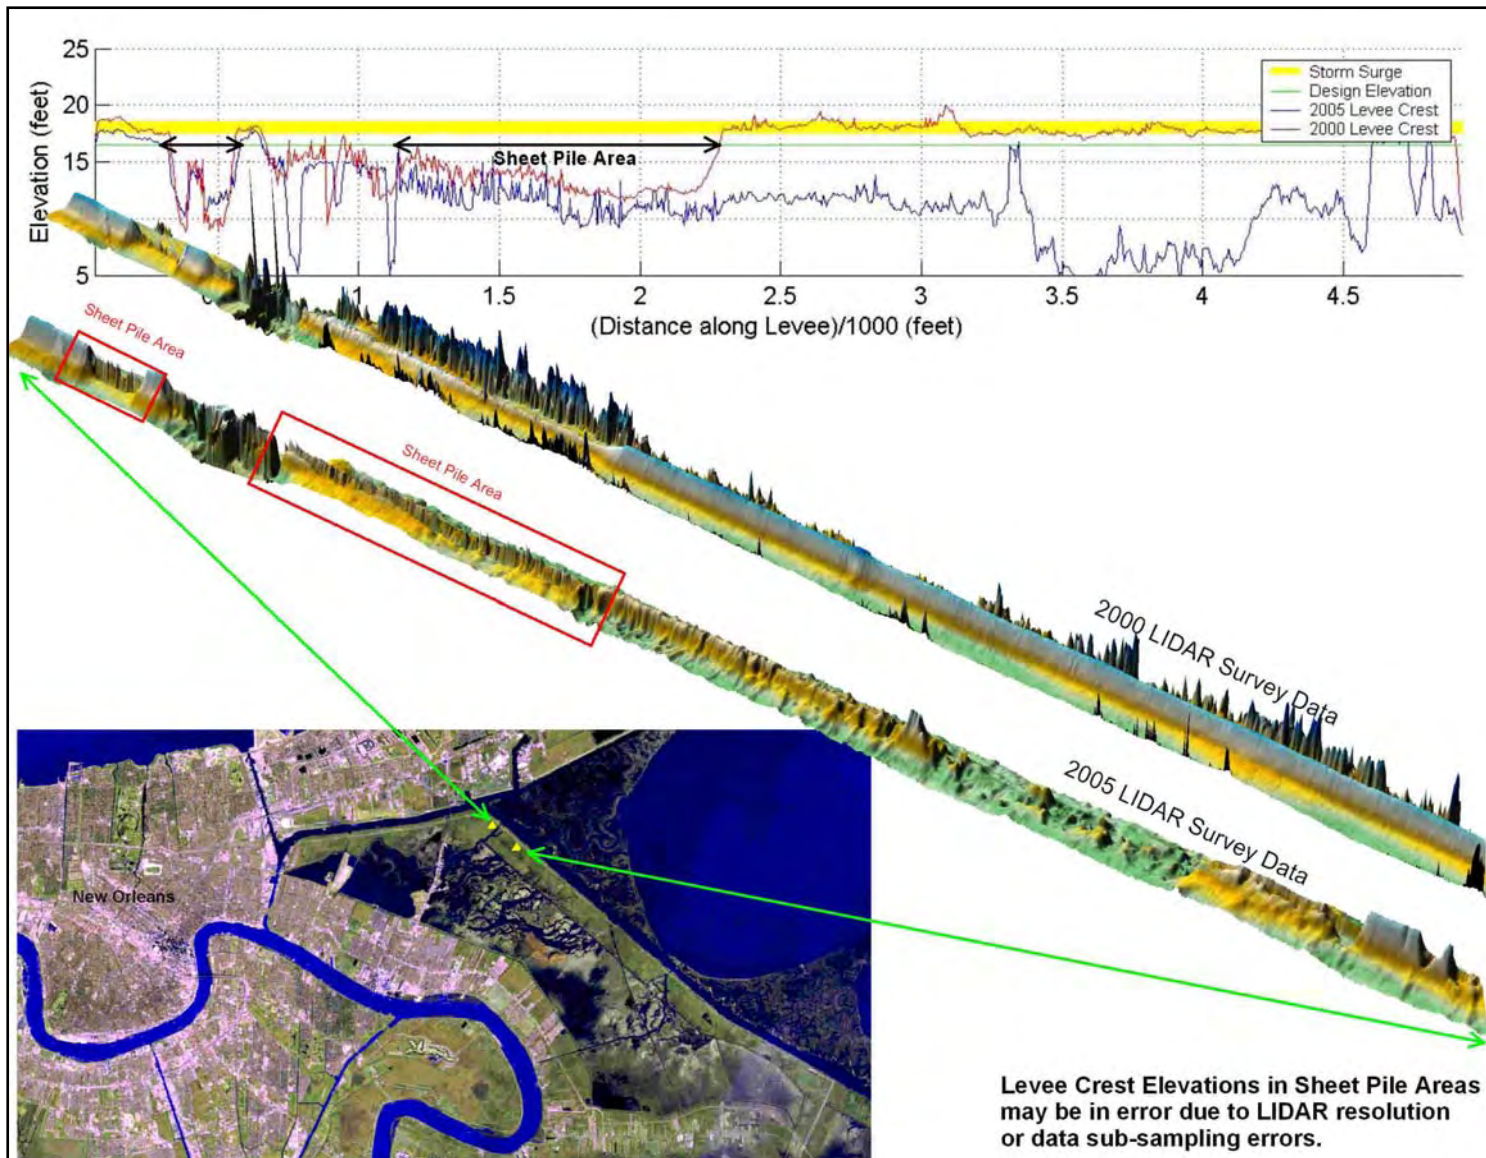
Figure 16-1. MRGO levee damage determined from LIDAR surveys; Station 0 to 4,500 ft

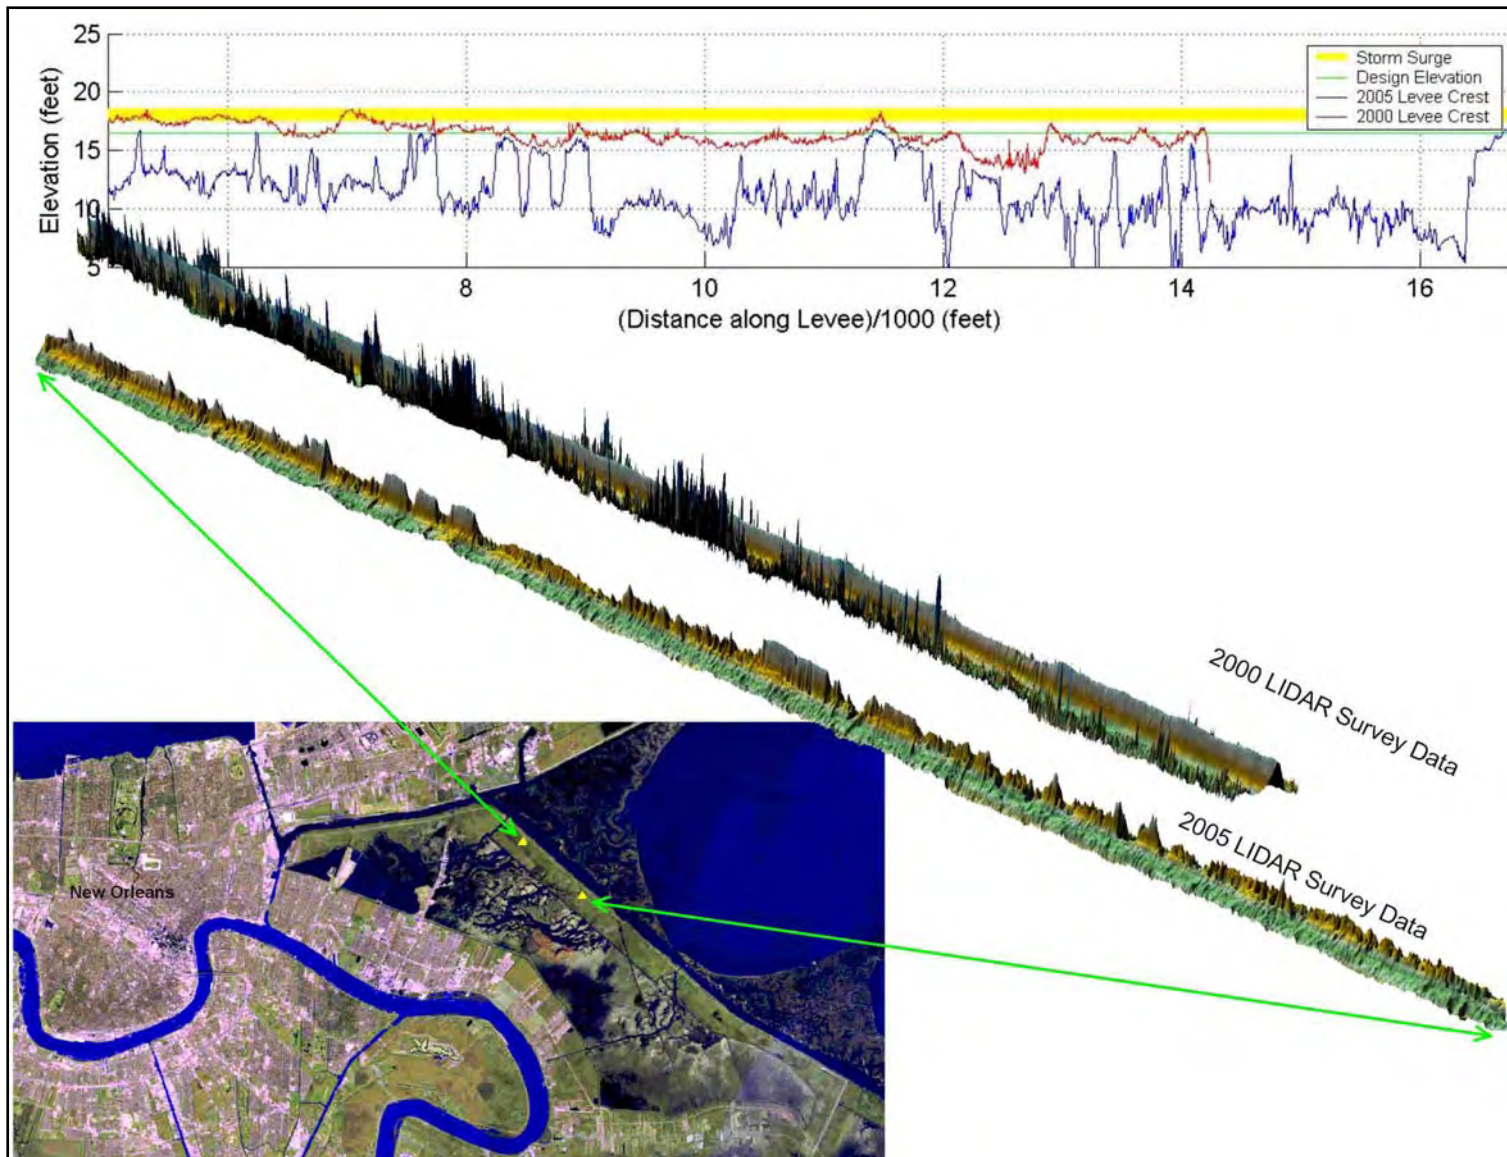
Figure 16-2. MRGO levee damage determined from LIDAR surveys; Station 6,000 to 16,000 ft

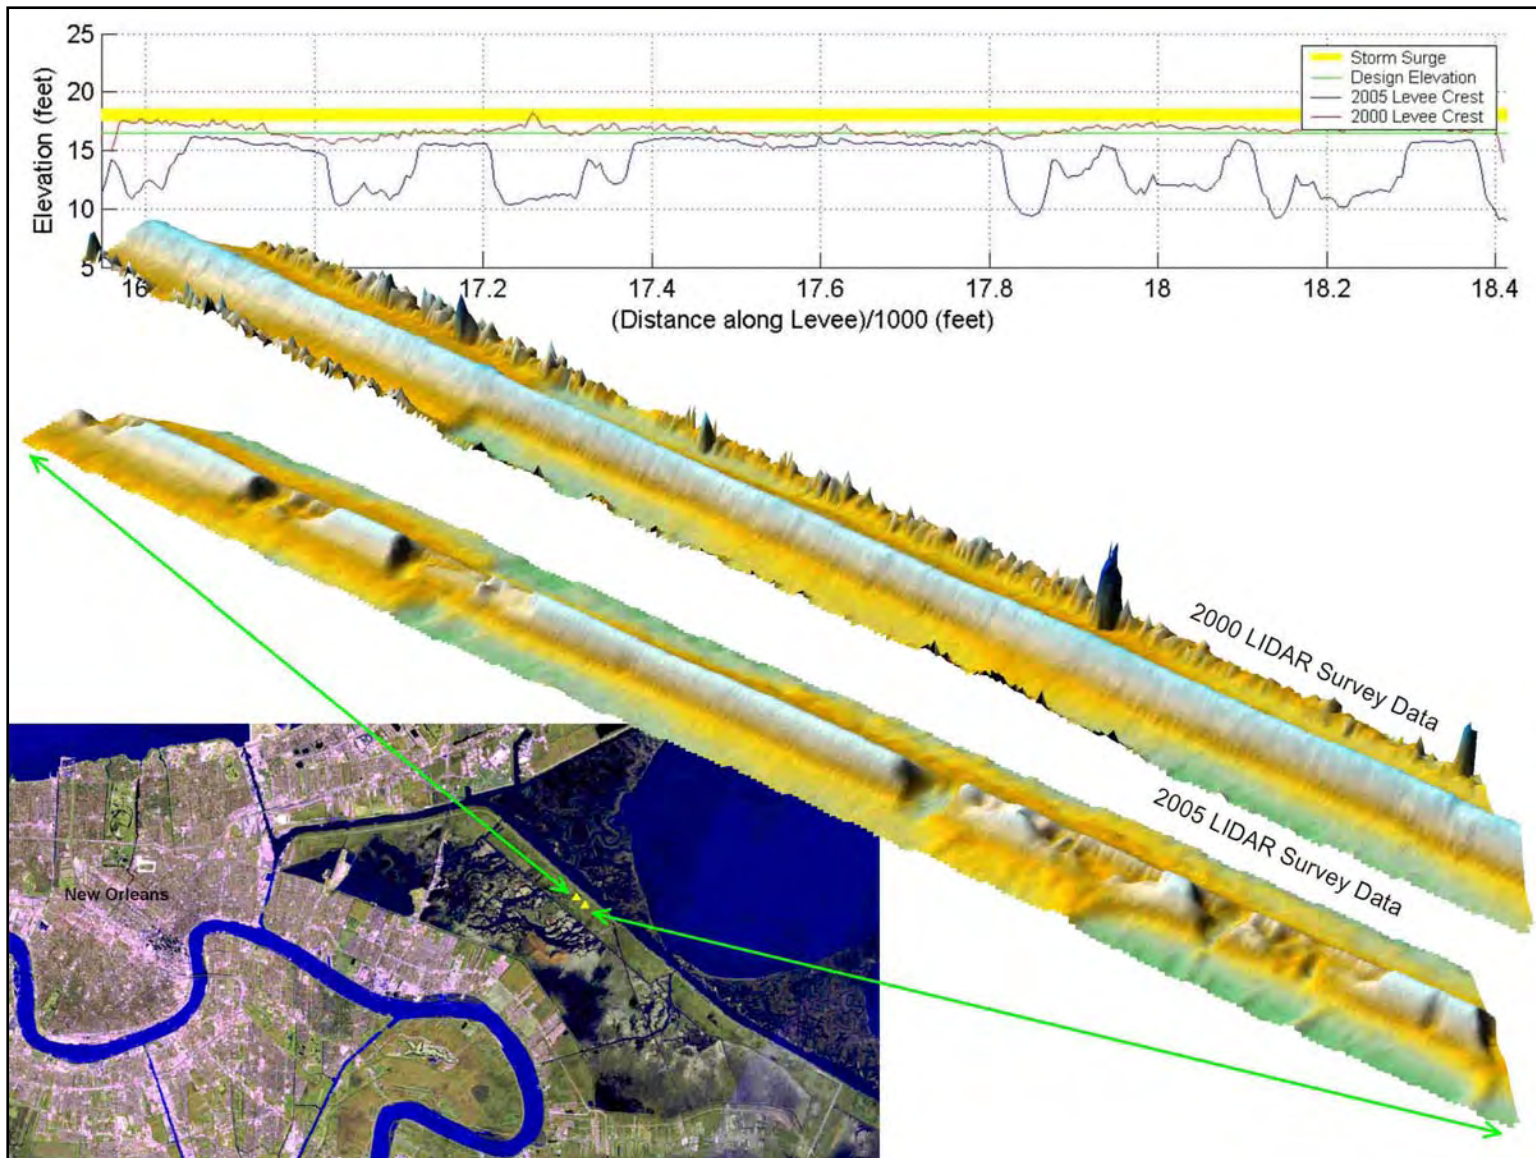
Figure 16-3. MRGO levee damage determined from LIDAR surveys; Station 16,800 to 18,400 ft

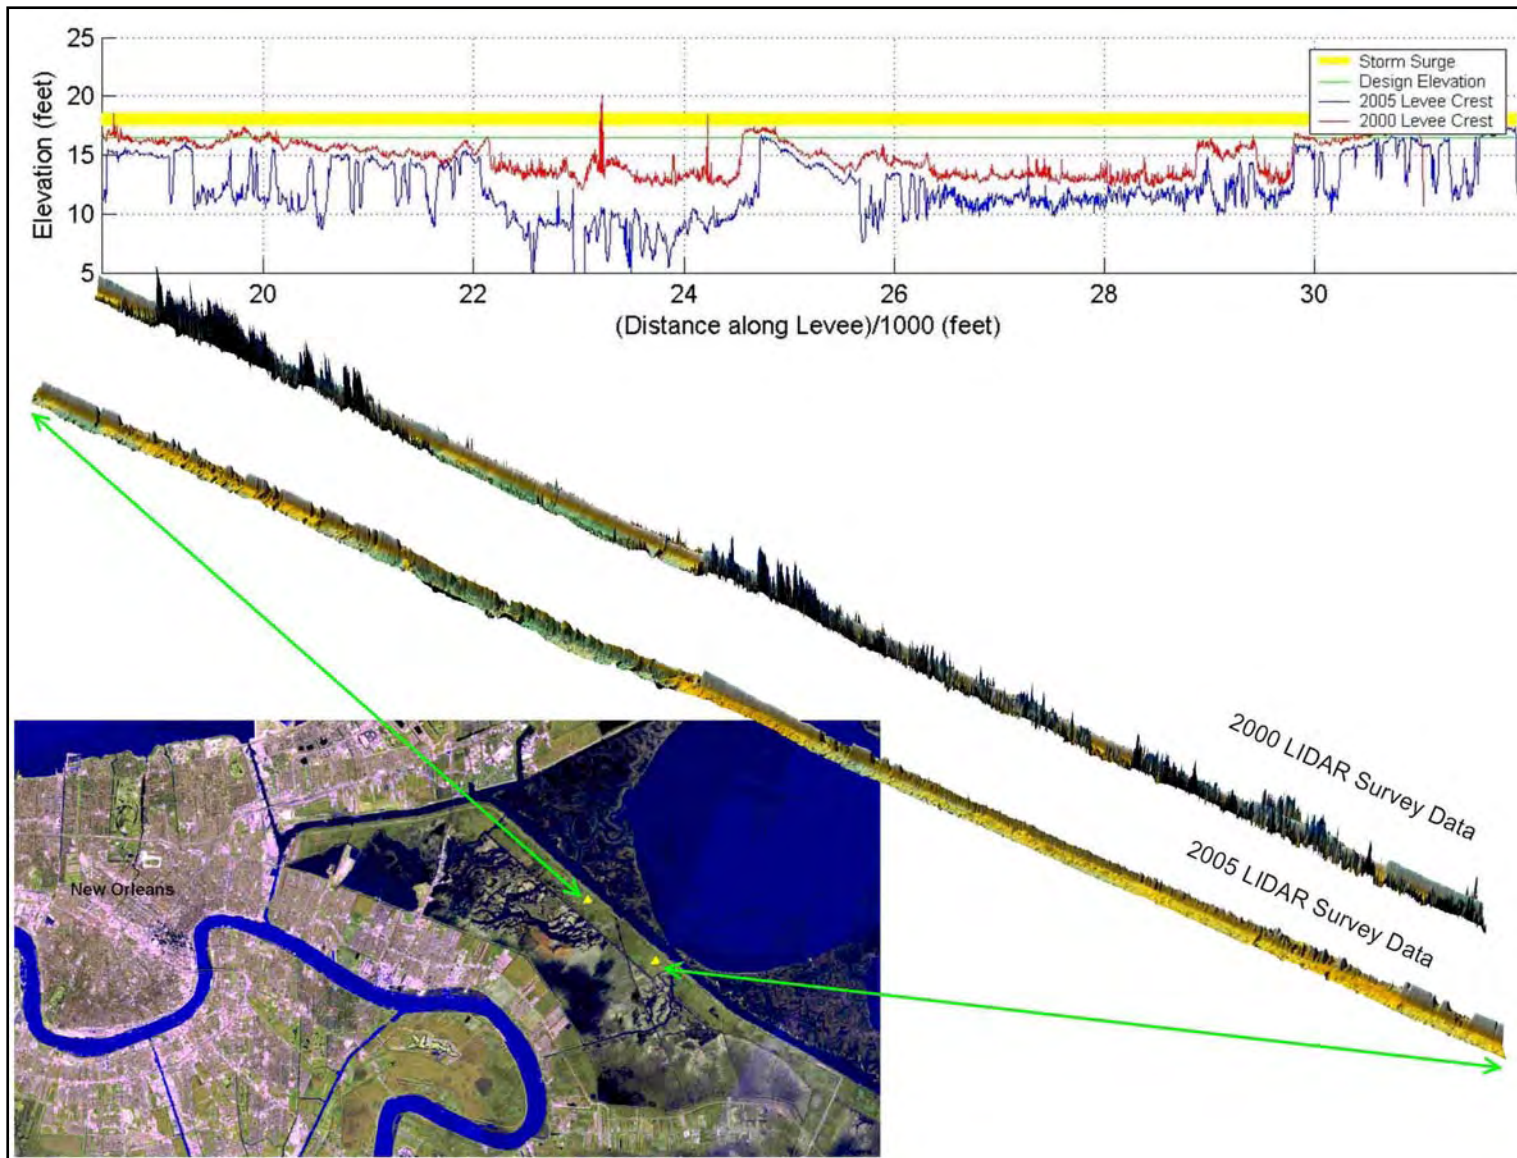
Figure 16-4. MRGO levee damage determined from LIDAR surveys; Station 20,000 to 30,000 ft

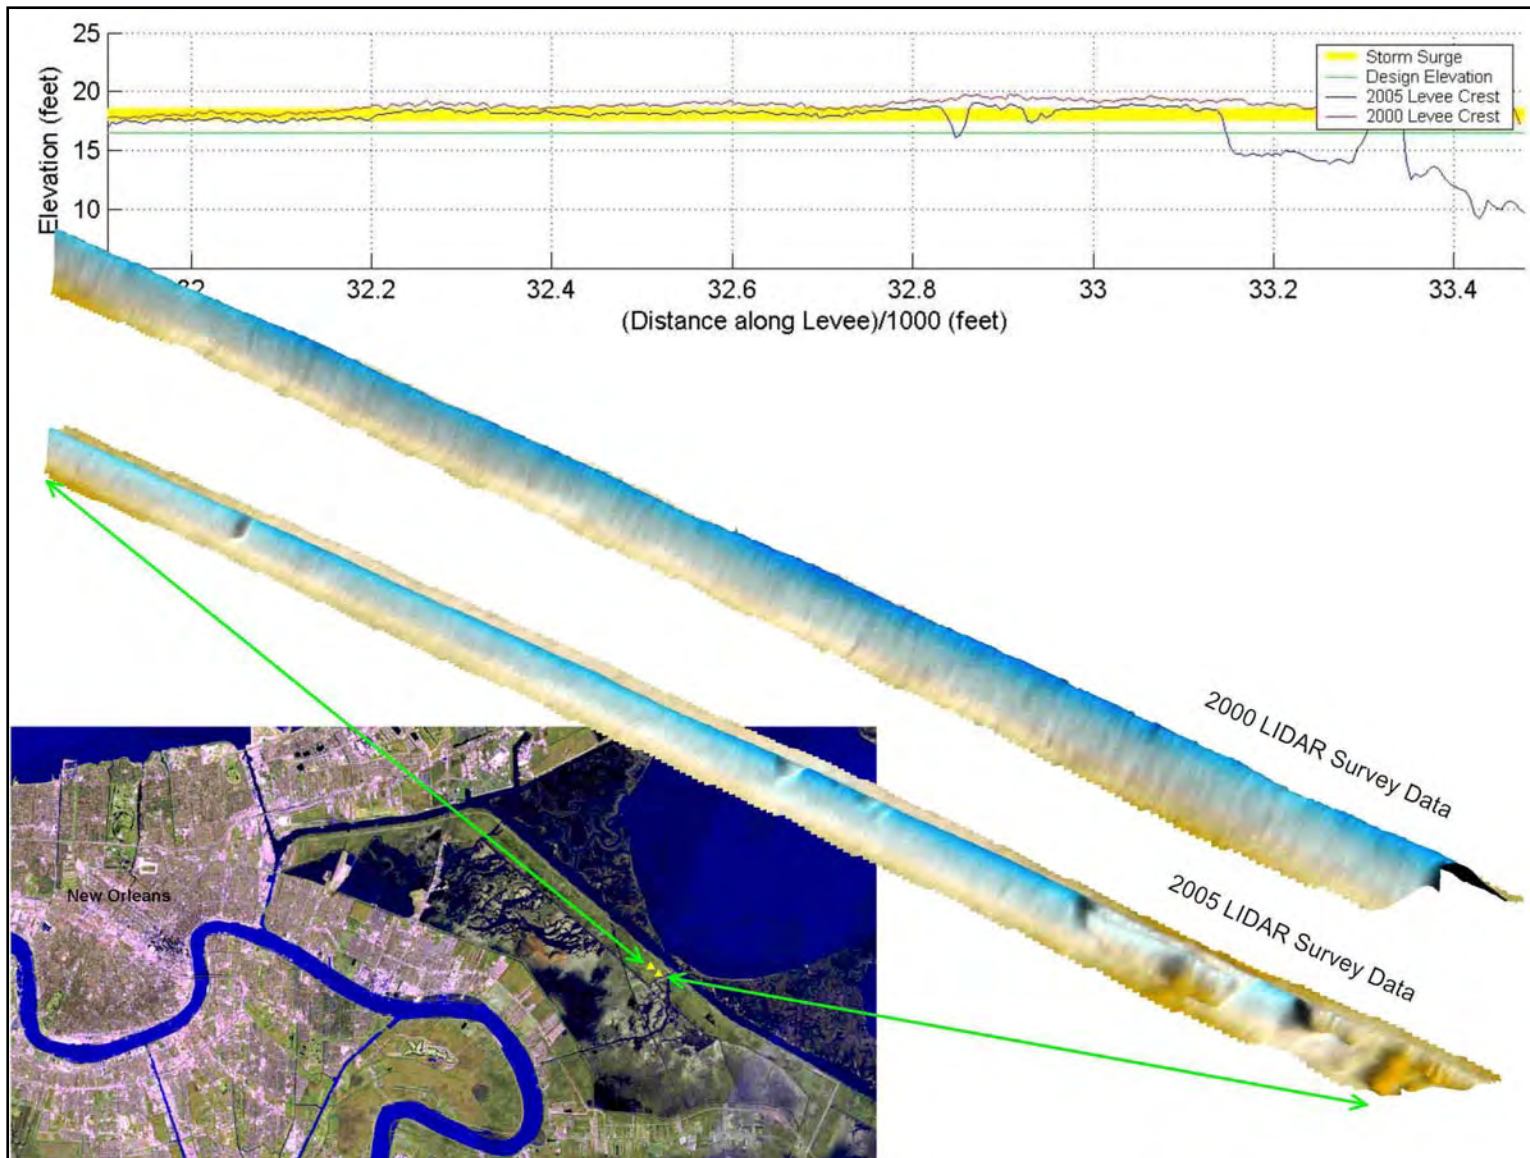
Figure 16-5. MRGO levee damage determined from LIDAR surveys; Station 32,000 to 33,400 ft

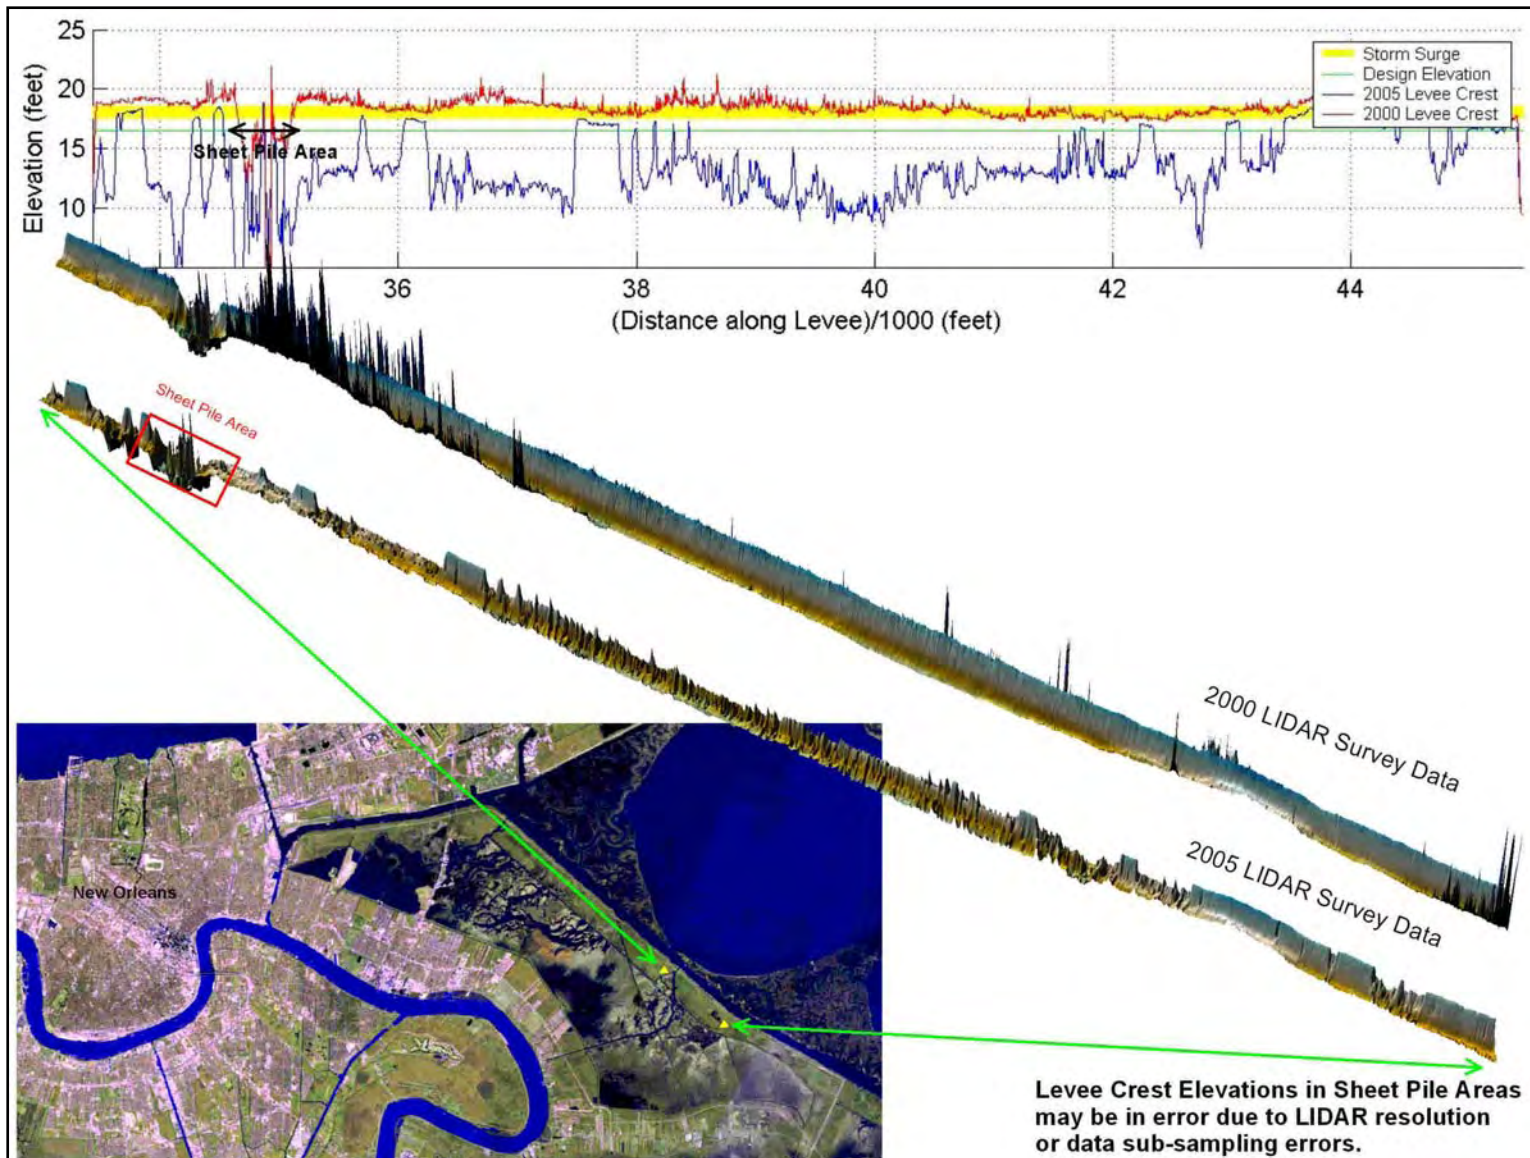
Figure 16-6. MRGO levee damage determined from LIDAR surveys; Station 34,000 to 44,000 ft

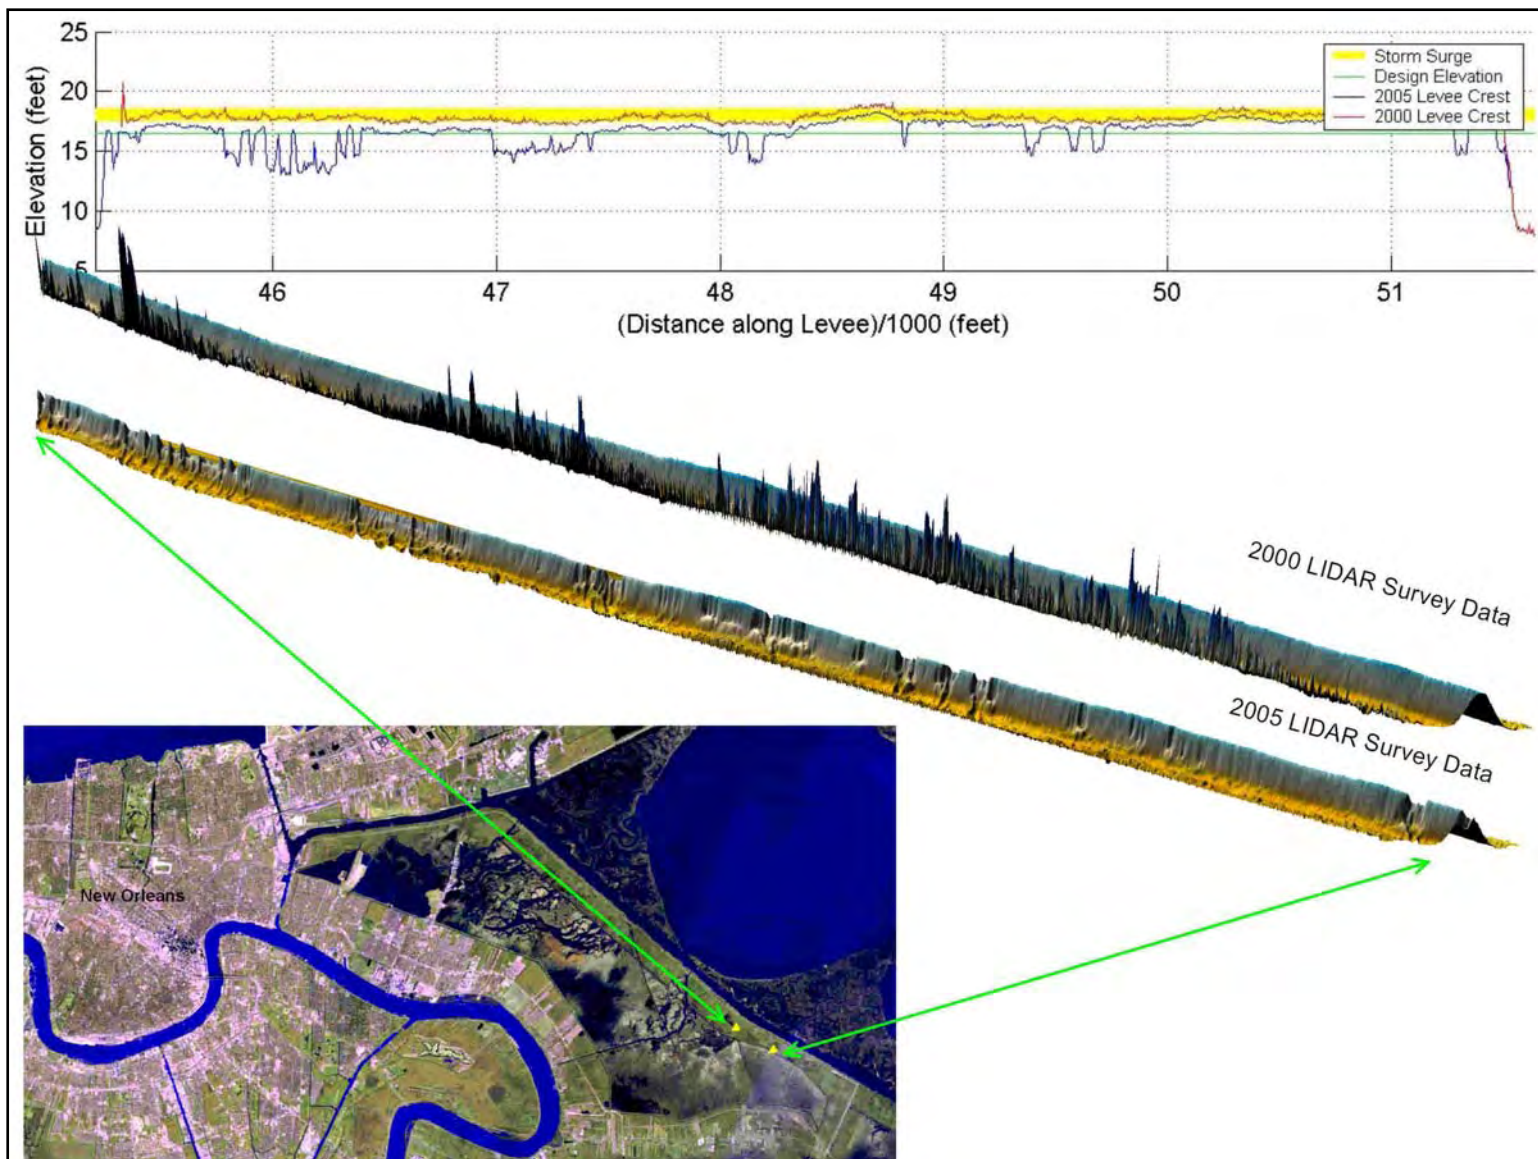
Figure 16-7. MRGO levee damage determined from LIDAR surveys; Station 46,000 to 51,000 ft

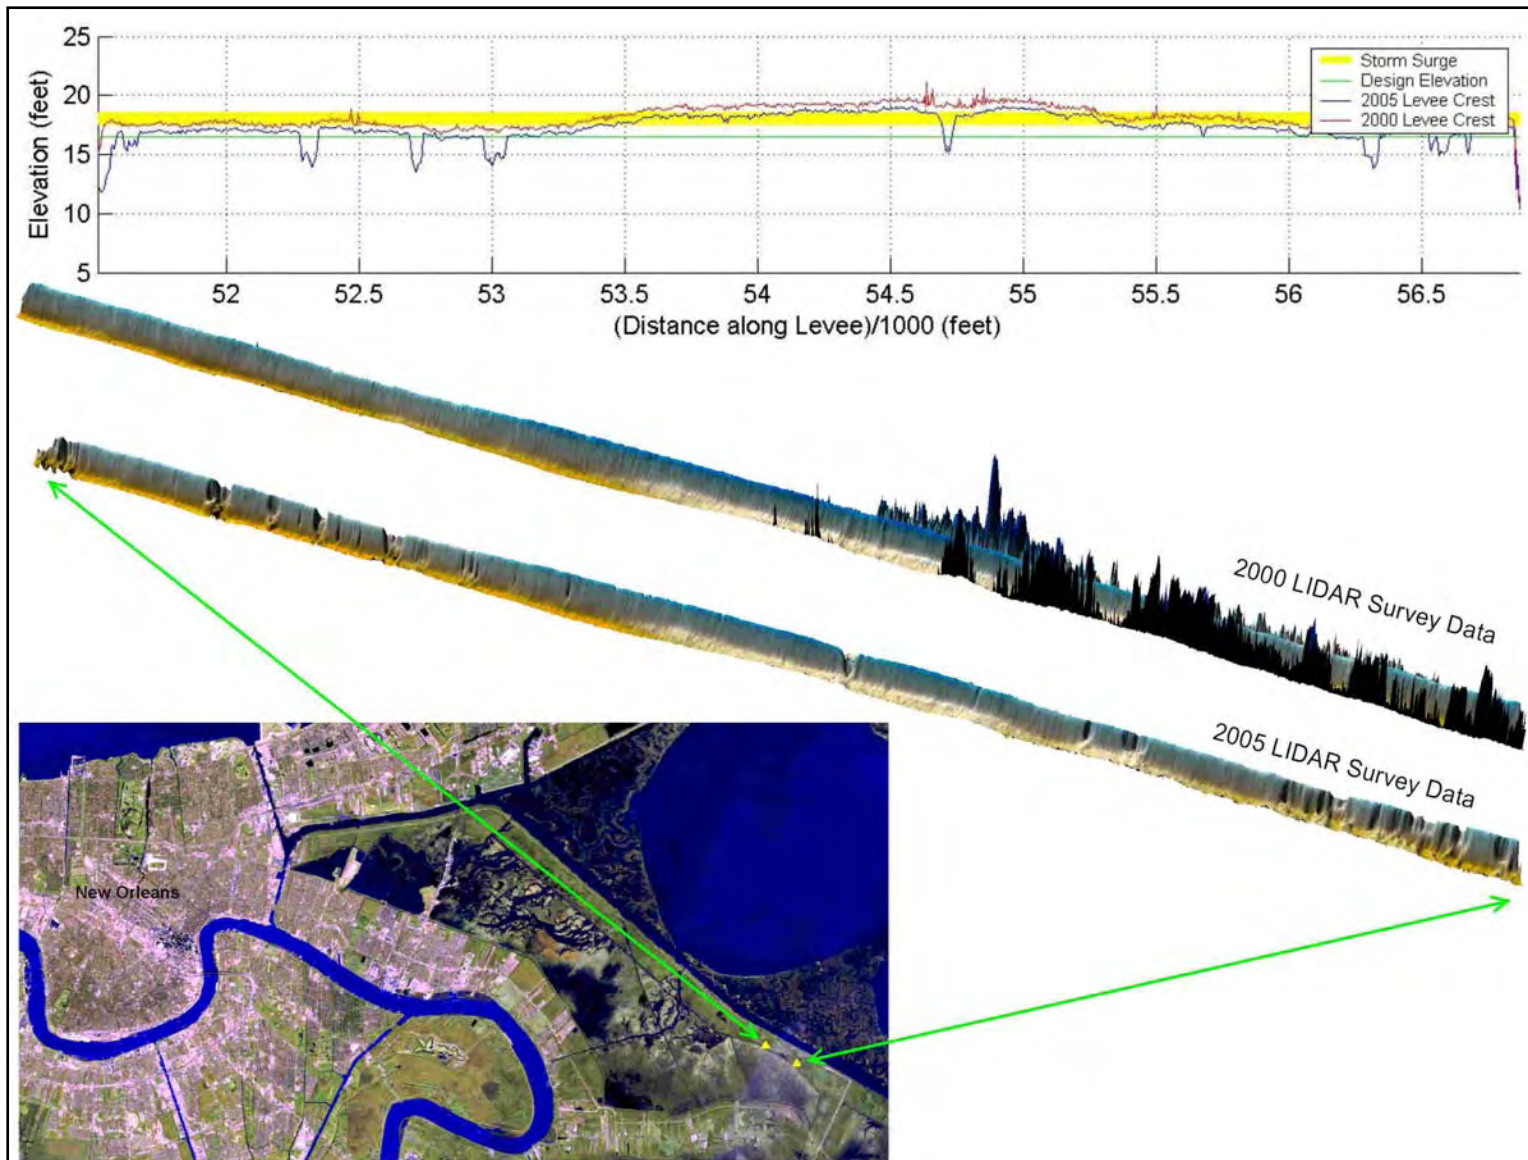
Figure 16-8. MRGO levee damage determined from LIDAR surveys; Station 52,000 to 56,500 ft

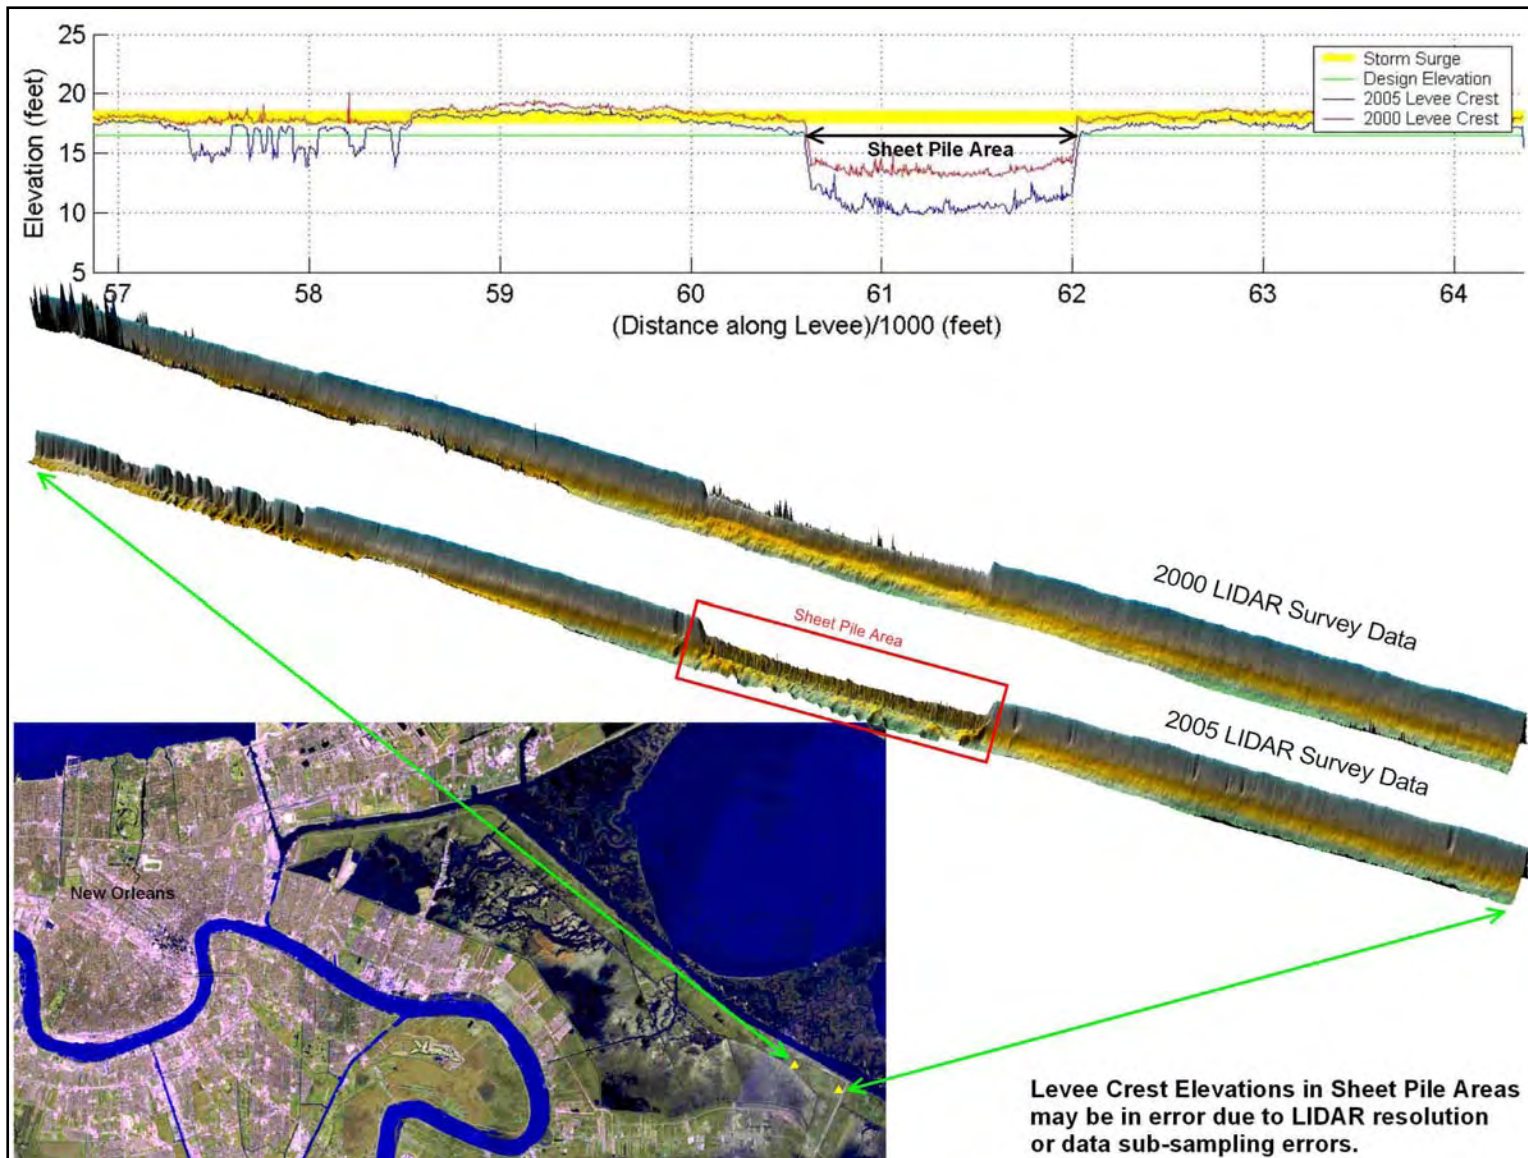
Figure 16-9. MRGO levee damage determined from LIDAR surveys; Station 57,000 to 64,000 ft
