# Geomorphology and Baldcypress Restoration of the Caernarvon Delta near the Caernarvon Diversion, Southeast Louisiana

2011 Report

Andy Baker, Theryn Henkel, John Lopez and Ezra Boyd  
Lake Pontchartrain Basin Foundation

*A Project of the Lake Pontchartrain Basin Foundation and the Coalition to Restore Coastal Louisiana*

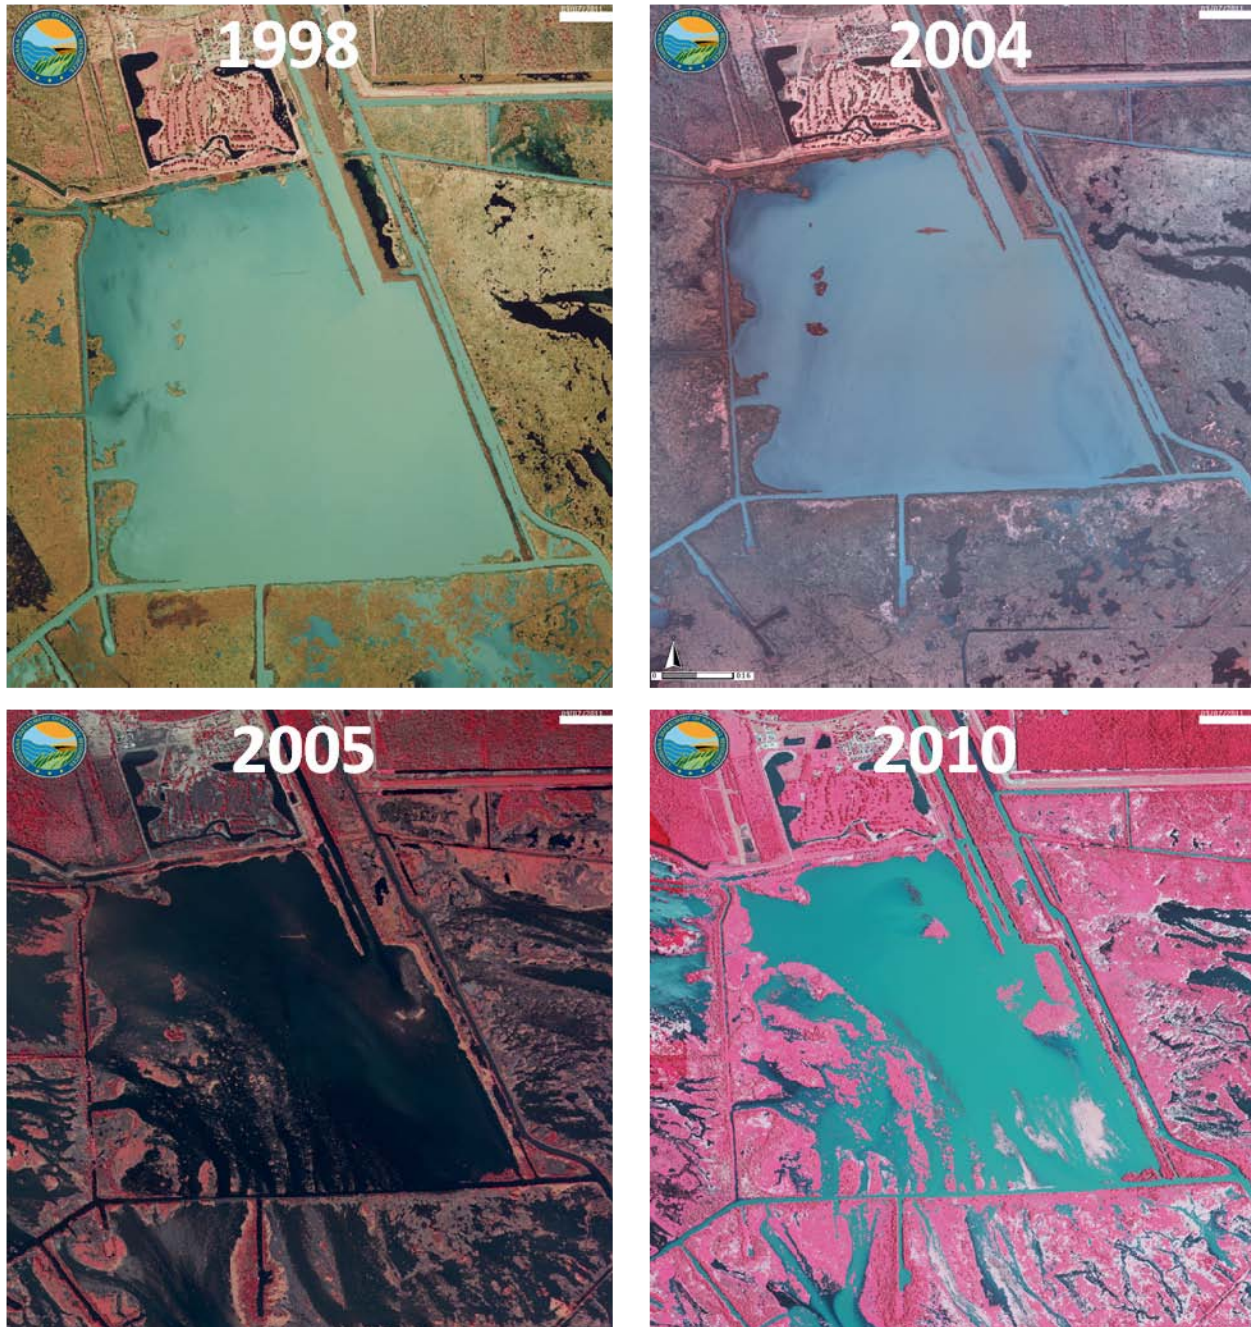
**Figure 1:** Land change in Big Mar Pond from 1998 to 2010. Notice the wrack and marsh balls deposited by Hurricane Katrina in 2005 and significant delta growth by 2010.

Prior to 2004, wetland growth (defined as persistent emergent wetland vegetation in formerly open water) within Big Mar Pond was negligible (**Figure 2**). Since 2004, wetland growth is significant and appears to be accreting annually. This wetland growth is a result of an active delta that has two distinct zones and, therefore, is referred to as the Caernarvon Delta Complex. The total area of Big Mar Pond is 1,720 acres. The emergent portion of the Caernarvon Delta Complex now occupies 35% to 50% of Big Mar Pond.

In the northeast quadrant of Big Mar Pond near the terminus of the Caernarvon conveyance canal, a mineral platform of radiating bars and shallow inter-bars (i.e. the delta platform) has become vegetated. This has the typical delta geomorphology of bars and small bifurcating distributary channels. In 2005, Hurricane Katrina pushed marsh balls from the surrounding marsh into the southwest portion of Big Mar Pond (**Figure 3**). The hurricane deposition in this zone became nucleation points in which wetland extent expanded since 2005. This expansion was initially floatant marsh, but appears to be acting as a sediment trap for fine sediment from Carnarvon Diversion discharge, thus comprising a proto-delta. This proto-delta area was not significantly impacted by Hurricane Gustav in 2008. Further, the appearance of some black willow indicates the marsh is not entirely floatant and has become more stable.

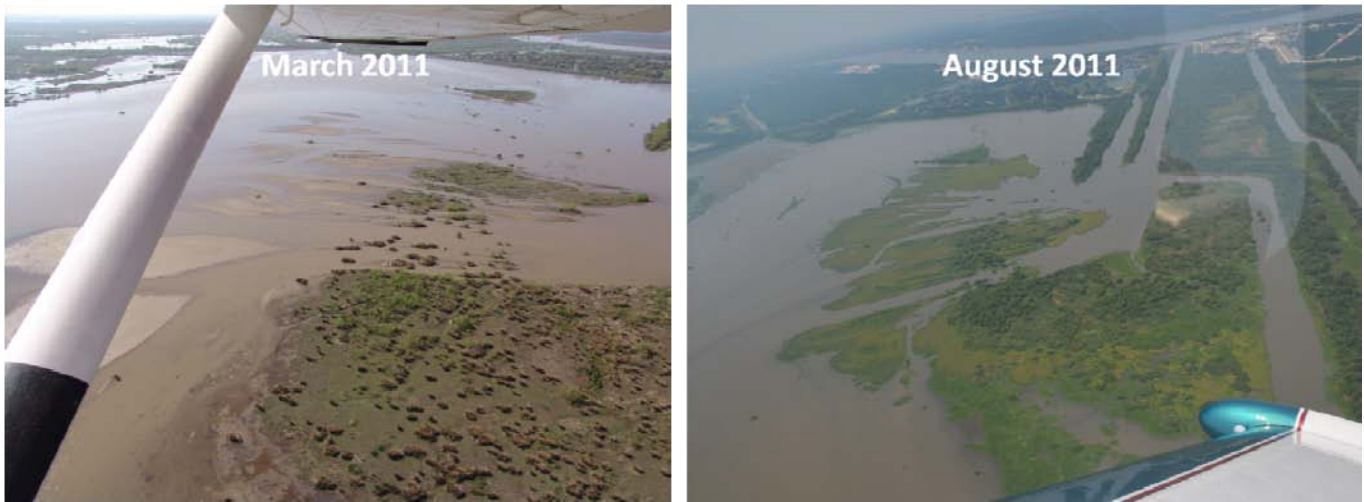
**Figure 5:** Picture of exposed mudflats in Big Mar Pond in March of 2011 and the nearly 100% vegetated delta in August 29, 2011.

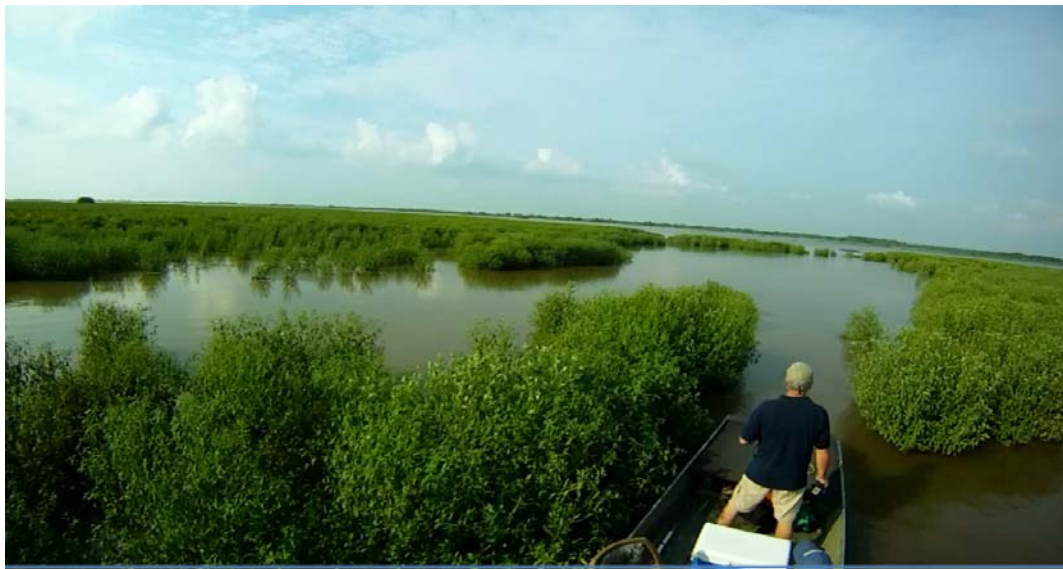
**Figure 6:** On the ground view of the vegetated delta on August 24, 2011. This area was bare mud flats six months prior.

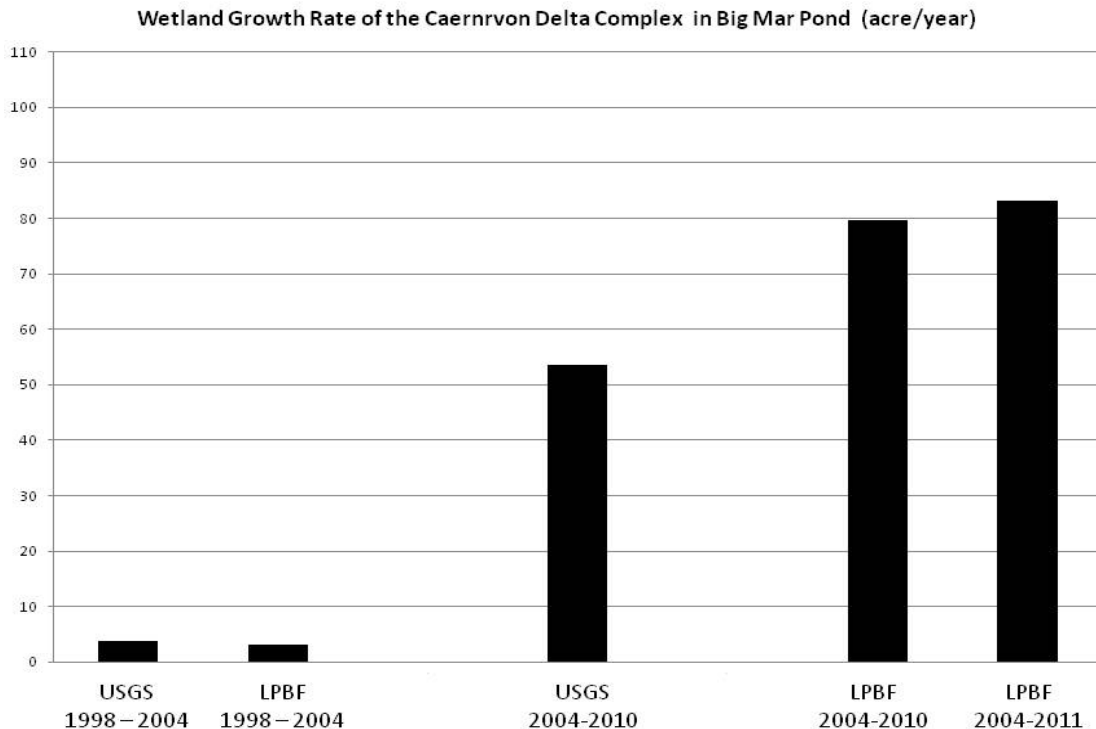
**Figure 7:** Bar graph showing wetland growth rates in Big Mar Pond calculated by LPBF and the USGS, from 1998 to 2011

2004, and 321 acres of growth from 2004 to 2010. The delta growth from 2010 to 2011 is estimated to be approximately 104 acres, which is significant growth in one growing season. LPBF data indicate that the wetland growth rate in Big Mar Pond from 1998 to 2004 is 3 acres per year. The rate of growth from 2004 to 2011 is 83 acres per year (Henkel et al. 2011). Both LPBF and USGS data clearly indicate an increase in rate of wetland growth after 2004 (**Figure 7**).

The rate of wetland expansion after 2004 is 14 times (1400%) greater than before. Big Mar Pond in 2011 is at least 40% emergent wetlands, but the remaining open water areas are all less than a foot deep under normal marsh water levels. Based on the observed trends of wetland emergence, LPBF projects the annual rate of wetland growth to be approximately 80 acres per year in Big Mar Pond. As Big Mar Pond becomes filled with sediment, it will reach a threshold for capacity to retain sediment. Most likely, the entire area will not become emergent wetland as water will continue to flow from the Caernarvon Diversion through the area. Because of this, there is future potential for wetland accretion or emergence outside Big Mar Pond as the ability to retain sediment within the pond diminishes.

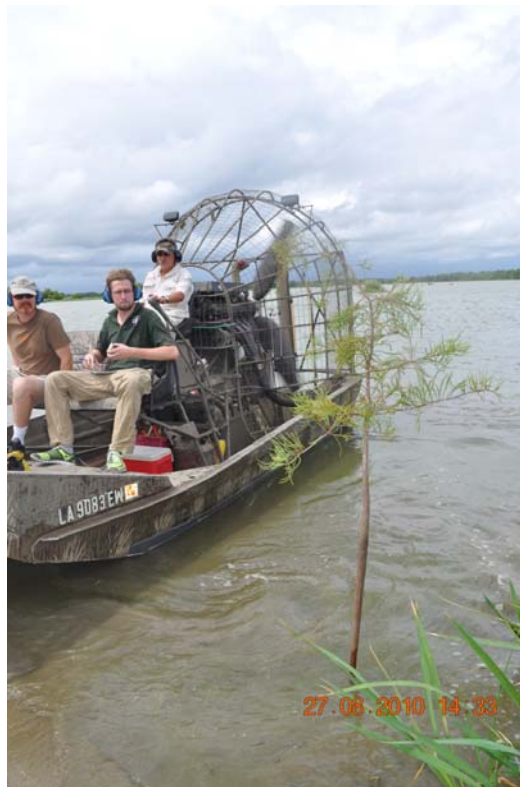
**Figure 8:** The first baldcypress planted without nutria protection in March 2010 in Big Mar Pond survived for several months indicating that habitat was suitable for a large scale re-forestation. Howard Callahan, driving the airboat, is the land manager who has been very helpful with the re-forestation project. (August 27, 2010)

LPBF planted a single baldcypress tree without nutria protection in March 2010 in Big Mar Pond. In August, the tree was still alive and thriving (**Figure 8**). Further reconnaissance indicated that water levels and salinity were suitable for a baldcypress reforestation project. Thus began planning for the fall planting of 2010.

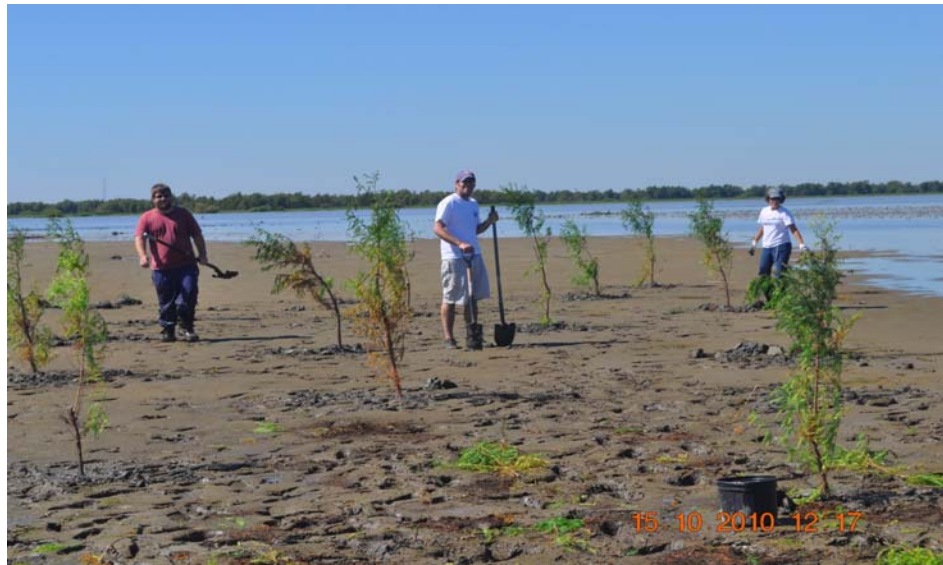
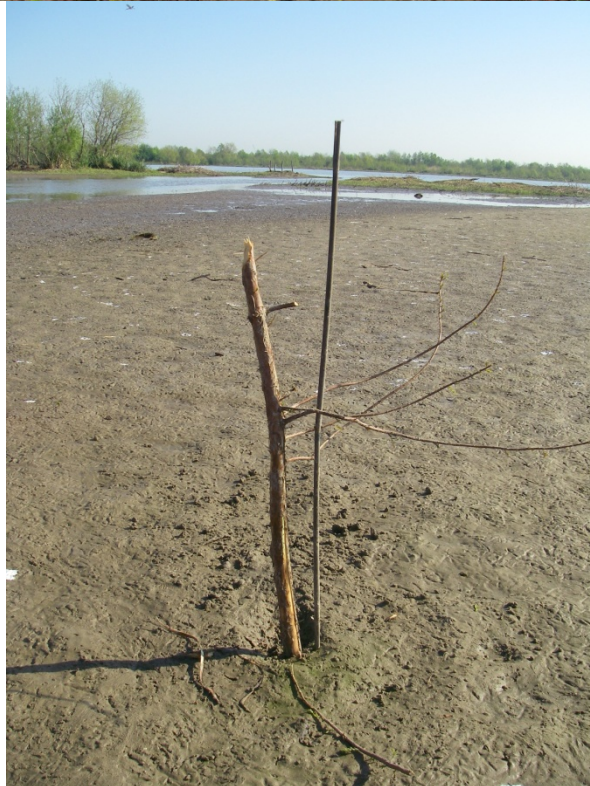
**Figure 9: Upper picture** - Volunteers plant cypress on newly emerged islands in October 2010. Nutria protection tubes were not used. There was 100% mortality of the first planting due to nutria and the instability of the un-vegetated bars. (Ezra Boyd, Blaise Pezold, and JoAnn Burke)  
**Lower picture** – One of the few trees found that were previously planted on bare mud flats. Most trees were entirely missing. April 1, 2011

When the planting site was surveyed in March, almost none of the trees were found. The 170 trees on the exposed sandbars were completely gone except for a couple of dead trees. Apparently the sandbars themselves had shifted, due to either winter storms or flow from the diversion. Nutria were also likely part of the high mortality.

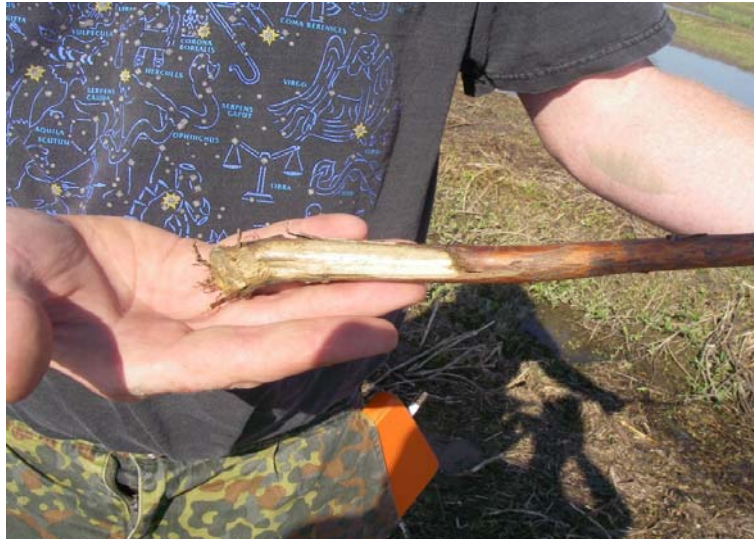
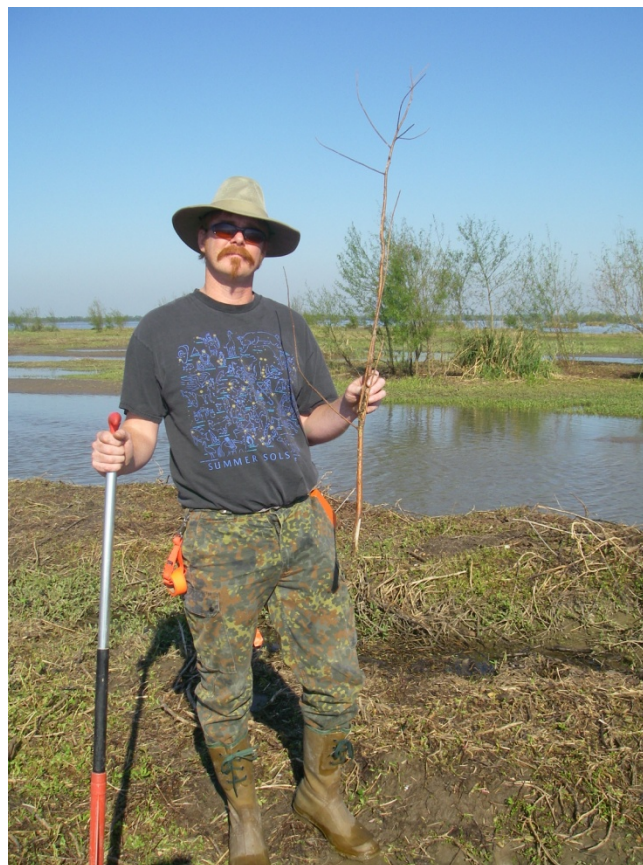
**Figure 12:** Examples of nutria herbivory damage to baldcypress planted in March 2011 without nutria protection tubes. Pictures taken April 1, 2011 just three weeks after planting.

On April 1<sup>st</sup>, (merely 18 days after the planting), two LPBF staff returned to the planting site to check on the trees. They found heavy mortality from nutria damage; only 44 of 175 trees remained (24%) (**Figures 11 and 12**). Planting sites in open, freshly deposited ground were hardest hit. (Due to an oversight during the planting process, the locations of approximately 50 trees were not recorded.). Despite dozens of alligators swimming nearby, nutria were evident and active.

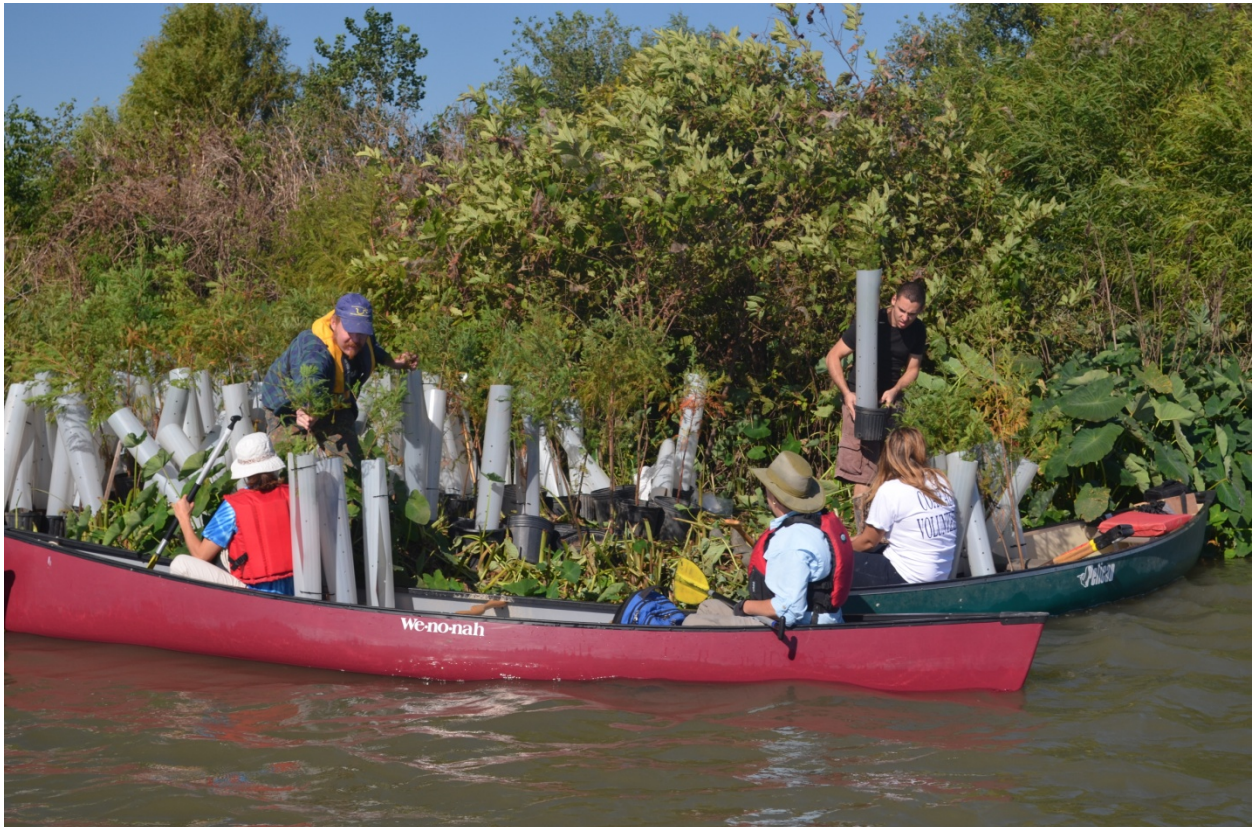
**Figure 13:** Staff and volunteers load baldcypress trees into canoes with nutria protection tubes. Andy Baker LPBF and Nathan Arthur (volunteer) – on land.

Initially, for the first two plantings, trees were grown in greenhouses in South Carolina (still with local seed stock) then transported to Louisiana for planting. For the most recent planting in November 2011, REF began to partner with a local grower and received the trees from local grower Aaron Peirce with Resource Environmental Solutions. In general, the trees were in three gallon pots and were three to five feet tall (see **Figures 13, 14 and 17**).

On November 1-3, 2011, 650 trees were planted over three days involving ten staff from LPBF and CRCL along with almost fifty volunteers, ten canoes, three airboats and two powerboats. The first day was spent moving trees one mile to a staging area at the end of the diversion canal. On the second and third days, volunteers moved trees from the staging area to planting sites by canoe and airboat (**Figure 13**).

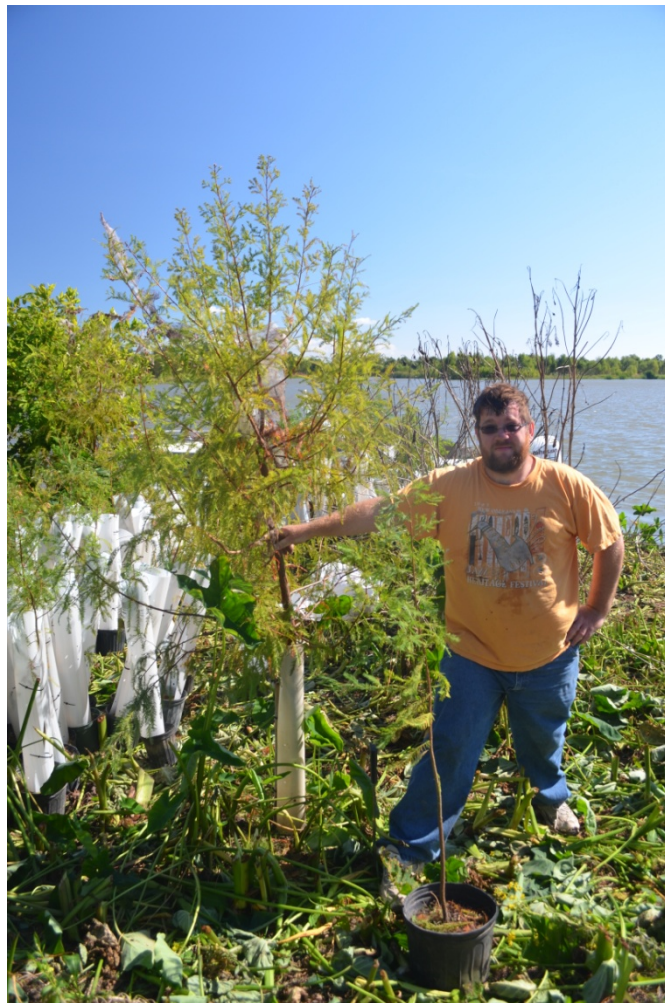
**Figure 17:** November 2011 - LPBF staff (Dr. Ezra Boyd) with an unplanted baldcypress tree, next to a tree that had been planted in March of 2011. The larger tree was roughly the same size as the smaller tree when planted, showing good growth over eight months. Note the nutria protection tube type used in March was a solid plastic cylindrical tube.

During the November planting, it was noted that the trees planted in March (8 months prior) which had nutria protection tubes had grown significantly. Tree heights seemed to have roughly doubled, and the tree circumference had more than doubled. (No systematic measurements were taken.)

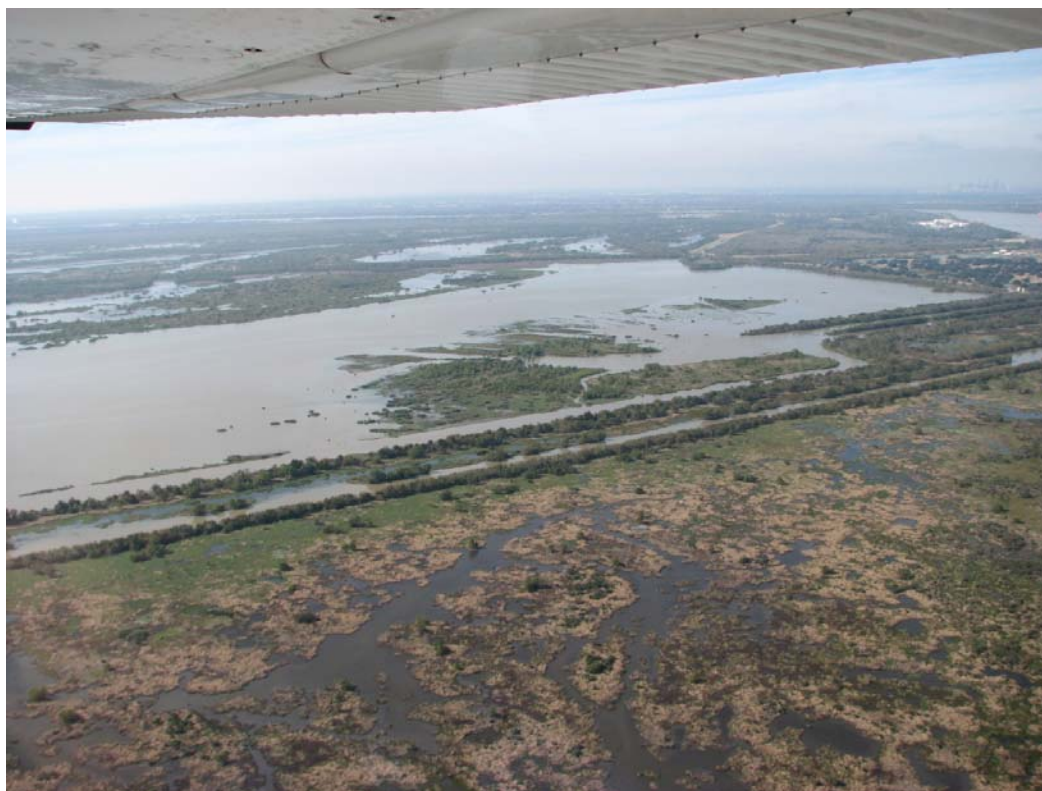
**Figure 18:** Photograph taken December 8, 2011 showing the Caernarvon Delta area in Big Mar Pond (Courtesy of Frank Cole -LA DNR-CMD).

**Figures 18 and 19** are oblique plane photographs taken over Big Mar Pond on December 8, 2011. They indicate some senescence and submergence of the delta area. The pro-delta area seems to have additional wetland area and to have consolidated into larger continuous areas of wetlands. This is further indication of this area's viability for future cypress planting. It is expected that continued wetland expansion will occur in Big Mar Pond and nearby areas.

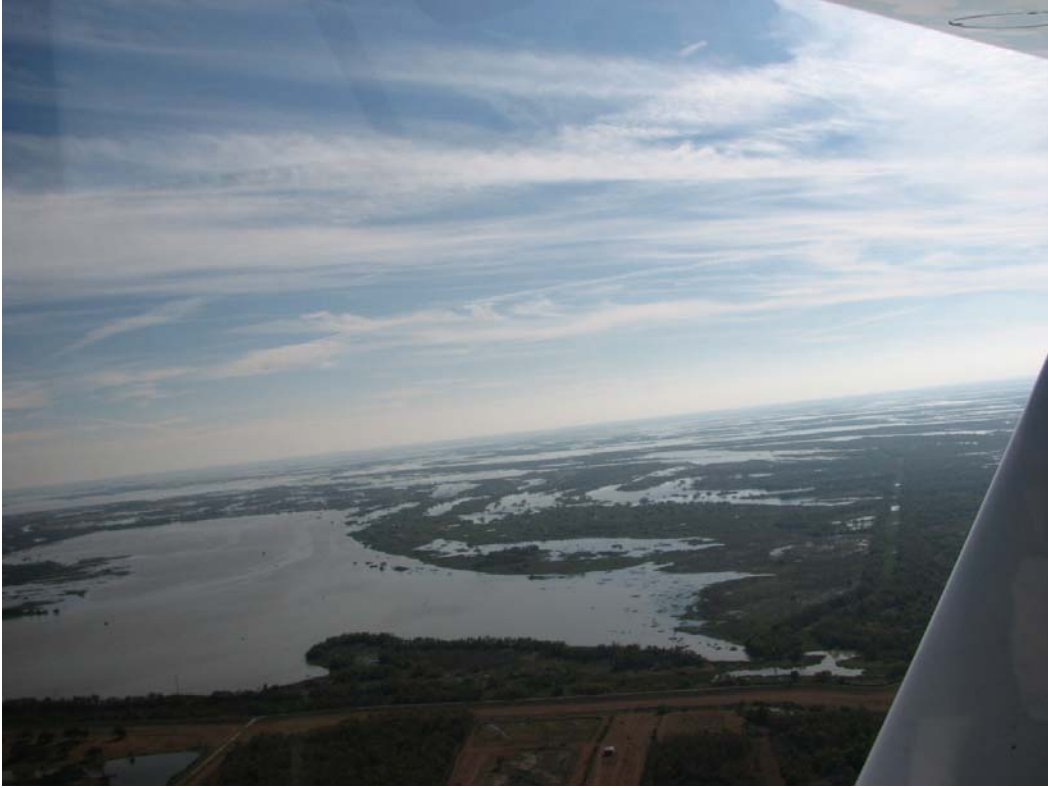
**Figure 19:** Photograph taken December 8, showing the pro-delta area in Big Mar Pond. 2011 (Courtesy of Frank Cole -LA DNR-CMD)
