Appendix 6

St. Bernard Basin

STB Basin – Layout of Reaches for Risk Model by Physical Feature (Pre-Katrina)

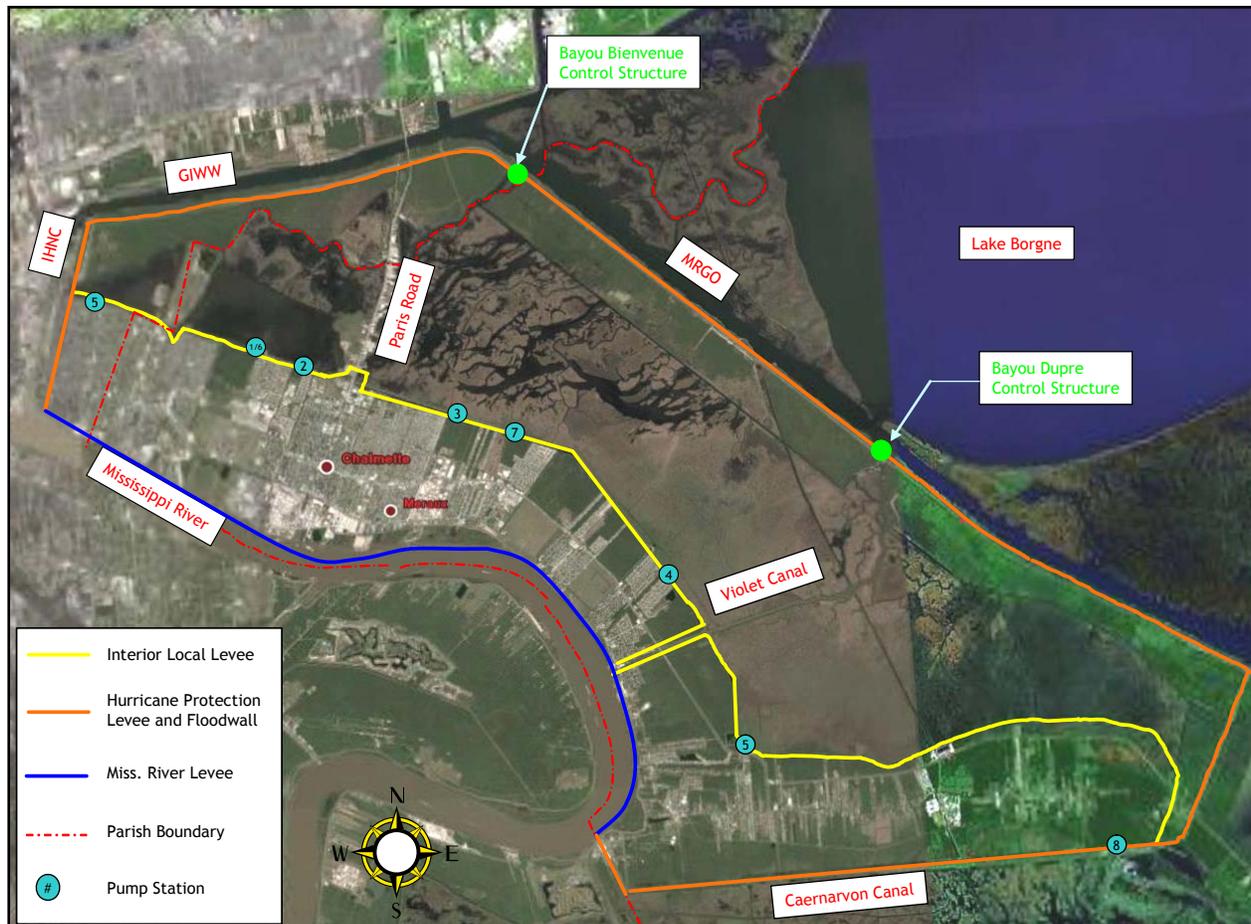
Figure STB 1. St. Bernard basin

The St. Bernard (STB) basin is defined by the protection system along the GIWW to the north, MRGO to the east, Caernarvon Canal to the south, and the Mississippi River and Inner Harbor Navigation Canal (IHNC) to the west. Like New Orleans East, it is essentially separated into two distinct areas, a residential/commercial area on the south side of the basin and a marshlands area on the north side. These two sections are separated by a non-federal, interior local levee that runs across the basin from the northwest to the southeast. This area, along with other pertinent information relative to the IPET assessment, is depicted in Figure STB-1.

The levee and floodwall system surrounding the STB basin consists of approximately 157,800 linear feet of varying levels of protection. This provides protection for an area of approximately 81 square miles for the entire basin. The residential area makes up approximately 27 square miles of the basin. In addition, there are two water control sector gate structures along the MRGO at Bayou Bienvenue and Bayou Dupre. There are a total of nine pump stations within the basin, primarily along the interior local levee; one of these is located along the Caernarvon Canal. These major structures are also depicted in Figure STB-1.

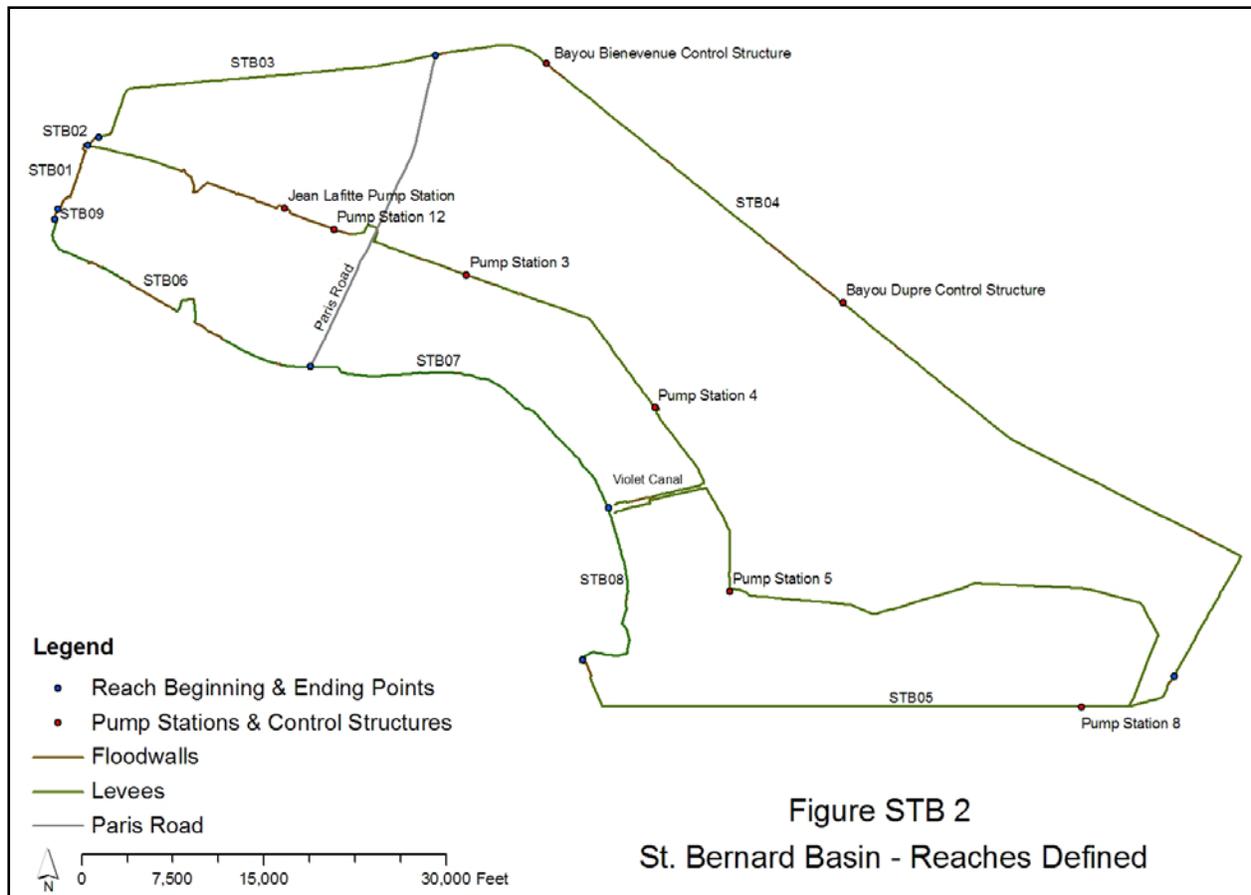
Figure STB 2A. St. Bernard Basin – Reaches Defined

Task 10 basin reach definitions for STB start at the tie-in to the north side of the IHNC Lock. The numbering system for reach definitions continues along the exterior protection system along the GIWW, MRGO, Caernarvon Canal, and then up through the Mississippi River levee system to where it ties back into the south side of the IHNC Lock. Finally, the interior local levee reaches' numbers begin at the IHNC and extend southeast until they end at the Caernarvon Canal. Please refer to Figure STB1, STB2A, and STB2B for further clarification. The STB basin is summarized by the reaches as follows:

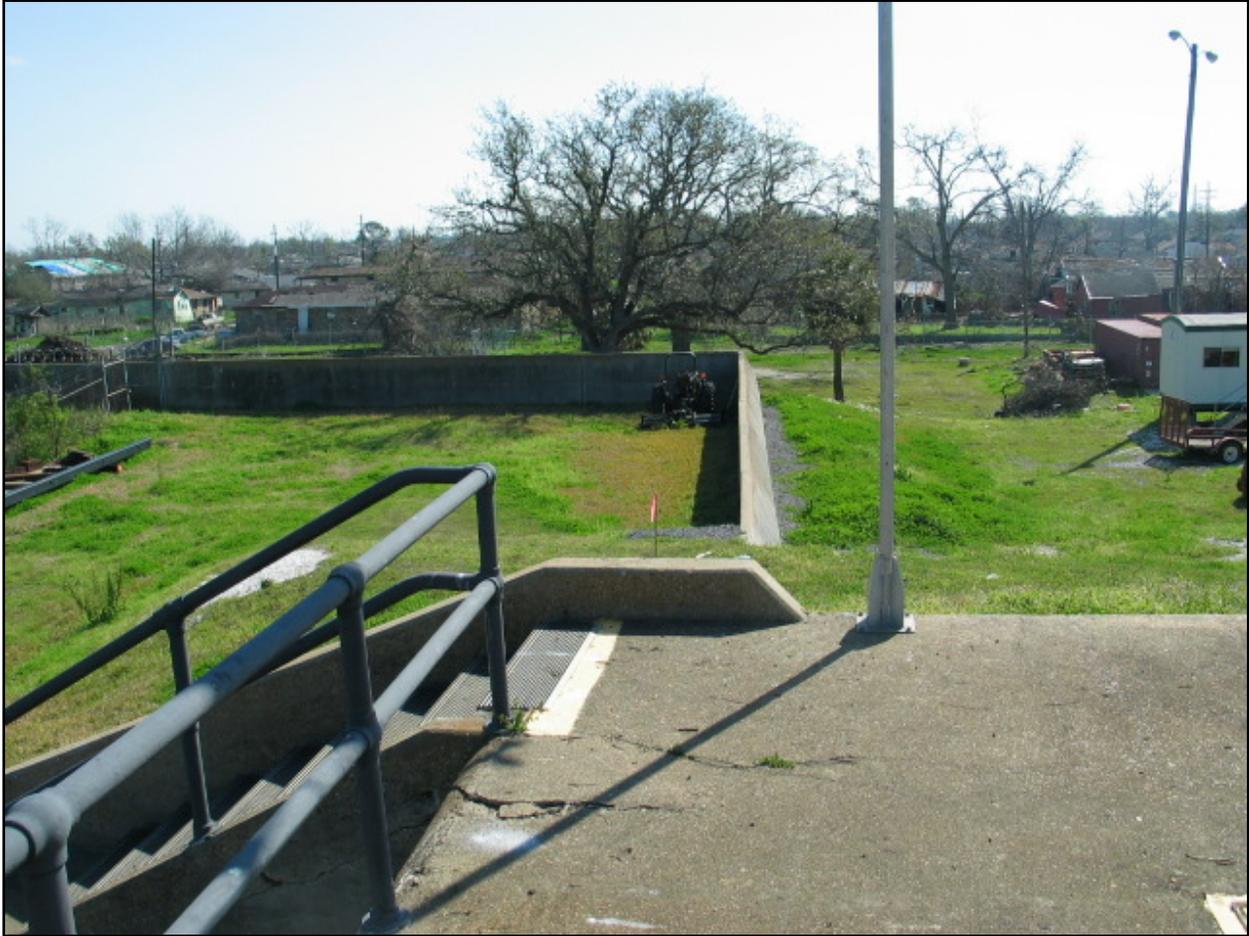
This reach is defined by concrete capped I-wall that ties into the northeast side of the IHNC Lock and generally follows the IHNC north, see Figure STB 3, which shows the beginning of the reach where it ties into the northeast lock wall of the IHNC. There is one key point (stb1a) at the beginning of this reach where the natural ground line transitions between the lock wall and I-wall, as shown in Figure STB 4. The reach ends at the south end of the I-wall failure that occurred in the Lower 9th Ward. Other sections of this reach were overtopped during Katrina, but did not fail, in particular near the Claiborne Bridge, as shown in Figure STB 4.

Figure STB 3. I-wall section tying into IHNC lock wall (standing on top of lock wall and looking away from IHNC)

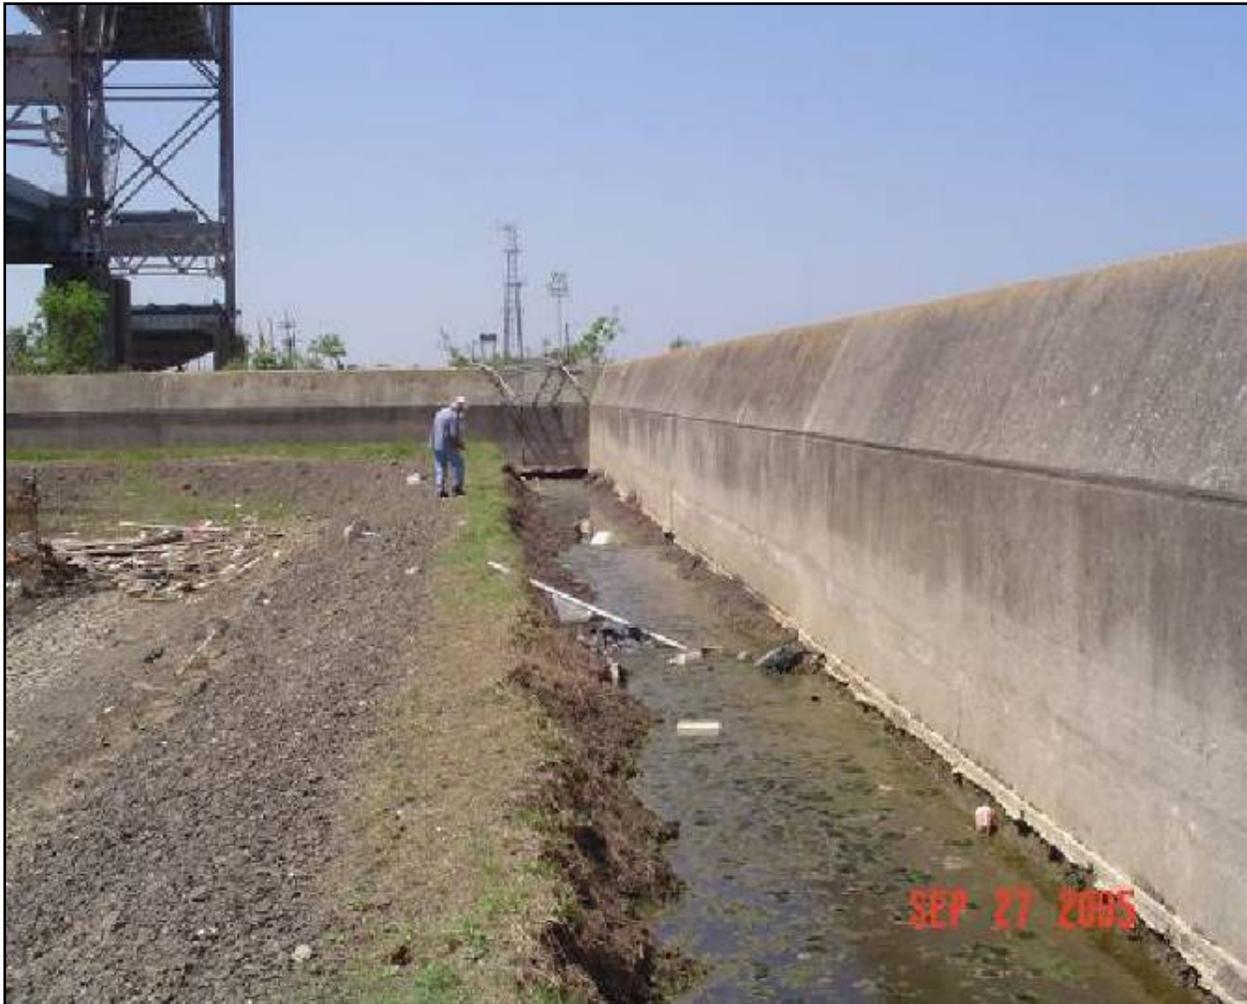
Figure STB 4. Section of Reach STB1 overtopped during Katrina (location is just north of Claiborne Avenue Bridge)

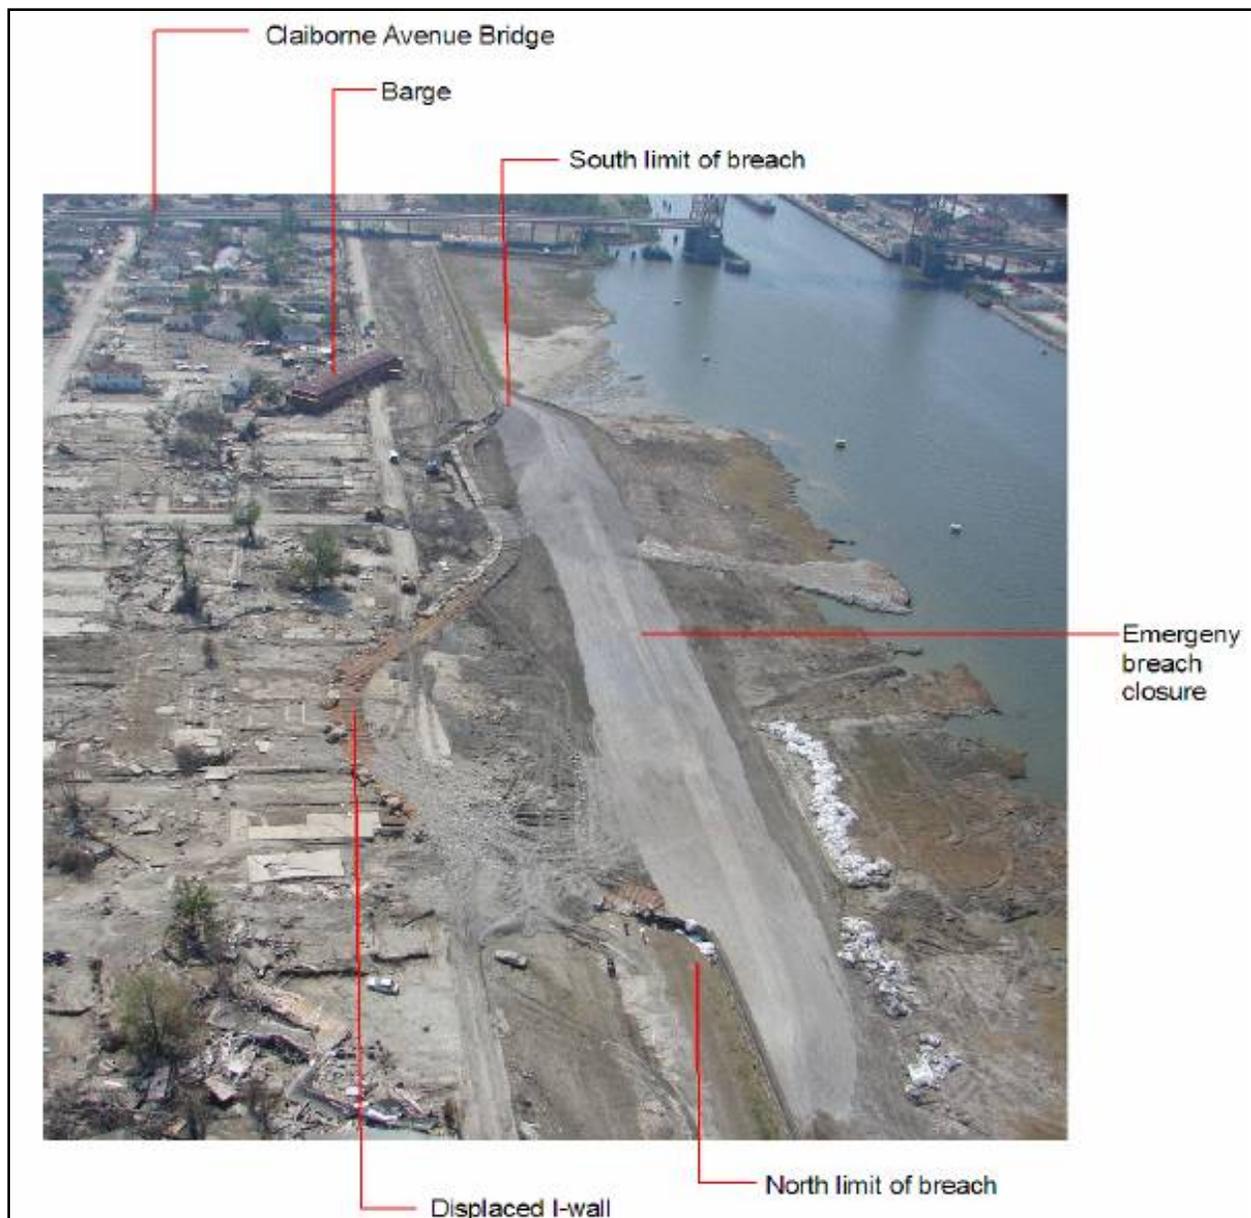
This reach also includes an I-wall between the Claiborne Avenue Bridge and the railroad bridge near Florida Avenue. There were two separate breaches of this I-wall during Katrina. The southern section of I-wall that failed in the Lower 9th Ward area of St. Bernard during Hurricane Katrina is shown in Figure STB 5. The northern section of I-wall that failed was near the blue railroad bridge close to Florida Avenue. This breach is depicted in Figure STB 7. There were no “key points” within this entire reach. Refer to changes made by Task Force Guardian (TFG) in the post-Katrina narrative.

Figure STB 5. Failed I-wall section of Lower 9th Ward (Reach STB2) (looking south along IHNC)

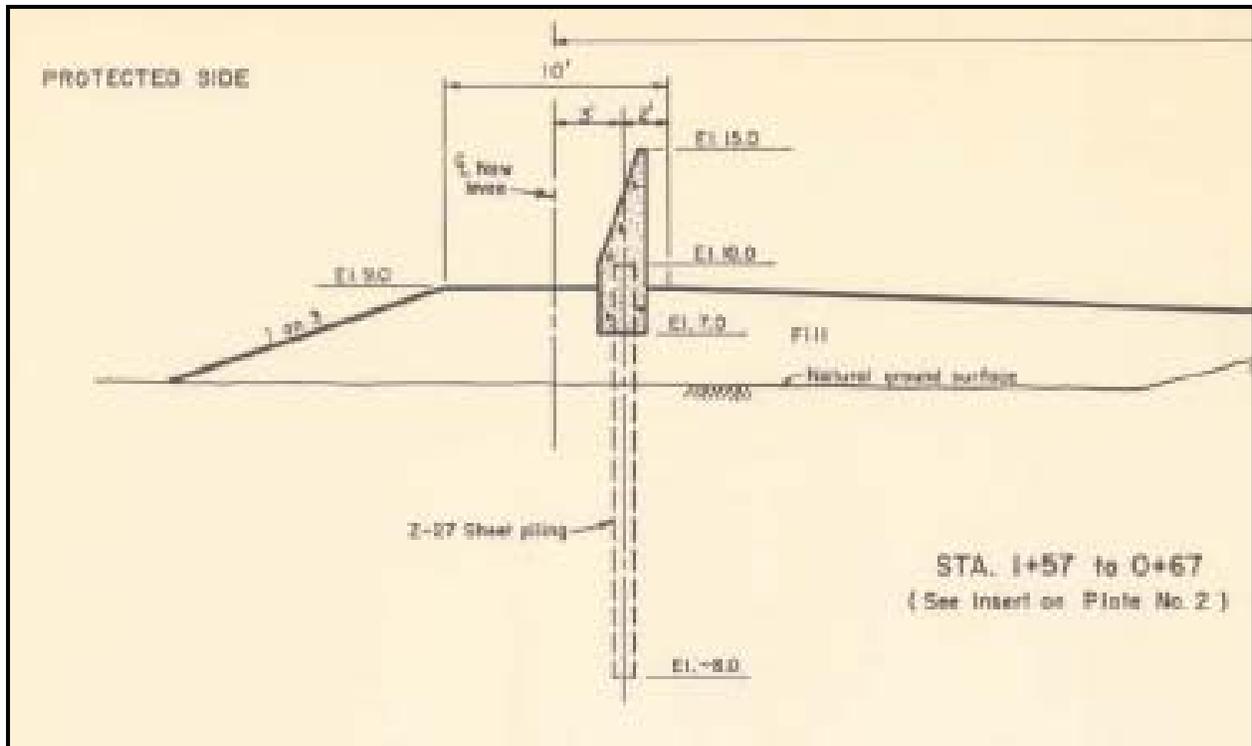
Figure STB 6. Pre-Katrina I-wall design section for Reach STB2 (depicts authorized elevations, not actual elevations)

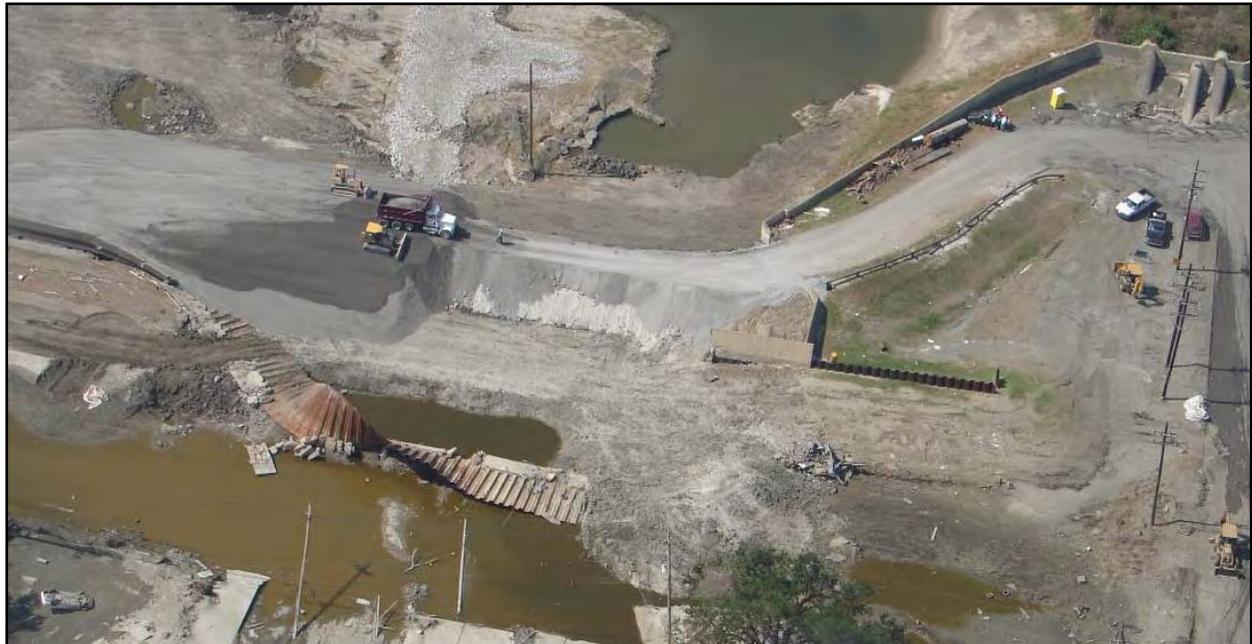
Figure STB 7. North I-wall failure within Lower 9th Ward (Reach STB2) (Note: pipes on right side of photo are associated with Pump Station #5)

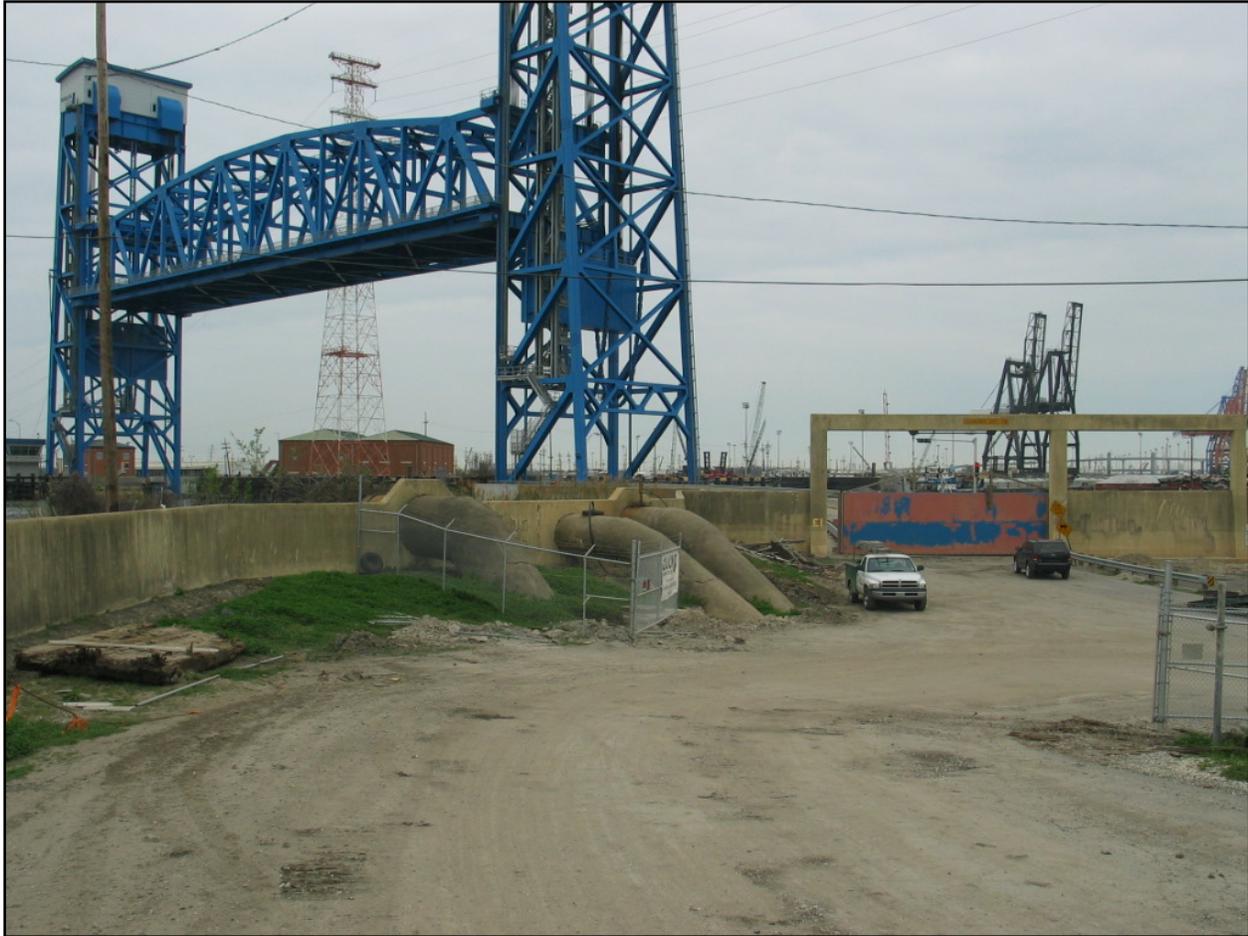
This also includes an existing T-wall that is located adjacent to the Surekote Road ramp over the floodwall. There are multiple key points within this reach including the closure gate E-1, as

shown in Figure STB 8. Closure gate S-1 at Harbor Road and Florida Avenue and railroad closure gate E-2 are also key points within this reach.

Figure STB 8. Existing T-wall near Florida Ave. Bridge (Reach STB3) (looking from protected side towards IHNC)

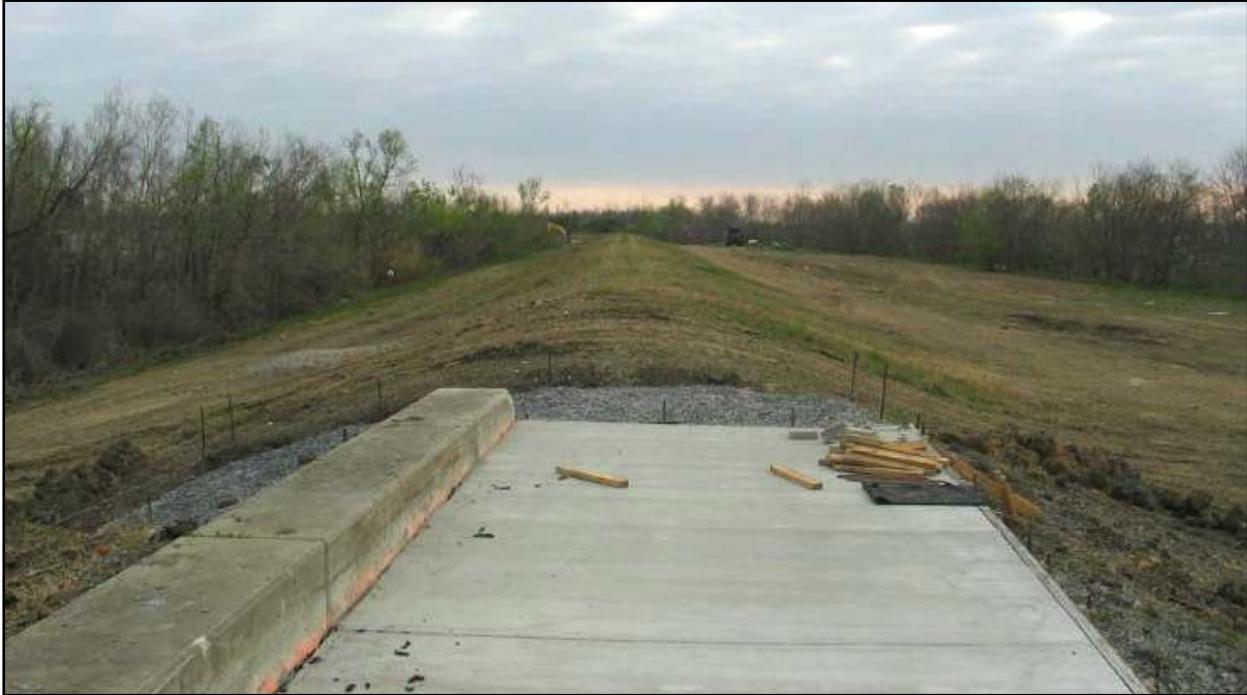
This reach also includes an I-wall that ties into the levee along the GIWW. There are no key points in this reach. This reach ends where the I-wall ties into the levee. This section of I-wall was overtopped during Katrina, but suffered no major damage. This reach is defined between the end of the IHNC I-wall and the floodwalls surrounding closure gates S-2 and S-3 near the Southern Scrap Building. There are no key points within this reach. This levee is depicted in Figure STB 9. There was no significant damage to this section from Katrina.

Figure STB 9. Beginning of Reach STB5 at end of I-wall (Note TFG improvements to Reach STB4 in foreground)

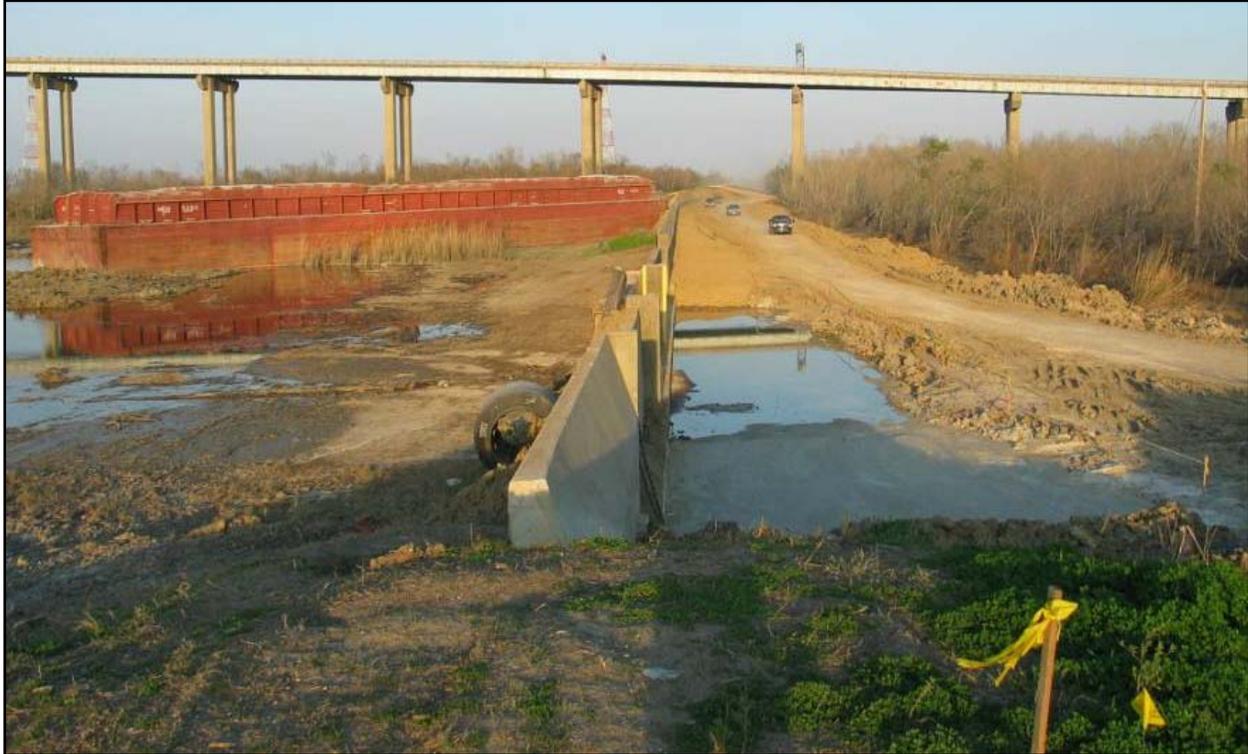
I-walls and T-walls just west of the Paris Road overpass along the GIWW. It is often referred to as the Paris Road floodwall. There is one key point (stb8a), a gate closure, within this floodwall reach. This structure was overtopped during Katrina, but only suffered scour damage. See Figure STB 10 for a photograph depicting this wall during repairs following Katrina.

Figure STB 10. Paris Road Floodwall (Reach STB8) (looking east from the west end of the floodwall)

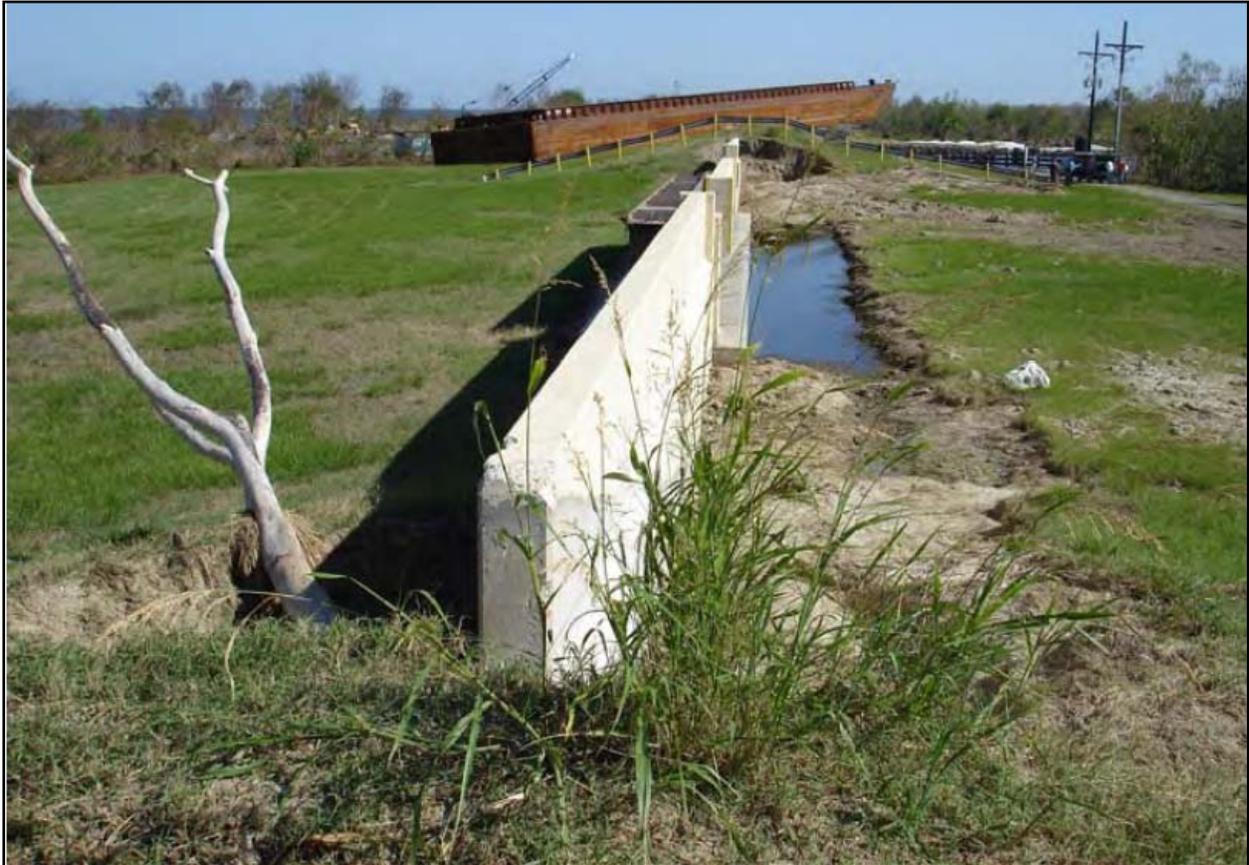
This reach is defined by a levee along GIWW that goes between the Paris Road floodwall and the floodwalls just prior to reaching the Bayou Bienvenue control structure. There are no key points within this reach. There was some overtopping in this reach during Katrina, but no major damage to the levee. This reach also includes a section defined by a relatively short 229-ft stretch of floodwall located just northwest of the Bayou Bienvenue Control Structure. During original construction, this short section of wall was to serve as an access point for an industry that was to be located near the Bayou Bienvenue Control Structure. However, the industry went out of business, and it has never been utilized, and the flood gate remains permanently closed. This section of wall was overtopped during Katrina as evidenced in Figures STB 11 and STB 12. Since the gate remains permanently closed, there are no “key points” within this reach.

Figure STB 11. Floodwall Northwest of the Bienvenue Structure (Reach STB10) (looking southeast toward Bayou Bienvenue just after Katrina)

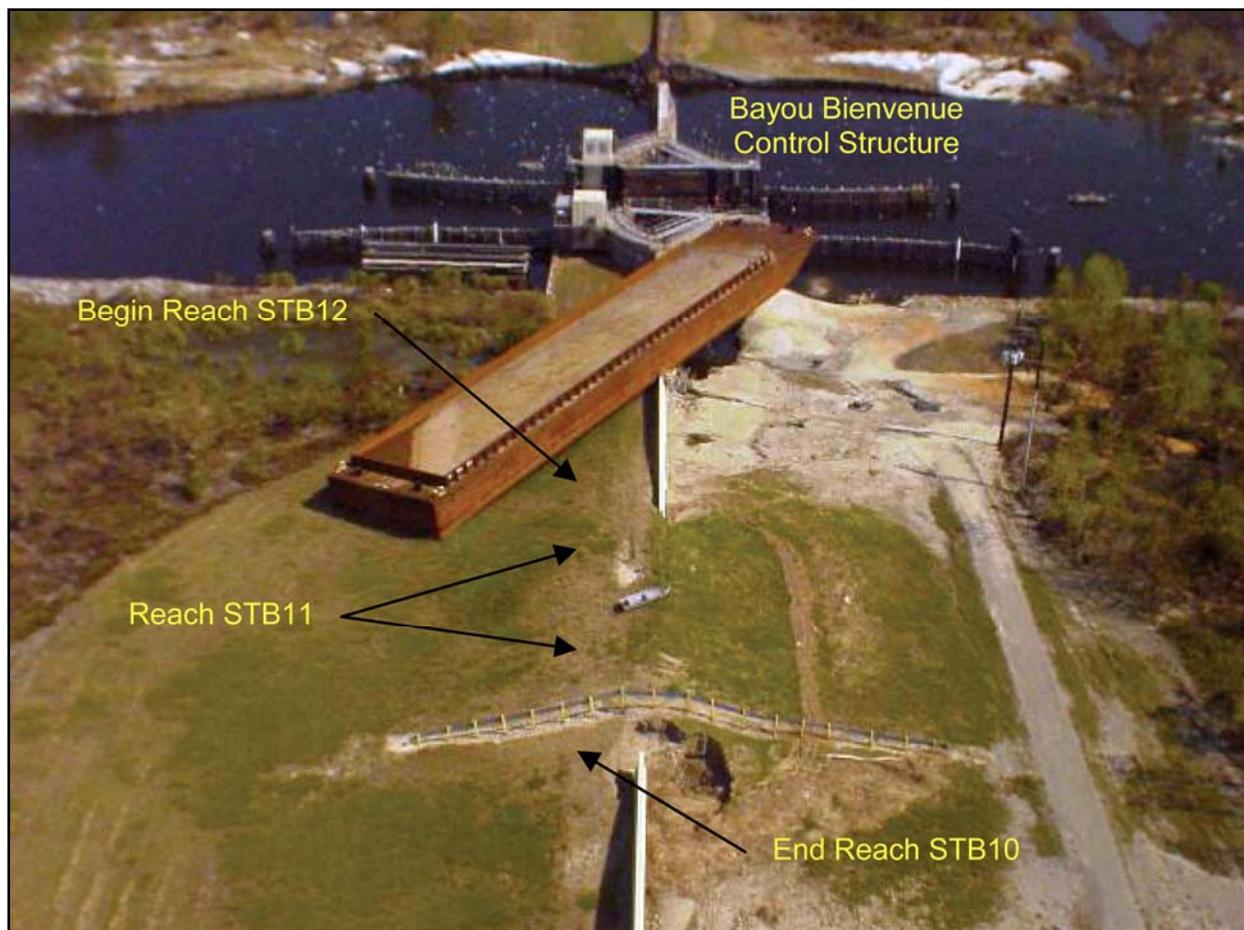
This reach also includes a short section of levee between the floodwall described in reach STB10 and the beginning of the floodwall leading to Bayou Bienvenue Control Structure. The levee section is only 96 feet long and received some damage during Katrina at the transitions to adjoining I-wall sections, as shown in Figure STB 12. There are no “key points” within this short reach.

Figure STB 12. Short levee section between floodwalls (Reach STB11)

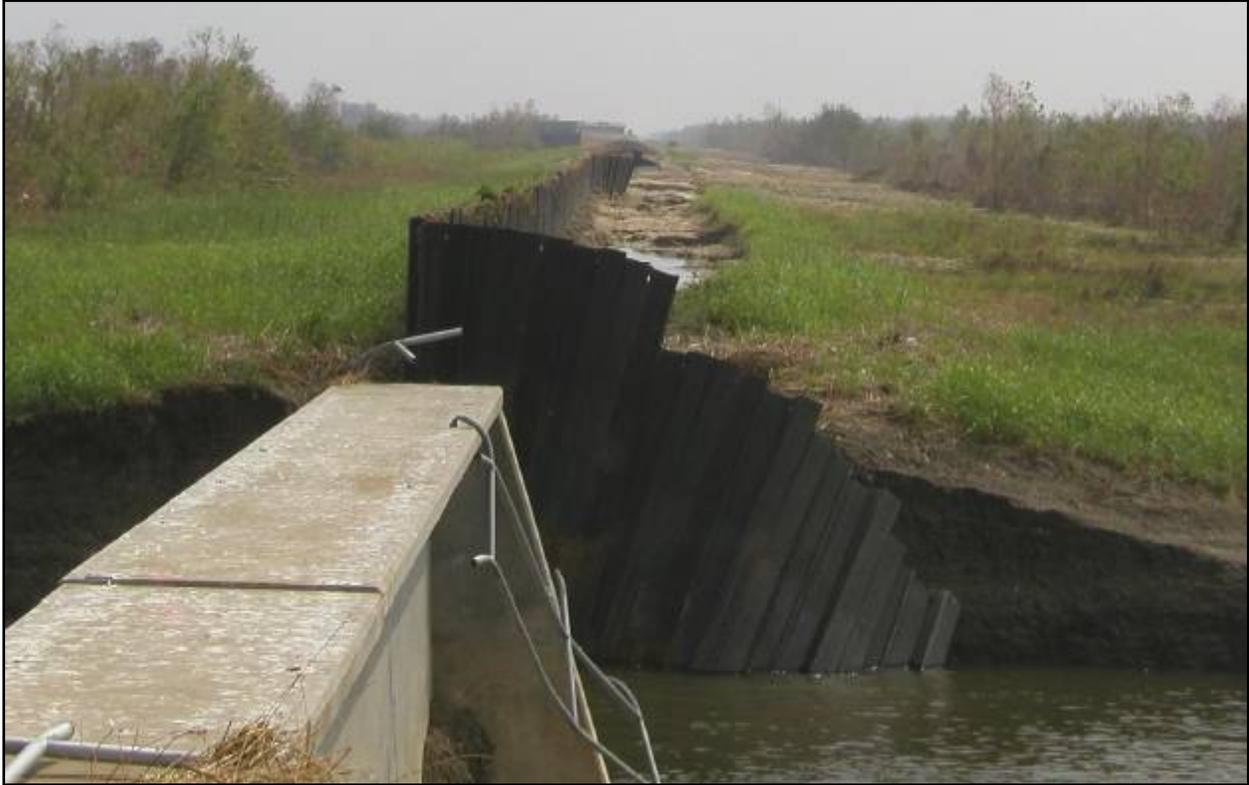
This reach also contains the Bayou Bienvenue Control Structure and surrounding floodwalls on either side of it. Prior to Katrina, this reach was made up of 77 feet of concrete capped I-wall, 187 feet of T-wall surrounding the control structure itself and an uncapped, sheet pile I-wall). As shown in Figures STB12, 13, and 14, the surrounding floodwalls received heavy damage and the uncapped I-wall section breached during Katrina. The sector gate closure itself serves as the only “key point” (stb12a) within this reach.

Figure STB 13. Uncapped I-wall Section on Southeast side of Bayou Bienvenue Control Structure (looking southeast along the MRGO)

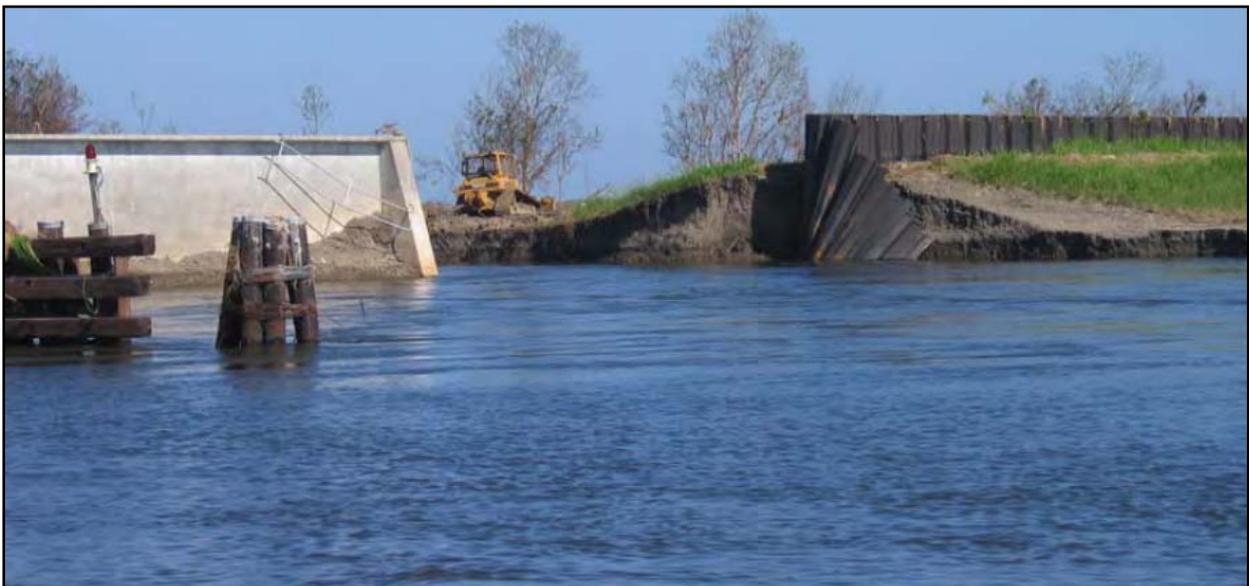
Figure STB 14. Picture of breached Bienvenue I-wall from Protected Side

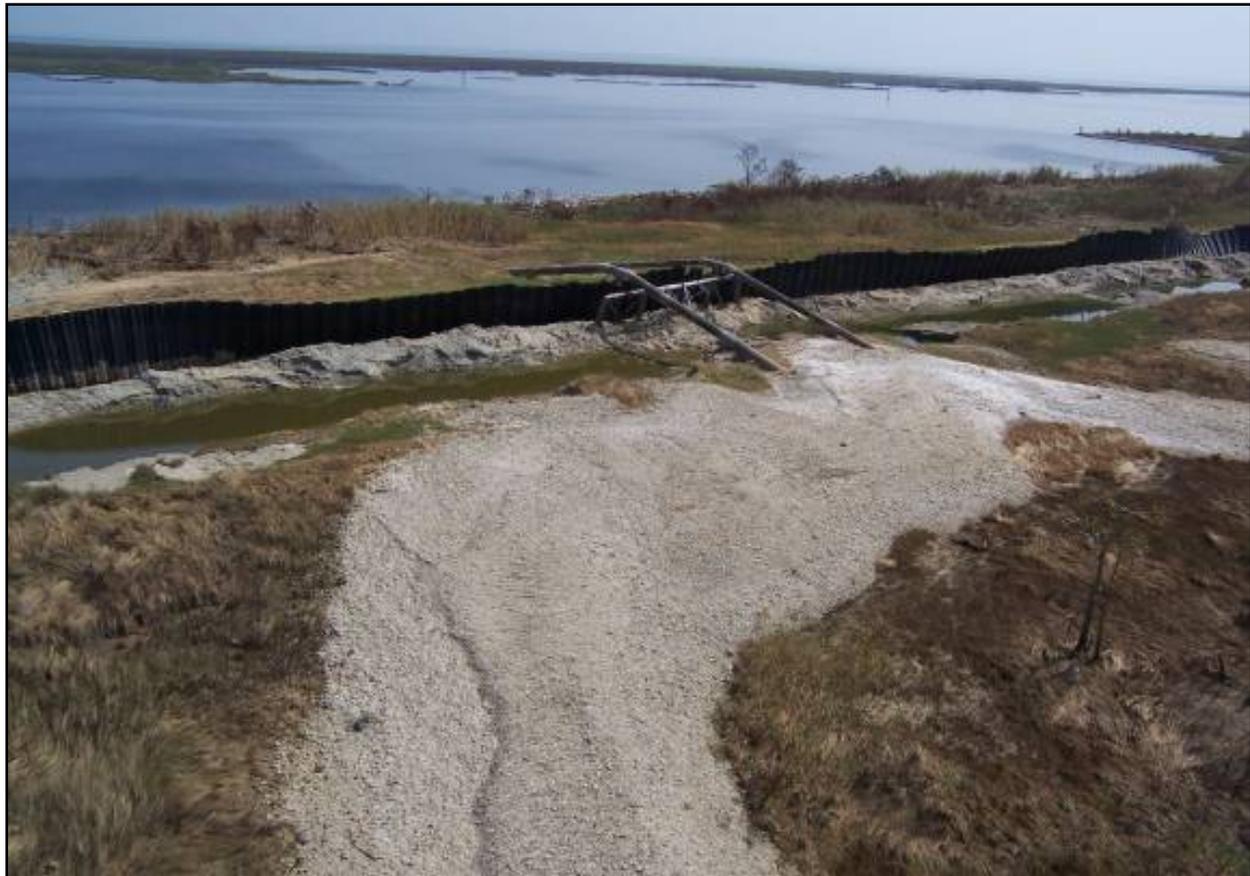
This reach includes an uncapped I-wall embedded within the levee. The sheetpile I-wall was installed in 1992 as part of USACE repairs along the MRGO. This section of wall was heavily damaged during Katrina, as evidenced in Figure STB 15. As shown in the photo, there are pipe crossings along this reach, but they extend over the levee and do not represent a major change in design or performance parameters; therefore, they are ignored in the risk assessment for this purpose.

Figure STB 15. Breached I-wall along MRGO

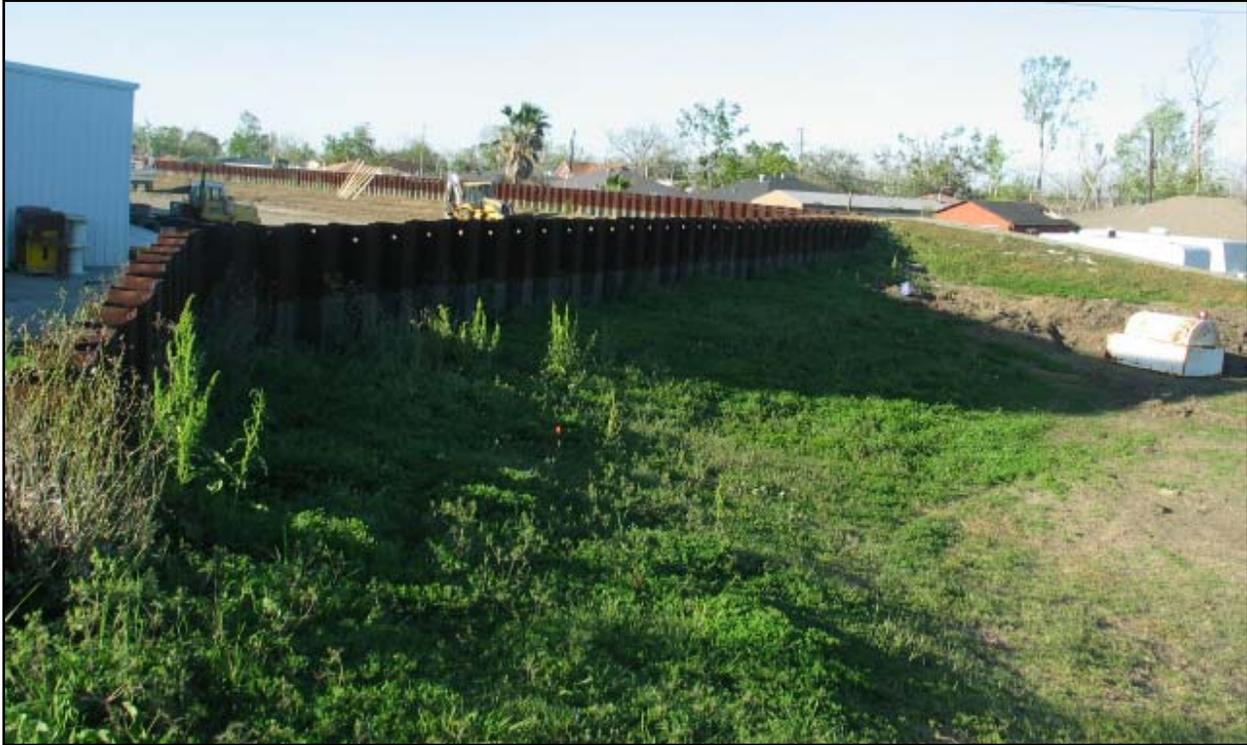
This reach is as a levee along the Caernarvon Canal. It starts on the east side at the where it ties into the west end of the Pump Station #8 floodwall and continues until it ties into a sheetpile wall near the Caernarvon Freshwater Diversion Structure. This section received little or no damage during Katrina. There are several utility crossings along this reach, but none significant enough to warrant as a “key point.” This reach consists an uncapped, sheet pile I-wall near the Caernarvon Freshwater Diversion Structure. There are no “key points” within this reach. It received little or no damage from Katrina. The reach has a weighted average top elevation of 12.8 (NAVD88) taken from a physical survey following Katrina. See Figure STB 18 for a photograph of this reach.

Figure STB 18. Uncapped Sheetpile I-wall near Caernarvon Canal (building on left side is on flood side)

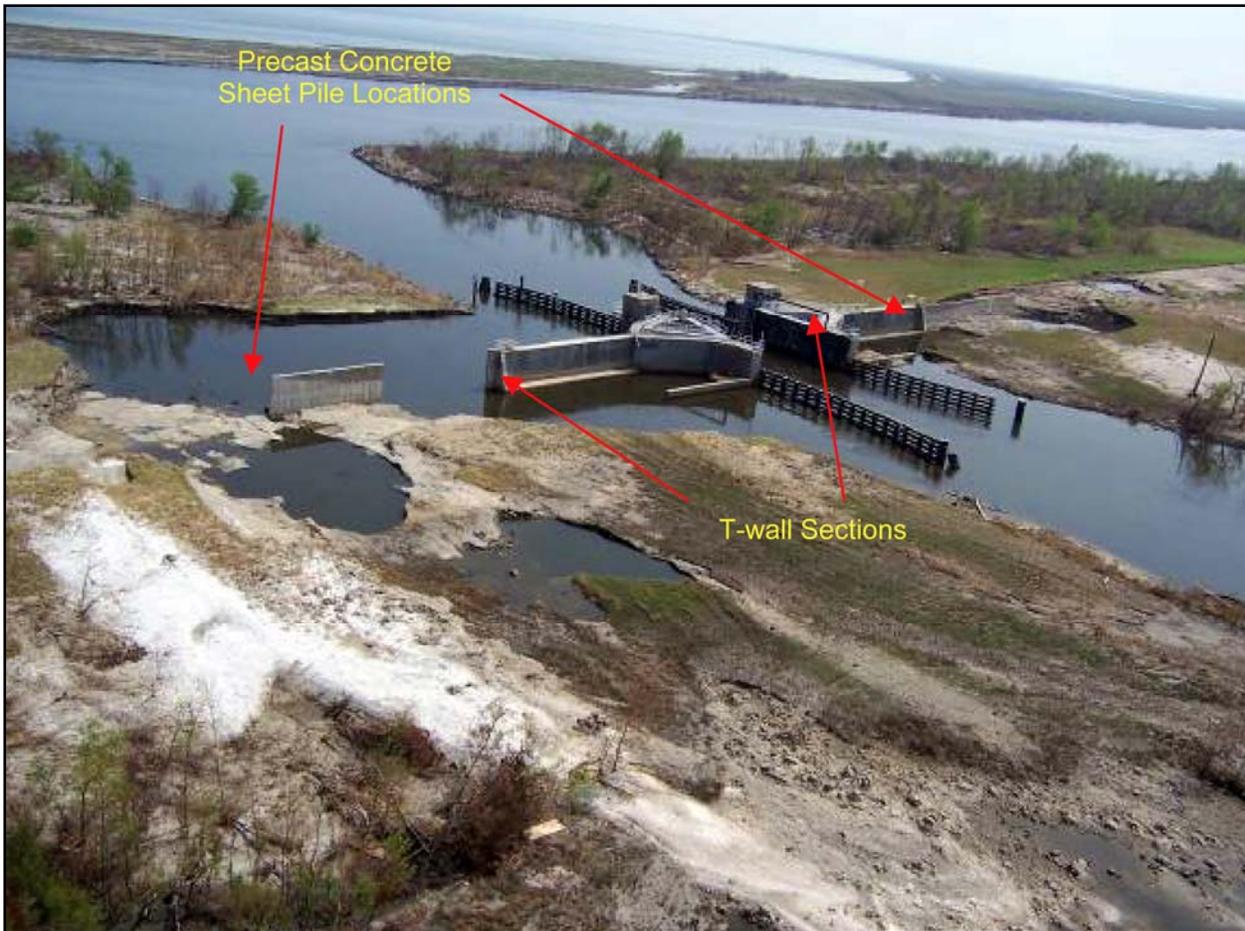
This stretch of levee runs from the end of the uncapped I-wall to the northwest transition wall leading to the Bayou Dupre Control Structure. This reach includes the Bayou Dupree Control Structure and the adjoining transition flood walls. Prior to Katrina, the reach started with 92 linear feet of precast concrete sheetpile wall on the northwest side of the gate structure, 69 feet of T-wall on the northwest side of the gate closure, 134 feet across the closure structure, 69 feet of T-wall on the southeast side of the closure structure, and 92 feet of precast concrete sheetpile wall on the southeast side of the closure structure. shown in Figure STB 16, the northwest precast concrete sheet pile I-wall failed during Katrina. The only “key point” in this reach is the closure structure itself.

Figure STB 16. Damage at Bayou Dupre Control Structure (note breached section of precast concrete pile wall)

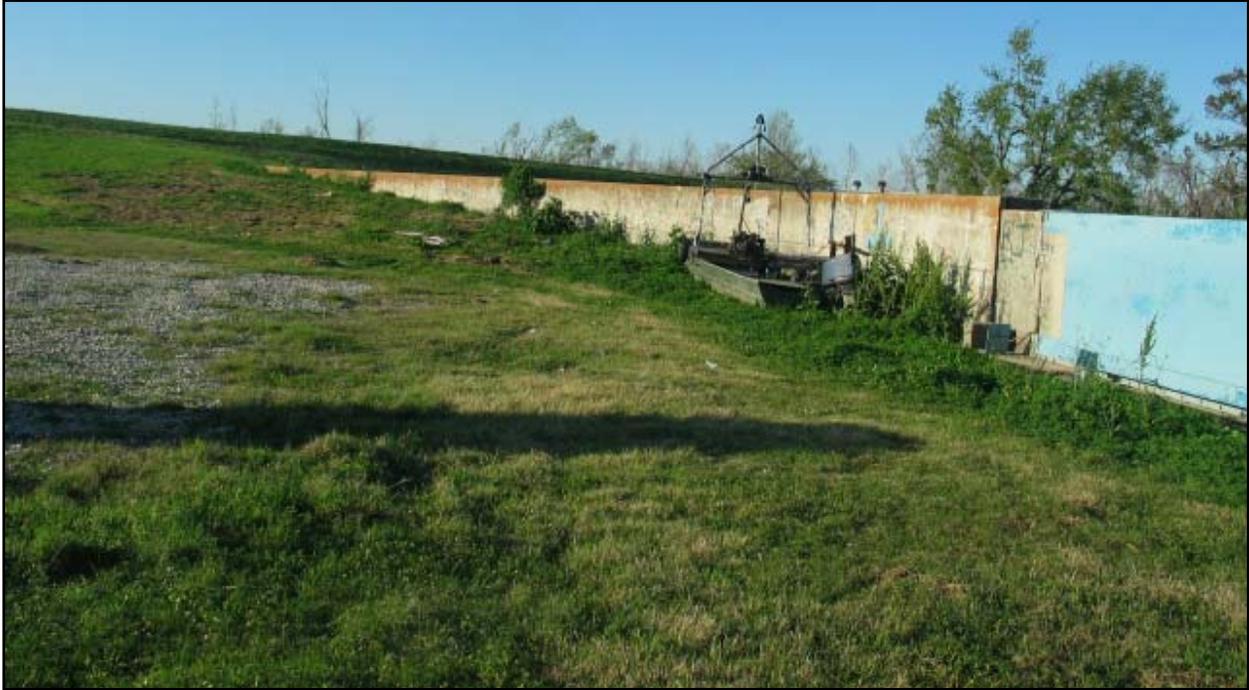
This reach consists of concrete capped I-walls that extend from the end of the sheetpile wall to where the Caernarvon section ties into the Mississippi River levee. There are two “key” points within this reach, and both are closure gates; one for a rail line and the other for Highway 39. The location where the floodwall ties into the higher Mississippi River levee is shown in Figure STB 19.

This reach is the most southern section of levee within the STB basin, as reflected as the higher ground area of Figure STB 19. Refer to Figure STB 2 for reference to the reach location relative to the entire basin. The reach consists of a levee, and it ends at the southern end of the concrete capped I-wall near the Battlefield site along the Mississippi River. This reach consists of concrete capped I-wall near the Battlefield site. There is one key point with this reach, and it is a small access closure gate. A typical stretch of this wall along with the access closure gate is shown in Figure STB 20.

Figure STB 19. Caernarvon Canal Floodwall tie-in to higher MRL (gate is for Highway 39 closure)

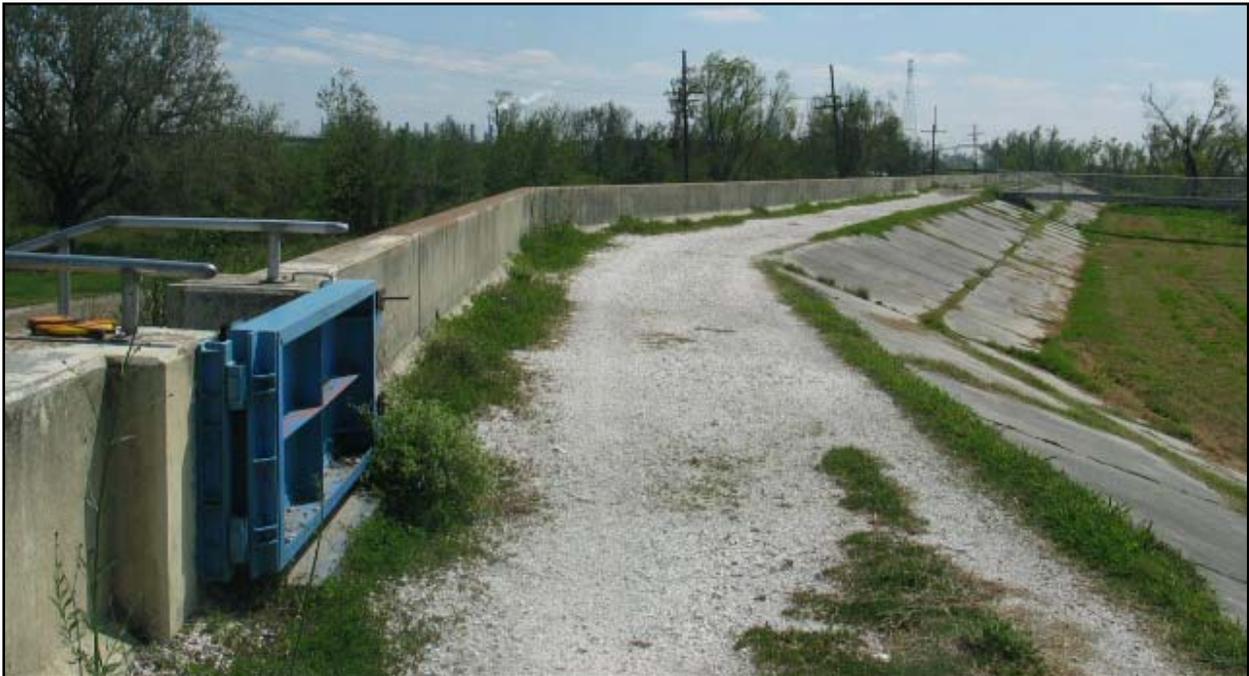
Figure STB 20. Concrete capped I-wall along Miss. River near Battlefield (access closure gate is key point within this reach)
