Appendix 6

St. Bernard Basin

STB Basin – Layout of Reaches for Risk Model by Physical Feature (Pre-Katrina)

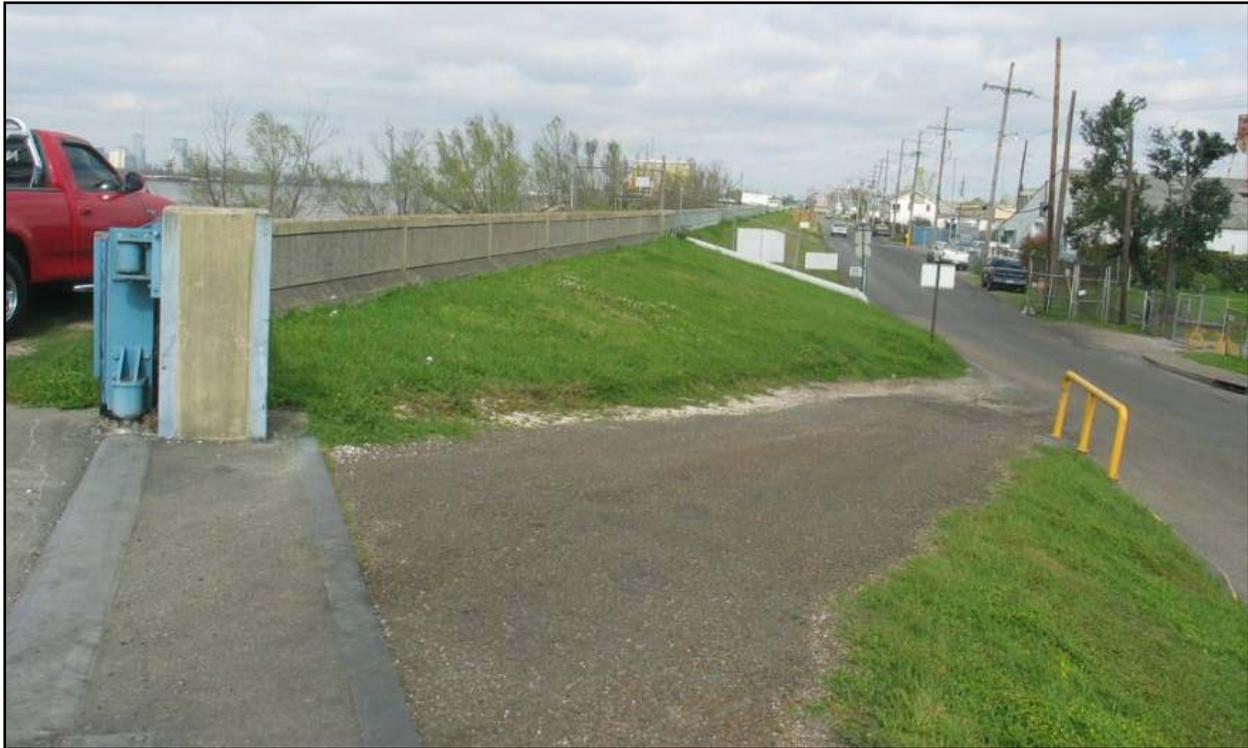
defined by of a concrete capped I-wall that begins near the Domino Sugar Plant. There are three key points within this reach, all of them closure gates. One is located at the Domino Plant, one at the Port Ship Service Dock, and the last one at Mehle Avenue. One of the closure areas and typical I-wall along this stretch is shown in Figure STB 21.

Figure STB 21. Concrete capped I-wall near Domino Sugar Plant (closure represents key point within this reach)

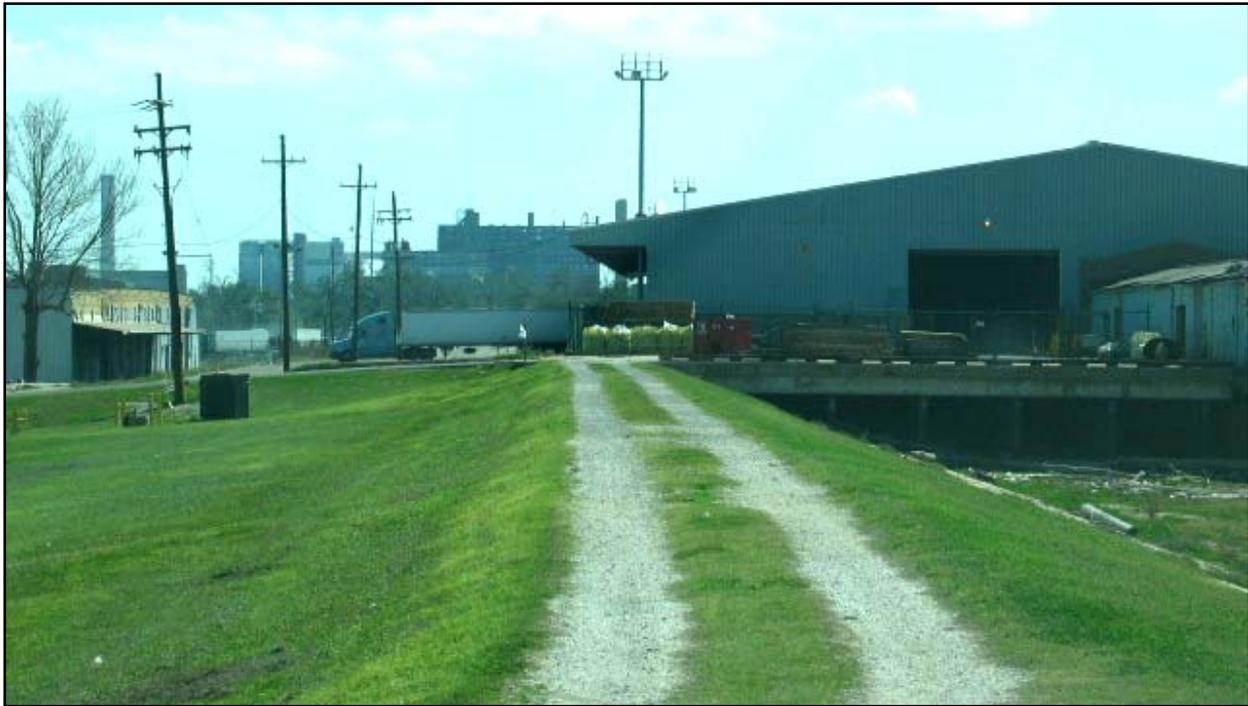
This reach consists of a levee that is primarily covered with paved slopes and roads. It begins near the Jackson Barracks and ends at the warehouse and dock area near Flood Street. There are no key points within this reach, although there are some pipe crossings noted but not considered significant enough to effect the overall reliability of the reach. The end of this reach (viewed from the Reach STB30 side) is shown in Figure STB 22.

Figure STB 22. End Reach STB31 where levee ties into Dock Facility (Viewed from Reach STB30 side)
