Katrina Hindcast - Scenario A1: Maximum surge elevation in and around St. Bernard Parish

Katrina Hindcast - Scenario A1: HWM comparison of model to data

Katrina Hindcast - Scenario A1: Flooding conclusions for Plaintiff Properties

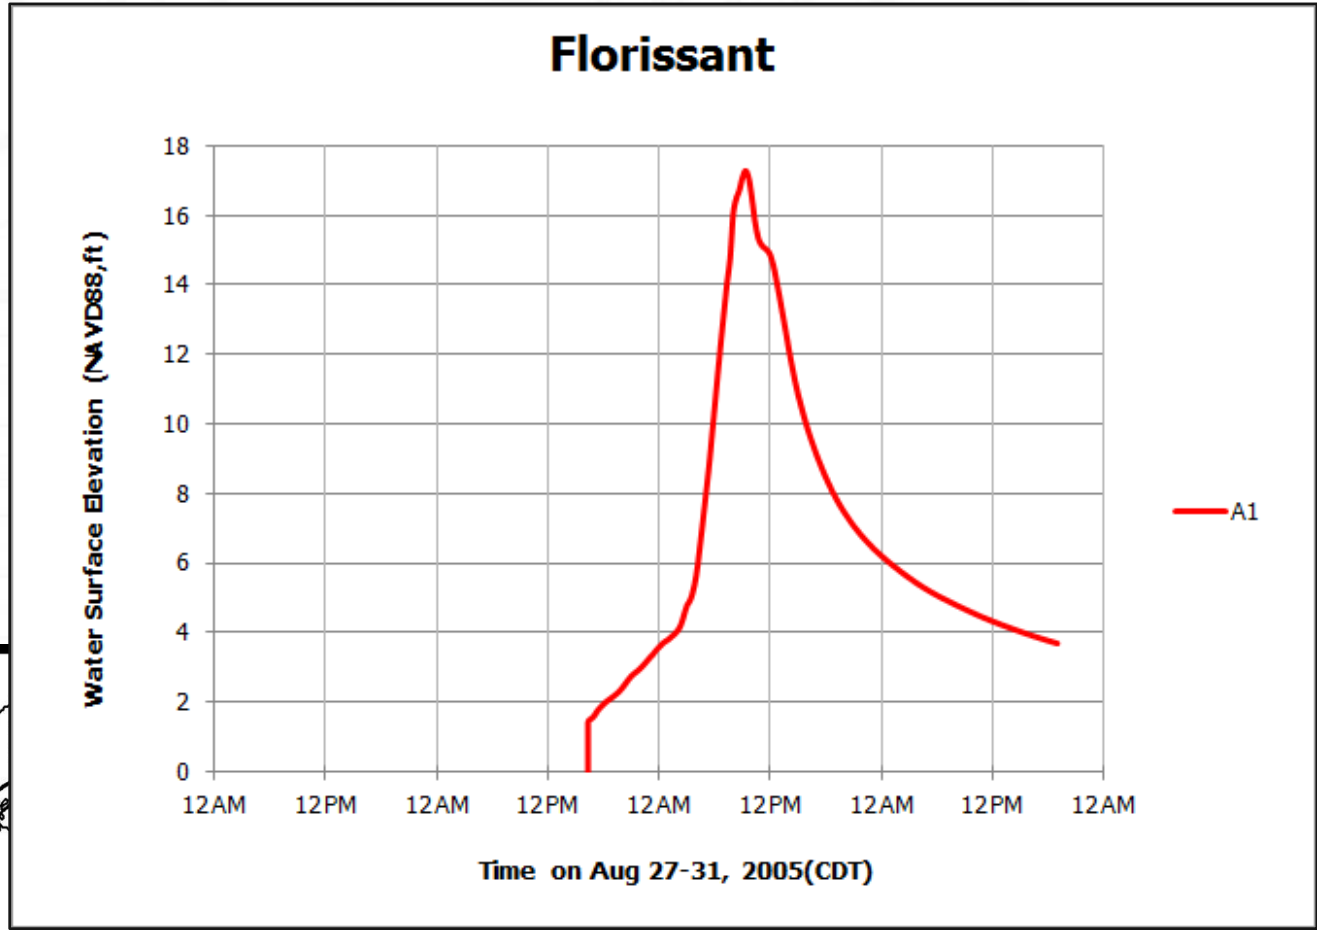
Figure 22q

- The next series of slides (Figures 22a-q) features hydrographs that show the flooding and timing of the flooding interior to St. Bernard Polder and on each Trial Property.
- Specifically, I have plotted hydrographs for the Scenario A1 modeling results at several additional non-Plaintiff Properties located in close proximity to the Plaintiff Properties.
 - The non-Plaintiff interior hydrographs are plotted against historic high water level data or stopped-clock data collected at each of these locations.
 - The Scenario A1 **ADCIRC** modeling accurately depicts flooding at each of these locations, closely matching both the elevations and *timing* of the high water data recorded during Hurricane Katrina.
 - These results further validate the **ADCIRC** modeling inside St. Bernard Polder, and confirm the accuracy of the results reached at each of the Plaintiff Properties.

Plaintiff Location "Florissant"

Location	Scenario A1
Adams	10.5
SBP #1	10.7
SBP #2	10.8
Tommaseo	11.0
SBP #3	11.3
SBP #4	11.5
Steve's RV	11.5
SBP #5	11.5
Bordelon	11.6
PSSI	11.7
Florissant	17.3
