**Expert Report**  
**of**  
**Robert Glenn Bea, Ph.D., P.E.**

Katrina Canal Breaches Consolidated Litigation  
[Civil Action Number: 05-4182 “K” (2)]

United States District Court  
Eastern District of Louisiana

**Pertains to: MR-GO, Robinson**

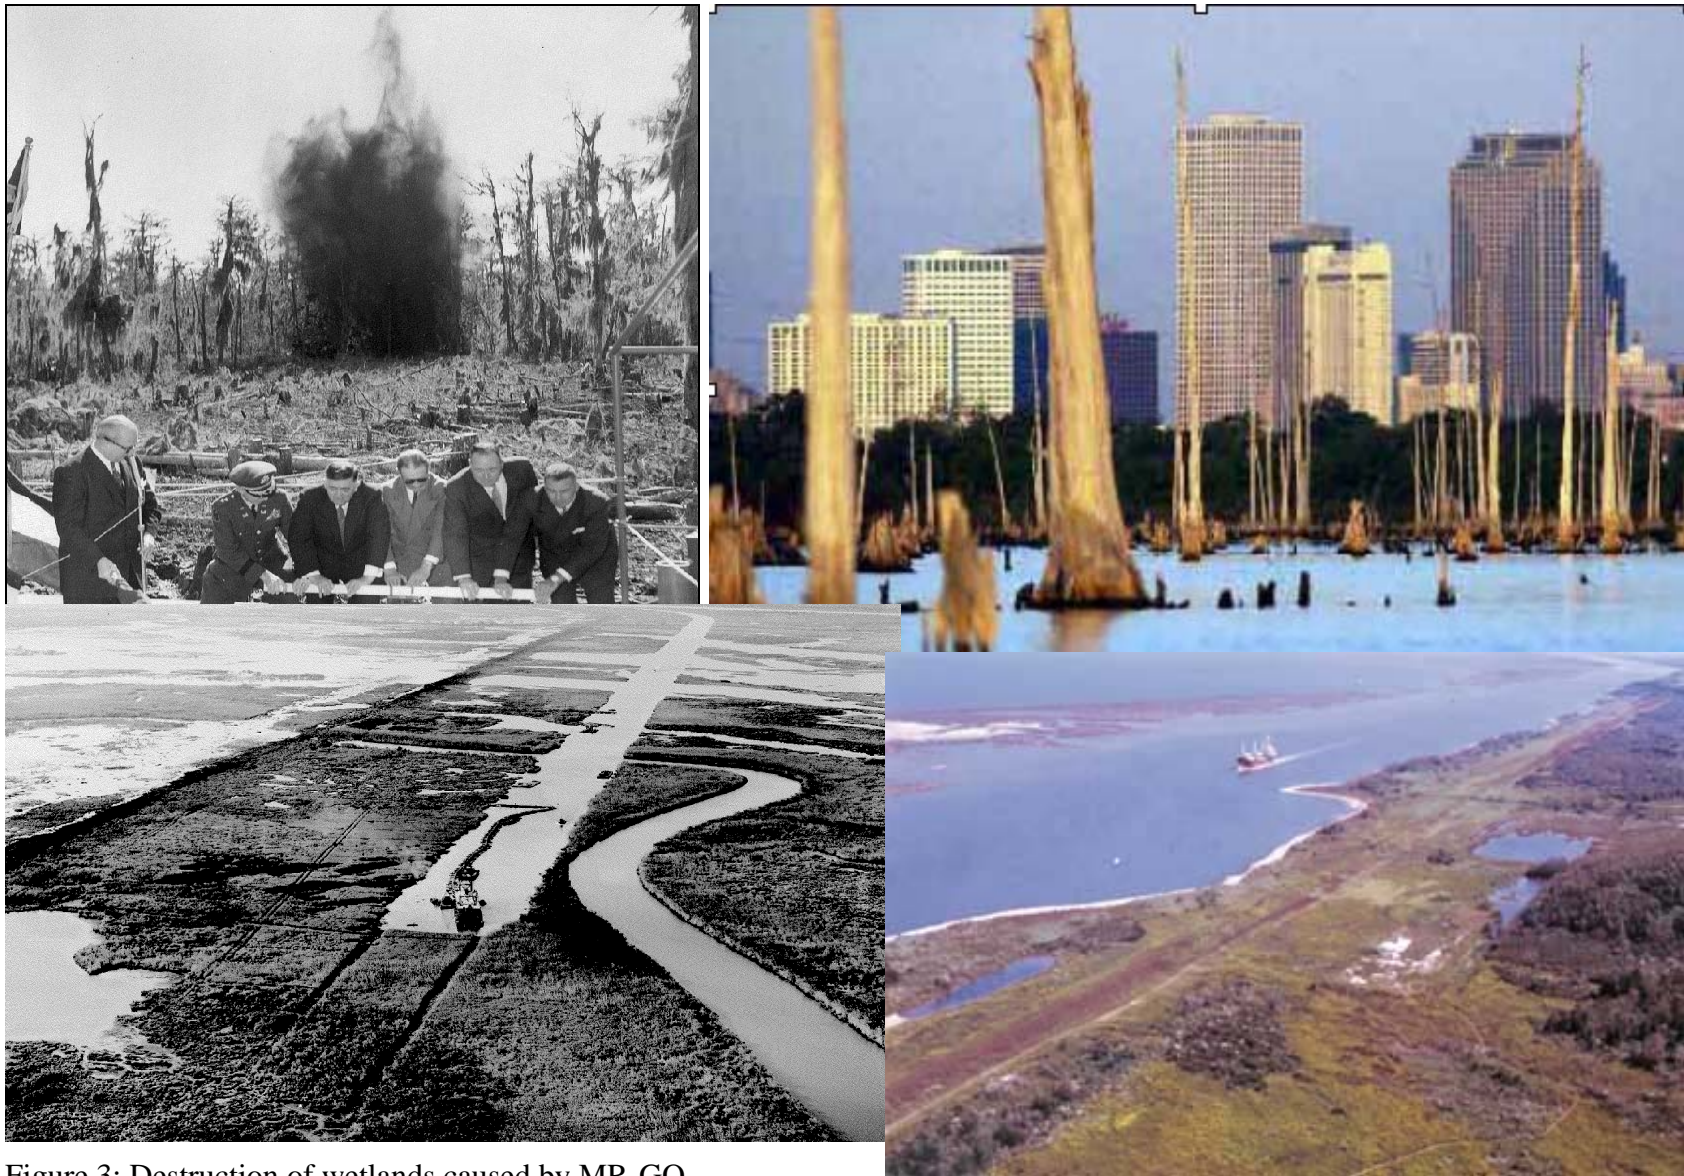
3. **Loss of Existing Wetlands** - Selection of land route for the MR-GO Deep Draft Navigation Channel and subsequent salt water intrusion and channel erosion caused catastrophic damage to existing trees, swamp, and wetland vegetation, ground cover, and inhibited the natural sustenance of these features after channel construction was completed (Figure 3). This damage and the absence of sufficient sustenance significantly reduced the areas natural ability to reduce surge heights and wave action.

Figure 3: Destruction of wetlands caused by MR-GO.

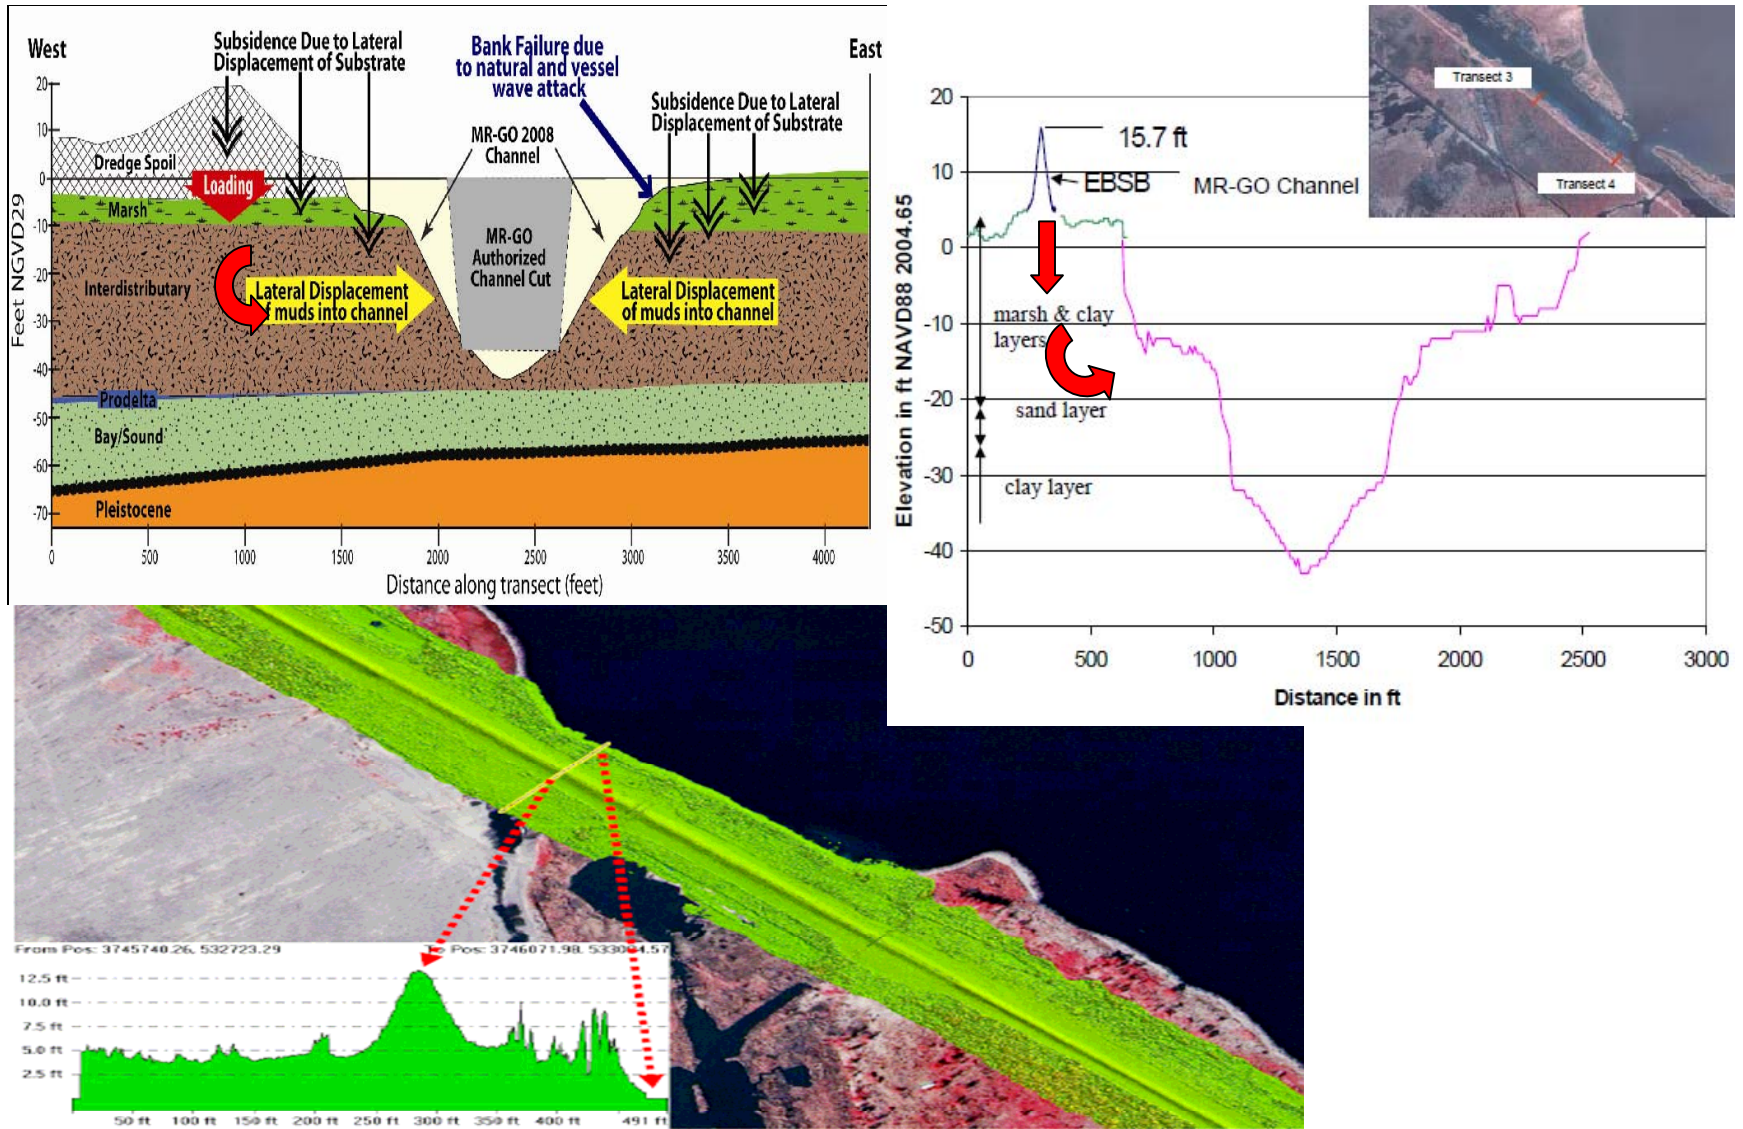
6. **Accelerated and Increased Settlement** - The close proximity of the deep water MRGO navigation channel to the MR-GO hurricane flood protection structures increased settlement (due to soil creep and ‘squeezing’) and loss of levee crest elevation (Figure 6). The proximity of the MR-GO channel to the hurricane flood protection structures also threatened their stability. The low areas of the levee crest had an increased exposure to both erosive wave action and overtopping. Many of the portions of the levee that were the lowest at the time of Katrina experienced the most breaching. This series of connections provides a direct link between the MR-GO channel and the flooding of populated areas.

Figure 6: Accelerated and increased settlements caused by encroachment of MR-GO channel.

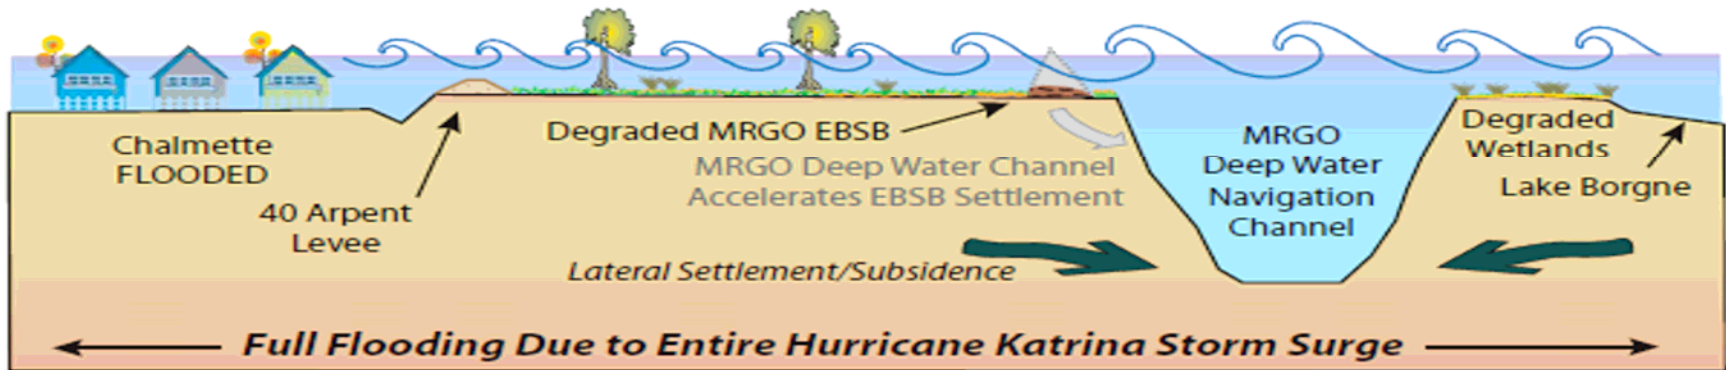
**MRGO Levees WITH the MRGO Deep Water Navigation Channel (Scenario 1)**

**MRGO Levees WITHOUT the MRGO Deep Water Navigation Channel (Scenario 2C)**

Figure 8: Flooding of St Bernard Parish due to Hurricane Katrina and due to Hurricane Katrina with a Neutral MR-GO.

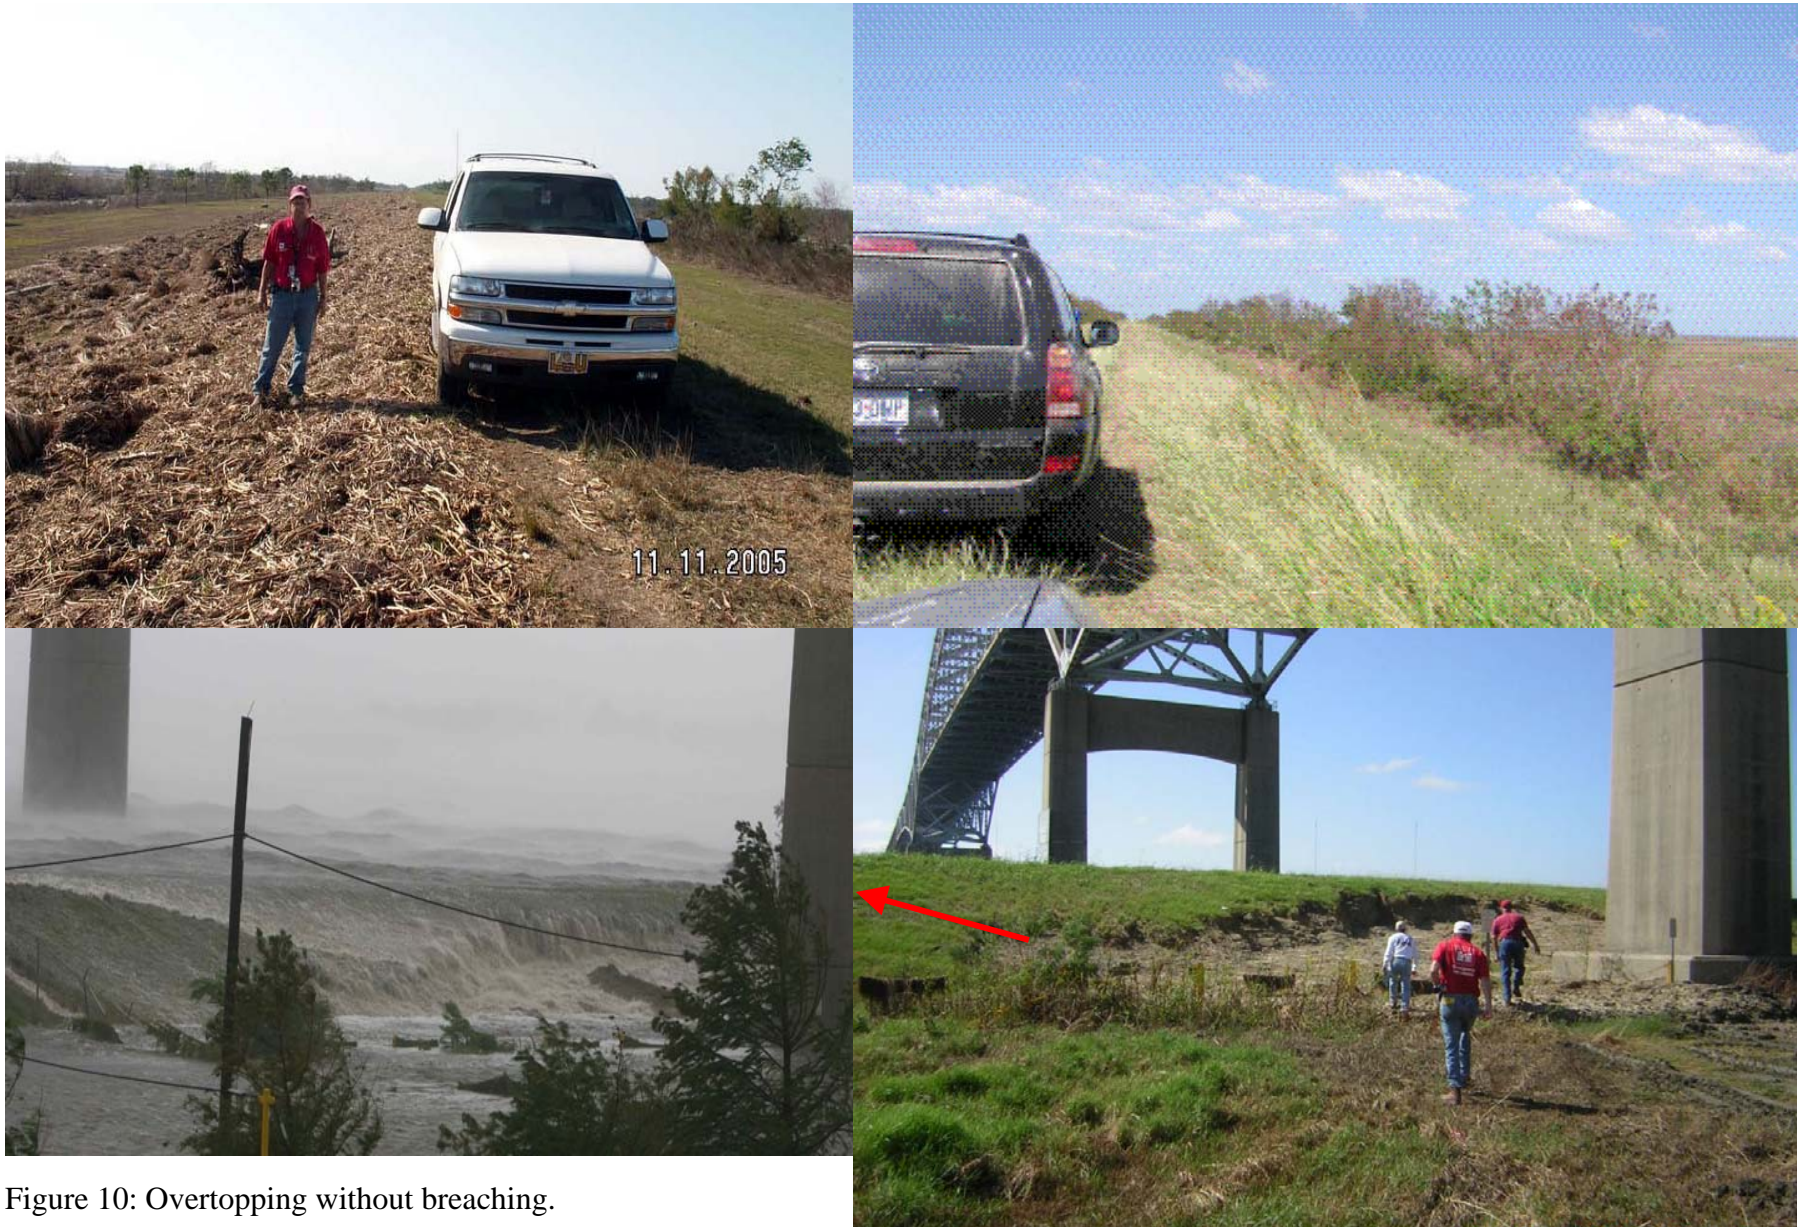
14. To examine the impact of wave action on performance of the earthen flood protection structures one should look at the impact of overtopping without wave action on nearby flood protection structures (Figure 10). Overtopping alone does not mean that a flood protection structure (e.g. earthen levee) will be breached or fail, as the following examples illustrate.

- The hurricane protection earthen levee south of Reach 2, in the area where the levee does not front along the deepwater navigation channel, suffered no breaching even though significant overtopping occurred in this area. It should be noted that this section of levee is fronted by natural wetlands.
- The hurricane protection levee that fronts the eastern side of New Orleans East west of the Paris Road Bridge was severely overtopped and did not fail. This levee was protected from hurricane waves by the fronting wetlands.
- The south side of the Intracoastal Waterway levees were exposed to significant overtopping, yet no breaching occurred.

Figure 10: Overtopping without breaching.

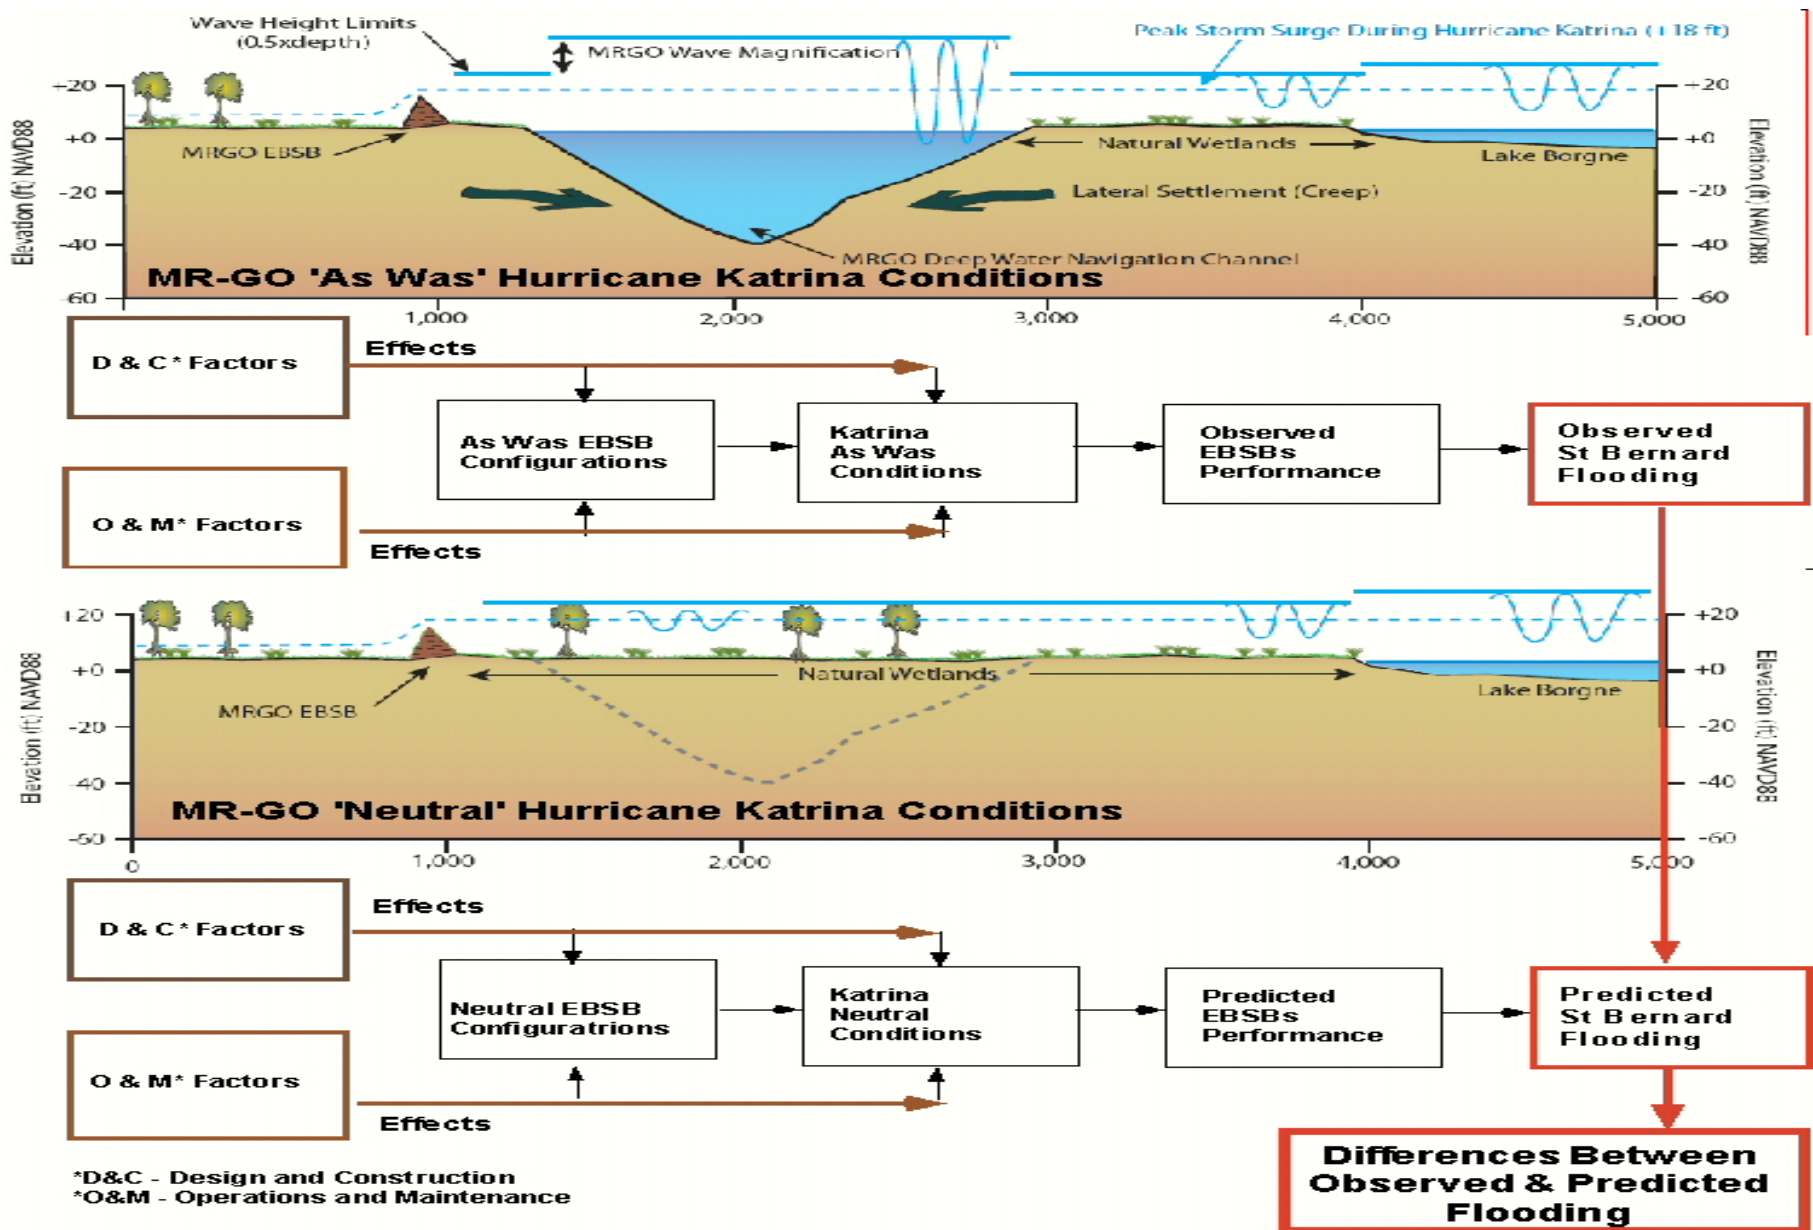
18. Figure 12 is a schematic structure (mental map) of the primary ‘elements’ that I have considered in my July 2008 Expert Report pertaining to the effects that the MR-GO had on the performance of the man-made earthen flood protection structures (Earthen Berm – Spoil Banks; EBSBs) sited along Reach 2 of the MR-GO (Bea 2008). I have used the same approach during my review of the observations, analyses, and opinions documented in the December 2008 Defense Expert Reports by Mr. B. Ebersole, Dr. D. Resio, Dr. R. Mosher, and Dr. T. Wolff.

20. Two general categories of environmental conditions are defined in Figure 12 (Figure 5): MR-GO ‘As Was’ Hurricane Katrina conditions (Scenario 1), and MR-GO ‘Neutral’ Hurricane Katrina conditions (Scenario 2C). ‘D&C Factors’ refers to the factors involved in design and construction of the MR-GO channel. ‘O&M Factors’ refers to the factors involved in the operation and maintenance of the MR-GO channel. The combination – integration - of multiple effects from the MR-GO D&C and O&M factors had very important cumulative adverse effects on the performance of the man-made flood protection structures adjacent to Reach 2 of the MR-GO during Hurricane Katrina. The integrated effects of the MR-GO life-cycle activities on the ‘hydrologic system’ are addressed in greater detail in my October 2008 Declaration (responding to Defendant’s Motion for Partial Summary Judgment).

23. The structure in Figure 12 defines two categories of:

Figure 12: Schematic structure of review of Defense Expert Reports.
