DECLARATION OF ROBERT G. BEA

II. PERFORMANCE OF THE MR-GO REACH 2 MAN-MADE FLOOD

PROTECTION STRUCTURES DURING HURRICANE KATRINA 38

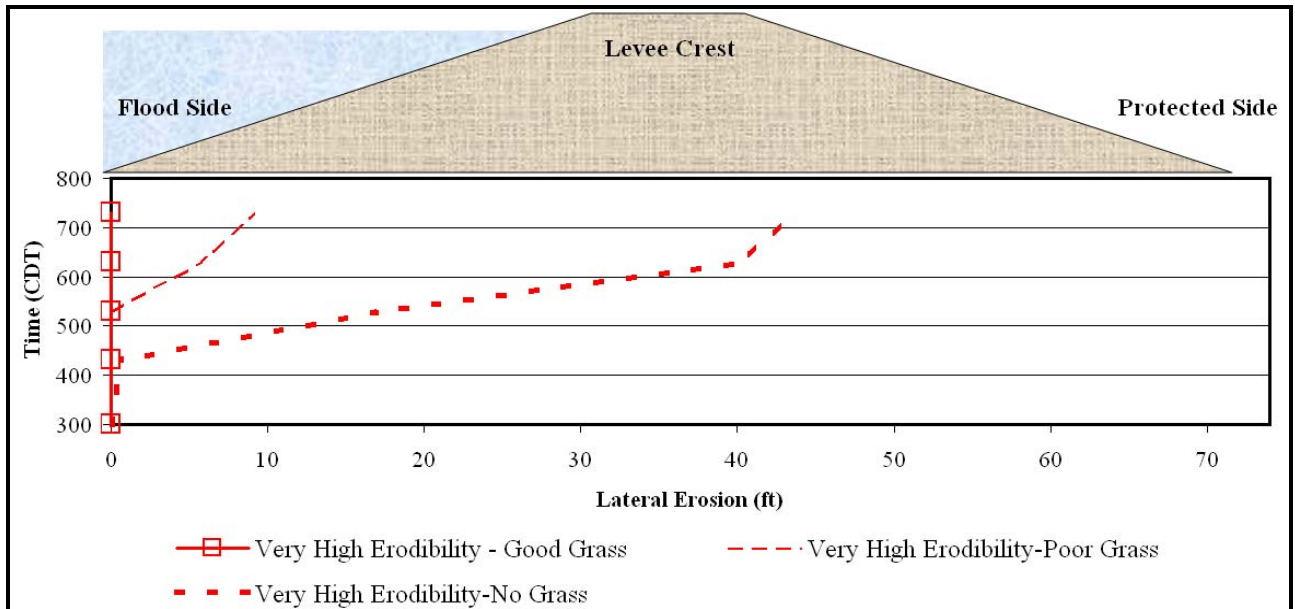
Figure 2: A plot of lateral erosion induced from wave-attack on the MR-GO EBSB for the Scenario 2C hydrodynamic conditions with very high erodibility materials and different levels of grass armor (good grass turf, poor grass turf, and no grass turf).

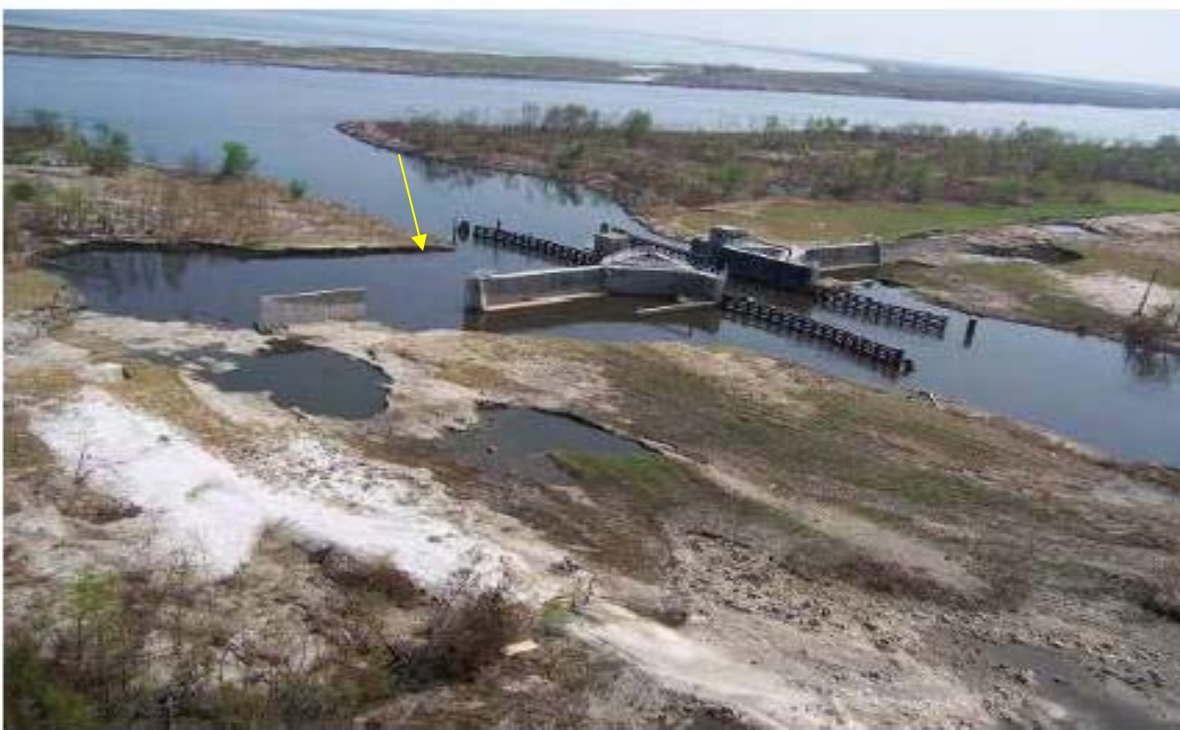
103. Figure 3 is a copy of the figure referenced in this quotation. Figure 3 shows the breach that purportedly developed during Hurricane Katrina at the north end of the Bayou Dupre structure's interface with the adjacent EBSB. The referenced photograph clearly shows the missing concrete sheet piling section and the very large scour holes that are referred to in this quotation. No other analyses, data, or information are cited to justify the observations and conclusions that were reached about development of this large breach in the flood protection structure. The conclusion is that these features developed during Hurricane Katrina.

Figure 51. Bayou Dupre Control Structure

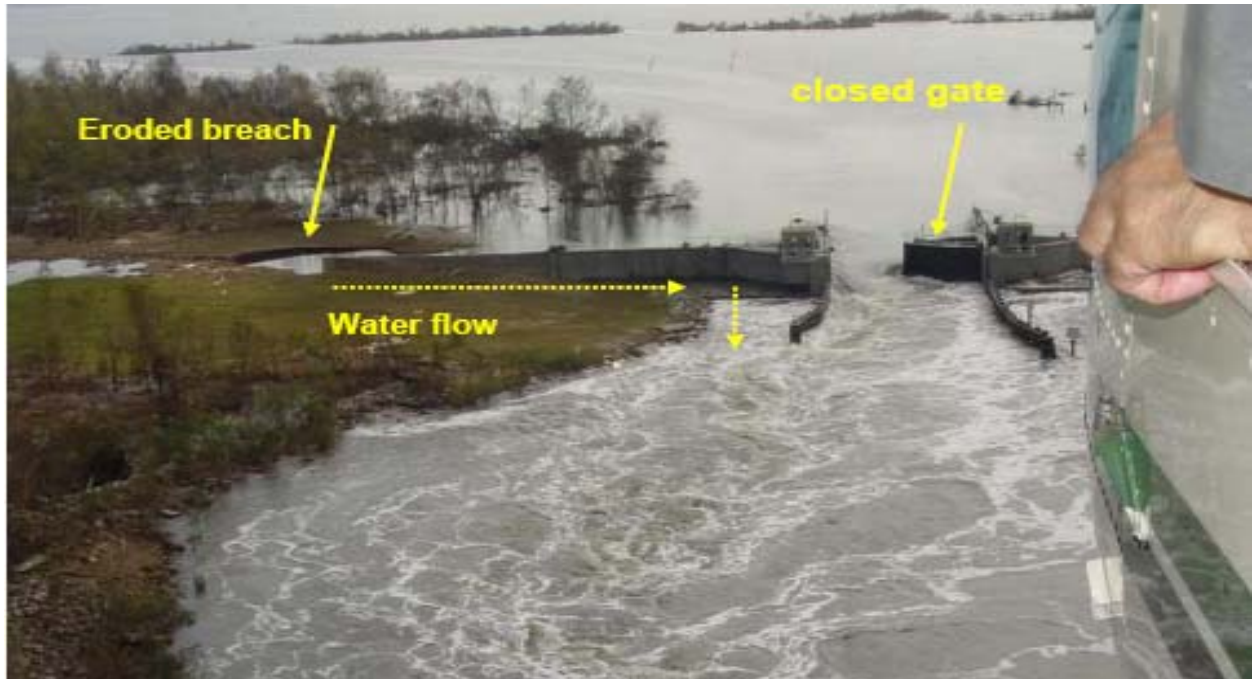
106. The photographs taken the morning following Hurricane Katrina clearly do not show the same ‘features’ as those found during the time following Hurricane Rita (e.g. Figure 3). The erosional feature at the concrete sheet pile – EBSB interface is much narrower. The breach has not developed fully at the interface with the adjacent EBSB. The concrete panel has not separated from the adjacent sections – it is intact. The strong flood and storm tide flow is evident.

Figure 10: Large eroded breach at the contact between the north end of the concrete navigation lock structure at Bayou Dupre and the adjacent EBSB (EPA 2005).

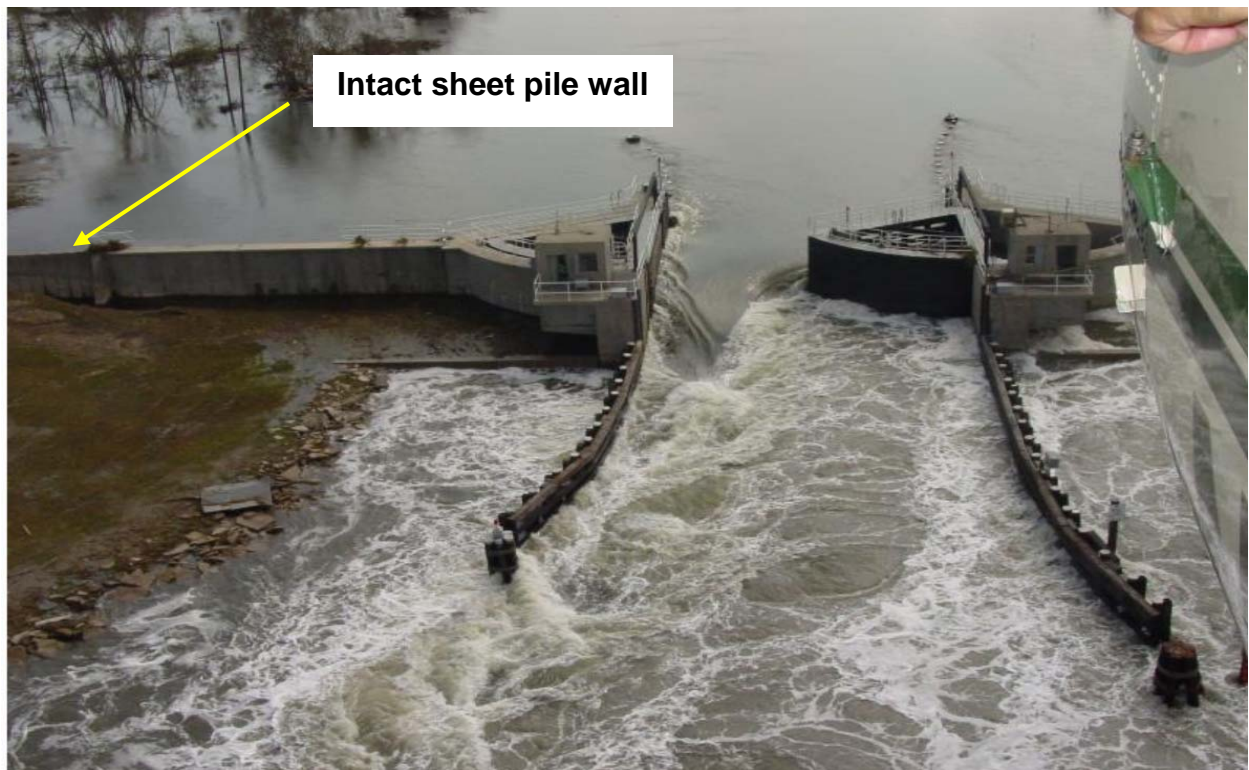
Figure 5: Photograph of Bayou Dupre navigation – water control structure taken the morning following Hurricane Katrina (EPA photograph). Photograph shows that the concrete sheet piling adjacent to the abutment of the structure are intact.

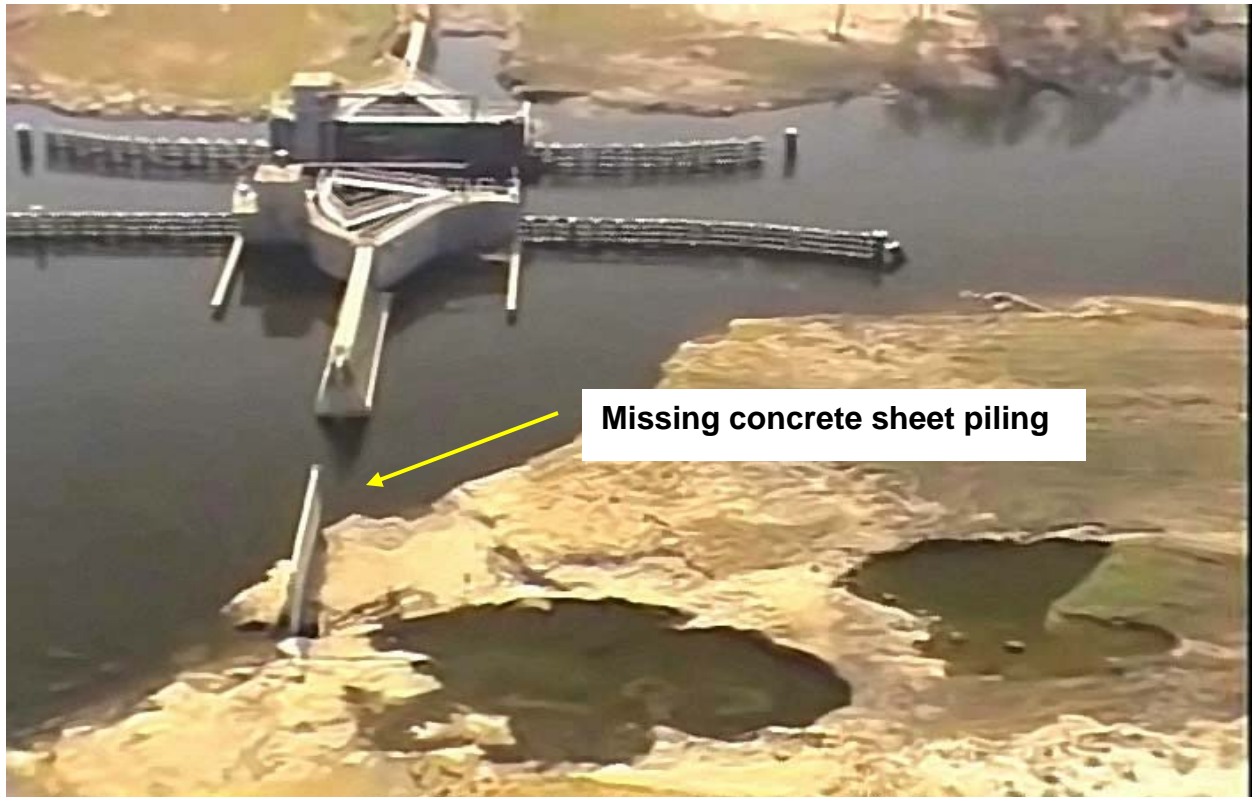
Figure 6: Aerial video frame from survey performed for USACE on September 14, 2005.

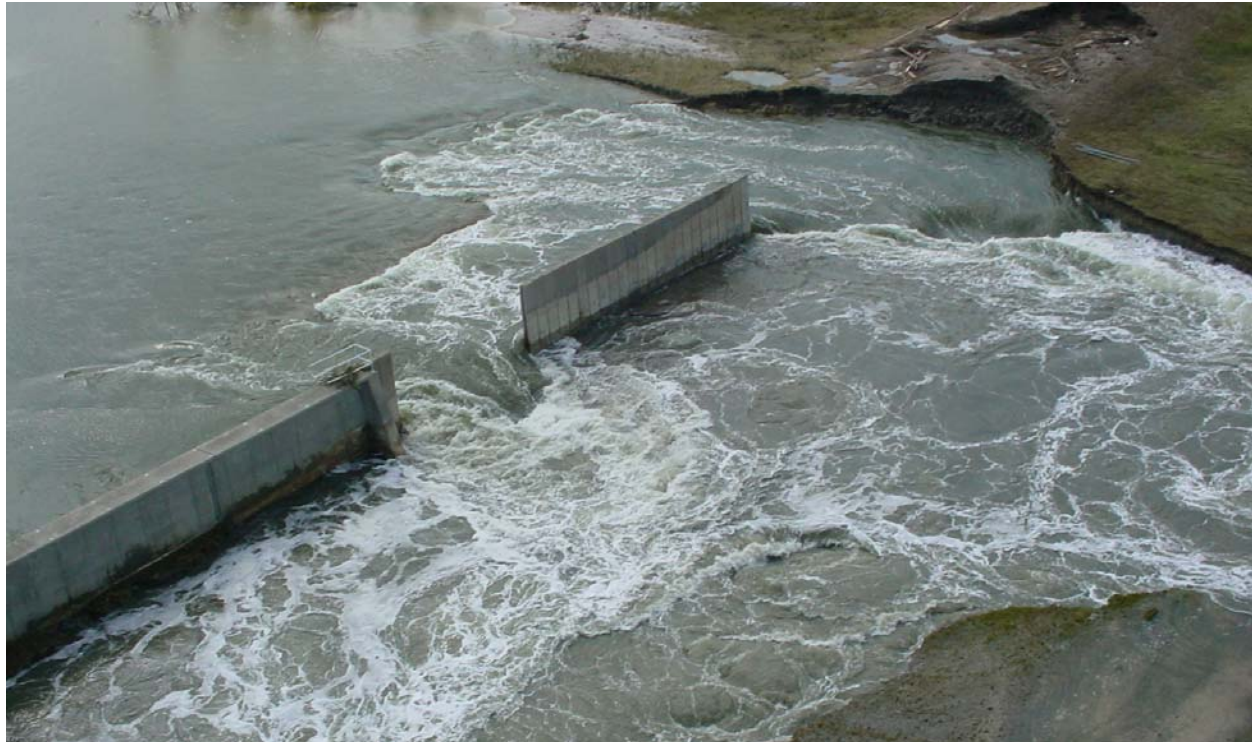
108. During this investigation, contacts were made with the contractor who performed the repairs of this breach (Ehrensing 2006). The contractor reported that the concrete panel/s were found on the bottom of the scour hole on the flood (east) side of the breach facing the MR-GO channel. The concrete panel did not fail during the passage of Hurricane Katrina. Further the concrete panel did not fail during the Hurricane surge overtopping (it would fallen toward the protected side). The concrete panel failed after Hurricane Katrina and before Hurricane Rita. The concrete panel most likely failed during storm tide outflows after the passage of Hurricane Katrina (Figure 7).

Figure 7: Aerial photograph of Bayou Dupre north side breach developing during ebb tidal flow following Hurricane Katrina (USACE photograph). Note breach development at EBSB – concrete sheet pile interface.

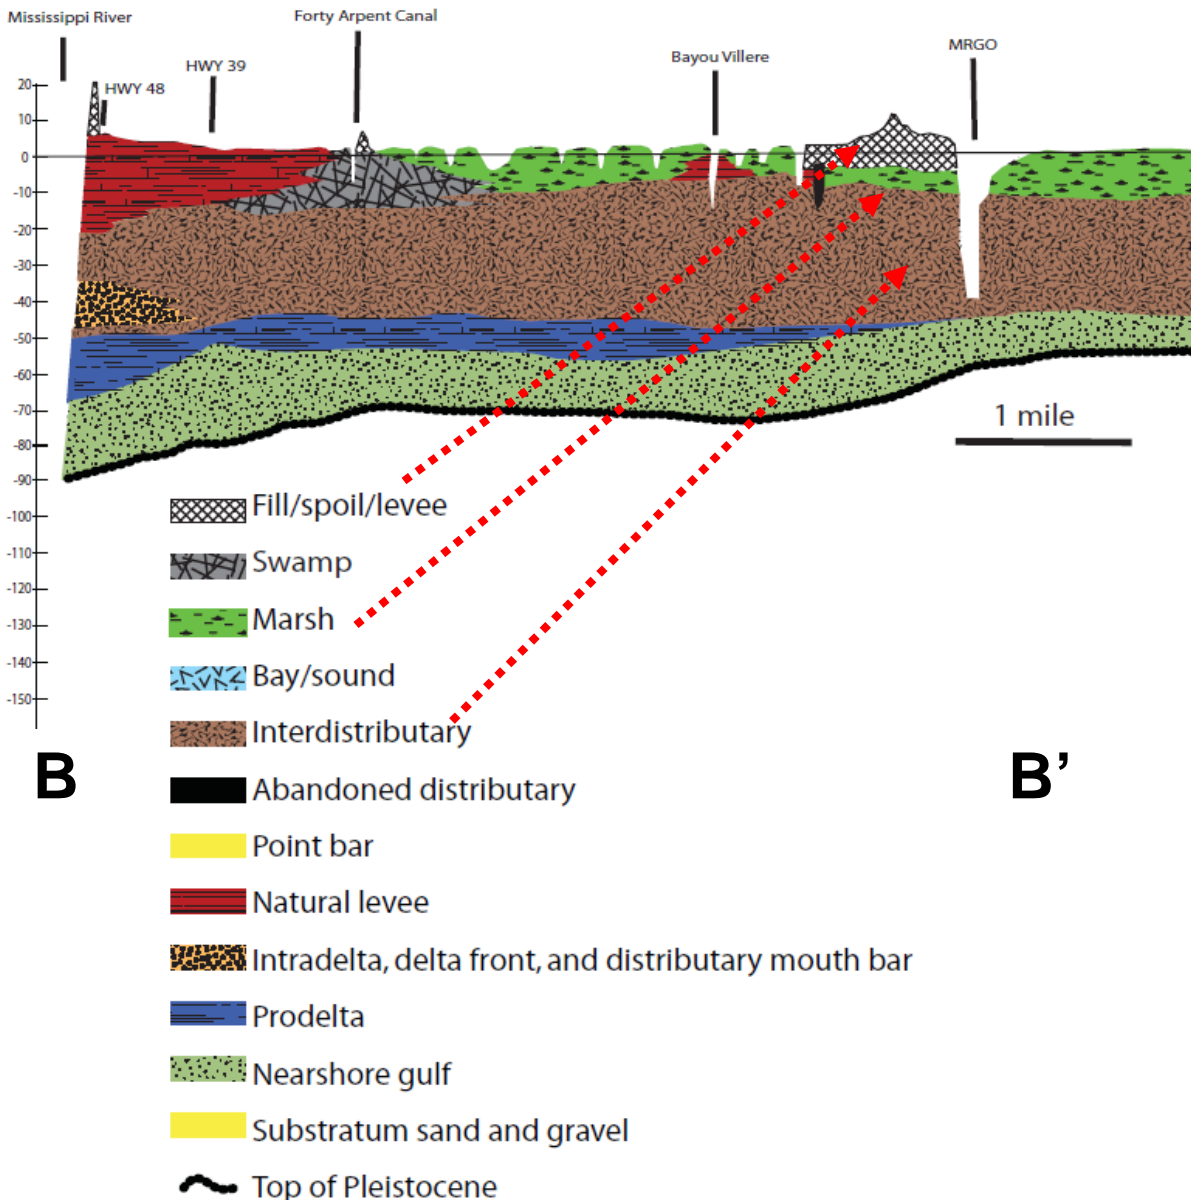
construction. According to the U.S. Army Corps of Engineers remarks in the 1958 report titled *Geological Investigation of the Mississippi River Gulf Outlet Channel*,it is possible that the poorly consolidated, high –water-content interdistributary clays will tend to flow laterally into [the MR-GO channel] excavation particularly under the extra weight of a spoil bank (Table 6.1, USACE, 1958.”

Figure 9: Geologic cross section (B-B') perpendicular to MR-GO channel showing soil deposits in the Lake Borgne region (adapted from Fitzgerald et al 2008).

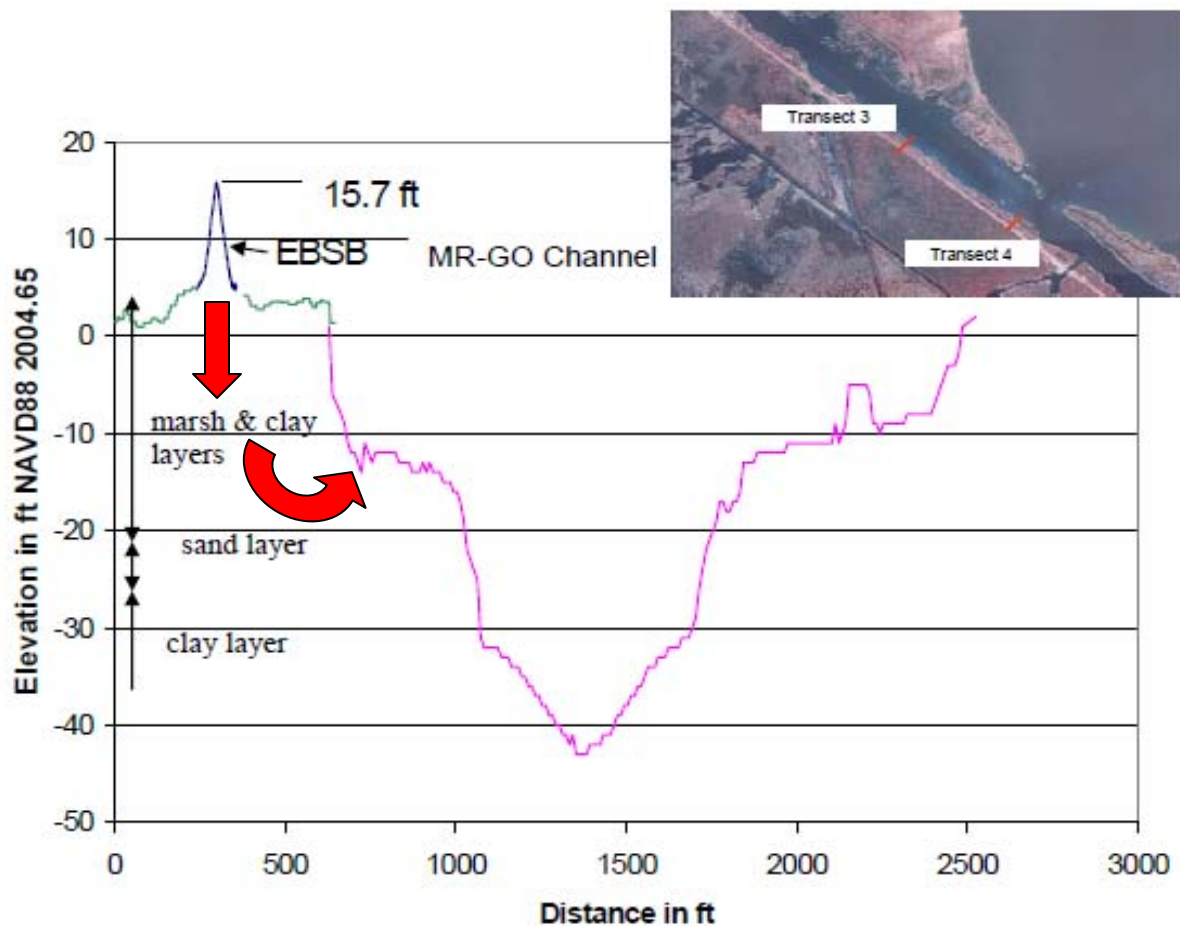
“This concern was raised again when cross sections were produced that showed the MR-GO channel adjacent to the EBSBs before Hurricane Katrina (Figures 155 and 156) (Morris 2007). The channel dredging and erosion of the banks of the MR-GO had widened to the point where there would be concerns for both the EBSB stability and exacerbation of the creep related displacements. The ‘drop off’ into the MR-GO channel was within 200 feet to 250 feet of the toes of the EBSBs.”

Figure 12: Cross section at EBSB (after Morris 2007).

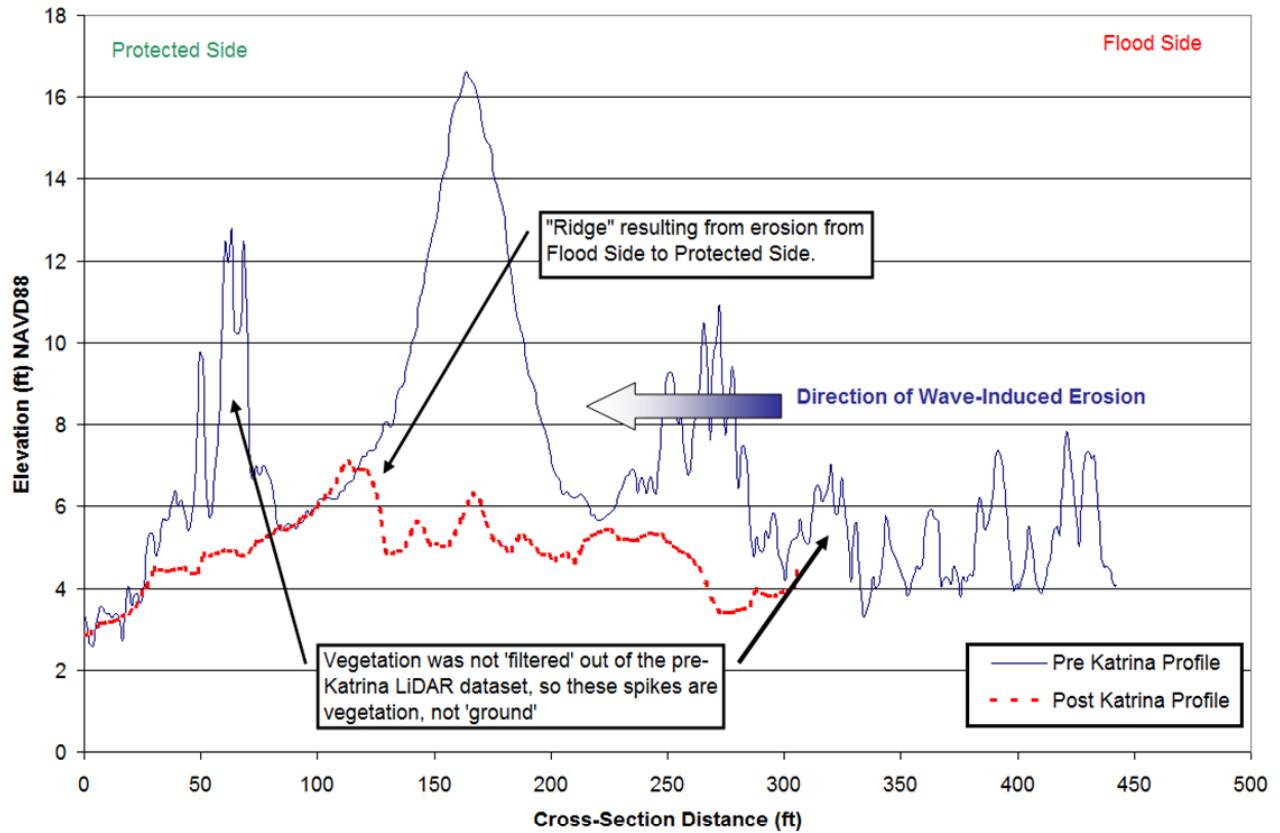
Figure 22: Pre and post-Hurricane Katrina comparisons of EBSB Wave Breaching Study Location (Station 497+00) cross-sections. Note distinctive shape of the post-hurricane EBSB cross-section.

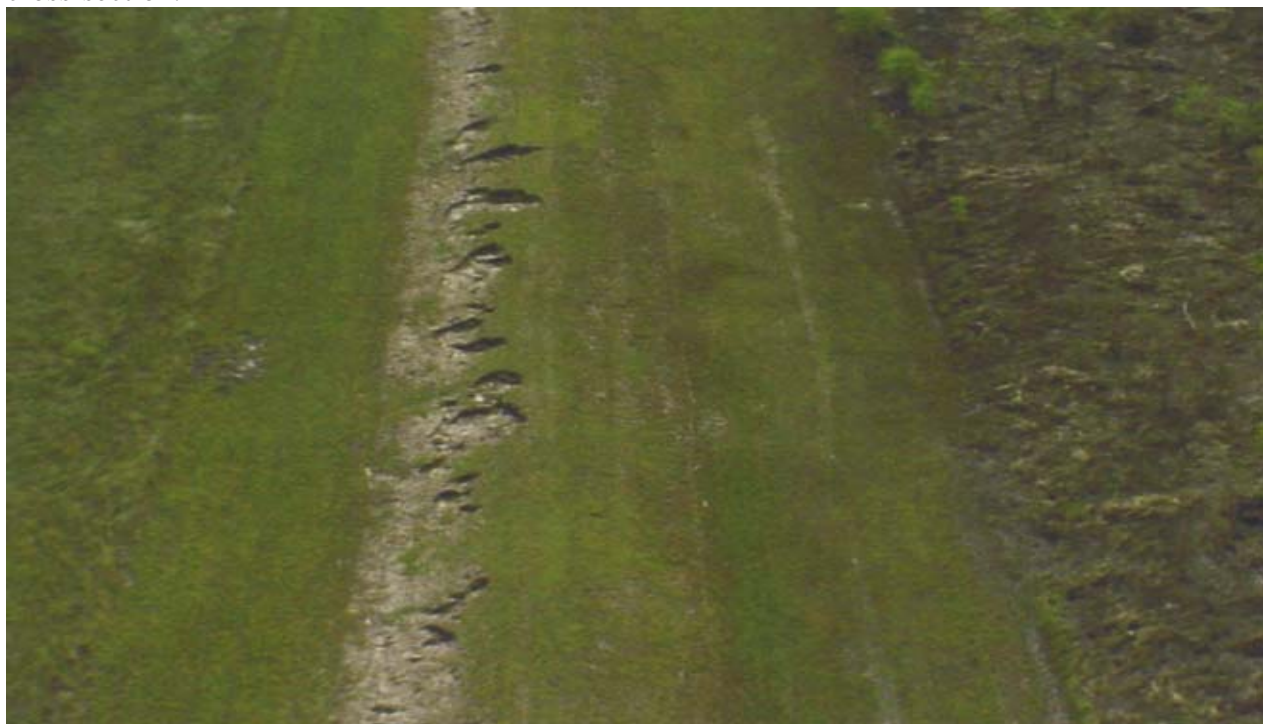
Figure 23: Wave erosion of floodside of EBSBs. Note wave eroded ‘mowed strip’ on flood side.

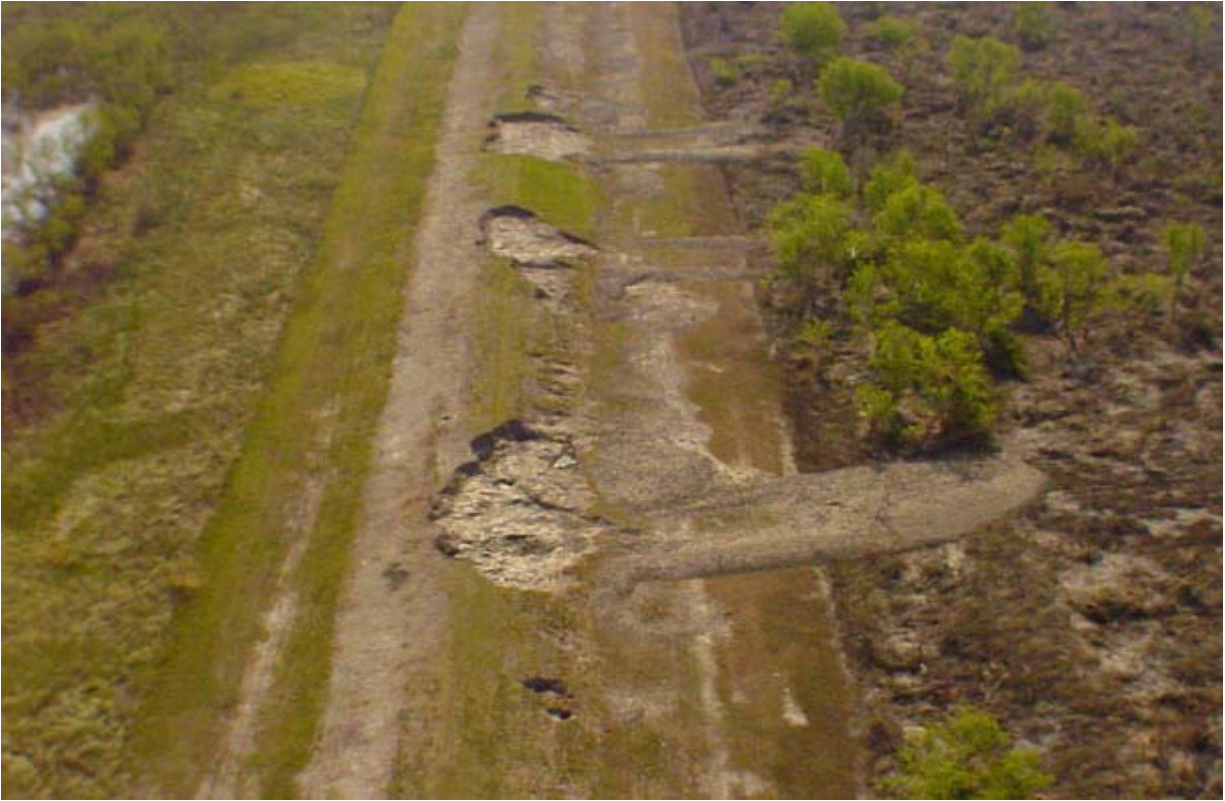
Figure 24: Overtopping erosion of protected side of EBSBs.

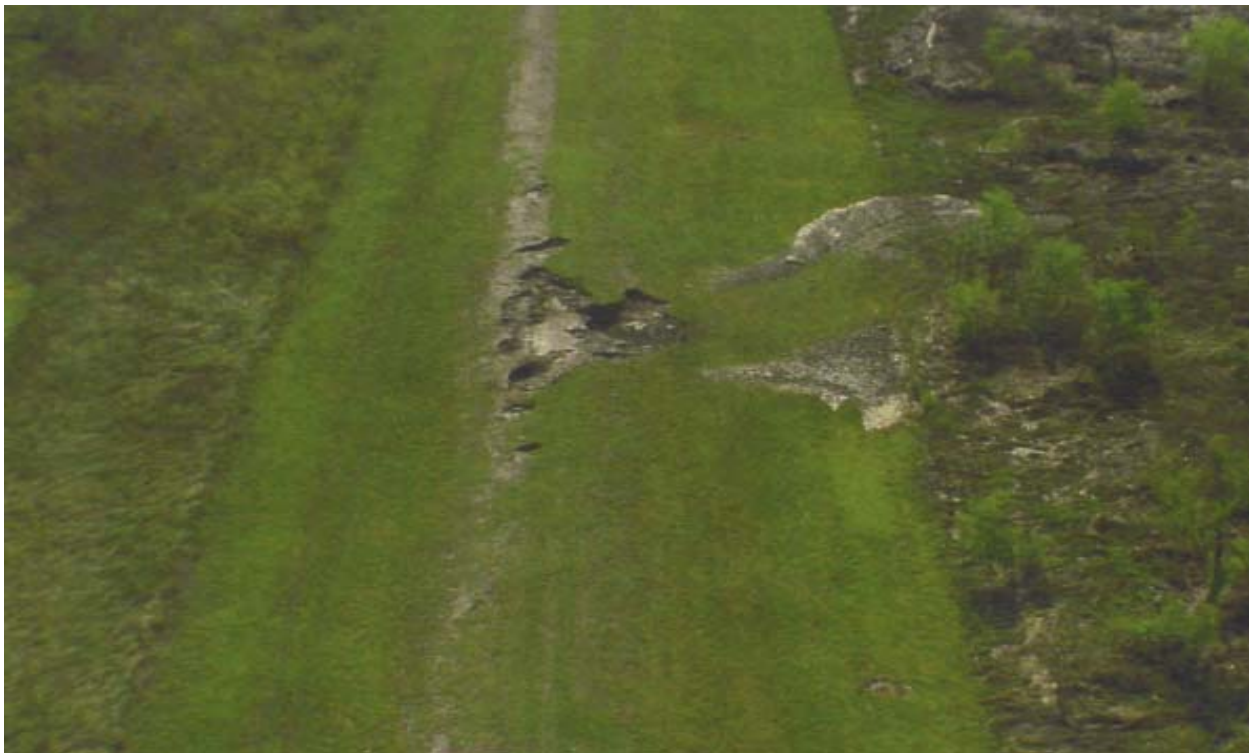
Figure 25: Wave head cutting – crenellation - of the crest of the EBSBs.

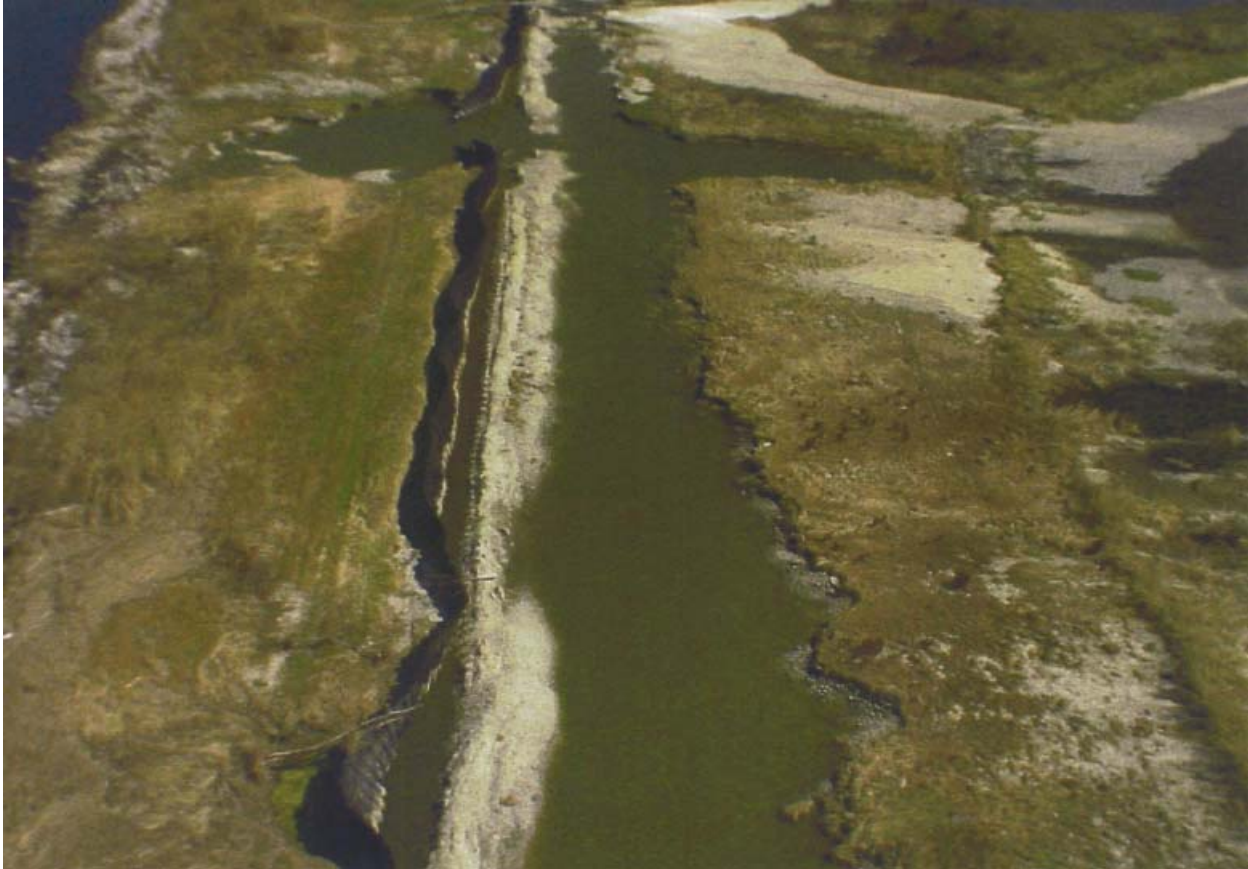
Figure 26: Sheet piling overtopping erosion of EBSBs.

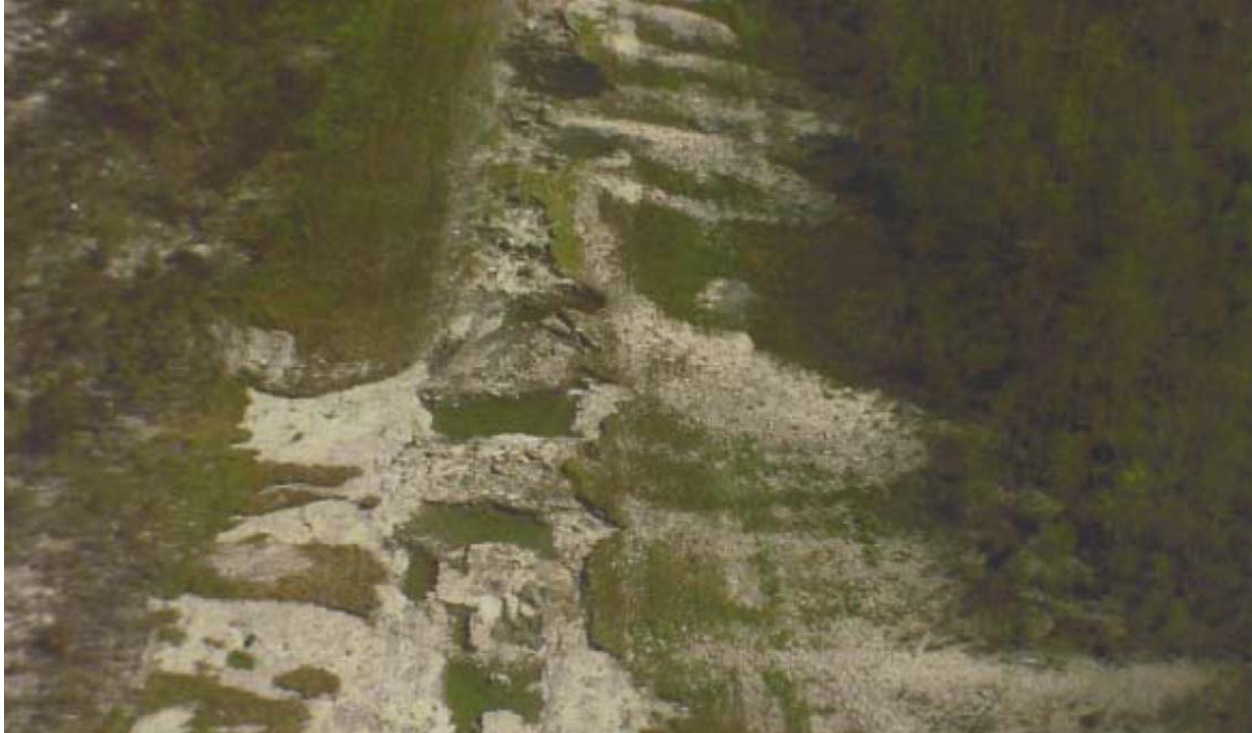
Figure 29: Location B – Wave initiated overtopping exploited breaching (flood side to protected side).

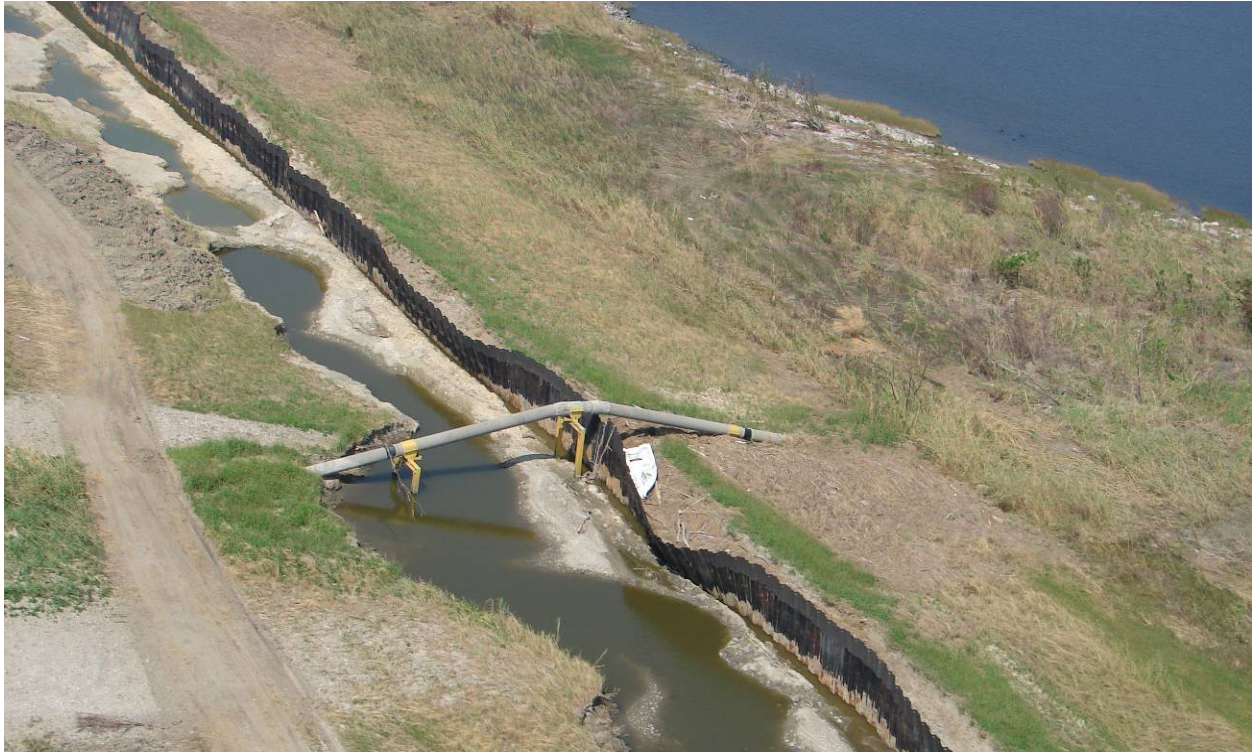
Figure 30: Location C – Sheet pile overtopping erosion and breaching.

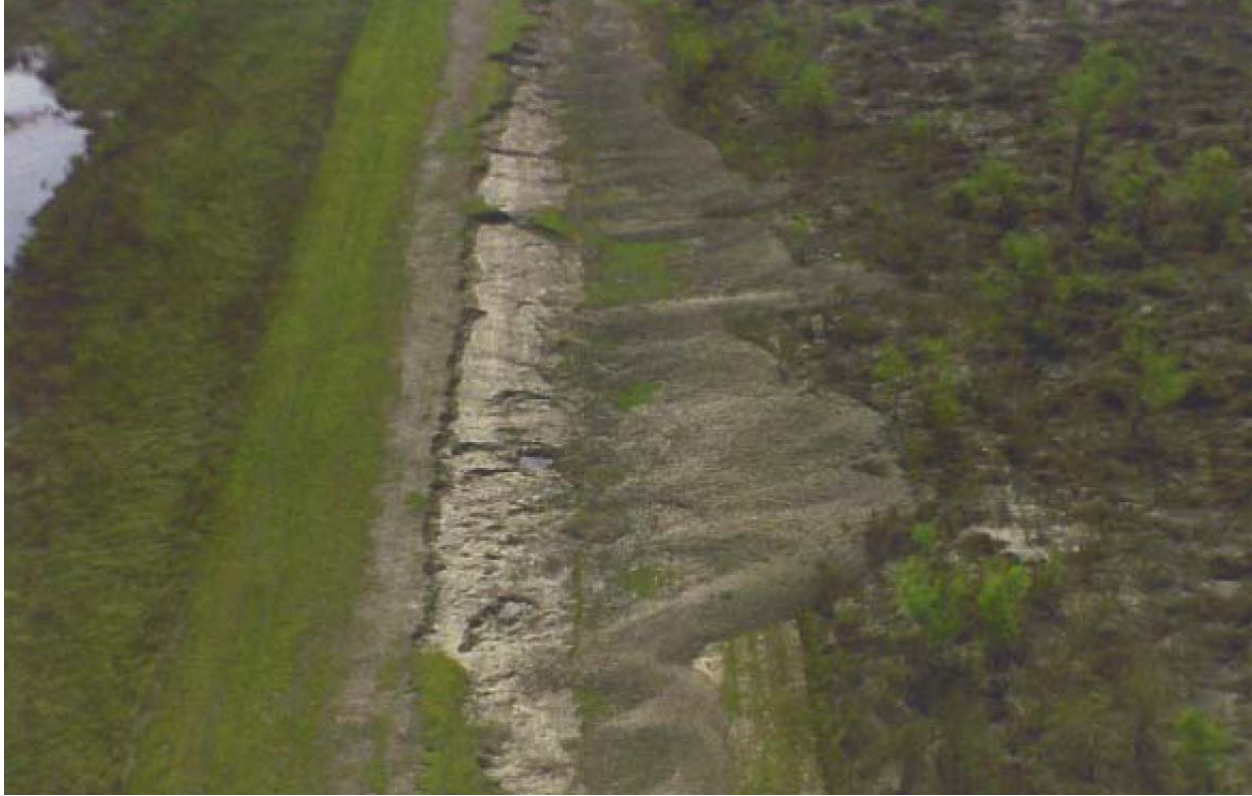
Figure 31: Location D – Surge overtopping initiated breaching (protected side to flood side).

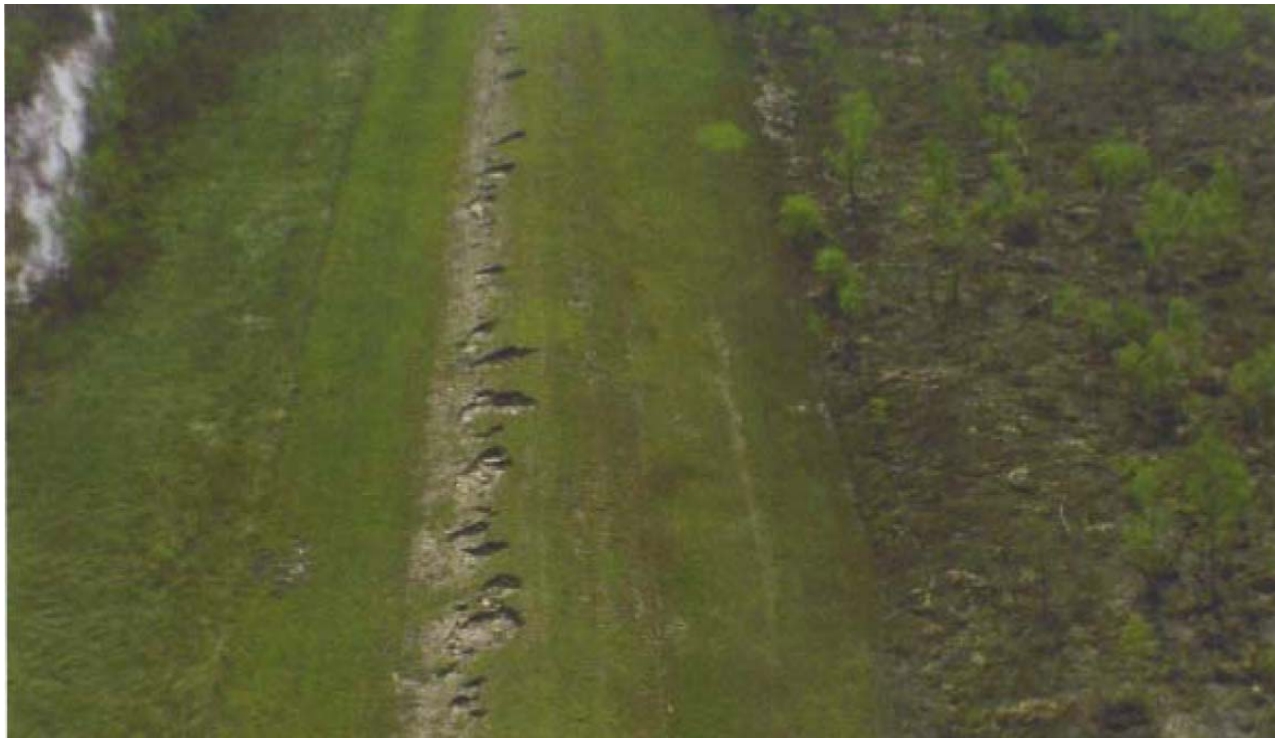
Figure 32: Location E – Wave head cutting (crenellation).

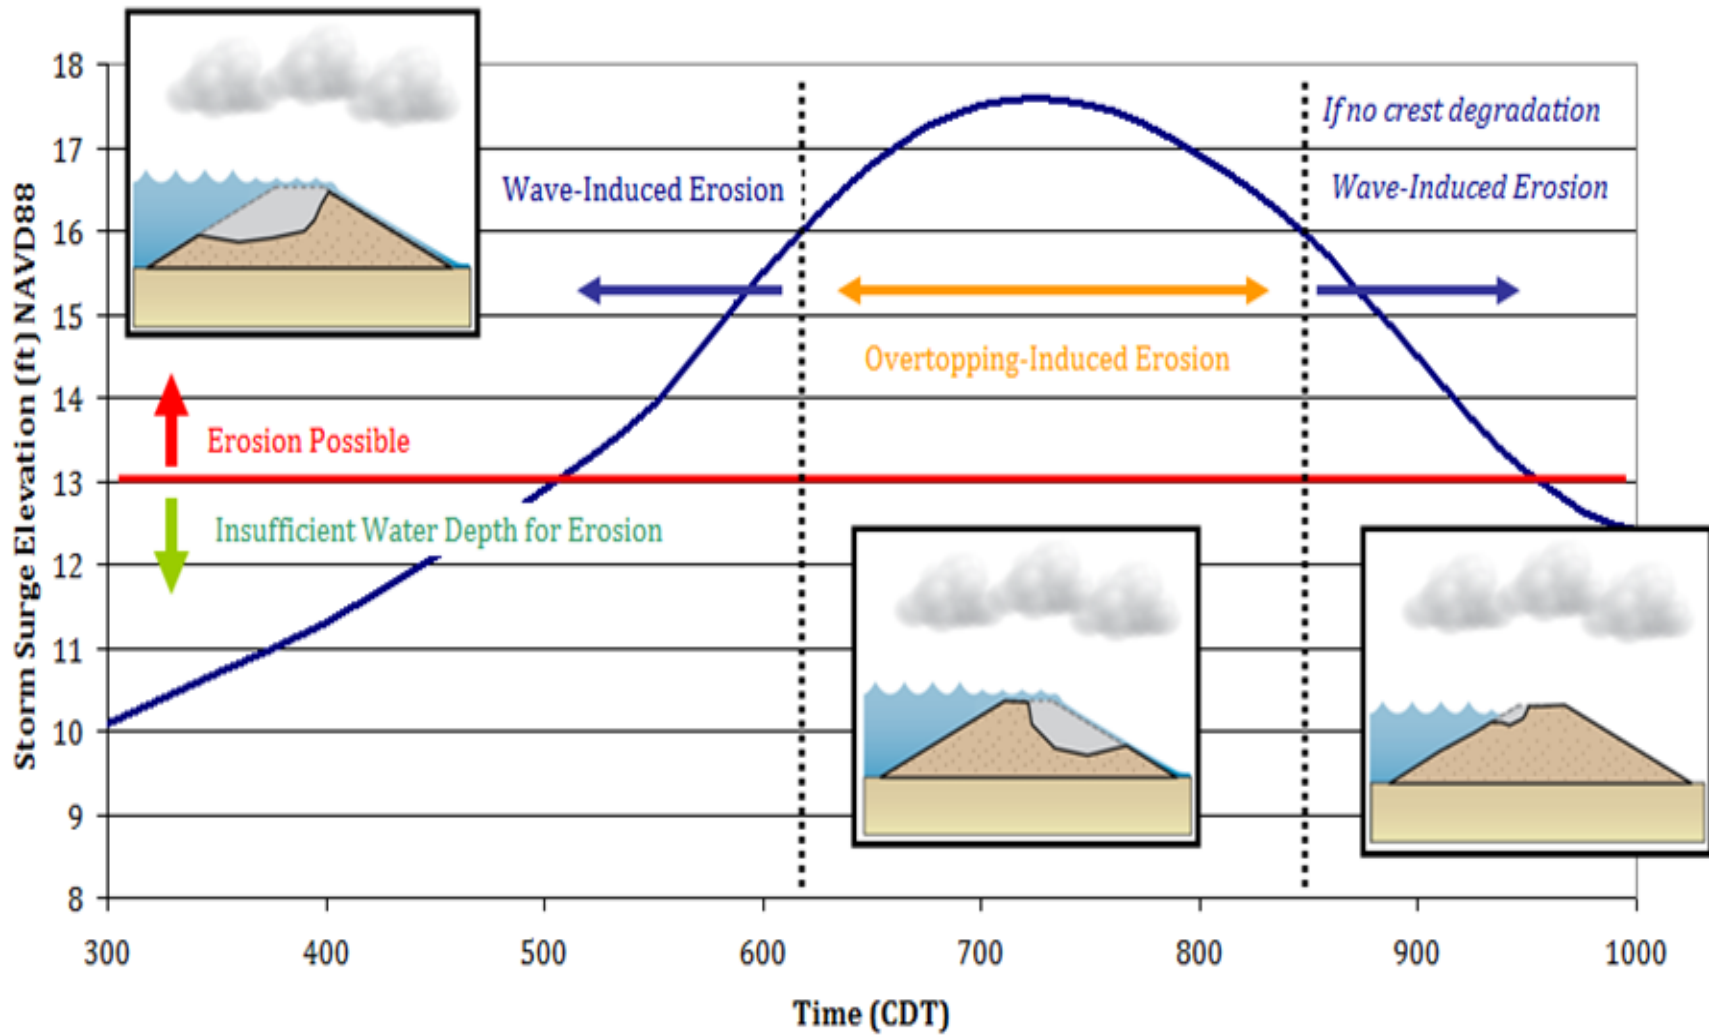
Figure 34: Overview of erosion mechanism timeline.

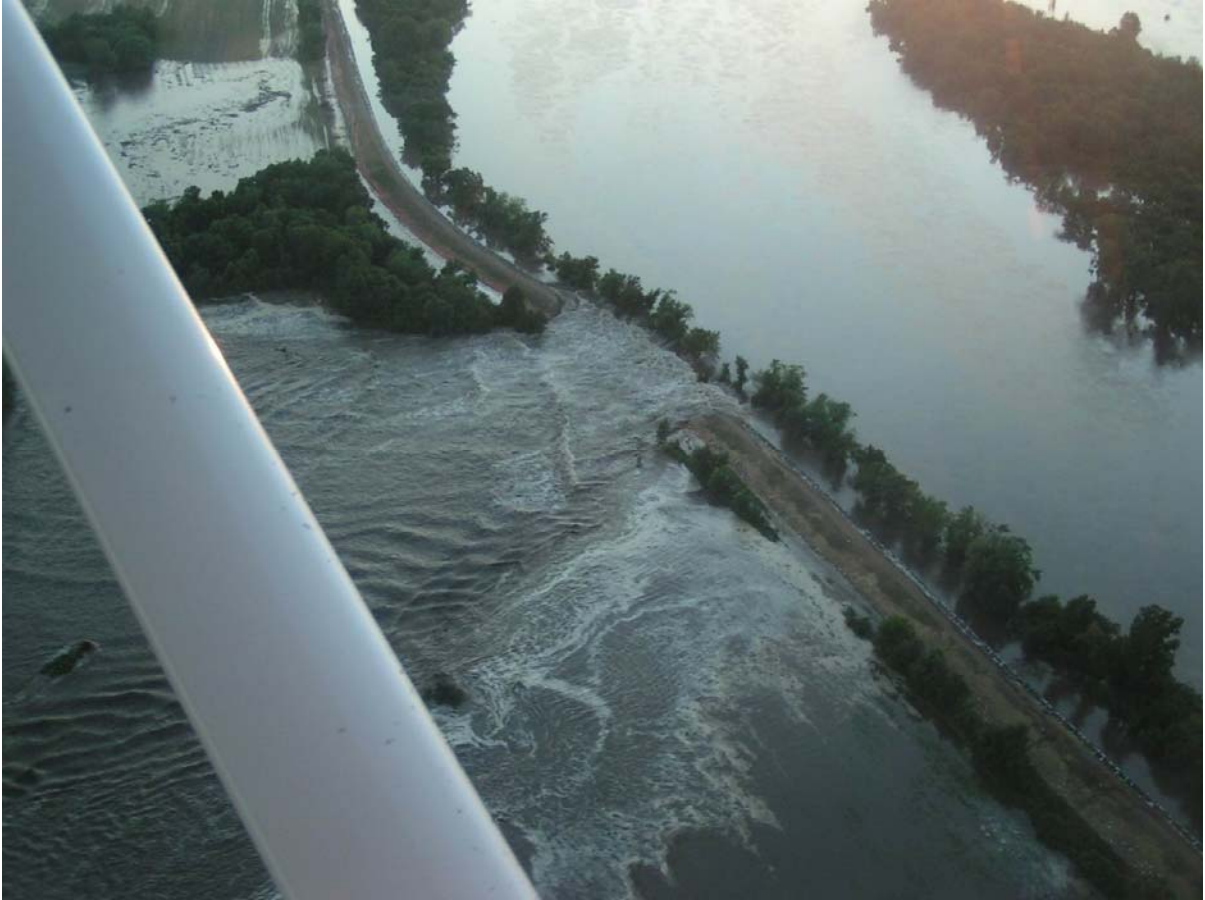
Figure 39: Levee breached before overtopping

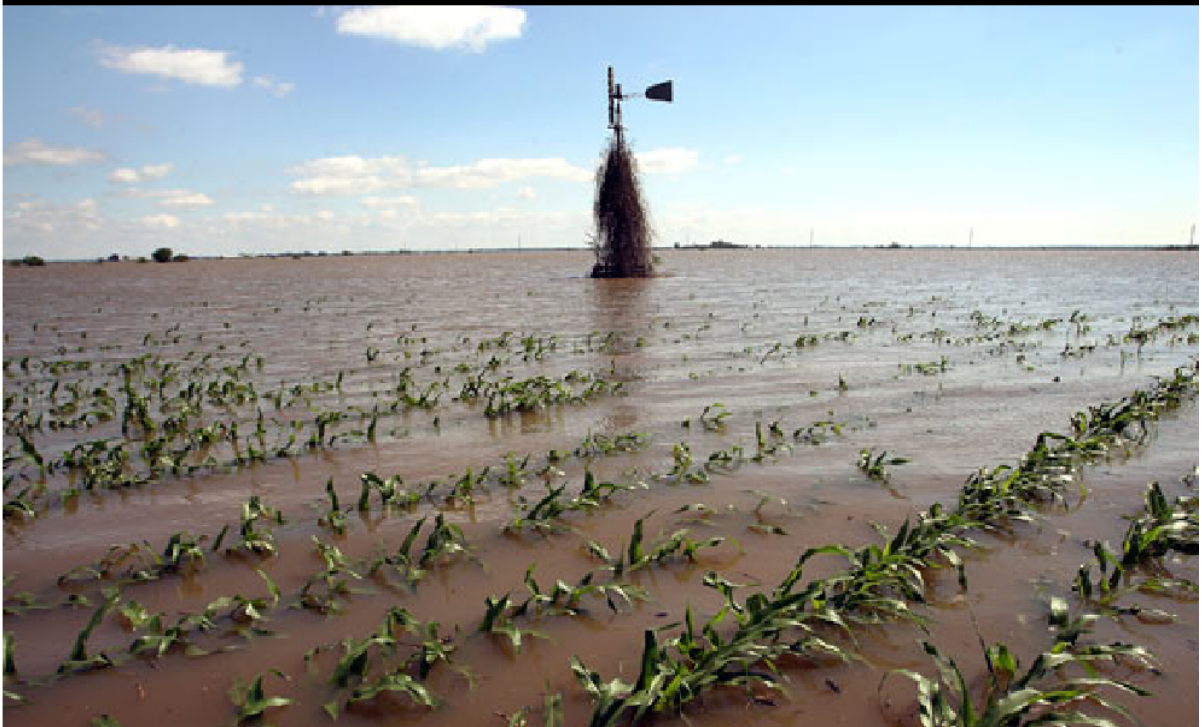
Figure 40: Shallow aquifer water pressures developed during flood stage

163. The photograph shown in Figure 40 was taken on a farm next to the river during the high water stages of the July 2008 mid-west flood. The windmill in the photograph was used to pump water from the shallow (20 feet below surface) sand aquifer under the cornfield. This sand aquifer connects to the nearby river. At normal water stages, the water had to be pumped to the surface. It is evident that when this photograph was taken (high water stage in the river. The water pressures in this shallow sand aquifer obviously are very high – a ‘gusher’ of sediment laden water is being forced almost to the top of the windmill. After this photograph was taken, a breach developed in a section of the adjacent levee (Figure 41) (Storesund et al 2008).

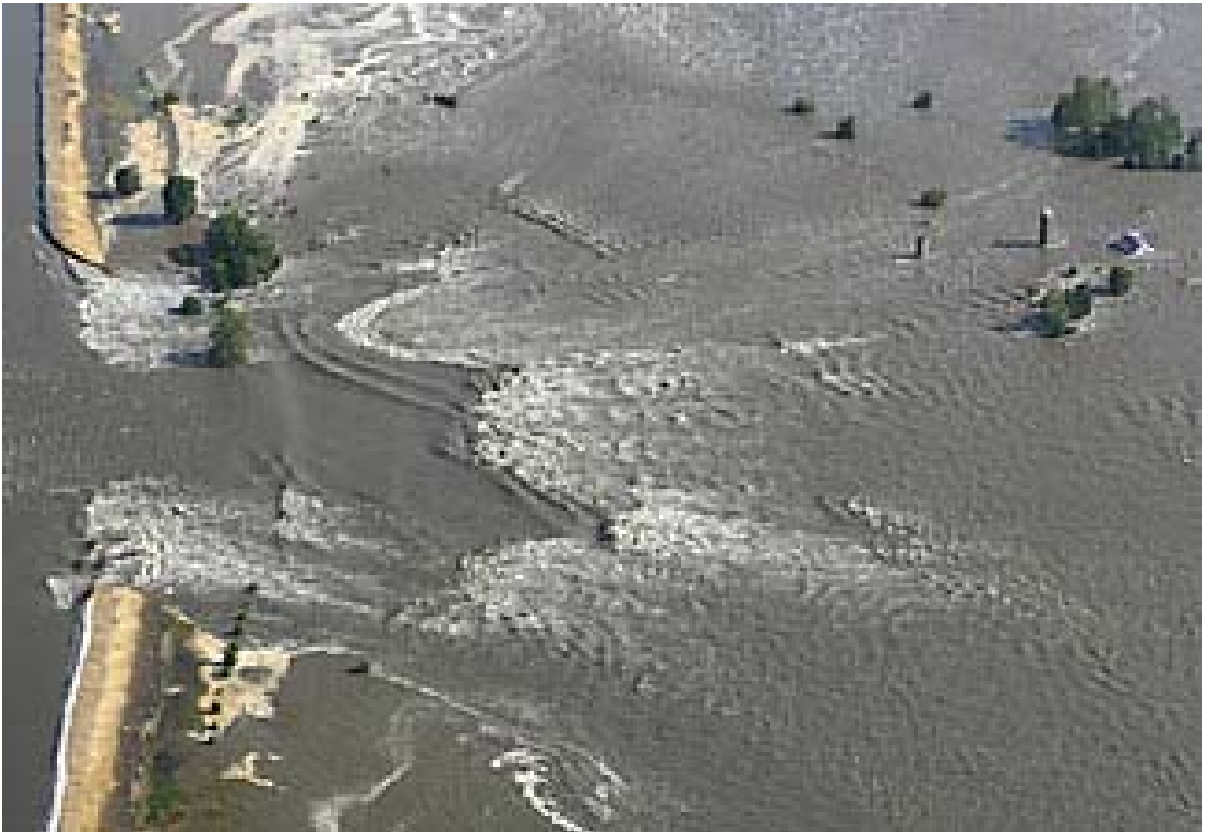
Figure 41: Levee adjacent to windmill developed breach prior to overtopping
