DECLARATION OF ROBERT G. BEA

II. PERFORMANCE OF THE MR-GO REACH 2 MAN-MADE FLOOD

PROTECTION STRUCTURES DURING HURRICANE KATRINA 38

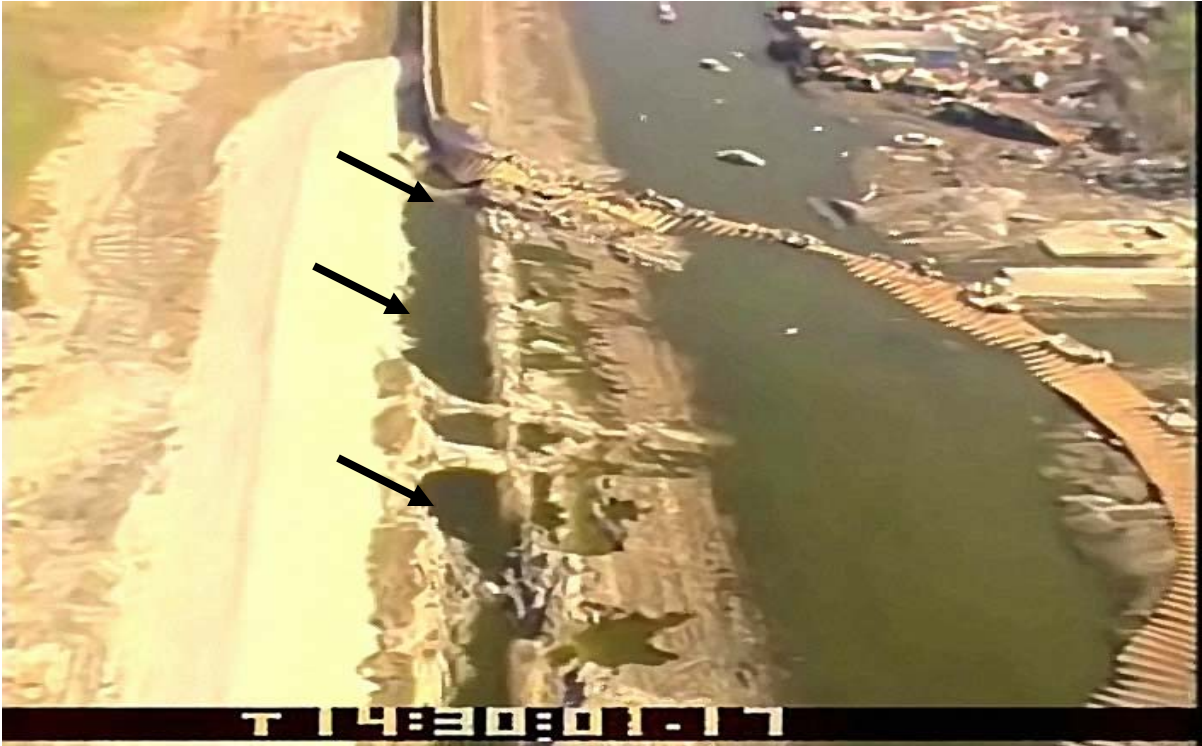
Figure 46: Video frame from aerial survey of Lower 9th Ward on September 14, 2005 – South Breach (USACE Video Survey). Light ground area to left is breach repair.

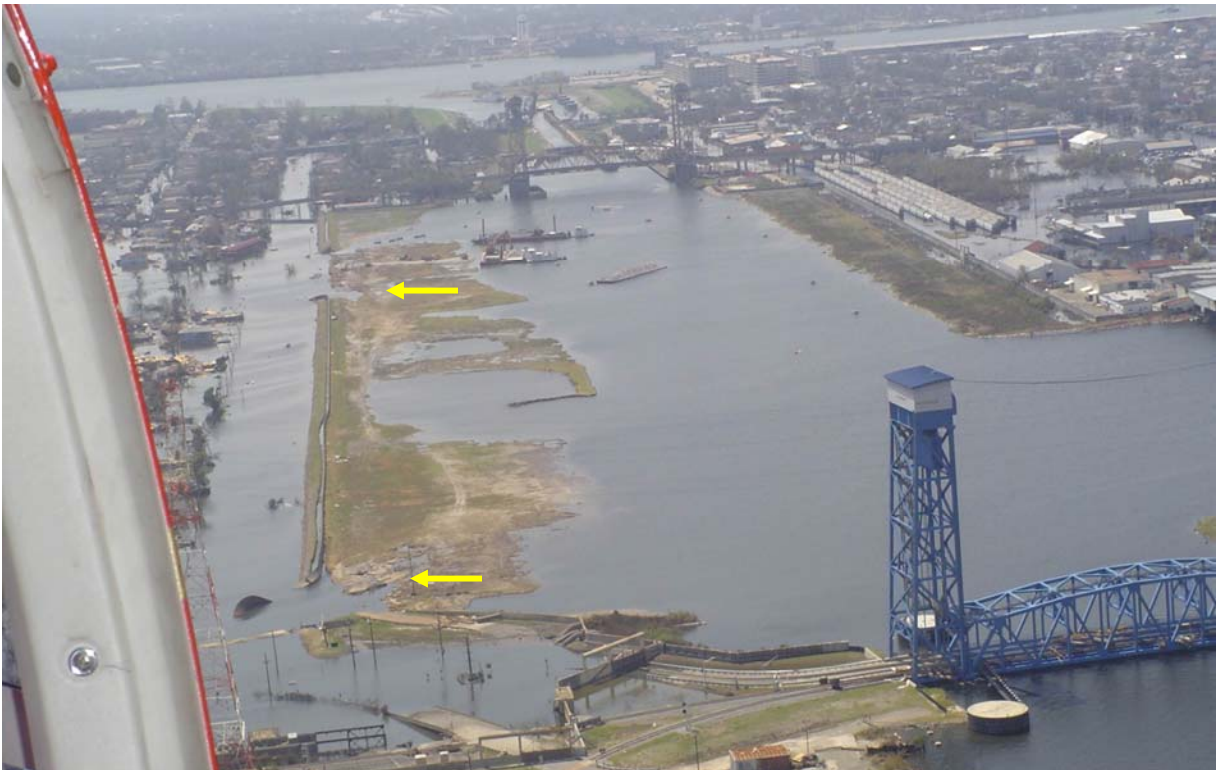
Figure 47: Aerial photograph showing ‘depressions’ *outside* the Lower 9th Ward floodwall before breach repair operations were initiated (USACE photograph).

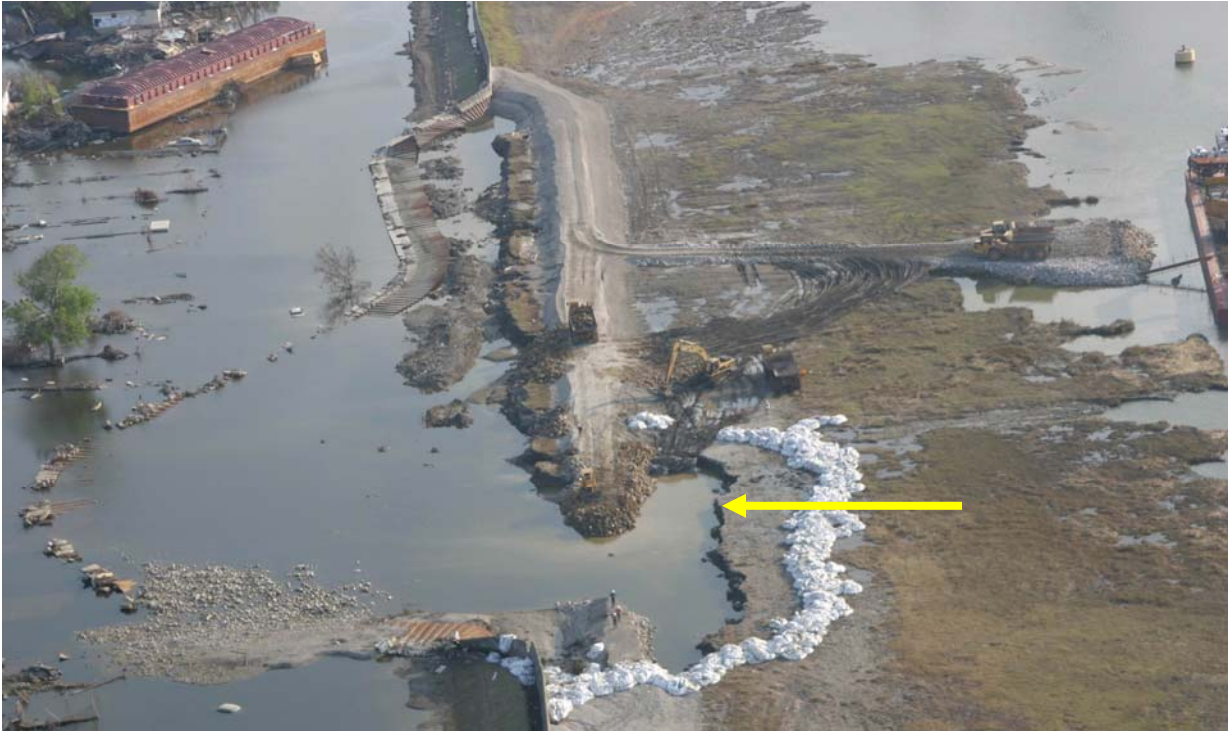
Figure 48: South Breach during initial repair period before hole outside of the floodwall is covered (USACE photograph).

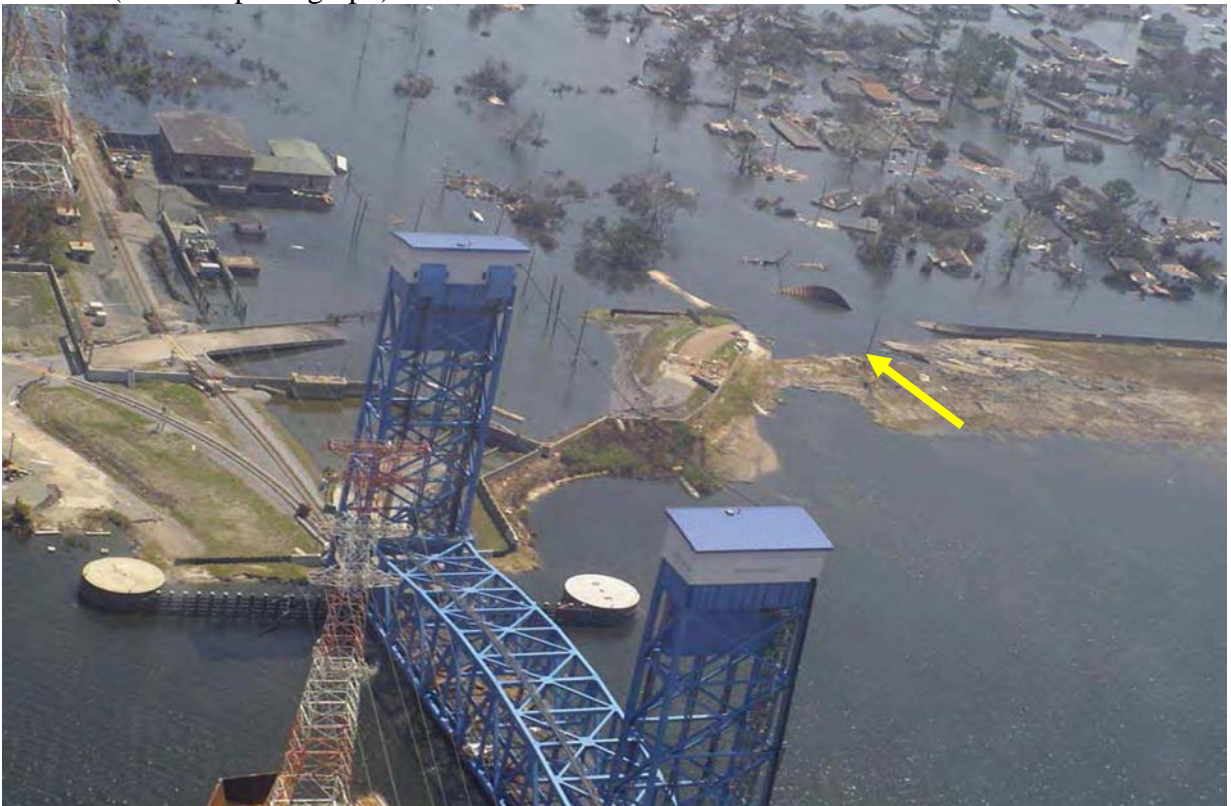
Figure 49a: North Breach during initial repair period before hole outside of the floodwall is covered (USACE photograph).

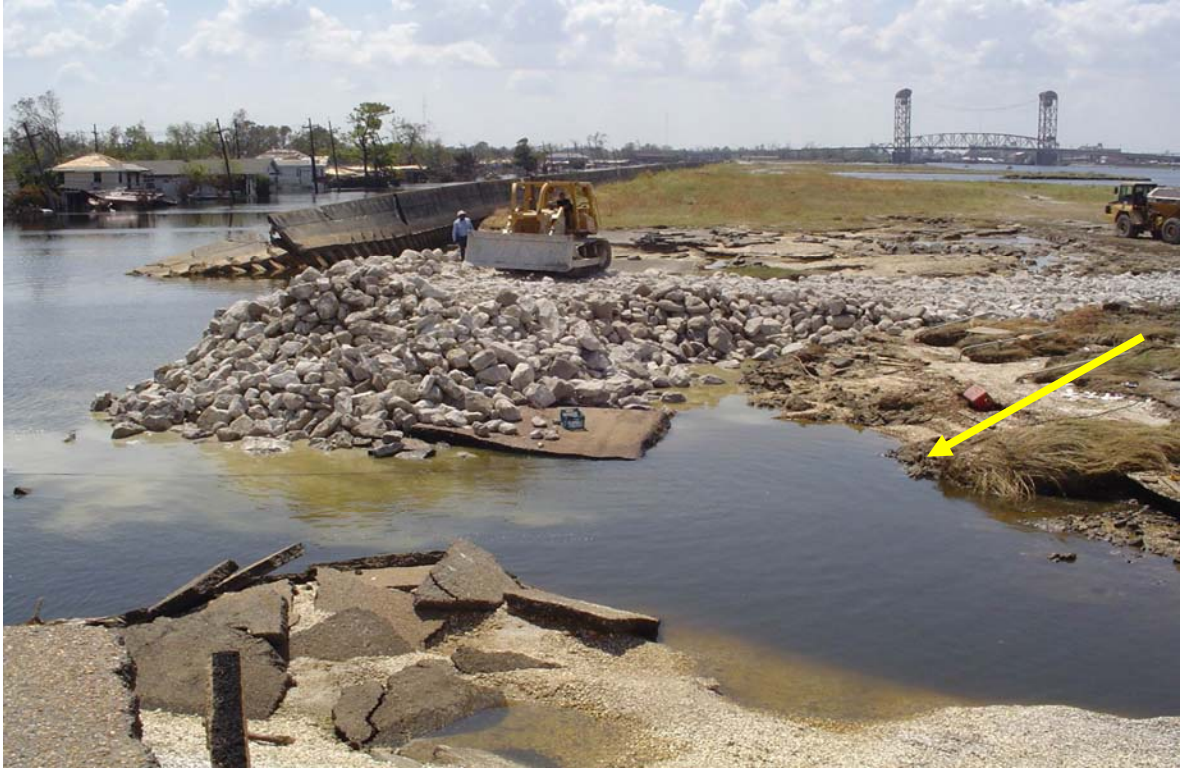
Figure 49b: North Breach during initial repair period before hole outside of the floodwall is covered (USACE photograph).

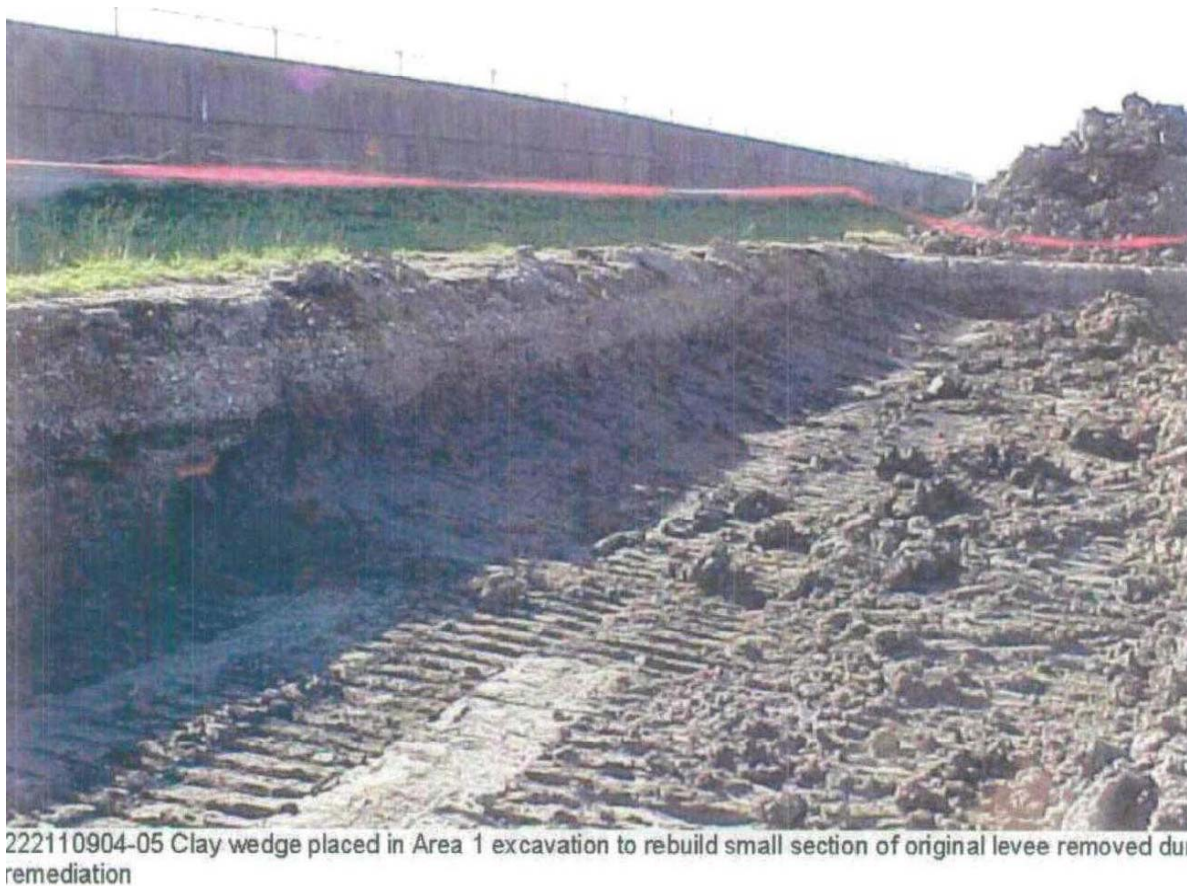
Figure 50: Clay lining placed on walls of borrow pit before flooding with water from IHNC.

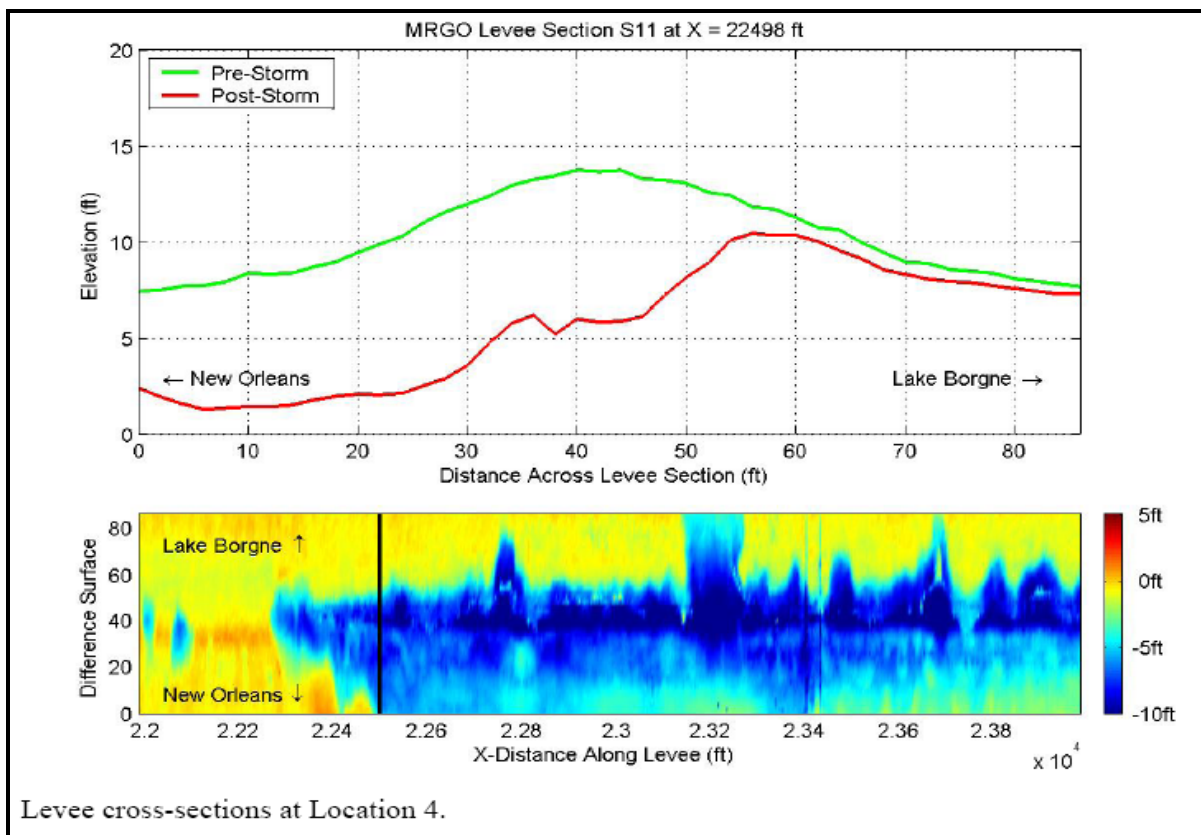
Figure B-2: Erosion shape was evaluated, but not the required erodibility characteristics of the levee material to result in this shape (Ebersole page 248/307).

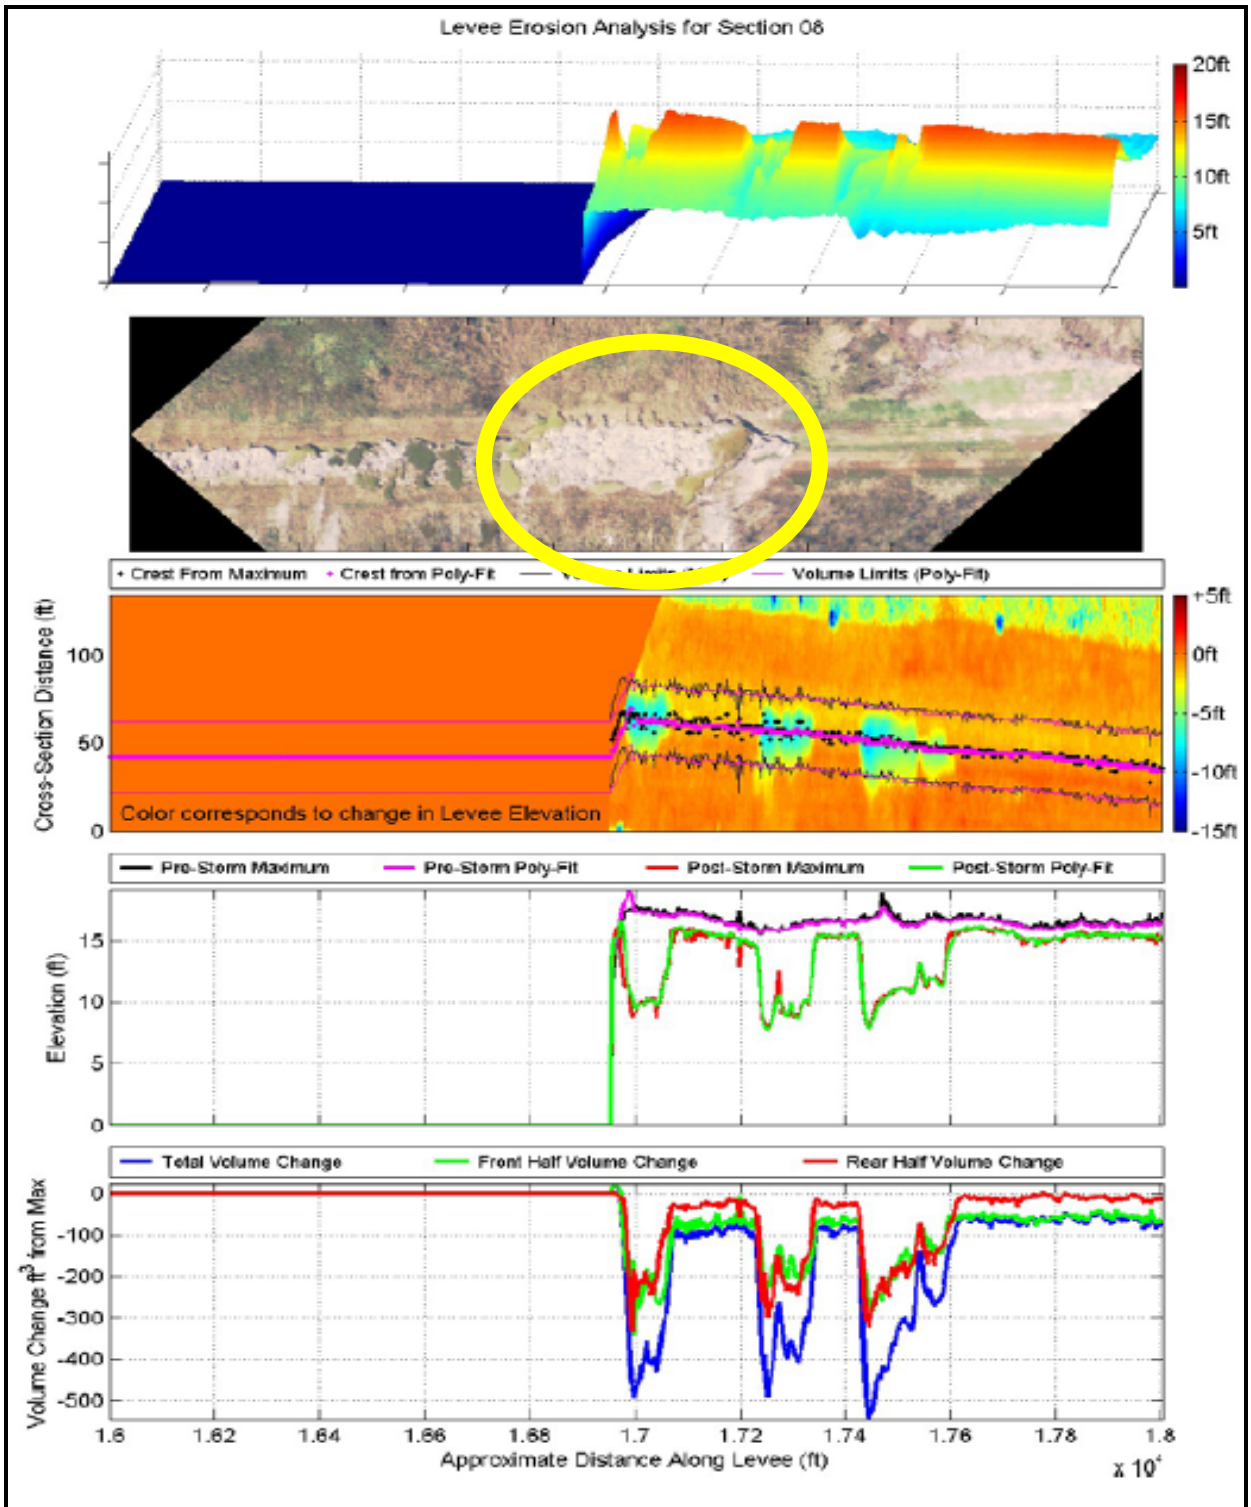
Figure B-3. Volume analyses at this location do not confirm overtopping OR wave induced erosion. The value of this analysis is unclear and ambiguous (Ebersole page 271/307).

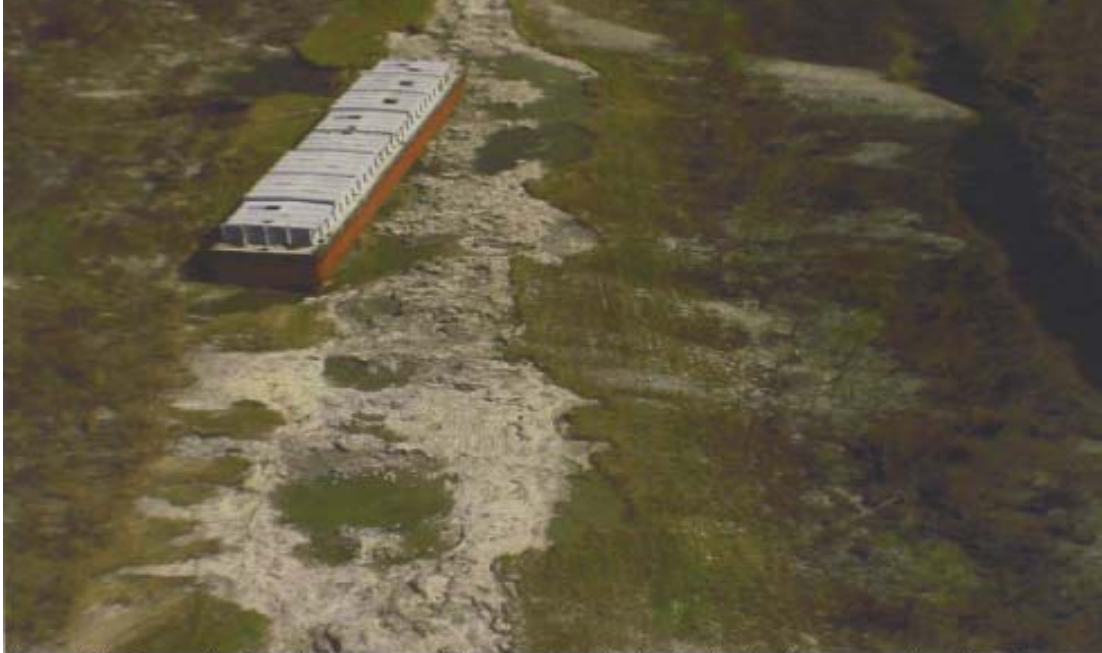
Figure A4. Severely degraded levee. Evidence of overtopping indicated by overwash sediment deposits on back side. Channel present just to south (top edge) of the barge. Backside elongated sediment deposit suggests high overflow. Traces of deposited sediment at front of the channel mouth also suggest outflowing water. Channel likely formed on outflow. Lowest spots on the degraded levee likely served as outflow channels for water exiting the polder following storm's passage. Situation in lower half of photo is less clear.

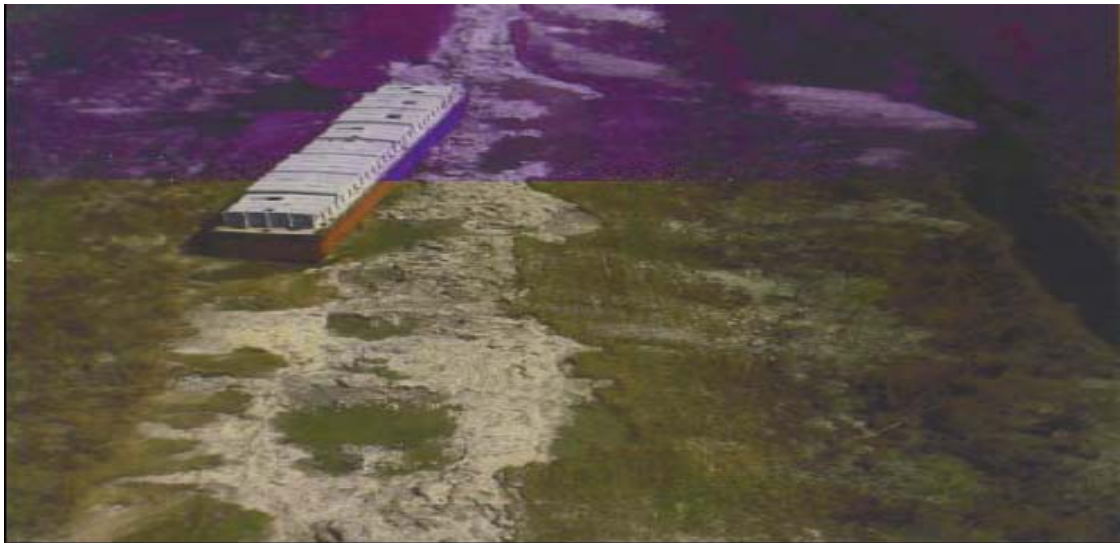
Figure A4. Severely degraded levee. Evidence of overtopping indicated by overwash sediment deposits on back side. Channel present just to south (top edge) of the barge. Backside elongated sediment deposit suggests high overflow. Traces of deposited sediment at front of the channel mouth also suggest outflowing water. Channel likely formed on outflow. Lowest spots on the degraded levee likely served as outflow channels for water exiting the polder following storm's passage. Situation in lower half of photo is less clear. Overwashed sediment evident, erosion pattern at bottom could be due to entering or exiting flow. Predominance of sediment deposits on the back side in the upper part of the photo suggests degradation caused by overtopping/head-cutting.

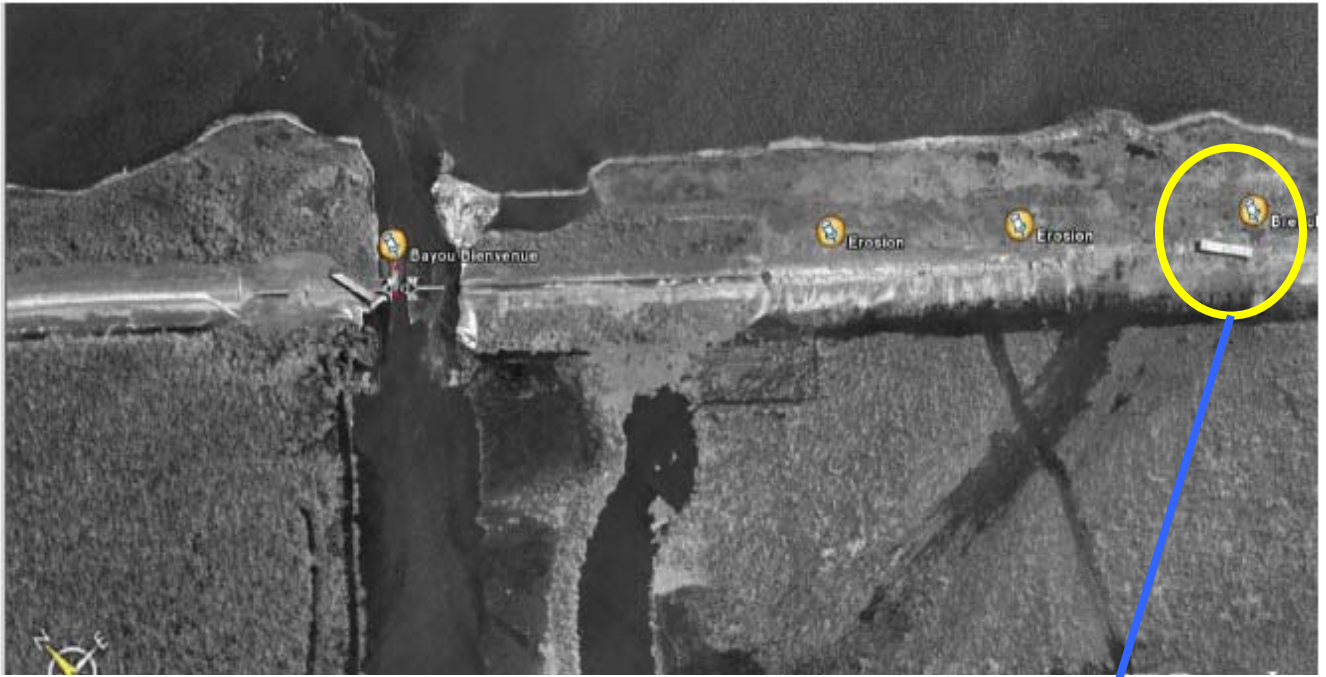
Figure B-9. Cargo barge position relative to crest elevations of EBSBs (from USACE IPET 2007).

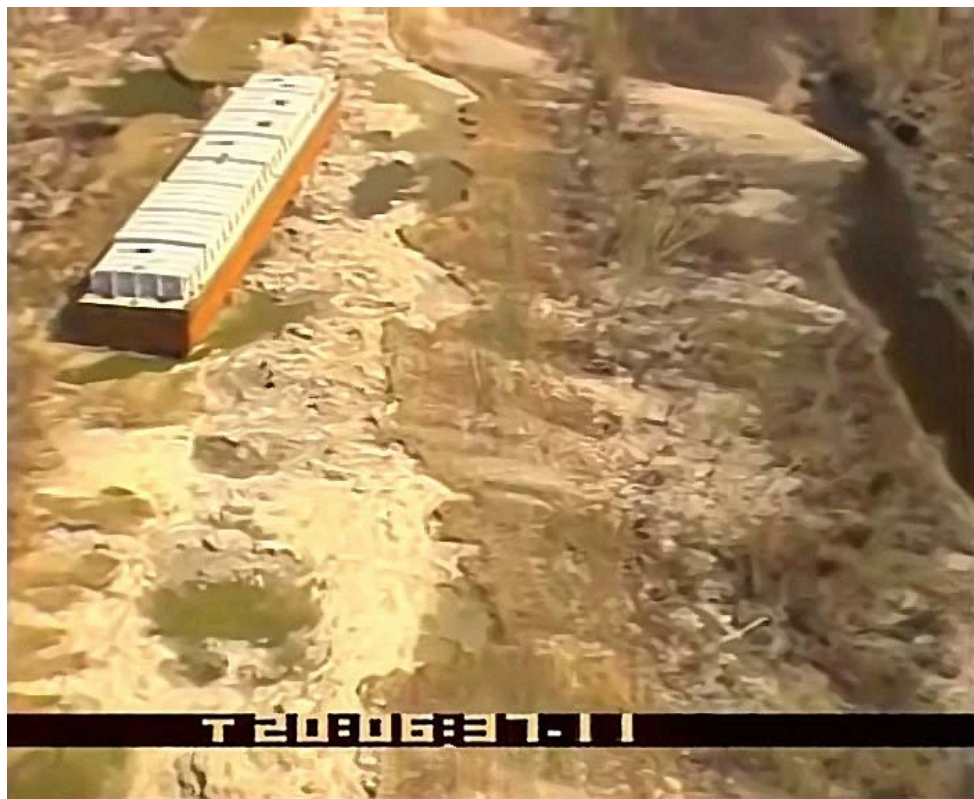
Figure B-10. Video frame from USACE aerial survey (September 14, 2005).

The erosion features at the ends of the cargo barge indicate both surge in-flow and out-flow scour. Clearly, the barge was grounded before the peak surge arrived at this location. This observation is corroborated given that the unloaded cargo barge had a draft of approximately 2 to 3 feet and the elevation of the EBSB at the grounded location was approximately 12 feet, the water depth at the time of grounding would have been approximately 14 feet to 15 feet. Thus, there would be a water depth of about 3 feet that would flow around the barge ends as the surge continued to rise; thus developing the landward erosion features. The unique barge-end scour features were not present away from the barge ends. The barge is sitting on top of these erosion features. These features clearly show both wave and overtopping flow characteristics that had to be developed before the grounding of the barge. Thus, it would not be reasonable to conclude that these features were developed after surge overtopping.

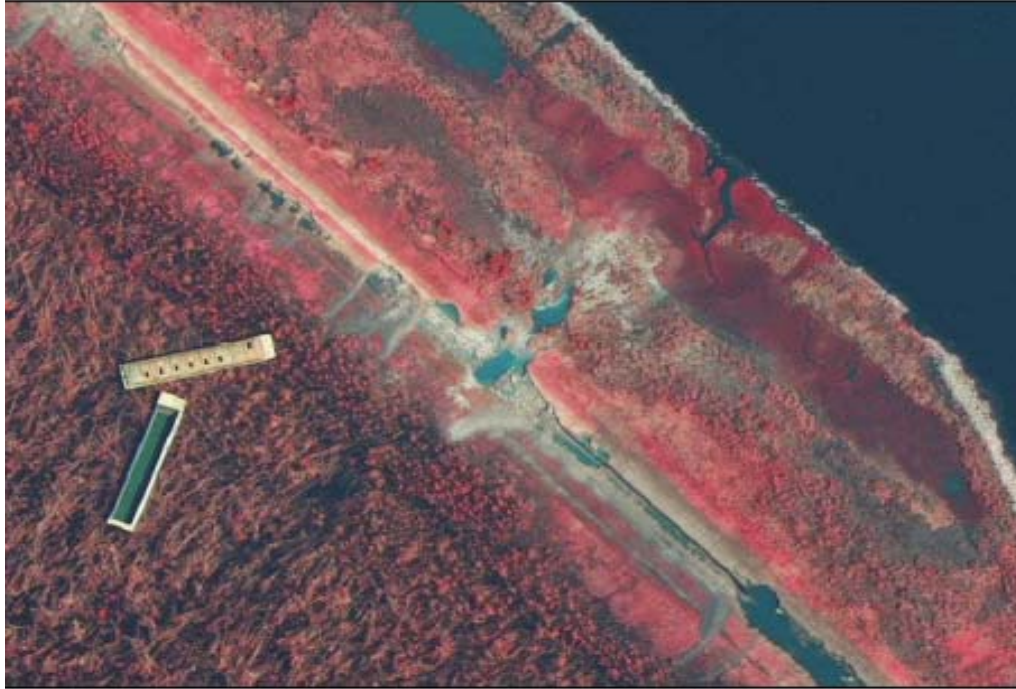
Figure B-12. Aerial photograph of grounded cargo barges on protected side of Reach 2 EBSBs (Morris 2008).

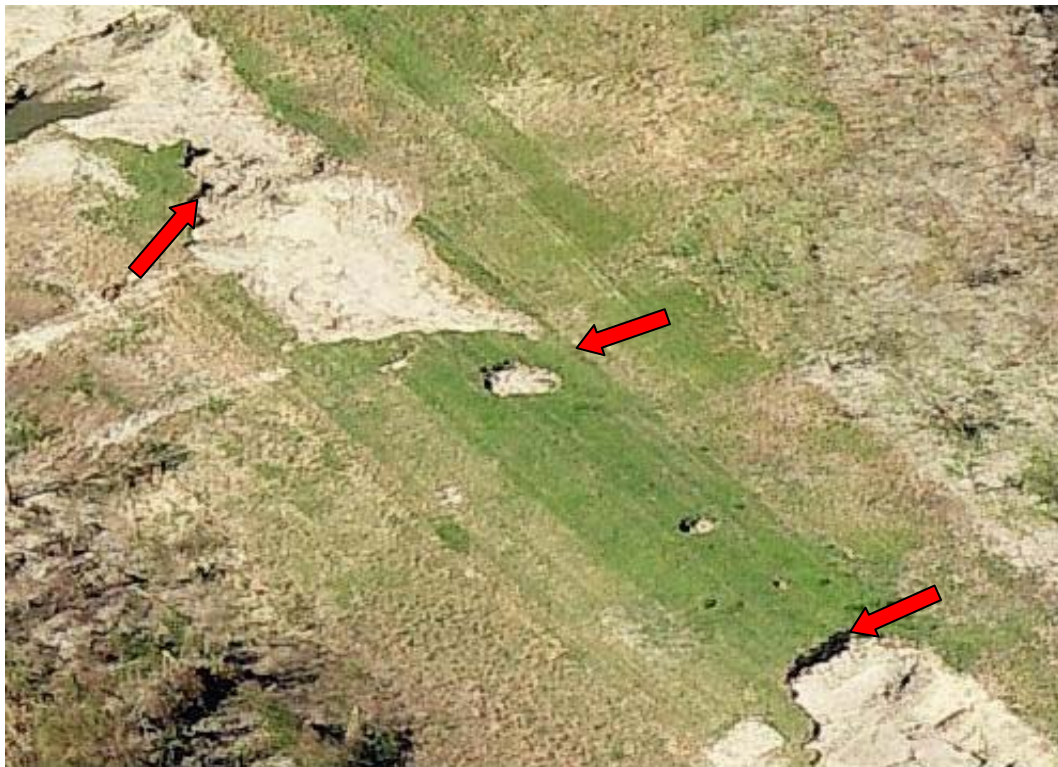
This and other photographic evidence (e.g. Figures B-14 - B-17) clearly indicate the presence of water side wave erosion initiated breaching that was subsequently exploited by the rising surge waters. This evidence is not concordant with the observations developed by Mr. Ebersole and Dr. Mosher as documented in their December 2008 Expert Reports. Evidence clearly shows remnant features of extensive sections of the Reach 2 EBSBs that indicate water side wave induced erosion breaching exploited by the rising surge waters to develop the major breaches that were developed during the passage of Hurricane Katrina.

Figure B-14. High resolution pictograph of Reach 2 EBSBs showing wave erosion features (photograph provided by Dr. Paul Kemp).

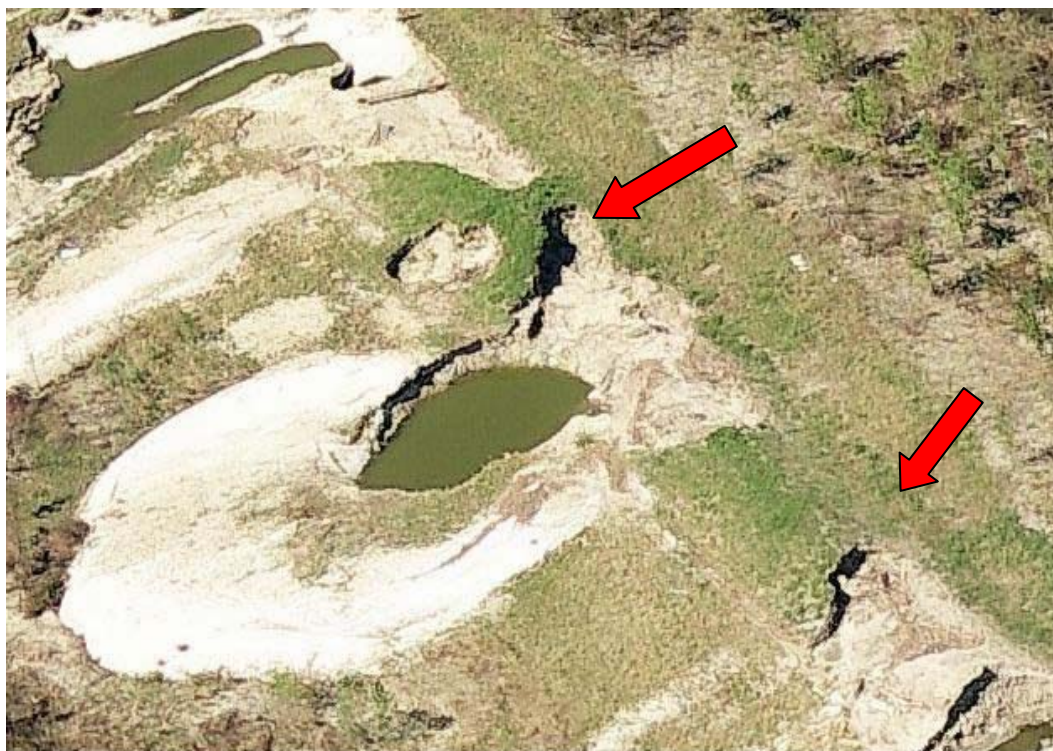
Figure B-15. High resolution pictograph of Reach 2 EBSBs showing wave erosion features (photograph provided by Dr. Paul Kemp).

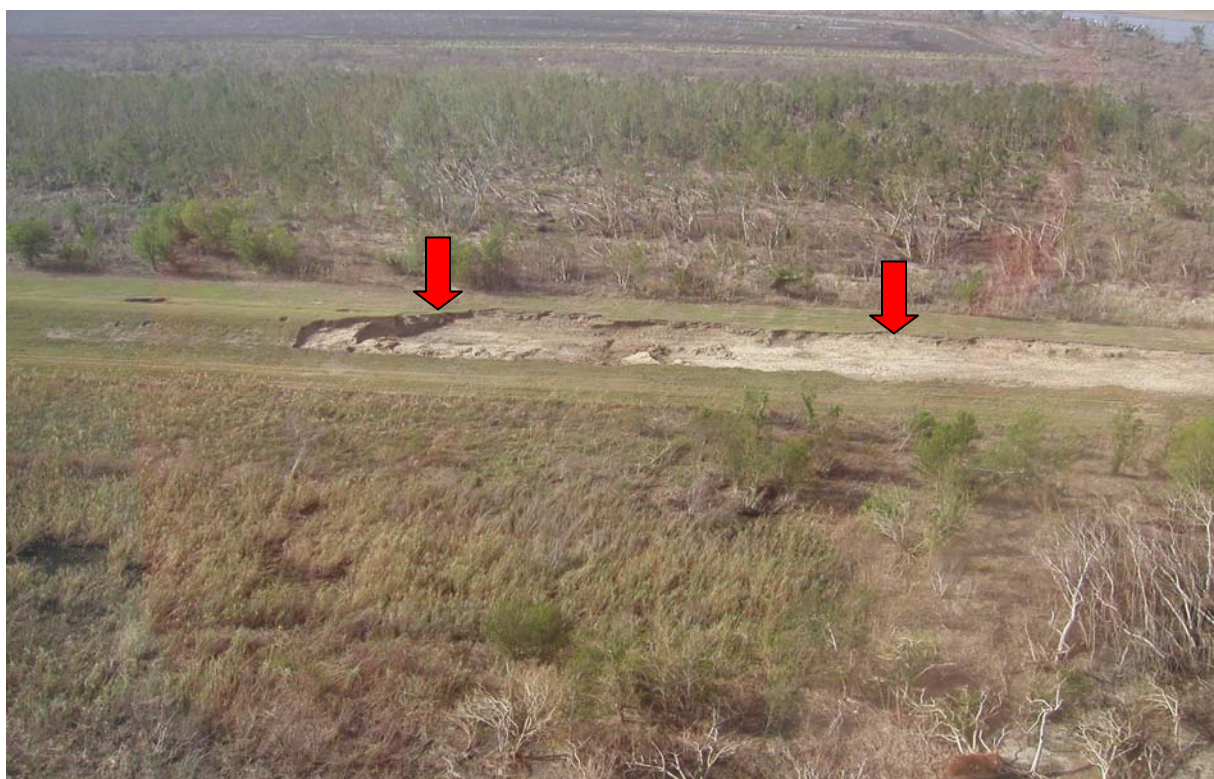
Figure B-16. High resolution pictograph of Reach 2 EBSBs showing wave erosion features (photograph provided by Dr. Paul Kemp).

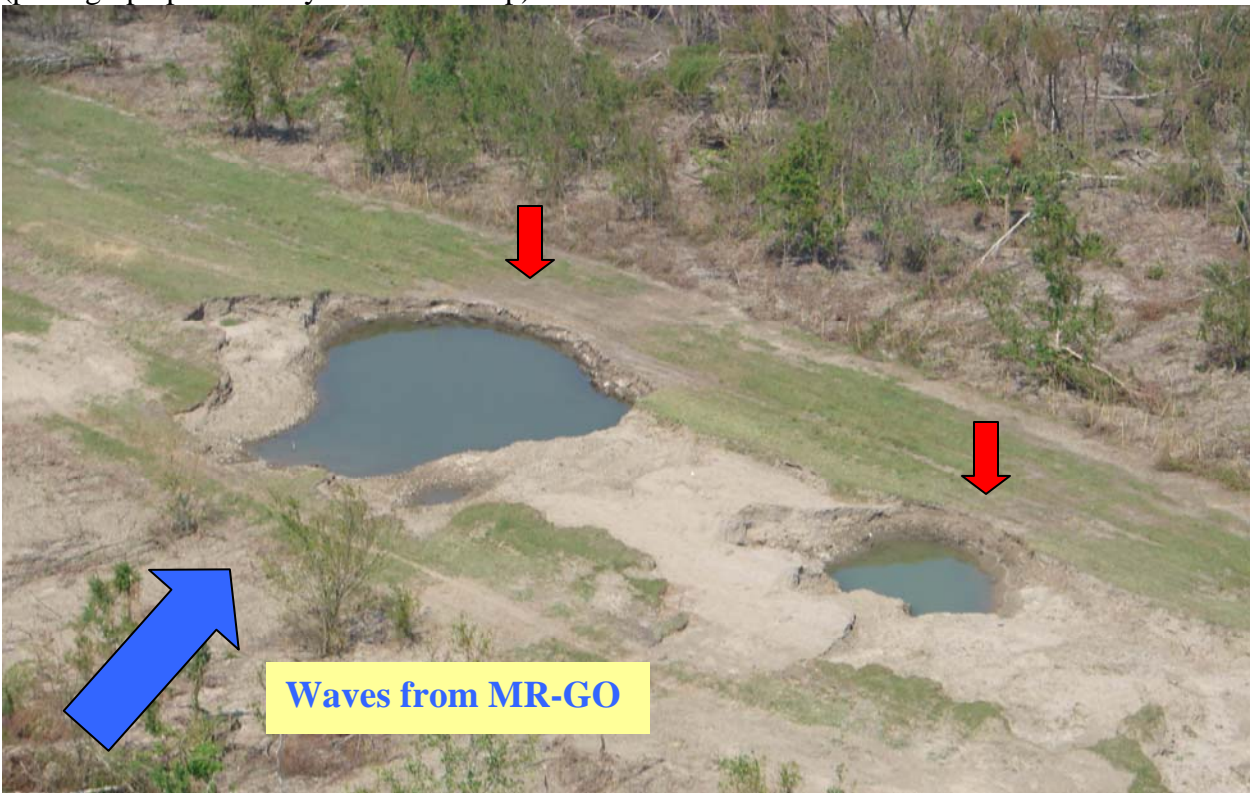
Figure B-17b. Aerial photograph of Reach 2 EBSB showing wave erosion features (photograph provided by Mr. Less Harder).

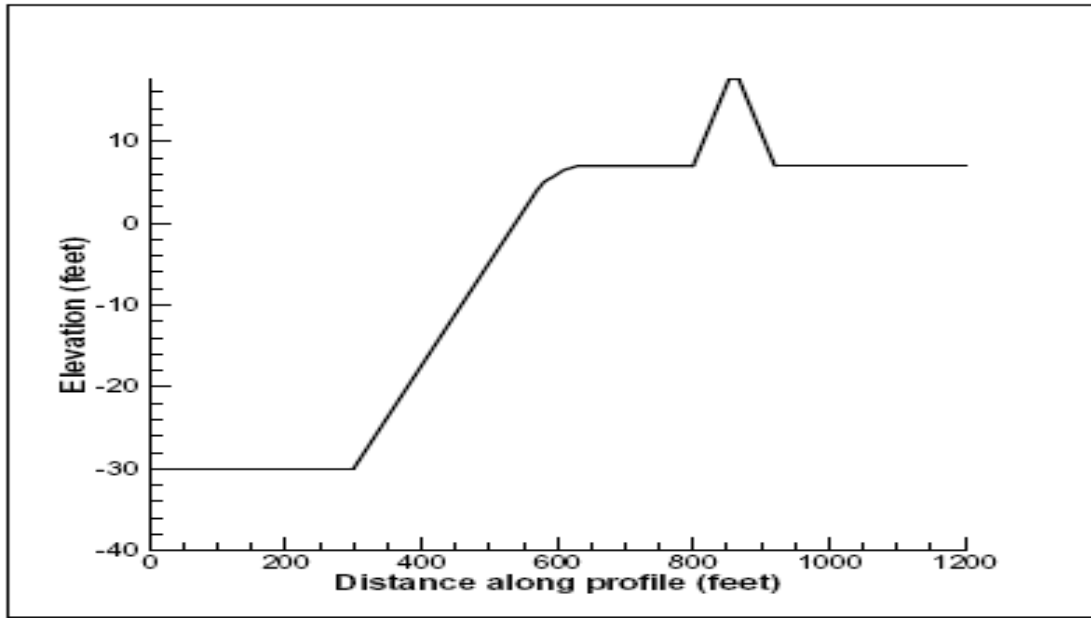
Figure 23. Generic profile for Boussinesq simulations with COULWAVE.
