VEGETATIVE DELINEATION REPORT

**WEST POINT A LA HACHE
FRESHWATER DIVERSION (BA-4)**

Delineation date: June 23, 1992
Report completion date: March 30, 1993

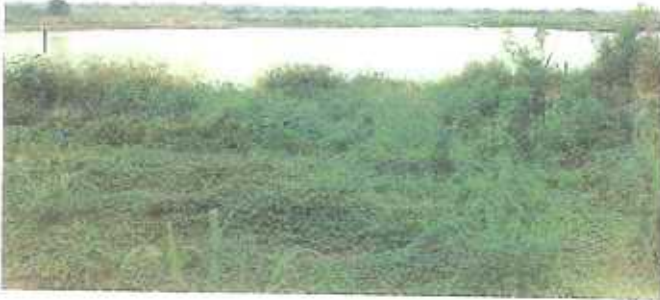
Figure 1

<u>Figure</u>	<u>Page</u>
1	The outfall pond of the West Pointe a la Hache Freshwater Diversion facility. Photo direction to the southeast 19
2.	Small distributary canals have been installed Photo direction to the southeast 19

Station 1 is near the end of the northern-most distribution ditch of the structure's outfall pond (figure 1). Several small ditches were cut using a suction dredge and the material excavated was discharged into the marsh. Vegetation is growing on these spoil sites and is mainly smooth cordgrass (figure 2). The discharge ditches terminated in the marsh interior but did not connect to adjacent existing waterways (figures 3 and 4). Salinity at Station 1 was 11

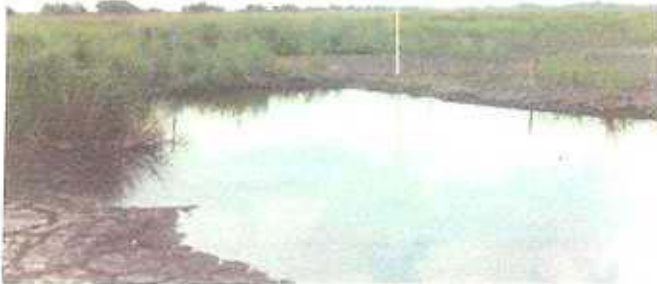
Figure 3

3.	Smooth cordgrass has become established on the spoil from the distributary canals. Photo direction to the south 19
4.	An existing small drainage canal adjacent to the outfall pond. Photo direction to the southwest 19
5	Station 1 is a smooth cordgrass marsh at the end of one of the distributary canals. Photo direction to the southeast 19

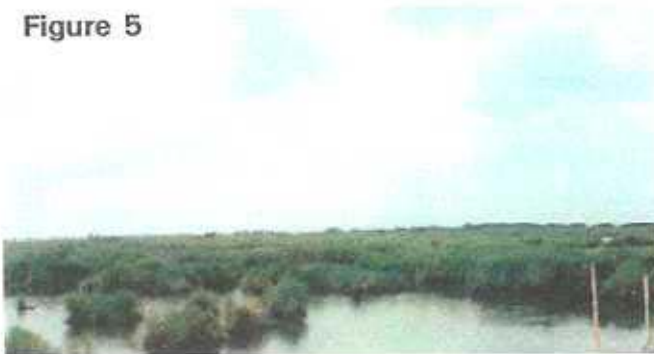
Figure 5

ppt and vegetation was smooth cordgrass (60%), salt grass (35%), and marshhay cordgrass (5%). The general area is composed of approximately 50% open water (figure 5).

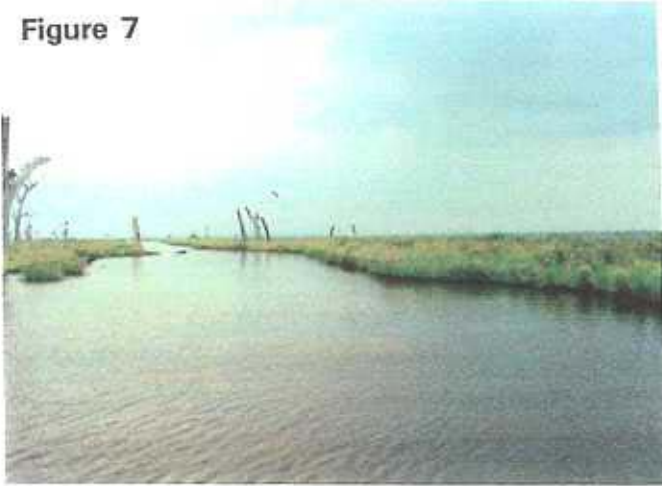
Figure 7

6.	Station 2 is in a small marsh on the north of the Jefferson Lake Sulphur Company canal. Photo direction to the north 19
7.	Dead trees are common along the Bayou Grande Chenier natural bayou bank at the Jefferson Lake Sulphur Company Canal crossing, Station 3. Photo direction to the northwest 20

Station 3 is located where the Jefferson Lake Sulphur Company Canal crosses Bayou Grande Chenier. Salinity at this site was 10.5 ppt. All of the original large tree species on the old bayou banks have been killed by subsidence and saltwater intrusion (figure 7). Marsh plants are dominantly marshhay cordgrass (60%) and smooth cordgrass (35%) with some salt grass (5%).

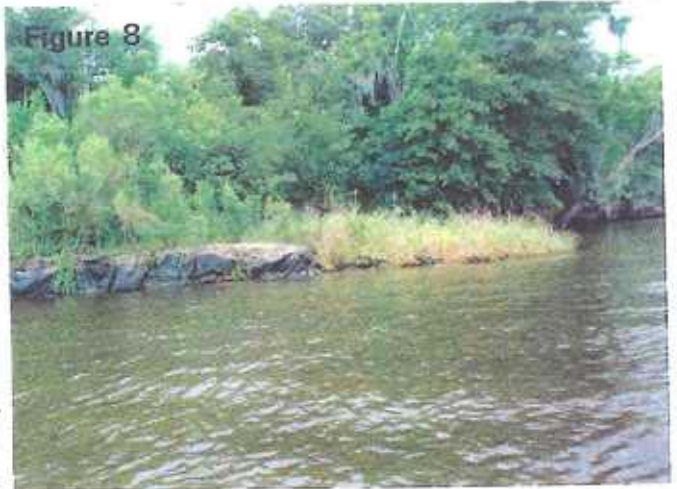
Figure 8

8.	An earthen plug had been installed across the United Gas Pipeline canal at Bayou Grande Chenier, however the plug washed out. Photo of the east bank . . 20

Station 4 is located where United Gas Pipeline canal crosses Bayou Grande Chenier. Plant composition is marshhay cordgrass (60%) and smooth cordgrass (35%) with some salt grass (5%). Water salinity was 10.5 ppt. This canal has been plugged in the past, but is now open and provides an excessive amount of water interchange through the natural ridge system (figures 8 and 9).

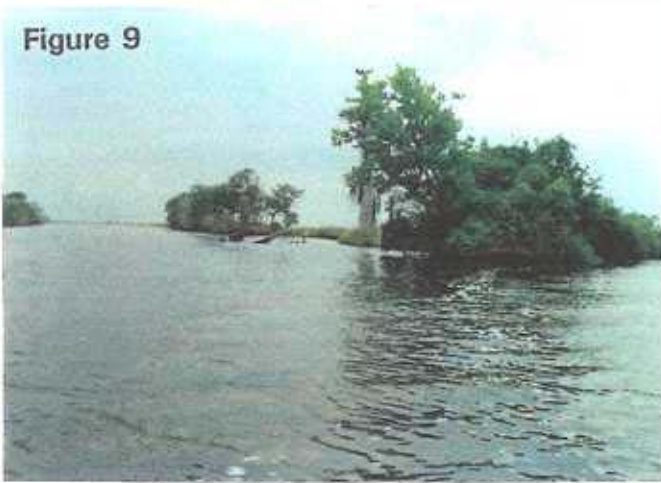
Figure 9

9.	Station 4 is at the United Gas Pipeline crossing at Bayou Grande Chenier. Photo direction to the southwest 20
10.	Station 5 is located at the earthen plug on a mineral access canal at Bayou Grande Chenier. Photo direction to the southeast 20

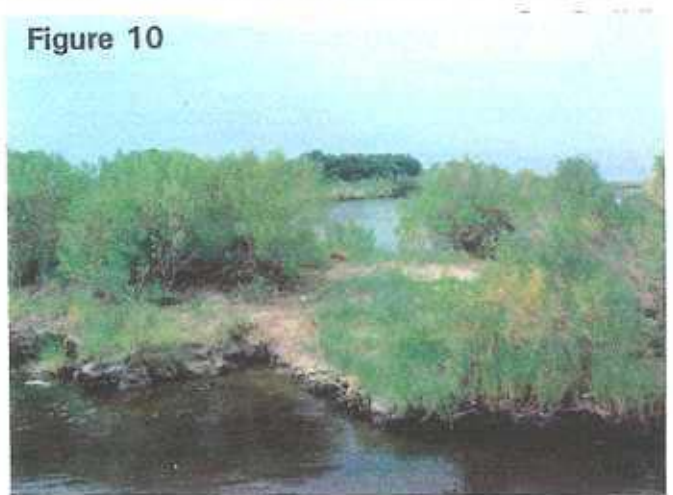
Figure 10

Station 5 is at a dead end mineral canal system that has been plugged on both sides of Bayou Grande Chenier. The plugs are constructed with soil and will need periodic maintenance to prevent wash out (figure 10). Marsh vegetation in this area is 60% marshhay cordgrass with approximately 30% smooth cordgrass and 10% salt grass.

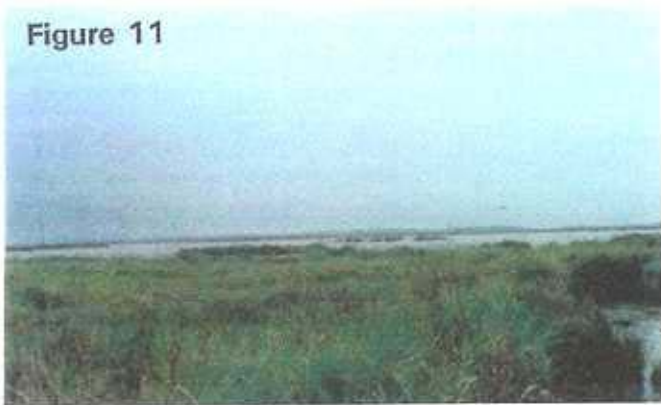
Figure 11

11.	Station 6 is in an area of broken marsh that has converted into large open lakes. Photo direction to the southeast 20
12.	Aquatic vegetation in the area was widgeongrass and was found in only a few sites, Station 7. Photo direction is to the north 20

Station 6 is near the outfall center in a section of intensive oil and gas operations. Several large ponds have developed (figure 11). Vegetation in this area has approximately 45% marshhay cordgrass and 45% smooth cordgrass with a good stand of salt grass (10%) along the edge of the levees.

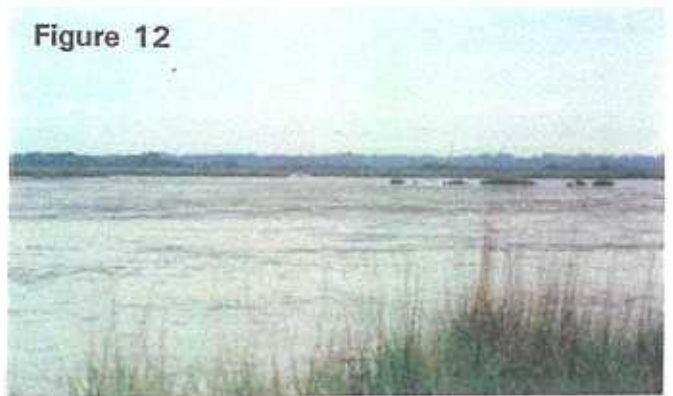
Figure 12

Station 7 is at an area where large ponds exist on the west side of Grand Bayou. Pond areas were supporting good stands of widgeongrass (*Ruppia maritima*) (100%) and approximately 80% of the ponds were covered (figure 12). Salinity in this area was 12.5 ppt. The spoil bank along the edge of the ponds was covered with 80% salt grass, 10% marshhay cordgrass, and 10% smooth cordgrass.

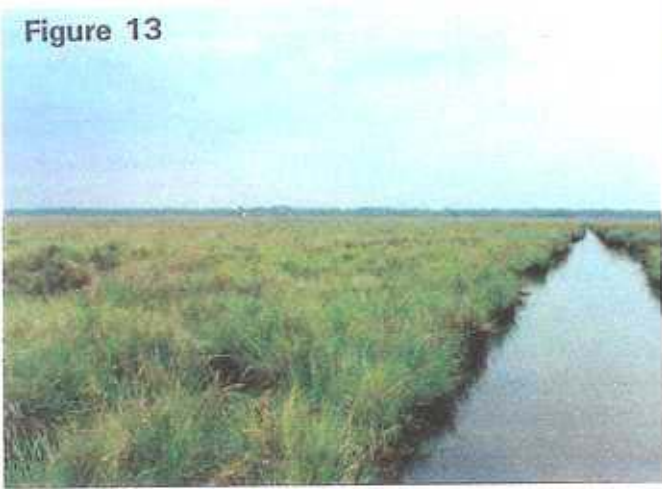
Figure 13

13.	A large number of small ditches exist along the river side of Grand Bayou, Station 8. Photo direction is to the north 21

Station 8 is in the mouth of a small ditch off Grand Bayou which leads from the high ground near the back protection levee to Grand Bayou (figure 13). Vegetation in this area was 60% smooth cordgrass, 35% salt grass, and 5% marshhay cordgrass. Salinity was 12 ppt. Marshhay cordgrass was present but in minor amounts. A large pumping station discharges into the marsh in this area. There was no indication from the vegetation that enough freshwater was available to influence the brackish-saline marsh plant species composition.

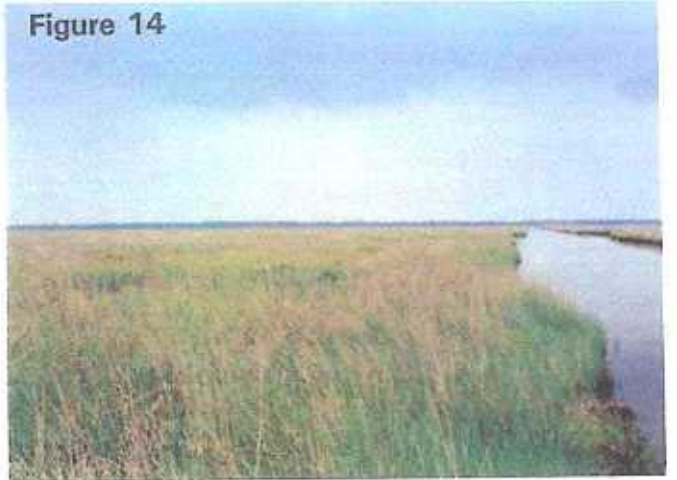
Figure 14

14.	Some of the ditches that empty into Grand Bayou from the river terrace are quite large and allow for extensive interchange of water, Station 9. Photo direction is to the north	21

Station 9 is in a small drainage canal on the lower side of Grand Bayou village and is between the bayou and the Mississippi River. Salinity in this canal was 15 ppt and the marsh vegetation was 70% smooth cordgrass, 20% salt grass, 5% marshhay cordgrass, and 5% saltmarsh bulrush (figure 14). Very little marshhay cordgrass was noted and some saltmarsh bulrush was observed. These species were in scattered sprigs in the smooth cordgrass.

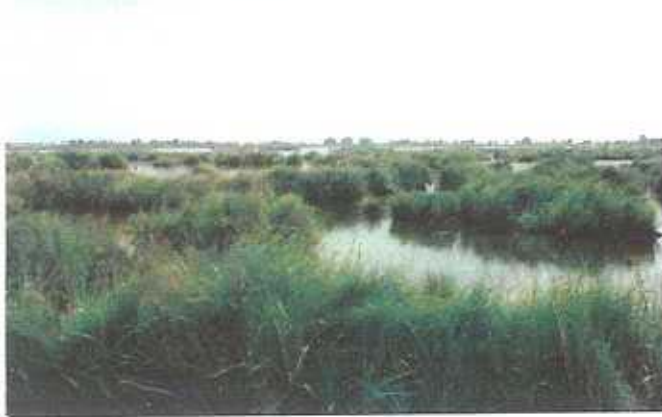
Figure 15

15.	Broken marsh at Station 10 looking toward Grand Bayou village from the river side. Photo direction is to the southeast	21
16.	The Grand Bayou remote sensing facility adjacent to the Jefferson Lake Sulphur Company canal. Photo direction is to the east	21
	Station 11 is near the Hermitage Ridge complex west of Lake Hermitage in marshhay cordgrass. Photo direction is to the northwest	21

ppt and the marsh was very broken. Approximately 70% of the area was open water and the plant communities were composed mainly of smooth cordgrass (70%) and salt grass (20%), with only 10% marshhay cordgrass (figure 15). Widgeongrass covered approximately 60% of the pond areas.

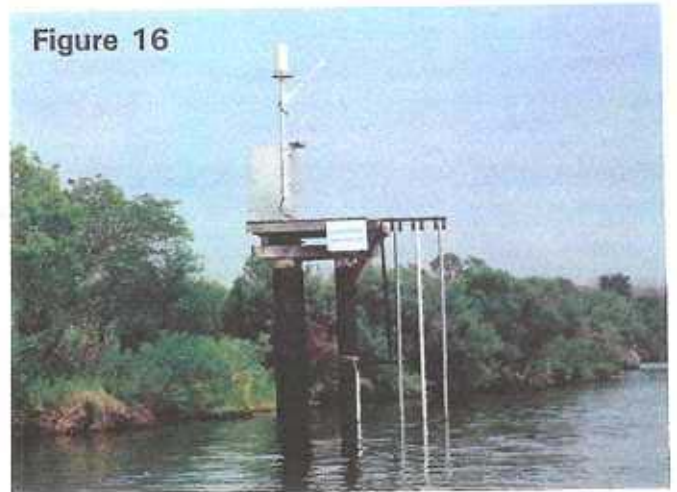
Figure 16

A remote sensing station is located in Grand Bayou near the point where the Jefferson Lake Sulphur Company Canal crosses (figure 16). This unit will provide excellent information that will be used to guide area management functions regarding water quality and levels.

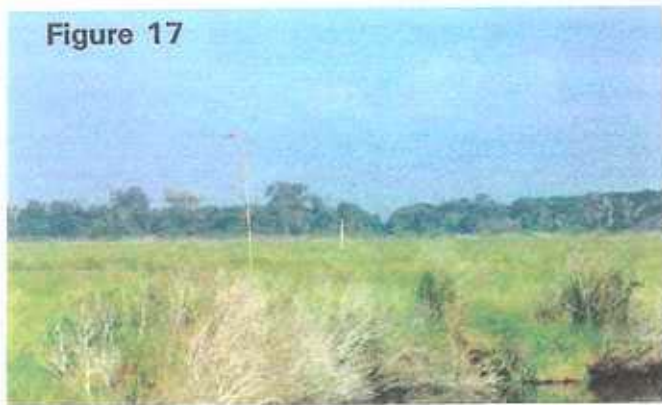
Figure 17

Station 11, on the northwest side of Lake Hermitage, should provide good comparative data for restoration attempts south and east of the lake. A new pipeline will be installed adjacent to an existing line through this section of marsh (figure 17). Vegetation in this area was 95% marshhay cordgrass with a 5% combination of deerpea (*Vigna luteola*), eastern baccharis (*Baccharis halimifolia*), and marshmallow (*Hibiscus lasiocarpo*). Water salinity was 10 ppt. The main ridge system in this area still supports live trees; however, the section between this site and Lake Hermitage village has extensive stands of dead trees. This section of coastal wetlands was impacted several years ago by an active mosquito control program that included extensive ditching efforts to remove standing water from the ridge edge. This program also allowed high tides to introduce saltwater into areas that were previously isolated from daily tidal action. This process may have accelerated the killing of some vegetation.

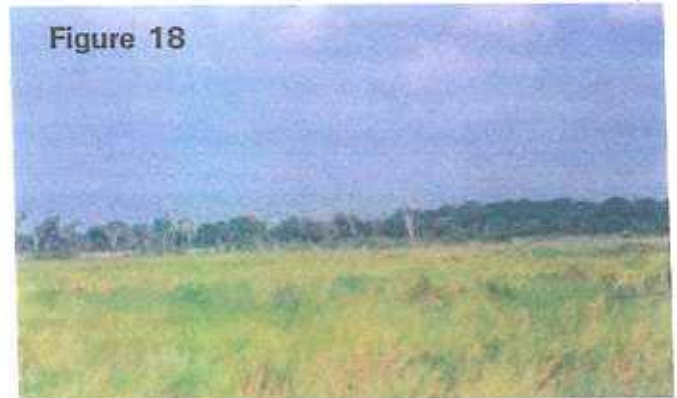
Figure 18

18.	From Station 12, dead trees along the Hermitage Ridge are visible. Photo direction is to the southwest	21
19.	Small patches of three-cornered grass are mixed with marshhay cordgrass at Station 13, north of Lake Hermitage. Photo direction is to the northwest	22
	A private drainage station on Citrus Lands of Louisiana empties into a bayou leading into Lake Hermitage, Station 14. Photo direction is to the northeast	22

killed along the ridge system from this point south because of subsidence and saltwater intrusion (figure 18).

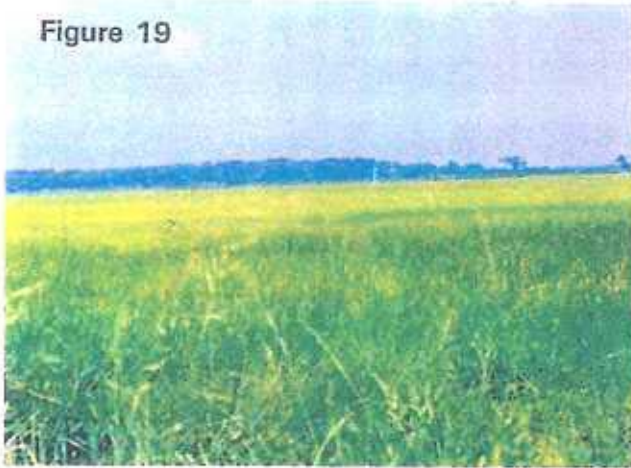
Figure 19

Station 13 is west of a small ditch out of the north end of Lake Hermitage. Salinity was 10 ppt and the marsh vegetation was 90% marshhay cordgrass with small patches of three-cornered grass (5%) and smooth cordgrass (5%) (figure 19). A few muskrat houses were observed in this area.

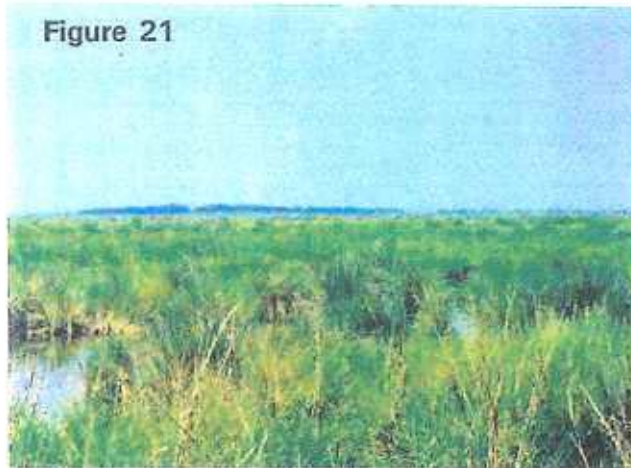
Figure 21

21.	Station 15 is located along the area where smooth cordgrass and marshhay cordgrass appear to be evenly distributed in the plant composition. Photo direction is to the southwest	22

Station 15 is in ponds east of Lake Hermitage and near the Citrus Lands of Louisiana levee system. This site is where marshhay cordgrass dominance (45%) gives way to smooth cordgrass (55%) (figure 21). The large trees visible in the background of this figure are where the Jefferson Lake Sulphur Company Canal crosses the Bayou Grande Chenier ridge system. Salinity in the area was 9 ppt.

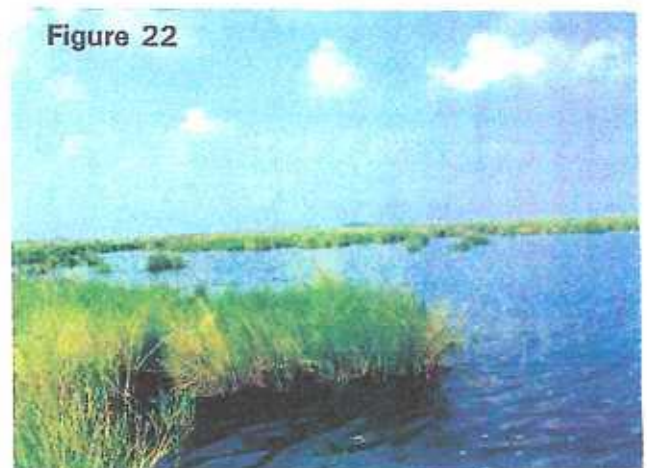
Figure 22

22.	Pond edges are broken in the area of Station 16. Photo direction is to the southwest	22
	Deep water is found at the break in the spoil banks of many oil and gas canals, and contribute to tidal exchange, Station 17. Photo direction is to the northwest	22
	At the site where the Southern Natural Gas pipeline crosses Bayou Grande Chenier. Photo direction is to the west	22

Station 16 is north of the Jefferson Lake Sulphur Company Canal. This site has broken marsh vegetation along the edge of natural ponds and the dominate vegetation is smooth cordgrass (60%) with a decreased percentage of marshhay cordgrass (40%) (figure 22). Salinity was 10.5 ppt this area. Tidal action in this area is excessive, and openings of water depth. Salt grass is established along pond and canal edges.

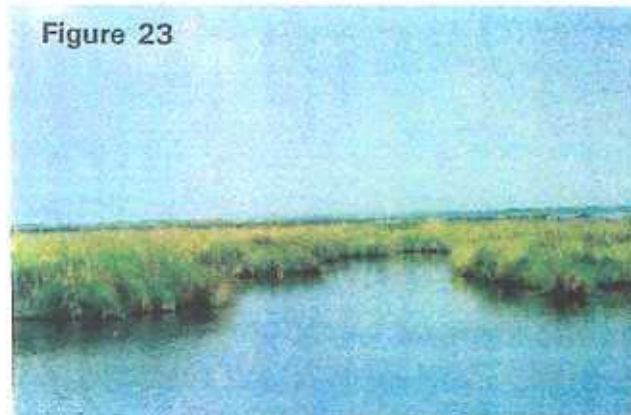
Figure 23

Station 17 is at the end of a mineral access canal where an existing Shell Pipeline crosses (figure 23). Salinity in this area was 12 ppt and some widgeongrass was noted in the edge of the ponds. Marsh vegetation was smooth cordgrass (80%) and marshhay cordgrass (20%). Salt grass was also present in minor amounts along the pond bank edges.

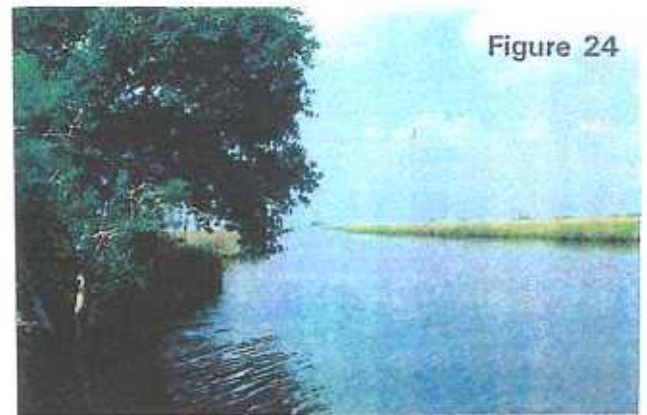
Figure 24

Station 18 is located where a Southern Natural Gas Pipeline crosses the Bayou Grande Chenier ridge system (figure 24). A bulkhead and rip-rap pipeline closure are approximately 1000 ft southeast of the natural ridge system. An opening has been created in the structure and is serving as a small weir (figure 25). Salinity in the area was 13.5 ppt and the marsh vegetation was dominated by 95% smooth cordgrass and 5% marshhay cordgrass. Tidal action was moving into the area during field observation on June 24, 1992.

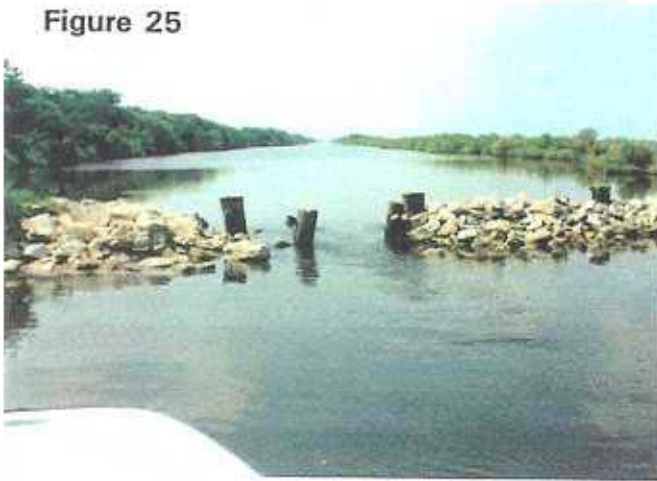
Figure 25

25.	Station 18 is near the S.N.G. rip rap weir and Bayou Grande Chenier. Photo direction is to the southeast	23
26.	Station 19 is at the intersection of Johnson Bayou and Bayou Grande Chenier. Photo direction is to the southwest	23

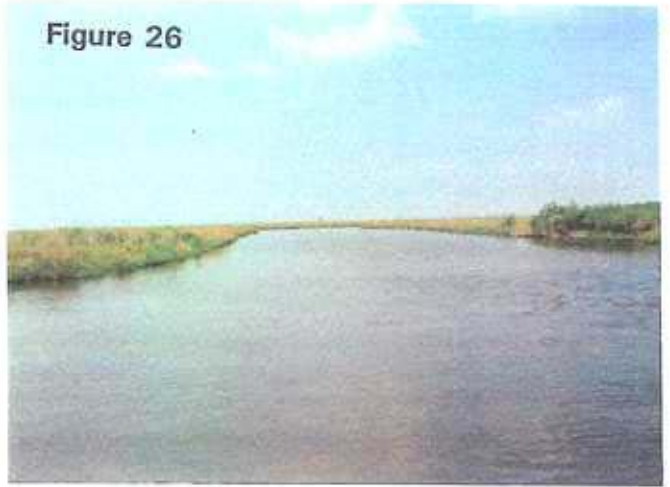
Figure 26

Station 19 is located where Johnson Bayou crosses Bayou Grande Chenier (figure 26). Some live oak, yaupon, toothache, hackberry, and wax myrtle trees are still alive on the natural bayou banks (figure 27). Such sites may reveal archeological middens. Marsh vegetation was dominated by smooth cordgrass (95%) with 5% marshhay cordgrass. The water salinity was 14 ppt. This site should be included in any outfall management plan calling for structural control of saltwater intrusion.

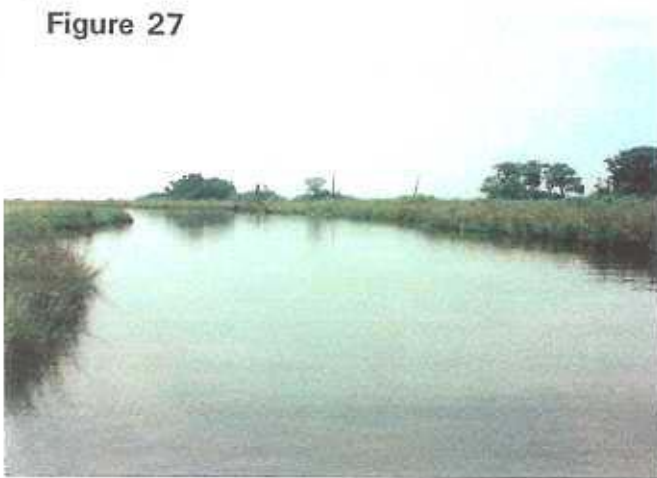
Figure 27

A few sites exist along the natural ridge of Bayou Grande Chenier which may contain archeological material. Photo direction is to the southeast 23

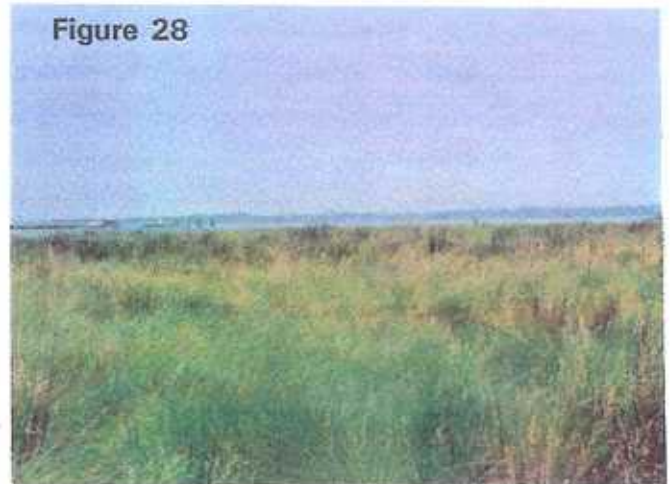
Figure 28

Station 21 is near where Willow Bayou empties into Lake Hermitage.
Photo direction is to the northwest 23

this portion of the Lake Hermitage watershed. The marsh is very broken and the natural waterway is no longer discernable from the ponds (figure 28). Vegetation in the area is 50% smooth cordgrass and 50% marshhay cordgrass. Salinity was 10 ppt and tidal action was very noticeable.
