Performance Evaluation of the New Orleans and Southeast Louisiana Hurricane Protection System

Draft Final Report of the Interagency Performance Evaluation Task Force

Volume V – The Performance — Levees and Floodwalls

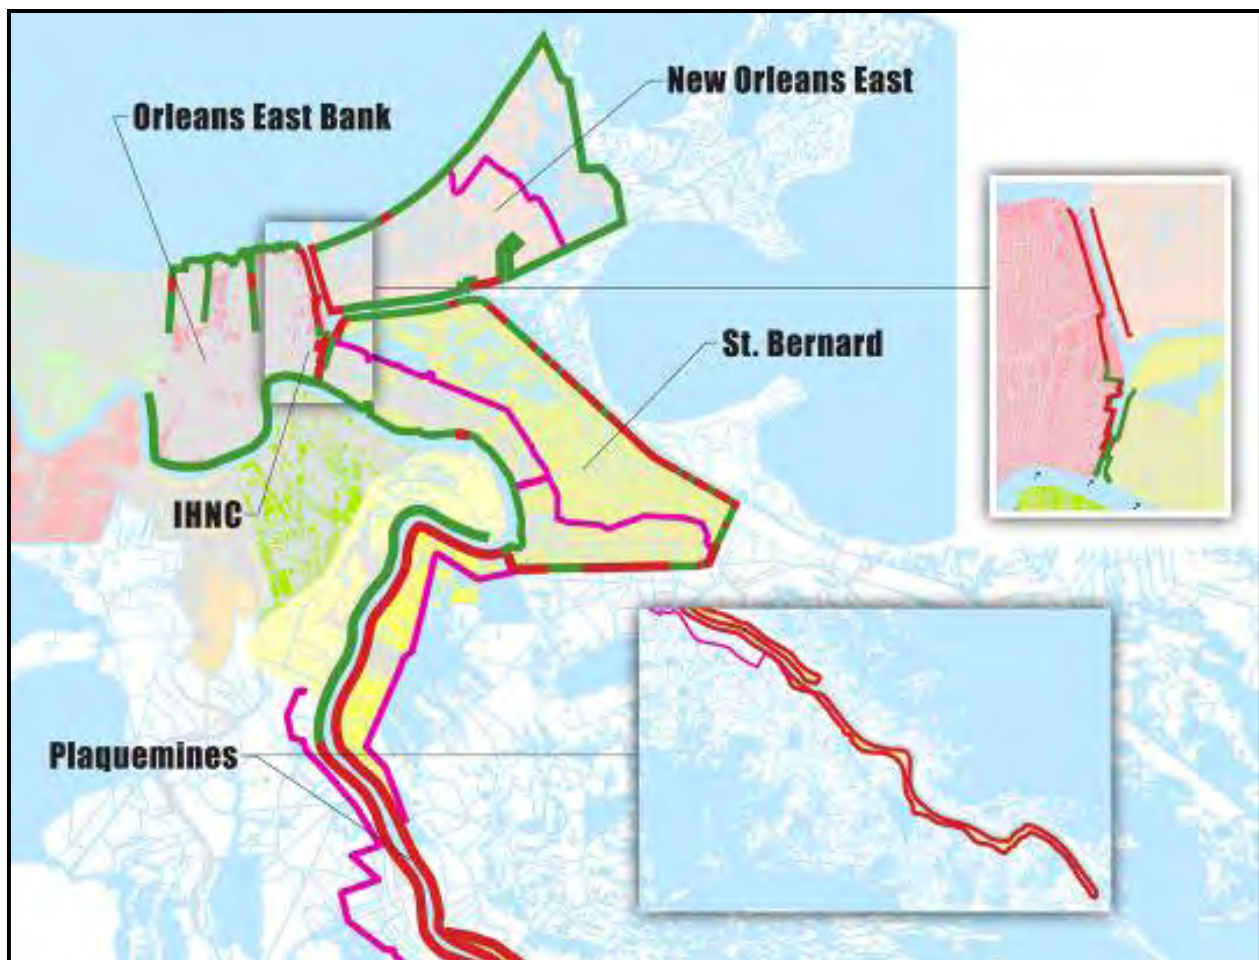
Figure 1. Damage to the New Orleans Hurricane Protection System

Breaches due to instability of floodwalls occurred at one location on the 17th Street Canal, at two locations on the London Avenue Canal, and at one location on the Inner Harbor Navigation Canal (IHNC). Breaches due to erosion as a result of overtopping occurred at three locations on the Inner Harbor Navigation Canal and at many locations on the Mississippi River Gulf Outlet, the Gulf Intracoastal Waterway, and the Mississippi River levees. Figure 1 shows in red the extent of the damage to the levees and floodwalls. Of the 284 miles of levees and floodwalls,

169 miles were damaged. Figure 2 shows the locations of the major breaches in the flood control system.

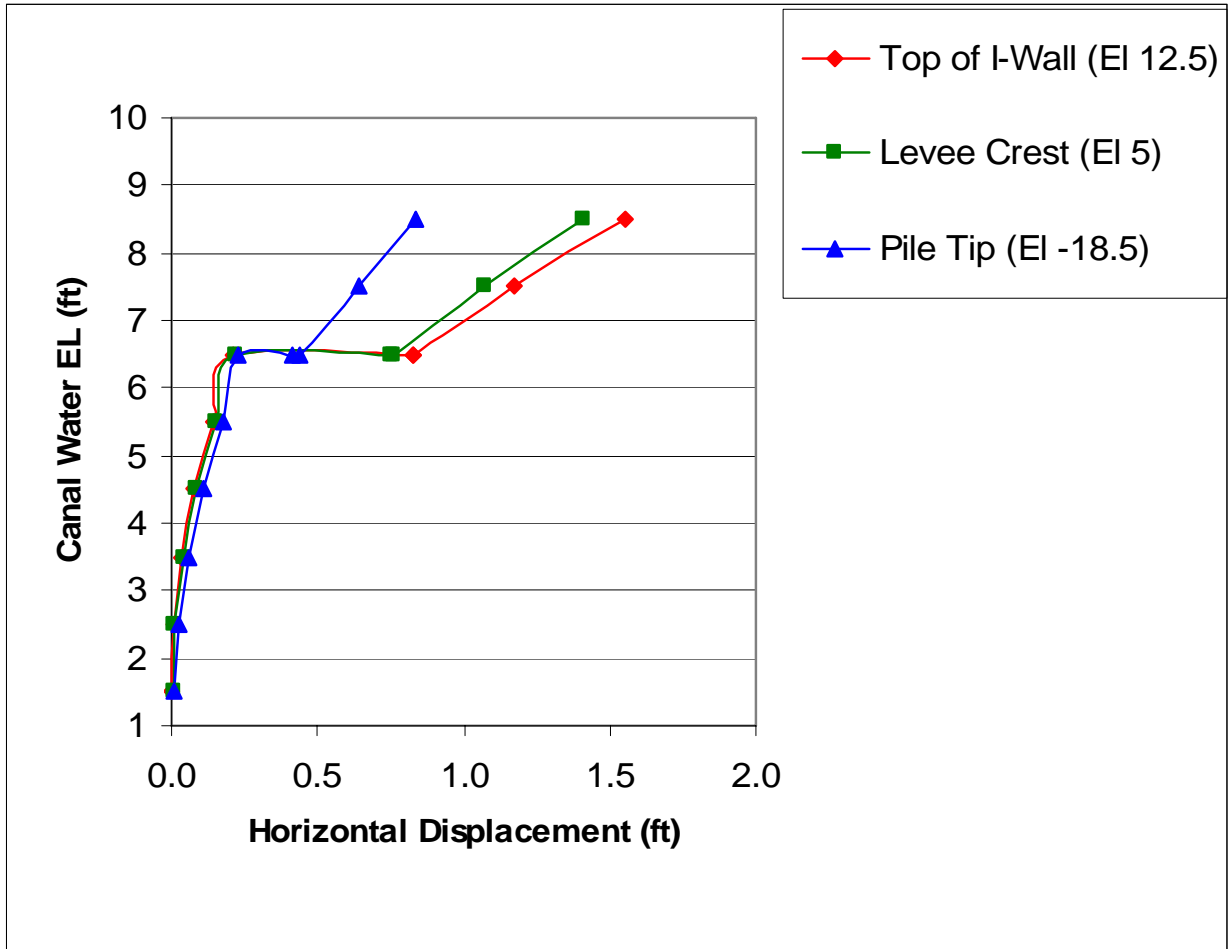
Figure 23. Horizontal Sheet Pile Deflections Versus Canal Water Elevation Computed in the Soil-Structure Interaction Analysis of Station 10+00 on the 17th Street Canal East Side Breach

The development of a gap, which immediately filled with water, resulted in a marked increase in calculated displacements, as shown in Figure 23. As the water in the canal rises from El 6.5 to El 9.0, the maximum lateral deformation increases from 1.6 ft, the condition shown in Figure 24, to 5.3 ft, the conditions shown in Figure 25; and the factor of safety decreases from 1.16 to 0.98. Figure 26 shows that the contours of maximum shear strains form a shear surface that compare well with the critical failure surface found in the limit equilibrium stability analysis, Figure 27.

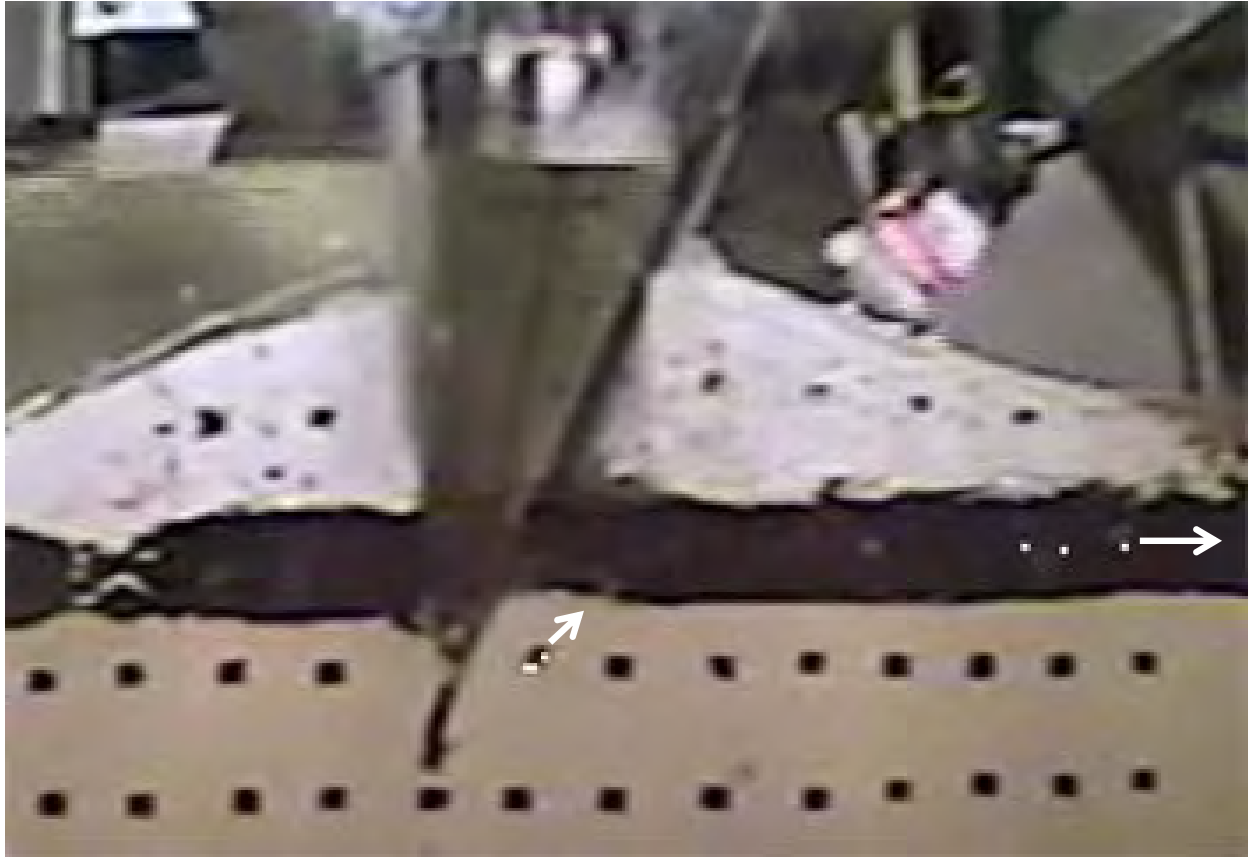
Figure 34 Superposition of Video Images of the Rotational Failure of the London South Model Wall, Model 1

In the London Avenue Canal model tests, where the toe of the sheet pile wall penetrated into the sand and was restrained from lateral movement by the sand, the opening of the gap on the canal side of the floodwall was followed by rotation of the top of the wall landward. With the opening of the gap, the model tests for the London south breach and the London north breach both showed gross movements indicative of wall failure, as may be seen in Figure 34. Rotation of the wall was accompanied by a translational sliding of the landward part of the levee and marsh layer, on top of the underlying sand. Rotation of the wall is linked to reduction in effective stress on the sand layer beneath the landward side of the levee. Once the gap was fully opened, pore pressure transducers in the foundation sand layer showed that the pore pressure in the sand rose very significantly. The increasing water pressure in the sand layer reduced the effective stress at the base of the marsh layer. The reduction in vertical effective stress has two effects: the first is to increase the likelihood of uplift of the swampy marsh (as the increasing water pressure in the foundation balances or exceeds the weight of the levee and marsh layer above) and the second is to reduce the stiffness of the sand surrounding the toe of the sheet pile wall, reducing the passive resistance that the sand provides.

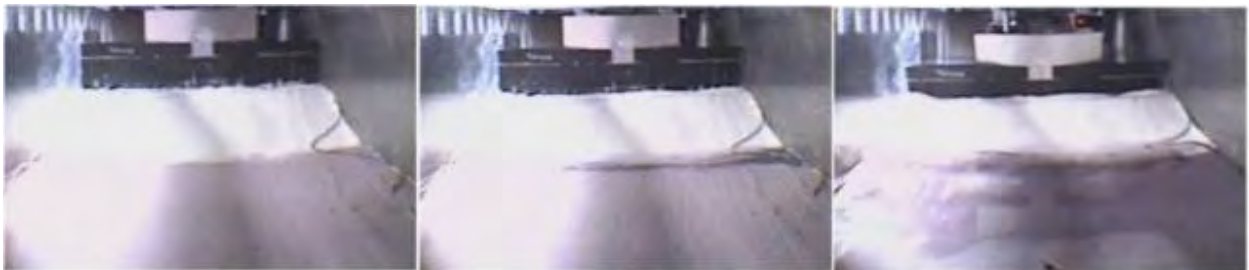
Figure 35. Water Emerging From Toe of Levee as Failure Progresses, London South Model 2

The high pore water pressures under the toe of the levee on the landward side and under the swampy marsh led to water being ejected from the ground at the toe of the levee. This may be deduced from the piezometric heads near the toe of the levee, and can be seen clearly in the video images of the landward toe. Figure 35 shows a view of the levee and floodwall as seen from the ‘backyard’ of houses behind the levee, showing ‘black’ water emerging from the toe of the levee as the flood wall rotates landward. This supports the earlier assessment based on seepage analyses that a rupture through the marsh layer overlying the sand at the south breach led to a failure initiated by erosion and piping.

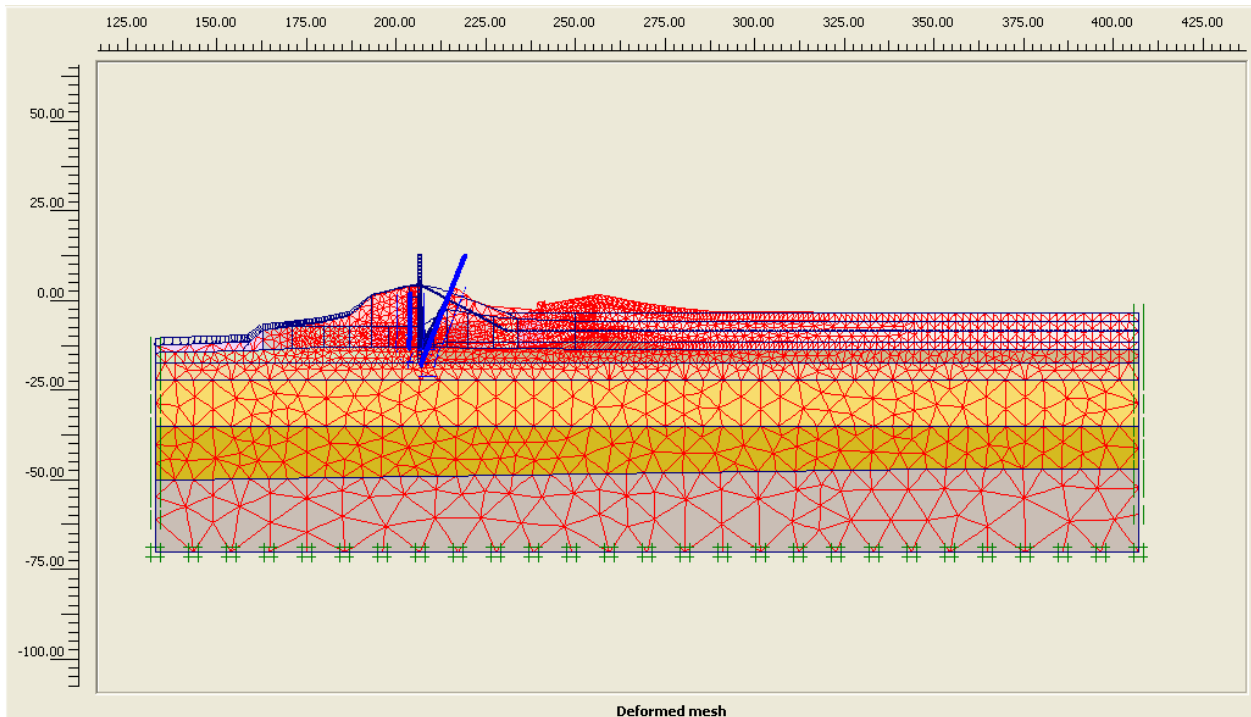
The finite element soil-structure interaction analyses are consistent with the behavior observed in the centrifuge tests, where the opening of the gap on the canal side of the floodwall was followed by rotation of the wall landward, as shown in Figure 40. Figure 41 shows the horizontal displacement of the top and tip of the wall as the canal water rises. It shows that the

Figure 40. Ultimate Mechanism from Strength Reduction Analysis Using Average Stiffness Values with Canal Elevation 6.0 ft and Gap to Elevation -12.9 ft, London Avenue North Breach (displacements are exaggerated)

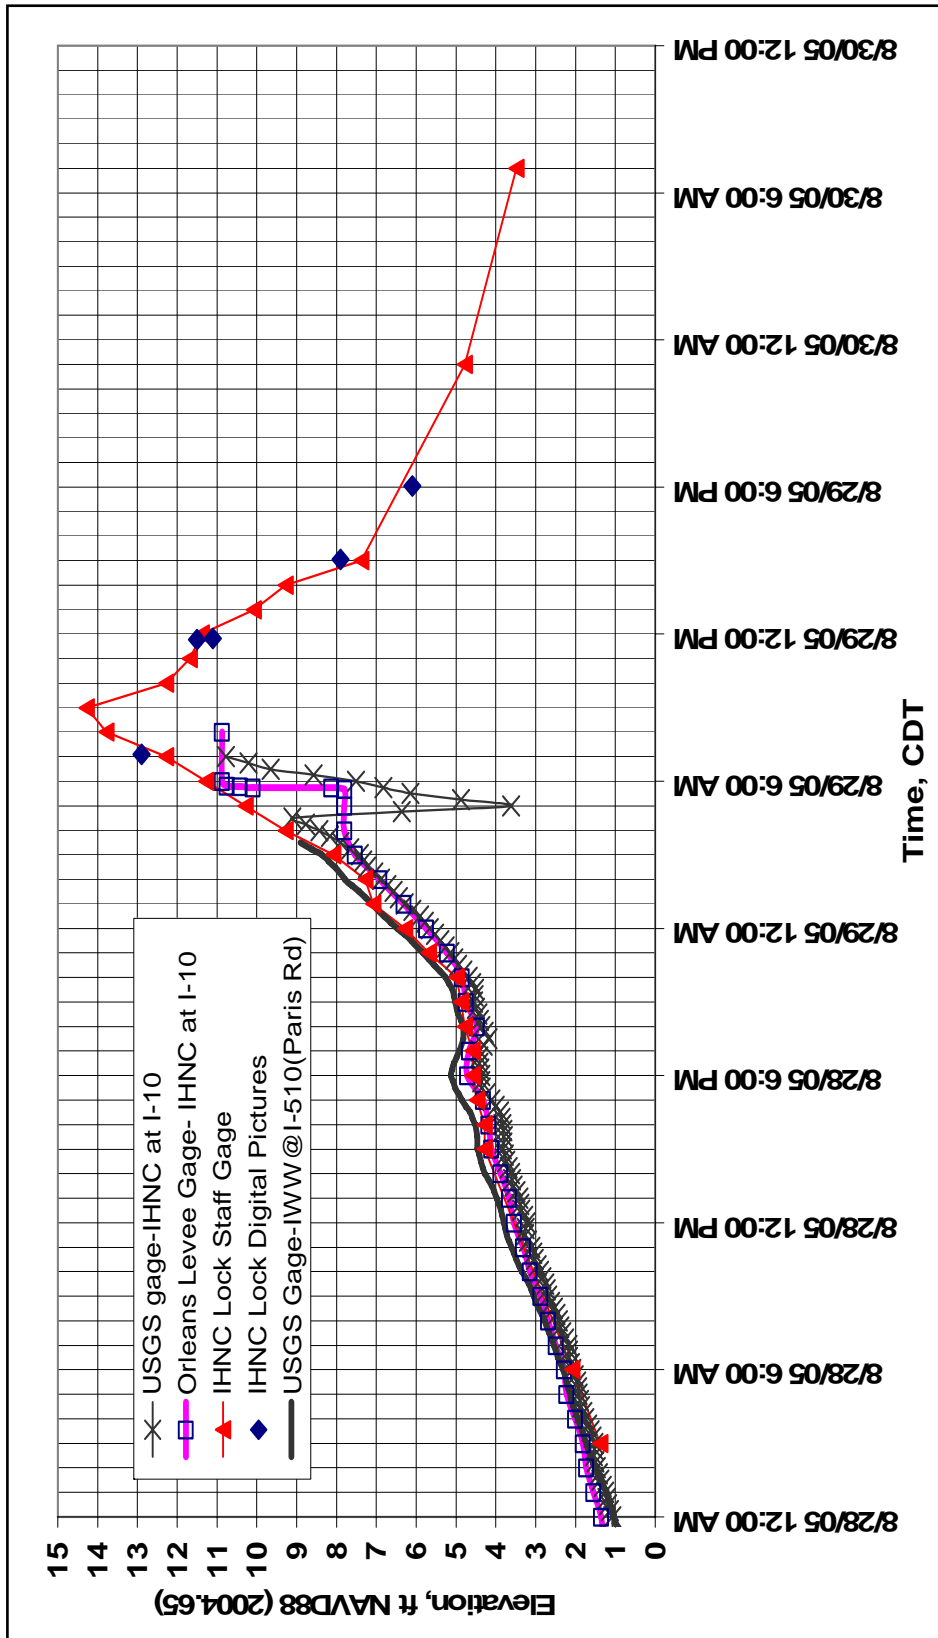
All of the IHNC floodwalls and levees were overtopped on August 29th. The peak storm surge elevation in the IHNC was 14.2 ft at 9:00 AM, as can be seen in Figure 44. This peak water level is about 1.7 ft above the tops of the floodwalls and levees. The reaches where the floodwalls and levees did not collapse have, therefore, survived water loading considerably higher than the design loading.

Figure 44. Katrina Hydrograph for the Inner Harbor Navigation Canal

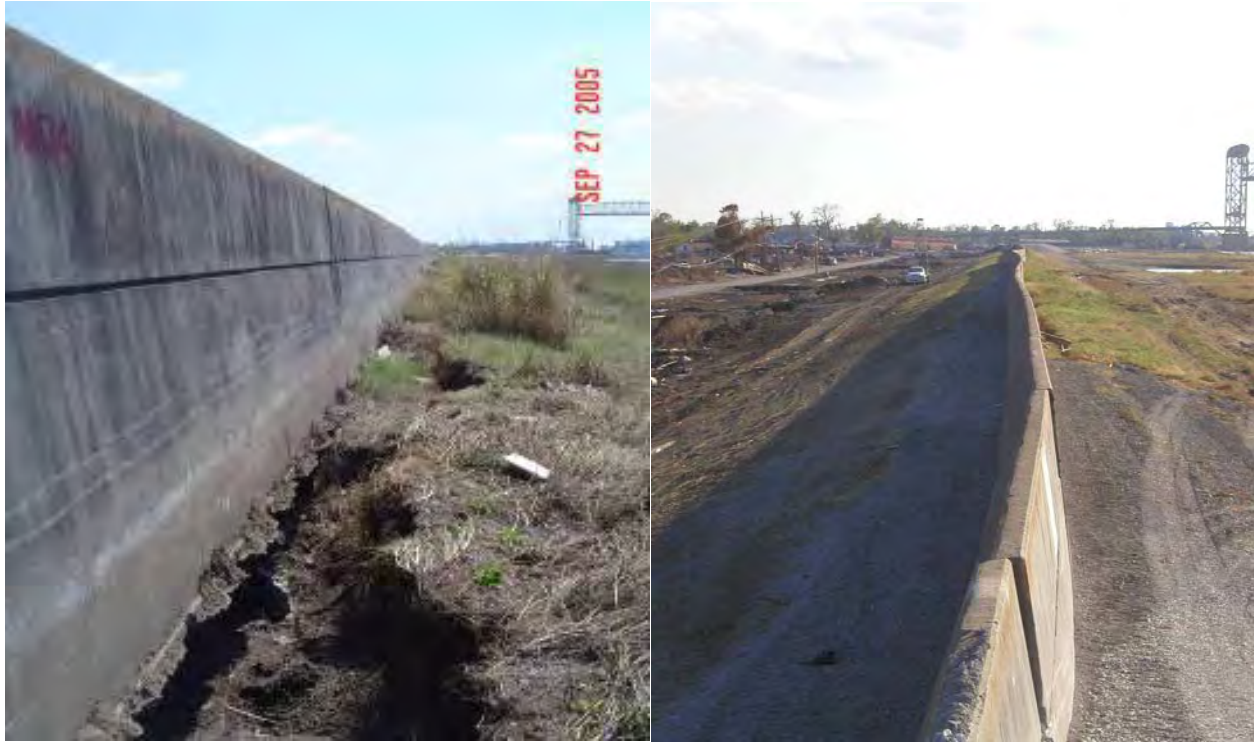
Formation of a gap on the canal side of the wall, allowing hydrostatic water pressure acting through the full depth of the gap, causes a very significant reduction in the value of the calculated factor of safety. Evidence that a gap did form behind the wall near the breaches can be seen in Figures 48 and 49.

Stability analyses of the north breach on the east side resulted in a computed factor of safety equal to 1.0, with a gap on the canal side of the wall and water in the IHNC at elevation 11.2 ft. This is about 1.0 ft higher than the average IHNC water level at the time flood water was observed in the Lower 9th Ward. Considering that the effective water level could have been one foot higher due to wave effects, this result is consistent with the observed IHNC water level when flood water was first reported in the Lower 9th Ward. It thus appears that the north breach

Figure 49. IHNC East Bank – North Breach – Wall Movement
