Analysis of the Interstate 10 Twin Bridge's Collapse During Hurricane Katrina

By Genda Chen, Emitt C. Witt III, David Hoffman, Ronaldo Luna, and Adam Sevi

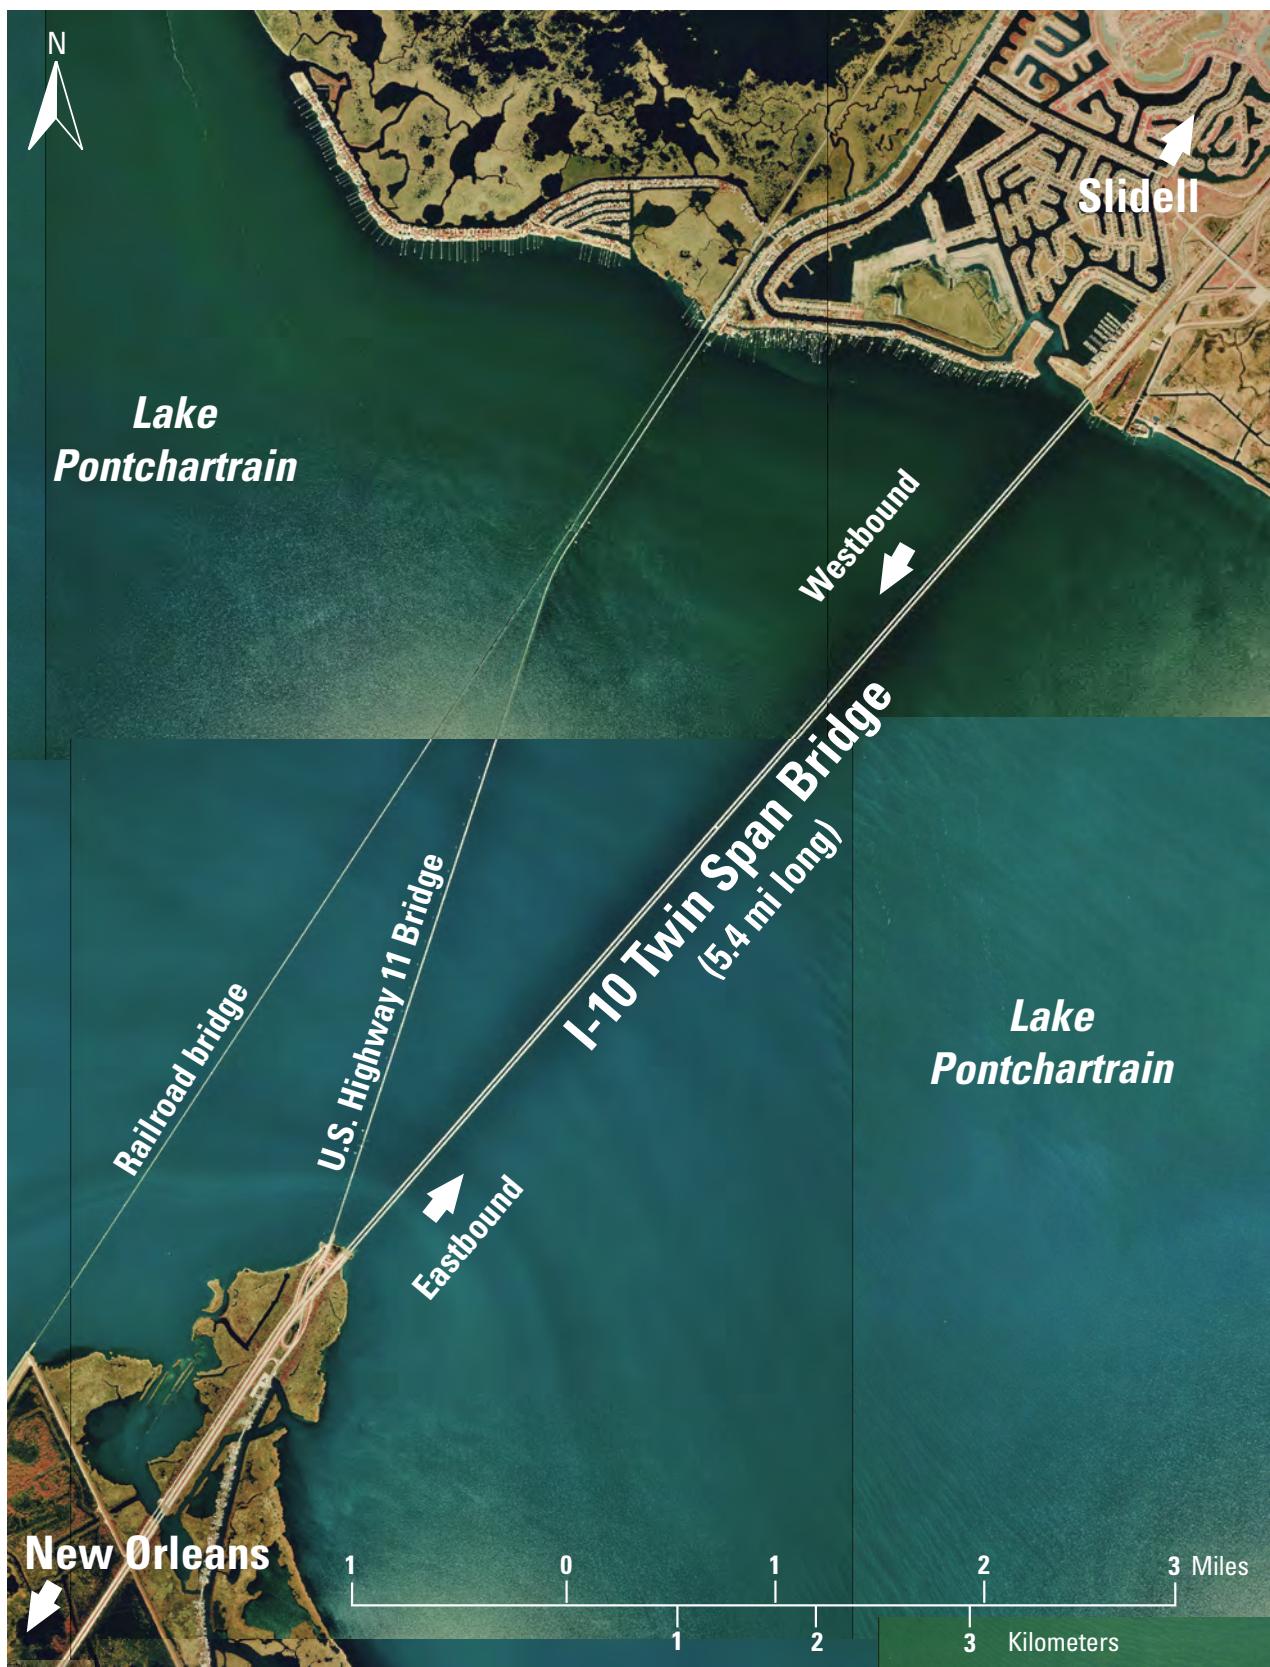
Still further west is a railway bridge (fig. 2) that did not suffer any structural damage except for a portion of track that washed away. The railroad bridge consists of solid slabs and supporting piers that are illustrated in figure 10. This design makes it difficult to trap air beneath the slabs to reduce their effective gravity loads; consequently, the bridge spans were unlikely to float during the hurricane. Even though a portion of railroad tracks were washed away, there was no evidence that bridge segments had dislocated. The shear keys at both ends of the cap beams may also have helped in this regard.

Figure 2. Location and relationship between the Interstate 10 Twin Span Bridge and the U.S. Highway 11 and railroad bridges across Lake Pontchartrain between New Orleans and Slidell, La.

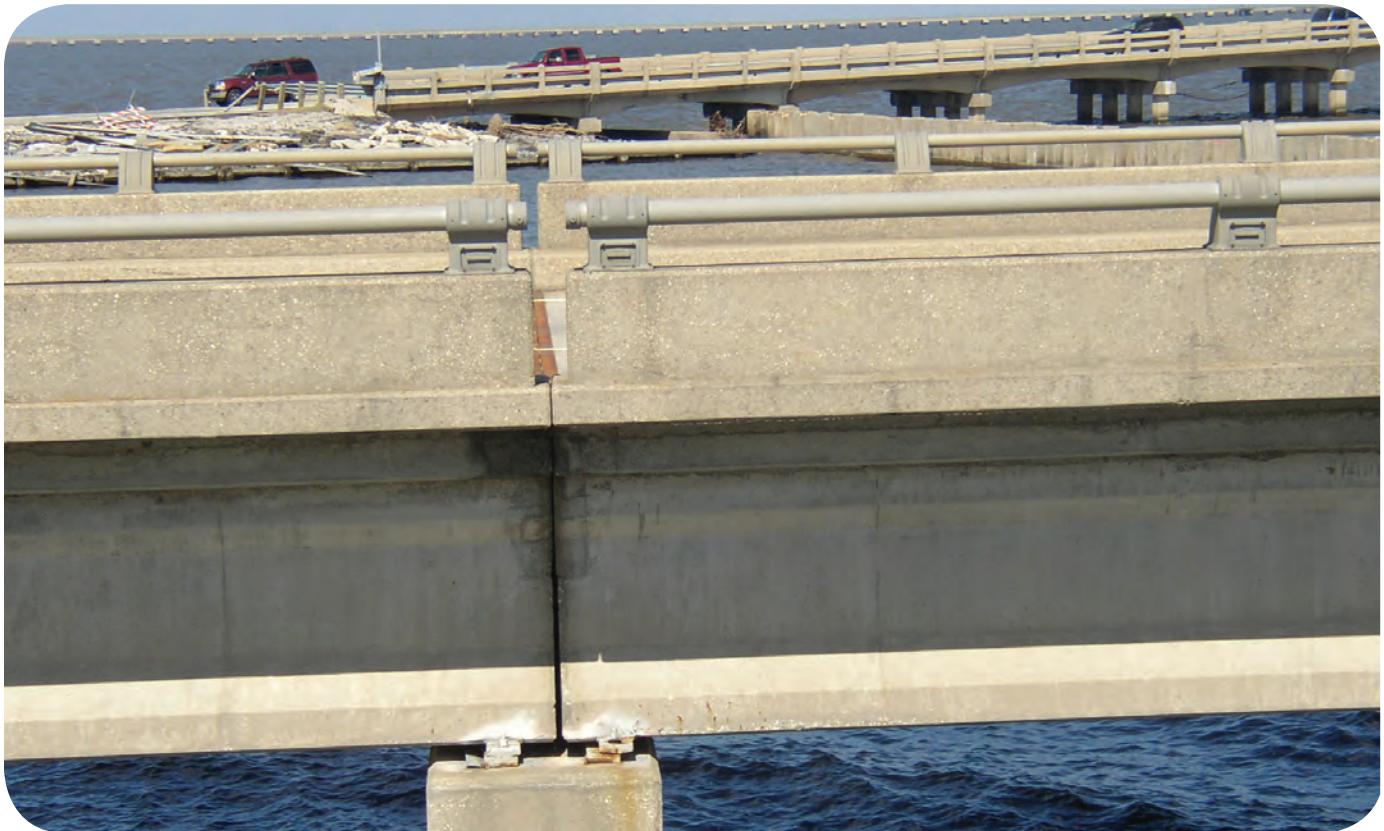
The “rectangular box” theory explained above is strongly supported by evidence collected from several bridge structures in the areas affected by Katrina. As shown in figures 2 and 8, west of and parallel to the I-10 twin bridges is a highway bridge carrying vehicular traffic on U.S. Highway 11 (US-11). This bridge was open to vehicles after only a short period of traffic interruption. As shown in figure 9, the US-11 bridge is a simply supported concrete girder structure similar to the I-10 bridges. The span lengths are shorter, however, and the depths of all of its girders are significantly shallower than those of the I-10 bridges. In addition, all girders are arch shaped, creating an even shallower section in the middle of every span. The deck sections also had holes in the lateral diaphragms that allowed air to escape the “box.” Therefore, the possibility of having significant air mass trapped beneath the decks of the US-11 bridge is much smaller in comparison with the I-10 bridges.

Figure 8. Close spatial proximity of Interstate 10 Twin Span Bridge (front), U.S. Highway 11 bridge (middle), and railroad bridge (back) across Lake Pontchartrain between New Orleans and Slidell, La.
