CHAPTER TEN: ENGINEERING OVERVIEW; EARTHEN LEVEES AND FLOODWALLS

10.1. Overview

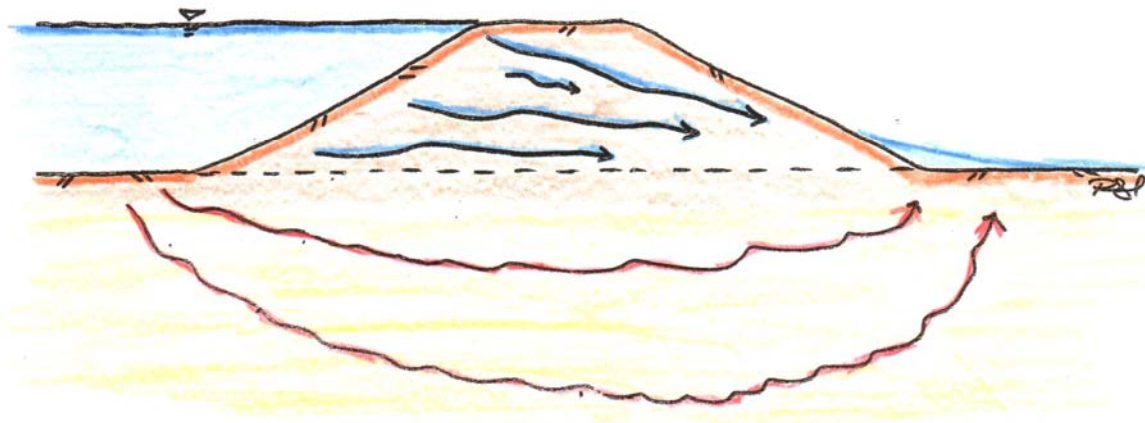
Figure 10.1: Underseepage in highly permeable underlying foundation materials (red lines) can result in the catastrophic failure of the levee in that once the foundation materials have been eroded, the levee (which may be completely undamaged) has no underlying support and falls into the resulting void and essentially washes away.

Internal erosion and piping (blue lines) occurs in levee materials that have high permeabilities (such as sand and gravel) and allow for water to rapidly flow from high pressure areas to low pressure areas. As the water flows through the levee, smaller/finer soil particles are “washed” out of the levee resulting in the internal erosion of the levee. Enough internal erosion of the levee can lead to the collapse and subsequent “wash-out” of the levee.

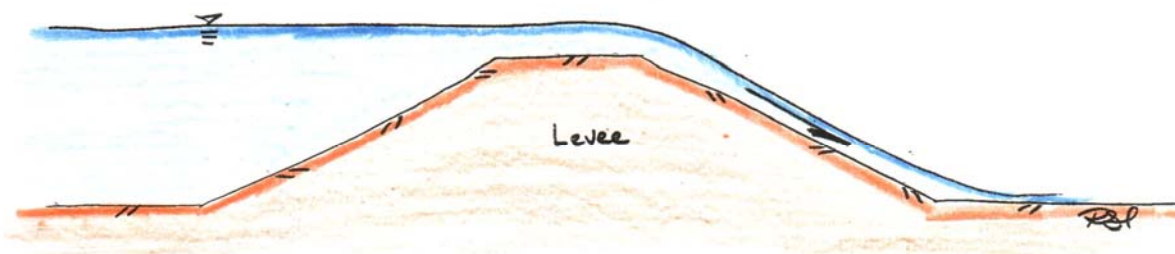
Figure 10.2: Overtopping occurs when the water level on the outboard side of the levee exceeds the crest elevation of the levee. The inboard side of the levee acts as a spillway for the overtopping water and damage is inflicted on the levee as a result of water scour.

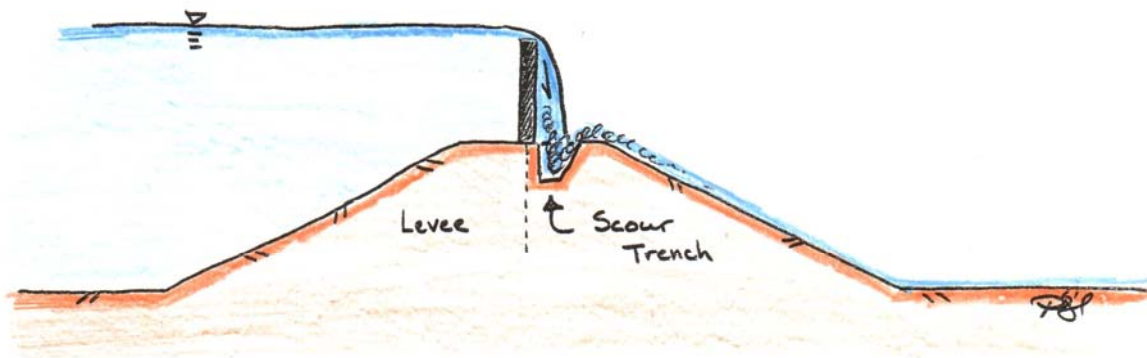
Figure 10.3: Jetting occurs when the water level on the outboard side of the levee exceeds the top of wall elevation for structural walls that are founded within the earthen levee. Unlike overtopping of a conventional earthen levee, the floodwall acts as a weir and water impacts the levee in a concentrated stream that is much more energy intensive than conventional overtopping.

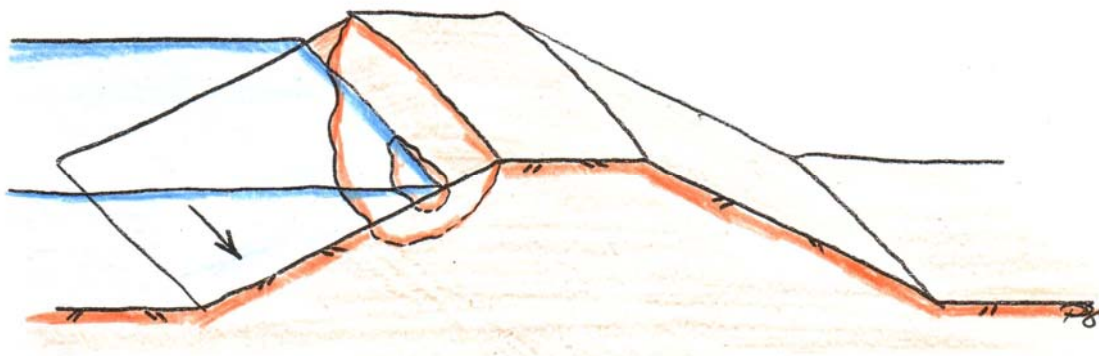
Figure 10.4: Surface erosion generally occurs on the outboard side of the levee and is the result of water flowing past the levee face. If the imposed shear stress from the water abrading against the soil levee face is high enough, soil scour occurs and the integrity of the overall levee is significantly reduced.

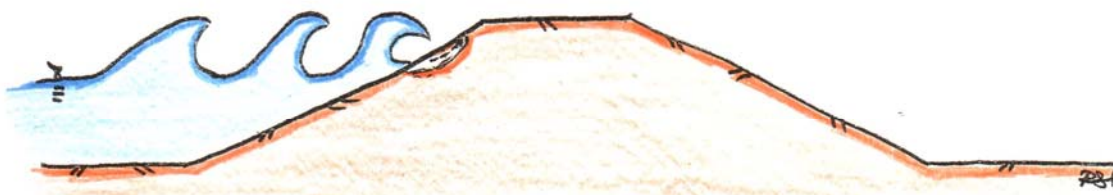
Figure 10.5: Wave impacts can cause significant erosion to levee faces. Wave-induced erosion consists of run-up (sloshing up and down of water as a result of staggered wave arrival) and “mini-jetting” when the crest of the waves breaks on the levee face.

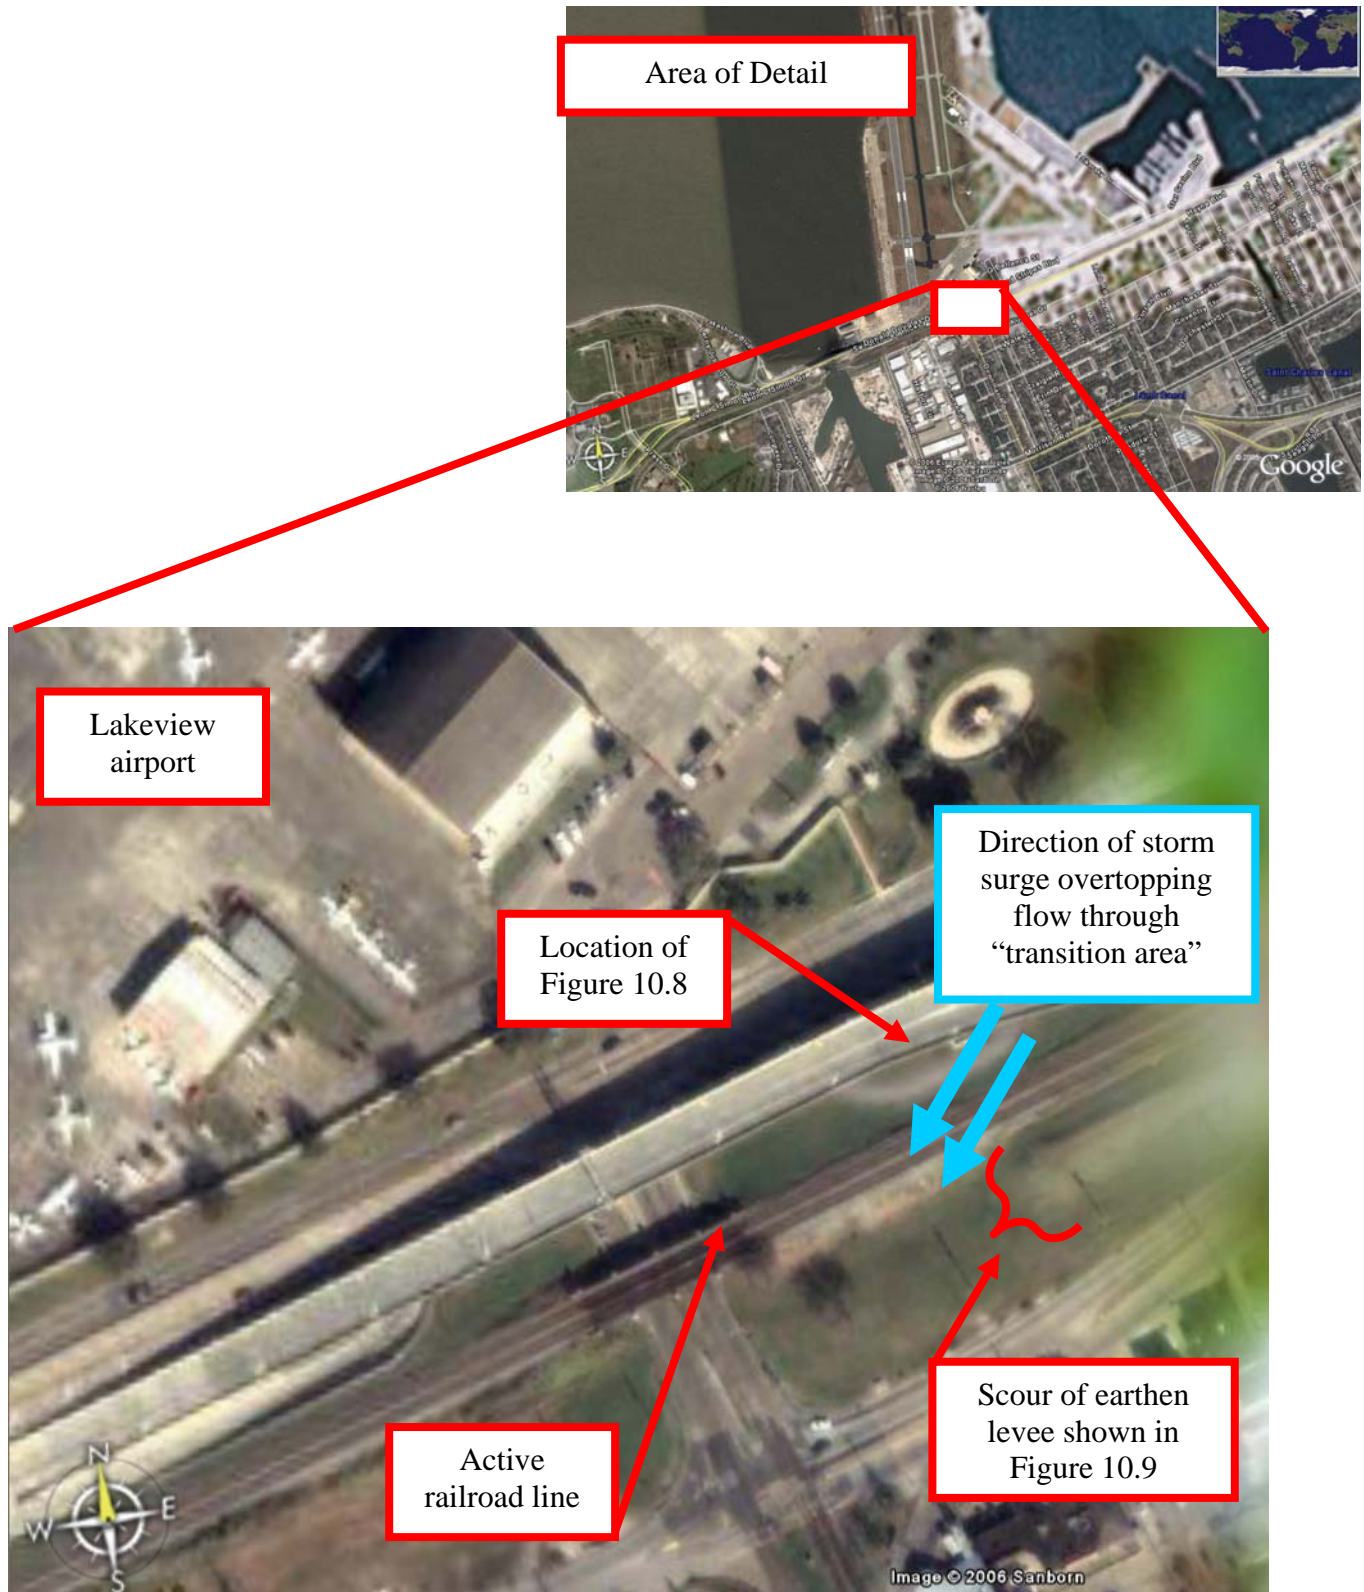
Figure 10.7: Storm-surge induced overtopping traveled through the granular gravel ballast for the railroad line and eroded the railroad line embankment, which served as a transition levee between the concrete floodwall and the earthen levee shown in Figure 10.8.

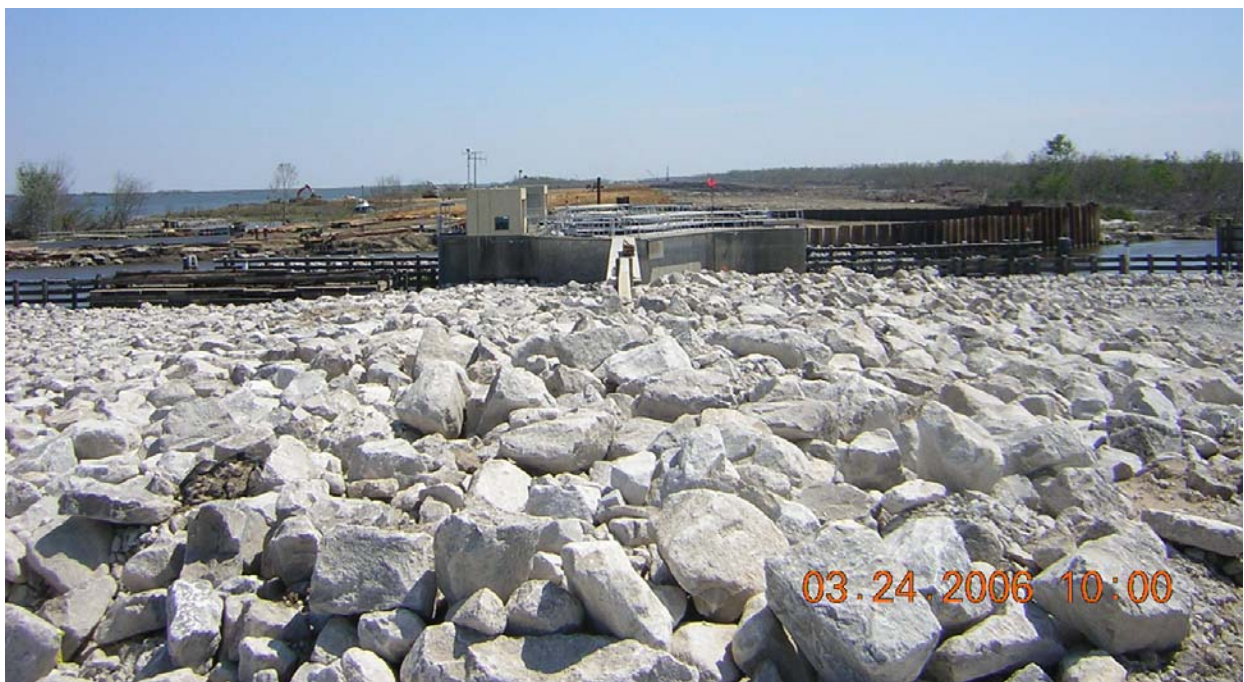
Figure 10.24: The northern side of the Bayou Bienvenue control structure has been repaired, and then heavily reinforced with new rip-rap transported to New Orleans from Kentucky. This photograph was taken about 6 months after Hurricane Katrina and the barge, which can be seen in Figure 10.21, has been removed.

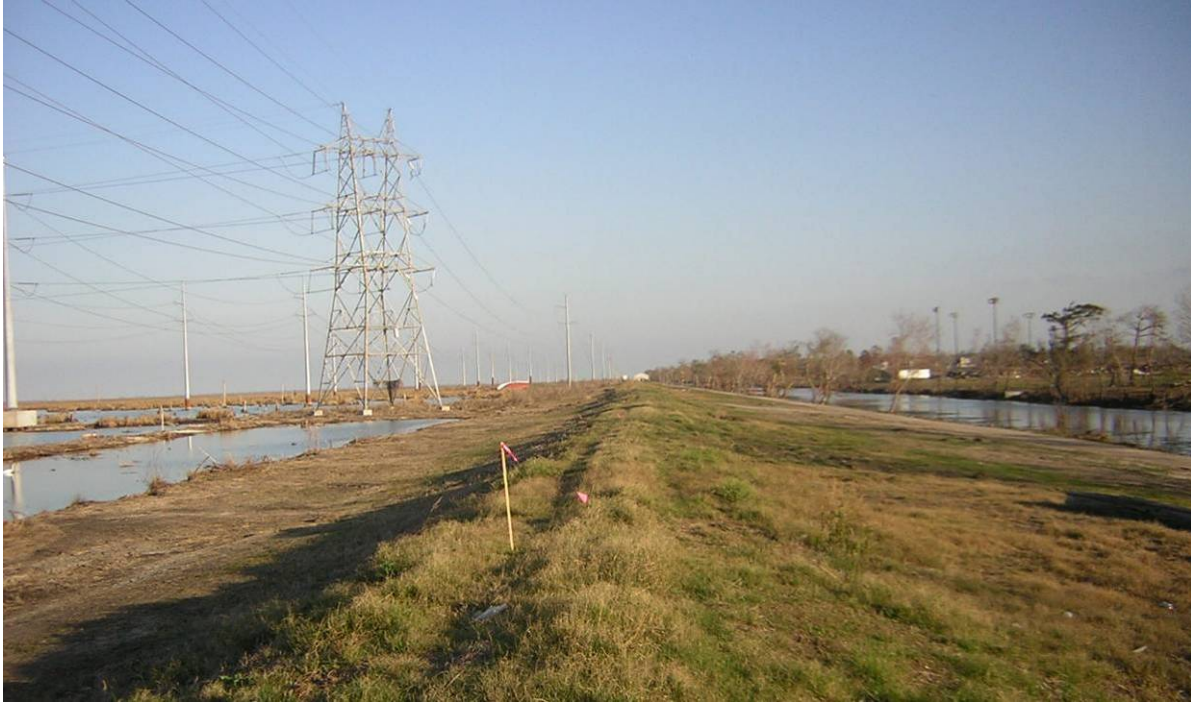
Figure 10.34: Eastward looking view of the secondary earthen levee (constructed to approximately Elevation +6.0 feet MSL) immediately to the north of the Corinne Canal, east of Paris Road (location 10 on Figure 10.6). This levee was significantly overtopped and did not experience significant damage.

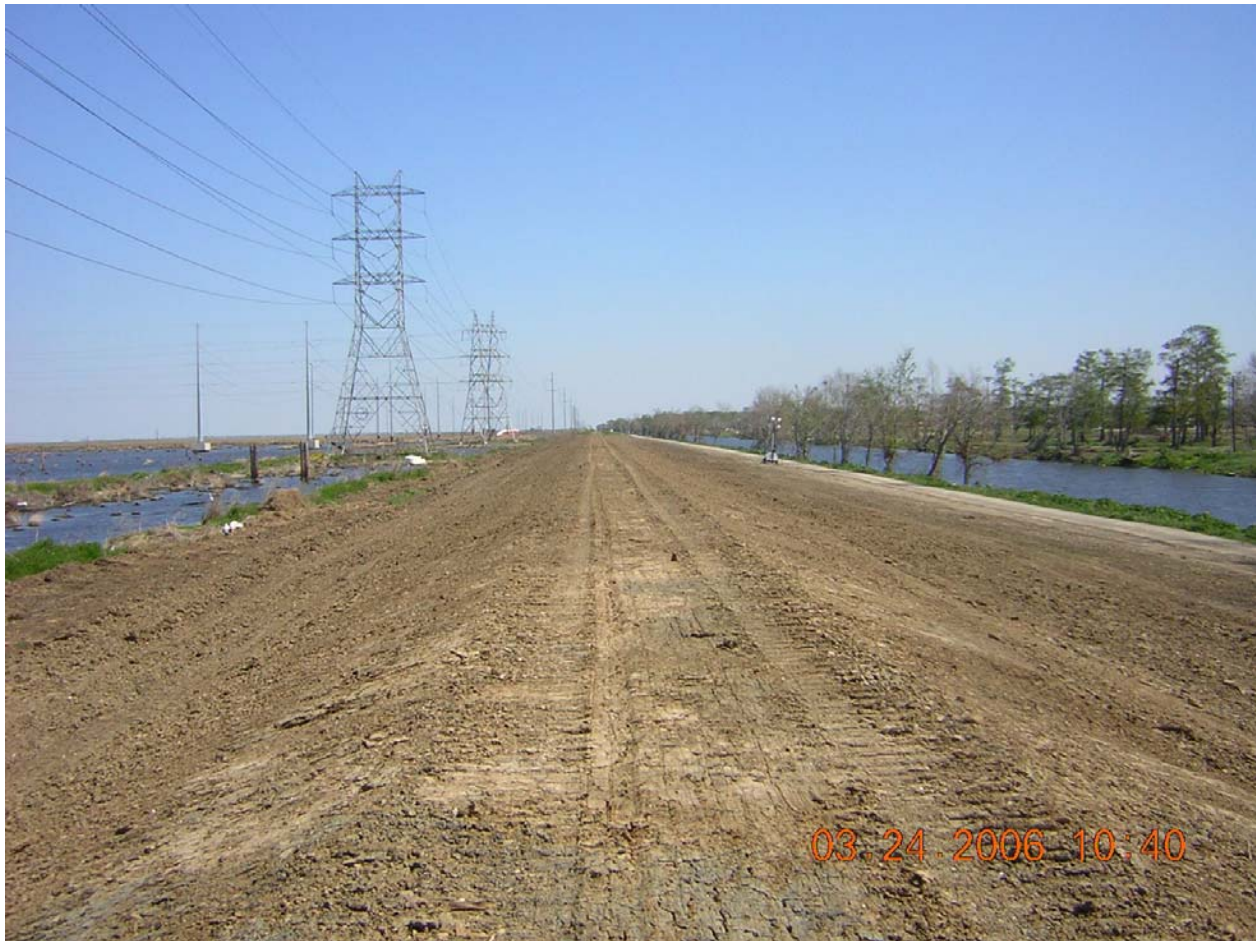
Figure 10.36: The same levee shown in Figure 10.34, where a fishing boat washed over the levee during Hurricane Katrina, has now been raised from an elevation of approximately +6 feet MSL to an elevation of approximately +10 feet MSL by March of 2006.

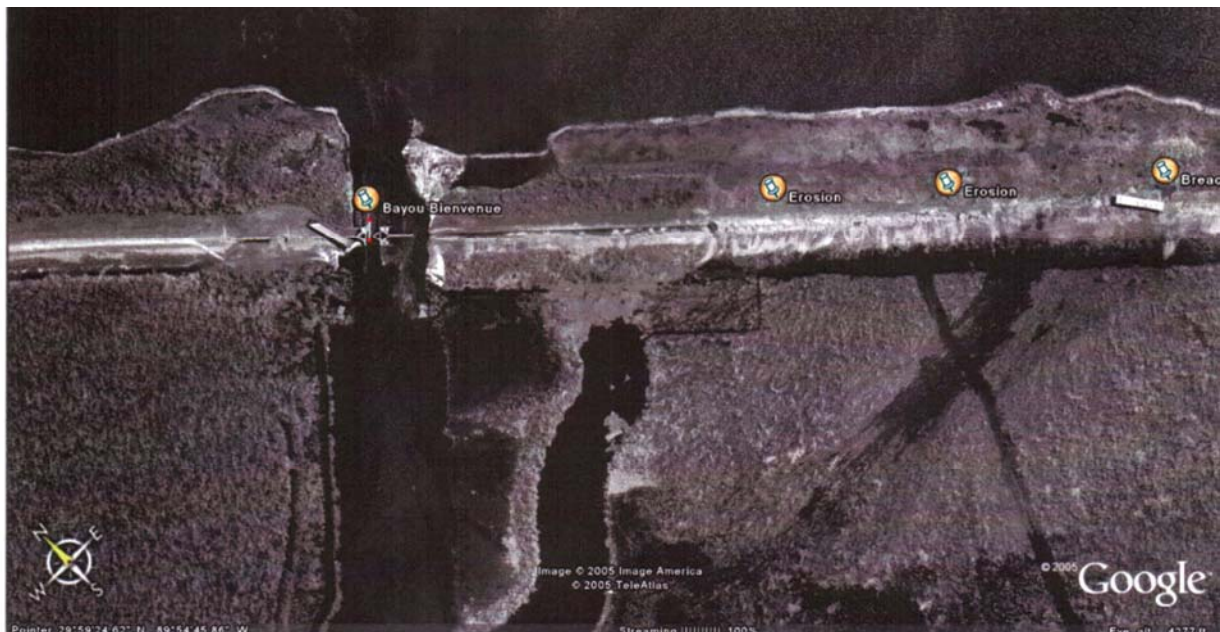
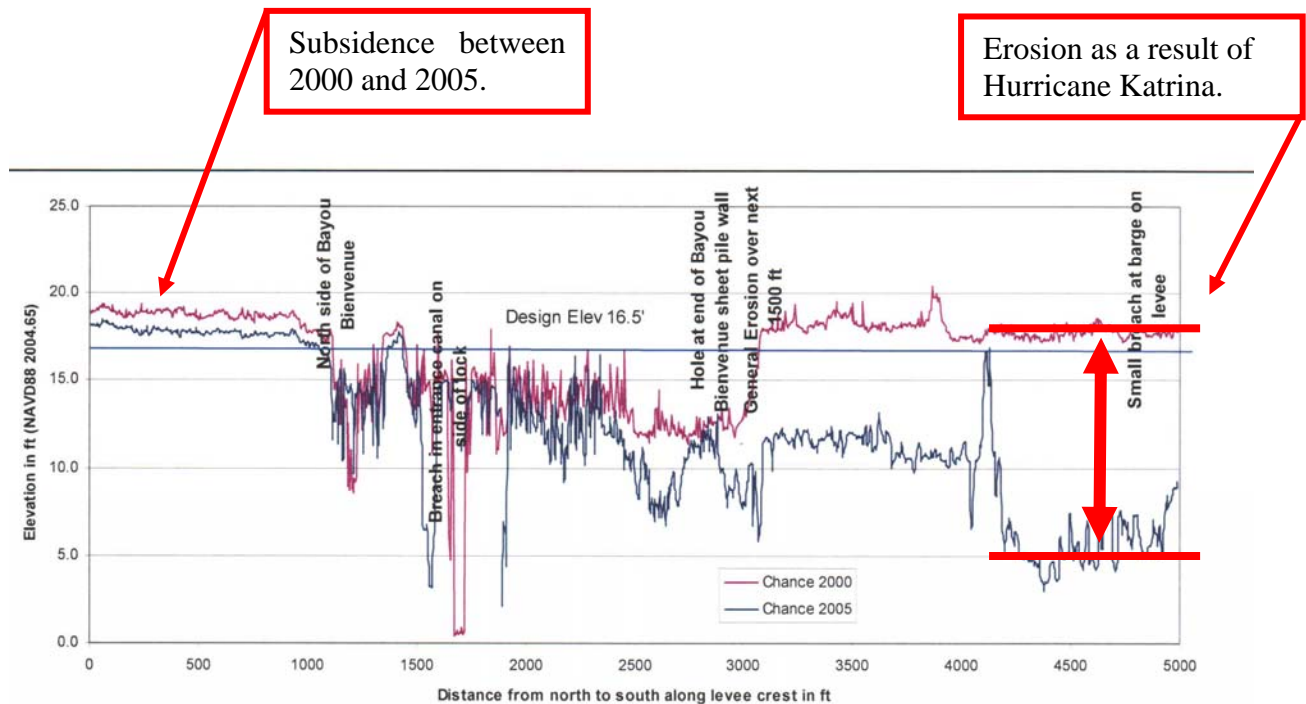
Figure 10.37: This is a comparison of two LiDAR surveys of the MRGO levee system at the Bayou Bienvenue control structure, near the intersection of the GIWW at the northeast corner of St. Bernard Parish. Effects of subsidence can be clearly seen in the elevation differences on the north side of the control structure and the control structure itself between 2000 and immediately following Hurricane Katrina in 2005. The levee on the north side of the Bayou Bienvenue control structure was largely undamaged. The levee on the south side of the control structure was catastrophically damaged. The magnitude of the erosion has been highlighted and white “splotches” of displaced levee materials can be seen in the aerial photograph (USACE 2006).

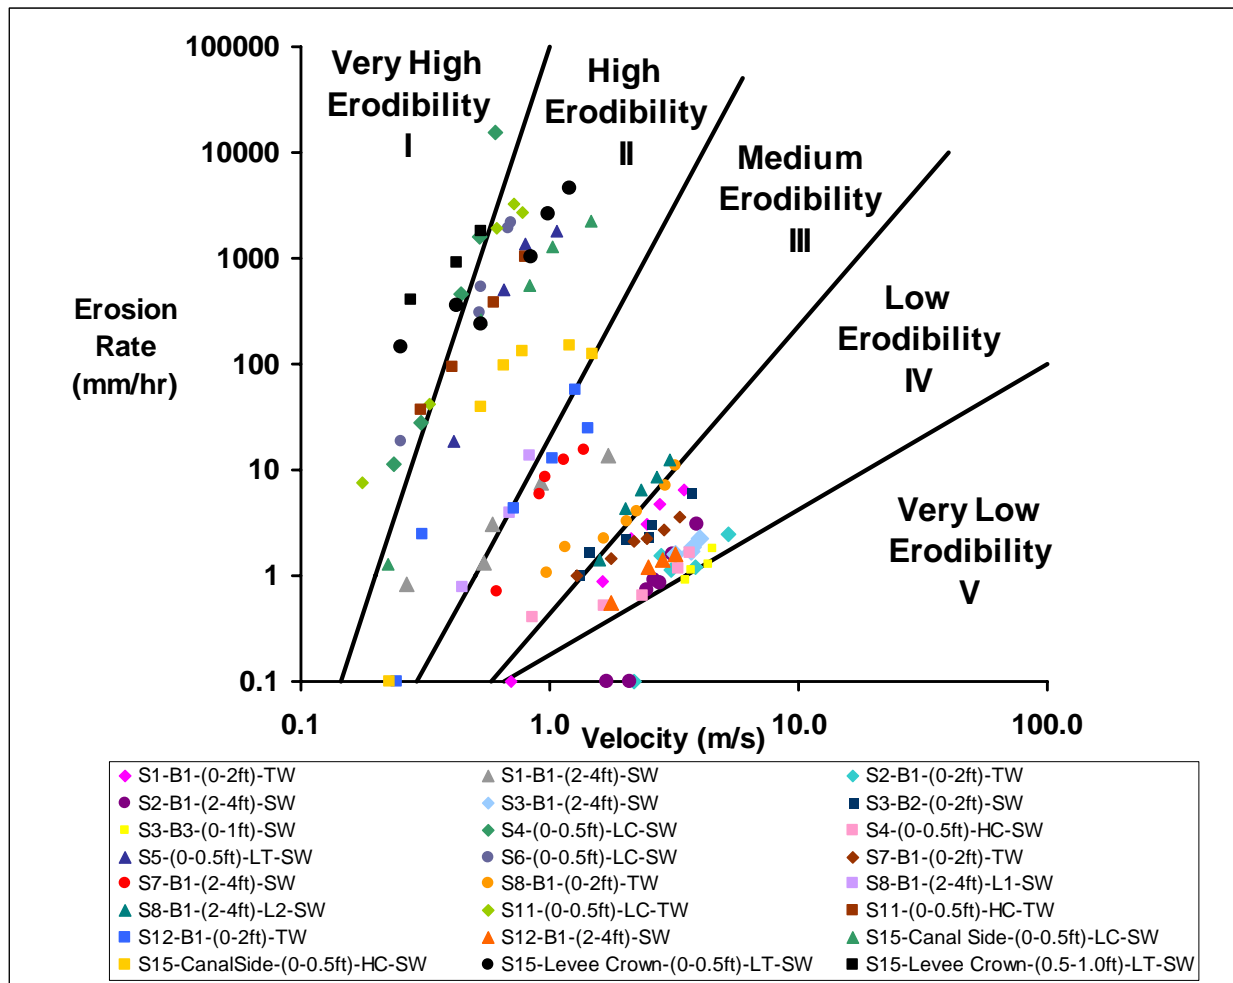
Figure 10.41: Summary of all EFA test results. The test result designations are based on the Site Number, the boring number at the site, the depth interval over which the sample was collected and sample notes. The EFA test results indicate that the materials used in levee construction varied from very high to very low erodibility, which matched the observed performance of these levees.

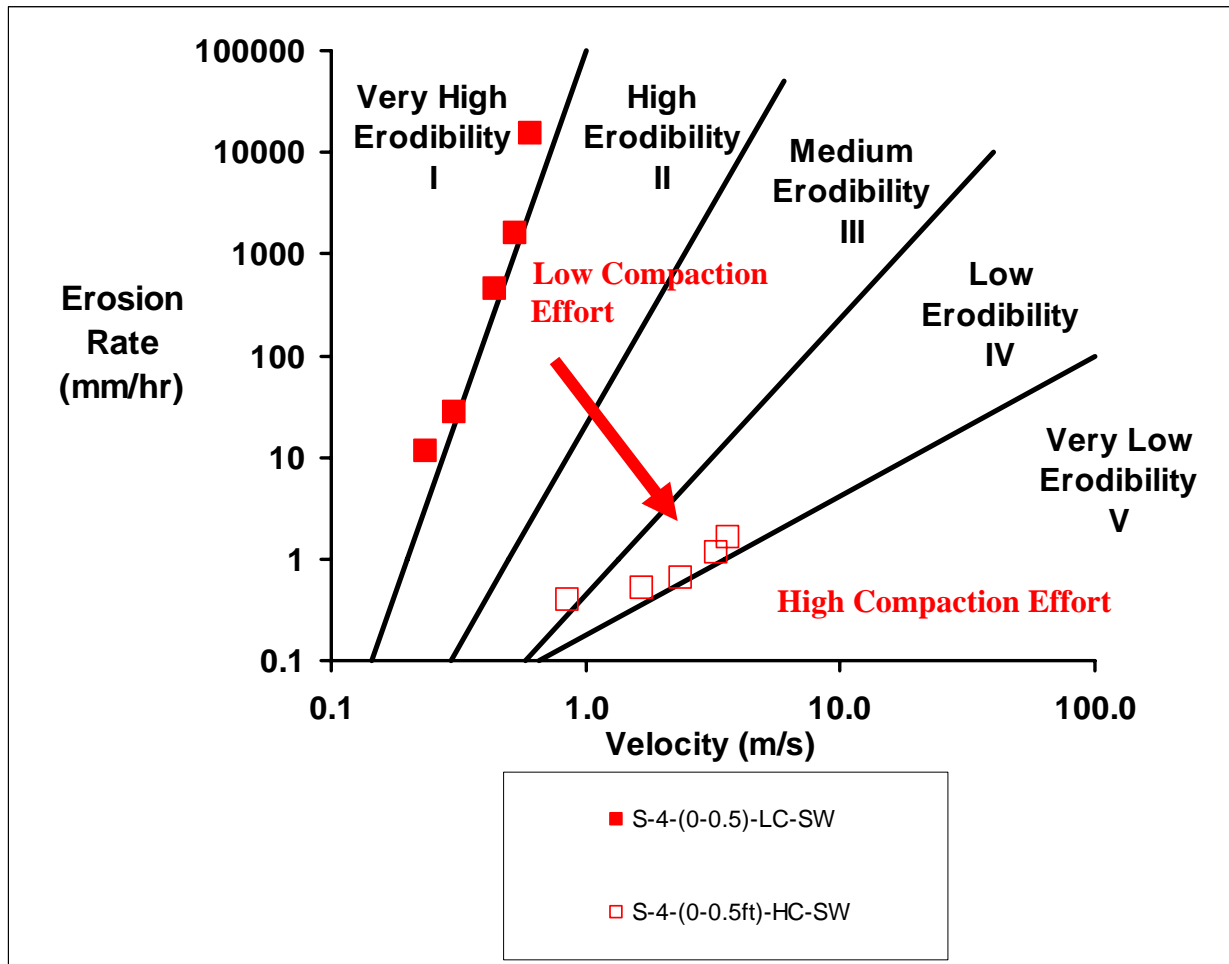
Figure 10.43: Here materials sampled from the MRGO were tested at two levels of compaction. This figure shows the dramatic impact proper compaction has on the erodibility of soils. Materials sampled from the MRGO levee were tested at two compaction levels: low compactive effort and high compaction effort. The corresponding results speak volumes to the importance of compaction in earthen levees. The low-compaction sample was found to be very highly erodible, whereas the high-compaction sample exhibited low erodibility characteristics.

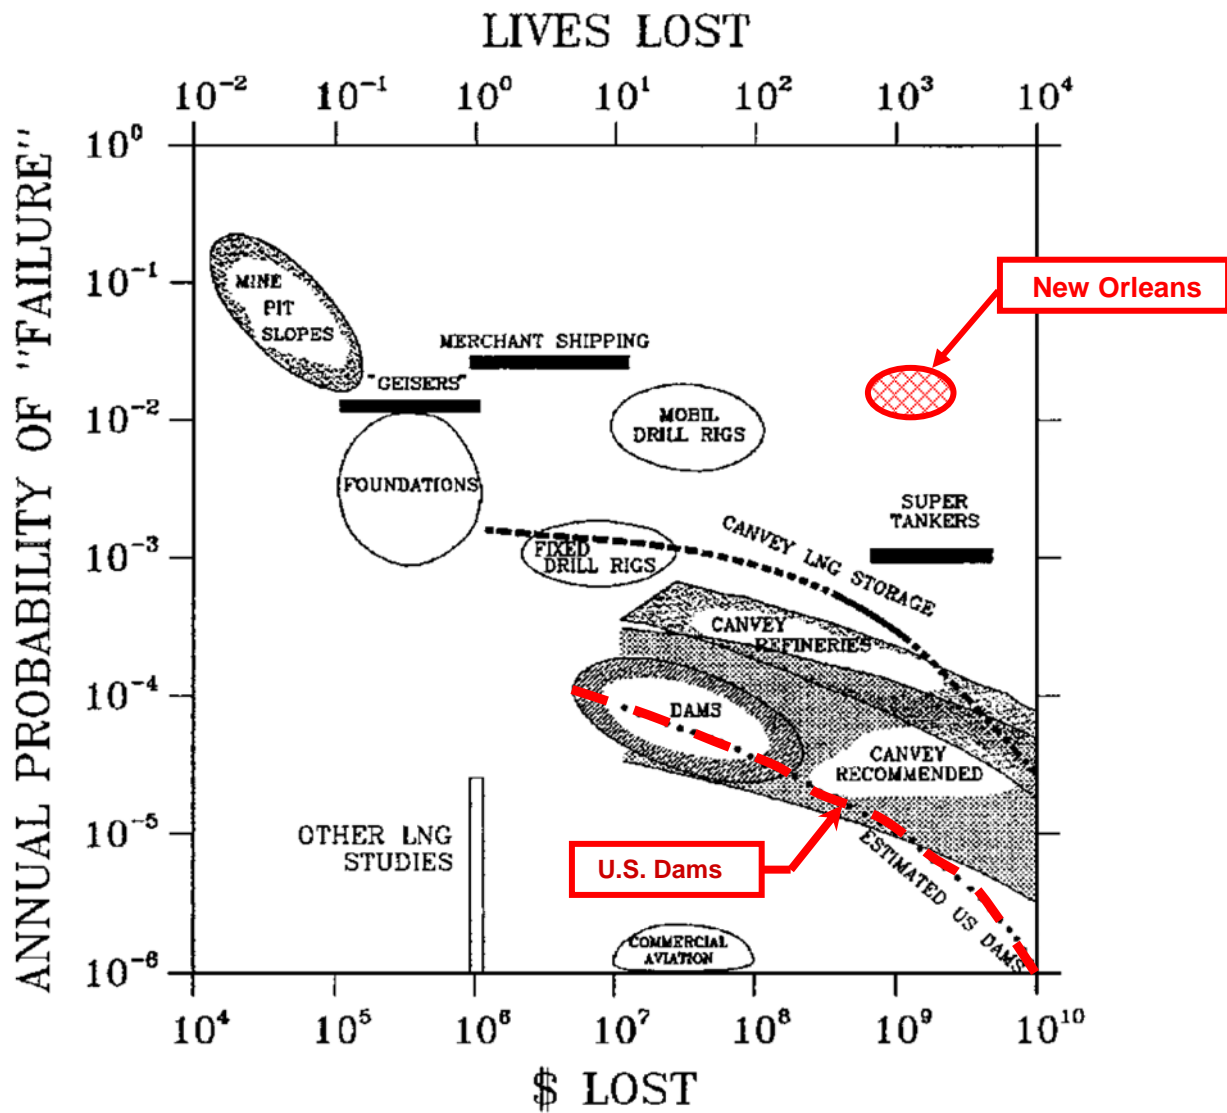
Another good way to look at targeted levels of reliability for flood protection is to re-examine Figure 10.45. This figure is re-plotted as Figure 10.47, with a red cross-hatched region showing approximately the level of reliability associated with the New Orleans regional flood protection system at the time of Katrina's arrival. Based on the studies of the ILIT team, it is inferred that the New Orleans flood defense system would have been expected to fail catastrophically about once every 50 to 100 years. The consequences of the failures during Katrina were on the order of 1,300 lives lost, and/or about \$100 to \$200 billion in economic losses.

A red dashed line indicating the approximate levels of reliability targeted by current U.S. practice with regard to dams is also shown in Figure 10.47. It is interesting to note that current U.S. practice for dams would have called for approximately three orders of magnitude higher level of reliability than that which was apparently provided by the New Orleans regional flood protection system (a factor of approximately 1,000 times higher reliability or assured safety.) That is largely because "dams" are generally assumed to be associated with large consequences in the event of failure. Few U.S. dams, however, have likely consequences of failure larger than those associated with the failure of the New Orleans regional flood defense systems during hurricane Katrina. This would appear to suggest that the flood defense systems for major metropolitan areas should be engineered to have targeted levels of reliability on a par with those commonly targeted for U.S. dams.

Figure 10.47: Figure 10.45 repeated, with approximate level of reliability and consequences for the New Orleans regional flood protection systems indicated, and with current U.S. practice for dams highlighted (red dashed line.)

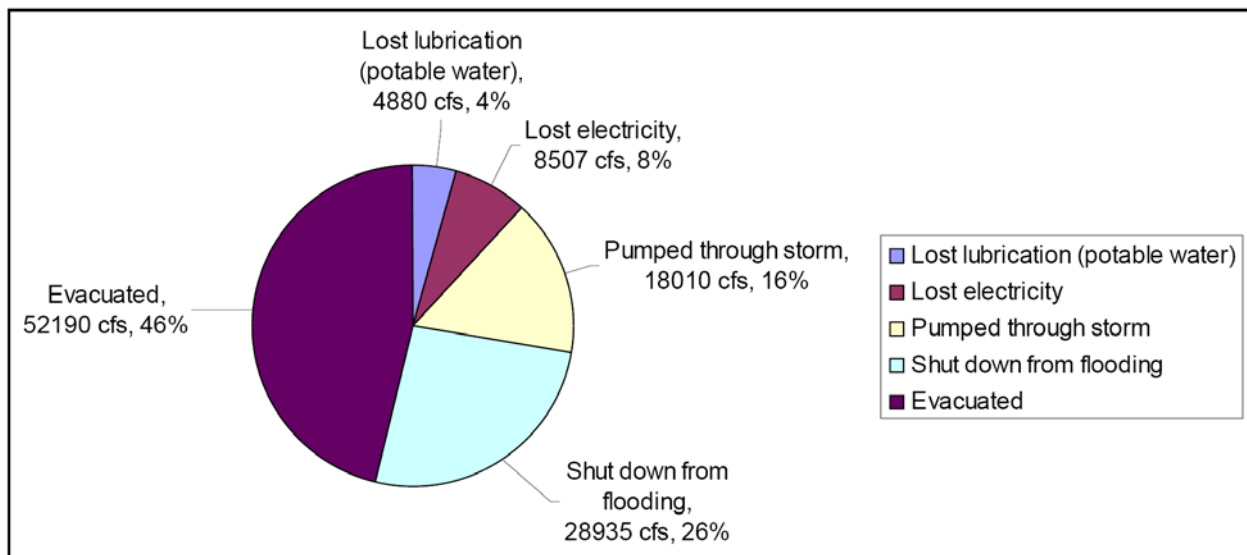
of electricity to power the pumping station, and (4) shut-down or disruption of the pump facilities as a result of flooding. Pumping failure from evacuations, flooding, loss of electricity, and loss of lubrication (potable water) accounted for 46%, 26%, 8%, and 4% loss of total pumping capacity, respectively (Figure 10.53). These failures and breakdowns do not reflect multiple failure modes, such as a pump station being evacuated, only later to be overwhelmed as a result of breaches in the flood defense system (i.e. a break in the drainage canal wall such as at 17th Street Canal).

Figure 10.53: Performance of the pumping system (and causes of pumping capacity loss) during and after hurricane Katrina.

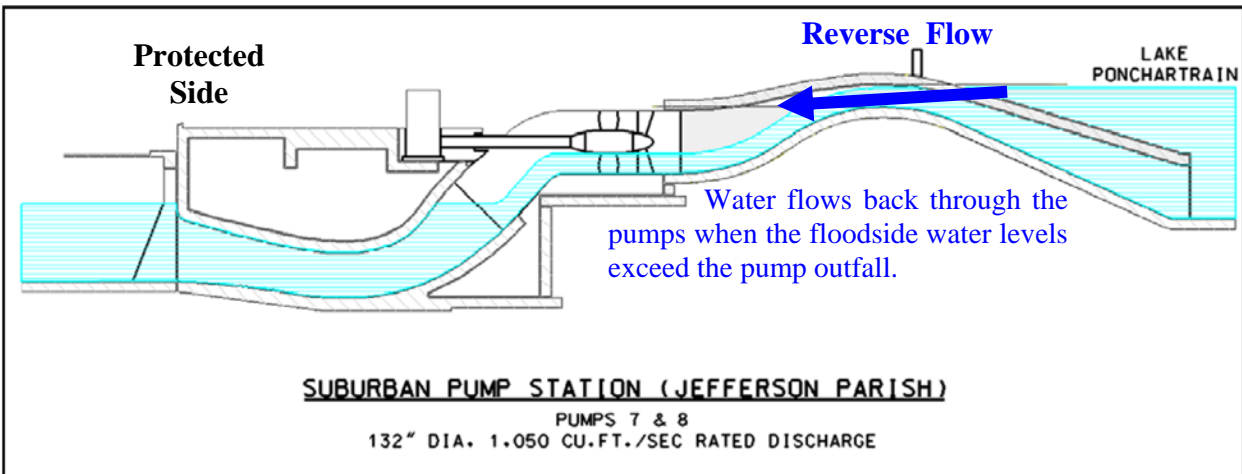
In addition to these four failure modes, there are three other significant pump and drainage system-based failure modes that impacted the proper performance of the pump and drainage system during Hurricane Katrina. These failure modes are (1) reverse flow (Figure 10.54) through the pumping stations due to inadequate pump discharge elevation clearance (and a lack of internal reverse-flow protection), (2) loss of drainage capabilities as a result of breach of the drainage canal [such as within the 17th Street Drainage Canal, the Orleans Canal, and the London Avenue Drainage Canal as shown in Figure 10.55], and (3) lack of sufficient temporary storage capacity [such as within St. Bernard parish between the interior levee and the MRGO exterior levee], where discharged water is ponded behind the MRGO levee until the gates of the two control structures can be opened to allow the stored water to drain into Lake Borgne. It is interesting to note that water discharged from the Lower 9th Ward must drain through approximately 10.5 miles of bayou (Figure 10.55) until it is finally discharged from the protected area through the control structure gates, which are not configured to allow discharge of water during storm events, instead of having the pump station discharge directly into the much closer IHNC about 650 feet from the pump station.

Figure 10.54: Conditions where the water level on the outboard side of the pumping station is higher than the pump infrastructure, resulting in reverse flow from the flood side back into the “dry” side. [IPET; June 1, 2006]

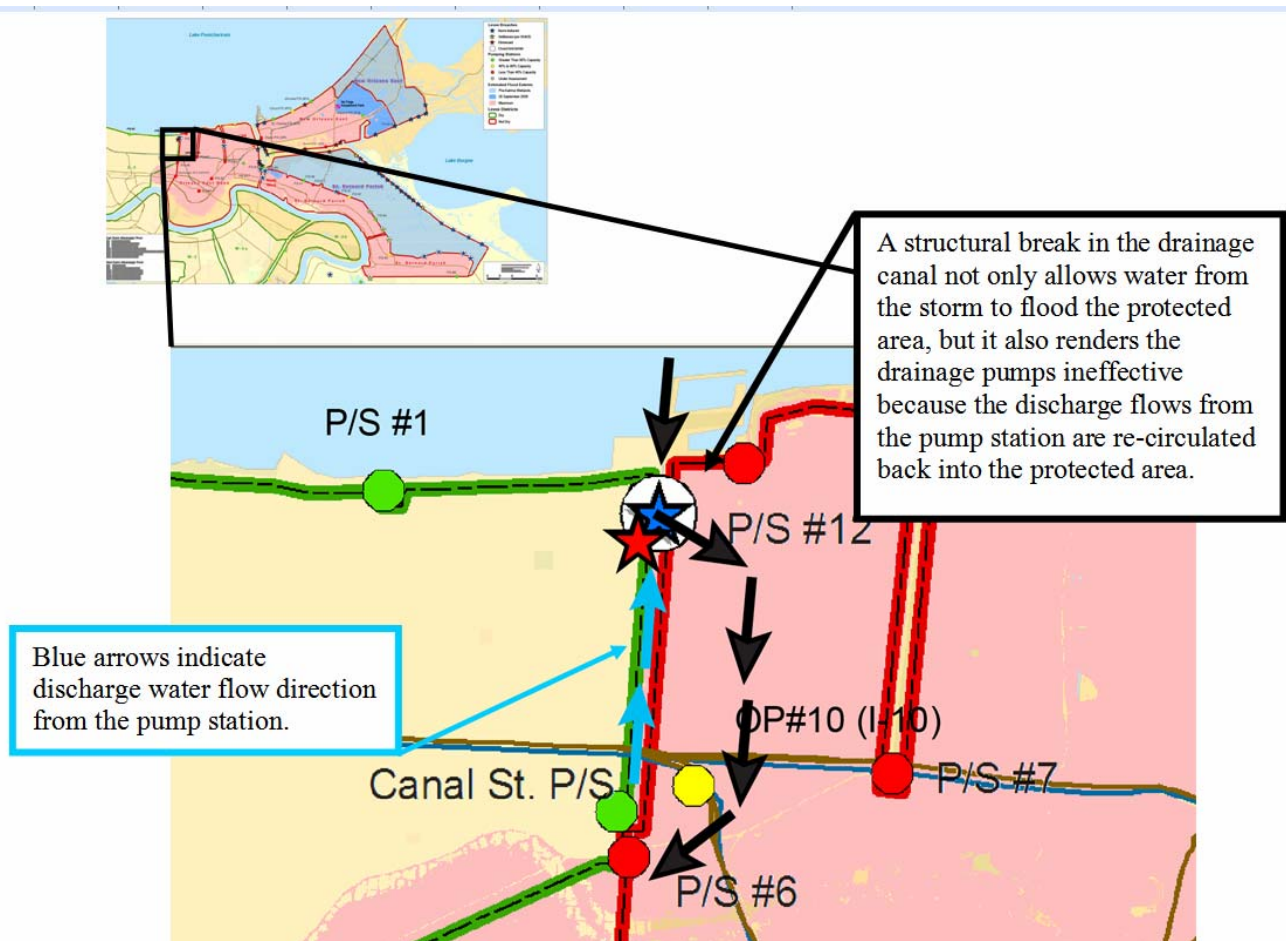
Figure 10.55: Breakdown of the pumping and drainage system as a result of structural failures within the drainage canals. Flood waters and discharge water from the pumping station flow back into the protected area where structural failures have occurred.
