CHAPTER TWO: OVERVIEW OF HURRICANE KATRINA AND ITS AFTERMATH

2.1 Hurricane Katrina

2.2 Overview of the New Orleans Flood Protection Systems

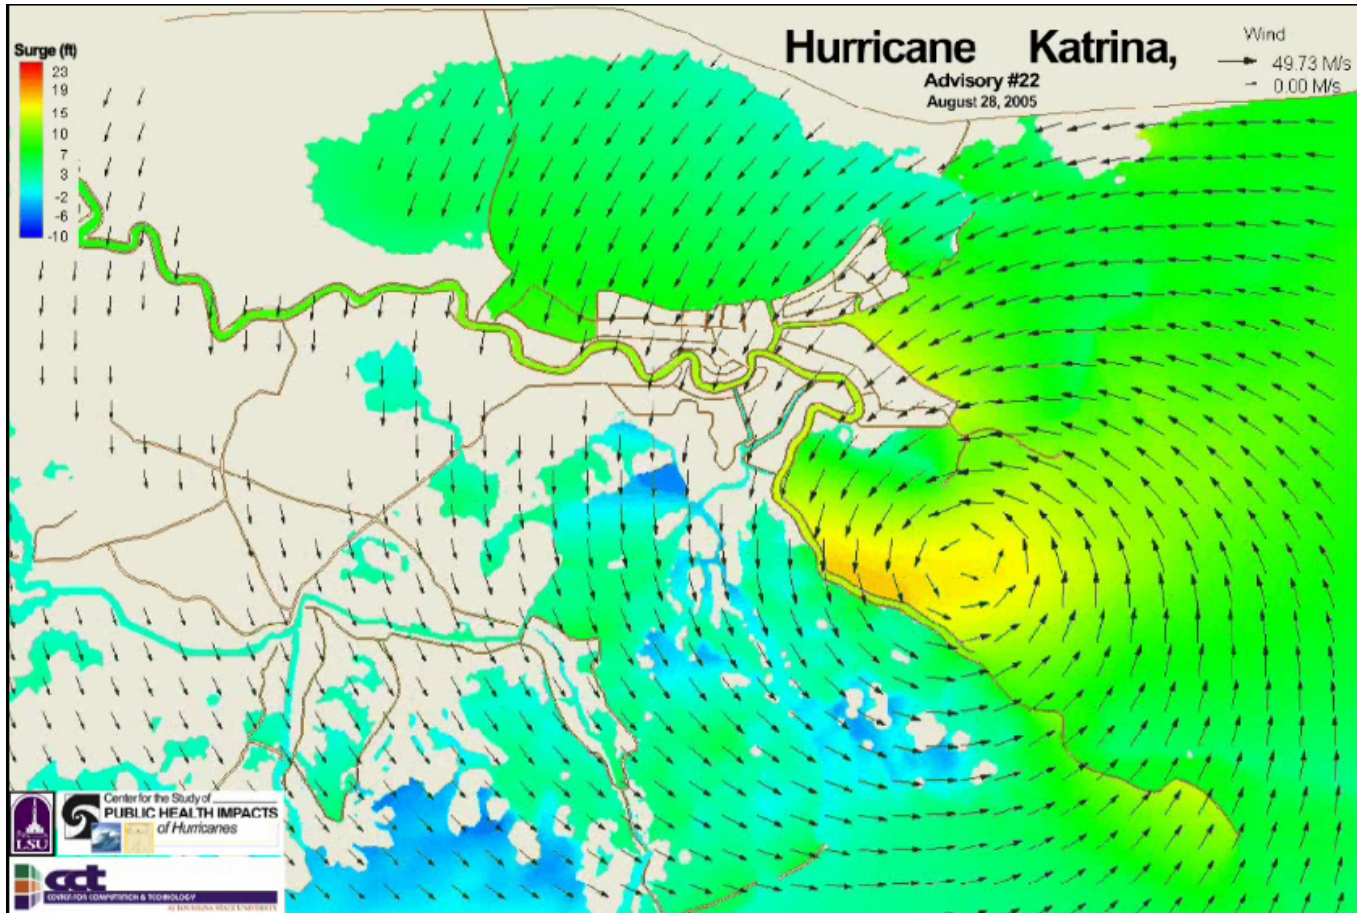
Hurricane Katrina, as expected, produced a large onshore storm surge from the Gulf of Mexico. As shown in Figures 2.8 through 2.10 this produced significant overtopping of storm levees along the lower Mississippi River reaches in the Plaquemines Parish area, and numerous levee breaches occurred in this area, as shown previously in Figure 2.5. In simple terms, the “storm” levees of Plaquemines Parish were largely overwhelmed by the large storm surge; they were overtopped by the storm surge and by the large storm waves that accompanied the average rise (storm surge) in water levels. Fortunately, the Plaquemines Parish protected corridor is only sparsely populated, and the local inhabitants were acutely aware of the risk that they faced so that evacuation in advance of the storm was unusually complete.

Figure 2.8: Calculated storm surge against the coast at about 7:30 am (CDT), August 29, 2006.

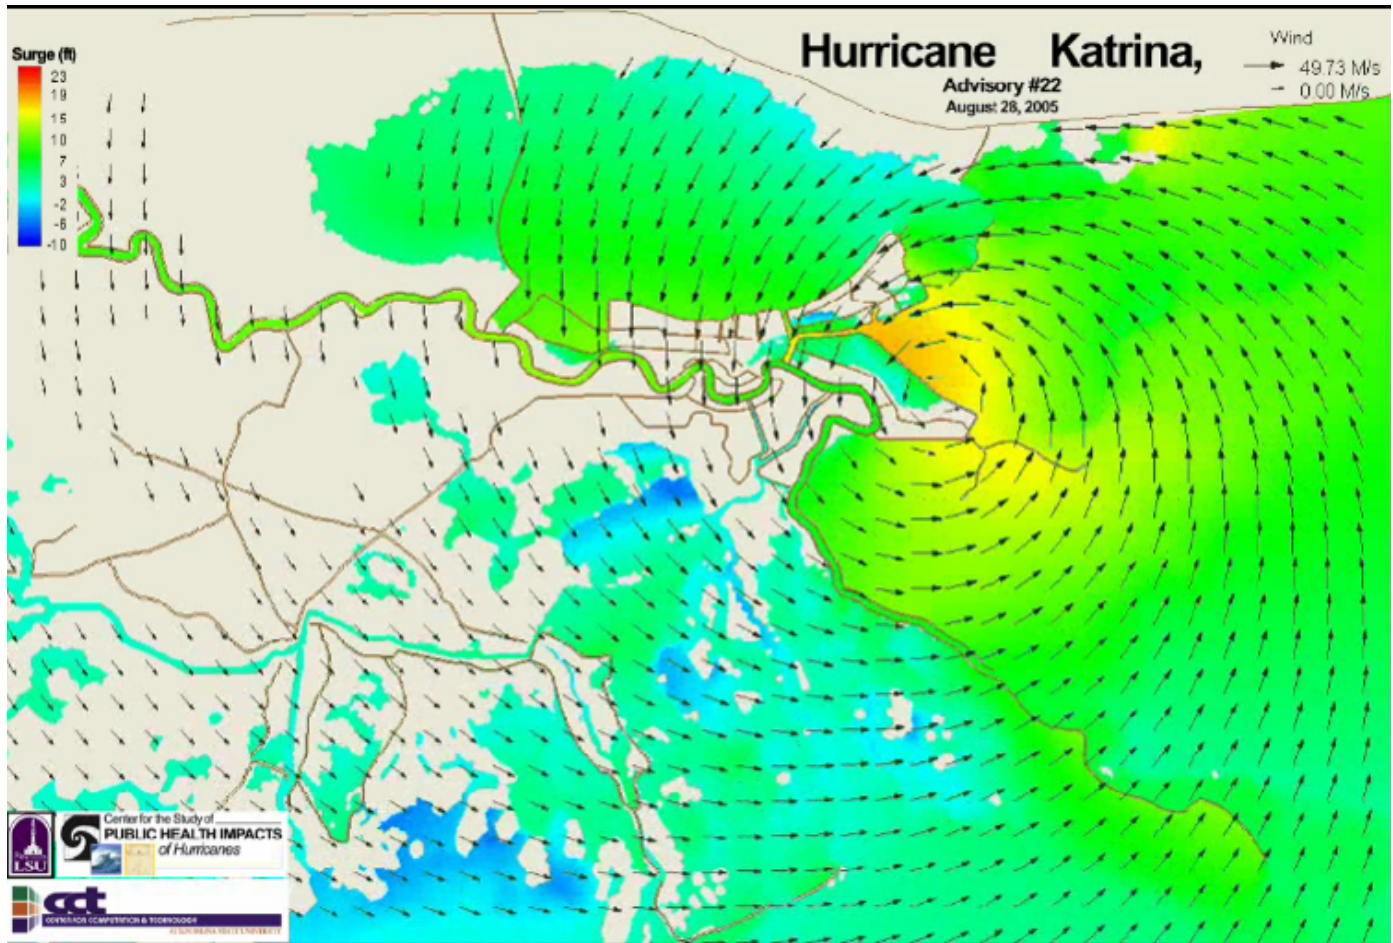
The large onshore storm surge also raised water levels within Lake Borgne (which is directly connected to the Gulf.) Lake Borgne rose up, and outgrew its normal banks. As the storm then passed to the east of New Orleans, the prevailing counterclockwise swirl of the storm winds drove the waters of Lake Borgne as a large storm surge to the west, against the eastern flank of the regional flood protection systems as shown schematically in Figure 2.11. This produced a storm surge estimated at approximately +16 to +18 feet (MSL), as shown in Figures 2.9 and 2.10.

Figure 2.9: Map of calculated storm surge levels, at time when the eye of the storm passed close to the east of New Orleans at about 8:30 am (CDT).

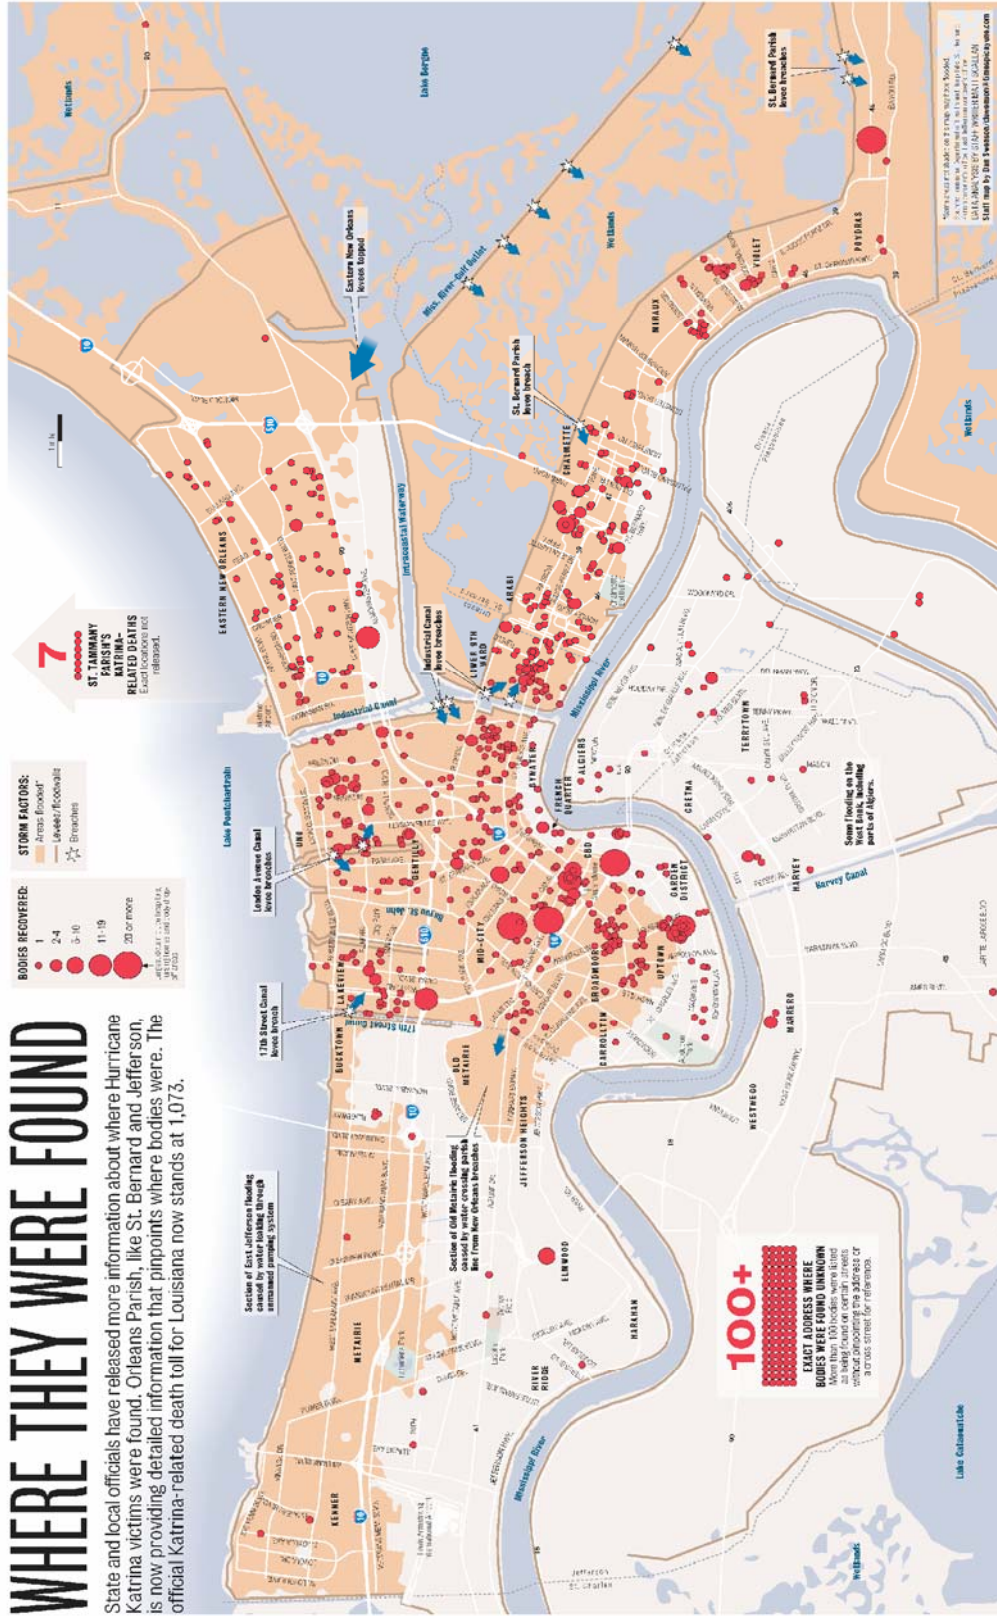
Figure 2.12 shows a plot of the locations where dead bodies were retrieved after the disaster as of December 2005. This map shows locations for only approximately 960 of the approximately 1,296 official deaths (to date) in the greater New Orleans area, but this map serves well to show the general distribution of deaths attributed to the flooding produced by this event. As shown in Figure 2.12, approximately 30% of these deaths occurred in St. Bernard Parish. In addition to those who perished, considerable damage was done to many thousands of homes and businesses in this area (see Chapter 6.)

Figure 2.12: Map showing locations of confirmed deaths (as of December 2005) as a result of Hurricane Katrina.

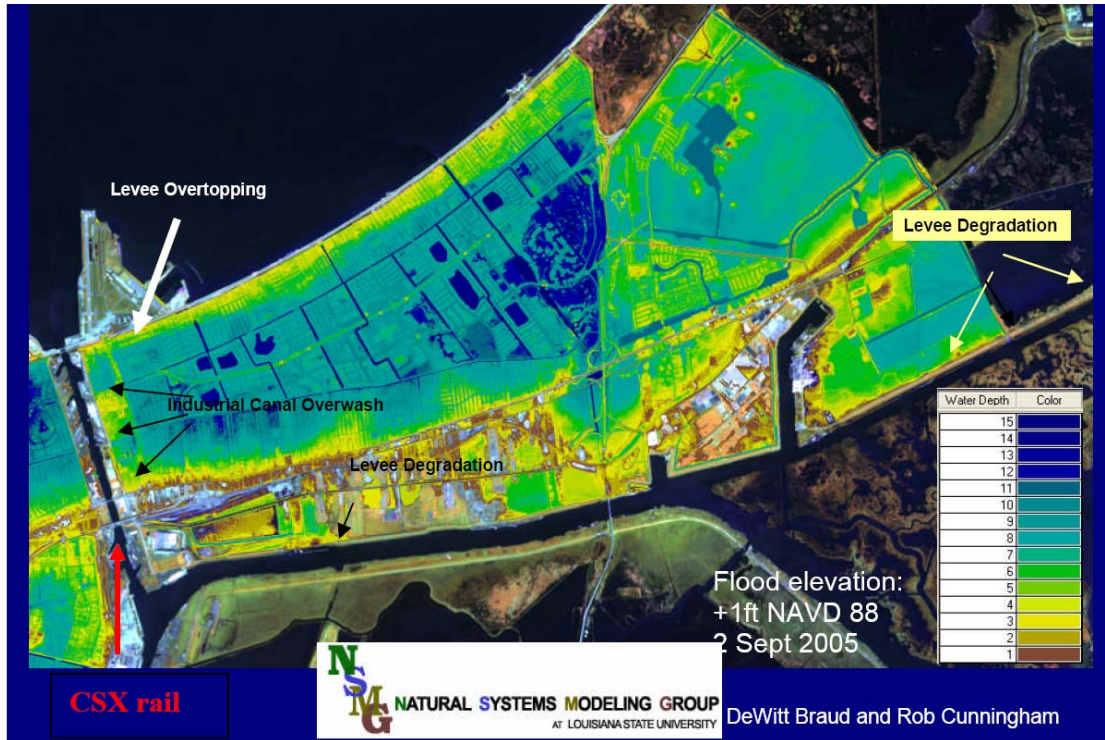
Figure 2.16 shows the approximate depth of flooding that remained on September 2nd, again four days after the hurricane, in the New Orleans East protected area. As this protected area filled slowly during and after the hurricane, and as it was “unwatered” relatively slowly over the days and weeks that followed, this represents nearly the full depth of flooding in this area.

Figure 2.15: Depth of flooding of New Orleans East on September 2nd (4 days after Hurricane Katrina)

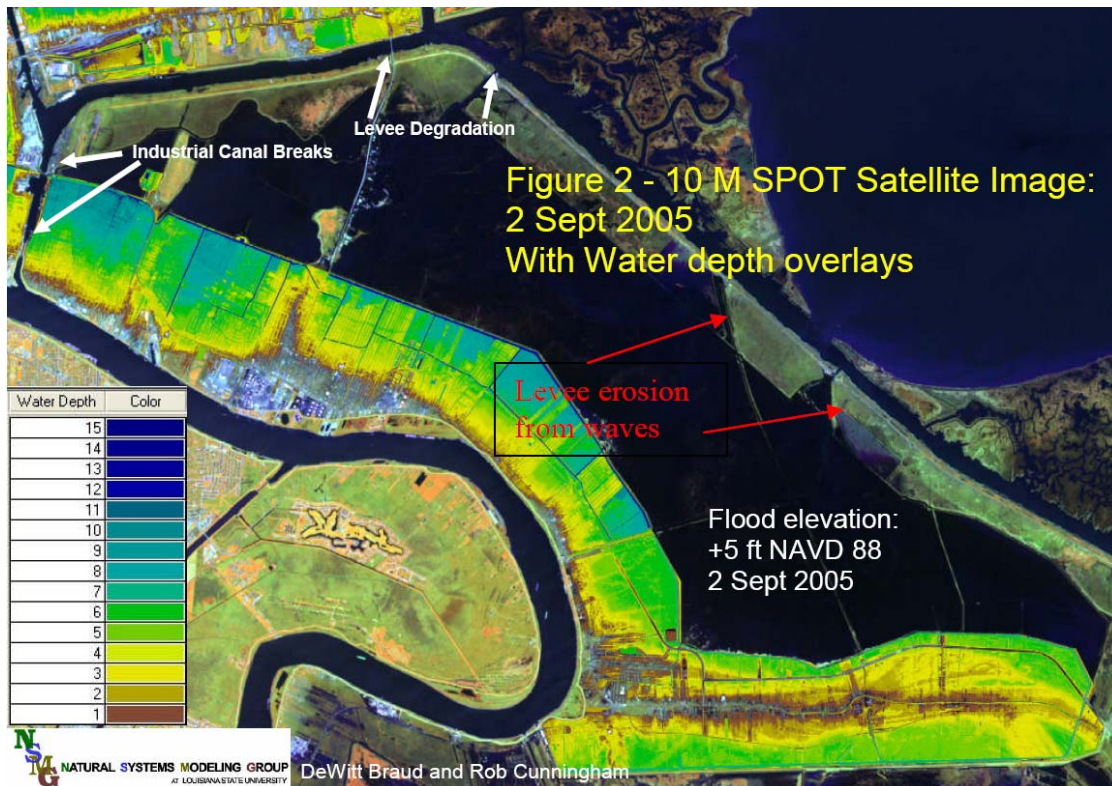
Figure 2.15 shows the approximate depth of flooding that remained on September 2nd, four days after Hurricane Katrina, in the St. Bernard Parish and Lower Ninth Ward protected area, based on an estimated surface water elevation of approximately +5 ft. (MSL) at that time. This is a significantly lower flood level than the estimated peak flooding to an elevation of up to +10 to 12 feet above mean sea level during the actual hurricane. The undeveloped swampland to the north of the populated areas can be seen in this Figure to also still be flooded on September 2nd, but the flood depths are not indicated.

Figure 2.16: Depth of flooding of St. Bernard Parish and the Lower Ninth Ward on Sept. 2nd (4 days after Hurricane Katrina).

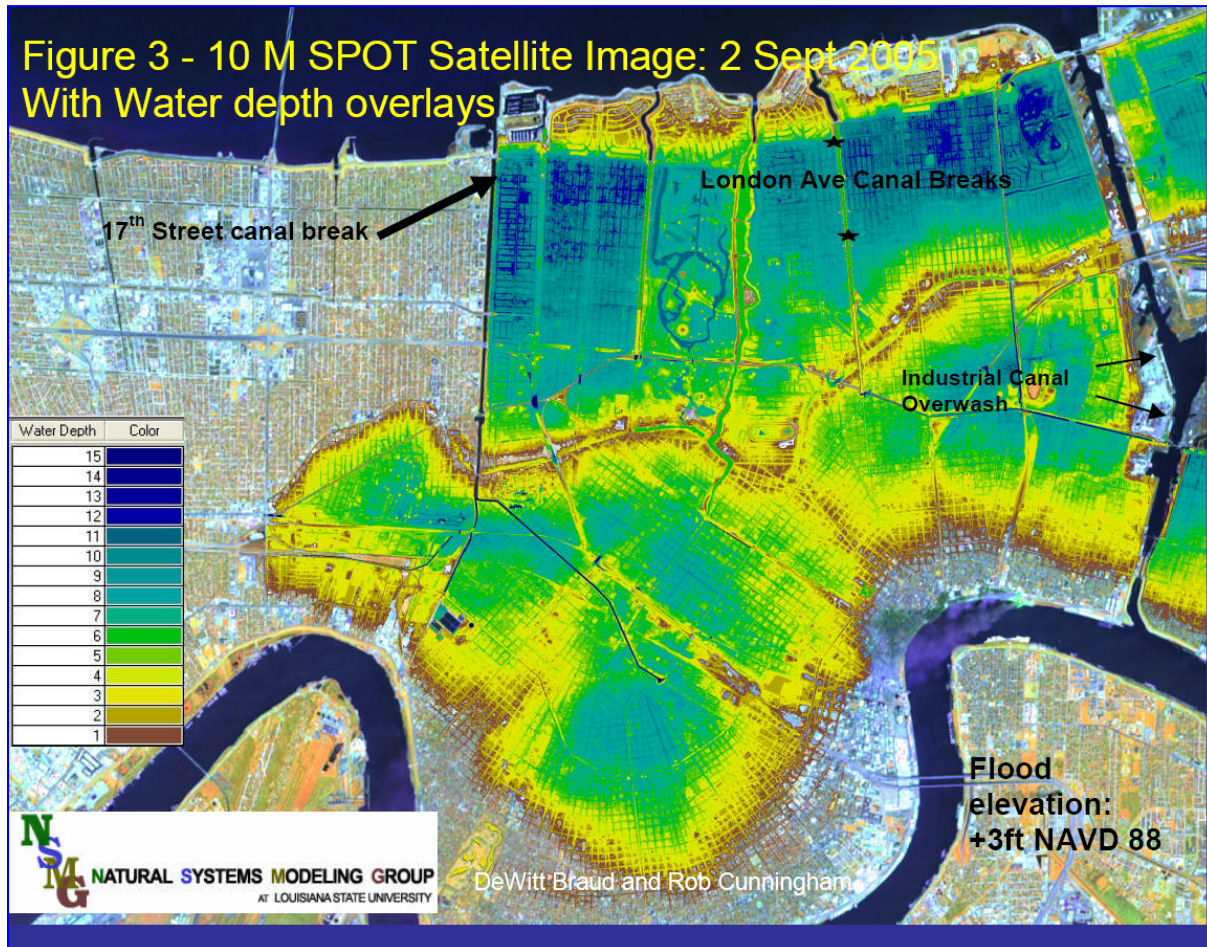
Figure 2.17 shows the approximate depth of flooding of the main Orleans East Bank (downtown) protected area on September 2nd. Like the New Orleans East protected area, this large protected “basin” filled relatively slowly over time. By September 2nd, the breaches had not yet all been closed by emergency repairs, so the depths of flooding in Figure 2.17 represent the nearly the full depth of flooding at its worst in this area.

Figure 2.17: Depth of flooding of the Orleans East Bank (Downtown) protected area on September 2nd (4 days after Hurricane Katrina).
