## CHAPTER SIX: THE ST. BERNARD AND LOWER NINTH WARD PROTECTED AREA

### 6.1 Introduction

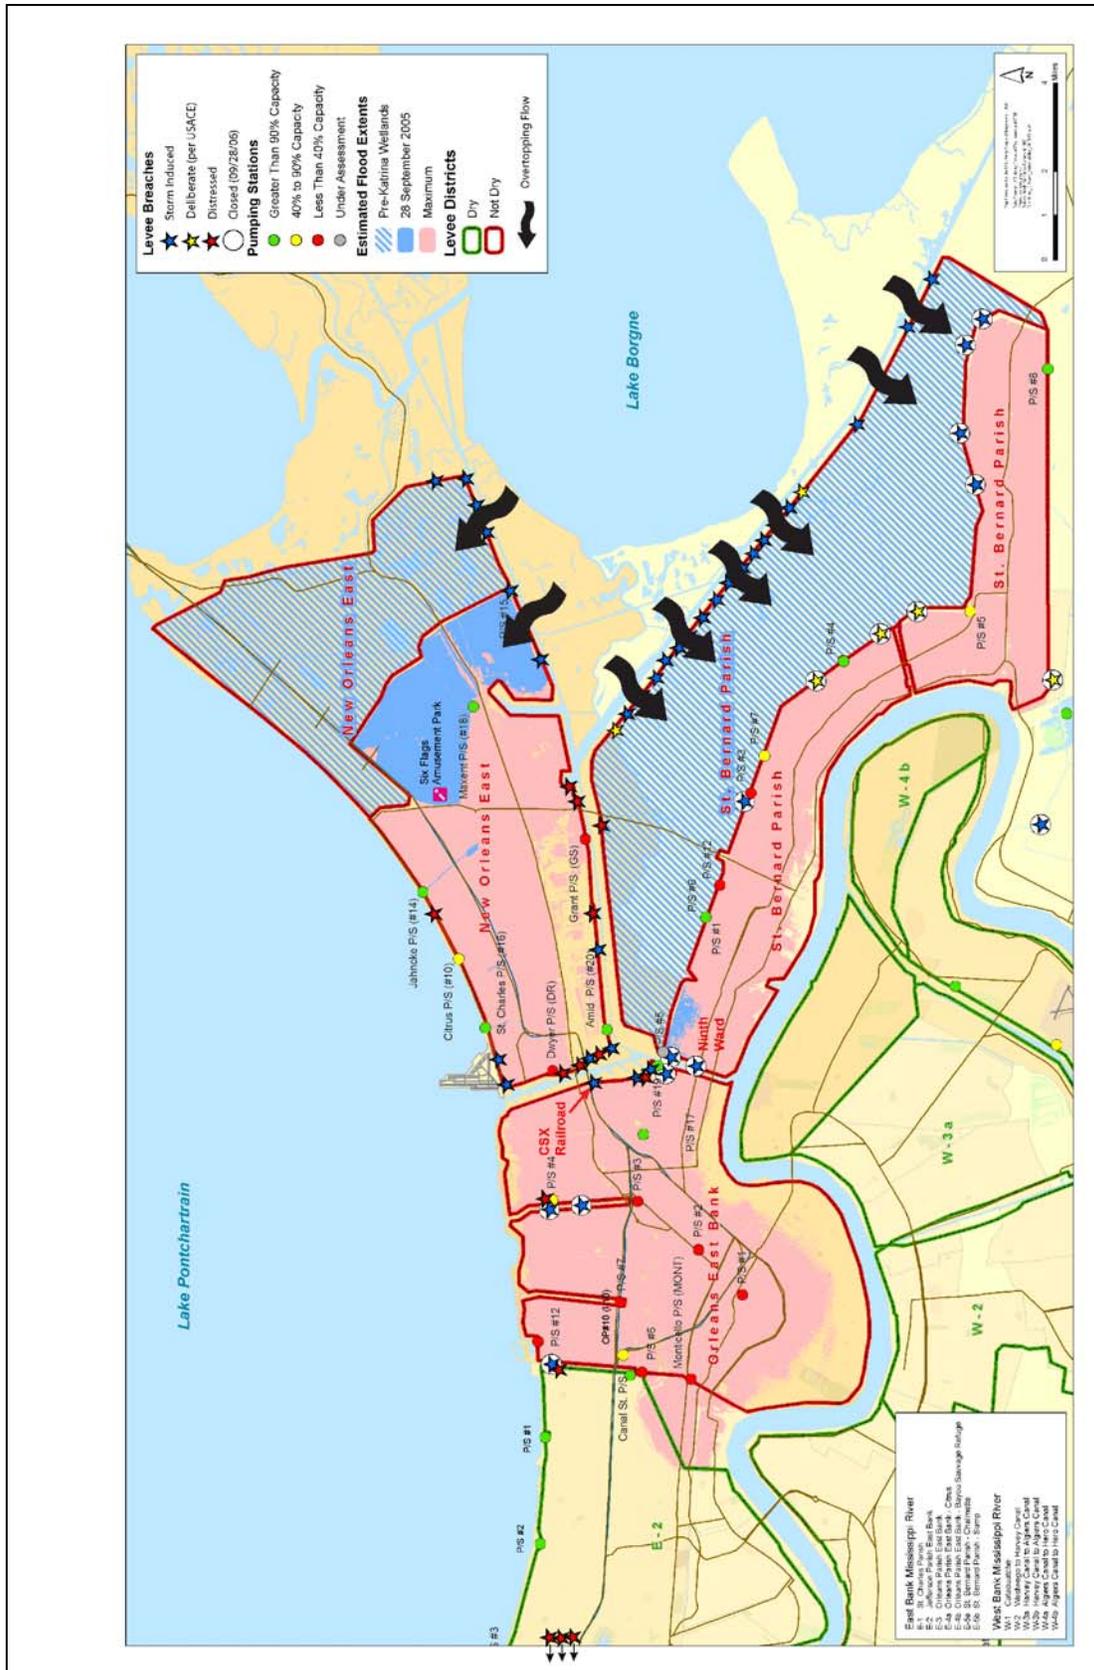
After the hurricane passed, and the storm surge had subsided, a number of “notches” were deliberately excavated through several of the levees to facilitate drainage of ponded floodwaters by simple gravity flow (as indicated by the yellow stars in Figure 6.1).

Figure 6.1: Map showing locations of levee breaches and distressed levee sections.

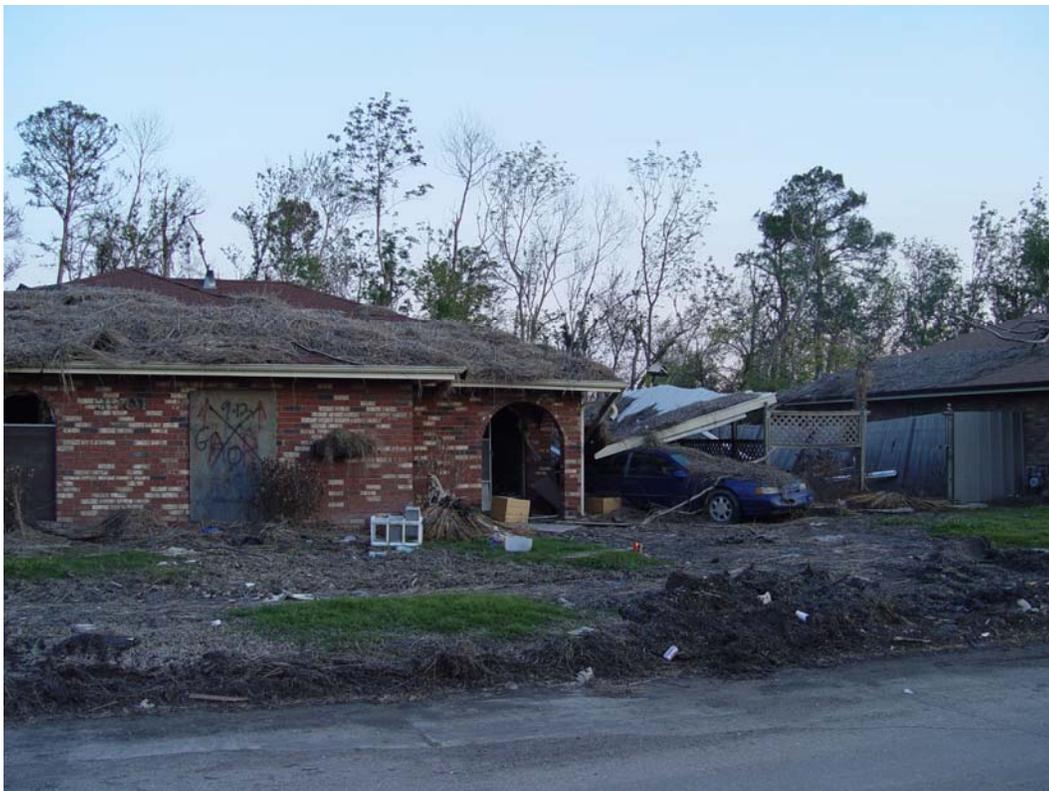
Figure 6.15: View of tree limbs and detritus on roofs of homes in St. Bernard Parish.

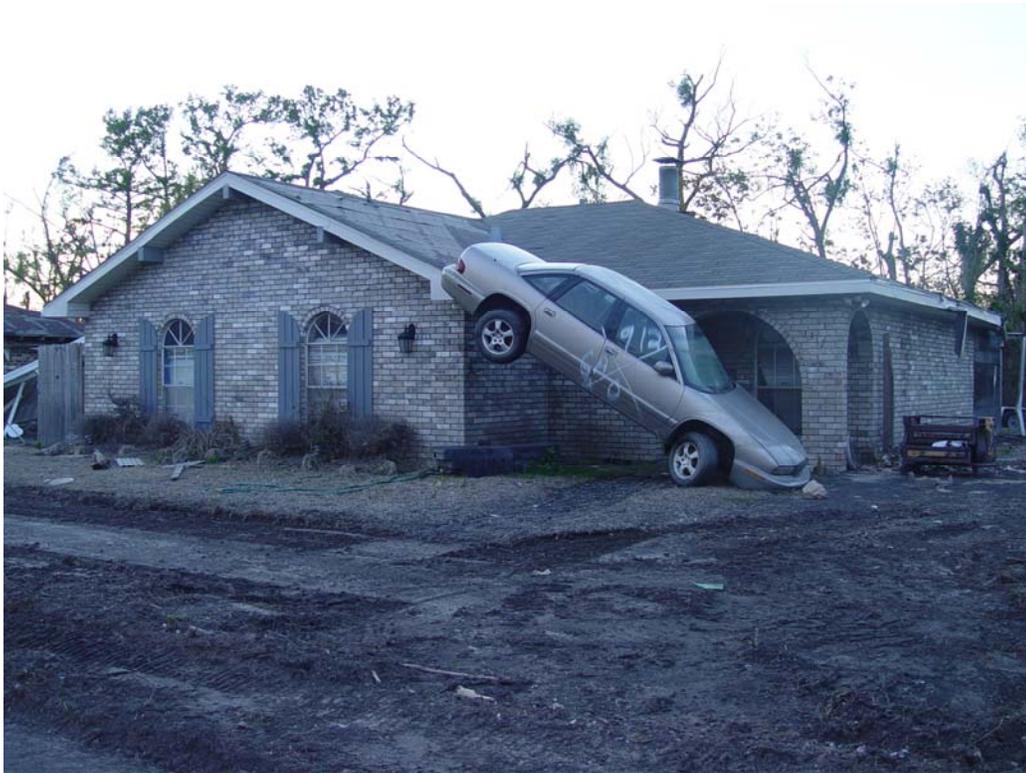
Figure 6.16: Car tossed and flipped in St. Bernard Parish.

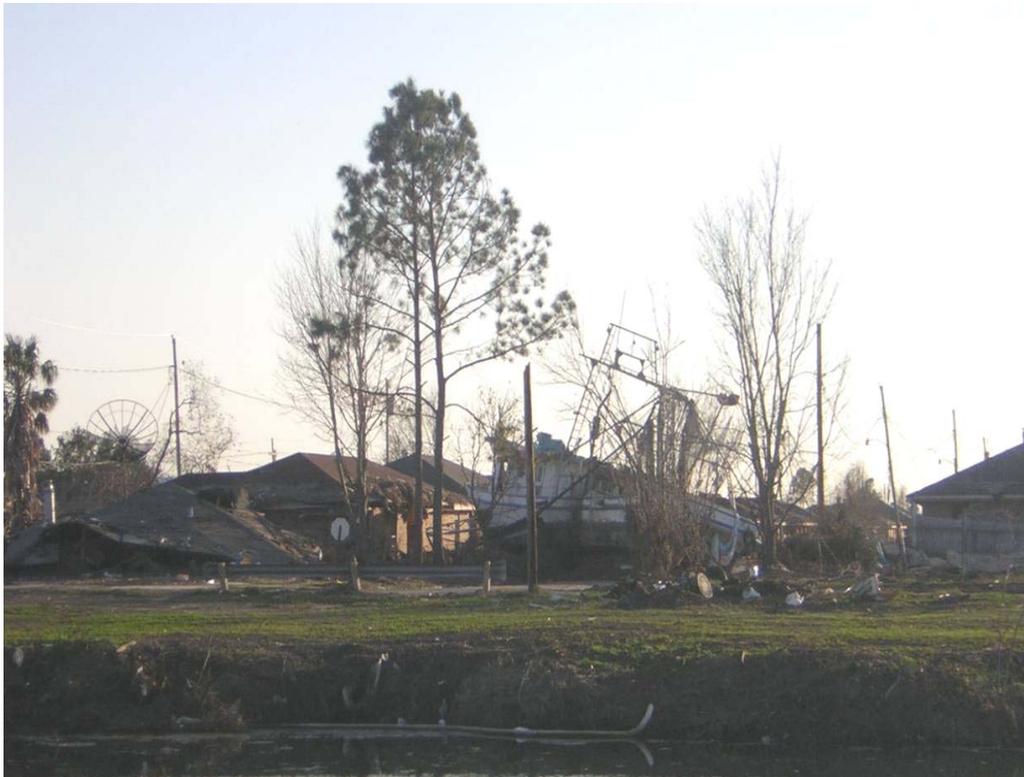
Figure 6.17: Boat deposited in neighborhood in St. Bernard Parish.

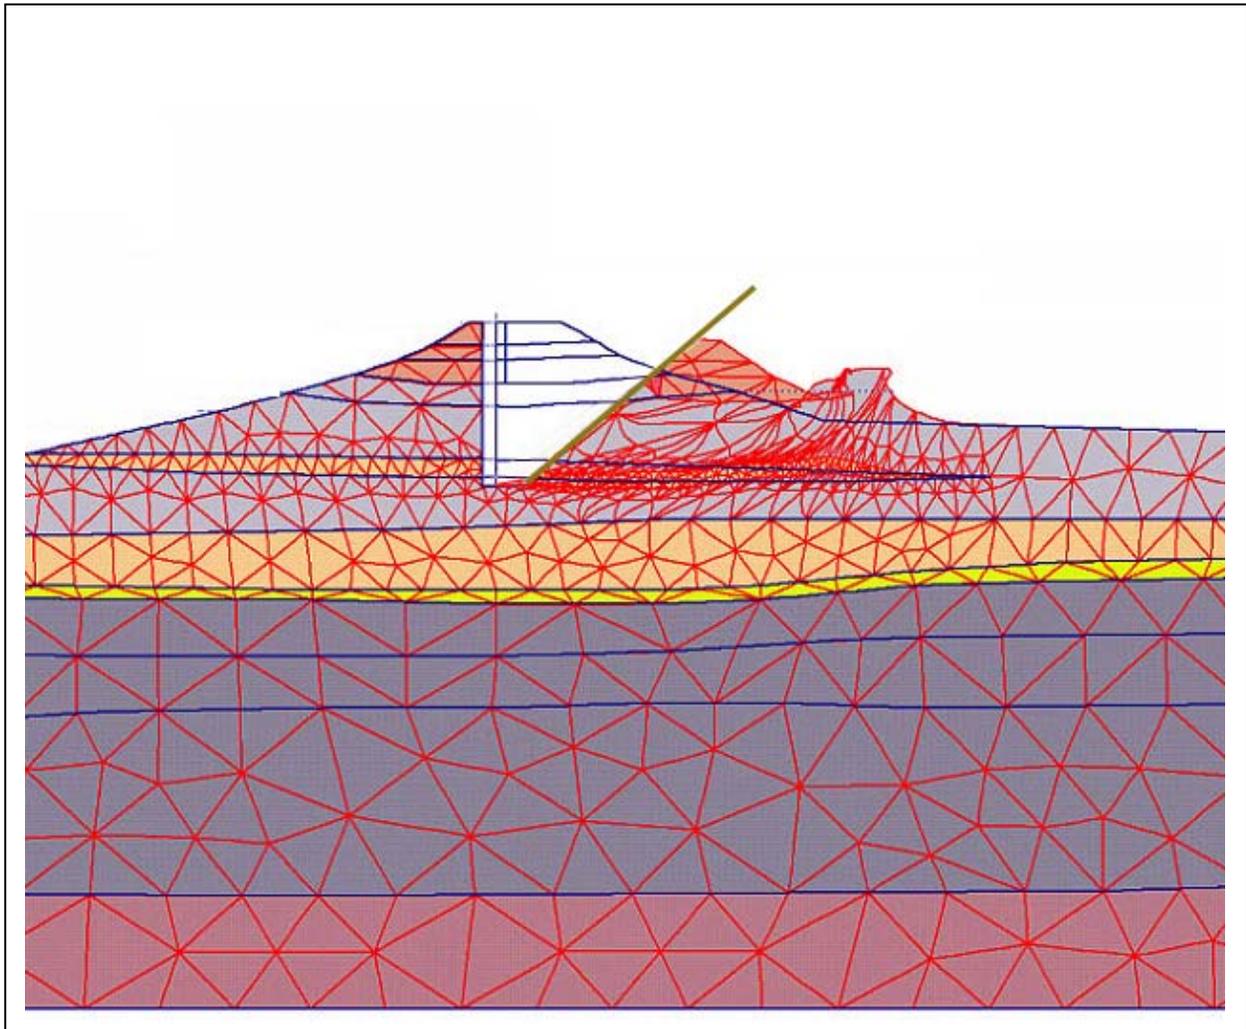
**Figure 6.29:** Deformed mesh for storm surge elevation of +13.5ft (MSL) for Lower Ninth Ward, East Bank, South Breach.

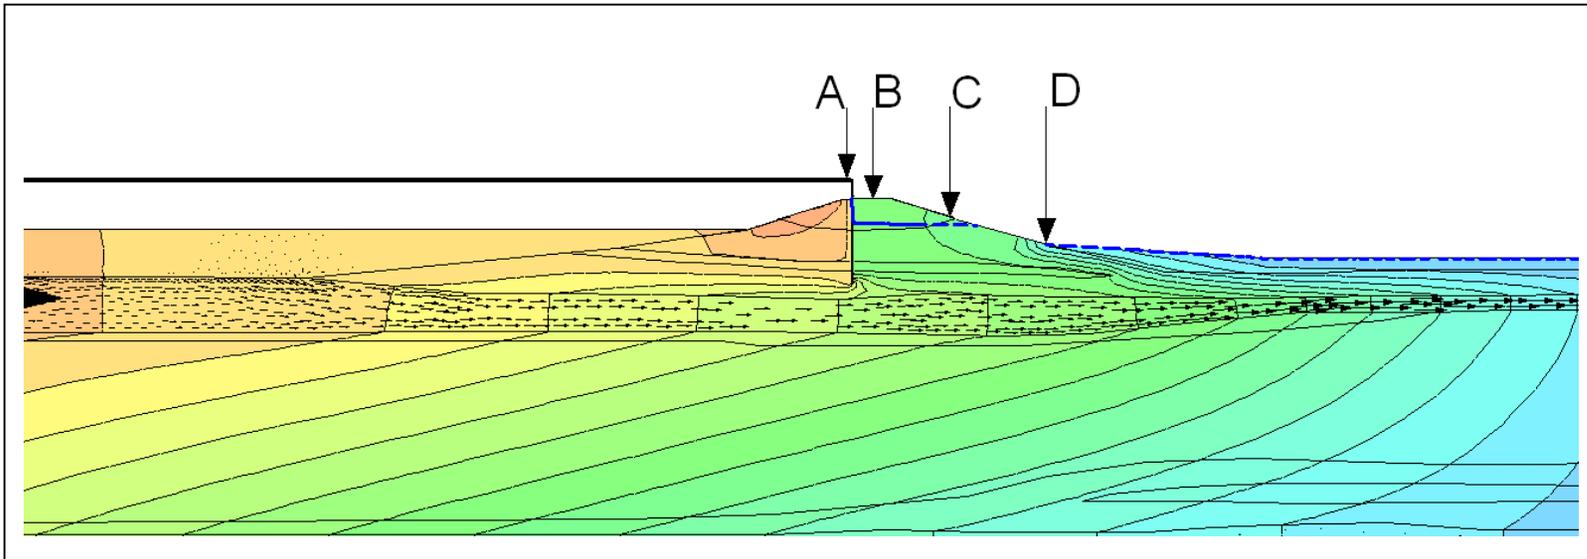
Figure 6.35: Flow net for the south breach on IHNC; storm surge at 14.4ft (MSL). Head contours at 1-foot intervals of head.

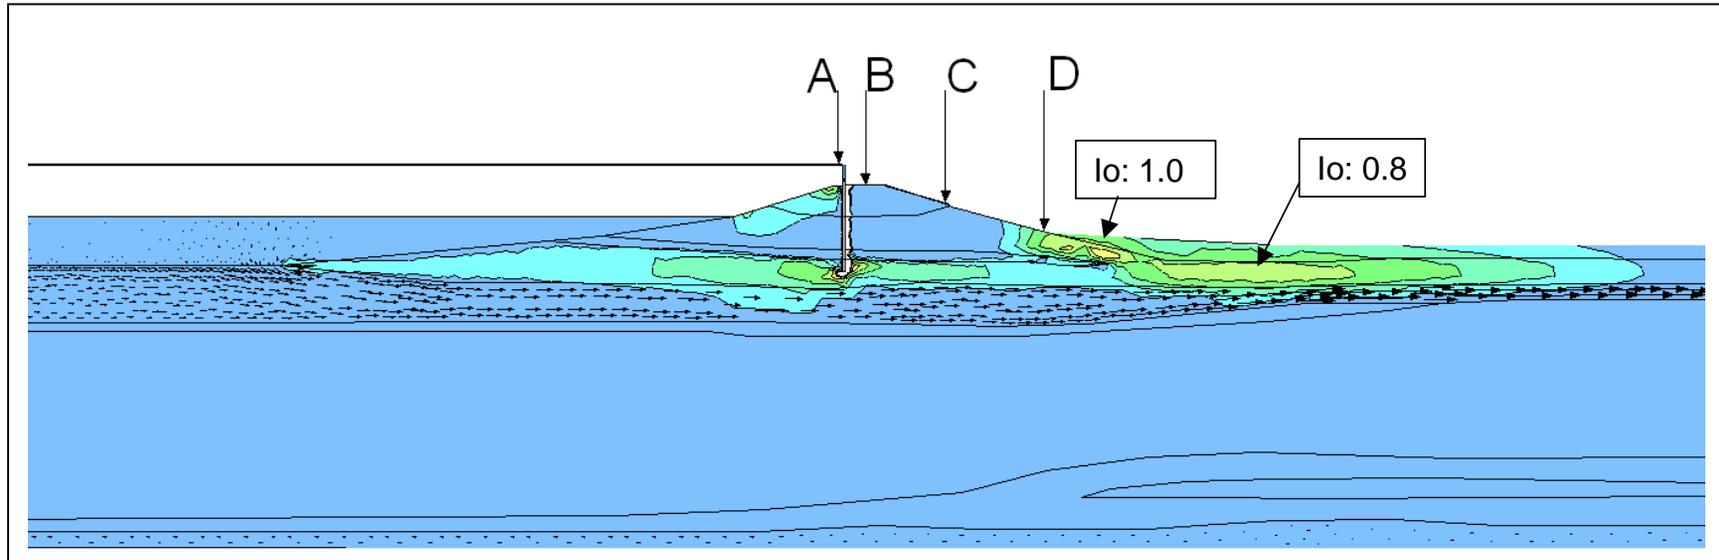
Figure 6.37: Hydraulic gradients for the south breach on IHNC east bank; storm surge at 14.4ft (MSL). Maximum exit gradient at the levee toe is  $i_o \approx 0.8$  to 1.0.

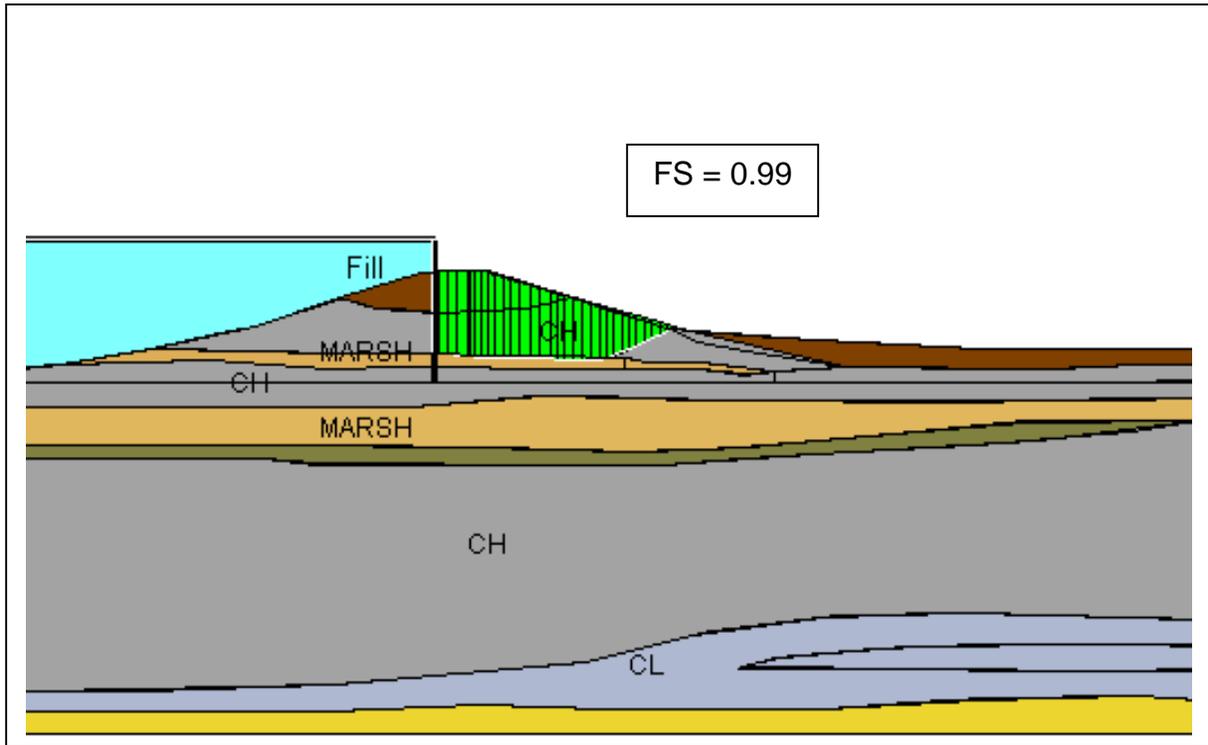
Figure 6.42: Critical failure surface for the south breach on IHNCEast bank; storm surge at 14ft (MSL), failure through upper marsh layer with gap at front of sheetpiles fully developed.

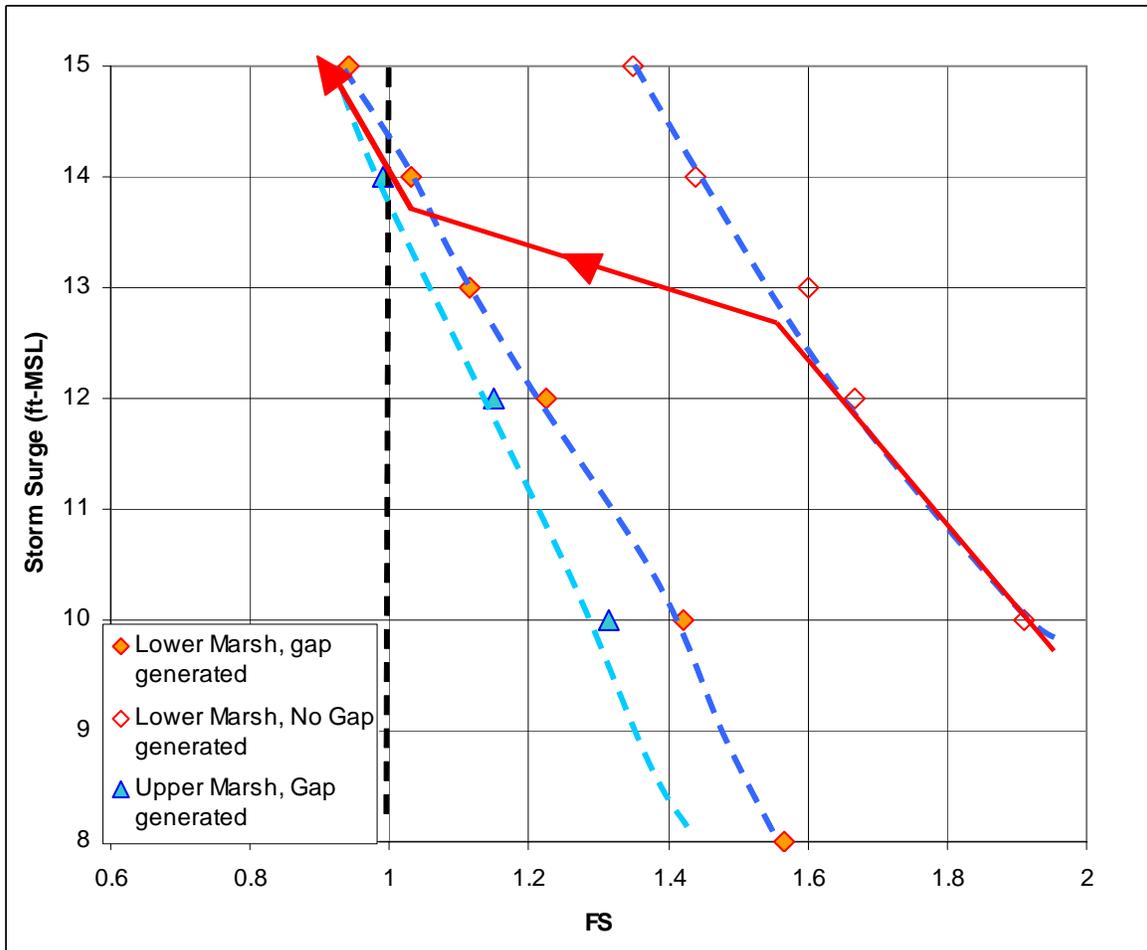
Figure 6.44: Calculated Factors of Safety for three modes based on SLOPE/W analyses of the Lower Ninth Ward South breach site (east bank IHNC) for various canal water elevations; showing the best-estimated path to failure.

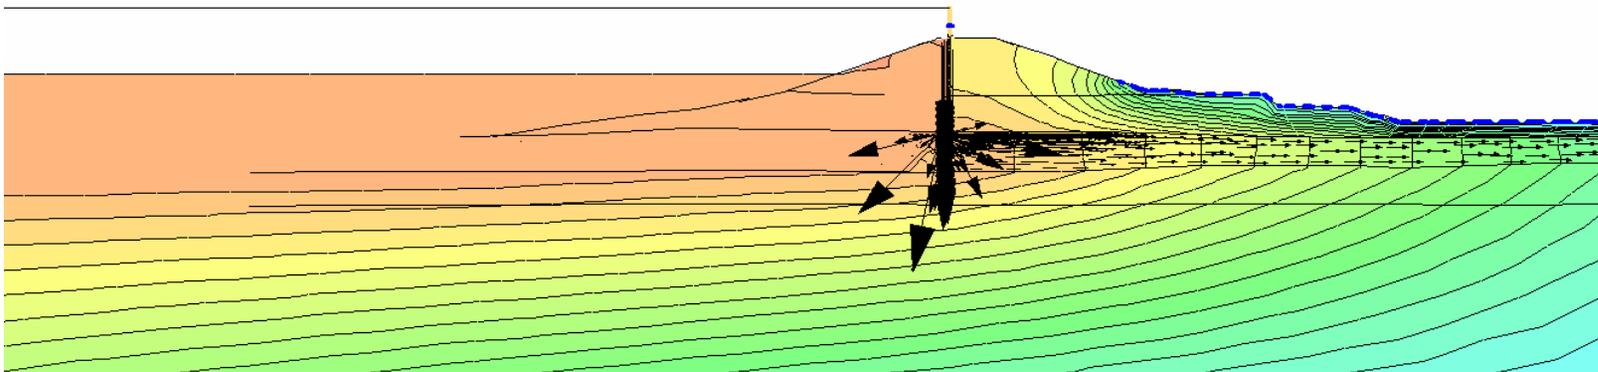
Figure 6.49 shows the calculated flownet equipotential lines for a canal water surge elevation of +14 feet (MSL). Once again, as with the larger breach just to the south, the flow travels through the continuous marsh layer that was left frustratingly open to flow by the shallow sheetpiles that were an inadequate cut-off at this site.

Figure 6.49: Flow net generation for the north breach on IHNC east bank. Storm surge at +14.4ft (MSL). Head contours at 1 foot intervals of hydraulic head.

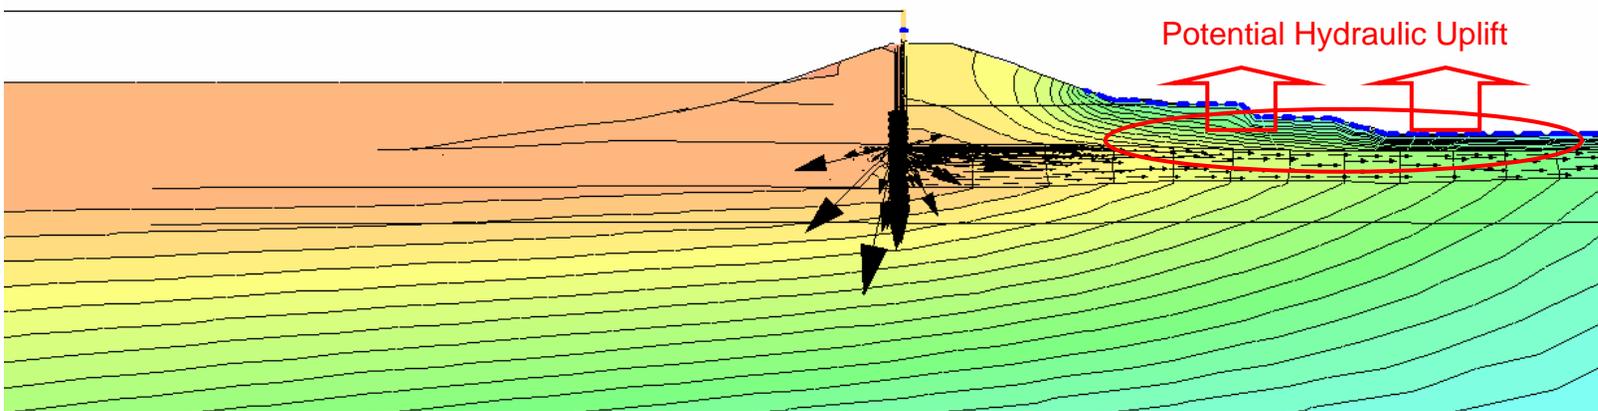
Figure 6.50 shows pore pressure contours for the same conditions as Figure 6.49. Once again the hydraulic uplift pressures represent potential instability with regard to lifting or "blowout" of the thin surficial strata of impervious and relatively lightweight soils overlying the marsh stratum at and near the inboard toe.

Figure 6.50: Pressure contours for the north breach on IHNC east bank. Storm surge at +14.4ft (MSL). Pore pressure contours at intervals of 62.4 lb/ft<sup>2</sup>.

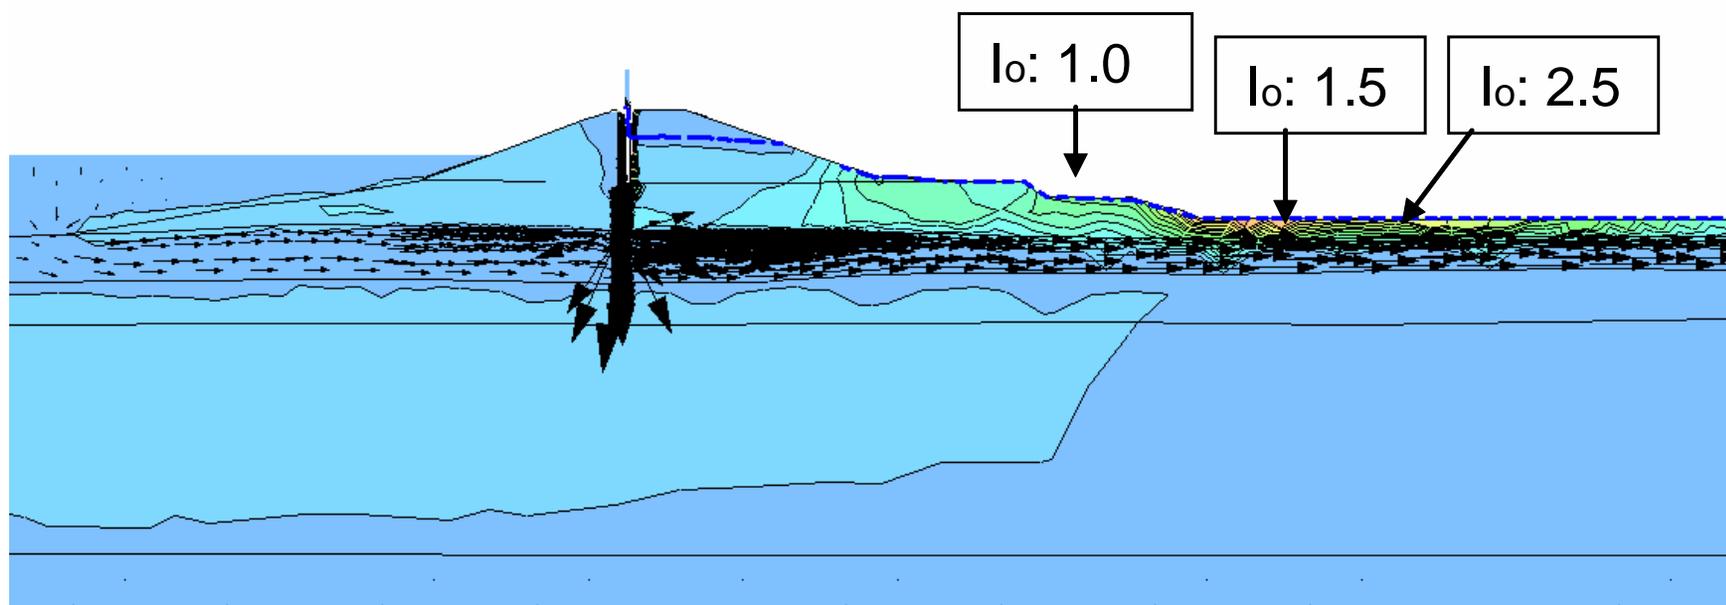
Similarly, as shown in Figure 6.51, seepage exit gradients at and near the inboard toe are massively unsafe with regard to the initiation of seepage erosion and piping in these relatively lightweight soils.

Figure 6.51: Hydraulic gradients for the north breach on IHNC. Storm surge at +14.4ft (MSL). Maximum exit gradient on the upper levee toe is  $i_o \approx 1.0$ , and  $i_o \approx 1.5$  to 2.5 at the lower toe.

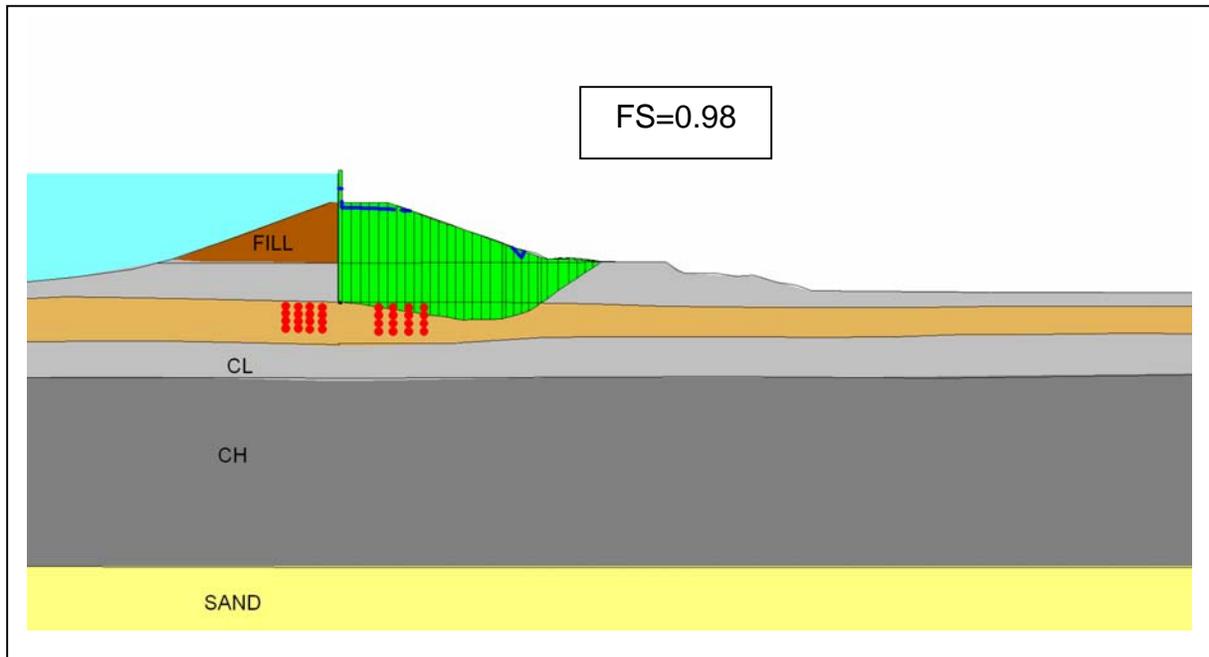
And finally, as with the adjacent breach section to the south, the section is also marginally unstable with regard to limit equilibrium (Spencer's method), as shown in Figure 6.52, as a result of underseepage-induced pore pressures and resultant loss of strength. The most critical failure surface this time passes through (and largely within) the main marsh layer, though a secondary failure surface concentrated near the interface between this marsh layer and the overlying clay layer has a nearly similar (unstable) factor of safety.

Figure 6.52: Critical potential stability failure surface for the north breach on IHNC. Storm surge at +14 ft (MSL).

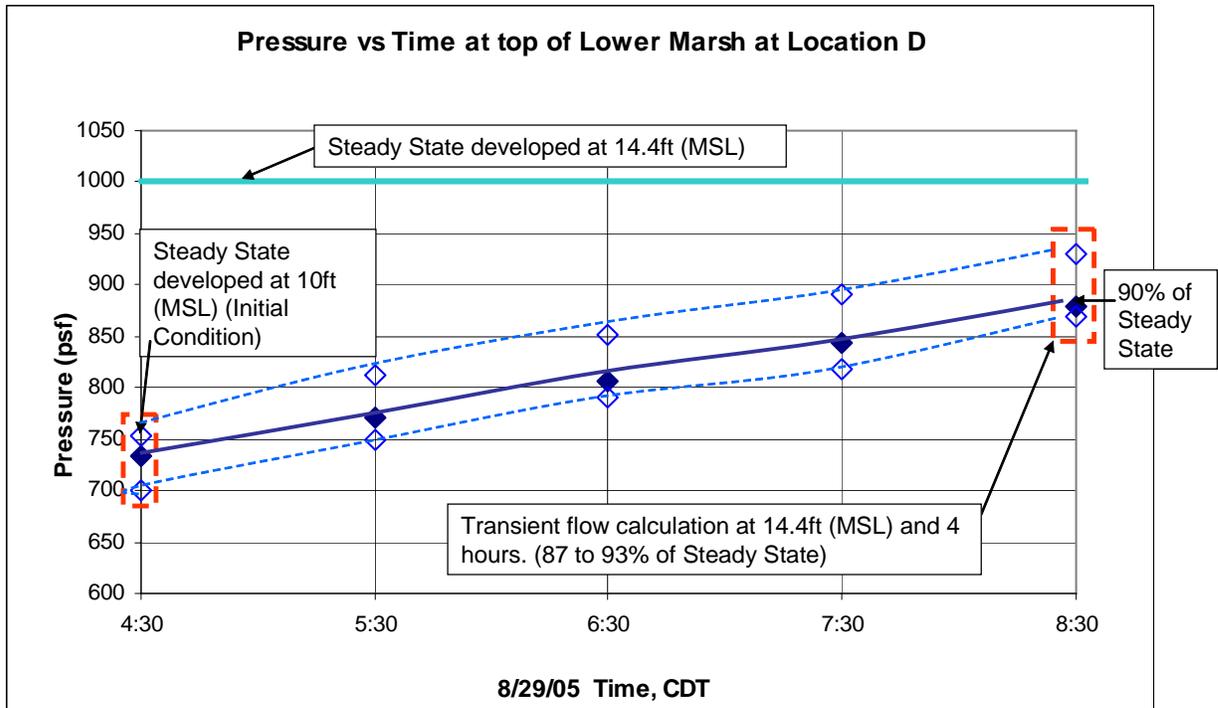
Figures 6.53 and 6.54 show calculated transient pore pressures (6.53) at the top of the marsh stratum beneath the inboard toe of the levee, and (6.54) at various depths beneath the inboard levee toe. As for the breach section immediately to the south, the upper and lower bound lateral permeability estimates are also shown in Figure 6.53; and again a large fraction of the overall rise in canal water levels has resulted in corollary water pressure increases at the inboard toe region by about 7:00 to 8:00 a.m.

Figure 6.53: Transient flow pore pressure generation for the north breach on IHNC east bank.

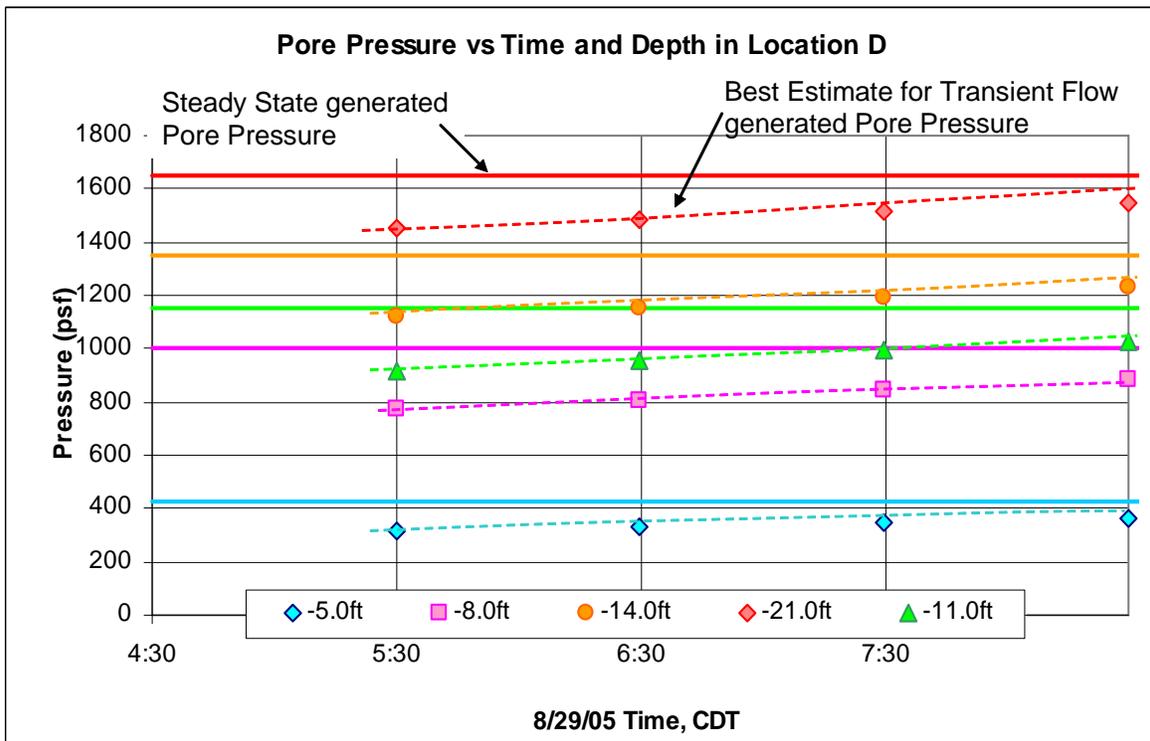
Figure 6.54: Pore pressure generation at different times and depths at the inboard toe of the north breach on IHNC east bank.

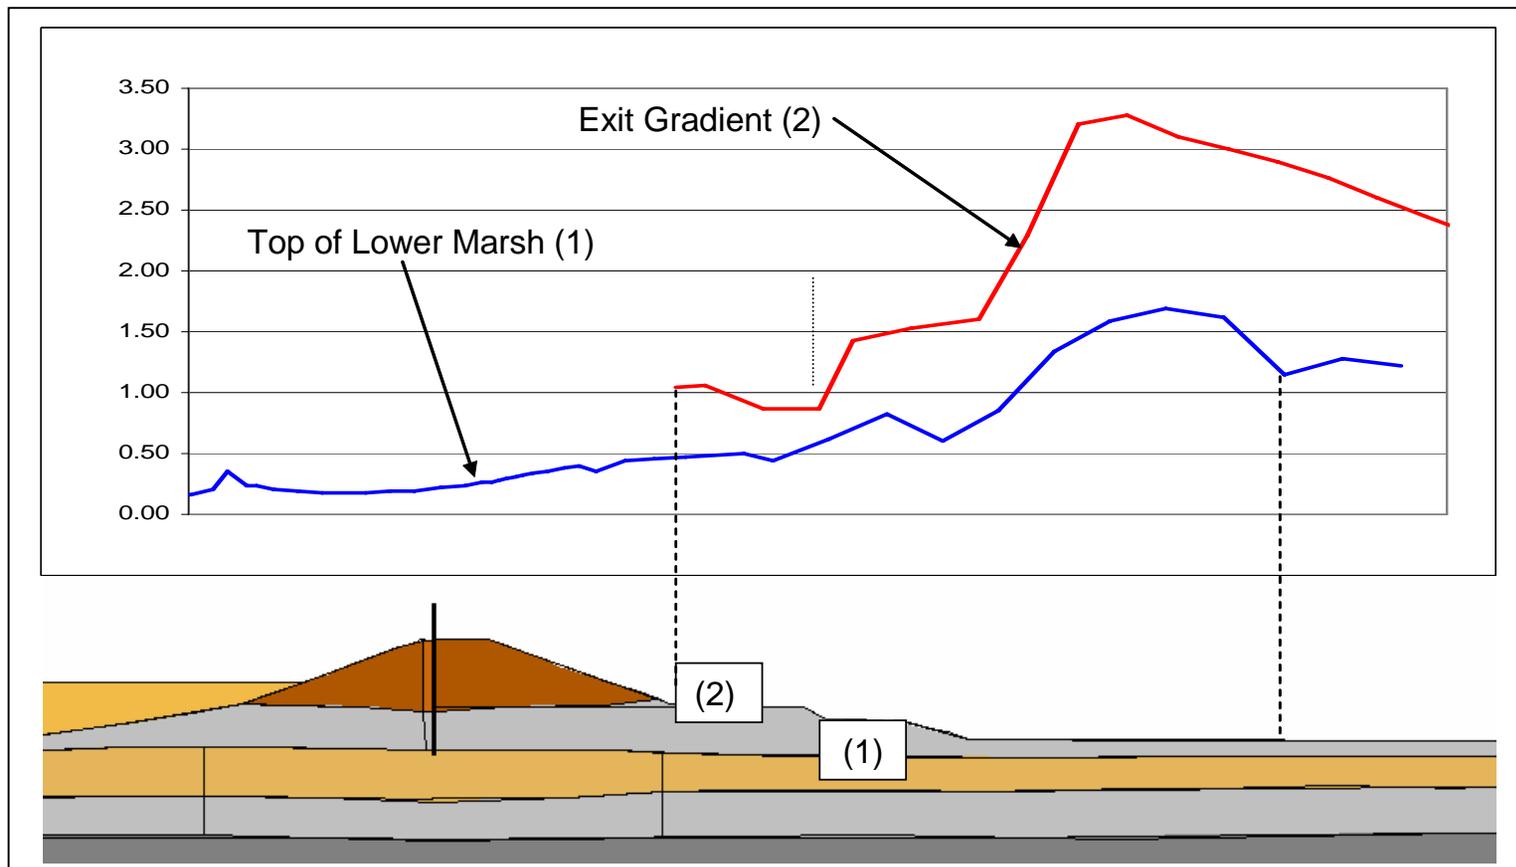
Figure 6.55 shows the progressive increase in pore pressure at the top of the marsh stratum vs. time, and the pore pressures are high enough to pose a very high risk of hydraulic uplift (or "blowout") at the inboard toe region.

Figure 6.55: Hydraulic gradients on the south breach on IHNC east bank.

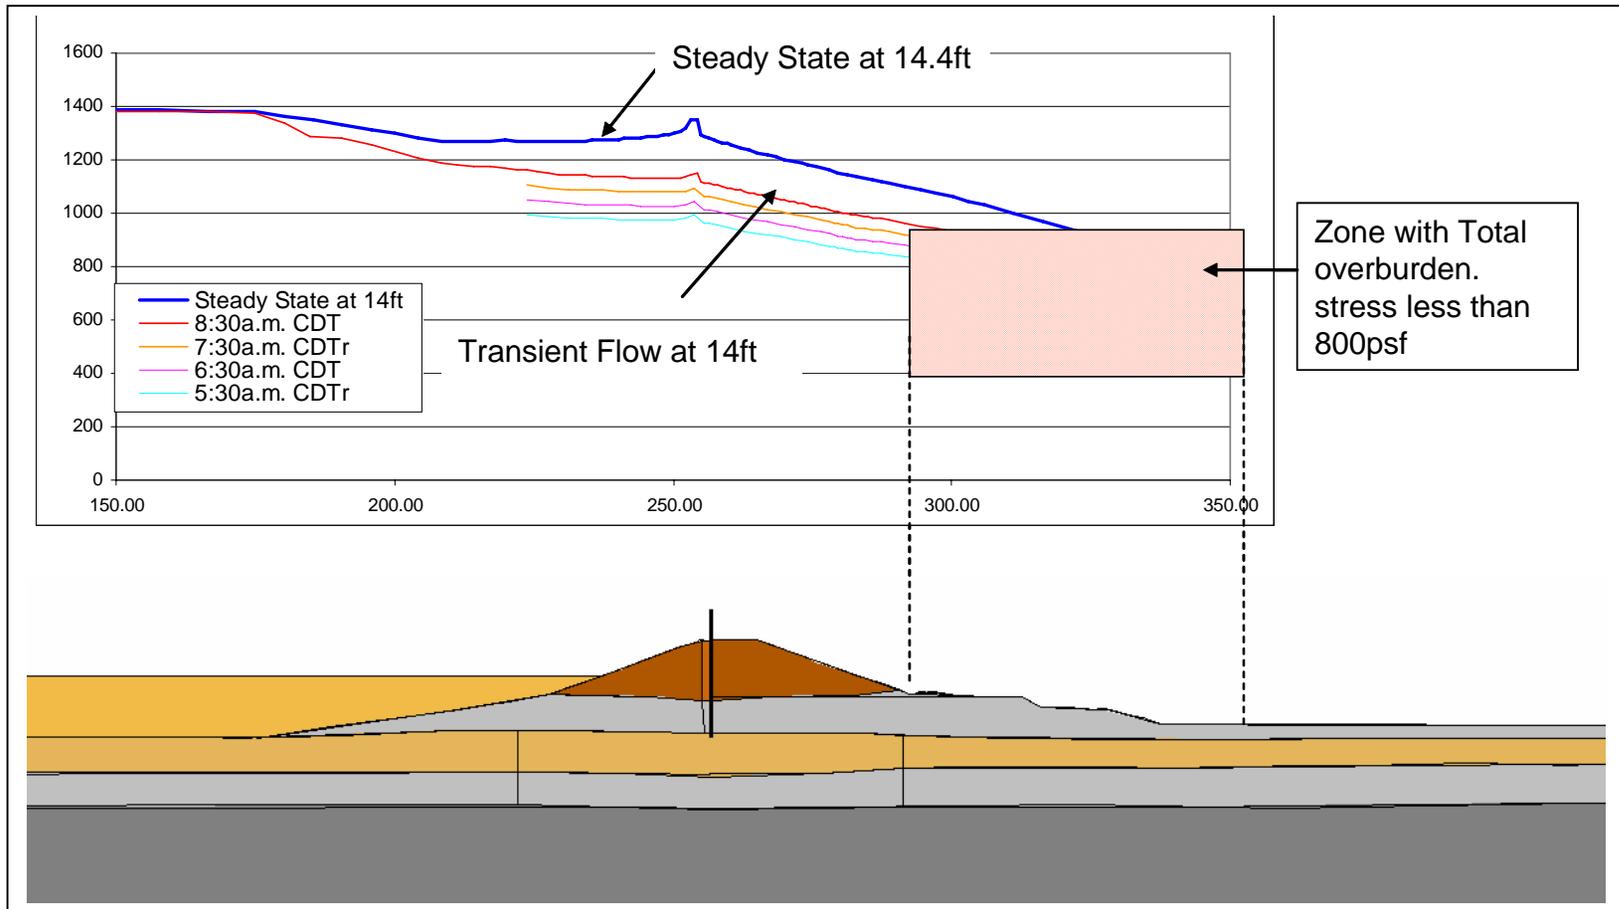
Figure 6.56 shows a potential path to failure by means of lateral translational foundation instability; reaching a condition of marginal lateral instability (with full

Figure 6.56: Pore pressure versus horizontal distance and time on the north breach on IHNC east bank.

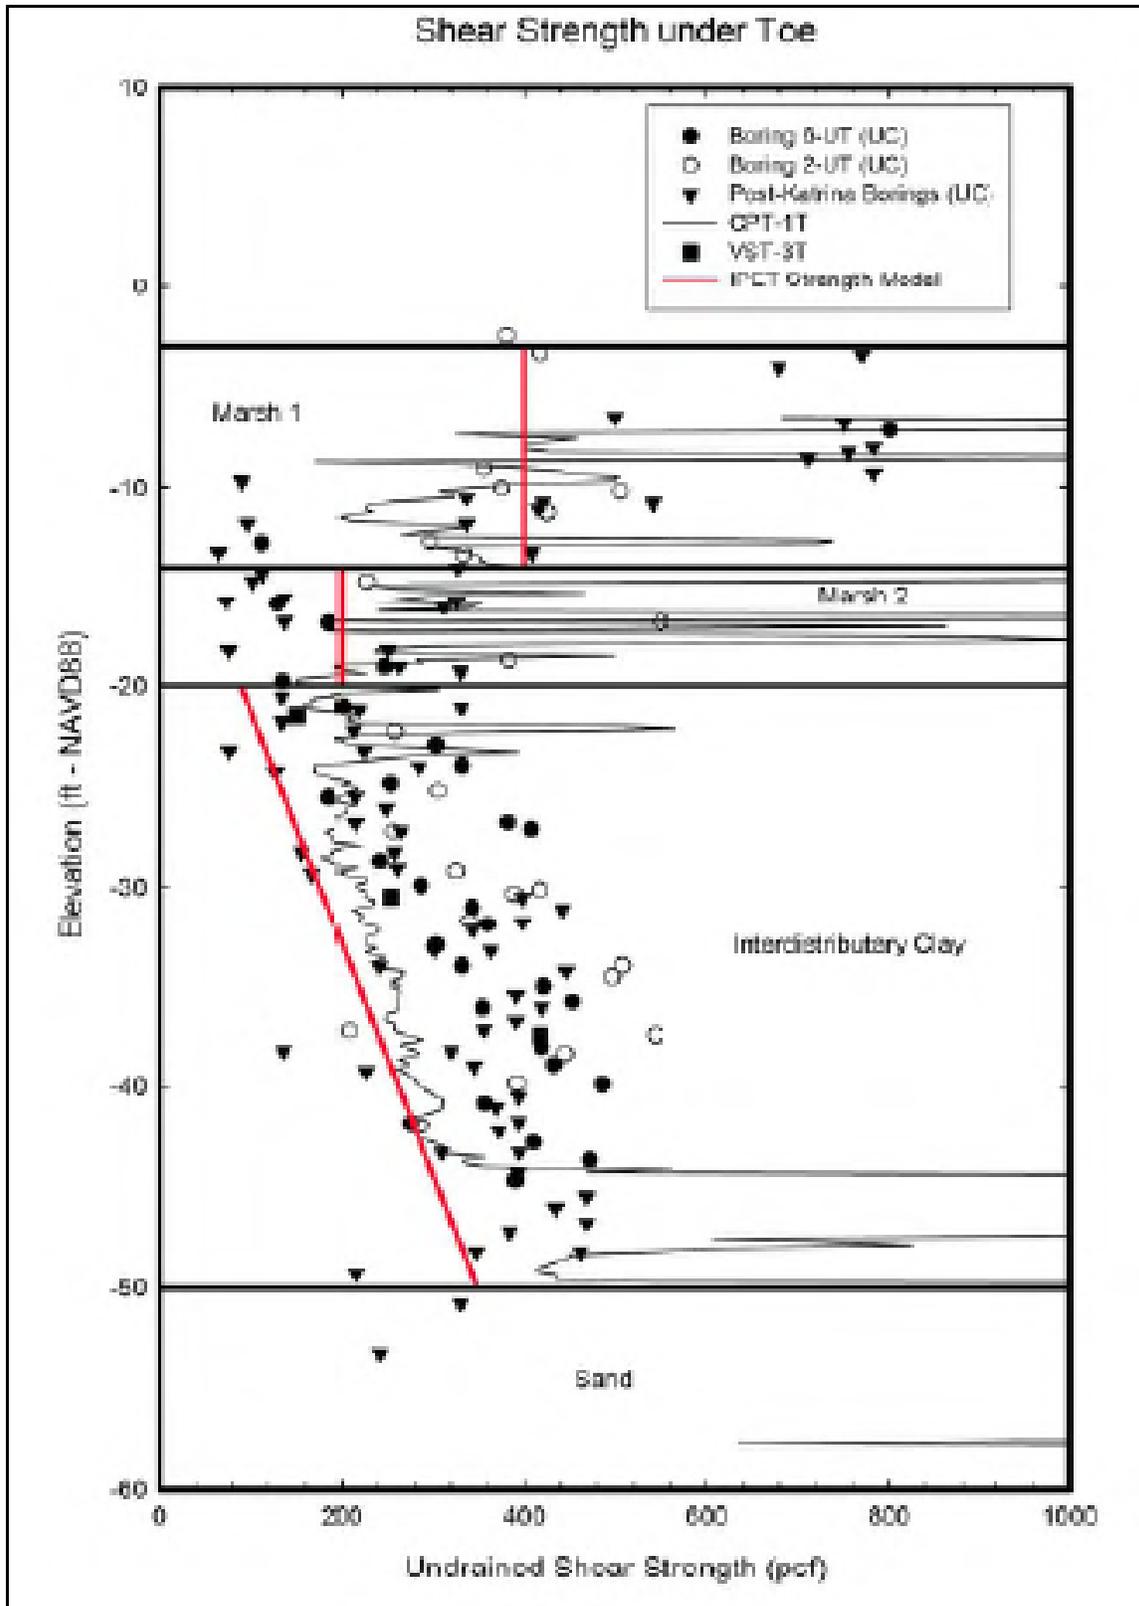
Repetition of the limit equilibrium analysis (Spencer's Method) of the failure surface shown in Figure 6.58, but using our own (ILIT) interpretation of undrained shear strengths within the critical lower clay layer (Figure 6.60) results in a calculated factor of safety, even conservatively assuming the presence of a water-filled gap on the outboard side of the sheetpile curtain, of  $FS = 1.89$ . This underestimates the actual overall Factor of Safety, which should actually be on the order of 10% to 15% higher based on three-dimensional considerations for this narrow, deep failure. It is therefore not likely that a deep, semi-rotational failure occurred, early on and at a relatively low canal water level, at this site.

Figure 6.58: IPET shear strength profile; IHNC east bank/Lower Ninth Ward (North) breach.

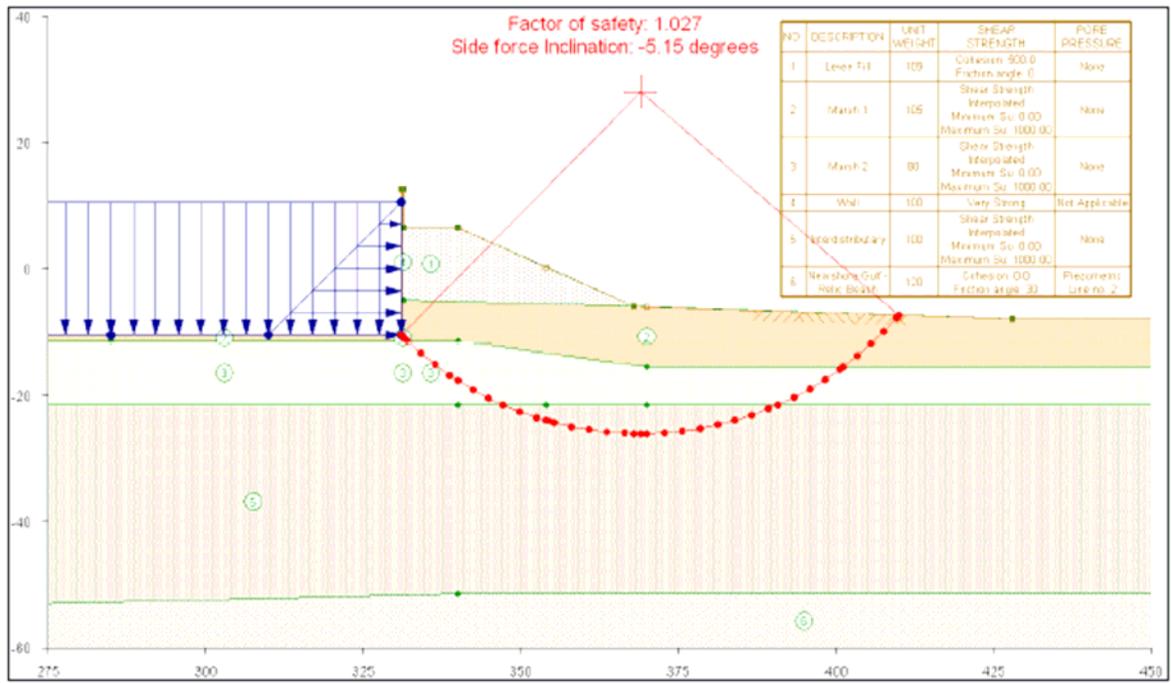
Figure 6.59 shows the IPET interpretation of shear strength data for this section, and the red lines are the IPET shear strength profiles for stability analyses (IPET: June 1, 2006.) In this figure, the values of undrained shear strength based on the CPT tip resistance data are based on a CPT tip factor of  $N_k = 15$ . This appears to be an overly conservative value of  $N_k$  within the lower clay stratum, as the CPT-based shear strengths within this stratum are significantly lower than the trend based on the unconsolidated-undrained triaxial tests on “undisturbed” samples obtained with a 5-inch diameter thin-walled fixed-piston sampler. In

Our own studies determined (based on  $B_q$  values from the CPTU) indicated that values of  $N_{kt} = 12$  were more appropriate for this lower soft clay (CH) layer, and the resulting re-interpretation of this CPT data based on  $N_{kt} = 12$  is shown (with a dark blue trace) superposed over the previous Figure 6.59 in Figure 6.60. Similarly, the dark blue lines in Figure 6.60 show our (ILIT) interpretation of the layering at this location, and the light blue dashed lines show our interpretations of shear strength vs. depth at this section. The IPET shear strength interpretation, in addition to being low, was also based on the assumption that this lower clay stratum was normally consolidated over its full depth. As shown previously in Figures 6.25 and 6.26, our own interpretations showed several clear desiccation-induced overconsolidation profiles near the middle and top of this clay layer, and additional moderate overconsolidation near the base (likely to the base being well-drained and thus partially overconsolidated due to secondary compression), and these are reflected in our ILIT shear strength profile. In this figure, the CPTU-based shear strengths (based on  $N_{kt} = 12$ ) can be seen to be in better agreement with the other shear strength data, and the overall shear strength vs. depth profile is more consistent with this data.

Figure 6.59: Critical limit equilibrium stability failure mode from IPET Draft Final Report; canal water elevation at +9 feet (MSL). Factor of Safety: 1.03.
