## CHAPTER SIX: THE ST. BERNARD AND LOWER NINTH WARD PROTECTED AREA

### 6.1 Introduction

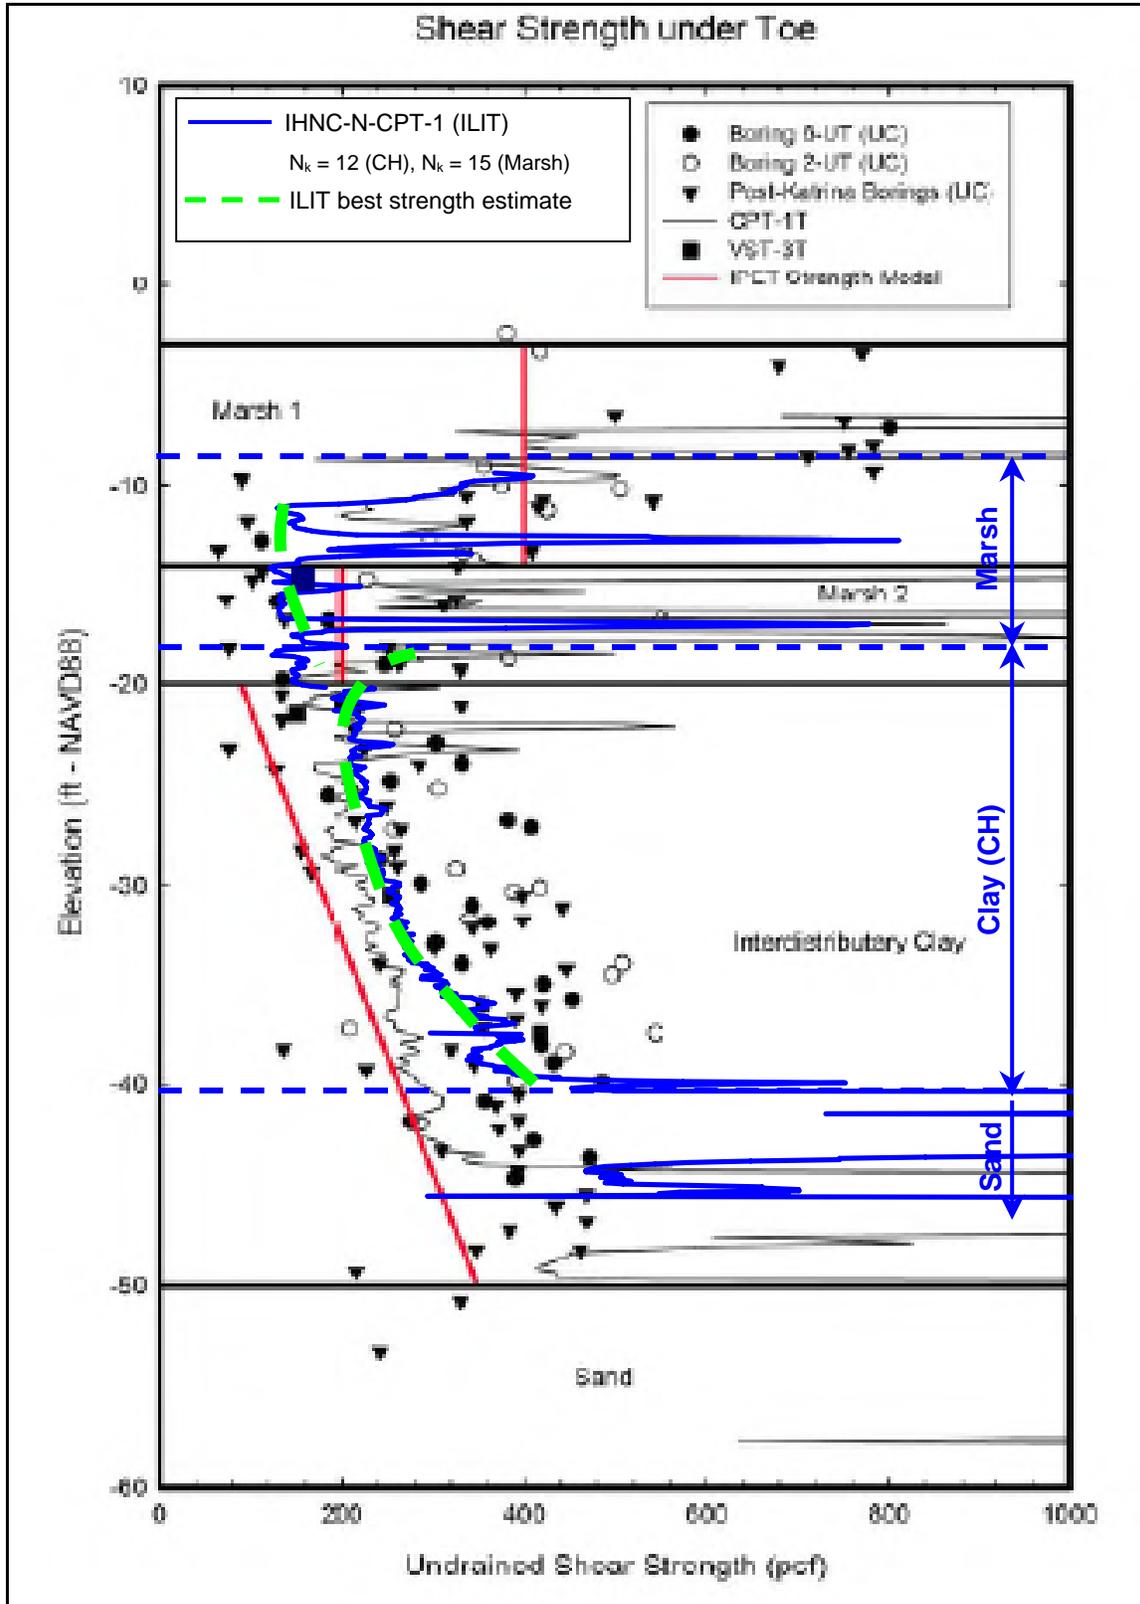
Figure 6.59 shows the IPET interpretation of shear strength data for this section, and the red lines are the IPET shear strength profiles for stability analyses (IPET: June 1, 2006.) In this figure, the values of undrained shear strength based on the CPT tip resistance data are based on a CPT tip factor of  $N_k = 15$ . This appears to be an overly conservative value of  $N_k$  within the lower clay stratum, as the CPT-based shear strengths within this stratum are significantly lower than the trend based on the unconsolidated-undrained triaxial tests on “undisturbed” samples obtained with a 5-inch diameter thin-walled fixed-piston sampler. In

Repetition of the limit equilibrium analysis (Spencer's Method) of the failure surface shown in Figure 6.58, but using our own (ILIT) interpretation of undrained shear strengths within the critical lower clay layer (Figure 6.60) results in a calculated factor of safety, even conservatively assuming the presence of a water-filled gap on the outboard side of the sheetpile curtain, of  $FS = 1.89$ . This underestimates the actual overall Factor of Safety, which should actually be on the order of 10% to 15% higher based on three-dimensional considerations for this narrow, deep failure. It is therefore not likely that a deep, semi-rotational failure occurred, early on and at a relatively low canal water level, at this site.

Figure 6.59: Critical limit equilibrium stability failure mode from IPET Draft Final Report; canal water elevation at +9 feet (MSL). Factor of Safety: 1.03.
