CHAPTER SEVEN: THE NEW ORLEANS EAST PROTECTED AREA

7.1 Introduction

7.3 Performance of the New Orleans East Hurricane Protection System in Hurricane Katrina

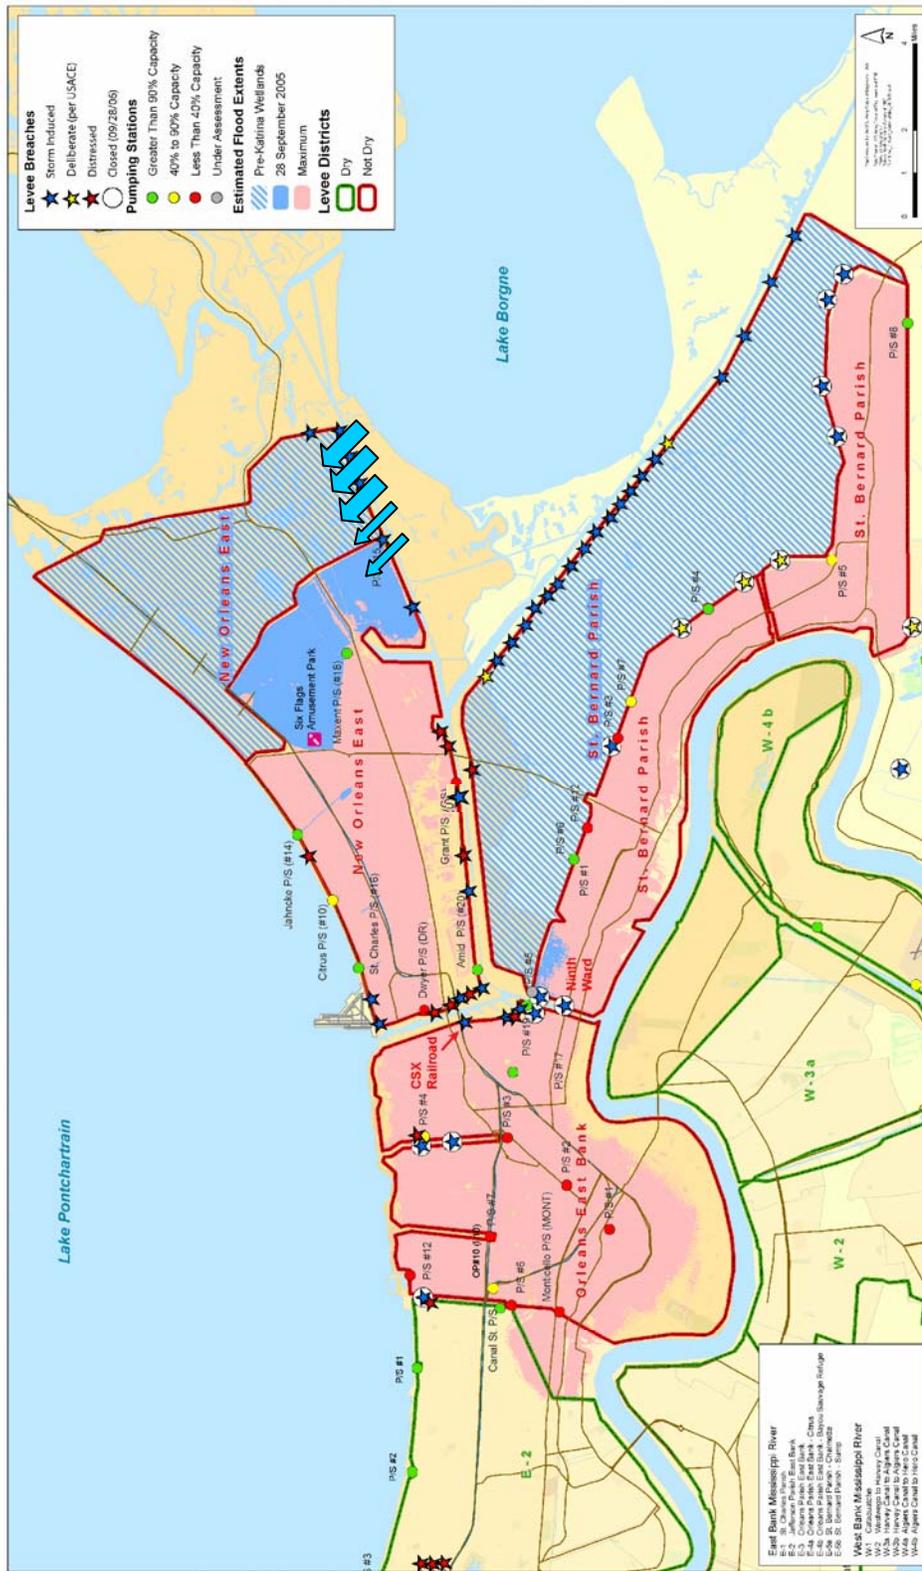
Figure 7.1: Map showing principal features of the main flood protection rings or “protected areas” in the New Orleans area.

Figure 7.1 shows the New Orleans East (NEO) protected area, a contiguously ringed area that includes some of the lowest ground in the metropolitan region. This is a repeat of Figure 2.4, and the blue stars again represent levee breaches, and the red stars locations of significant levee distress. Multiple levee breaches and significant overtopping produced complete flooding of this protected area, and the resulting damage was extensive.

Figures 7.1 and 7.2 show the locations of damage to the levee system surrounding the New Orleans East (NOE) protected area. The most significant damage to the system occurred to East Back Levee that fronts the GIWW and Lake Borgne. Here the storm surge completely destroyed (and massively eroded) large expanses of earthen levee in the southeastern corner of the NOE protected area. Additional smaller, but nevertheless significant breaches also occurred along other portions of these NOE back levee reaches. As the storm surge next passed west two significant levee breaches occurred, both due to overtopping, along the north bank of the east-west trending channel of the GIWW/MRGO. Damage (mostly in the form of scour) also occurred along the IHNC East Levee and portions of the New Orleans Lakefront Levee located near the Lakefront Airport as the storm surge raised the water levels within the IHNC. Finally, the reverse (counterclockwise) swirl of the storm winds raised the levels along the south shore of Lake Pontchartrain. Portions of the levee system fronting Lake Pontchartrain, such as the New Orleans Lakefront, Citrus Lakefront, and New Orleans East Lakefront Levees, generally performed well in the hurricane, as did most of the New Orleans East Levee located to the east.

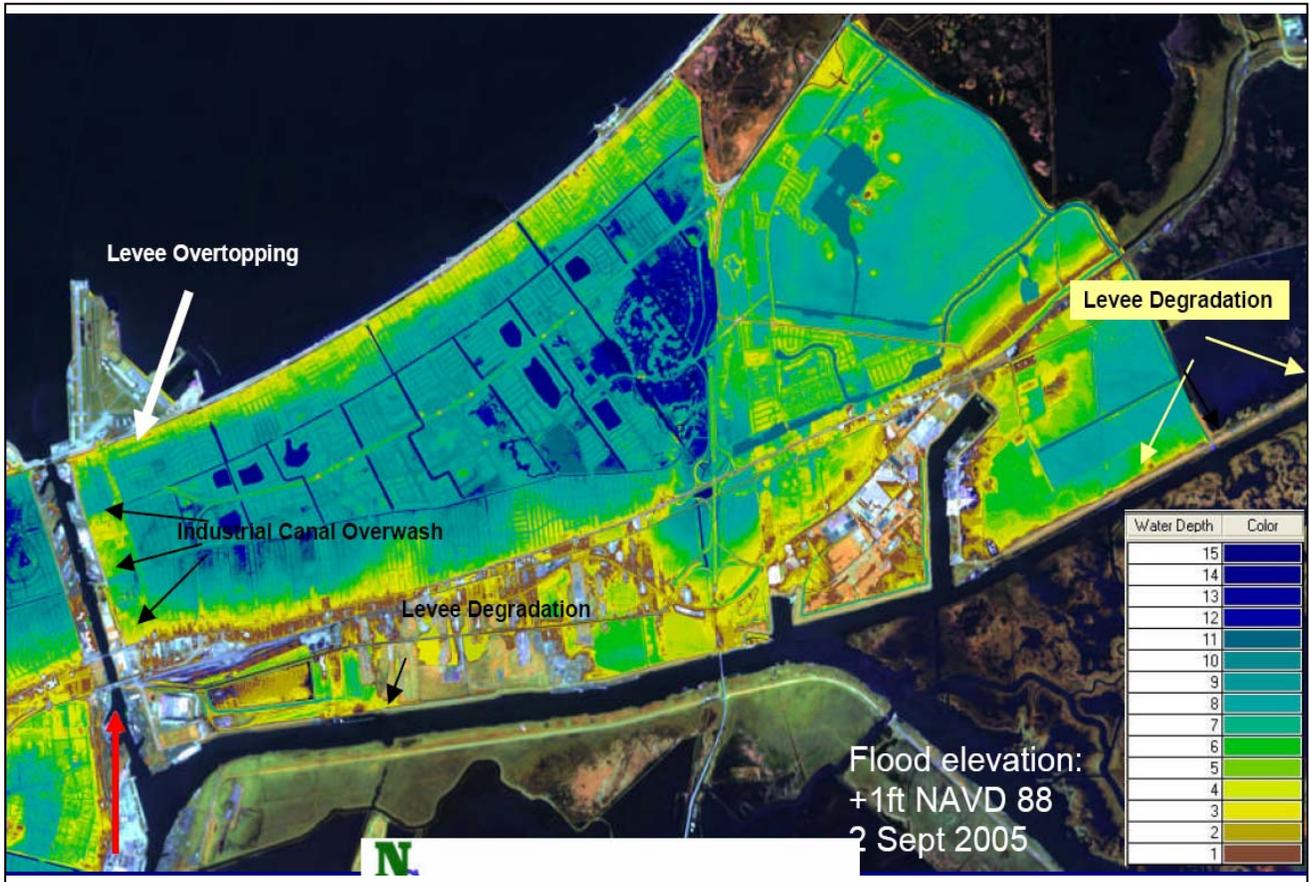
Figure 7.4: Depth of flooding of New Orleans East on September 2nd (4 days after Hurricane Katrina)

Figure 7.3 shows the depths of flooding on September 2, four days after hurricane Katrina, at a time when the water levels were at equilibrium with the still slightly swollen waters of Lake Pontchartrain (Elev. ~ +1 foot, MSL), and this map of flooding depths thus serves well to illustrate the distribution of ground elevations across this protected area. Elevations typically range from approximately +10 feet to -8 feet (MSL), with the higher elevation reaches located south of the Chef Menteur Highway. This Highway follows along a ridge of "high ground" known as the Bayou Sauvage ridge which is the result of an earlier river depositional channel (see Chapter 3), and this slight ridge serves to nearly separate the large northern section of the protected area from a smaller basin to the south. This separation was incomplete, however, as floodwaters managed to cross this ridge at a number of locations.

As the hurricane then passed northward to the east of New Orleans, the counterclockwise direction of the storm winds also produced a storm surge southward towards the shore of Lake Pontchartrain. The lake level rose, but largely stayed below the crests of most of the lakefront levees. The lake rose approximately to the tops of the lakefront levees at a number of locations, especially along the shoreline of New Orleans East, and there was modest overtopping (storm surge + wave splash-over) and some resulting erosion on the crests and inboard faces of some lakefront levee sections along the Lake frontage. However, there were no breaches in this area. Overtopping occurred over a section of floodwall near the west end of the New Orleans East protected area lakefront, where the floodwall was lower than the adjacent earthen levee sections. This, too, added to the flow into the New Orleans East protected area, which was now beginning to fill with water even as the original storm surges subsided. As shown in Figure 7.4, water depths ultimately approached 10 feet in area. Sadly, some of the deepest waters were in the NOE protected area's principal residential neighborhoods.

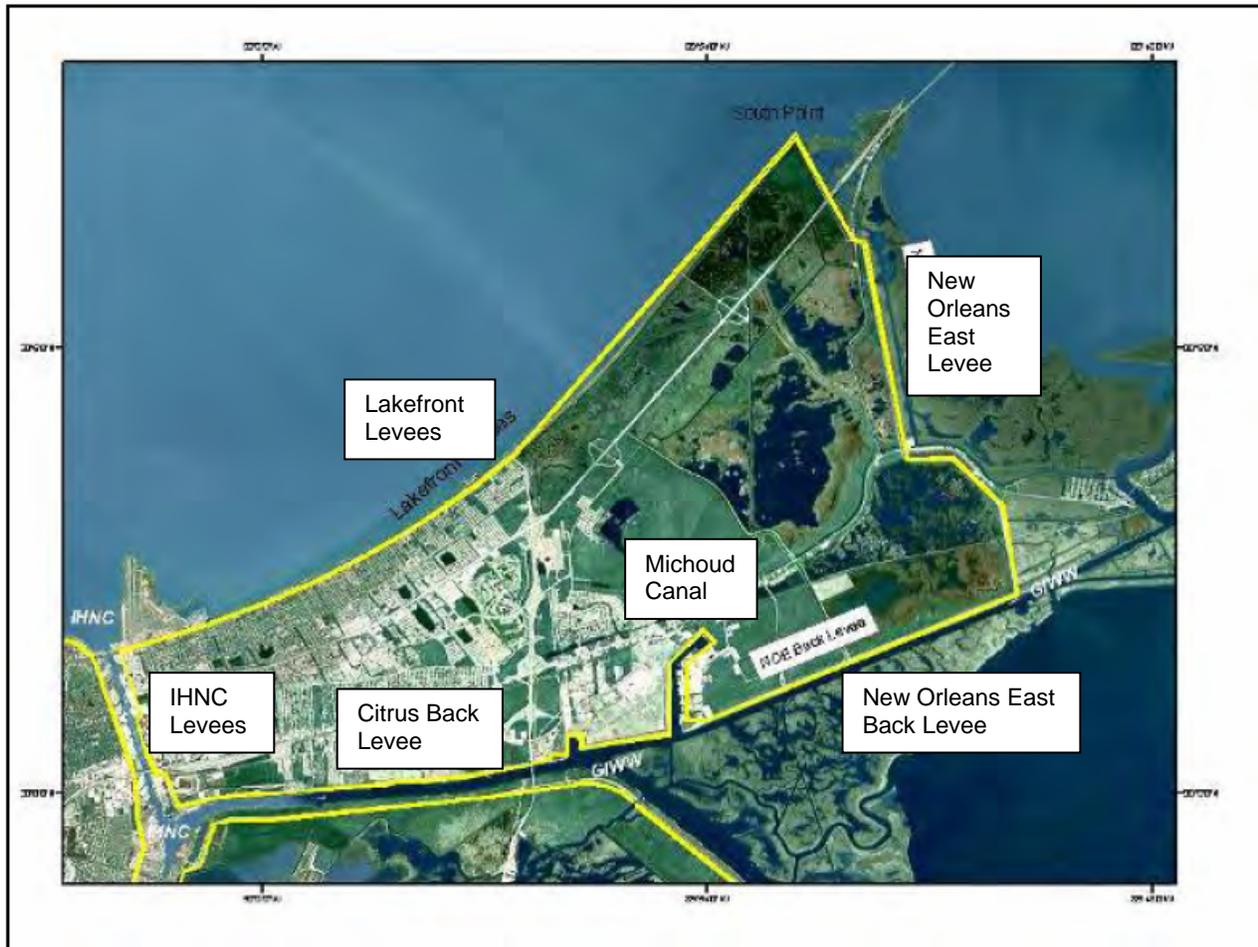
Figure 7.5: Principal sections of the New Orleans East perimeter defense levees; including the Lakefront Levees, the New Orleans East Levee, the New Orleans East Back Levee, the Michoud Canal, the Citrus Back Levee, and the IHNC Levees.

The following sections summarize damage to the individual frontages of the levee system (Figures 7.1 and 7.2). For consistency, locations are referred to using the designations assigned by the USACE Task Force Guardian levee system rebuilding team. These names associated with each of the main levee sections are shown in Figure 7.5.

As shown in Figure 7.5, the New Orleans East back levee extends from the southeast corner of the NOE protected area west along the GIWW waterway, and it fronts both the GIWW channel and Lake Borgne as well. As noted earlier, the most severe damage to the NOE Levee System occurred along an approximately 5,300 foot long section of the New Orleans East Back levee, which is situated in the southeast corner of the protected area (Figures 7.1 and 7.2). The protection system at this location consists of earthen levee sloped at 4 horizontal: 1 vertical with a 10-foot wide crown.

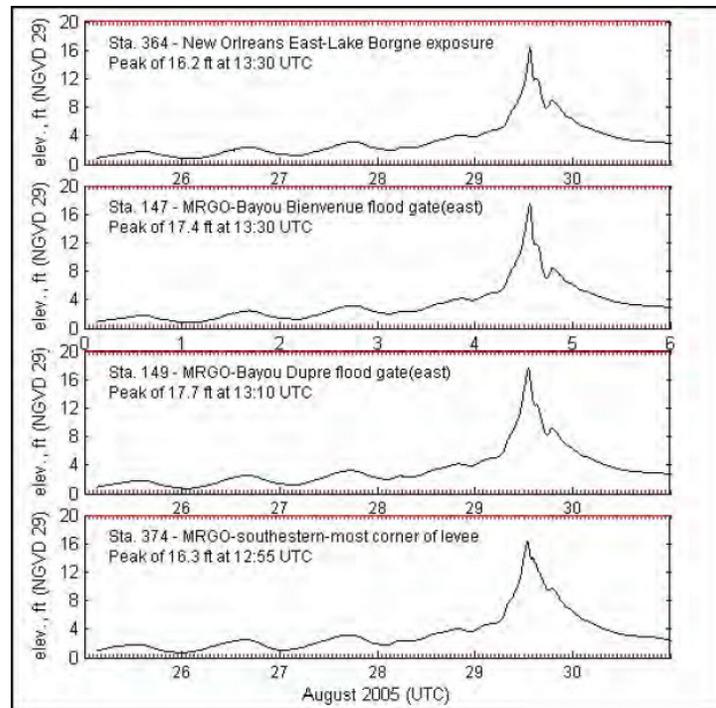
Figure 7.7: Approximate hydrograph of storm surge elevation (feet, MSL) vs. time at the west end of Lake Borgne. [IPET Interim Report; April, 2006]

Figure 7.7 shows hydrographs of calculated (modeled, back-calculated) water levels vs. time during and after hurricane Katrina’s passage, as calculated by IPET, for locations at and near the NOE back levee frontage. Similar calculations by Team Louisiana give similar results. The storm surge at the western end of Lake Borgne rose fairly slowly to Elev. +4 feet (MSL), then as the eye of the storm approached more closely it rose rapidly and peaked at about Elev. +16 to +18 at about 8:30 a.m.(CDT; local New Orleans time.) After peaking, the storm surge dropped rapidly at this location. [Many of the hydrographs in this report, and others, are based on GMT (Greenwich Mean Time), and so must be converted to CDT (local time). Similarly, the hydrographs of Figures 7.7 and 7.9 are based on the NGVD datum, and actual MSL elevations are approximately 1.7 feet lower. Some adjustment to elevations as shown are being inferred herein, as the calculated elevations of Figures 7.7 and 7.9 may be a bit low (on the order of about a foot or so) based on field observations and similar calculations by Team Louisiana.]

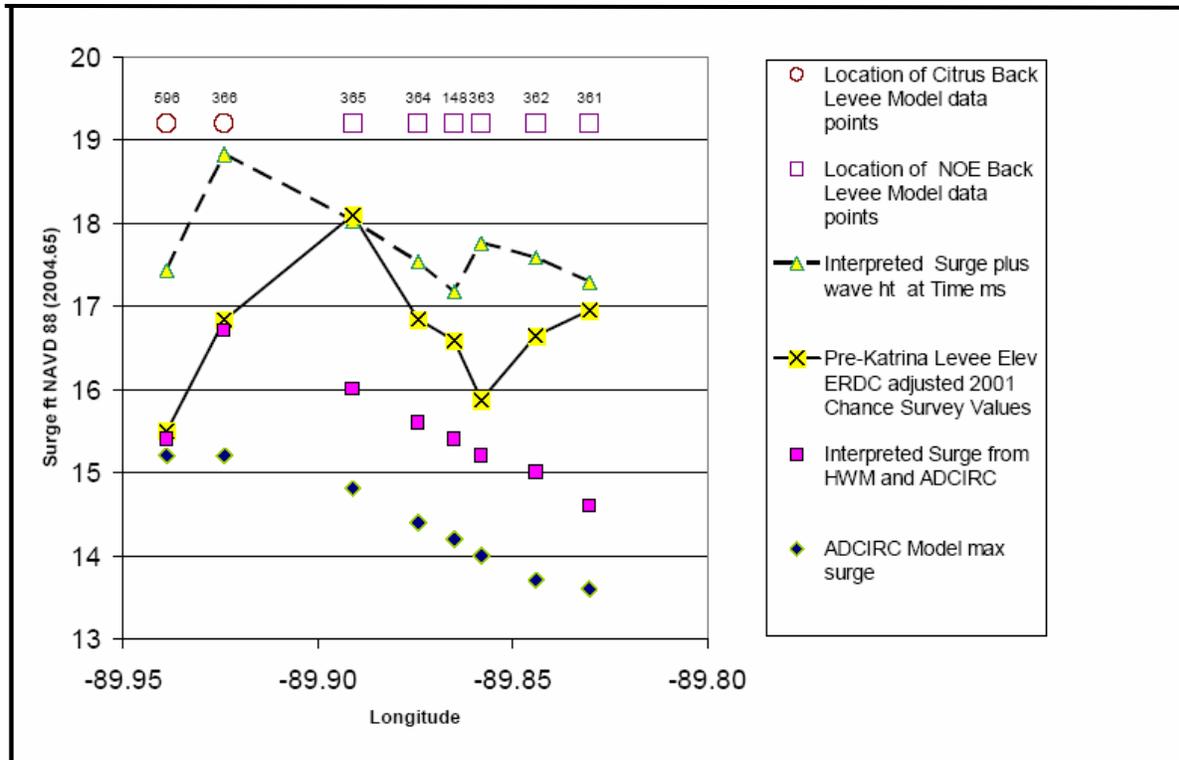
Figure 7.8: Pre-Katrina crest elevations, and various estimates of storm surge + wave height; New Orleans East back levee facing Lake Borgne [IPET; June 1, 2006]

Figure 7.8 shows calculated maximum storm surge (and also storm surge + wave) elevations, again based on IPET analyses, and also levee crest heights along this frontage. This figure shows that peak surge + waves might have overtopped this frontage at several locations at the eastern end, and at the far west end as the GIWW and MRGO “funnel” necks down to become the joint, east-west trending shared GIWW/MRGO channel.
