CHAPTER EIGHT: THE ORLEANS EAST BANK (DOWNTOWN) AND CANAL DISTRICT PROTECTED AREA

8.1 Overview

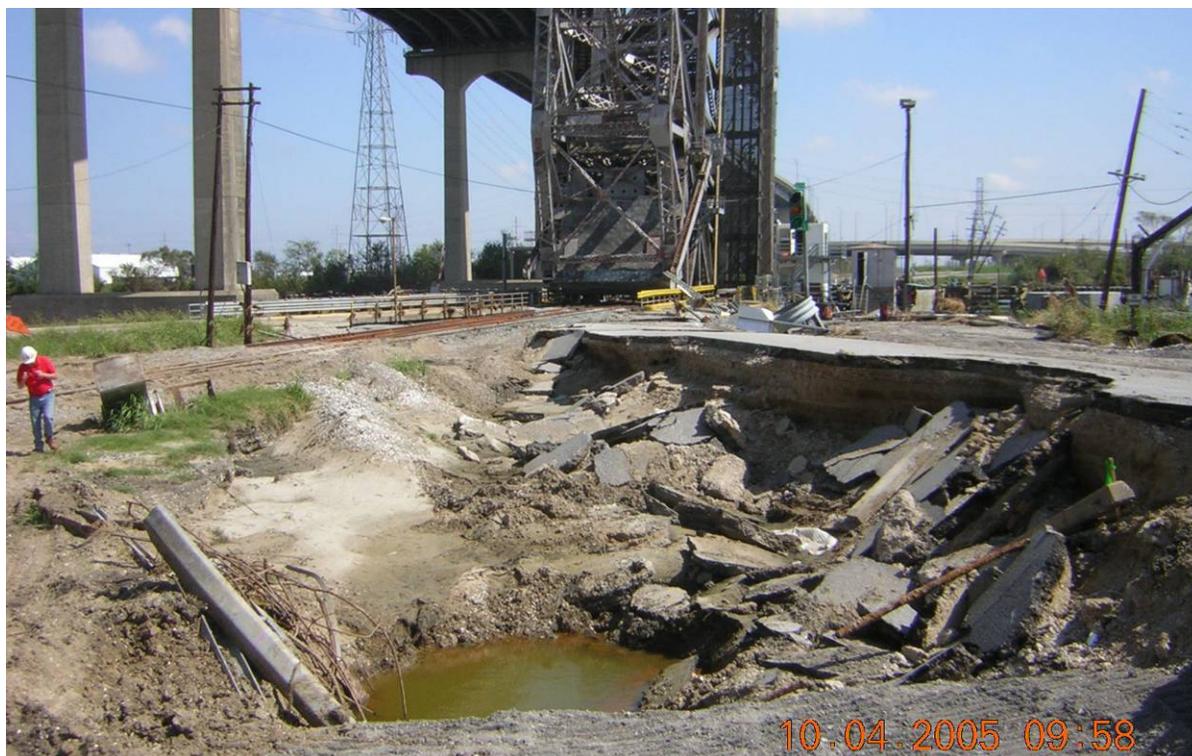
Figure 8.5: View from the inboard side of the CSX Railroad breach site from Figure 8.4 showing scour of the roadway fill adjacent to the railway embankment fill.

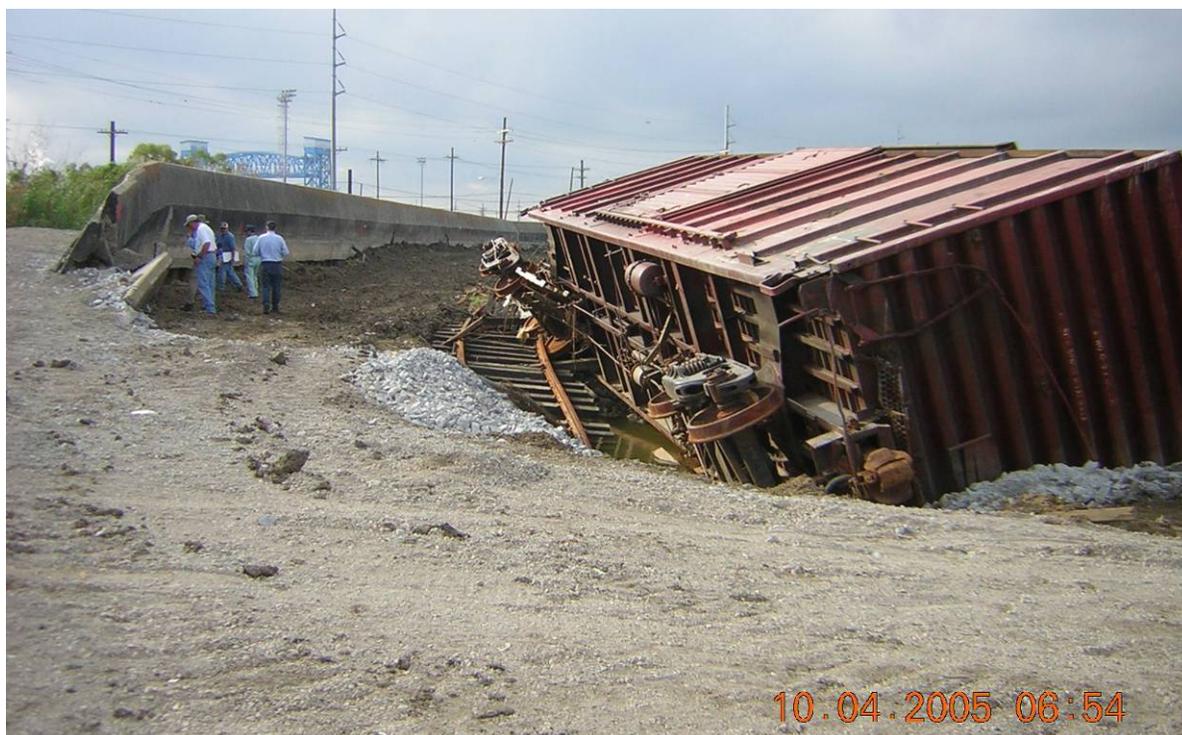
Figure 8.6: The I-wall section breach behind the Port of New Orleans, showing floodwall failure.

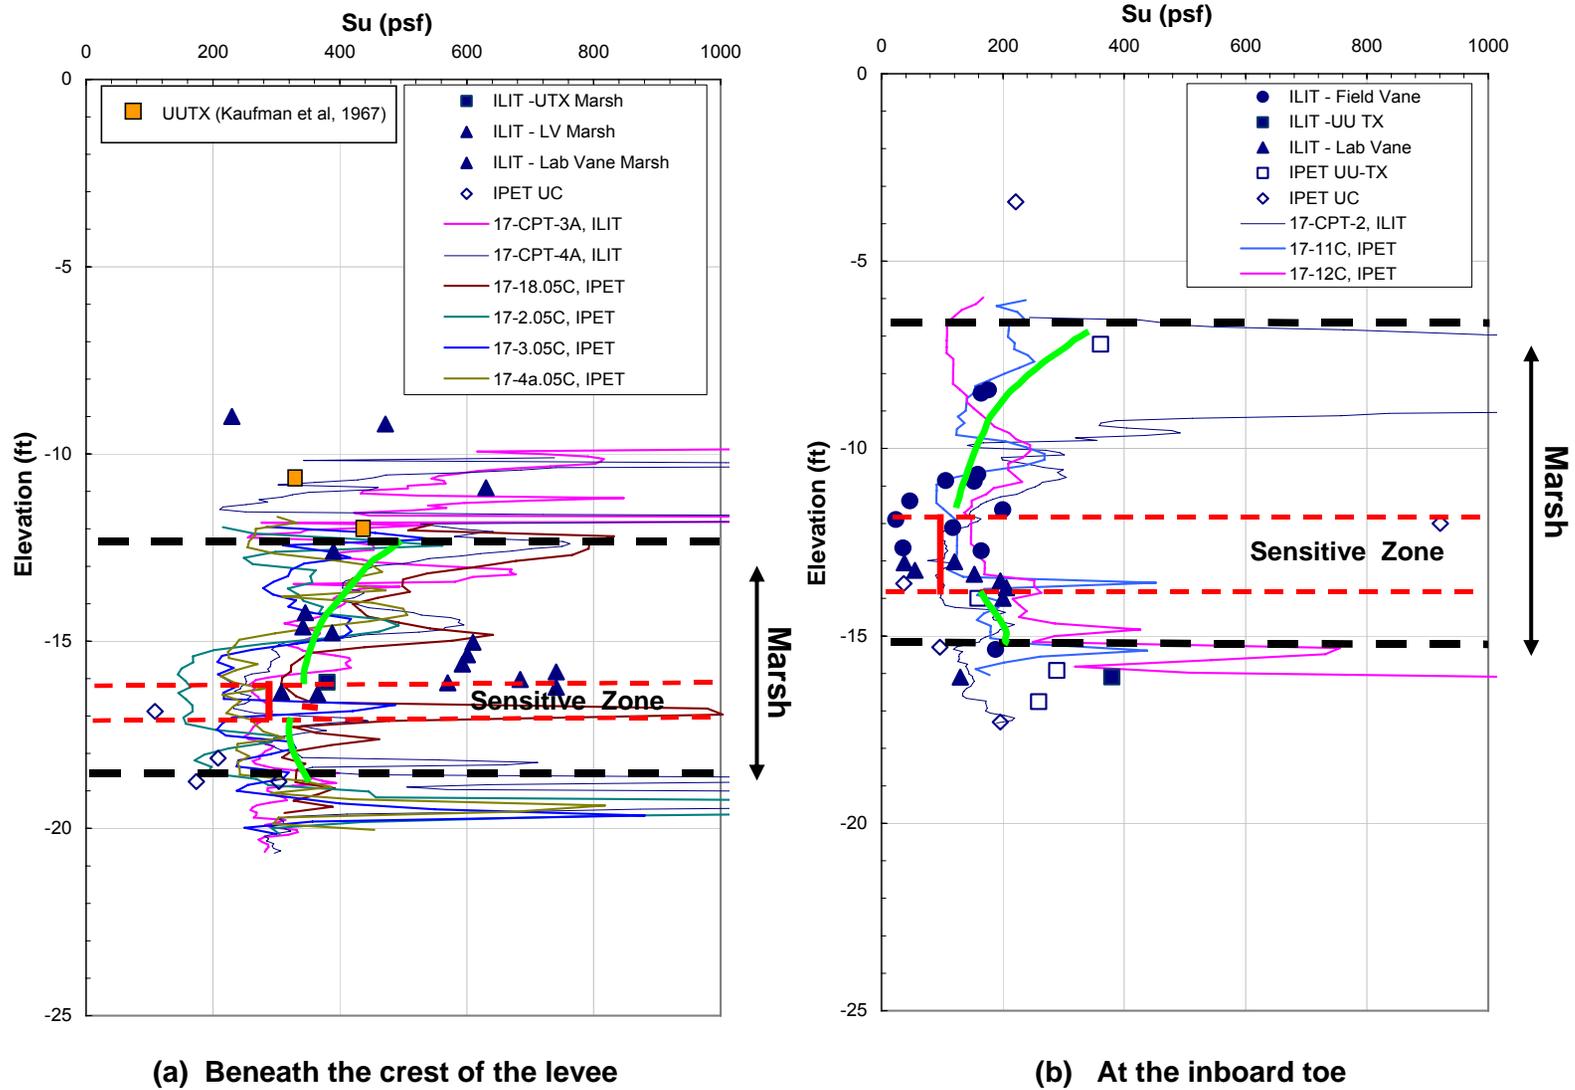
Figure 8.50 then shows the resulting interpretation, based on all available data, of strength vs. depth within this complex marsh unit for conditions (a) beneath the overburden of the central embankment, and (b) inboard of the toe of the levee. The green lines in this figure represent the final interpreted soil shear strength profiles at these two indicative locations. As with the soft clays, these strengths were, finally, further slightly reduced by multiplying them by a factor of 0.82 to develop the DSS-type strengths needed for the stability analyses performed in these studies.

The red zone near the center of the “marsh” deposits shown in Figure 8.50 is a thin layer of soft, highly sensitive organic silty clay that varies slightly in depth across the profile (and so is thinner than it appears in this figure.) This was the material in which the main lateral translational shear failure occurred at this site.

Figure 8.50: Shear strength vs. depth within the marsh deposits at the 17th Street Canal breach site (a) beneath the crest of the levee, and (b) at the inboard toe.

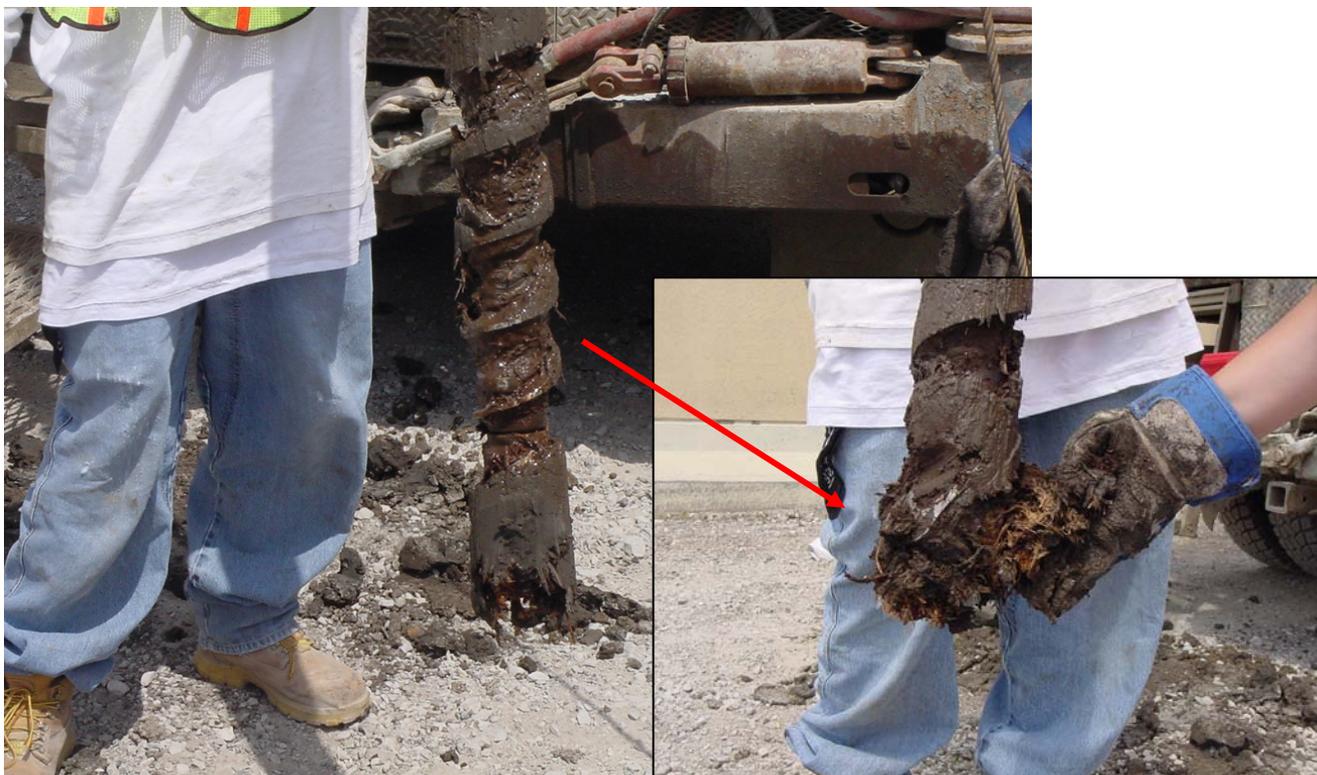
This layer is typically only one to several inches in thickness, but was found to be laterally continuous across essentially the full site (as well as at the distressed section on the opposite, west side of the canal.) It is exceedingly difficult to spot, and to sample, because it is closely overlain (and even partially mixed with) a layer of leaves and twigs and bark that is typically also one to several inches in thickness, as illustrated on the auger stem in Figure 8.51. The very dark, shiny material also coating the auger stem in this photo is the sensitive organic silty clay and indicates that we have just drilled through the layer in question (and so now have to move our hole laterally a few feet and re-drill to attempt to sample it.)

Figure 8.51: Shiny dark brown to black sensitive organic clay on auger stem and (inset) closeup view of leaves and twigs; 17th Street Canal breach site.

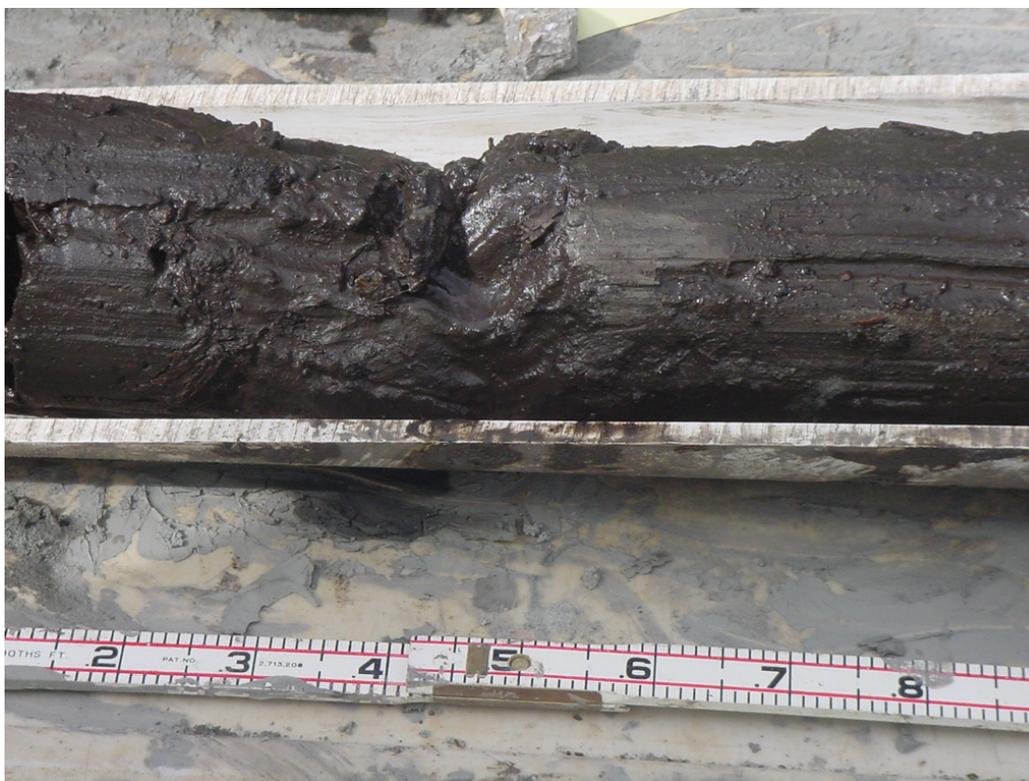
Figure 8.52: Shear zone within disturbed area, middle of 17th Street Canal breach, adjacent to displaced block at Elev. -9 feet (MSL).

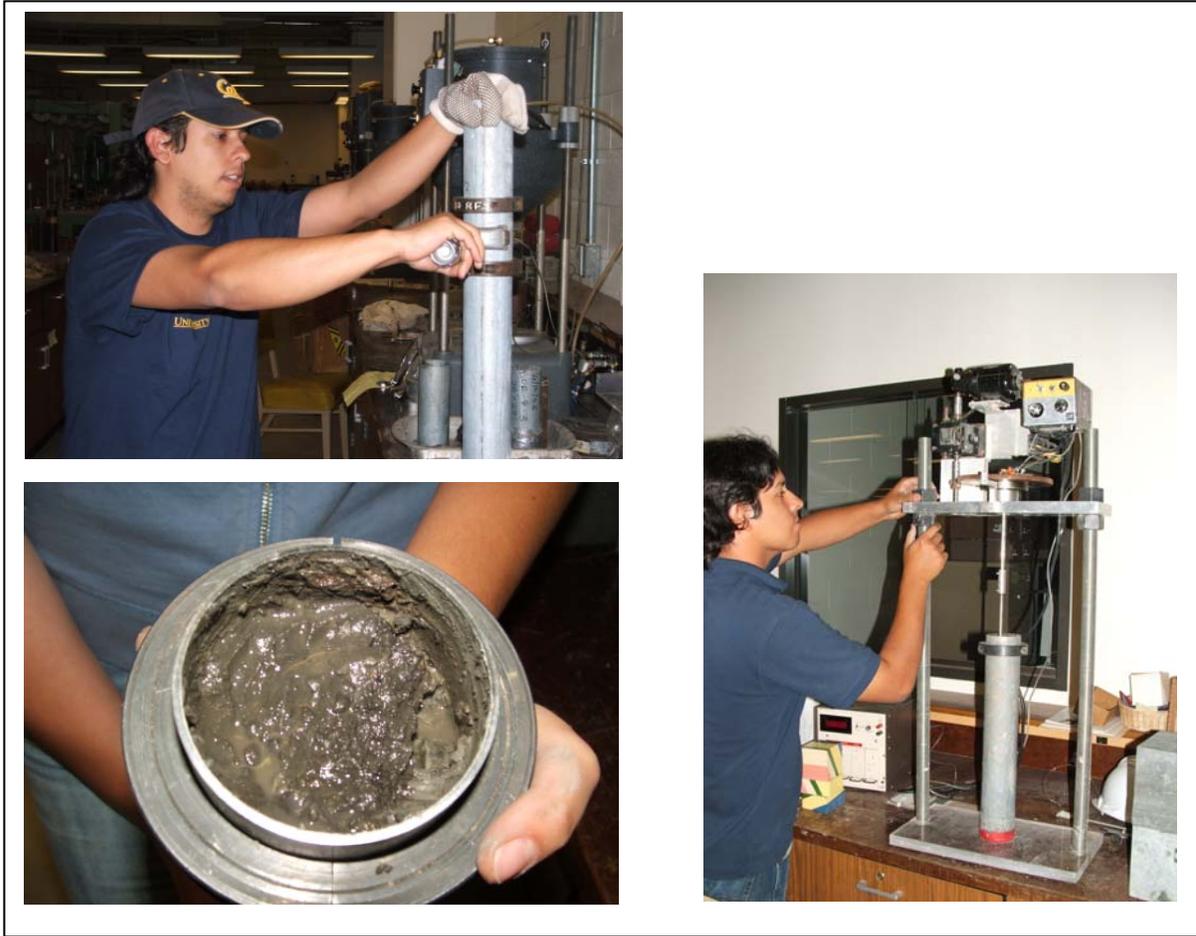
Figure 8.55: Laboratory vane shear testing of the thin layer of sensitive organic silty clay.

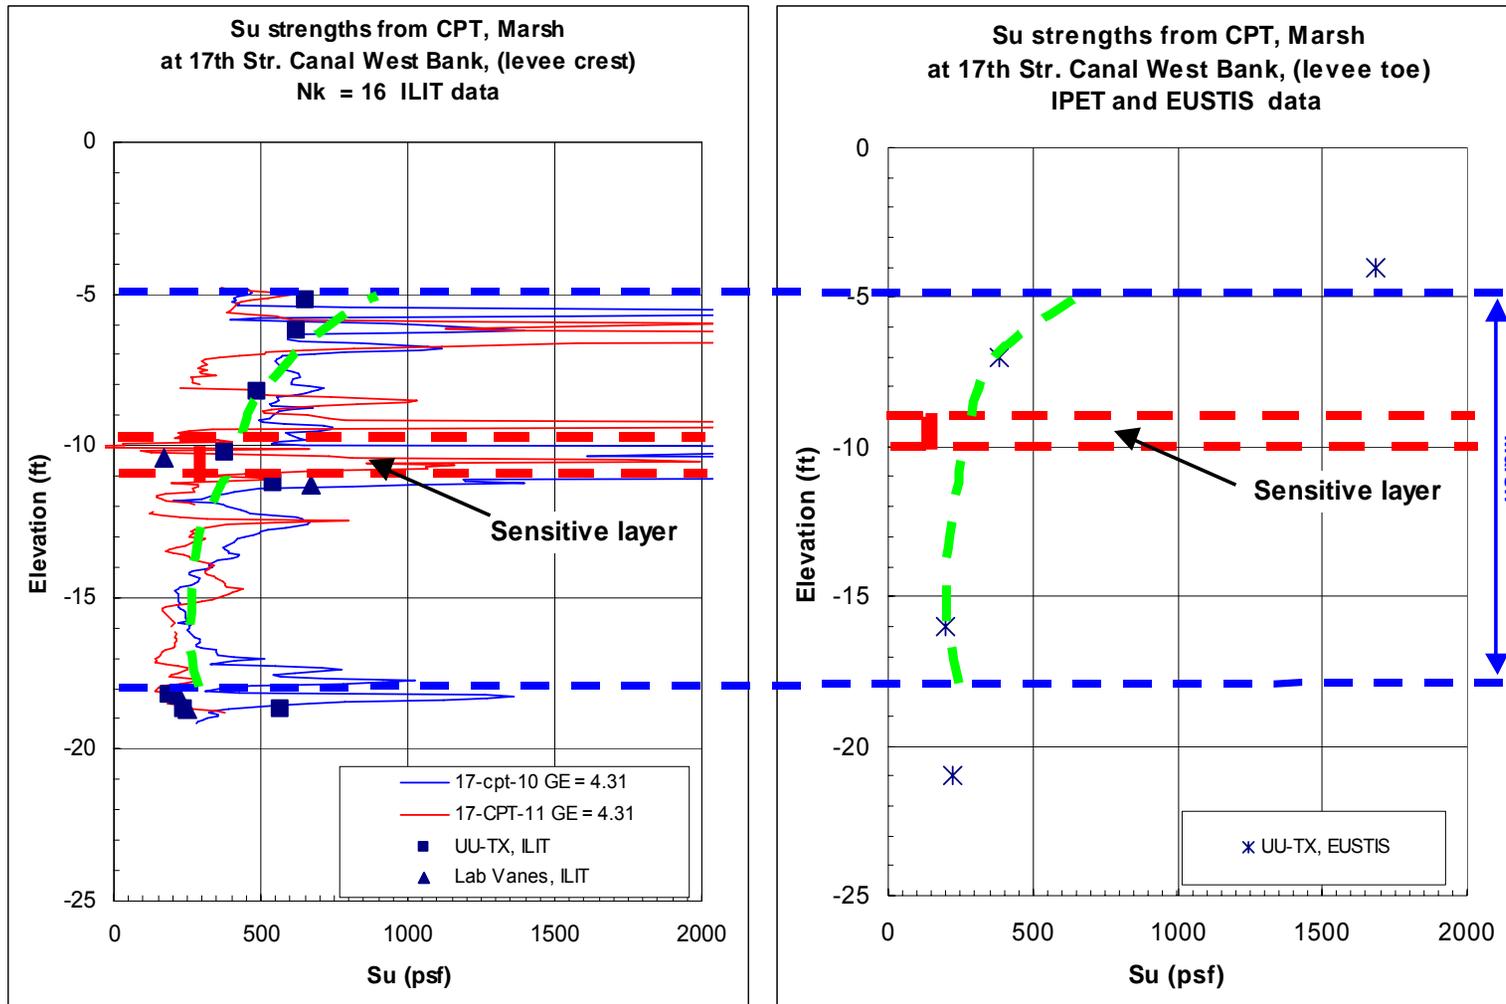
Figure 8.83 presents the resulting overall profiles of strength vs. depth within the marsh deposits (a) beneath the crest, and (b) at the toe, along with all available data (including CPT tip resistances interpreted using $N_{kt} = 16$). The thin layer of sensitive organic silty clay was encountered in one boring, again at the approximate mid-point in the “marsh” deposits, and again closely overlain by leaves and twigs. This sample is shown in Figure 8.76. Strengths for this thin layer were based on S_u/P values from the east bank deposit. This thin layer was not critical at this west bank site, as the sheetpiles penetrated well below this sensitive layer and so forced a deeper, more rotational failure through the soft gray clays to be the most critical mode.

Figure 8.83: Shear strength vs. depth within the marsh deposits at the site on the west side of the 17th Street Canal (a) beneath the crest of the levee, and (b) beneath the inboard toe of the embankment.

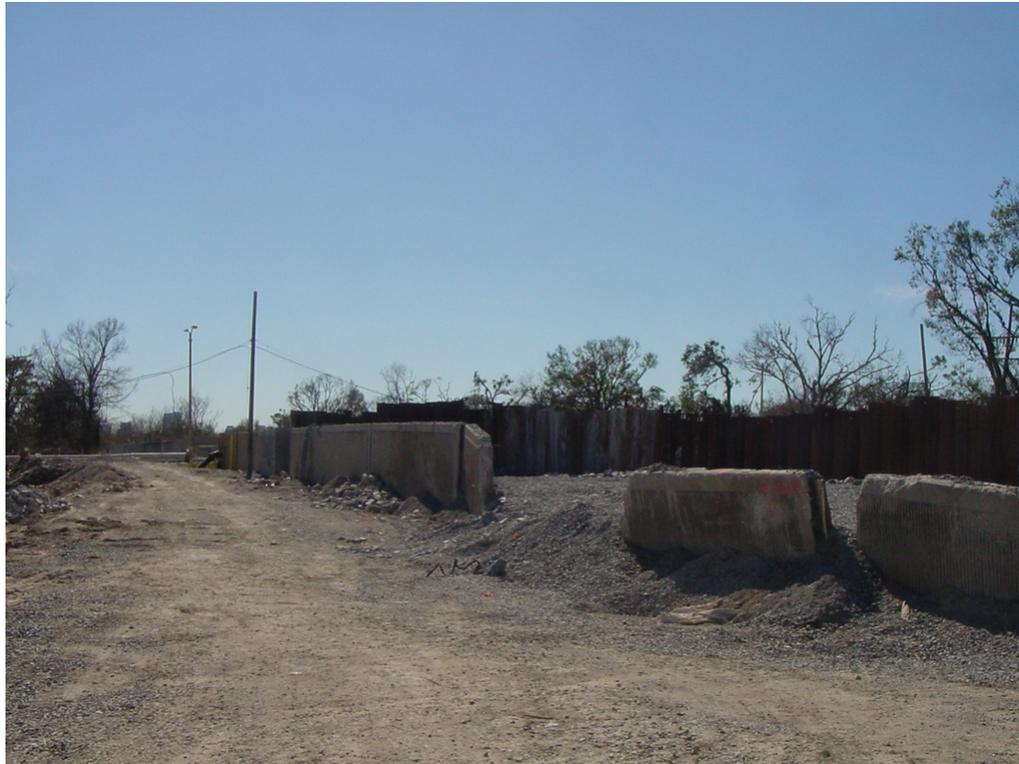
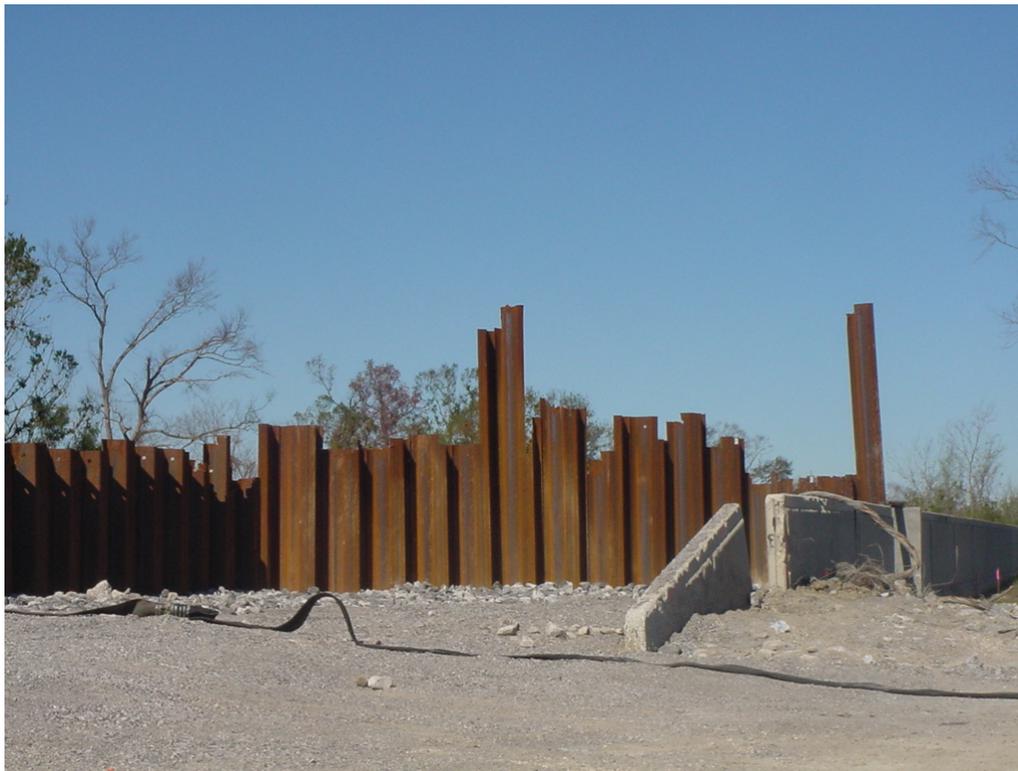
Figures 8.91 and 8.92 show the floodwall sections at the south and north ends of the breach, respectively. In these photos it can be seen that these wall sections have not displaced (translated) laterally towards the inboard (“protected”) side; instead they have simply “dropped” into the hole eroded by the scour of the breach flow.

Figures 8.91 and 8.92: Views of floodwall panels “dropping” into the eroded void at the north and south ends of the south London Avenue canal breach.

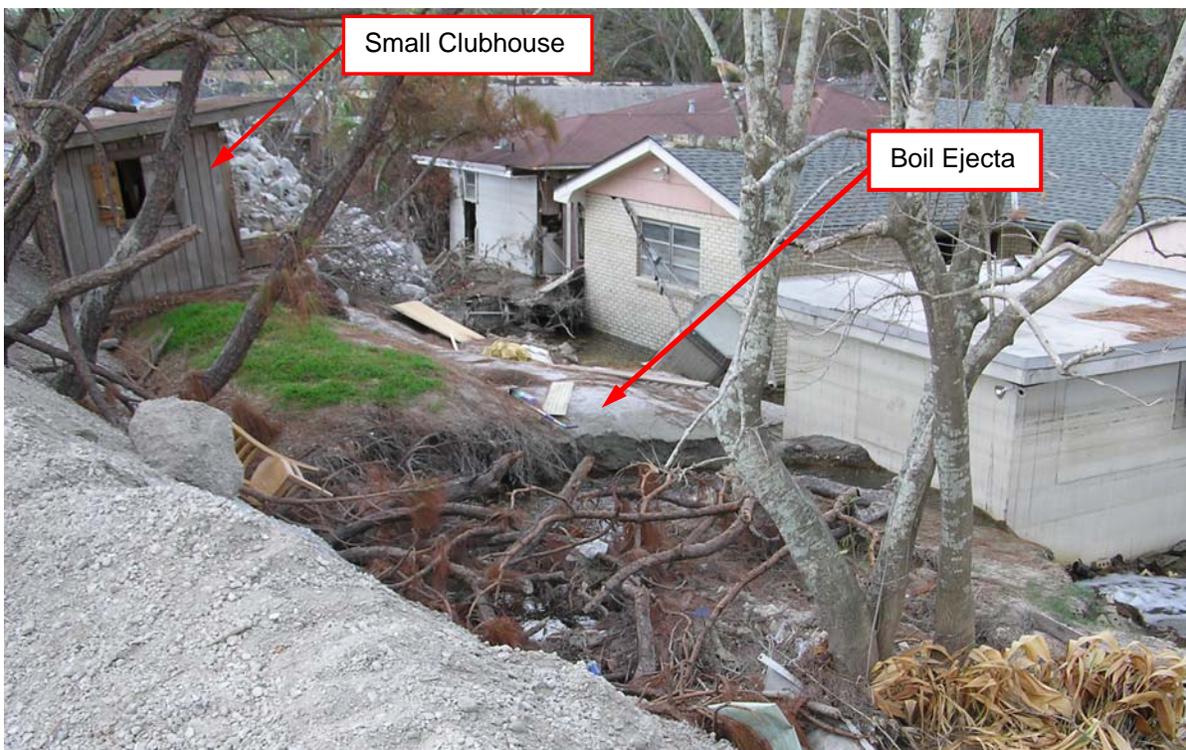
Figure 8.113: View of the inboard of the displaced embankment on the west side of the London Avenue canal showing heaving at the toe (and beneath the small wooden clubhouse), and the boil ejecta in front of the heave feature.

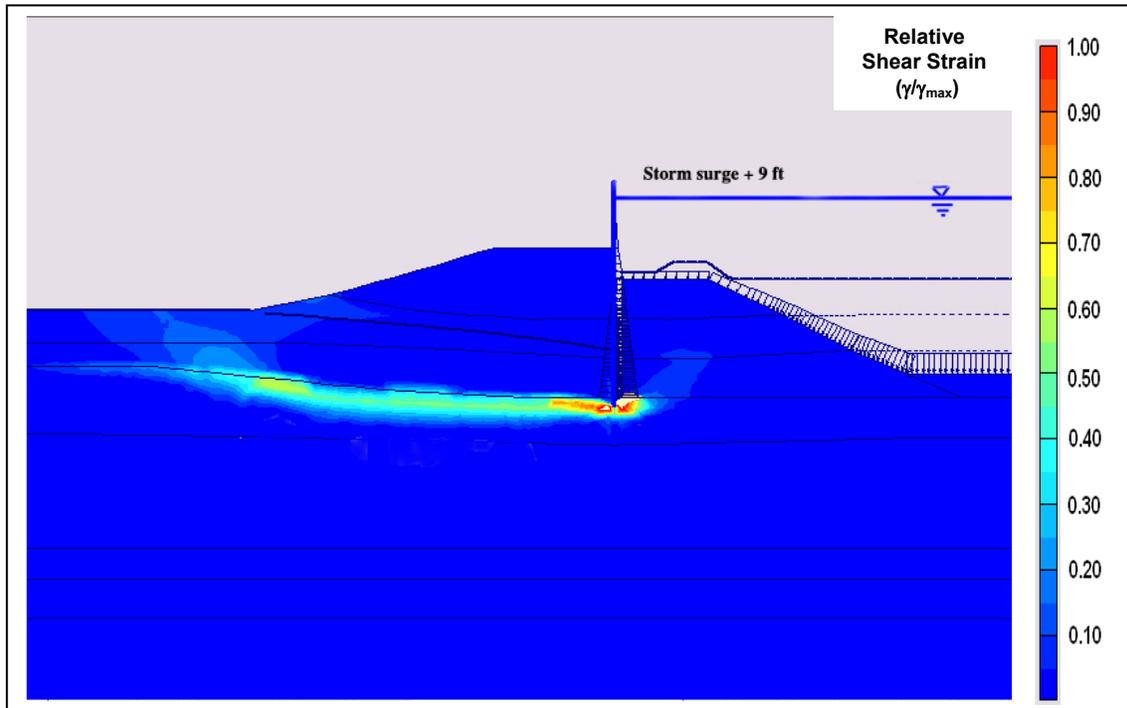
Figure 8.132 shows normalized shear strain contours for the west bank (breach) section at a storm surge level of Elev. +9 feet (MSL). Gapping initiated at the outboard side of the floodwall and its supporting sheetpile curtain initiated in this analysis at a canal surge elevation of between +7 to +8 feet (MSL), and was fully developed by a surge elevation of +9 feet, as shown in this figure.

Figure 8.132: Normalized shear strain contours (shear strain divided by strain to failure) for a storm surge at Elev. + 9 feet (MSL) at the London Avenue Canal breach site (west bank); gapping at outboard toe of floodwall is developed to full depth.

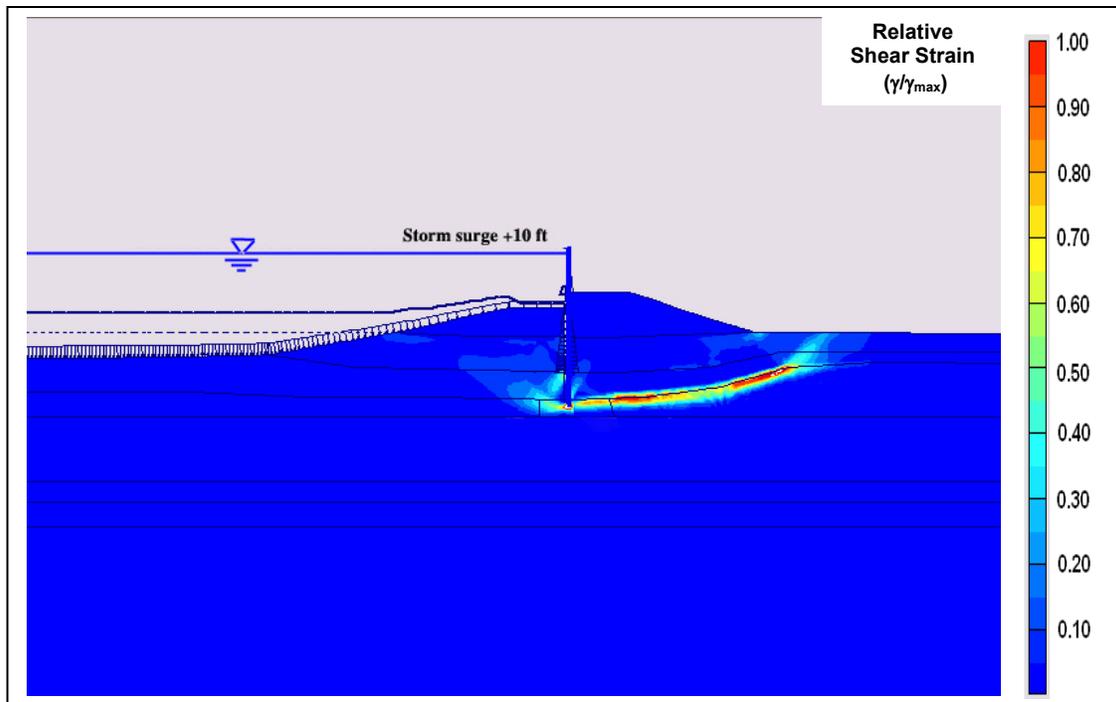
Figure 8.133 shows normalized shear strain contours for the east bank (distressed) section, this time for a slightly higher surge to elevation +10 feet (MSL). This the upper bound estimate of the surge elevations achieved during Katrina. Gapping developed in this east bank section at a surge elevation of between +7 to +8 feet, and was fully developed by a surge elevation of +9.5 feet (MSL).

Figure 8.133: Normalized shear strain contours (shear strain divided by strain to failure) for a storm surge at Elev. + 10 feet (MSL) at the London Avenue Canal distressed site (east bank); gapping at outboard toe of floodwall is developed.

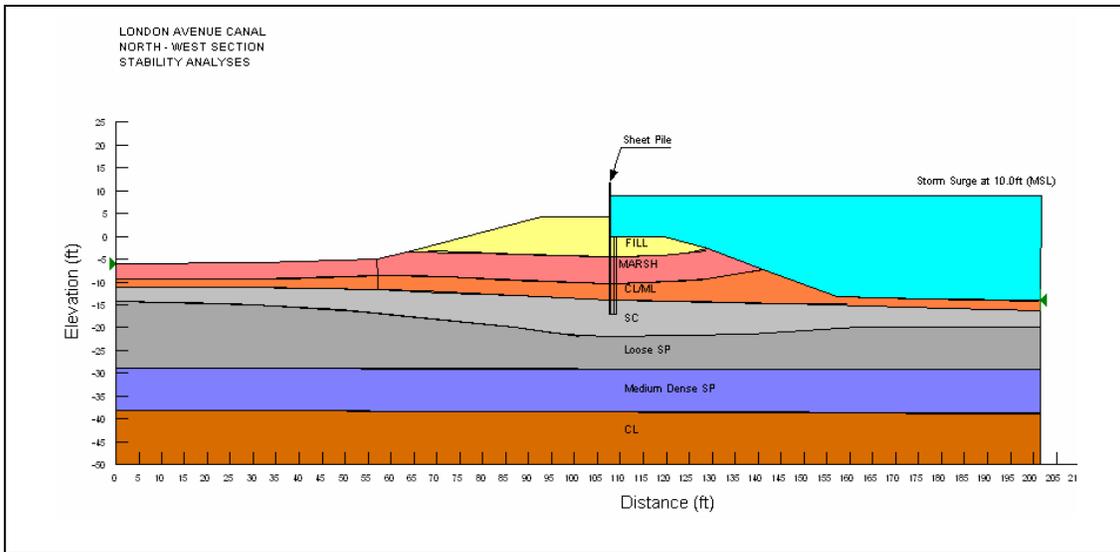
Figure 8.137: Geometry and input parameters for Limit Equilibrium and Steady State seepage analyses for London Avenue Canal North, West bank.

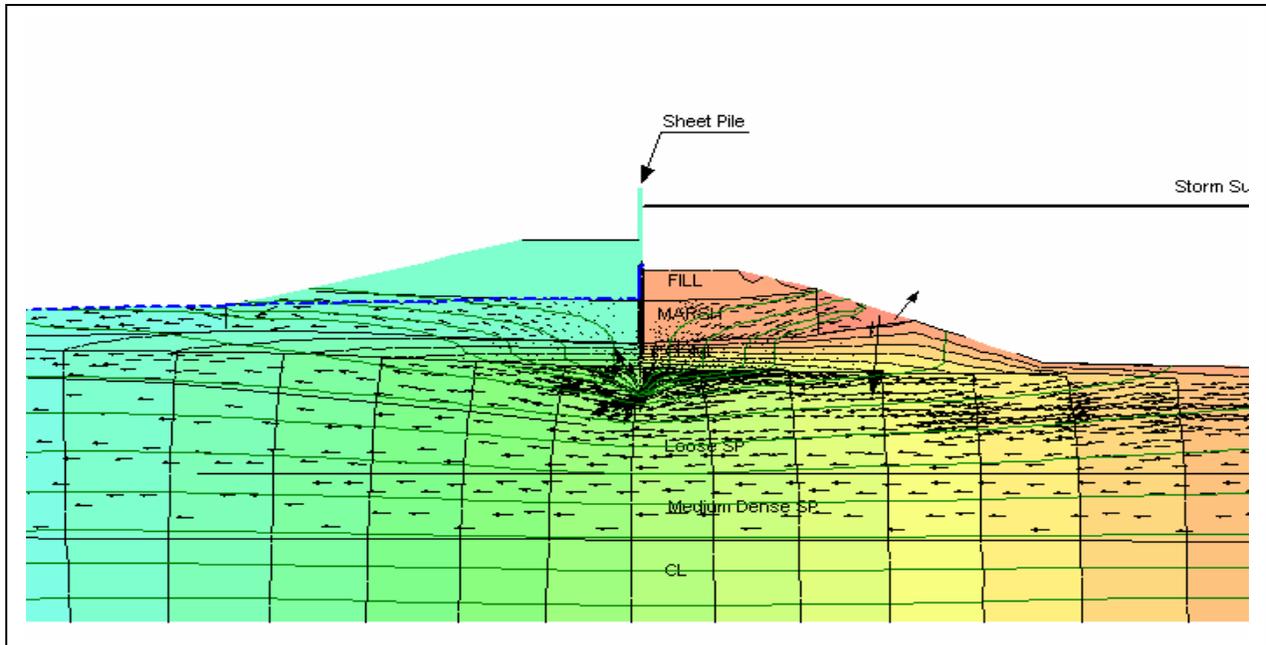
Figure 8.139: Flow net generation without the gapping in the outboard toe of the floodwall, London Avenue Canal North, West bank. Storm surge at 9ft (MSL).

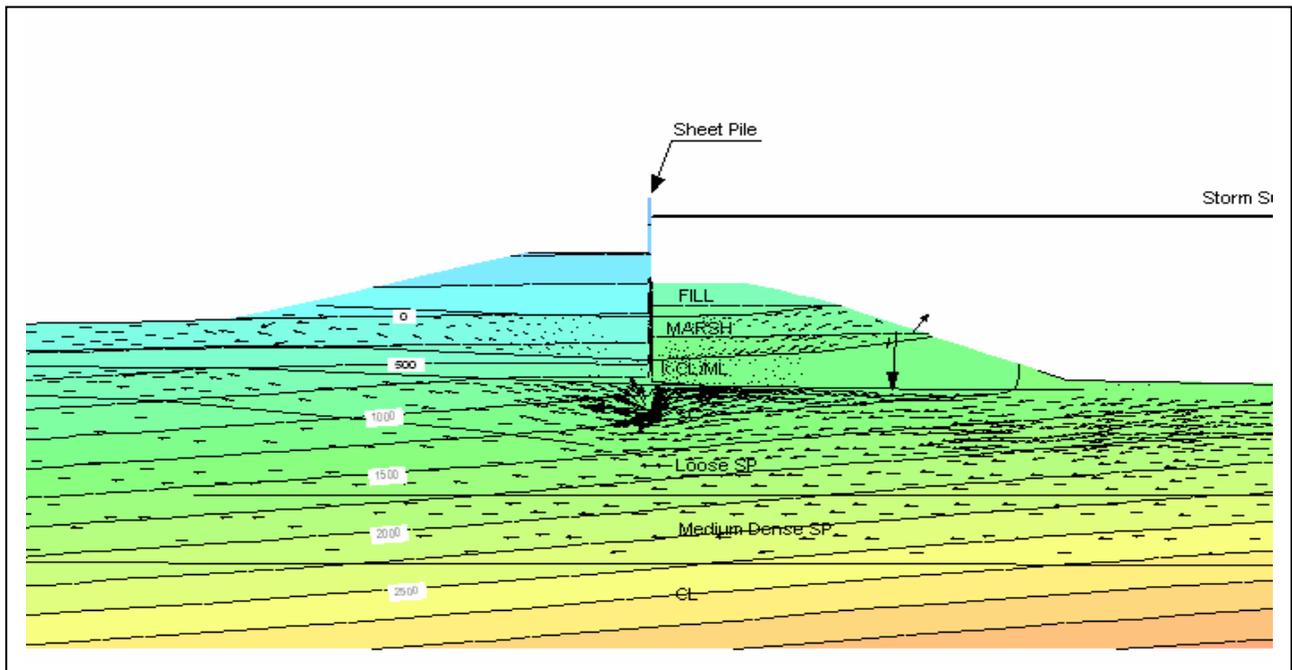
Figure 8.140: Pore water pressure contours without the gapping in the outboard toe of the floodwall, London Avenue Canal North, West bank. Storm surge at 9ft (MSL).

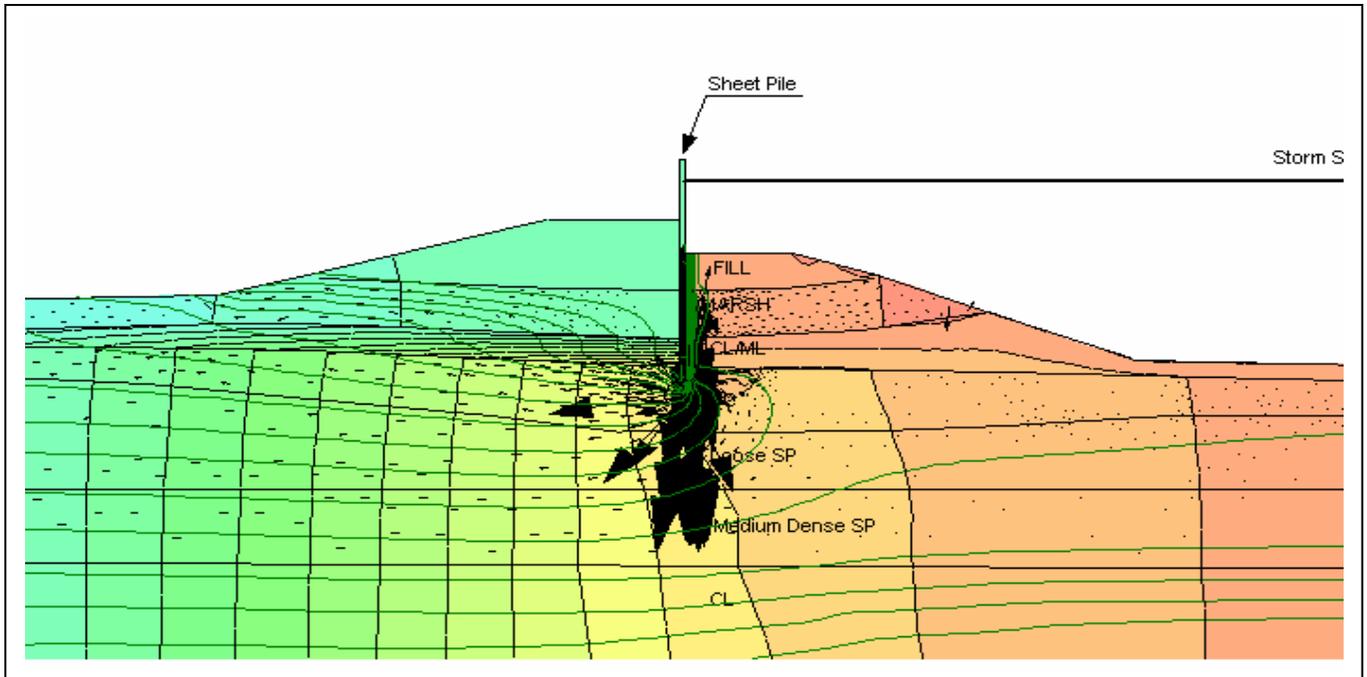
Figure 8.143: Flow net generation with the gapping in the outboard toe of the floodwall, London Avenue Canal North, West bank. Storm surge at 9ft (MSL).

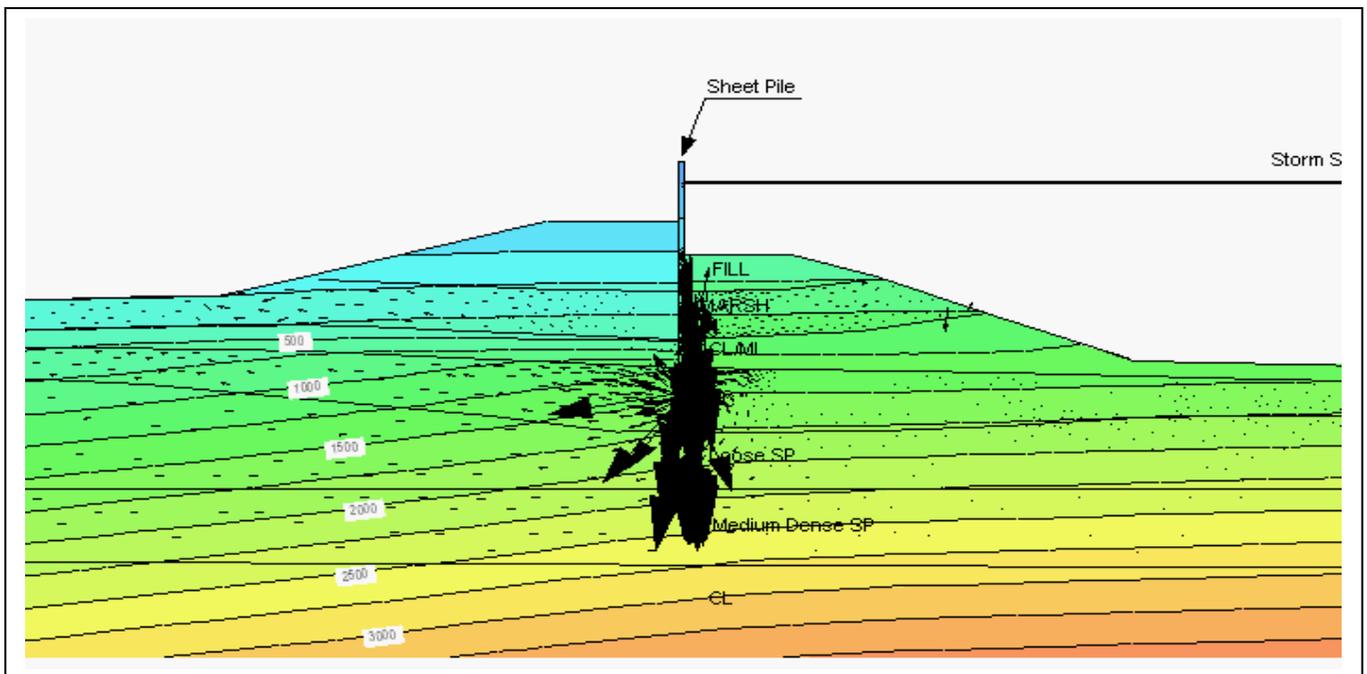
Figure 8.144: Pore water pressure contours with the gapping in the outboard toe of the floodwall, London Avenue Canal North, West bank. Storm surge at 9ft (MSL).

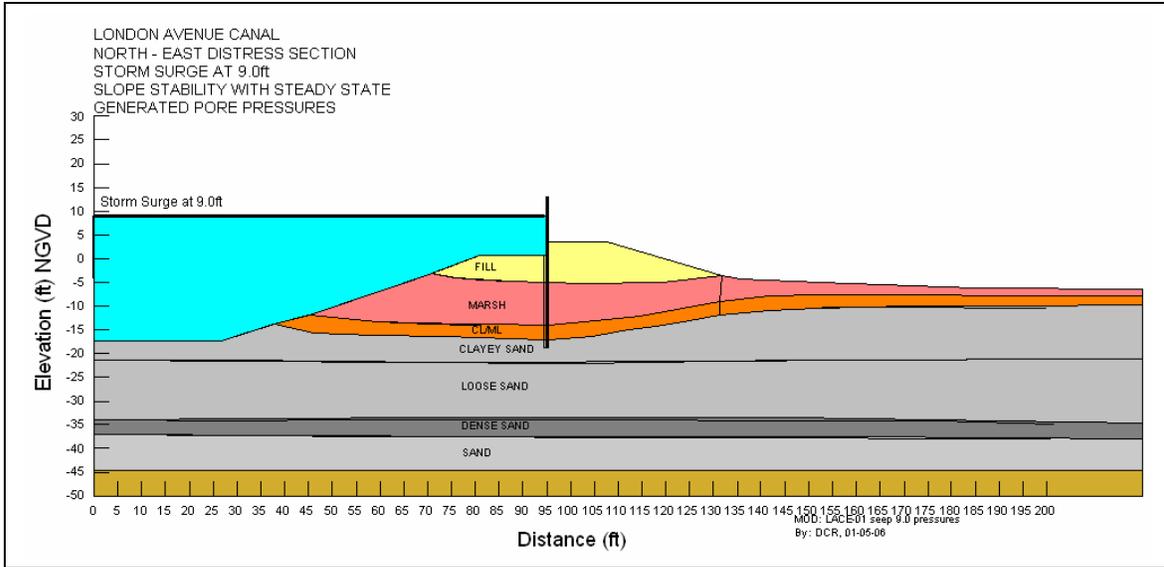
Figure 8.148: Geometry and input parameters for Limit Equilibrium and Steady State seepage Analyses for London Avenue Canal North, East bank.

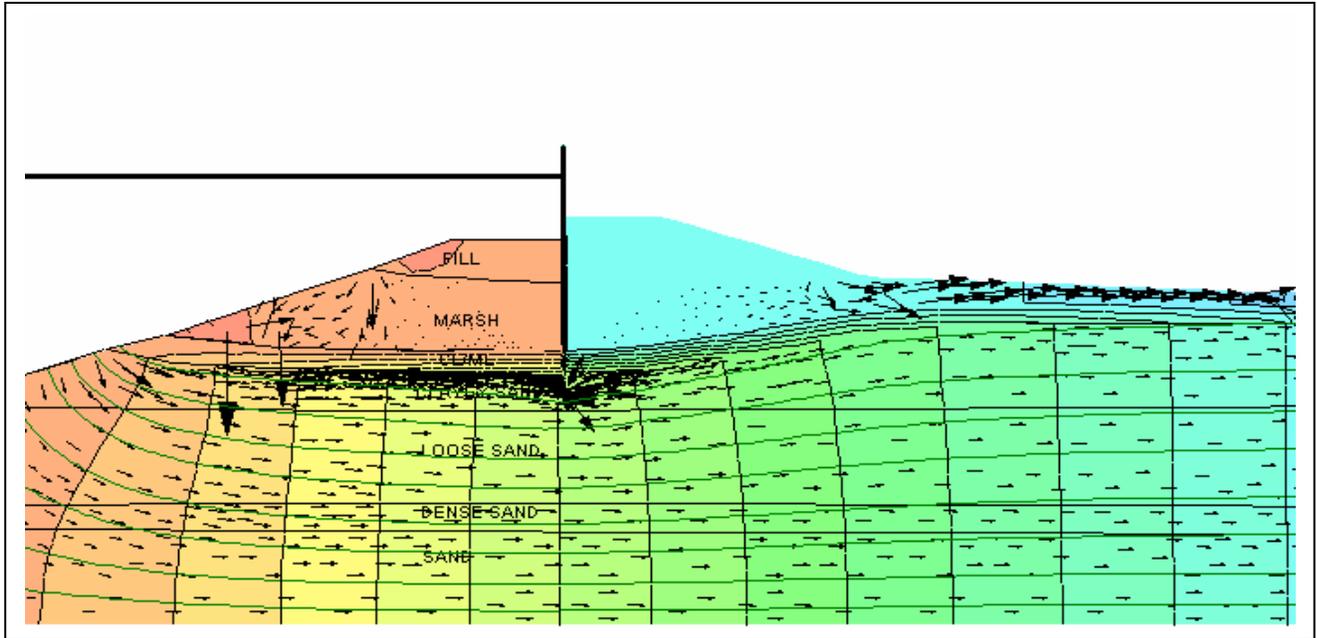
Figure 8.150: Flow net generation without the gapping in the outboard toe of the floodwall, London Avenue Canal North, East bank. Storm surge at 9ft (MSL).

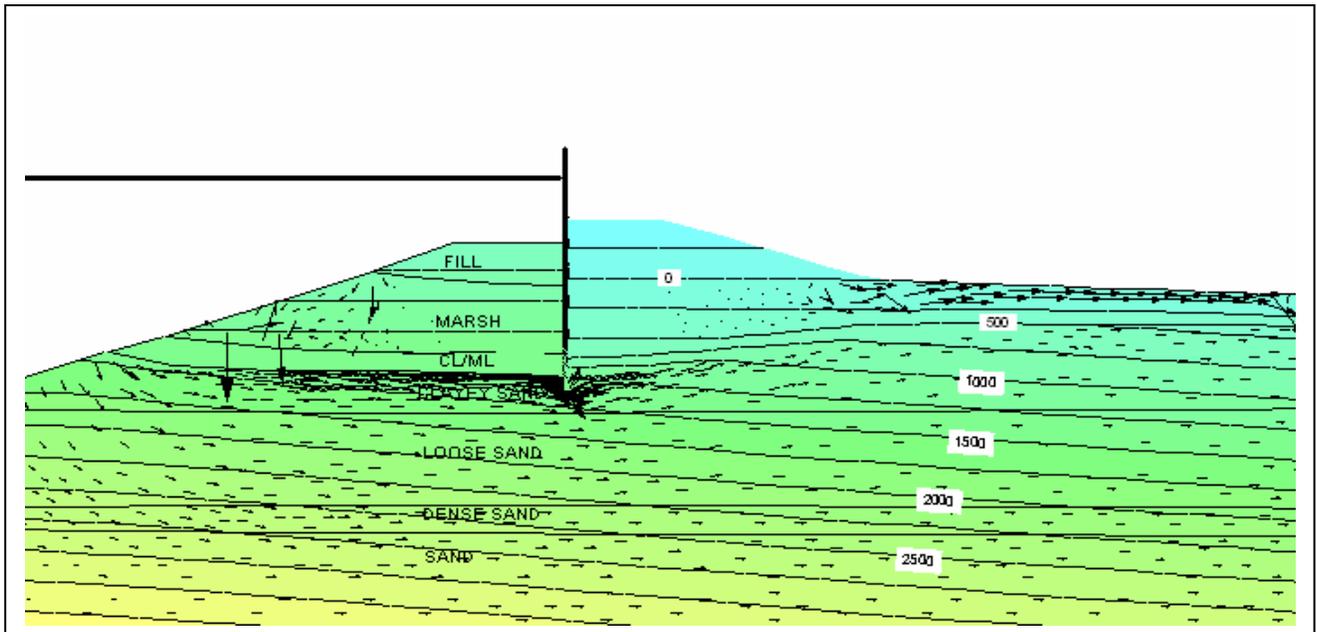
Figure 8.151: Pore water pressure contours without the gapping in the outboard toe of the floodwall, London Avenue Canal North, East bank. Storm surge at 9ft (MSL).

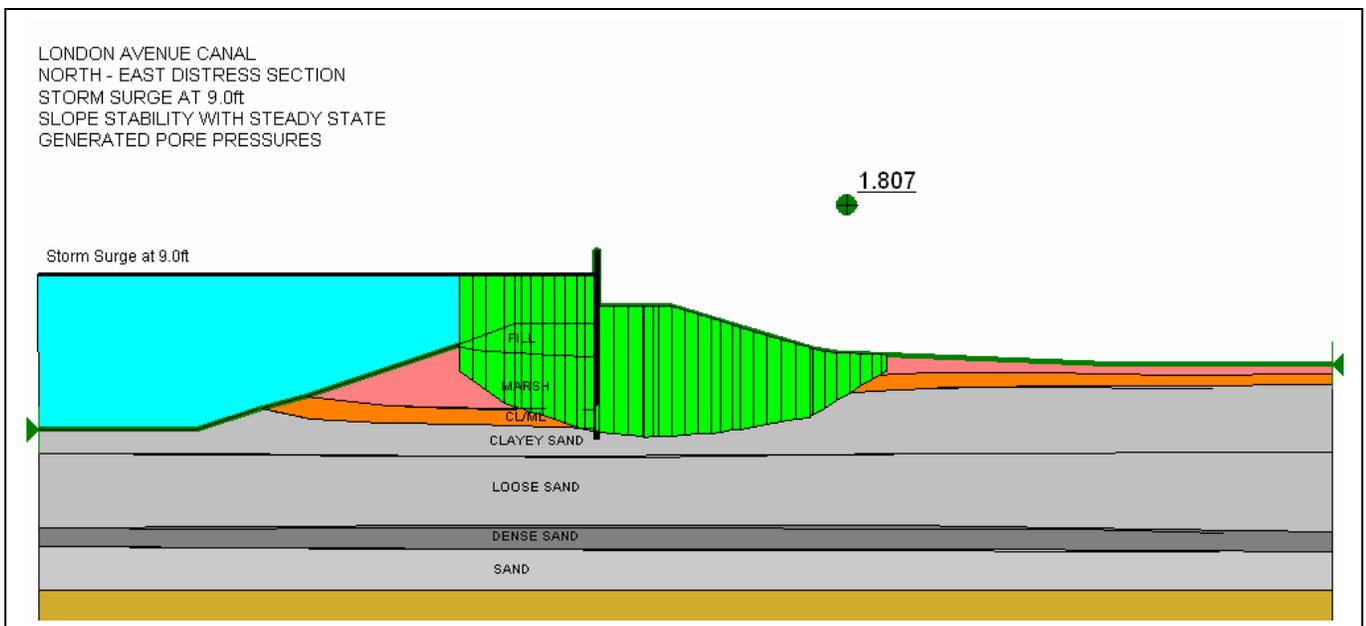
Figures 8.142 and 8.146 show the most critical failure surfaces on the west bank (breach) side for a surge elevation of +9 feet (MSL), with and without gapping respectively. Figures 8.153 and 8.157 show the same two cases for the east bank (distressed) side, again for a surge height of +9 feet (MSL).

Figure 8.153: Critical failure surface without the gapping in the outboard toe of the floodwall, London Avenue Canal North, East bank. Storm surge at 9ft (MSL).

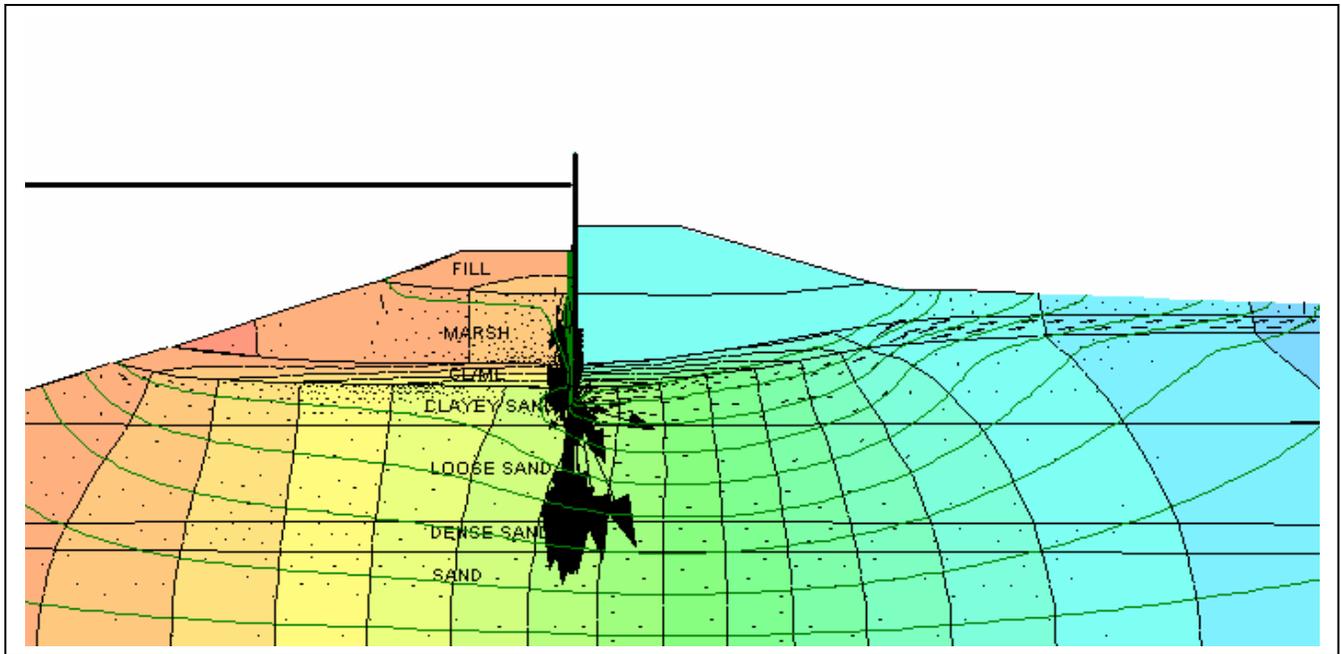
Figure 8.154: Flow net generation with the gapping in the outboard toe of the floodwall, London Avenue Canal North, East bank. Storm surge at 9ft (MSL).

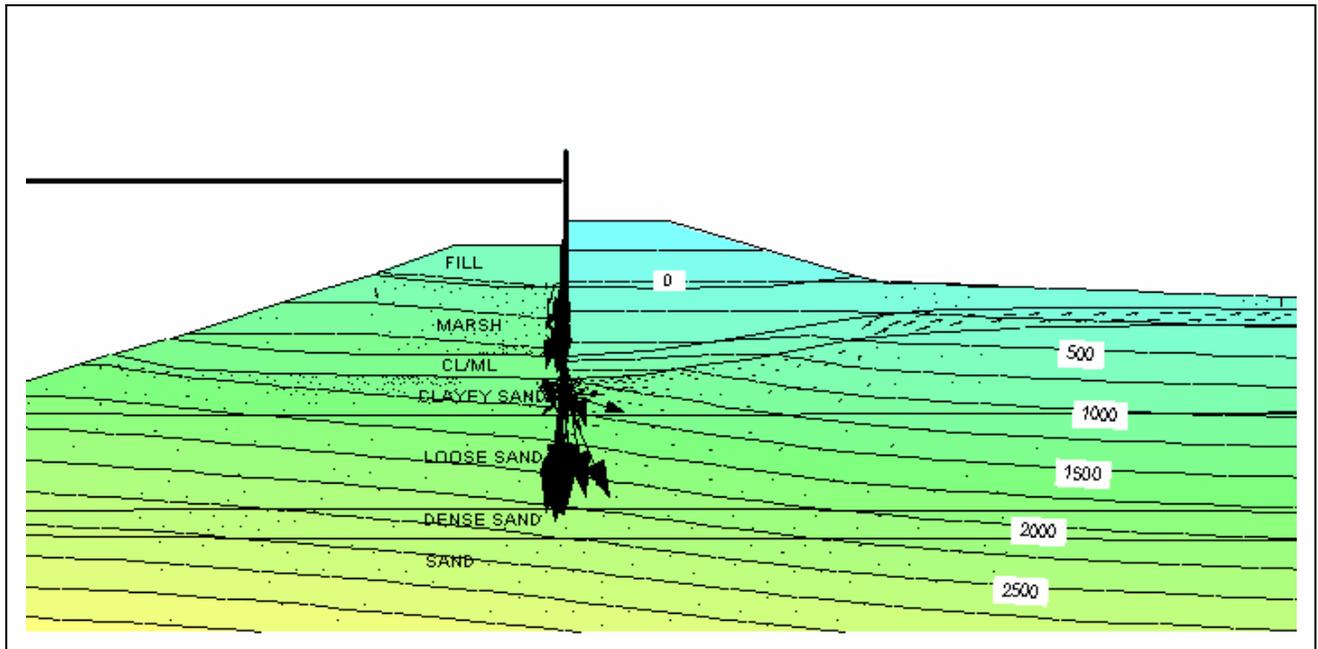
Figure 8.155: Pore water pressure contours with the gapping in the outboard toe of the floodwall, London Avenue Canal North, East bank. Storm surge at 9ft (MSL).
