# Investigation of the Performance of the New Orleans Flood Protection Systems in Hurricane Katrina on August 29, 2005

## Volume I: Main Text and Executive Summary

**Final Report**  
**July 31, 2006**

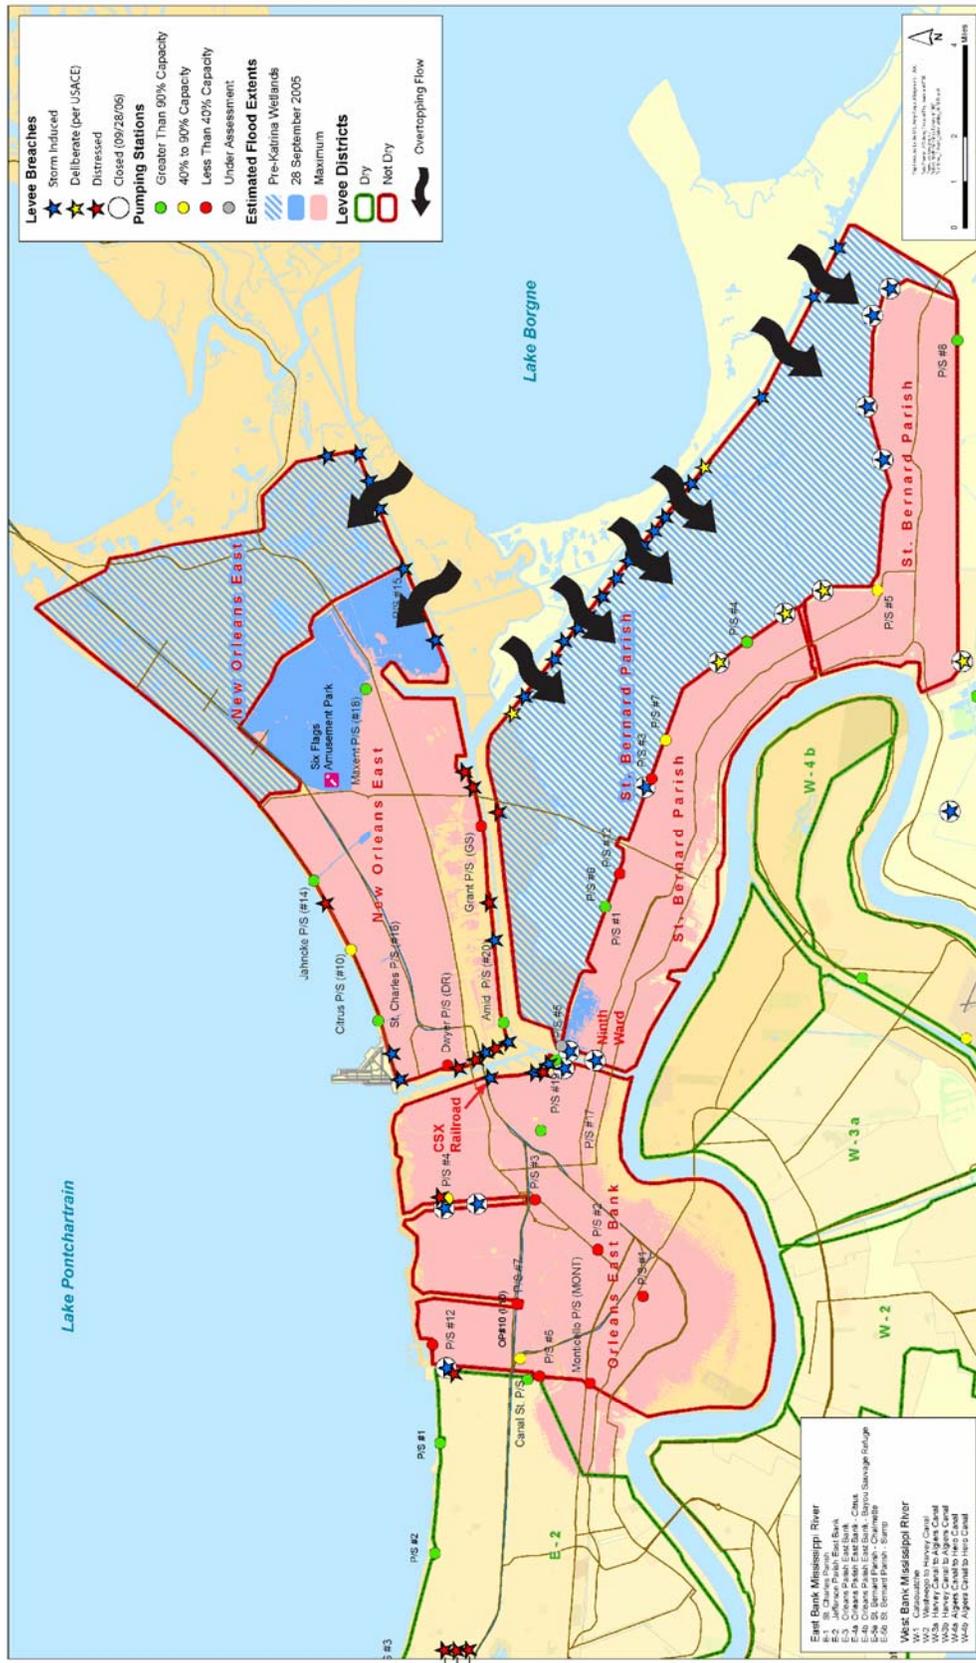
Figure 2.11: Storm surge overtopping the eastern flank of the regional flood protection system at the northeast edge of the St. Bernard Parish and Ninth Ward protected areas.

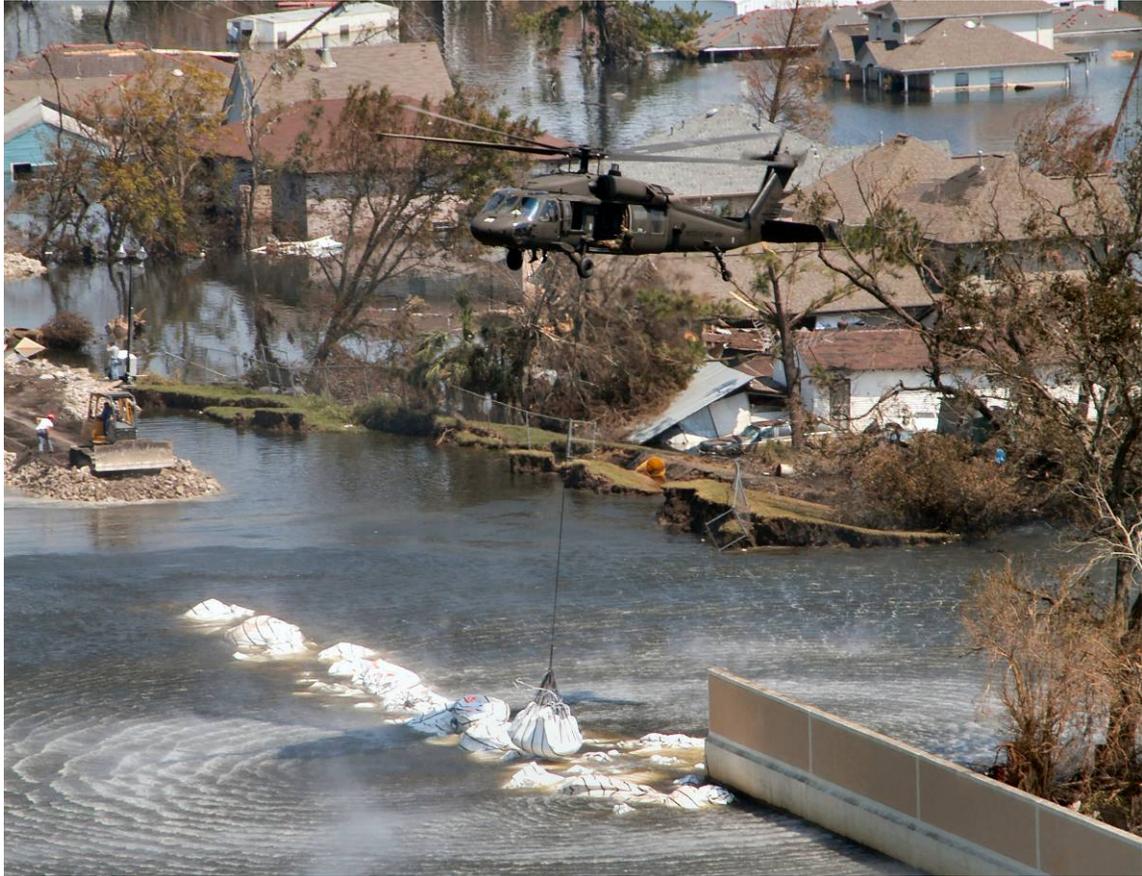
Figure 2.14: Initial closure of the large breach at the north end of the 17<sup>th</sup> Street Canal.

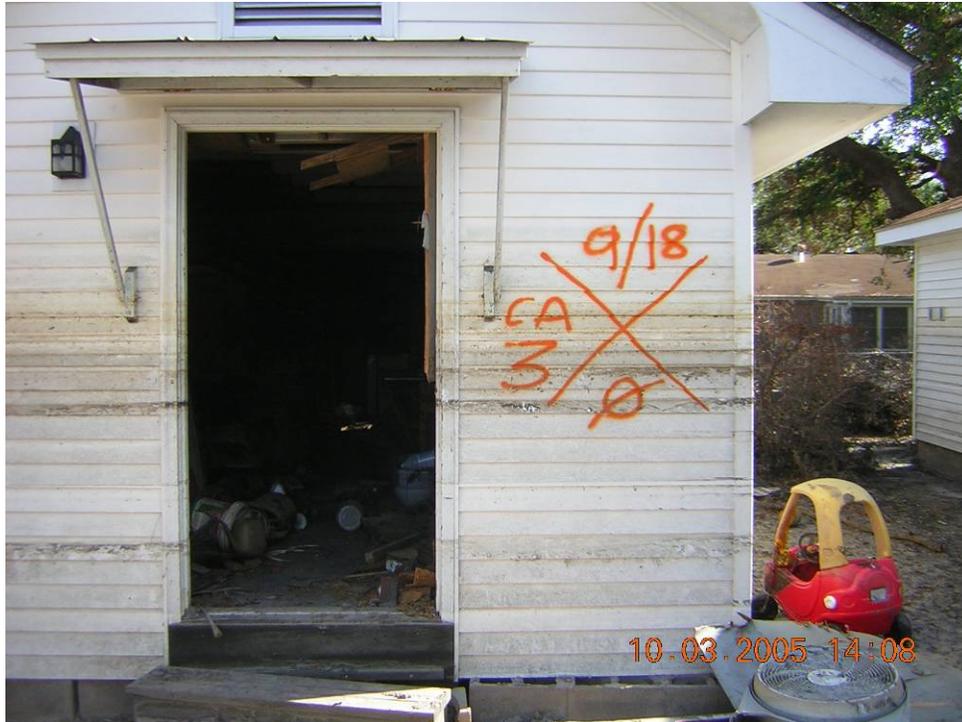
Figure 2.18: High water marks remain on structures after temporary levee repairs have been completed and flood waters have been pumped out.

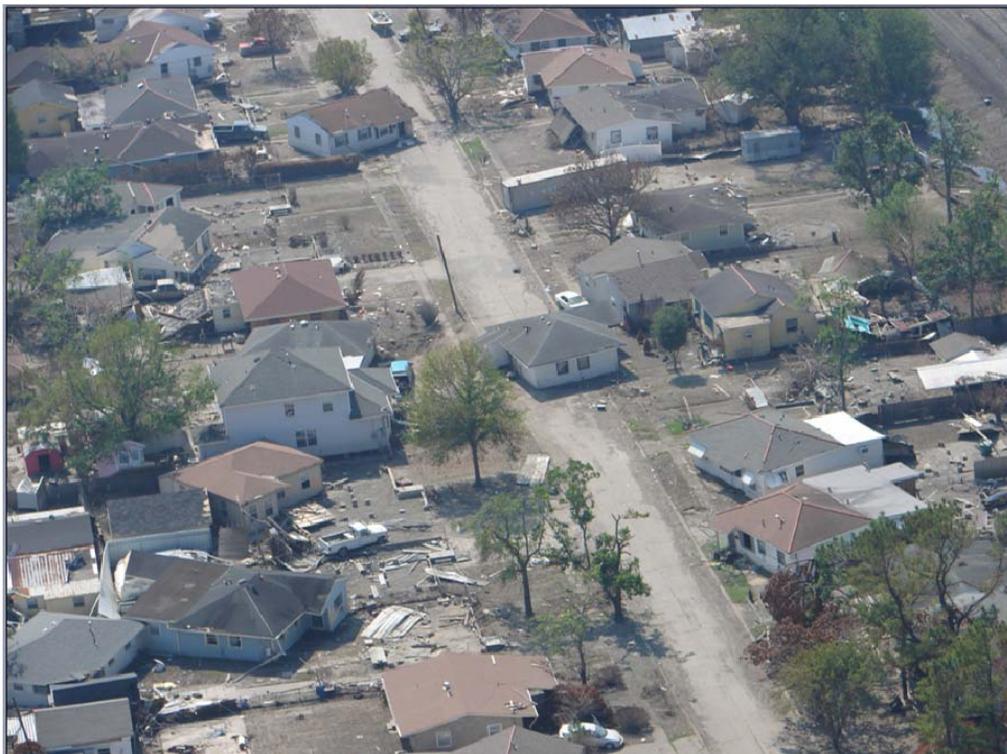
Figure 2.19: Flooded neighborhood in St. Bernard Parish, showing homes floated off their foundations and transported by floodwaters.

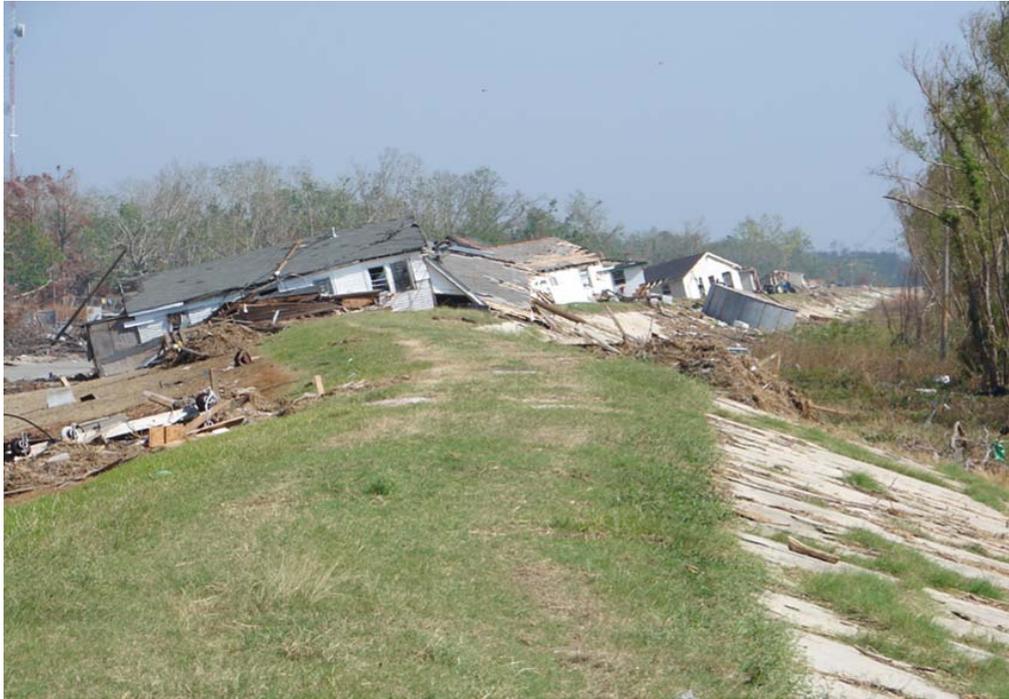
Figure 2.20: Homes in Plaquemines Parish carried from left to right in photo and strewn across the crown of the Mississippi Riverfront levee.

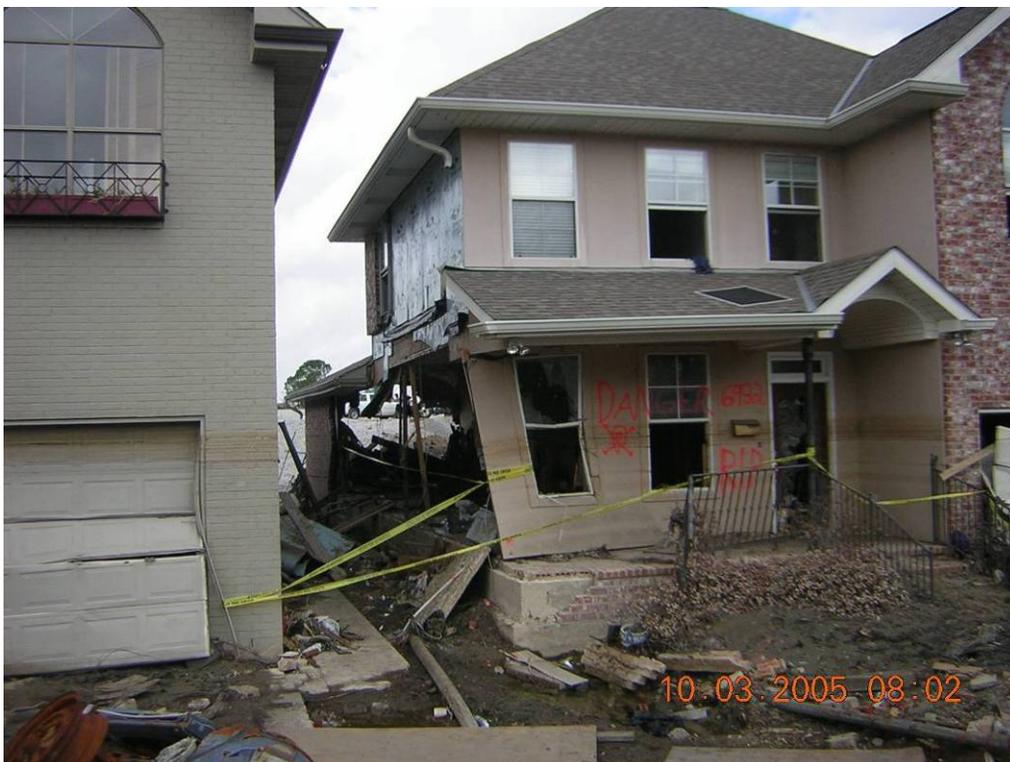
Figure 2.21: Damage to a residential neighborhood in the 17<sup>th</sup> Street Canal area due to flooding.

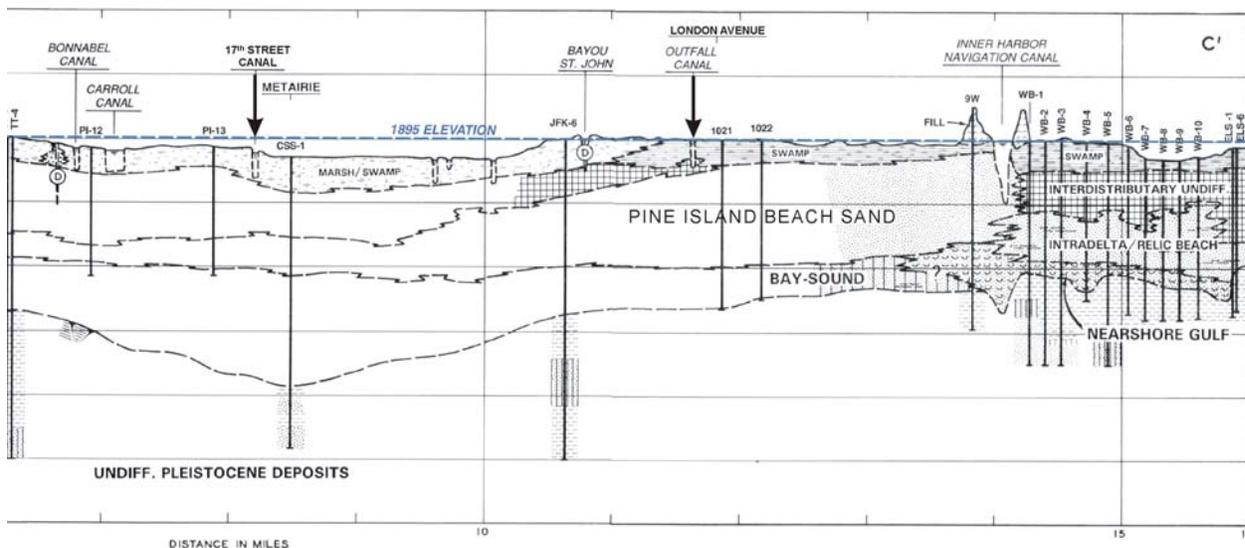
Figure 3.14: Geologic cross section along south shore of Lake Pontchartrain in the Lakeside, Gentilly, and Ninth Ward neighborhoods, where the 17<sup>th</sup> Street, London Avenue, and IHNC levees failed during Hurricane Katrina on Aug 29, 2005. Notice the apparent settlement that has occurred since the city survey of 1895 (blue line), and the correlation between settlement and non-beach sediment thickness. This east-west section was taken from Dunbar et al. (1994).

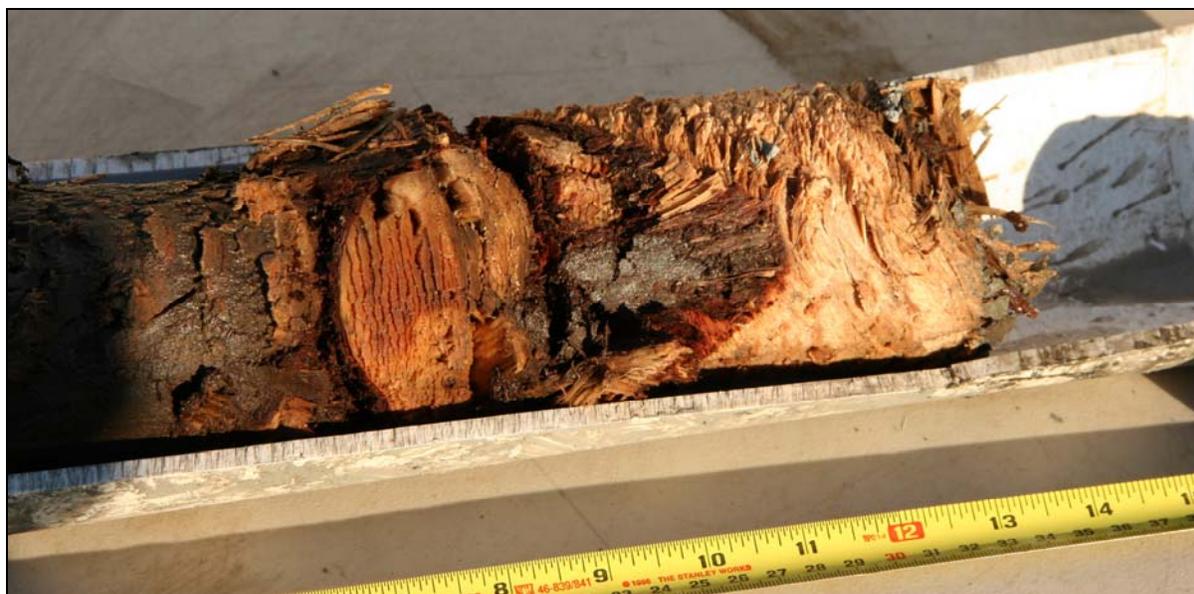
Figure 3.15: Wood and other organic debris was commonly sampled in exploratory borings carried out after Hurricane Katrina throughout the city. This core contains wood from the old cypress marsh that was recovered near the 17<sup>th</sup> Street (Metairie Relief) Canal breach. Organic materials are decaying throughout the city wherever the water table has been lowered, causing the land surface to subside (photo by C. M. Watkins).

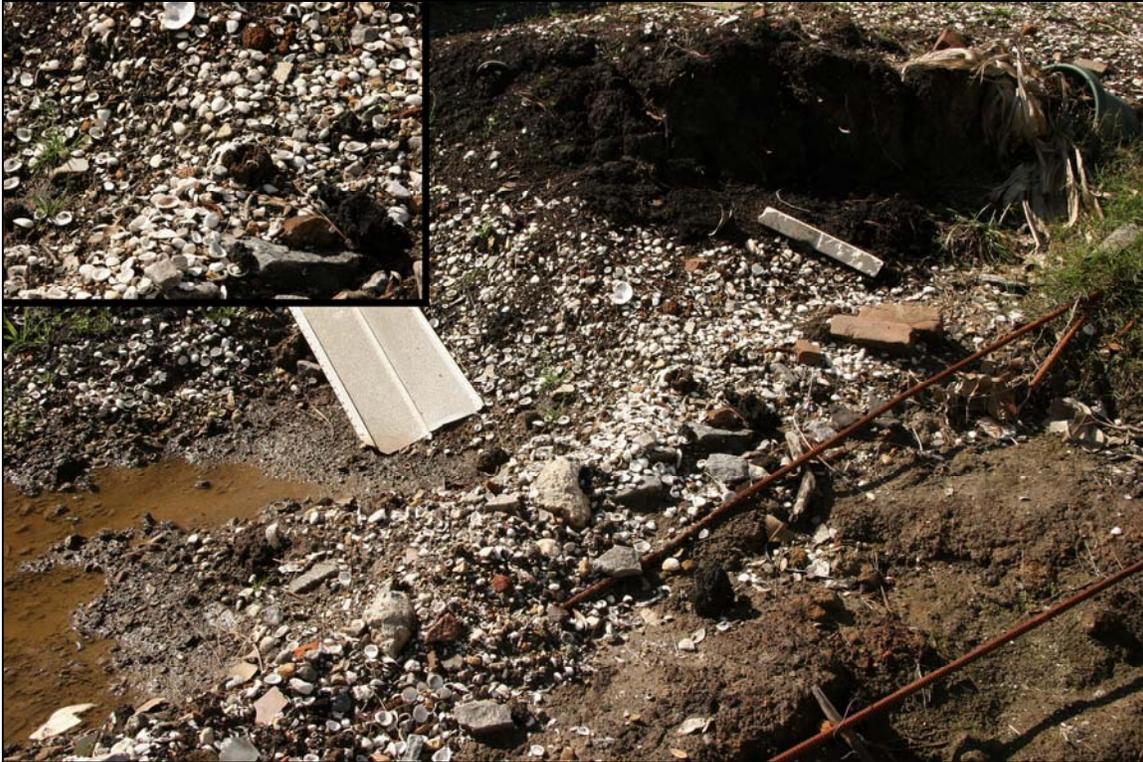
Figure 3.19: West-to-east geologic cross section through the 17<sup>th</sup> Street Canal failure approximately 140 feet north of the northern curb of Spencer Avenue, just north of the first surviving home next to the canal. Large quantities of bivalve shells were extruded by high water pressure along the regressing toe thrusts (shown in Figure 3.20). Note the slight back rotation of the distal thrust block.

Figure 3.20: Bivalve shells ejected by high pore pressures emanating from toe thrusts on landside of failed levee at the 17 Street Canal (detail view at upper left). These came from a distinctive horizon at a depth of 2 to 5 feet below the pre-failure grade (photo by C.M. Watkins).

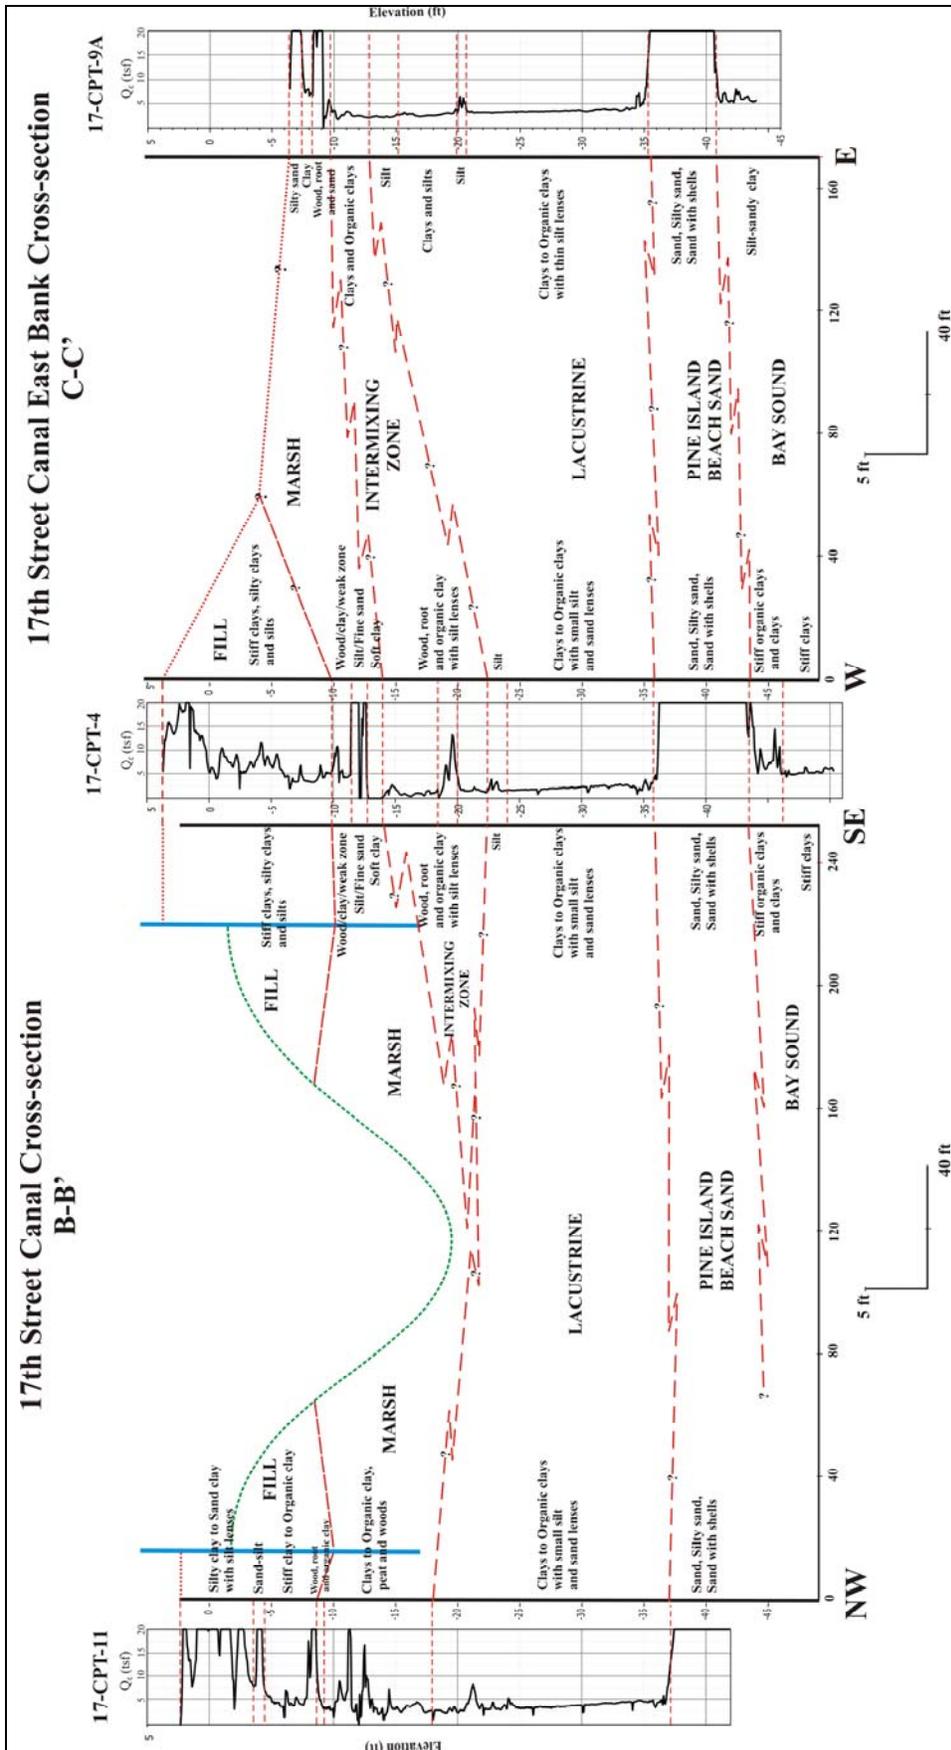
Figure 3.21- lower: Stratigraphic interpretations and cross-canals correlations in vicinity of the 17<sup>th</sup> Street Canal breach on August 29, 2005. The swamp much appeared to be thinning northerly, as does the underlying Pine Island Beach Trend. The lacustrine clays appear to thicken northward, as shown. The approximate positions of the flood walls (light blue) and canal bottom (dashed green) are indicated, based on information provided by the Corps of Engineers (IPET, 2006).

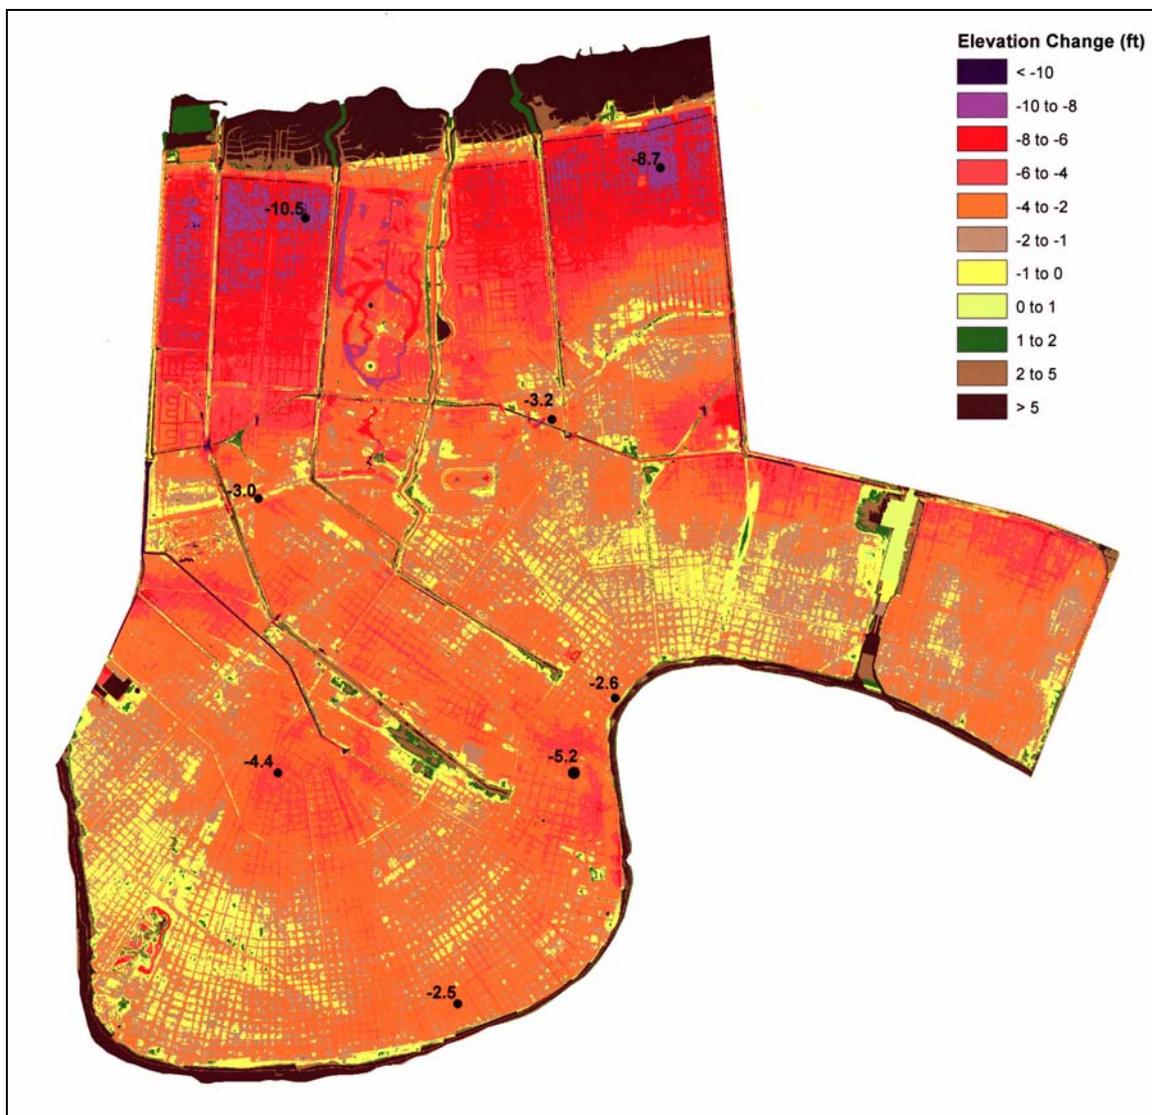
Figure 3.23: Map showing relative elevation change between 1895 and 1999/2002, taken from URS (2006). The approximate net subsidence was between 2 and 10+ feet, depending on location. The brown colored zones along Lake Pontchartrain and the Mississippi River are areas where substantive fill was placed during the same interim.

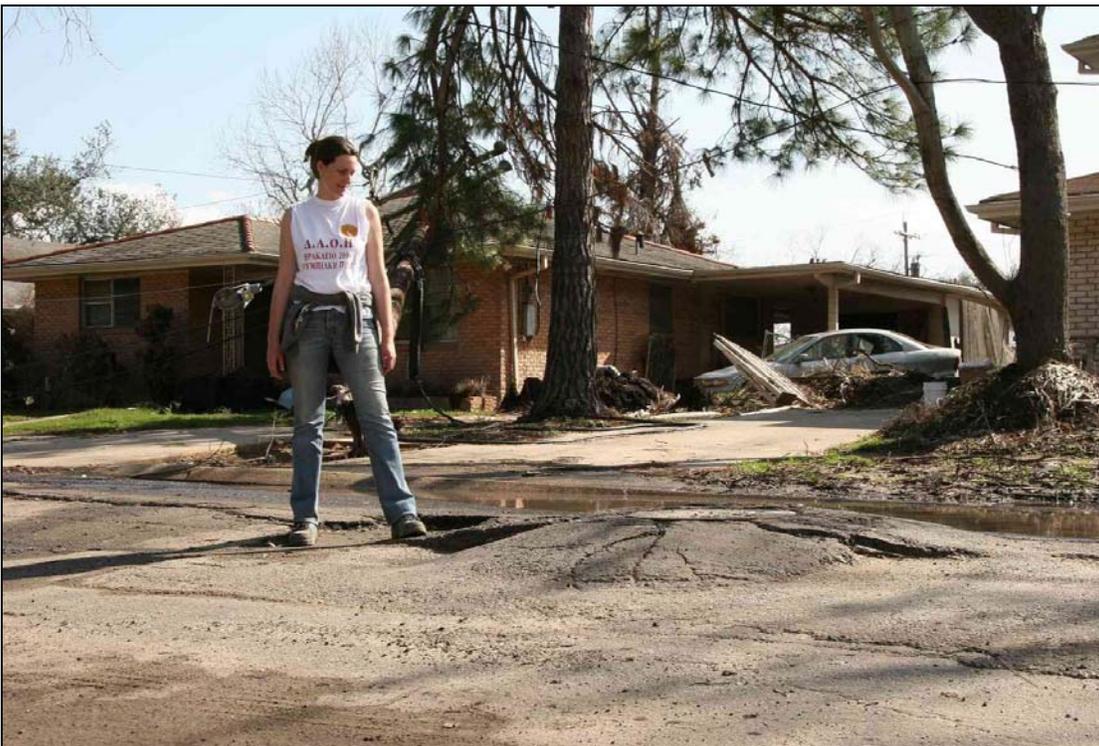
Figure 3.28: Upper photo shows gross near-surface settlement of homes in the Lakeview neighborhood, close to the 17<sup>th</sup> Street Canal breach. Most of the homes were constructed from 1956-75 and are founded on wood piles about 30 feet deep. The lower photo shows protrusion of a brick-lined manhole on Spencer Avenue, suggestive of at least 12 inches of near surface settlement during the same interim (photos by J. D. Rogers).

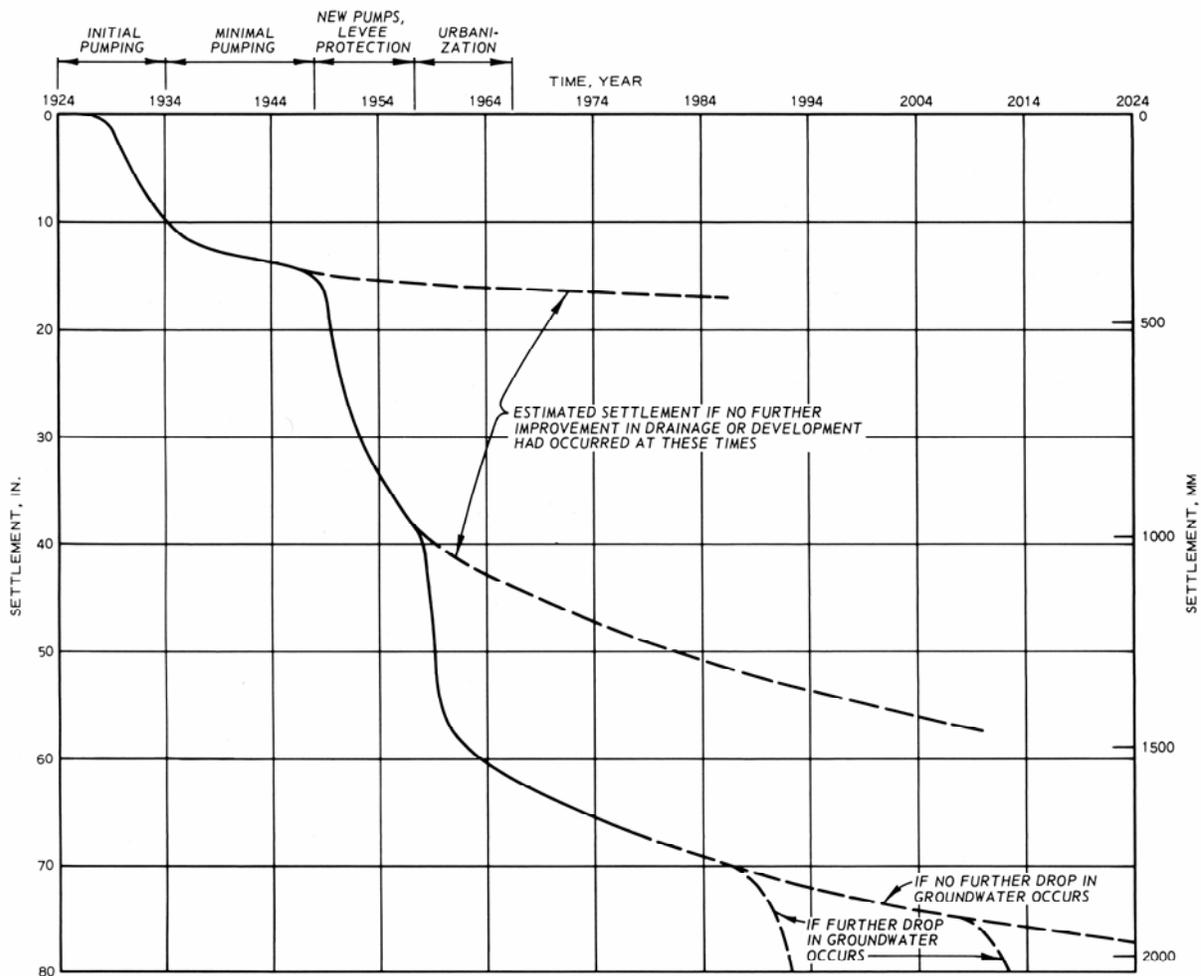
Figure 3.29 – Record of historic settlement in the town of Kenner, which is characterized by 6.5 to 8 feet of surficial peaty soils (taken from Kolb and Saucier, 1982). The earlier episodes of settlement were triggered by groundwater withdrawal (for industrial and municipal usage), while the later episode was caused by drainage associated with urban development. This area was covered by dense cypress swamps prior to development.

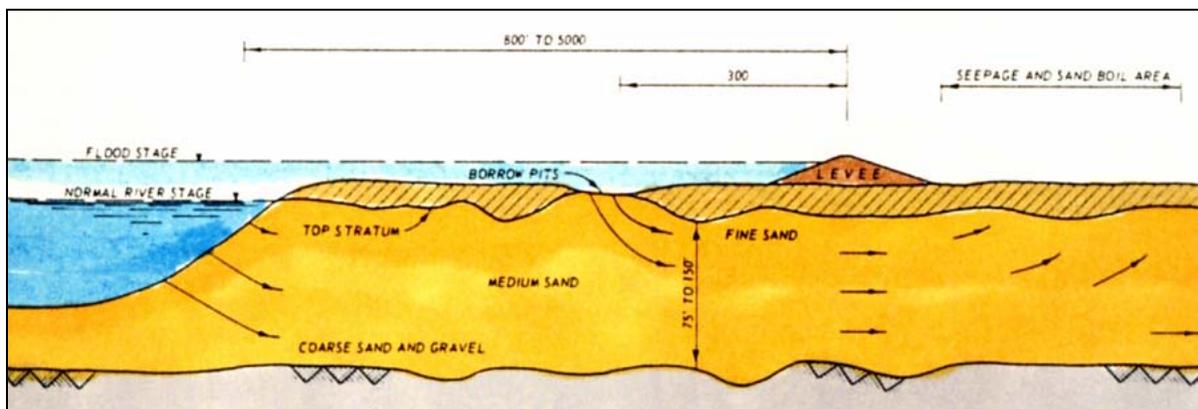
Figure 4.7 – Cross section through a typical Corps of Engineers levee in an alluvial valley (from Mansur and Kaufman, 1956). Analyses of levee stability depend in large measure on various assumptions made about seepage conditions beneath and adjacent to such structures. For instance, the coarse sand and gravel shown here may be 1000x more permeable than the overlying medium sand.

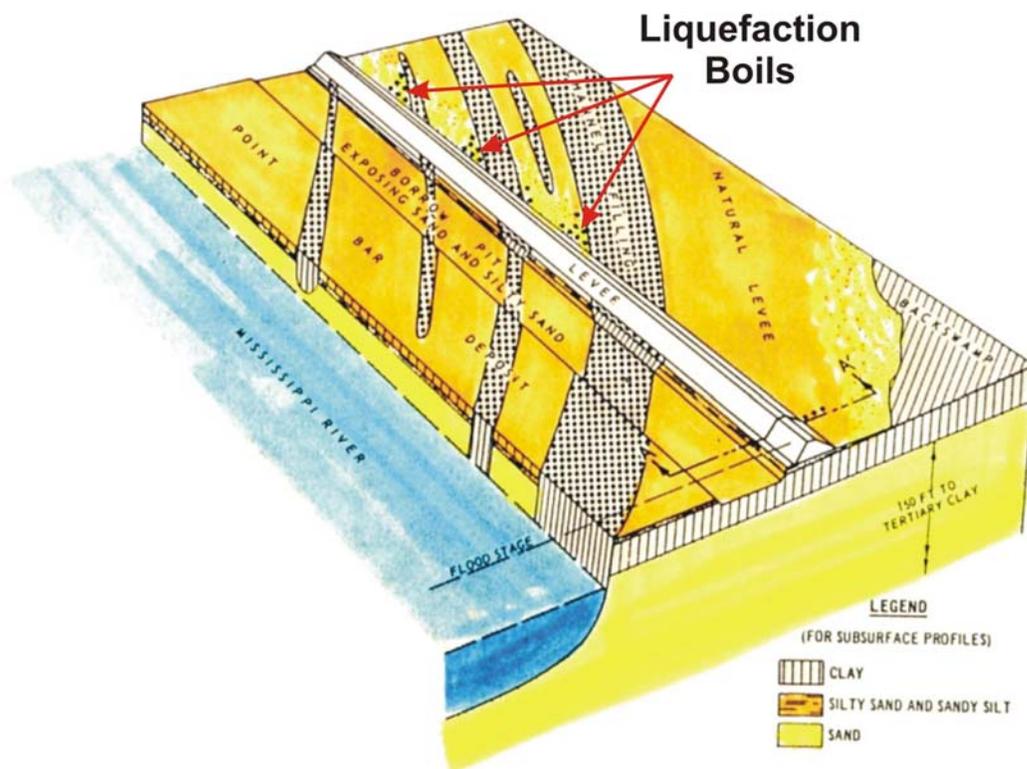
Figure 4.8: A major problem with man-made levees constructed during the MR&T Project is that they are necessarily constructed upon highly heterogeneous foundations, as portrayed here (taken from Kolb, 1976). The sharp contrast between highly organic channel fills (stippled zones) and natural levee sands and gravelly point bars promotes dangerous concentrations of seepage and differential settlement.

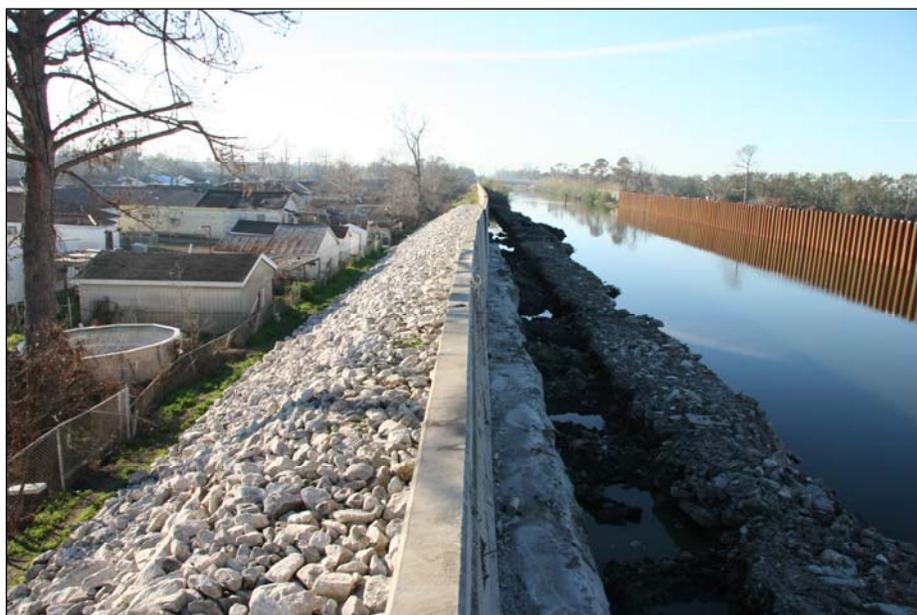
Figure 4.24 (upper): View looking up the east side of the London Avenue Canal near Robert E. Le Boulevard crossing showing the encroachment of homes against the slope of the levee. This situation was common across New Orleans (photo by C. M. Watkins).

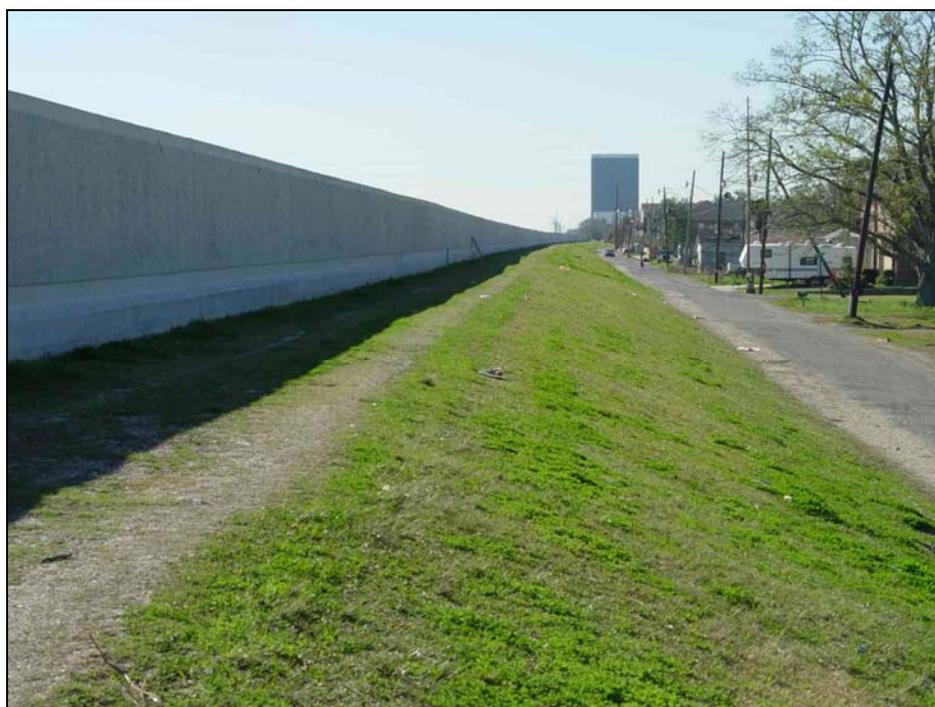
Figure 4.24 (lower): Concrete flood wall along the west side of the 17<sup>th</sup> Street Canal in Jefferson Parish, where a street runs along the toe of the embankment. This scene is typical of the concrete I-walls constructed on steel sheetpiles driven into the crest of the drainage canal embankments in New Orleans in the 1990s to provide additional flood freeboard from hurricane-induced storm surges (photo by J. D. Rogers).

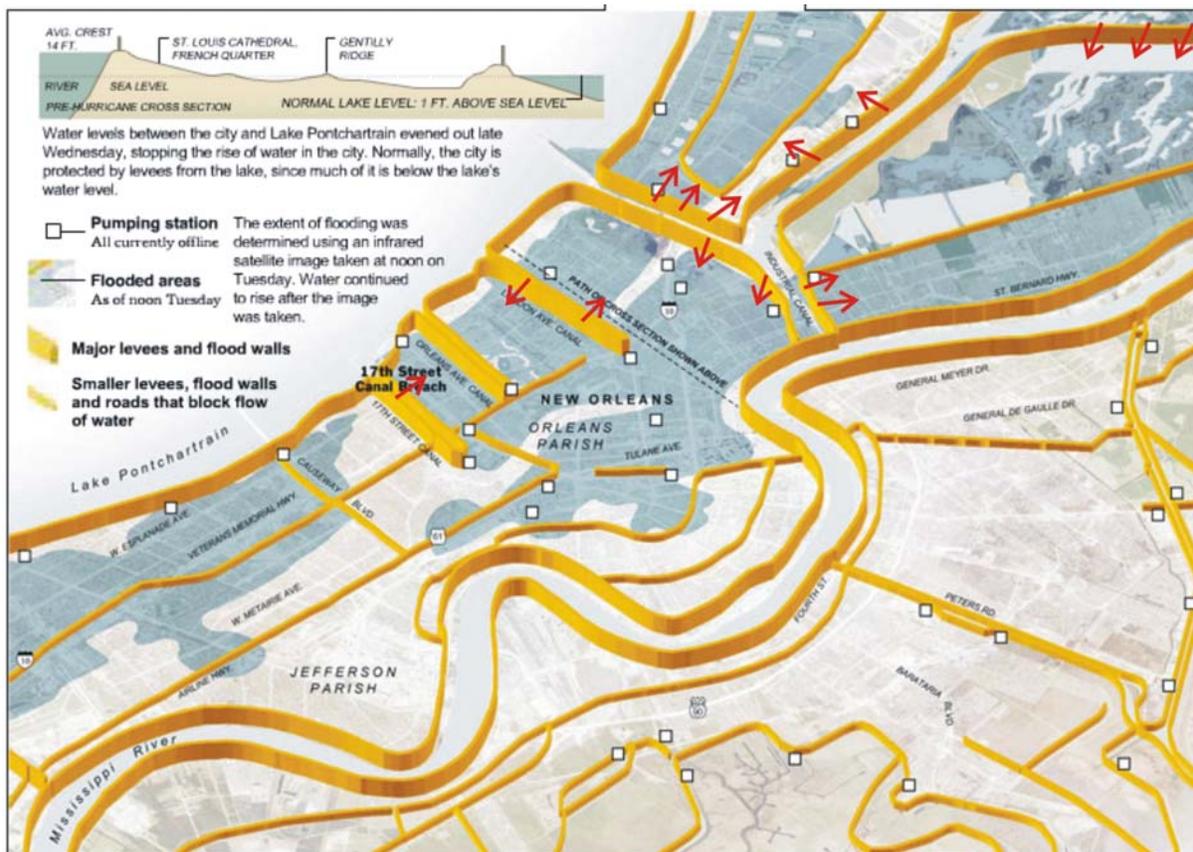
Figure 4.26: Schematic layout of levees and flood walls protecting the New Orleans area at the time Hurricane Katrina struck on August 29, 2005 (from image by the New York Times). Red arrows denote locations of levee failures.

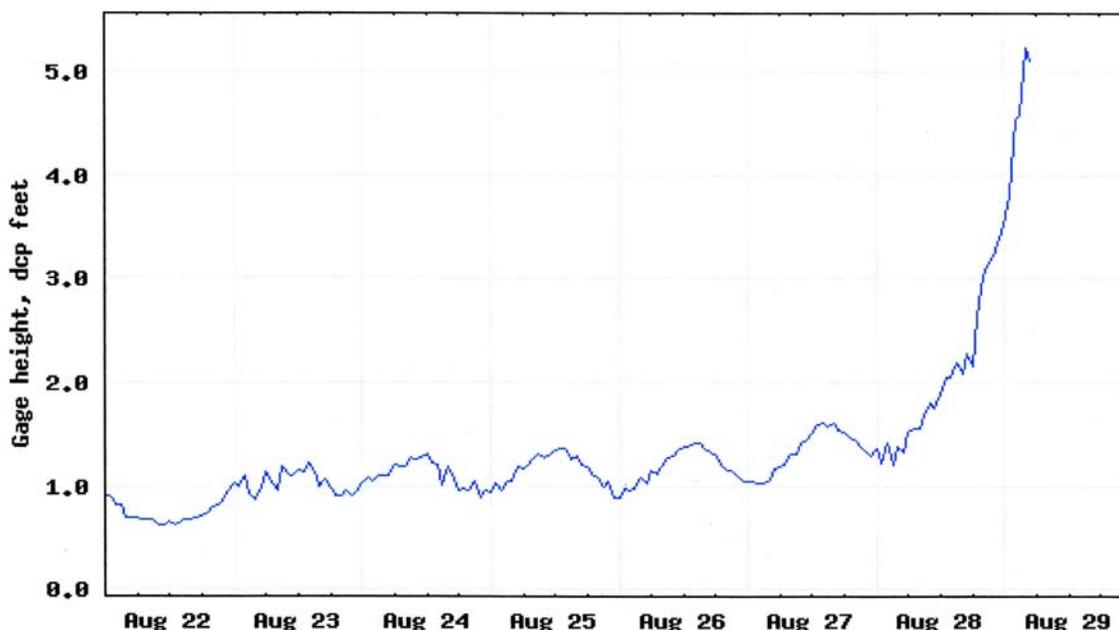
Figure 4.27: Incomplete record of the Lake Pontchartrain tidal stage gage at West End, near the mouth of the 17<sup>th</sup> Street Canal during the early stages of Hurricane Katrina (from U.S. Geological Survey). This record shows the progressive building of tidal stages, days before the storm made landfall. Significant “ramping” of the storm surge began on August 28<sup>th</sup>, with the sharpest increase on the morning of August 29<sup>th</sup>, when the hurricane made landfall. The gage failed when the lake level reached 5.3 ft, before the peak surge was recorded.

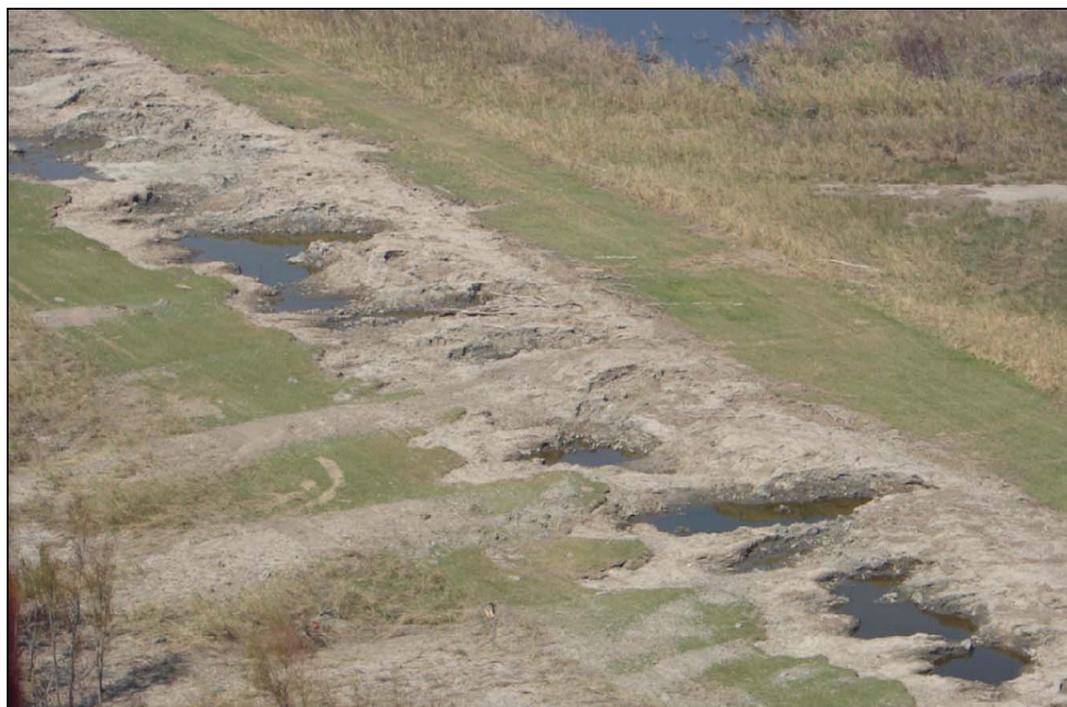
Figure 4.32: Area where the southwest bank of the MRGO channel levee within two miles southeast of Bayou Dupree was completely swept away by overtopping from Lake Borgne (photo by L. F. Harder).

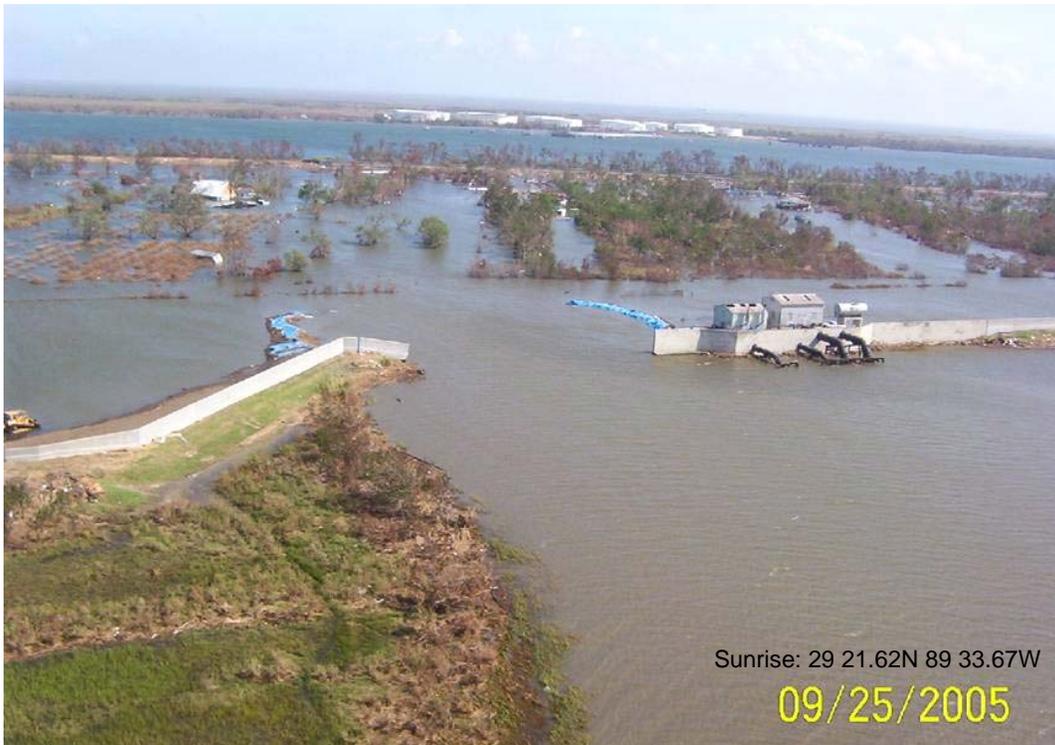
Figure 5.4 shows an aerial photograph of a levee breach of the hurricane (back) levee on the western side of the Mississippi River near the community of Sunrise. The breach occurred at a “transition” between an earthen levee section with a sheetpile-supported concrete I-wall, and a plain structural floodwall section. Failures at transitions between different adjoining sections were relatively common throughout the affected area during Hurricane Katrina.

Figure 5.4: Aerial photograph of levee breach of storm (back) levee along western side of the Mississippi River near the community of Sunrise. [September 25, 2005]

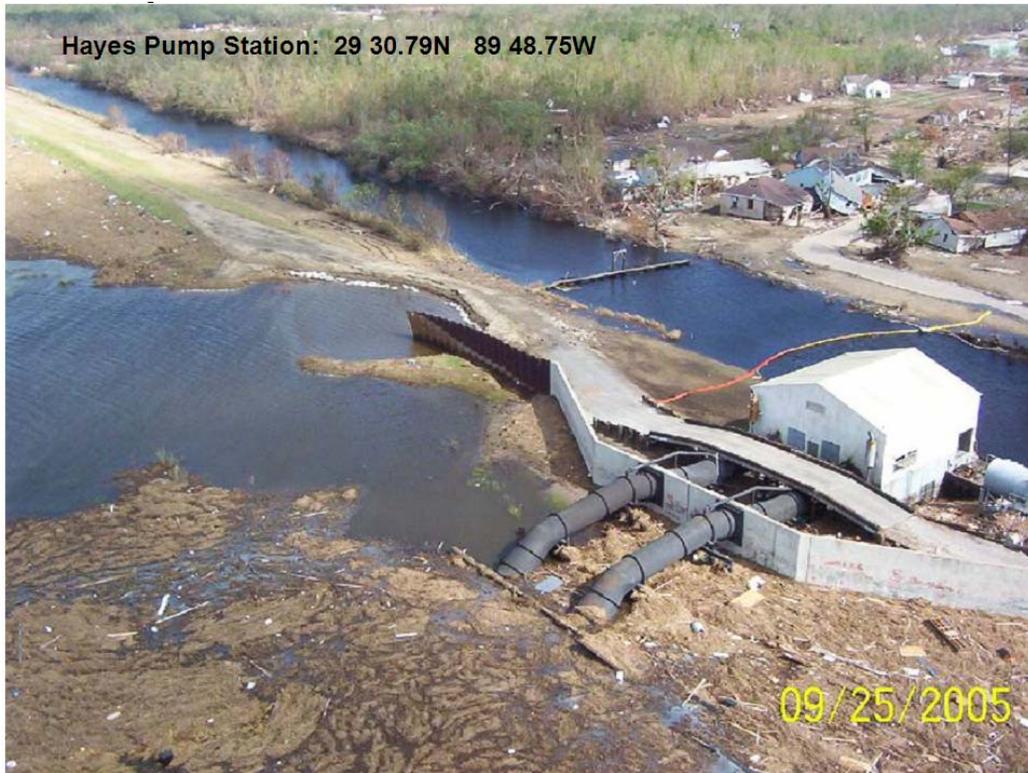
Figure 5.5 shows an aerial photograph of a breach of the hurricane (back) levee at another “transition” near the Hayes Pump Station. This time the failure occurred at a sheetpile transition between an earthen embankment and a structural floodwall section, and sheetpile to earthen embankment connection appears to have been the weak link.

Figure 5.5: Aerial photograph of levee breach of storm (back) levee at levee-to-wall transition near Hayes Pump Station. [September 25, 2005]

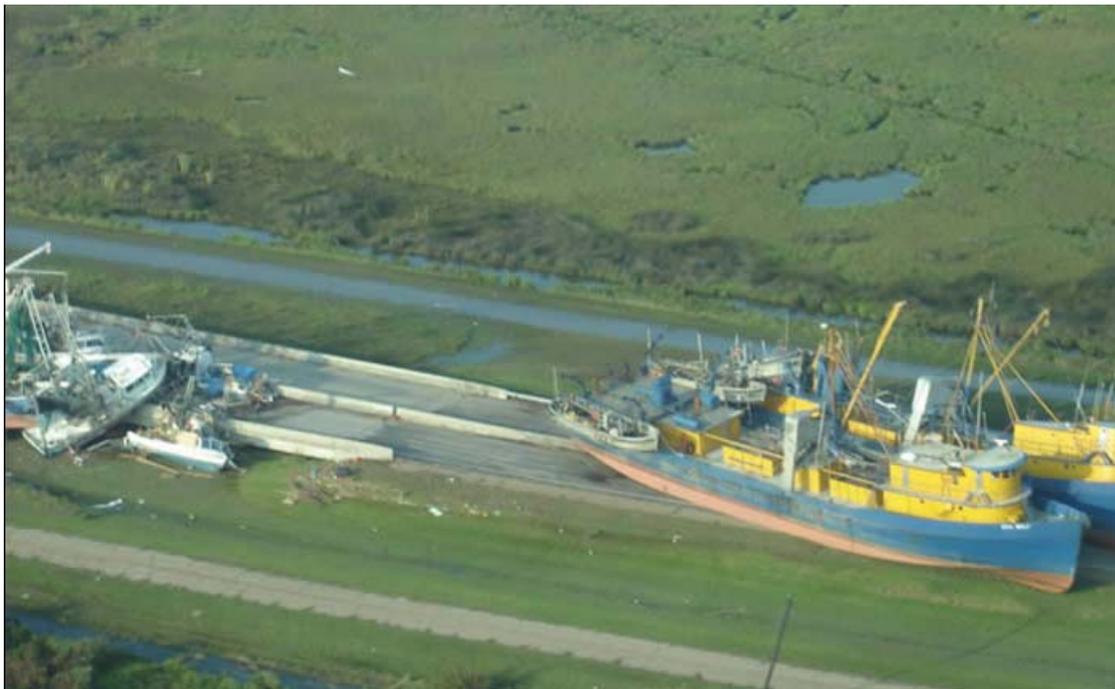
Figure 5.6: Aerial view of two large shrimp boats deposited on Highway 23 at the foot of the Empire High Rise Bridge.
