# Investigation of the Performance of the New Orleans Flood Protection Systems in Hurricane Katrina on August 29, 2005

## Volume I: Main Text and Executive Summary

**Final Report**  
**July 31, 2006**

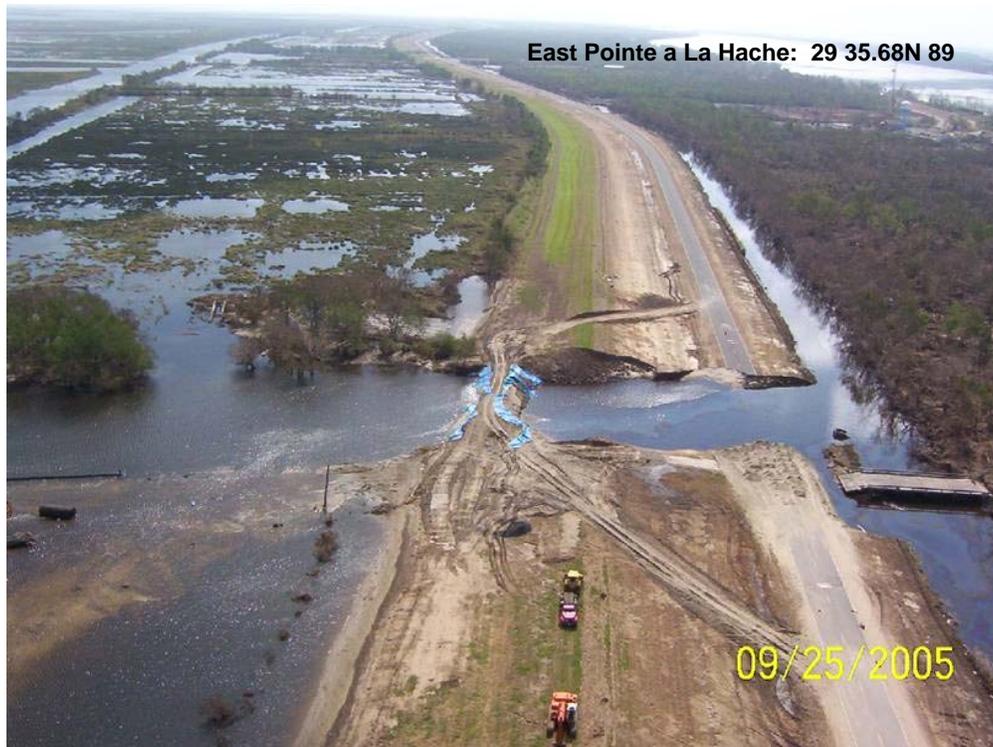
Point a la Hache is the parish seat for Plaquemines Parish and is located along the east side of the Mississippi River. Storm surges from the east largely overwhelmed the back levee, breached it in several places, and inflicted deep flooding and widespread destruction in this town. Figure 5.7 presents an aerial photograph of one such breach taken on September 25, 2005 (from Plaquemines Parish Government Website). Shown in this photograph is a temporary road constructed across the interim breach repair to facilitate access and repairs.

Figure 5.7: Aerial photograph of levee breach of storm (back) levee East of Pointe a la Hache. [September 25, 2005]

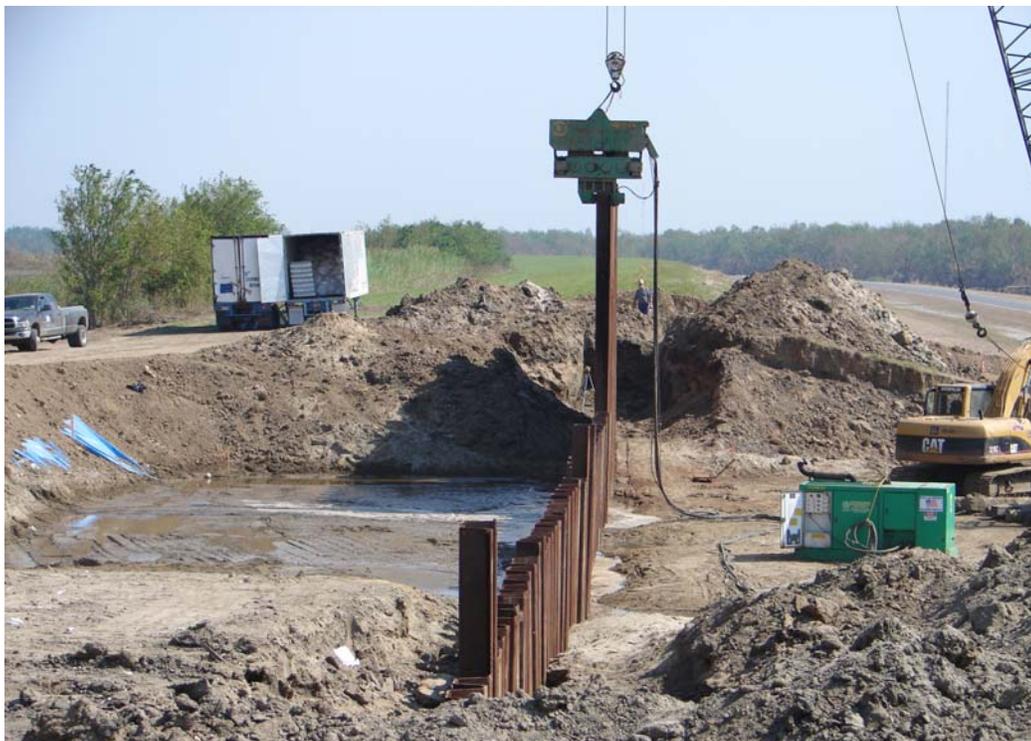
Figure 5.8: Photograph of Sheetpile Cutoff Being Placed into Levee Breach of Storm (Back) Levee East of Pointe a la Hache. [October 12, 2005]

Figure 5.8 shows this same levee breach a few weeks later during the installation of a sheetpile cutoff that was undoubtedly intended to be part of an interim, and perhaps permanent repair. The team members viewing the installation believed that the sheetpile wall was a good concept to affect a positive cutoff of seepage through the deeply scoured breach and loose debris. However, during the installation, team members noted that the contractor was having difficulty advancing the southern portion of the sheetpiles very far into the ground using the equipment in use at the time of the team’s visit. It is hoped that the pilings ended up being driven to their needed depths.

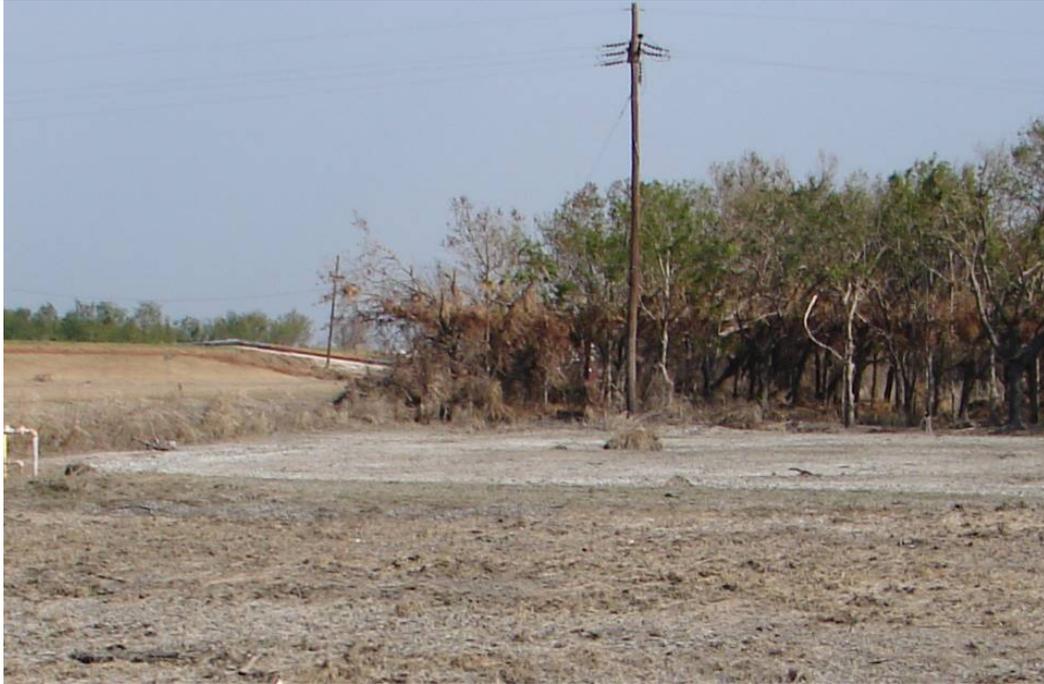
Figure 5.9: Photograph of flood elevation on trees landward of hurricane levee East of Pointe a la Hache – illustrating that flood waters remained to large depths for extended periods. [October 12, 2005]

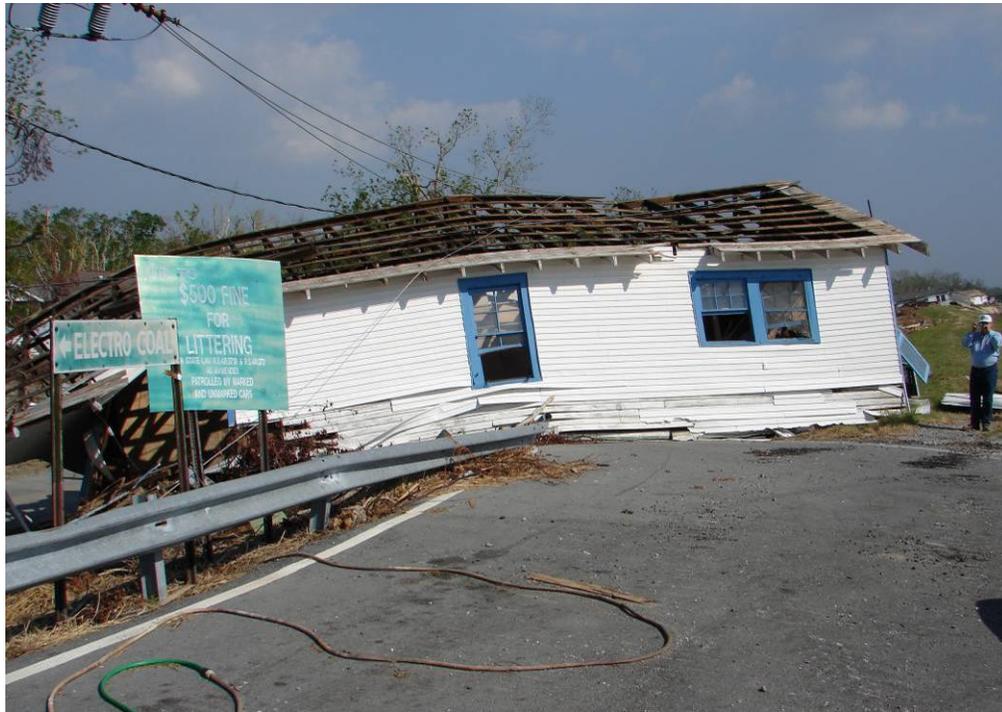
Like many New Orleans residences, the small wooden homes in Pointe a la Hache were commonly founded on cinderblock piers. As a result of the deep flooding and the flow towards the Mississippi River, homes in Pointe a la Hache were commonly picked up and floated away from their foundations. Many ended up being deposited on or across the Mississippi River Levee as a result of storm surges flowing from the overtopped “storm” levees towards the “river” levees alongside the Mississippi River (see Figures 5.10 through 5.12).

Figure 5.10: Photograph of Pointe a la Hache home deposited on Mississippi River levee crown after storm surges overtopped the storm levee from the East (left) towards the River – which is to the right in this photograph.

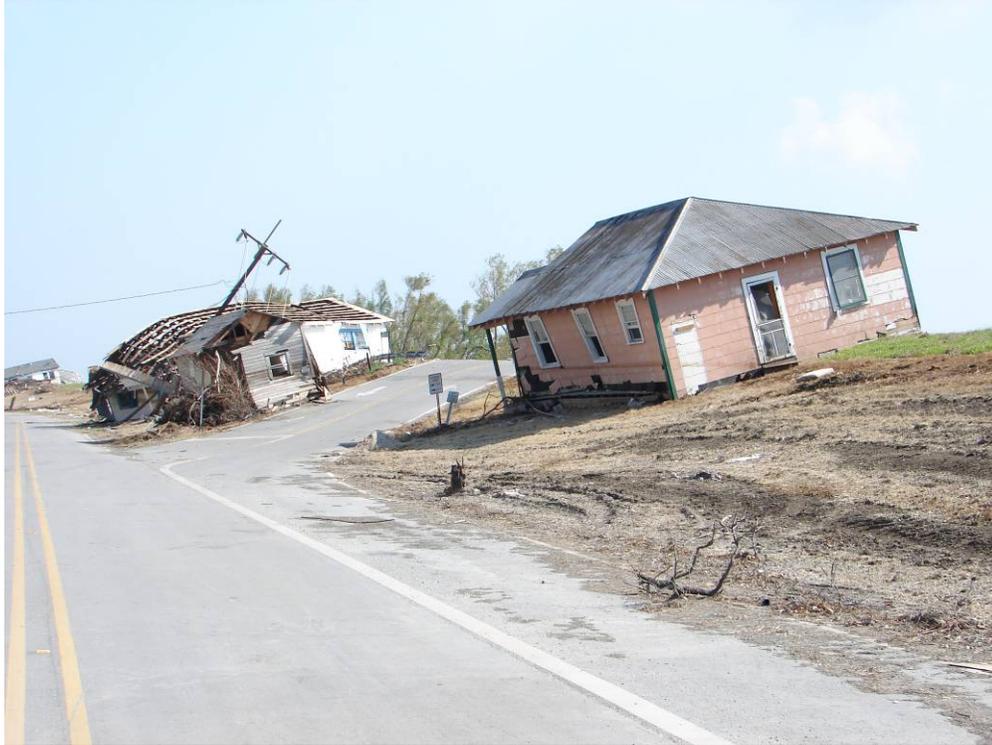
Figure 5.11: Photograph of Pointe a la Hache homes deposited on Mississippi River Levee after storm surges overtopped the levee from the East (left) towards the River (right). [October 12, 2005]

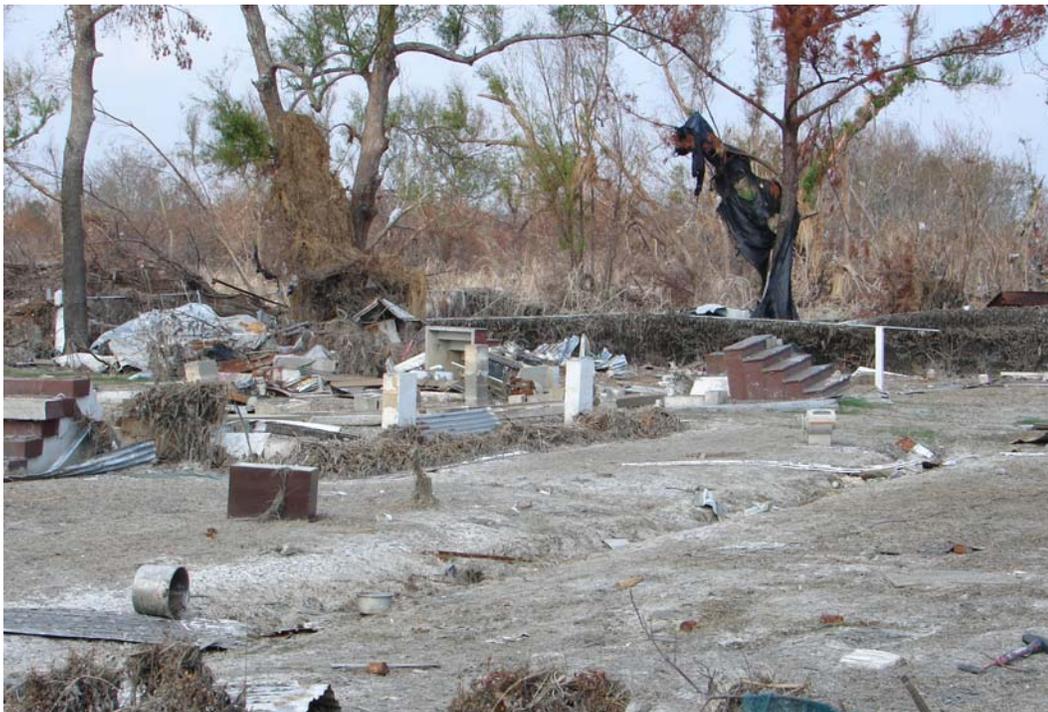
Figure 5.12: Photograph of Pointe a la Hache home site where a wood home was floated off of its cinderblock piers. [October 12, 2005]

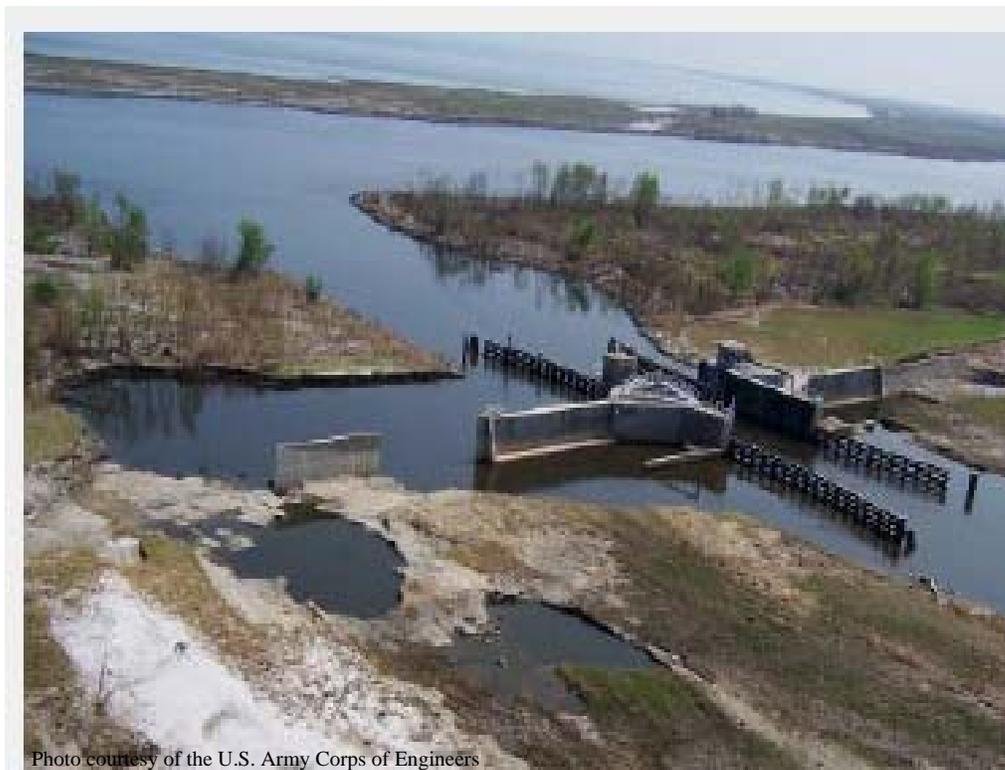
Figure 6.9(a) is an oblique aerial of the smaller Bayou Dupres concrete navigation structure situated farther to the south along this same MRGO levee frontage, showing a similar massive eroded breach at the juncture between the northwest end of the concrete structure and the adjoining earthen levee section. Figure 6.9(b) shows a second view, taken from the eroded breach and looking to the inboard (protected) side along the north flank of Bayou Dupres, showing the eroded detritus strewn inland from this breach. In this figure, it can be clearly seen that large fractions of the eroded material consisted of shell sand fill. The use of lightweight shell sand fill had been called for at this interface section in order to

Figure 6.9(a): Aerial view of the large erosional breach at the contact between the north end of the concrete navigational lock structure and the adjoining levee embankment at Bayou Dupres.

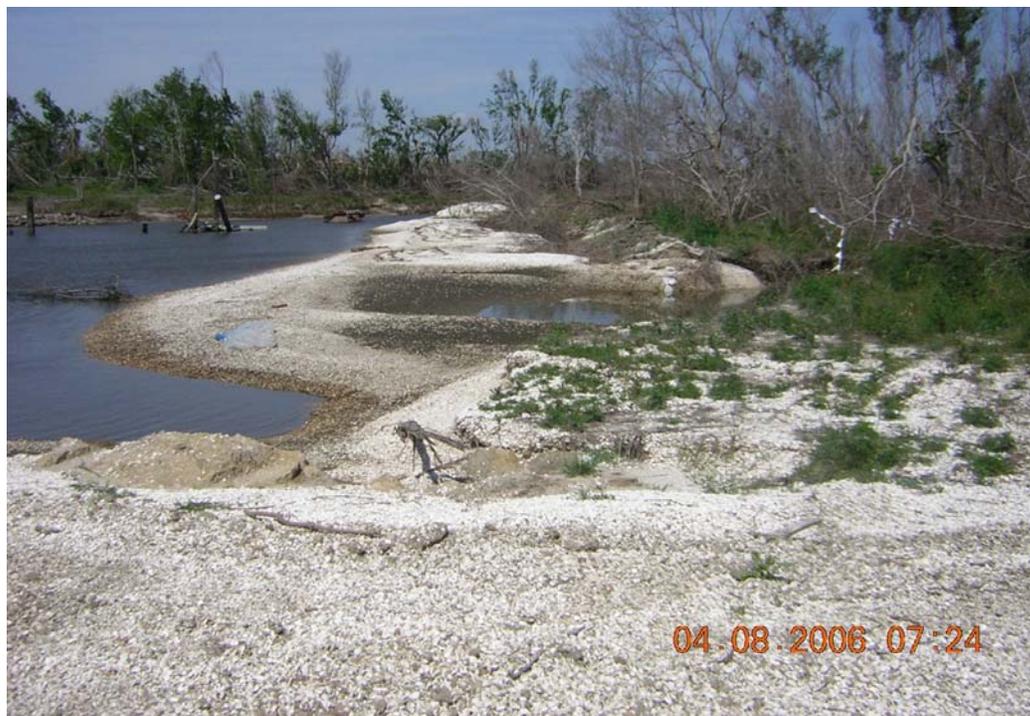
Figure 6.9(b): View looking to the inboard side from the breach shown in Figure 6.5 above; showing eroded shell sand detritus deposited from the breach.

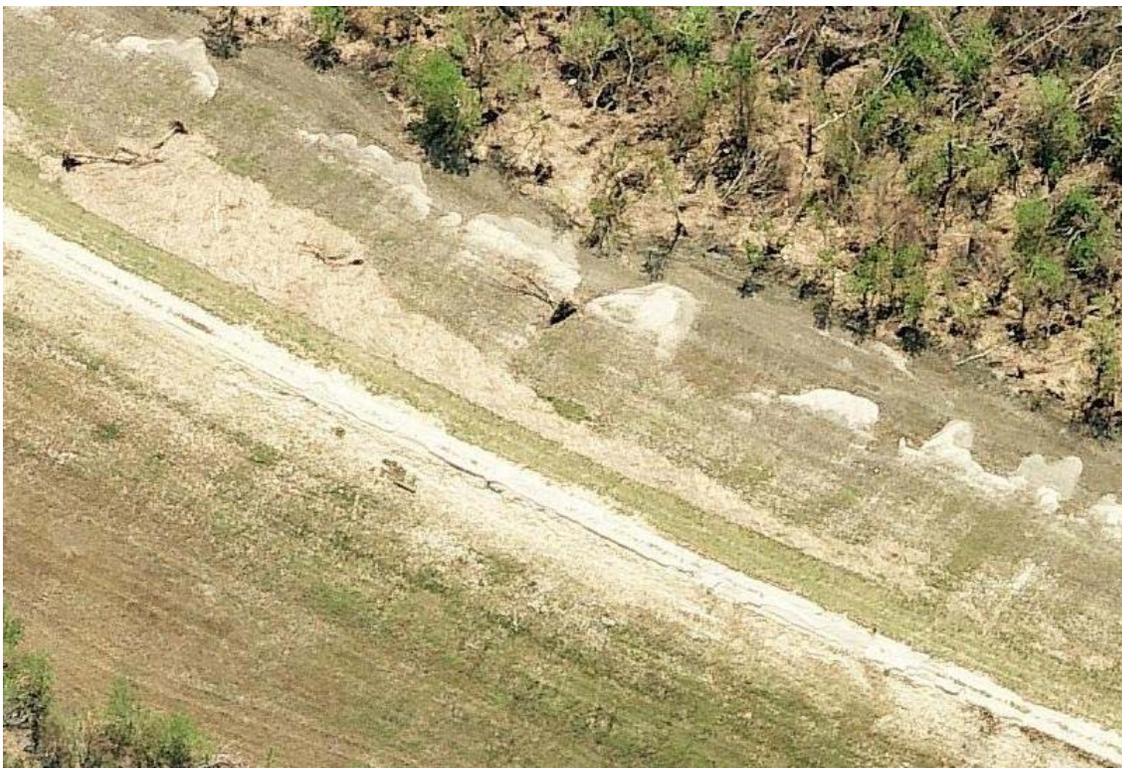
Figure 6.11(b) illustrates two additional potential sets of erosion modes likely to have been active along sections of the MRGO frontage levees. One is the attacking of the outboard side (water side) face of the levee by storm waves. These high energy waves can scallop and erode the outboard face. They can also rush up the face toward the crest, and can erode “notches” in the crest from the front side. Subsequent waves can then pass through these notches, especially as the storm surge continues to rise, and the flow can widen the notches and also erode the back face levee slope (as discussed above as “sheet flow overtopping erosion”.) This exploitation and widening of crest notches is called crenellation, after the crenellation (notched shape) that often tops castle walls.

Figure 6.12: Photo of outboard side wave-induced erosion on the MRGO levee frontage at the northeast edge of the St. Bernard/Ninth Ward protected area.

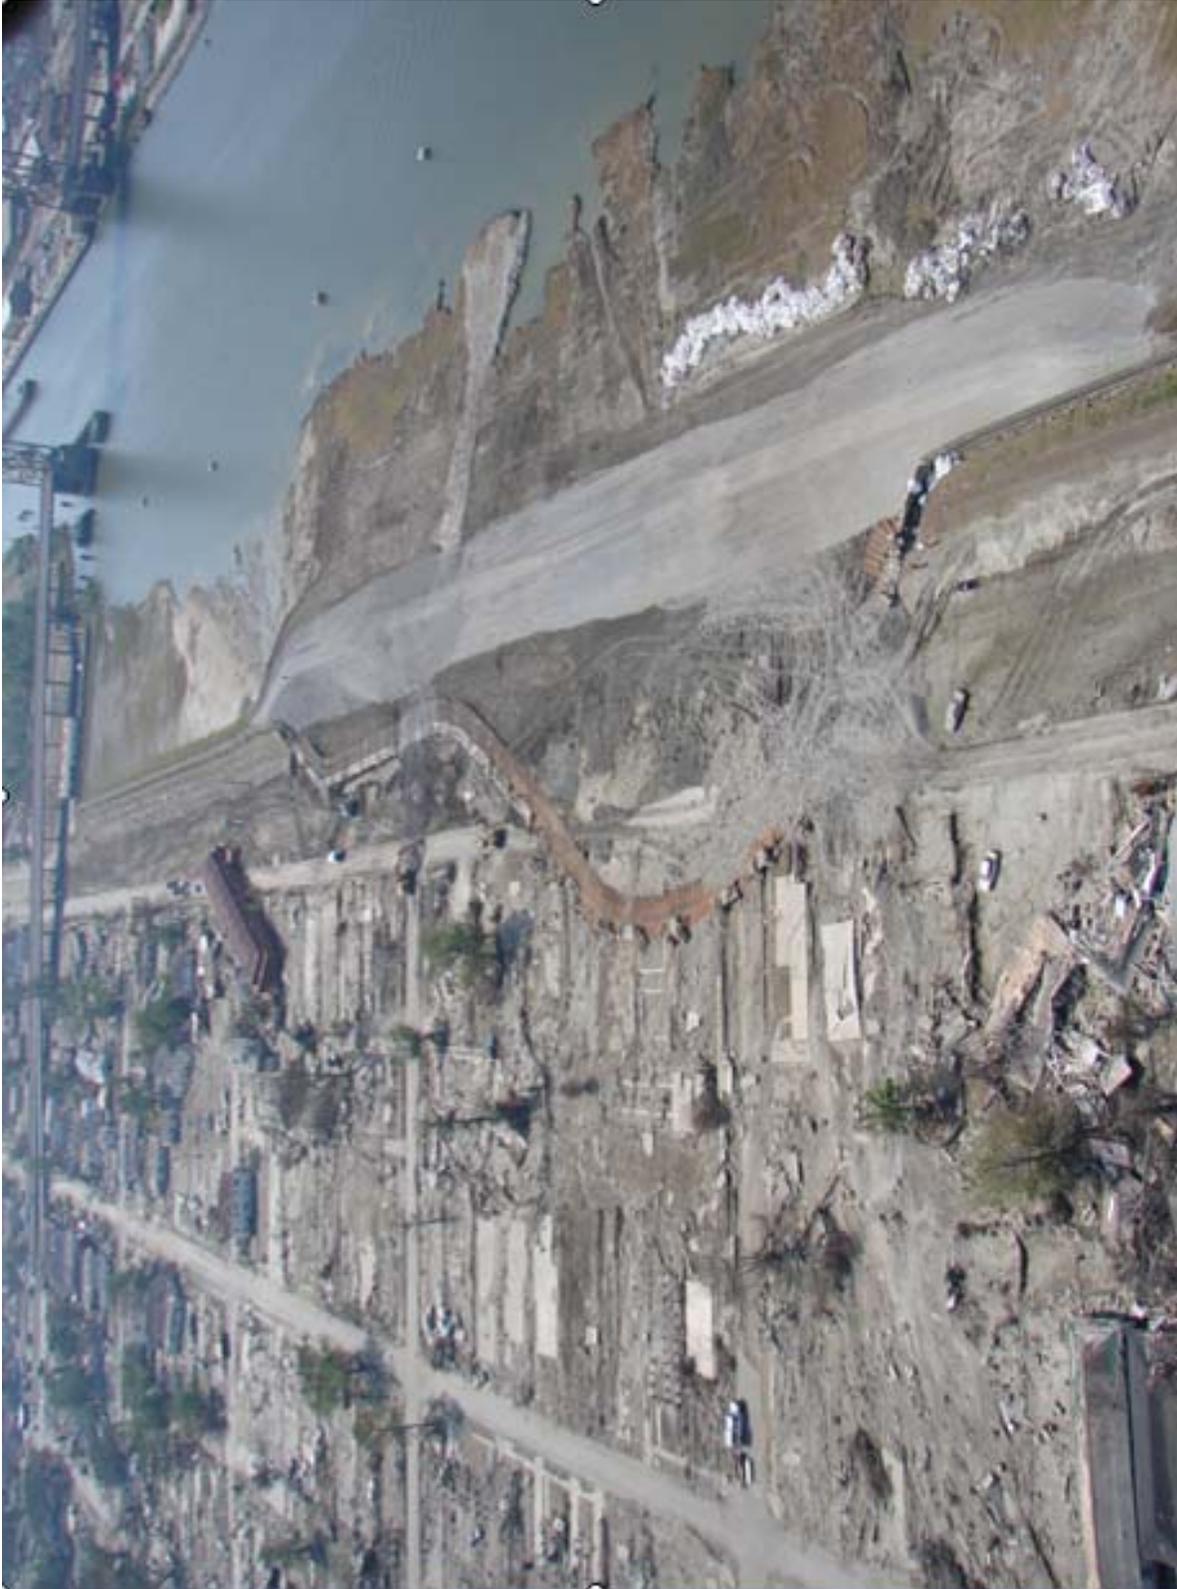
The larger of these two breaches was the south breach, and this is shown in Figure 6.19 (which is a repeat of Figure 2.13). This was a very long breach, nearly 900 feet in length, and the intruding waters entered the adjacent community with great force. As shown

Figure 6.19: Oblique view of the (south) levee break at the Inner Harbor Navigation Canal into the lower Ninth Ward.

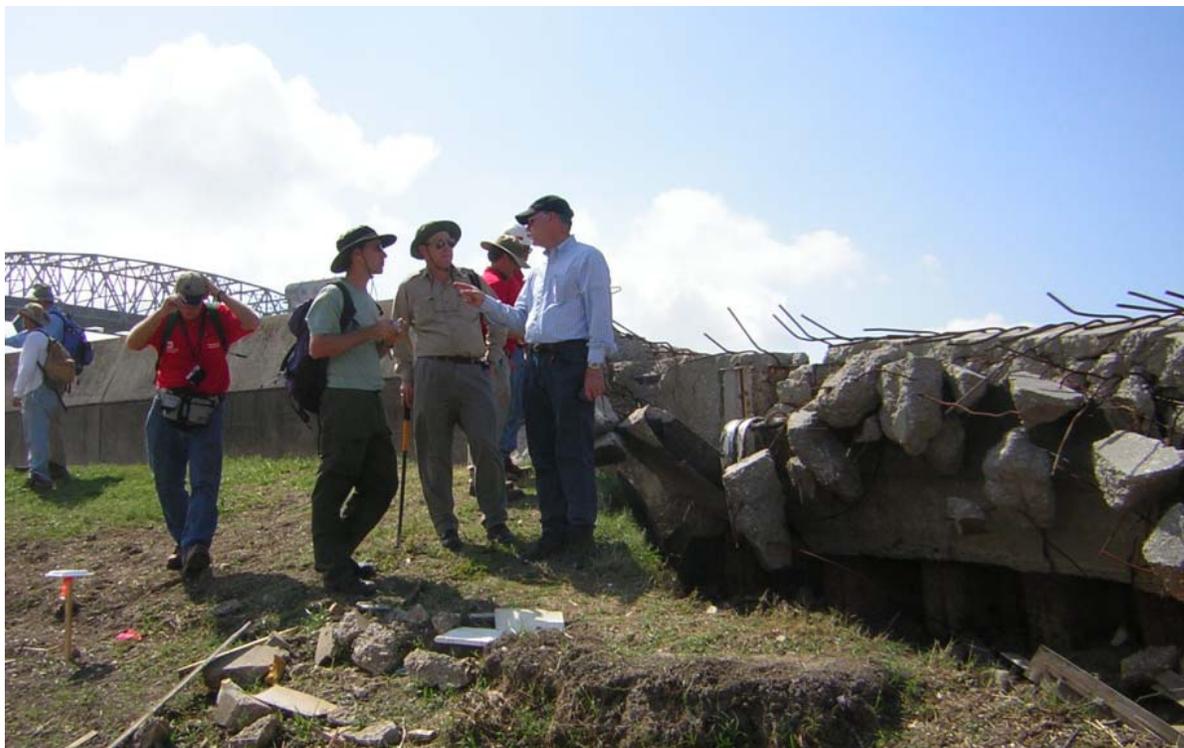
**Figure 6.21:** Close-up view of crushed (impacted) concrete floodwall at the south end of the south breach at the east bank of the IHNC at the west end of the Lower Ninth Ward.

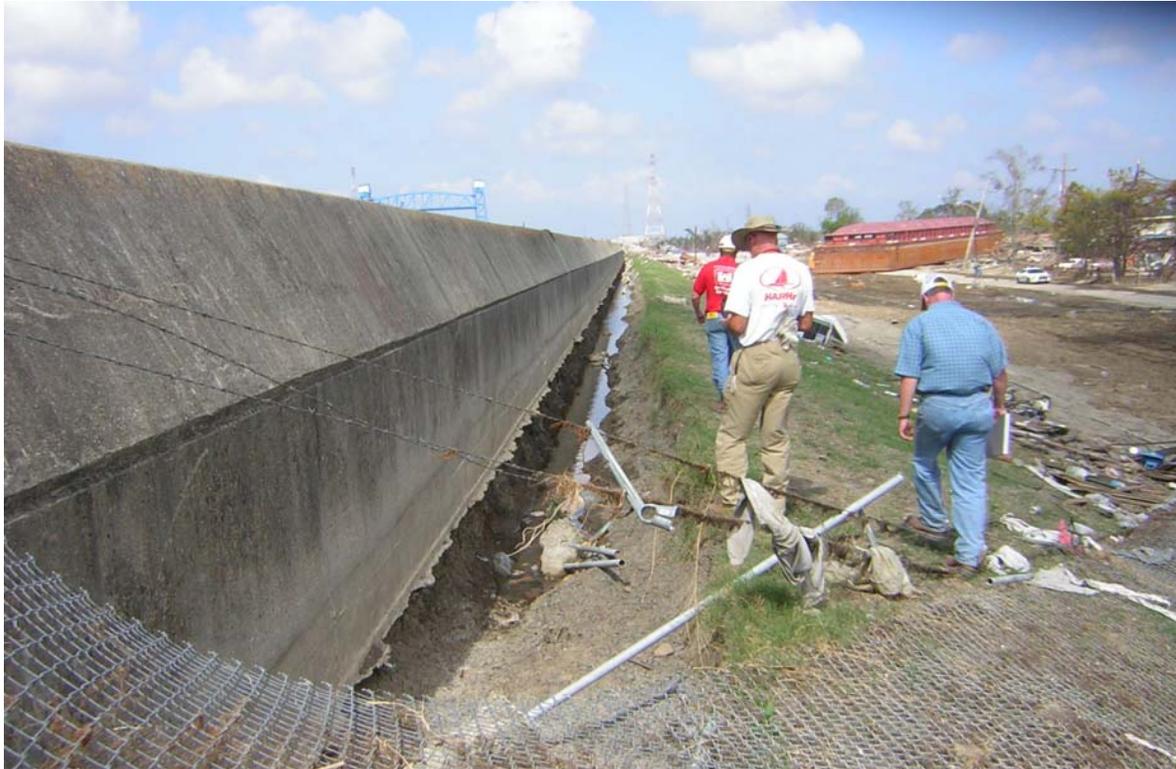
**Figure 6.22:** Eroded trench at the rear (inboard) side of the floodwall at the south end of the south breach at the east bank of the IHNC at the west end of the Lower Ninth Ward.

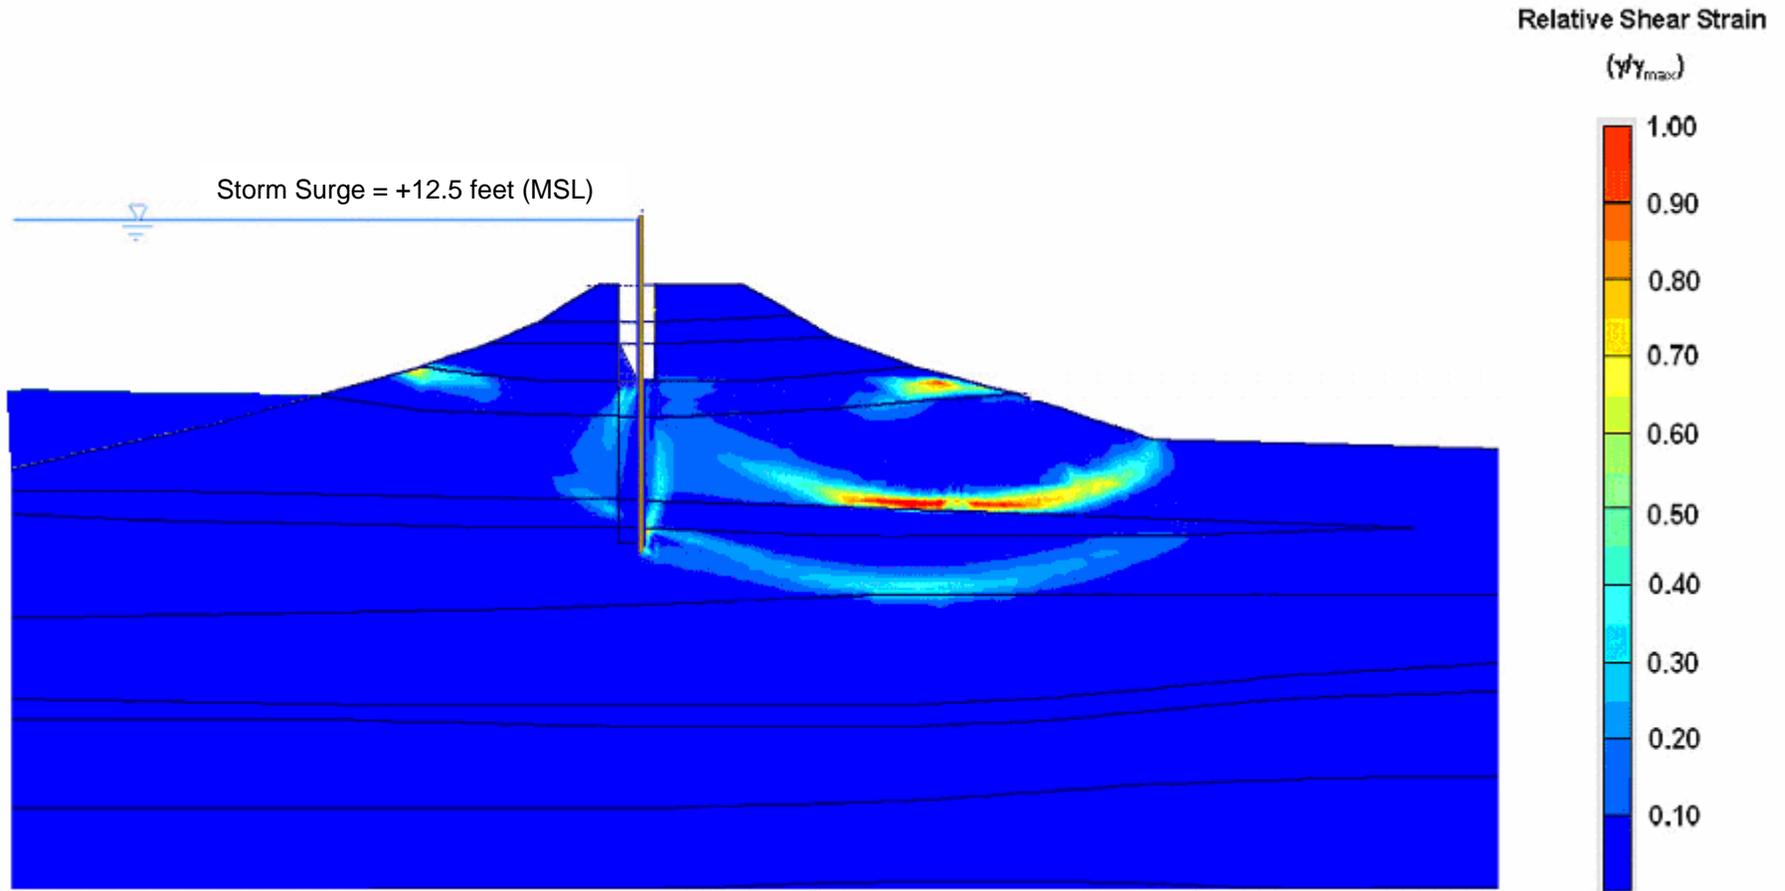
**Figure 6.30:** Normalized shear strain contours (shear strain divided by strain to failure) for a storm surge at Elev. + 12.5 feet (MSL) at the Lower Ninth Ward, IHNC East Bank, South breach site; gapping at outboard toe of floodwall is developed fully through the embankment fill material.

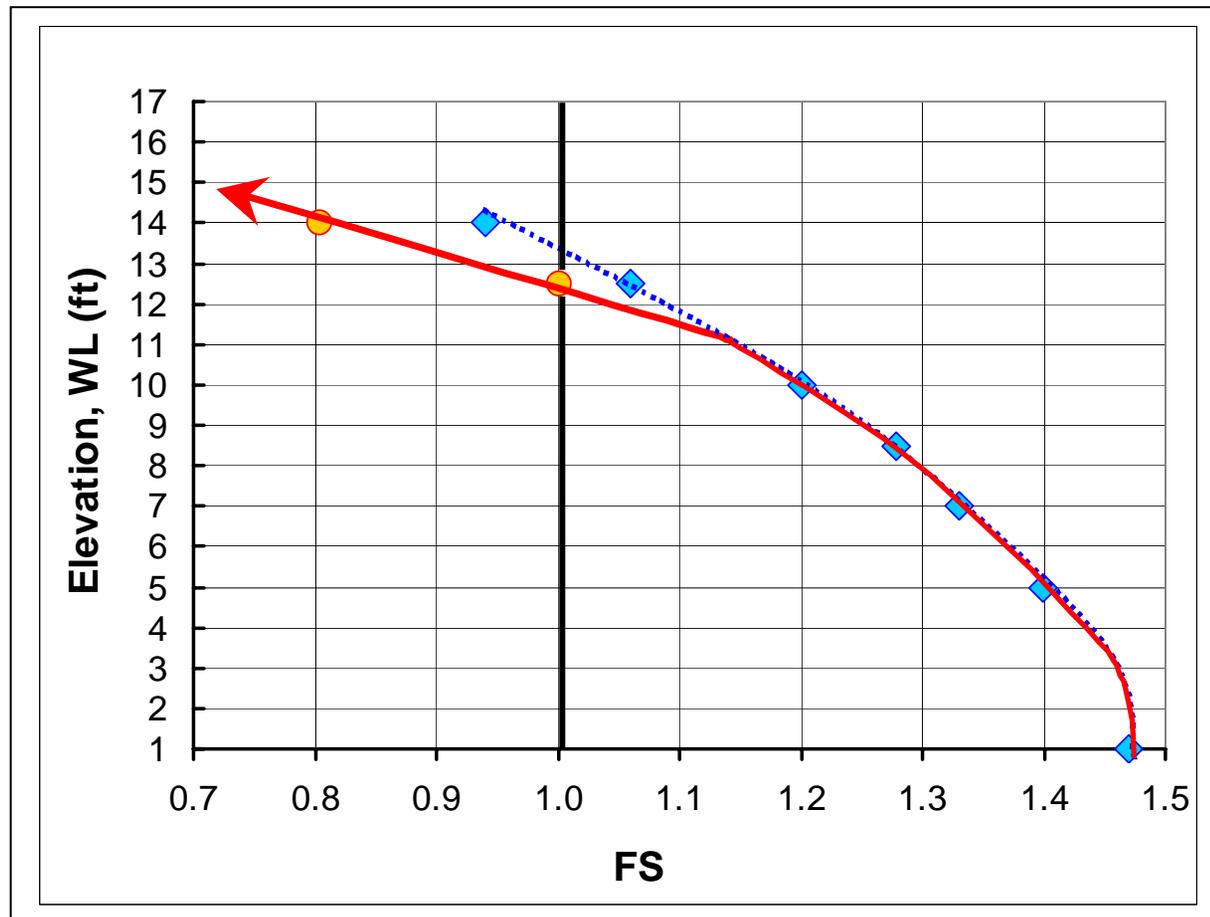
**Figure 6.32:** Calculated Factors of Safety for two modes based on PLAXIS analyses of the Lower Ninth Ward South breach site (east bank IHNC) for various canal water elevations; showing the best-estimated path to failure.

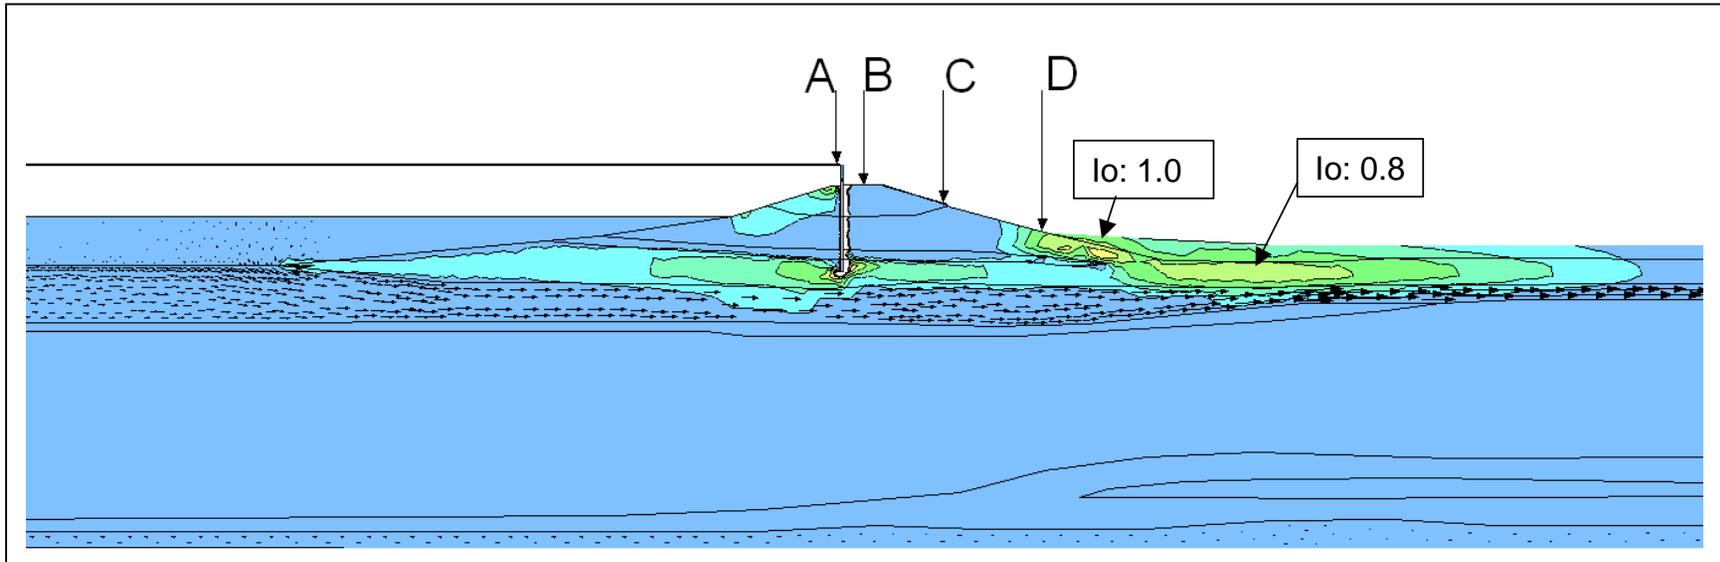
Figure 6.37: Hydraulic gradients for the south breach on IHNC east bank; storm surge at 14.4ft (MSL). Maximum exit gradient at the levee toe is  $i_o \approx 0.8$  to 1.0.

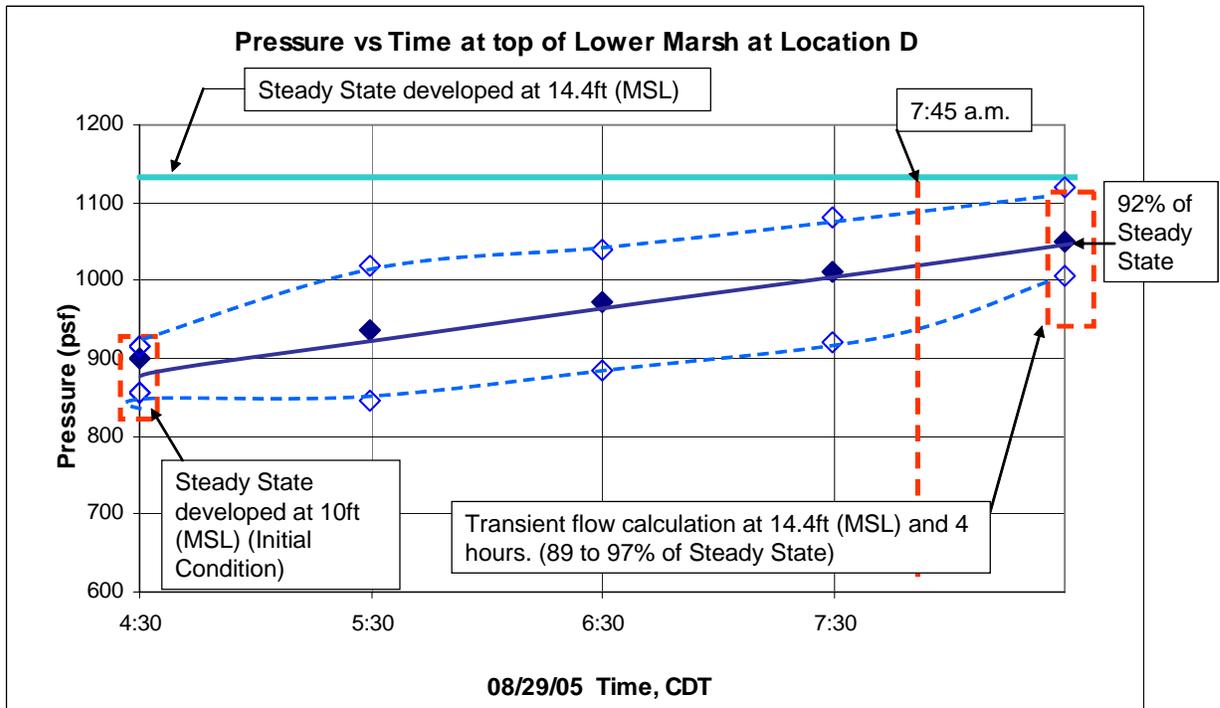
Figure 6.38: Transient flow pore pressure generation for the south breach on IHNC east bank.

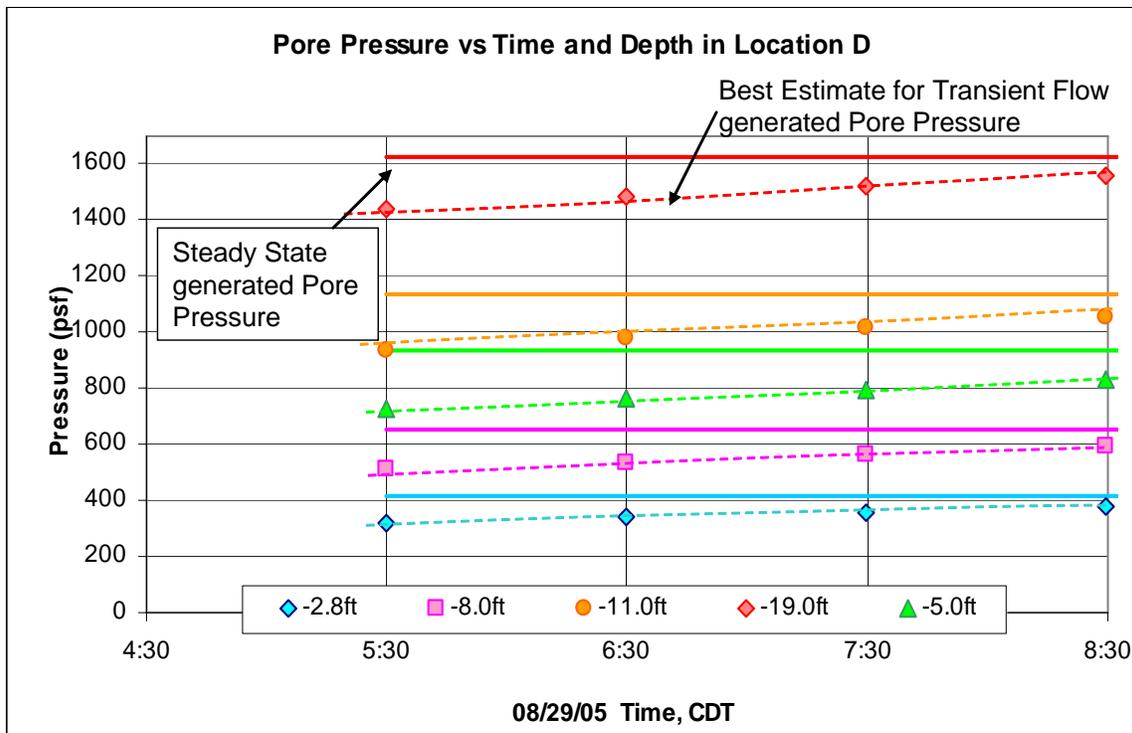
Figure 6.39: Pore pressure generation at different times and depths at the inboard toe of the south breach on IHNC east bank.

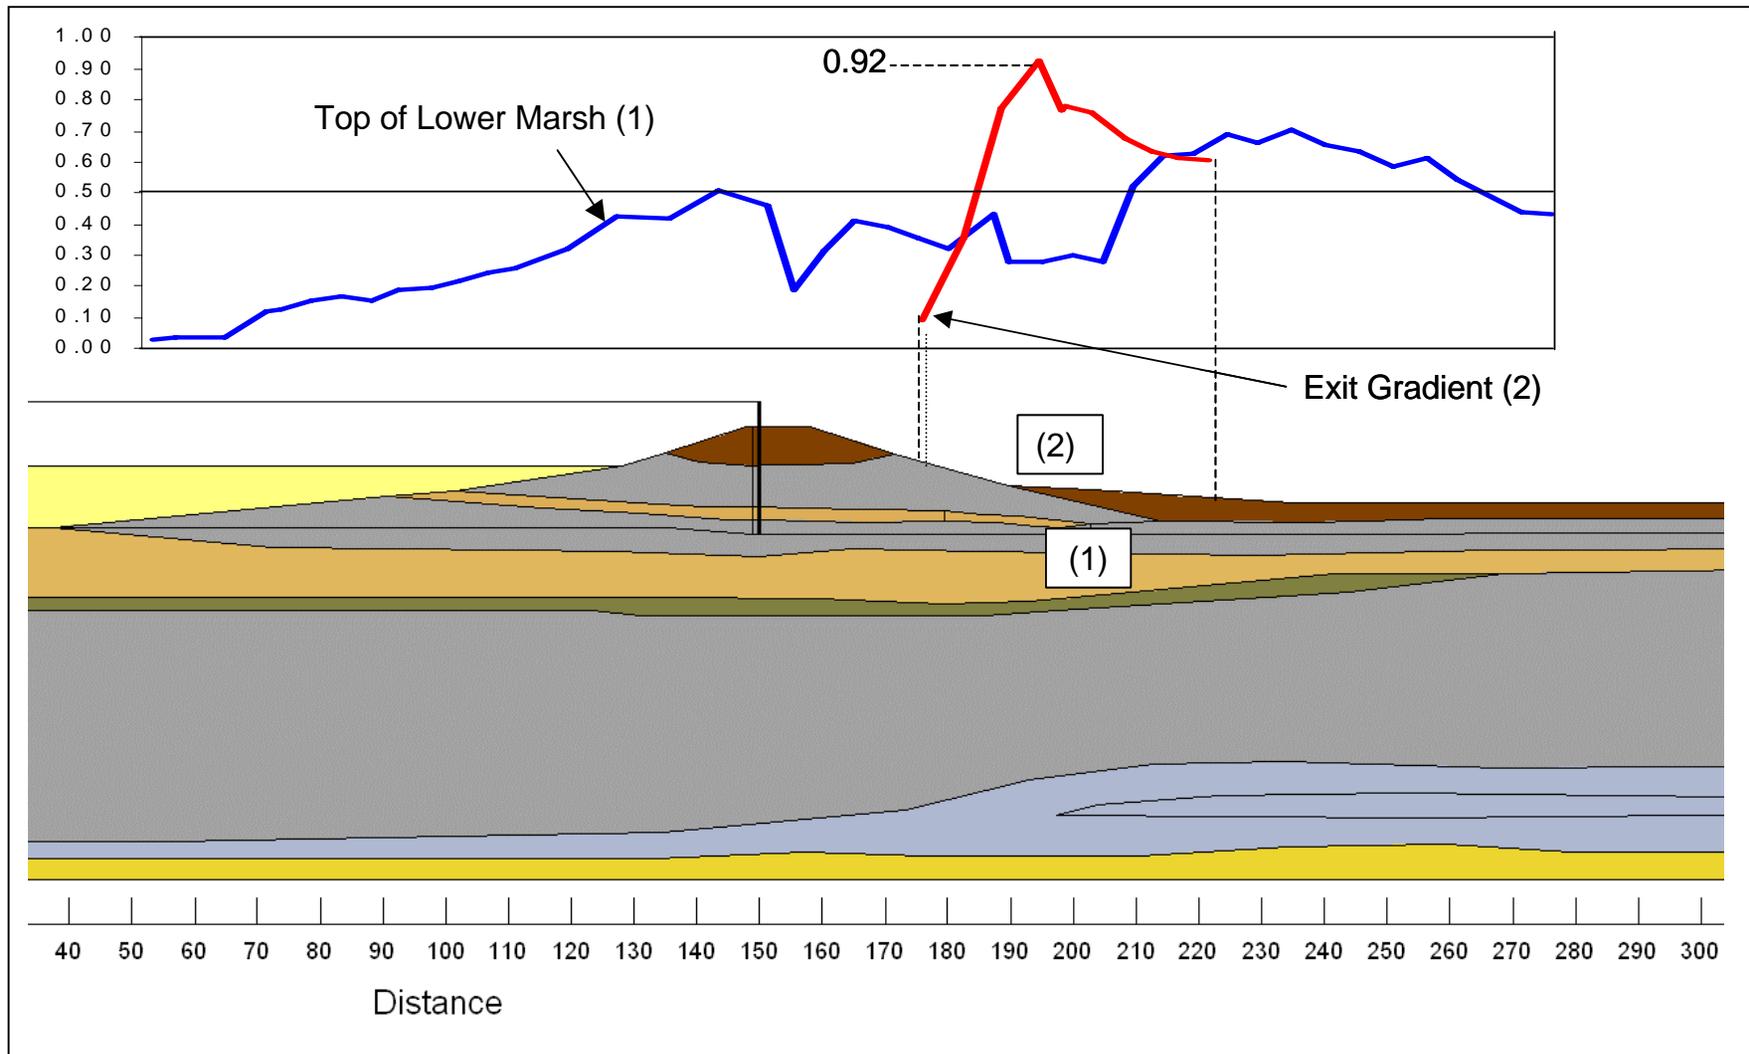
Figure 6.40: Hydraulic gradients at the south breach on IHNC east bank.

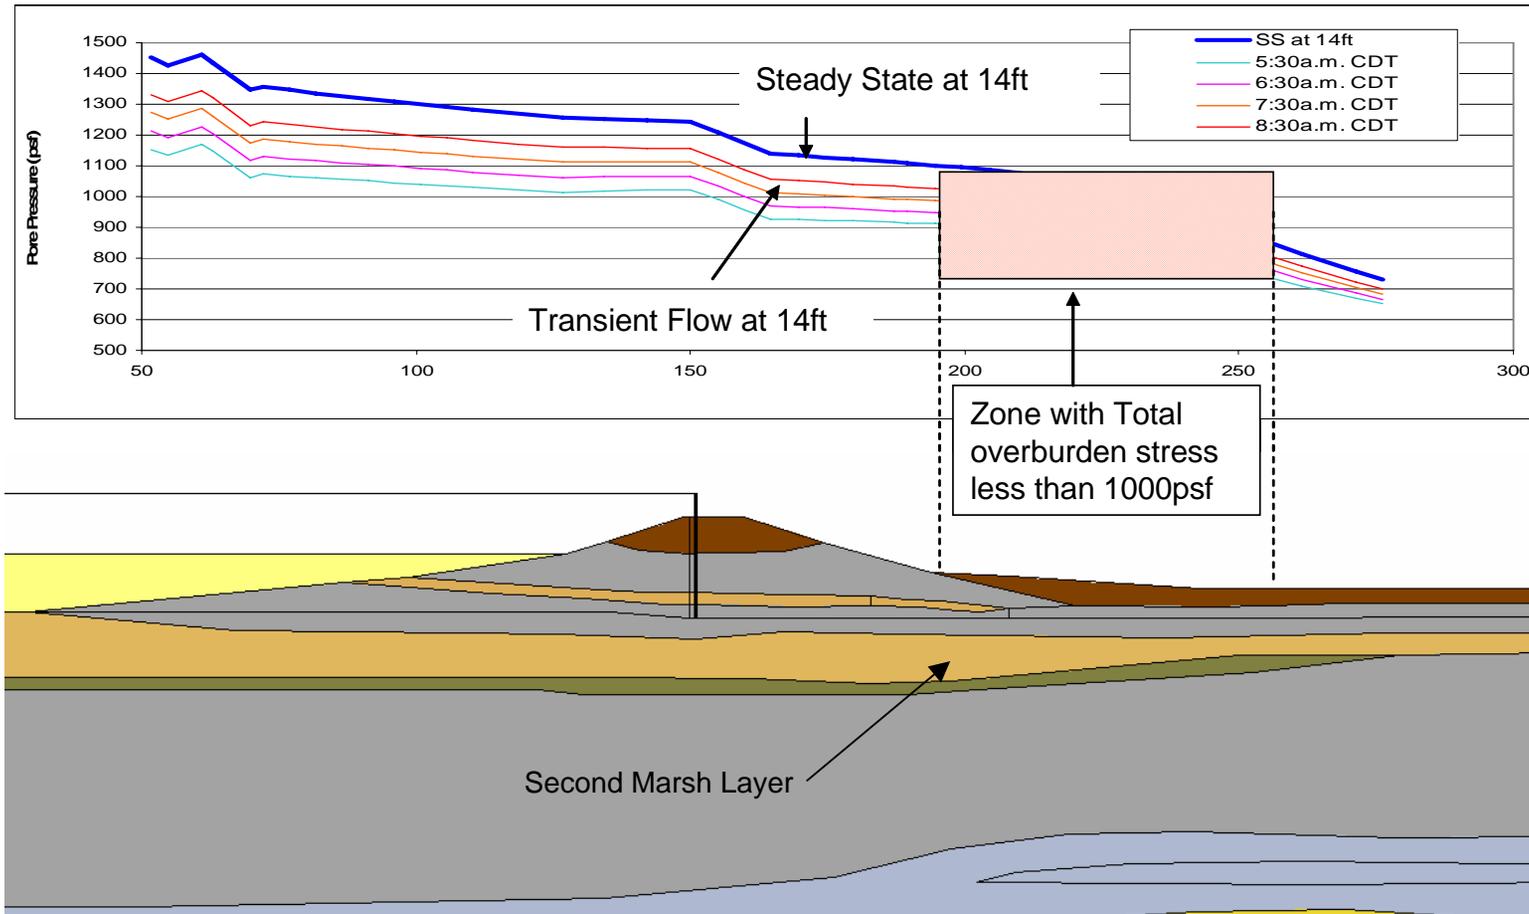
Figure 6.41: Pore pressure versus horizontal distance and time at the top of the second marsh layer; south breach on IHNC east bank.

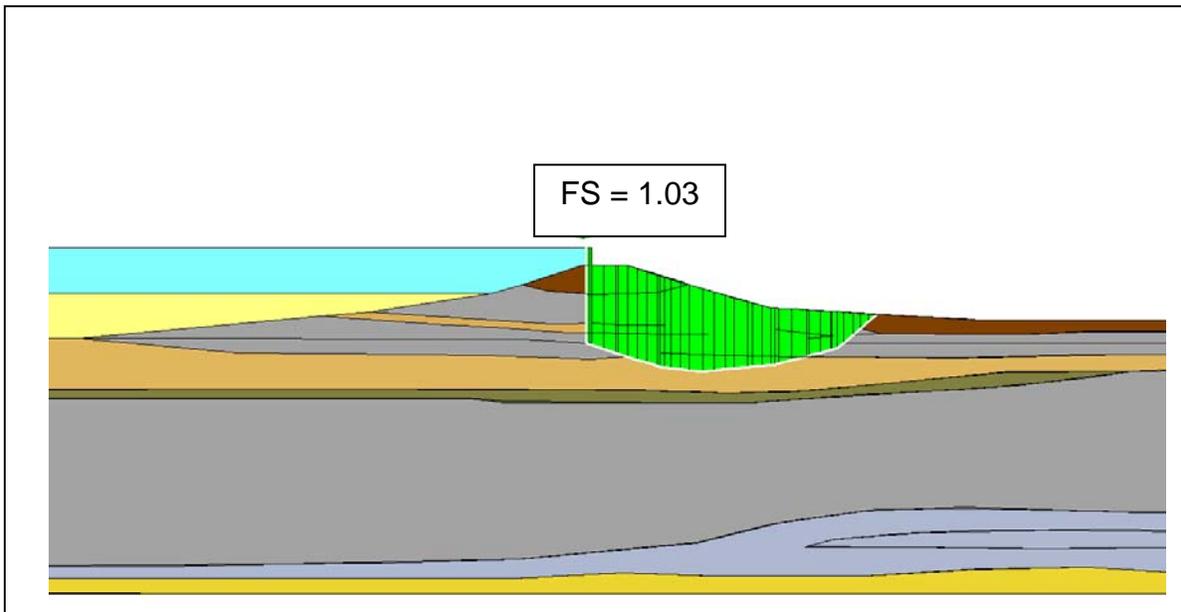
Figure 6.43: Deeper failure surface for the south breach on IHNCEast bank; storm surge at 14ft (MSL), gap at front of sheetpiles fully developed.

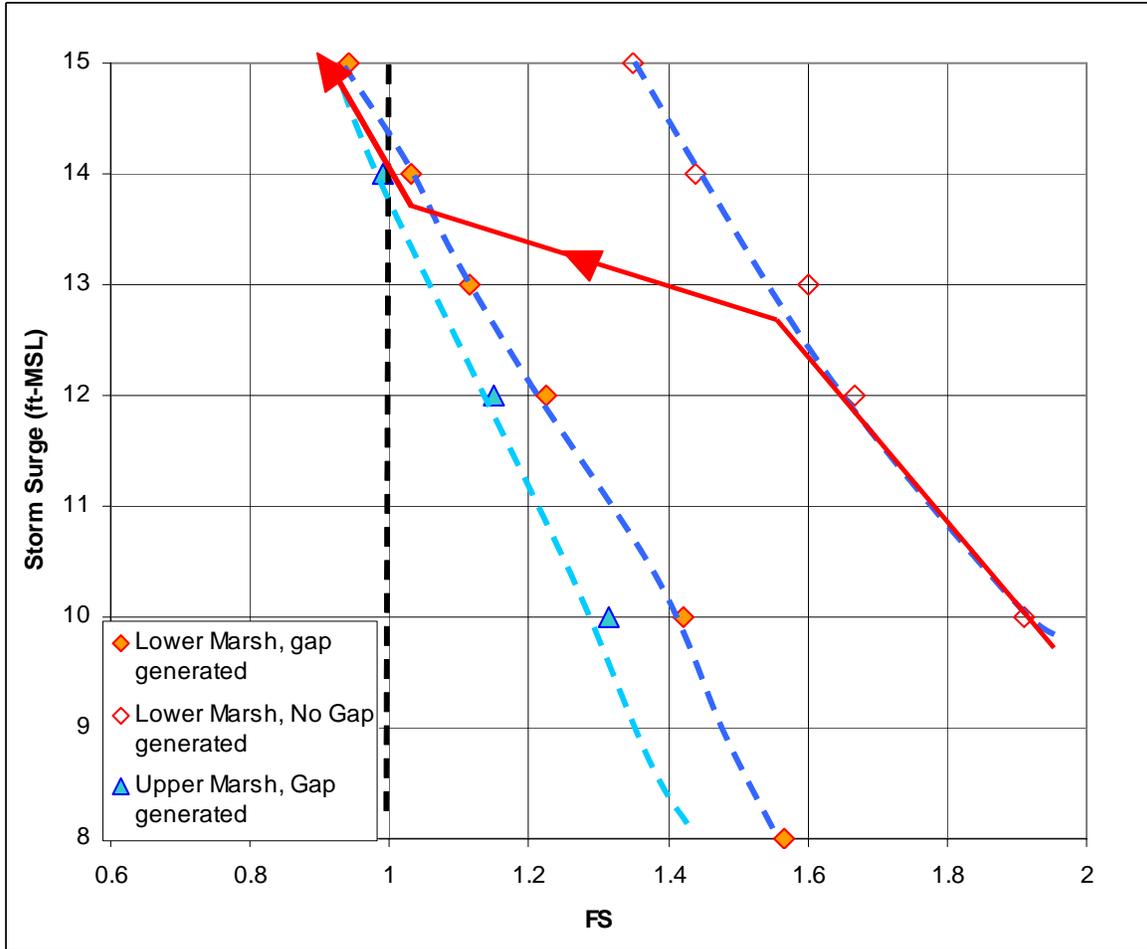
Figure 6.44: Calculated Factors of Safety for three modes based on SLOPE/W analyses of the Lower Ninth Ward South breach site (east bank IHNC) for various canal water elevations; showing the best-estimated path to failure.
