# Investigation of the Performance of the New Orleans Flood Protection Systems in Hurricane Katrina on August 29, 2005

## Volume I: Main Text and Executive Summary

**Final Report**  
**July 31, 2006**

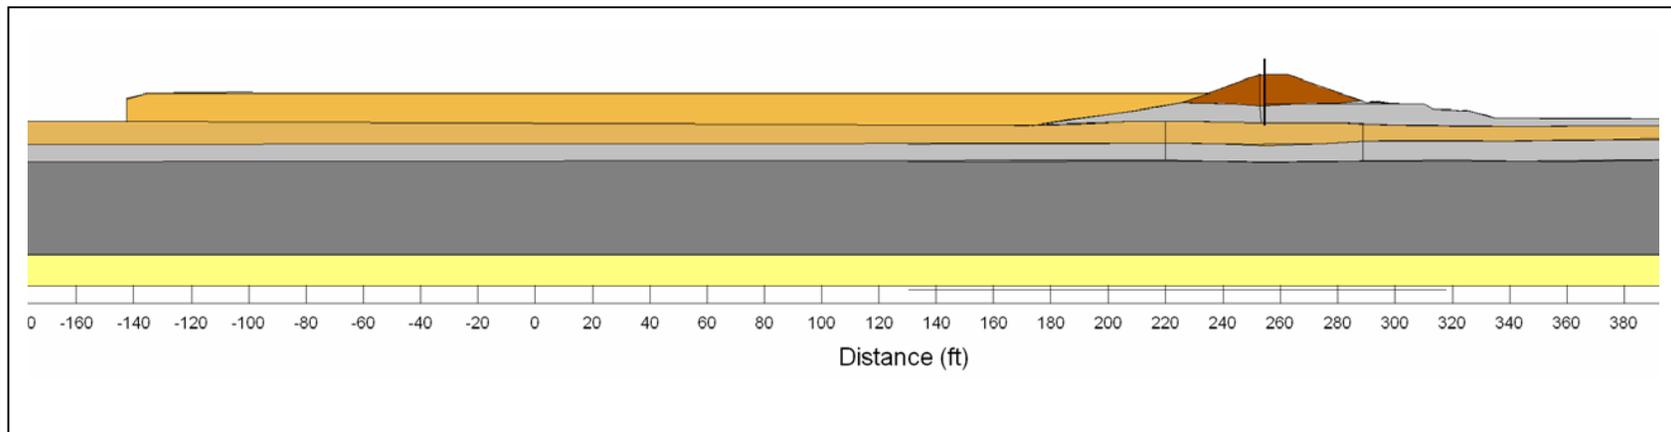
Figure 6.47: Geotechnical cross-section for analysis of the IHNC east bank, north breach.

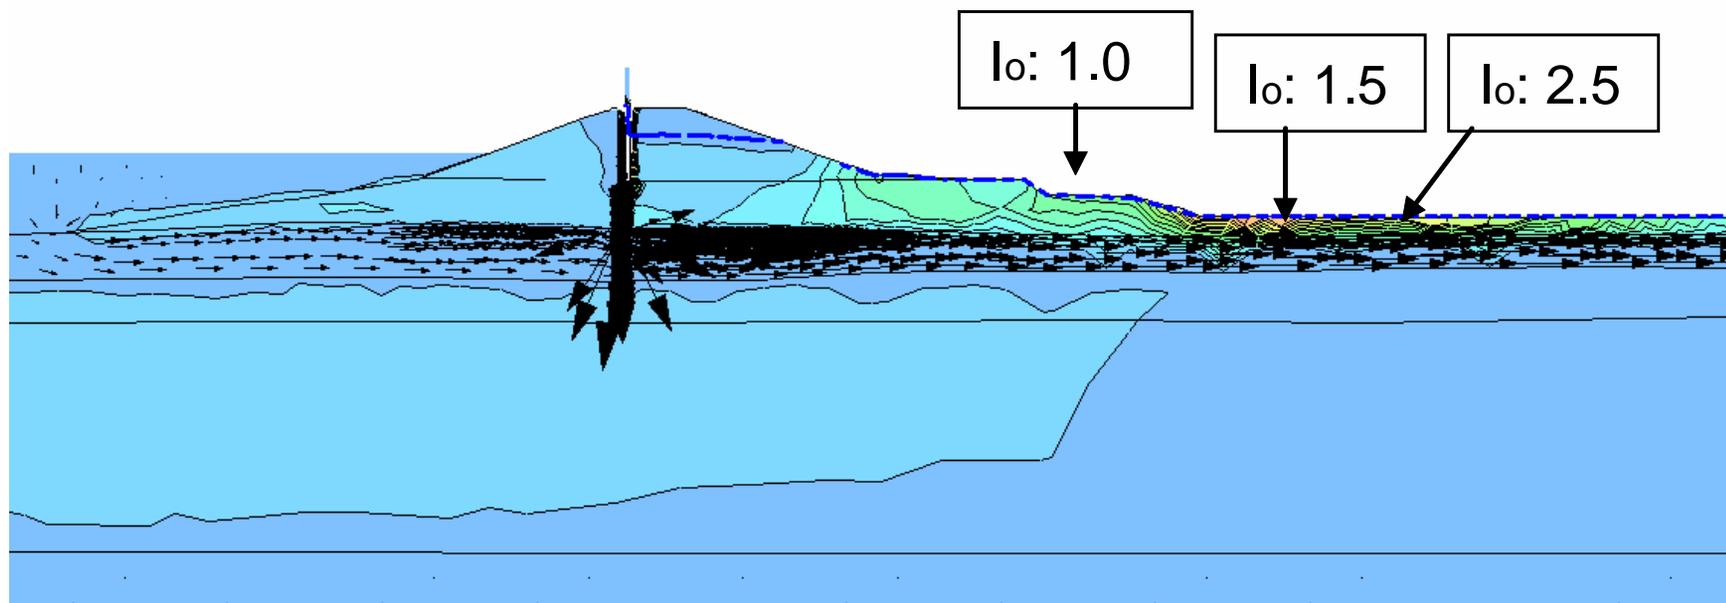
Figure 6.51: Hydraulic gradients for the north breach on IHNC. Storm surge at +14.4ft (MSL). Maximum exit gradient on the upper levee toe is  $i_o \approx 1.0$ , and  $i_o \approx 1.5$  to 2.5 at the lower toe.

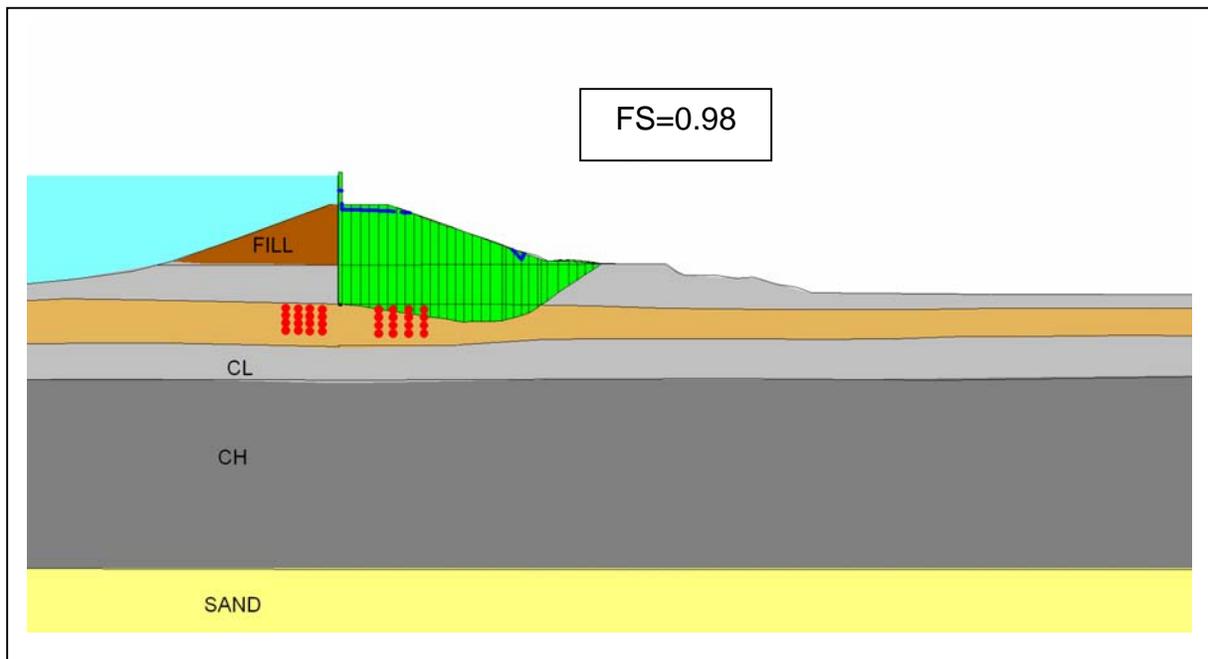
Figure 6.52: Critical potential stability failure surface for the north breach on IHNC. Storm surge at +14 ft (MSL).

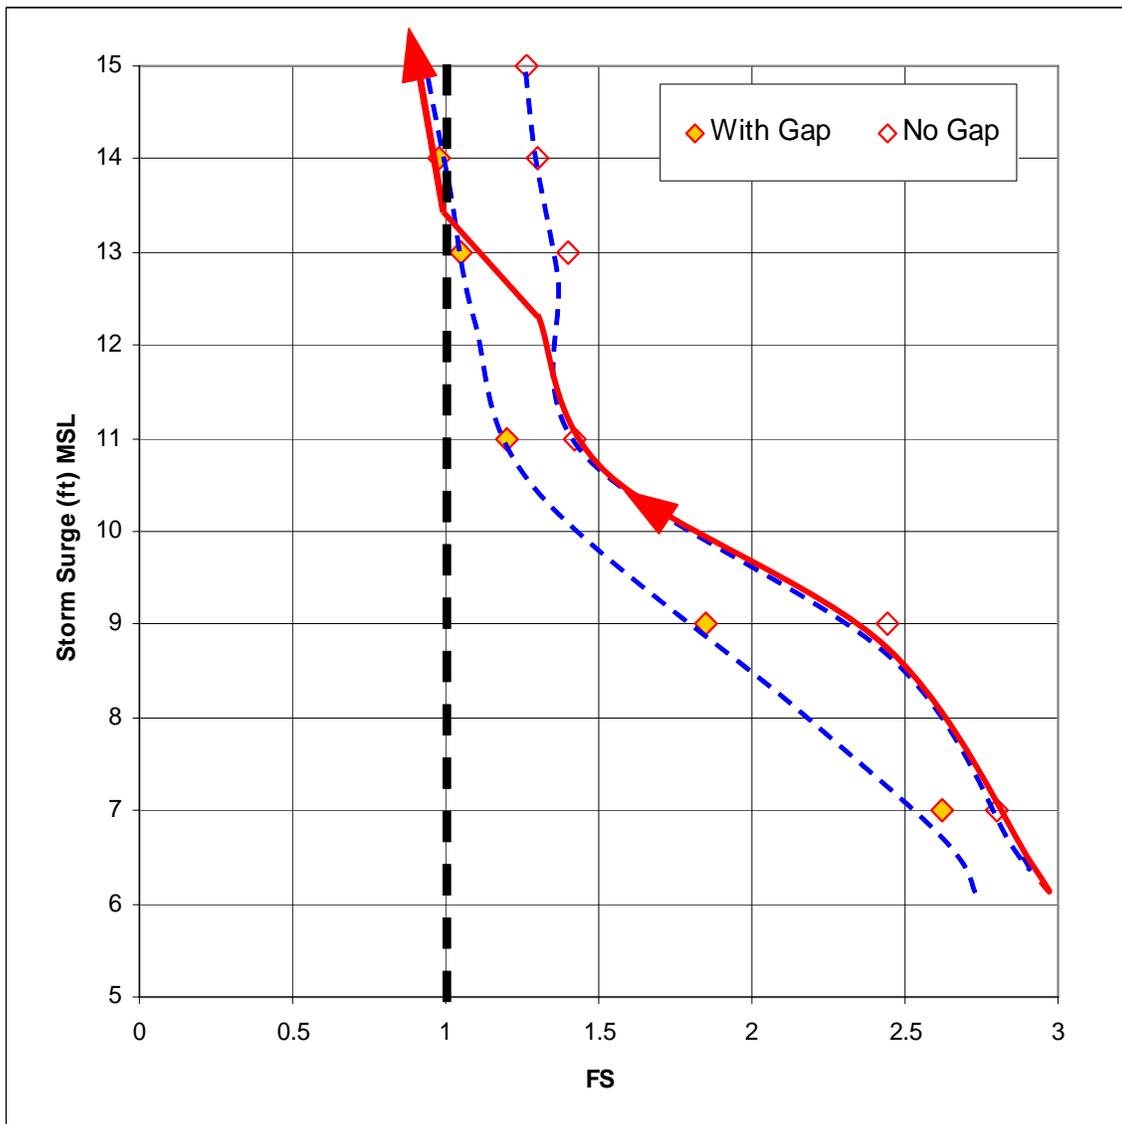
Figure 6.57: Factor of Safety vs. water elevation (ft, MSL) for the north breach, east bank of the IHNC at the west end of the Lower Ninth Ward.

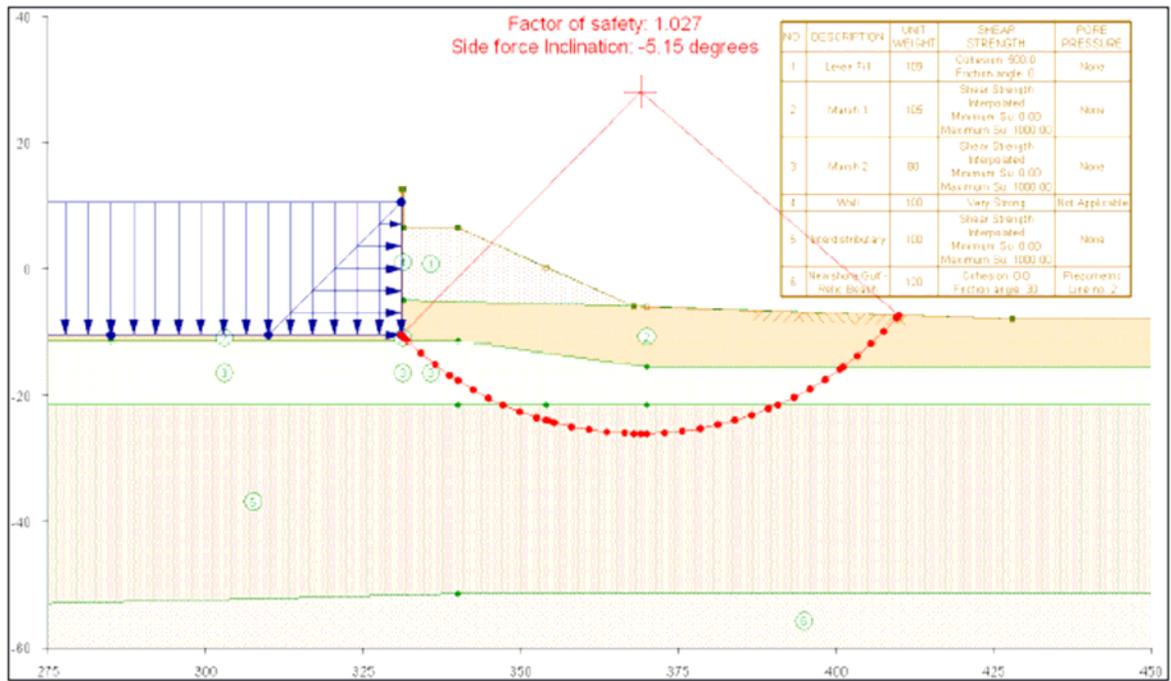
Figure 6.59: Critical limit equilibrium stability failure mode from IPET Draft Final Report; canal water elevation at +9 feet (MSL). Factor of Safety: 1.03.

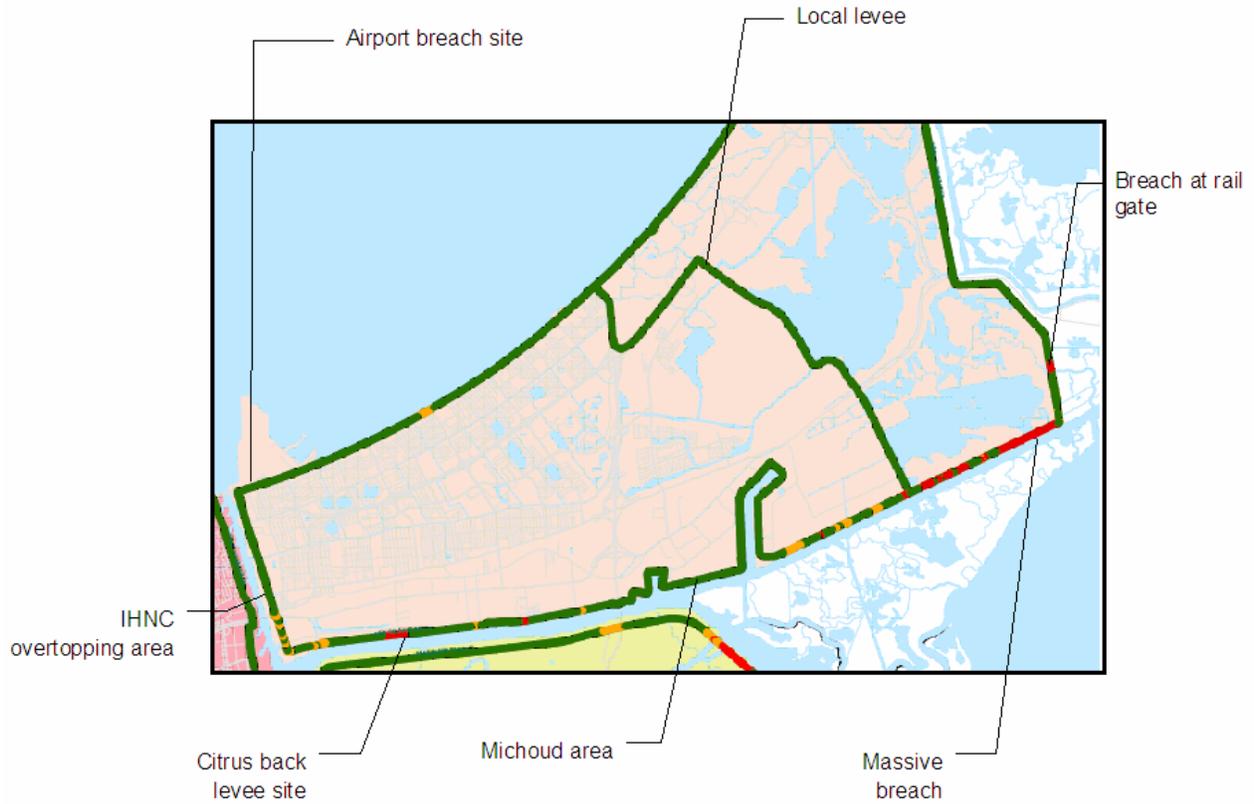
Figures 7.1 and 7.2 show the locations of damage to the levee system surrounding the New Orleans East (NOE) protected area. The most significant damage to the system occurred to East Back Levee that fronts the GIWW and Lake Borgne. Here the storm surge completely destroyed (and massively eroded) large expanses of earthen levee in the southeastern corner of the NOE protected area. Additional smaller, but nevertheless significant breaches also occurred along other portions of these NOE back levee reaches. As the storm surge next passed west two significant levee breaches occurred, both due to overtopping, along the north bank of the east-west trending channel of the GIWW/MRGO. Damage (mostly in the form of scour) also occurred along the IHNC East Levee and portions of the New Orleans Lakefront Levee located near the Lakefront Airport as the storm surge raised the water levels within the IHNC. Finally, the reverse (counterclockwise) swirl of the storm winds raised the levels along the south shore of Lake Pontchartrain. Portions of the levee system fronting Lake Pontchartrain, such as the New Orleans Lakefront, Citrus Lakefront, and New Orleans East Lakefront Levees, generally performed well in the hurricane, as did most of the New Orleans East Levee located to the east.

**Figure 7.2:** Damage locations in the NOE protected area (base map from USACE.) Color indicates severity of damage, with red being the worst. [IPET; March 10, 2006]

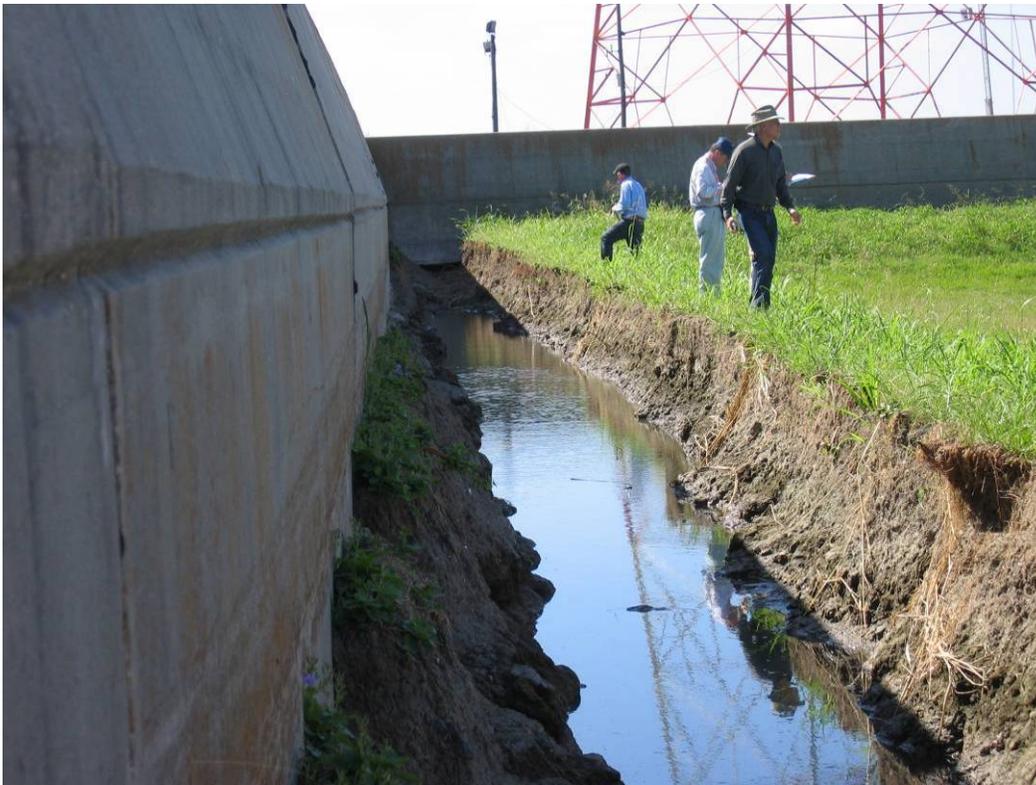
**Figure 7.11:** Scour at the base of floodwalls near the Michoud Canal.

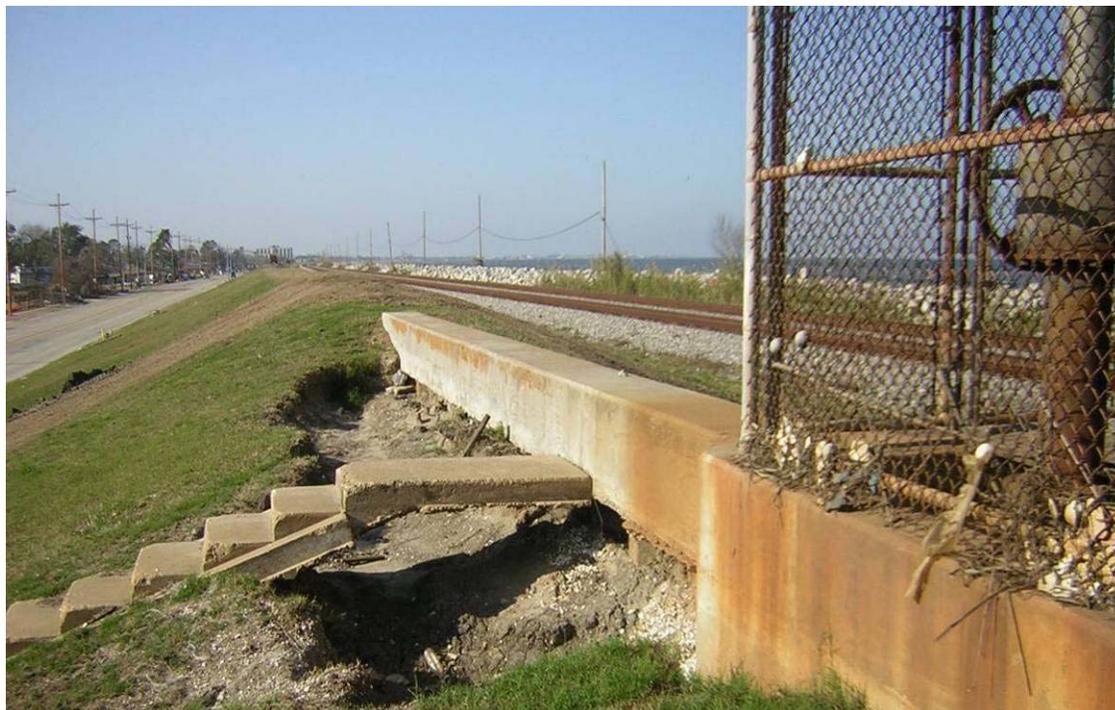
**Figure 7.28:** Observed scour at the Jahncke Pump Station outfall structure, Lakefront. Scour was limited to areas of soil-structure interfaces, and no full breach occurred.

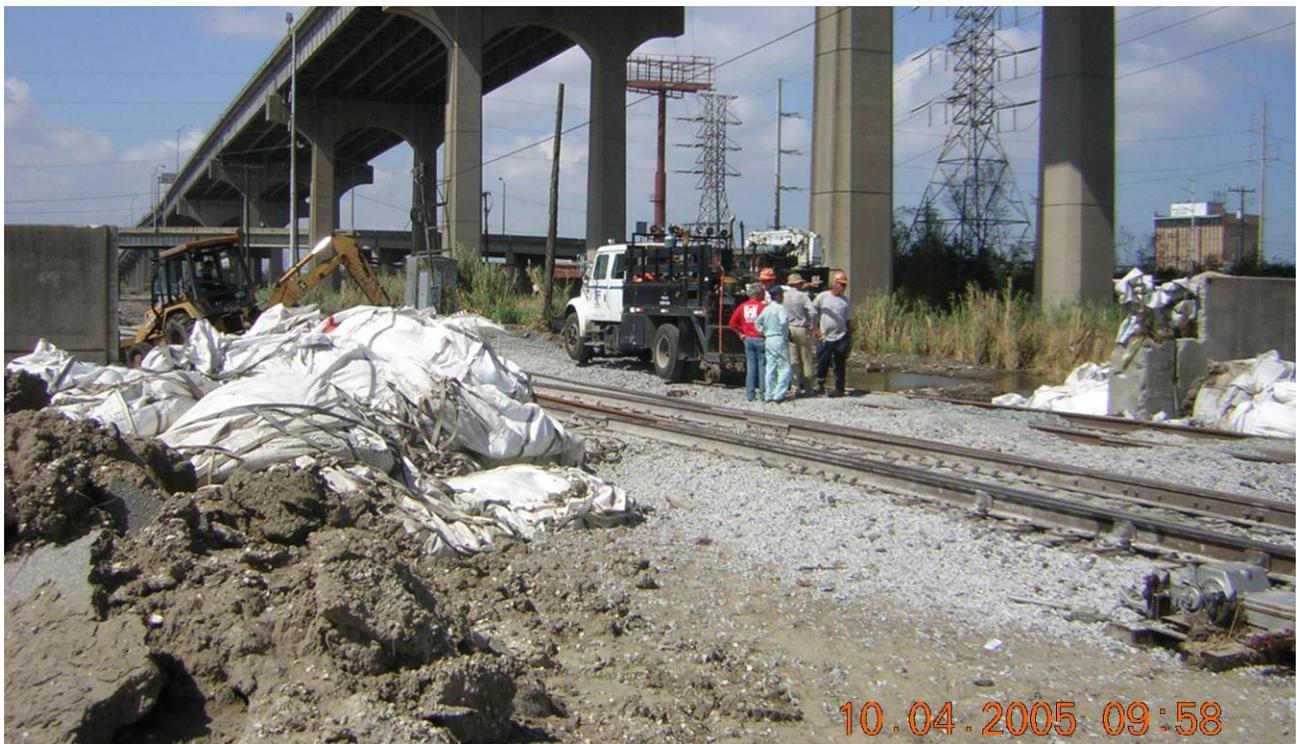
Figure 8.4: Concrete storm gate at the west bank of the CSX Railroad crossing of the IHNC, after Hurricane Katrina, showing the steel floodgate missing.

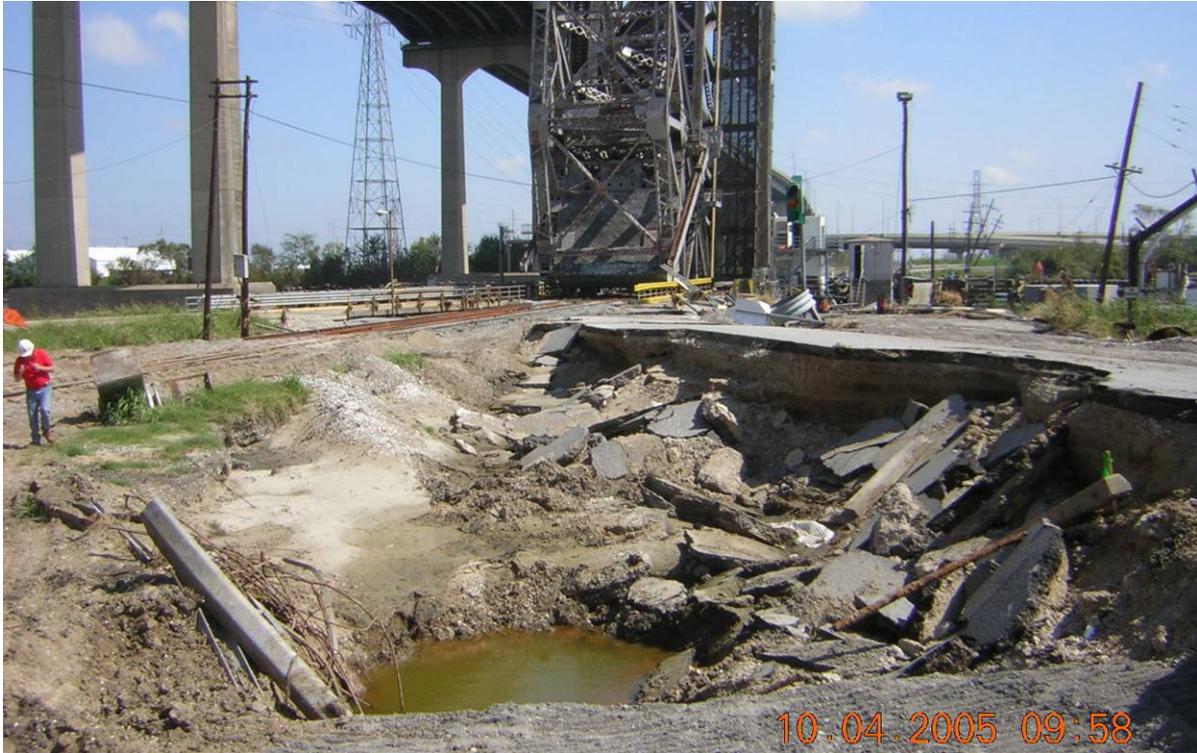
Figure 8.5: View from the inboard side of the CSX Railroad breach site from Figure 8.4 showing scour of the roadway fill adjacent to the railway embankment fill.

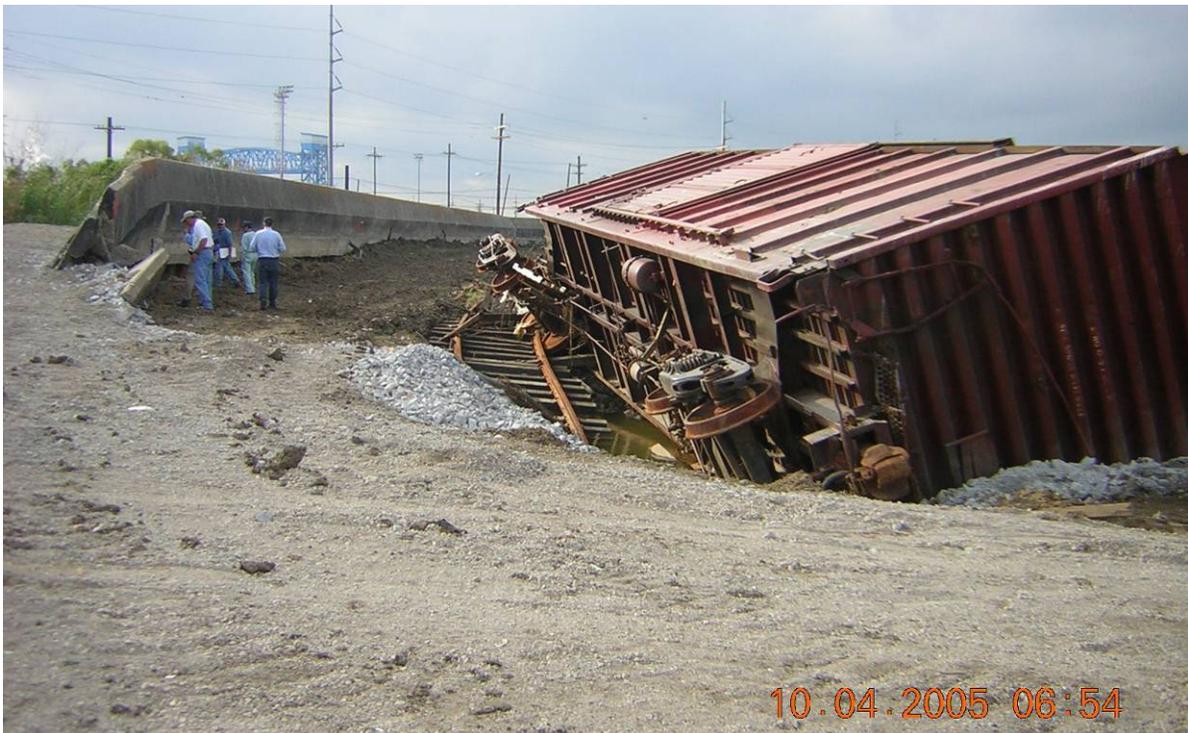
Figure 8.6: The I-wall section breach behind the Port of New Orleans, showing floodwall failure.

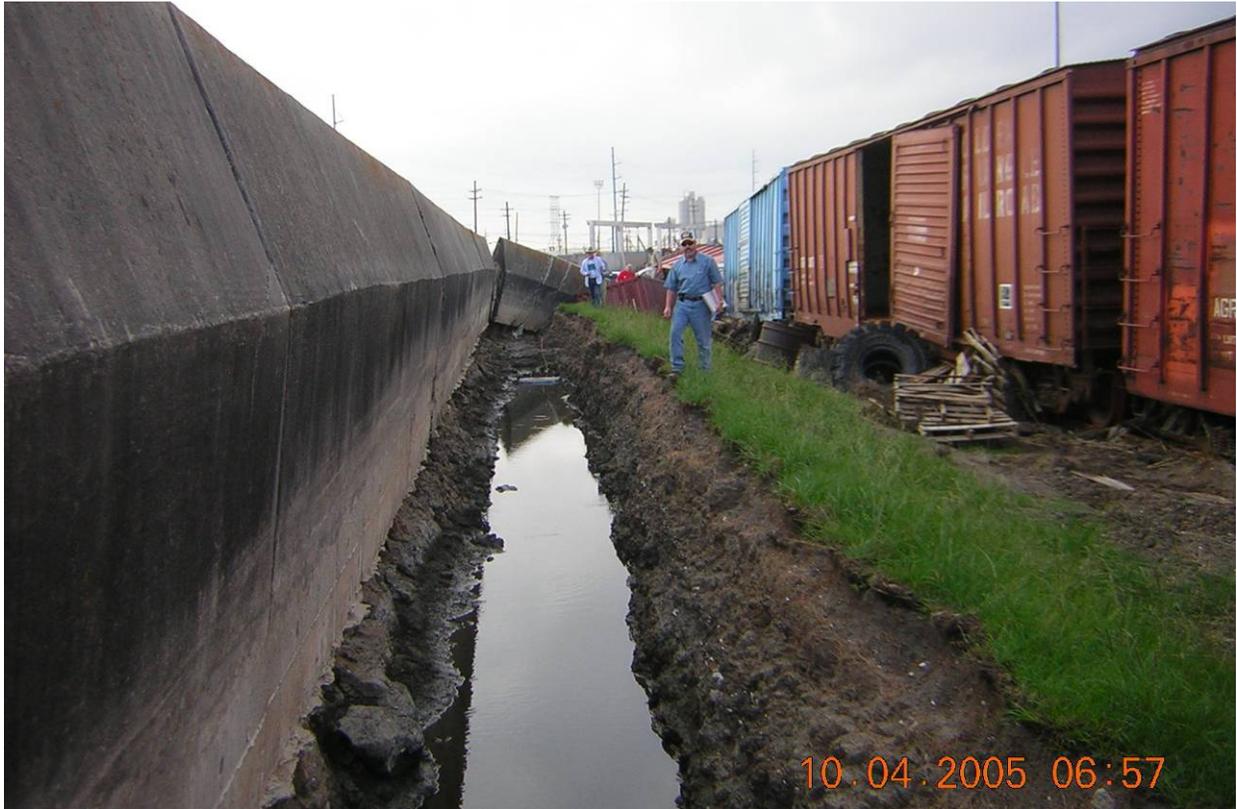
Figure 8.7: Second view of the I-wall failure at the Port of New Orleans showing the trench scoured by overtopping flows.

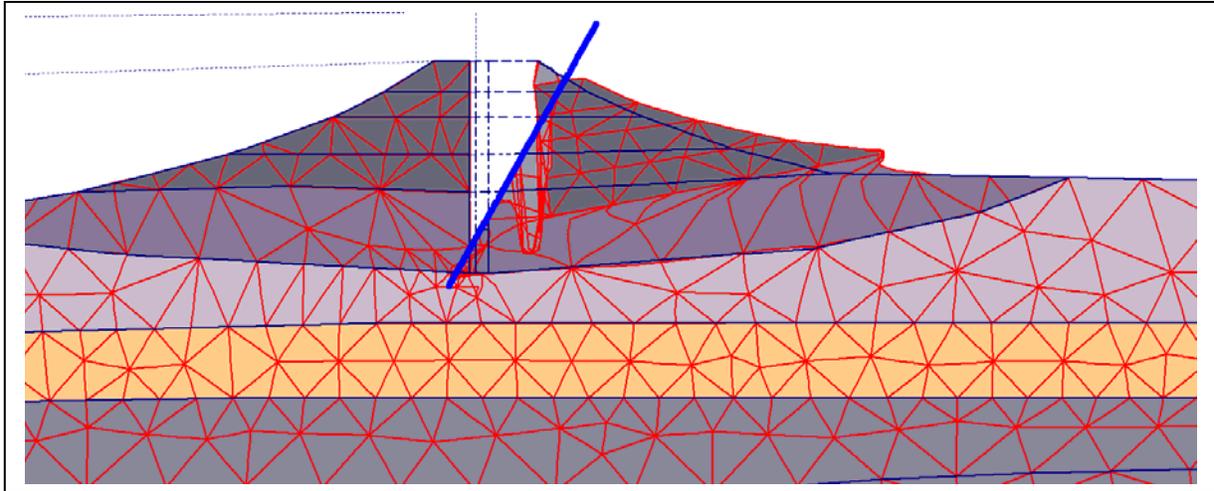
Figure 8.8: Deformed mesh of I-wall failure at the IHNC behind the Port of New Orleans.

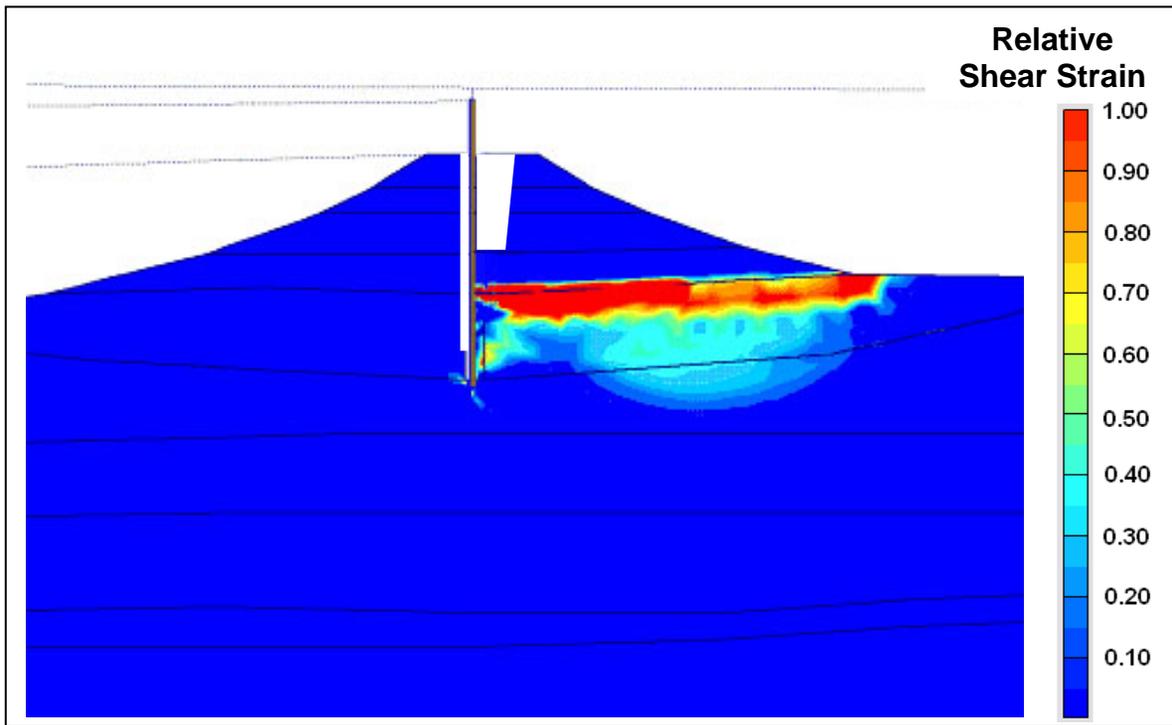
Figure 8.9: Finite element analysis of I-wall failure at the IHNC behind the Port of New Orleans, showing shear strain contours at point of wall failure.

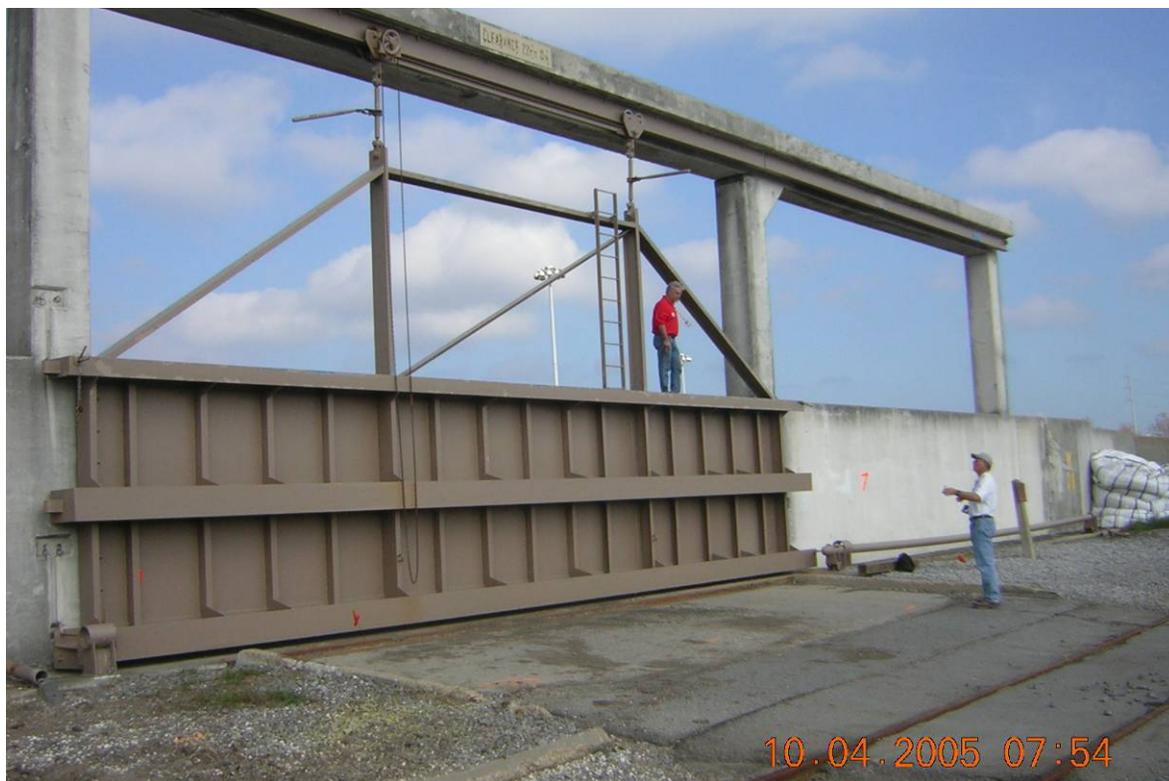
Figure 8.11: Concrete floodwall and steel floodgate structure at railroad yard behind the Port of New Orleans.

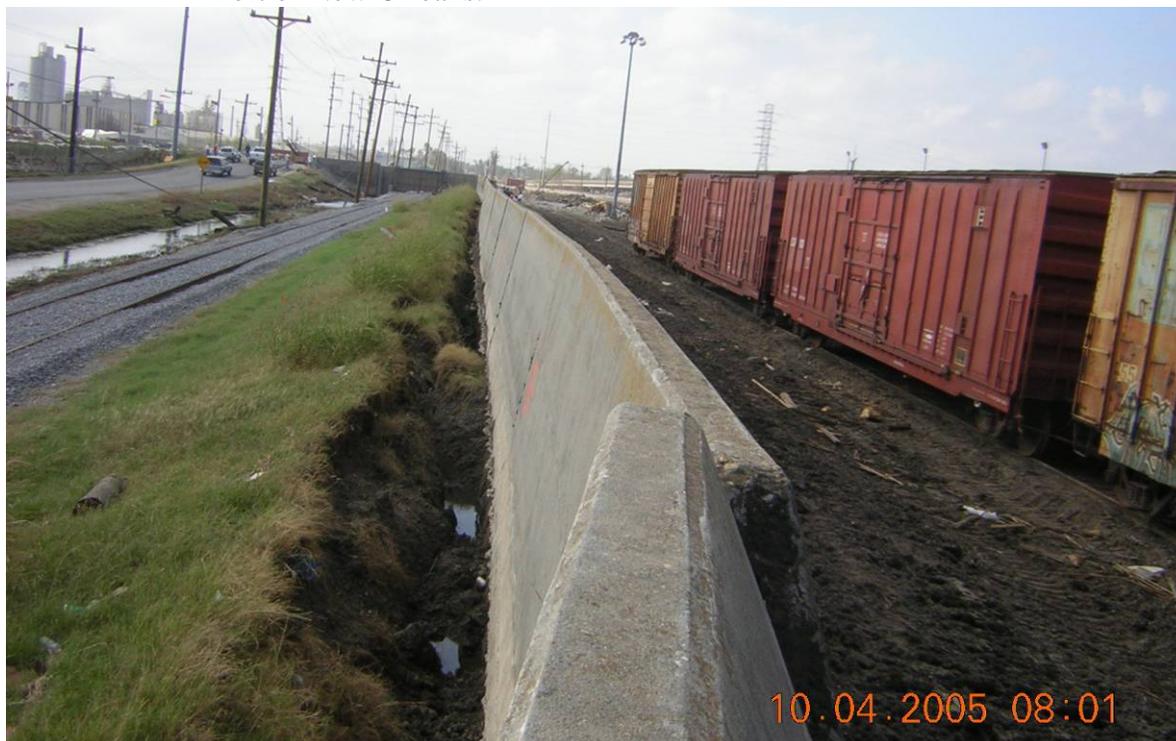
Figure 8.12: Erosion, gapping and offset of adjacent wall sections at the east end “transition” of the concrete floodwall and gate structure from Figure 8.11.

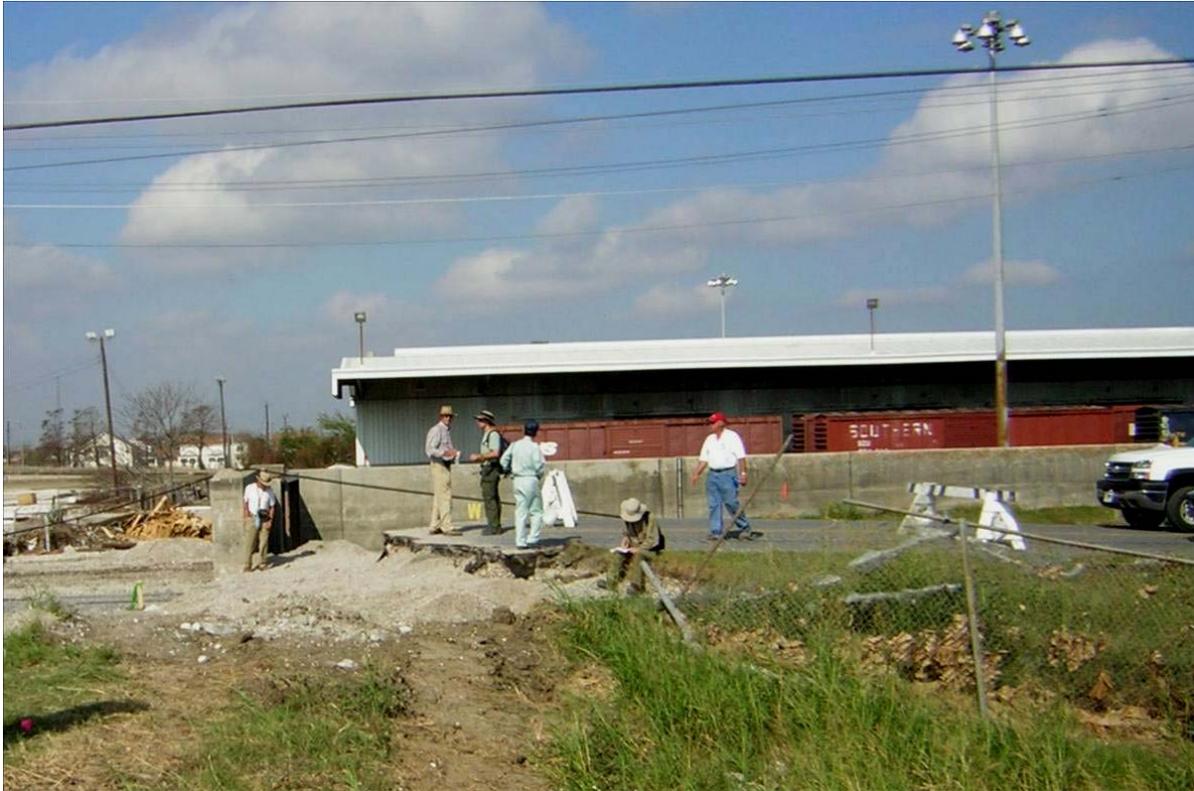
Figure 8.13: Erosional breach behind the southern end of the Port of New Orleans at contact between embankment section and structural concrete monolith.

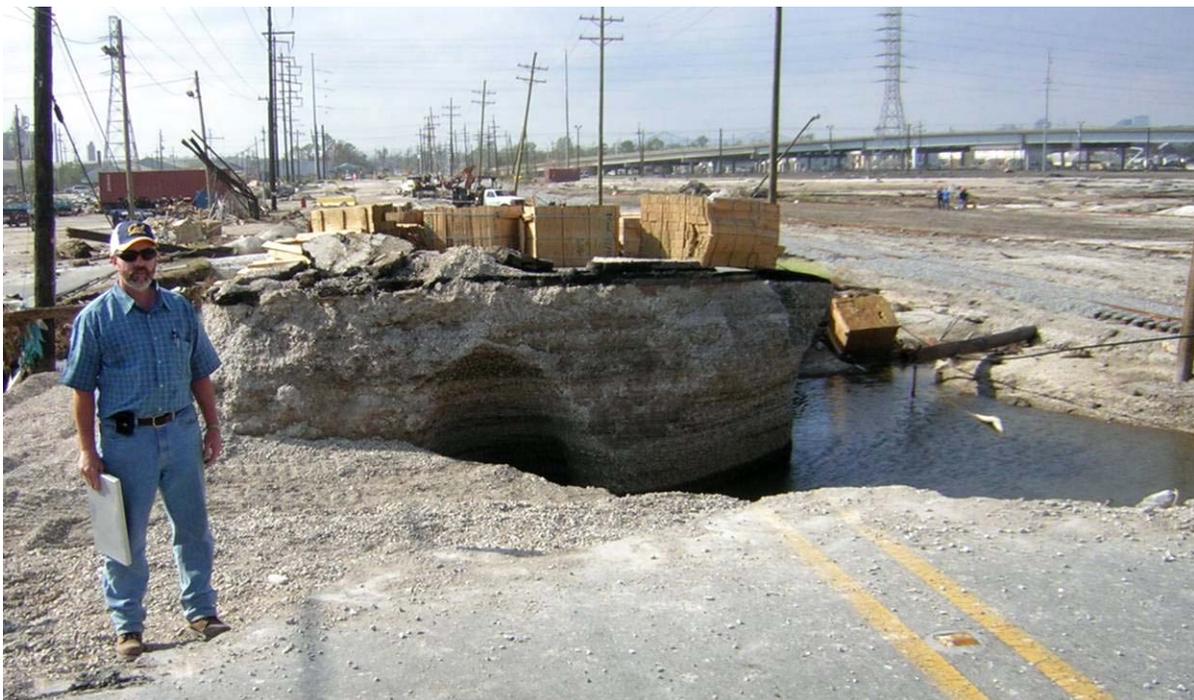
Figure 8.14: Close-up view of the highly erodeable shell sand fill at the breach shown above in Figure 8.12.

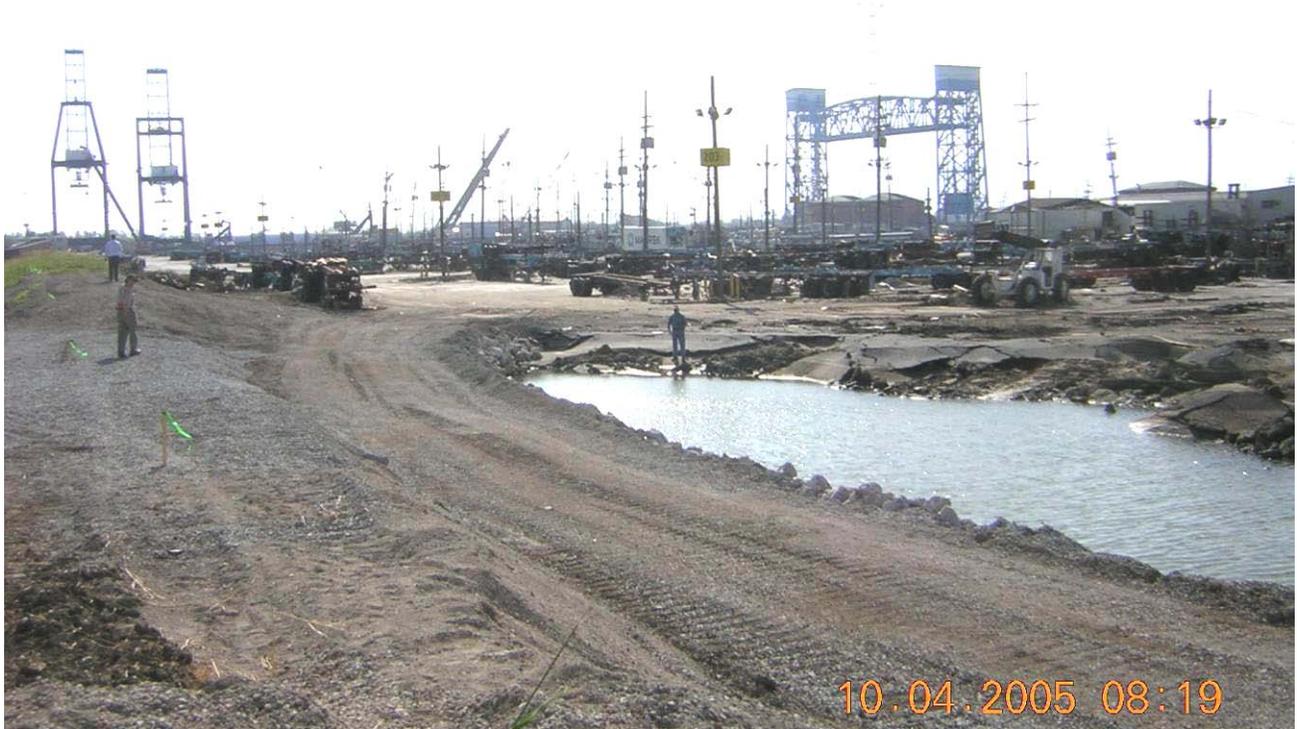
Figure 8.15: View of second large erosional breach behind the southern end of the Port of New Orleans.

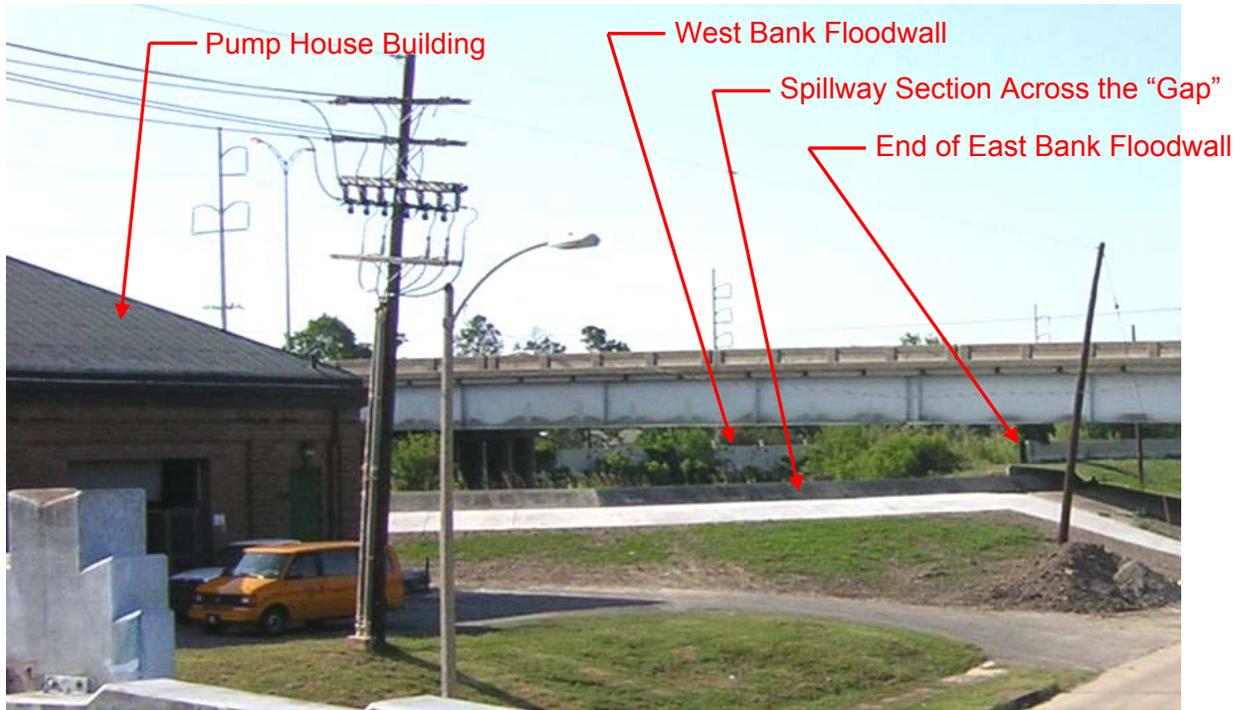
Figure 8.19: View of the pump house, levees and floodwalls, and the “gap” at the south end of the Orleans canal.

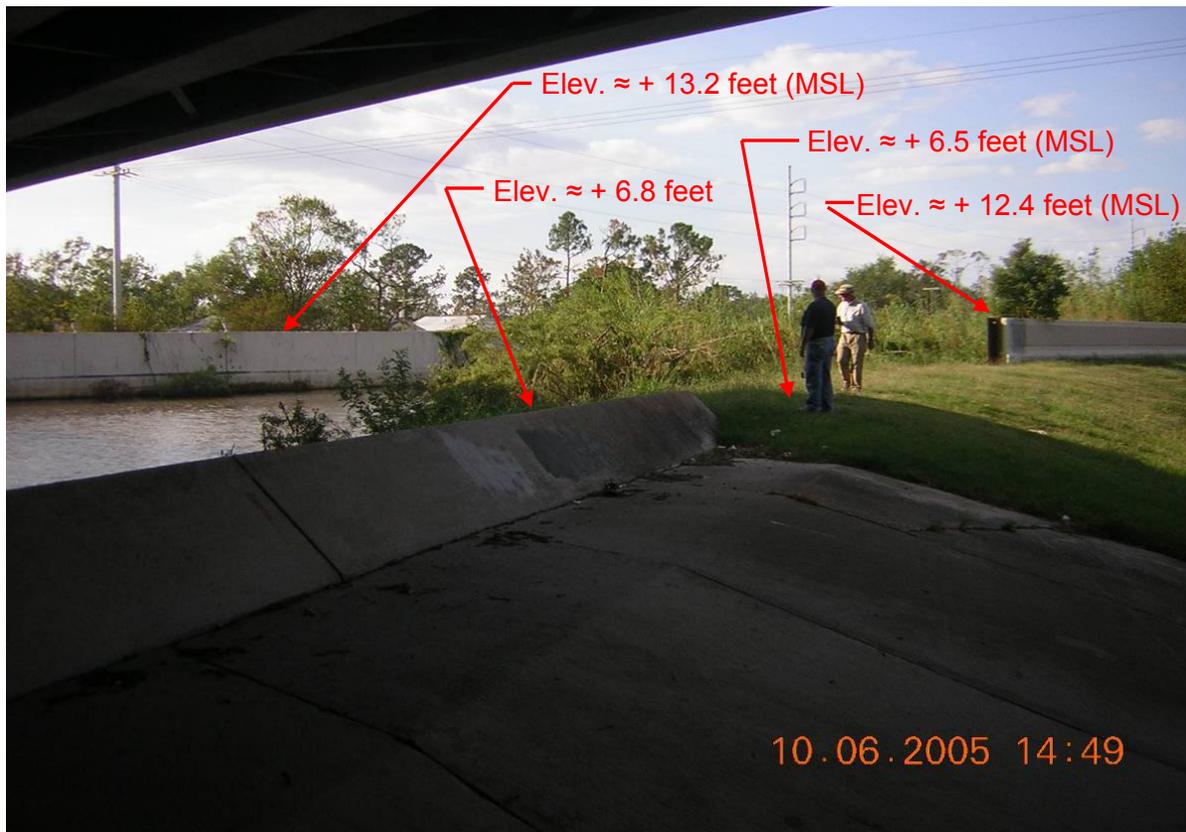
Figure 8.20: Side view of the “gap” at the south end of the Orleans canal.

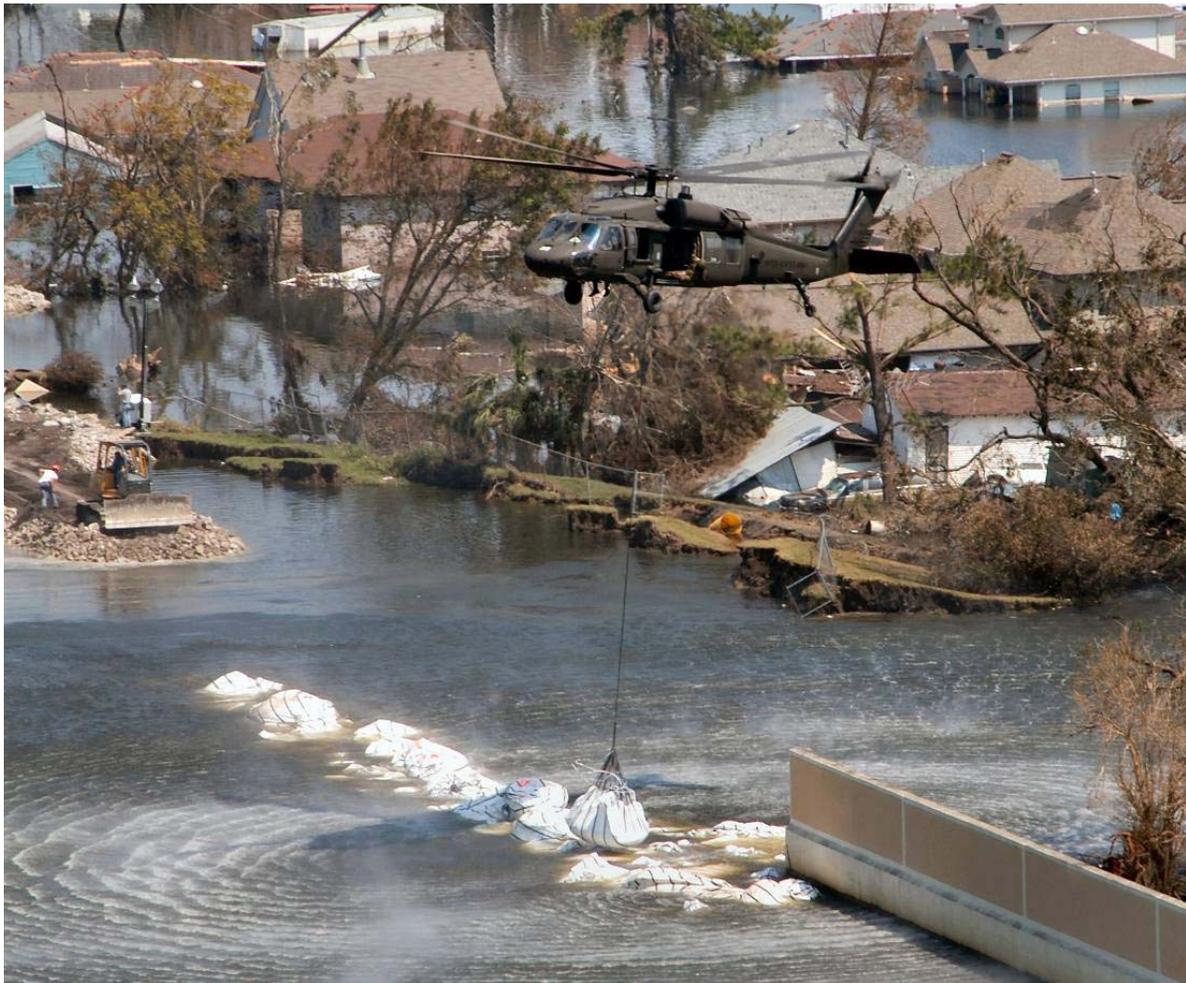
Figure 8.24: Oblique aerial view of the breach at the 17<sup>th</sup> Street Canal.

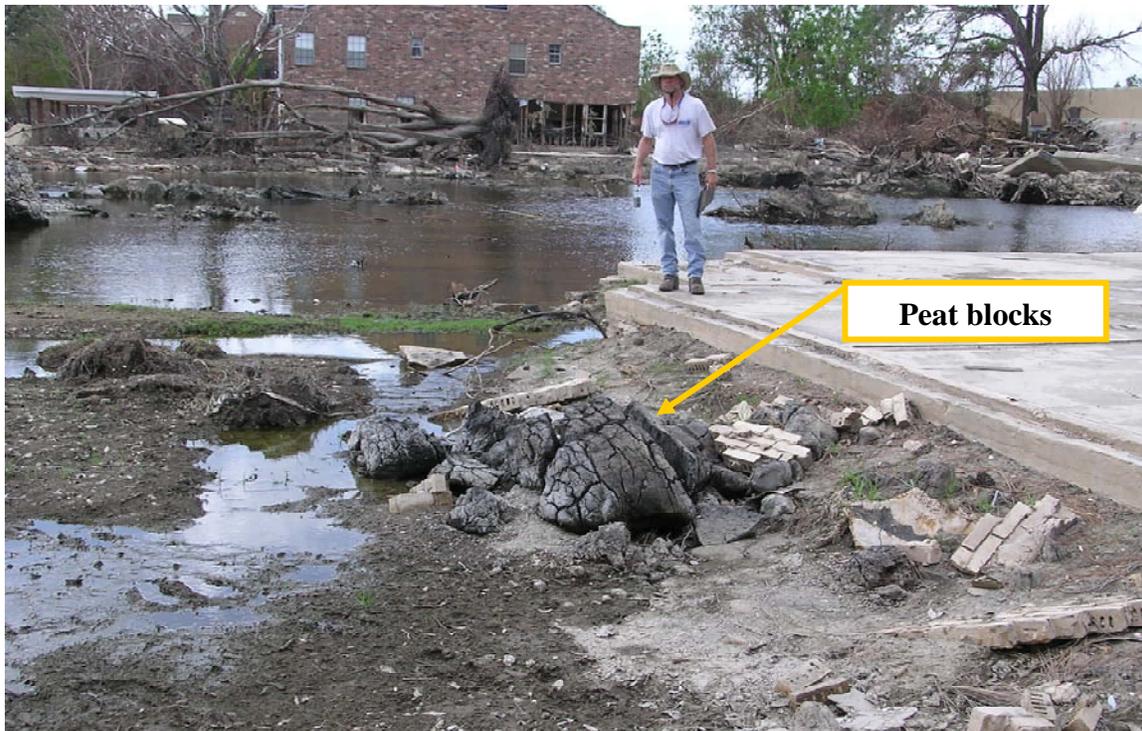
Figure 8.31: View of the foundation slab shown in the cross-section from Figure 8.27.

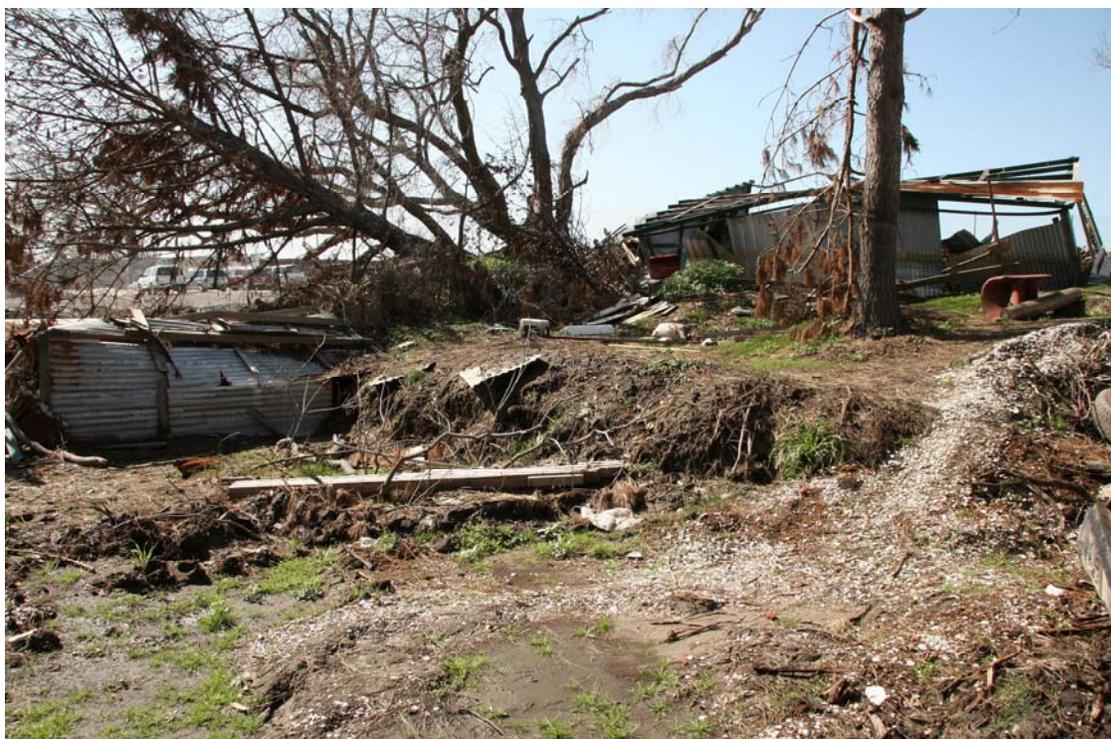
Figure 8.33: View of toe scarps No's. 2 and 3 at the inboard edge of the lateral translational failure at the 17<sup>th</sup> Street drainage canal.
