# Investigation of the Performance of the New Orleans Flood Protection Systems in Hurricane Katrina on August 29, 2005

## Volume I: Main Text and Executive Summary

**Final Report**  
**July 31, 2006**

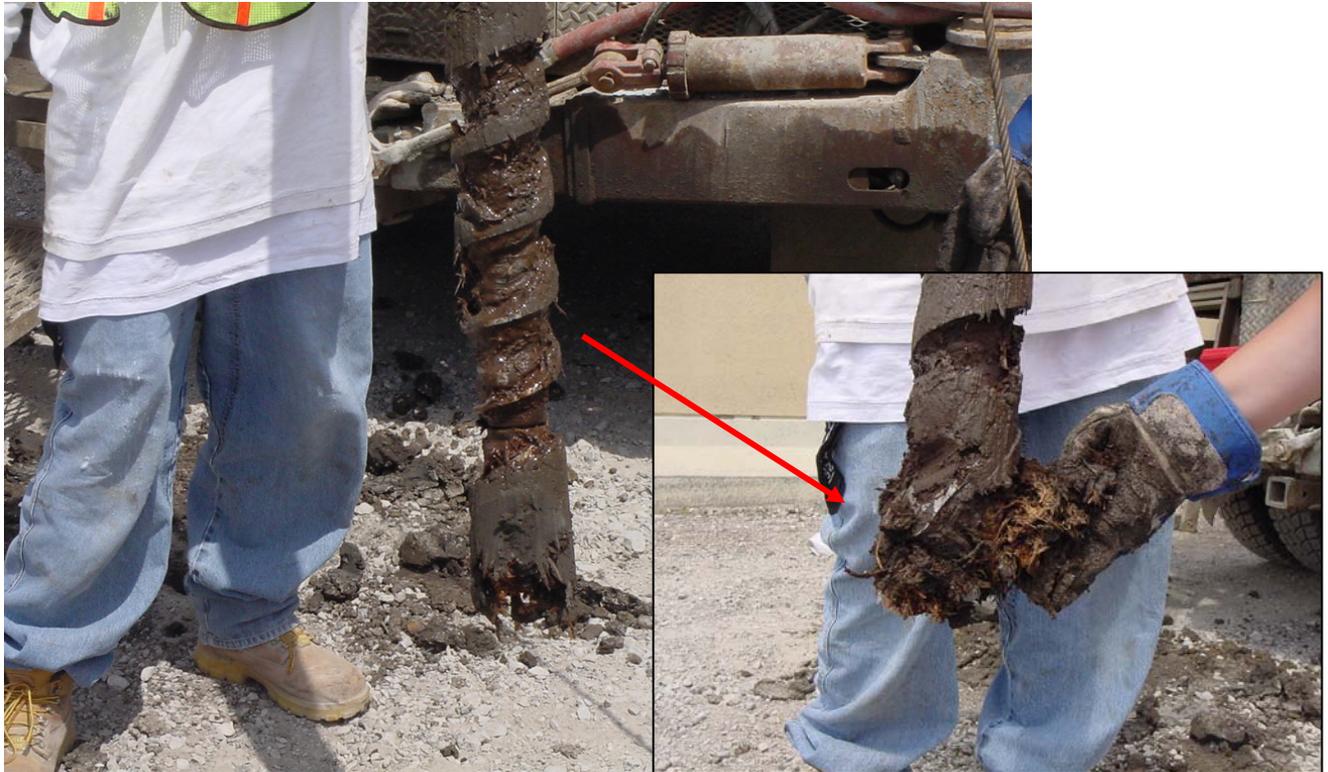
Figure 8.51: Shiny dark brown to black sensitive organic clay on auger stem and (inset) closeup view of leaves and twigs; 17<sup>th</sup> Street Canal breach site.

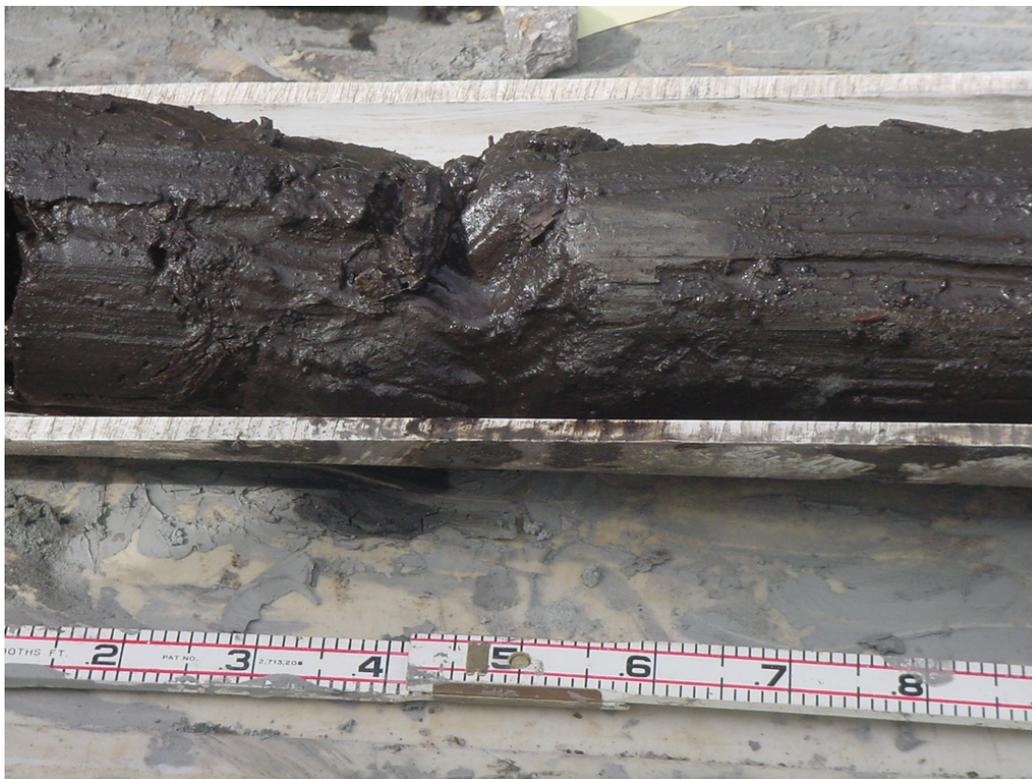
Figure 8.52: Shear zone within disturbed area, middle of 17<sup>th</sup> Street Canal breach, adjacent to displaced block at Elev. -9 feet (MSL).

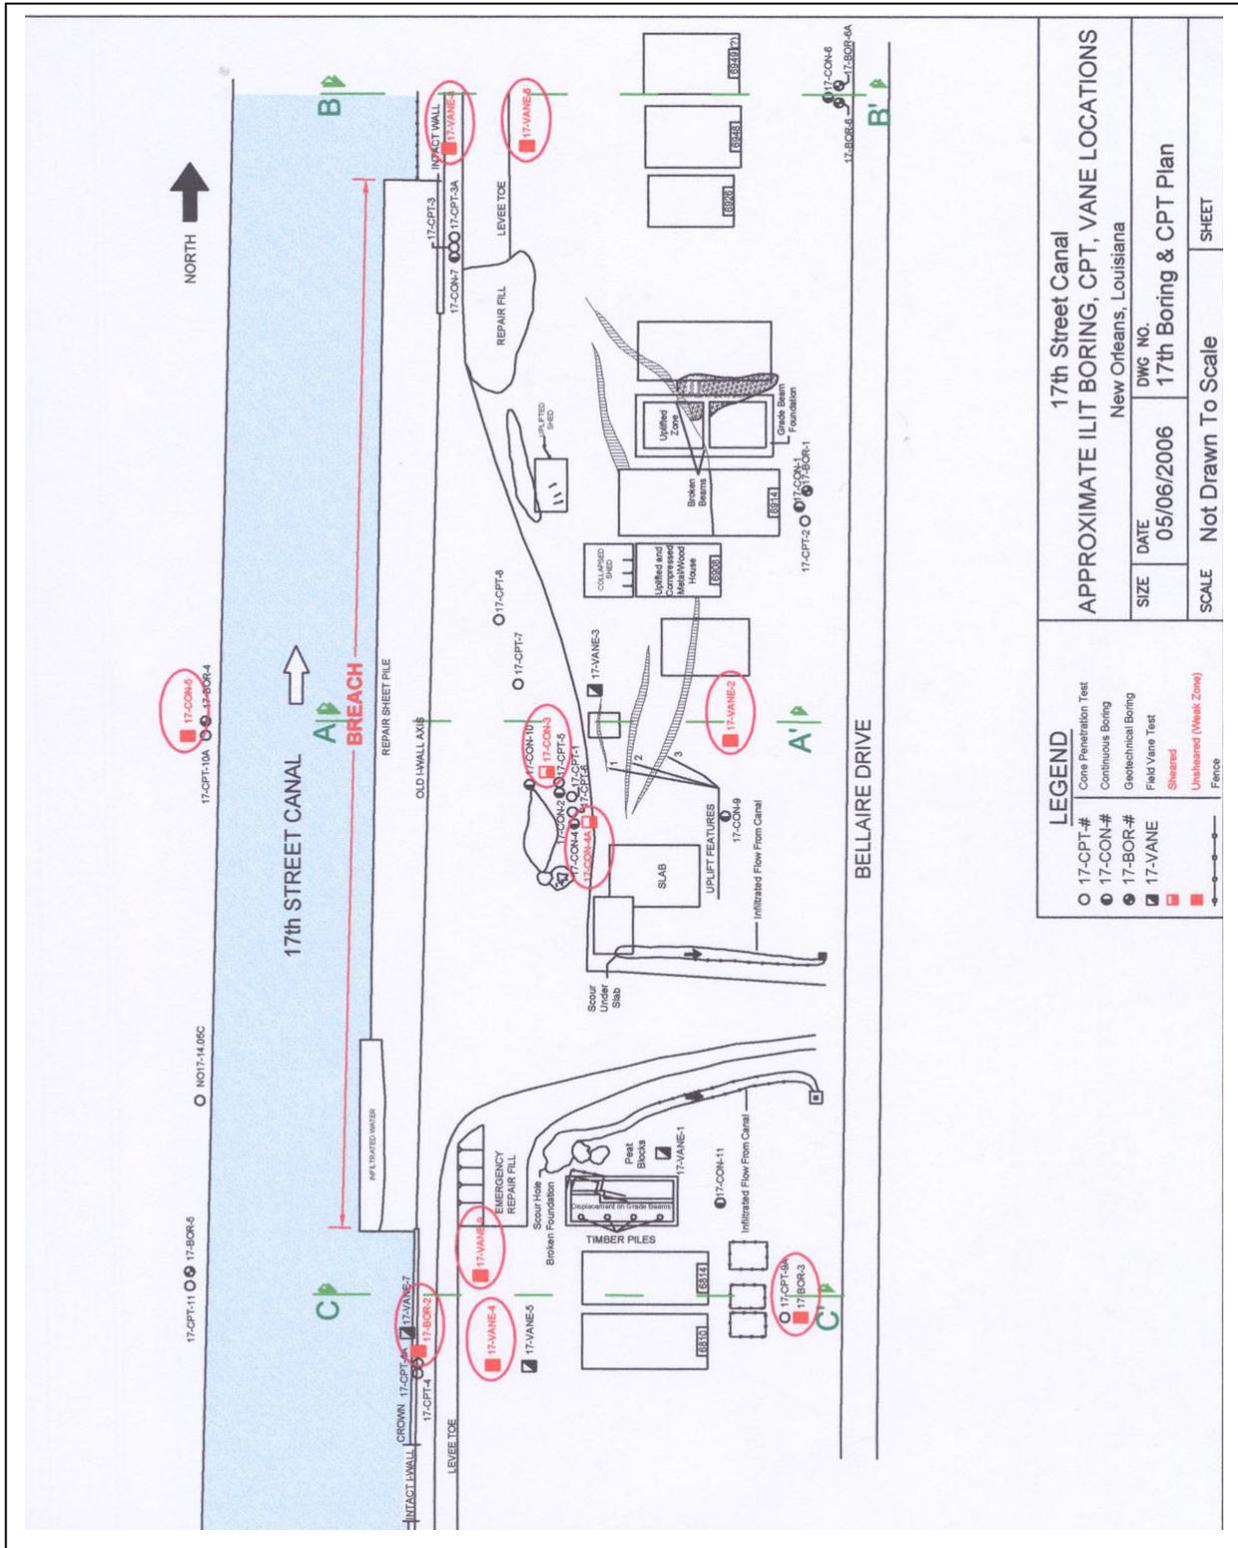
Figure 8.53 shows a plan view of the site, highlighting with red the 10 locations at which this layer was positively identified. It was not always possible to positively identify this thin layer in CPT, as the strength of this layer is not much less than that of the closely overlying and underlying soils; it is the combination of low strength and high sensitivity that made this thin layer so dangerous. “Thin layer” effects also made spotting this layer in CPT (based on tip resistance) difficult. The best initial “marker” or signature of the presence of this layer was found to be a positive spike in friction ratio; as the sleeve continued to drag through the overlying and underlying deposits but the tip resistance dipped a bit.

Figure 8.53: Plan view of the 17<sup>th</sup> Street Canal breach site showing locations at which the shear zone and/or the sensitive layer” within the marsh deposits was positively identified, sampled, or tested.

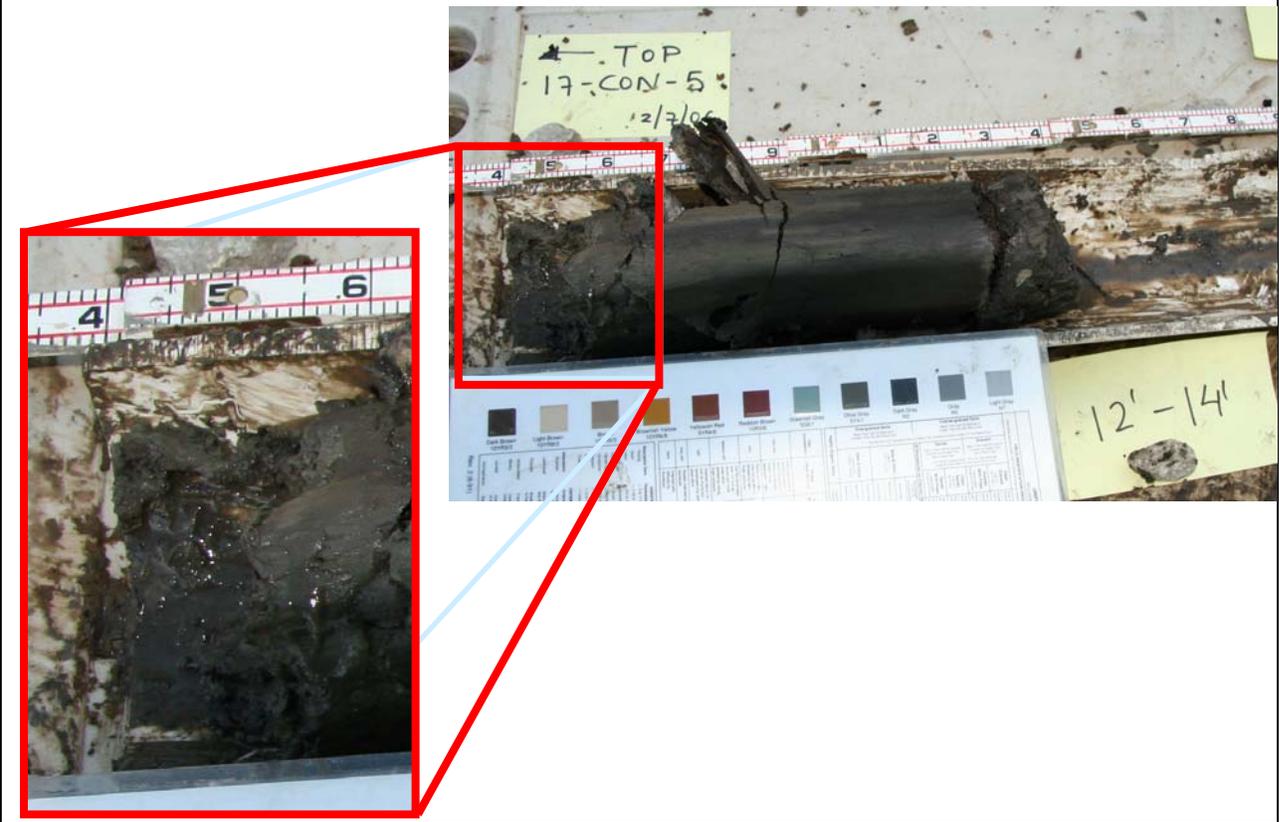
Figure 8.54 shows a photo of an “undisturbed” sample of this sensitive organic silty clay. The local clays have a gray, peanut butter-like appearance and consistency. They are not highly shiny, but rather semi-glossy, and their stiffness and texture are not unlike peanut butter. The sensitive organic clay, on the other hand, is dark and has a very shiny and translucent appearance; much like “jelly”, as shown in Figure 8.54. In Figure 8.54, hints of the organic detritus that closely overlies and masks access to this thin layer can also be seen.

Figure 8.54: Photo of an “undisturbed” sample of the sensitive organic silty clay.

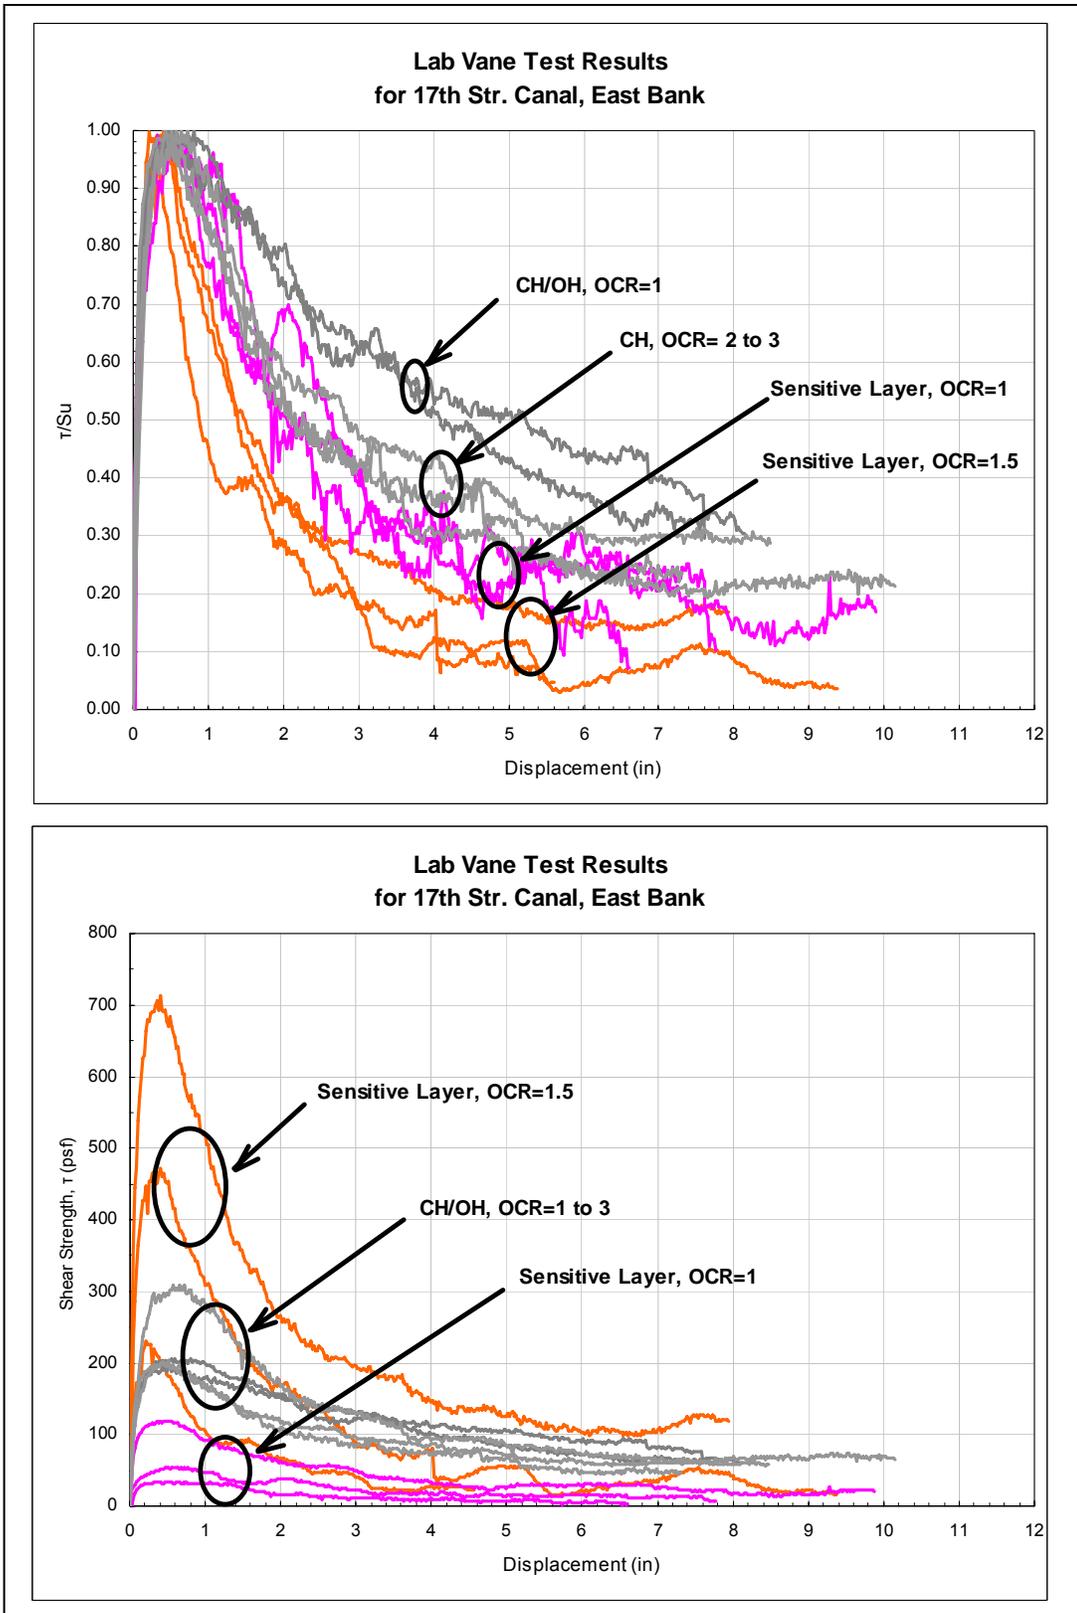
Figure 8.56 shows typical stress-displacement plots for tests on the thin layer of highly sensitive organic silty clay, and on the local deposits of sensitive gray clay. As shown in Figure 8.56(b), which shows normalized behavior in the form of shear strength divided by maximum shear strength on the vertical axis, the sensitive organic clay was more highly brittle, failed at lower displacement, and exhibited even more pronounced sensitivity and rapid post-peak strength degradation. It was the combination of low strength, and this very brittle sensitivity, that caused this material to “capture” the failure surface at this site.

Figure 8.56: Stress-displacement behavior for soft gray clay (CH and CH/OH) and “sensitive” layer of organic clay within marsh deposit.

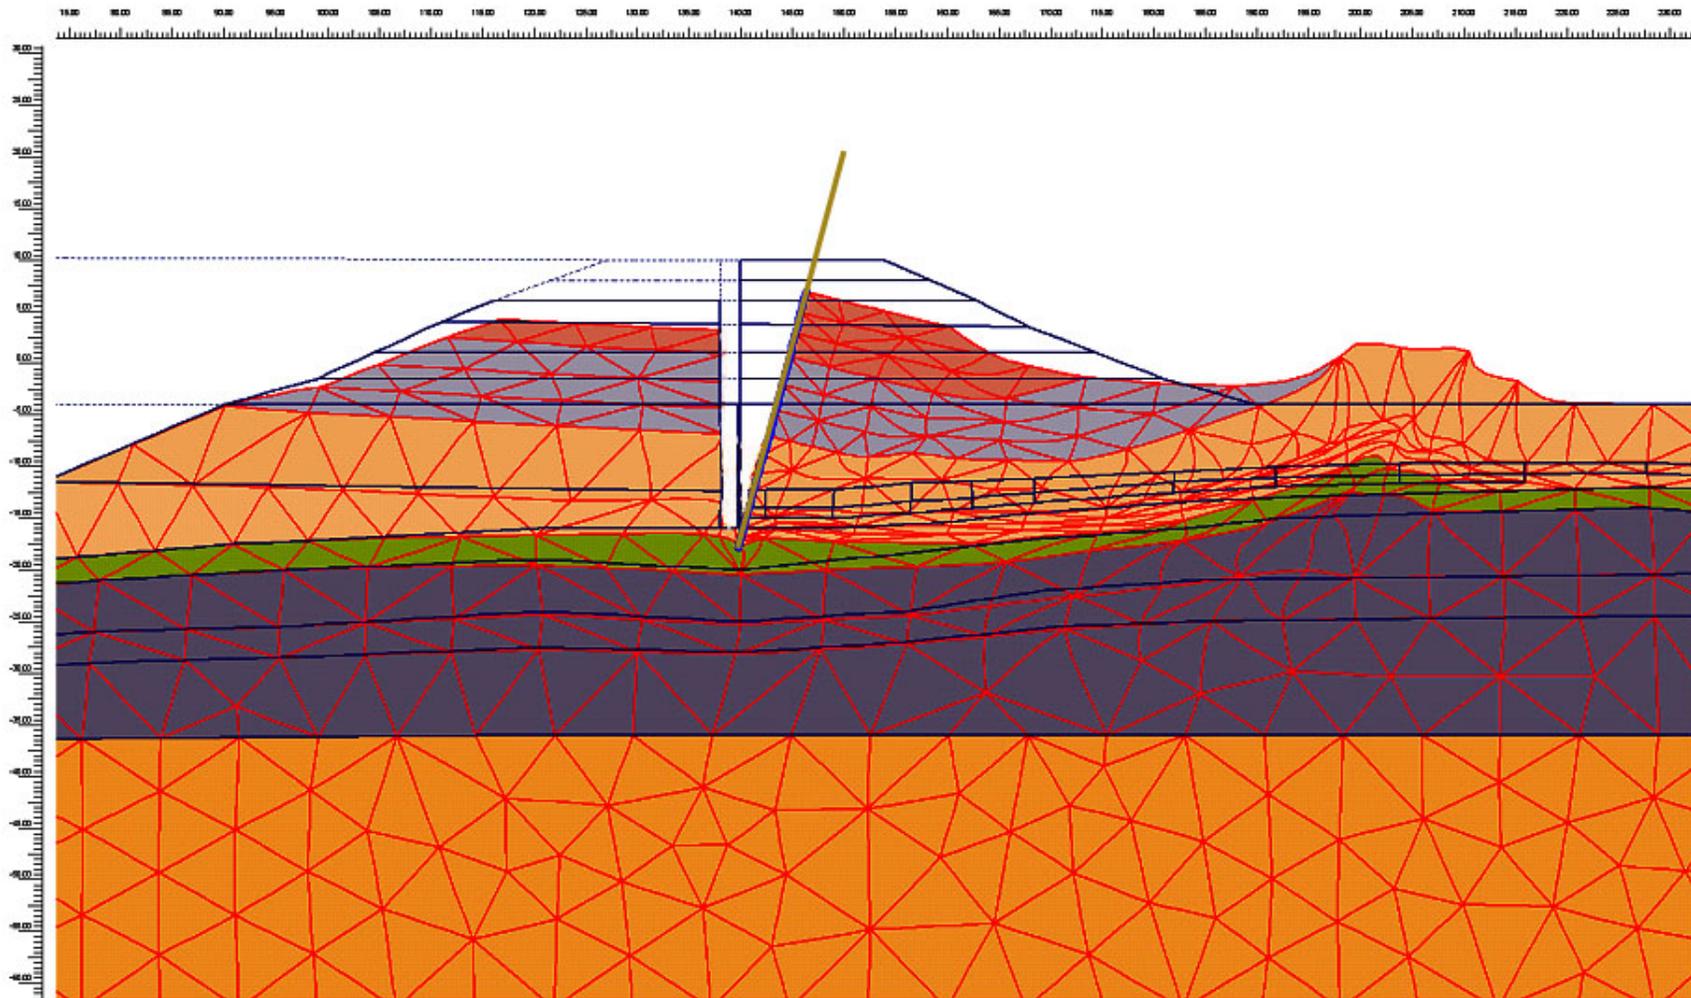
Figure 8.61: Displaced mesh for storm surge height at Elev. + 8.5 feet (MSL) at the 17<sup>th</sup> Street Canal breach site; displacements are increased by a factor of 3 in this figure.

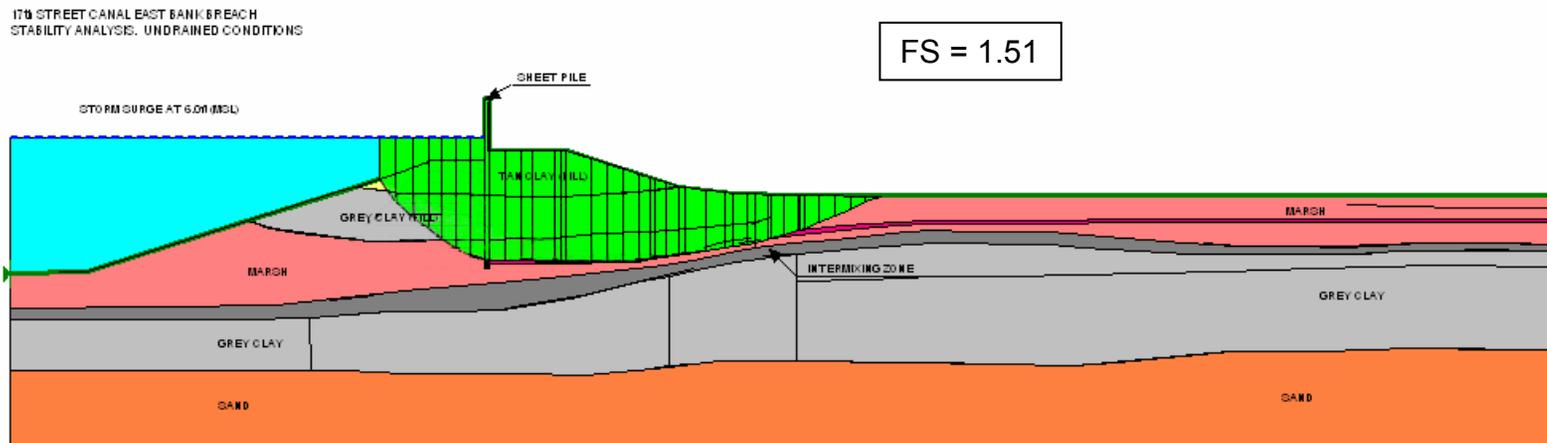
Figure 8.65: Stability analysis (worst case) for storm surge to Elev. + 6 feet (MSL) at the 17<sup>th</sup> Street Canal breach section.

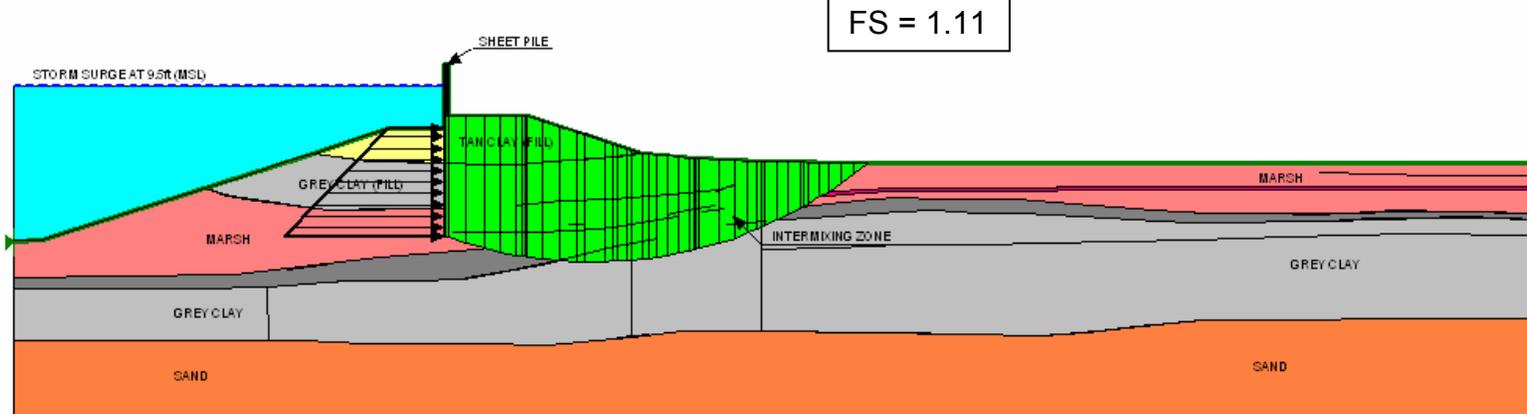
Figure 8.67: Stability analysis for shear failure through the deeper soft gray clays (CH) at the 17<sup>th</sup> Street Canal breach section, with storm surge at Elev. + 9.5 feet (MSL) and with fully developed crack at the outboard side of the sheetpile/floodwall.

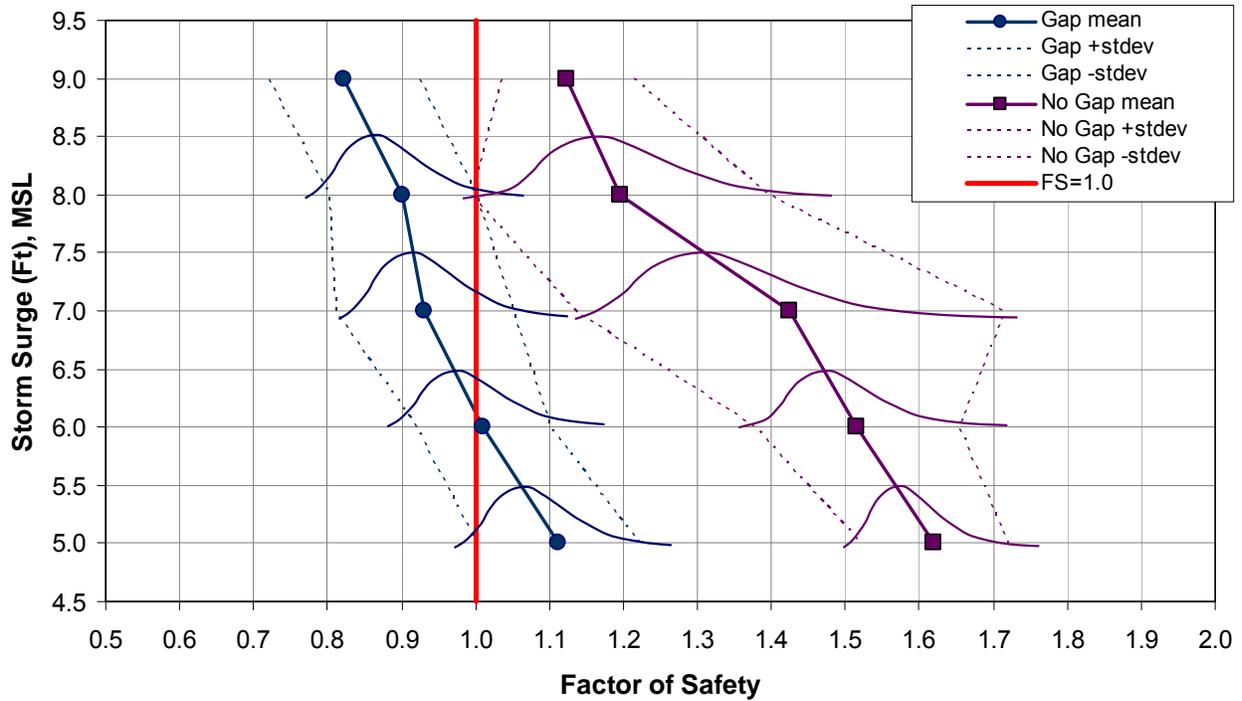
Figure 8.68(a): Distributions of Factor of Safety for the Ungapped and Water-Filled Gap Cases as a function of increasing canal water level; 17<sup>th</sup> Street Drainage Canal, east bank breach section.

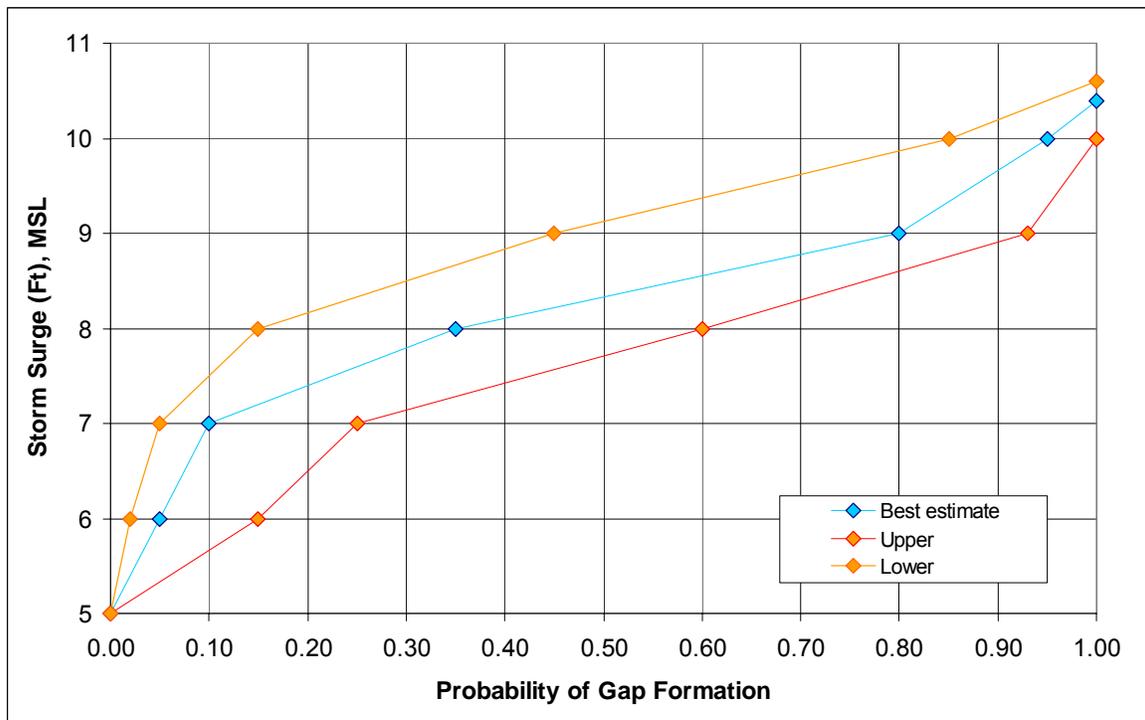
Figure 8.68(b): Estimated probabilities of formation of a significant water-filled gap as a function of increasing canal water level; 17<sup>th</sup> Street Drainage Canal, east bank breach section.

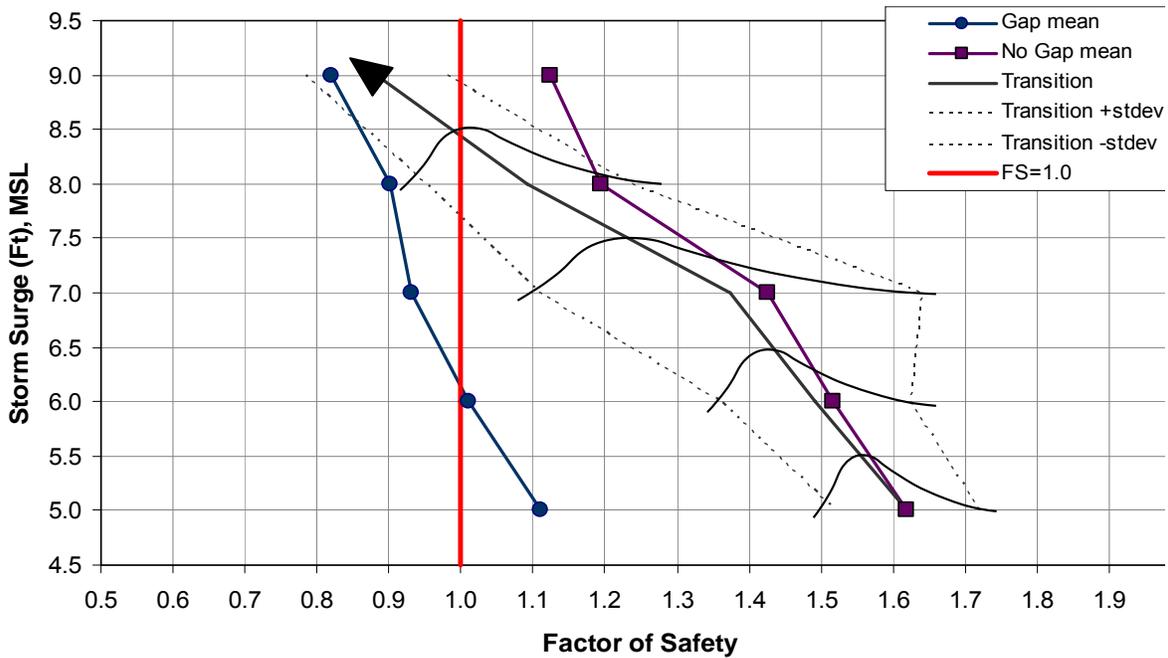
Figure 8.68(d): Distribution of Factor of Safety vs. canal water level with progressive transition from ungapped to water-filled gap conditions; 17<sup>th</sup> Street Canal, east bank breach section.

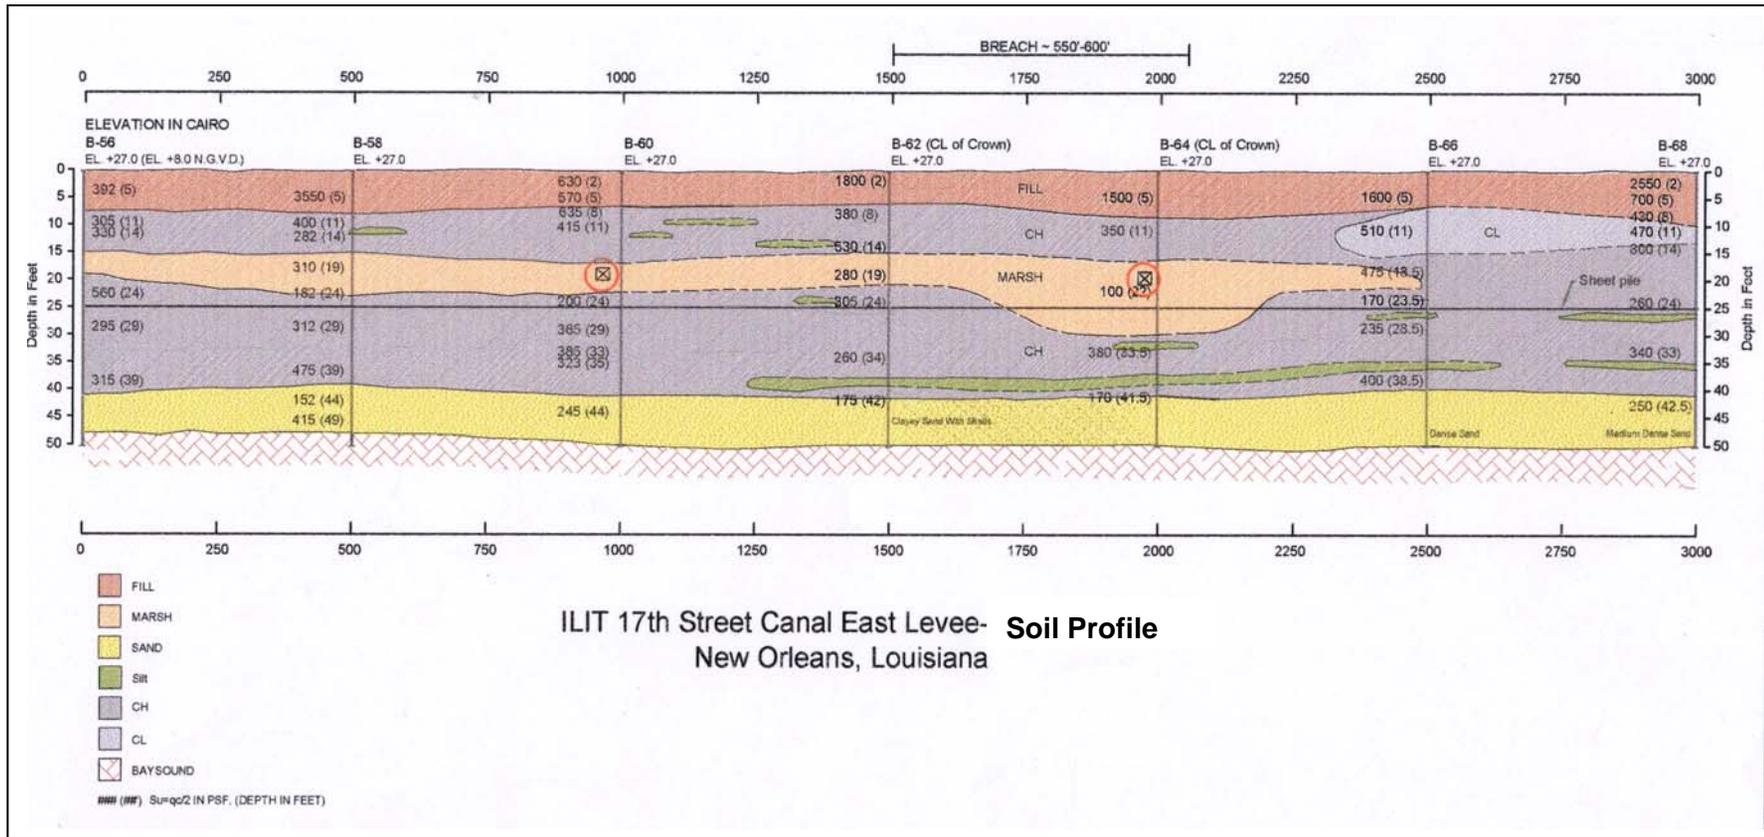
Figure 8.71: Re-interpreted longitudinal subsurface soil profile, showing location of breach section on the east side of the 17<sup>th</sup> Street Canal, and with non-tested samples highlighted.

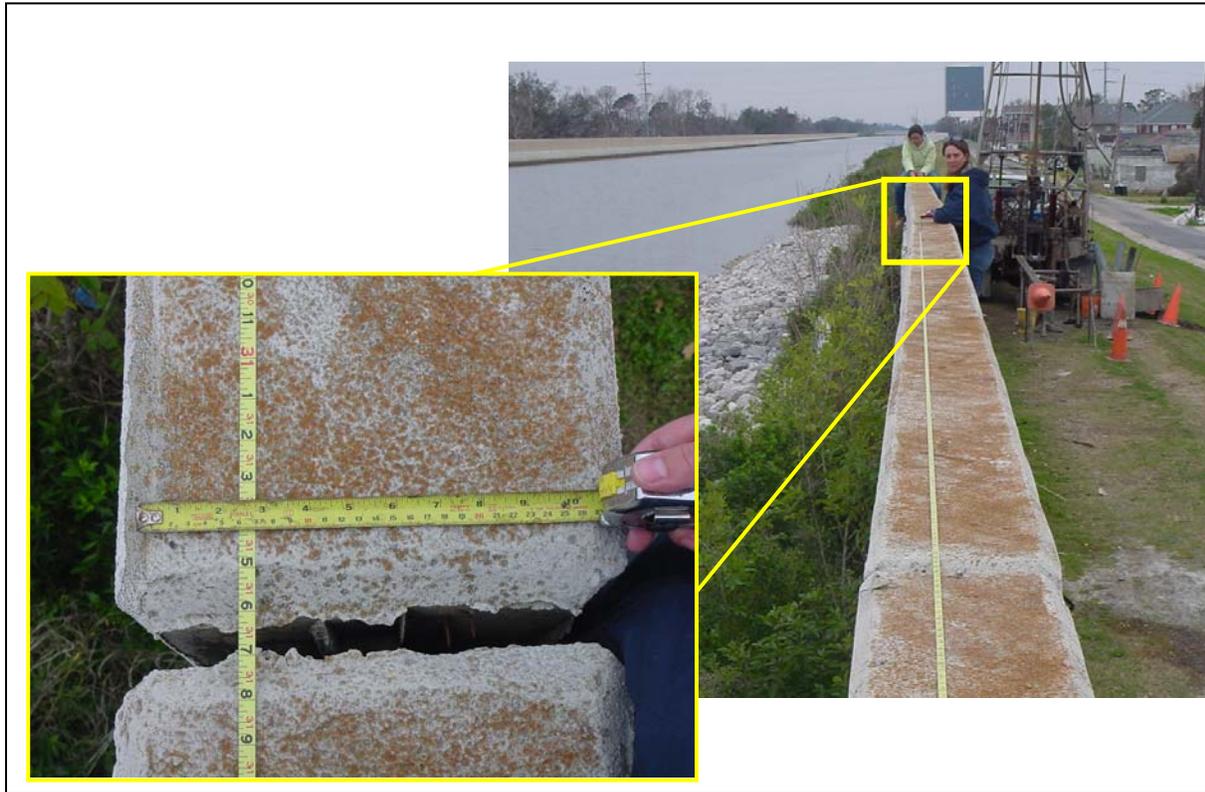
Figure 8.75 shows measurement of observed lateral wall offset at the point of maximum offset. Wall tilt is less than 0.75 inches, and the maximum lateral offset is approximately 3.5 inches.

Figure 8.75: View of floodwall displacement on the west bank of the 17<sup>th</sup> Street Canal.

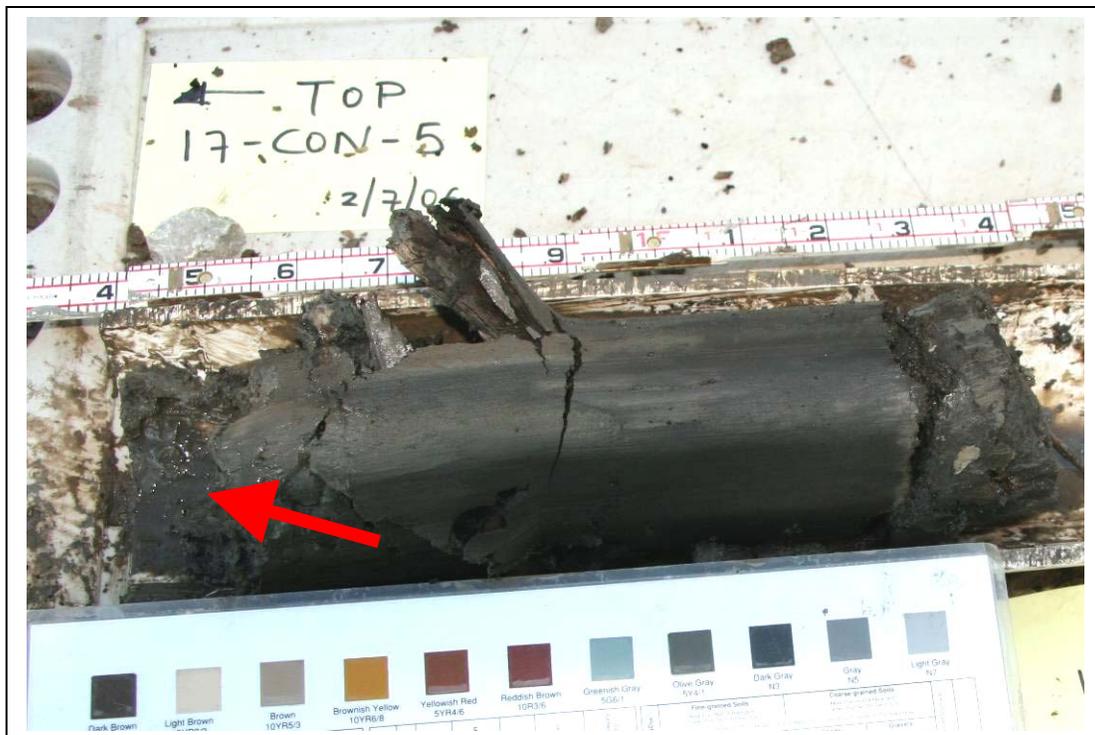
Figure 8.76: View of sample of “sensitive” clay layer within the marsh soils at the west side of the 17<sup>th</sup> Street Canal.

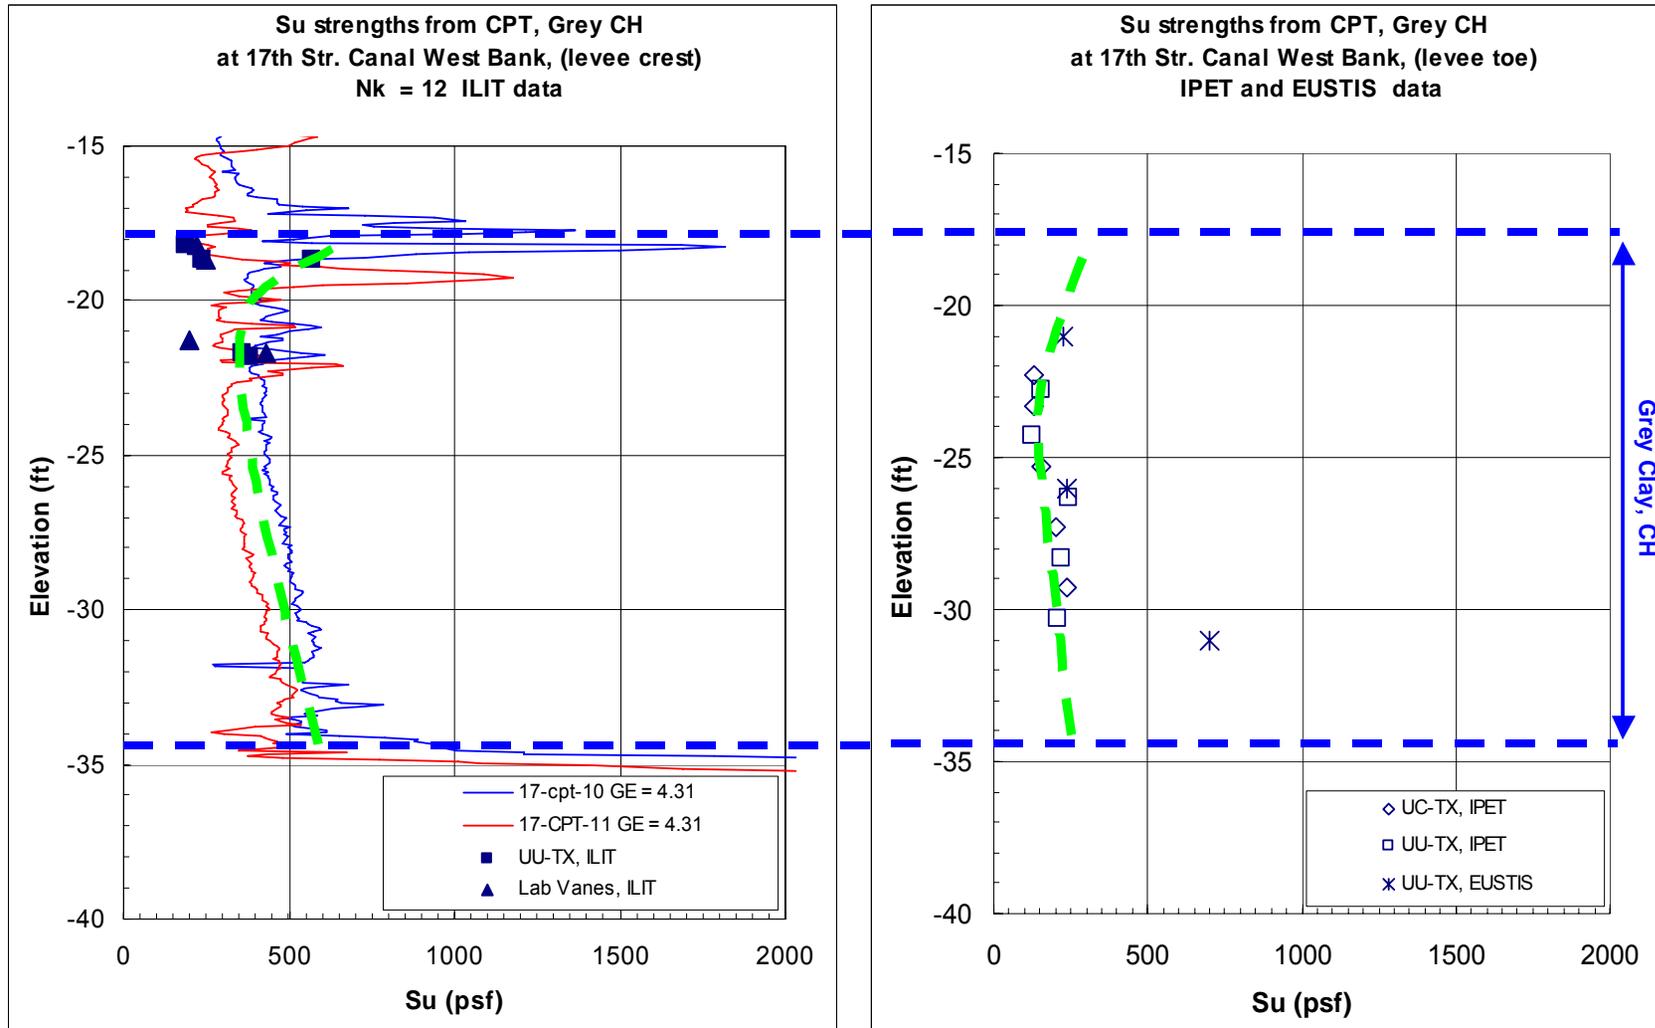
Figure 8.81 then presents our SHANSEP-based profiles of strength vs. depth (a) beneath the crest, and (b) at the toe, along with the available strength and CPT data. The fit with the available data is excellent.

Figure 8.81: Shear strength vs. depth within the soft gray clay (CH) for the site on the west side of the 17<sup>th</sup> Street Canal (a) beneath the crest of the levee, and (b) beneath the inboard side toe of the levee embankment.

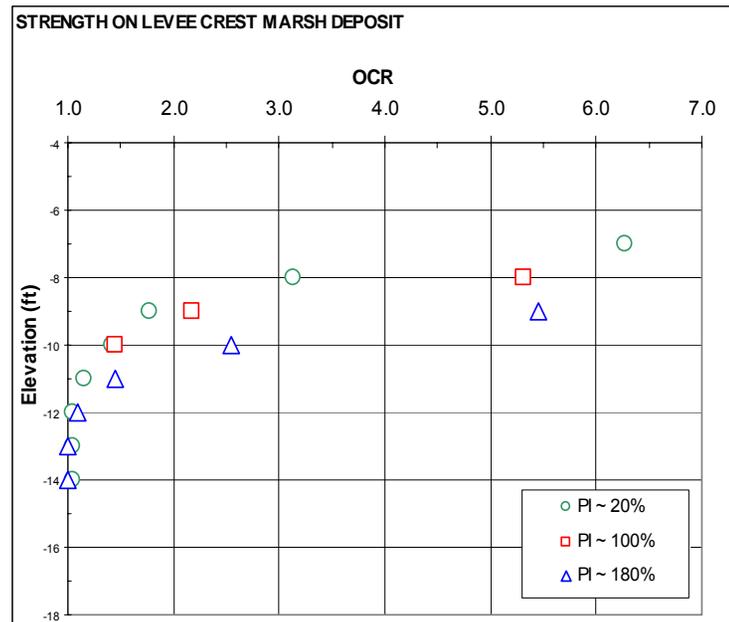
Figure 8.82 shows the use of the correlation proposed by Mayne and Mitchell to develop profiles of  $S_u/P$  vs depth and OCR vs. depth within the “marsh” deposits overlying the soft gray clays. This matches well with the CPTU-based interpreted OCR profile within this stratum, and with the data from the east bank as well.

Figure 8.82: Su/P and OCR estimation from PI and vane shear tests for the marsh deposits at the site on the west side of the 17<sup>th</sup> Street Canal.

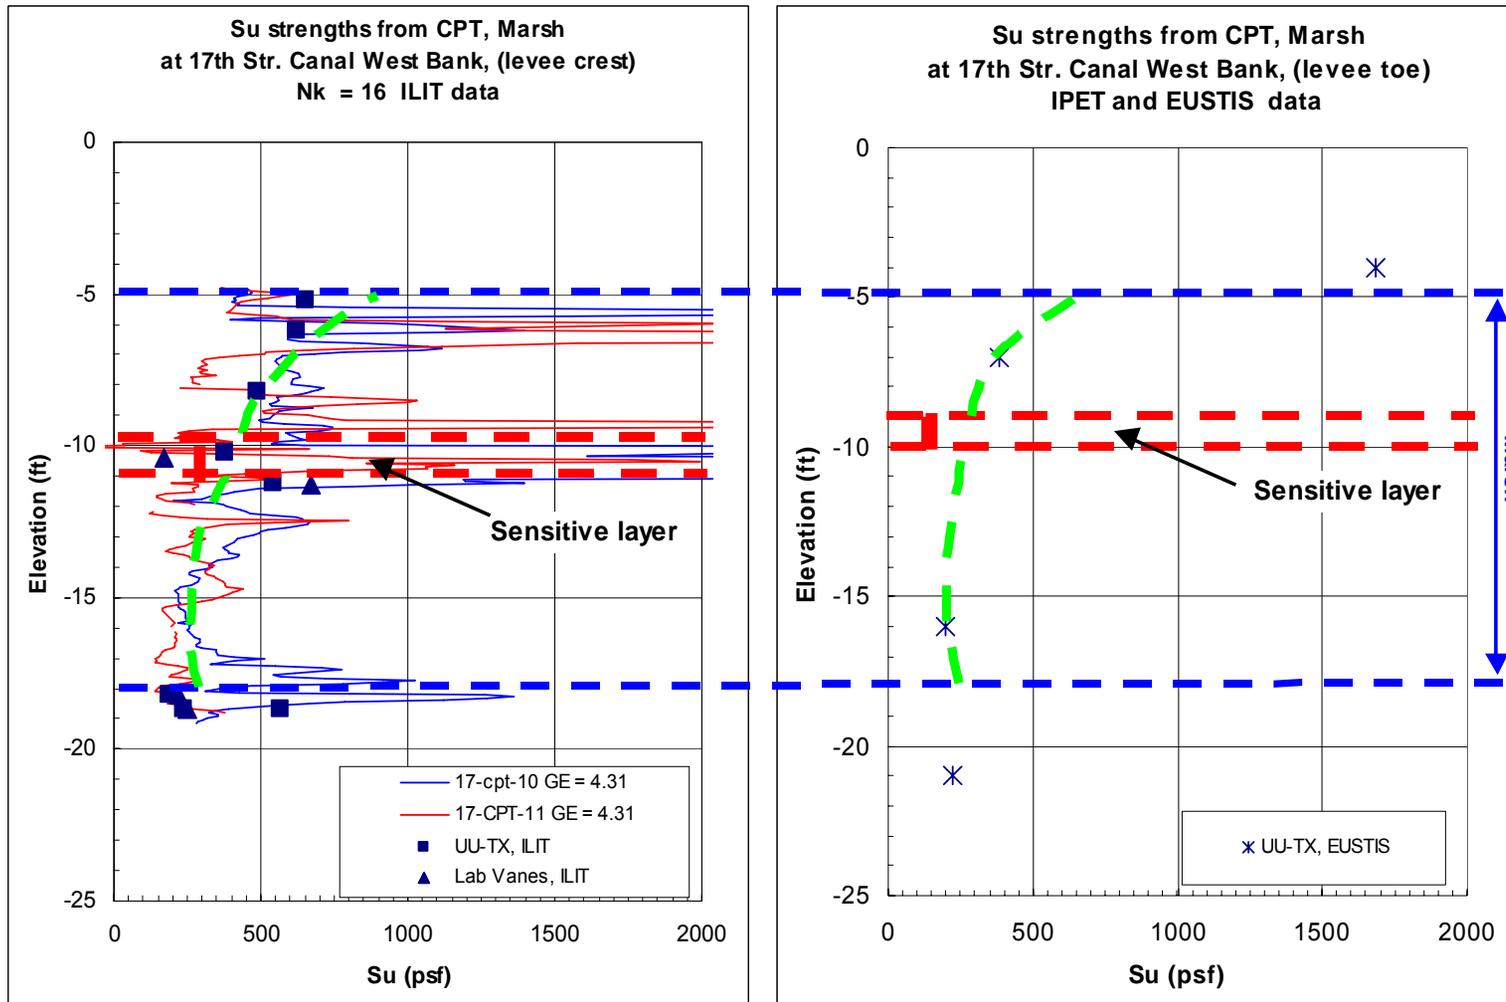
Figure 8.83 presents the resulting overall profiles of strength vs. depth within the marsh deposits (a) beneath the crest, and (b) at the toe, along with all available data (including CPT tip resistances interpreted using  $N_{kt} = 16$ ). The thin layer of sensitive organic silty clay was encountered in one boring, again at the approximate mid-point in the “marsh” deposits, and again closely overlain by leaves and twigs. This sample is shown in Figure 8.76. Strengths for this thin layer were based on  $S_u/P$  values from the east bank deposit. This thin layer was not critical at this west bank site, as the sheetpiles penetrated well below this sensitive layer and so forced a deeper, more rotational failure through the soft gray clays to be the most critical mode.

Figure 8.83: Shear strength vs. depth within the marsh deposits at the site on the west side of the 17<sup>th</sup> Street Canal (a) beneath the crest of the levee, and (b) beneath the inboard toe of the embankment.

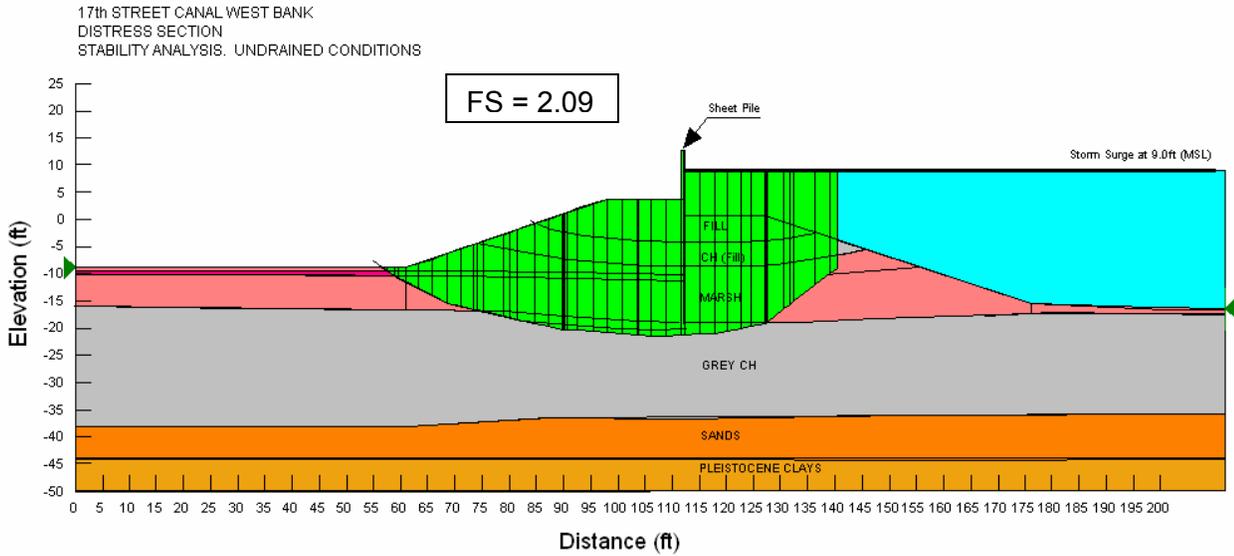
Figures 8.84 and 8.85 show the most critical failure surfaces (without gapping) for a storm surge level of +9 feet (MSL) for failure (a) to the top of the soft gray clay, and (b) within the lower marsh deposits. These both give low Factors of Safety, but the failure through the lower marsh strata is the more critical case.

Figure 8.84: Stability analysis of the west side of the 17<sup>th</sup> Street Canal with water at Elev. + 9 feet (MSL) for case of rotational failure through the soft gray clay (CH) with no gap developed.

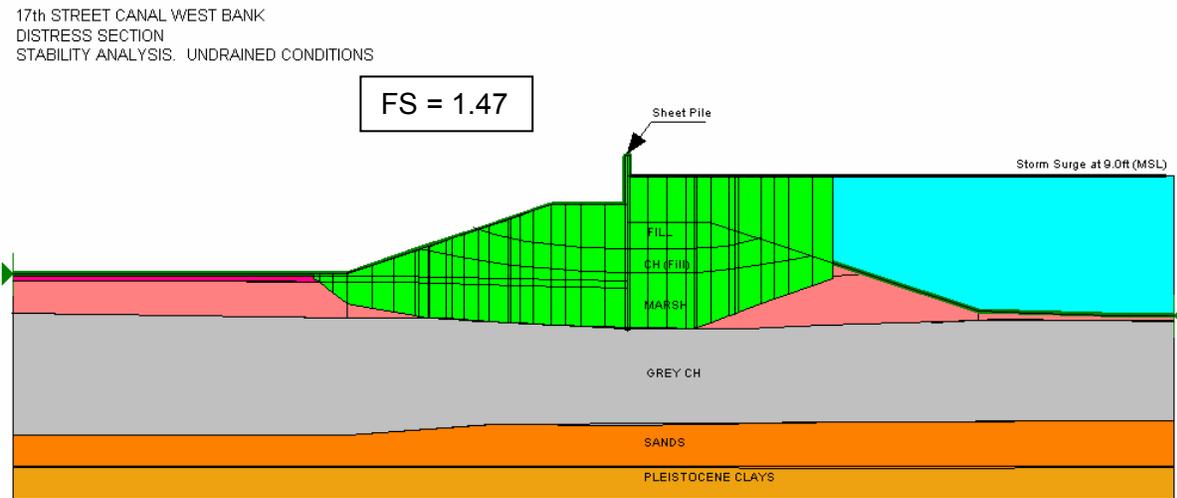
Figure 8.85: Stability analysis of the west side of the 17<sup>th</sup> Street Canal with water at Elev. + 9 feet (MSL) for case of failure through the base of the “marsh” layer (with no gap developed).

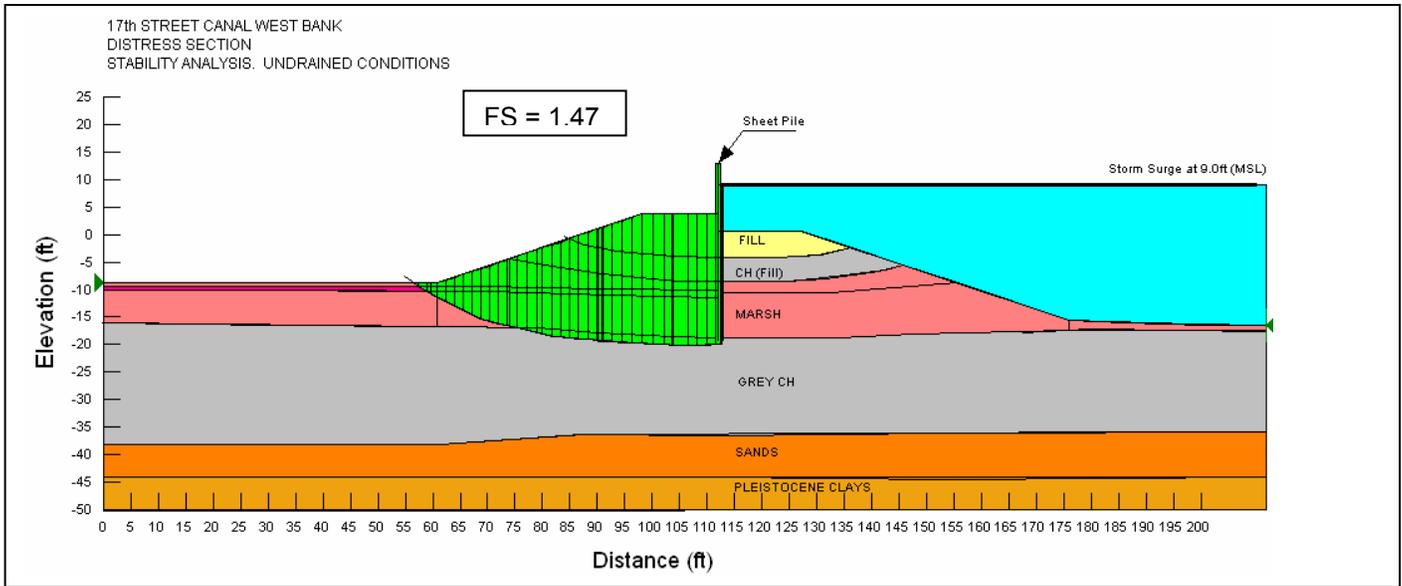
Figures 8.84 and 8.85 show these same two potential failure modes, again for a storm surge elevation of +9 feet (MSL), but this time with an assumed water-filled gap at the outboard face of the sheetpile curtain. Once again the lower marsh units present the more critical mechanism.

Figure 8.86: Stability analysis of the west side of the 17<sup>th</sup> Street Canal with water at Elev. + 9 feet (MSL) for case of rotational failure through the soft gray clay (CH) (with water-filled gap).
