# Investigation of the Performance of the New Orleans Flood Protection Systems in Hurricane Katrina on August 29, 2005

## Volume I: Main Text and Executive Summary

**Final Report**  
**July 31, 2006**

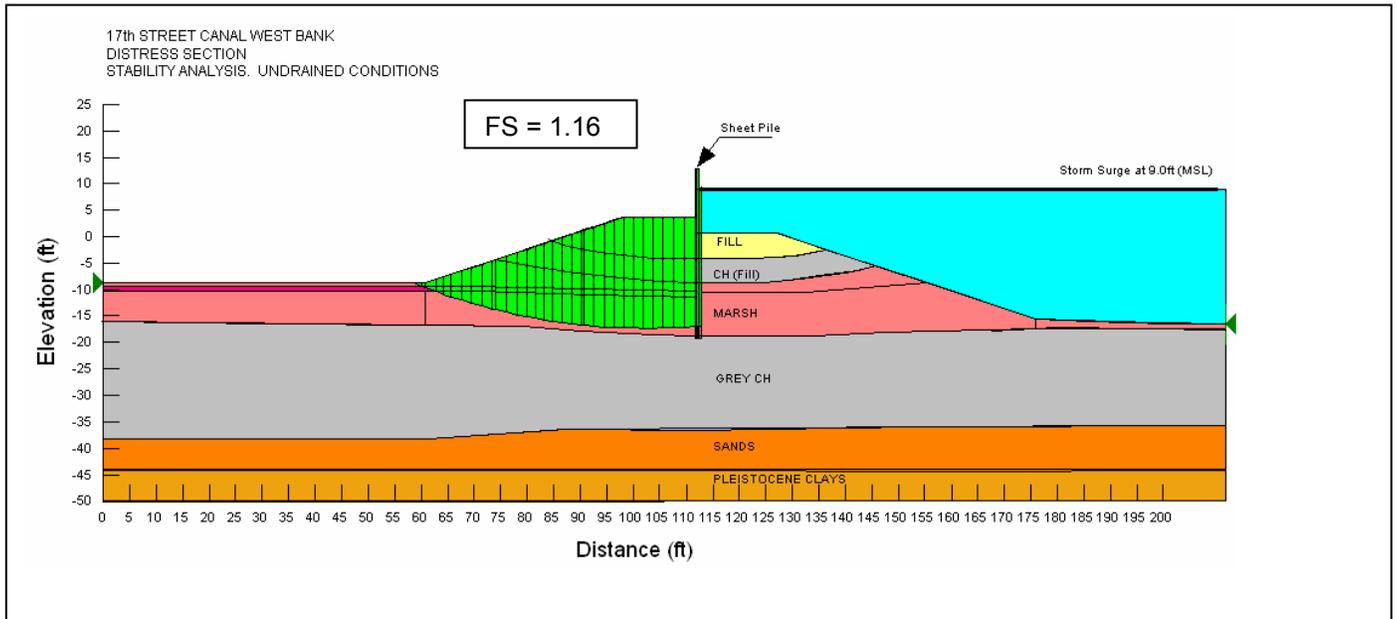
Figures 8.84 and 8.85 show these same two potential failure modes, again for a storm surge elevation of +9 feet (MSL), but this time with an assumed water-filled gap at the outboard face of the sheetpile curtain. Once again the lower marsh units present the more critical mechanism.

Figure 8.87: Stability analysis of the west side of the 17<sup>th</sup> Street Canal with water at Elev. + 9 feet (MSL) for case of failure along the base of the “marsh” layer (with water-filled gap).

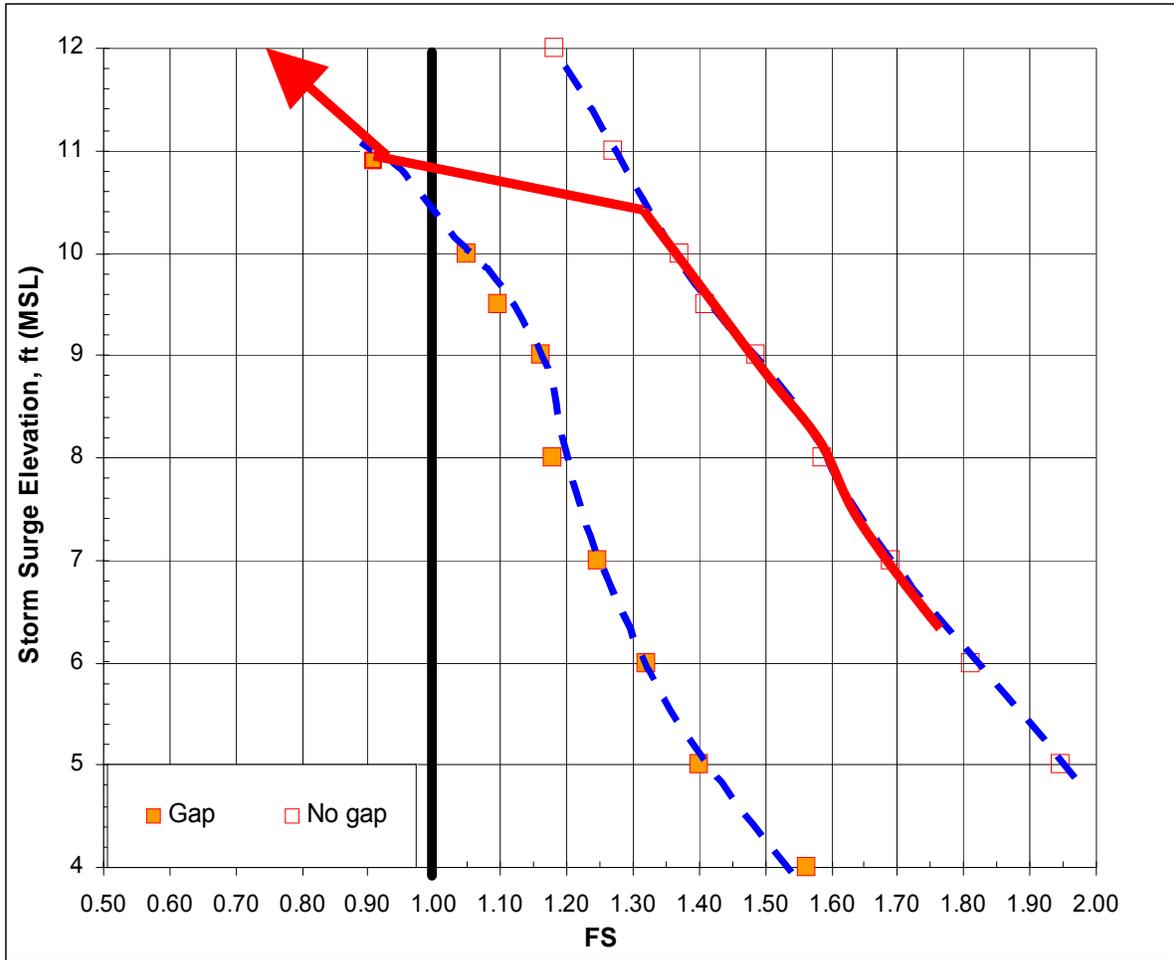
Figure 8.88 shows calculated Factors of Safety vs. canal water elevation for the failure through the lower marsh stratum, both with and without gapping. The heavy red line in this figure shows the best estimate of the likely critical failure path, based on these limit equilibrium analyses. It is judged that gapping is most likely to be initiated at surge elevations of approximately +10 to +11 feet (MSL) as the Factor of Safety (without gapping) drops below about 1.25 to 1.35. Gapping was relatively unlikely during Katrina (max surge level ~ +10 feet, MSL), and indeed no gap could be seen.

Figure 8.88: Factor of safety vs. water level on the west bank of the 17<sup>th</sup> Street Canal.

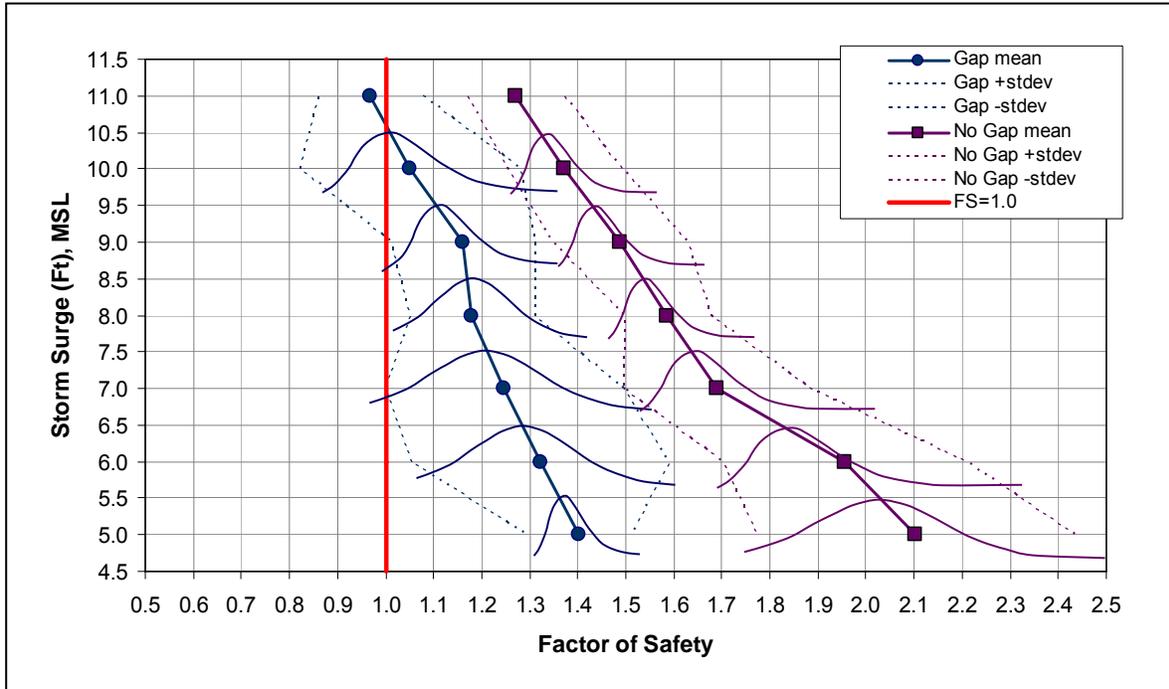
Based on these analyses, probabilities of failure were again estimated using the same procedure as described previously in Section 8.3.7.1. Figure 8.88(a) shows distributions of factor of safety as a function of rising canal water elevations for the “water-filled gap” and the “ungapped” cases, and Figure 8.88(b) shows the resulting estimated distributions of the overall conjugate factor of safety for this west bank section.

Figure 8.88(a): Distributions of factors of safety for the “Water-filled Gap” and the “Ungapped” cases as a function of rising canal water elevations; 17<sup>th</sup> Street Drainage Canal; west bank distressed section.

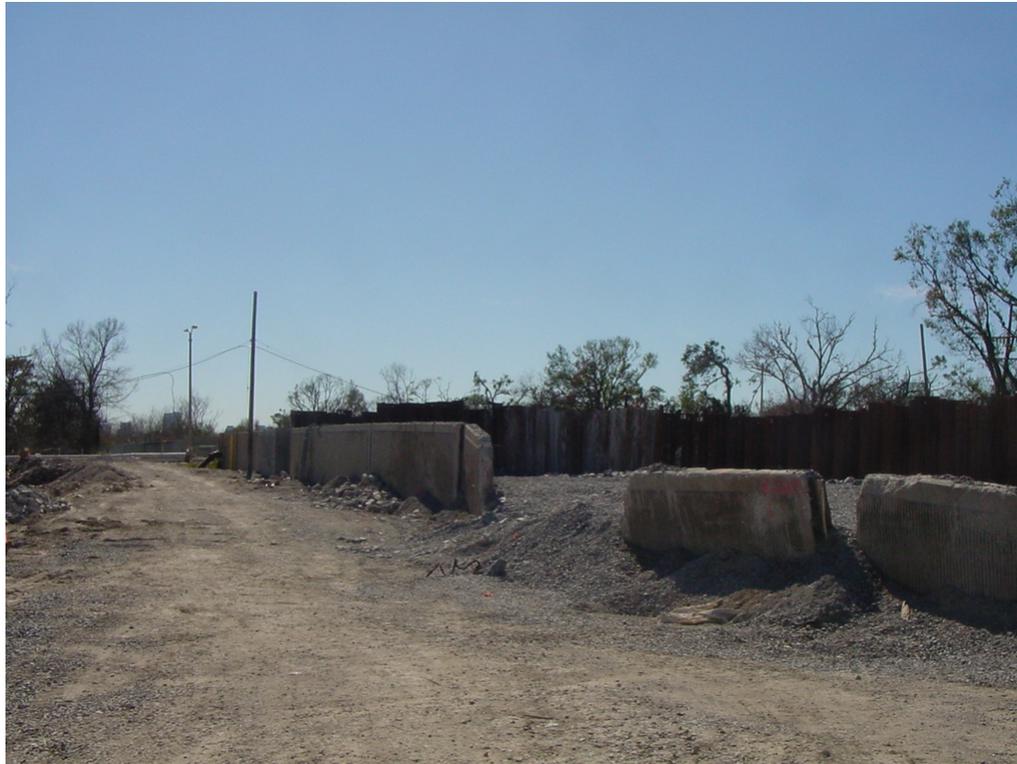
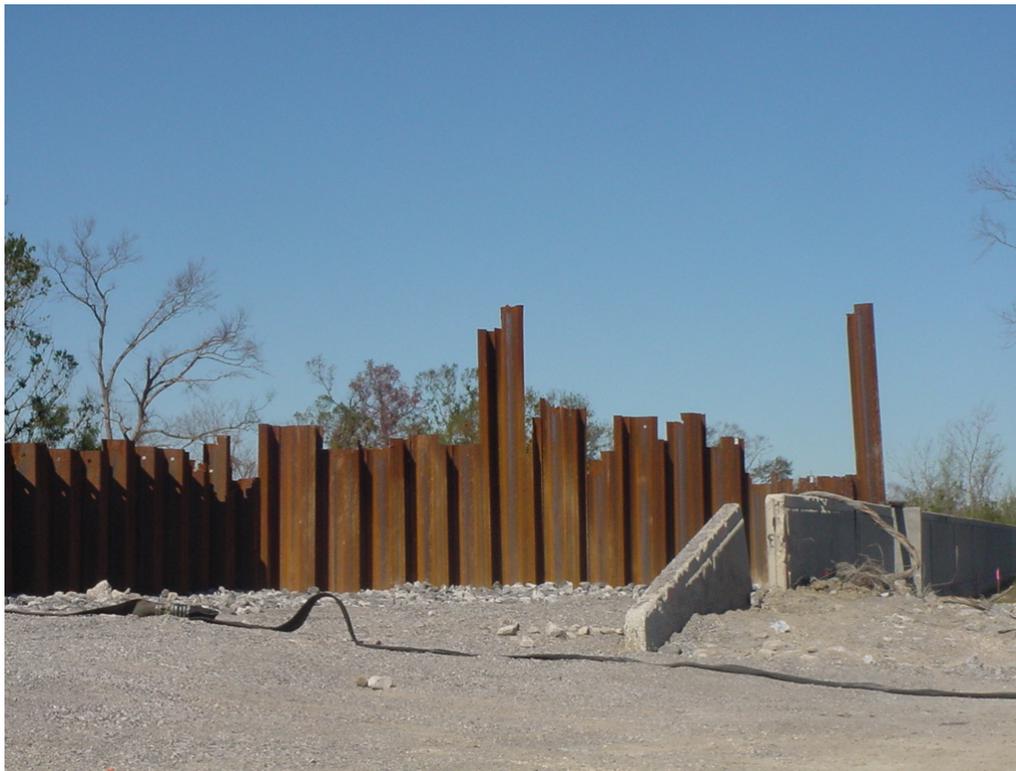
Figures 8.91 and 8.92 show the floodwall sections at the south and north ends of the breach, respectively. In these photos it can be seen that these wall sections have not displaced (translated) laterally towards the inboard (“protected”) side; instead they have simply “dropped” into the hole eroded by the scour of the breach flow.

Figures 8.91 and 8.92: Views of floodwall panels “dropping” into the eroded void at the north and south ends of the south London Avenue canal breach.

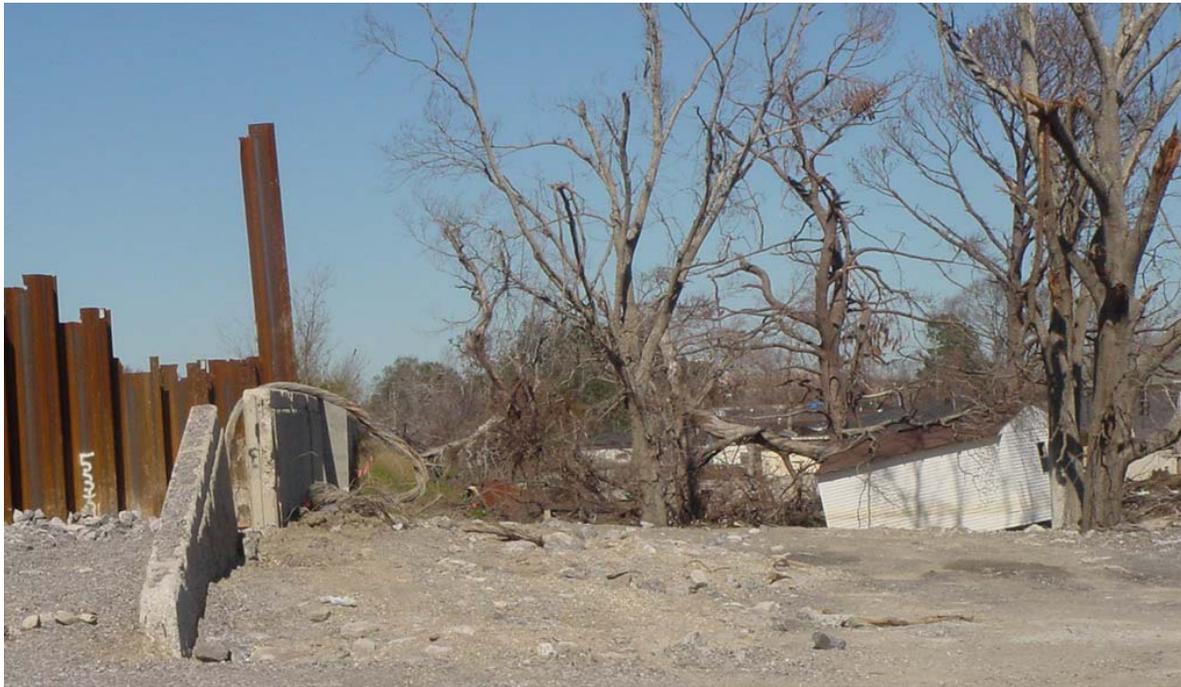
Clearance for the footprint of the levee and floodwall was very limited, and the neighboring homes and their back yards encroached closely on the levee. Levee maintenance was very poor along this section, and numerous large trees had been allowed to grow along the inboard toe. Many of these were actually rooted part way up the inboard slope face of the levee embankment itself, as shown in Figure 8.93 which is a view looking north from the breach location. These trees at the inboard toe represented an unacceptable risk as they can be blown over by storm winds, creating sudden voids that represent favorable paths for concentration of seepage flows and erosion in the critical toe area. Also, when they die the rotting root system can leave voids that can pose a significant hazard with regard to seepage and erosion in the critical inboard toe area.

Figure 8.93: View of trees at the inboard levee toe immediately to the north of the end of the south breach in the London Avenue Canal.

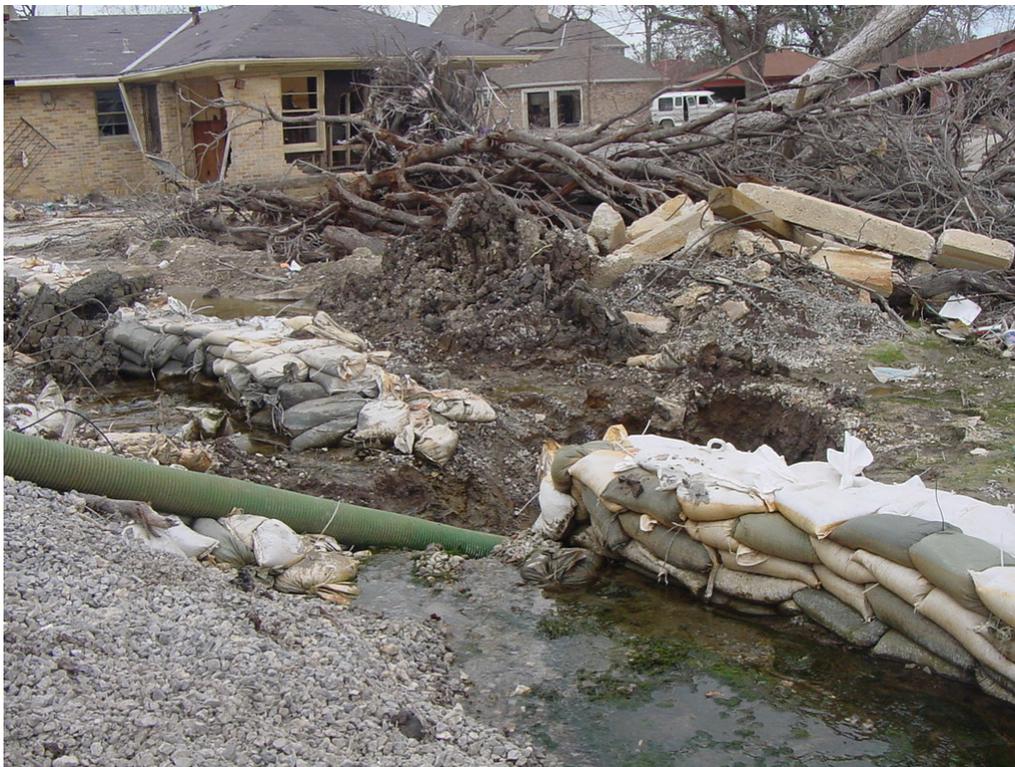
Several large trees did topple at this site during Katrina, but in the absence of eyewitnesses it is not possible to be certain if they toppled before the breach, or as a result of erosion and scour after the breach opened. Figure 8.94 shows toppled trees at this site. Two large trees from the levee toe area within the breach footprint toppled during this event.

Figure 8.94: View of toppled trees at the London Avenue Canal south breach site.

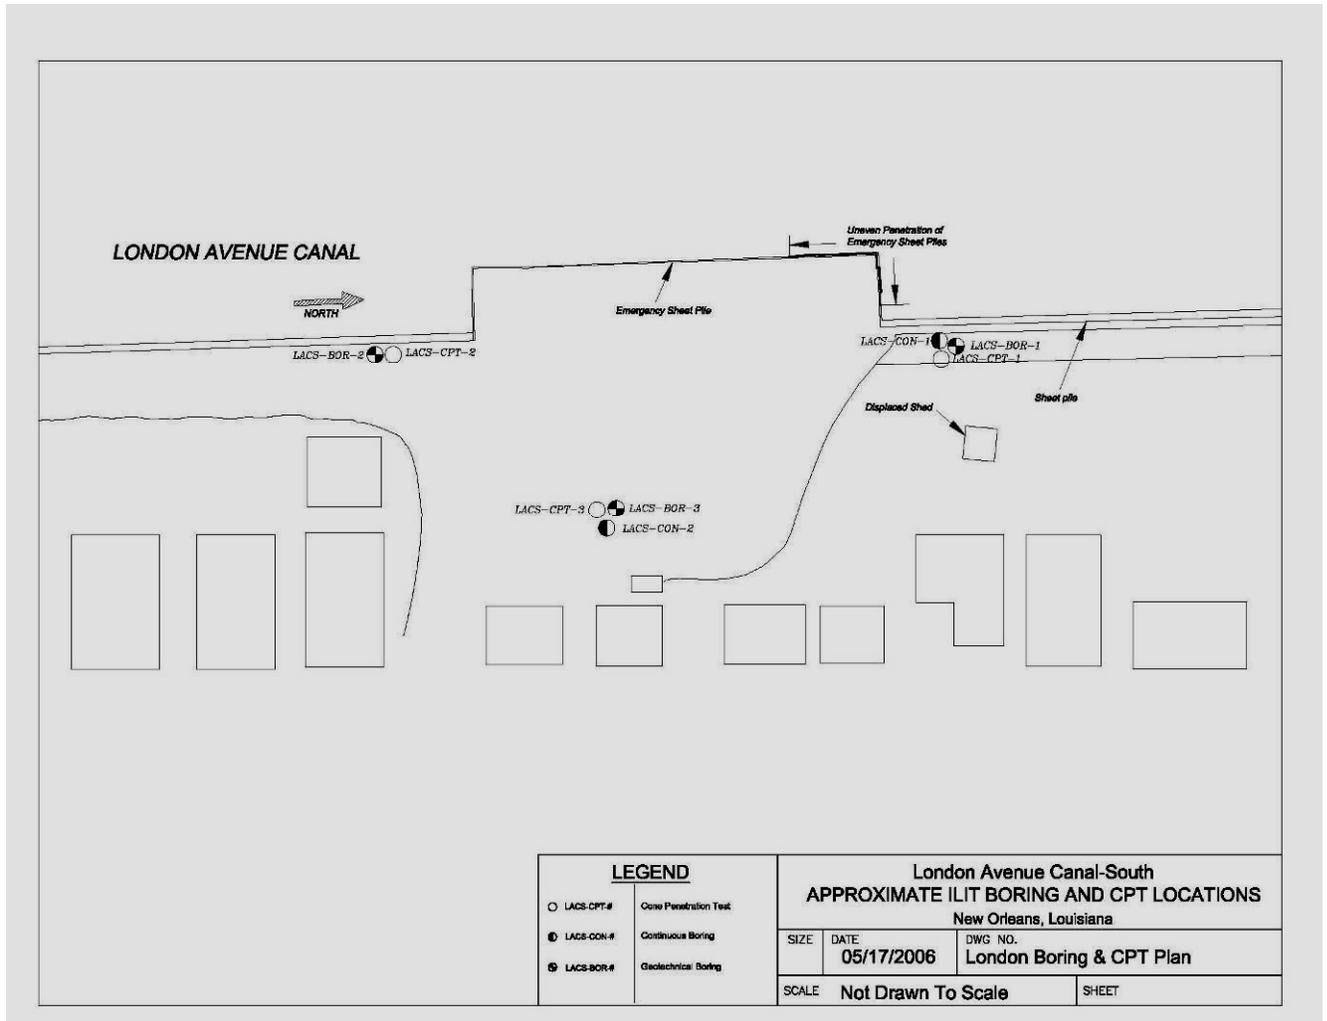
Figure 8.95 shows the locations of borings and CPT probes performed by the ILIT investigation at this site. Figure 8.96 shows a cross-section through the breach, based on our

Figure 8.95: Plan view of the London Avenue Canal (South) breach site.

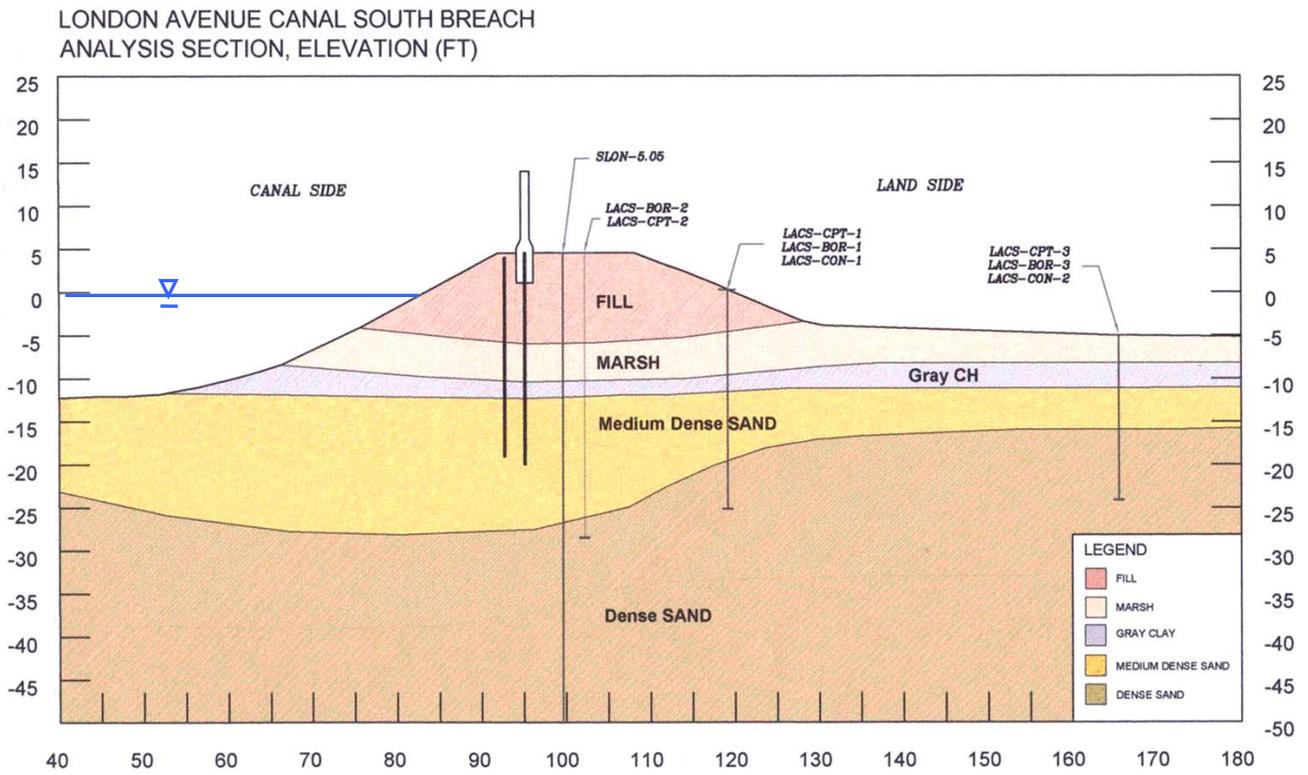
Figure 8.96: Cross-section through the breach near the south end of the London Avenue Canal.

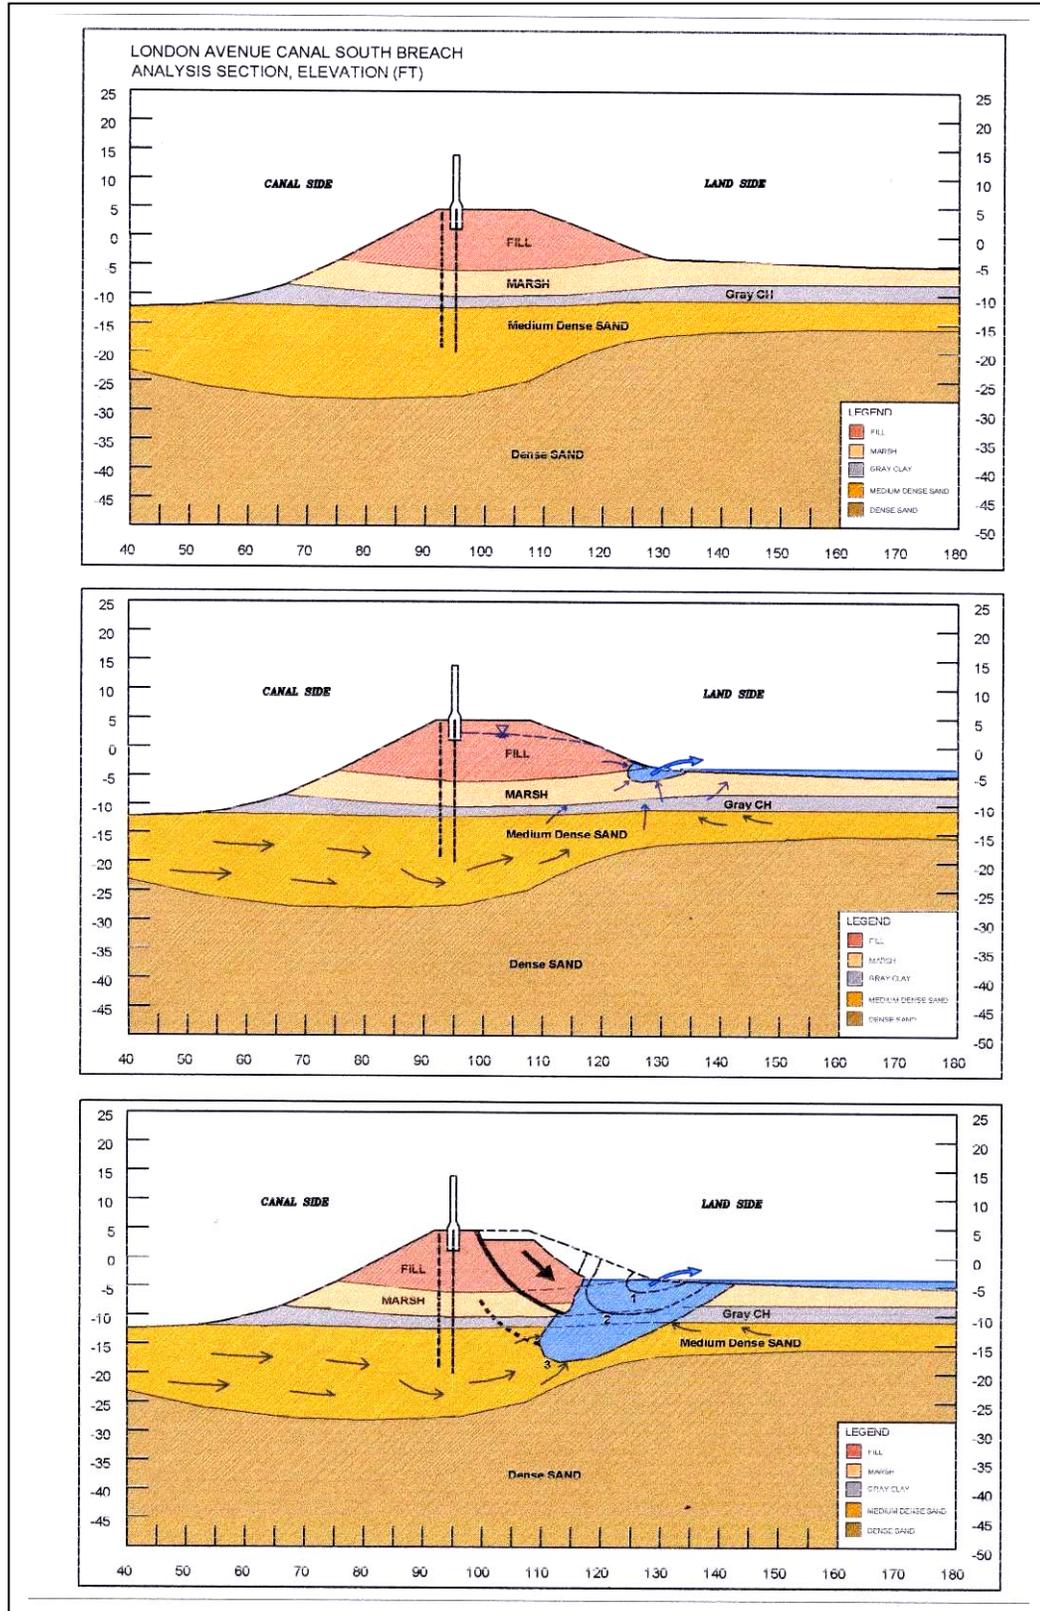
Figure 8.107: Schematic illustration of progressive erosion development at inboard toe.

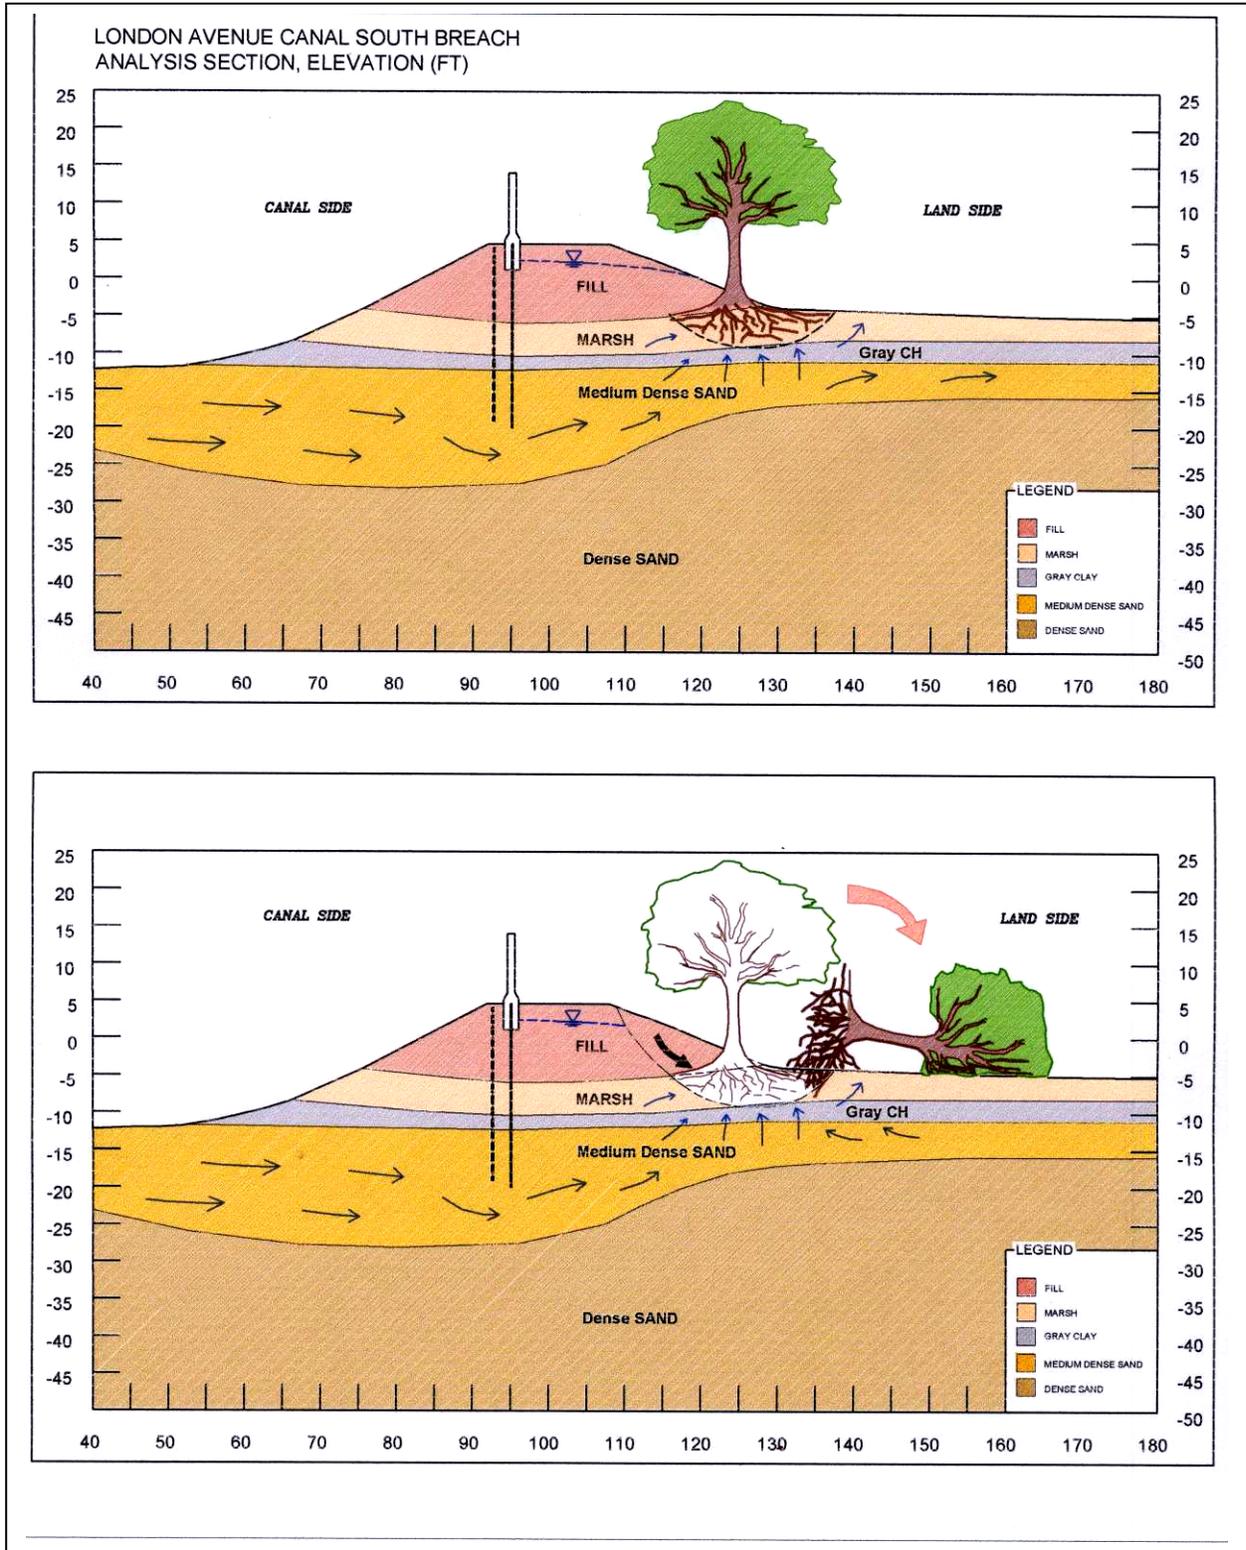
Figure 8.108: Schematic illustration of toppling of tree at inboard toe of levee.

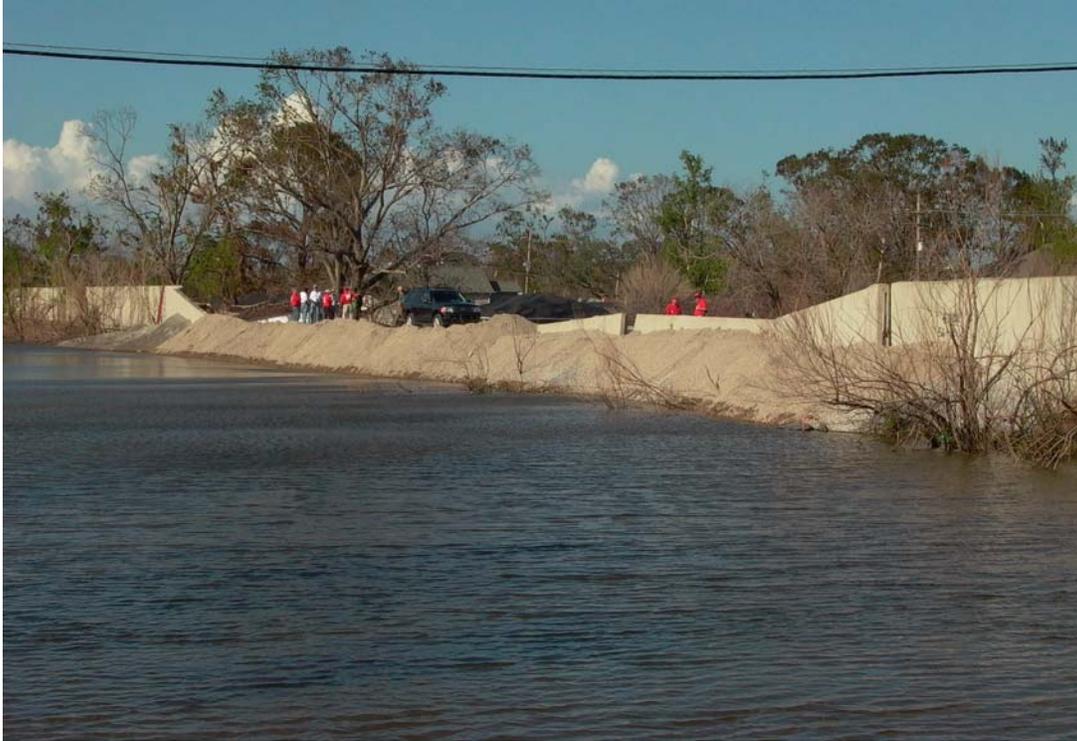
Figure 8.109: View of the breach near the south end of the London Avenue Canal from the canal side in late September of 2005.

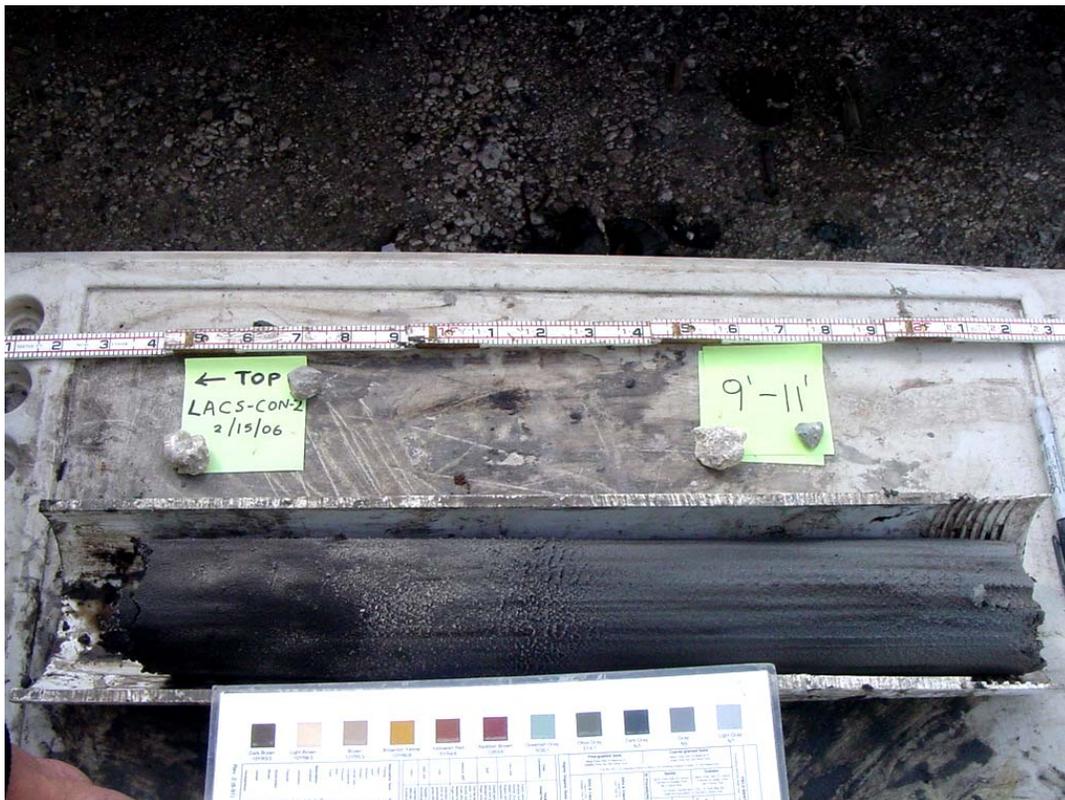
Figure 8.109(a) shows an “undisturbed” sample from the transition across the silty clay into the underlying sands. As shown in this figure, this transition was semi-gradational rather than abrupt. The base of the silty clay layer is underlain by fine clayey sands with variable fines content. Near the contact the fines content is high enough that the clayey fines dominate the shear strength behavior. The fines content rapidly decreases over the next 6 inches or so, and eventually the fines content of the remainder of the layer remains relatively stable at between 5% to 10%. The green line in this figure represents our best estimate of the approximate operative effective friction angle through this zone.

Figure 8.109(a): Sample across transition zone at London Avenue Canal, South Breach Section

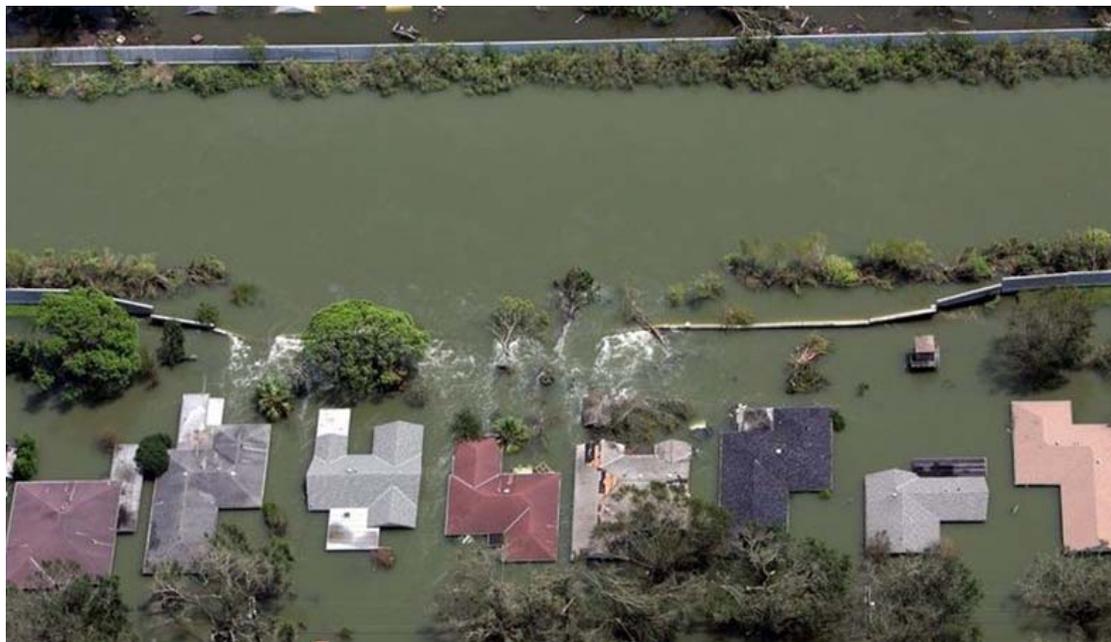
Figure 8.110: Overhead view of the breach section on the west bank near the north end of the London Avenue Canal.

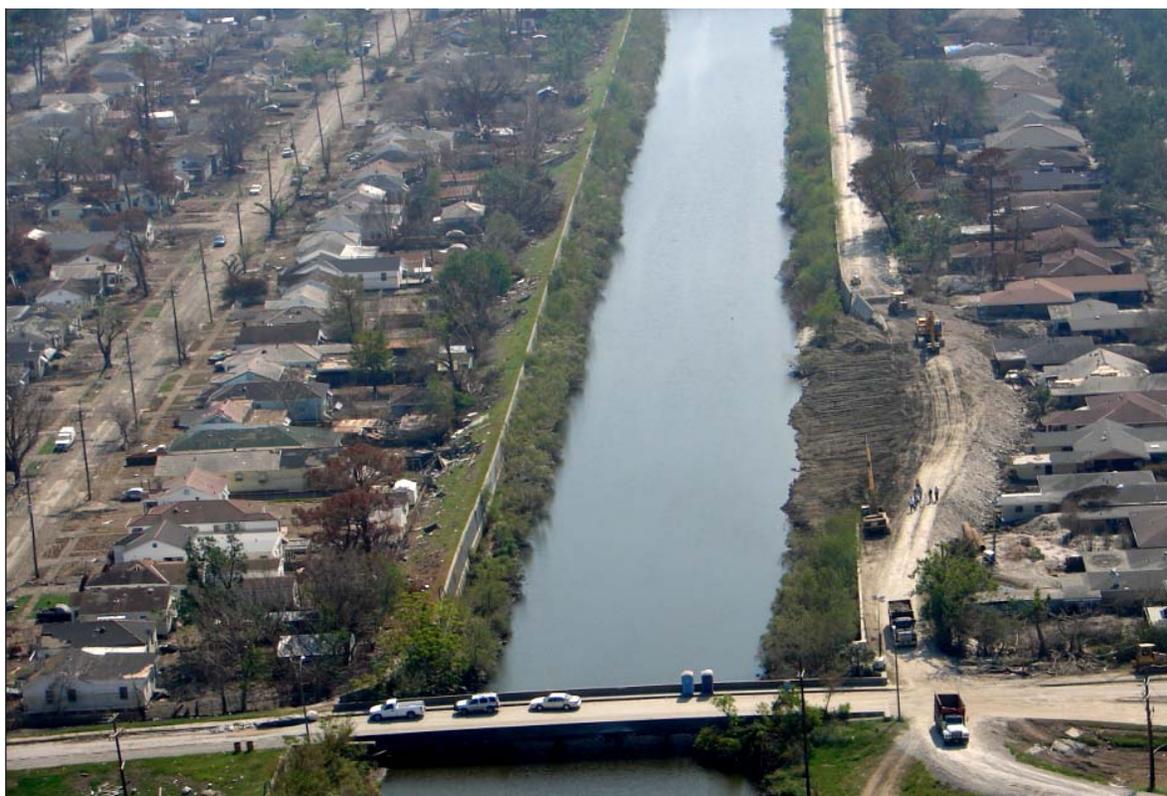
Figure 8.111: Oblique aerial view of the breached section on the west bank of the London Avenue Canal (North) and the “distressed” section on the east bank (on the left in this photo, which is taken looking to the south.)

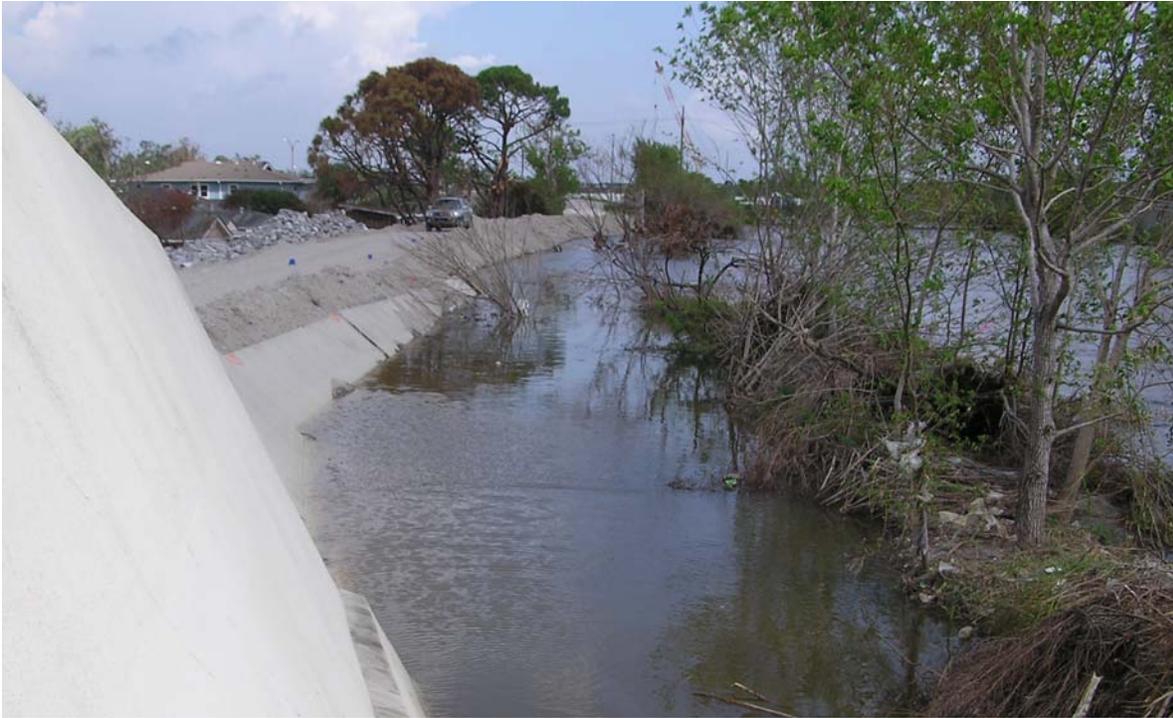
Figure 8.112: View of the west bank breach near the north end of the London Avenue Canal from the south end showing the outboard side embankment section still in place.

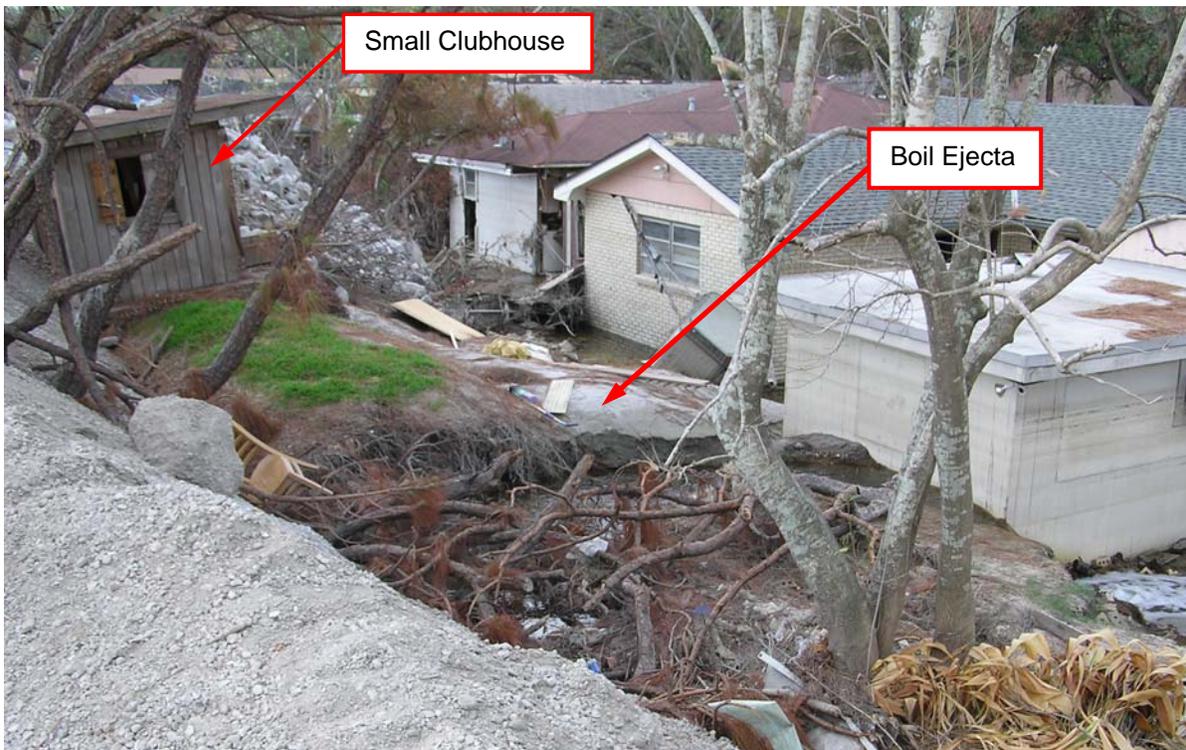
Figure 8.113: View of the inboard of the displaced embankment on the west side of the London Avenue canal showing heaving at the toe (and beneath the small wooden clubhouse), and the boil ejecta in front of the heave feature.

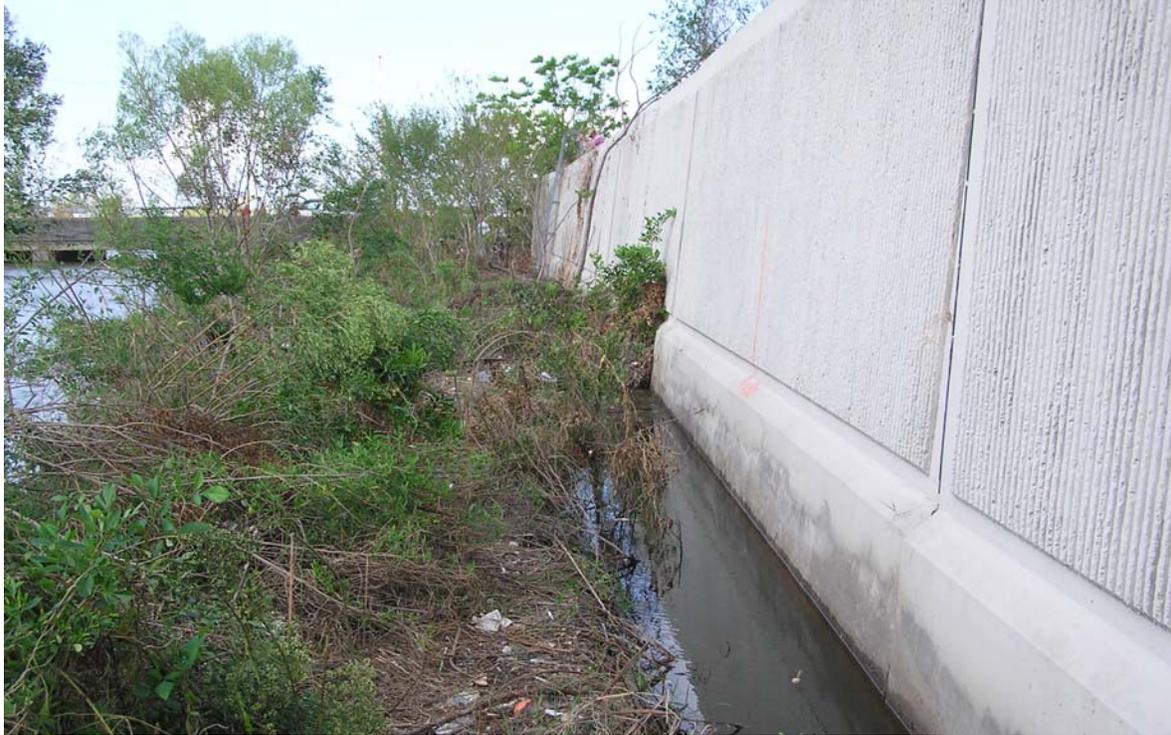
This exactly fits with the observed field data. The "sinkholes" at the crest of the embankment on the east side were the result of tilting of the slightly displaced floodwall, and the resulting opening of a gap between the floodwall and the embankment into which embankment soils could fall. This correlates with the observation the "sinkhole features" were all narrow, and were all parallel and adjacent to the floodwall (see Figures 8.114 and 8.117.)

Figure 8.114: Water-filled gap at outboard side of east bank distressed section.

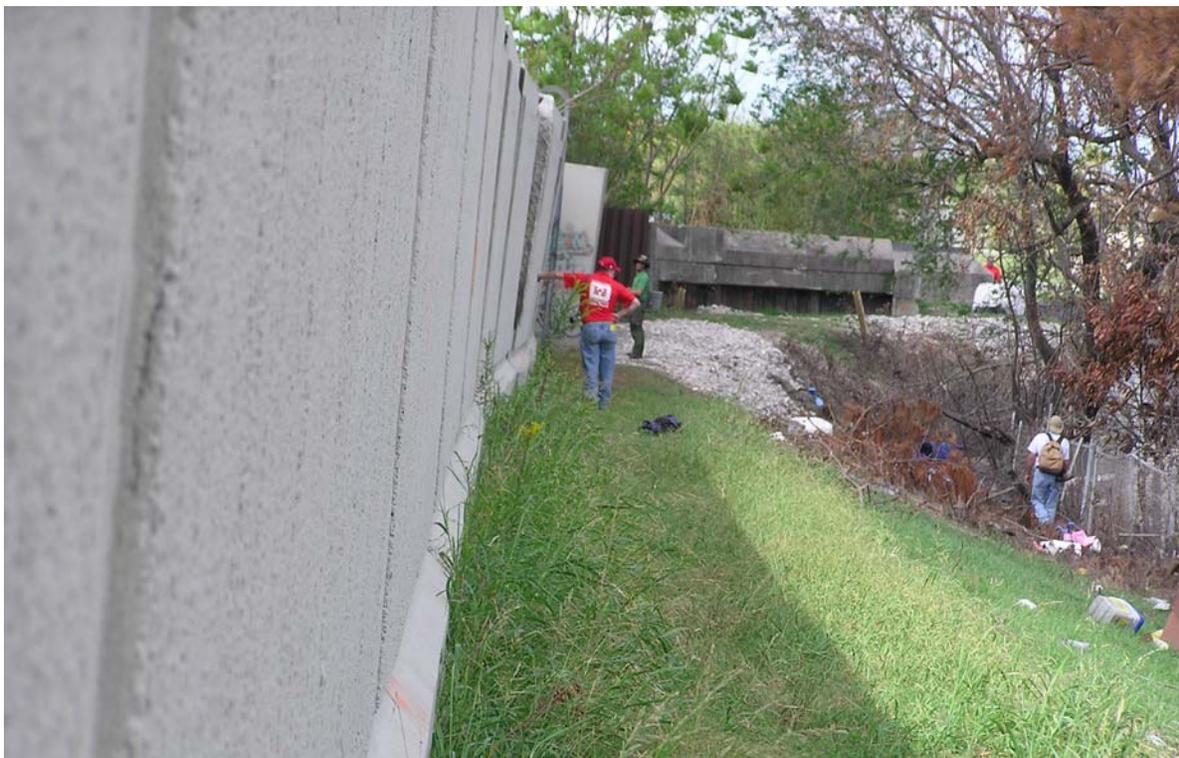
Figure 8.115: Inboard leaning floodwalls on the other side of the floodwalls shown above in Figure 8.112.

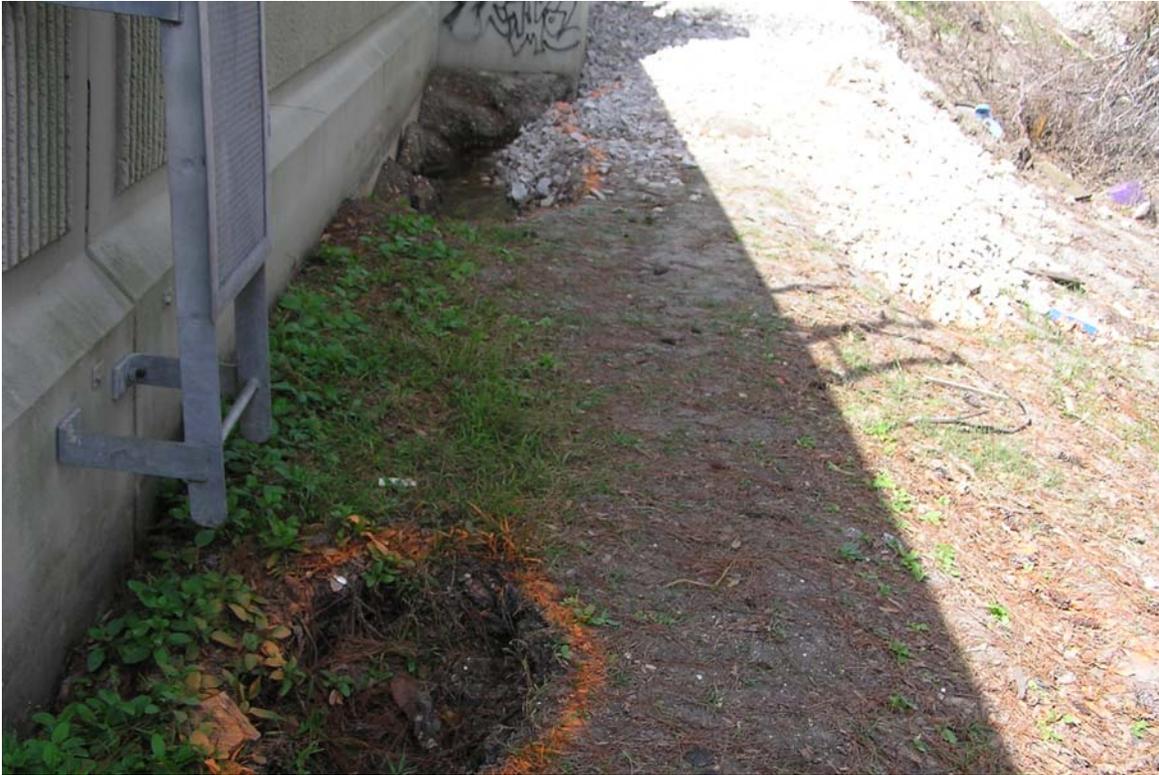
Figure 8.116: Sinkholes along the contact at the inboard side base of the floodwall and the levee crest.

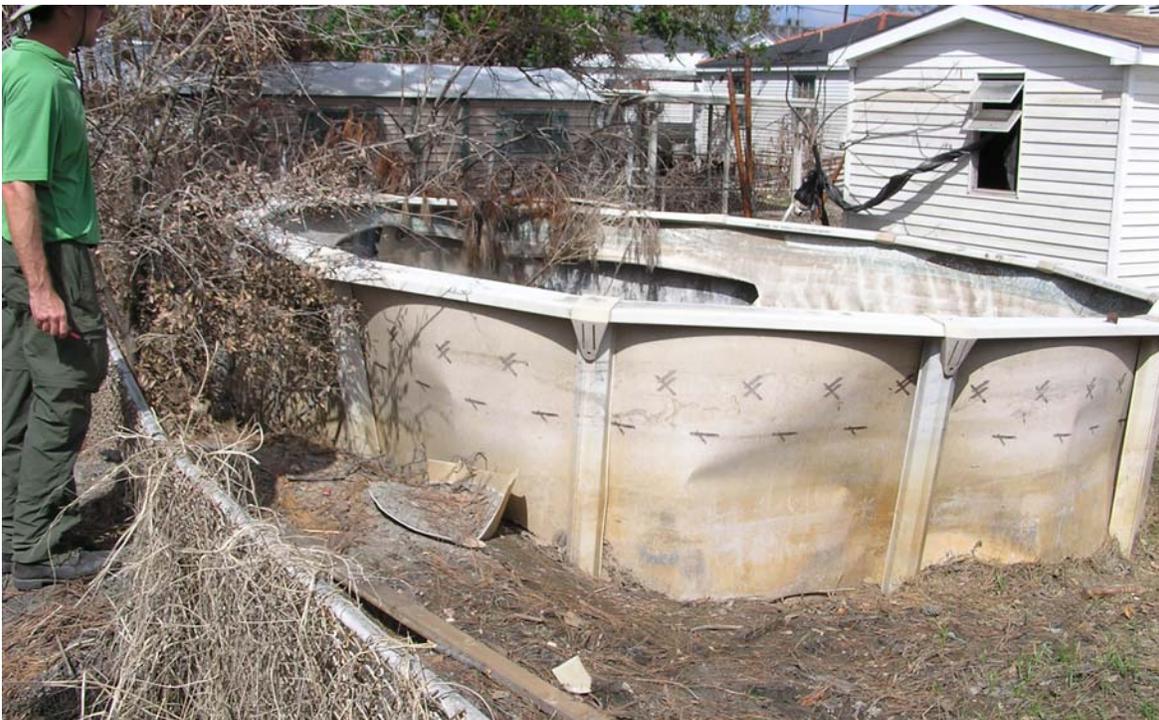
Figure 8.117: Sand ejecta from toe boil, and edge of toe thrust feature; London Avenue canal (north) east bank distressed section.
