# Investigation of the Performance of the New Orleans Flood Protection Systems in Hurricane Katrina on August 29, 2005

## Volume I: Main Text and Executive Summary

**Final Report**  
**July 31, 2006**

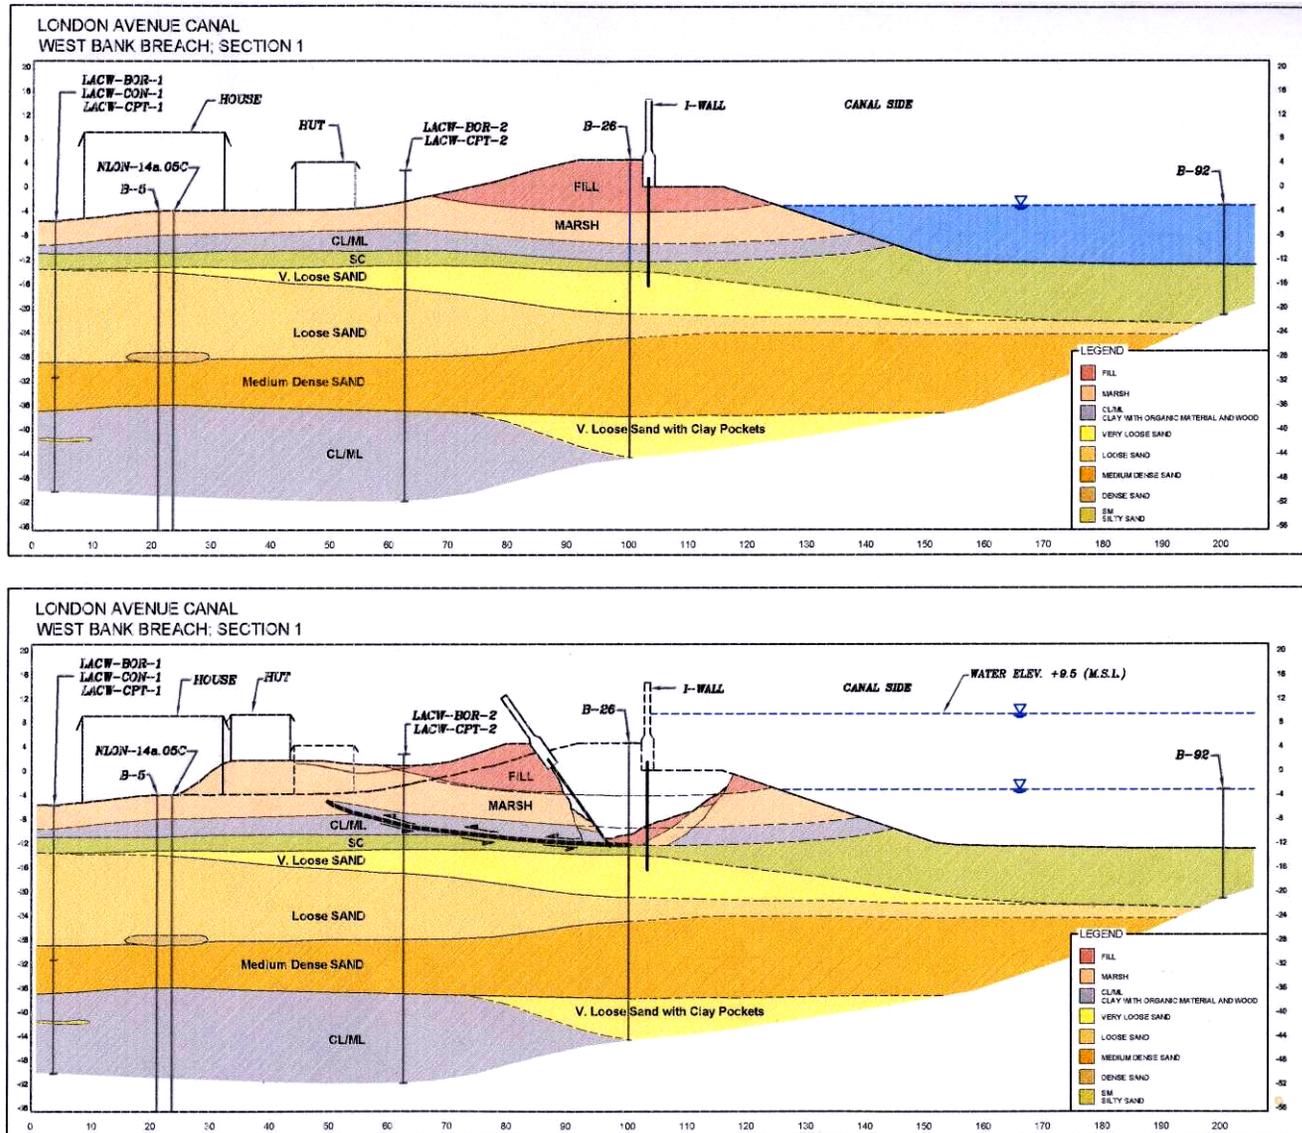
Figure 8.118(a) shows a cross-section through the west side breach prior to Katrina, and Figure 8.118(b) shows this same section after the failure. The failure on the west side was a translational failure of the embankment, sliding along the interface between the foundation sands and the overlying less pervious layer of silty clay (CL/ML).

Figure 8.118: Pre-Katrina and Post-Katrina cross-section for London Avenue Canal North, west bank breach section.

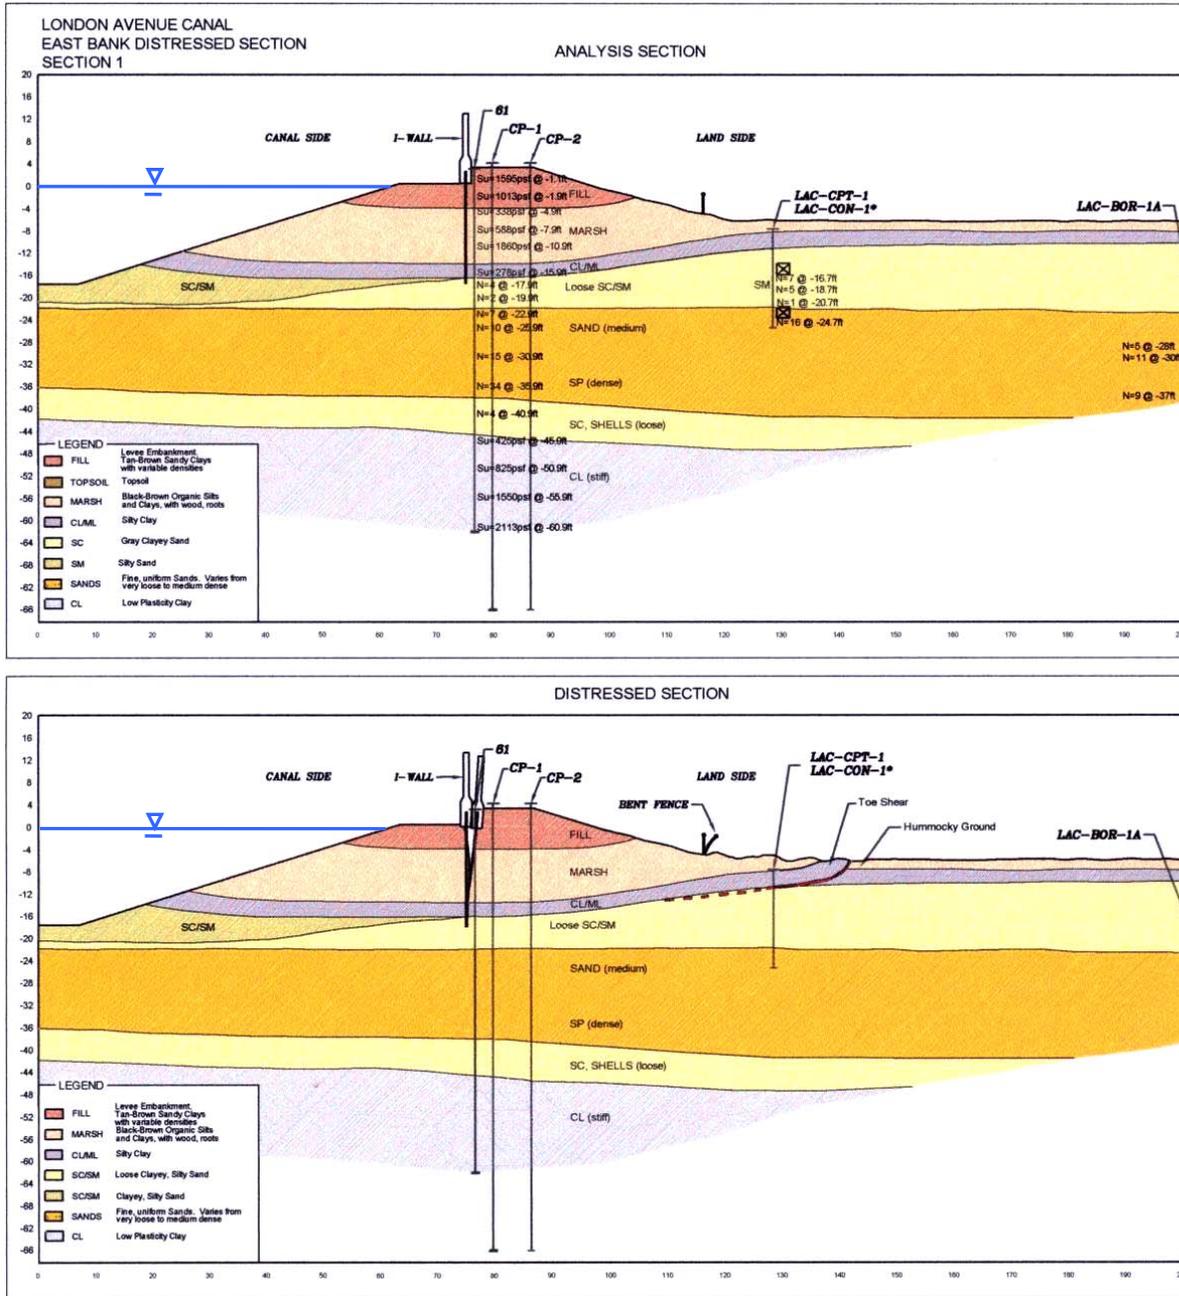
Figure 8.119(a) shows a cross-section through the east side “distressed” section prior to Katrina, and Figure 8.119(b) shows this same section after the hurricane. The displacement and tilting of the floodwall was the result of the initiation of slippage, once again at the interface between the foundation sands and the overlying less pervious layer of silty clay. Unlike the west bank, this slippage progressed only enough to produce displacements of approximately 1.5 to 2.5 feet, whereupon these movements were arrested as the failure and breaching on the opposite bank rapidly drew down the canal water level and reduced the lateral push against the sheetpile curtain and floodwall.

Figure 8.119: Pre-Katrina and Post-Katrina cross-section for London Avenue Canal North, east bank, distressed section.

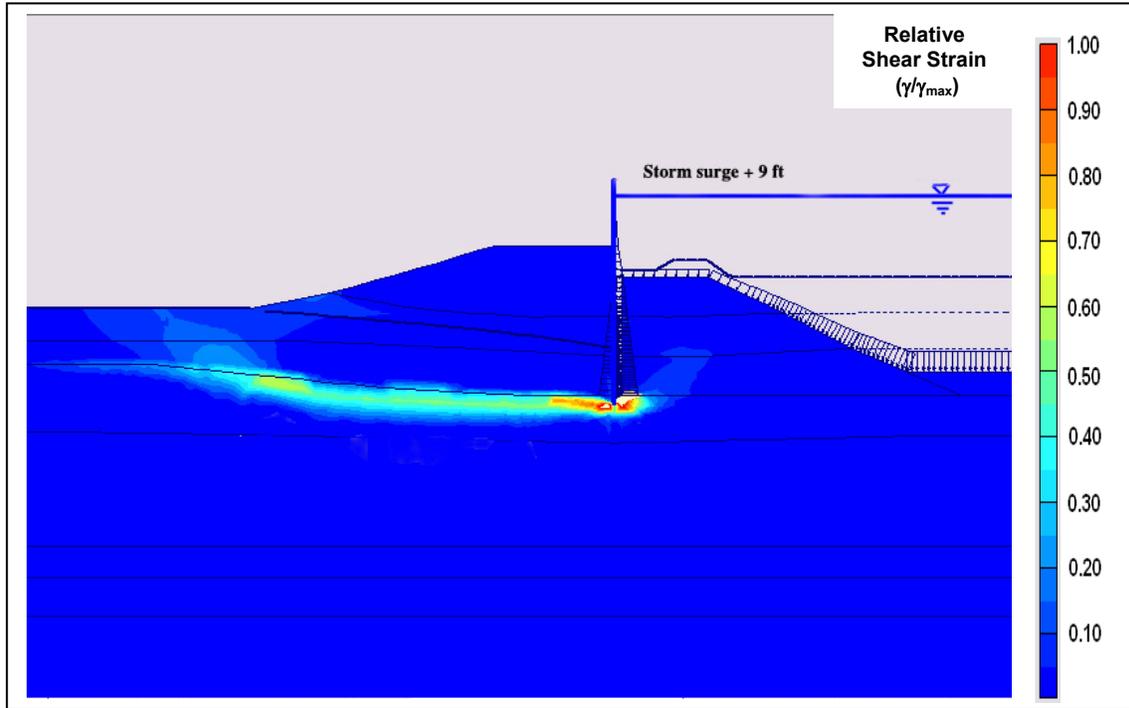
Figure 8.132 shows normalized shear strain contours for the west bank (breach) section at a storm surge level of Elev. +9 feet (MSL). Gapping initiated at the outboard side of the floodwall and its supporting sheetpile curtain initiated in this analysis at a canal surge elevation of between +7 to +8 feet (MSL), and was fully developed by a surge elevation of +9 feet, as shown in this figure.

Figure 8.132: Normalized shear strain contours (shear strain divided by strain to failure) for a storm surge at Elev. + 9 feet (MSL) at the London Avenue Canal breach site (west bank); gapping at outboard toe of floodwall is developed to full depth.

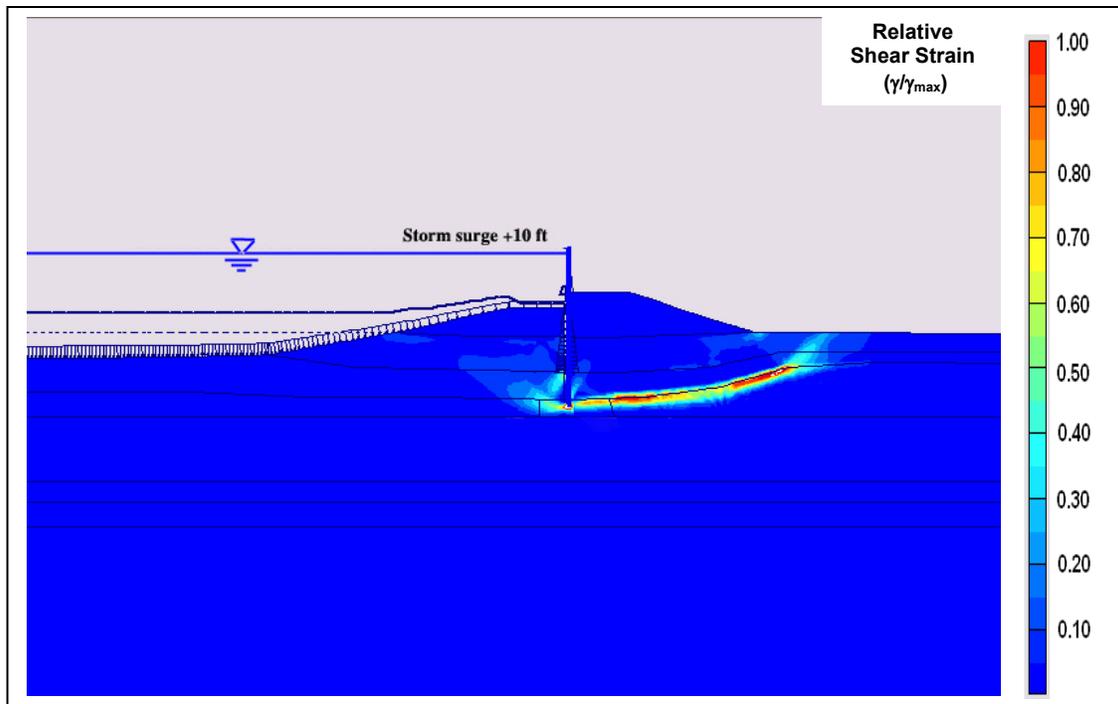
Figure 8.133 shows normalized shear strain contours for the east bank (distressed) section, this time for a slightly higher surge to elevation +10 feet (MSL). This the upper bound estimate of the surge elevations achieved during Katrina. Gapping developed in this east bank section at a surge elevation of between +7 to +8 feet, and was fully developed by a surge elevation of +9.5 feet (MSL).

Figure 8.133: Normalized shear strain contours (shear strain divided by strain to failure) for a storm surge at Elev. + 10 feet (MSL) at the London Avenue Canal distressed site (east bank); gapping at outboard toe of floodwall is developed.

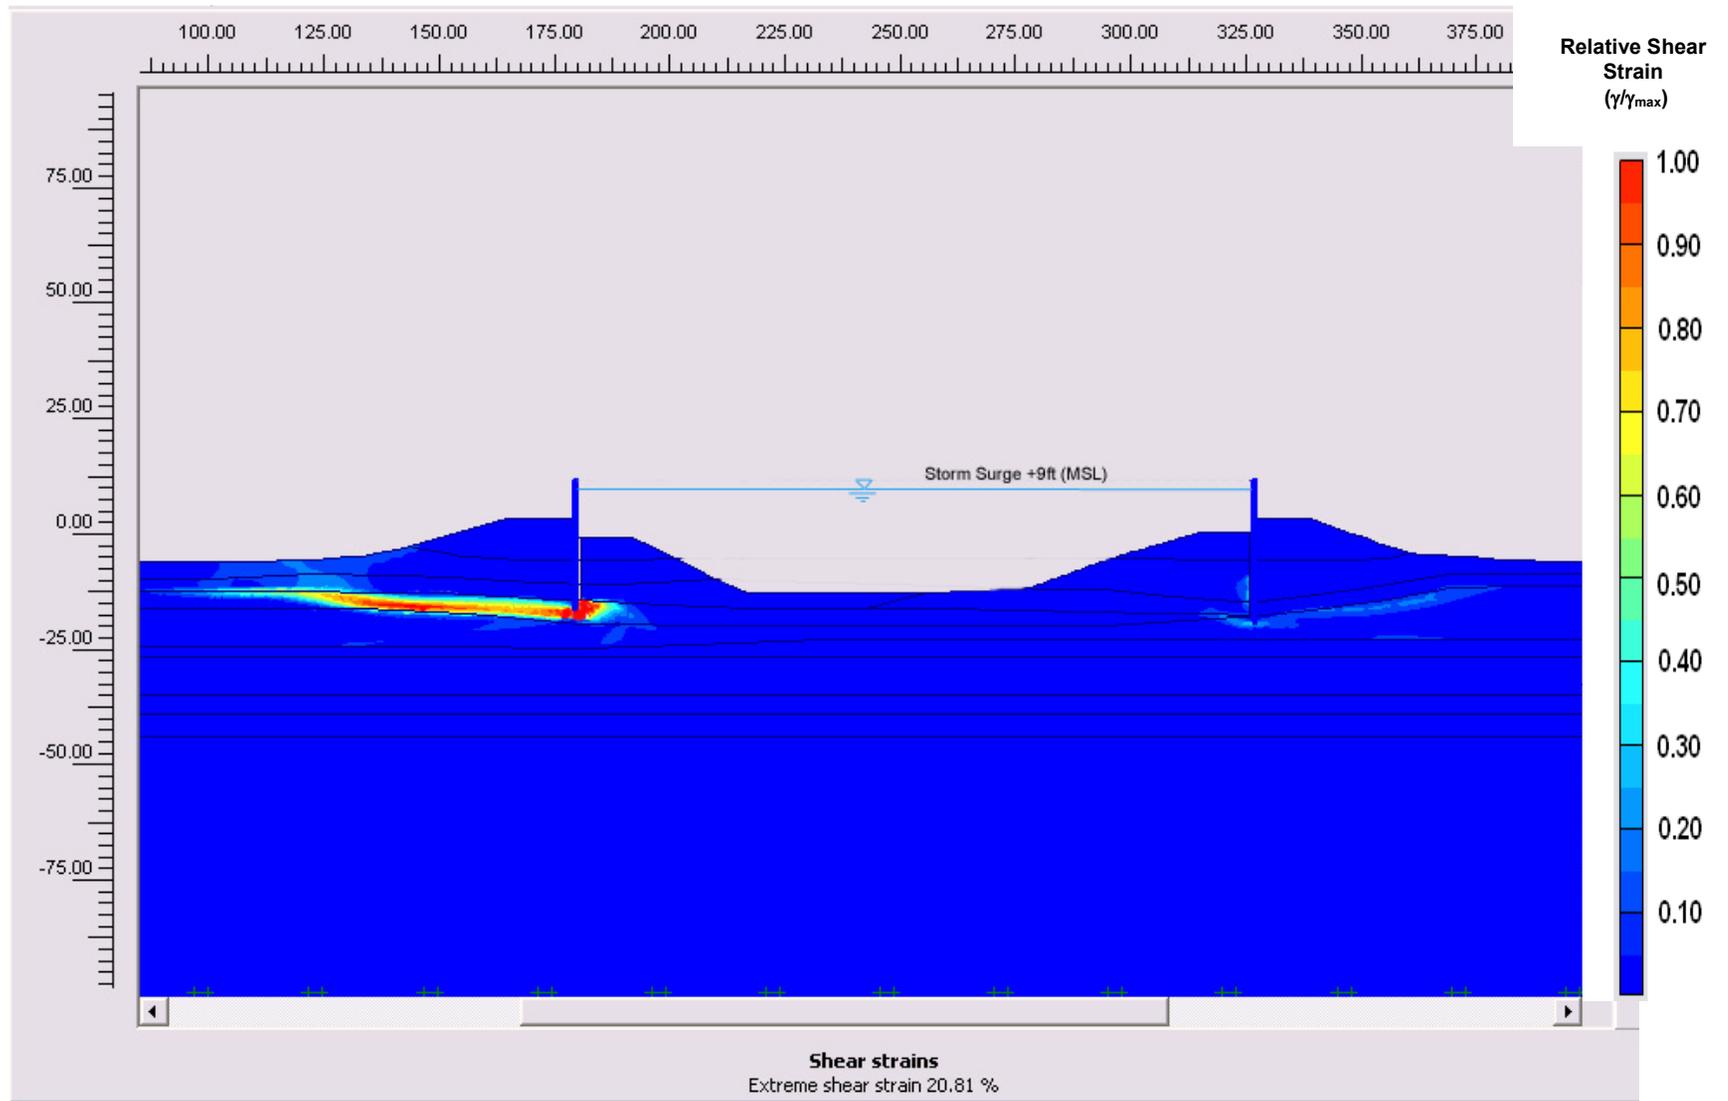
Figure 8.134: Normalized shear strain contours (shear strain divided by strain to failure) for a storm surge at Elev. + 9 feet (MSL) at the London Avenue Canal (east and west banks).

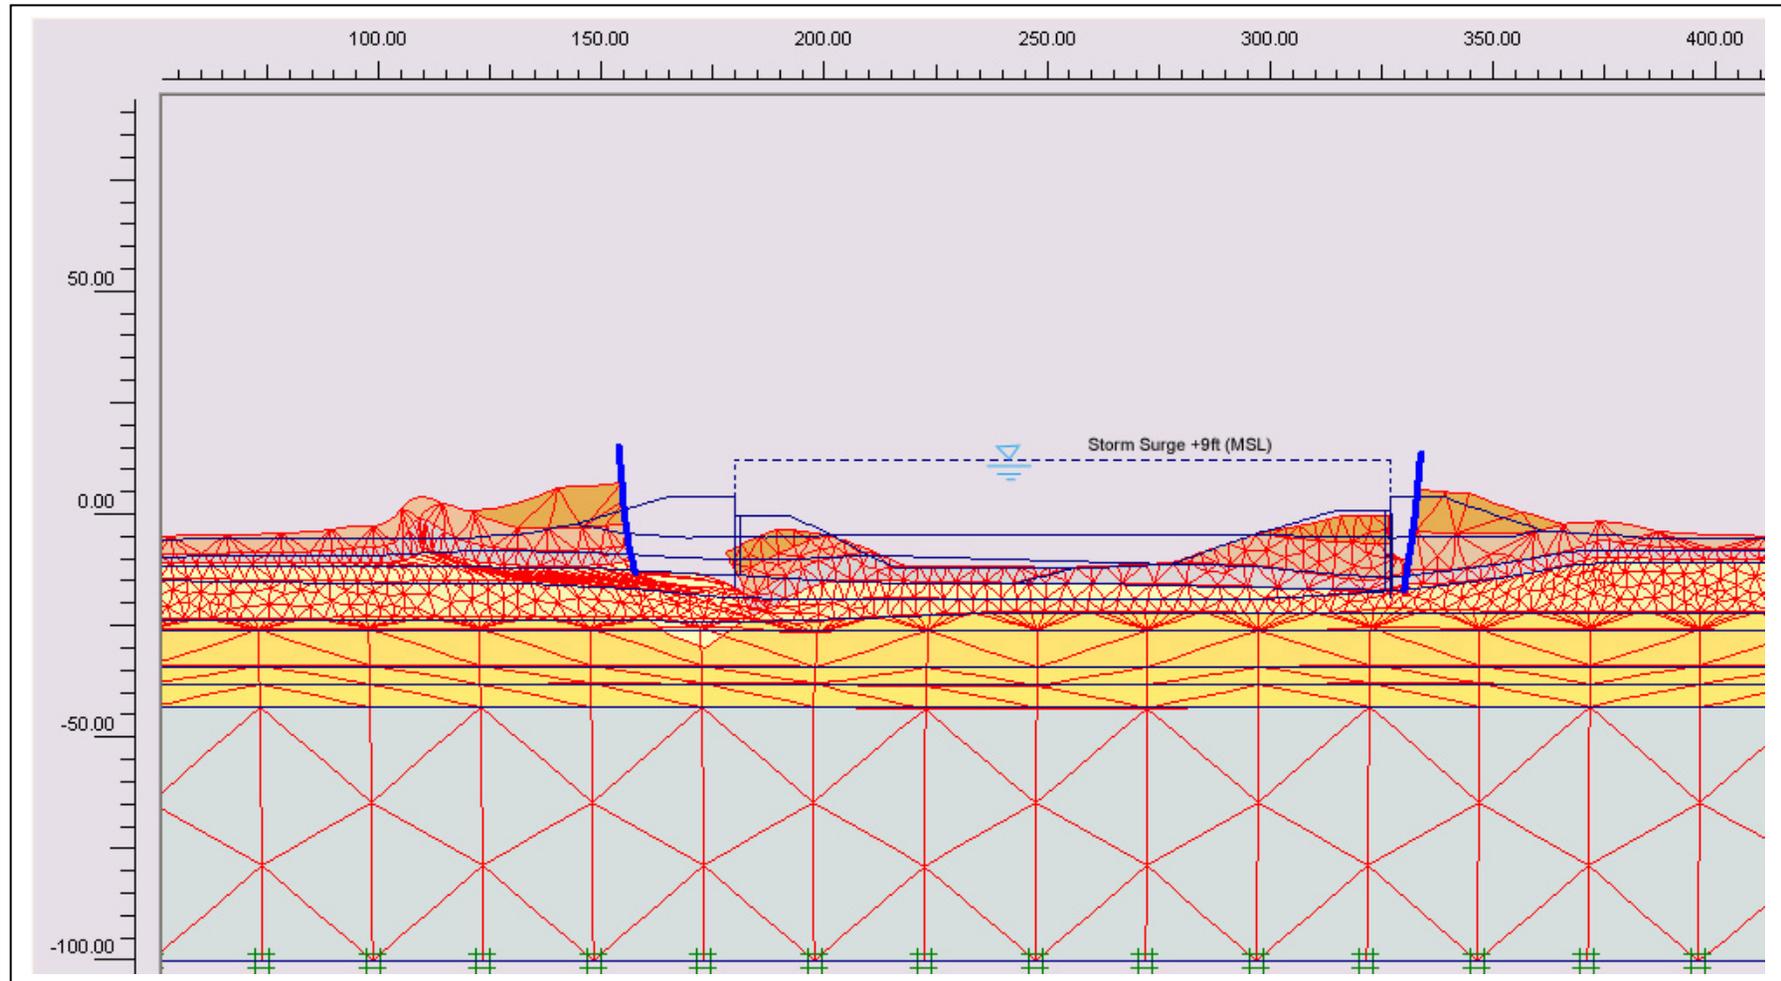
Figure 8.135: Deformed mesh for a storm surge elevation + 9 feet (MSL), London Avenue Canal (east and west banks). Displacements are exaggerated for clarity.

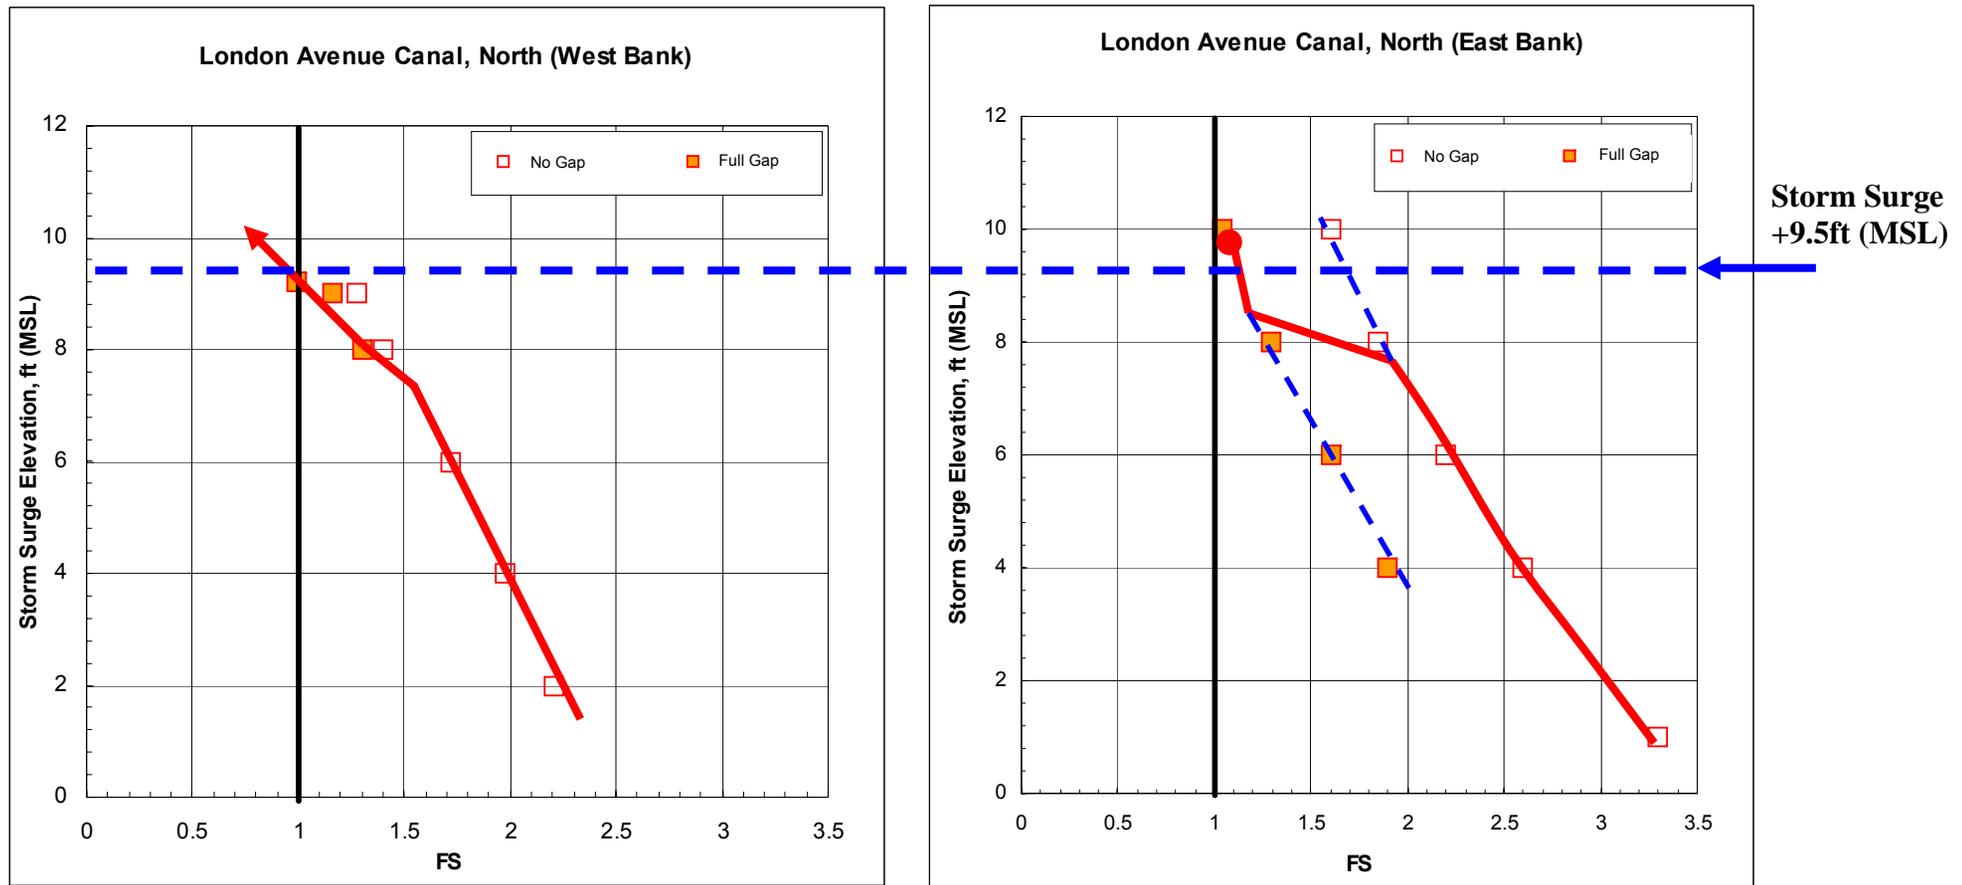
Figure 8.136: Calculated Factors of Safety for two modes based on PLAXIS analyses of the London Avenue Canal breach and distressed section for various canal water elevations; showing the best-estimated path to failure.

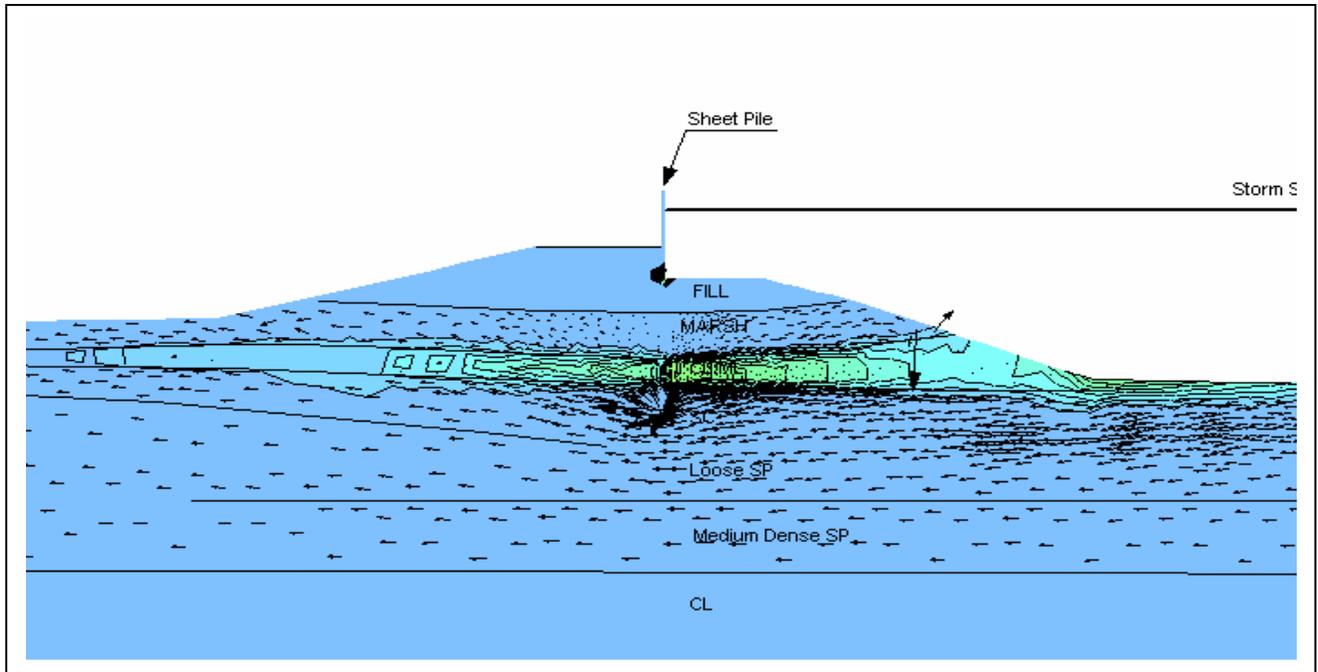
Figure 8.141: Hydraulic gradient contours without the gapping in the outboard toe of the floodwall, London Avenue Canal North, West bank. Storm surge at 9ft (MSL). Exit gradient at the inboard toe is 0.20.

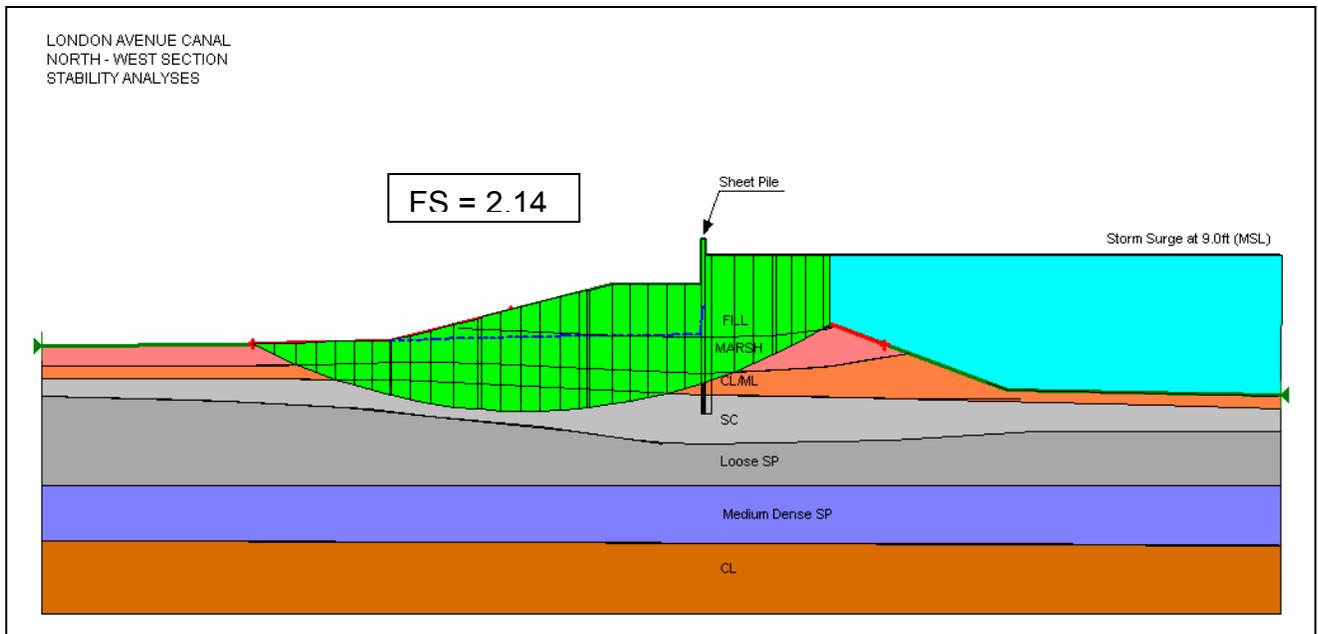
Figure 8.142: Critical failure surface without the gapping in the outboard toe of the floodwall, London Avenue Canal North, West bank. Storm surge at 9ft (MSL).

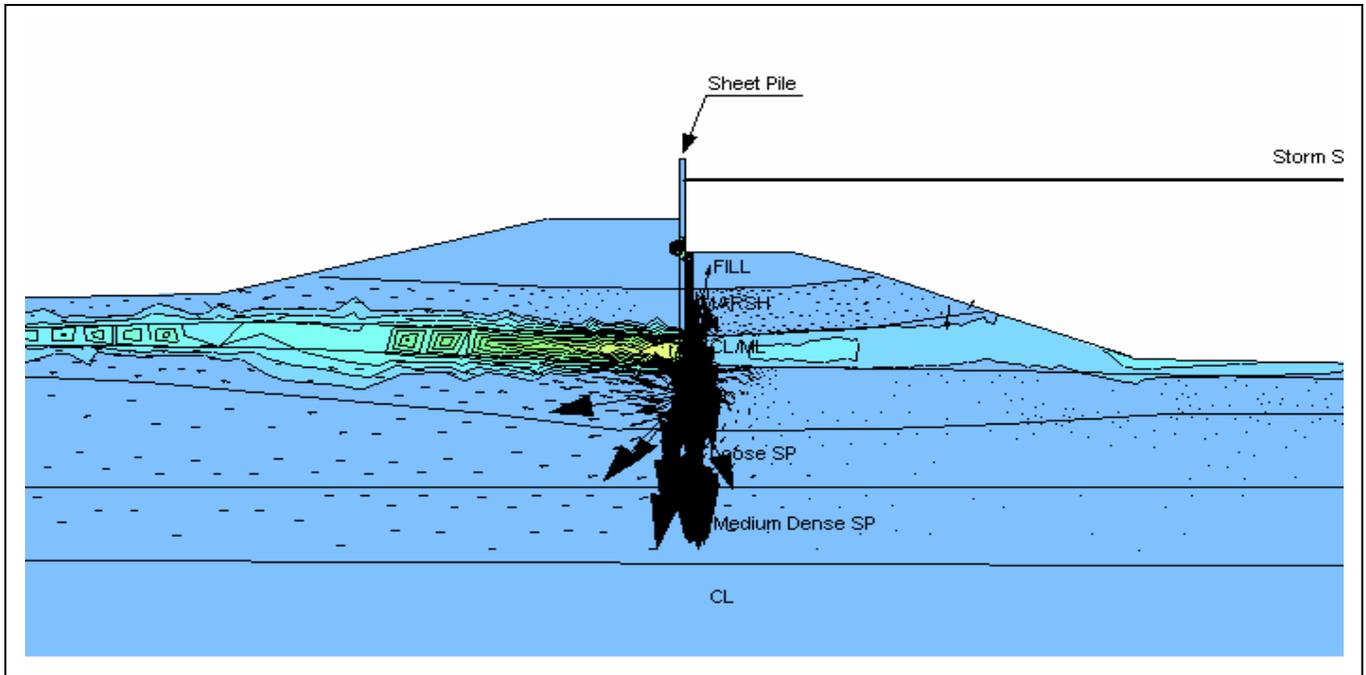
Figure 8.145: Hydraulic gradient contours with the gapping in the outboard toe of the floodwall, London Avenue Canal North, West bank. Storm surge at 9ft (MSL). Exit gradient at the inboard toe is 0.32.

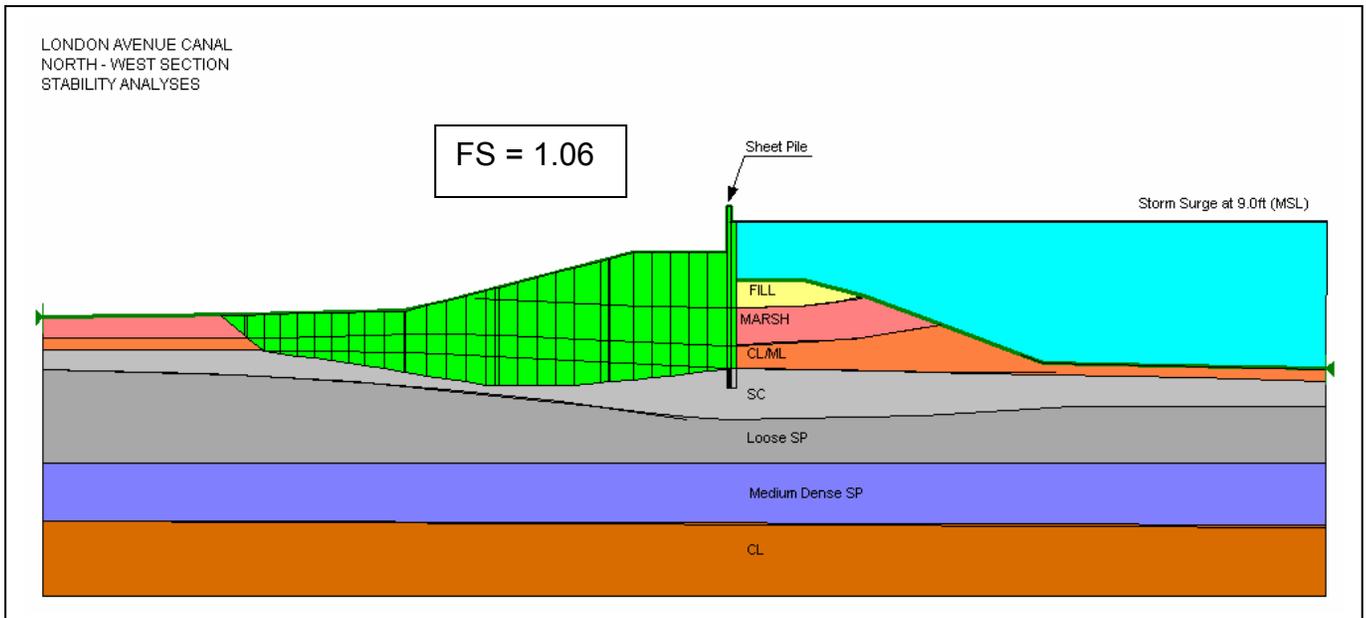
Figure 8.146: Critical failure surface with the gapping in the outboard toe of the floodwall, London Avenue Canal North, West bank. Storm surge at 9ft (MSL).

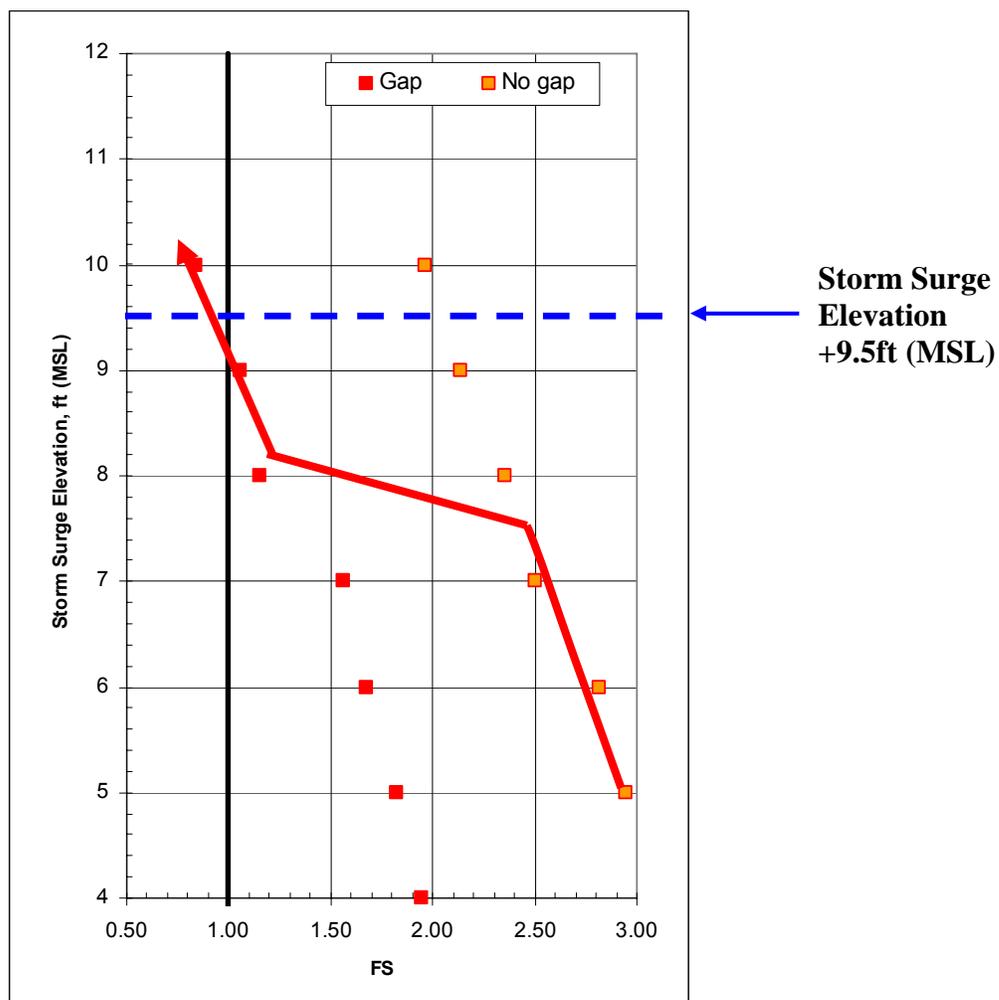
Figure 8.147 : Calculated Factors of Safety for two models based on Limit Equilibrium Analyses of the London Avenue Canal, North West bank.

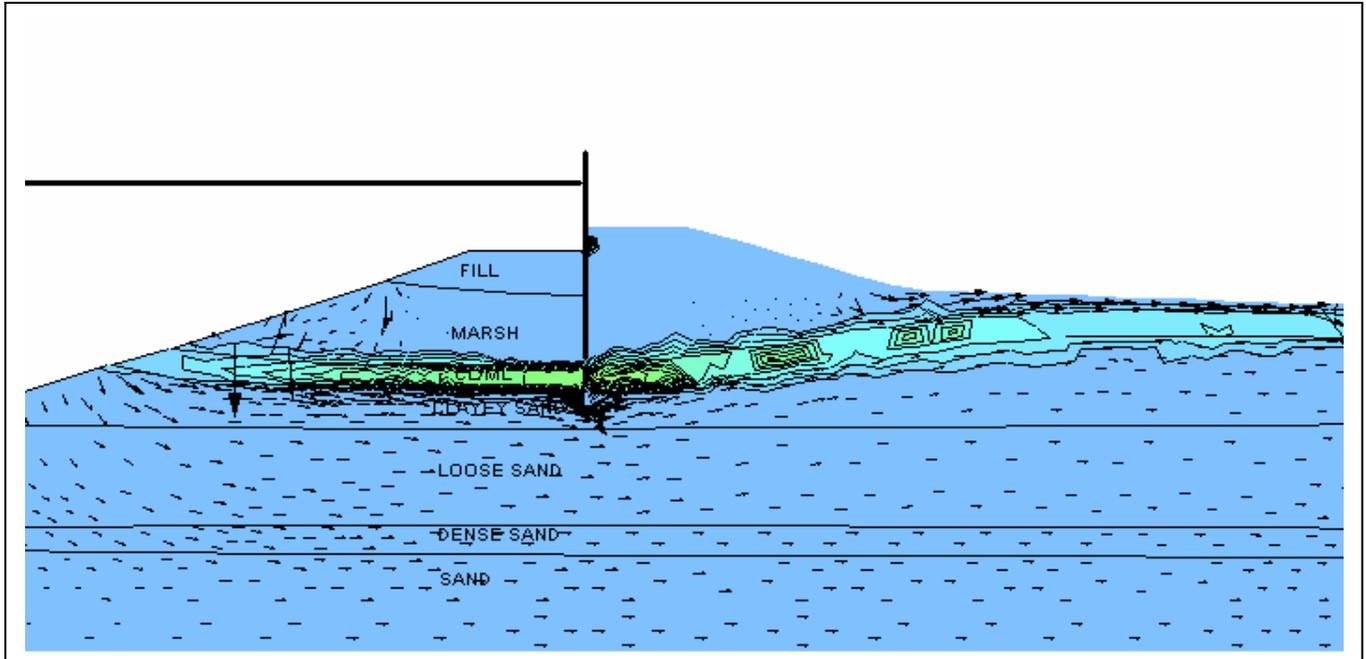
Figure 8.152: Hydraulic gradient contours without the gapping in the outboard toe of the floodwall, London Avenue Canal North, East bank. Storm surge at 9ft (MSL). Exit gradient at the inboard toe is 0.20.

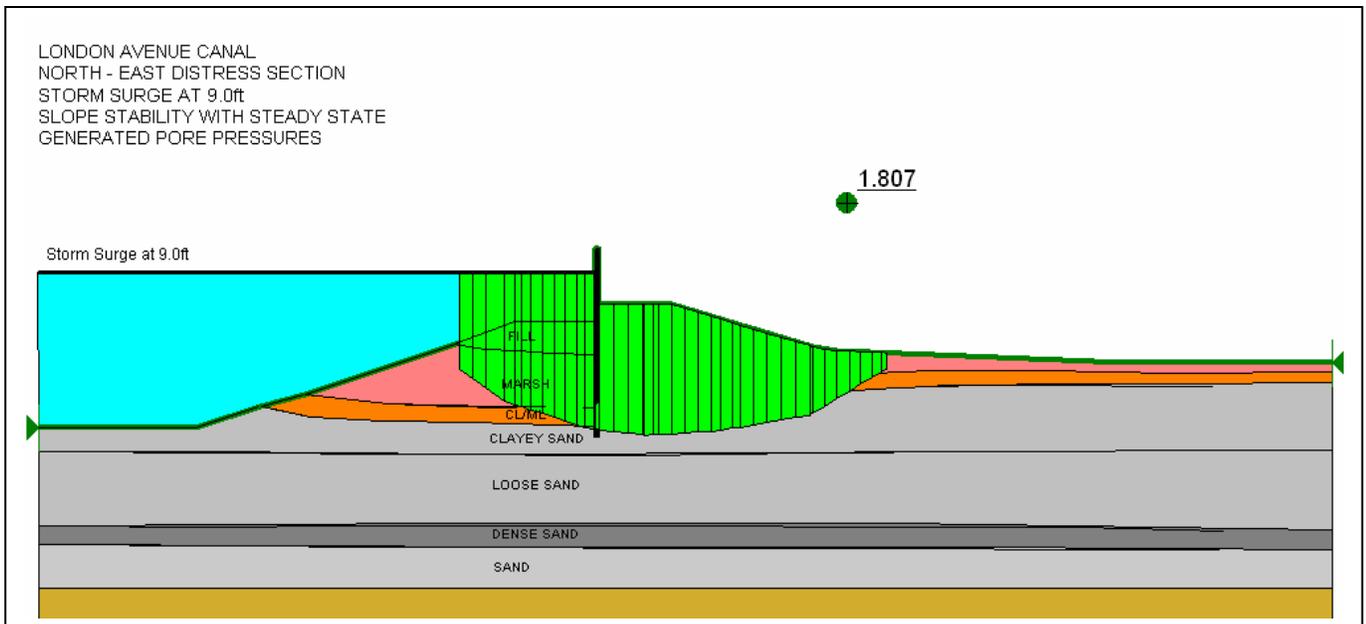
Figure 8.153: Critical failure surface without the gapping in the outboard toe of the floodwall, London Avenue Canal North, East bank. Storm surge at 9ft (MSL).

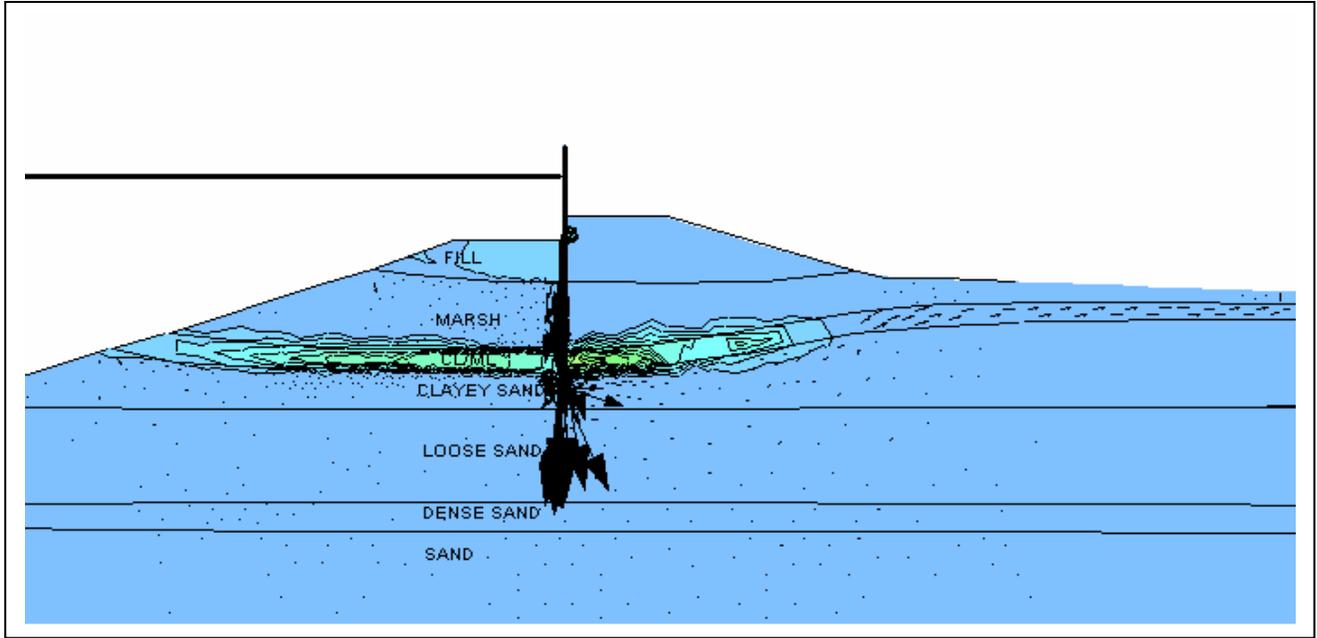
Figure 8.156: Hydraulic gradient contours with the gapping in the outboard toe of the floodwall, London Avenue Canal North, East bank. Storm surge at 9ft (MSL). Exit gradient at the inboard toe is 0.25.

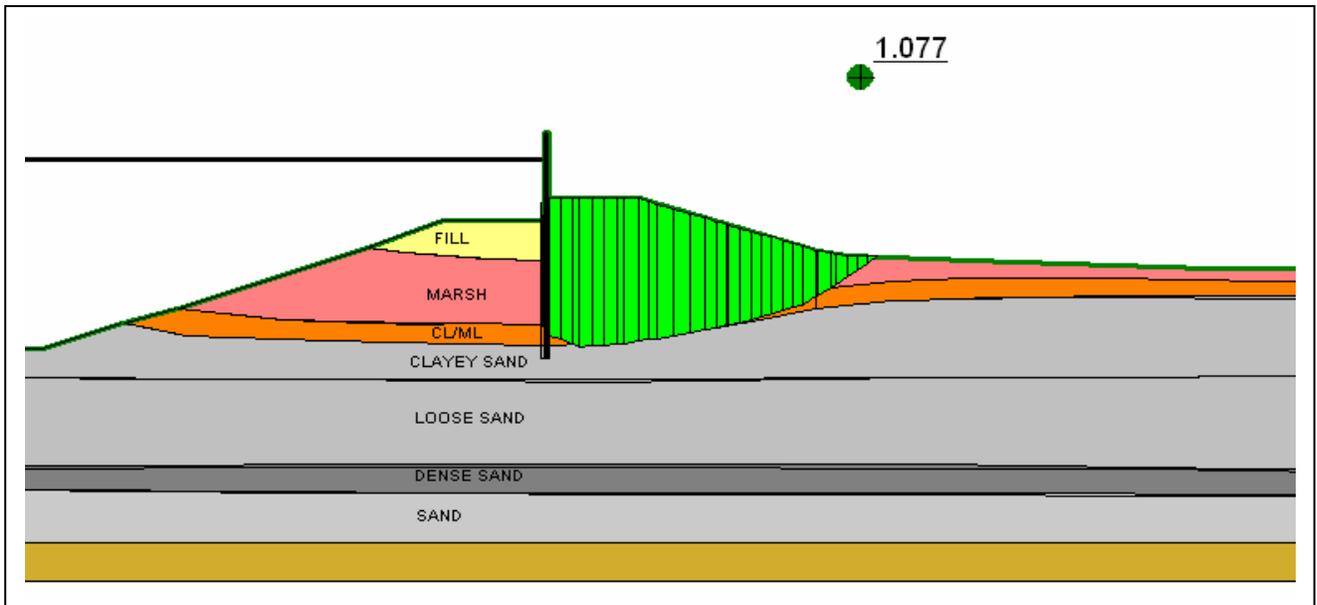
Figure 8.157: Critical failure surface with the gapping in the outboard toe of the floodwall, London Avenue Canal North, East bank. Storm surge at 9ft (MSL).

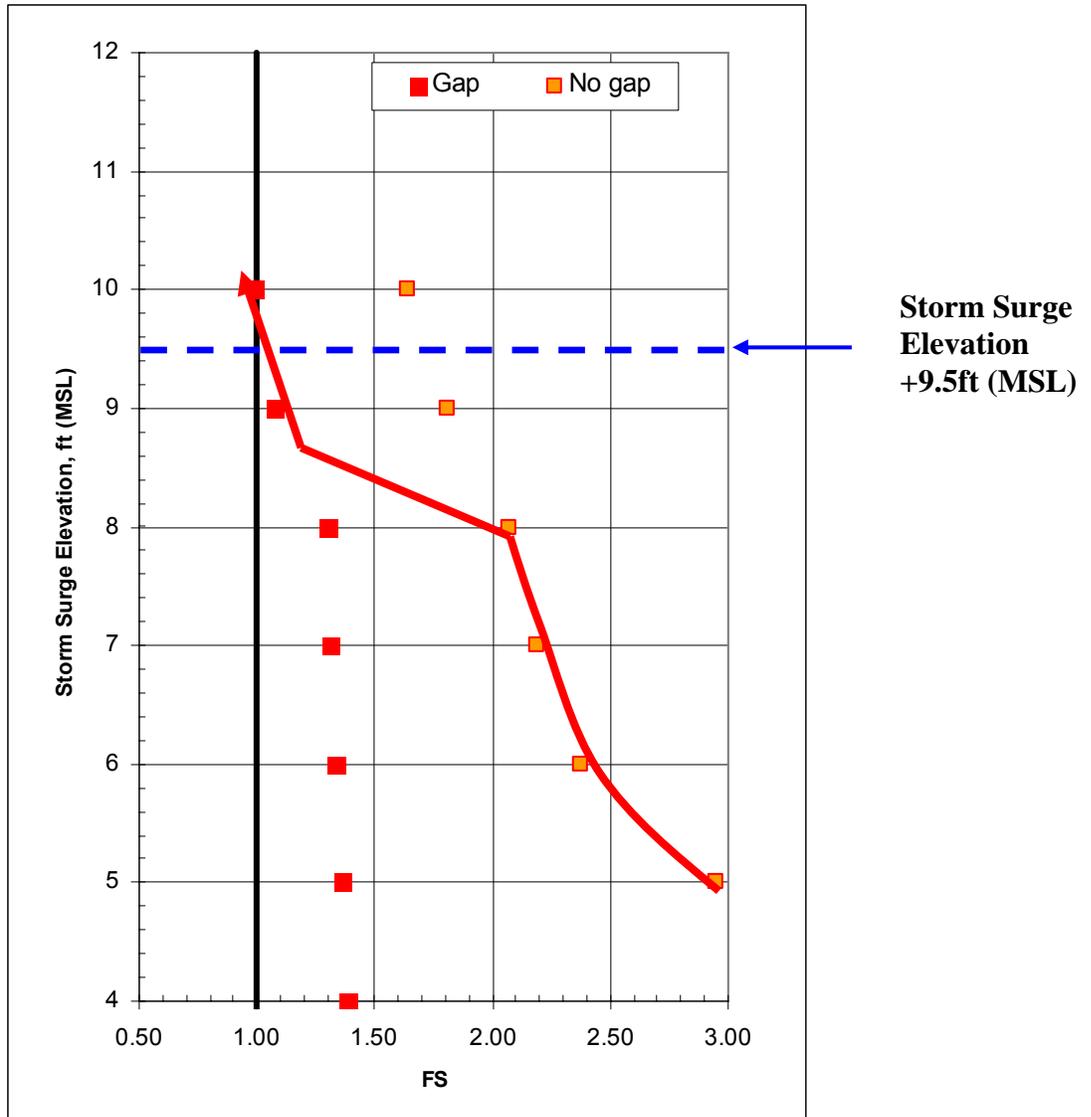
Figure 8.158 : Calculated Factors of Safety for two models based on Limit Equilibrium analyses of the London Avenue Canal, North East bank.

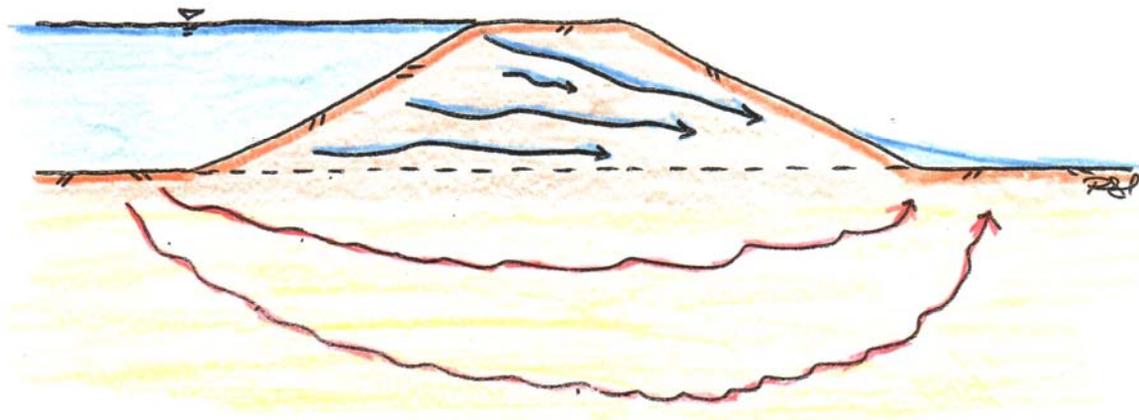
Underseepage/Instability – As shown in Figure 10.1 (red lines), if the underlying foundation materials that support the levee are adequately permeable, water can quickly travel through these porous materials as the water head differential between the outboard and inboard sides of the levee increases. This underseepage raises the pore pressures within the soils at the inboard side, and this in turn reduces the shear strengths of these soils. This can result in catastrophic failure by means of resultant slope instability (as described in the previous section).

**Figure 10.1:** Underseepage in highly permeable underlying foundation materials (red lines) can result in the catastrophic failure of the levee in that once the foundation materials have been eroded, the levee (which may be completely undamaged) has no underlying support and falls into the resulting void and essentially washes away.

Internal erosion and piping (blue lines) occurs in levee materials that have high permeabilities (such as sand and gravel) and allow for water to rapidly flow from high pressure areas to low pressure areas. As the water flows through the levee, smaller/finer soil particles are “washed” out of the levee resulting in the internal erosion of the levee. Enough internal erosion of the levee can lead to the collapse and subsequent “wash-out” of the levee.

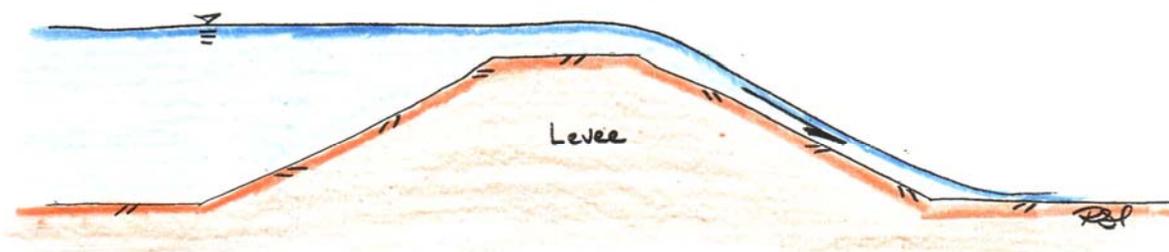
(a) Overtopping – As shown in Figure 10.2, overtopping occurs when the water level on the outboard side of the levee exceeds the crest elevation of the levee. The inboard side of the levee acts as a spillway for the overtopping water and damage is inflicted on the levee as a result of water scour. Levees are not generally designed for overtopping and as a result, if overtopping does occur, they are can be highly susceptible to catastrophic failure unless overtopping duration and intensity are limited and erosion-resistant materials are used to construct the levee (or unless erosion protection, in the form of “armoring” is applied to the exposed crest and faces of the levee.) As water passes over the top of the levee, its velocity increases as it runs down the back side, and the erosive shear force of the water increases with this increase in velocity.

**Figure 10.2:** Overtopping occurs when the water level on the outboard side of the levee exceeds the crest elevation of the levee. The inboard side of the levee acts as a spillway for the overtopping water and damage is inflicted on the levee as a result of water scour.

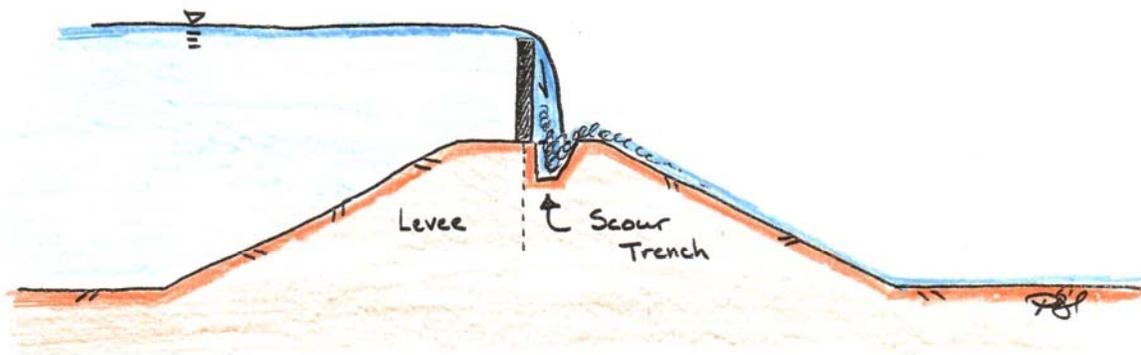
(b) Sharp Overtopping and Jetting – This is more likely to occur on levees with floodwalls. As shown in Figure 10.3, jetting occurs when the water level on the outboard side of the levee exceeds the top of wall elevation for structural walls that are founded within the earthen levee. Unlike overtopping of a conventional earthen levee, the floodwall acts as a weir and water falling over the wall impacts the levee in a concentrated stream that is much more energy intensive than conventional overtopping. For typical New Orleans floodwalls, the water impact velocities are on the order of 6 to 8 m/s. Levees are not generally designed for overtopping and jetting and as a result, if overtopping and jetting does occur, a deep scour trench can rapidly develop against the land-side face of the floodwall. This reduces the earth pressure providing lateral support for the wall, making the wall highly susceptible to potential catastrophic lateral failure (when pushed by the water pressures on its outboard side). This erosive trenching can be prevented by installing “splash-pads”, coarse rip-rap, or other energy dissipating devices at the inboard side toe of the floodwall, and the use of highly erosion-resistant materials to construct the crown section of the levee is also advisable here.

**Figure 10.3:** Jetting occurs when the water level on the outboard side of the levee exceeds the top of wall elevation for structural walls that are founded within the earthen levee. Unlike overtopping of a conventional earthen levee, the floodwall acts as a weir and water impacts the levee in a concentrated stream that is much more energy intensive than conventional overtopping.
