# Investigation of the Performance of the New Orleans Flood Protection Systems in Hurricane Katrina on August 29, 2005

## Volume I: Main Text and Executive Summary

**Final Report**  
**July 31, 2006**

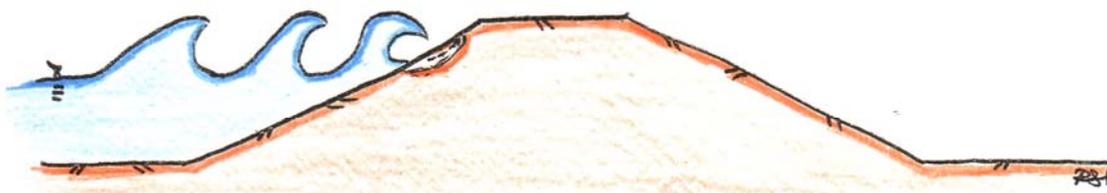
(d) Wave Impacts – As shown in Figure 10.5, wave impacts can cause significant erosion to levee faces. Wave-induced erosion consists of run-up (sloshing up and down of water as a result of staggered wave arrival) and “mini-jetting” when the crest of the waves breaks on the levee face. Levees that are anticipated to be impacted by waves are generally designed with armoring to prevent damage from wave impacts.

**Figure 10.5:** Wave impacts can cause significant erosion to levee faces. Wave-induced erosion consists of run-up (sloshing up and down of water as a result of staggered wave arrival) and “mini-jetting” when the crest of the waves breaks on the levee face.

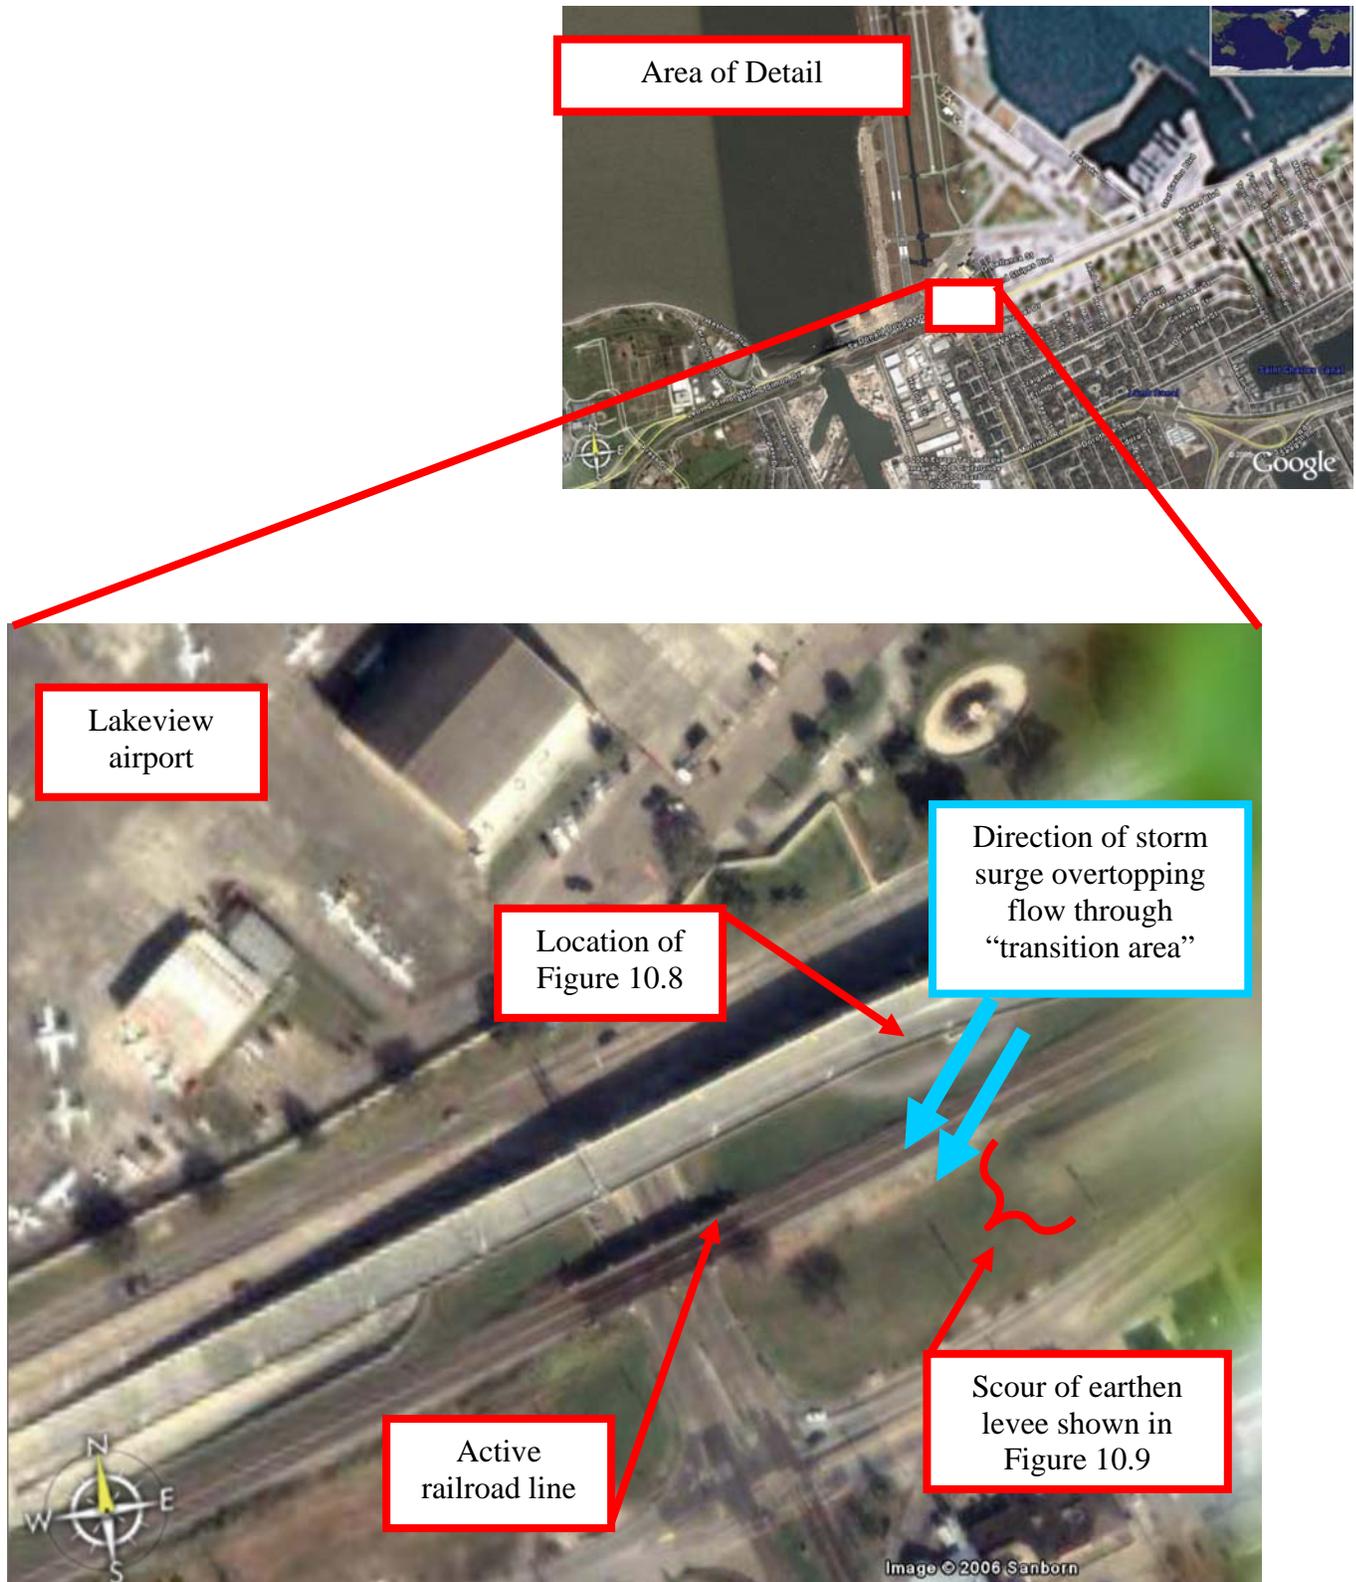
Storm-surge induced overtopping traveled through the low spot at this complex transition/penetration, which was the granular gravel ballast for the railroad line, and this flow eroded the railroad line embankment, which served as a transition levee between the concrete floodwall (design Elevation + 13.5 feet MSL = +11.8 feet NAVD 88-2004.65) and the earthen levee (design Elevation +14.5 feet MSL = +12.8 feet NAVD88-2004.65) shown in Figure 10.7. Figure 10.8 shows the location where overtopping occurred resulting in significant scour around the floodwall and Figure 10.9 provides a view across the railroad line where the railroad line embankment was eroded allowing for the terminus of the earthen levee to be scoured. Note that at the time of our visit, the railroad embankment had already been repaired by railroad personnel.

**Figure 10.7:** Storm-surge induced overtopping traveled through the granular gravel ballast for the railroad line and eroded the railroad line embankment, which served as a transition levee between the concrete floodwall and the earthen levee shown in Figure 10.8.

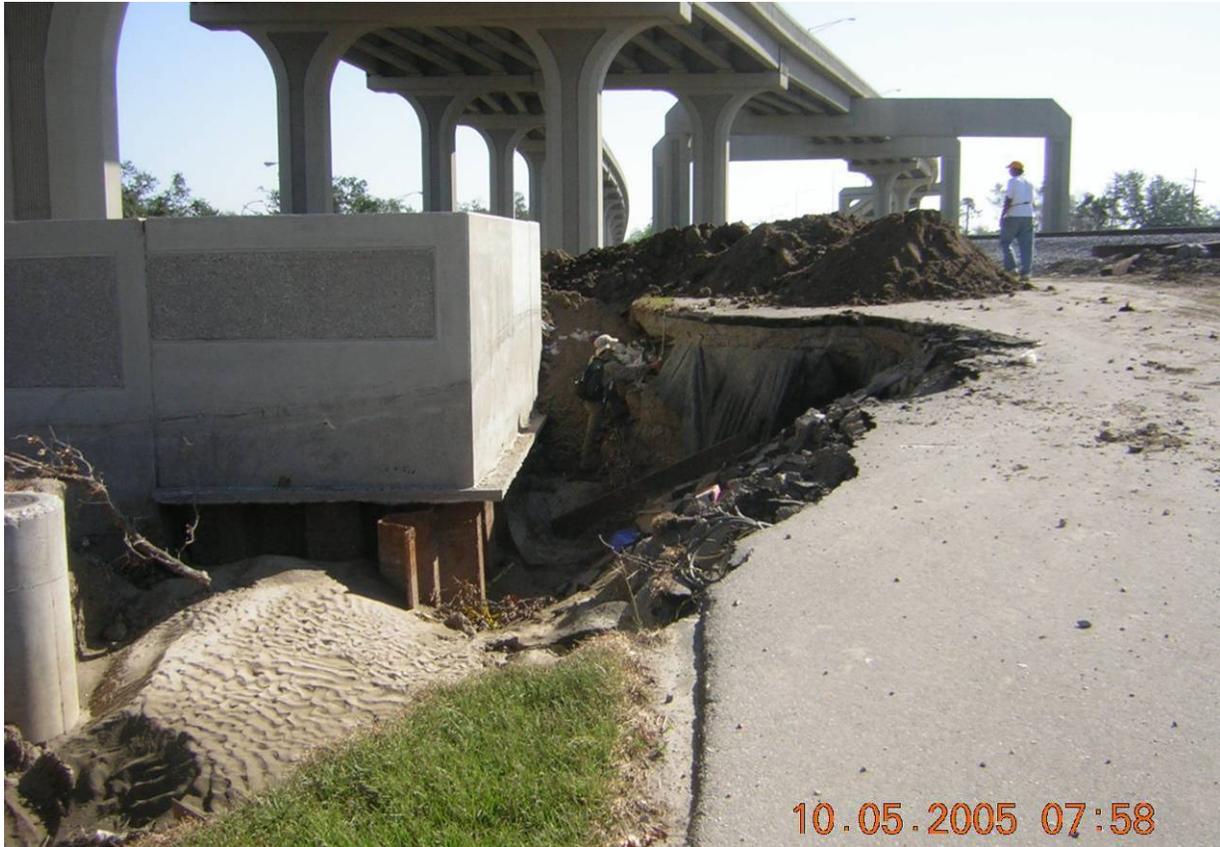
**Figure 10.8:** Lakefront levee near the Lakefront Airport at location 1 (as indicated on Figure 10.7) where overtopping occurred and significant scour around the floodwall was observed.

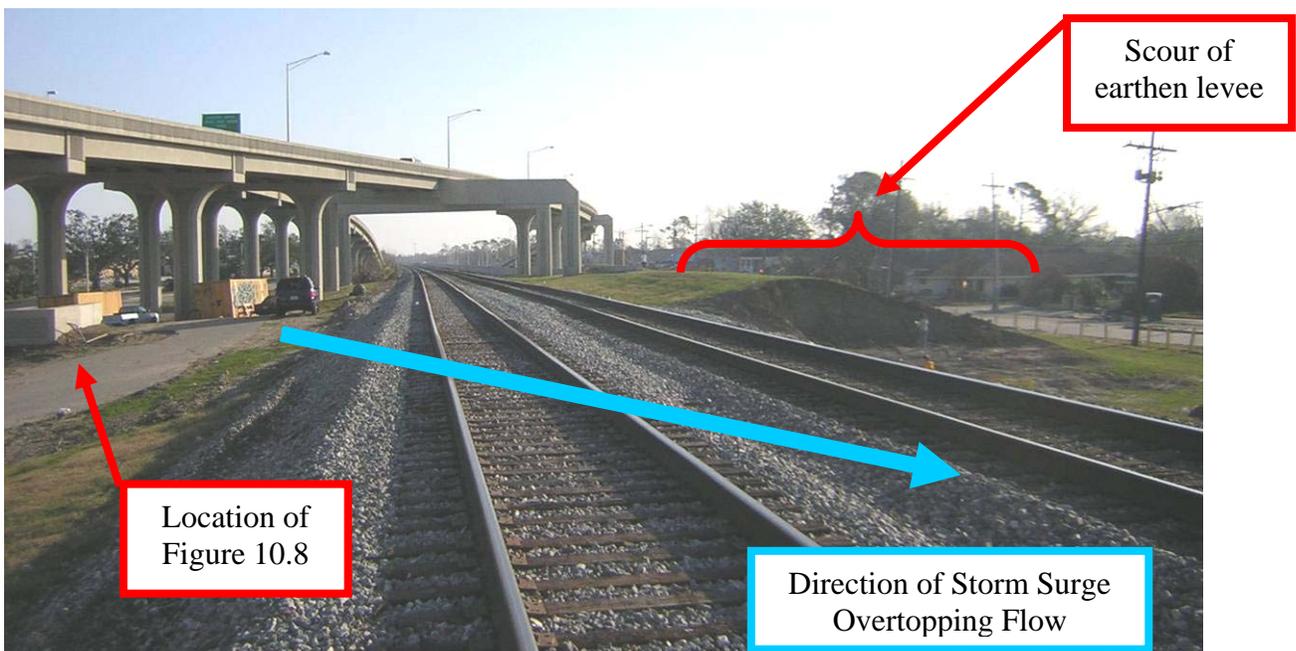
**Figure 10.9:** Significant erosion was observed on the levee behind the floodwall shown in Figure 10.8. The storm surge overtopped the floodwall and railroad ballast and failed the earthen levee.

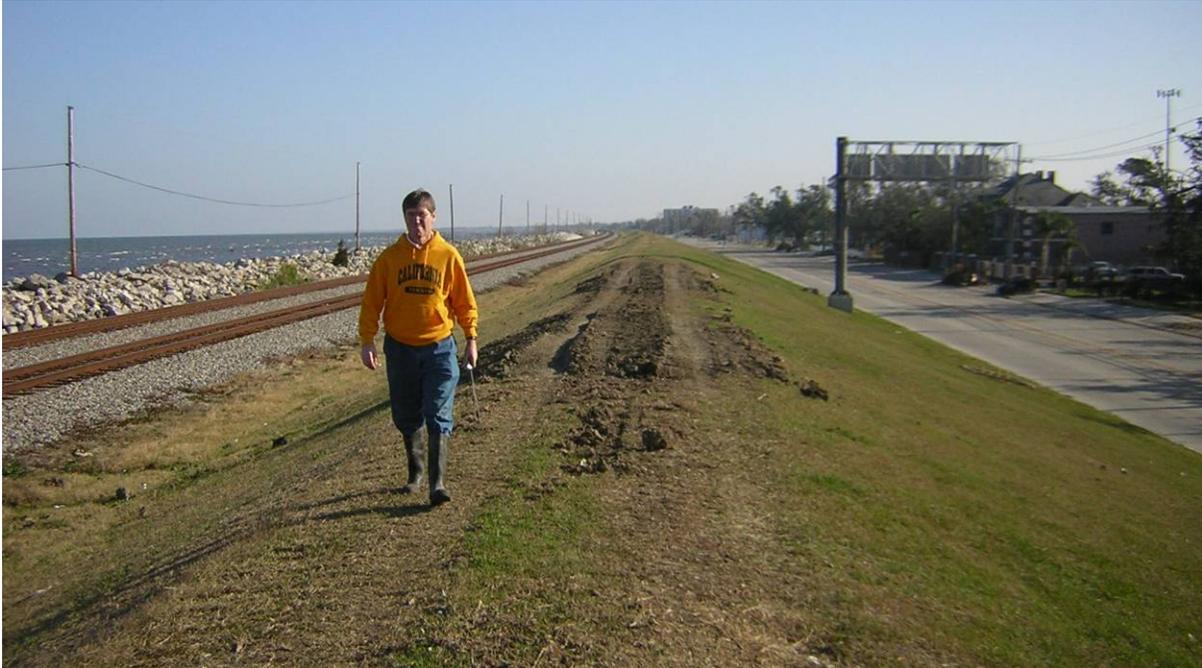
Location 2 is situated near the intersection of Hayne Boulevard and Jahncke Road, near Lake Pontchartrain. At this location a concrete outfall structure protrudes through the flood protection levee. High water marks, as reported by IPET (2006), at this location reached a maximum Elevation of +12 feet (NAVD88-2004.65). The design elevation of the levee system at this location was Elevation +14.5 feet (NGVD29). Exact datum conversions in this area are not clearly established and are still under review by the IPET team, but the design elevation has been identified as Elevation +12.8 feet (NAVD88-2004.65), resulting in a minor degree of overtopping at this location. Our field reconnaissance verified that minor overtopping occurred at this location, as can be seen in Figures 10.10 and 10.11.

Figure 10.10 provides an eastward looking view. Small patches can be seen on the levee crest where minor erosion occurred. Figure 10.11 presents a view of scour-related erosion behind the concrete outfall structure transition.

As shown in Figures 10.10 and 10.11, performance at this location was acceptable despite the moderate overtopping; only limited erosion occurred at select locations across the earthen levee crest and on the back face, and additional erosion occurred preferentially at several soil/structure interfaces. None of this erosion was sufficient as to result in a breach of the flood defenses at this location. The moderate erosion that did occur, however, suggests that more severe overtopping would likely be more problematic and might well cause full breaching if this section is not upgraded for erosion resistance.

**Figure 10.10:** Lakefront levee at location 2 (as indicated on Figure 10.6) where minor overtopping occurred. These levees performed well and only minor, surficial damage was observed.

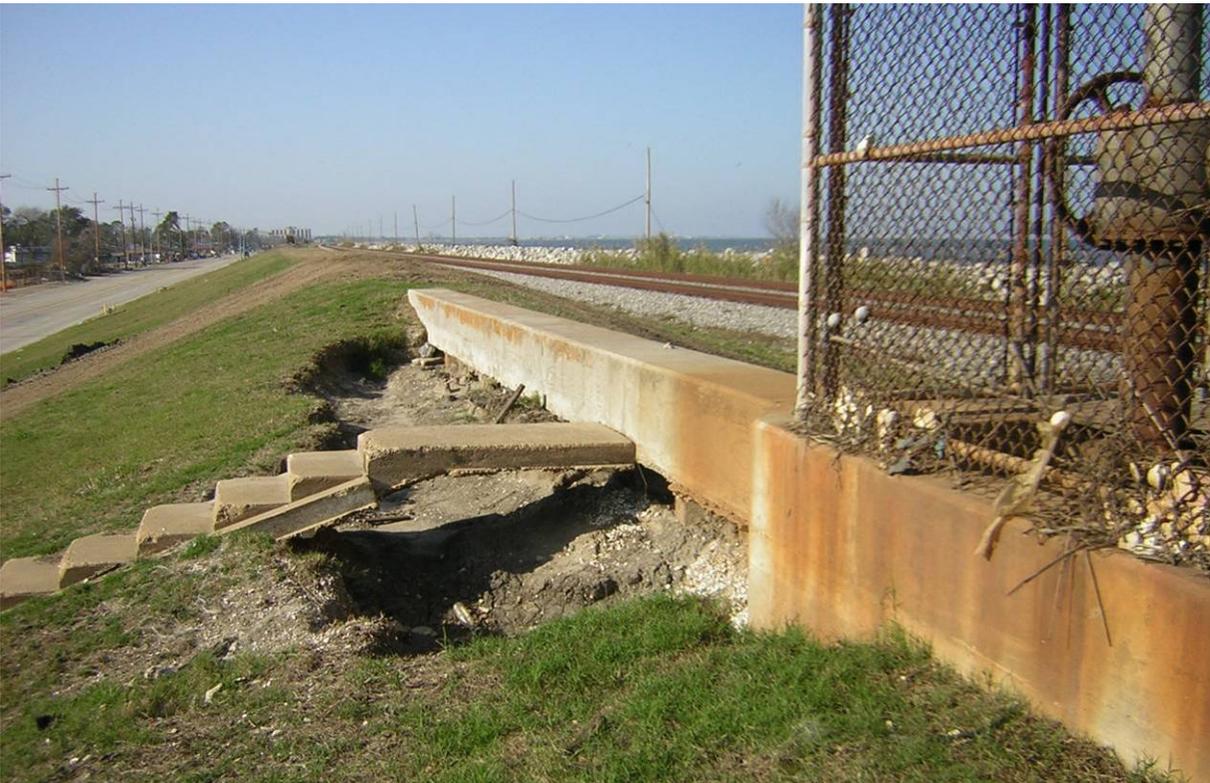
**Figure 10.11:** Observed scour at the Jahncke Pump Station outfall structure (location 2 as indicated on Figure 10.6). Scour was limited to areas of soil-structure interfaces, and no full breach occurred.

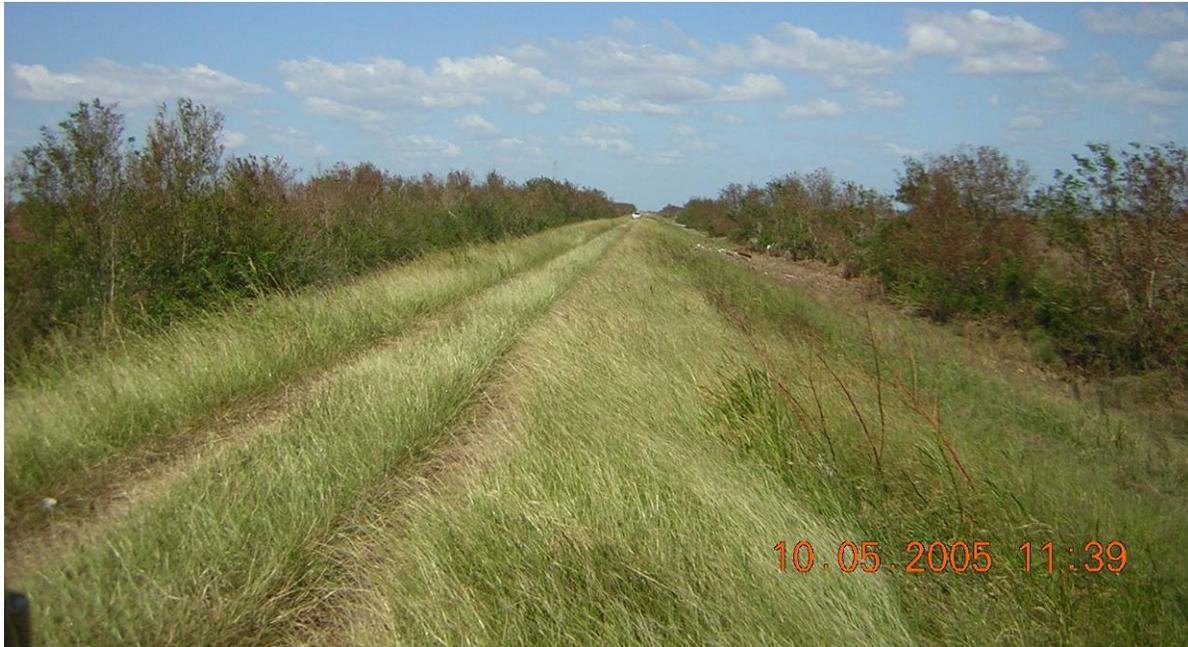
**Figure 10.12:** Condition of levees east of HWY 11 (location 3 on Figure 10.6) in October 2005. These levees performed exceptionally well and were not eroded during Hurricanes Katrina or Rita.

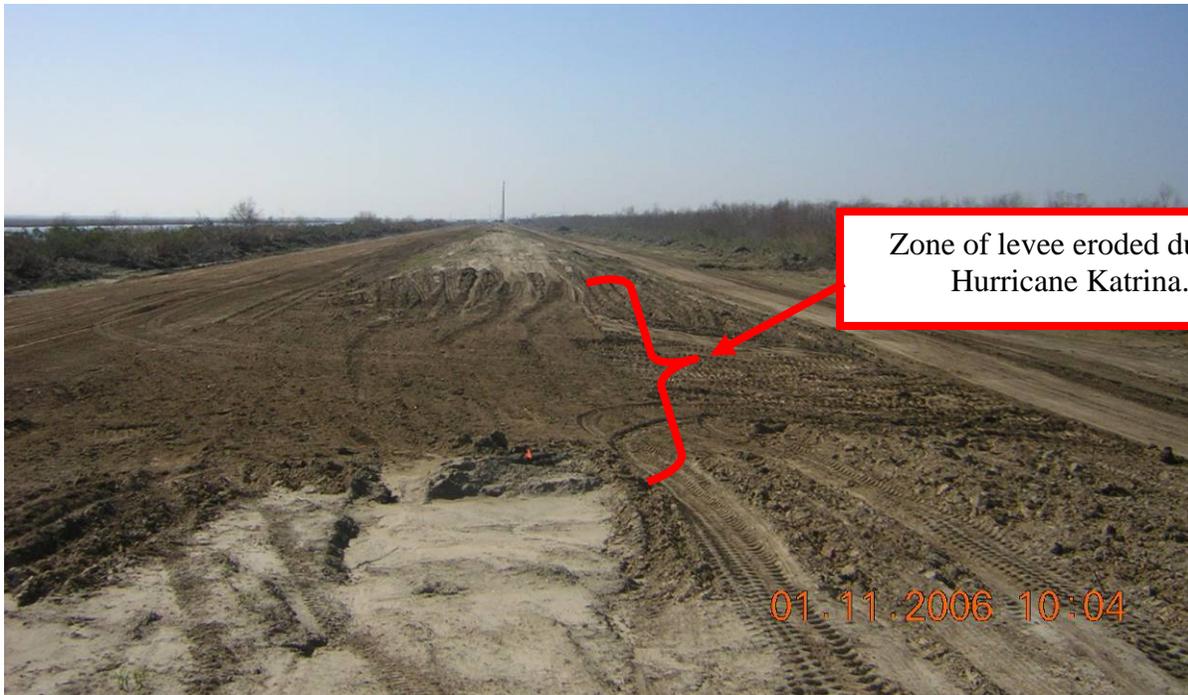
**Figure 10.14:** Zones of earthen levees at the southeast corner of the New Orleans East polder (location 4 on Figure 10.6) were washed out during Hurricane Katrina allowing water to rush in.

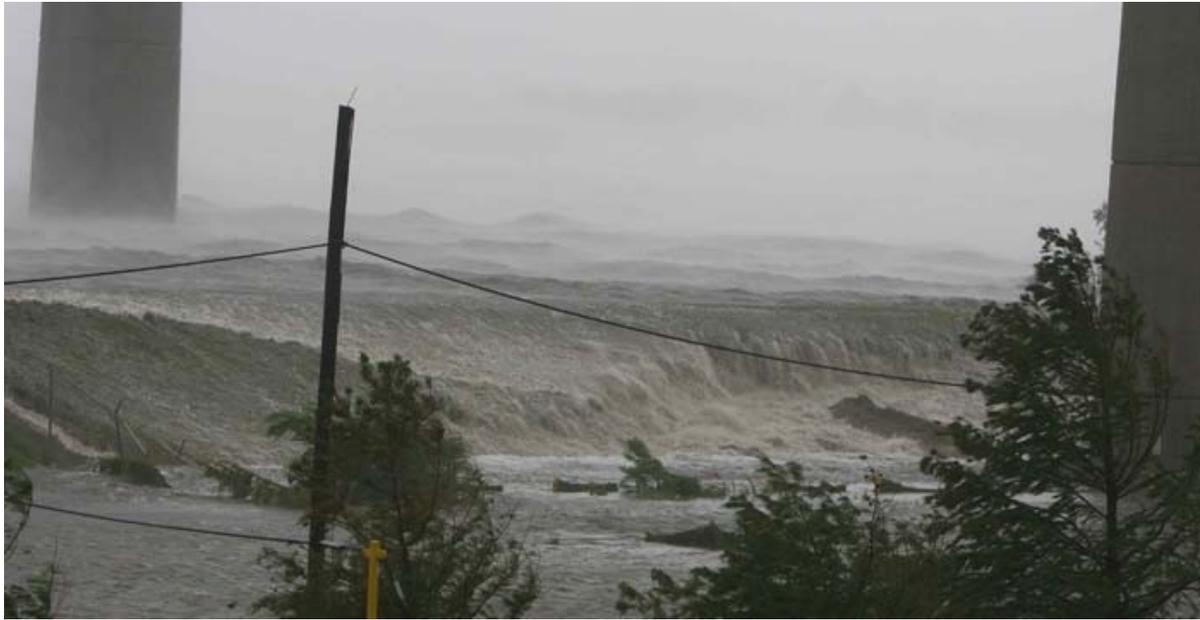
**Figure 10.16:** Photographs (location 5 on Figure 10.6) captured by a security camera at the Entergy Michoud Generating Plant beneath Route 47, on the IWW/MRGO show active overtopping during Hurricane Katrina.

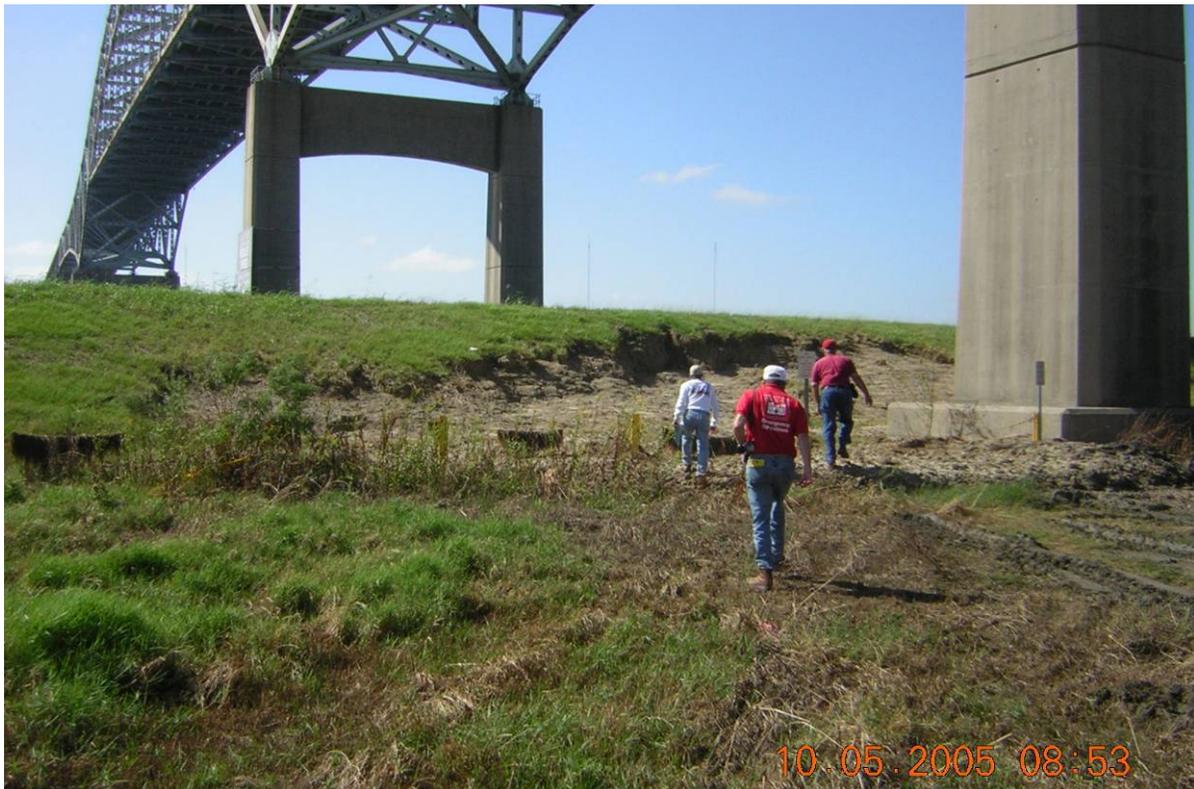
**Figure 10.17:** Post Hurricane Katrina view of the earthen levee shown in Figure 10.16. Only minor damage on the protected side was observed, with the majority of the damage a result of wave reflection from the bridge abutment at the right-hand side of the picture.

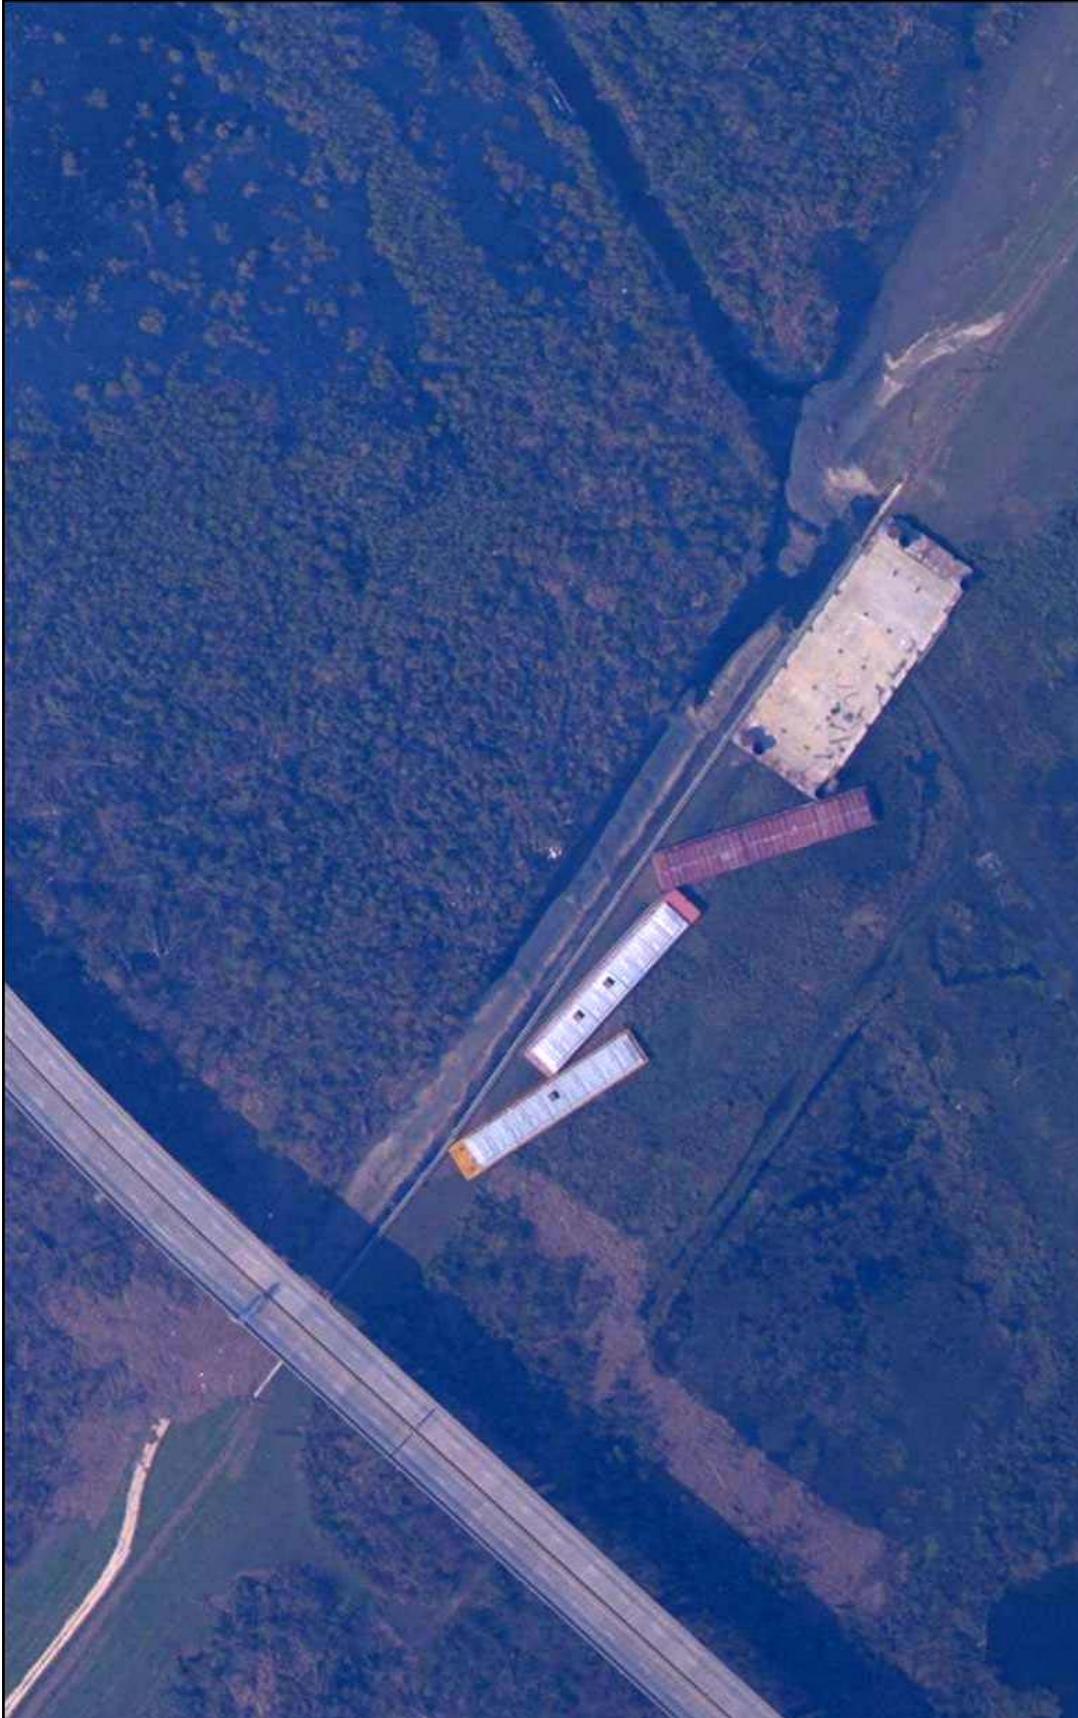
**Figure 10.18:** The presence of a concrete floodwall beneath the Hwy 47/Parish Road Bridge acted as a weir during the overtopping stages of the storm and “sucked” in nearby barges. Scour can be observed behind the concrete floodwall, but there is only minor scour damage visible at the earthen levee/concrete floodwall transition. Overall, this system performed well (also considering the impact associated with the barges).

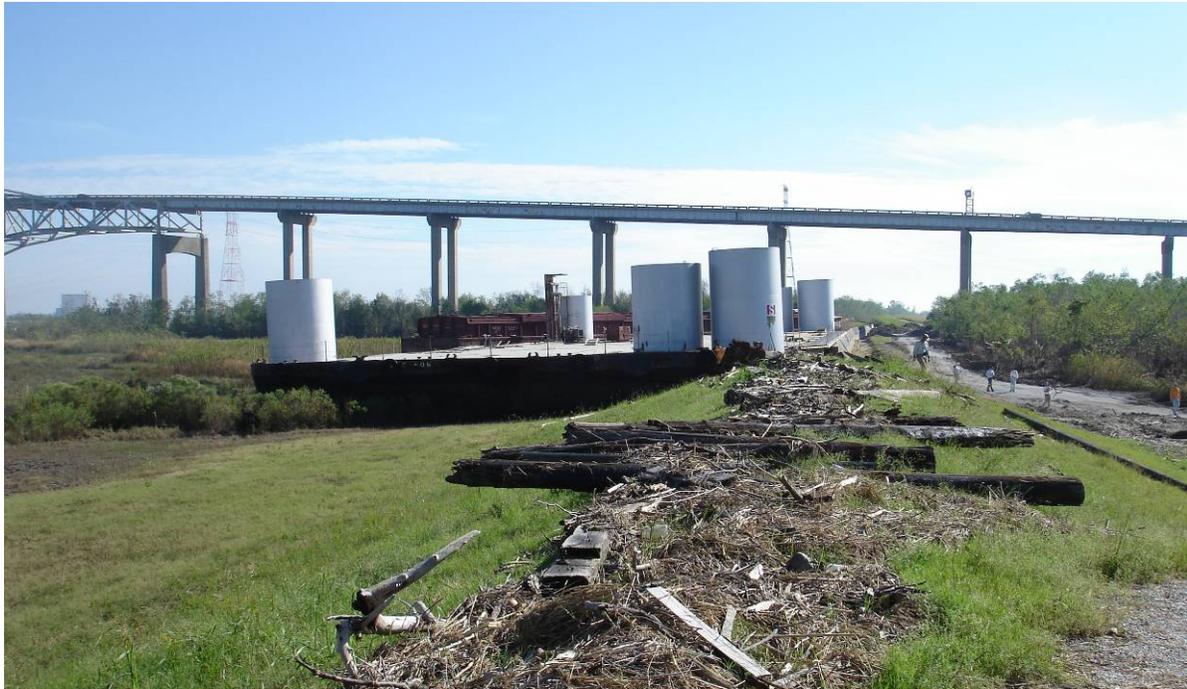
**Figure 10.19:** Woody debris and steel barges “washed up” on the southern ICWW/MRGO levee just west of Route 47 (location 6 on Figure 10.6). This is a side view from the aerial photograph presented in Figure 9.24.

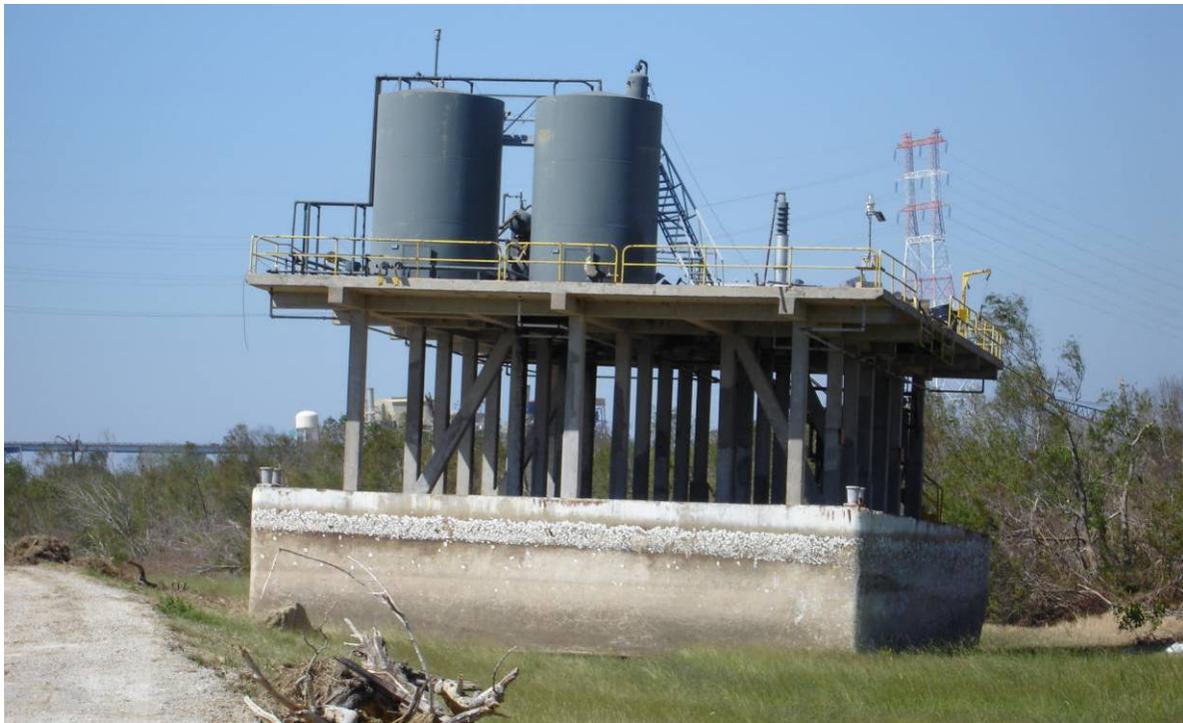
**Figure 10.20:** A gas processing barge “washed up” on the southern IWW/MRGO levee just east of Route 47 (location 6 on Figure 10.6). This levee was also overtopped and was not significantly damaged by the barge impact.

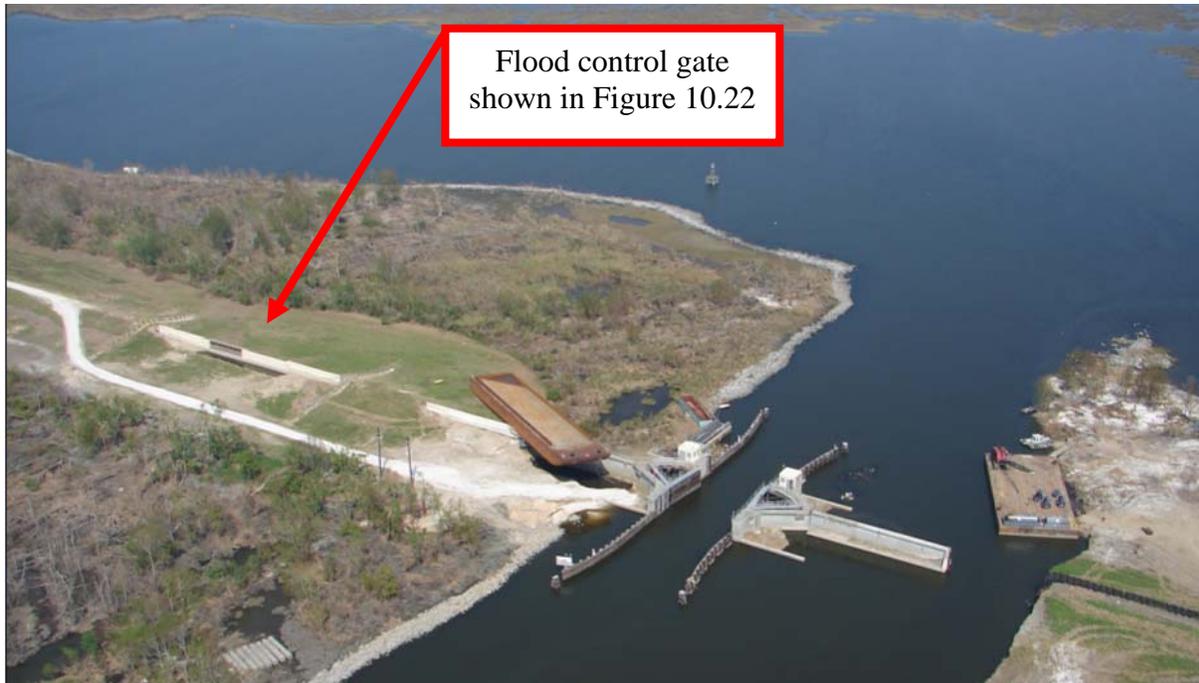
**Figure 10.21:** Aerial photograph of the Bayou Bienvenue Control Structure (location 7 on Figure 10.6). The northwestern half of the control structure levee system performed extremely well (withstanding significant impact loads from the steel barge), while the southeastern portion suffered severe erosion.

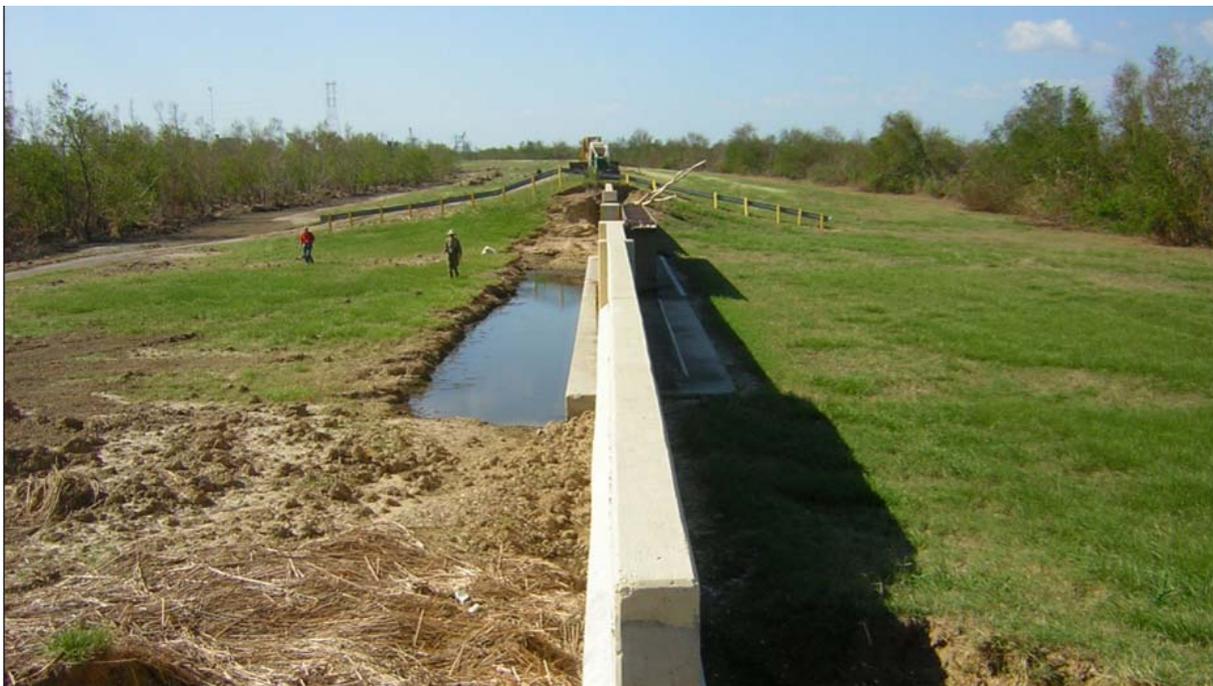
**Figure 10.22:** This flood control gate acted like a weir as water overtopped the structure during the storm surge. Significant scour and erosion was observed around the flood control gate structure.

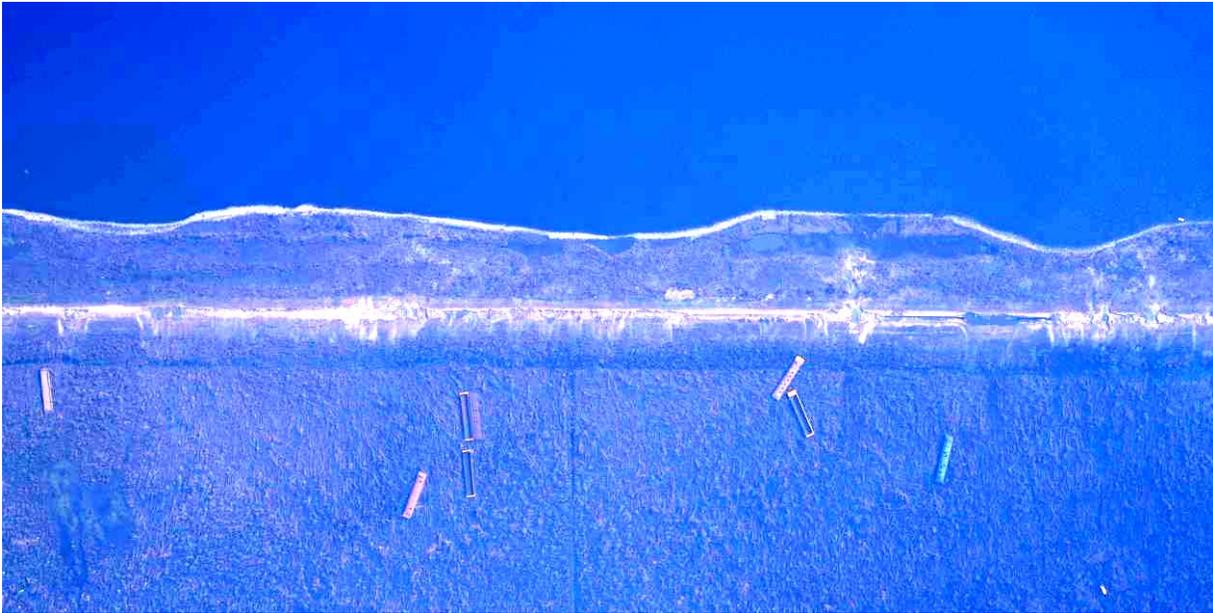
**Figure 10.27:** Aerial photograph taken by NOAA in early September 2005 along the MRGO showing severe erosion/breaches of the earthen levee and transport and deposition of large barges over the levee as a result of the storm surge (location 8 on Figure 10.6).

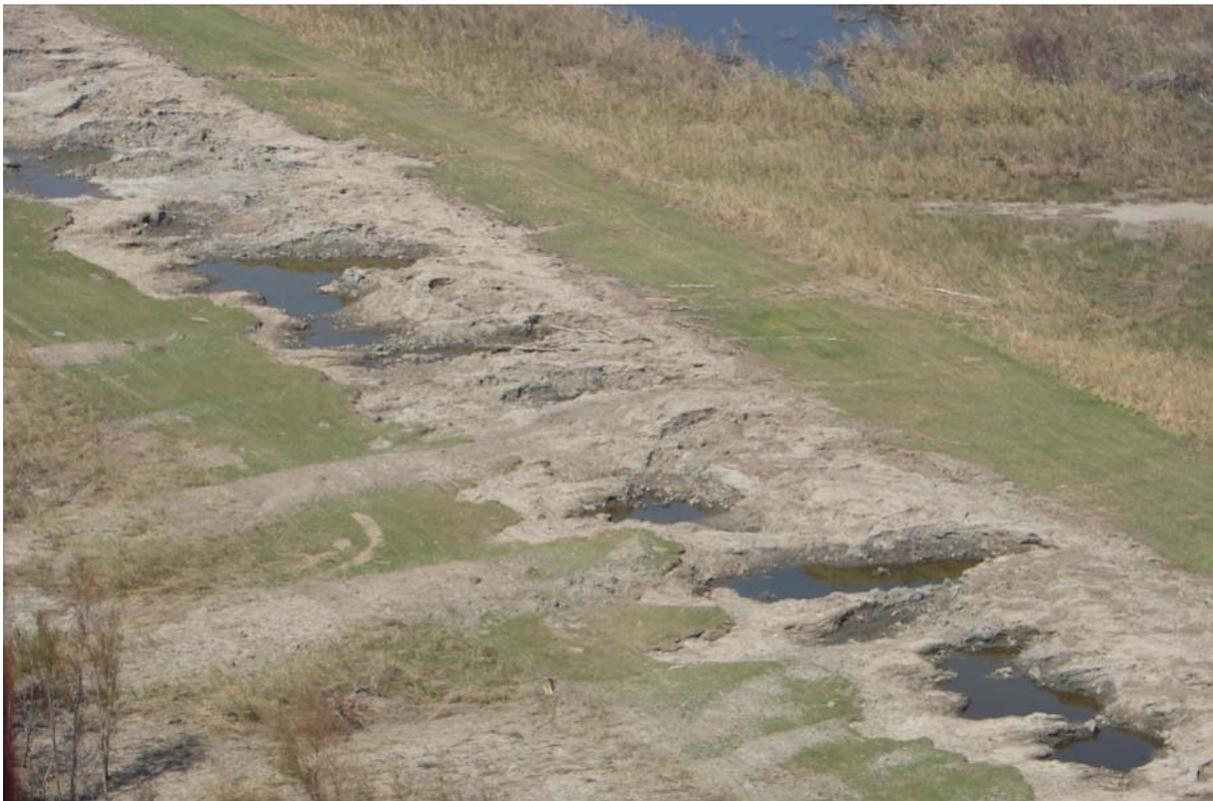
**Figure 10.28:** Close up aerial photograph of severely eroded MRGO levees at location 8 on Figure 10.6.

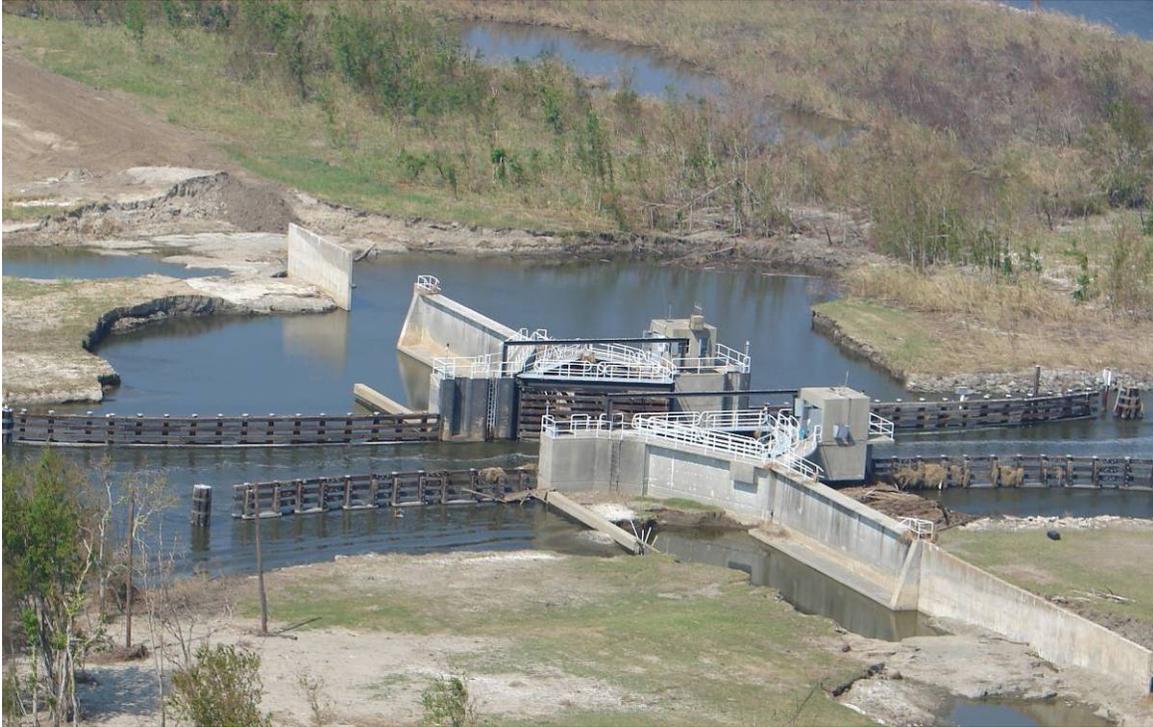
**Figure 10.29:** Control structure at Bayou Dupre (location 9 on Figure 10.6) suffered extensive scour and erosion during the storm surge and overtopping conditions associated with Hurricane Katrina.

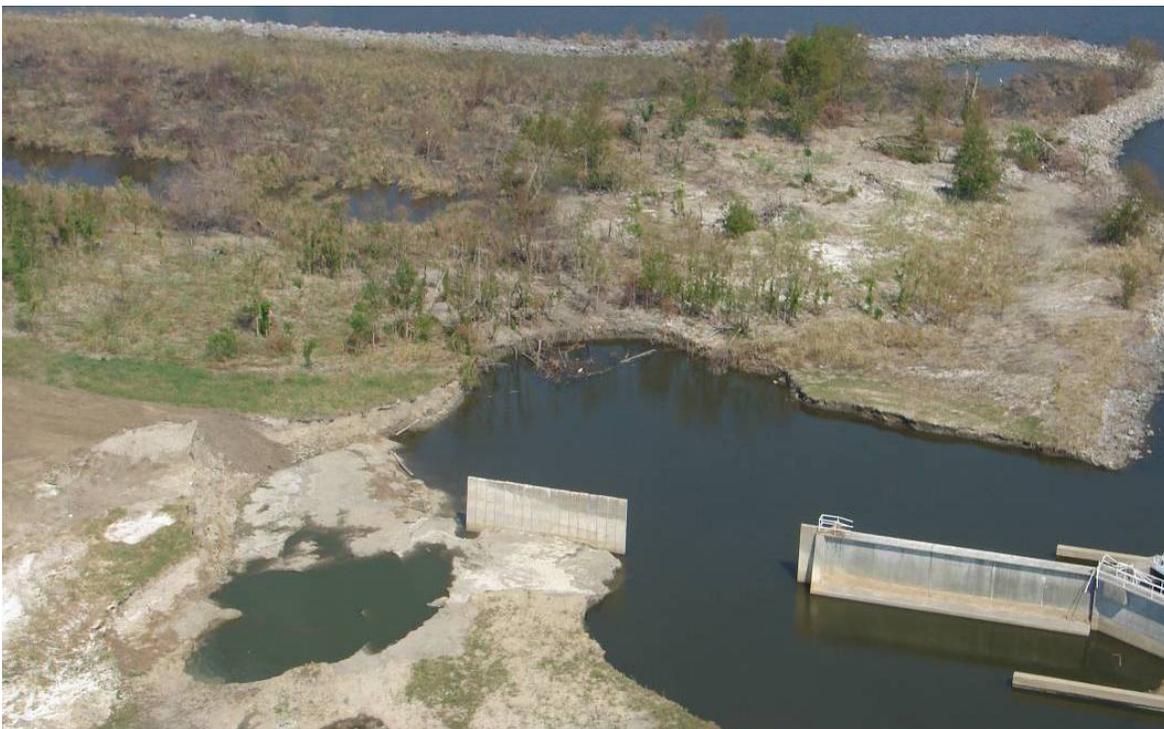
**Figure 10.30:** Another aerial photograph of the scour and erosion damage to the Bayou Dupre control structure.

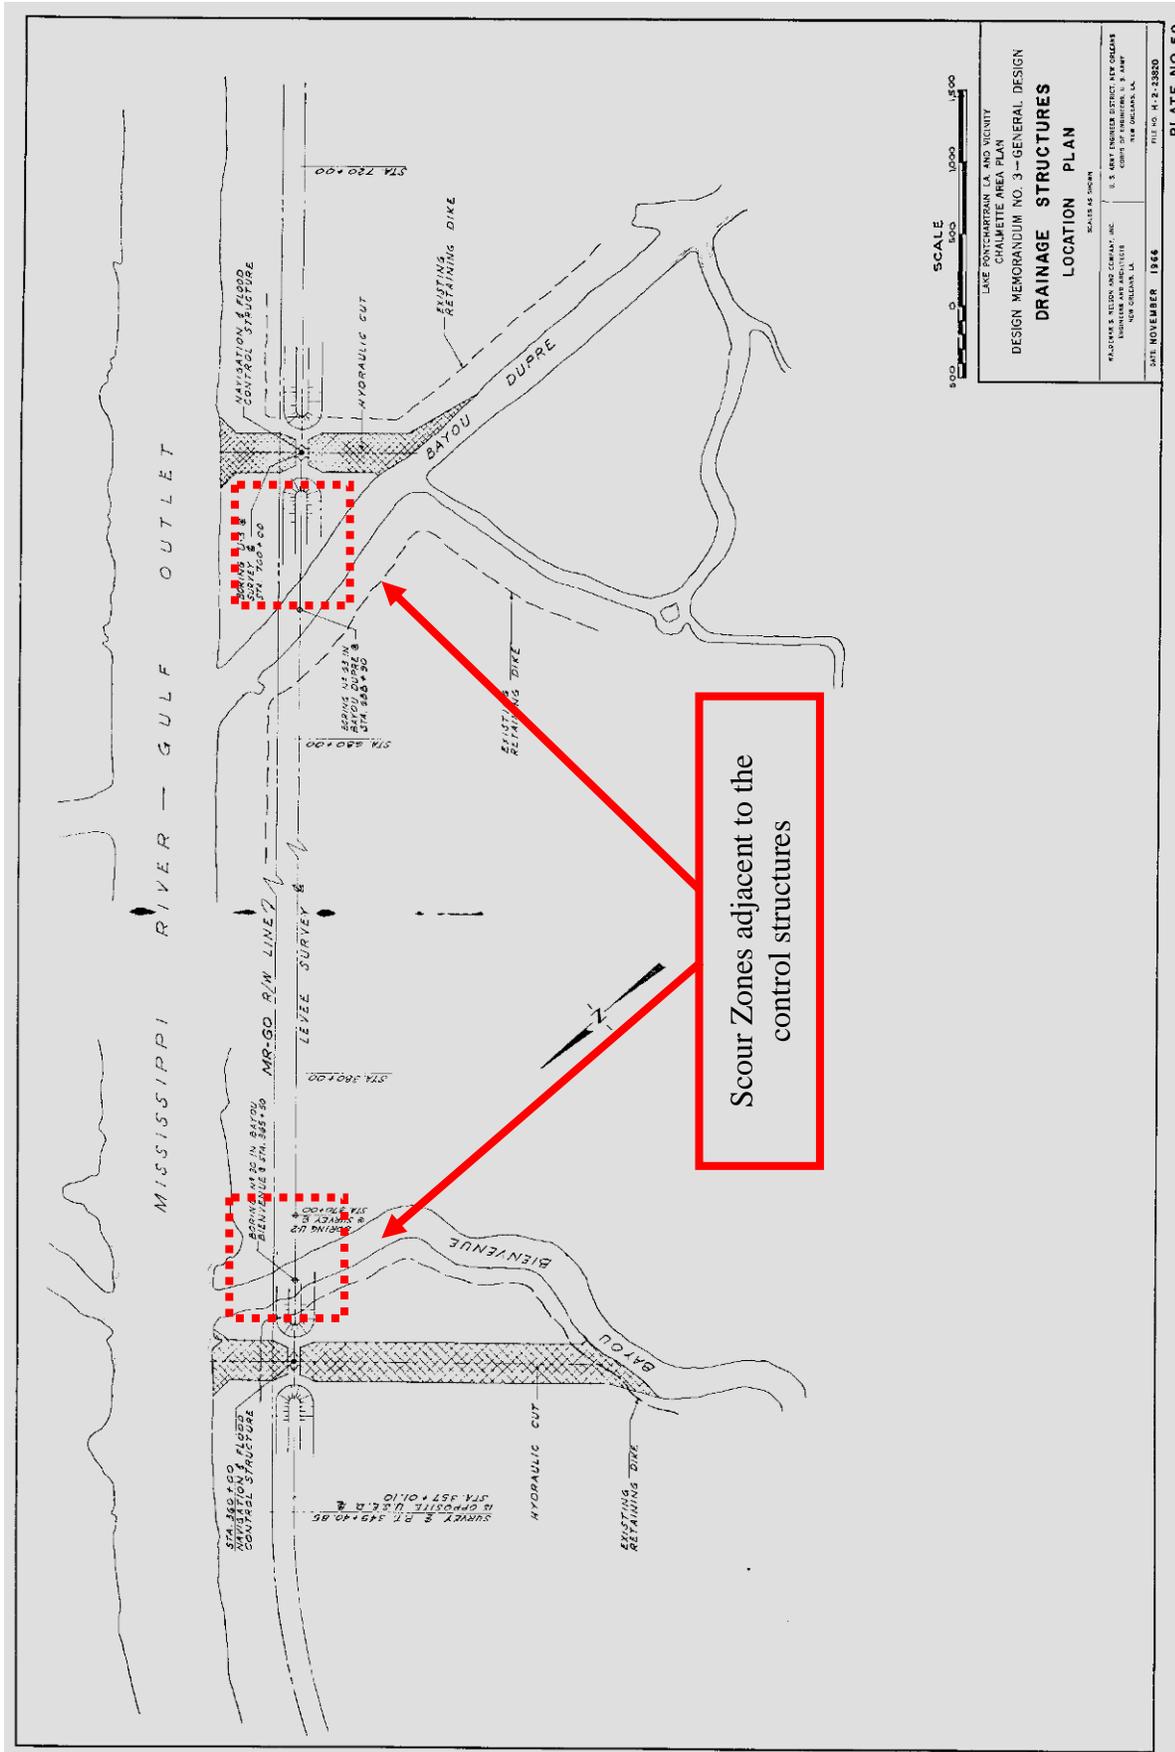
**Figure 10.31:** Areas of severe scour and erosion damage to the two control structures appear to correspond to the alignment of the abandoned original channel.

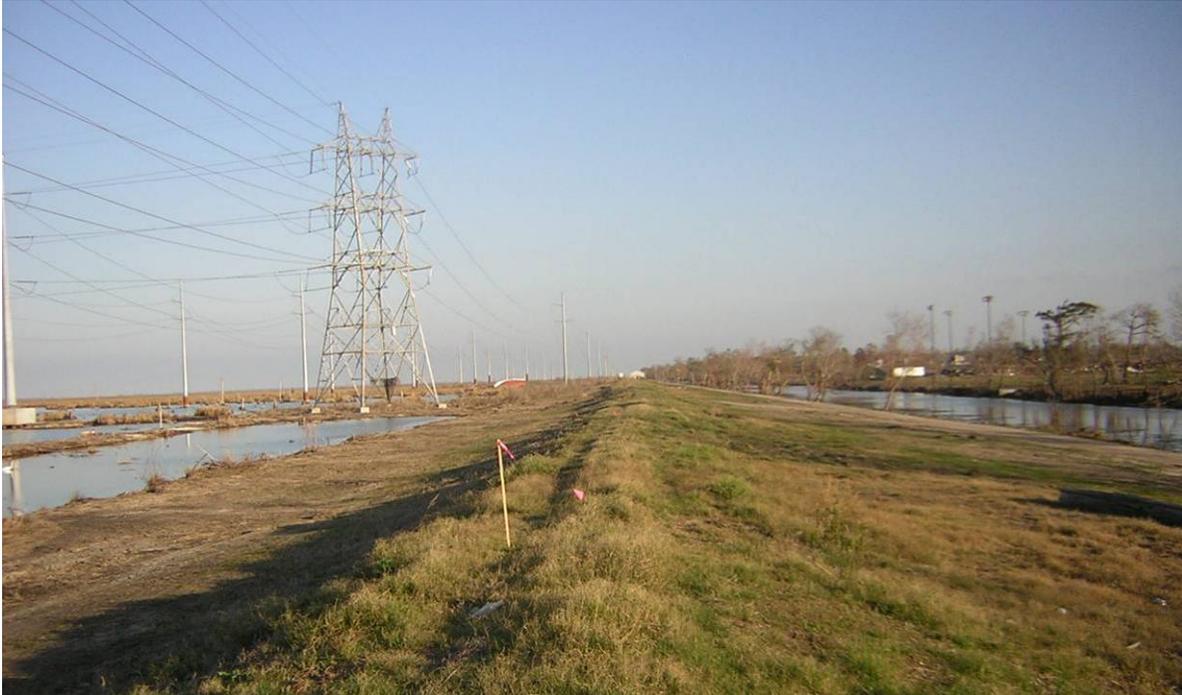
**Figure 10.34:** Eastward looking view of the secondary earthen levee (constructed to approximately Elevation +6.0 feet MSL) immediately to the north of the Corinne Canal, east of Paris Road (location 10 on Figure 10.6). This levee was significantly overtopped and did not experience significant damage.
