# Investigation of the Performance of the New Orleans Flood Protection Systems in Hurricane Katrina on August 29, 2005

## Volume I: Main Text and Executive Summary

**Final Report**  
**July 31, 2006**

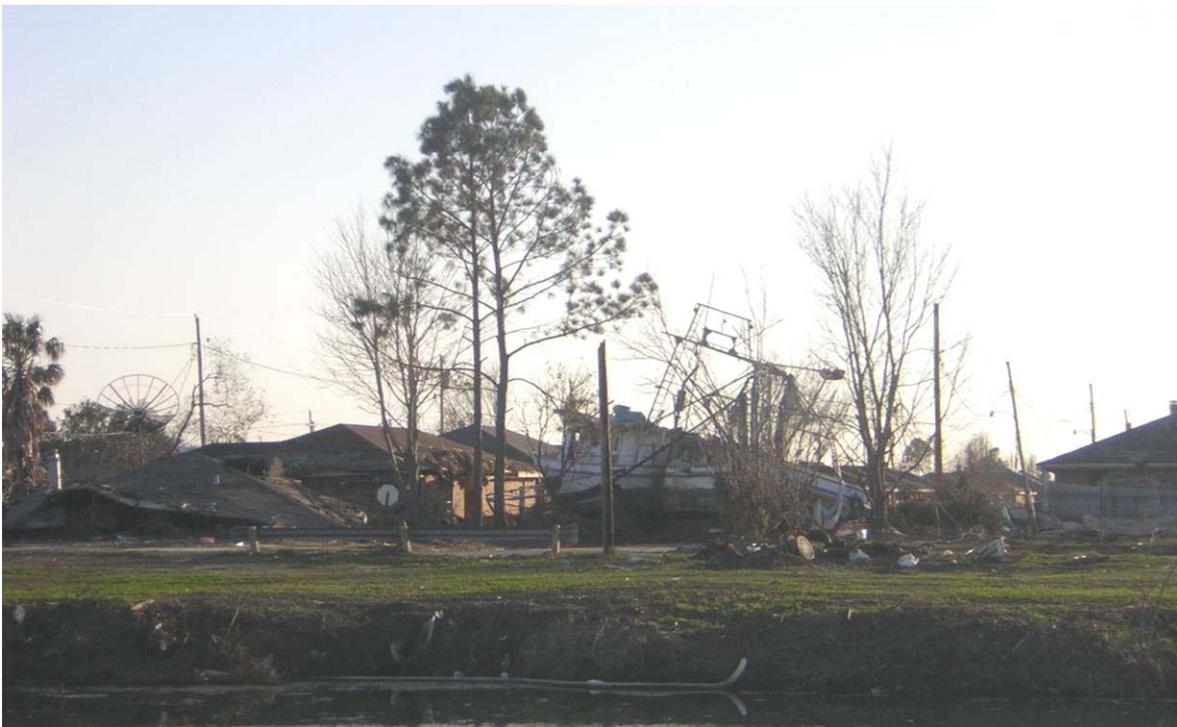
**Figure 10.35:** A fishing boat was washed over the levee shown in Figure 10.34 and landed in this Chalmette residential neighborhood within St. Bernard Parish.

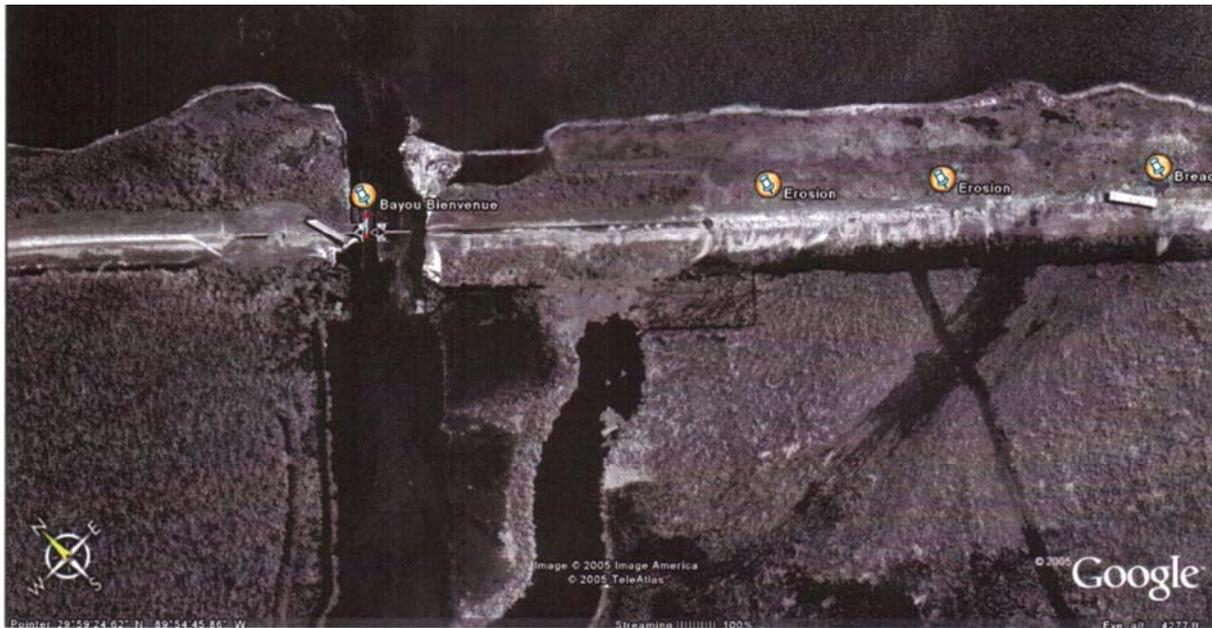
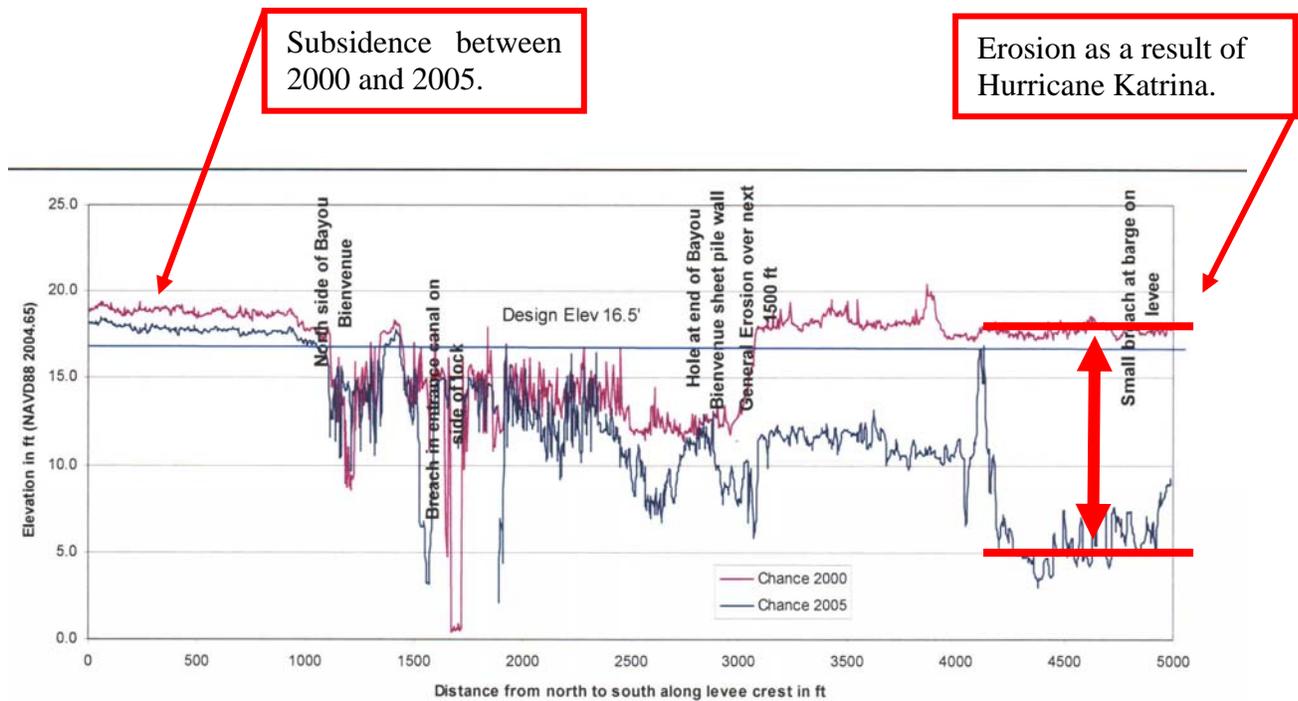
Subsidence between  
2000 and 2005.

Erosion as a result of  
Hurricane Katrina.

**Figure 10.37:** This is a comparison of two LiDAR surveys of the MRGO levee system at the Bayou Bienvenue control structure, near the intersection of the GIWW at the northeast corner of St. Bernard Parish. Effects of subsidence can be clearly seen in the elevation differences on the north side of the control structure and the control structure itself between 2000 and immediately following Hurricane Katrina in 2005. The levee on the north side of the Bayou Bienvenue control structure was largely undamaged. The levee on the south side of the control structure was catastrophically damaged. The magnitude of the erosion has been highlighted and white “splotches” of displaced levee materials can be seen in the aerial photograph (USACE 2006).

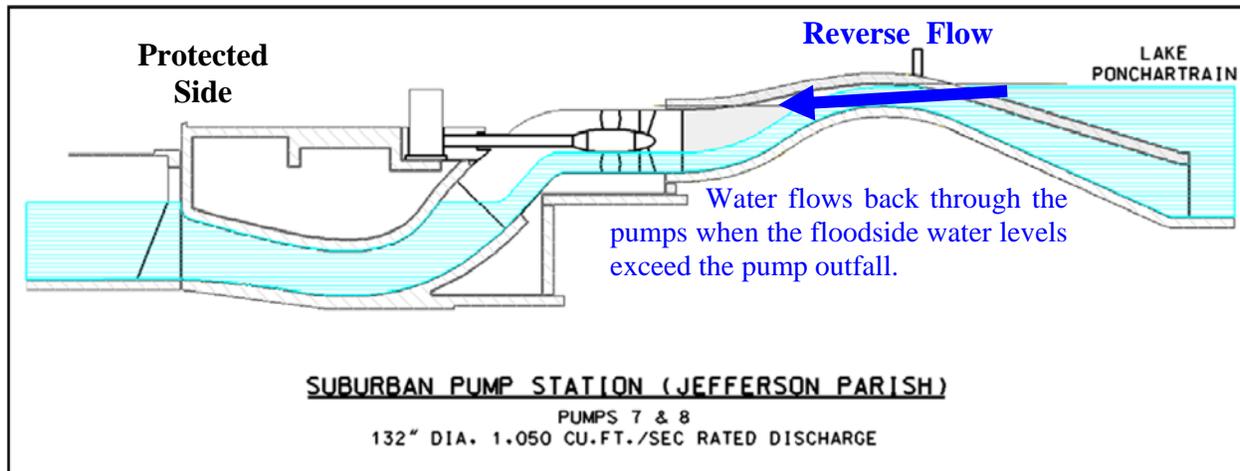
Figure 10.53: Performance of the pumping system (and causes of pumping capacity loss) during and after hurricane Katrina.

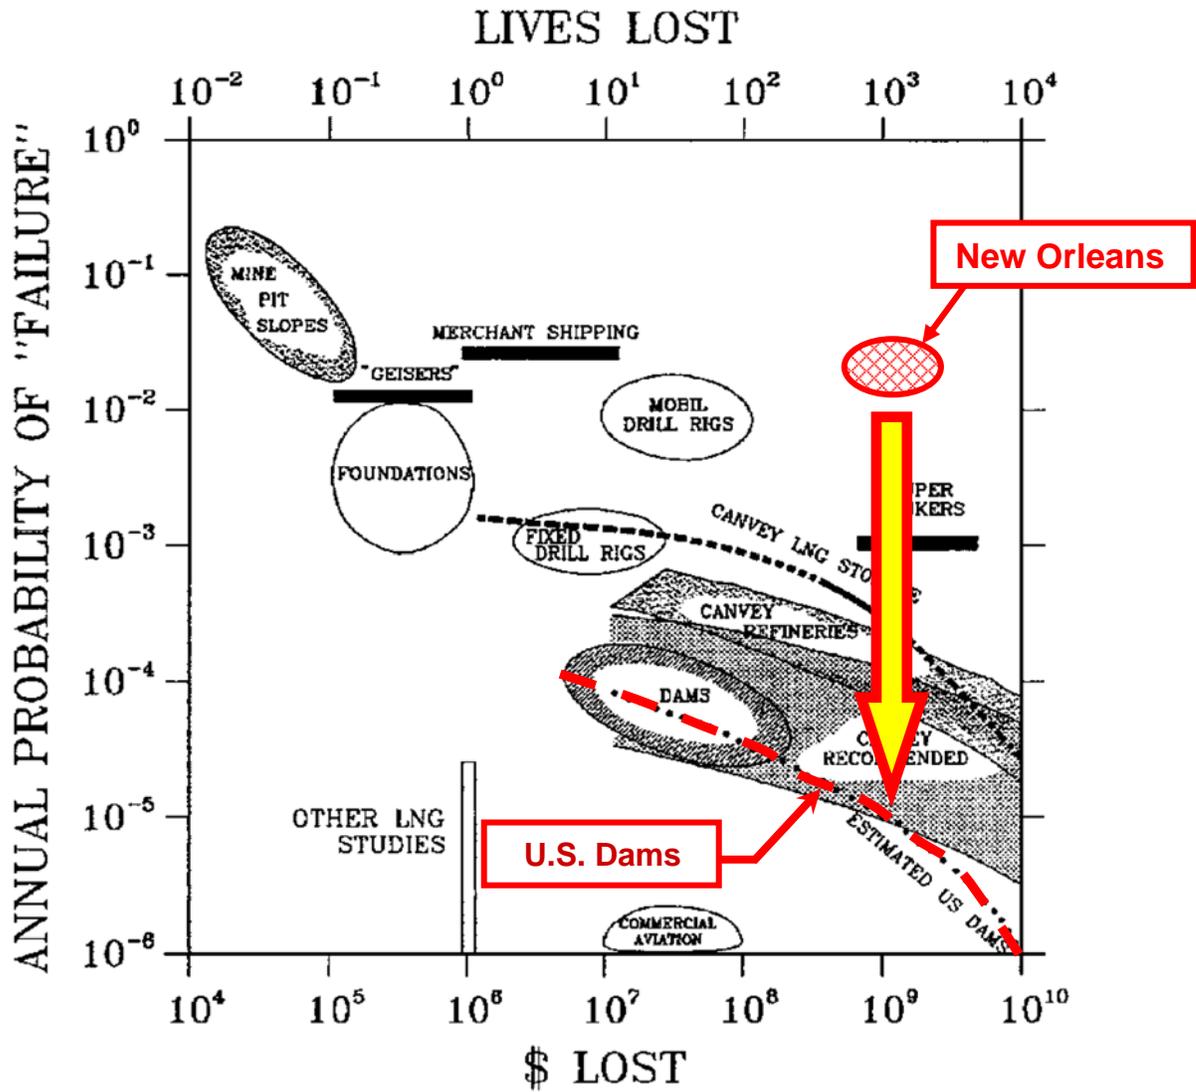
Also shown on this plot is our investigation’s view of the level of reliability associated with the New Orleans regional flood protection systems prior to hurricane Katrina. Our best estimate, based on information currently available, and given the targeted design levels and the flaws and vulnerabilities embedded in the system, is that the pre-Katrina system was likely to fail catastrophically approximately every 30 to 75 years. The cost of the failure (in hurricane Katrina) was on the order of \$100 to \$200 billion in losses, and approximately 1,500 lives were lost.

As indicated by the large arrow in Figure 11.1, the difference between the level of risk (or reliability) of the New Orleans regional flood protection systems and conventional U.S. dam practice is approximately three orders of magnitude; a factor of roughly 1,000 times safer and more reliable. Reliability is a function of two sub-elements: (1) the targeted level of

The New Orleans regional flood protection systems were never specifically targeted at any given level of reliability with regard to formal definition of storm levels for design (e.g.: the Standard Project Hurricane was never quantified as a “100-year storm” or a “300-year storm”, etc.), and this was a lapse, as it put the design of the regional flood protection system out of step with current practice. Our assessment in plotting the pre-Katrina New Orleans case in Figure 11.1 is that the system as it existed was likely to be failed by roughly the 30-year to the 75-year (average recurrence interval) storm.

Figure 11.1: Risk plot showing the estimated pre-Katrina risk associated with the New Orleans regional flood protection system, and customary risk levels for current U.S. Practice with dams.

- 28. ***Design standards, especially with regard to targeted levels of system reliability, need to be reconsidered (see Figures 11.1 and 11.2). This is already underway; the USACE is performing a comprehensive re-assessment of design procedures and standards, and treatment of flood protection systems on a risk-based systems basis is anticipated to be an important element of this. That is a very promising development.***

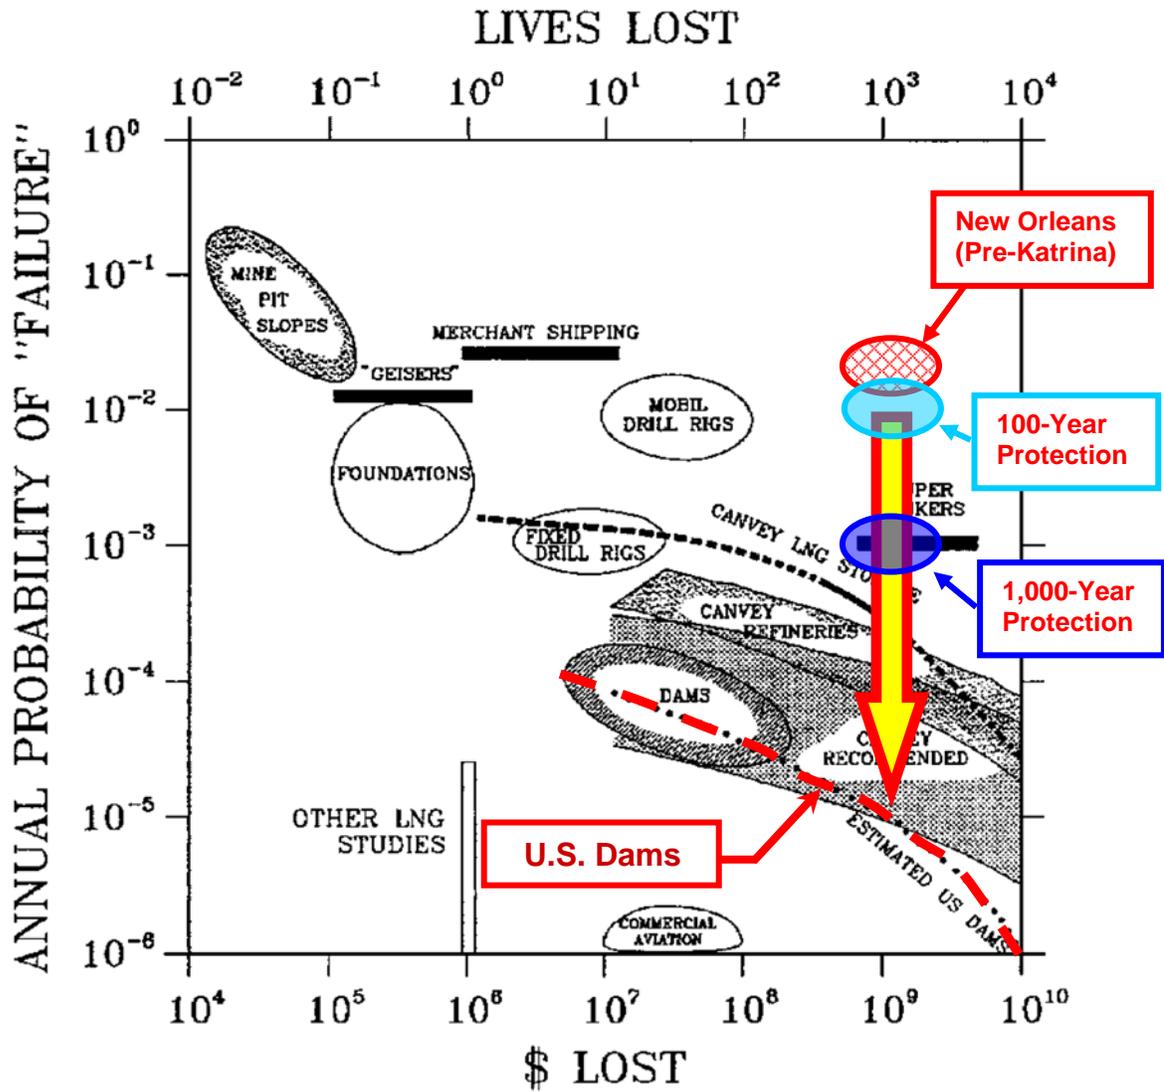
If the system is re-engineered to safely (successfully) handle a 100-year storm (storm loading likely to be exceeded typically once every 100 years), then the large red area of Figure 11.1 would move to the location shown by the light blue area in Figure 11.2. That would not bring the level of safety and reliability anywhere near to current U.S. practice for dams. Targeting a 1,000-year level of flood protection, and achieving that level, would result in the darker blue zone in Figure 11.2.

Figure 11.2: Risk plot showing the estimated pre-Katrina risk associated with the New Orleans regional flood protection system, and customary risk levels for current U.S. Practice with dams. Also shown are projected New Orleans risk levels for “successful” 100-year and 1,000-year storm and flood design.

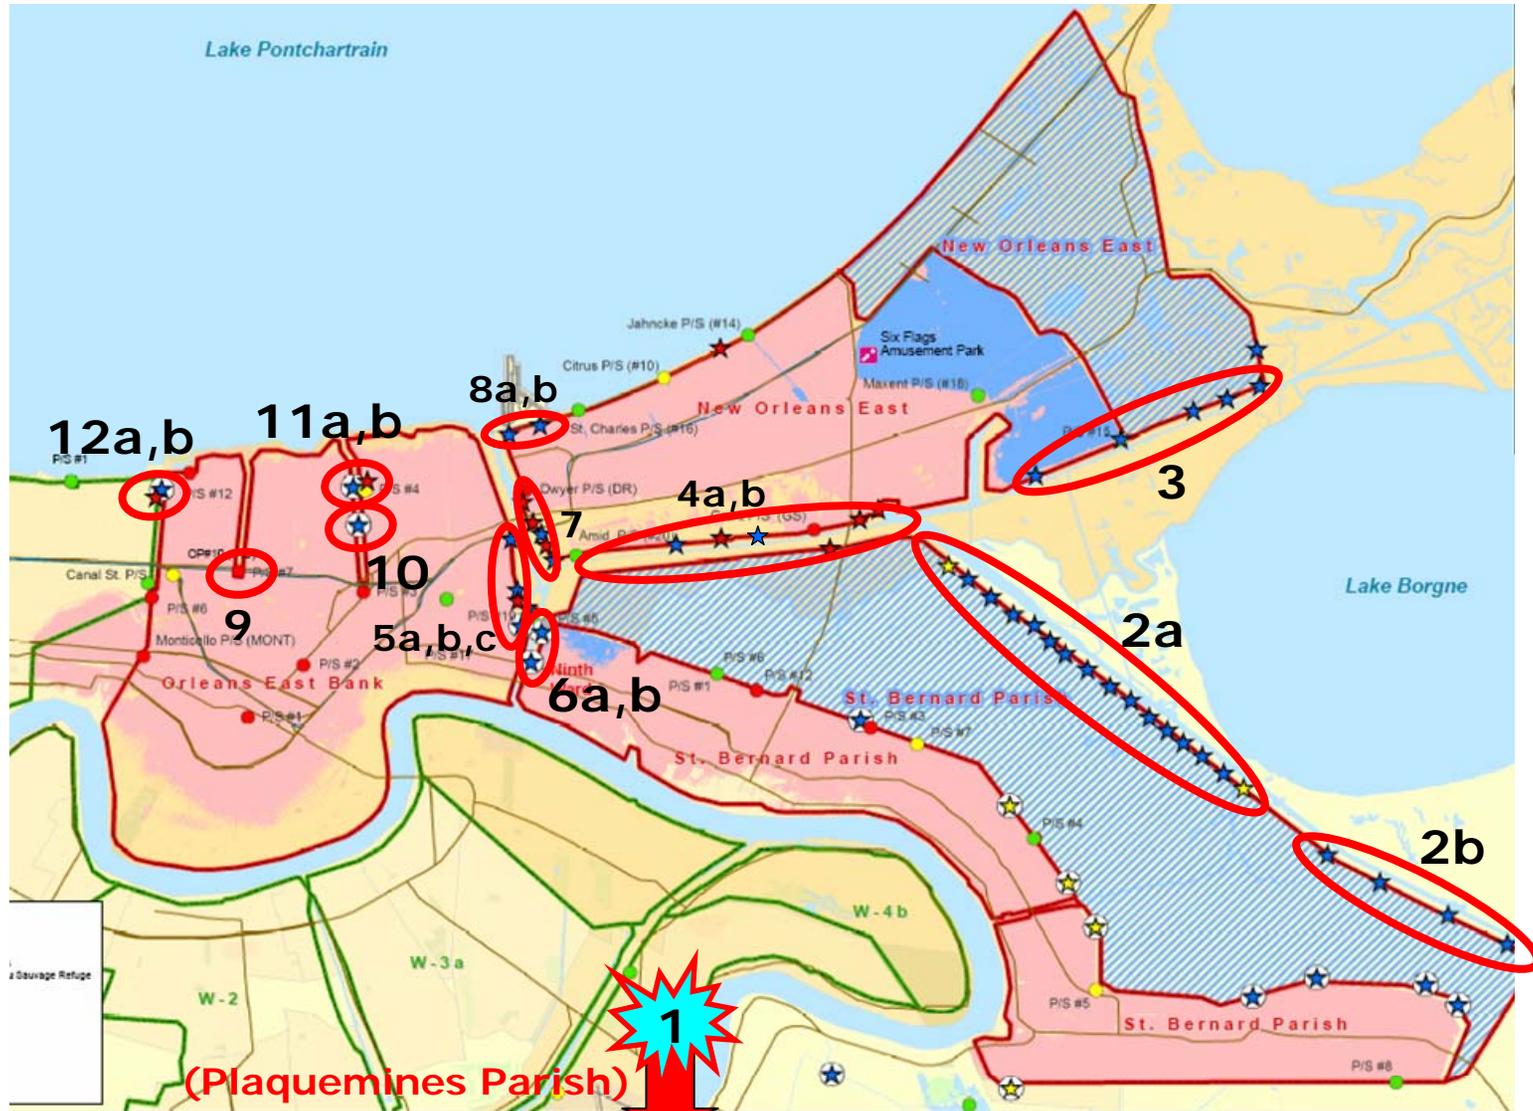
Figure 11.4 shows an overview of the New Orleans area, indicating the locations of the principal failures, breaches, and distressed sections of the New Orleans regional flood protection system studied in this investigation. Plaquemines parish (along the lower reach of the Mississippi River) is not included in this figure; instead it is indicated by the large arrow at the bottom. The individual features, and groups of features, in Figure 11.4 are numbered for purposes of discussion. Table 11.1 presents a summary of issues at each of these locations, using the same numbering scheme as Figure 11.4.

An additional set of partially developed erosional features occurred at a number of locations on the east bank of the IHNC at the west edge of the New Orleans East protected area. These are grouped together as “Site #7” in Figure 11.4 (and Table 11.1.) Overtopping occurred along much of this frontage, but the erosional distress systematically occurred at “transitions” between adjacent, disparate system elements (e.g. at transitions between full height earthen embankments and adjacent gated concrete floodwall segments, etc.) Here, again, it was transitions rather than the main segments themselves that proved problematic.

Figure 11.4: Summary of principal failures, breaches, and other locations of interest. (Blue stars mark breaches, red stars mark locations of distress.) [Base map provided by the USACE]
