# Appendix 1

## Hydrograph and High Water Mark Analysis

### Introduction

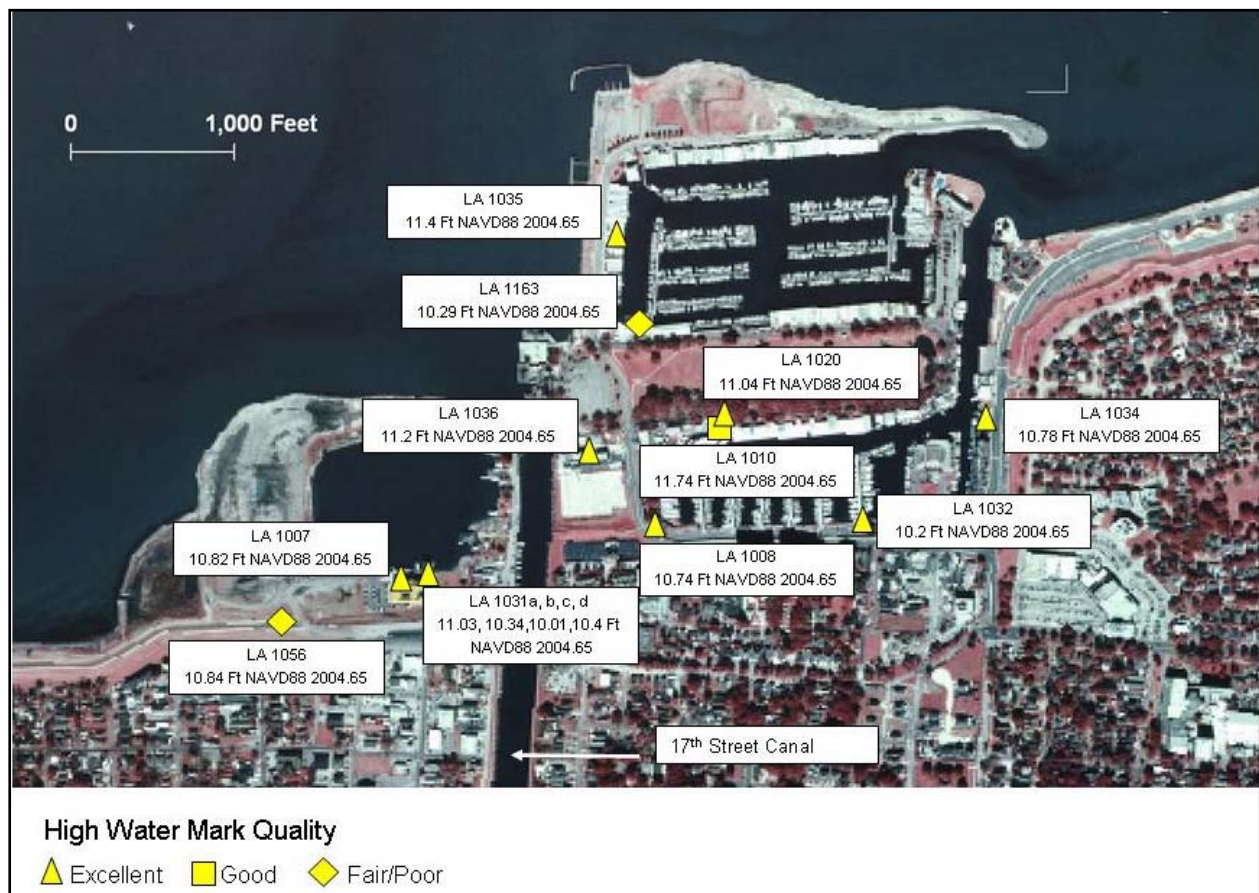
Figure 1-1 is an example image of a HWM presentation, which includes the HWM identifier, and water elevation. The shape of the HWM identifier indicates the HWM reliability. The setting in which a high water mark was collected is important in assessing the quality of a mark and those processes that might be reflected in the mark. Superposition of the mark on a photographic image aids in assessment and interpretation of HWMs in light of their geographic setting. Images 1 through 58 (two photo index images and 56 separate images with HWMs) at the end of this chapter show the HWMs in the metropolitan New Orleans vicinity and southeastern Louisiana area, which were utilized in this study. Images depict the location, elevation and reliability of all HWMs, focusing on unprotected areas.

Figure 1-1. Sample image of the 17th Street Canal Entrance showing locations of HWMs and water elevation for each mark.

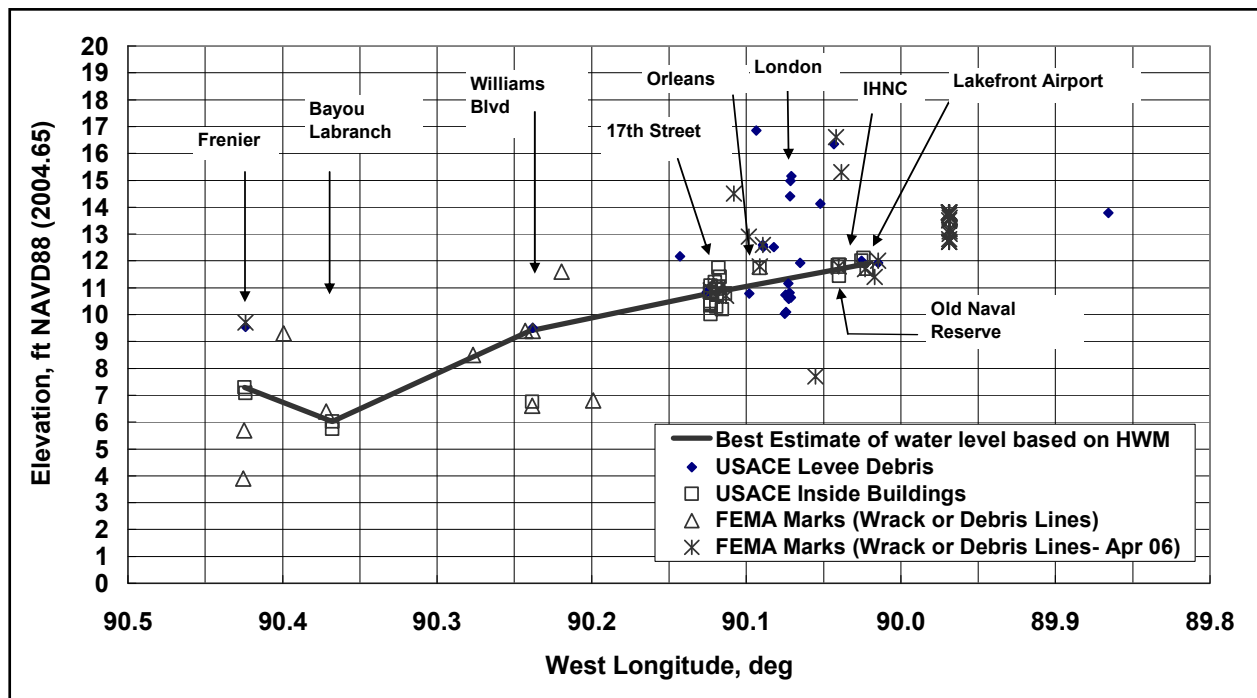
Figure 1-4 shows a plot of high water marks along the south shore of Lake Pontchartrain. The marks are separated into 3 categories of USACE marks inside buildings, USACE levee debris, and FEMA wrack or debris lines with the last two categories being essentially the same type of mark. The plot also shows a best estimate of peak storm water level based on the high water marks. With the exception of the Williams Boulevard location, the best estimate line is based on USACE marks inside buildings. At Williams Boulevard, there is a restroom that has all the characteristics of an excellent stilling well. The elevation of the mark (6.5 ft) in this restroom is much lower than the levee debris found by both the USACE and the FEMA teams. The 6.5 ft elevation is consistent with the elevations from Hurricane Rita. Any marks on Figure 1-4 less than about 7.5 ft and to the east of Bayou Labranch could reflect Hurricane Rita rather than Hurricane Katrina. The levee debris is accepted at this location because the foreshore slope between the levee debris and the lake is extremely flat and long that would have resulted in minor wave action at the location where the levee debris was deposited.

Figure 1-4. Variation of peak water level along south shore of Lake Pontchartrain based on high water marks.

Starting at Frenier on the west, the best estimate line is based on two excellent marks inside buildings. At the next point east at Bayou Labranch, the best estimate is based on two excellent marks inside buildings at 5.75 ft and 6.0 ft and the Bayou Labranch gage. Notice that the Bayou Labranch readings are affected by the fact that the gage and the HWMs are connected to the Lake by a channel that is about 0.5 mile long. An alternate estimate of water level along the south shore is to connect Frenier and the Williams Blvd points. The next point on the best estimate line at Williams Boulevard has already been discussed. From Williams Blvd to the next points at 17th Street Canal, the profile is assumed to be linear but water levels could have stayed high for some distance west of 17th Street before dropping to the level at Williams Blvd. The

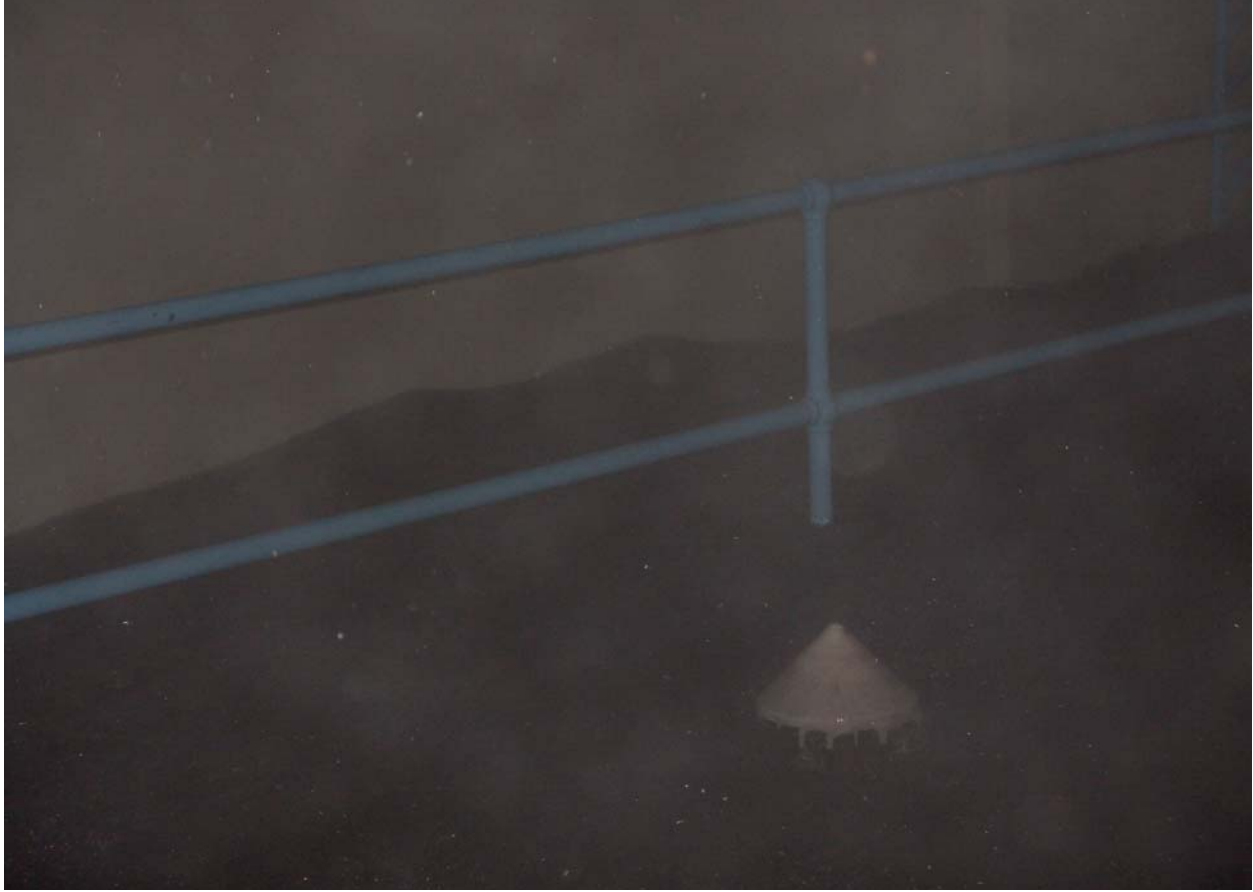
- a.* 0552 (CDT) on 8/29/05, elevation 6.6 ft: Figures 1-9 and 1-10 show pictures taken of the blue rail at 0552 (CDT). By knowing the distance between the top and bottom rails and the elevation of both rails, the distance from the bottom rail to the water surface can be determined using the ratio of distances in the photograph. In Figure 1-9 the water level is 1.0 ft below the lower rail. In Figure 1-10, the water levels at the 3 vertical posts are 0.2, 0.6, and 0.7 ft below the lower rail. The differences in distance below the lower rail is the result of wave action that has a wave height (trough to crest) of at least 0.8 ft based on these two pictures. By averaging the distances, the wave effects are reduced but not eliminated. Averaging all 4 yields an average distance below the lower rail of 0.6 ft for a water surface elevation of  $7.2 - 0.6 = 6.6$  ft.

Figure 1-9. Picture DSC02231.JPG taken at 0552:00 CDT on 8/29/05, elevation 6.6 ft. Looking southwest. Water level is 1.0 ft below lower rail.

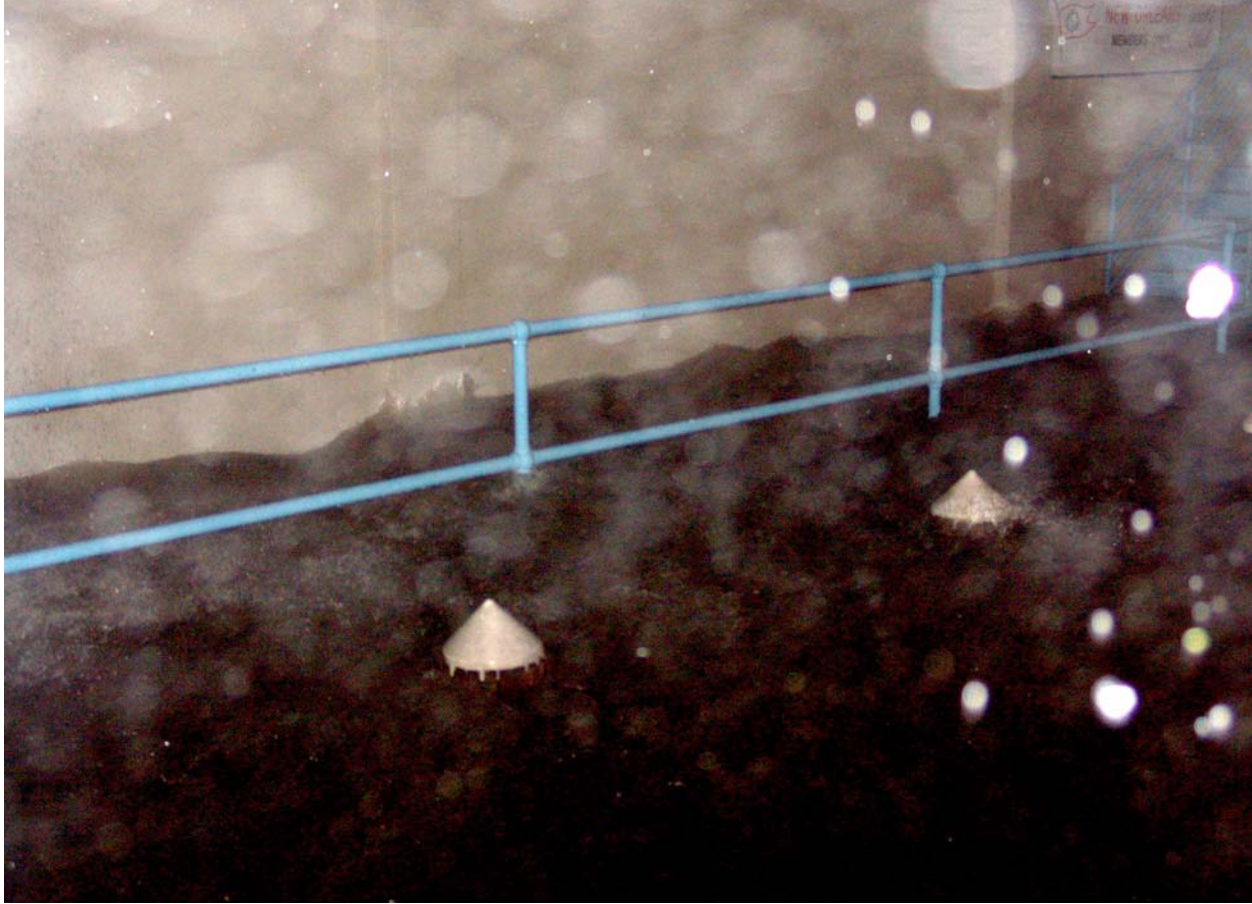
Figure 1-10. Picture DSC02232.JPG taken at 0552:22CDT on 8/29/05, elevation 6.6 ft. Looking southwest. Left vertical post: water level 0.2 ft below lower rail. Center vertical post: water level 0.6 ft below lower rail, right vertical post: water level 0.7 ft below lower rail. Average of all observations from DSC02231 and DSC02232 is 0.6 ft. Picture brightness and contrast adjusted.

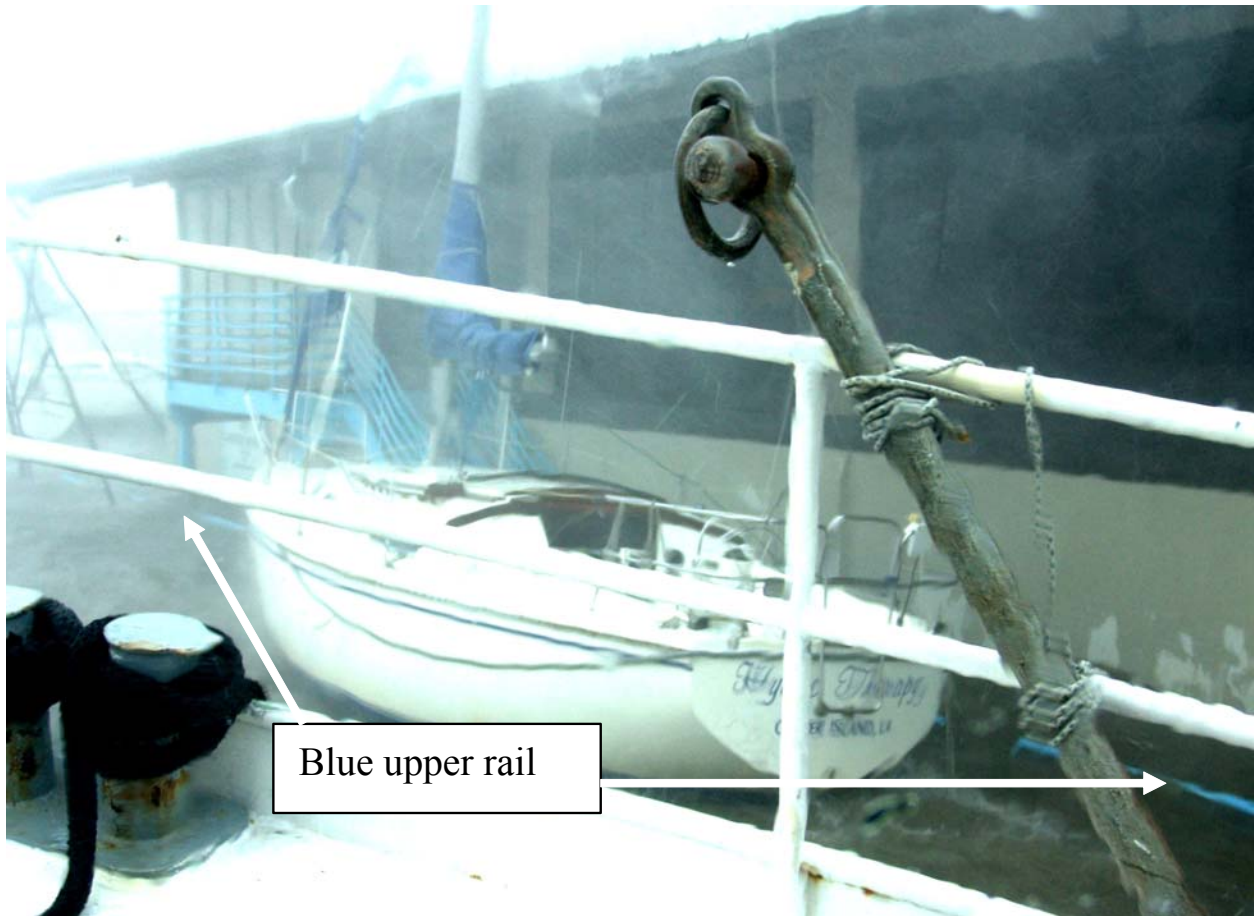
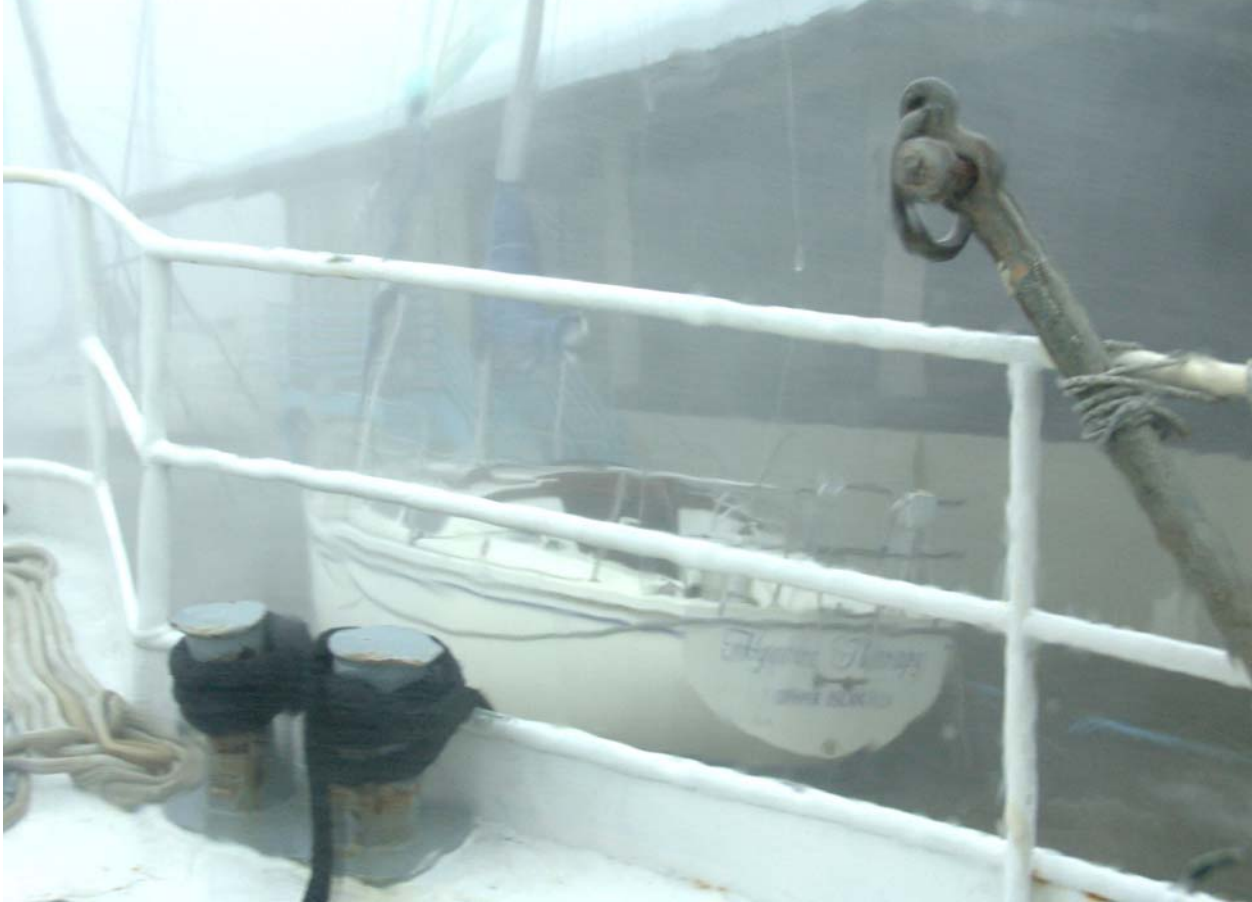
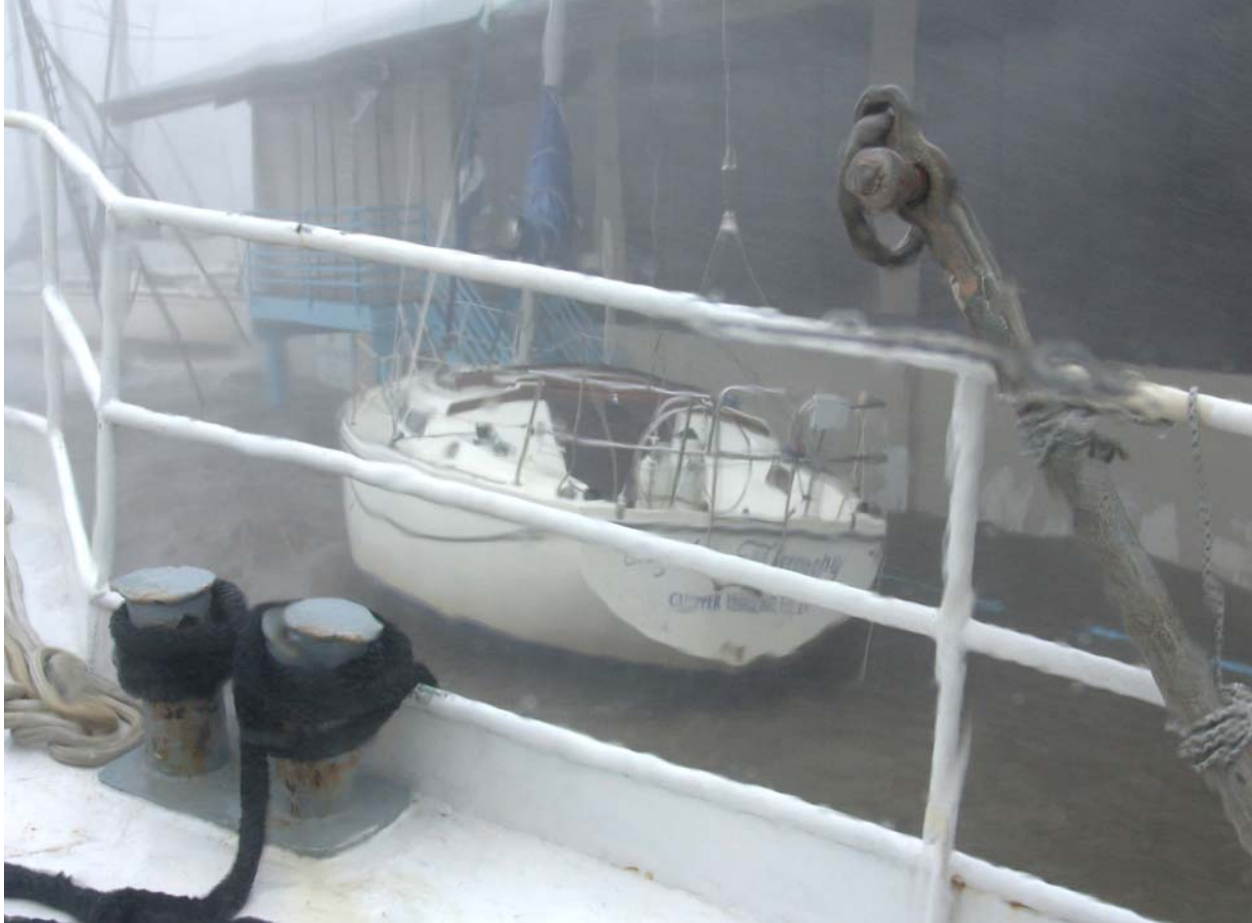
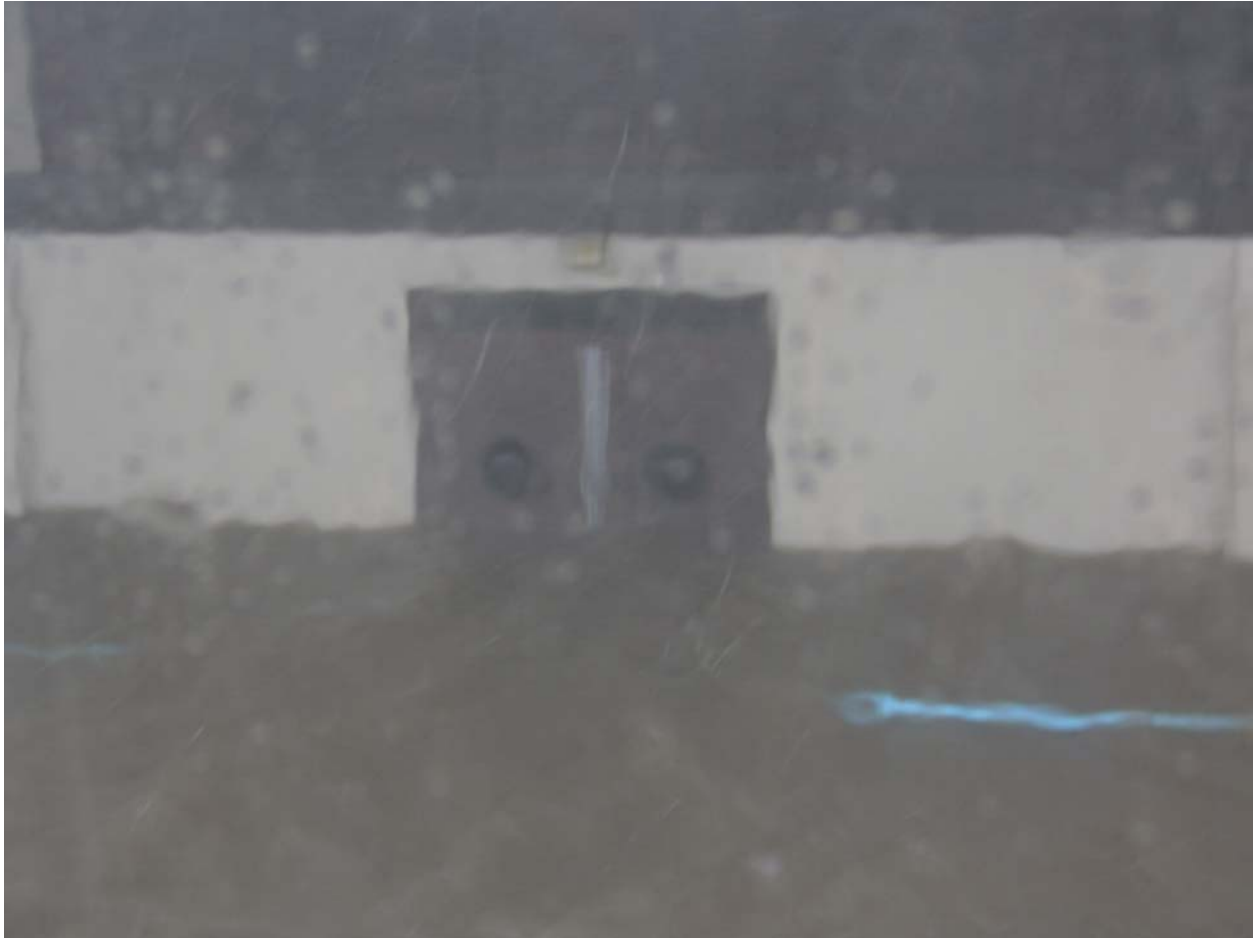
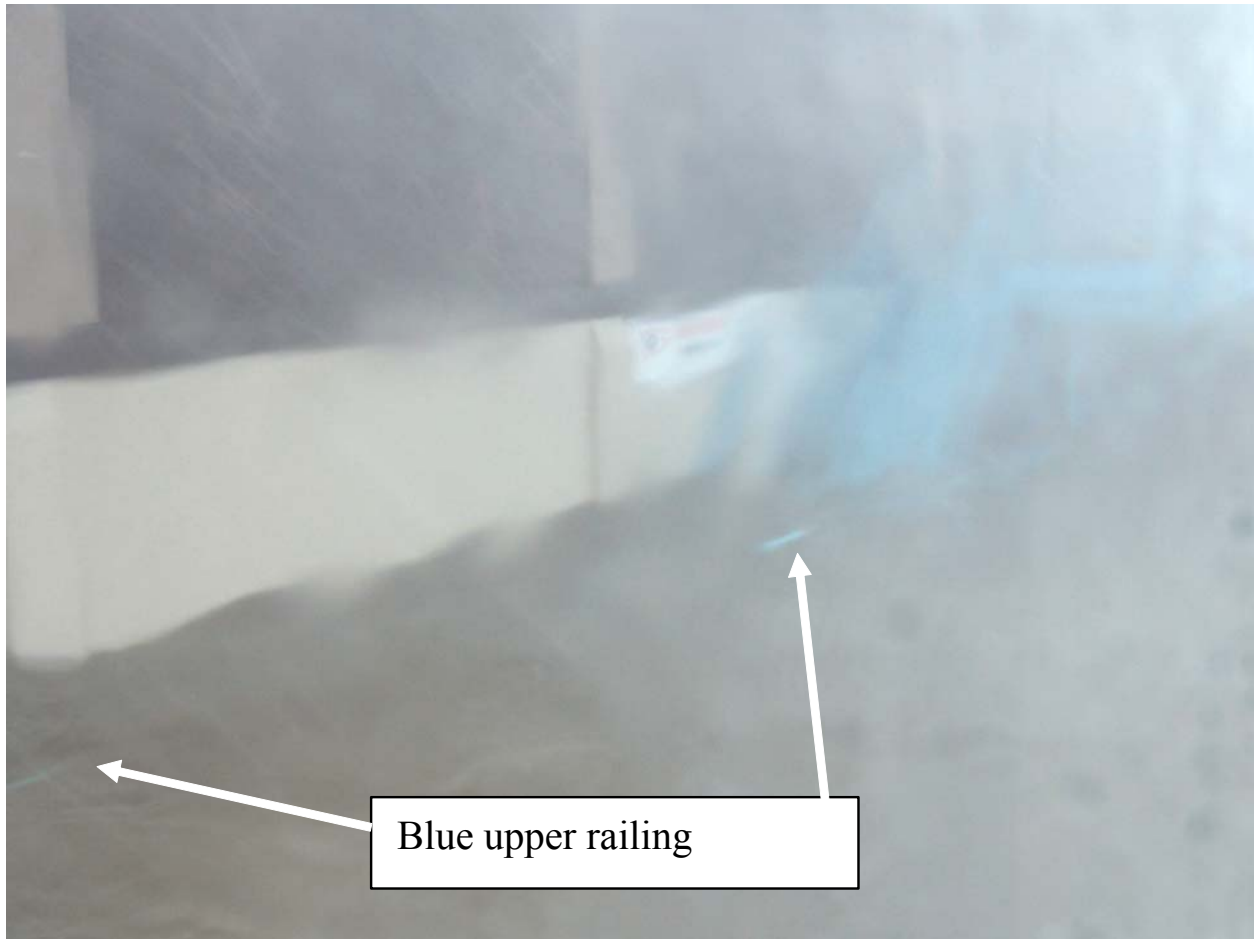
- b.* 0814 (CDT) on 8/29/05: Pictures DSC02233-DSC02236 show the harbor with no tops of piling visible but no elevations can be determined.
- c.* 0816 (CDT) – 0826 (CDT) on 8/29/05, elevation 9.1 ft: Figures 1-11 to 1-15 (pictures DSC02237-DSC02241) show the water level at the top rail in all available pictures. Figure 1-14 shows the double door in the middle of the north wall of the MYH building. The boat owner said the double door was knocked down sometime on the 8/29/05. Elevation of the top rail is 9.1 ft.

Figure 1-11. Picture DSC02237.JPG taken at 0816:22 (CDT) on 8/29/05, elevation 9.1 ft. Looking southeast. Water level at upper rail. Brightness and contrast adjusted.

Figure 1-12. Picture DSC02238.JPG taken at 0816:28 (CDT) on 8/29/05, elevation 9.1 ft. Looking southeast. Water level at upper rail. Brightness and contrast adjusted

Figure 1-13. Picture DSC02239.JPG taken at 0816:52 (CDT) on 8/29/05, elevation 9.1 ft. Looking southeast. Water level at upper rail. Brightness and contrast adjusted.

Figure1-14. Picture DSC02240.JPG taken at 0826:32 (CDT) on 8/29/05, elevation 9.1 ft. Looking south.  
Water level at upper rail.

Figure 1-15. Picture DSC02241.JPG taken at 0826:36 (CDT) on 8/29/05, elevation 9.1 ft. Looking south. Water level at upper rail. Brightness and contrast adjusted.

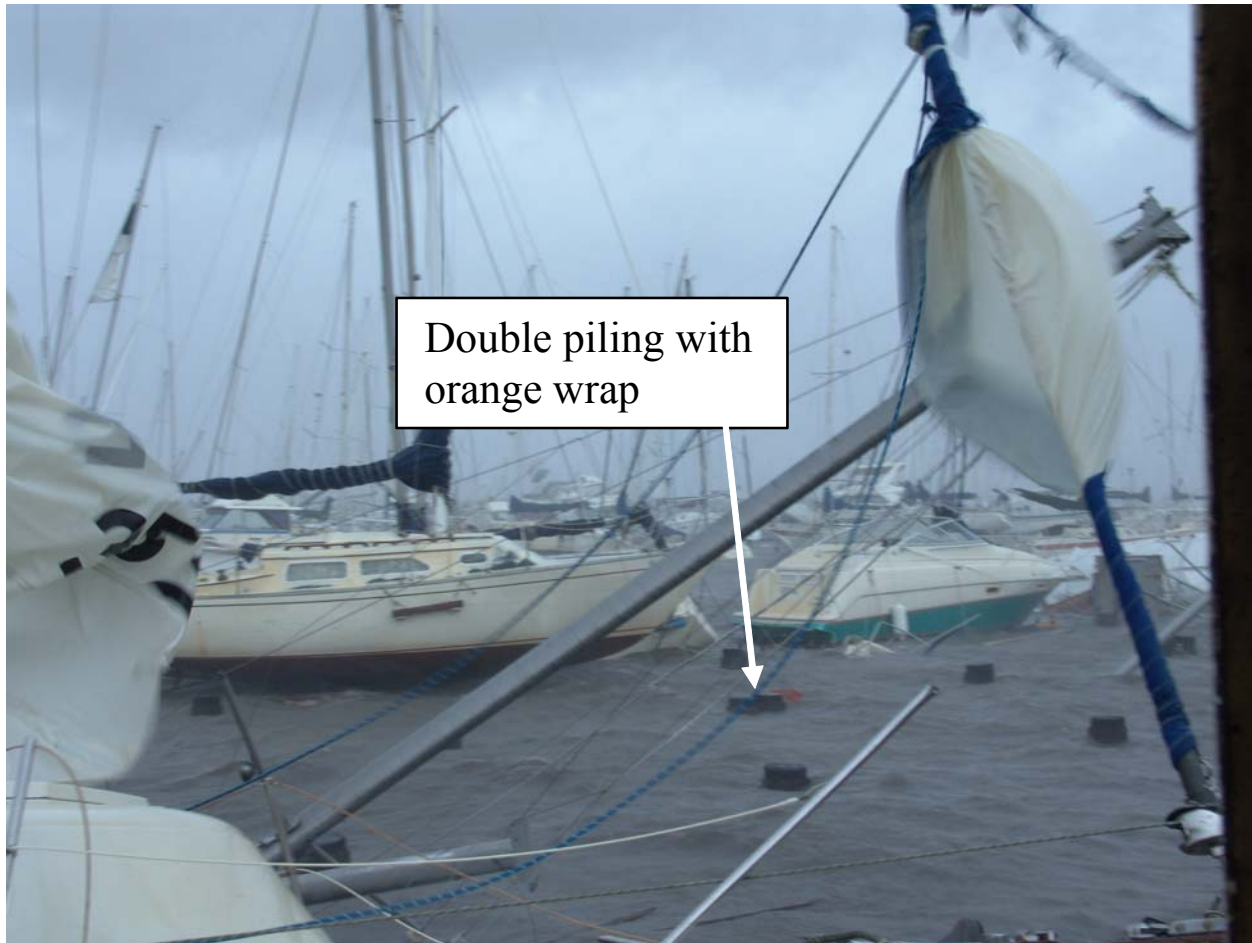
- f.* 1312 (CDT) – 1313 (CDT) on 8/29/05, elevation 6.3 ft: Pictures DSC02251-DSC02256 show pilings in the harbor. Figure 1-16 (DSC02255) shows a double piling with some orange visible beside the piling. At the site visit, only one double piling had an orange wrap that was loose at the bottom and would have floated up during the higher water level. A mark was placed on this piling at the water level estimated from the picture. The mark was 0.5 ft below the top of the piling. This mark was surveyed and found to be at elevation 6.2 ft. Other pilings in the picture were also about 0.5 ft below the top of piling providing an elevation of 6.4 ft. A value of 6.3 ft is used for this time.

Figure 1-16. Picture DSC02255.JPG taken at 1313 (CDT) on 8/29/05, elevation 6.3 ft. Looking northeast

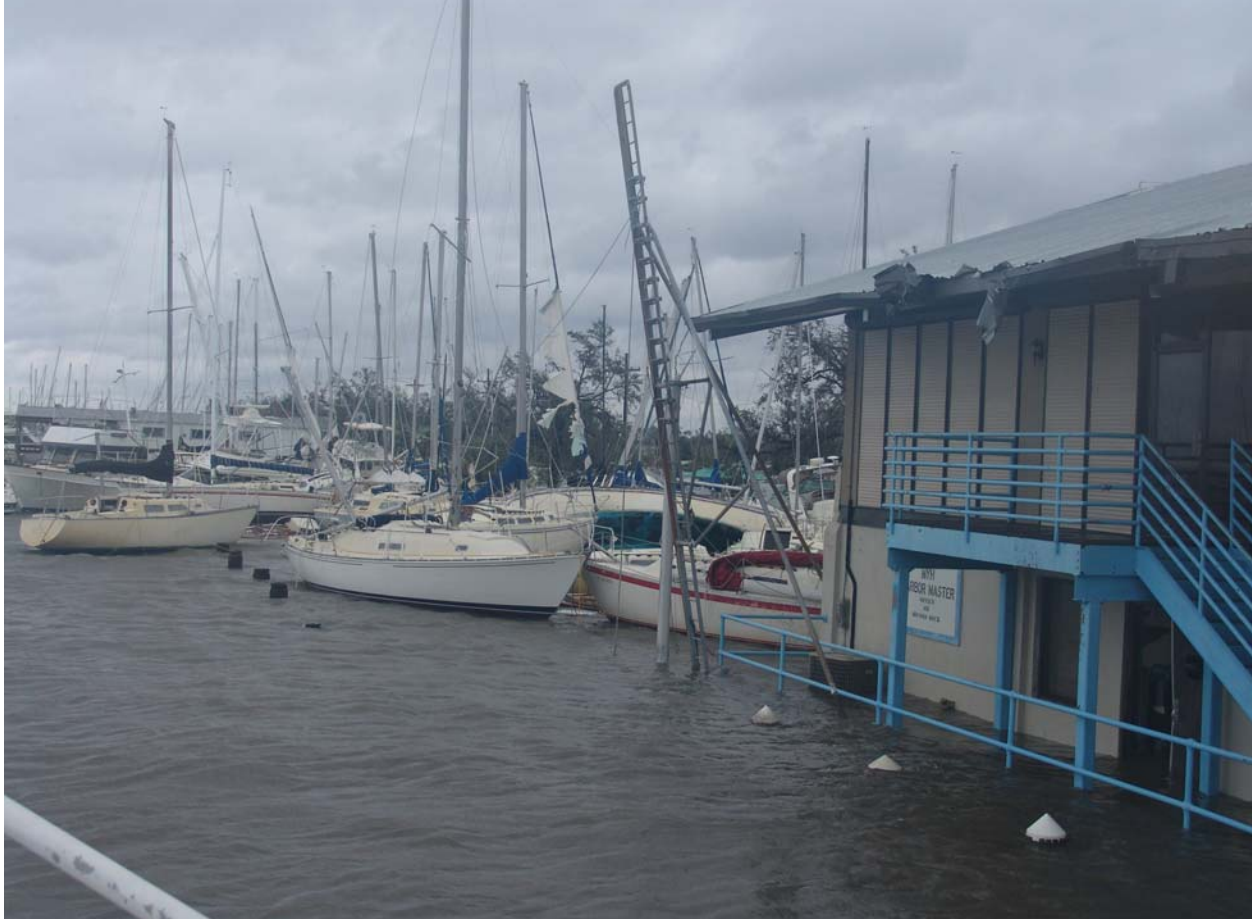
- g. 1537 (CDT) – 1543 (CDT) on 8/29/05, elevation 6.5 ft: Numerous pictures provide rail evidence and top of piling evidence. Figure 1-17 (DSC02262- 1538:44) shows the water level at 5 vertical posts at 0.7, 0.8, 0.8, 0.7, and 0.6 ft below the lower rail that averages 0.7 ft. Figure 1-18 (DSC02263- 1538:54) show the water level at 4 vertical posts at 0.5, 0.7, 0.7, and 0.9 ft below the lower rail that averages 0.7 ft below the lower rail that gives an elevation of  $7.2 - 0.7 = 6.5$  ft. Figures 1-19 (DSC02267- 1539:34) and 1-20 (DSC02269- 1539:56) show the double piling with the orange cushion. Based on the photographs, the water level is about 0.1 ft below the top of piling giving an elevation of 6.5 ft.

Figure 1-17. Picture DSC02262.JPG taken at 1538:44 (CDT) on 8/29/05, elevation 6.5 ft. Looking east-southeast. From left to right vertical posts, water level is 0.7, 0.8, 0.8, 0.7, and 0.6 ft below the center of the lower rail.

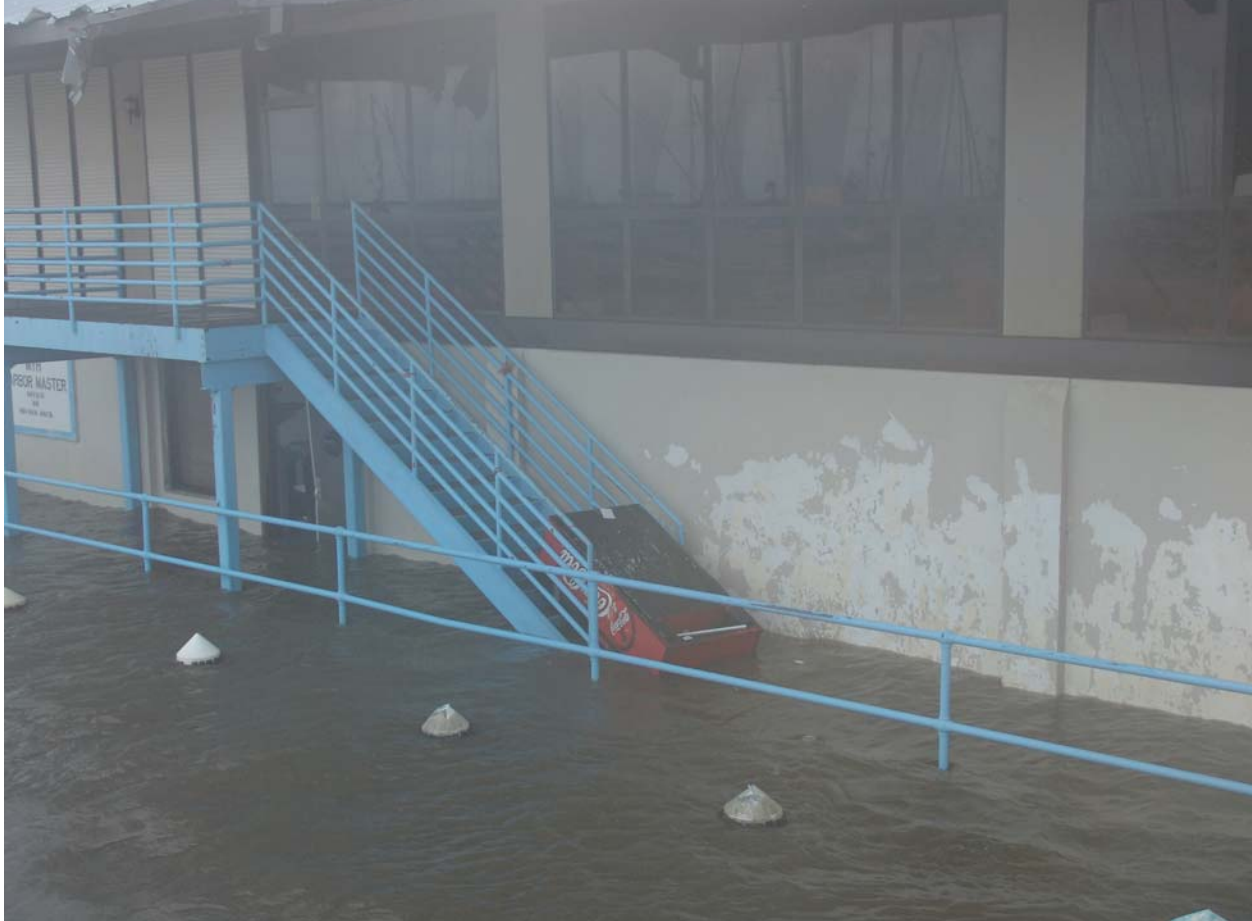
Figure 1-18. Picture DSC02263.JPG taken at 1538:54 (CDT) on 8/29/05, elevation 6.5 ft. Looking southeast. From left to right, water level is 0.5, 0.7, 0.7, and 0.9 ft below the center of the lower rail.

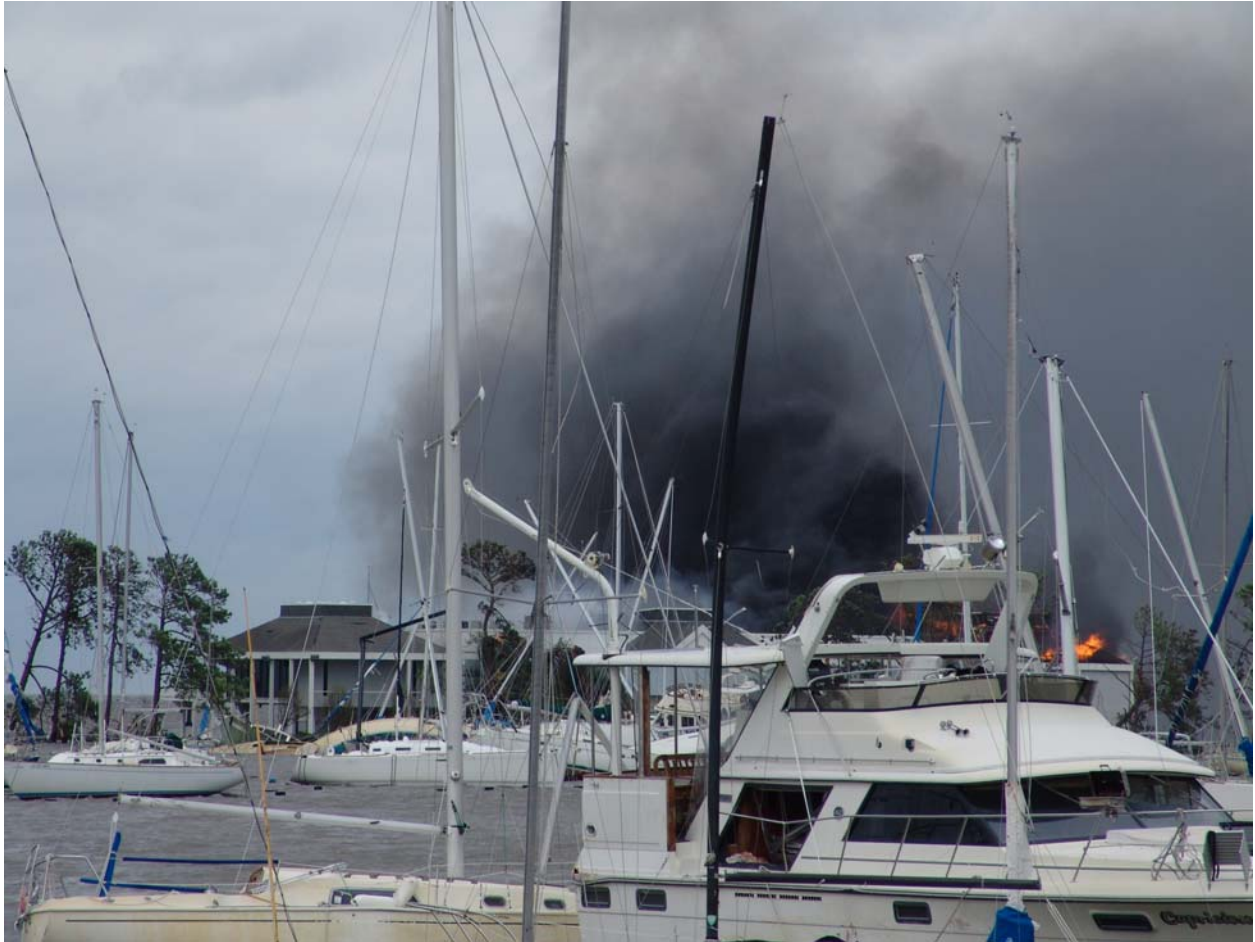
- h. 1648 (CDT) – 1650 (CDT) on 8/29/05, elevation 6.7 ft: Numerous pictures (DSC02280- DSC02296) of fire in background and top of piles both close to the boat and far away. Figure 1-21 (DSC02287) shows a typical picture of top of piling relative to water level. Average distance of water level below tops of piling was about 0.1-0.3 ft. Based on surveyed average top of piling, average elevation was 6.7 ft.

Figure 1-21. Picture DSC02287.JPG taken at 1649 (CDT) on 8/29/05, elevation 6.7 ft. Looking northeast.

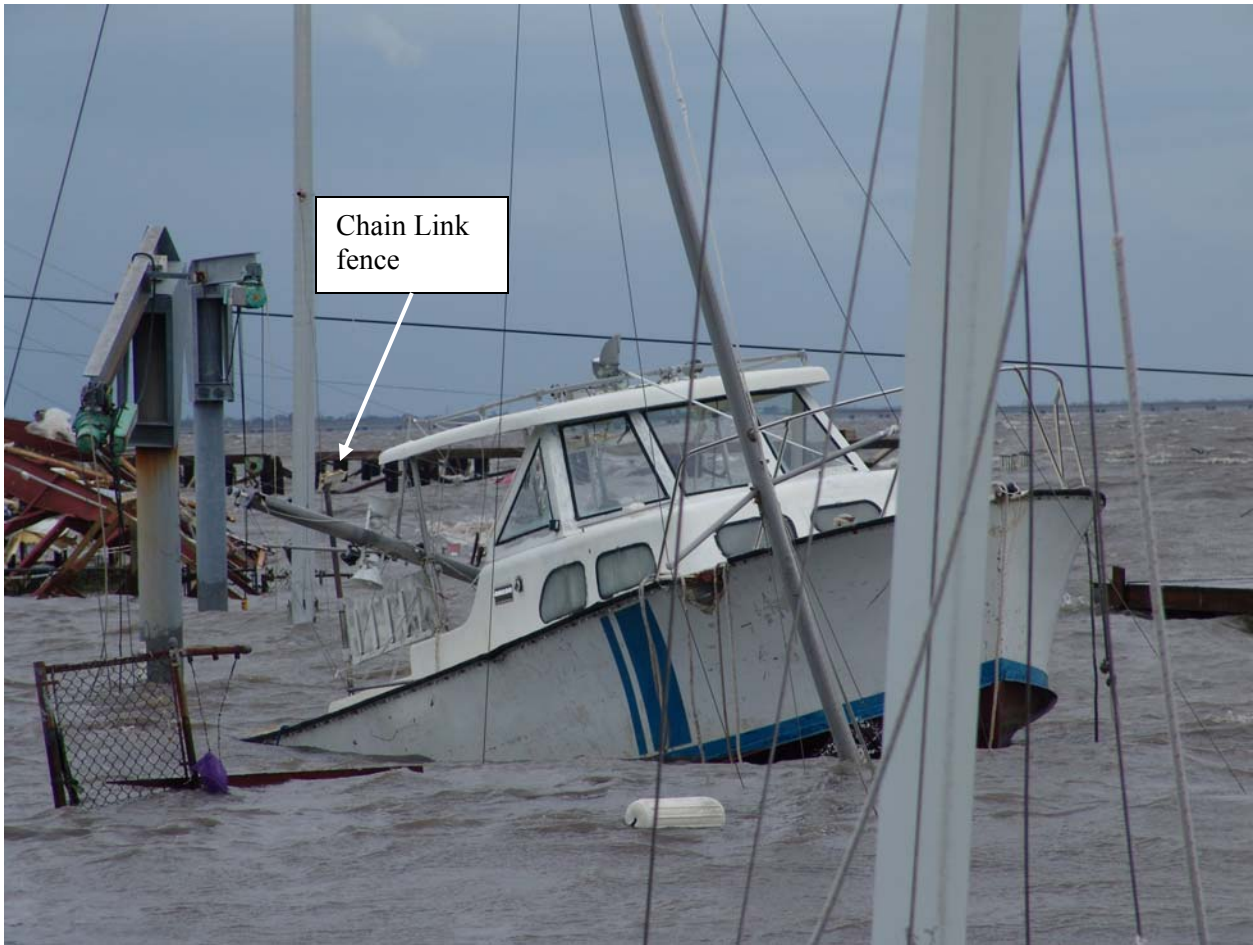
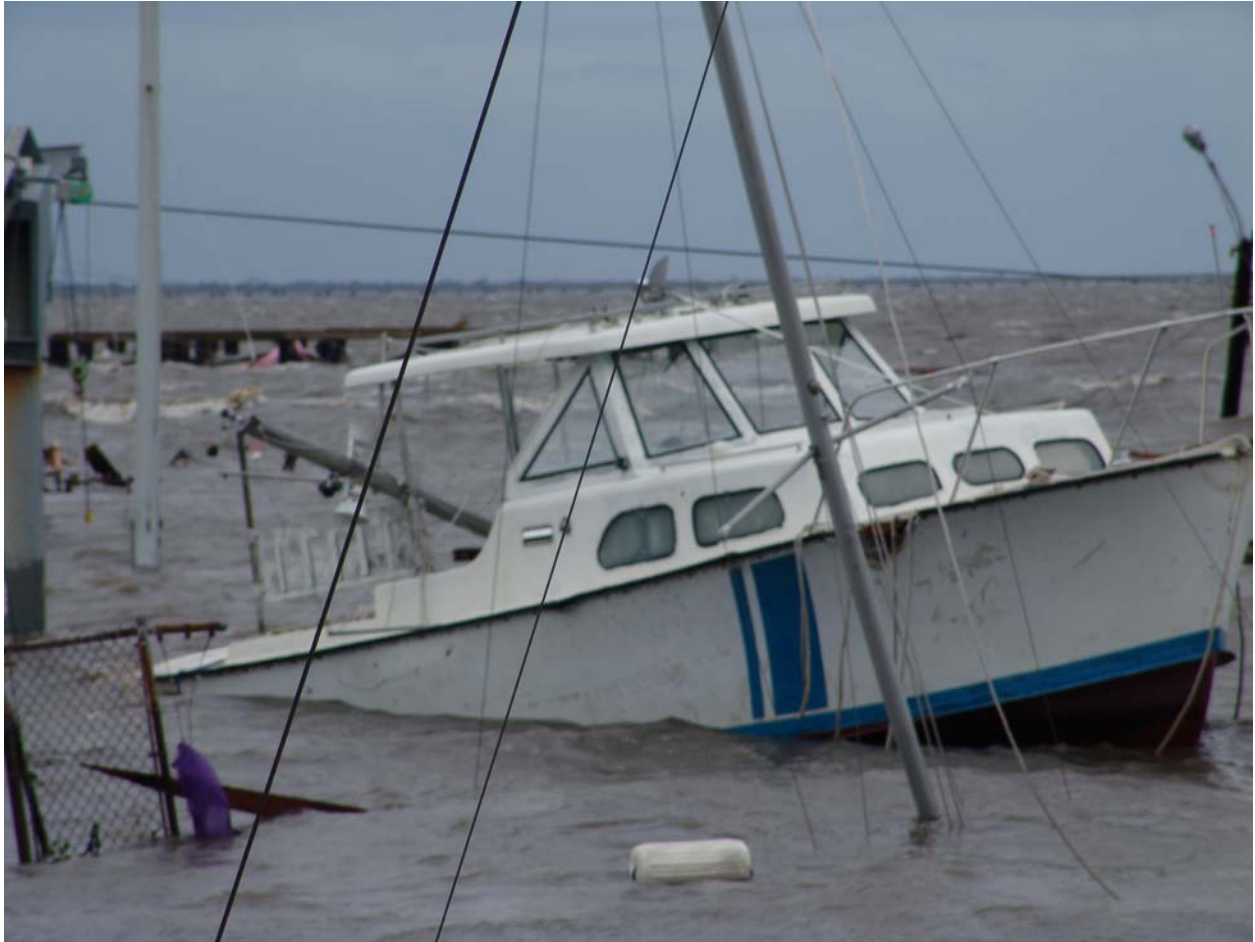
- i. 1710 (CDT) – 1724 (CDT) on 8/29/05, elevation 6.9 ft: Pictures DSC02297 – DSC02327 show distance of water level below tops of highest pilings of about 0.1 ft or an elevation of 6.8 ft. Figures 1-22 (DSC02305- 1711:04) and 1-23 (DSC02306- 1711:14) show the chain link fence section west of the moored boat. The water level position on the fence

Figure 1-22. Picture DSC02305.JPG taken at 1711:04 (CDT) on 8/29/05, elevation 7.5 ft. Looking west

Figure 1-23. Picture DSC02306.JPG taken at 1711:14 (CDT) on 8/29/05, elevation 6.5 ft. Looking west.

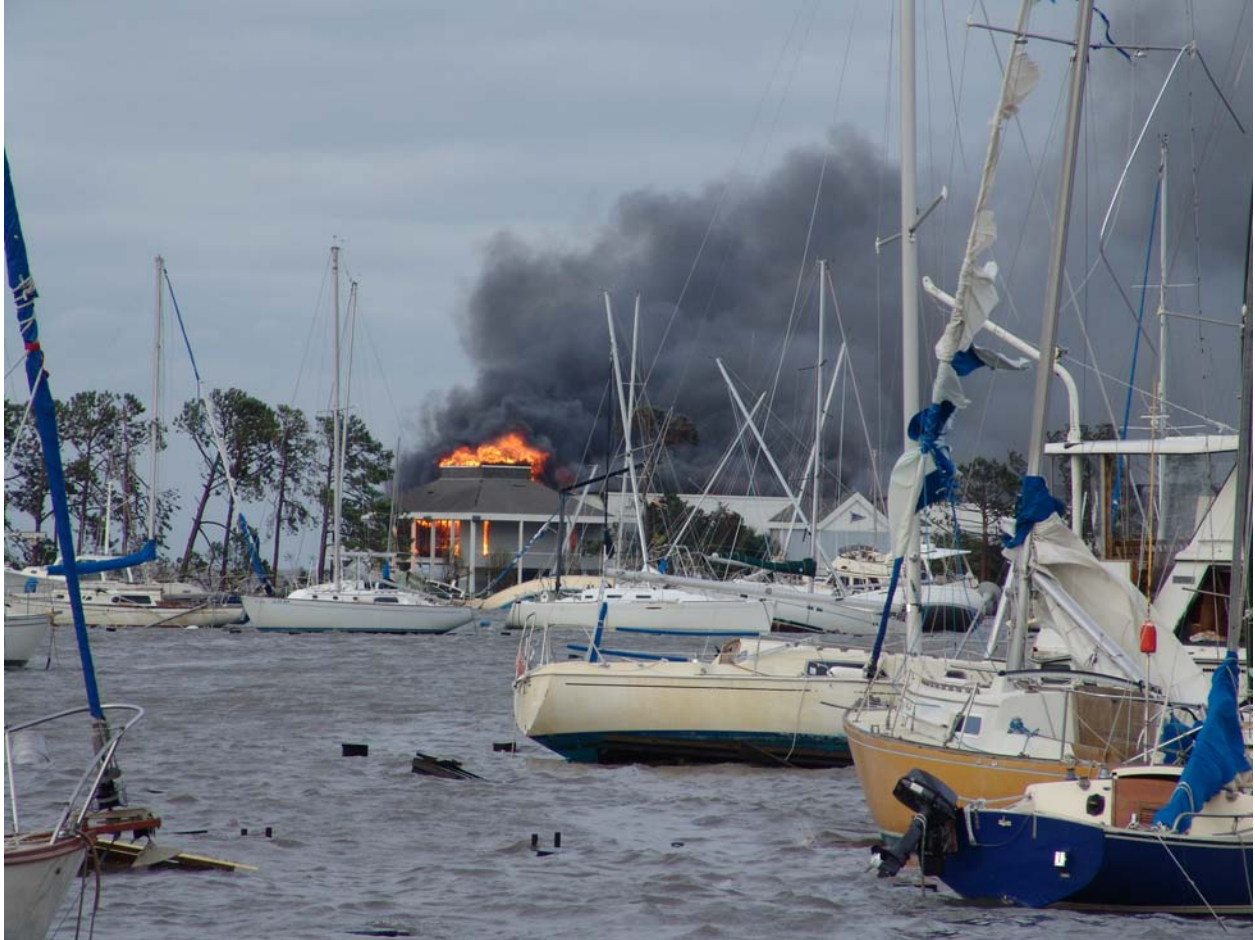
- j.* 1757 (CDT) – 1758 (CDT) on 8/29/05, elevation 6.7 ft: Pictures DSC02328- DSC02337 show the water level at about 0.2 ft below the tops of the highest pilings giving an average elevation of about 6.7 ft. Figure 1-24 (DSC02333) shows a typical top of piling picture.

Figure 1-24. Picture DSC02333.JPG taken at 1757 (CDT) on 8/29/05, elevation 6.7 ft. Looking northeast

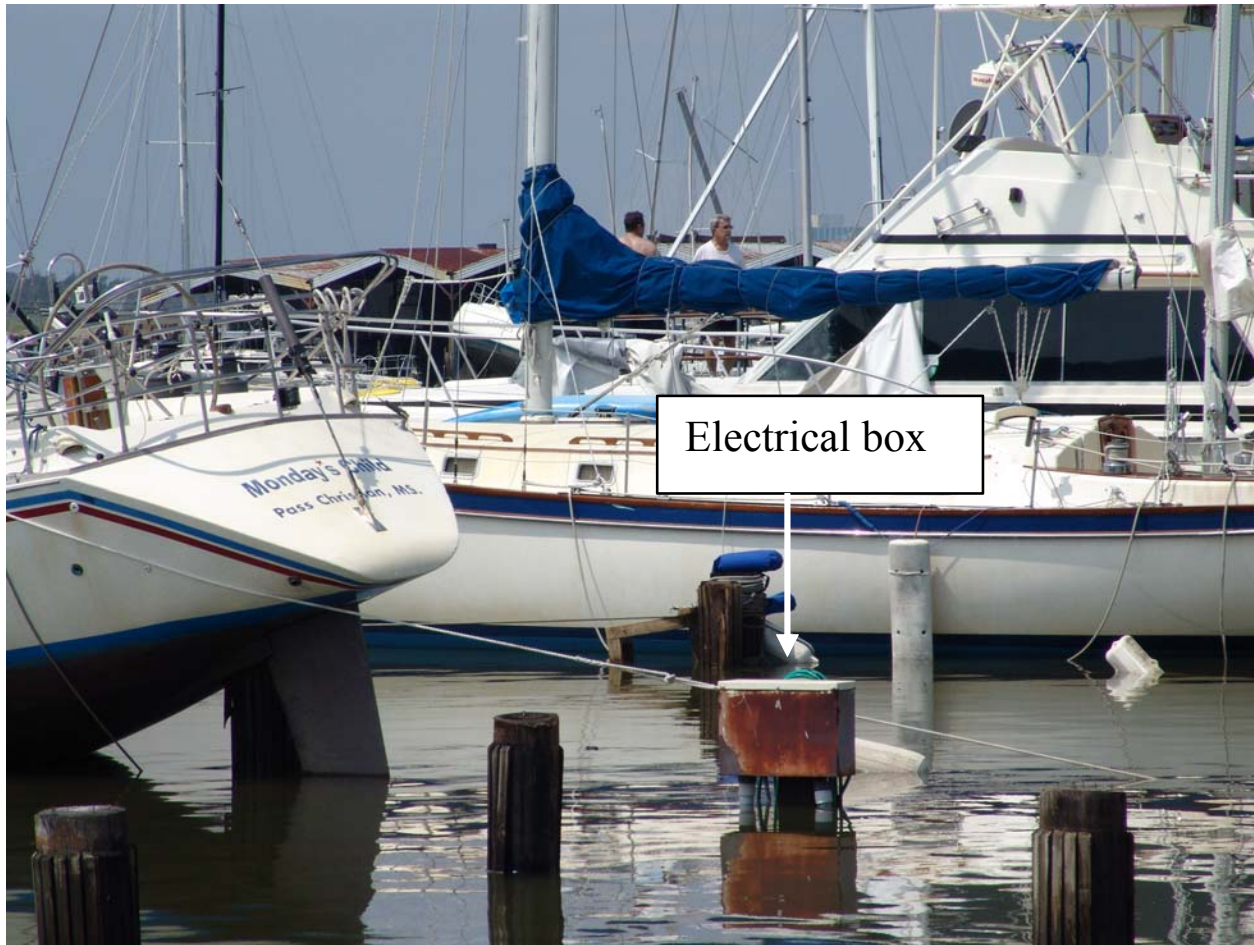
- k.* 1132 (CDT) on 8/30/05, elevation 4.55 ft: Figure 1-25 (DSC02338) shows electrical box where the water level on 8/30 is 4.0 ft above the water level on 11/8 based on measuring the location of the water on the box in the picture down to the water level on 11/8. This point was not surveyed in the initial survey. The electrical box is located on the east end of the third row of docks. The water level on 11/8 was 5.8 ft lower than a surveyed mark on a piling that was at elevation 6.15 giving a water level of  $6.2 - 5.8 = 0.4$  ft on 11/8. The water level on 8/30 =  $4.0 + 0.4 = 4.4$  ft. In the resurvey in 2006, this point was at an elevation of 4.55 ft.

Figure 1-25. Picture DSC02338.JPG taken at 1132 (CDT) on 8/30/05 elevation 4.4 ft. Electrical box at east end of third row of docks
