# Appendix 1

## Hydrograph and High Water Mark Analysis

### Introduction

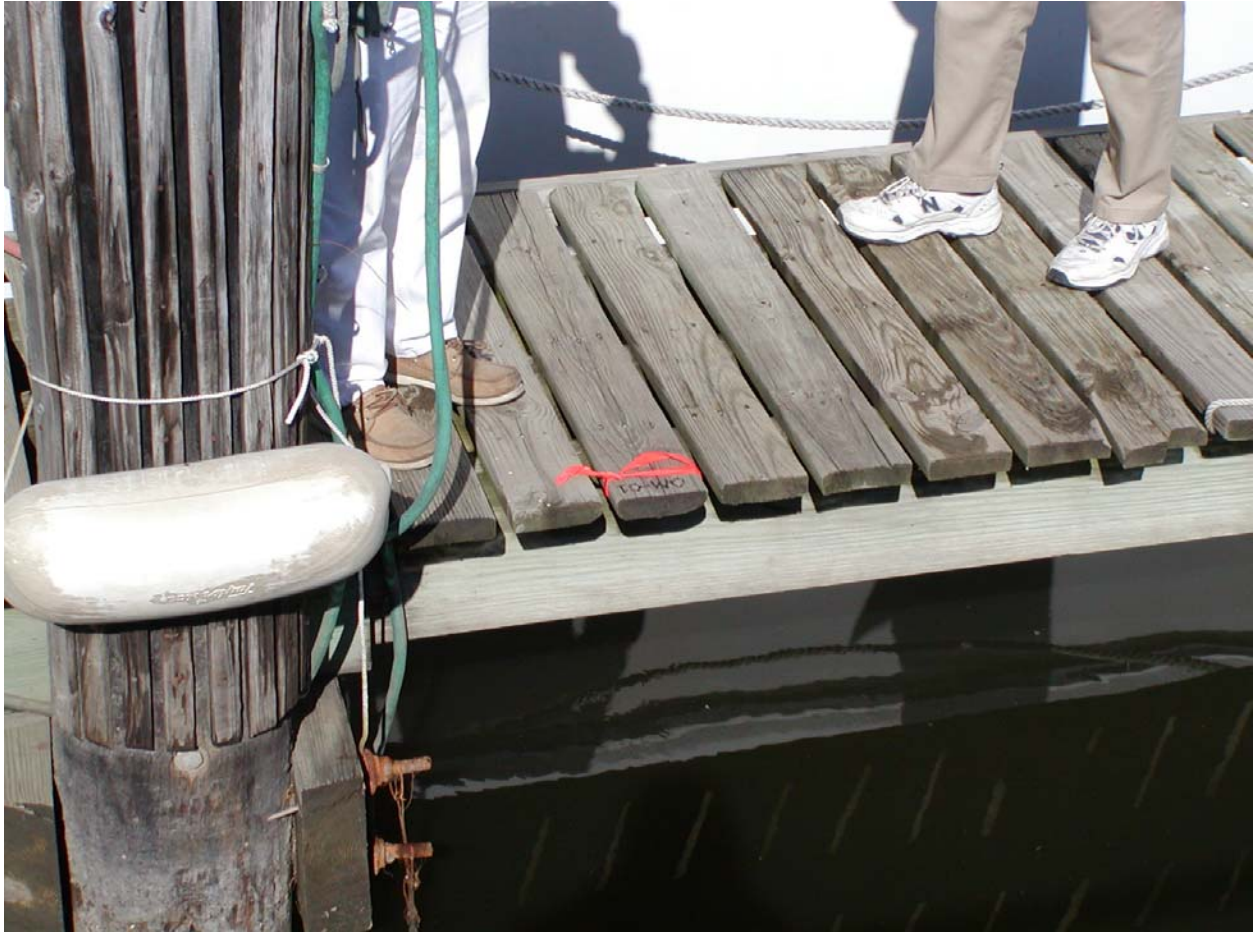
- a. Sunday 8/28/05, 16:00 hrs: Water level 1 ft above normal. No mark will be surveyed because uncertain how to quantify “normal.”
- b. Sunday 8/28/05. 23:00 hrs, elevation 3.0 ft: Water level at bottom side of the 2X6’s covering the deck of the finger pier. Survey point OM-01, Figure 1-26.
- c. Monday 8/29/05,01:30, elevation 3.7 ft: Water level at top of 1<sup>st</sup> step up from finger pier. Survey point OM-02, Figure 1-27.
- d. Monday 8/29/05,04:00, elevation 5.1 ft: Water level at top of concrete pile cap. Survey point OM-03, Figure 1-28.
- e. Monday 8/29/05,06:00, elevation 5.6 ft: Water level at top of steps equal to top of main concrete dock in Figure 1-28. Survey point OM-04.
- f. Monday 8/29/05,06:15, elevation 7.0 ft: Water level at 1<sup>st</sup> rail. Survey point OM-05, Figure 1-29.

Figure 1-26. Time 23:00 on 8/28/05, elevation 3.0 ft. Bottom of 2X6 deck board

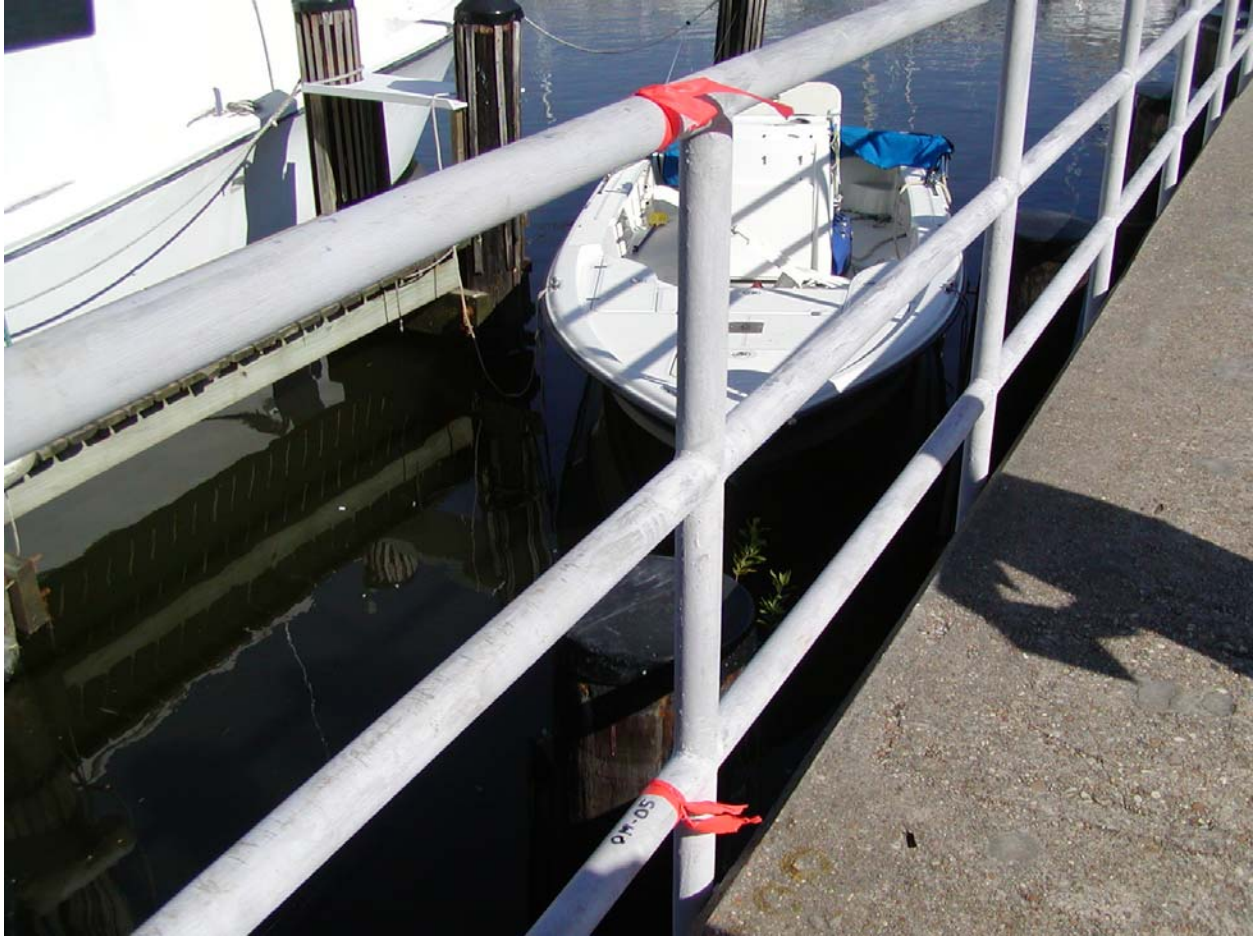
- g. Monday 8/29/05, 10:00, elevation 10.1 ft: Water level at top rail. Survey point OM-06, Figure 1-29.

Figure 1-29. Time 6:15 on 8/29/05, elevation 7.0 ft (bottom rail) and 10.1 ft (top rail)

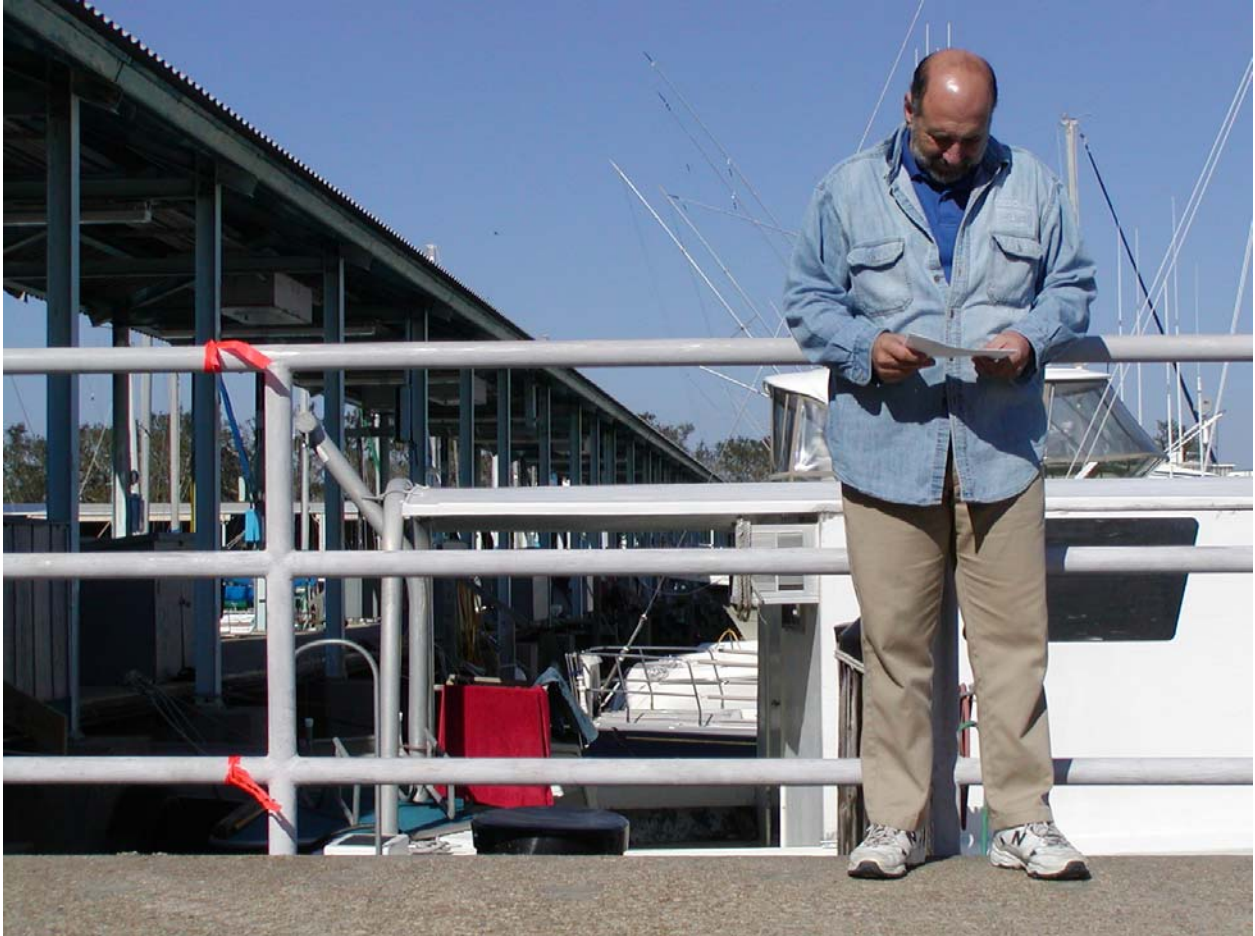
- i. Monday 8/29/05, from 12:45 to 15:00, elevation 6.5 ft: Water level at top of main walkway that supports metal railing. Elevation scaled from Figure 1-31 as 6.5 ft.

Figure 1-31. Main walkway of Orleans Marina. Boat is just behind individual on the walkway.

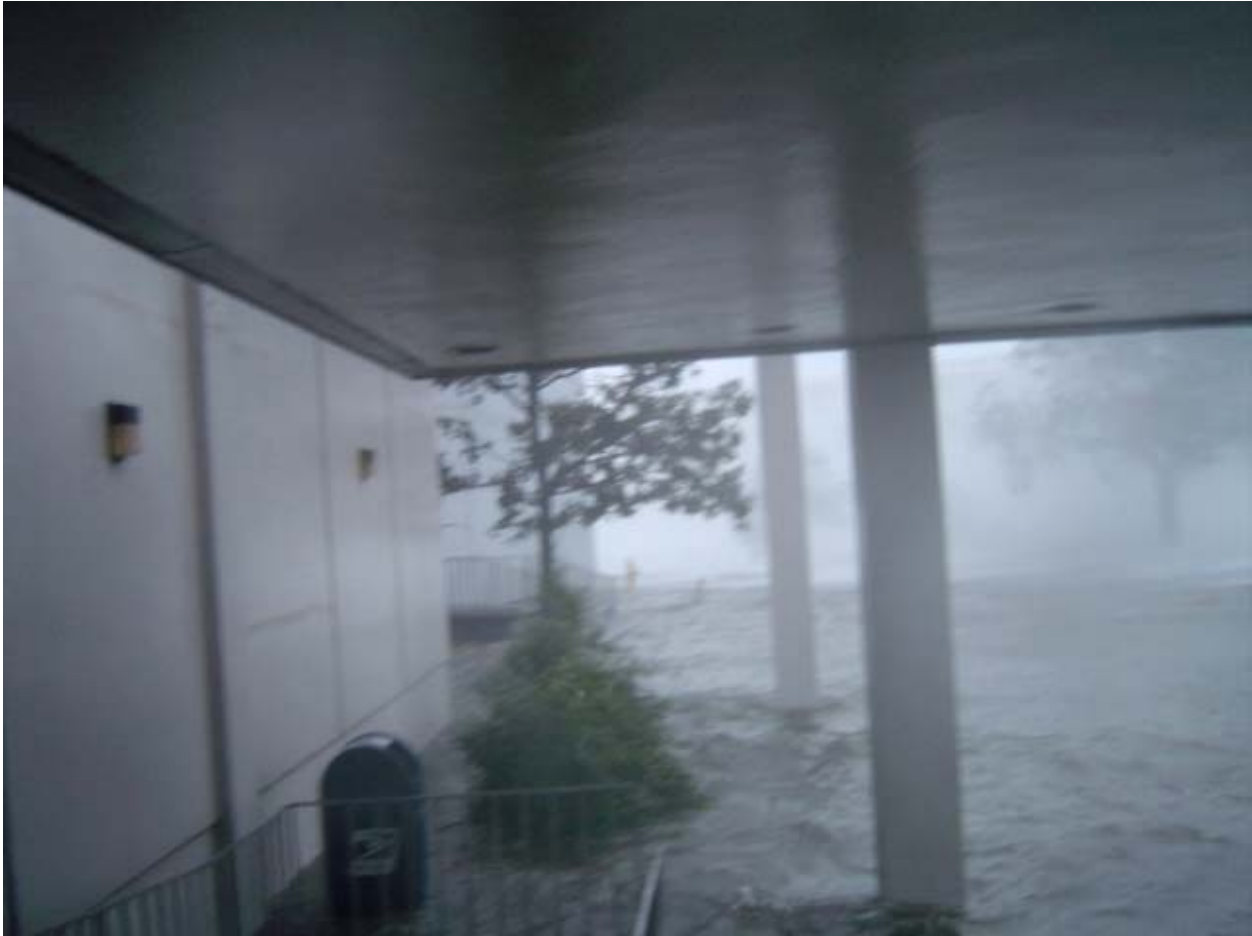
Figure 1-35. Time = 7:29, APH-22. Wall on south side of terminal building, east walkway

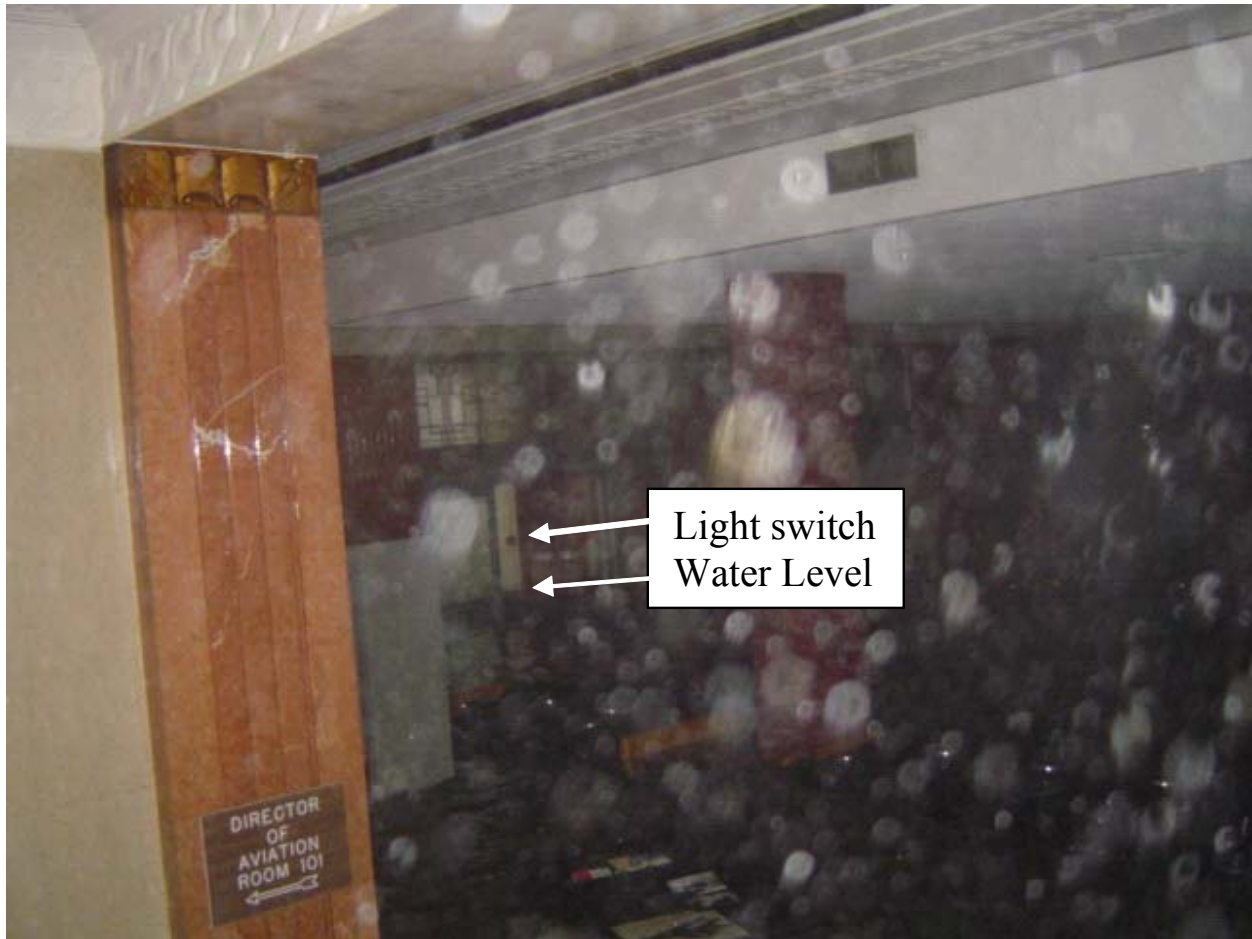
Figure 1-37. Time = 8:28 AM, APH-15. Door at south side of terminal building lobby

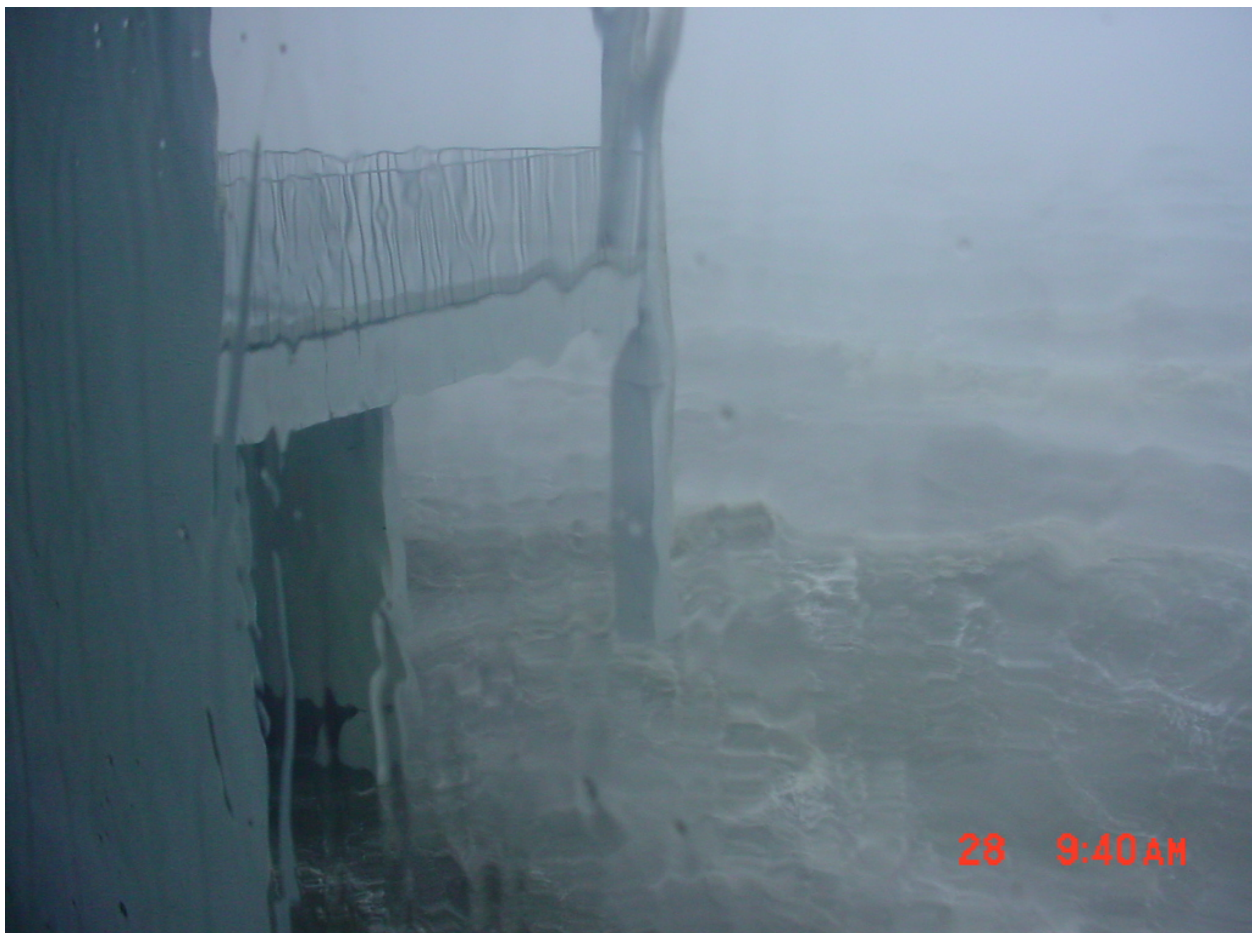
- e.* Time = 9:40 AM, APH-04, elevation 11.7 ft, Figure 1-38. On column outside northeast of lobby of terminal building. This mark was determined by measuring from the top of the metal rail to the bottom of the beam supporting the deck (a distance of 5.4 ft). The photograph was used to scale this distance in the photograph to the distance from the bottom of the deck beam to the water level. The distance from the photograph was 9.6 ft and this location on the column was surveyed as 12.0 ft. This value must be adjusted because the actual distance from the location of the camera and the 5.4 ft measurement is less than the actual distance from the camera location to the 9.6 ft measurement. Based on site measurements, the distance from the camera to the center of the 5.4 ft measurement is 47.2 ft versus the distance from the camera to the center of the 9.6 ft measurement was 48.4 ft. The actual distance of the 9.6 ft scaled from the photograph is  $9.6 \times 48.4 / 47.2 = 9.9$  ft. The location surveyed on the column should have been 0.3 ft lower resulting in an elevation of 11.7 ft. This was the only mark in the data set where the distance correction was felt to be important. The elevation of this mark has significant uncertainty because it is exposed to high wave activity (see Figure 1-38).

Figure 1-38. Time = 9:40 AM, APH-04. Water level on column northeast of lobby.

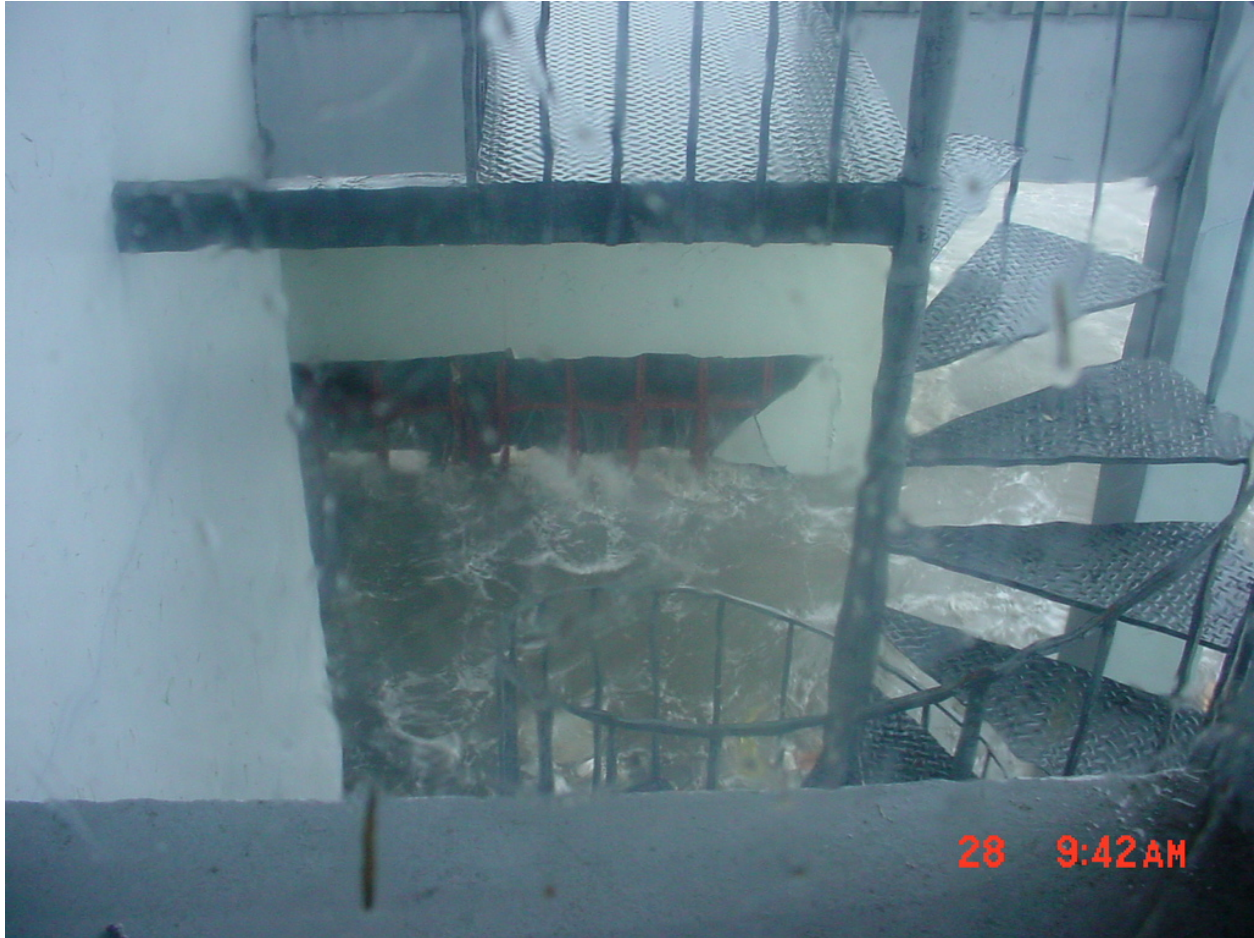
- f.* Time = 9:42 AM, APH-03, elevation 10.6 ft, Figure 1-39. On outside wall north of east spiral staircase where plaster is broken. The elevation of this mark has significant uncertainty because it is exposed to high wave activity.

Figure 1-39. Time = 9:42 AM, APH-03. Wall north of east spiral staircase.

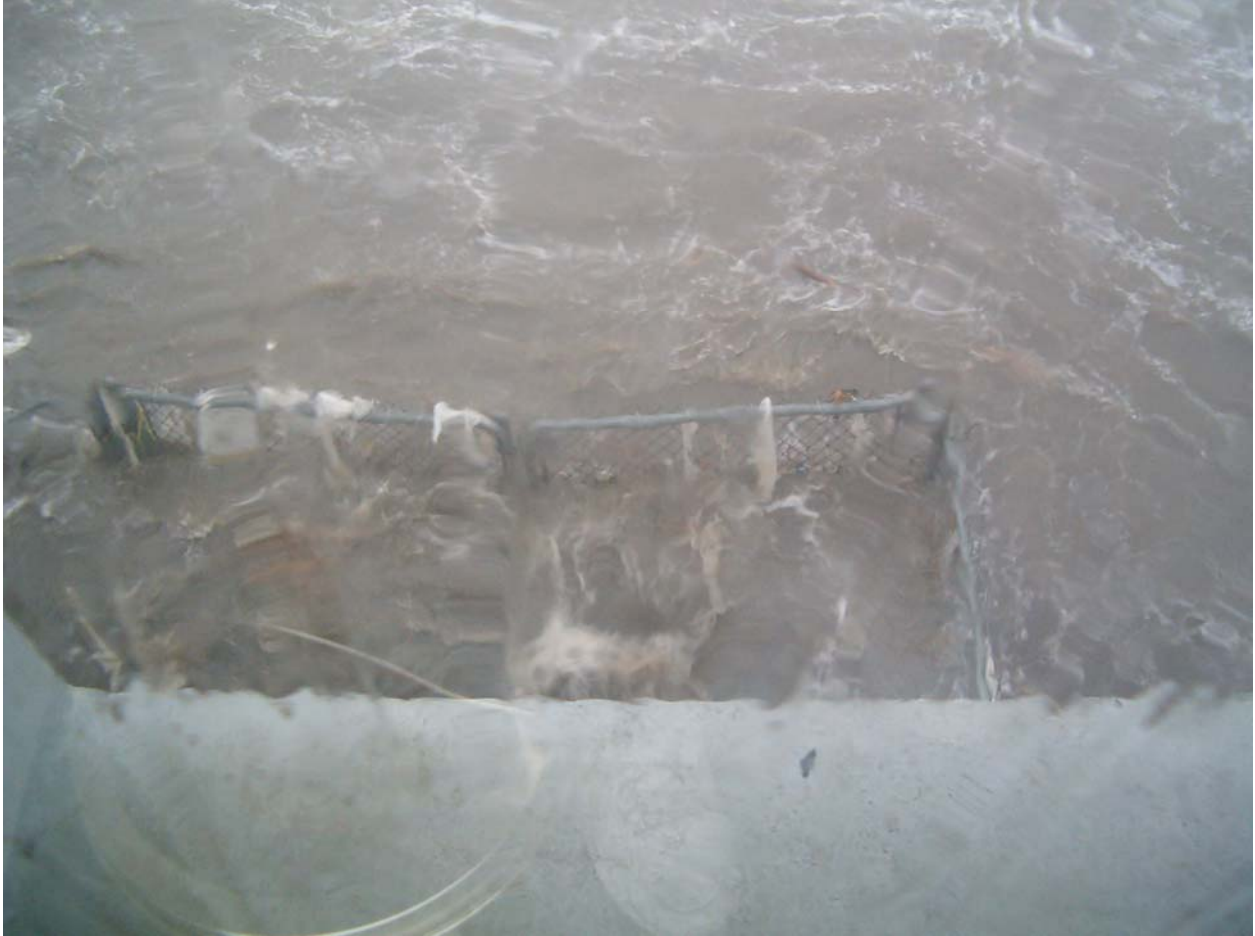
- g.* Time = 9:55 AM, APH-05, elevation 11.3 ft, Figure 1-40. Mark is located on the chain link fence. This mark is exposed to high wave activity. The number of openings in the chain link fence between the top bar of the fence and the water surface were counted from the photograph. The same number was used in the field to determine the position to be surveyed.

Figure 1-40. Time = 9:55 AM, APH-05. Chain link fence, north side of building, east of lobby.

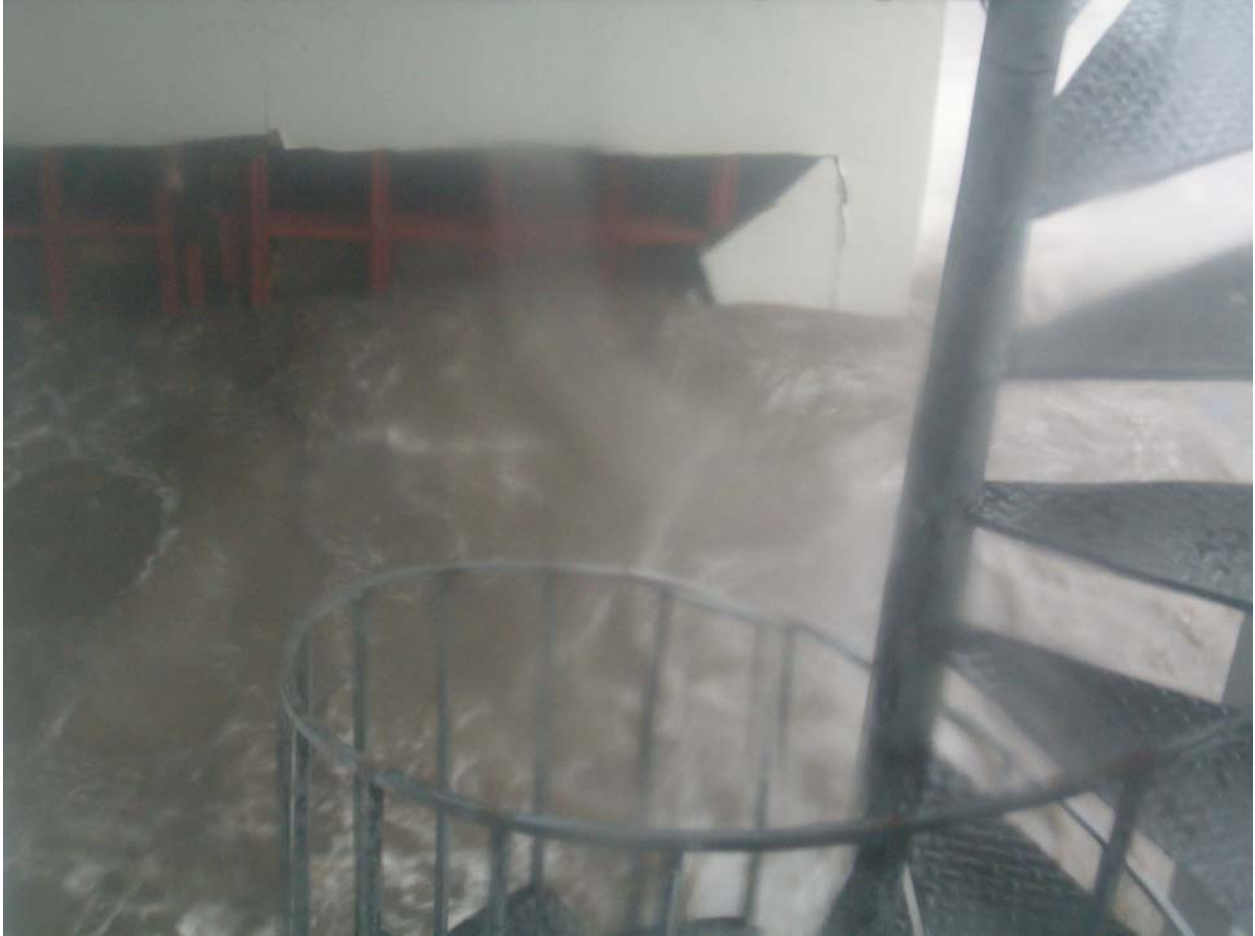
- h.* Time = 9:56 AM, APH-16, elevation = 10.9 ft, Figure 1-41. Located on the outside wall north of east spiral staircase where plaster is broken. This mark is exposed to high wave activity.

Figure 1-41. Time = 9:56 AM, APH-16. Wall north of east spiral staircase.

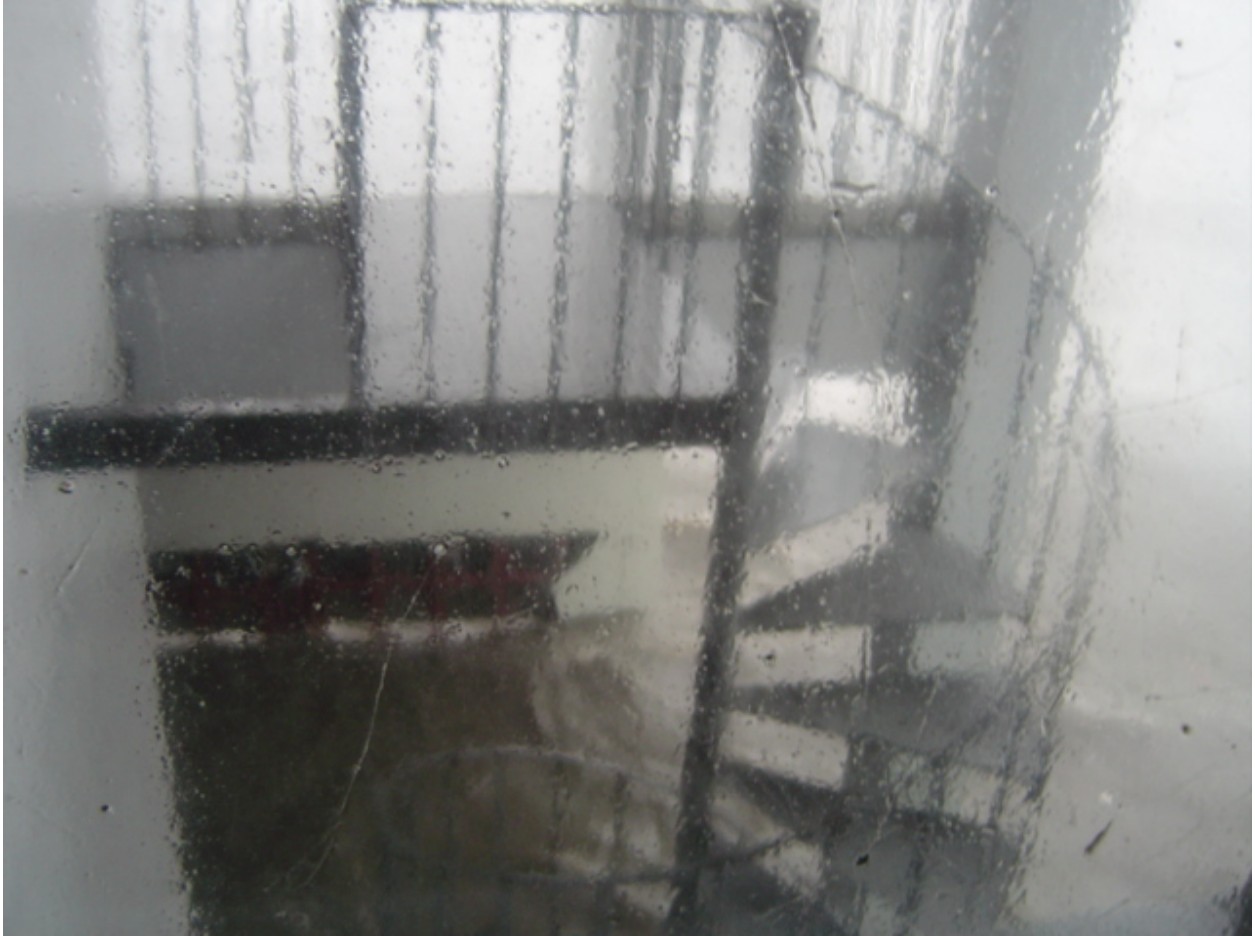
- i.* Time = 10:30 AM, APH-17, elevation = 10.6 ft, Figure 1-42. On outside wall north of east spiral staircase where plaster is broken. This mark is exposed to high wave activity.

Figure 1-42. Time = 10:30 AM, APH-17. Wall north of east spiral staircase.

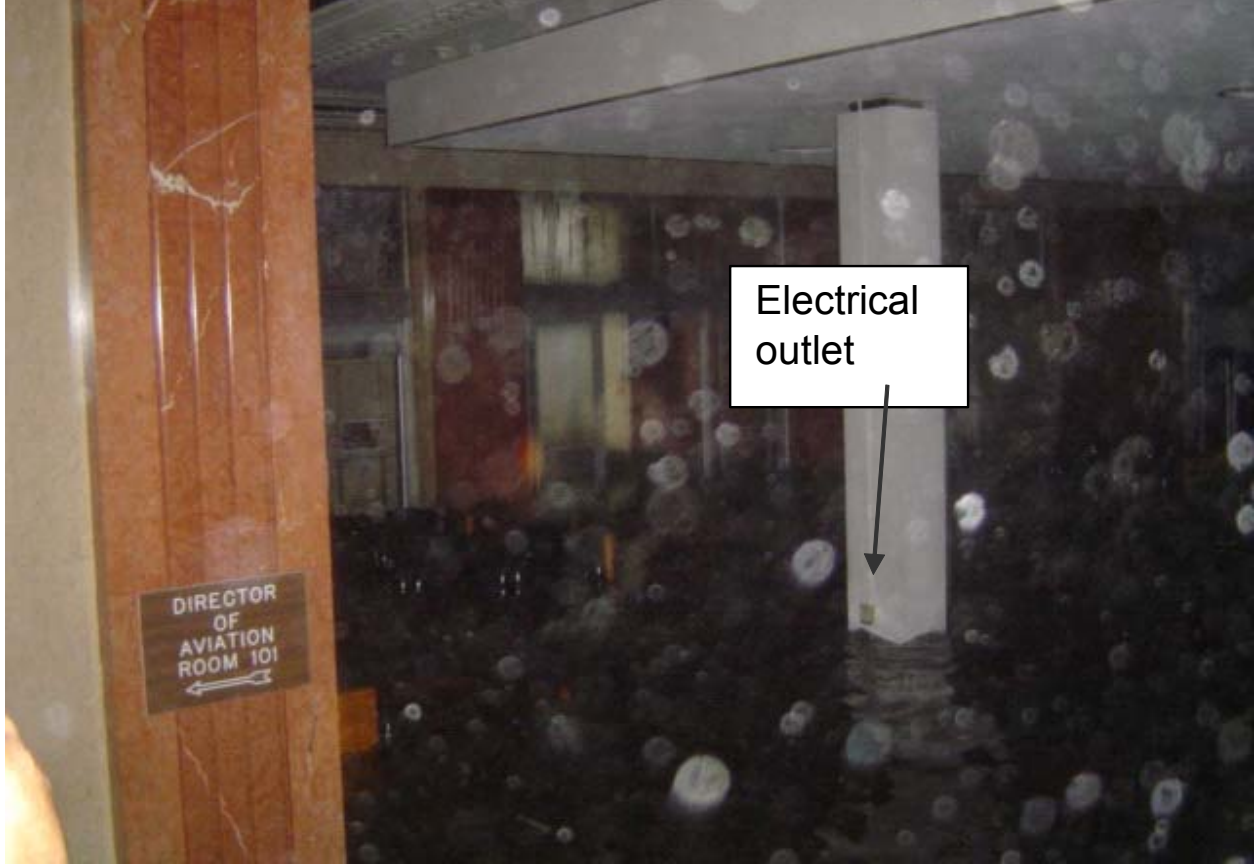
- k.* Time = 10:56 AM, APH-08, elevation 10.2 ft, Figure 1-44. Located on the column just below the electrical outlet in the lobby of the terminal building. The mark was determined by scaling from the photograph the height of the outlet and the distance from the bottom of the outlet to the water surface. The height of the outlet was measured at the airport and the ratio of the photograph measurements were used to position the mark. The broken doors on the north side of the building provided limited openings to this room that should have resulted in low wave activity and low uncertainty of this mark. Some wave action is apparent in Figure 1-44.

Figure 1-44. Time = 10:56 AM, APH-08. Column in terminal building lobby.

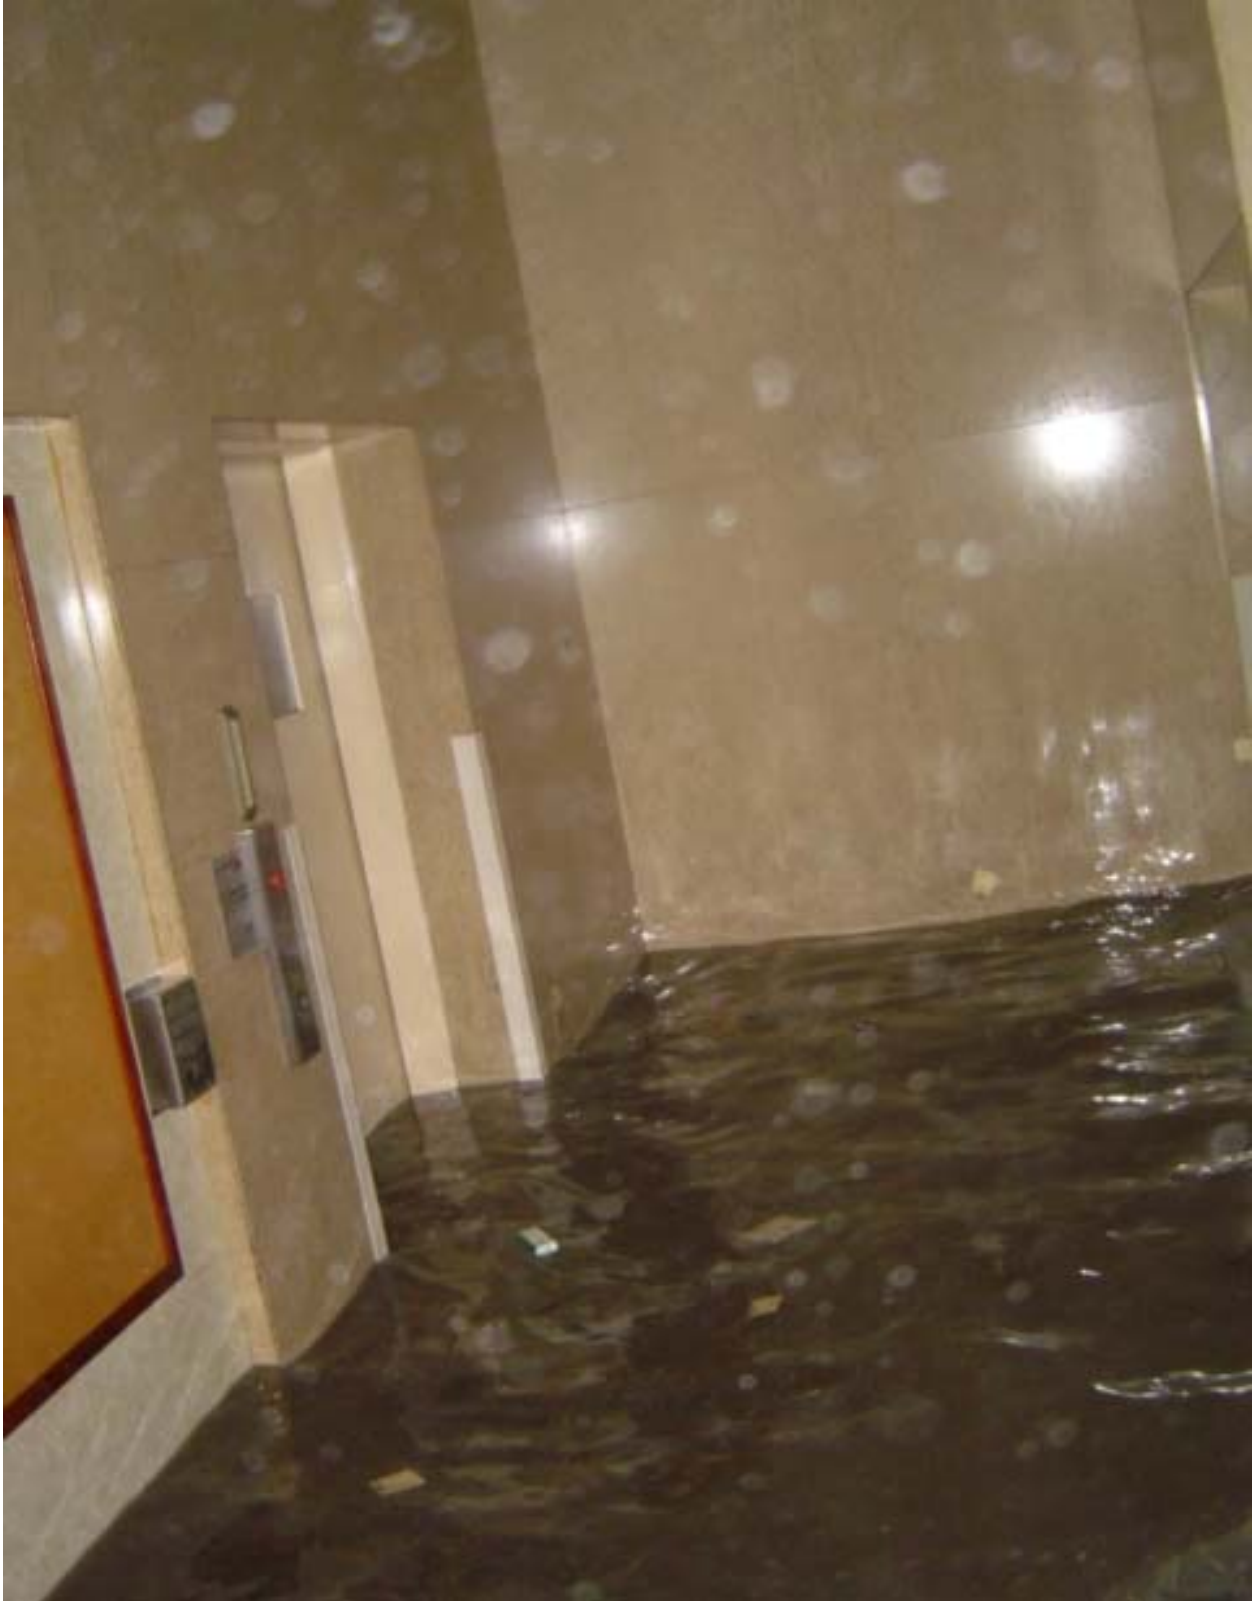
- l.* Time = 10:56 AM, APH-10, elevation 10.3 ft, Figure 1-45. Mark was determined by scaling from the photograph the distance from the top of the white strip on the elevator door facing to the top of the elevator door opening and the distance from the top of the white strip to the water surface. The distance from the top of the white strip to the top of the elevator door opening was measured at the airport and the ratio of the photograph measurements were used to position the mark. The elevator is in a side hallway off the main lobby of the terminal building and should have little wave activity. The agreement of this mark and APH-08 is strong evidence supporting these two marks.

Figure 1-45. Time = 10:56 AM, APH-10, elevator east of lobby.

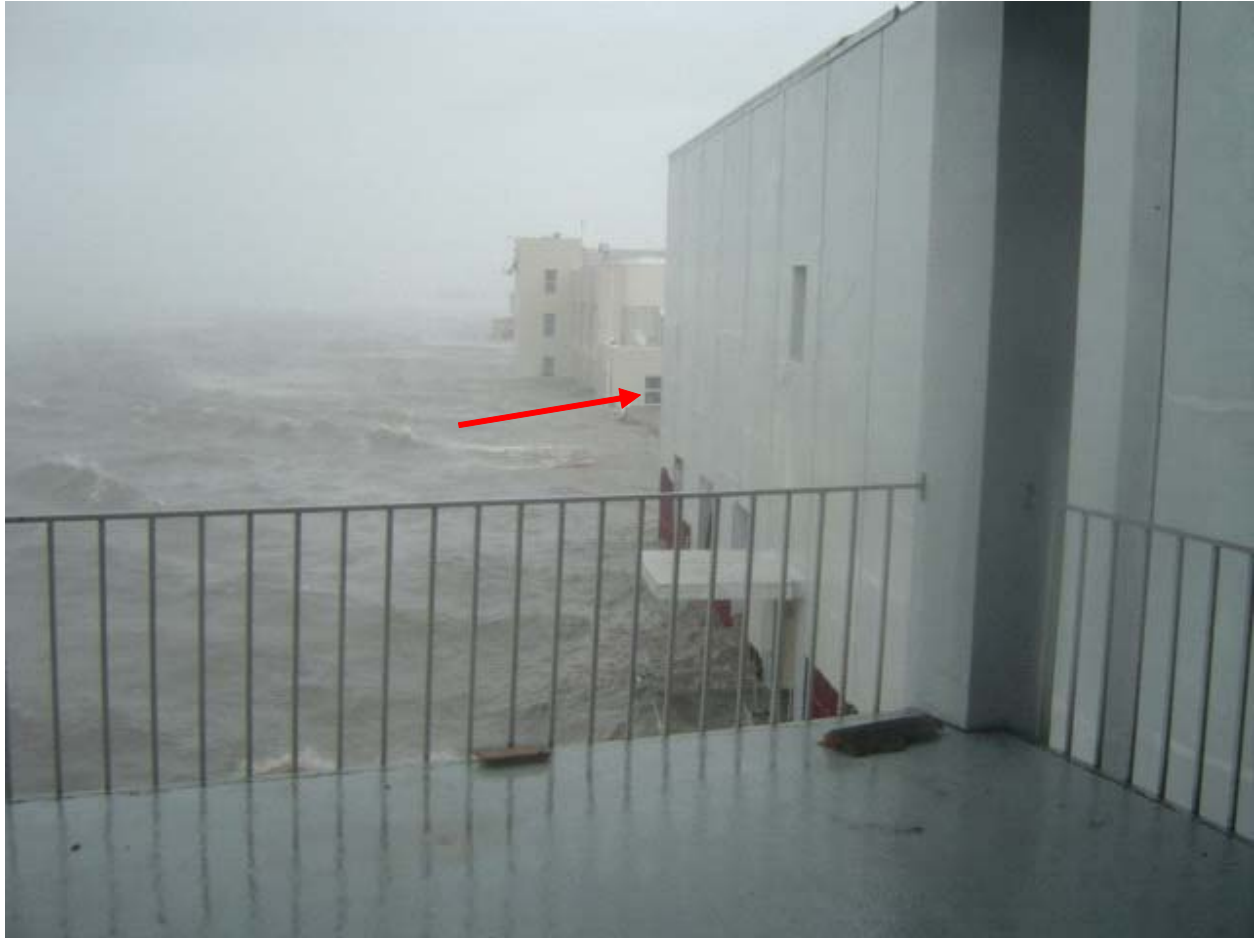
- m.* Time = 11:48 AM, APH-18, elevation 10.3 ft, Figure 1-46. On the west side of the building east of the terminal building, the water level is at the top of the lowest window.

Figure 1-46. Time = 11:48 AM, APH-18. Top of lowest window on building east of terminal building.

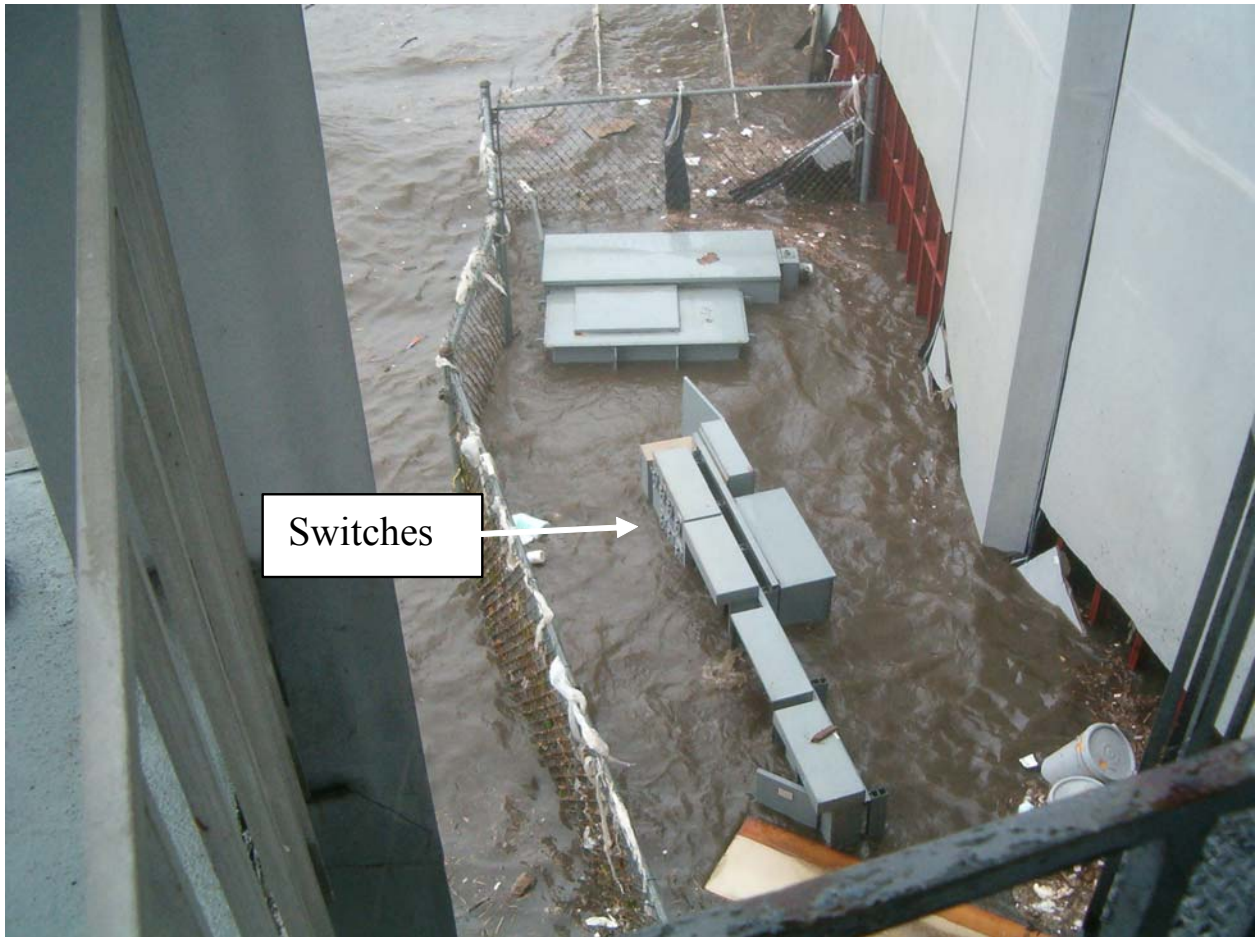
- n.* Time = 11:49, APH-06, elevation 9.7 ft, Figure 1-47. Inside the chain link fence of the north side of the building east of the lobby of the terminal building. By zooming the picture, the water level is just below the 2<sup>nd</sup> row of switches on the electrical box in the middle of the picture. The location of the switches on the north side of the airport building and the 11:48 AM picture in Figure 1-46 show this point is exposed to significant wave activity.

Figure 1-47. Time = 11:49 AM, APH-06. On switchbox in middle of picture.

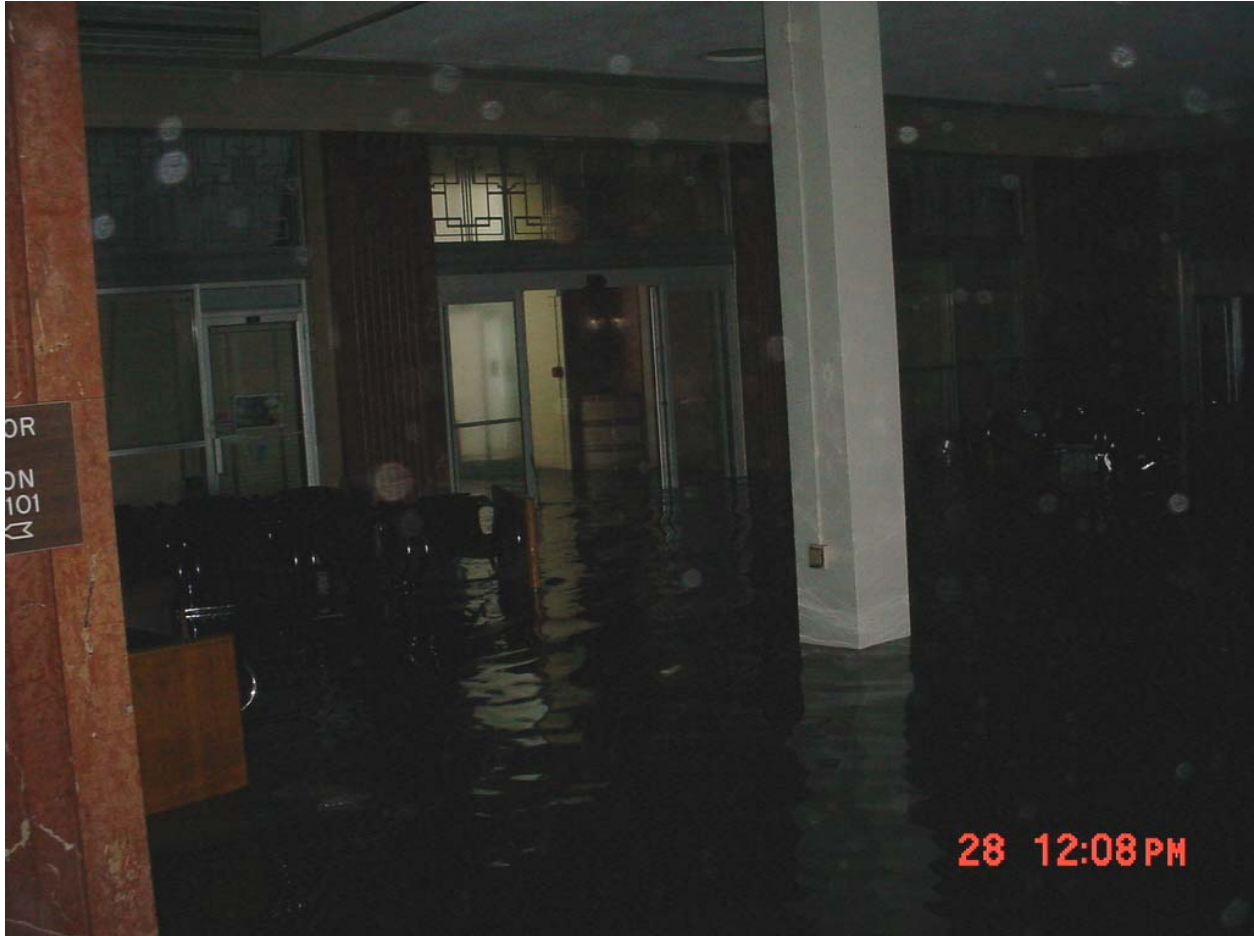
- o.* Time = 12:08 PM, APH-09, elevation 8.9 ft, Figure 1-48. Used technique described for APH-08. Since water depth over lobby floor of the terminal building was about 0.5 ft and the lobby has limited door openings, waves in the lobby should be minor and this point has low uncertainty. The water surface around the column in Figure 1-48 has less wave activity than the earlier time in Figure 1-44.

Figure 1-48. Time = 12:08, APH-09. On column in terminal building lobby.

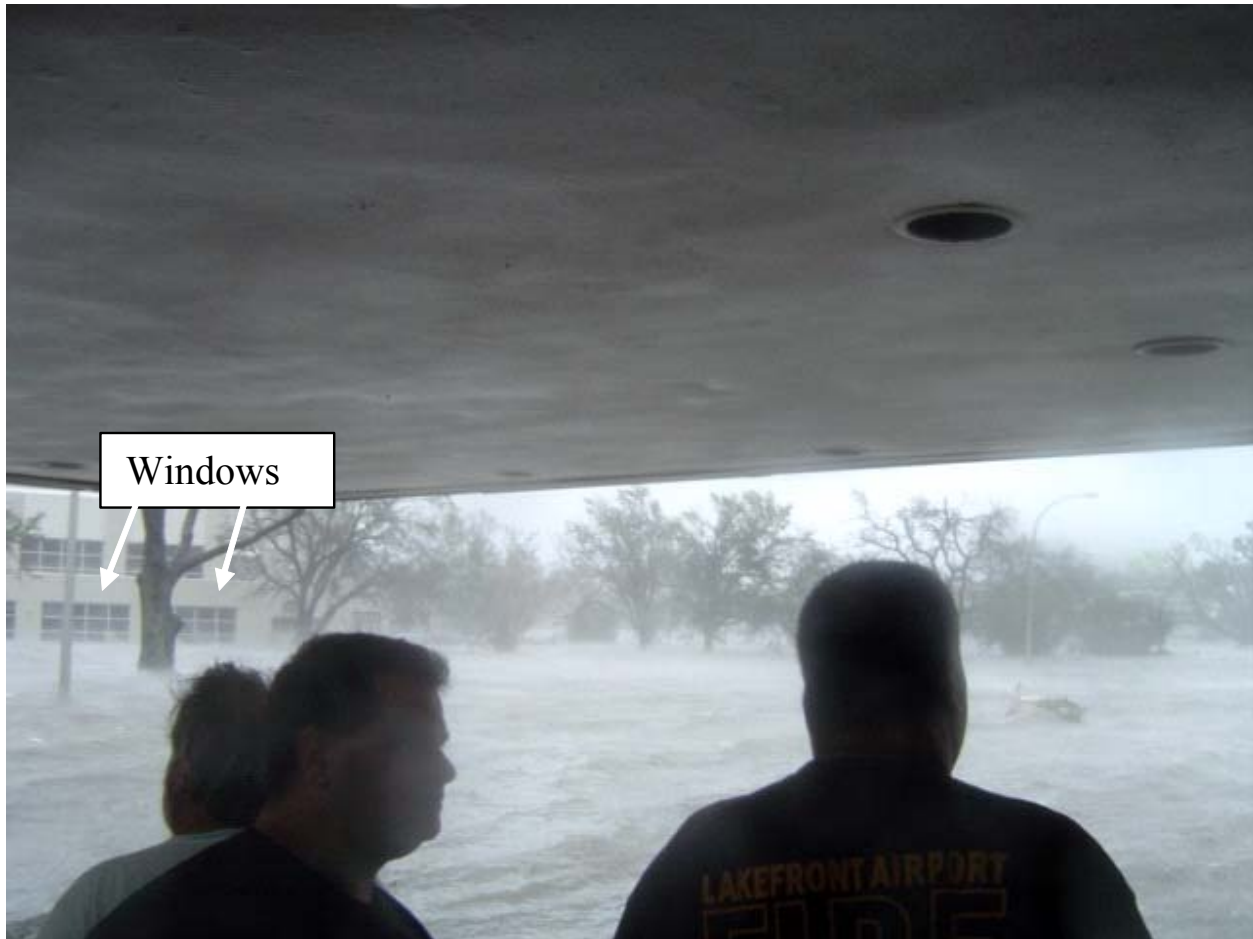
- p.* Time = 12:31, APH-19, elevation 8.8 ft, Figure 1-49. The left side of the photograph was zoomed to the windows on the building east of the airport. Mark to be surveyed was determined by scaling from the photograph the height of the window and the distance from the top of the lowest window to the water surface. The height of the window (2.5 ft) was measured at the airport and the ratio of the photograph measurements were used to position the mark. The size of the windows and the haziness in the photograph along with the wave activity cause significant uncertainty in this mark.

Figure 1-49. Time = 12:31 PM, APH-19. Windows on building just east of terminal building.

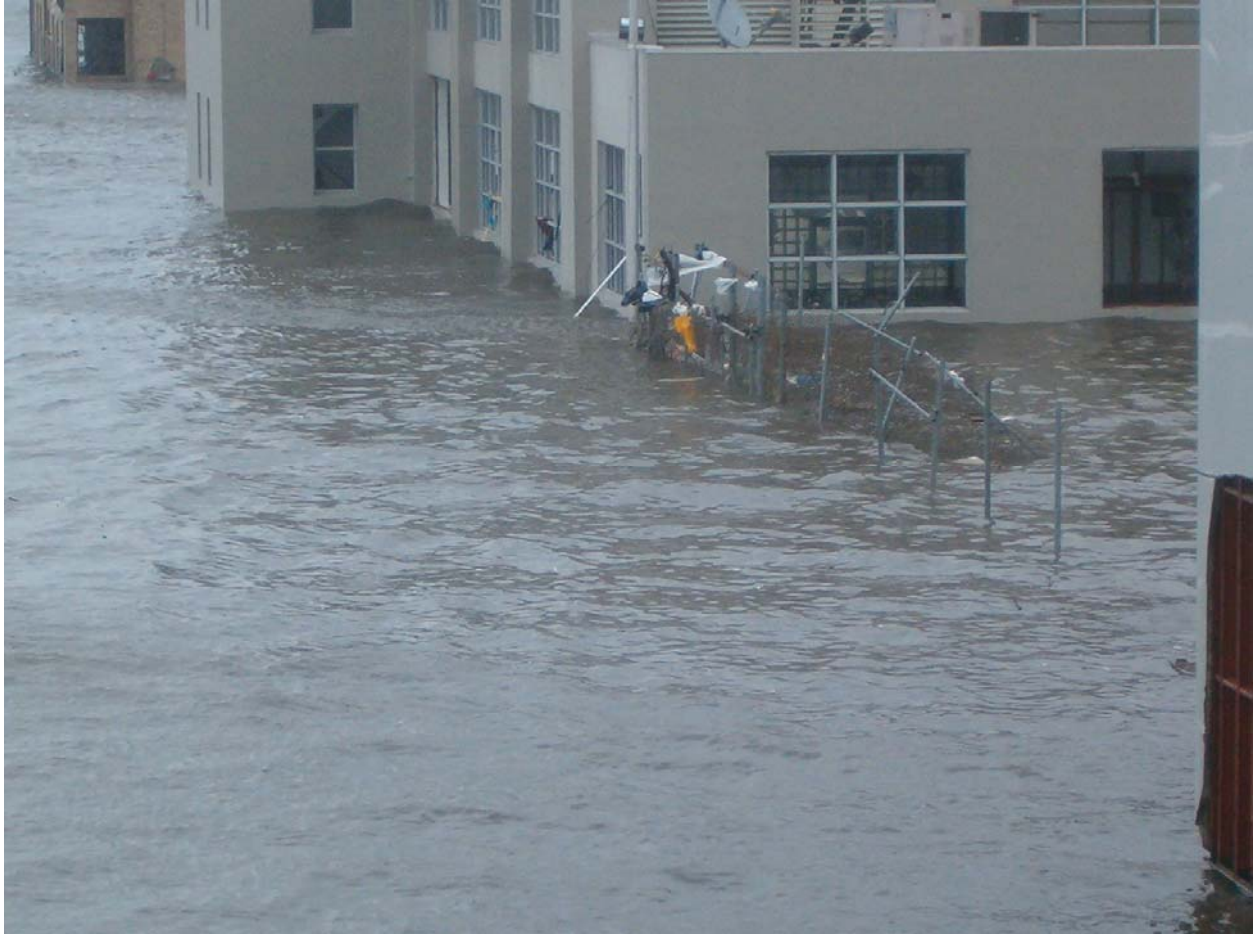
- r.* Time = 2:46 PM, APH-12, elevation 7.1 ft, Figure 1-51. Mark is below the windows on the building east of the terminal building. The mark to be surveyed was determined by scaling from the photograph the height of the window and the distance from the bottom of the lowest window to the water surface. The height of the window (2.5 ft) was measured at the airport and the ratio of the photograph measurements were used to position the mark which was 0.5 ft below the bottom of the lowest window. This is the first photograph where the water is calmed significantly which makes this a mark with little uncertainty.

Figure 1-51. Time = 2:46 PM, APH-12. Below windows on building east of terminal building.
