# Appendix 1

## Hydrograph and High Water Mark Analysis

### Introduction

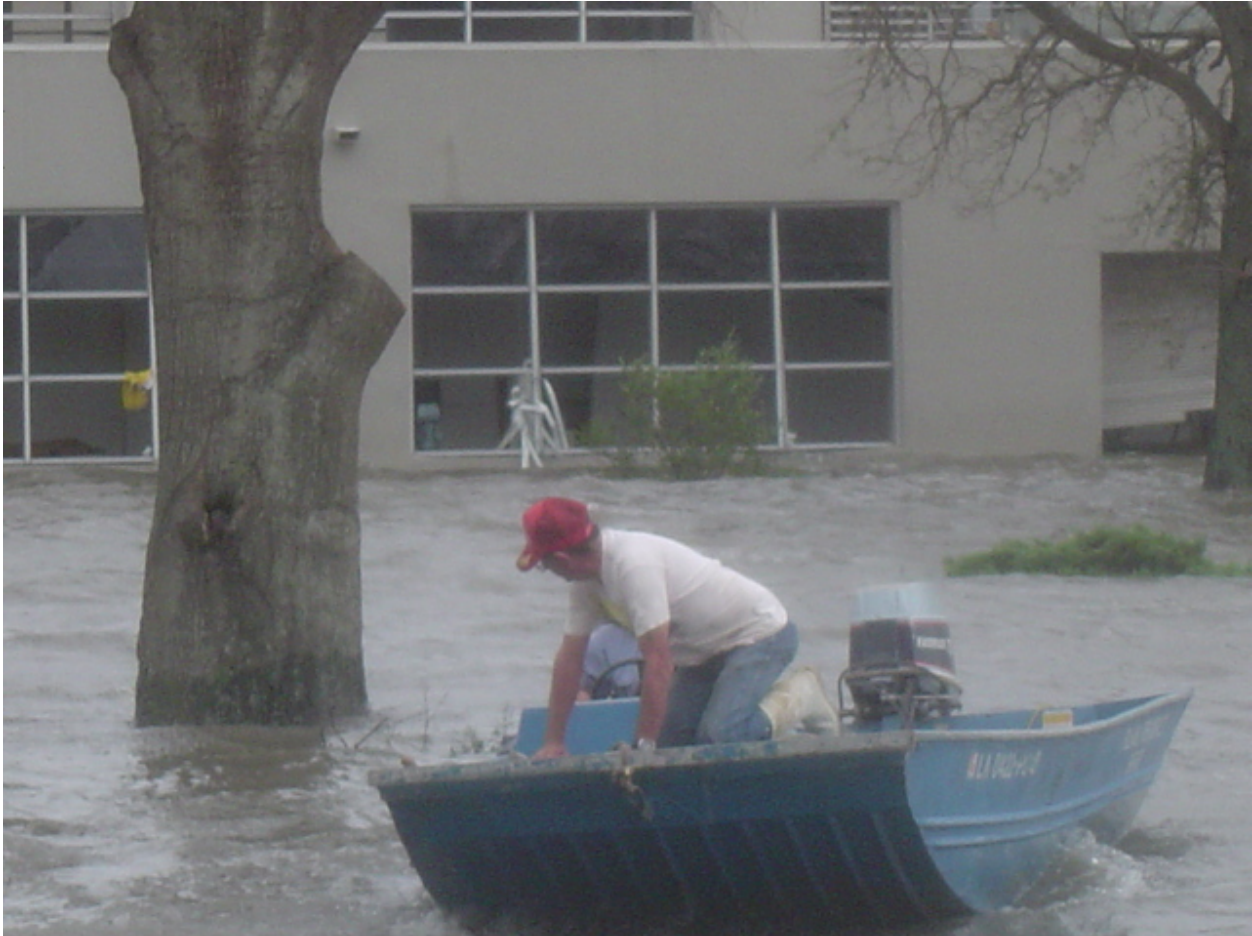
- s. Time = 5:14 PM, APH-20, elevation 7.3, Figure 1-52. Mark is below the windows on the building east of the terminal building. The mark to be surveyed was determined by scaling from the photograph the height of the window and the distance from the bottom of the lowest window to the water surface. The height of the window (2.5 ft) was measured at the airport and the ratio of the photograph measurements were used to position the mark which was 0.0 to 0.3 ft below the bottom of the window.

Figure 1-52. Time = 5:14 PM, APH-20. Below windows on building east of terminal building.

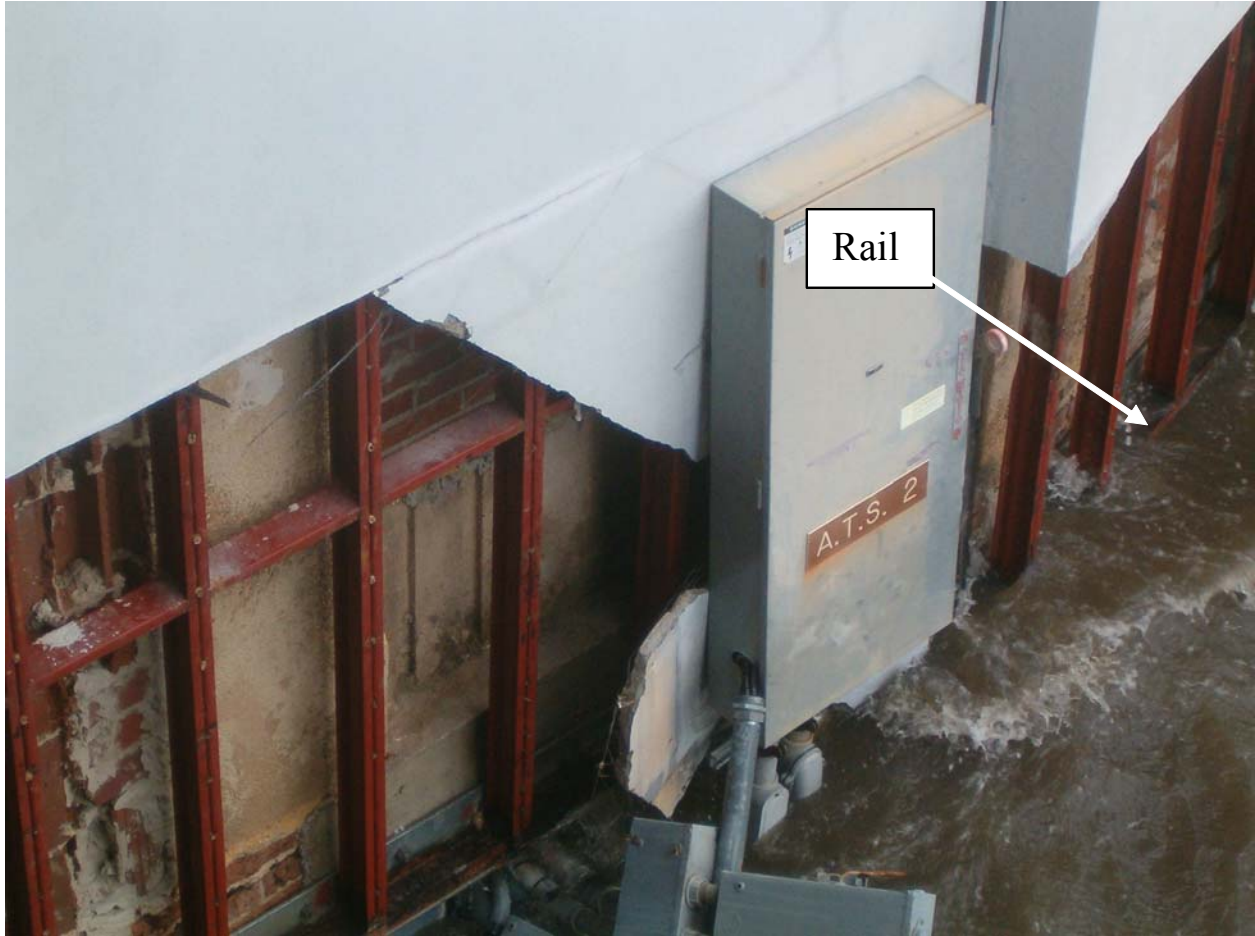
- t. Time = 5:30 PM, APH-11, elevation 7.4 ft, Figure 1-53. Located on north side of terminal building, west of lobby. Water level is at horizontal framework just to the west or right of the electrical panel box. Wave activity was low.

Figure 1-53. Time = 5:30 PM, APH-11. Bottom of horizontal rail to right of electrical panel box on north side of terminal building, east of lobby.

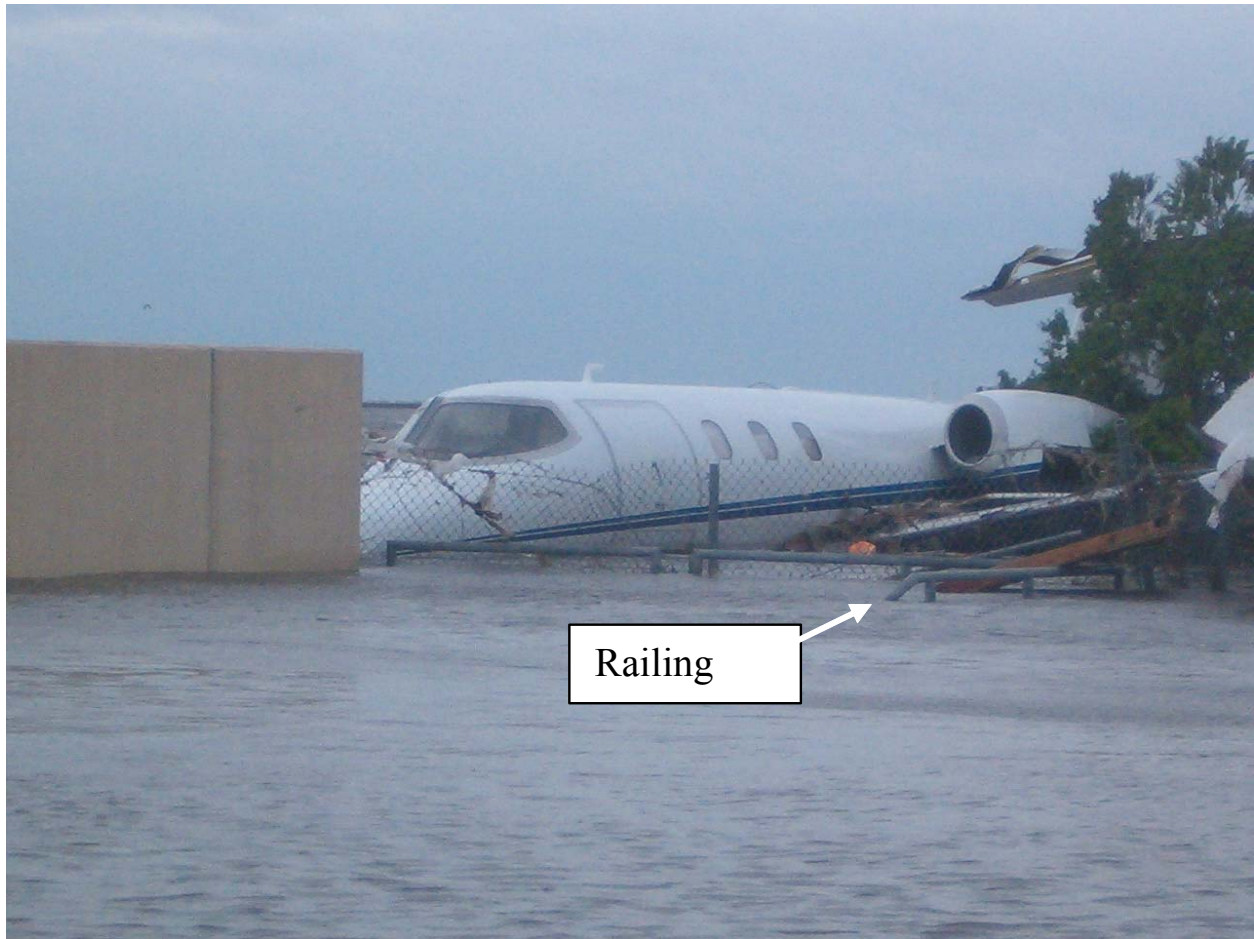
- u. Time = 6:30 PM, APH-14, elevation 7.0 ft, Figure 1-54. Located southwest of terminal building near floodwall opening. Mark to be surveyed was on sloping handrail that is below and slightly to the left of the jet engine. The absence of wave activity makes this a mark with little uncertainty.

Figure 1-54. Time = 6:30 PM, APH-14. On slanted railing just below jet engine.

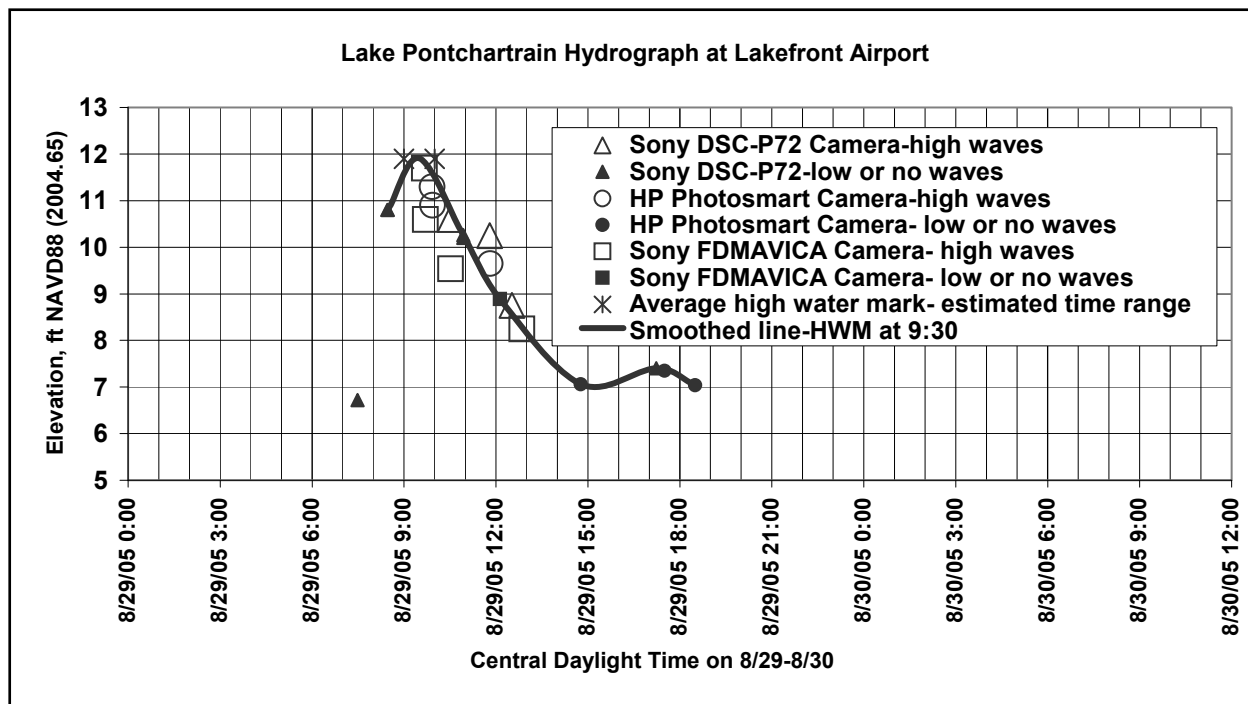
Figure 1-55. Constructed hydrograph at Lakefront Airport. Note that the point at 7:28 AM is not considered representative of Lake Pontchartrain because of relatively high topography around airport building (elevated runways) and is not included in the smoothed line of the hydrograph. The recession side may also have some of this effect but the lower rate of fall may reduce the impact.

**Hydrograph Plot.** The above data was used to construct a hydrograph as shown in Figure 1-55. Solid points are used to signify points with little or no wave effects. Larger open data points are used to signify points with significant uncertainty in elevation due to factors such as wave effects. Note that these open symbol points can be either high or low estimates of storm surge depending on the timing of the photograph relative to the wave crest or trough. The time of the high water mark in Figure 1-55 is based on extrapolating the digital photograph points along the recession of the storm surge up to a level of 11.9 ft while considering the 8:28 time of the two points at 10.8. The resulting time of peak storm surge is between 9:00 and 10:00. The smoothed line hydrograph is shown with a time of 9:30 AM on the plot. Due to the rapid rise of the storm surge and the presence of the runways and other high topographic features, the data at 7:28 AM should not be used in developing a hydrograph to represent levels in Lake Pontchartrain. The recession side of the hydrograph may have some effects of the high topography but the lower rate of fall may reduce these effects.

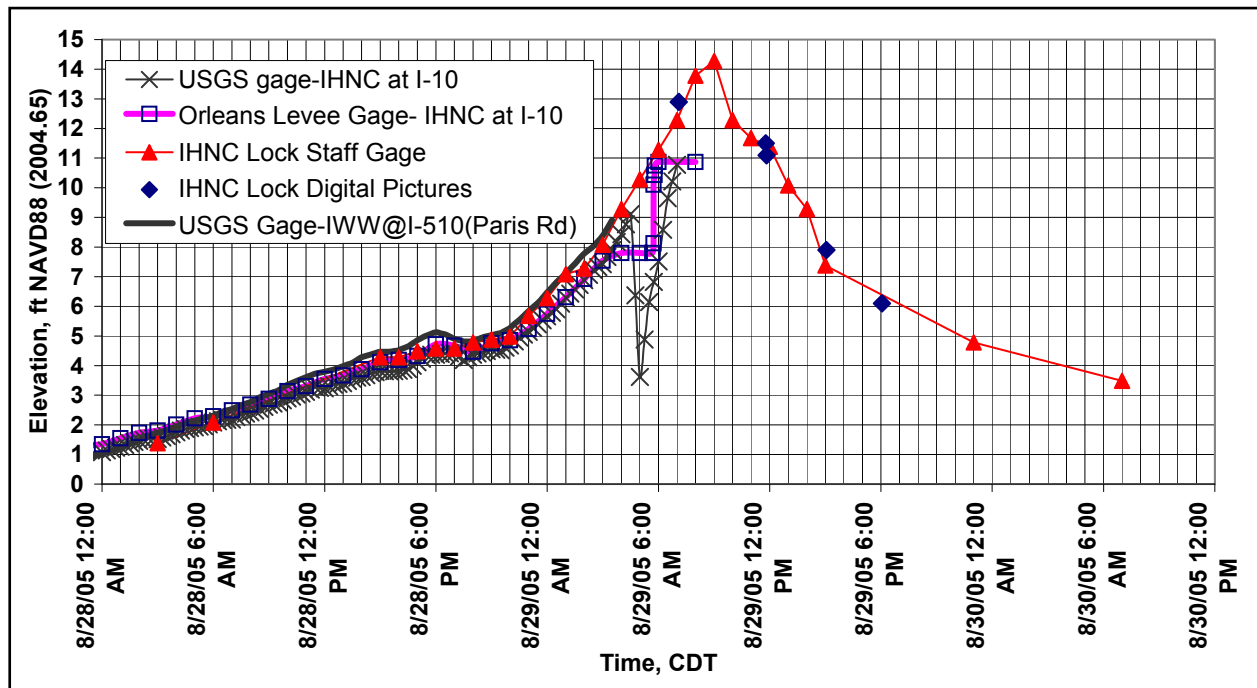
**Recorded Hydrographs at IHNC Lock.** Figure 1-56 shows a plot of data from two self-recording gages at I-10 on the IHNC, a self-recording gage at Paris Road (I-510) on the MRGO, staff gage readings at the IHNC Lock, and water levels derived from digital pictures taken at the IHNC Lock. Each source of data in Figure 1-56 is described in the following paragraphs.

Figure 1-56. Hydrographs on the IHNC.

As shown in Figure 1-56, the USGS gage at I-10 on the IHNC (1-65) experienced a 5 ft drop in stage at about 4:30 AM on August 29 when the stage was about 9.5 ft. At first, this drop was interpreted to mean that a breach on the IHNC occurred at this time but most people doubted that the water level dropped 5 ft. Figure 1-64 shows that the white PVC pipe holding the USGS gage has a top elevation of about 9 ft on the staff gage. The larger PVC pipe is the OLD gage. The electronic cable holding the USGS pressure transducer inside the PVC pipe is exposed above the top of the pipe. One possible explanation of the 5 ft drop is that the high velocities through the railroad/I-10 bridge opening, along with debris, snagged the cable and pulled the transducer up out of the pipe giving it an apparent drop in water level. The OLD gage is a float gage and experienced identical 7.8 ft readings at 4:00 AM, 5:00 AM, and 5:40 AM followed by a rapid rise in 8 minutes to about 10.9 ft. The 10.9 ft reading is in agreement with the IHNC Lock readings. The constant readings followed by the rapid rise is consistent with a float gage that became stuck. Whether the OLD gage got stuck or the level readings indicate the time of a breach is unknown. Because the OLD and USGS gages are within 10 ft of each other, the difference in water levels after about 4:30 raises concerns about readings on both gages.

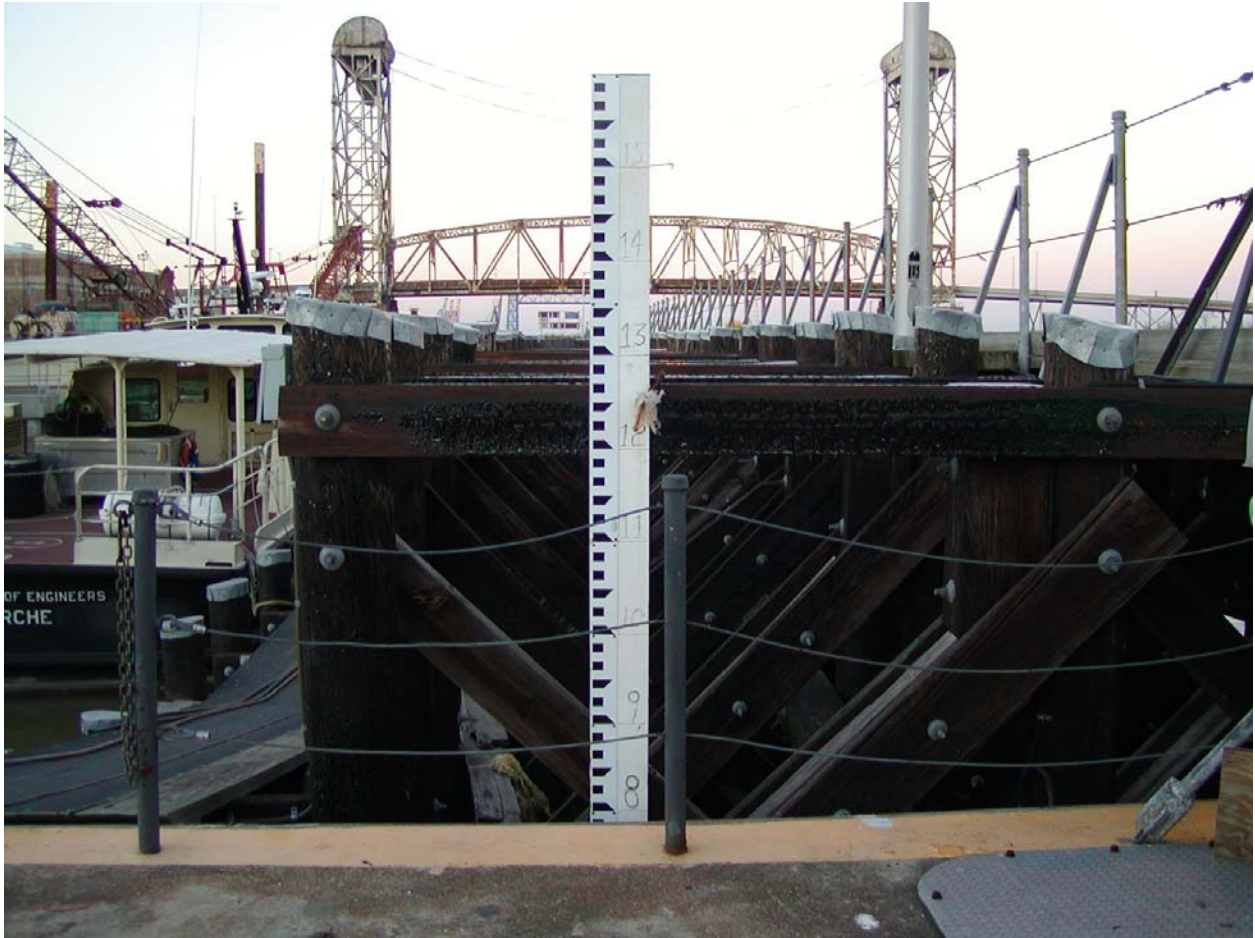
Figure 1-57. Staff gage at IHNC lock. Numbers were far more visible when the lock was visited in October 2005. Picture looking north.

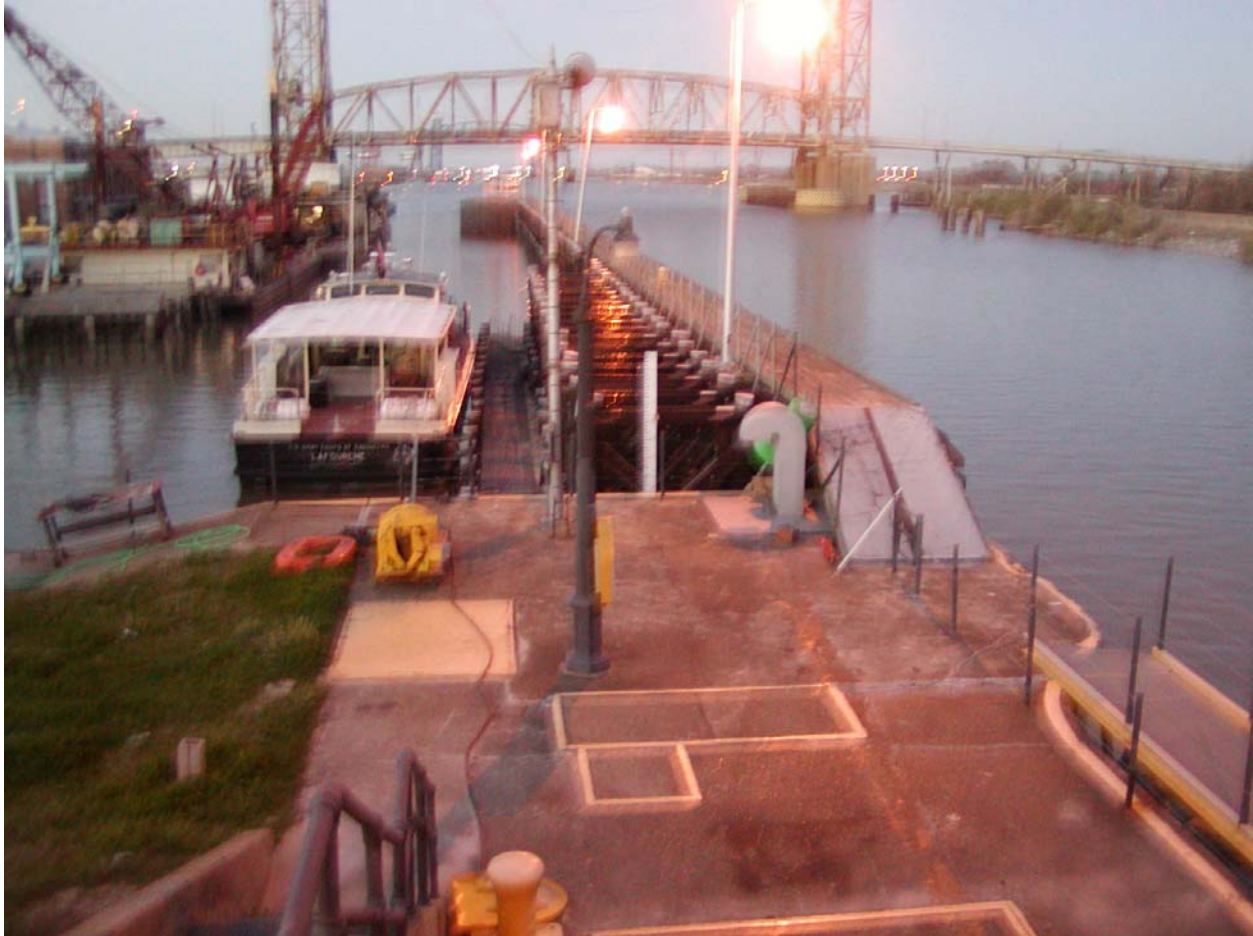
Figure 1-58. Staff gage from viewing location during storm. Picture looking north. Claiborne Avenue bridge in the background.

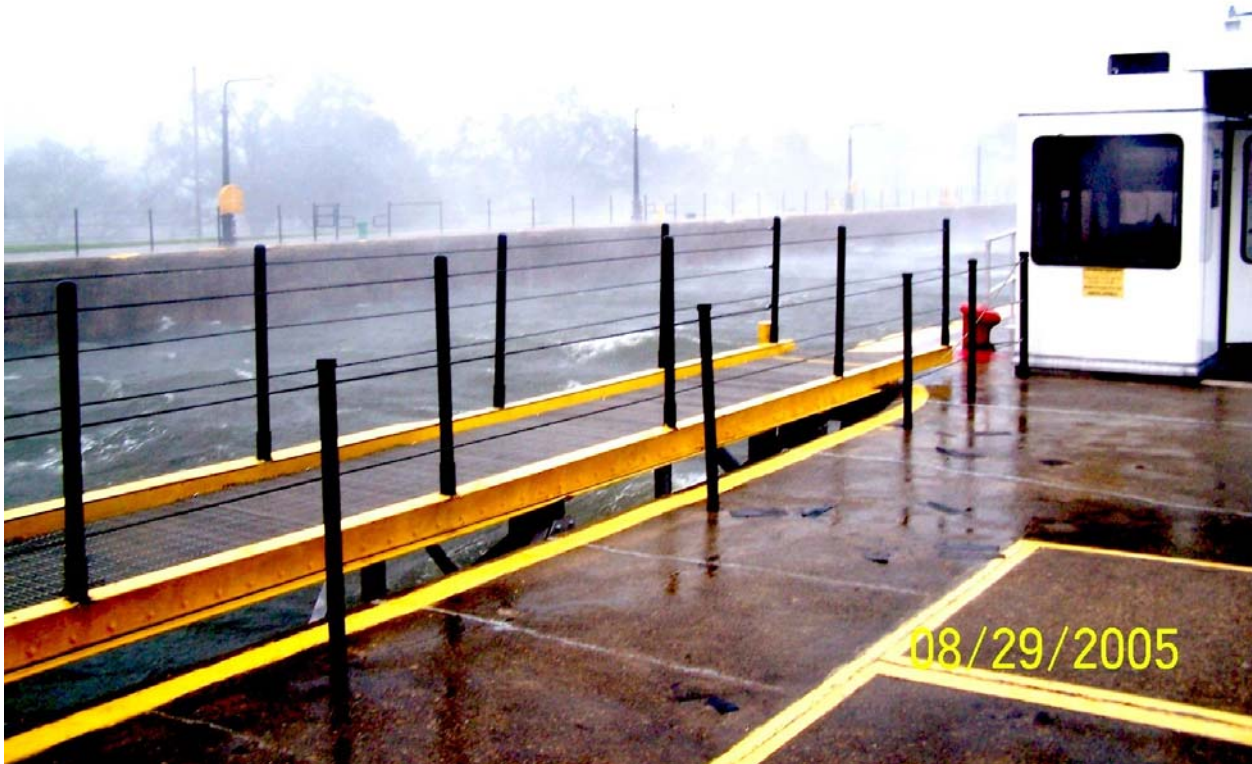
- a. File time 7:06 AM, Picture 100\_0498, Figure 1-59, looking southeast. Water level was based on distance below top of lockwall on east side of lock. Top of lockwall surveyed at 19.9 ft. Used height of post (3.55 ft) and height of top of yellow box (5.56 ft) to scale down to water surface at 4 points along wall. Distances below top of wall were 6.6 ft, 7.8 ft, 7.1 ft, and 6.5 ft for an average distance of 7.0 ft and a water level of 12.9 ft. The range of water level of 1.3 ft provides some information about wave height along the wall.

Figure 1-59. Time 7:06, file 100\_0498. Picture brightness and contrast adjusted to show water level. Looking southeast.

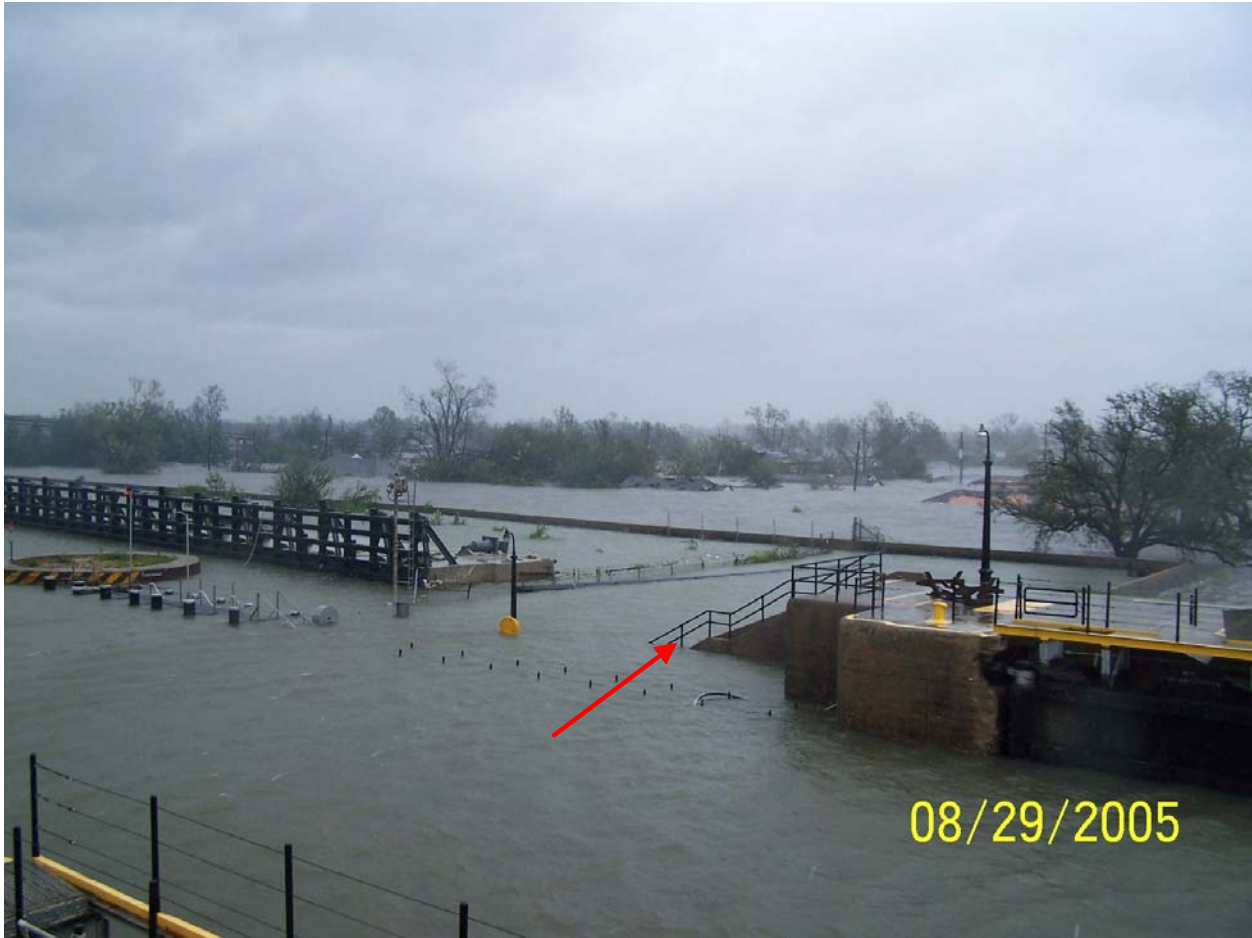
- b.* File time 11:47 AM, Picture 100\_0502, Figure 1-60, looking east-northeast into Lower Ninth Ward. Water level at location of sloping handrail. Elevation = 11.5 ft.

Figure 1-60. Time 11:47, picture 100\_0502. Red arrow shows location surveyed. Looking east-northeast into Lower Ninth Ward.

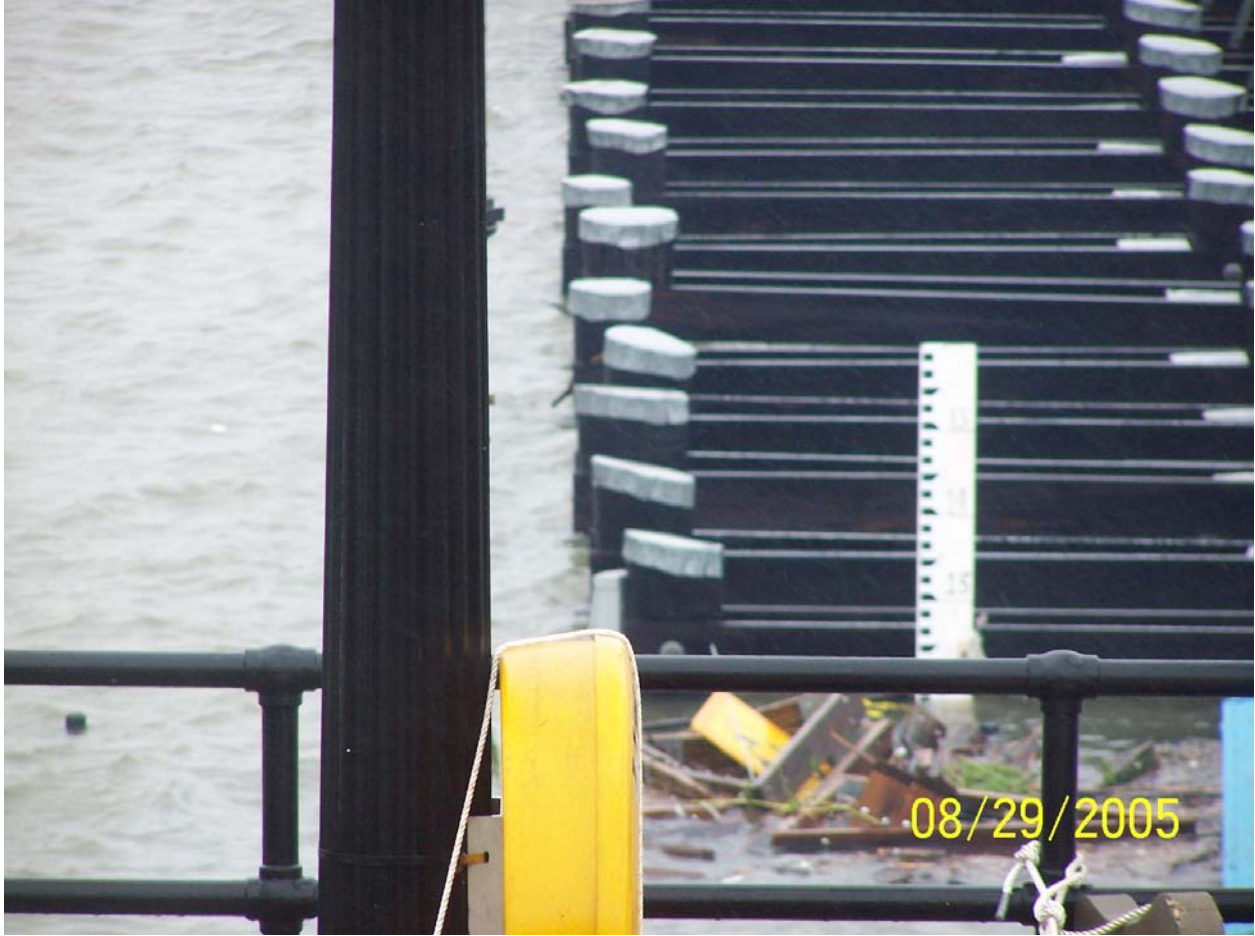
- c.* File time 11:50 AM, picture 100\_0507, Figure 1-61, looking north. Shows staff gage where water level is almost hidden by handrail. Using other objects in the picture such as tops of handrails, the staff gage reading is 11.8 ft, that is an elevation of 11.1 ft.

Figure 1-61. Time 11:50, picture 100\_0507, looking north.

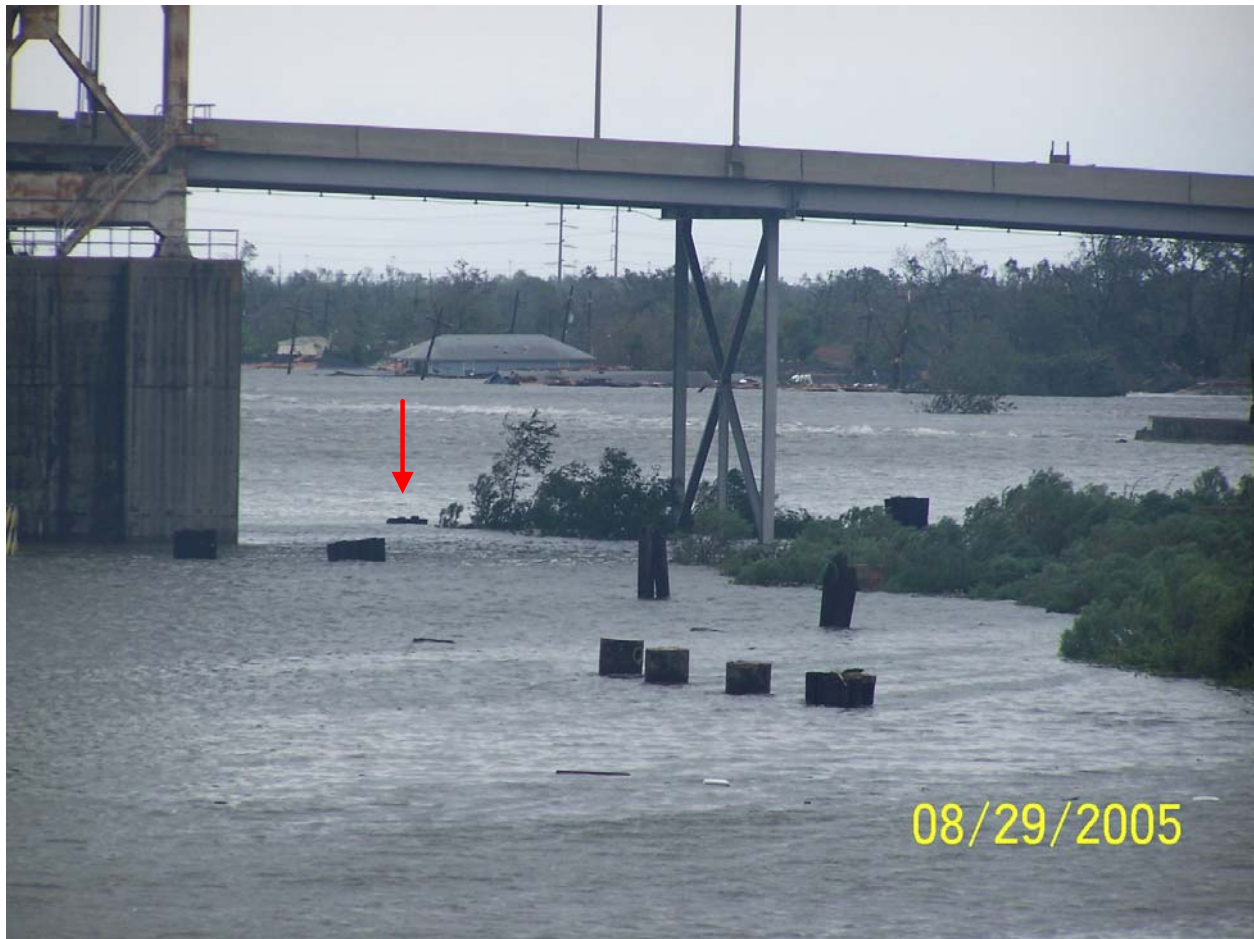
- d.* File time 3:03 PM, Picture 100\_0508, Figure 1-62, looking northeast into Lower Ninth Ward. Top of highest pile in cluster under arrow is at elevation 8.7 ft. Based on width of pile cluster of 4.8 ft, water level is 0.8 ft below top of highest pile for an elevation of 7.9 ft.

Figure 1-62. Time 3:03 PM, picture 100\_0508. Breach on east side of IHNC in background. Looking northeast into Lower Ninth Ward.

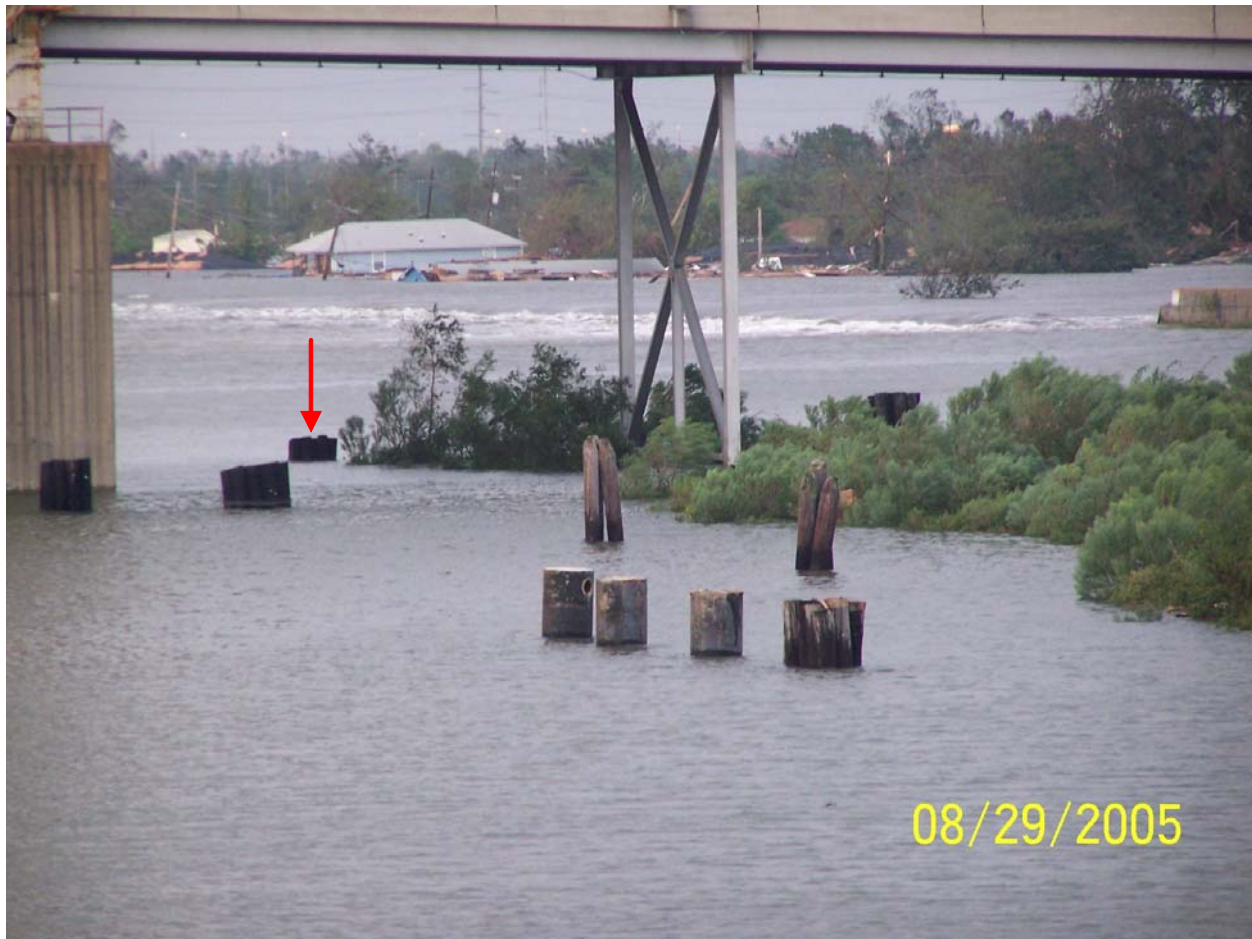
- e.* File time 6:03 PM, Picture 100\_0509, Figure 1-63, looking northeast into Lower Ninth Ward. Top of highest pile in cluster under arrow is at elevation 8.7 ft. Based on width of pile cluster of 4.8 ft, water level is 2.6 ft below top of highest pile for an elevation of 6.1 ft.

Figure 1-63. Time 6:03 PM, file 100\_0509. Breach on east side of IHNC in background. Looking northeast into Lower Ninth Ward.

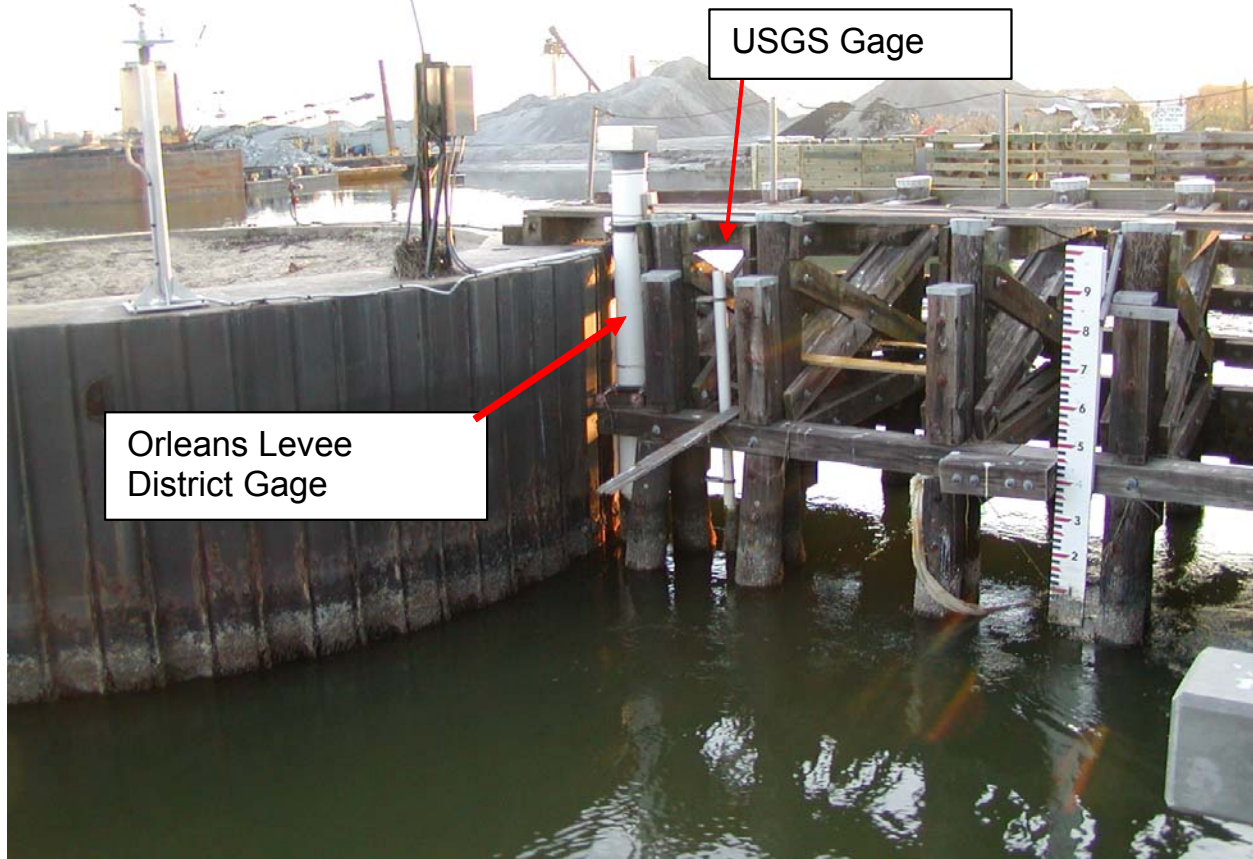
Figure 1-64. USGS and Orleans Levee District gages on east side of IHNC and south of railroad bridge at I-10. Picture looking southwest.

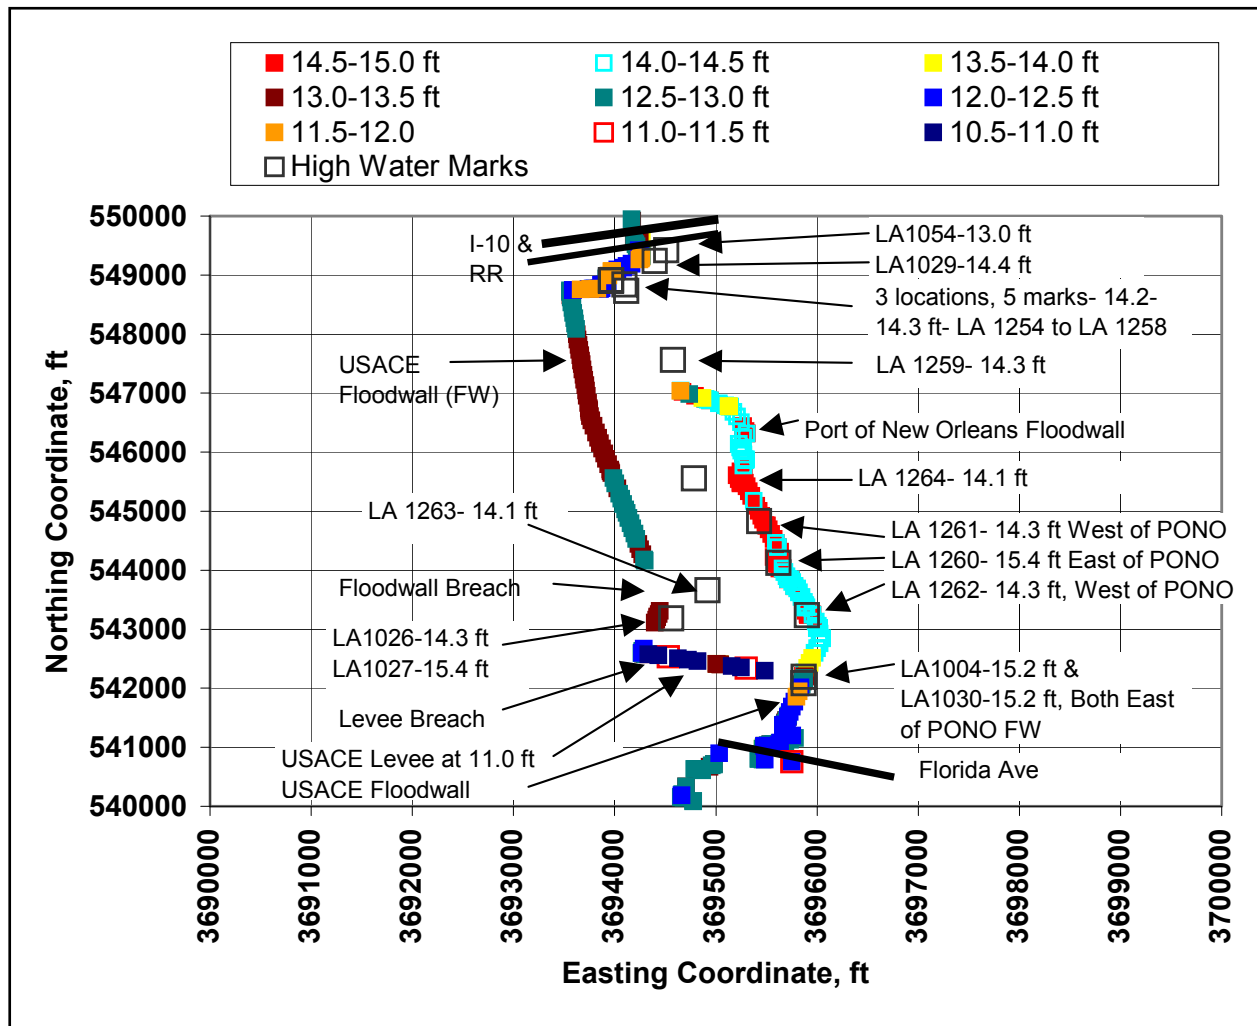
Figure 1-66. Floodwall layout, wall elevations, and high water marks along the west side of IHNC, I-10 to Florida Avenue railroad bridge.

One location west of the PONO floodwall has a single high water mark (LA 1027) that does not agree with the other high water mark data (See Figure 1-66). Mark LA 1027 is also shown on Figure 1-70 at latitude 29.987. Mark LA 1027 at elevation 15.4 ft is located in the same building as LA1026 at elevation 14.3 ft. Neither mark is a well-defined seed/debris line as are the other

marks in this area. Both marks are based on debris in the rafters of a heavily damaged building that is close to the floodwall and levee breach on the west side of the IHNC. Both LA 1026 and LA 1027 were described as possibly low. Subsequent visits to this building by other IPET members has not resolved the peak water level in this building. The agreement of LA 1026 at elevation 14.3 ft with 4 other marks west of the PONO is the reason LA 1027 is not accepted.

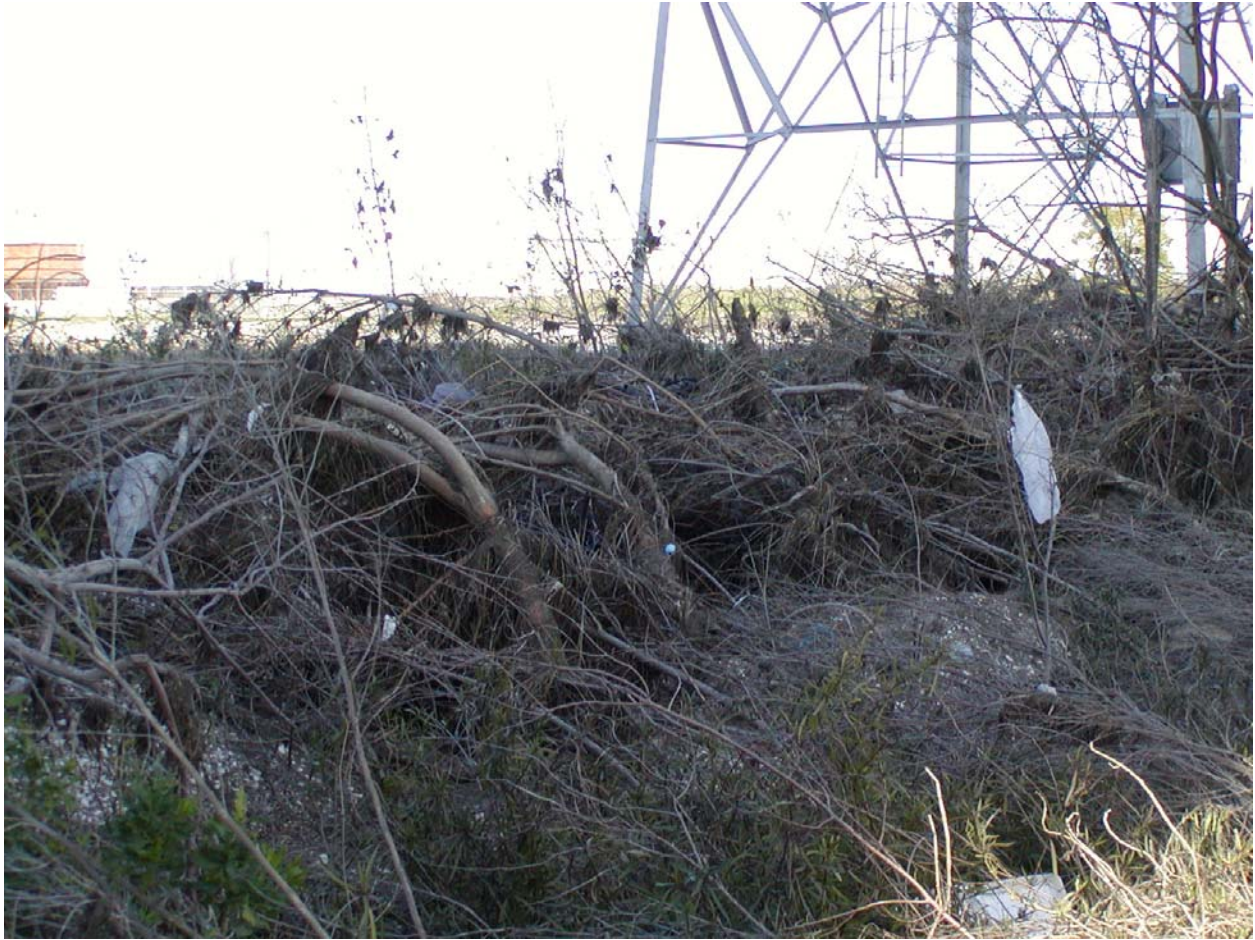
Figure 1-68. Vegetation at I-10 laid down in a northerly direction by flow in IHNC.

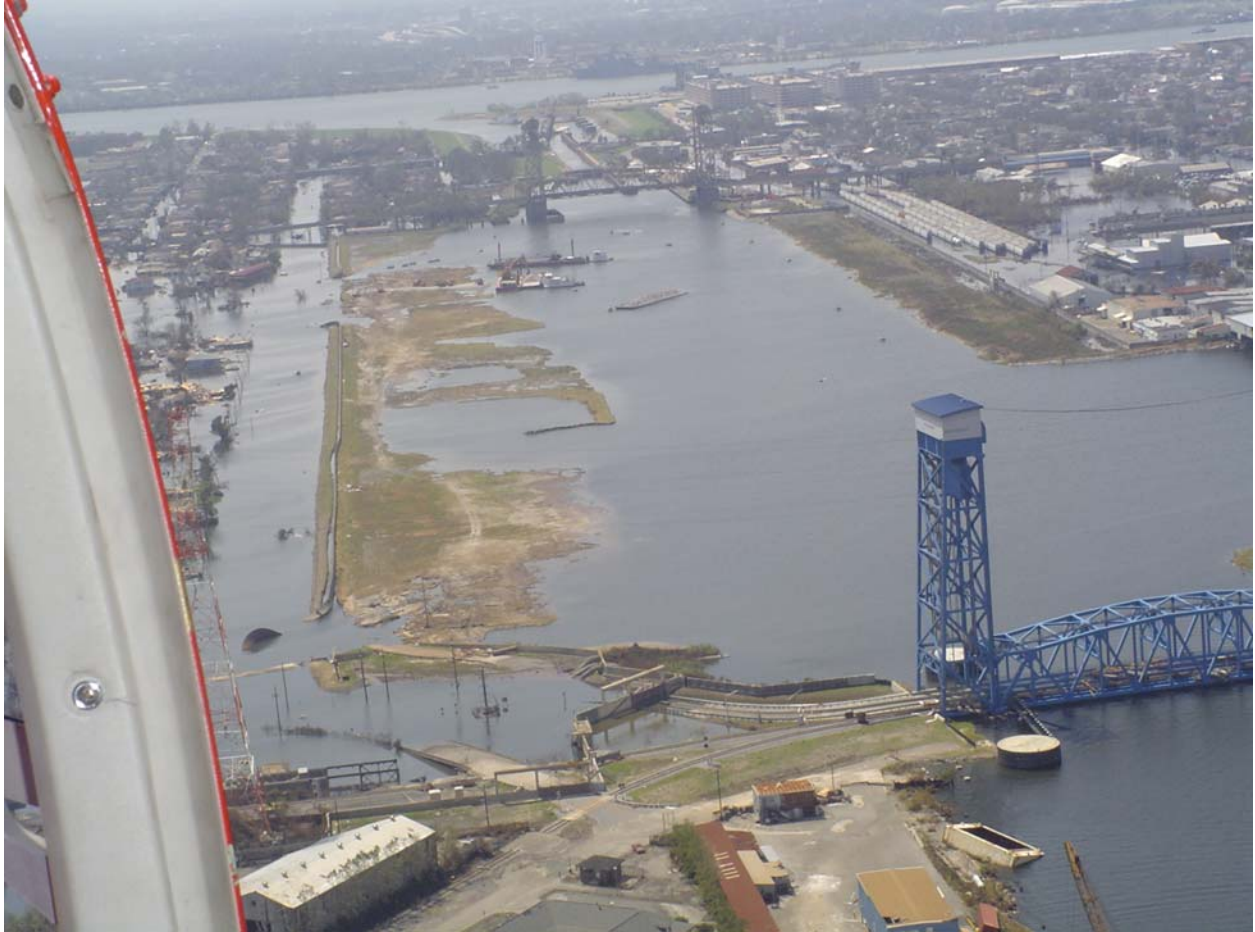
during the storm. Figure 1-69 shows the Florida Avenue Railroad bridge (blue bridge in foreground) in the down position on 7 Sept 05.

Figure 1-69. Florida Avenue railroad bridge (blue), two breaches on east side of IHNC into Lower 9<sup>th</sup> Ward, and IHNC lock at top of picture. Picture looking south-southwest. Note debris on railroad bridge.

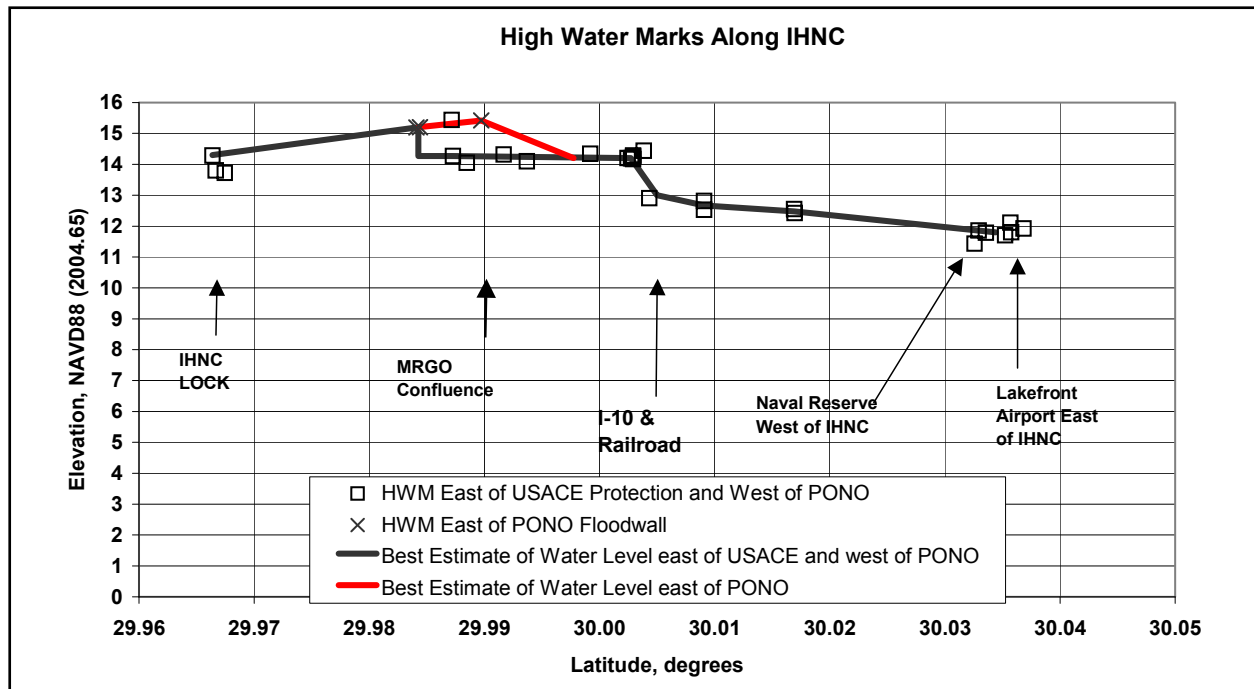
Figure 1-70 shows the variation of peak water level along the IHNC based on high water marks. Note that the area west of the PONO that experienced a levee and floodwall breaches is shown to have experienced a peak water level of about 14.2 to 14.3 ft. On the east side of the PONO, peak water levels were up to 15.4 ft at the junction of the MRGO. The difference in peak water level across the PONO floodwall is likely due to (1) the 1600 ft long east-west earth levee on the west side of the PONO that was at an elevation of about 11.0 ft and (2) USACE floodwall overtopping all along the reach west of the PONO.

Figure 1-70. Variation of peak water level along IHNC based on high water marks. Red line is Port of New Orleans (PONO) Floodwall that is not complete and is not tied in to the USACE protection on the north end.

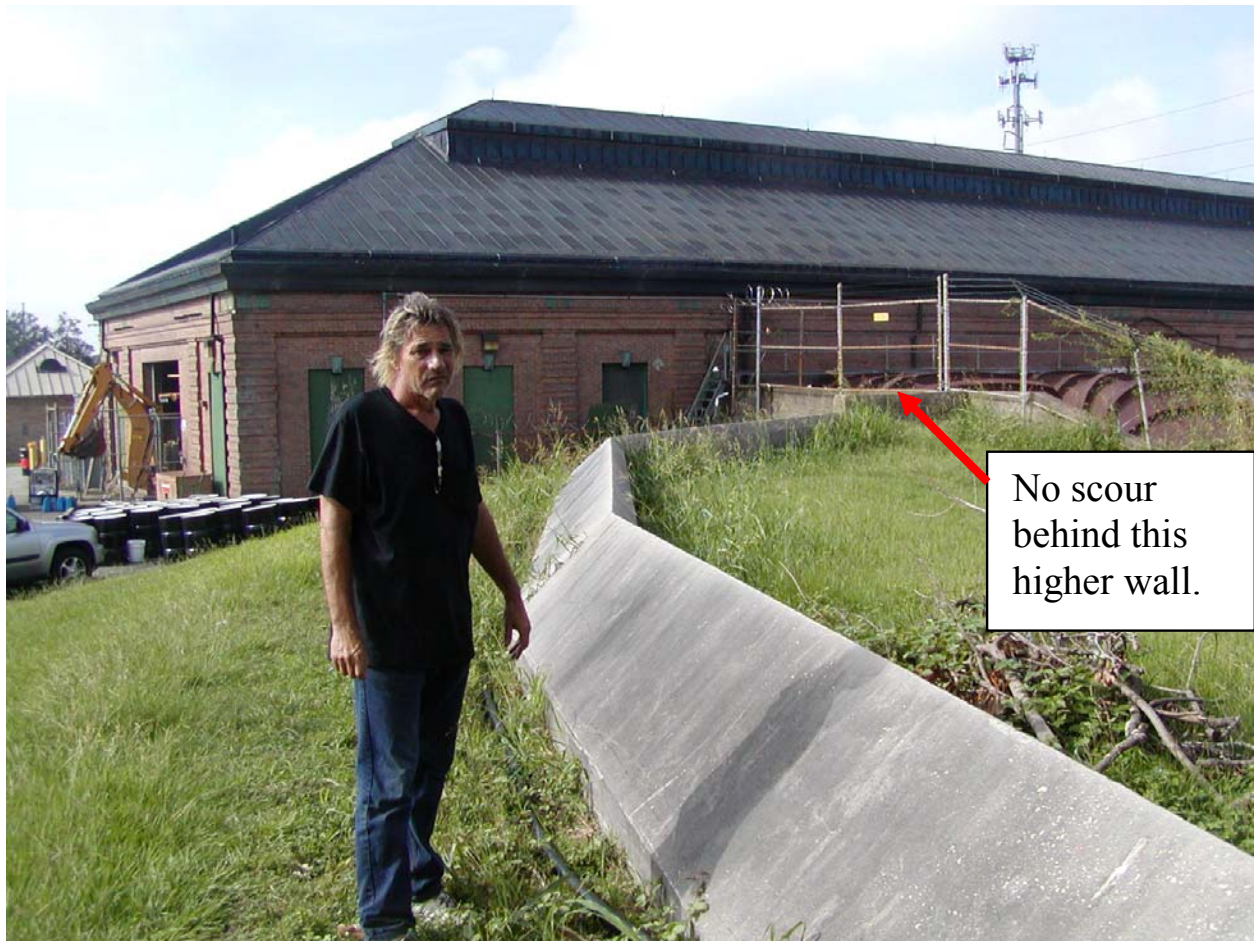
Figure 1-71. Low pump station wall at Orleans Avenue Pump station OP#7.
