# Appendix 1

## Hydrograph and High Water Mark Analysis

### Introduction

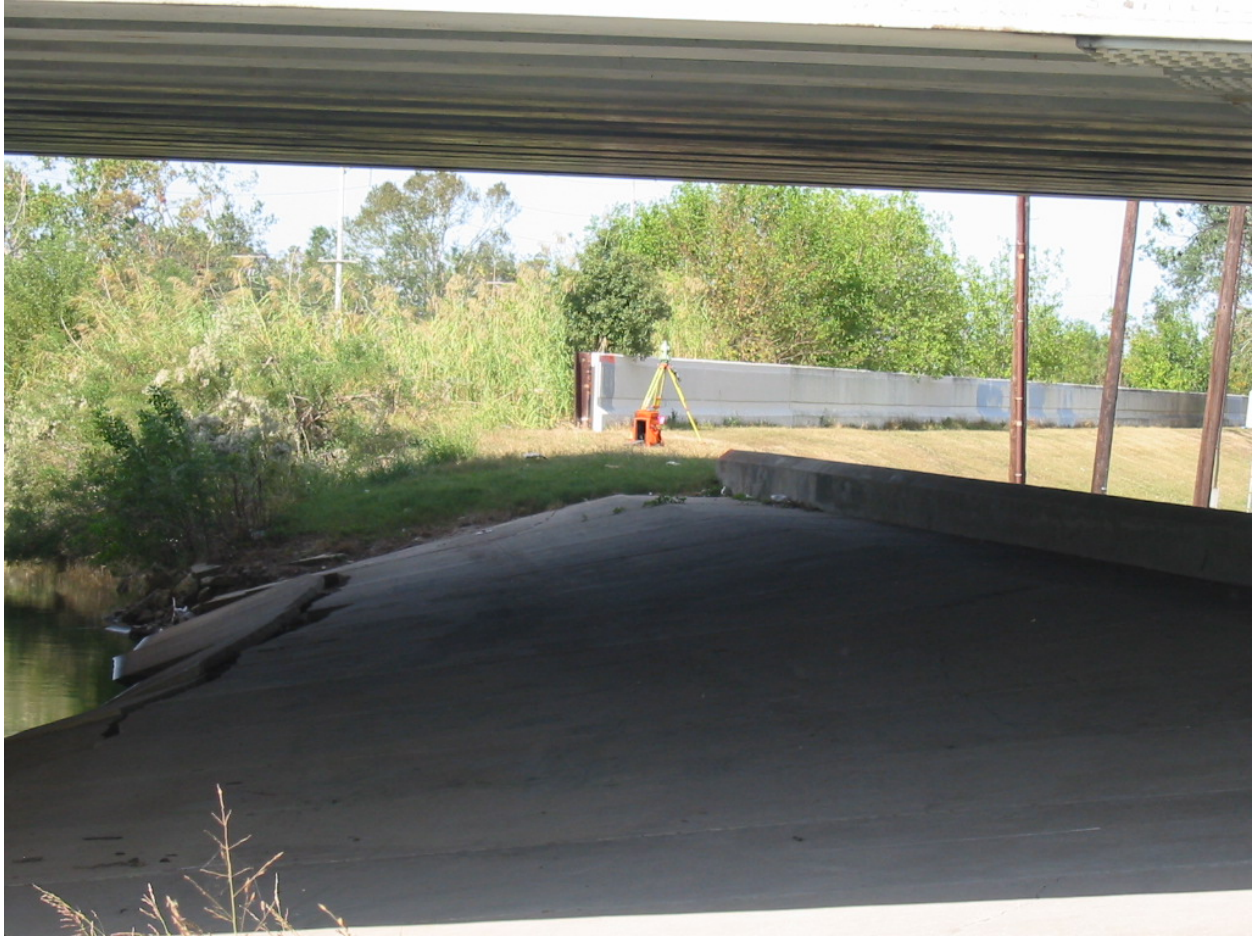
Figure 1-72. Low wall, earth levee, and floodwall in background on east side of Orleans Avenue Canal just north of pump station. Looking northwest.

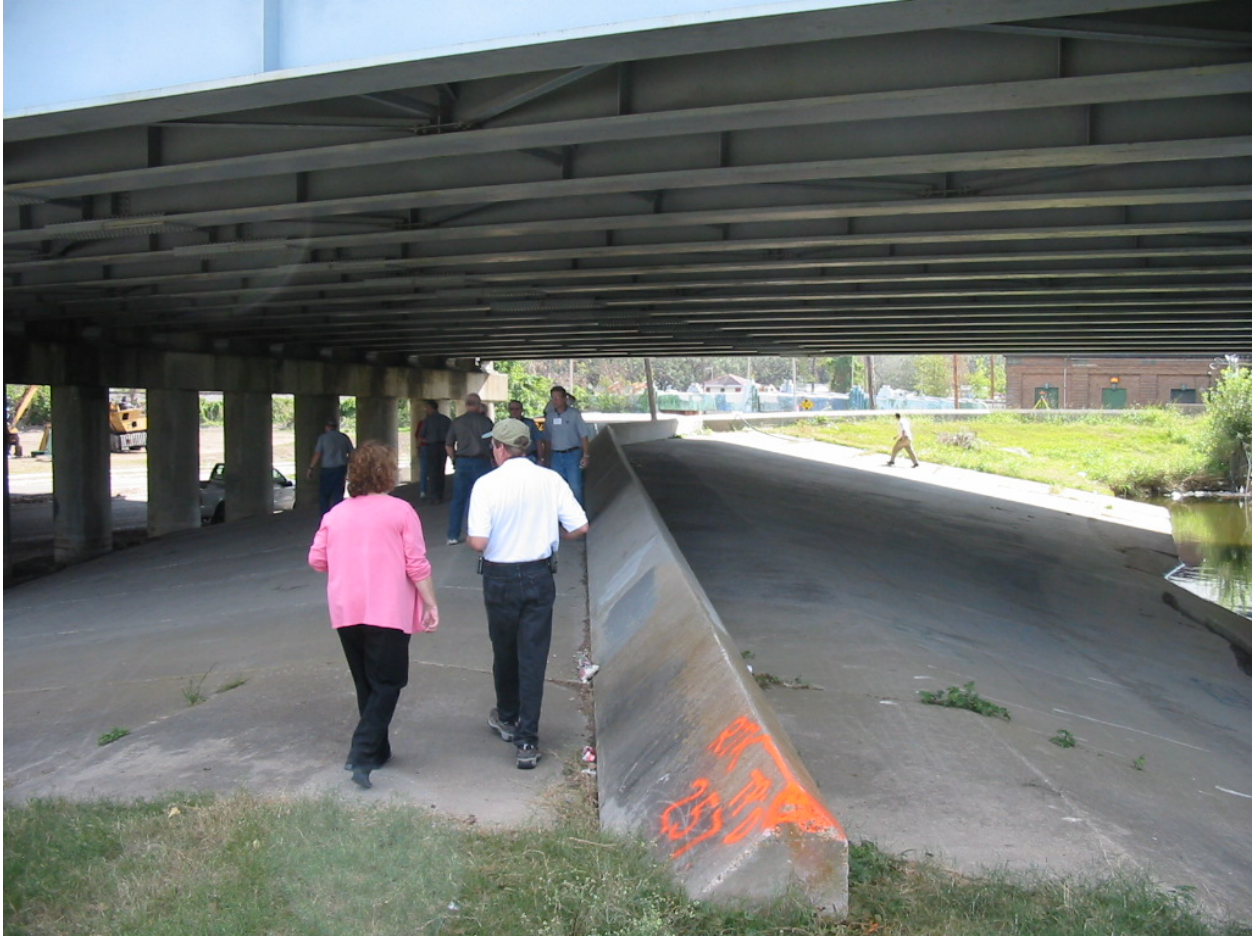
Figure 1-73. Low wall that connects to OP#7 at Orleans Avenue Canal looking south-southeast standing on earth levee.

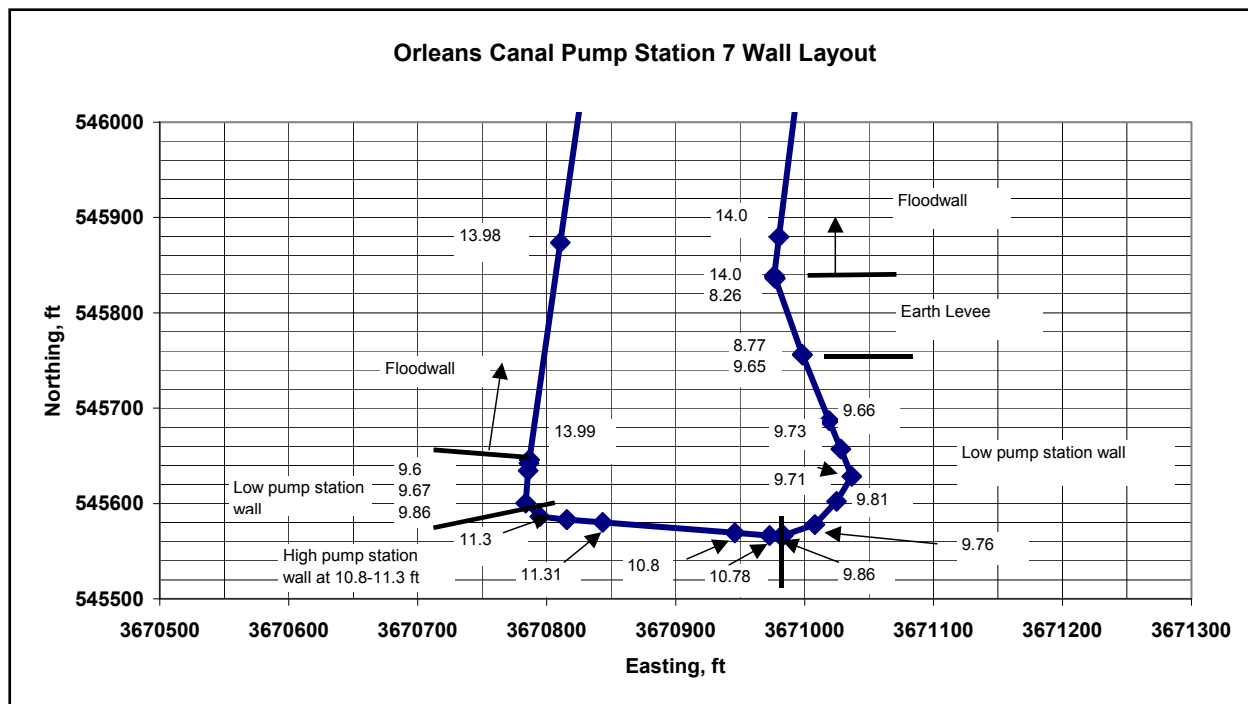
Figure 1-74. Floodwall, levee, and pump station wall elevations at OP#7.

The only high water mark at the pump station was debris around the south end of the east floodwall. The mark LA 1052 at 9.5 ft is a poor mark and represents a minimum level of the peak water.

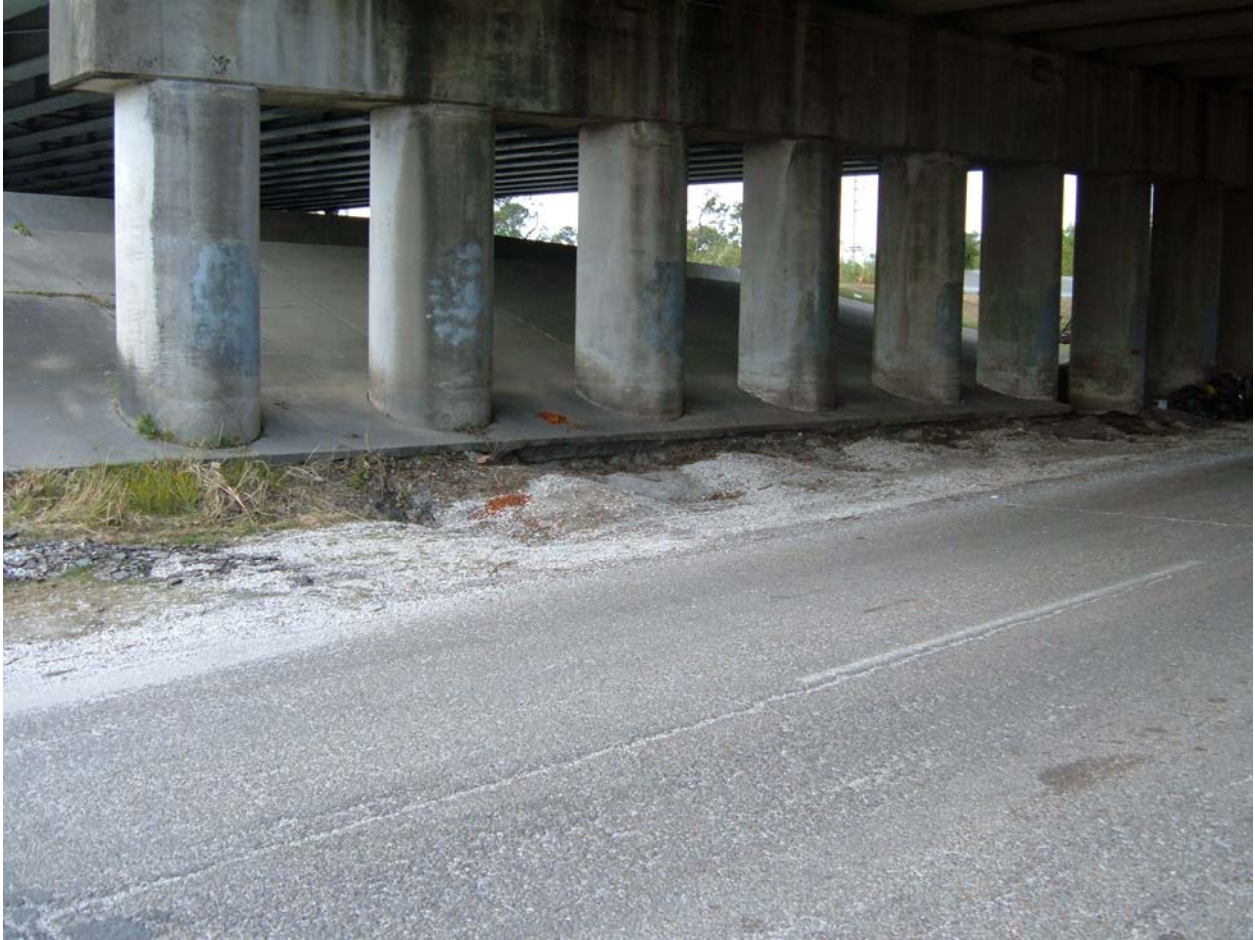
Another operator on another visit to OP#7 stated that the wall did not overtop. Water levels in Lake Pontchartrain, scour, and limited high water marks near the pump station show the wall did overtop. Although not easily seen in Figure 1-71, minor scour occurred below the low wall on the east side of the station. Note the rise of about 1 ft in the low wall in Figure 1-71 behind the individual in the picture. The walls adjacent to the low wall that are at elevation 10.8 ft on the east side and elevation 11.3 ft on the west side had no evidence of scour on the protected side of the wall supporting the first operator's account of the maximum amount of flow over the wall being about 1 ft. Figure 1-75 shows scour between the columns that could only have come from flow down the concrete slope that is adjacent to the low wall on the east side of the channel. Figure 1-76 shows scour around a power pole below the earth levee on east side of Orleans Ave Canal. Figure 1-77 shows scour below the concrete apron that is below the low wall on the east side of the canal. Figure 1-78 shows greater scour behind the low wall on the west side of Orleans Canal. Note that the west low pump station wall has a larger fall to the ground that is important in determining the amount of scour. Figure 1-79 shows where the west low wall ties into the higher pump station wall. Based on debris trapped in the vegetation, flow overtopped this wall by about 6" that supports the pump station operator's lower estimate of 6-12" of flow over the wall.

Figure 1-75. Scour between columns below low pump station wall at OP#7. Low wall is at top of slope behind concrete columns.

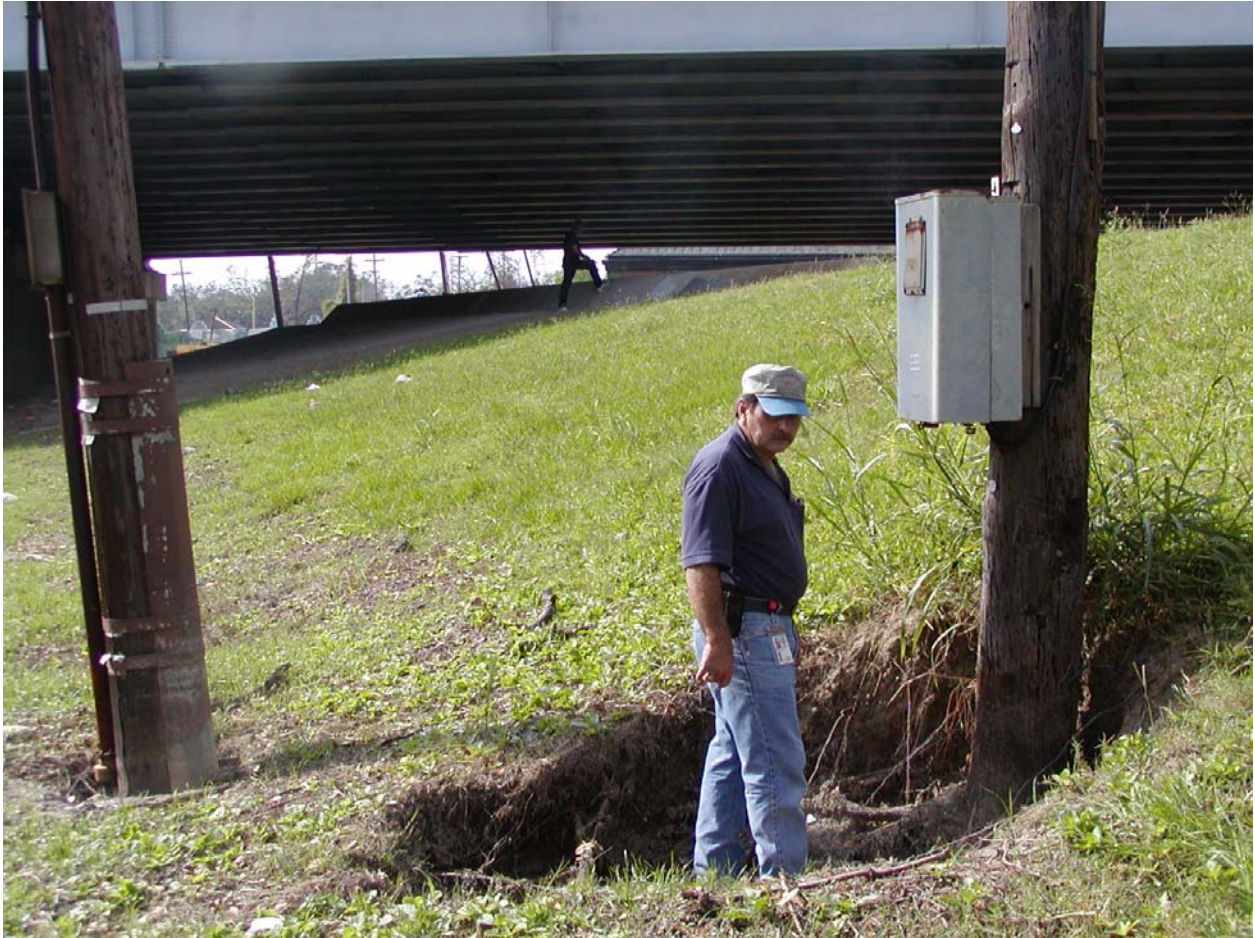
Figure 1-76. Scour around power pole below earth levee on east side of Orleans Ave Canal.

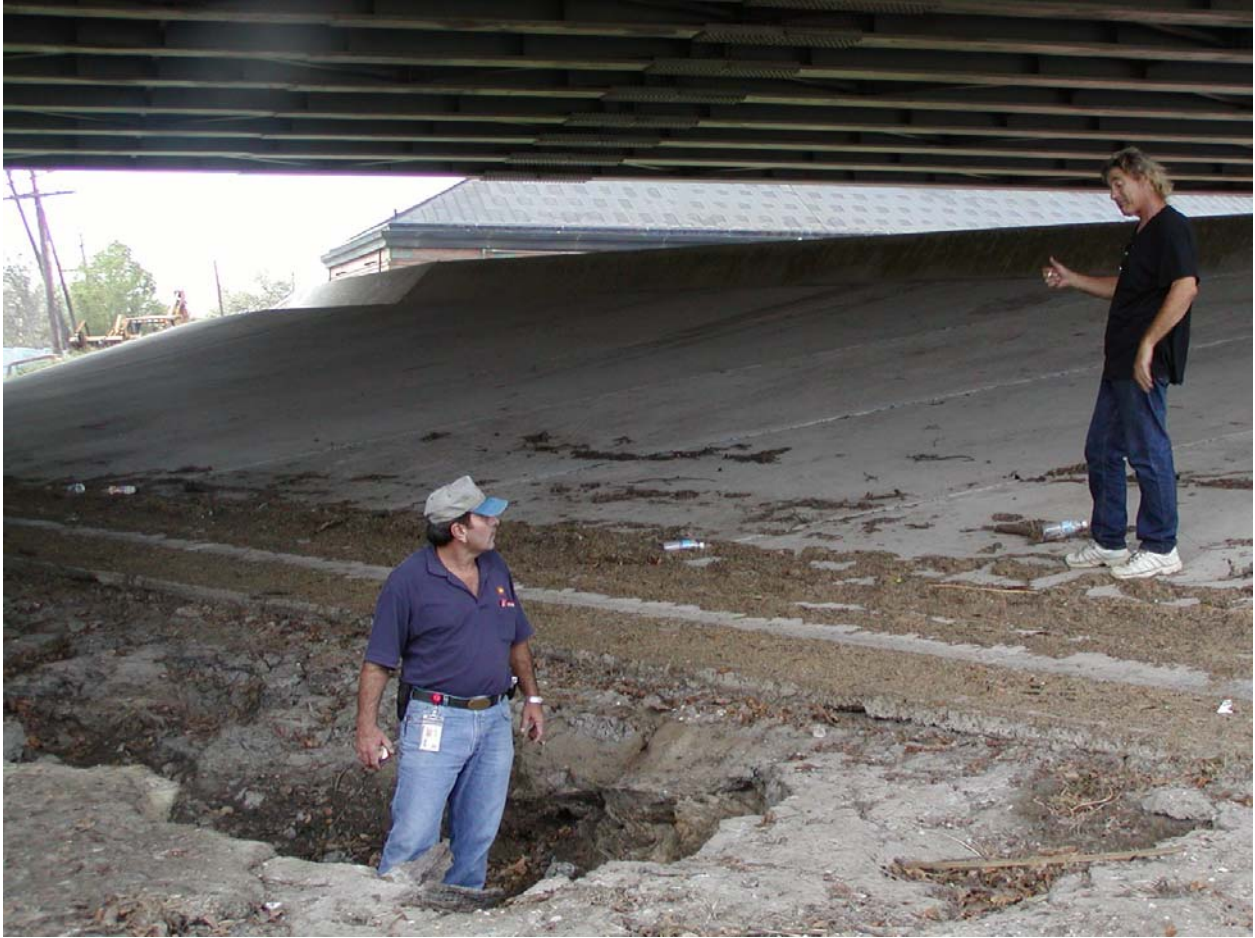
Figure 1-77. Scour below concrete apron that is below low pump station wall on east side of Orleans Ave Canal.

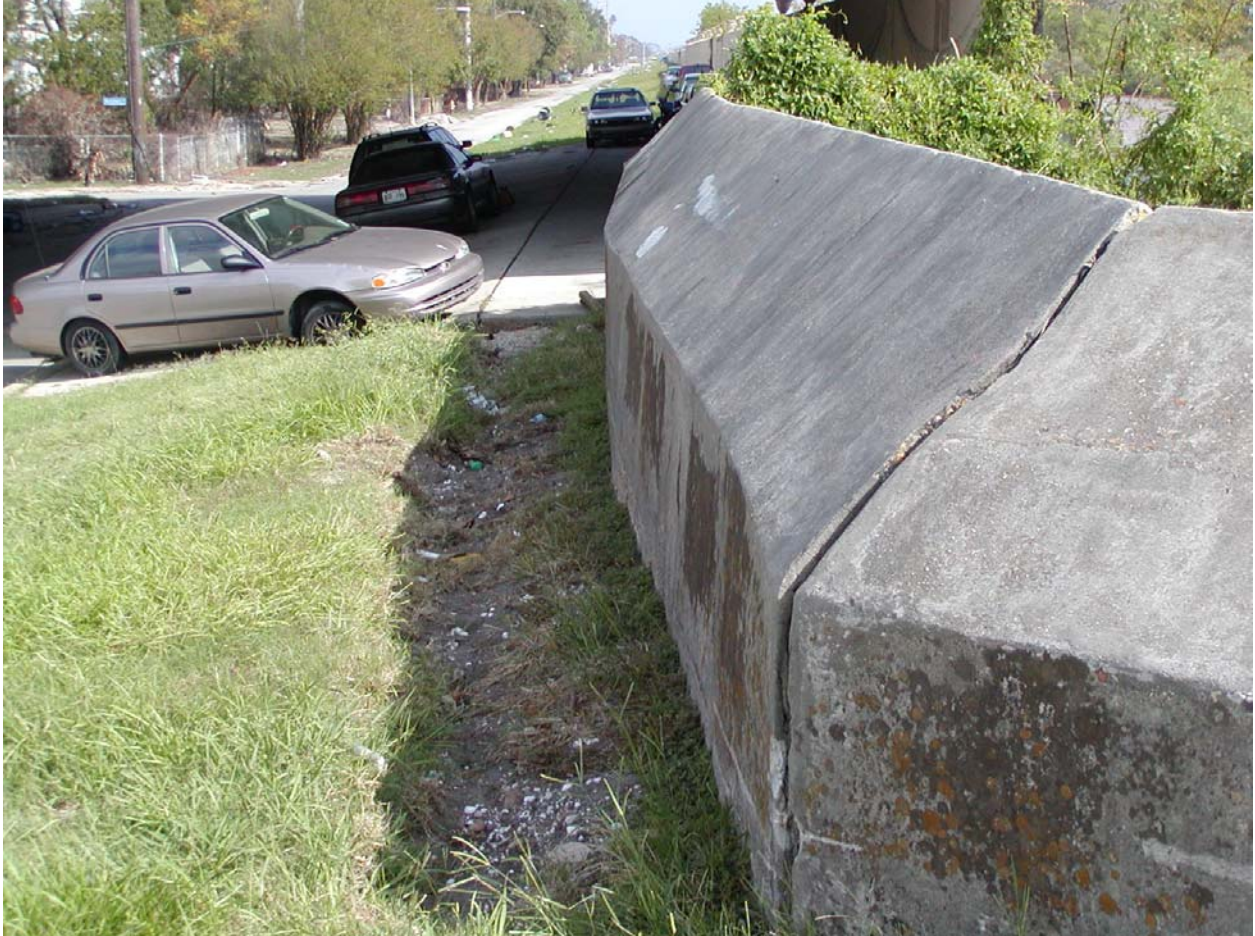
Figure 1-78. Scour below OP#7 low pump station wall on west side. Note that fall distance and scour is greater on this side than on the east side. Note floodwall in background that is about 4.3 ft higher.

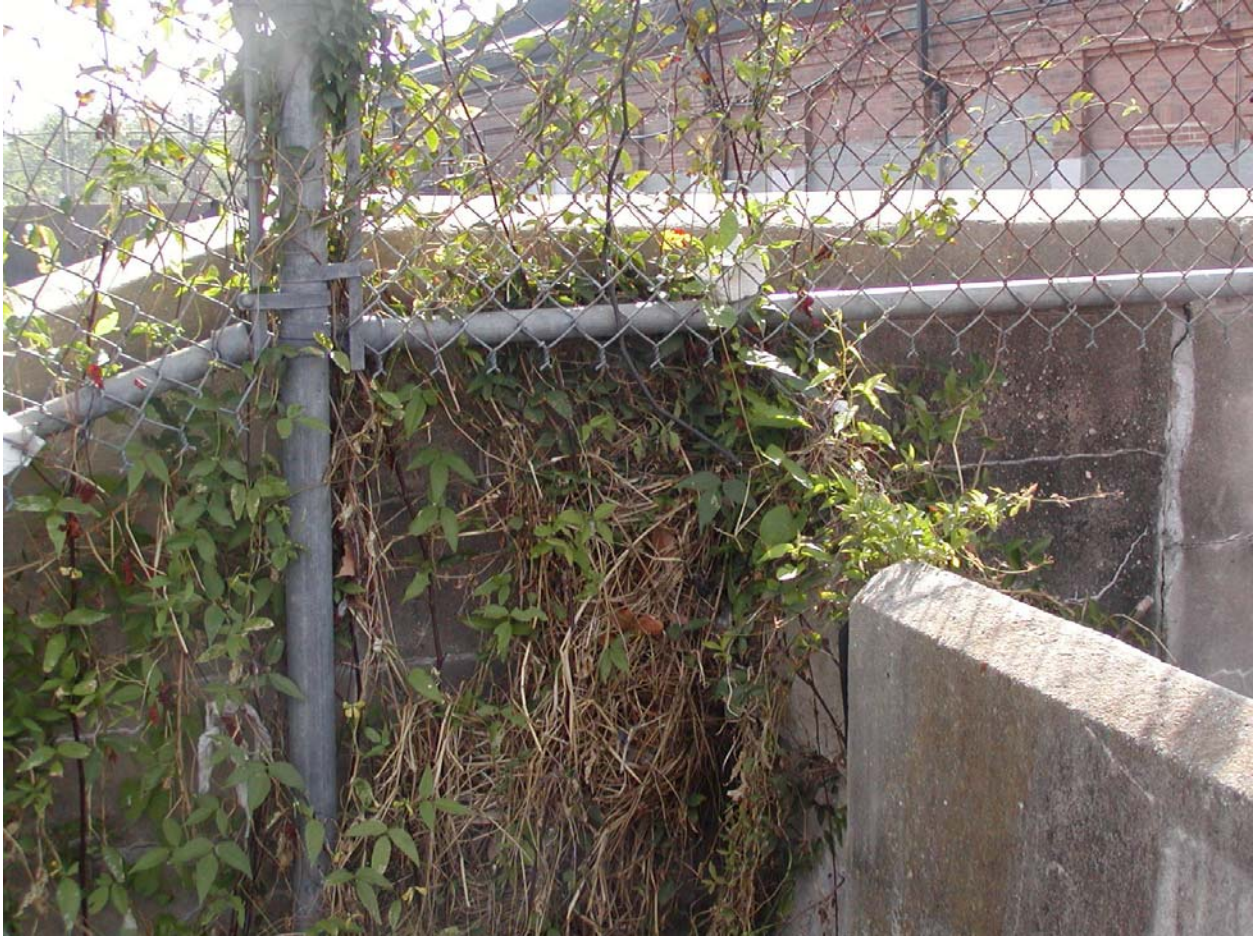
Figure 1-79. Debris caught in vegetation showing flow over low wall at OP#7. About 6" above low wall on west side.

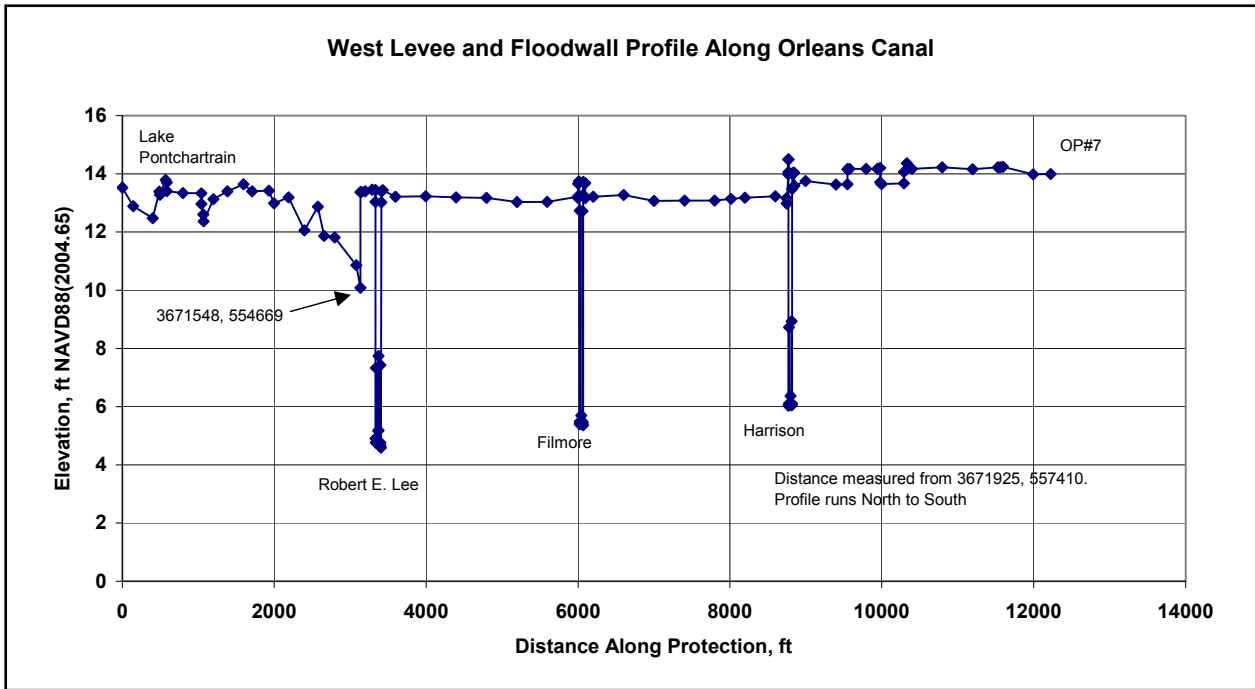
Figures 1-80 and 1-81 show wall profiles along the west and east sides of Orleans Avenue Canal, respectively. The low levee elevation on the west side of the canal just north of Robert E. Lee bridge suggest that water may have flowed over the levee at this location since the peak water levels were about 11.0 ft.

Figure 1-80. West Levee and Floodwall Profile for Orleans Avenue Canal. Note that low areas at bridges and pump stations are floodgate openings that were closed during the storm.

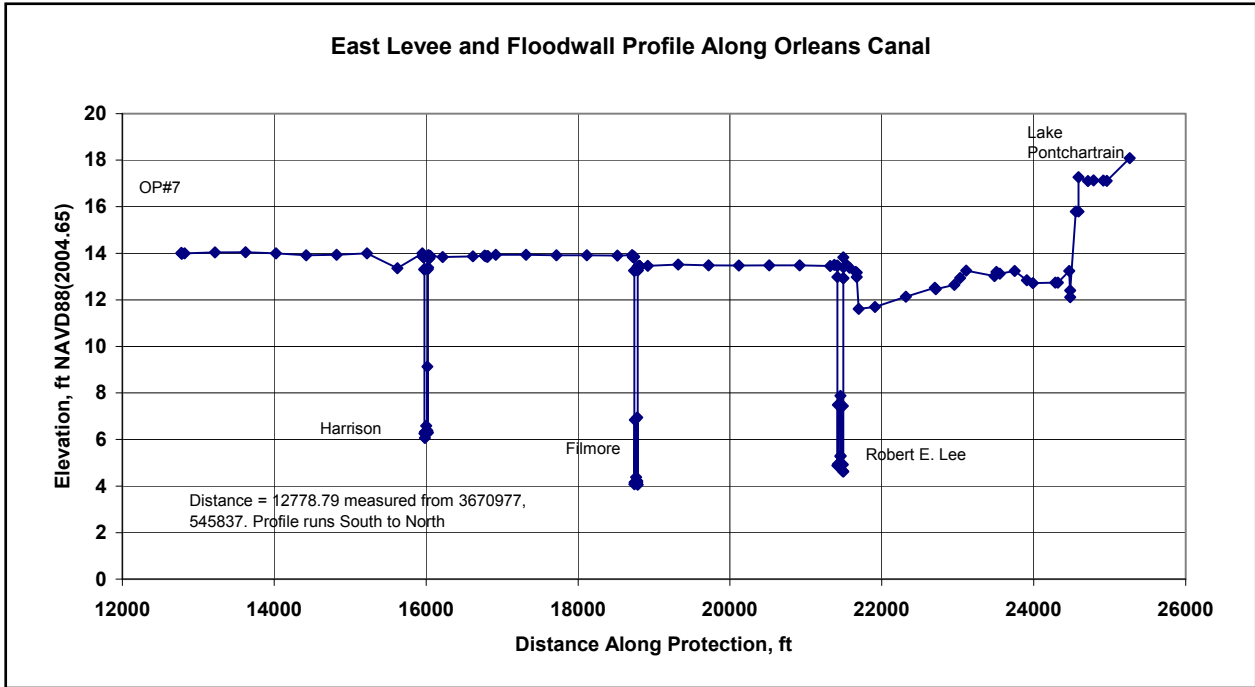
Figure 1-81. East Levee and Floodwall Profile for Orleans Avenue Canal. Note that low areas at bridges and pump stations are floodgate openings that were closed during the storm.

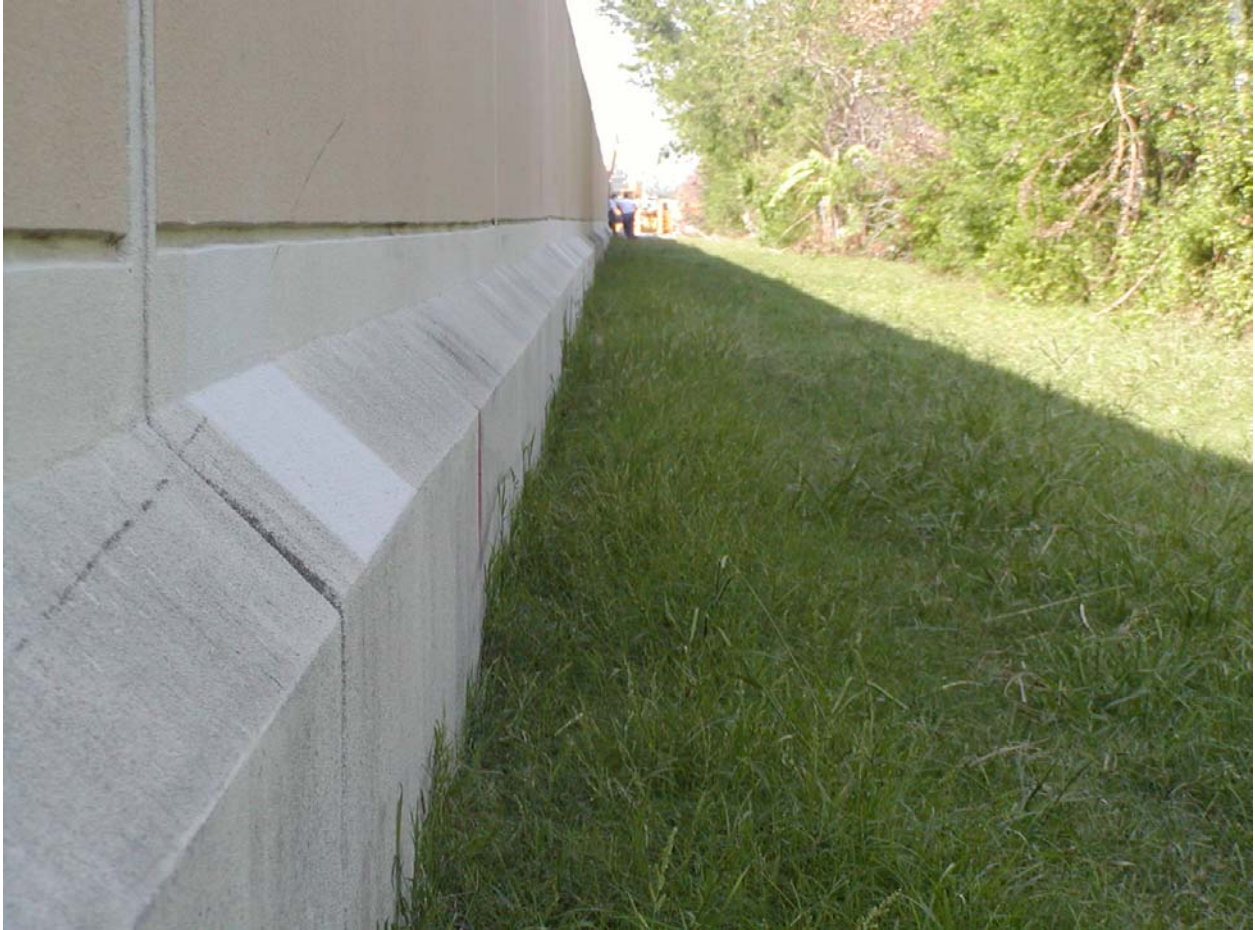
On 9/29/05, a location was observed about 200 ft south of the 17th Street Canal breach looked like ground that had flow over it. Further south of this location on the east side of the canal are the lowest wall elevations on 17th Street Canal of about 12.1 ft. The scour was possibly the result of minor wave overtopping but no visible scour was observed. A picture (Figure 1-82) was taken in this area but the effect on vegetation was so minor it does not show up.

Figure 1-82. Attempt to show possibility of minor scour along west floodwall, south of 17th Street Canal breach.

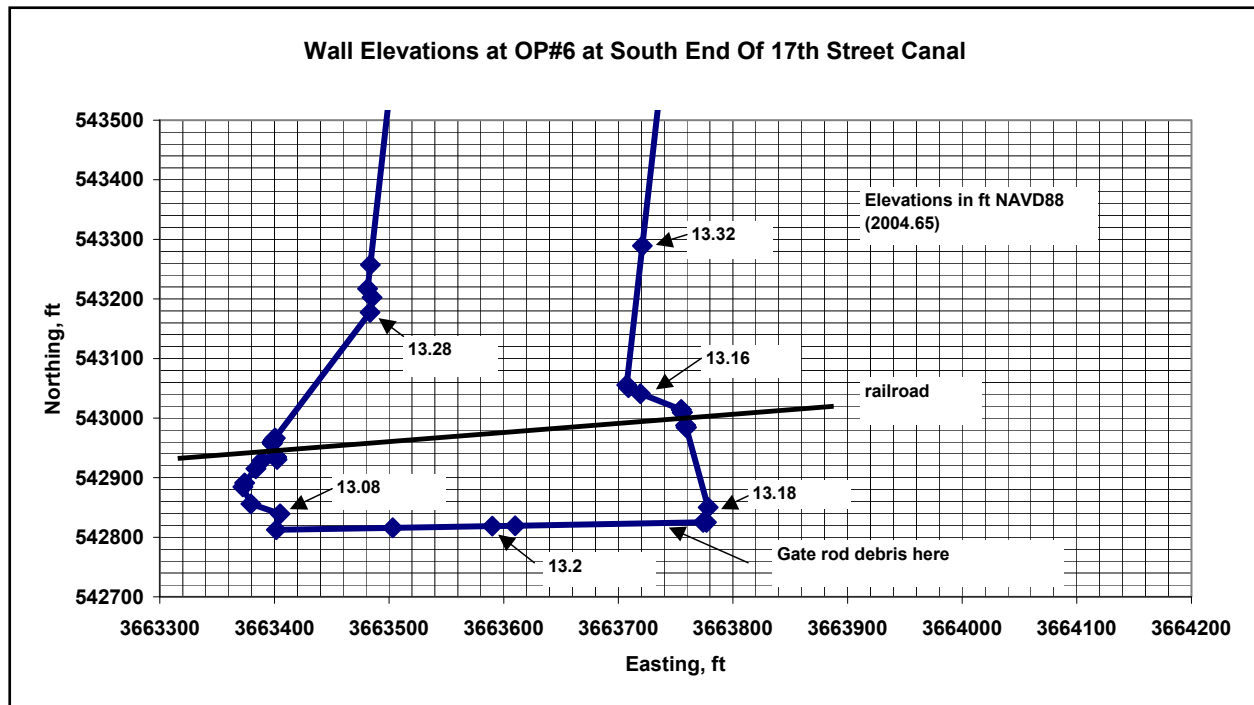
The floodwall and fronting protection walls at the pump station OP#6 are at about elevation 13-13.2 ft as shown in Figure 1-83. On 9/29/05, debris was observed at the top of the fronting protection wall as shown in Figure 1-84. This debris was only observed at the center portion of the fronting protection wall as shown on Figure 1-83, a location where waves coming down the canal would be largest. On 11/9/05, a debris HWM LA 1252 was found (Figure 1-85) around two gate rods, both at about 2.1 ft below the top of the floodwall for an elevation of about 11.1 ft. This type of mark is best described as “at least this high” because the debris can wrap around the gate rod at a higher water level and fall down when the stage drops/waves subside and settle on the gate rod support. The location of this HWM is 50-ft east of the point on the fronting protection wall that is inline with the east floodwall (Figure 1-83). This high water elevation was confirmed at another HWM LA 1251 found on 9/29/05 and located in an area on the west side of the discharge area where top of debris at a crack in the wall was found at 2.2 ft below top of floodwall (at the 13.08 ft point in Figure 1-83) for an elevation of 10.9 ft. Both marks, LA 1251 and 1252 were in areas exposed to some wave action. A picture (Figure 1-86) taken in 4/06/06 shows the location of LA 1251. In this picture the debris in the crack was no longer at the level of 2.2 ft below the top of the wall. A third HWM LA 1019 at this general location was levee debris at 9.0 ft. Levee debris high water marks have been inconsistent when compared to nearby marks inside structures.

Figure 1-83. Wall elevation at OP#6 at south end of 17th Street Canal.

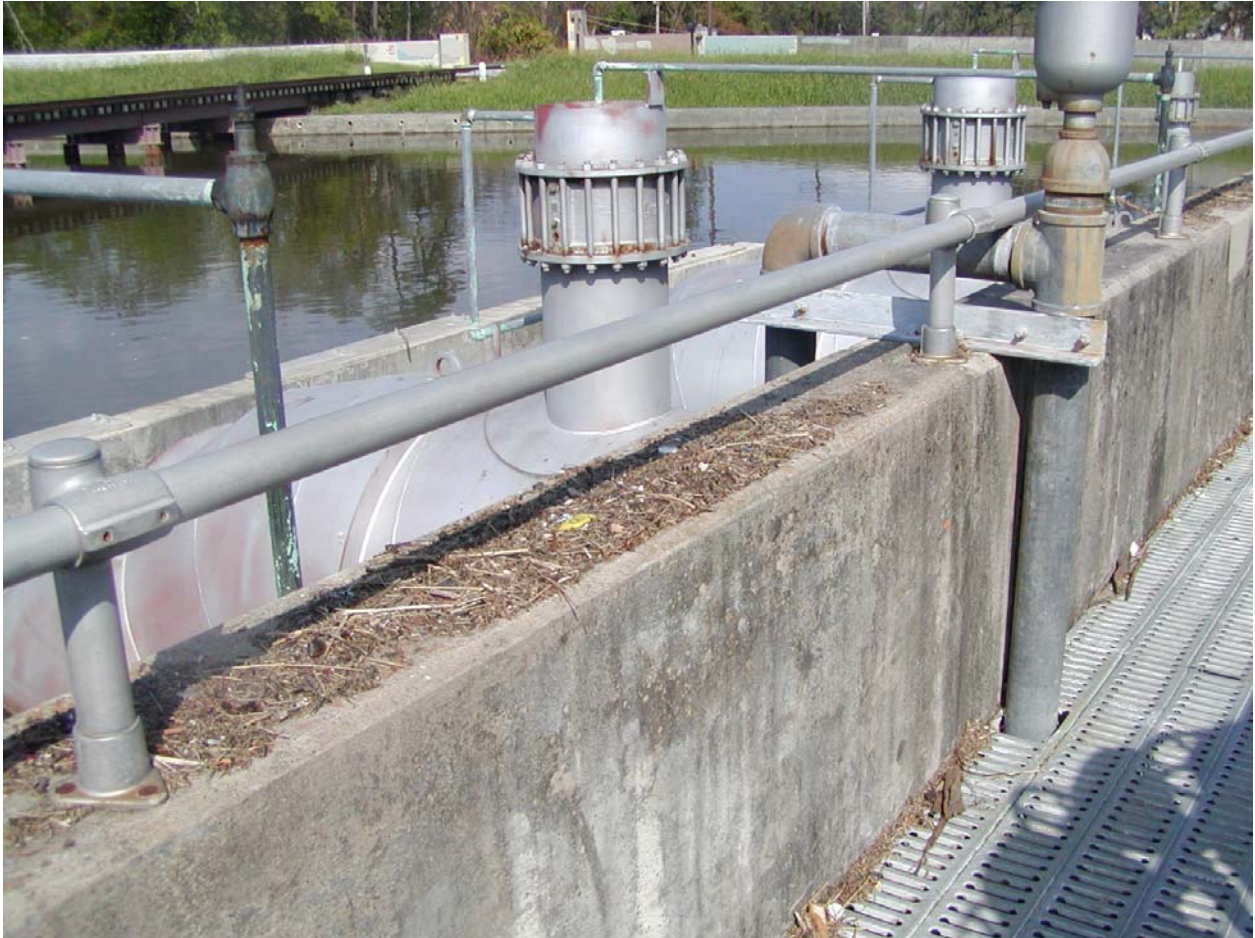
Figure 1-84. Debris on top of floodwall at OP#6 at 17th Street Canal.

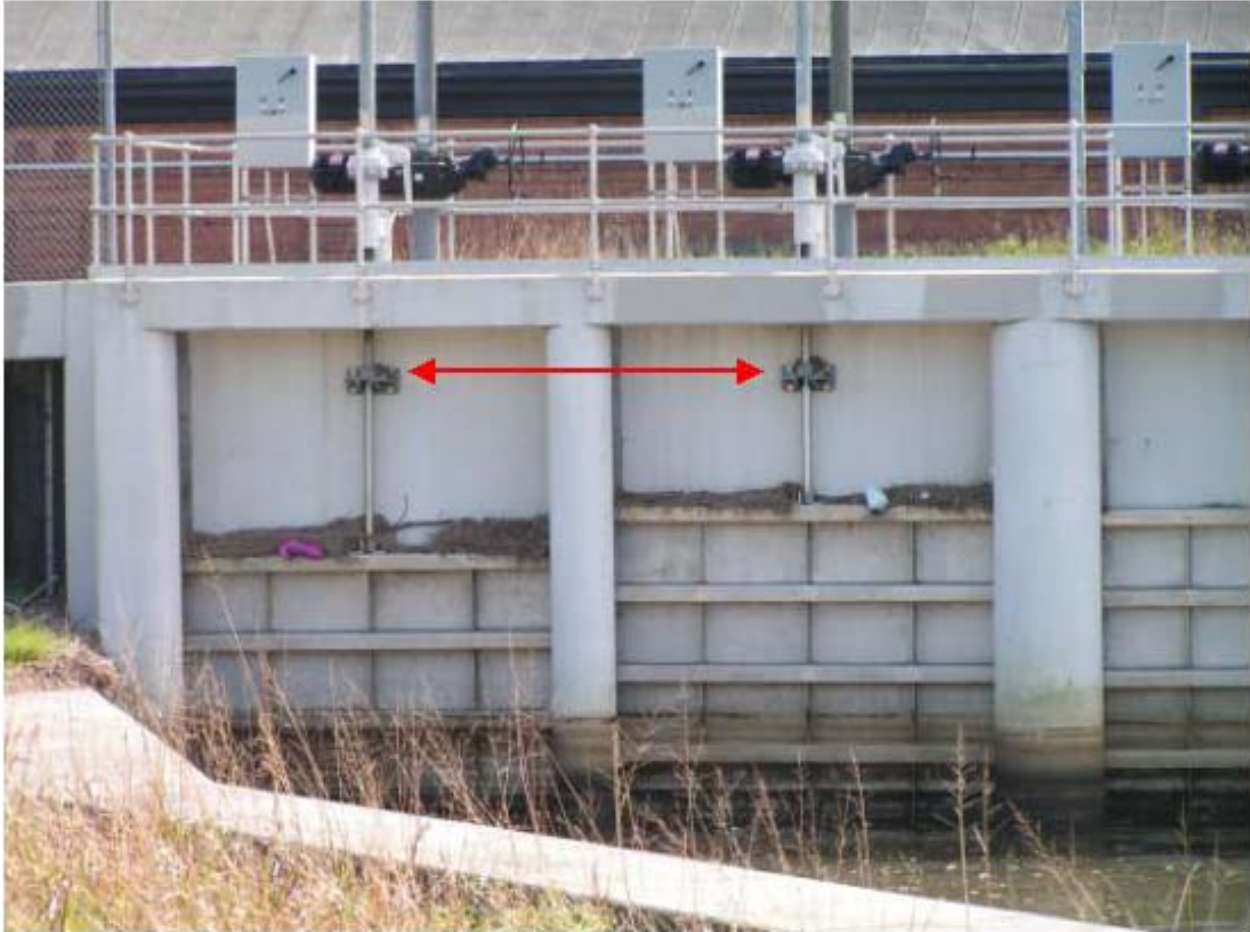
Figure 1-85. Debris high water mark at top of brackets holding gate rods on east side of discharge area.

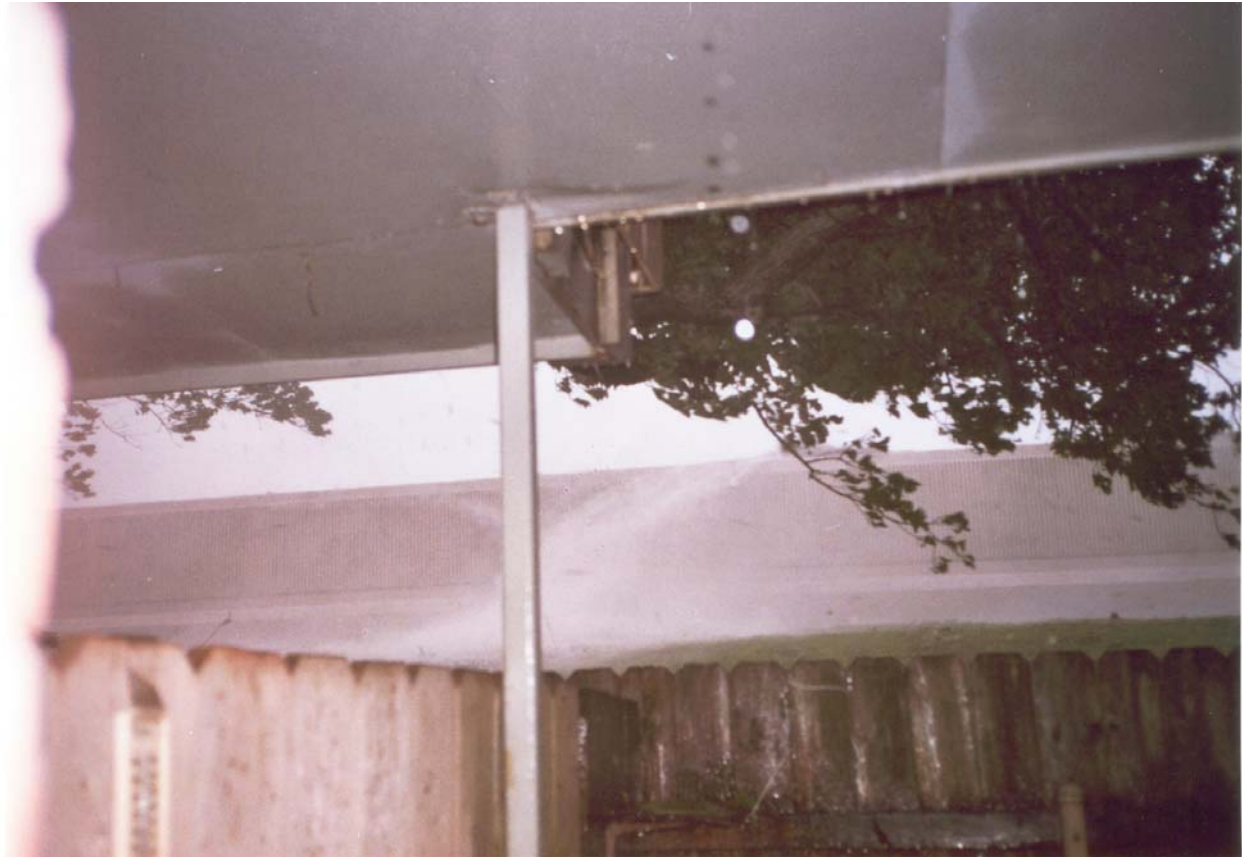
Figure 1-87. Wave spray or splash (left of tree limb) at west wall of 17th Street Canal north of Veterans Blvd and 1.0 mile south of Hammond Hwy. The individual who took this picture stated that the tree limb obscures the crest of a wave.

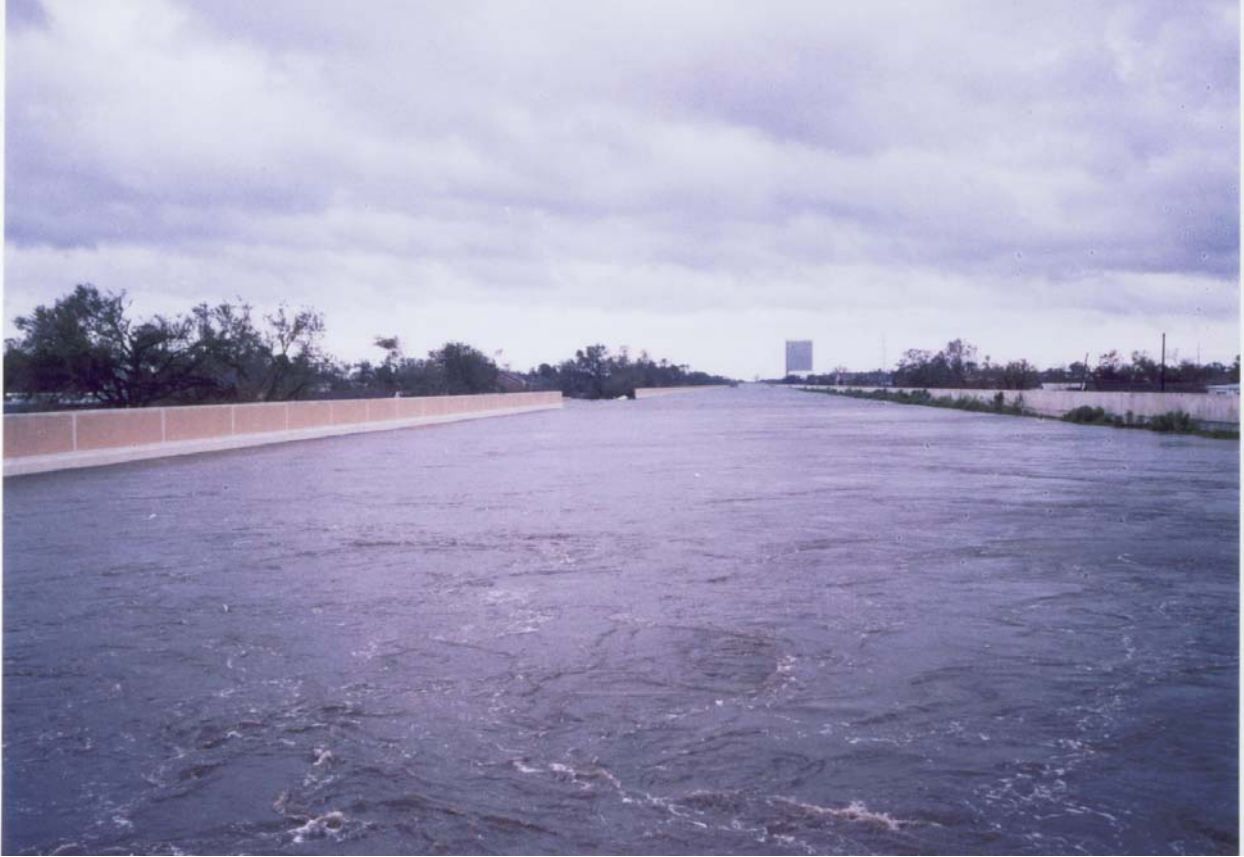
Figure 1-88. 17th Street Canal and breach at 2 pm on 8/29/05. Looking south.

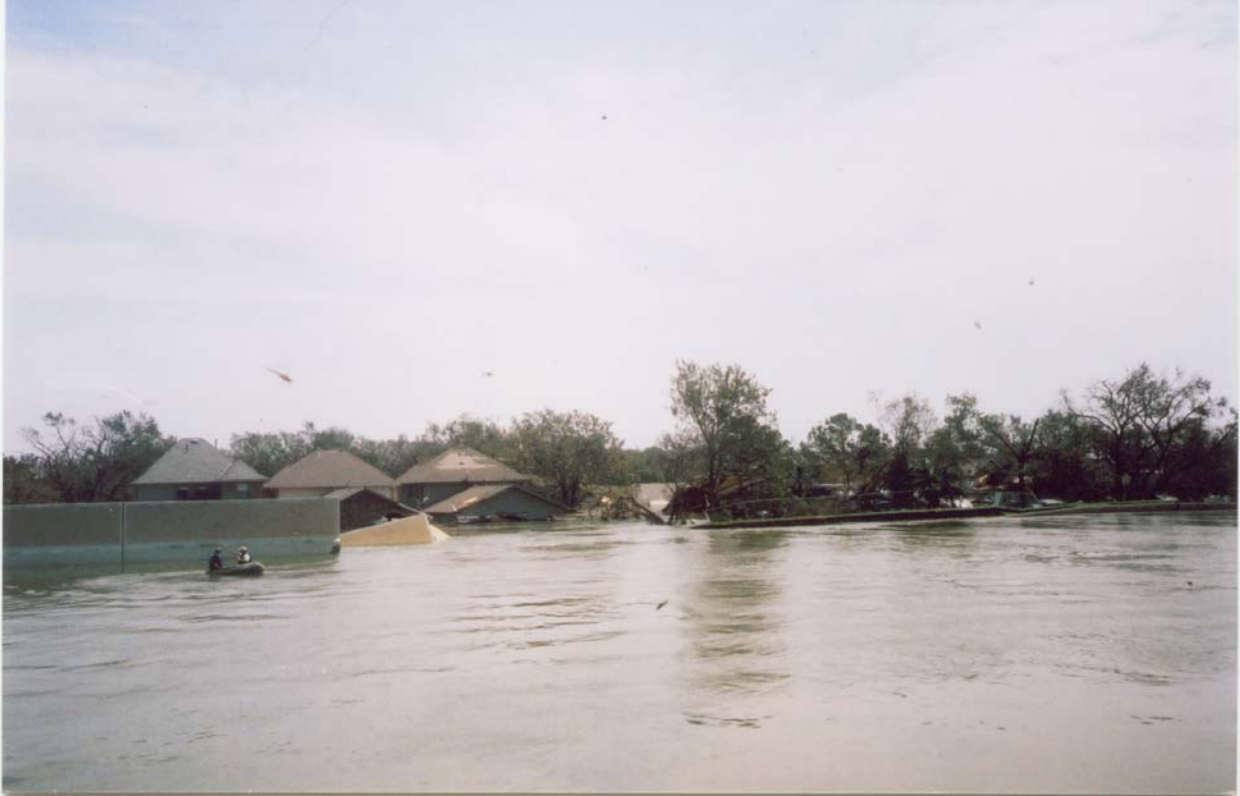
Figure 1-89. North end of 17th Street Canal breach at 3 PM on 8/29/05.

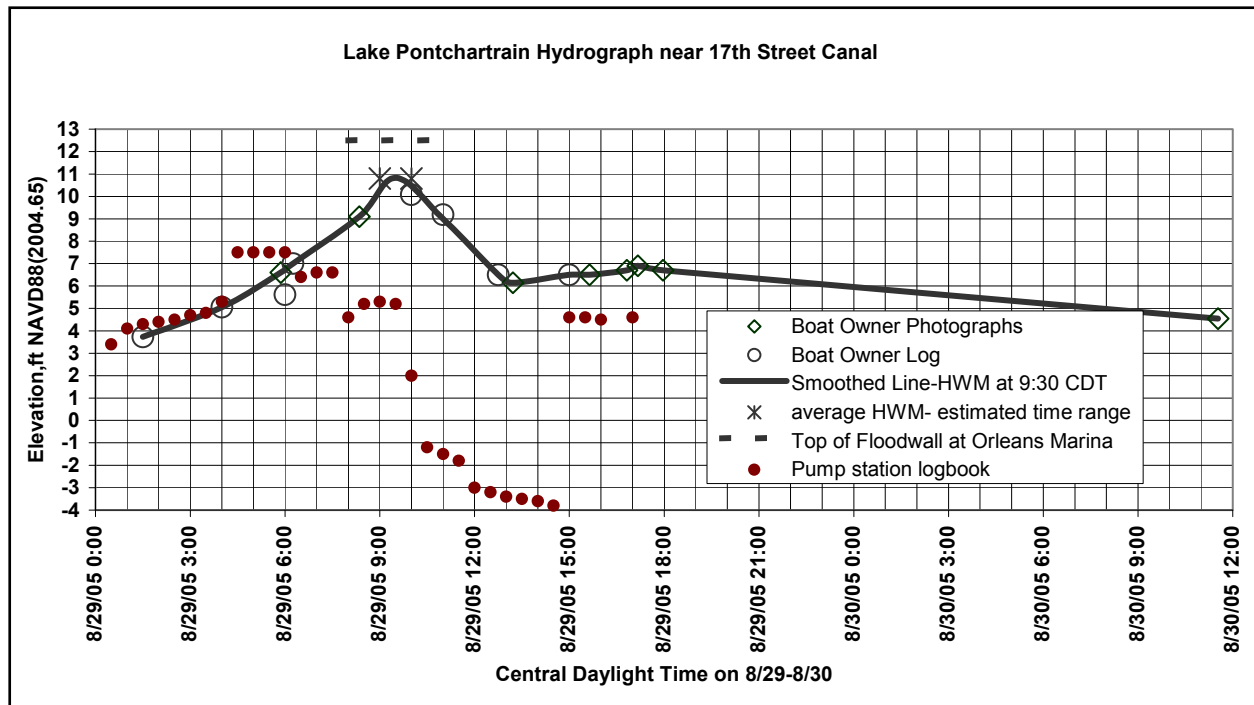
If valid, the most complete information on the canal water levels is the log of water levels recorded at OP#6 on the south end of the 17th Street Canal. The water levels at the pump station differ significantly from the constructed hydrograph for the 17th Street Canal entrance as shown in Figure 1-90. The IPET data collection team spent considerable effort to determine if the logbook readings correctly describe the water level in the 17th Street Canal during Hurricane Katrina on the morning and afternoon of 8/29/05. The logbook data shows that the water level in the canal peaked at an elevation of 7.5 ft between 4:30 AM and 6:00 AM and fell after that time. The datum of the pump station logbook data was established using Lake Pontchartrain hydrographs that have water surface elevations in NAVD88 (2004.65). From 12:00 AM to 12:00 PM on 8/28/05, the Orleans Levee District gage at Southshore Marina averaged 1.25 ft, the Pass Manchac gage averaged 1.09 ft, and the Bayou Labranch gage averaged 1.27 ft. Based on averaging the 3 gages, Lake Pontchartrain averaged an elevation of 1.20 ft from 12:00 AM to 12:00 PM on 8/28/05. During this time, no significant pumping was taking place at OP#6. Based on the pump station logbook for the same time interval, the average reading at OP#6 was 22.6 ft in the Cairo datum. The conversion from Cairo datum to NAVD88 (2004.65) is  $22.6 - 1.2 \text{ ft} = 21.4 \text{ ft}$  for OP#6 logbook readings on the discharge side of the pump station. This conversion value is considered to be valid for this location in the system. The conversion is used in Figure 1-90 and the derived hydrograph at the Lake and the pump station log are in fair agreement on the morning of 8/29/05 before 4:00 AM.

Figure 1-90. Pump station logbook values and constructed hydrograph at 17th Street Canal entrance.

As shown in Figure 1-90, the system appears to rebound to about correct values at about 3:00 PM. This appears impossible because the air compressor did not regain power. Close inspection of the logbook numbers indicated the possibility that a 2 had been written over the 1 in the logbook. For example, a value of 16 in the logbook became 26. It is possible that the outside staff gage was being read because winds had died down by this time.

Summarizing the bubbler system, the loss of electrical power beginning sometime between 4:00 to 5:00 AM on 8/29/05 along with the 2.2 ft increase in stage above the lake level from 4:00 AM to 4:30 AM followed by four identical 7.5 ft readings causes concern with the bubbler system. The rapid loss of pressure of the bubbler system when tested on 03/02/06 also causes concern for the 8/29/05 readings. Readings of the bubbler system below the berm elevation of 0 to -1 ft are likely not possible. These three problems with the bubbler system cast doubt on the entire set of readings after power was lost.
