# Appendix 1

## Hydrograph and High Water Mark Analysis

### Introduction

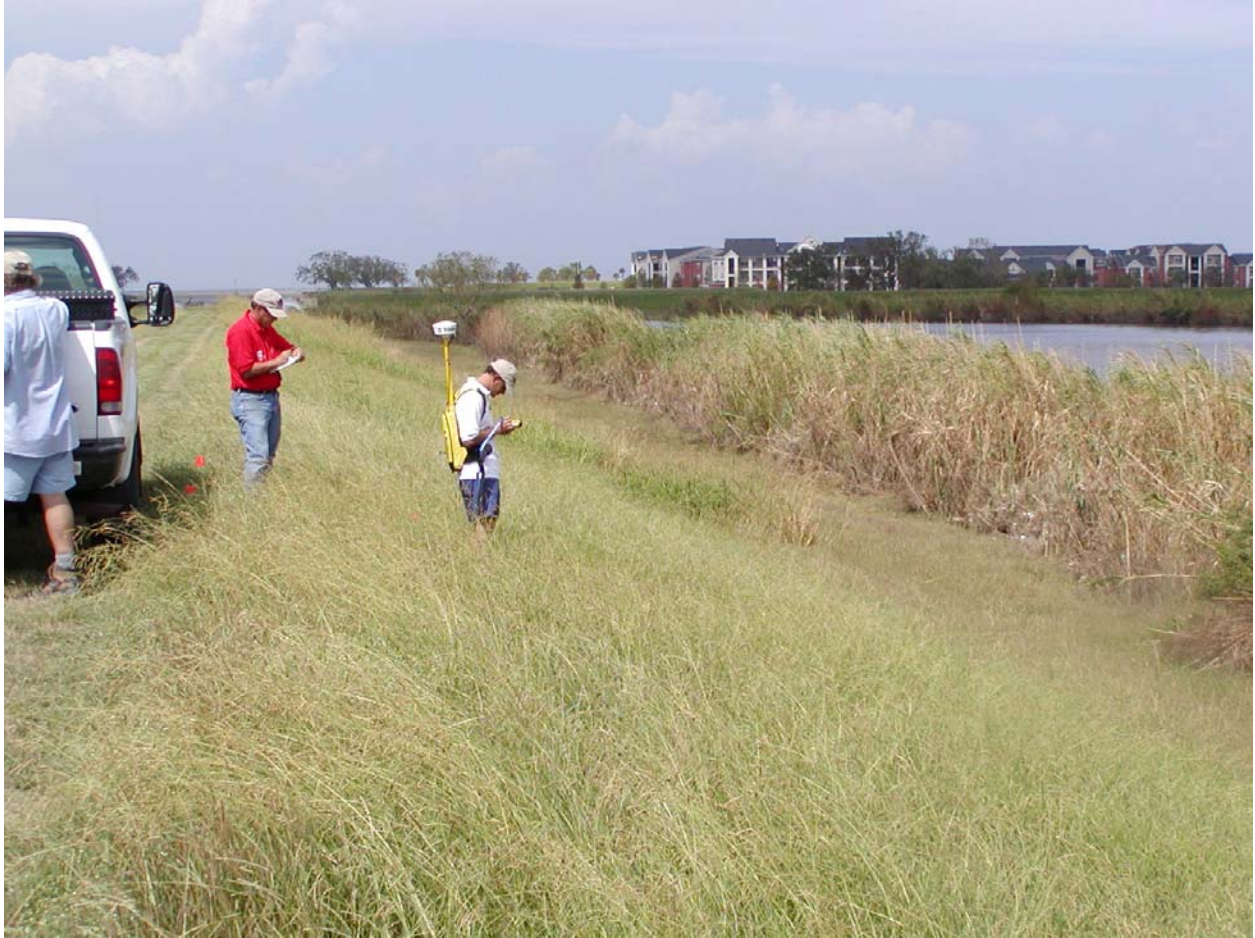
- a.* LA 1015- 10.8 ft- Levee debris on west side of canal north of Robert E Lee Bridge. Figure 1-94 shows the location of this mark and demonstrates the difficulty of providing good photographs with the high grass. The debris line could be easily seen by looking straight down into the high grass.
- b.* LA 1017- 7.6 ft- Levee Debris on west side of canal south of Lakeshore Drive- ASCE COPRI felt a better mark was found south of this location.
- c.* LA 1018- 7.9 ft- debris on area near railroad track at OP#3, east side of discharge area. This area is shown in Figure 1-95.
- d.* LA 1022- 10.6 ft- this is the ASCE COPRI mark near LA 1017. See Figure 1-96.
- e.* LA 1059- 11.2 ft- Levee Debris on west side of canal just north of Leon C Simon Bridge.

Figure 1-94. Debris high water mark LA 1015 located on 10/02/05 on west side of London Avenue Canal. Looking north between Lakeshore Drive and Leon Simon Drive.

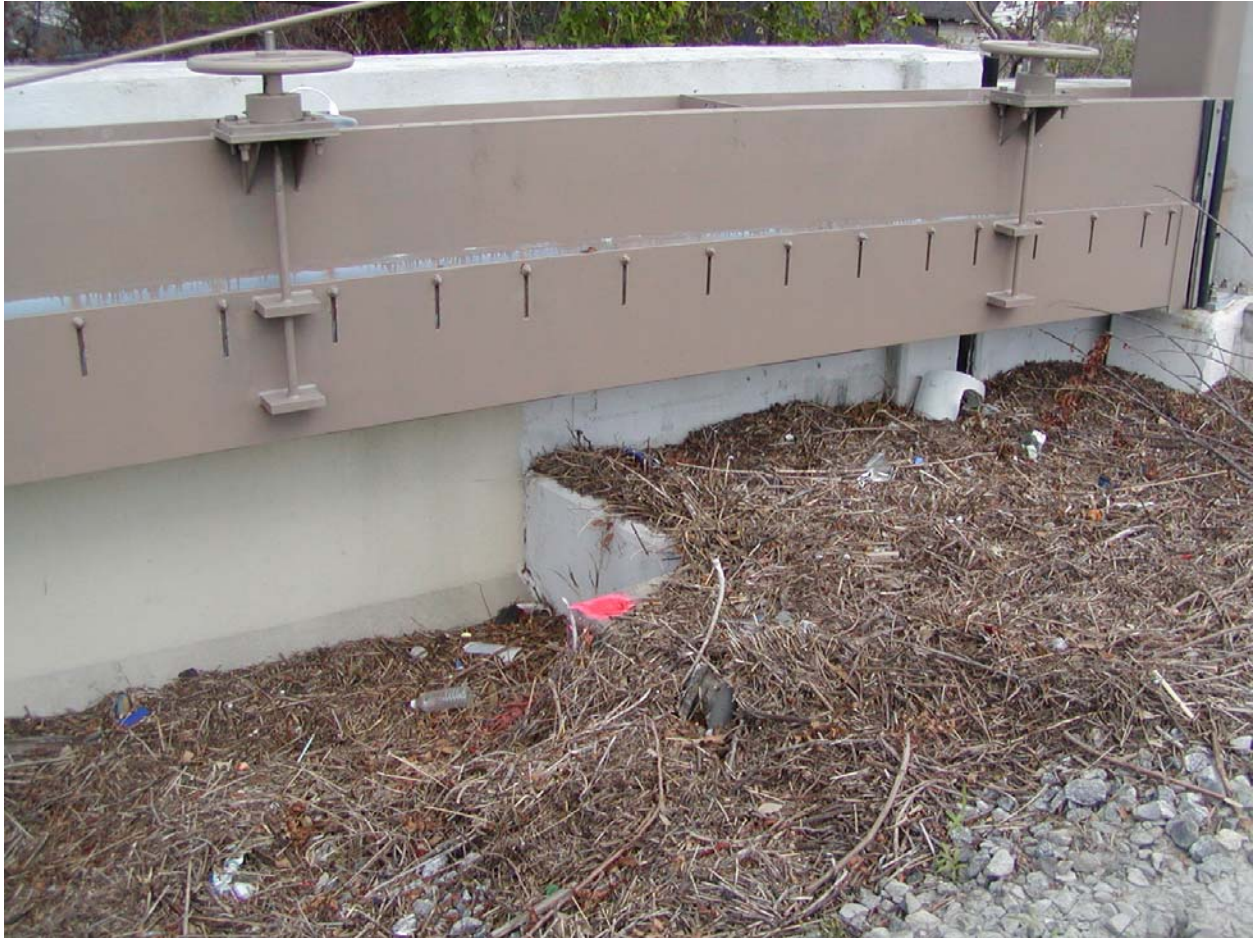
Figure 1-95. East floodgate at OP#3 at south end of London Avenue Canal. High water mark LA 1018 at top of painted concrete wall.

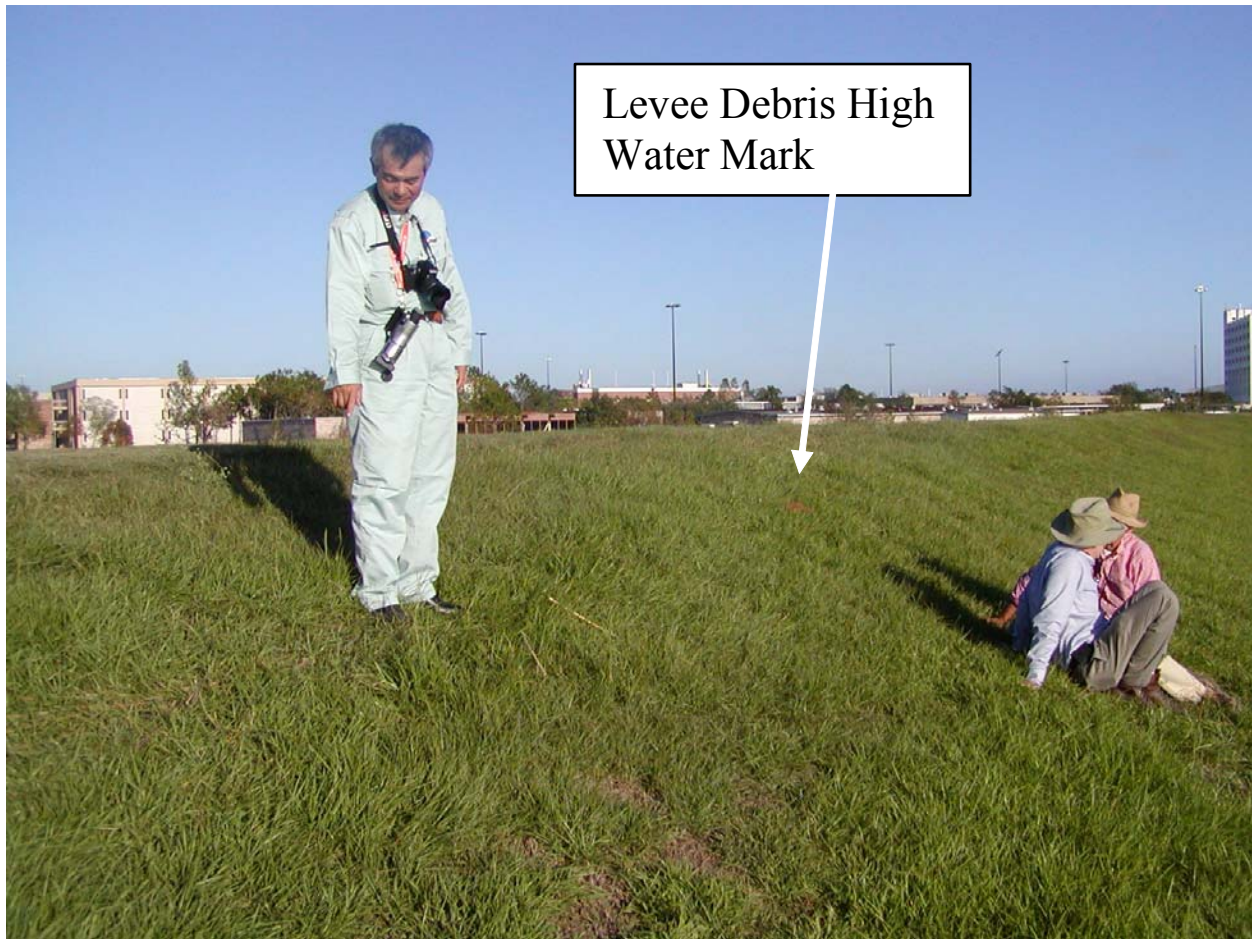
Figure 1-96. Debris high water mark LA 1022 on east levee of London Avenue Canal north of Leon C Simon Drive.

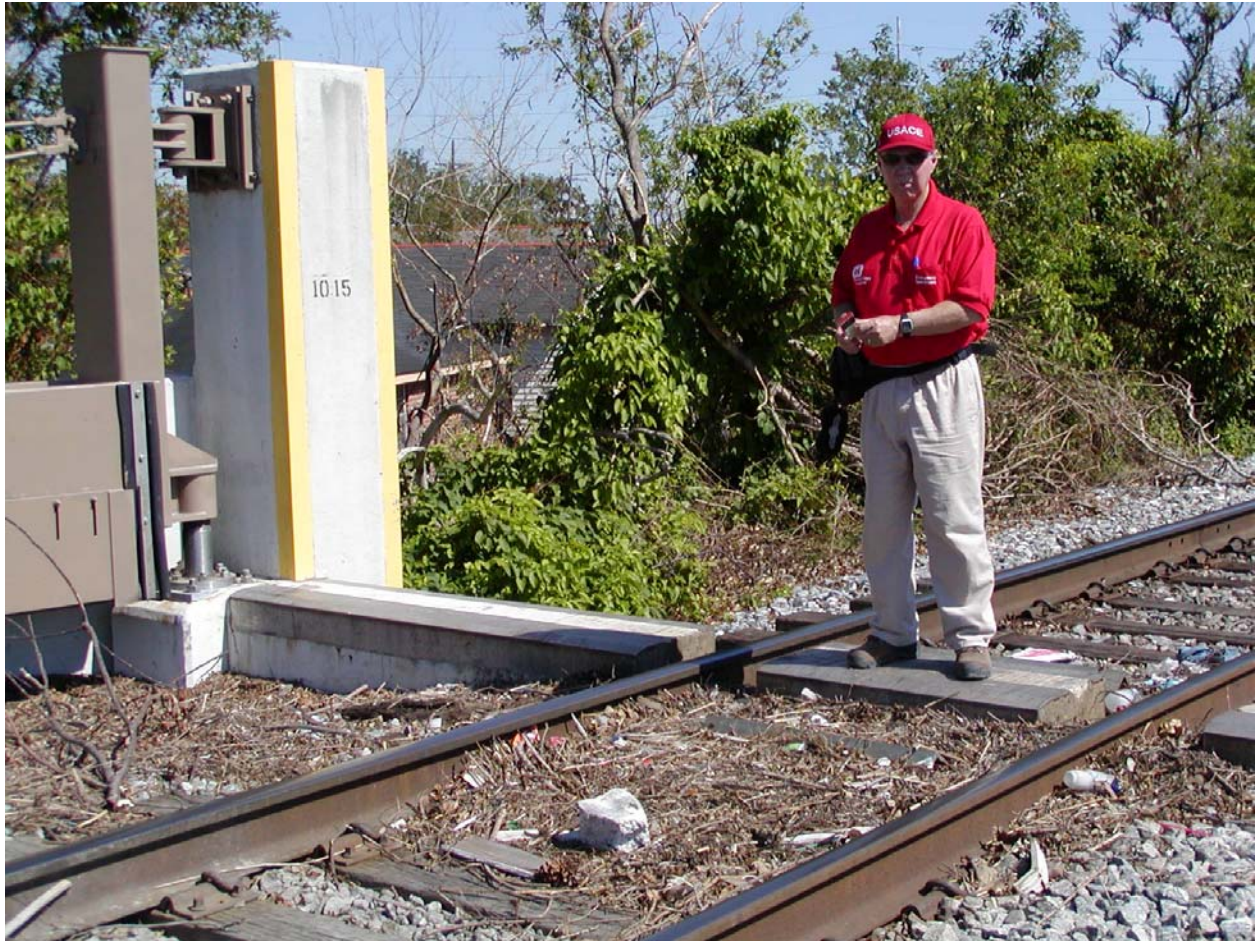
- h.* LA 1069- 10.6 ft- Debris on southwest side of Robert E. Lee Bridge.
- i.* LA 1227- 9.5 ft- revisit to site of LA 1018 at OP#3 on east side of discharge area. This is a difficult mark to assess because of the factors listed in the beginning of this section. Observers believe debris between railroad rails suggest the water level was at least as high as the railroad ties that was the elevation surveyed. Mark location shown in Figure 1-97.

Figure 1-97. East floodgate at OP#3 at south end of London Avenue Canal. High water mark LA 1227 at top of railroad ties.

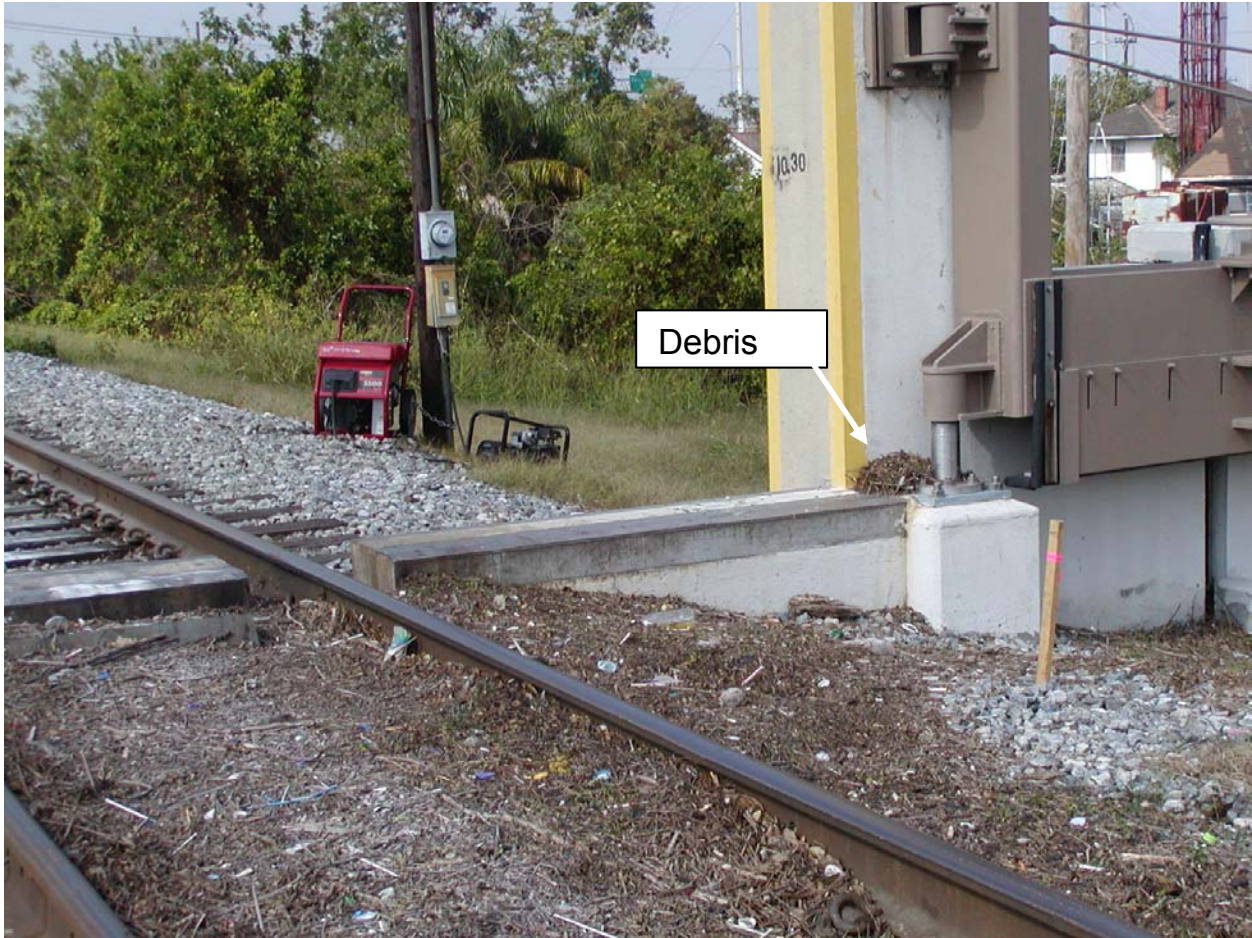
- j.* LA 1228- 10.0 ft- this mark is a debris mark on the west side of the discharge area. Debris is on a support for the floodgate and somewhat protected from any wave action in the canal as shown in Figure 1-98. The water level could have been higher as the debris may have been left behind as the water level dropped.

Figure 1-98. West floodgate at OP#3 at south end of London Avenue Canal. High water mark LA 1228 based on debris on top of sill at floodgate opening.

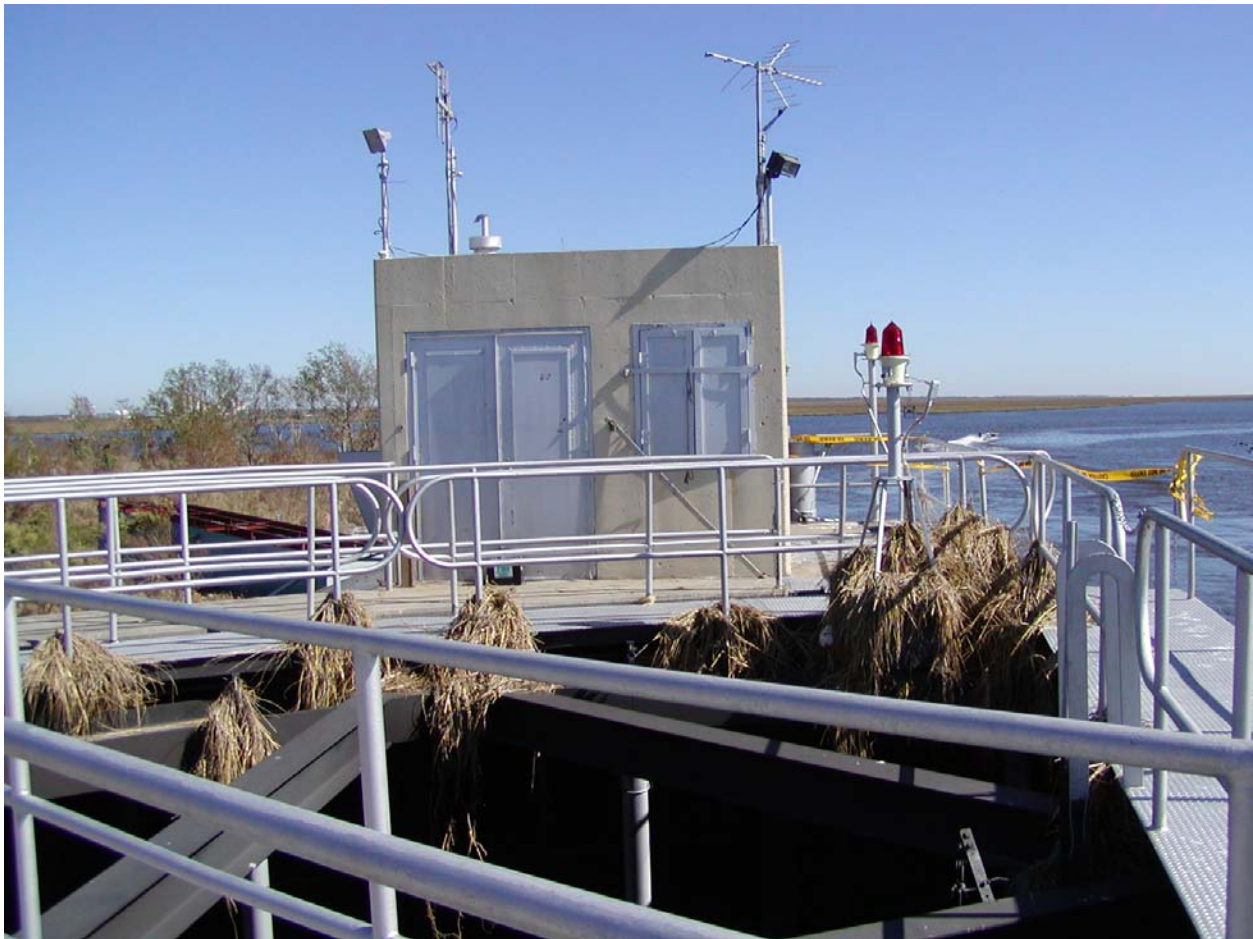
- g. LA 1043 (el 18.2 ft) - Located 1.1 mile southeast of the GIWW/ MRGO junction at the Bayou Bienvenue Structure. This mark is debris inside a radiator that is inside the gage house (Figure 1-101). The doors to this gage house were damaged by the storm surge and significant flow was passing through the gage house. The large amount of flow through the gage house and potential for wave effects within the gage house may cause this mark to be high.

Figure 1-101. Bayou Bienvenue Gage House.

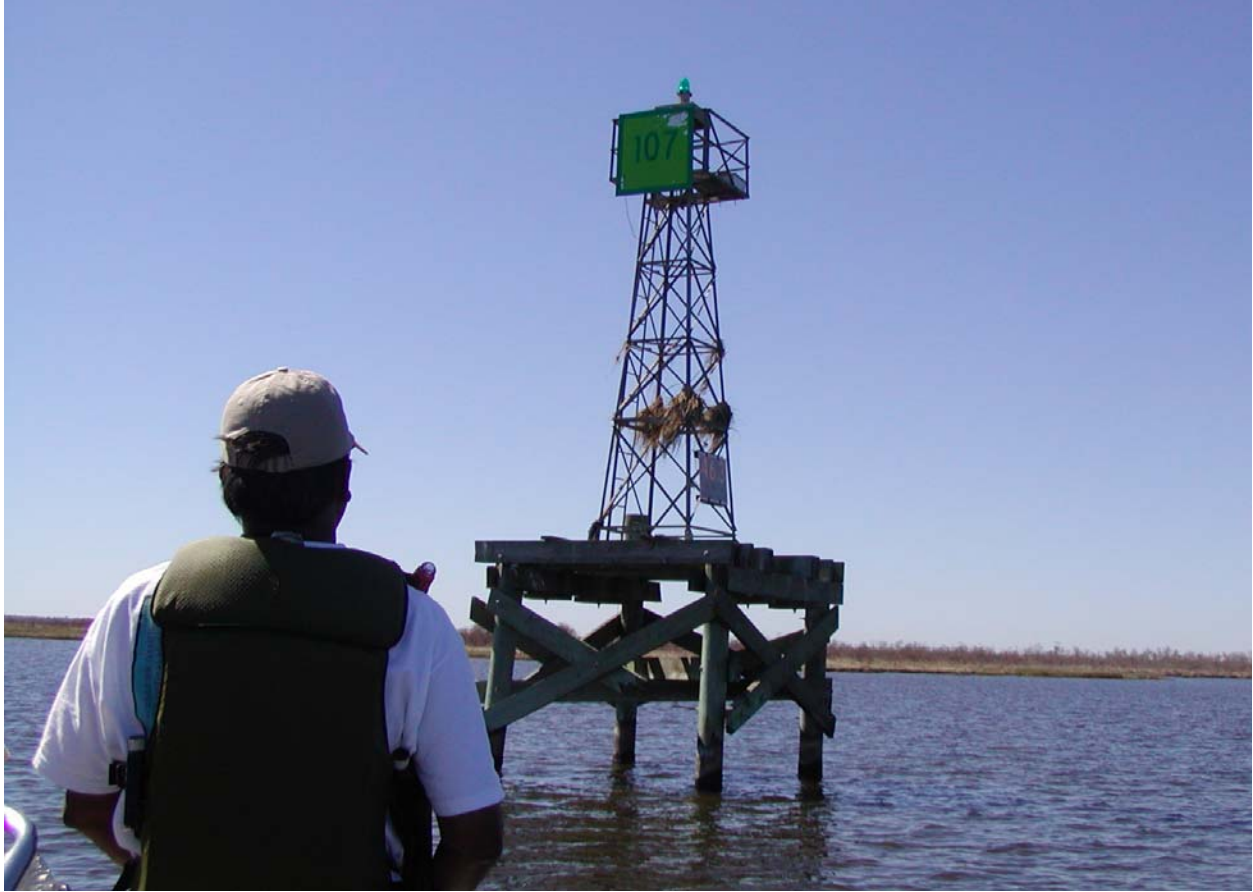
- n. LA 1155 - This mark was not surveyed and was only accessible by boat since it was on channel marker #107 (Figure 1-102). The marker is about 13.8 miles southeast of the GIWW/MRGO junction and about 0.7 miles southeast of where the levee protection leaves the MRGO. The debris on this tower was measured at 19.6 ft above the water level at 1345 hrs on 10/17/2005. The Bayou Dupre gage read about 1.8 ft on this same day giving an elevation of about 21.4 ft (relative to an uncertain datum). This debris elevation contains a large wave component. Water depth at the channel marker on the day of the inspection was about 12 ft.
- o. LA 1087 (el 18.1 ft) - Well-defined debris line inside bedroom of home (Figure 1-103) at Shell Beach that is about 19 miles southeast of the GIWW/MRGO junction. High water mark is 31" above second level floor.

Figure 1-102. LA 1155 on MRGO. Debris on tower.

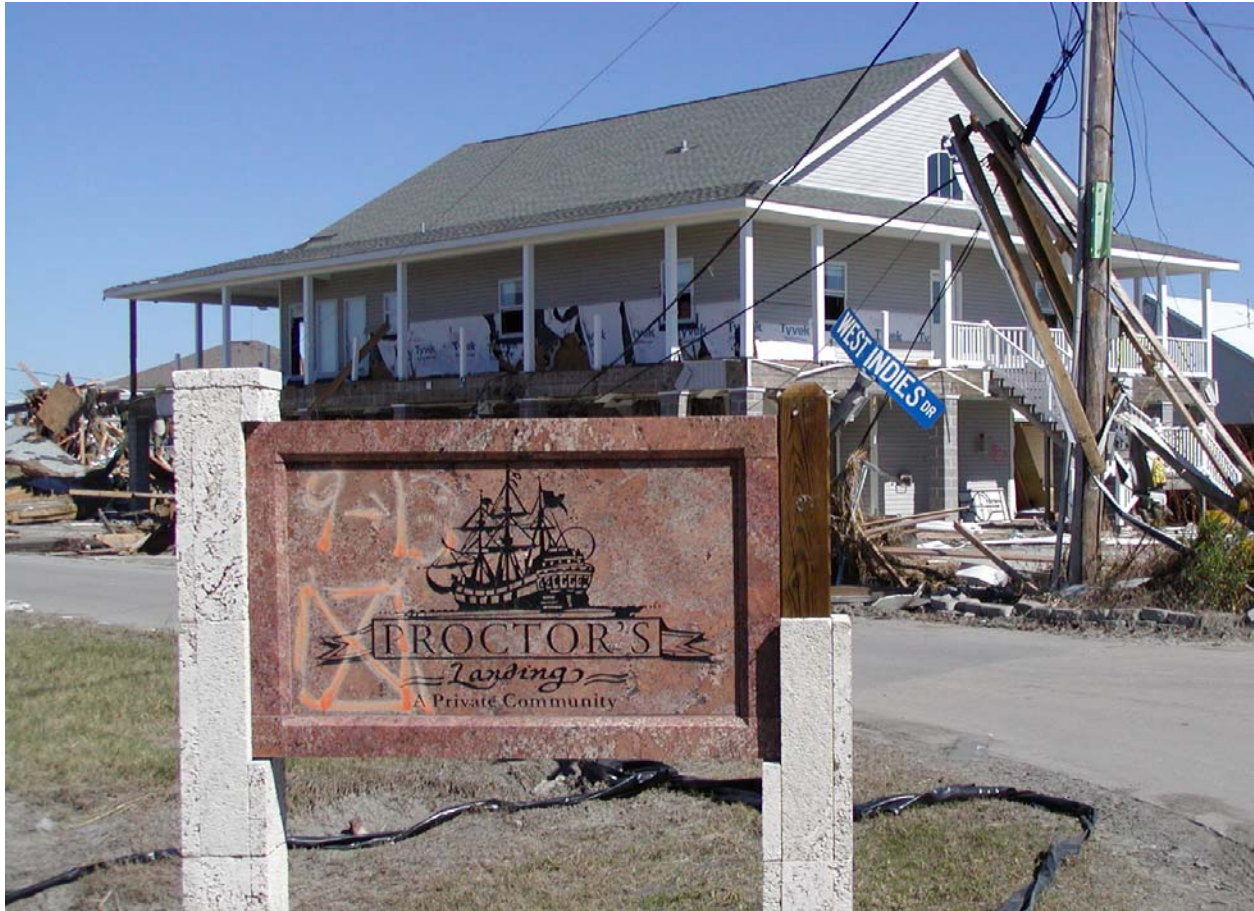
Figure 1-103. Home in Shell Beach containing high water mark LA 1087 at 31" above second level floor.

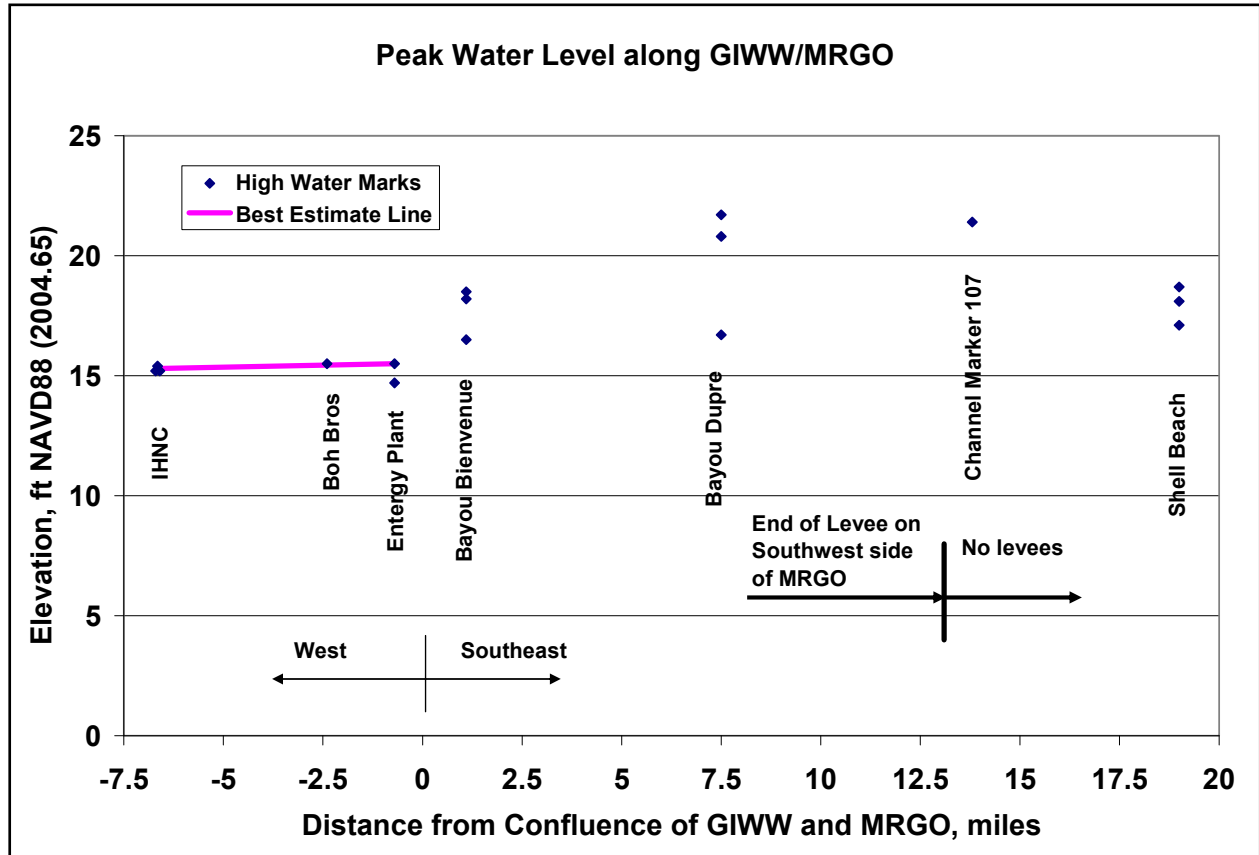
Figure 1-104 shows a plot of the high water mark data along the GIWW/MRGO along with a best estimate line. The best estimate line ends at the Entergy Plant because of uncertainty of high water marks at Bayou Bienvenue and Bayou Dupre, the large wave component at channel marker 107, and the fact that Shell Beach is beyond the levee protection. Of all the marks southeast of the GIWW/MRGO junction, the marks at Shell Beach are the most reliable estimates of the peak “still” water level.

Figure 1-104. Peak water level along GIWW and MRGO based on high water marks.

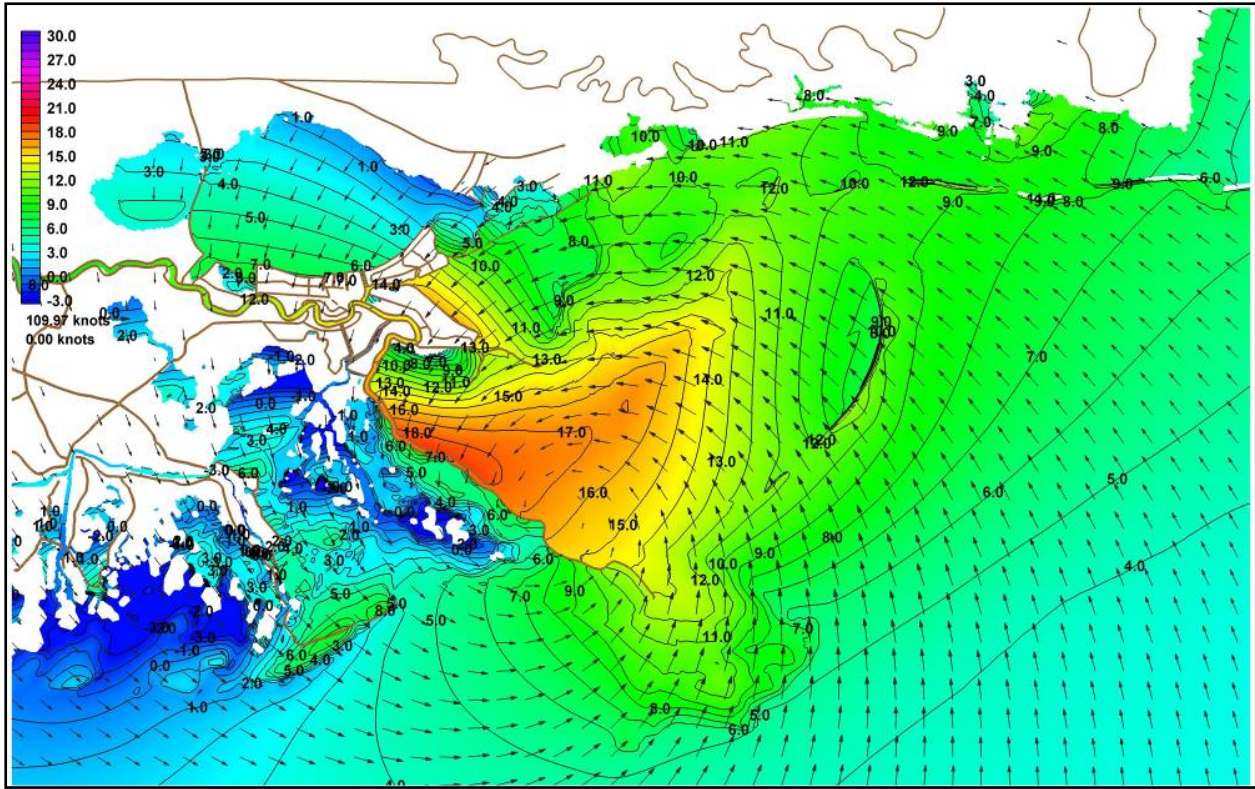
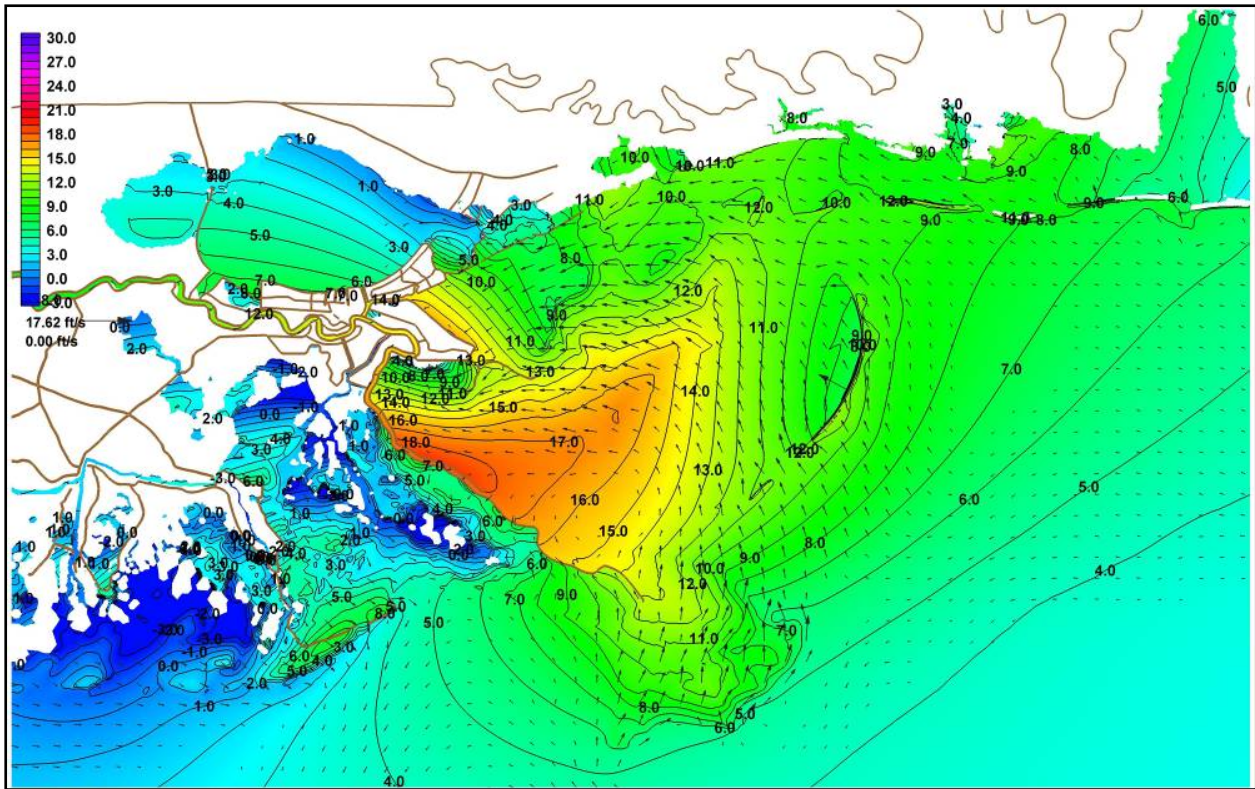
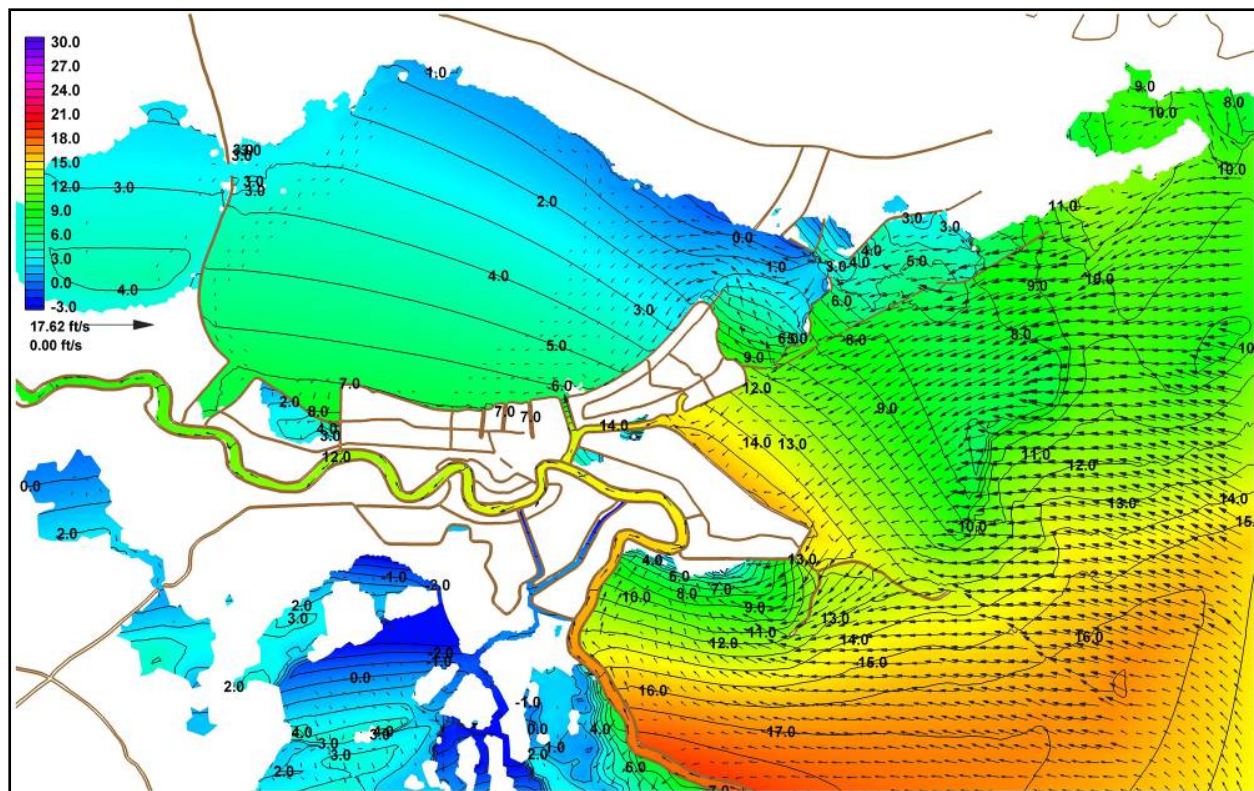
Figure 5-7d. Water surface elevation with respect to the NAVD 88 (ft) with boundary layer adjusted wind velocity vectors (knots) during Hurricane Katrina on August 29, 2005 at 1200UTC

On 8/29/1200 UTC (Figures 5-7d, 5-8d and 5-9d), the eye location has caused a significant shift in the wind patterns. Surge has started to be blown off the southernmost east-facing levees of Plaquemines Parish although surge continues to build up further north along the river levees. Surge has now reached 16 ft along the St. Bernard/Chalmette protection levee and is being driven through the GIWW into the IHNC and Lake Pontchartrain. In addition, the northeasterly winds over Lake Pontchartrain are building up surge against the lake levees of Jefferson Parish and Orleans Parish. In addition the continued strong surface water gradient aided by the winds between Lake Borgne and Lake Pontchartrain continue to drive water from Lake Borgne into Lake Pontchartrain. This process is still enhanced by the drawdown in the northeast corner of Lake Pontchartrain.

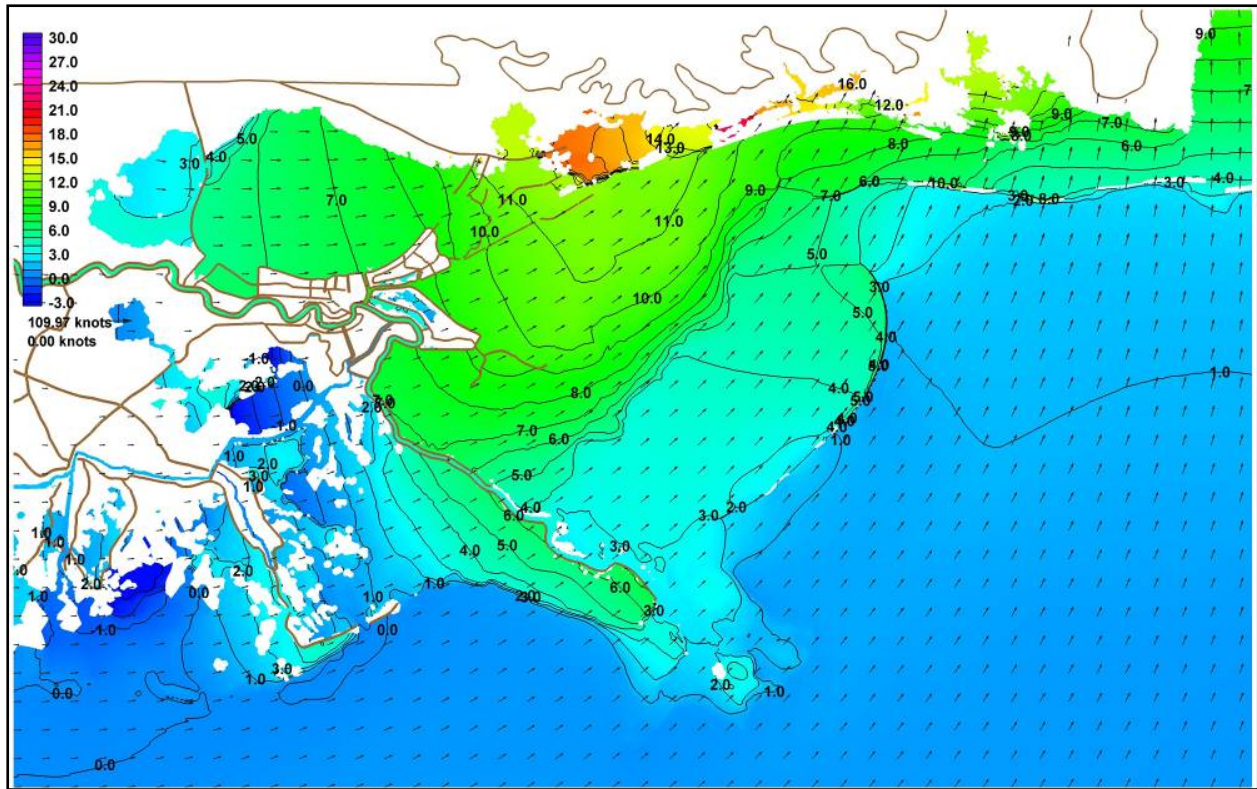
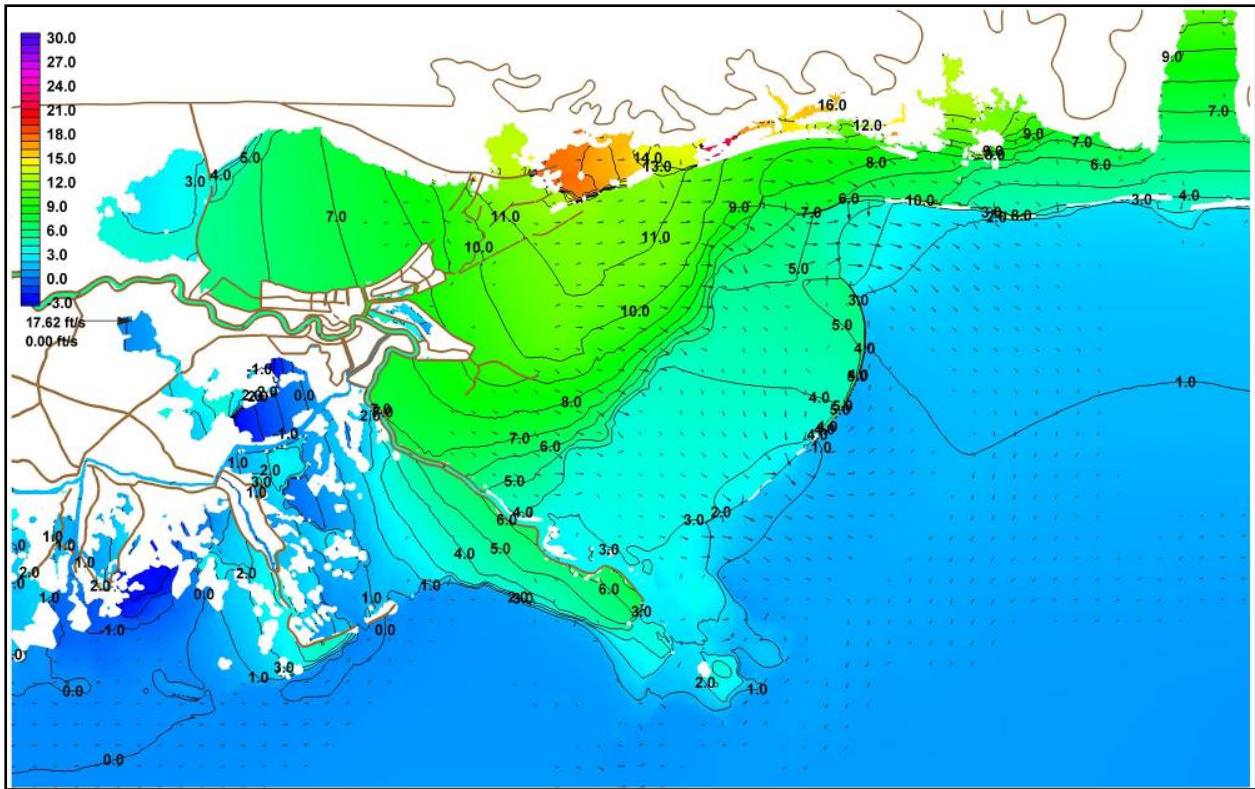
Figure 5-7j. Water surface elevation with respect to the NAVD 88 (ft) with boundary layer adjusted wind velocity vectors (knots) during Hurricane Katrina on August 29, 2005 at 2000UTC

On 8/29/20 UTC (Figures 5-7j, 5-8j and 5-9j), Katrina has moved well inland. Surge along the State of Mississippi coast is subsiding. However high water remains in Lake Pontchartrain as well as Lake Maurepas. In addition, water is withdrawing from Lake Borgne.

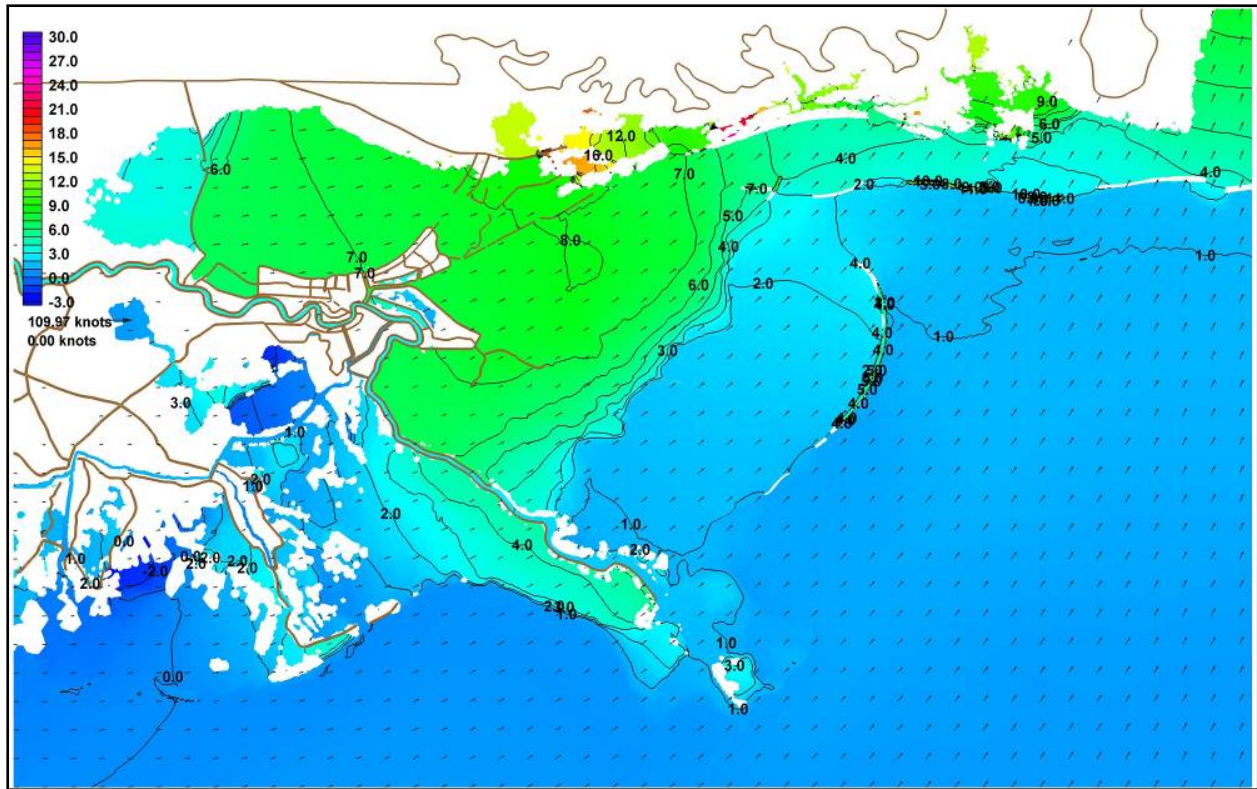
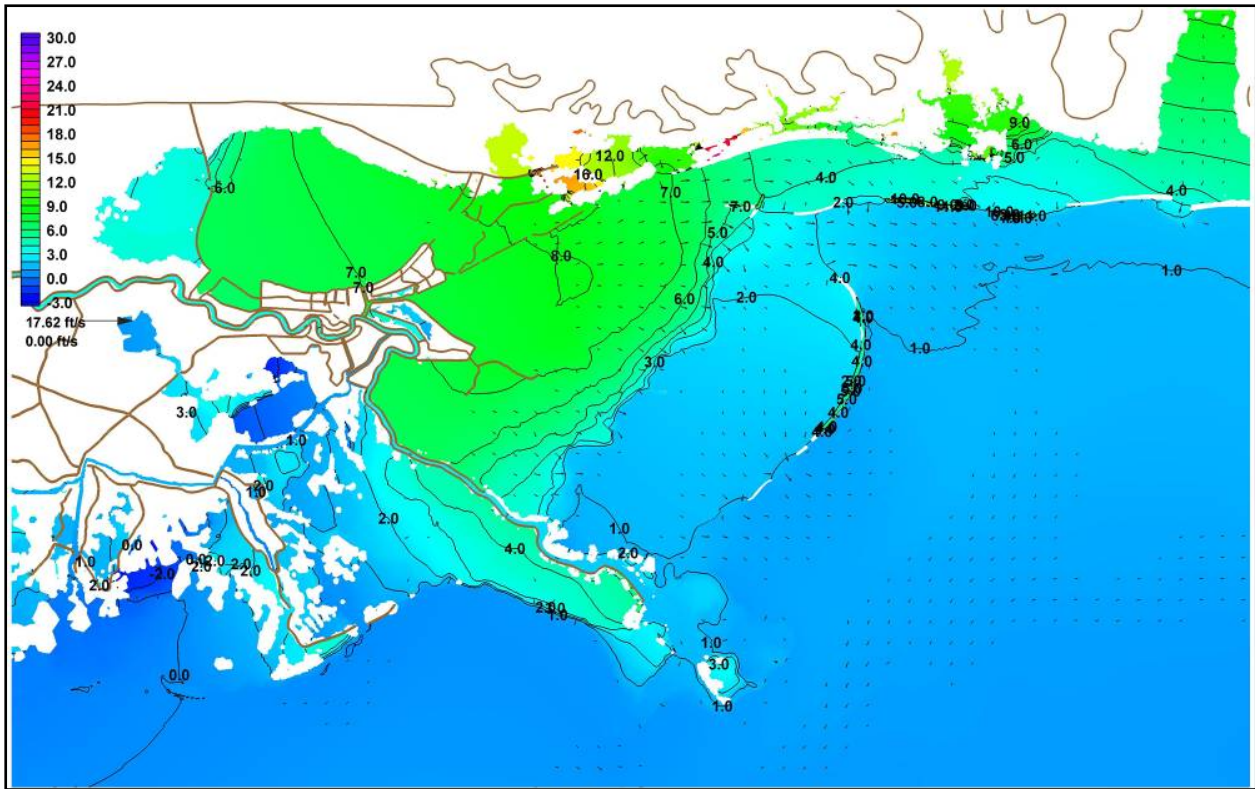
Figure 5-7k. Water surface elevation with respect to the NAVD 88 (ft) with boundary layer adjusted wind velocity vectors (knots) during Hurricane Katrina on August 29, 2005 at 2300UTC

This process continues as is shown on 8/29/23 UTC (Figures 5-7k, 5-8k and 5-9k). However note that Lake Pontchartrain is at 7 ft and is only slowly subsiding due to the lack of strong water surface elevation gradients between Lake Pontchartrain and Lake Borgne.

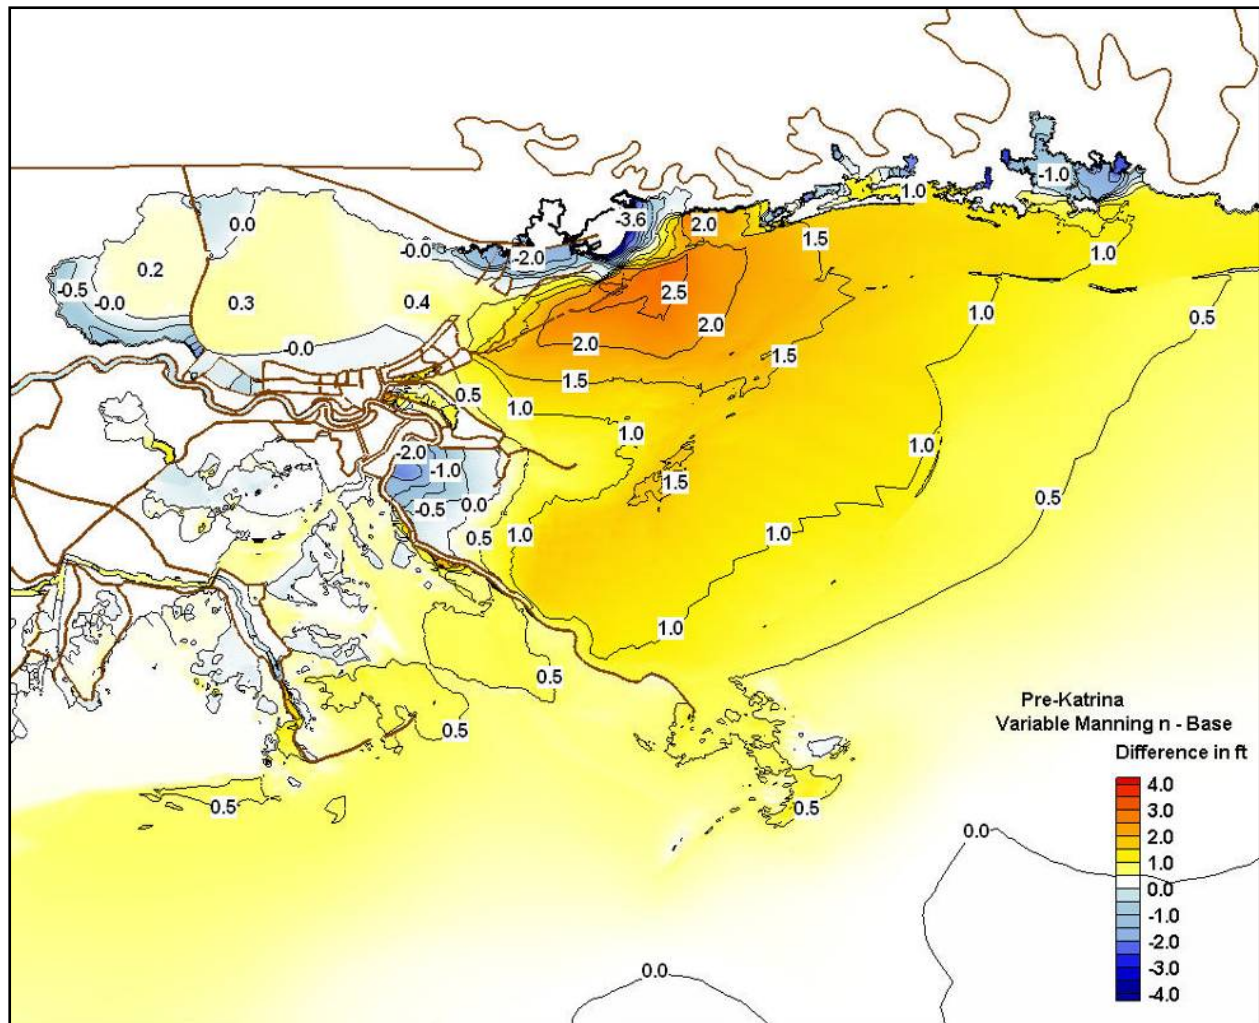
Figure 5-22. Difference in peak surge between sensitivity simulation with Pre-Katrina variable friction and the base simulation

Changing the Pre-Katrina friction formulation from a single value to a spatially-varying friction field to represent Pre-Katrina vegetation, results in an increase in peak water level in deeper water and a decrease in water level in the overland areas (Figure 5-22). This is related to the decrease in bottom friction in open waters with the Manning  $n$  specified equal to 0.020 there and the increase in frictional resistance in due to high Manning  $n$  values inland. Note that the extensive network of connecting channels that occur throughout the marshes, cyprus forests and other regions in Southern Louisiana were not considered in these simulations.

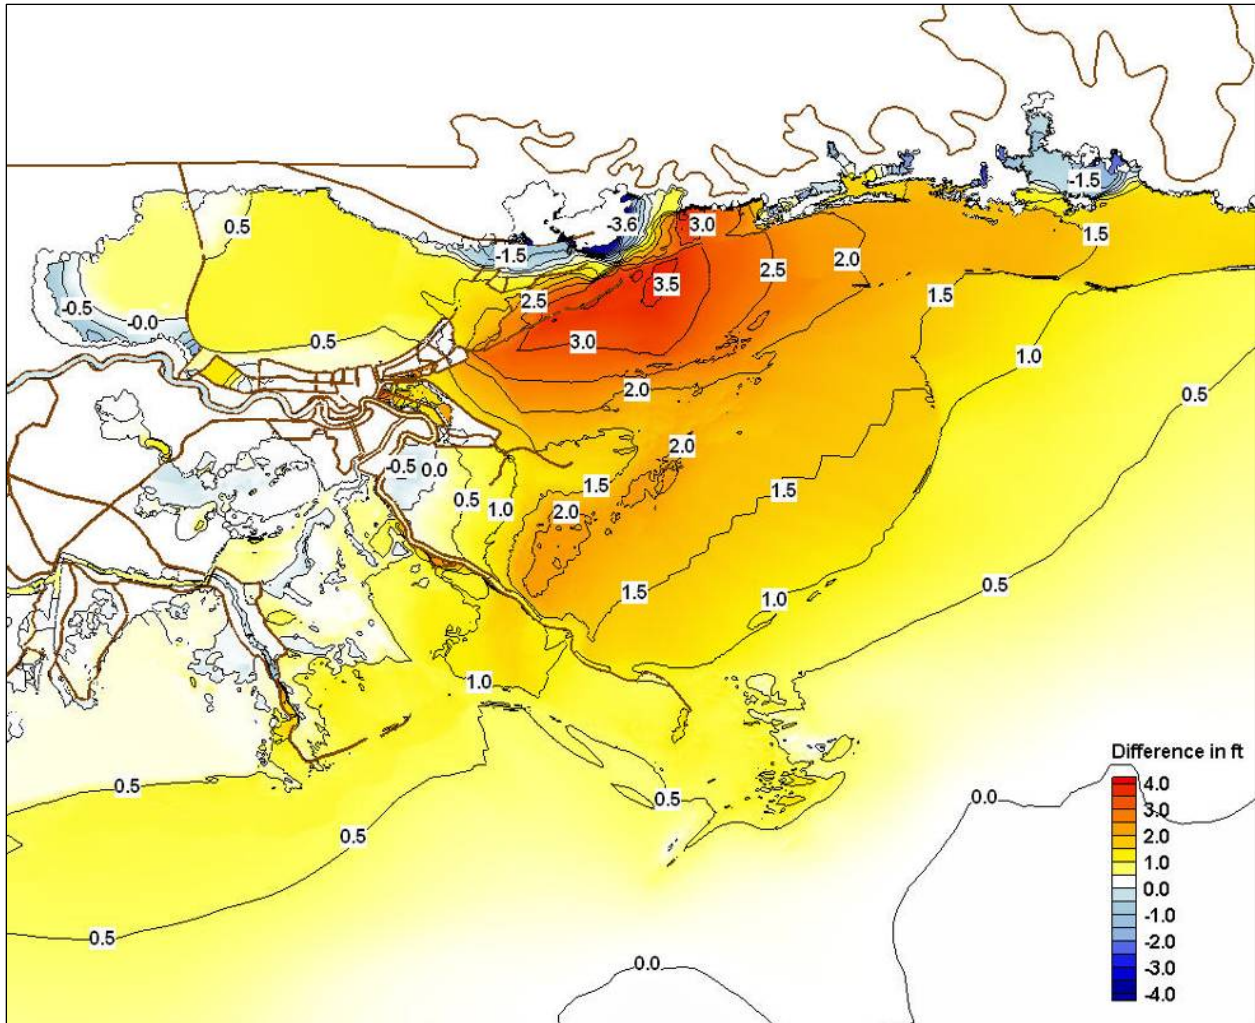
Figure 5-23. Difference in peak surge between sensitivity simulation with Post-Katrina variable friction and the base simulation

(Figures 5-22 and 5-23). Changing the friction formulation from a single value to a spatially-varying friction field to represent Post-Katrina vegetation, results in an increase in peak water level in deeper water and a decrease in water level in the overland areas. The increase in peak surge for Post-Katrina variable friction compared to the Base simulation (Figure 5-23) is greater than the increase in surge for the Pre-Katrina variable friction compared to the Base simulation (Figure 5-22). The comparison of Pre-Katrina and Post-Katrina peak surge (Figure 5-24) shows the reduction in vegetation (increase in open water) results in an increased peak surge of 0.5-1.5 ft.
