# Appendix 1

## Hydrograph and High Water Mark Analysis

### Introduction

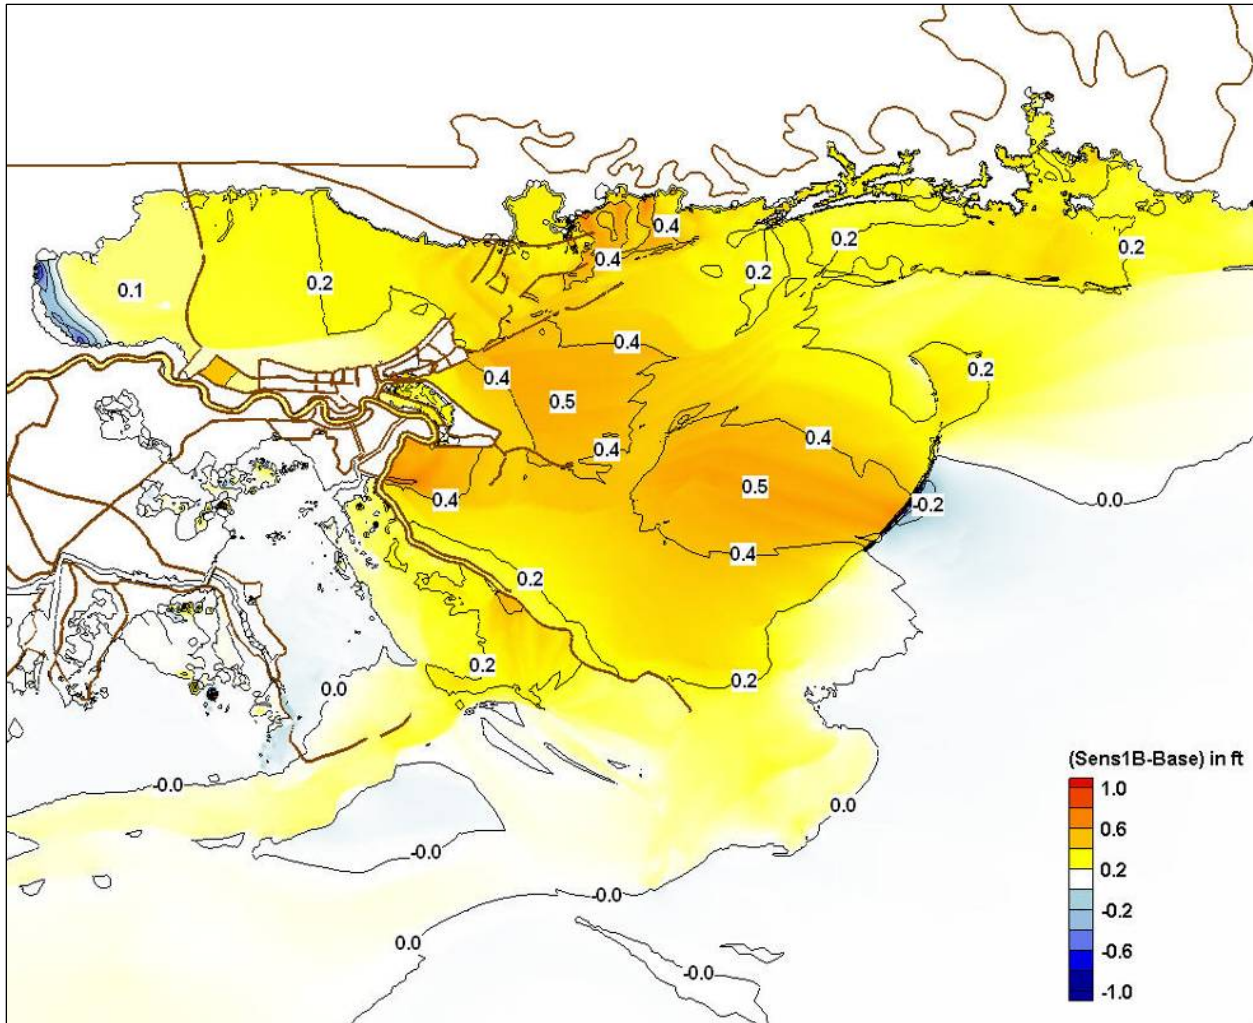
Figure 5-26. Difference in peak surge between sensitivity simulation with Post-Katrina configuration of Chandeleur Island and the base simulation

Deflation of the protective barrier islands along the Mississippi and Louisiana coast may leave these coastal regions more vulnerable to inundation from future storms. This supposition was examined by changing the bathymetric configuration of Chandeleur Island to the post-Katrina condition and repeating the ADCIRC simulation of Hurricane Katrina. A SHOALS survey of the barrier island was collected after Hurricane Katrina (Fall 2005) and shows that approximately half of the barrier island that was previously emergent had submerged after Hurricane Katrina (Figure 5-25). The majority of the loss of emergent area was from the southern end of the island. The post-Katrina configuration of Chandeleur Island was incorporated into the ADCIRC mesh for the sensitivity simulation. The results shown in Figure 5-26 indicate that deflation of Chandeleur Island provided a means for a greater volume of water to pass over the deflated island and increase water levels landward of the island. In general, peak water levels for the Chandeleur Island sensitivity simulation are 0.5 ft greater than the base conditions simulation.

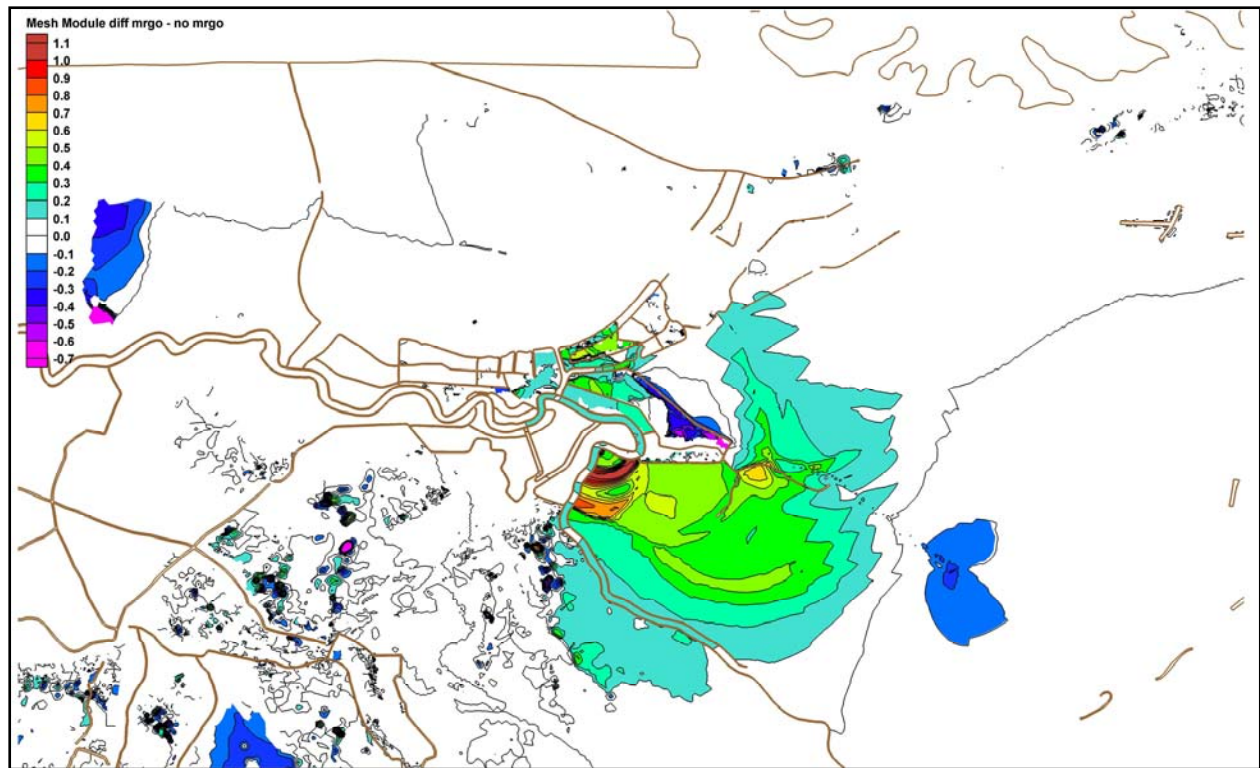
Figure 4a. Maximum Hurricane Katrina event differences in ft, for simulations with and without the MRGO in place. Positive differences indicate increased elevations with the MRGO in place while negative differences indicate decreased water levels with the MRGO in place

The simulation without the MRGO/Reach 2 results in very similar water levels in most of the domain for the Katrina event. Differences in the maximum Katrina event water levels with and without the MRGO in place are shown in Figures 4a and 4b. Notable differences with the MRGO Reach 2 channel in place are as follows: there is a reduction of water level of up to 0.2 ft at the entrance to the MRGO's inland cut; there is an increase of 0.3 to 0.4 ft in the marshes west of the MRGO in the region delineated by Pointe a la Hache, Carlisle, Stella, Caernarvon and Verret; a maximum increase of approximately 1.1 ft locally east of English Turn; in Lake Borgne along the MRGO there is a 0.1 to 0.2 ft increase; there is a 0.1 to 0.2 ft decrease along the St. Bernard Parish/Chalmette protection levee; and finally there is a 0.1 to 0.2 ft increase in a portion of the GIWW/MRGO/Reach 1. In all other regions, including in the IHNC, differences are less than 0.1 ft. In addition, the New Orleans and vicinity protection system is not impacted

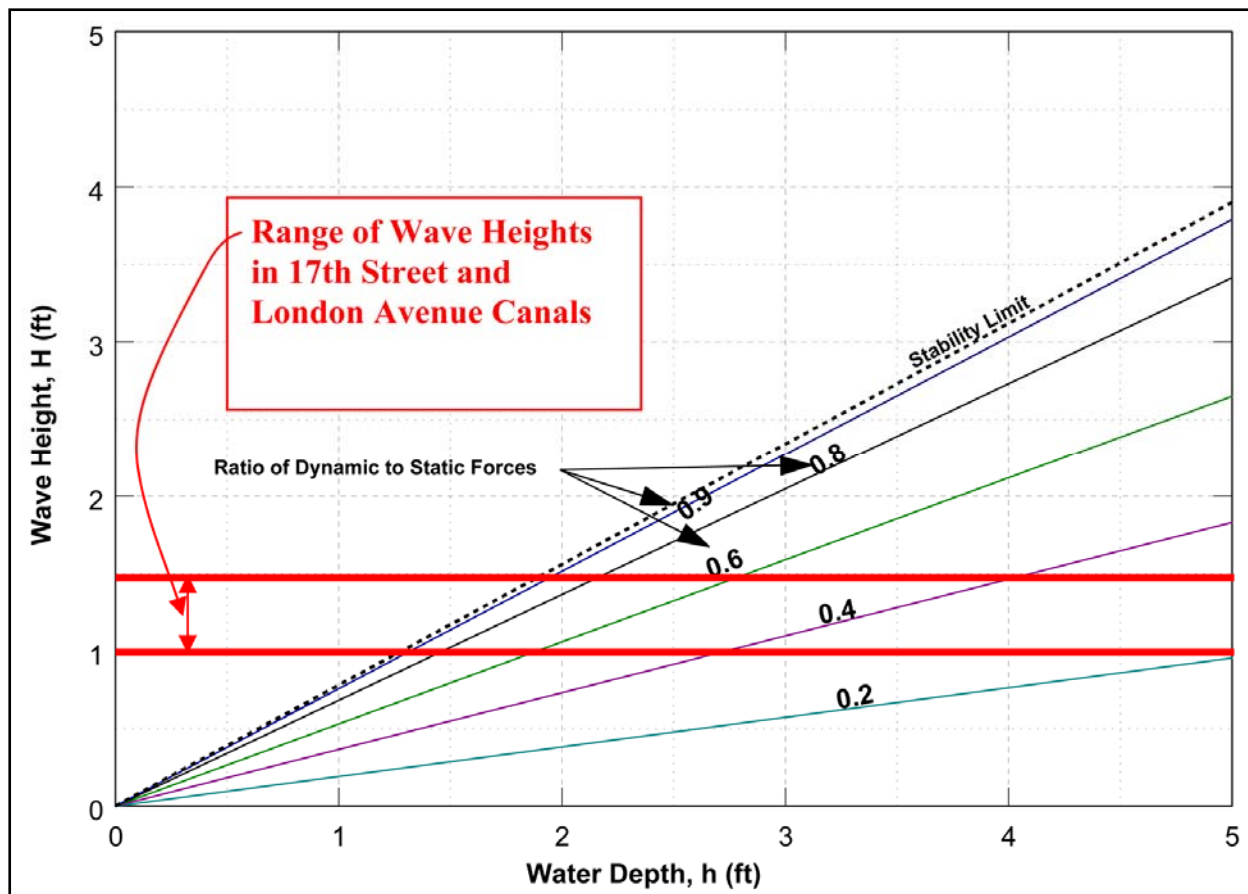
Figure 8-2. Isolines of Constant Values of the Ratio of Dynamic to Static Force Components,  $R_F$  versus water depth,  $h$ , and wave height,  $H$

Figure 8-2 presents the ratio of dynamic to static forces versus water depth and wave height. The stable shallow water wave height limit of  $H/h = 0.78$  is also shown. The range of wave heights from 1 ft to 1.5 ft is highlighted as the approximate wave height range determined to occur at the 17th Street and London Avenue floodwalls during Katrina. It is seen that for a water depth against the floodwall of, say, 4 ft, and a wave height of 1 ft to 1.5 ft, the *total force* ranges between approximately 128% and 140 % of the static force component.

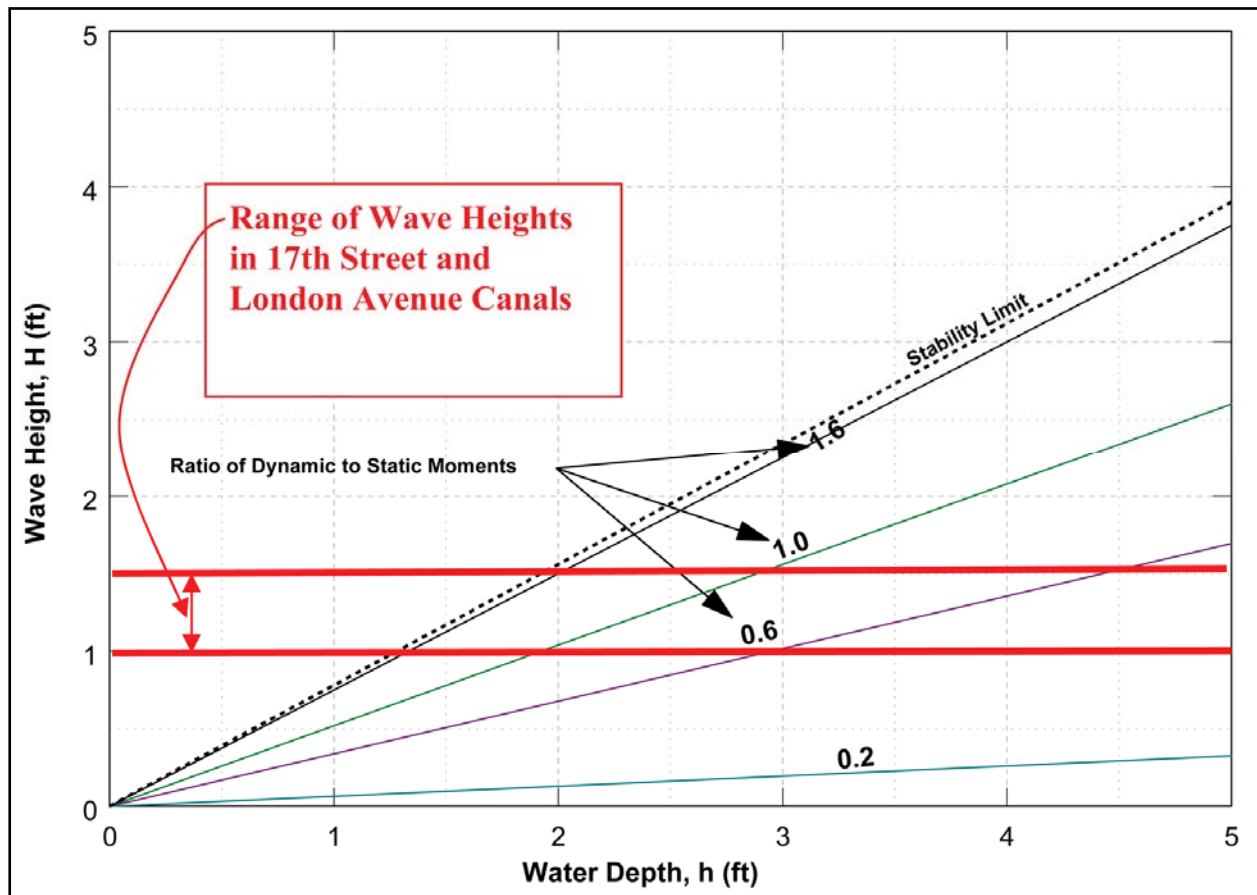
Figure 8-3. Isolines of the ratio of dynamic to static moment components,  $R_M$  versus water depth,  $h$  and wave height,  $H$

Figure 8-3 presents the ratio of dynamic to static moments versus water depth and wave height. The stability limit of  $H/h = 0.78$  is also shown. It is seen that the ratios of dynamic to static moment components are larger than their force counterparts (Figure 8-2). Again for a water depth against the floodwall of 4 ft, and a wave height range of 1 ft to 1.5 ft, the corresponding range of *total moments* would be approximately 145% to 165% of the static moment component.

The magnitudes of these ratios are such that the dynamic forces and moments associated with the presence of waves should be taken into account in floodwall design and analysis.

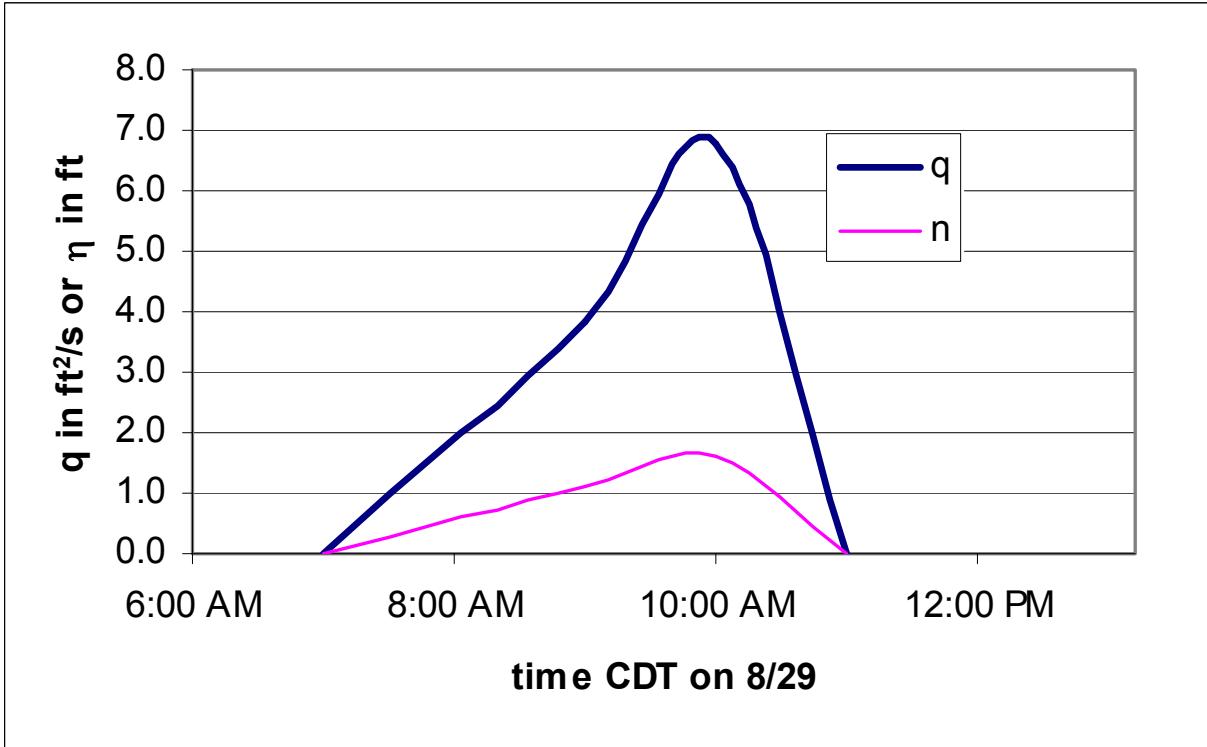
Figure 9-6. Overtopping flowrate at floodwall along IHNC at Lower Ninth Ward during Hurricane Katrina using Equations 4 and 5. Floodwall height used was 12.6 ft.

For overtopping of the Lower Ninth Ward floodwall, this velocity ranges from  $0$  to  $22$  ft/s. This indicates that the jet impacts over a relatively small footprint with a high velocity. Seiffert and Philipse (1990) showed experimentally that water velocities of  $13$  ft/s, running essentially parallel to the grass mats on the Dutch dikes, would cause erosion. Also, as the total head increases, the obliquity of the impacting jet to the ground increases. This results in a wider area of damage. Finally, as the jet impacts the ground it spreads and creates a wide area of damage on the lee side of the floodwall.

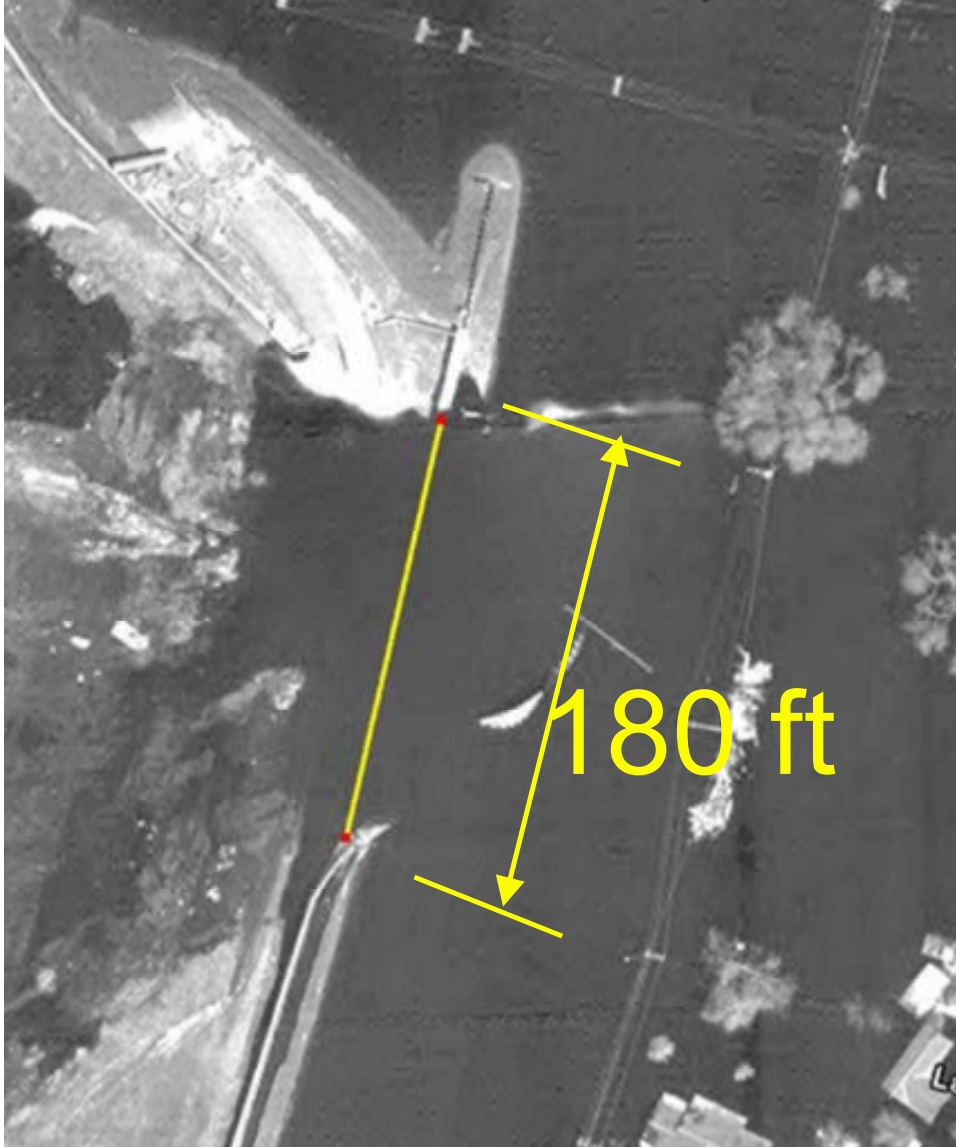
Once the IHNC floodwalls along the Lower Ninth Ward were breached, the flow into the area increased significantly. The breach sill heights appeared to be at elevation of roughly  $+1$  ft. The flow through the breaches at the IHNC can be approximated.

Figure 9-7. North breach on IHNC at Lower Ninth Ward

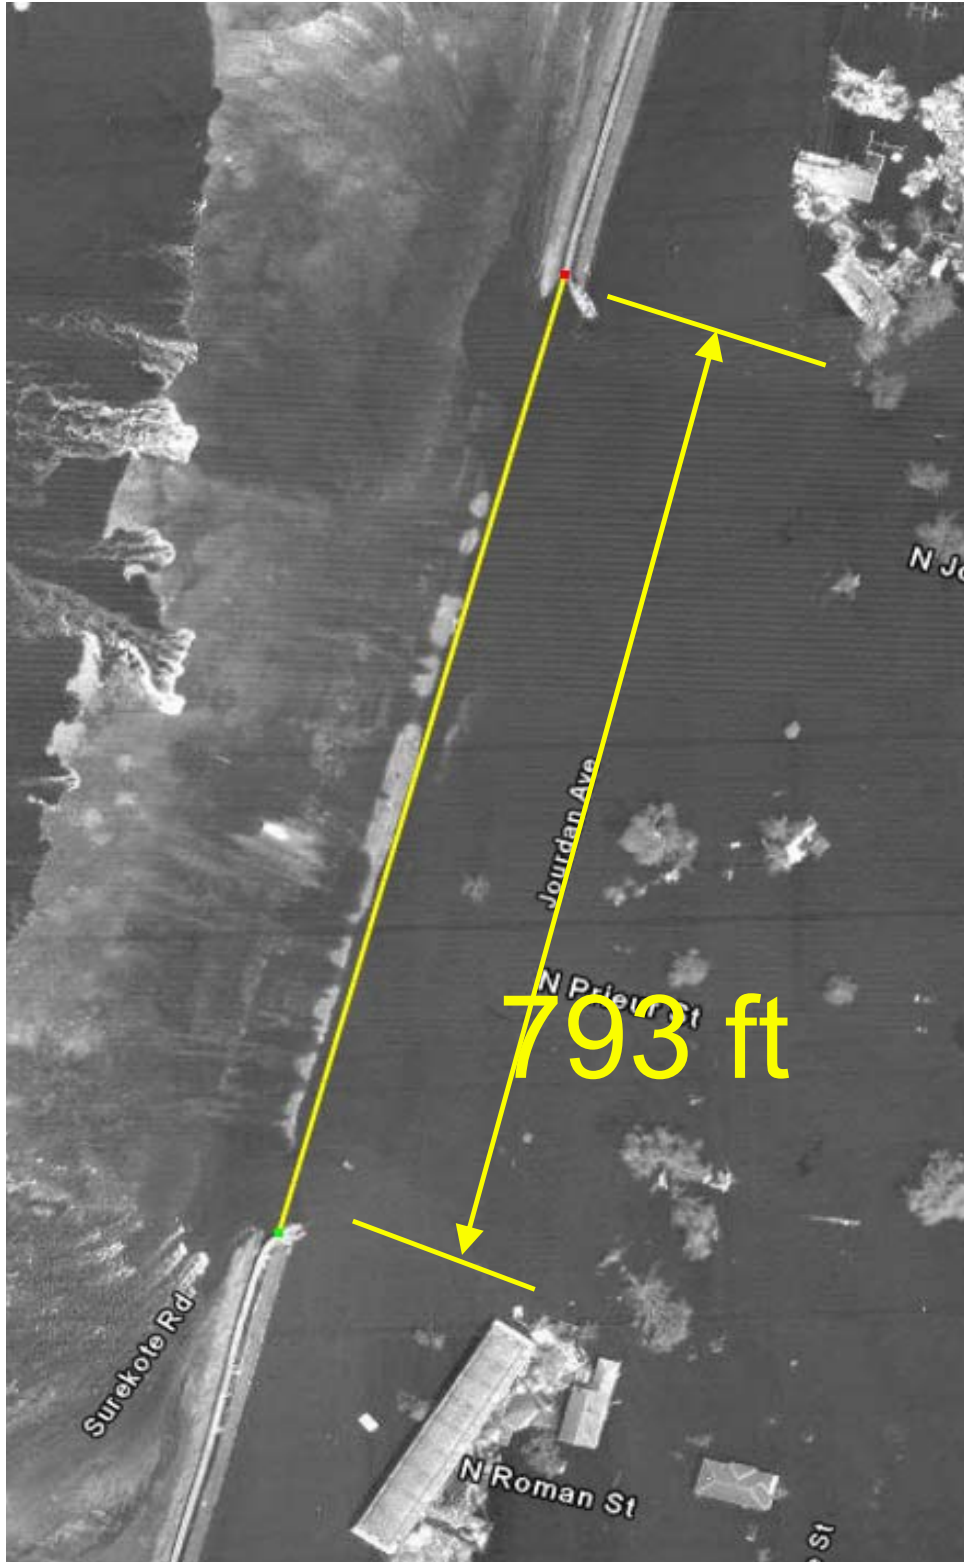
Figure 9-8. South breach on IHNC at Lower Ninth Ward

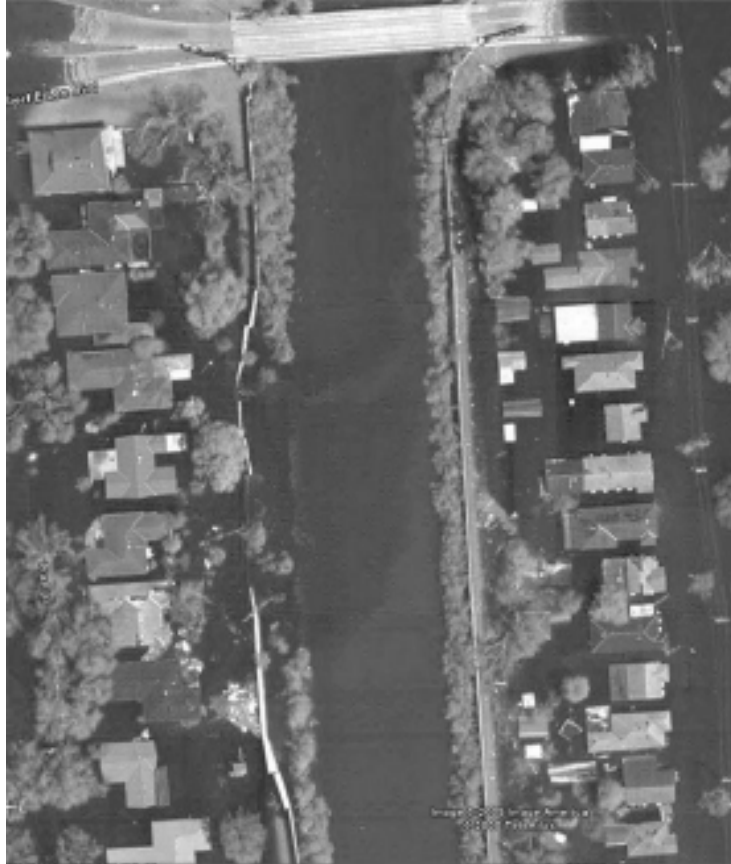
(a) North breach near Robert E. Lee Bridge  
Figure 11-1. London Avenue Canal breaches

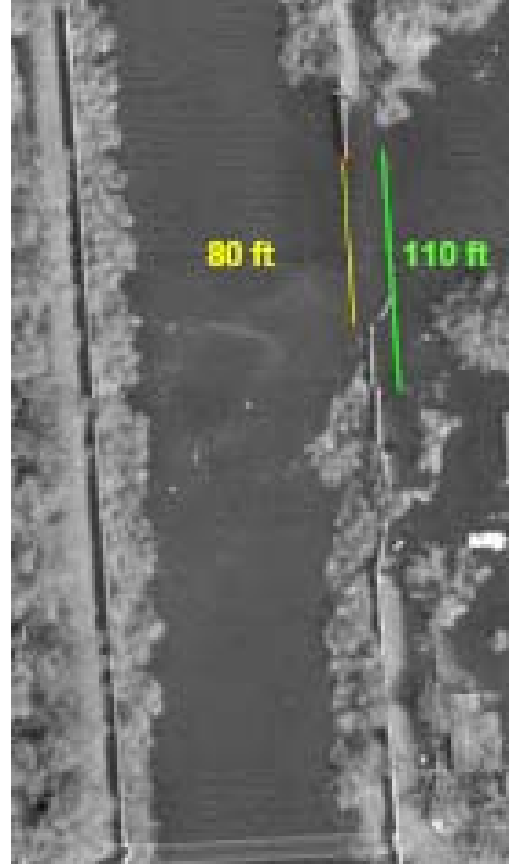
(b) South breach at Mirabeau Avenue

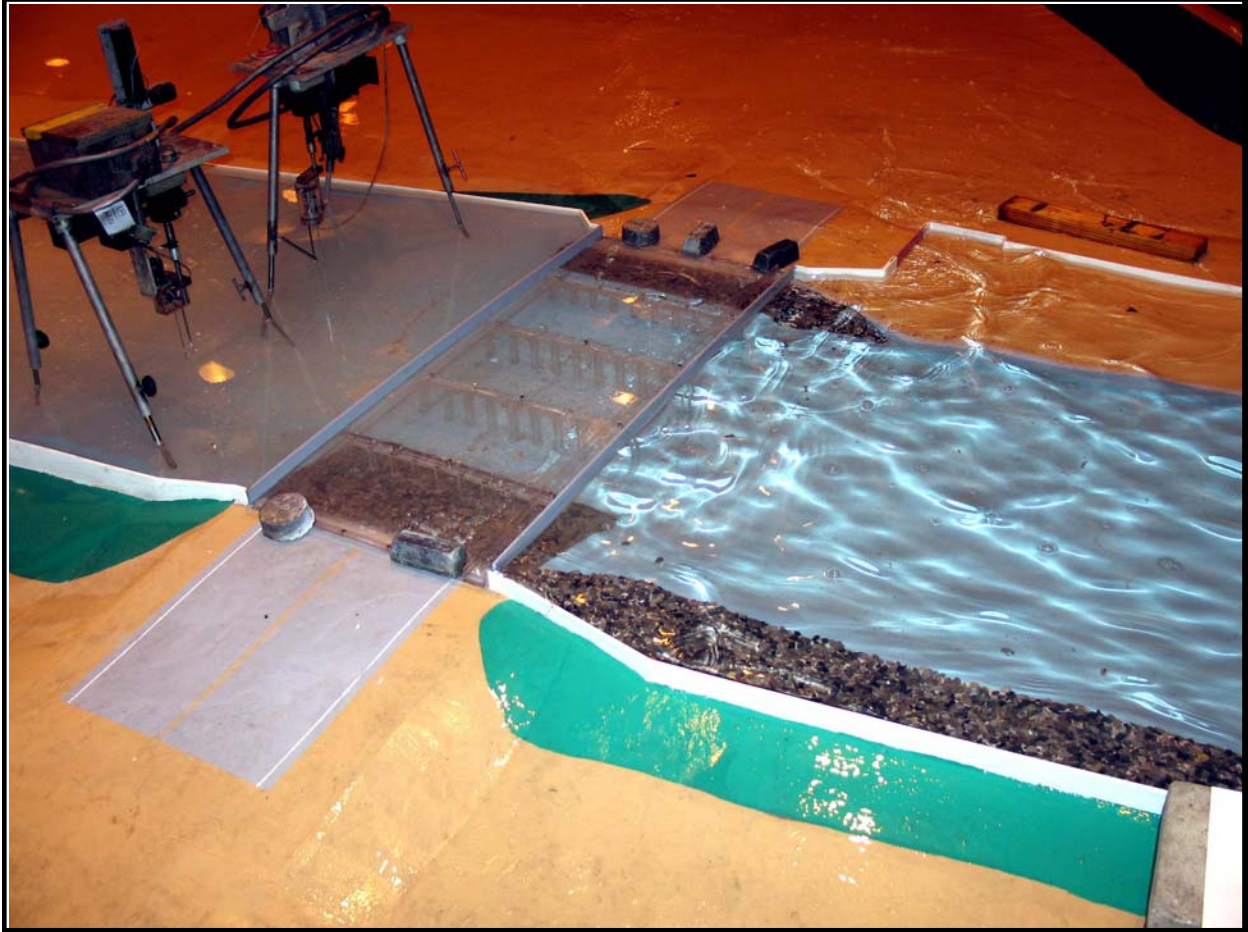
Figure 12-12 presents a photograph of the model in the region straddling the bridge. The rough water surface on the right-hand (north) side is indicative of reflected wave energy, whereas the left side is relatively quiescent. The results of reflection analyses, shown in Figure 12-13, indicate that as the hurricane surge rises, the reflection coefficient jumps from about 10 percent to nearly 35 percent. Figure 12-14 shows the change in wave behavior across the bridge as a function of time during the Katrina simulation.

Figure 12-12. Wave reflection at the Hammond Highway Bridge. Region to right of bridge is lake-side (north side)

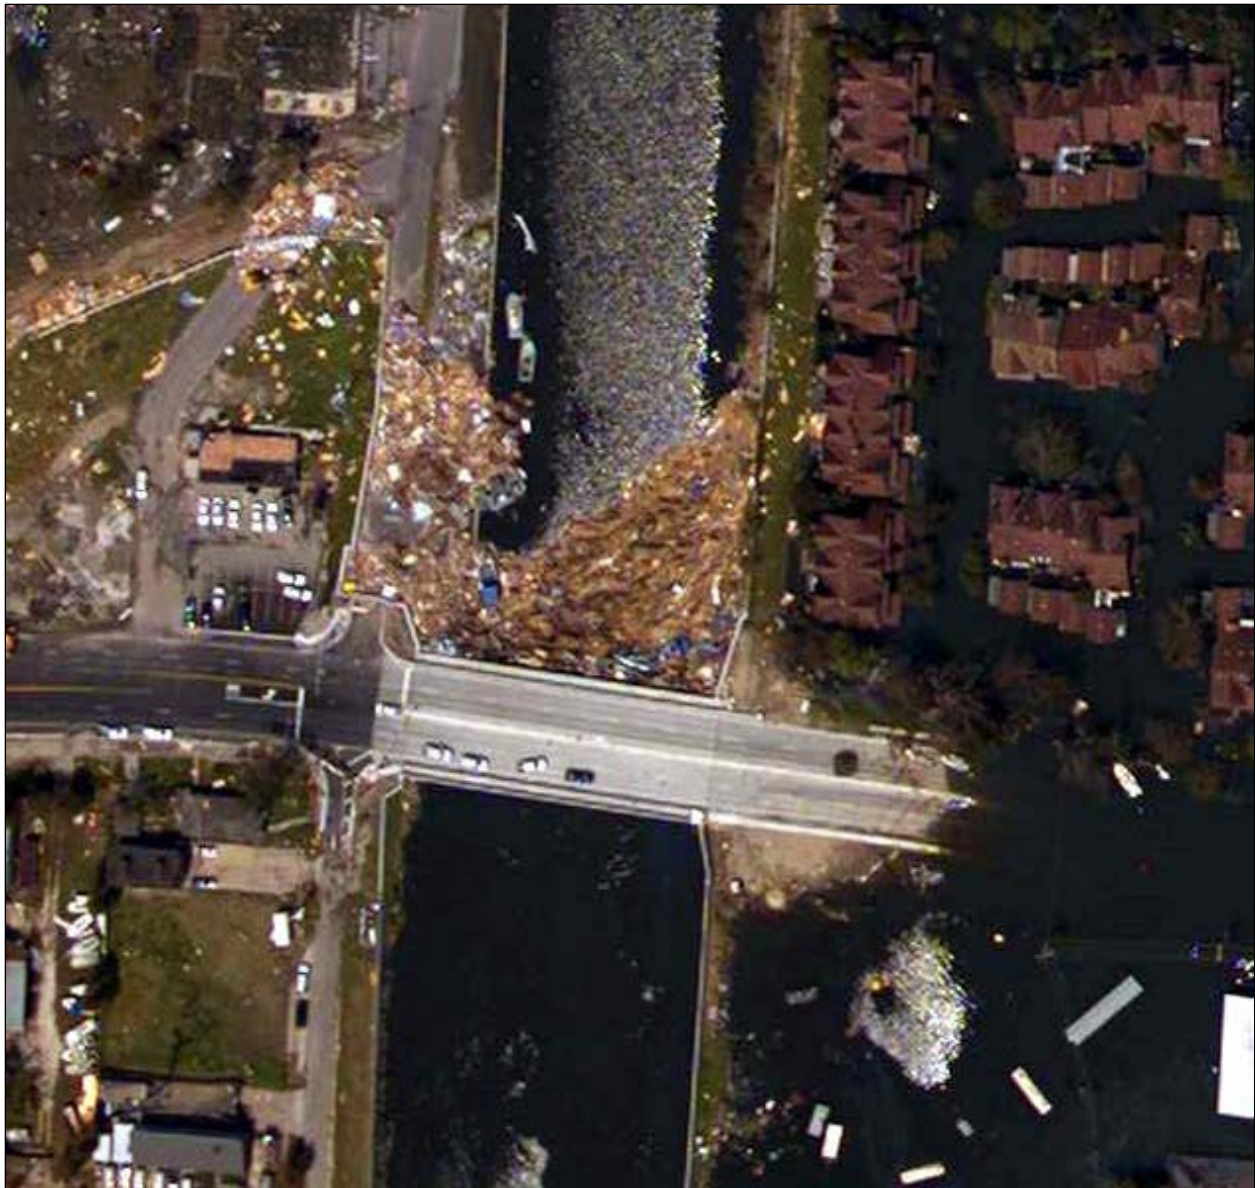
Post-storm aerial photos showed a large debris field jammed against the lake side of the Hammond Highway Bridge (see Figure 12-19). It reasonable to conclude that a major portion of the debris material was derived from structures that were on piles just north of the canal entrance, and that most likely debris started gathering at the bridge when flow through the breach was strong enough to draw water from Lake Pontchartrain. Initial tests of the physical model were conducted to determine the effect of the debris plug on wave transmission. Because it was unknown exactly when the material was deposited at the bridge, model data were collected from 0500 to 1100 hrs for two idealized debris conditions.

Figure 12-19. Post-storm debris at Hammond Highway Bridge. The triangular wedge is about 200 ft across at bridge

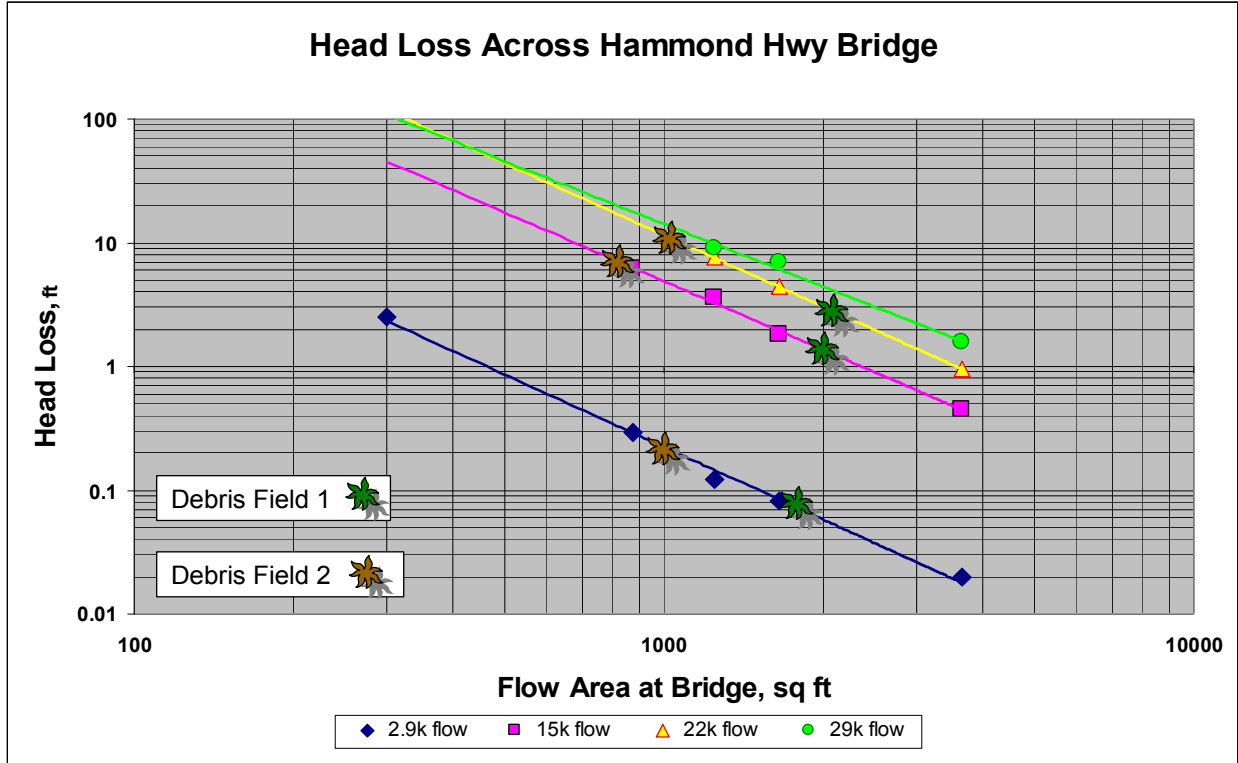
Figure 12-26. Head loss measured between north side and south side of Hammond Hwy Bridge for various canal discharges (lake level at +9.3 ft)

From Figure 12-26, the equivalent flow area of Debris Configuration 1 and 2 were found by finding the flow area on the chart for the measured head loss for the debris fields. Debris Configuration 1 had a flow cross-sectional area in the canal in the range of 1800 to 2000 sq ft. Debris Configuration 2 represented reduced cross-sectional flow area in the range of 850 to 1000 sq ft. Considering the total cross-sectional area under the bridge of 3651 sq ft at the surge level of 9.3 ft, Debris Configuration 1 represented a blockage of about 48 percent of the canal cross-section. Debris Configuration 2 represented about 75 percent blockage.

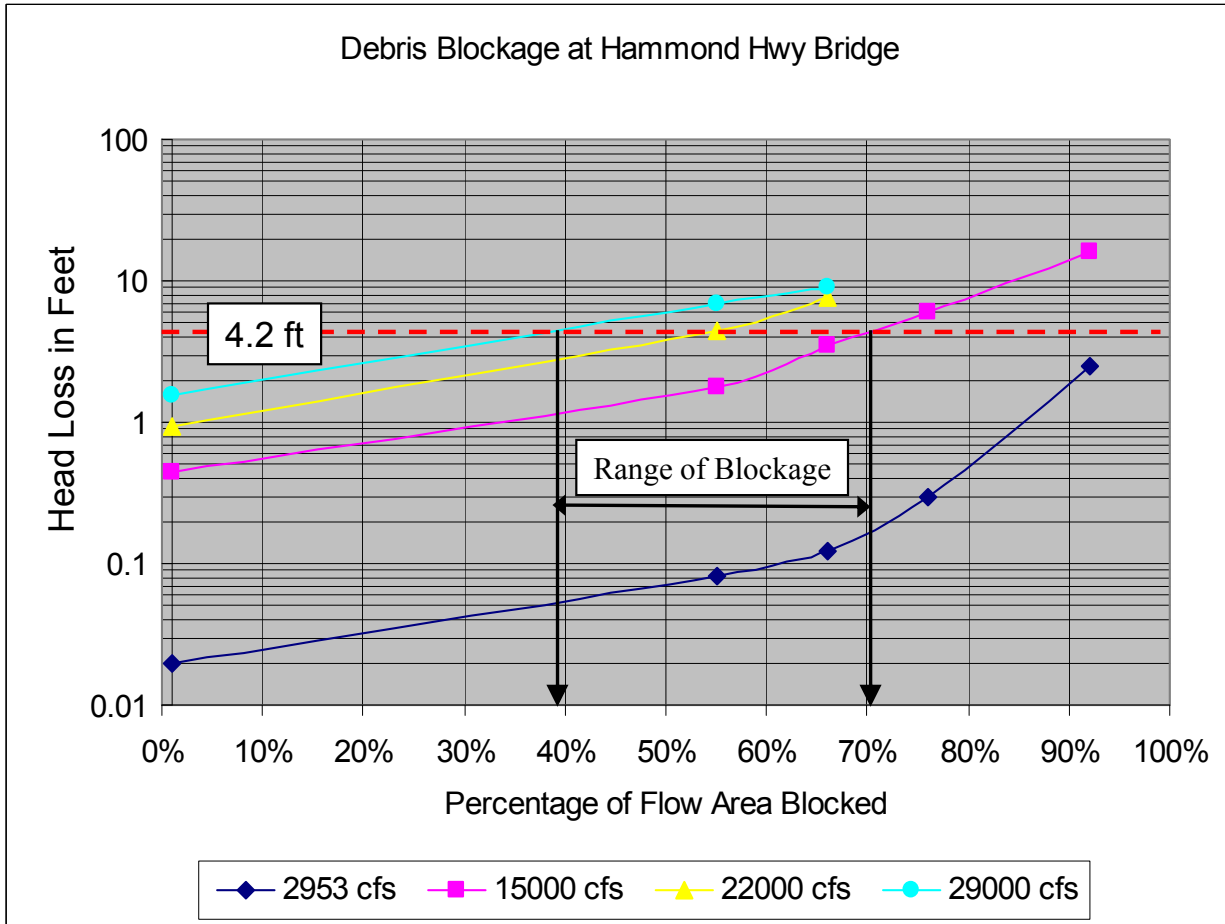
Based on a photograph taken at 1100 CDT looking through the actual breach into the canal, a graph may be created to estimate the blockage that occurred during the storm. From the photograph, the water elevation in the canal is estimated to be at approximately +3.0 ft. At 1100, Lake Pontchartrain was at elevation +7.2 ft, indicating a head difference of 4.2 ft. Re-plotting the data from Figure 12-26 in the manner shown in Figure 12-27, and assuming a flow range of 15,000 to 29,000 cfs through the breach (this range is representative of breach flow conditions based on analytical work performed in this task area and discussed in Appendix 10. Figure 12-27 shows the flow area blockage by the debris would be in the range of 40 to 70 percent.

Figure 12-27. Estimated blockage of 17th St Canal by debris at the Hammond Highway Bridge

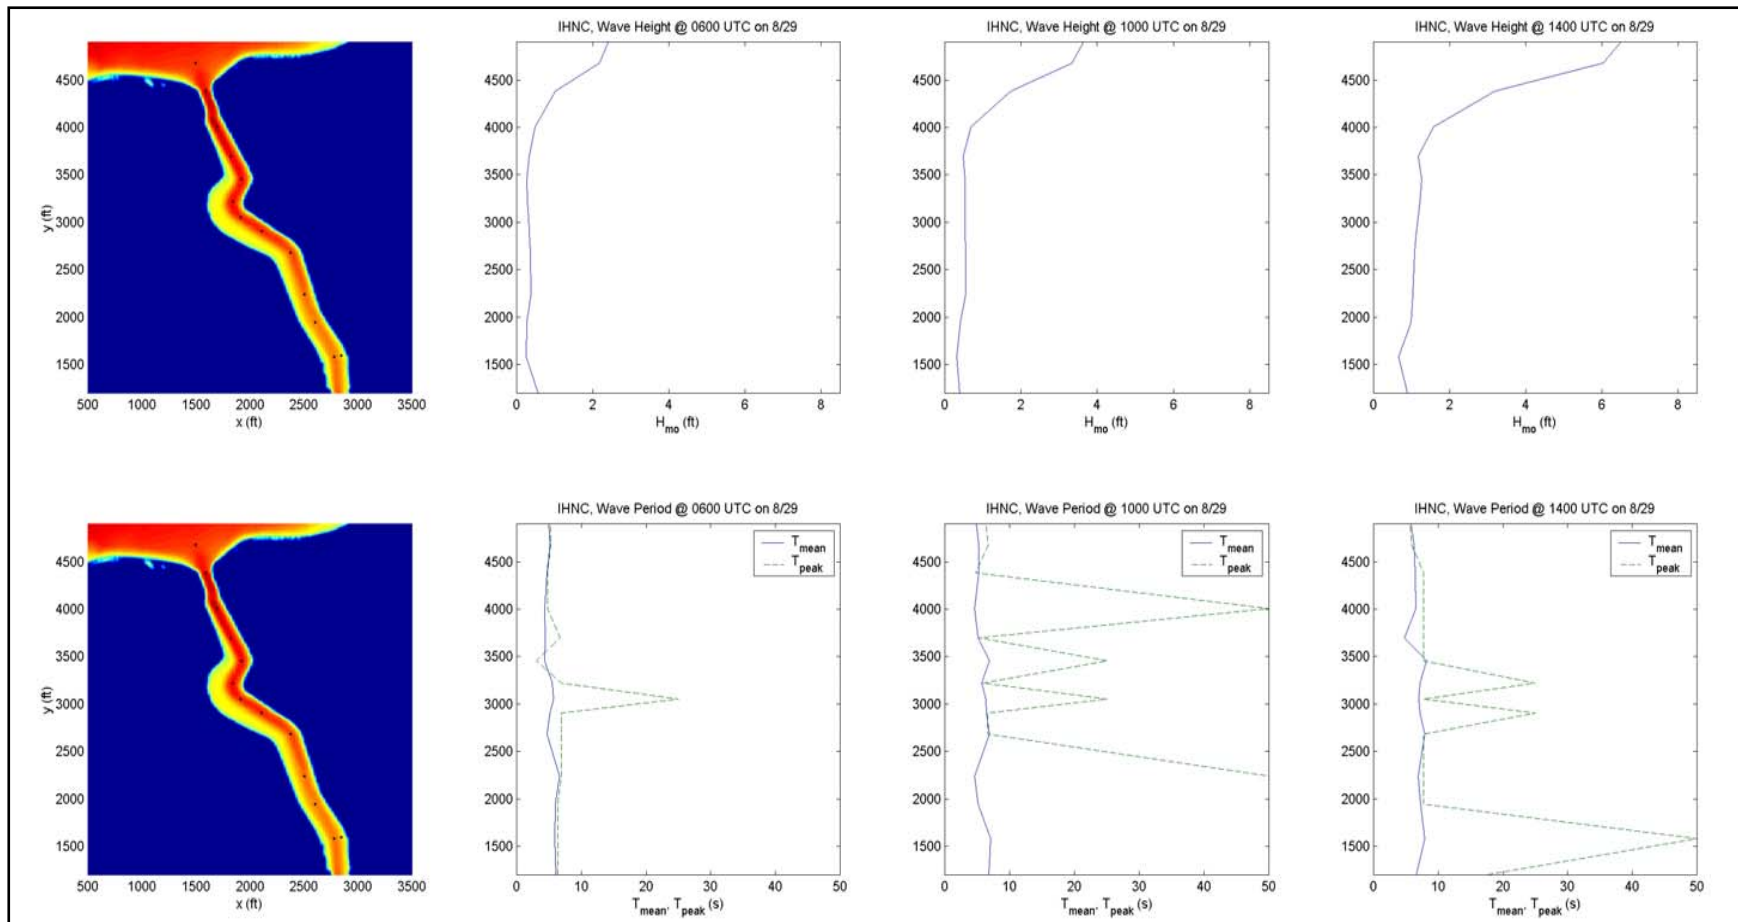
Figure 15-19. Transects of significant wave height and period along the London Avenue Canal at three times. Wave heights are given in the top row and periods in the bottom. Both peak (from spectral analysis) and mean (from zero-crossing) periods are shown, to provide a measure of the periods of dominant wave energy. The first plot on the left shows the domain and the recording points, given by the black dots

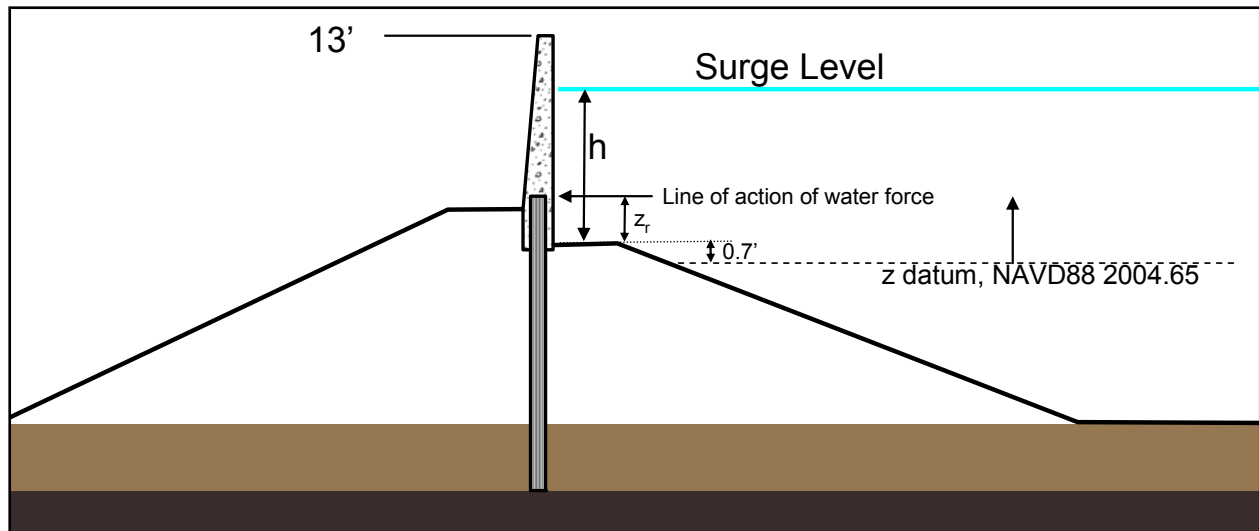
Figure 15-21. Cross-sectional schematic for London Avenue Canal walls near failure location just south of Robert E. Lee Bridge

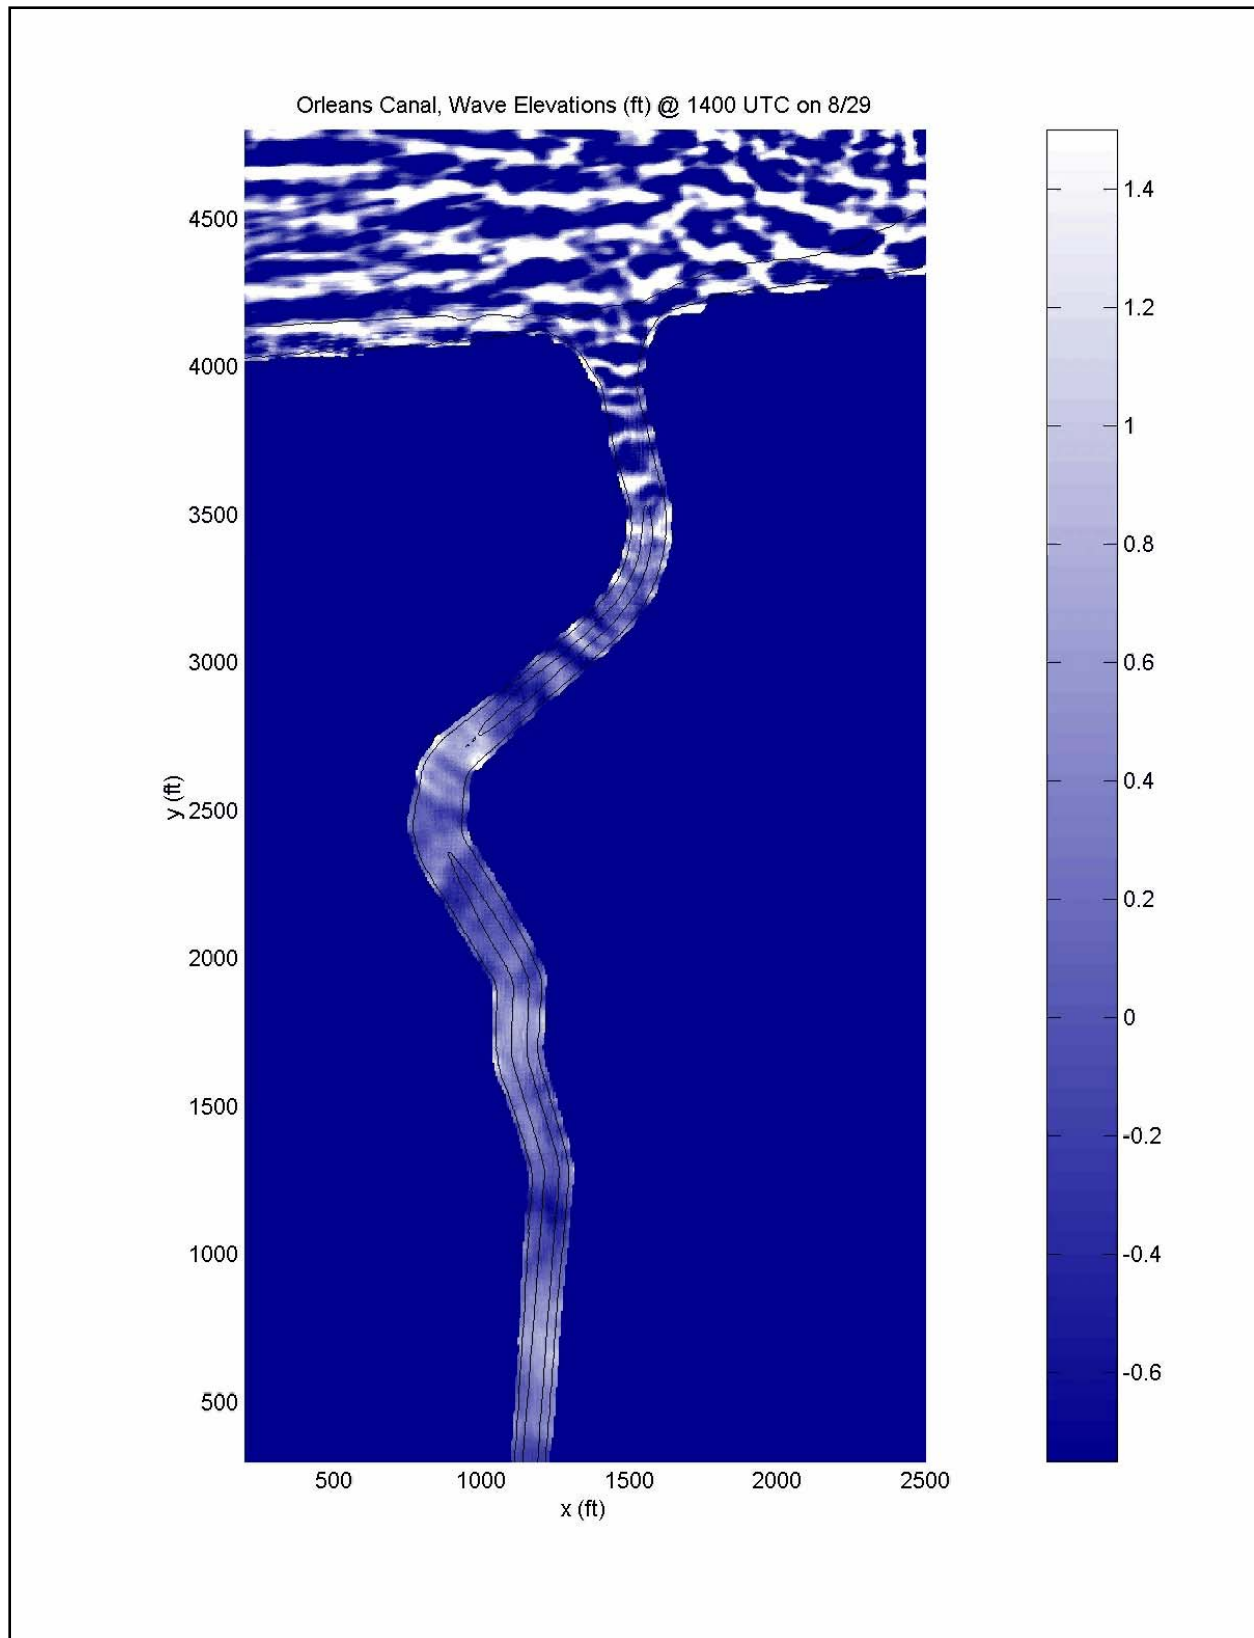
A plan view snapshot of the wave field at 1400 UTC is given in Figure 15-23. Waves approach the canal from the north, and waves are large for the first few hundred feet into the canal. The first major bend in the canal appears to restrict the wave energy entering the remainder of the canal, as can be seen in the wave height profile in Figure 15-24. This bend has the effect of reducing the high frequency energy, evident from the jump in peak wave period. In addition, bottom friction, driven by the relatively shallow banks of the canal in the northern section, damp out much of the high frequency energy. Peak wave periods through the majority of the canal are near 50 s. At the Robert E Lee Bridge, the wave height has been reduced to 1.3ft. As with the 17th Street Canal, wave-induced water level changes throughout the canal are minimal - on the order of a couple of inches.

Figure 15-23. Simulated wave field for Orleans Avenue Canal at 1400 UTC

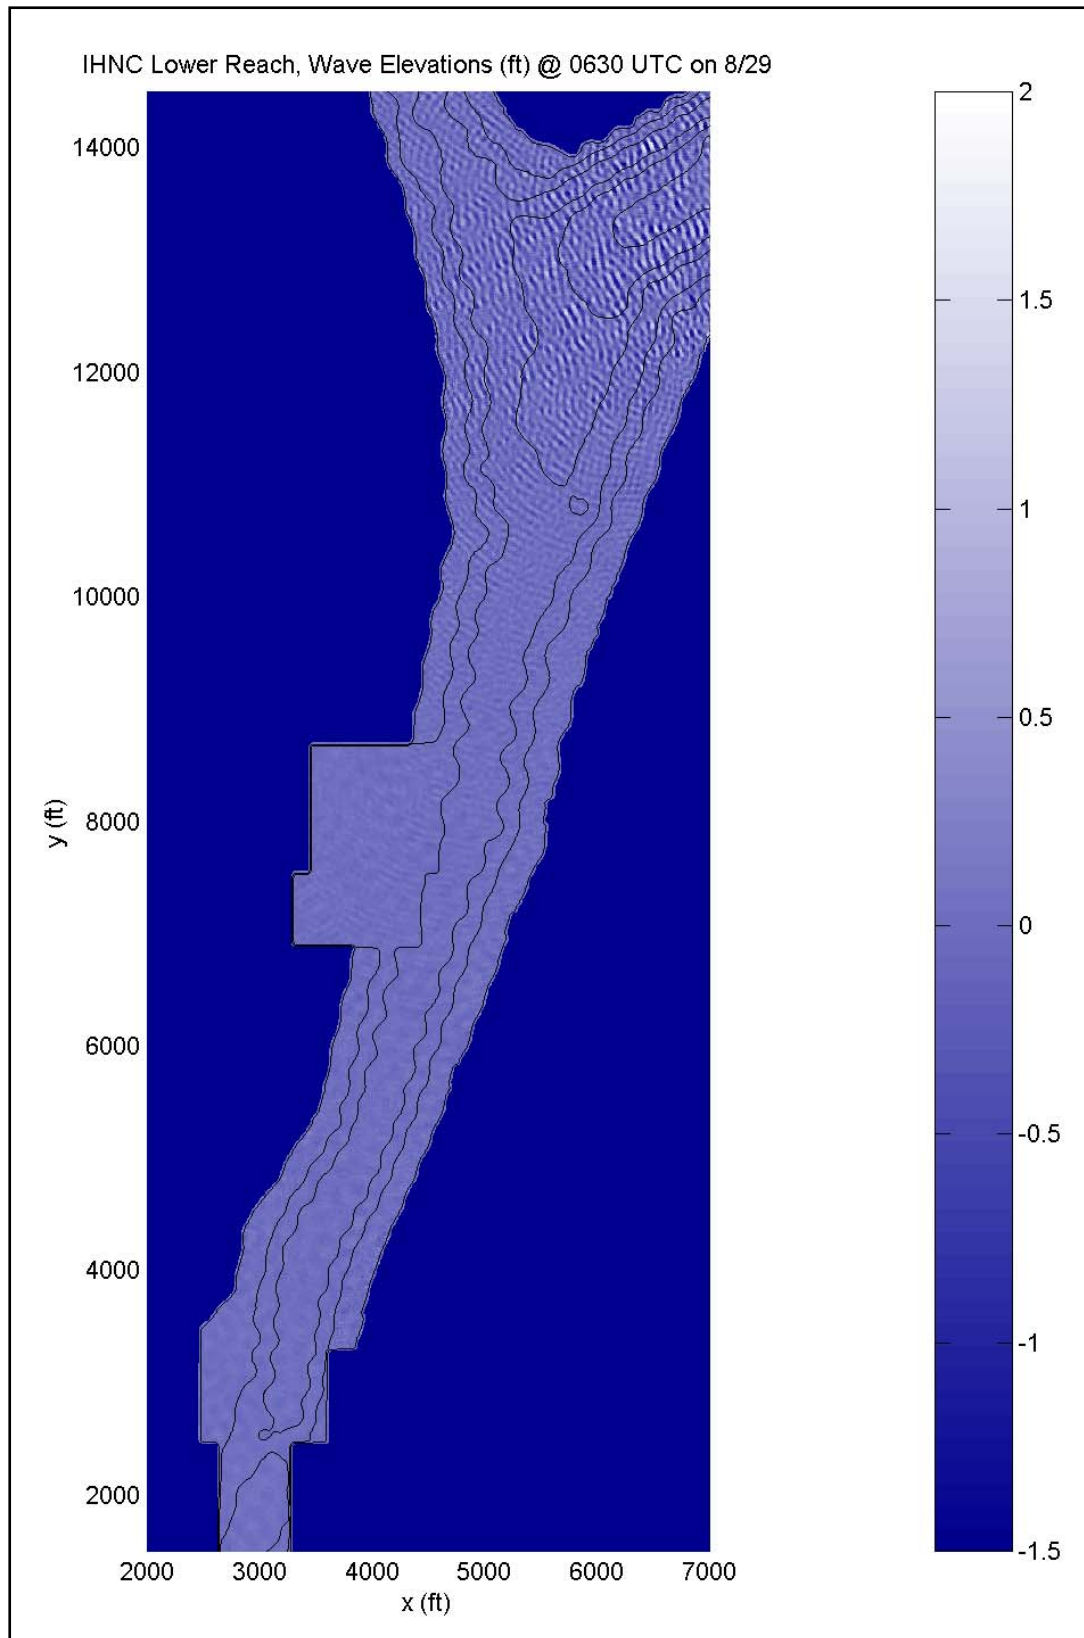
A plan view snapshot of the wave field at 0630 UTC is given in Figure 15-26. At this time, the significant wave height at the end of the GIWW is 2.4ft. Due to the nearly perpendicular angle of entry into the IHNC, little wave energy makes it south to near the Lock. The wave height transect along the IHNC is shown in Figure 15-27. Wave heights at the Florida Avenue Bridge are about a quarter of a foot. At 0930 UTC, the wave height in the GIWW is near 3.4ft, and wave heights near the Florida Avenue Bridge are close to 0.6ft. By 1030 UTC, the significant wave height at the end of the GIWW has grown to 4.1ft. A snapshot of the waves at this time is shown in Figure 15-28. Here, more wave energy is able to turn into the southern reach of the IHNC, such that the significant wave height near the Florida Avenue Bridge is 1ft. Wave properties through the IHNC at 1030 are also shown in Figure 15-27.

Figure 15-26. Simulated wave field for the lower IHNC at 0630 UTC
